Project Number 3113

Management Asbestos Survey Report

Kennet Centre, Market Street, Newbury,
Berkshire, RG14 5EN

3 Market Place and Associated Store

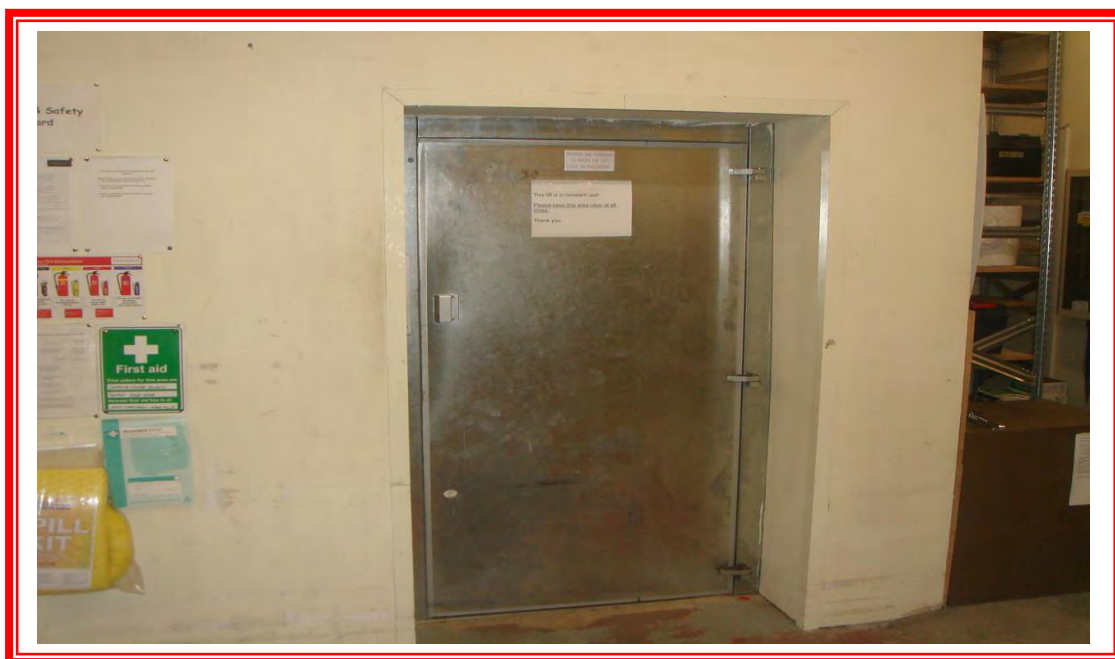
Location: 1/005 Lift and Shaft

Material Description:	No Access	
Identification:	Presumed to Contain Asbestos	
Approx. quantity:	Lift and Lift Shaft	
Accessibility	Low	Assessment Score
Product type:	No Access	3
Extent of Damage:	No Access	3
Surface Treatment:	No Access	3
Asbestos type:	No Access	3
Material Assessment Score:		12
Priority Assessment Score:		High
Action:	Further Inspection Required	
Comments:	No access as no lift engineer onsite

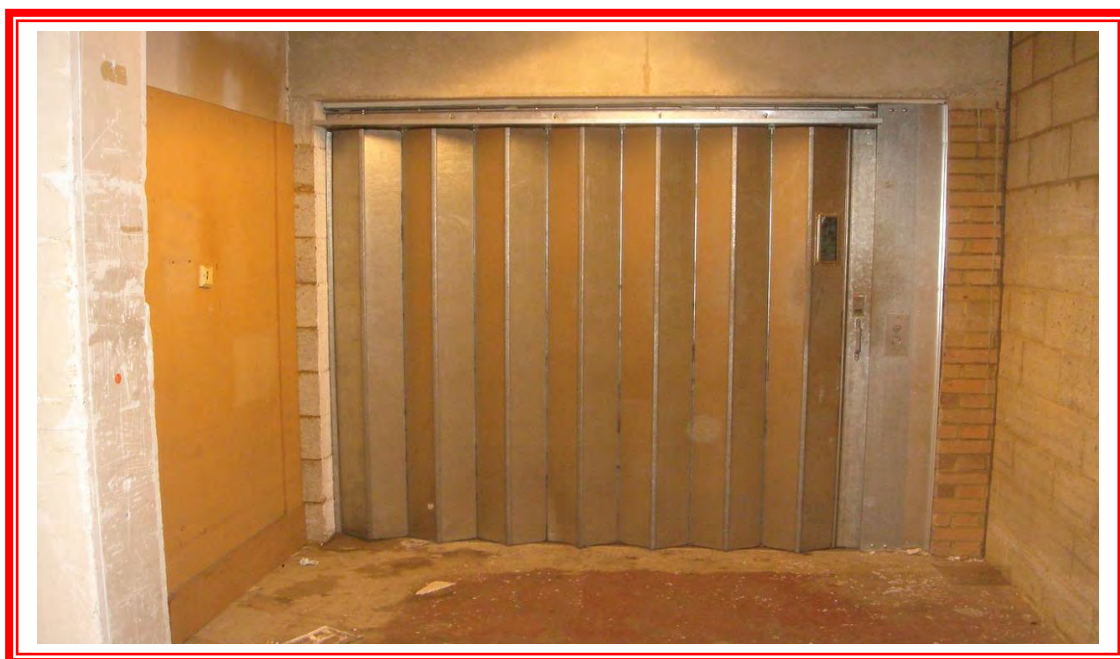
Material Description:	No Access to Lift and Shaft	
Identification:	Presumed to Contain Asbestos	
Approx. quantity:	Unknown	
Accessibility	Low	Assessment Score
Product type:	No Access	3
Extent of Damage:	No Access	3
Surface Treatment:	No Access	3
Asbestos type:	No Access	3
Material Assessment Score:		12
Priority Assessment Score:		High
Action:	Further Inspection Required	
Comments:	No Lift Engineer

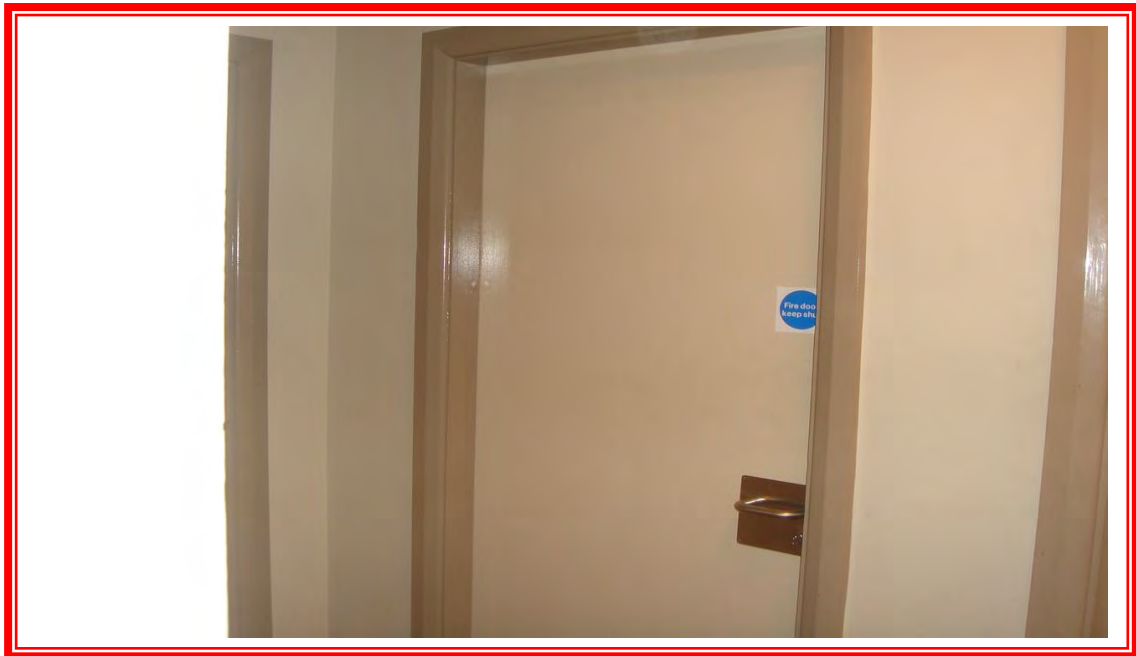
Material Description:	No Access as no Key Was Available	
Identification:	Presumed to Contain Asbestos	
Approx. quantity:	Unknown	
Accessibility	Low	Assessment Score
Product type:	No Access	3
Extent of Damage:	No Access	3
Surface Treatment:	No Access	3
Asbestos type:	No Access	3
Material Assessment Score:		12
Priority Assessment Score:		High
Action:	Further Inspection Required	
Comments:	No Key

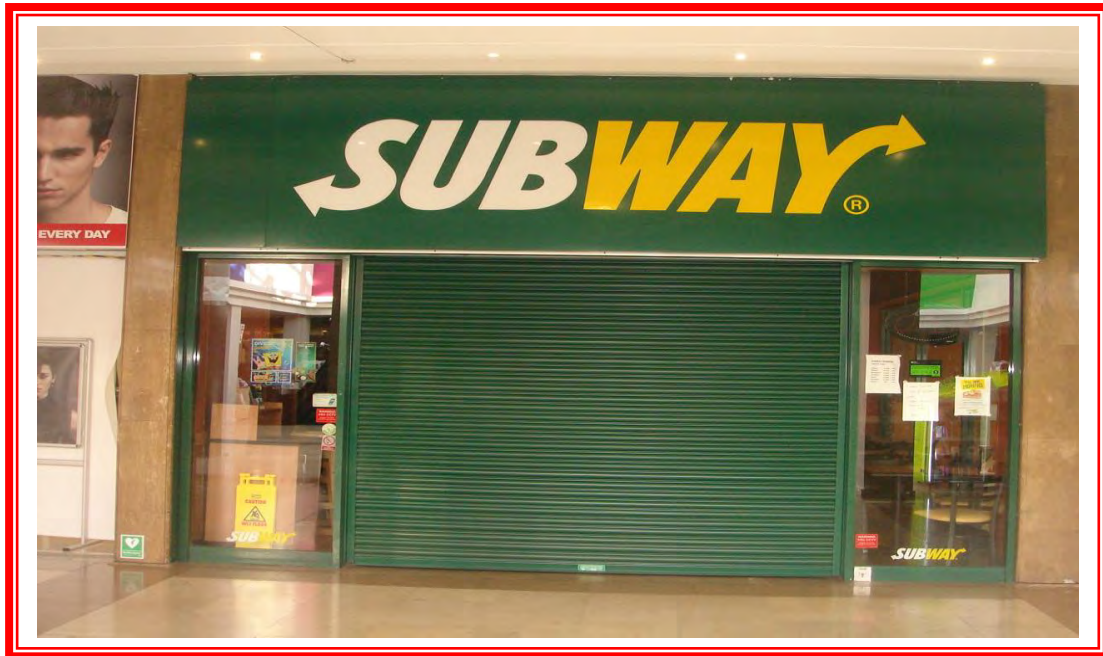
Material Description:	No Access	
Identification:	Presumed to Contain Asbestos	
Approx. quantity:	Unknown	
Accessibility	Low	Assessment Score
Product type:	No Access	3
Extent of Damage:	No Access	3
Surface Treatment:	No Access	3
Asbestos type:	No Access	3
Material Assessment Score:		12
Priority Assessment Score:		High
Action:	Further Inspection Required	
Comments:	No Access as still in lease but vacant – No Keys (The Vacant Nightclub)

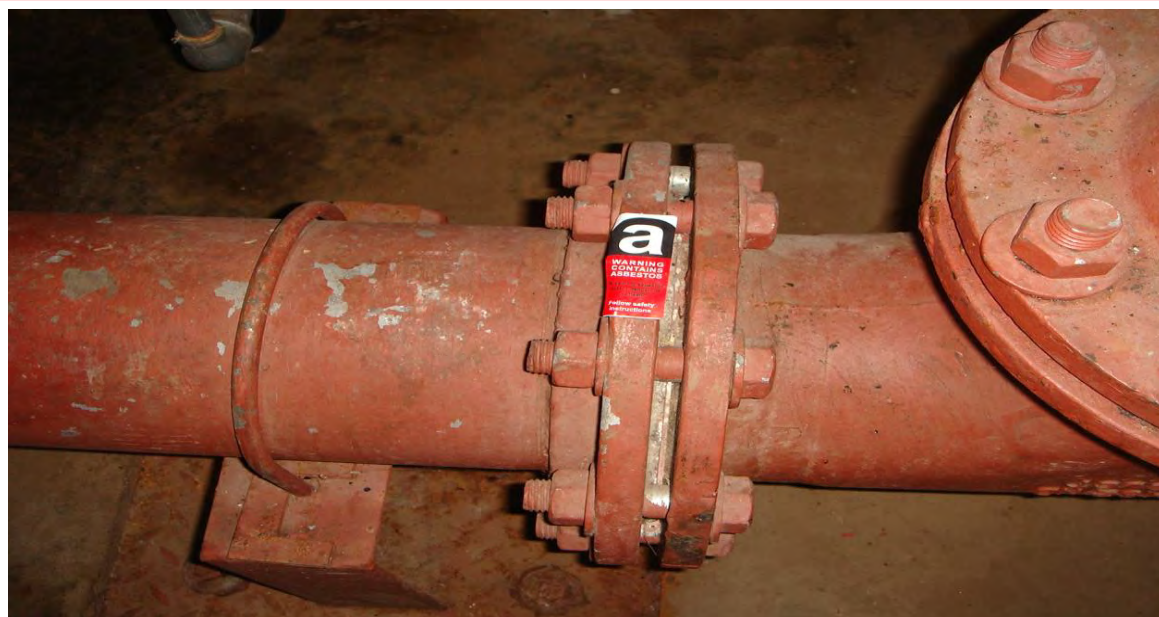
Material Description:	Pipe Gasket	
Identification:	Sampled – Asbestos Detected	
Approx. quantity:	All Gaskets	
Accessibility	Low	Assessment Score
Product type:	Gasket	2
Extent of Damage:	Good	0
Surface Treatment:	Gasket	1
Asbestos type:	Chrysotile	1
Material Assessment Score:		4
Priority Assessment Score:		Negligible
Action:	Manage	
Comments:	N/A

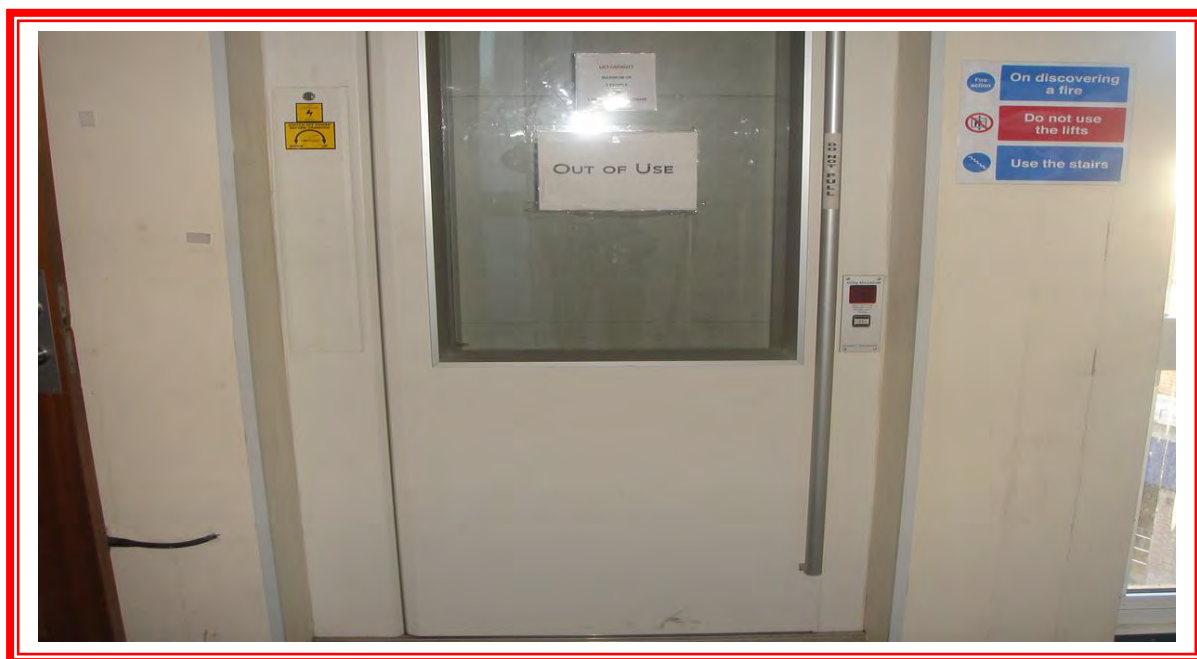
Material Description:	No Access to Lift or Shaft	
Identification:	Presumed to Contain Asbestos	
Approx. quantity:	Unknown	
Accessibility	Low	Assessment Score
Product type:	No Access	3
Extent of Damage:	No Access	3
Surface Treatment:	No Access	3
Asbestos type:	No Access	3
Material Assessment Score:		12
Priority Assessment Score:		High
Action:	Further Investigation Required	
Comments:	No Access as no lift engineer was onsite

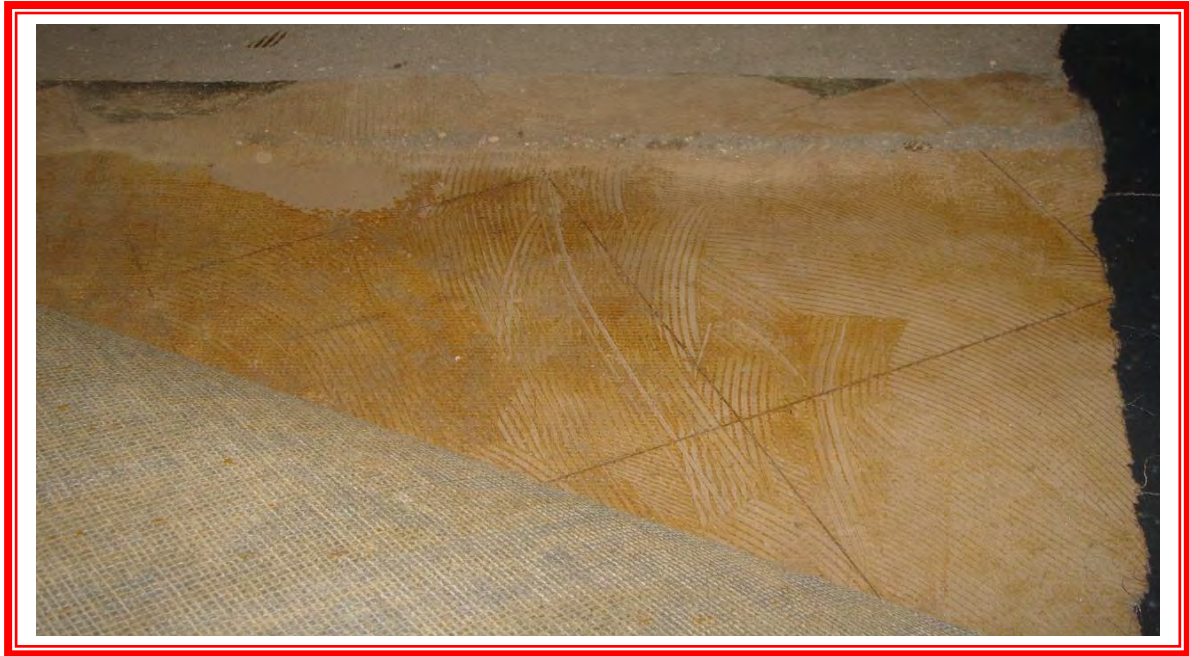
Material Description:	Vinyl Floor Tiles	
Identification:	Sampled – Asbestos Detected	
Approx. quantity:	20M2	
Accessibility	Low	Assessment Score
Product type:	Vinyl	1
Extent of Damage:	Minor	1
Surface Treatment:	Non-Friable	0
Asbestos type:	Chrysotile	1
Material Assessment Score:		3
Priority Assessment Score:		Negligible
Action:	Manage	
Comments:	N/A

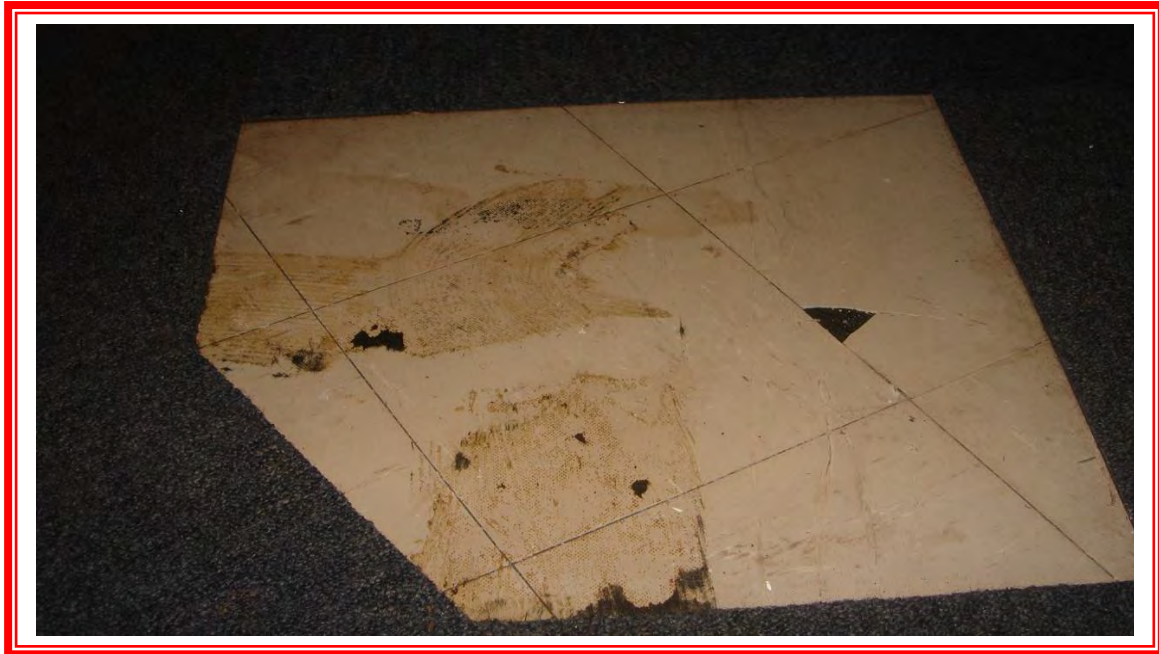
Material Description:	Vinyl Floor Tiles	
Identification:	Sampled – Asbestos Detected	
Approx. quantity:	50M2	
Accessibility	Low	Assessment Score
Product type:	Vinyl	1
Extent of Damage:	Minor	1
Surface Treatment:	Non-Friable	0
Asbestos type:	Chrysotile	1
Material Assessment Score:		3
Priority Assessment Score:		Negligible
Action:	Manage	
Comments:	N/A

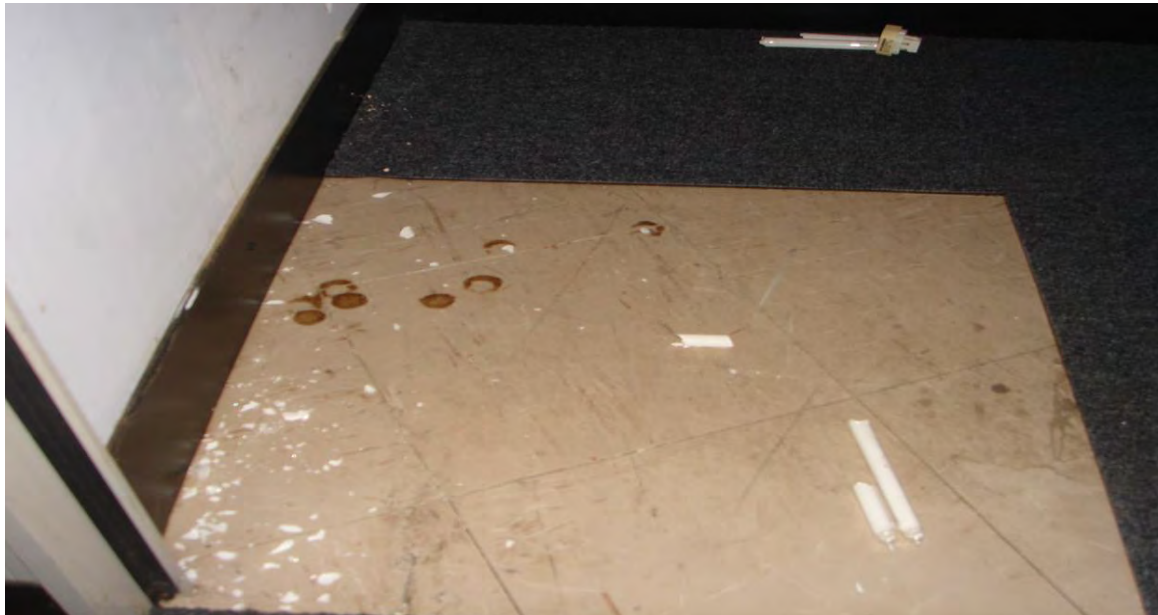
Material Description:	Vinyl Floor Tiles	
Identification:	As Per Sample NE/5 – Asbestos Detected	
Approx. quantity:	2M2	
Accessibility	Low	Assessment Score
Product type:	Vinyl	1
Extent of Damage:	Minor	1
Surface Treatment:	Non-Friable	0
Asbestos type:	Chrysotile	1
Material Assessment Score:		3
Priority Assessment Score:		Negligible
Action:	Manage	
Comments:	N/A

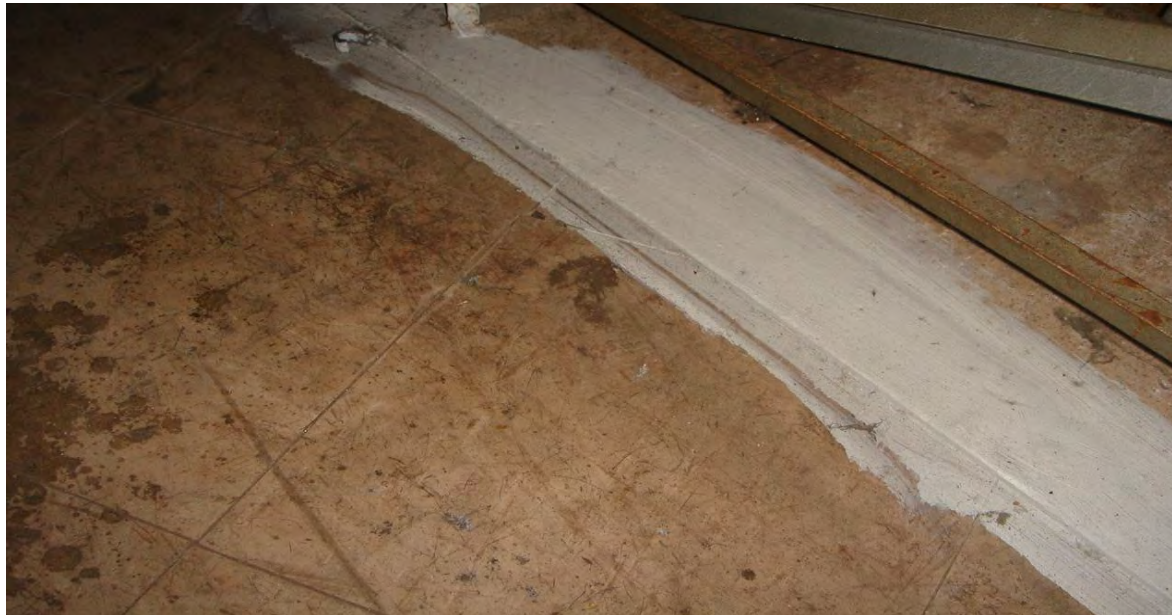
Material Description:	Asbestos Insulating Board to Boiler Floor Plinth	
Identification:	Sampled – Asbestos Detected	
Approx. quantity:	2M2	
Accessibility	Low	Assessment Score
Product type:	Asbestos Insulating Board	2
Extent of Damage:	Minor	1
Surface Treatment:	Encapsulated	1
Asbestos type:	Amosite	2
Material Assessment Score:		6
Priority Assessment Score:		Low
Action:	Manage	
Comments:	N/A

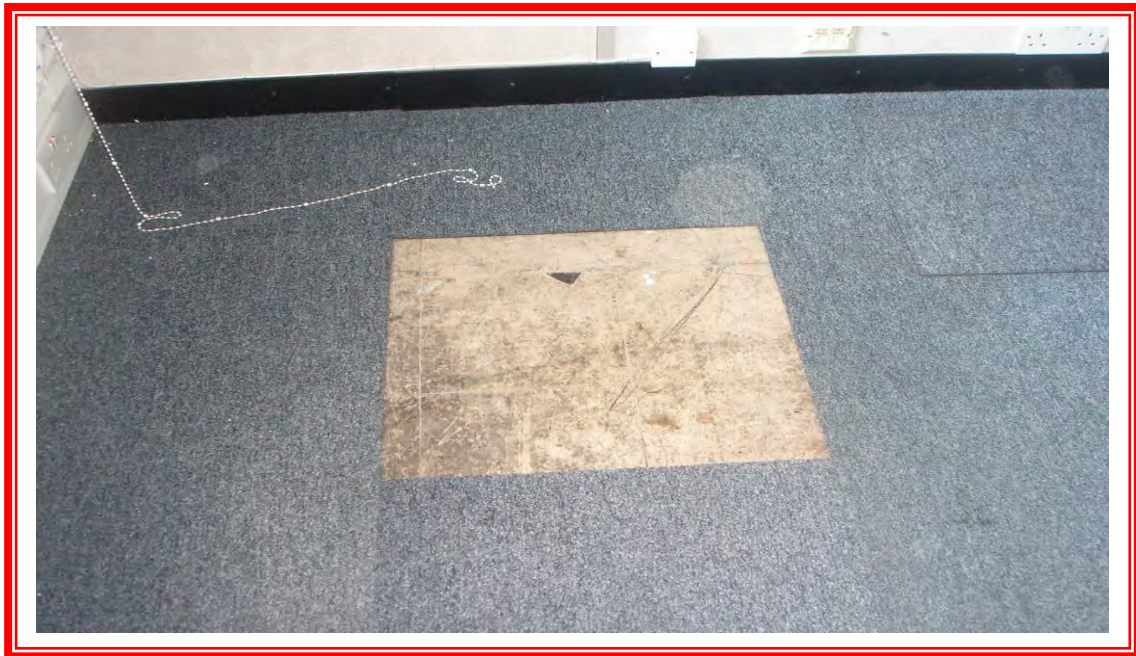
Material Description:	Vinyl Floor Tiles	
Identification:	Sampled – Asbestos Detected	
Approx. quantity:	12M2	
Accessibility	Low	Assessment Score
Product type:	Vinyl	1
Extent of Damage:	Minor	1
Surface Treatment:	Non-Friable	0
Asbestos type:	Chrysotile	1
Material Assessment Score:		3
Priority Assessment Score:		Negligible
Action:	Manage	
Comments:	N/A

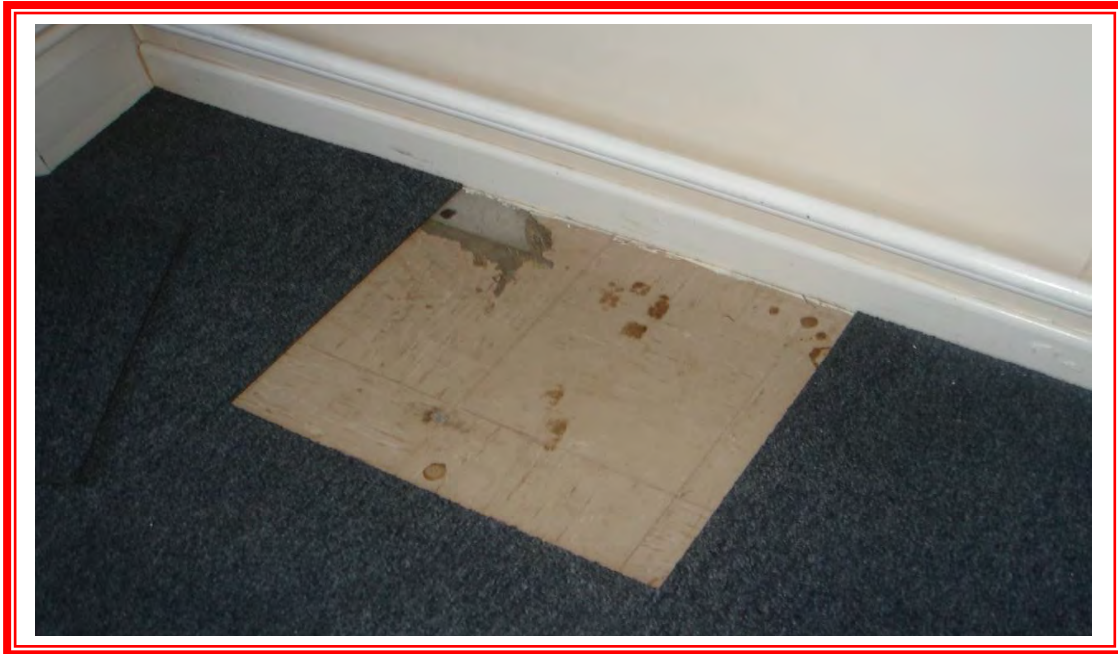
Material Description:	Vinyl Floor Tiles	
Identification:	As Per Sample NE/8 – Asbestos Detected	
Approx. quantity:	24M2	
Accessibility	Low	Assessment Score
Product type:	Vinyl	1
Extent of Damage:	Minor	1
Surface Treatment:	Non-Friable	0
Asbestos type:	Chrysotile	1
Material Assessment Score:		3
Priority Assessment Score:		Negligible
Action:	Manage	
Comments:	N/A

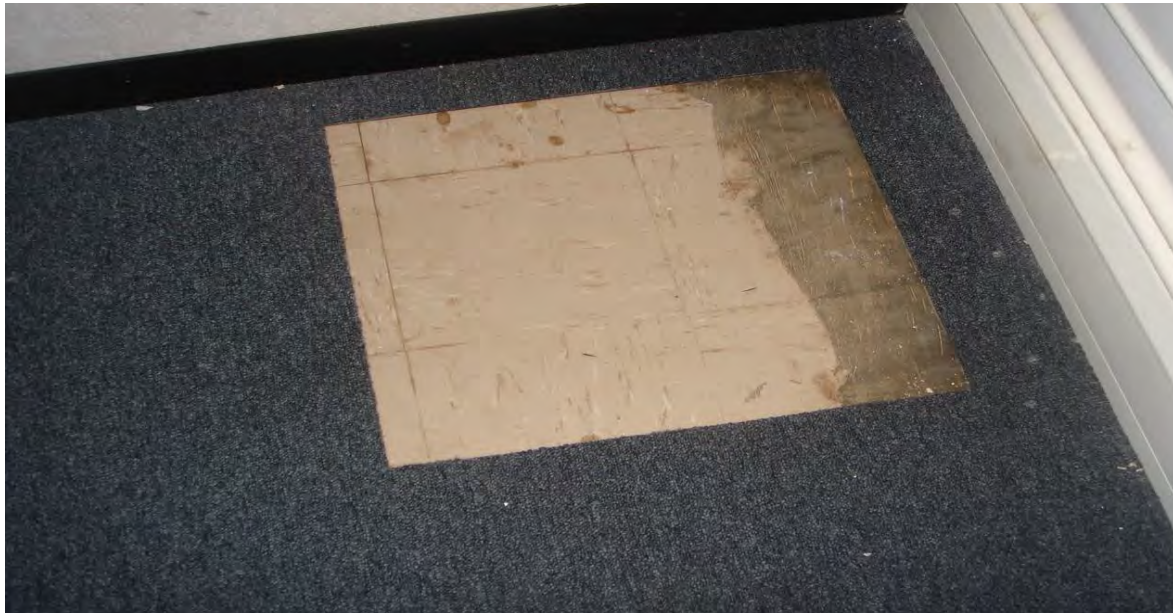
Material Description:	Vinyl Floor Tiles	
Identification:	As Per Sample NE/8 – Asbestos Detected	
Approx. quantity:	15M2	
Accessibility	Low	Assessment Score
Product type:	Vinyl	1
Extent of Damage:	Minor	1
Surface Treatment:	Non-Friable	0
Asbestos type:	Chrysotile	1
Material Assessment Score:		3
Priority Assessment Score:		Negligible
Action:	Manage	
Comments:	N/A

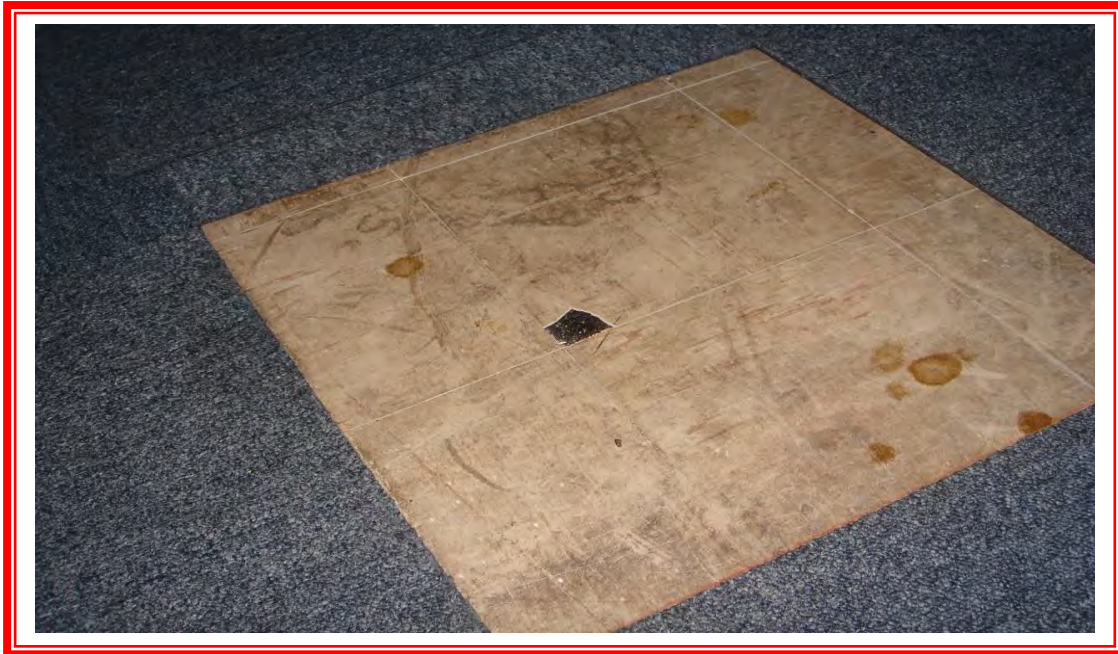
Material Description:	Vinyl Floor Tiles	
Identification:	Sampled – Asbestos Detected	
Approx. quantity:	32M2	
Accessibility	Low	Assessment Score
Product type:	Vinyl	1
Extent of Damage:	Minor	1
Surface Treatment:	Non-Friable	0
Asbestos type:	Chrysotile	1
Material Assessment Score:		3
Priority Assessment Score:		Negligible
Action:	Manage	
Comments:	N/A

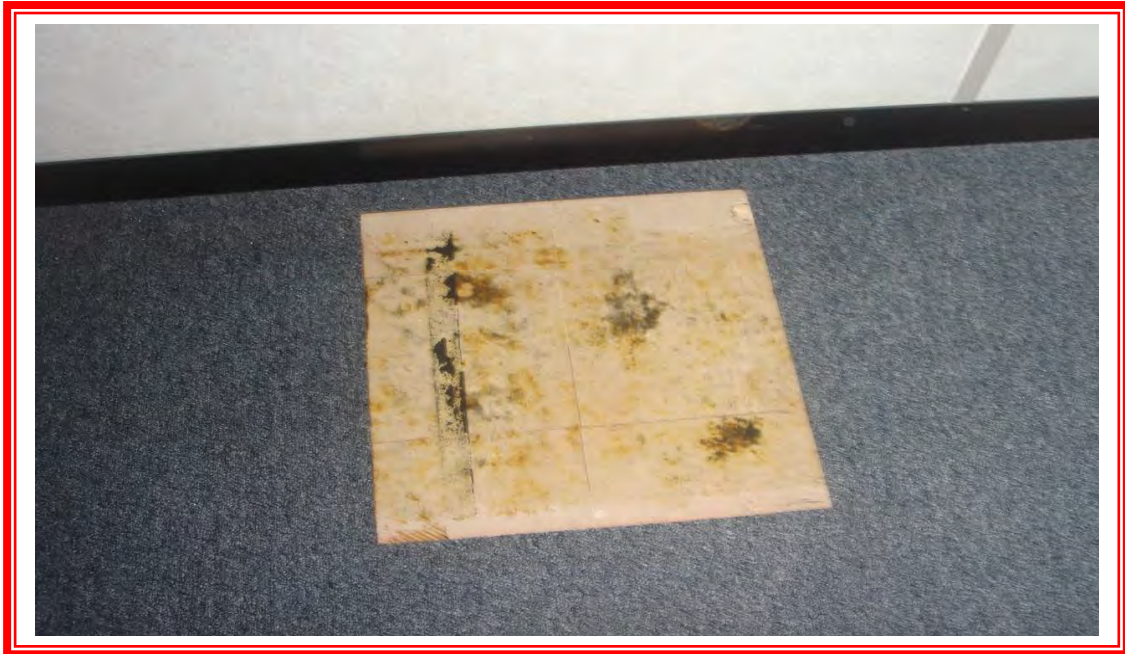
Material Description:	Vinyl Floor Tiles	
Identification:	As Per Sample NE/9 – Asbestos Detected	
Approx. quantity:	30M2	
Accessibility	Low	Assessment Score
Product type:	Vinyl	1
Extent of Damage:	Minor	1
Surface Treatment:	Non-Friable	0
Asbestos type:	Chrysotile	1
Material Assessment Score:		3
Priority Assessment Score:		Negligible
Action:	Manage	
Comments:	N/A

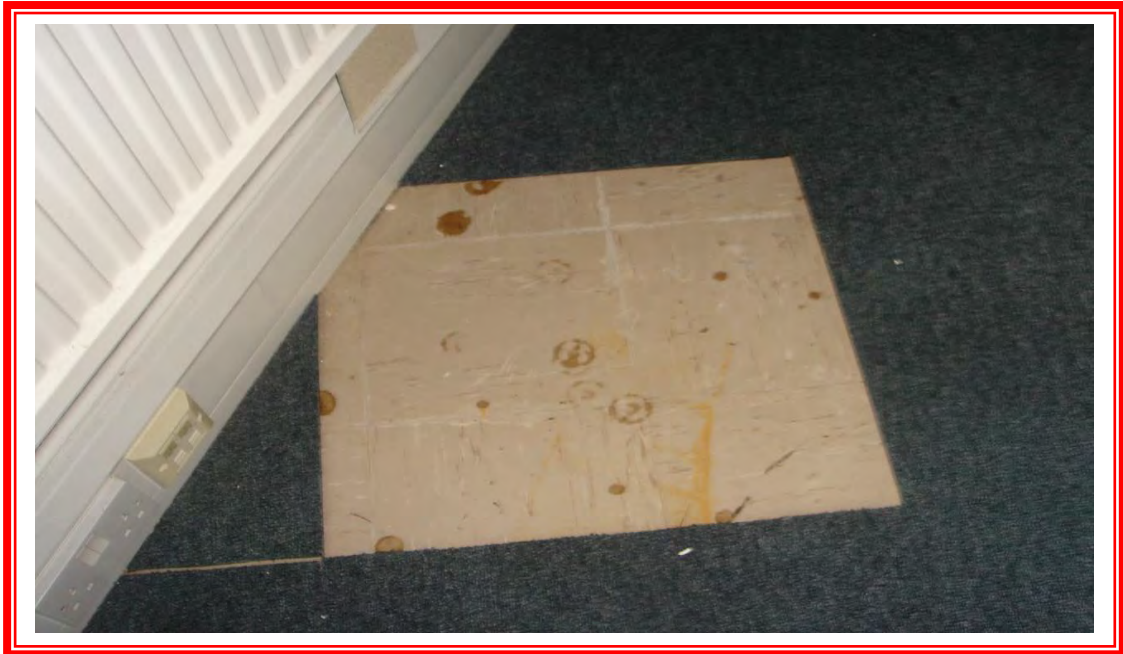
Material Description:	Vinyl Floor Tiles	
Identification:	As Per Sample NE/9 – Asbestos Detected	
Approx. quantity:	100M2	
Accessibility	Low	Assessment Score
Product type:	Vinyl	1
Extent of Damage:	Minor	1
Surface Treatment:	Non-Friable	0
Asbestos type:	Chrysotile	1
Material Assessment Score:		3
Priority Assessment Score:		Negligible
Action:	Manage	
Comments:	N/A

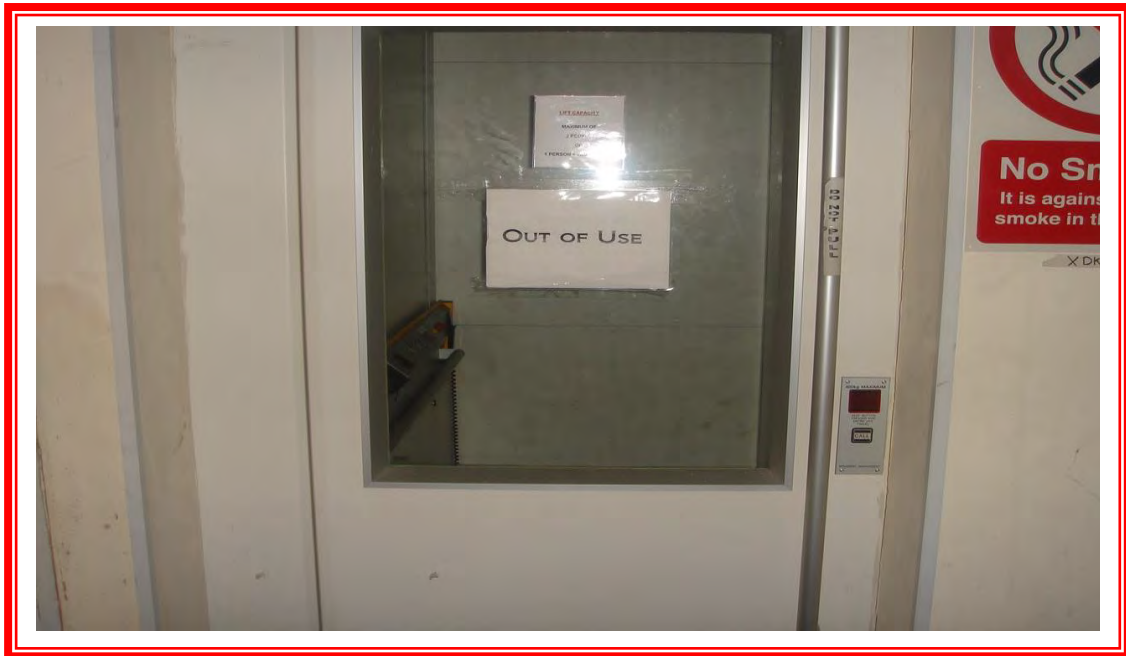
Material Description:	No Access to Lift or Shaft	
Identification:	Presumed to Contain Asbestos	
Approx. quantity:	Unknown	
Accessibility	Low	Assessment Score
Product type:	No Access	3
Extent of Damage:	No Access	3
Surface Treatment:	No Access	3
Asbestos type:	No Access	3
Material Assessment Score:		12
Priority Assessment Score:		High
Action:	Further Investigation Required	
Comments:	No Access as no lift engineer was onsite

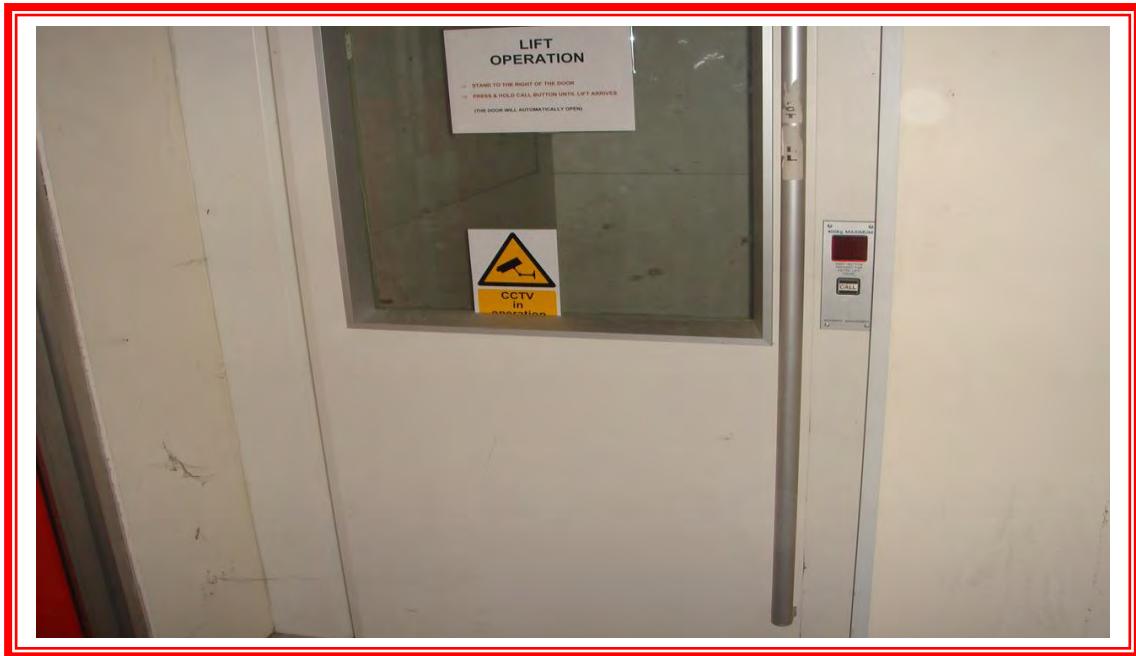
Material Description:	No Access to Lift or Shaft	
Identification:	Presumed to Contain Asbestos	
Approx. quantity:	Unknown	
Accessibility	Low	Assessment Score
Product type:	No Access	3
Extent of Damage:	No Access	3
Surface Treatment:	No Access	3
Asbestos type:	No Access	3
Material Assessment Score:		12
Priority Assessment Score:		High
Action:	Further Investigation Required	
Comments:	No Access as no lift engineer was onsite

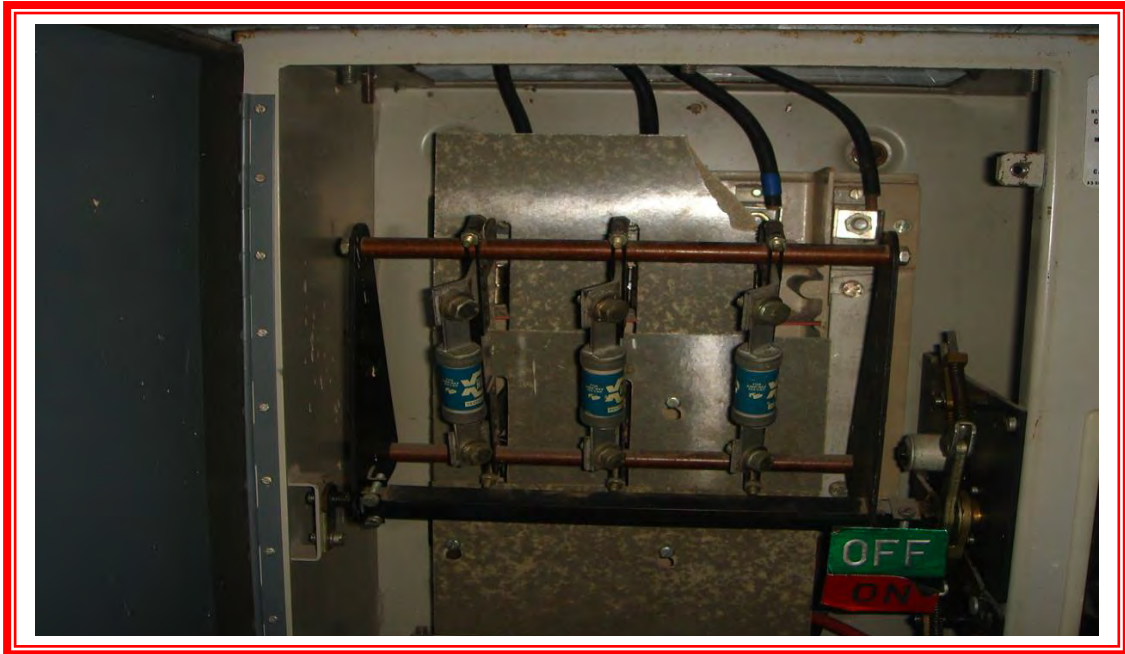
Material Description:	Flash Flash Guards to Redundant electrical box	
Identification:	Sampled – Asbestos Detected	
Approx. quantity:	All Flashguards	
Accessibility	Low	Assessment Score
Product type:	Cement	1
Extent of Damage:	Minor	1
Surface Treatment:	Non-Friable	0
Asbestos type:	Chrysotile	1
Material Assessment Score:		3
Priority Assessment Score:		Negligible
Action:	Manage	
Comments:	N/A

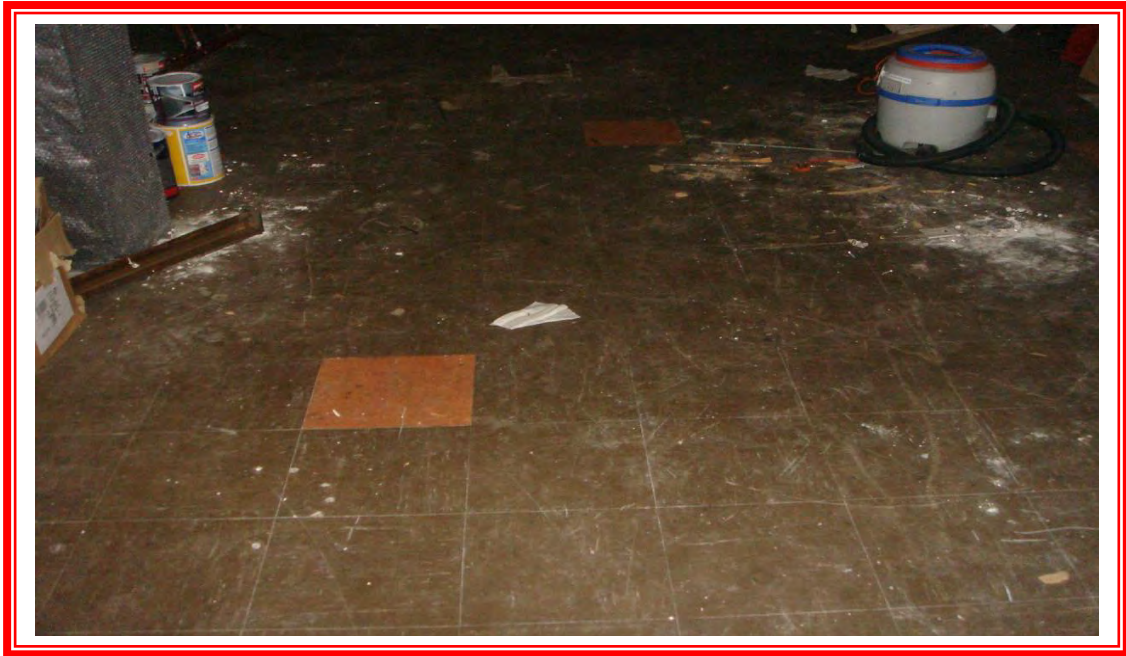
Material Description:	Vinyl Floor Tiles	
Identification:	As Per Sample 2 – Asbestos Detected	
Approx. quantity:	50M2	
Accessibility	Low	Assessment Score
Product type:	Vinyl	1
Extent of Damage:	Minor	1
Surface Treatment:	Non-Friable	0
Asbestos type:	Chrysotile	1
Material Assessment Score:		3
Priority Assessment Score:		Negligible
Action:	Manage	
Comments:	N/A

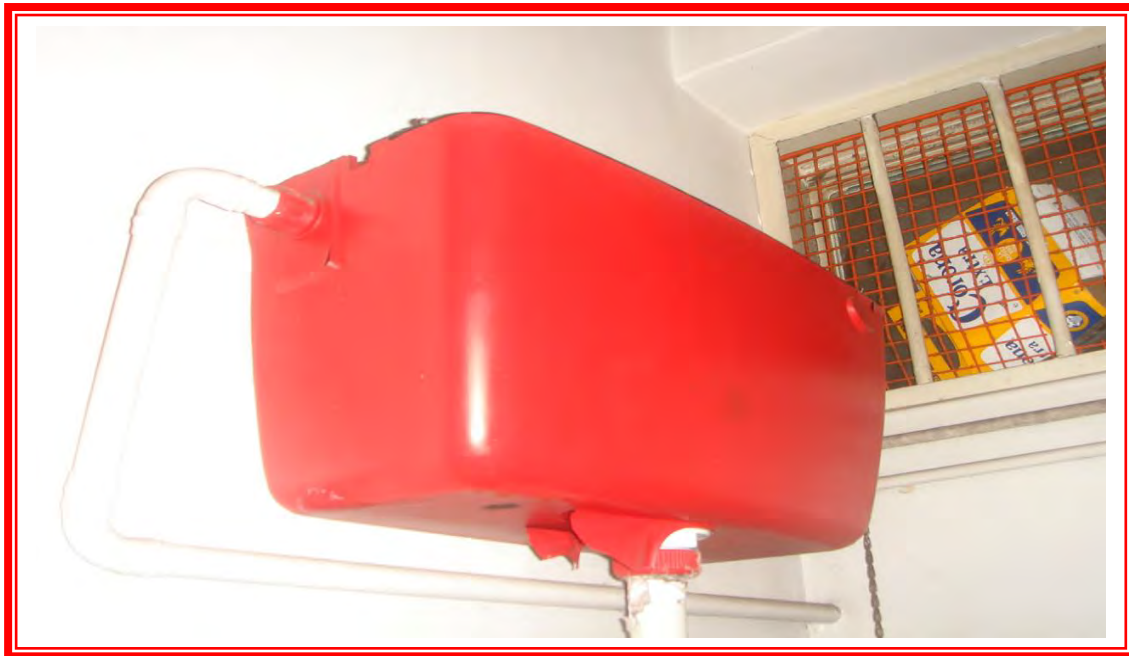
Material Description:	Toilet Cistern	
Identification:	As Per Sample 1 – Asbestos Detected	
Approx. quantity:	X 1	
Accessibility	Low	Assessment Score
Product type:	Composite	1
Extent of Damage:	Minor	1
Surface Treatment:	Non-Friable	0
Asbestos type:	Amosite	2
Material Assessment Score:		4
Priority Assessment Score:		Negligible
Action:	Manage	
Comments:	N/A
