Project Number 3113

Management
Asbestos Survey Report

Kennet Centre, Market Street, Newbury,
Berkshire, RG14 5EN

3 Market Place and Associated Store

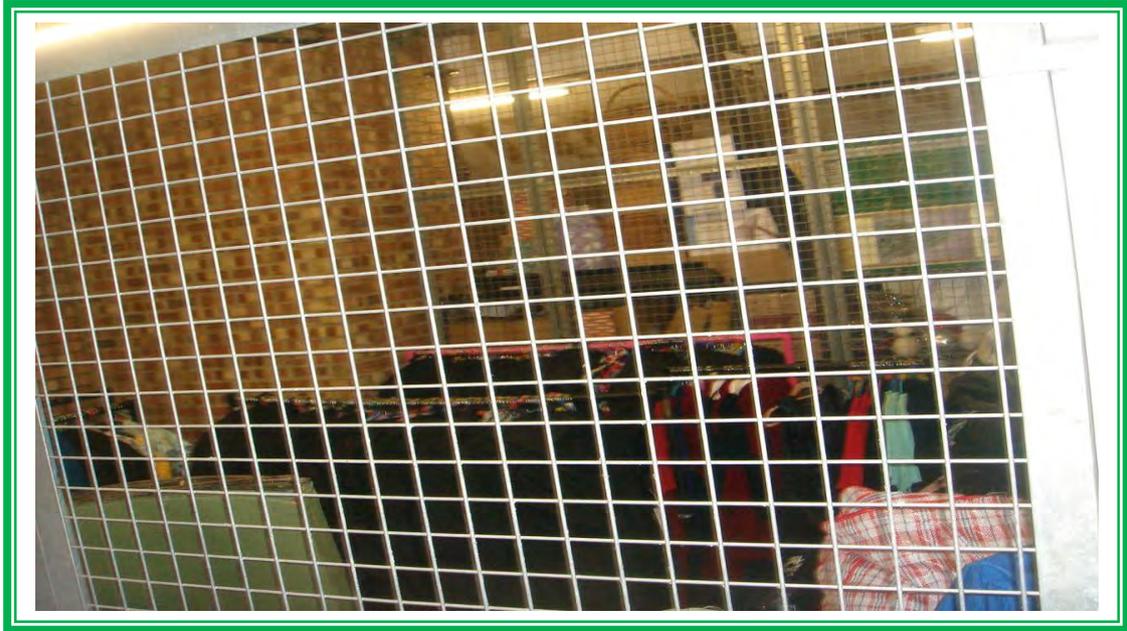
Item No: 1	Sample No: N/A
Location: 1/001 Store

Material Description:	Visual Inspection – No Suspect Materials Found	
Identification:	N/A	
Approx. quantity:	N/A	
Accessibility	N/A	Assessment Score
Product type:	N/A	N/A
Extent of Damage:	N/A	N/A
Surface Treatment:	N/A	N/A
Asbestos type:	N/A	N/A
Material Assessment Score:		N/A
Priority Assessment Score:		N/A
Action:	N/A	
Comments:	N/A

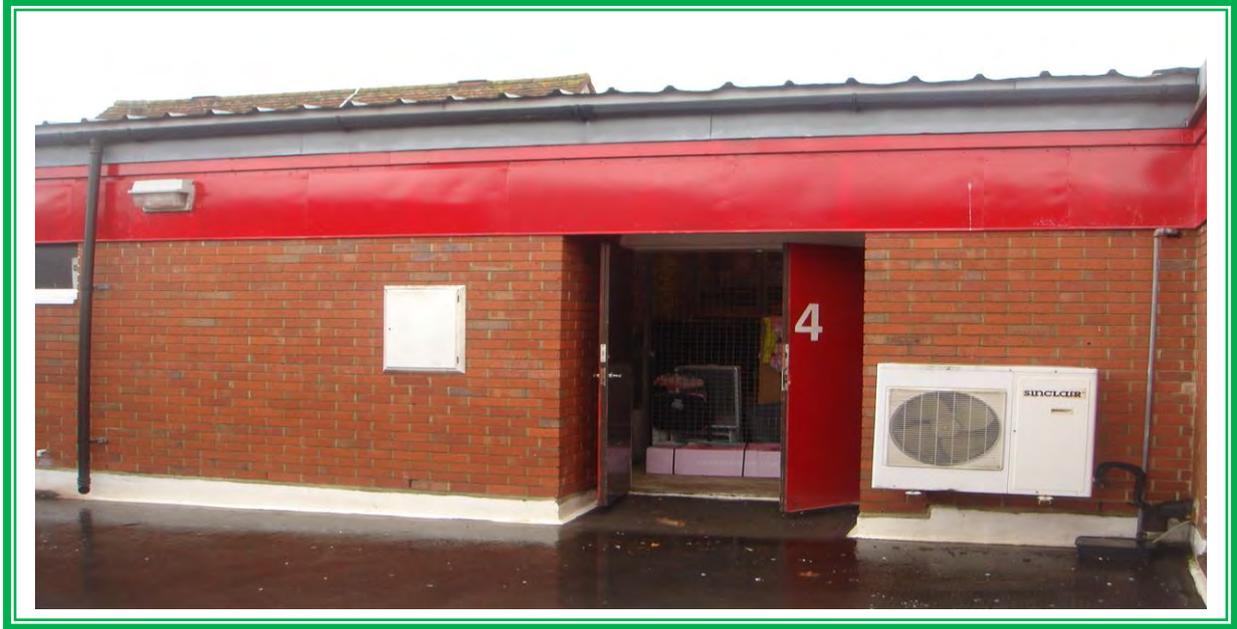
Location: 99/001 External

Material Description:	Visual Inspection – No Suspect Materials Found	
Identification:	N/A	
Approx. quantity:	N/A	
Accessibility	N/A	Assessment Score
Product type:	N/A	N/A
Extent of Damage:	N/A	N/A
Surface Treatment:	N/A	N/A
Asbestos type:	N/A	N/A
Material Assessment Score:		N/A
Priority Assessment Score:		N/A
Action:	N/A	
Comments:	N/A

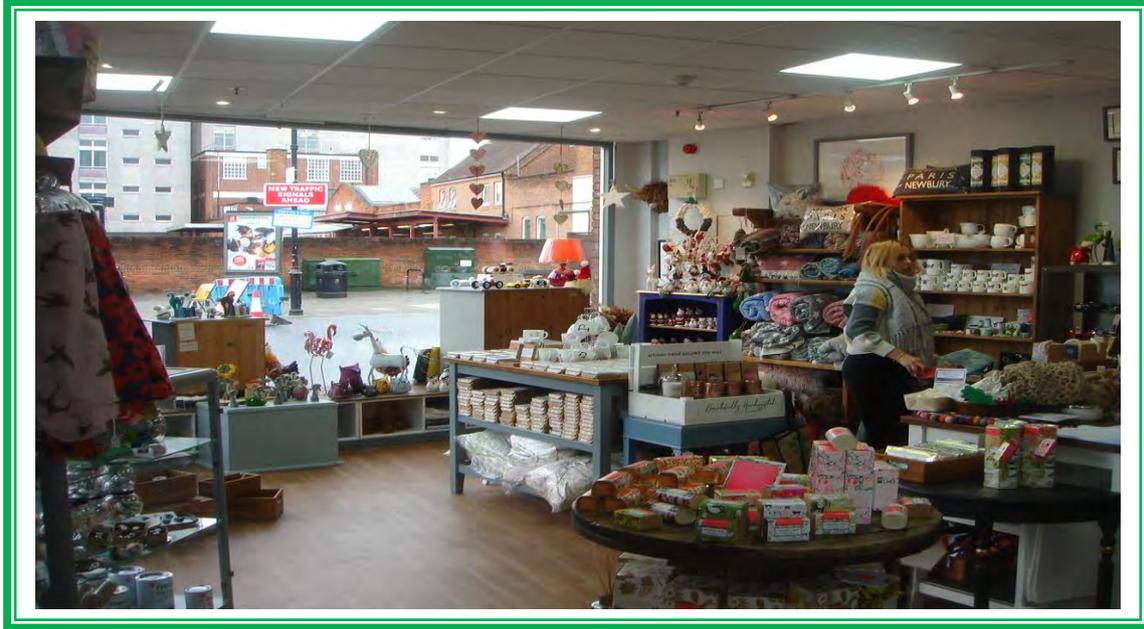
Location: 0/001 Shop Floor

Material Description:	Visual Inspection – No Suspect Materials Found	
Identification:	N/A	
Approx. quantity:	N/A	
Accessibility	N/A	Assessment Score
Product type:	N/A	N/A
Extent of Damage:	N/A	N/A
Surface Treatment:	N/A	N/A
Asbestos type:	N/A	N/A
Material Assessment Score:		N/A
Priority Assessment Score:		N/A
Action:	N/A	
Comments:	N/A

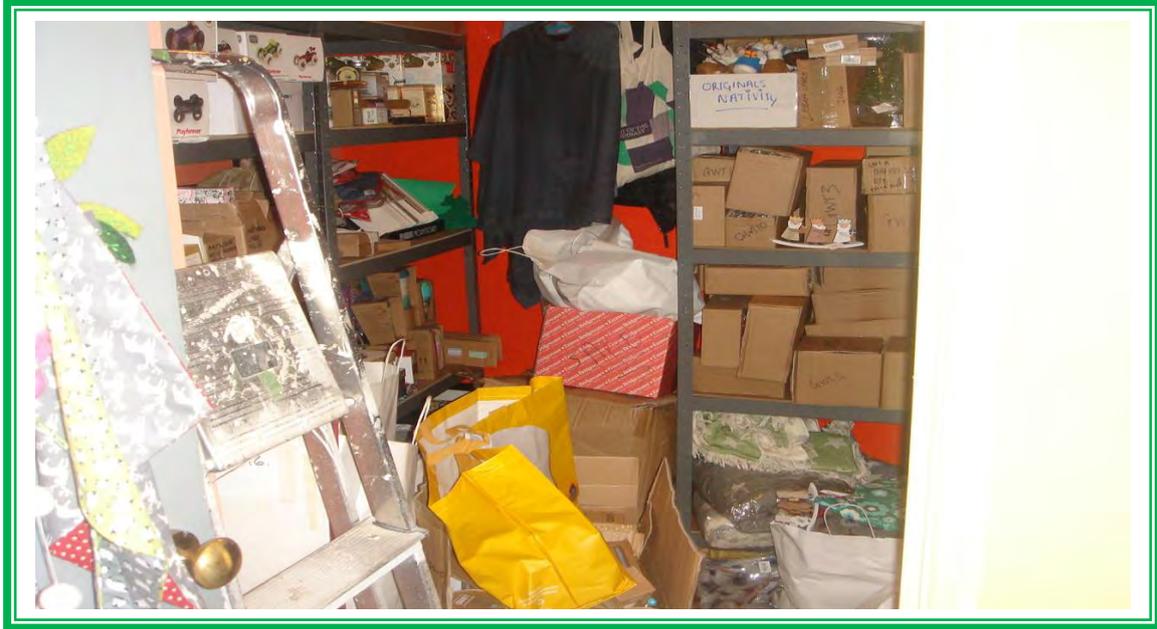
Location: 0/002 Store

Material Description:	Visual Inspection – No Suspect Materials Found	
Identification:	N/A	
Approx. quantity:	N/A	
Accessibility	N/A	Assessment Score
Product type:	N/A	N/A
Extent of Damage:	N/A	N/A
Surface Treatment:	N/A	N/A
Asbestos type:	N/A	N/A
Material Assessment Score:		N/A
Priority Assessment Score:		N/A
Action:	N/A	
Comments:	N/A

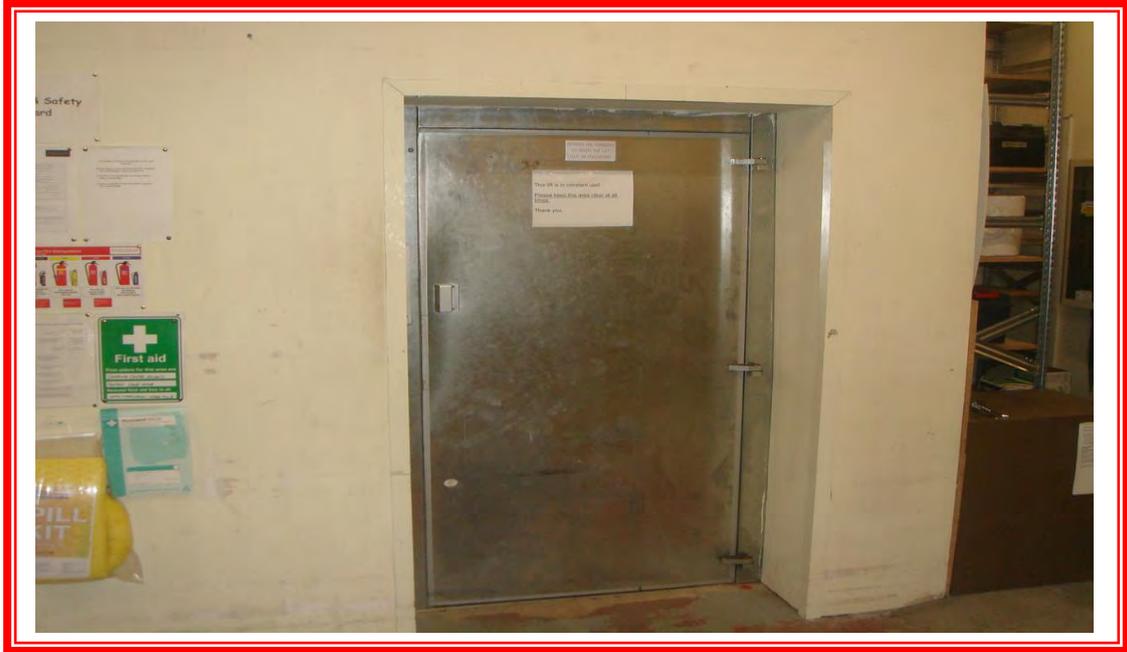
Material Description:	No Access	
Identification:	Presumed to Contain Asbestos	
Approx. quantity:	Lift and Lift Shaft	
Accessibility	Low	<i>Assessment Score</i>
Product type:	No Access	3
Extent of Damage:	No Access	3
Surface Treatment:	No Access	3
Asbestos type:	No Access	3
Material Assessment Score:		12
Priority Assessment Score:		High
Action:	Further Inspection Required	
Comments:	No access as no lift engineer onsite

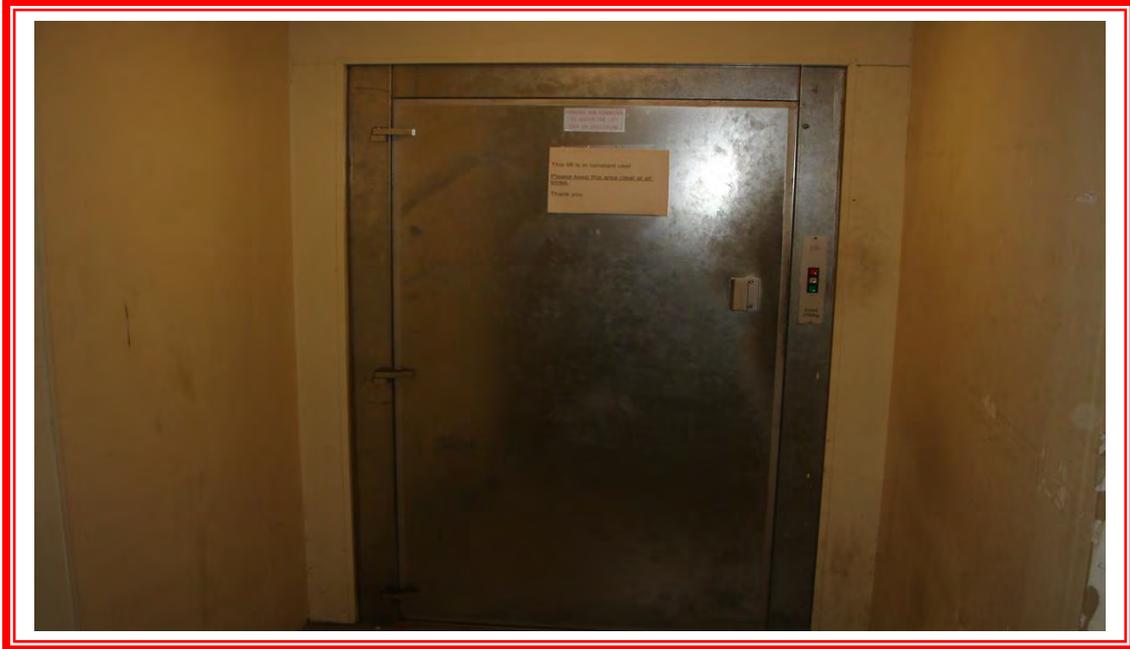
Material Description:	No Access	
Identification:	Presumed to Contain Asbestos	
Approx. quantity:	Lift and Lift Shaft	
Accessibility	Low	Assessment Score
Product type:	No Access	3
Extent of Damage:	No Access	3
Surface Treatment:	No Access	3
Asbestos type:	No Access	3
Material Assessment Score:		12
Priority Assessment Score:		High
Action:	Further Inspection Required	
Comments:	No access as no lift engineer onsite

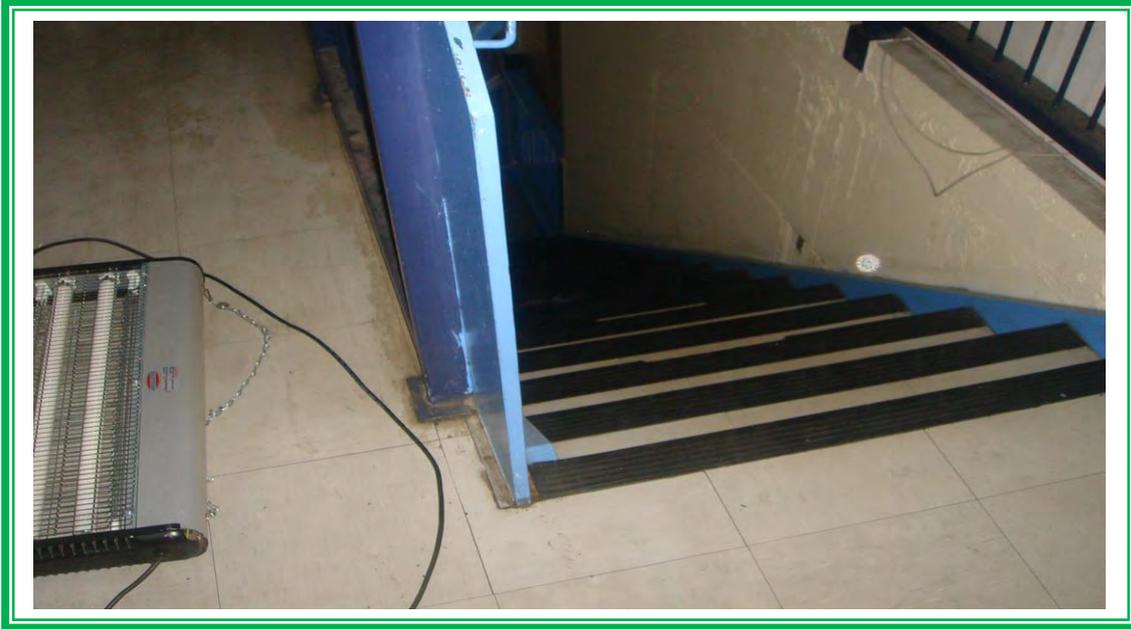
Material Description:	Vinyl Floor Tiles	
Identification:	As Per Sample NE/1 – No Asbestos Detected	
Approx. quantity:	10M2	
Accessibility	N/A	Assessment Score
Product type:	N/A	N/A
Extent of Damage:	N/A	N/A
Surface Treatment:	N/A	N/A
Asbestos type:	N/A	N/A
Material Assessment Score:		N/A
Priority Assessment Score:		N/A
Action:	N/A	
Comments:	N/A

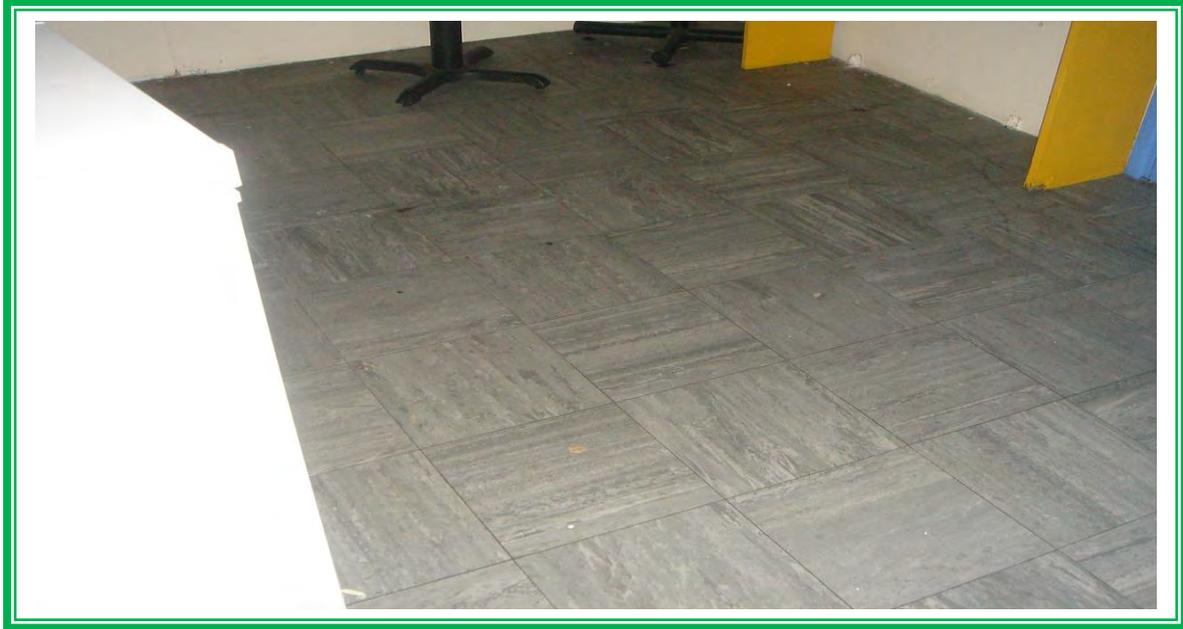
Material Description:	Vinyl Floor Tiles	
Identification:	Sampled – No Asbestos Detected	
Approx. quantity:	8M2	
Accessibility	N/A	Assessment Score
Product type:	N/A	N/A
Extent of Damage:	N/A	N/A
Surface Treatment:	N/A	N/A
Asbestos type:	N/A	N/A
Material Assessment Score:		N/A
Priority Assessment Score:		N/A
Action:	N/A	
Comments:	N/A

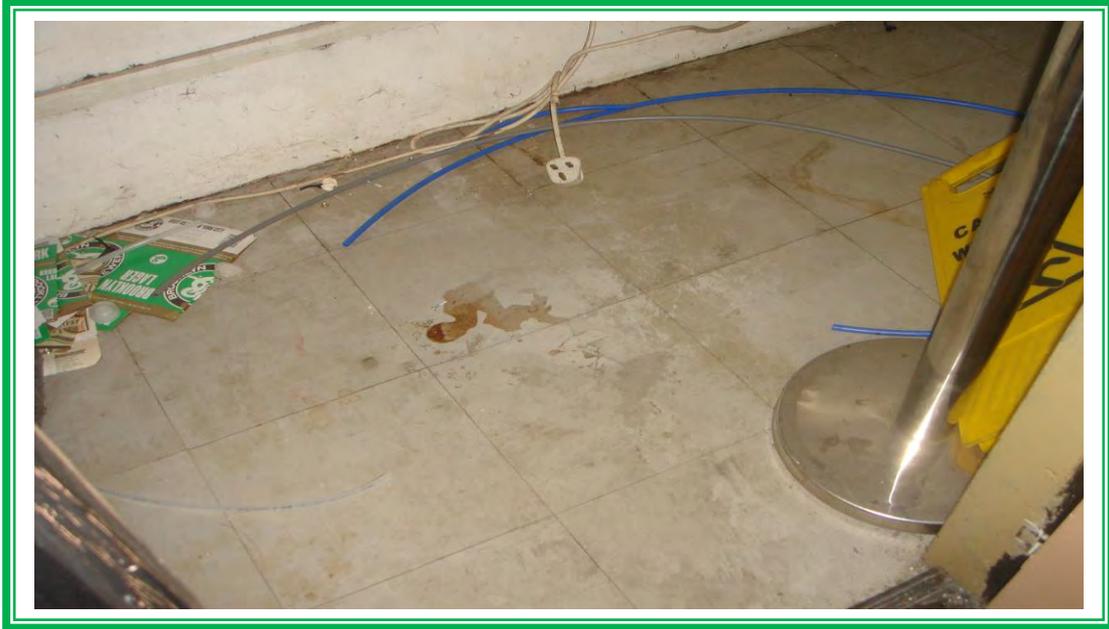
Material Description:	Vinyl Floor Tiles	
Identification:	Sampled - No Asbestos Detected	
Approx. quantity:	3M2	
Accessibility	N/A	Assessment Score
Product type:	N/A	N/A
Extent of Damage:	N/A	N/A
Surface Treatment:	N/A	N/A
Asbestos type:	N/A	N/A
Material Assessment Score:		N/A
Priority Assessment Score:		N/A
Action:	N/A	
Comments:	N/A

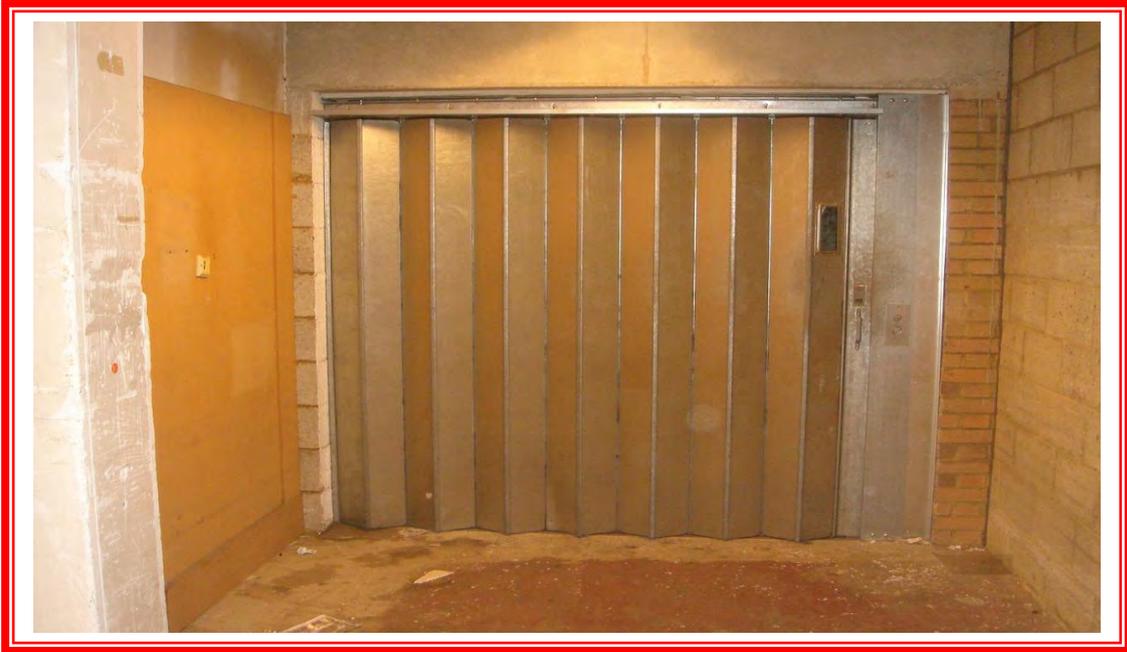
Material Description:	No Access to Lift and Shaft	
Identification:	Presumed to Contain Asbestos	
Approx. quantity:	Unknown	
Accessibility	Low	Assessment Score
Product type:	No Access	3
Extent of Damage:	No Access	3
Surface Treatment:	No Access	3
Asbestos type:	No Access	3
Material Assessment Score:		12
Priority Assessment Score:		High
Action:	Further Inspection Required	
Comments:	No Lift Engineer

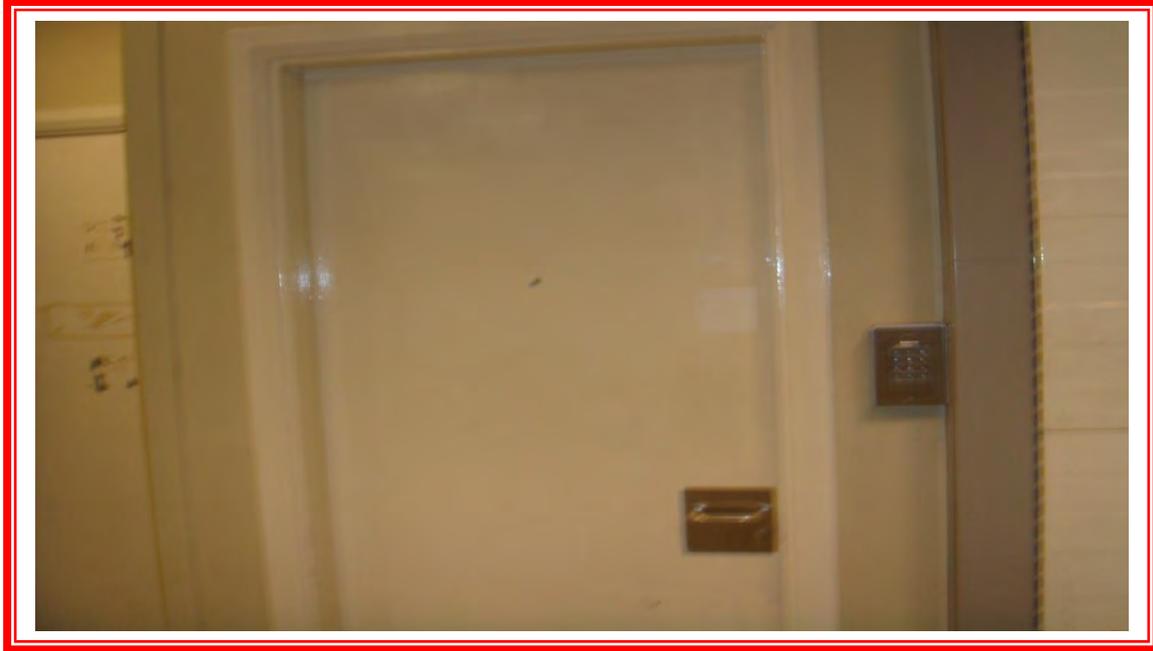
Material Description:	No Access as no Code Available	
Identification:	Presumed to Contain Asbestos	
Approx. quantity:	Unknown	
Accessibility	Low	Assessment Score
Product type:	No Access	3
Extent of Damage:	No Access	3
Surface Treatment:	No Access	3
Asbestos type:	No Access	3
Material Assessment Score:		12
Priority Assessment Score:		High
Action:	Further Inspection Required	
Comments:	No Code

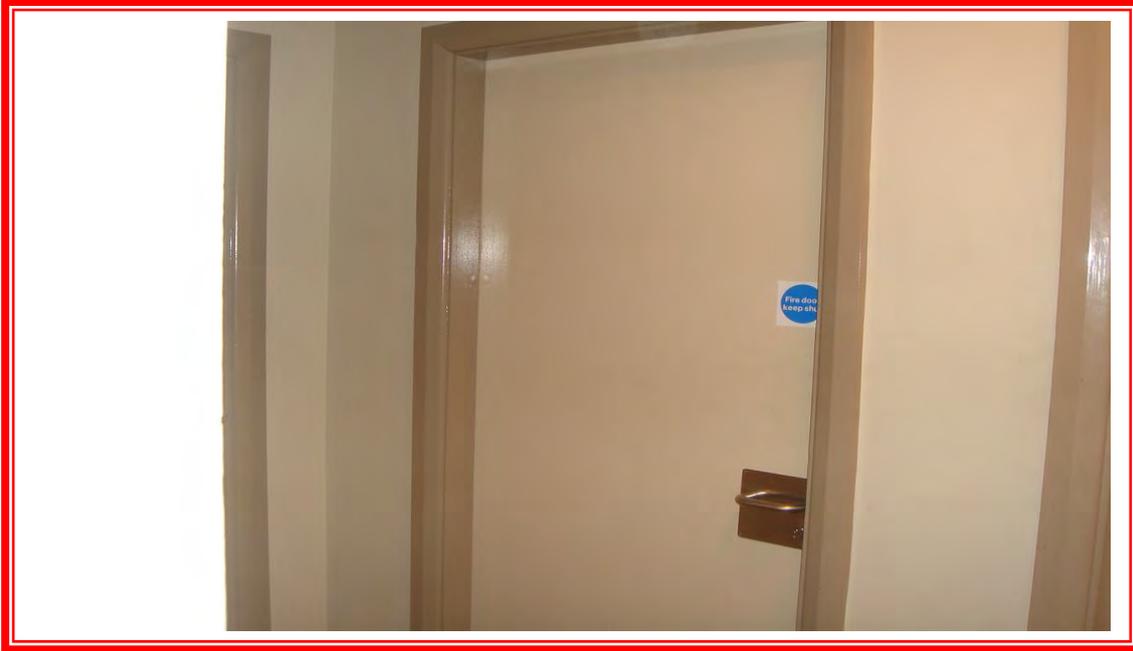
Material Description:	No Access as no Key Was Available	
Identification:	Presumed to Contain Asbestos	
Approx. quantity:	Unknown	
Accessibility	Low	Assessment Score
Product type:	No Access	3
Extent of Damage:	No Access	3
Surface Treatment:	No Access	3
Asbestos type:	No Access	3
Material Assessment Score:		12
Priority Assessment Score:		High
Action:	Further Inspection Required	
Comments:	No Key

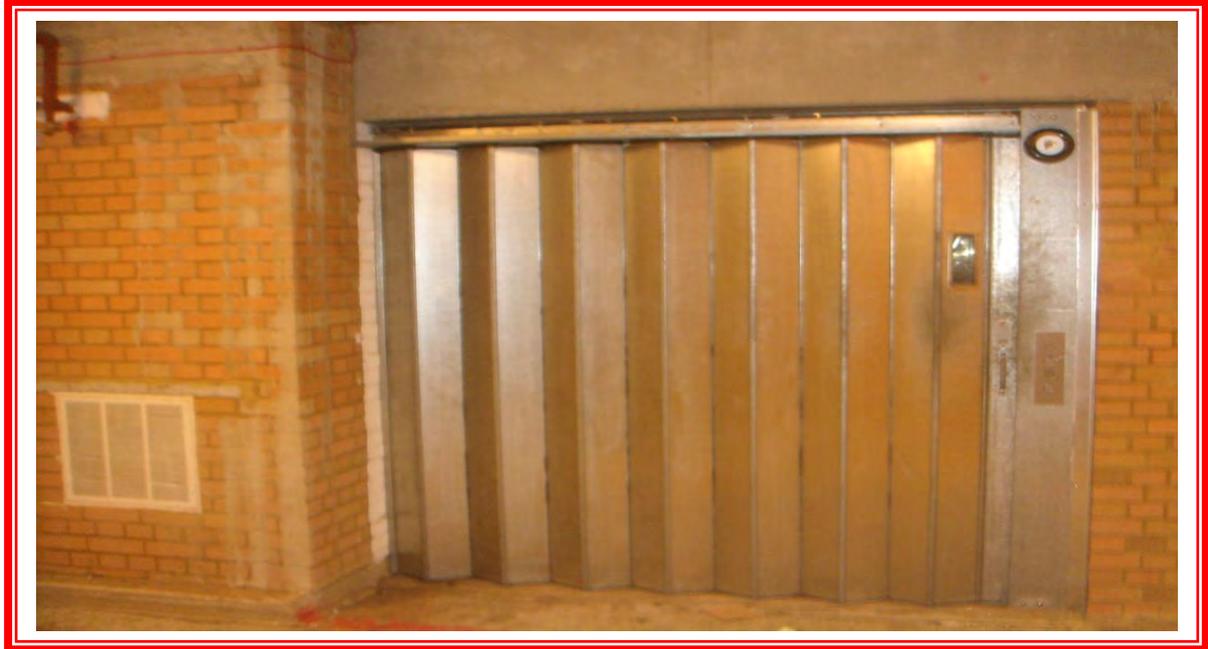
Material Description:	No Access to Lift or Shaft	
Identification:	Presumed to Contain Asbestos	
Approx. quantity:	Unknown	
Accessibility	Low	Assessment Score
Product type:	No Access	3
Extent of Damage:	No Access	3
Surface Treatment:	No Access	3
Asbestos type:	No Access	3
Material Assessment Score:		12
Priority Assessment Score:		High
Action:	Further Inspection Required	
Comments:	No Lift Engineer

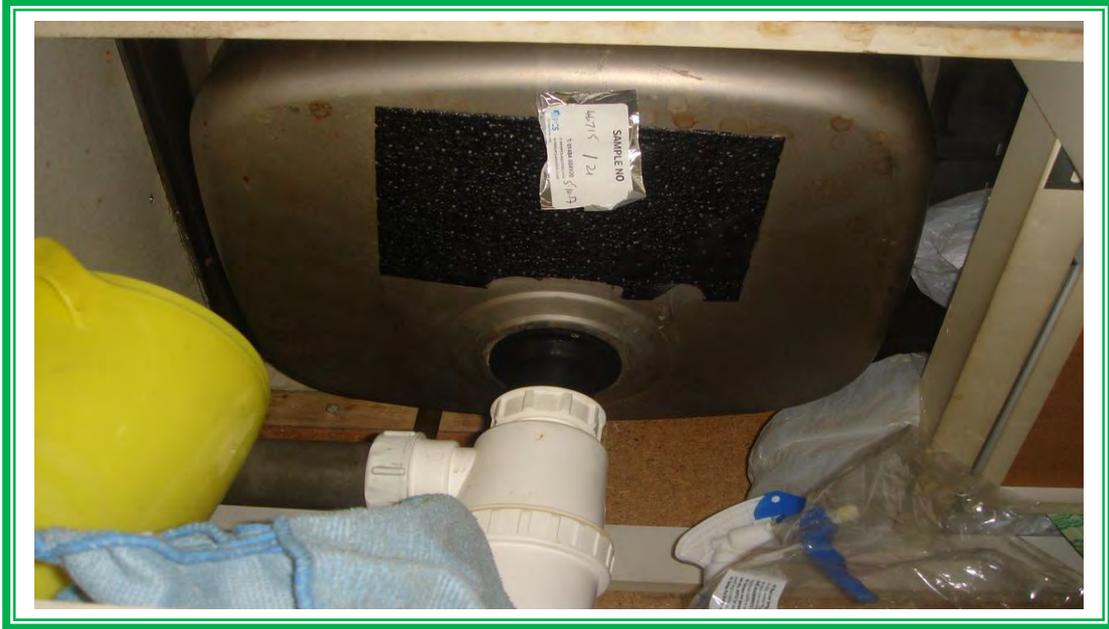
Material Description:	Sink Pad	
Identification:	Sampled - No Asbestos Detected	
Approx. quantity:	X 2	
Accessibility	N/A	Assessment Score
Product type:	N/A	N/A
Extent of Damage:	N/A	N/A
Surface Treatment:	N/A	N/A
Asbestos type:	N/A	N/A
Material Assessment Score:		N/A
Priority Assessment Score:		N/A
Action:	N/A	
Comments:	N/A

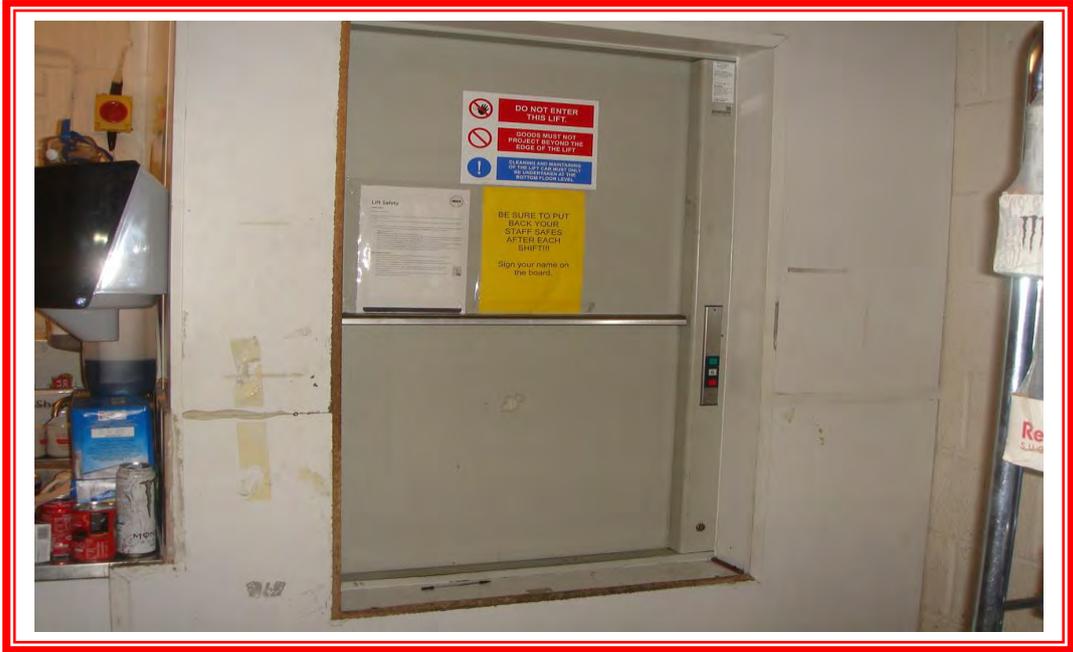
Material Description:	No Access	
Identification:	Presumed to Contain Asbestos	
Approx. quantity:	Entire Lift and Shaft	
Accessibility	Low	<i>Assessment Score</i>
Product type:	No Access	3
Extent of Damage:	No Access	3
Surface Treatment:	No Access	3
Asbestos type:	No Access	3
Material Assessment Score:		12
Priority Assessment Score:		High
Action:	Further Investigation Needed	
Comments:	Unable to access as there was no lift engineer
