Document Name	Author	Issued by	Revision Number	Issue Date	Page No
2019	Emma Humphreys	Armour AS	0	29/11/2019	25

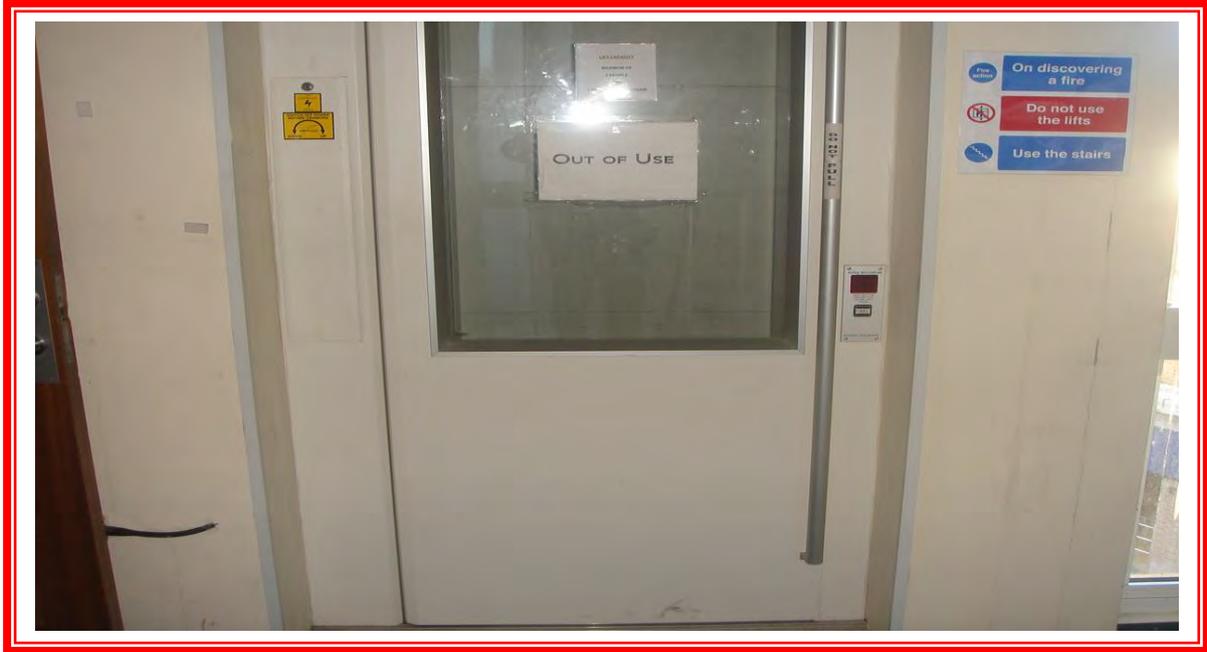
Location: 2/002 Lift

Material Description:	No Access to Lift or Shaft	
Identification:	Presumed to Contain Asbestos	
Approx. quantity:	Unknown	
Accessibility	Low	Assessment Score
Product type:	No Access	3
Extent of Damage:	No Access	3
Surface Treatment:	No Access	3
Asbestos type:	No Access	3
Material Assessment Score:		12
Priority Assessment Score:		High
Action:	Further Investigation Required	
Comments:	No Access as no lift engineer was onsite

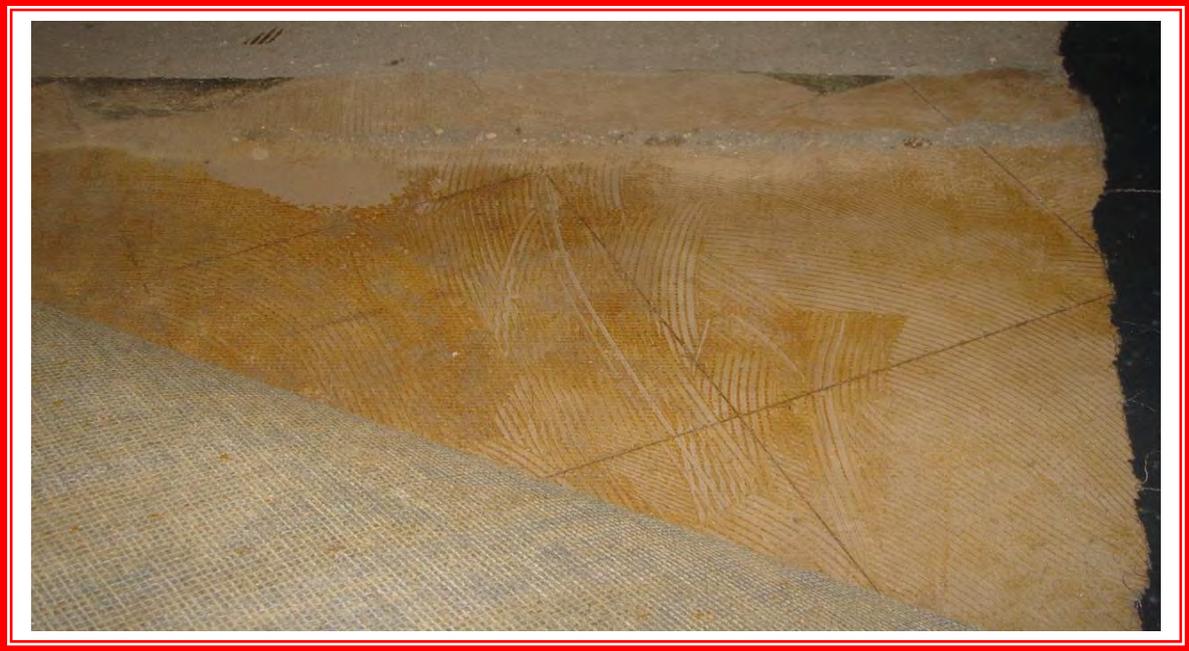
Material Description:	Vinyl Floor Tiles	
Identification:	Sampled - Asbestos Detected	
Approx. quantity:	20M2	
Accessibility	Low	Assessment Score
Product type:	Vinyl	1
Extent of Damage:	Minor	1
Surface Treatment:	Non-Friable	0
Asbestos type:	Chrysotile	1
Material Assessment Score:		3
Priority Assessment Score:		Negligible
Action:	Manage	
Comments:	N/A

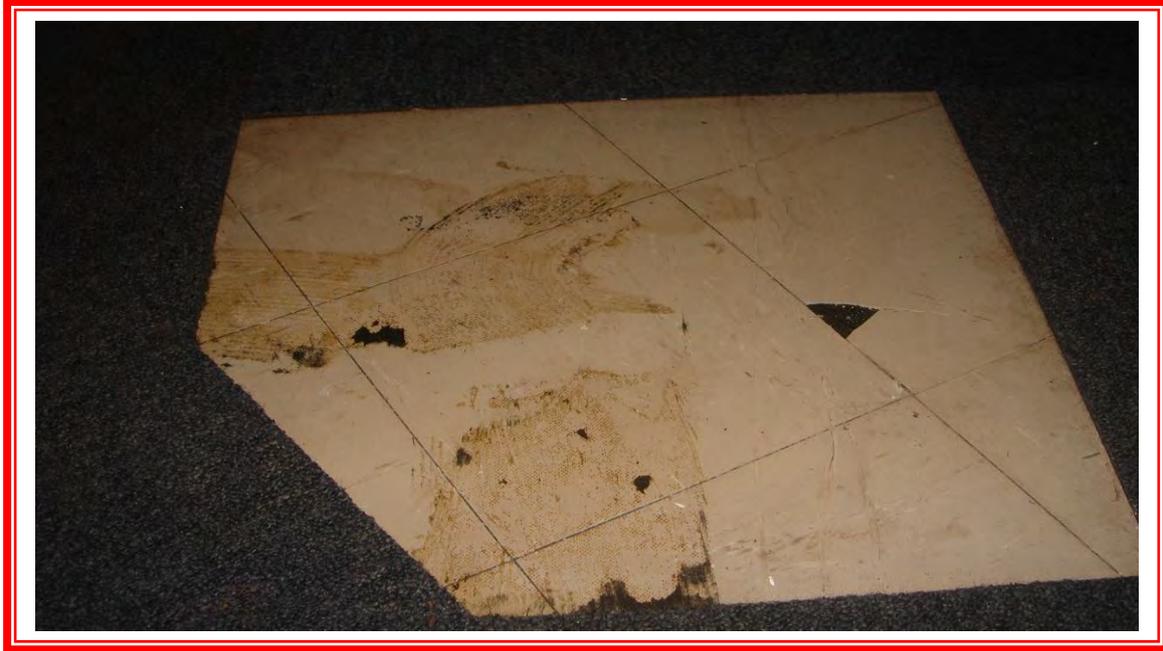
Material Description:	Vinyl Floor Tiles	
Identification:	Sampled - Asbestos Detected	
Approx. quantity:	50M2	
Accessibility	Low	Assessment Score
Product type:	Vinyl	1
Extent of Damage:	Minor	1
Surface Treatment:	Non-Friable	0
Asbestos type:	Chrysotile	1
Material Assessment Score:		3
Priority Assessment Score:		Negligible
Action:	Manage	
Comments:	N/A

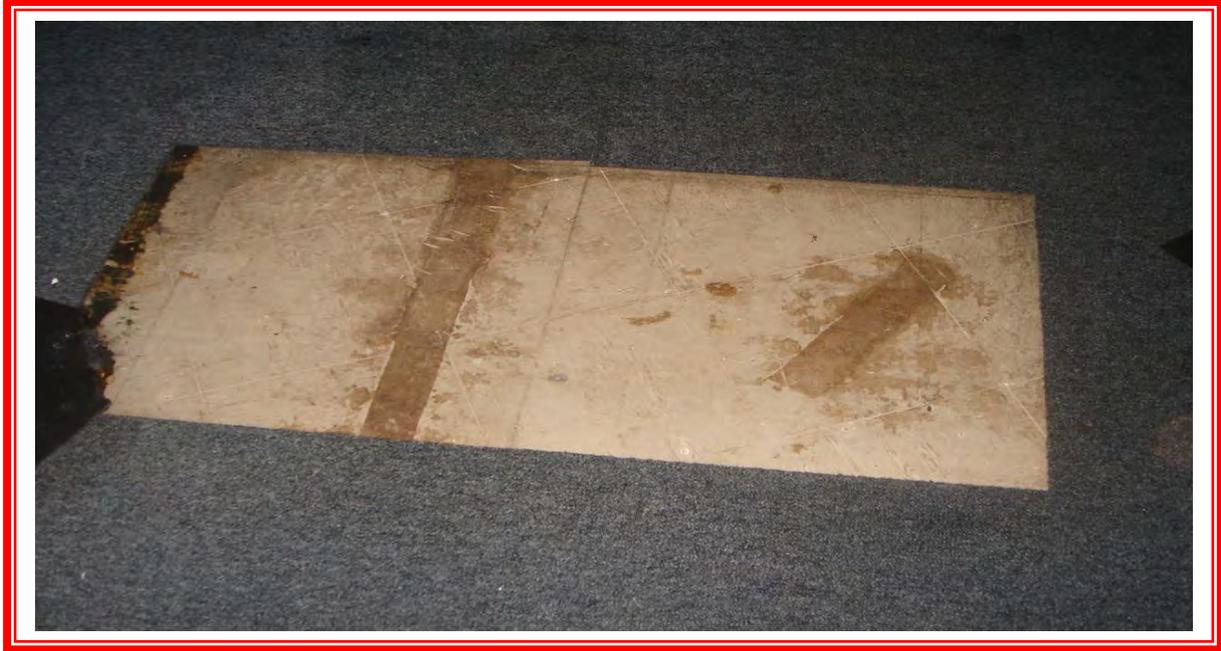
Material Description:	Vinyl Floor Tiles	
Identification:	As Per Sample NE/5 - Asbestos Detected	
Approx. quantity:	24M2	
Accessibility	Low	Assessment Score
Product type:	Vinyl	1
Extent of Damage:	Minor	1
Surface Treatment:	Non-Friable	0
Asbestos type:	Chrysotile	1
Material Assessment Score:		3
Priority Assessment Score:		Negligible
Action:	Manage	
Comments:	N/A

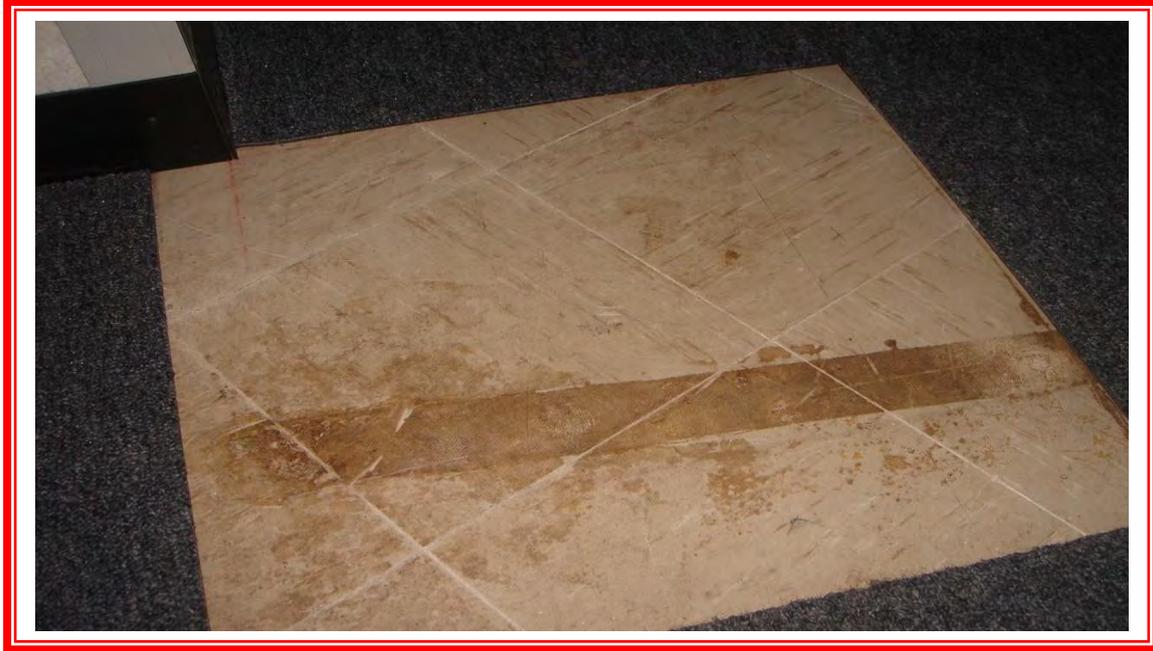
Material Description:	Vinyl Floor Tiles	
Identification:	As Per Sample NE/5 - Asbestos Detected	
Approx. quantity:	20M2	
Accessibility	Low	Assessment Score
Product type:	Vinyl	1
Extent of Damage:	Minor	1
Surface Treatment:	Non-Friable	0
Asbestos type:	Chrysotile	1
Material Assessment Score:		3
Priority Assessment Score:		Negligible
Action:	Manage	
Comments:	N/A

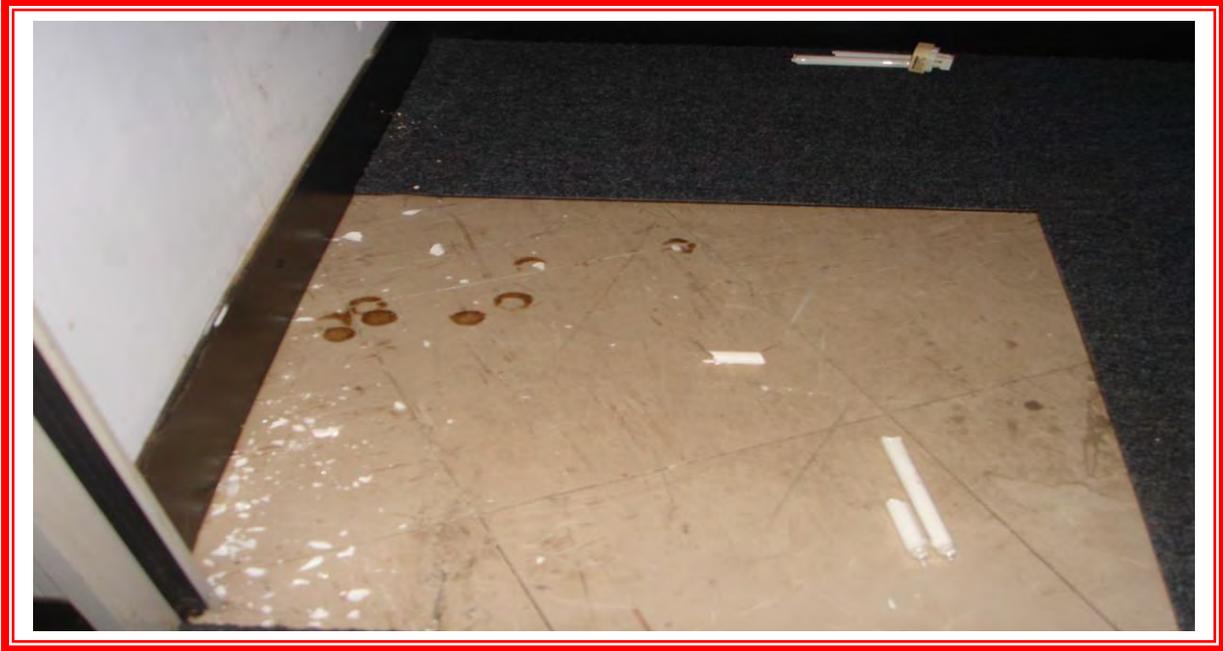
Material Description:	Vinyl Floor Tiles	
Identification:	As Per Sample NE/5 - Asbestos Detected	
Approx. quantity:	2M2	
Accessibility	Low	Assessment Score
Product type:	Vinyl	1
Extent of Damage:	Minor	1
Surface Treatment:	Non-Friable	0
Asbestos type:	Chrysotile	1
Material Assessment Score:		3
Priority Assessment Score:		Negligible
Action:	Manage	
Comments:	N/A

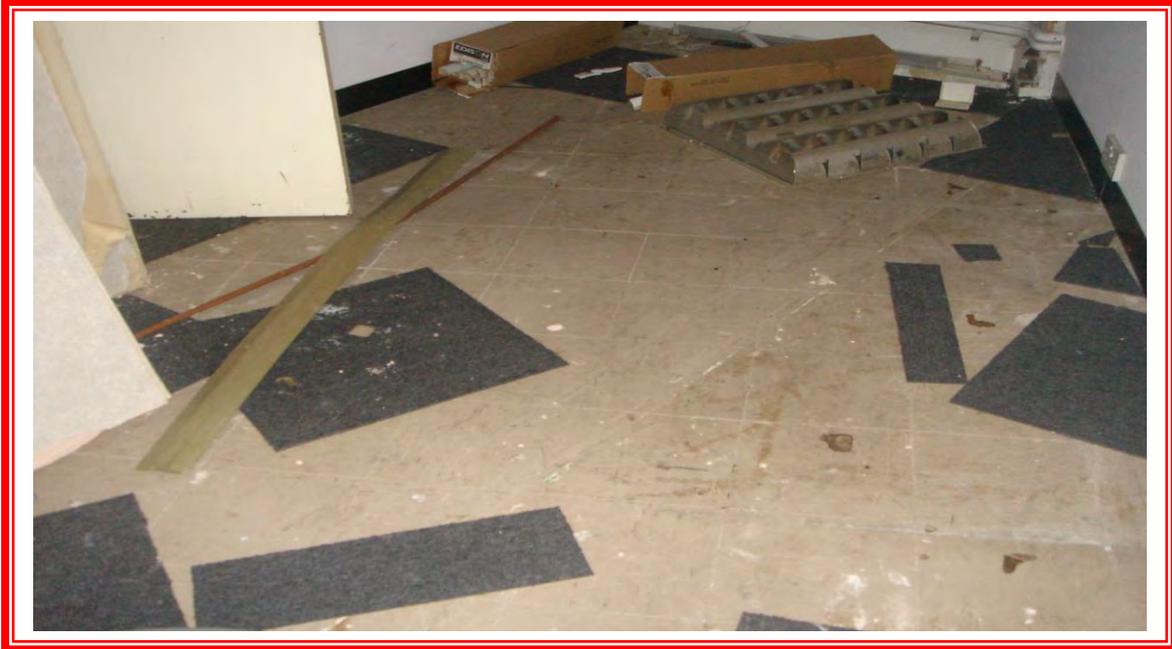
Material Description:	Vinyl Floor Tiles	
Identification:	As Per Sample NE/5 - Asbestos Detected	
Approx. quantity:	10M2	
Accessibility	Low	Assessment Score
Product type:	Vinyl	1
Extent of Damage:	Minor	1
Surface Treatment:	Non-Friable	0
Asbestos type:	Chrysotile	1
Material Assessment Score:		3
Priority Assessment Score:		Negligible
Action:	Manage	
Comments:	N/A

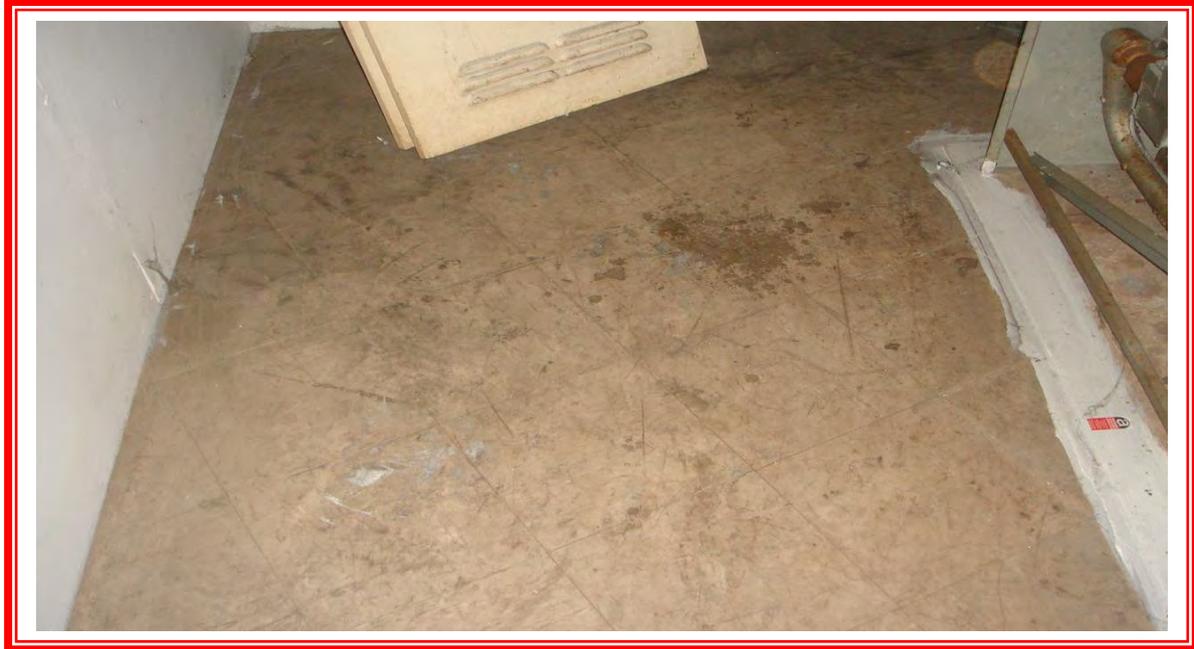
Material Description:	Vinyl Floor Tiles	
Identification:	As Per Sample NE/5 – Asbestos Detected	
Approx. quantity:	8M2	
Accessibility	Medium	Assessment Score
Product type:	Vinyl	1
Extent of Damage:	Minor	1
Surface Treatment:	Non-Friable	0
Asbestos type:	Chrysotile	1
Material Assessment Score:		3
Priority Assessment Score:		Negligible
Action:	Manage	
Comments:	N/A

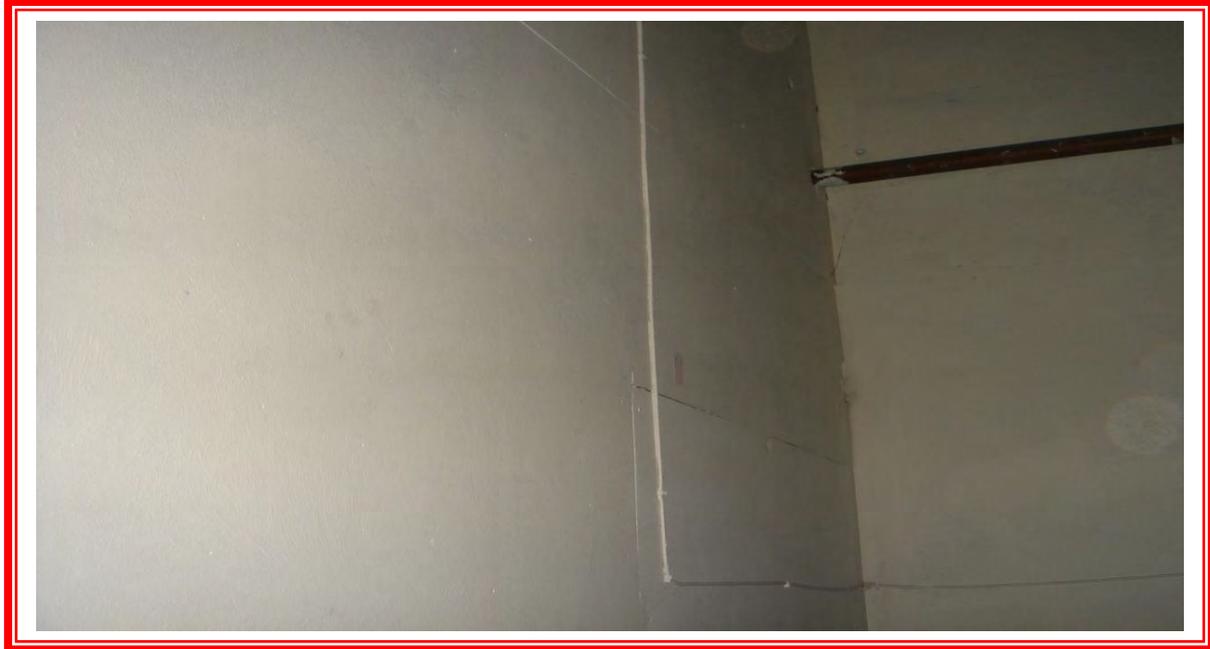
Material Description:	Asbestos Insulating Board to Walls	
Identification:	Sampled - Asbestos Detected	
Approx. quantity:	50M2	
Accessibility	Medium	Assessment Score
Product type:	Asbestos Insulating Board	2
Extent of Damage:	Minor	1
Surface Treatment:	Encapsulated	1
Asbestos type:	Amosite	2
Material Assessment Score:		6
Priority Assessment Score:		Low
Action:	Manage	
Comments:	All Four Walls

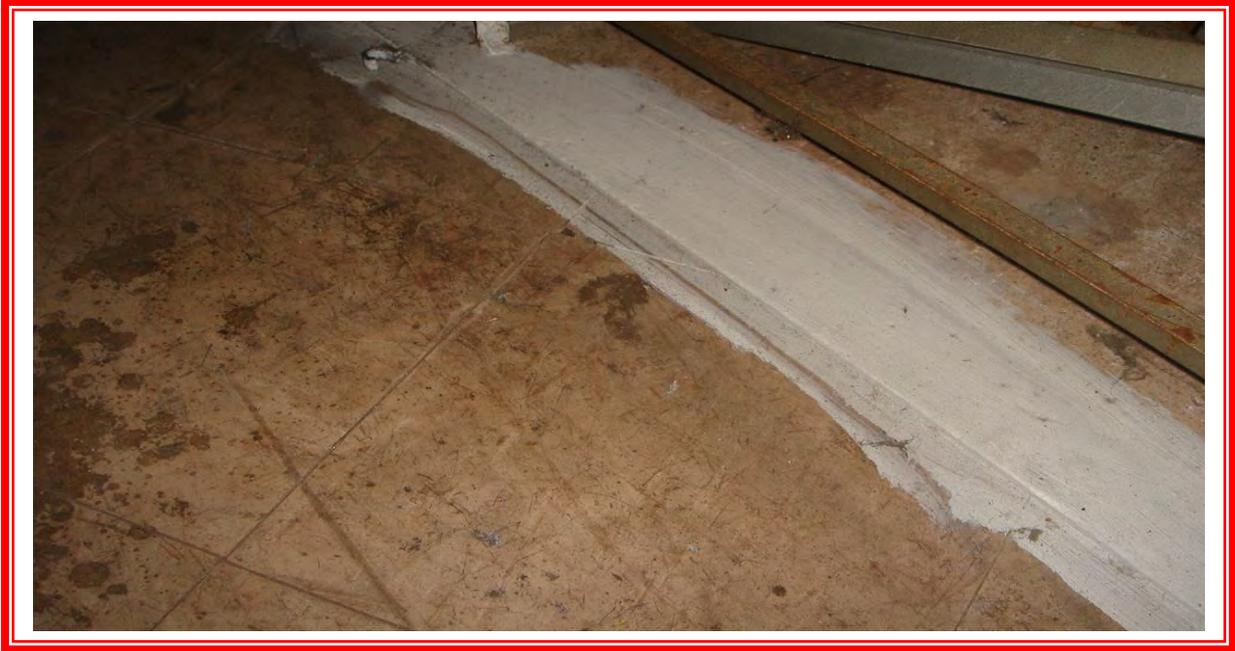
Material Description:	Asbestos Insulating Board to Boiler Floor Plinth	
Identification:	Sampled - Asbestos Detected	
Approx. quantity:	2M2	
Accessibility	Low	Assessment Score
Product type:	Asbestos Insulating Board	2
Extent of Damage:	Minor	1
Surface Treatment:	Encapsulated	1
Asbestos type:	Amosite	2
Material Assessment Score:		6
Priority Assessment Score:		Low
Action:	Manage	
Comments:	N/A

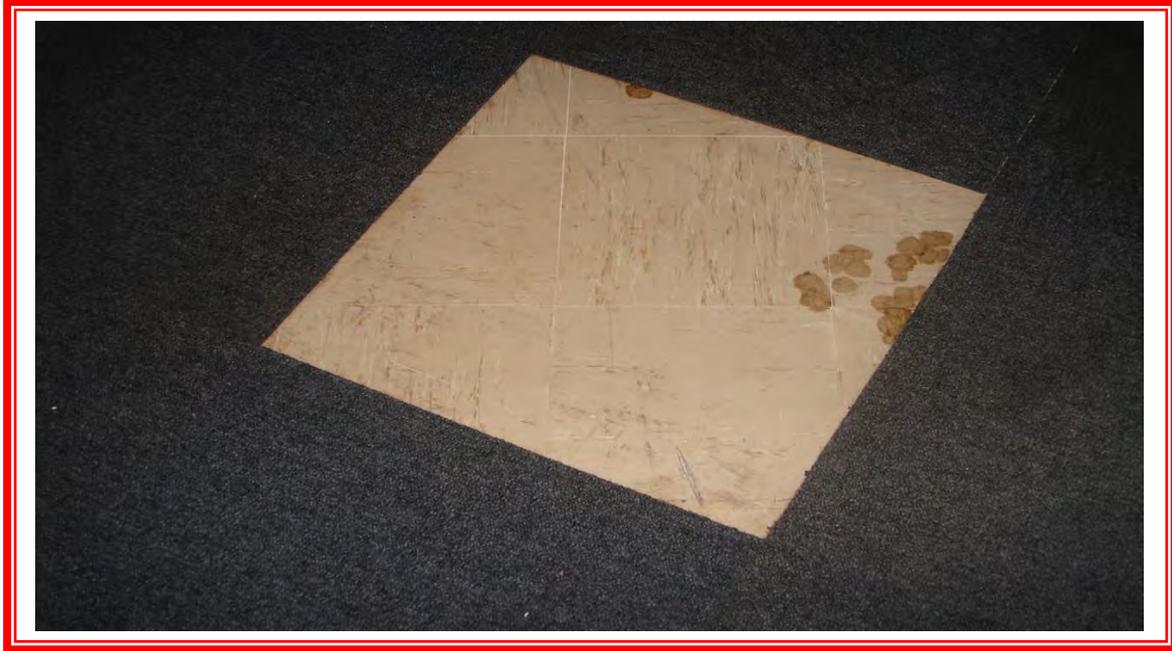
Material Description:	Vinyl Floor Tiles	
Identification:	As Per Sample NE/5 – Asbestos Detected	
Approx. quantity:	10M2	
Accessibility	Low	Assessment Score
Product type:	Vinyl	1
Extent of Damage:	Minor	1
Surface Treatment:	Non-Friable	0
Asbestos type:	Chrysotile	1
Material Assessment Score:		3
Priority Assessment Score:		Negligible
Action:	Manage	
Comments:	N/A

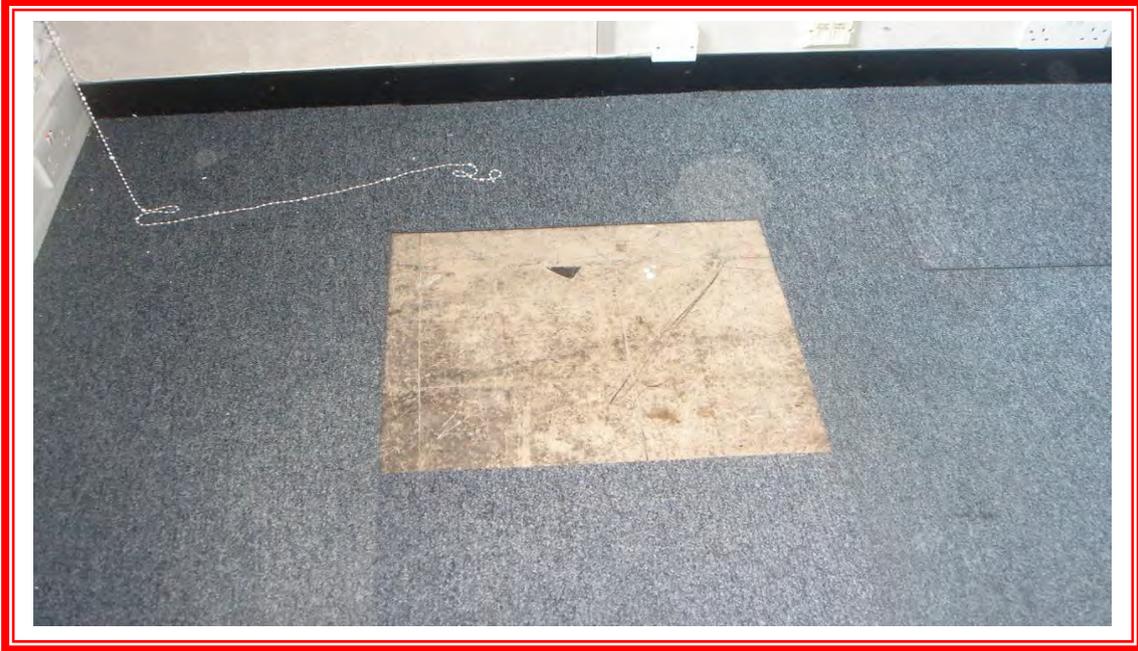
Material Description:	Vinyl Floor Tiles	
Identification:	Sampled - Asbestos Detected	
Approx. quantity:	12M2	
Accessibility	Low	Assessment Score
Product type:	Vinyl	1
Extent of Damage:	Minor	1
Surface Treatment:	Non-Friable	0
Asbestos type:	Chrysotile	1
Material Assessment Score:		3
Priority Assessment Score:		Negligible
Action:	Manage	
Comments:	N/A

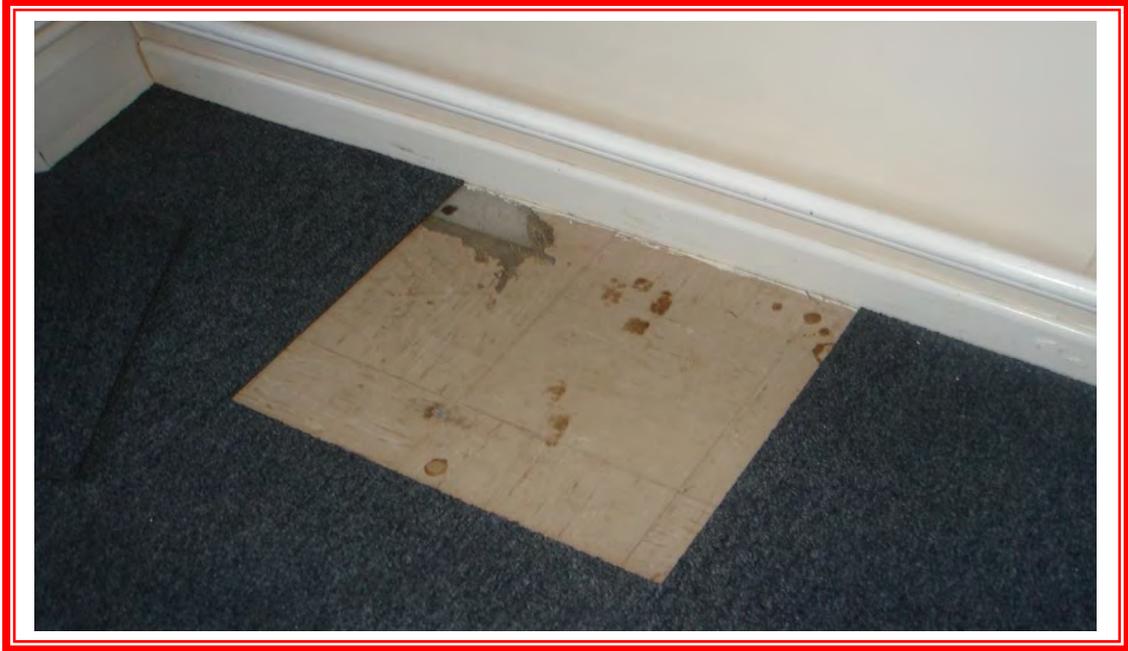
Material Description:	Vinyl Floor Tiles	
Identification:	As Per Sample NE/8 - Asbestos Detected	
Approx. quantity:	24M2	
Accessibility	Low	Assessment Score
Product type:	Vinyl	1
Extent of Damage:	Minor	1
Surface Treatment:	Non-Friable	0
Asbestos type:	Chrysotile	1
Material Assessment Score:		3
Priority Assessment Score:		Negligible
Action:	Manage	
Comments:	N/A

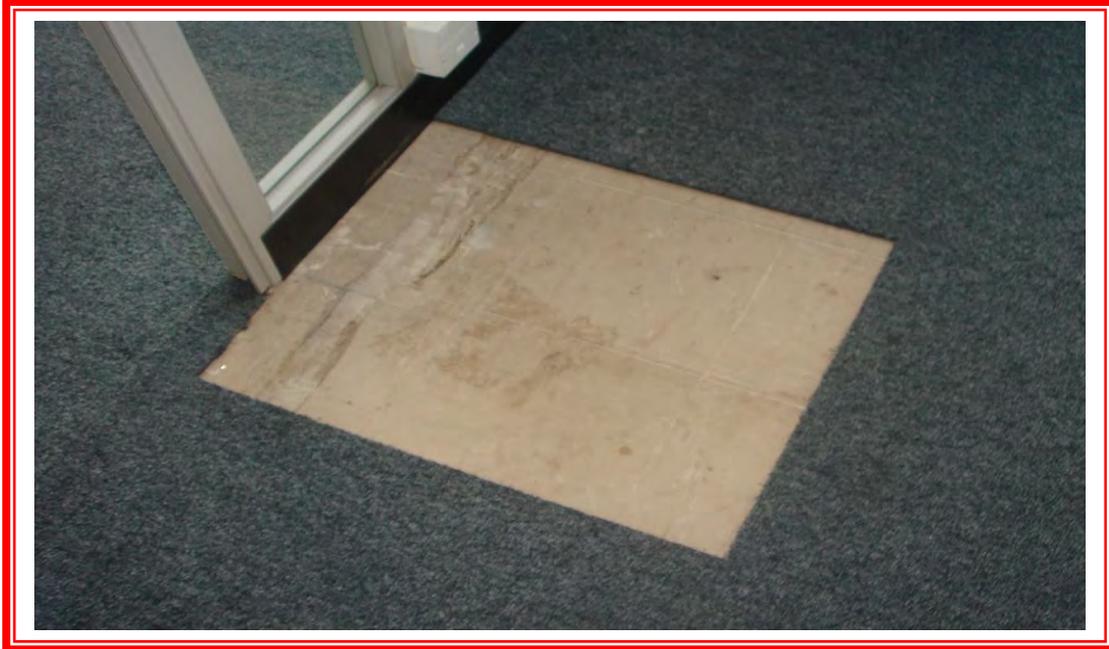
Material Description:	Vinyl Floor Tiles	
Identification:	As Per Sample NE/8 - Asbestos Detected	
Approx. quantity:	15M2	
Accessibility	Low	Assessment Score
Product type:	Vinyl	1
Extent of Damage:	Minor	1
Surface Treatment:	Non-Friable	0
Asbestos type:	Chrysotile	1
Material Assessment Score:		3
Priority Assessment Score:		Negligible
Action:	Manage	
Comments:	N/A

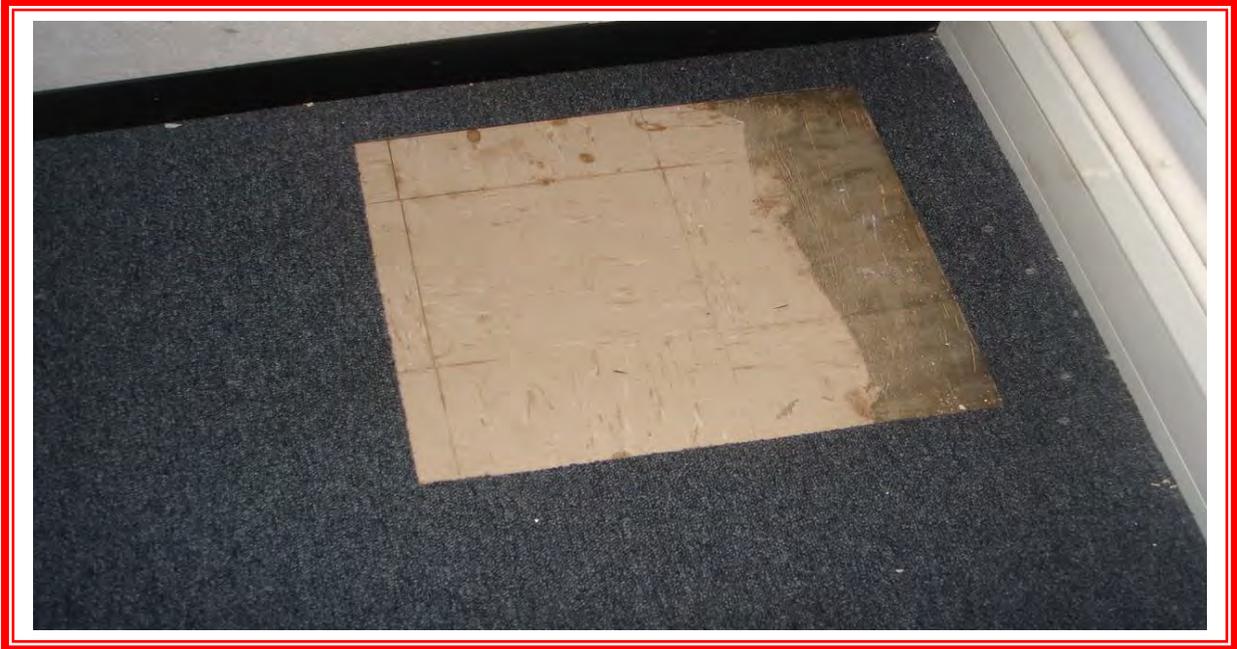
Location: 2/017

Material Description:	Vinyl Floor Tiles	
Identification:	As Per Sample NE/8 - Asbestos Detected	
Approx. quantity:	15M2	
Accessibility	Low	Assessment Score
Product type:	Vinyl	1
Extent of Damage:	Minor	1
Surface Treatment:	Non-Friable	0
Asbestos type:	Chrysotile	1
Material Assessment Score:		3
Priority Assessment Score:		Negligible
Action:	Manage	
Comments:	N/A

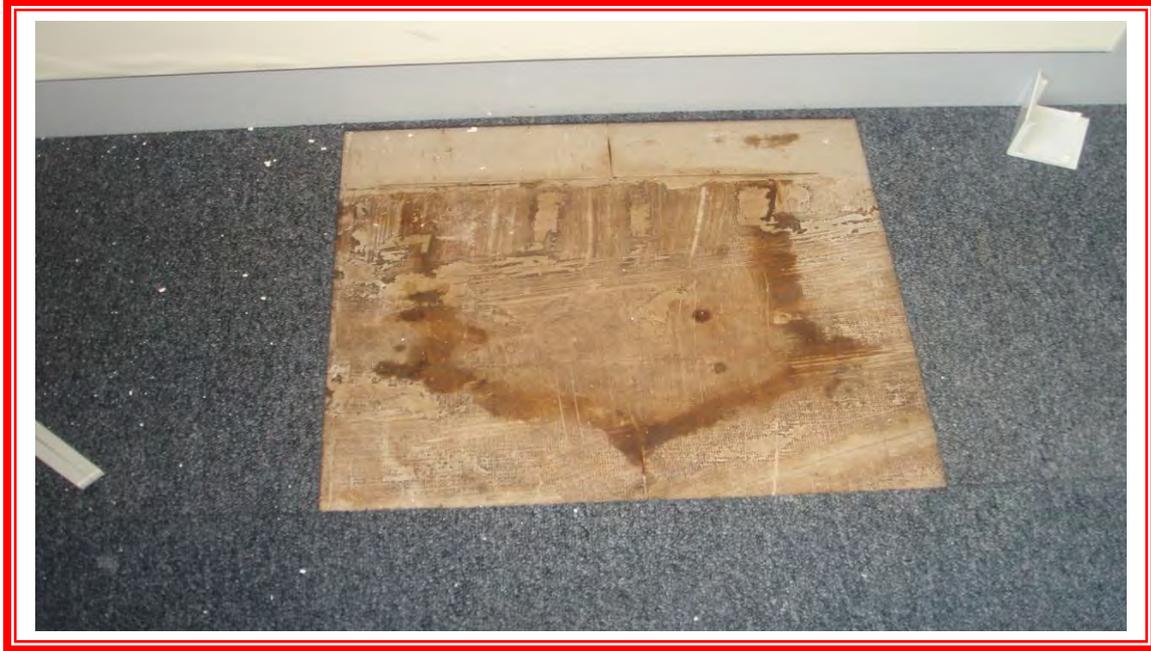
Material Description:	Vinyl Floor Tiles	
Identification:	As Per Sample NE/8 - Asbestos Detected	
Approx. quantity:	24M2	
Accessibility	Low	Assessment Score
Product type:	Vinyl	1
Extent of Damage:	Minor	1
Surface Treatment:	Non-Friable	0
Asbestos type:	Chrysotile	1
Material Assessment Score:		3
Priority Assessment Score:		Negligible
Action:	Manage	
Comments:	N/A

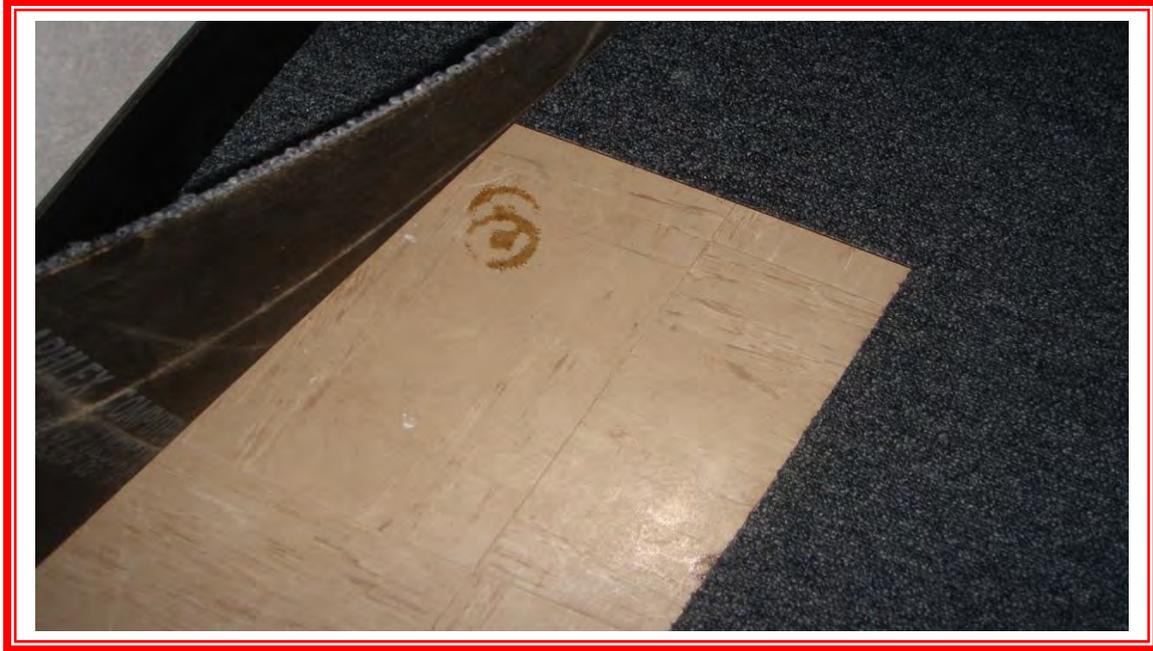
Material Description:	Vinyl Floor Tiles	
Identification:	As Per Sample NE/8 – Asbestos Detected	
Approx. quantity:	15M2	
Accessibility	Low	Assessment Score
Product type:	Vinyl	1
Extent of Damage:	Minor	1
Surface Treatment:	Non-Friable	0
Asbestos type:	Chrysotile	1
Material Assessment Score:		3
Priority Assessment Score:		Negligible
Action:	Manage	
Comments:	N/A

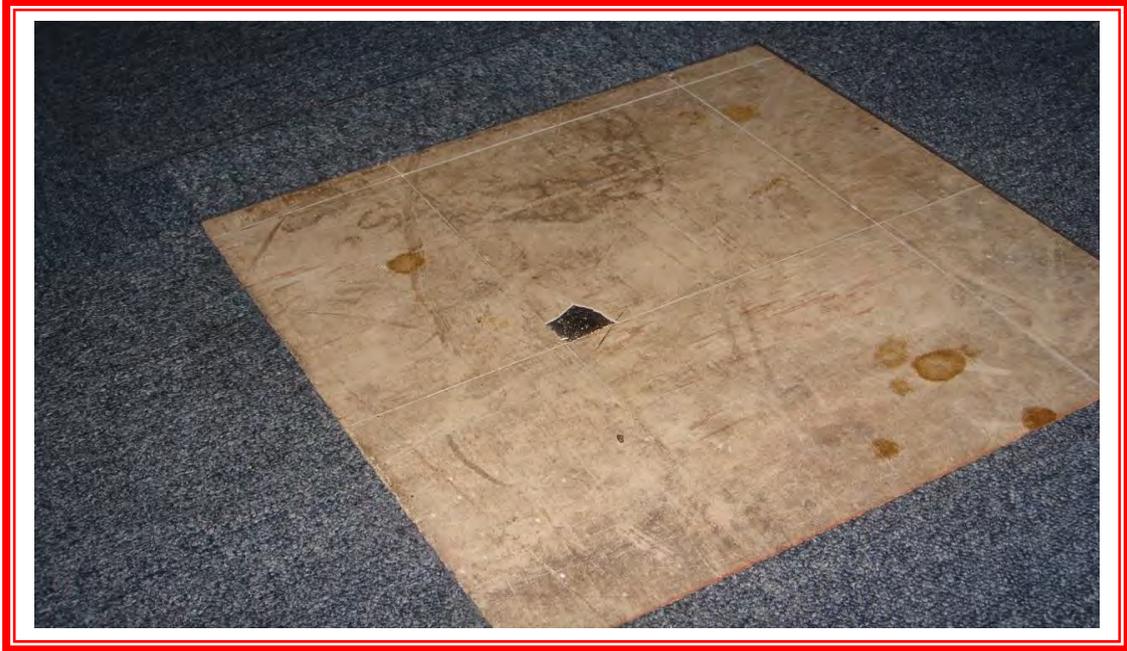
Material Description:	Vinyl Floor Tiles	
Identification:	Sampled – Asbestos Detected	
Approx. quantity:	32M2	
Accessibility	Low	Assessment Score
Product type:	Vinyl	1
Extent of Damage:	Minor	1
Surface Treatment:	Non-Friable	0
Asbestos type:	Chrysotile	1
Material Assessment Score:		3
Priority Assessment Score:		Negligible
Action:	Manage	
Comments:	N/A

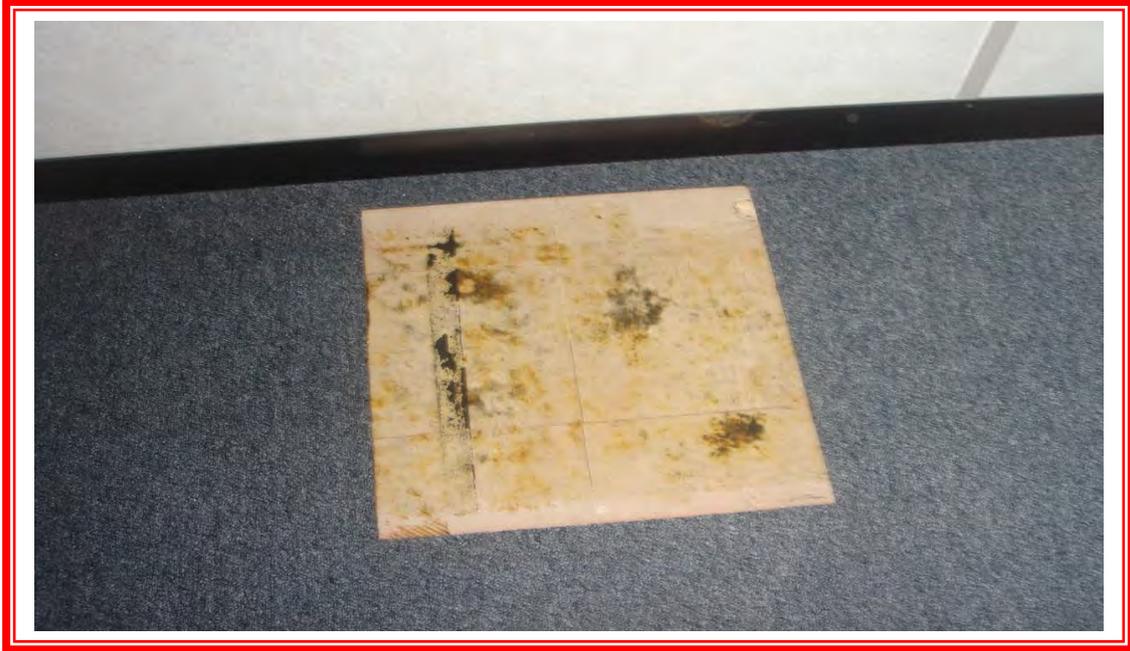
Material Description:	Vinyl Floor Tiles	
Identification:	As Per Sample NE/9 - Asbestos Detected	
Approx. quantity:	30M2	
Accessibility	Low	Assessment Score
Product type:	Vinyl	1
Extent of Damage:	Minor	1
Surface Treatment:	Non-Friable	0
Asbestos type:	Chrysotile	1
Material Assessment Score:		3
Priority Assessment Score:		Negligible
Action:	Manage	
Comments:	N/A

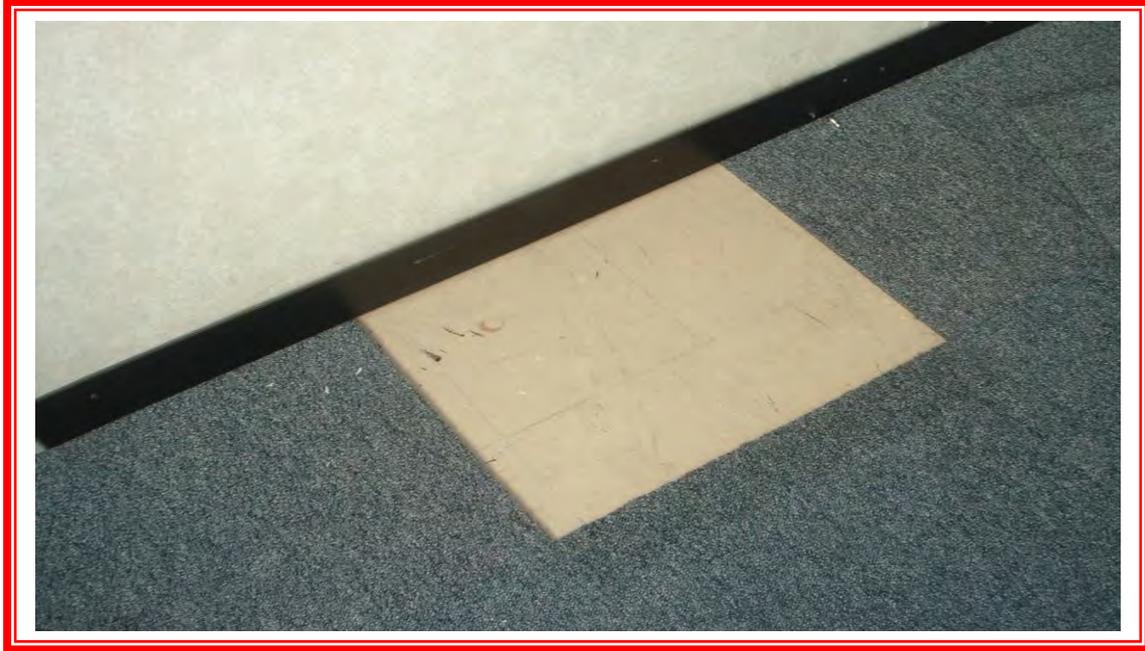
Material Description:	Vinyl Floor Tiles	
Identification:	As Per Sample NE/9 – Asbestos Detected	
Approx. quantity:	30M2	
Accessibility	Low	Assessment Score
Product type:	Vinyl	1
Extent of Damage:	Minor	1
Surface Treatment:	Non-Friable	0
Asbestos type:	Chrysotile	1
Material Assessment Score:		3
Priority Assessment Score:		Negligible
Action:	Manage	
Comments:	N/A

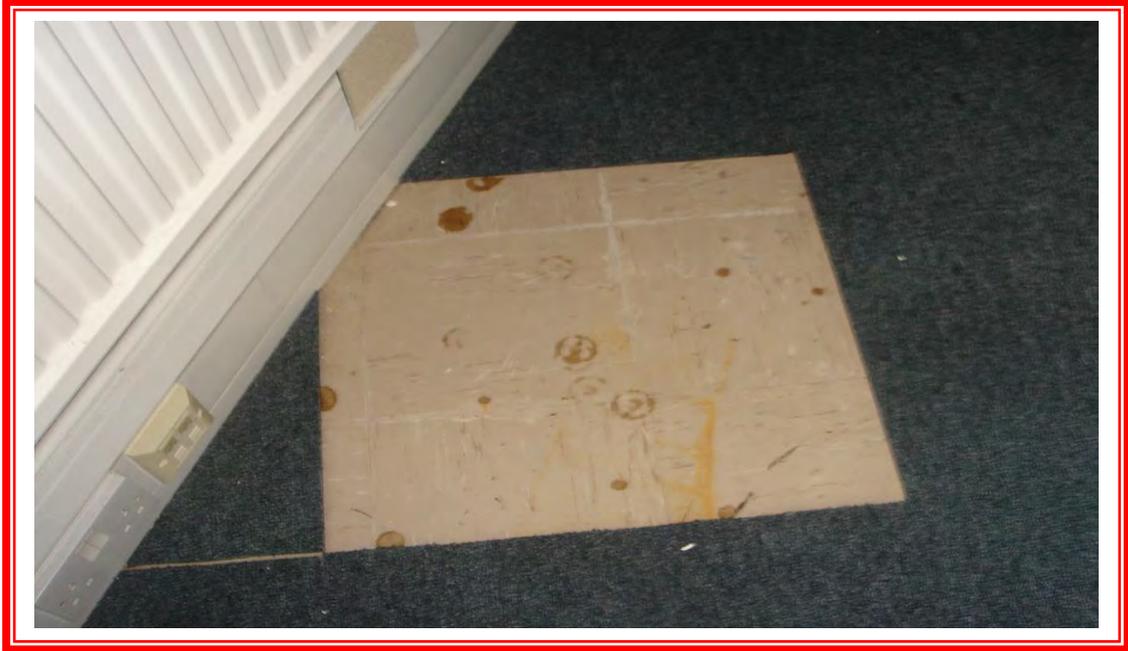
Material Description:	Vinyl Floor Tiles	
Identification:	As Per Sample NE/9 – Asbestos Detected	
Approx. quantity:	100M2	
Accessibility	Low	Assessment Score
Product type:	Vinyl	1
Extent of Damage:	Minor	1
Surface Treatment:	Non-Friable	0
Asbestos type:	Chrysotile	1
Material Assessment Score:		3
Priority Assessment Score:		Negligible
Action:	Manage	
Comments:	N/A

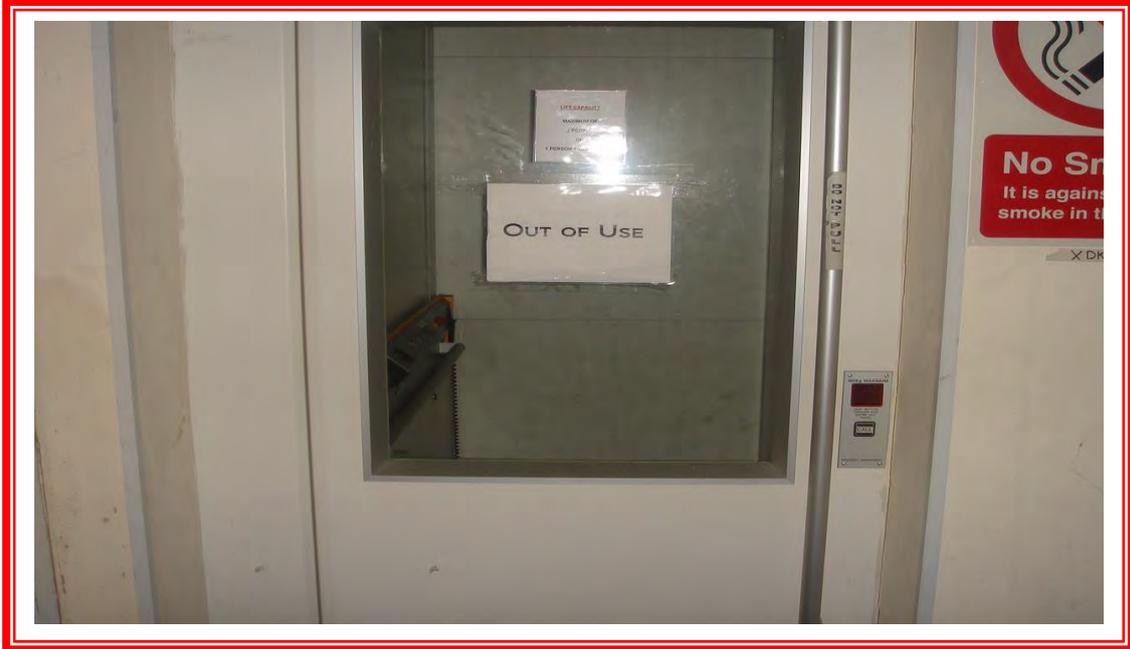
Material Description:	No Access to Lift or Shaft	
Identification:	Presumed to Contain Asbestos	
Approx. quantity:	Unknown	
Accessibility	Low	Assessment Score
Product type:	No Access	3
Extent of Damage:	No Access	3
Surface Treatment:	No Access	3
Asbestos type:	No Access	3
Material Assessment Score:		12
Priority Assessment Score:		High
Action:	Further Investigation Required	
Comments:	No Access as no lift engineer was onsite

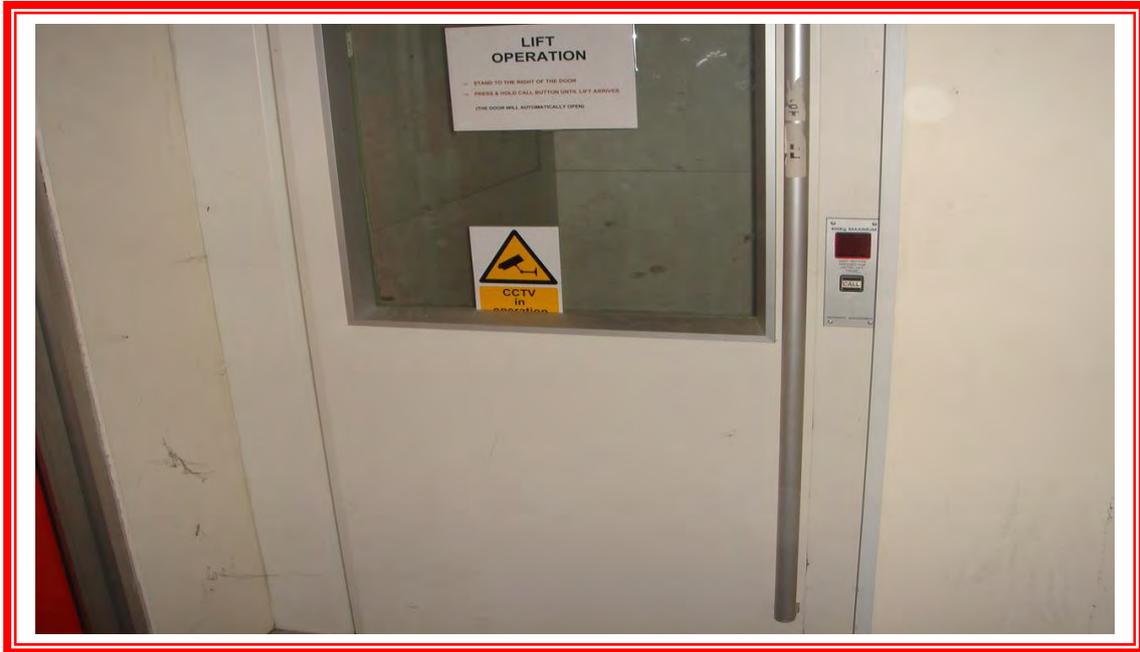
Material Description:	No Access to Lift or Shaft	
Identification:	Presumed to Contain Asbestos	
Approx. quantity:	Unknown	
Accessibility	Low	Assessment Score
Product type:	No Access	3
Extent of Damage:	No Access	3
Surface Treatment:	No Access	3
Asbestos type:	No Access	3
Material Assessment Score:		12
Priority Assessment Score:		High
Action:	Further Investigation Required	
Comments:	No Access as no lift engineer was onsite

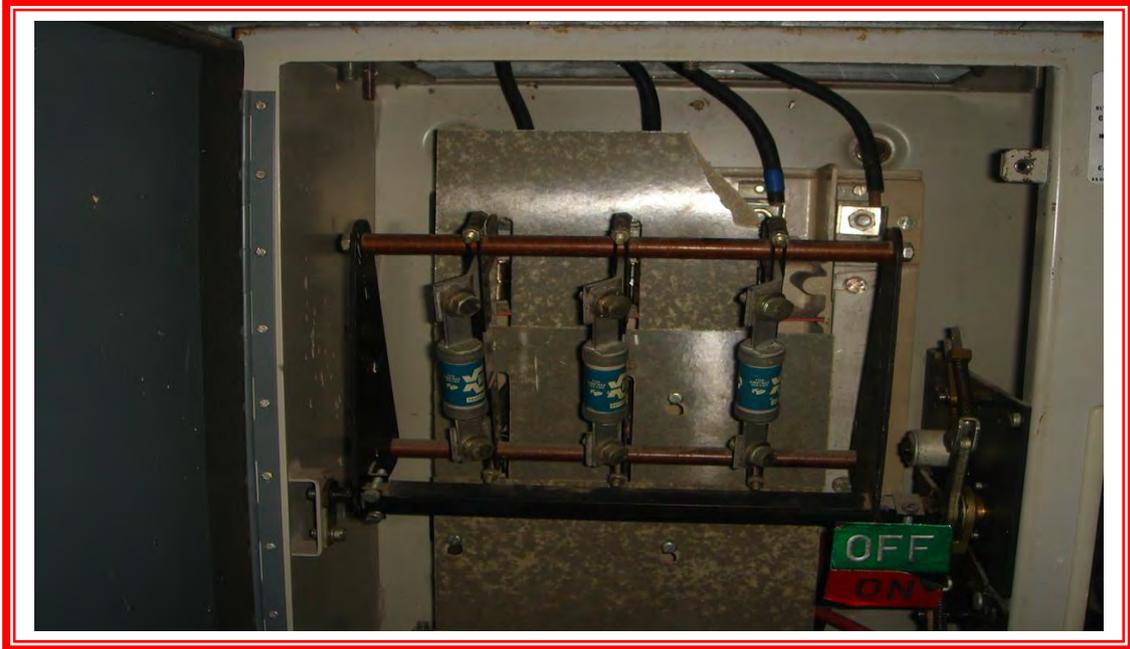
Material Description:	Flash Flash Guards to Redundant electrical box	
Identification:	Sampled – Asbestos Detected	
Approx. quantity:	All Flashguards	
Accessibility	Low	Assessment Score
Product type:	Cement	1
Extent of Damage:	Minor	1
Surface Treatment:	Non-Friable	0
Asbestos type:	Chrysotile	1
Material Assessment Score:		3
Priority Assessment Score:		Negligible
Action:	Manage	
Comments:	N/A

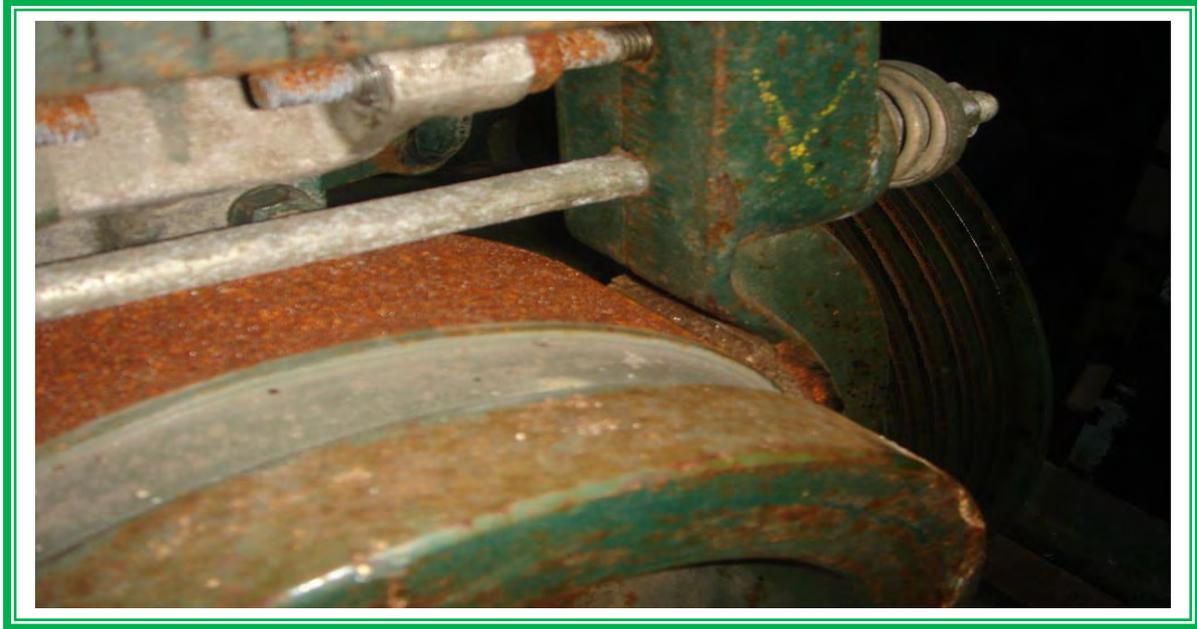
Material Description:	Lift Brake Shoes/Lining Textile	
Identification:	Sampled - No Asbestos Detected	
Approx. quantity:	<0.5M2	
Accessibility	N/A	Assessment Score
Product type:	N/A	N/A
Extent of Damage:	N/A	N/A
Surface Treatment:	N/A	N/A
Asbestos type:	N/A	N/A
Material Assessment Score:		N/A
Priority Assessment Score:		N/A
Action:	N/A	
Comments:	N/A

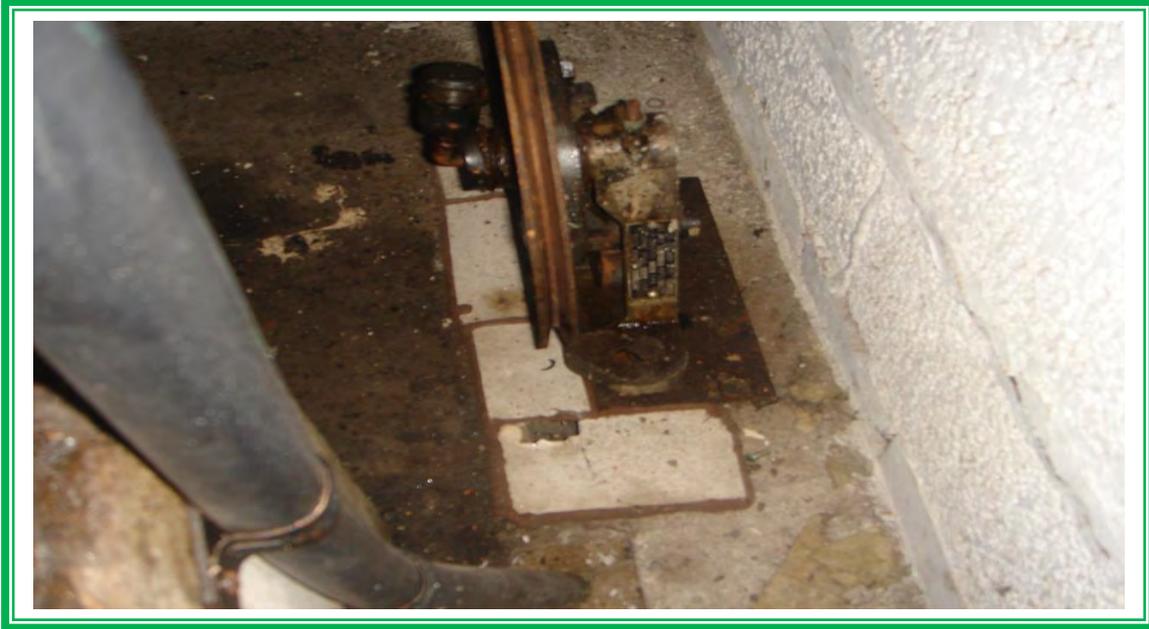
Material Description:	Insulating Board	
Identification:	Sampled - No Asbestos Detected	
Approx. quantity:	1M2	
Accessibility	N/A	Assessment Score
Product type:	N/A	N/A
Extent of Damage:	N/A	N/A
Surface Treatment:	N/A	N/A
Asbestos type:	N/A	N/A
Material Assessment Score:		N/A
Priority Assessment Score:		N/A
Action:	N/A	
Comments:	To Floor as Debris
