Document Name	Author	Issued by	Revision Number	Issue Date	Page No
2019	Emma Humphreys	Armour AS	0	29/11/2019	25

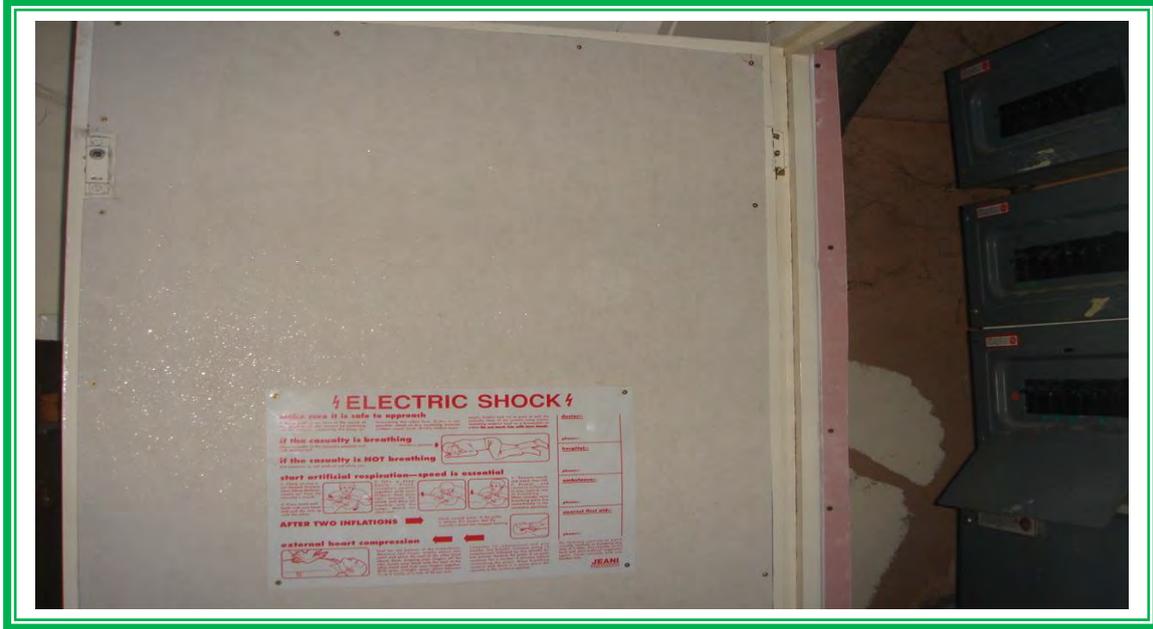
Material Description:	Insulating Board to Doors	
Identification:	Sampled – No Asbestos Detected	
Approx. quantity:	4M2	
Accessibility	N/A	Assessment Score
Product type:	N/A	N/A
Extent of Damage:	N/A	N/A
Surface Treatment:	N/A	N/A
Asbestos type:	N/A	N/A
Material Assessment Score:		N/A
Priority Assessment Score:		N/A
Action:	N/A	
Comments:	N/A

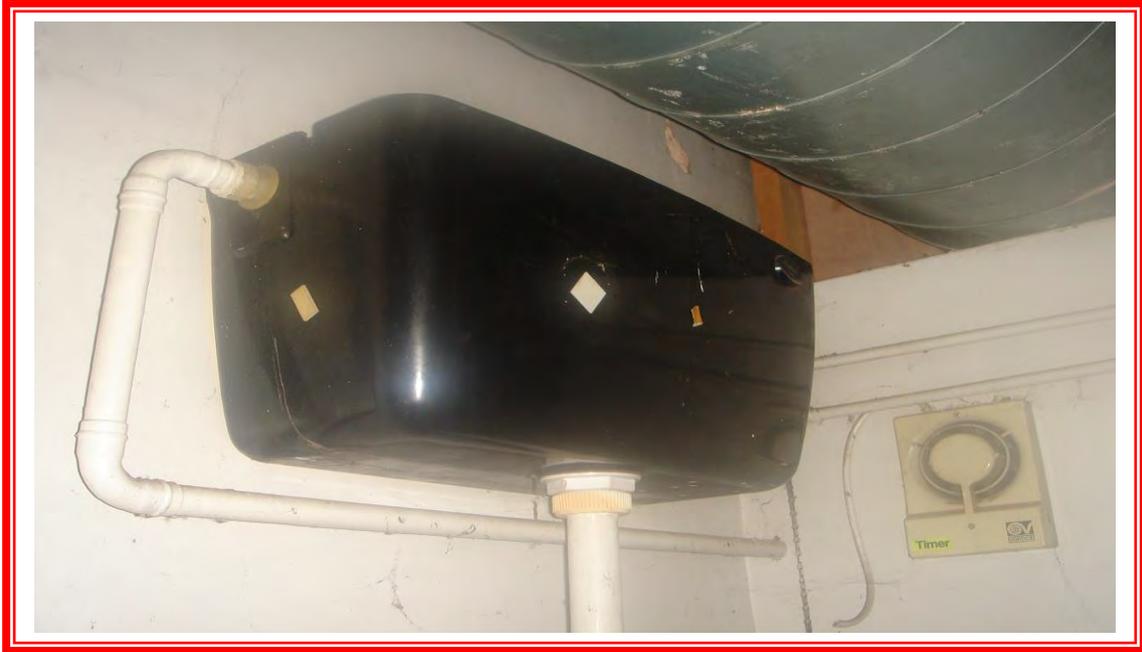
Material Description:	Toilet Cistern	
Identification:	Sampled – Asbestos Detected	
Approx. quantity:	X 1	
Accessibility	Low	<i>Assessment Score</i>
Product type:	Composite	1
Extent of Damage:	Minor	1
Surface Treatment:	Non-Friable	0
Asbestos type:	Amosite	2
Material Assessment Score:		4
Priority Assessment Score:		Negligible
Action:	Manage	
Comments:	N/A

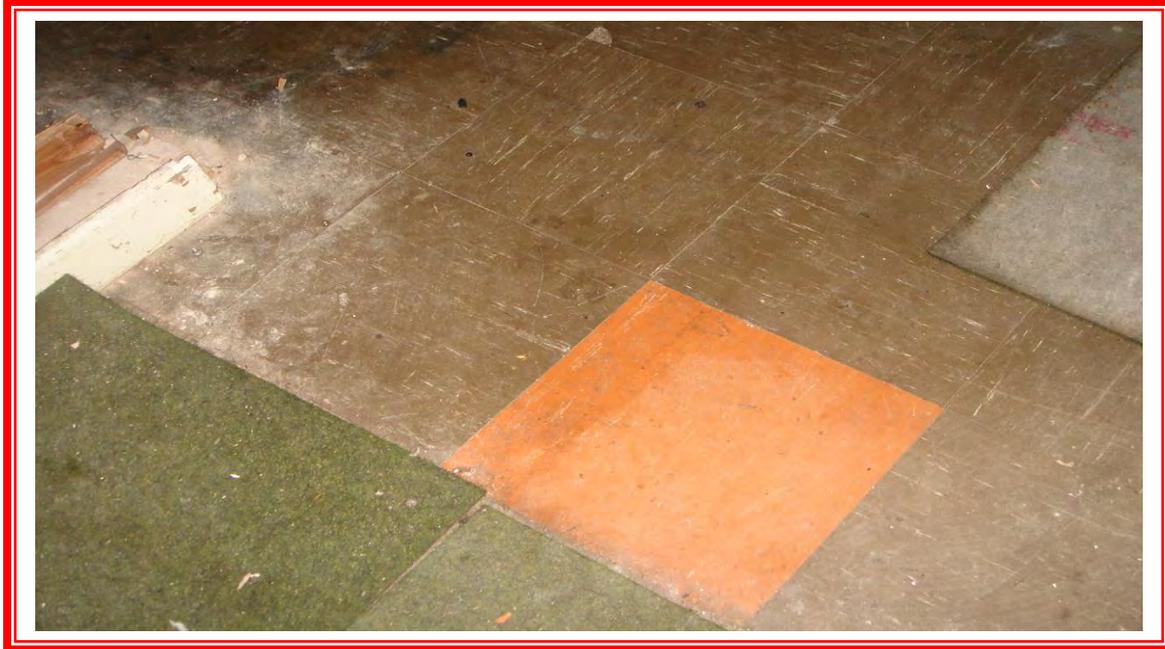
Material Description:	Vinyl Floor Tiles	
Identification:	Sampled - Asbestos Detected	
Approx. quantity:	8M2	
Accessibility	Low	Assessment Score
Product type:	Vinyl	1
Extent of Damage:	Minor	1
Surface Treatment:	Non-Friable	0
Asbestos type:	Chrysotile	1
Material Assessment Score:		3
Priority Assessment Score:		Negligible
Action:	Manage	
Comments:	N/A

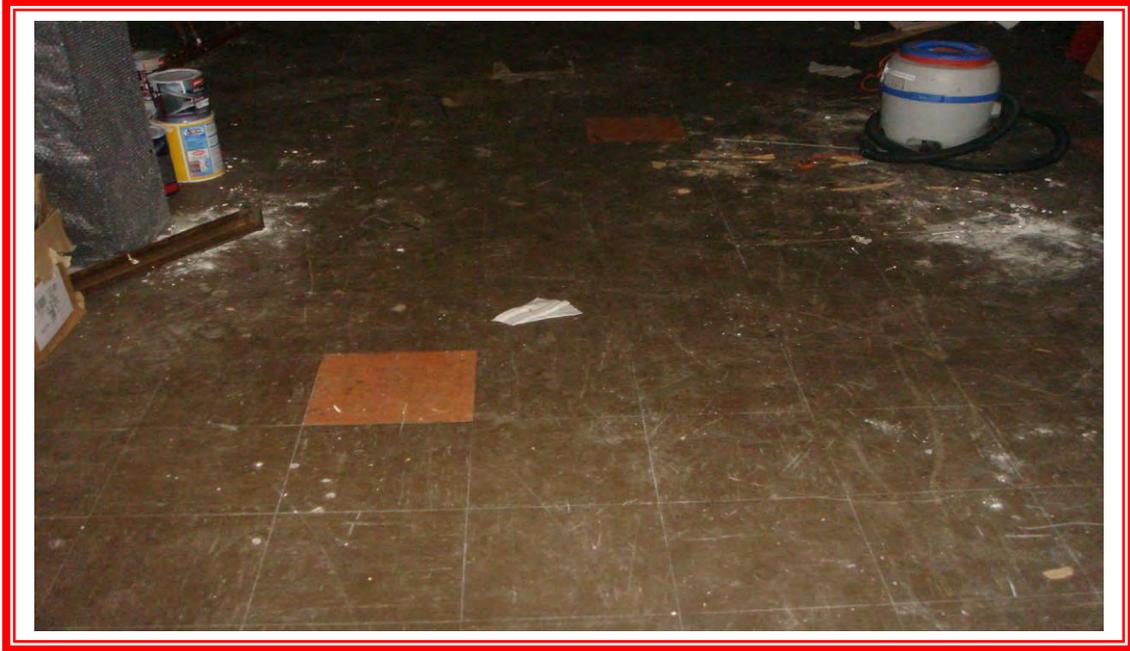
Material Description:	Vinyl Floor Tiles	
Identification:	As Per Sample 2 – Asbestos Detected	
Approx. quantity:	50M2	
Accessibility	Low	Assessment Score
Product type:	Vinyl	1
Extent of Damage:	Minor	1
Surface Treatment:	Non-Friable	0
Asbestos type:	Chrysotile	1
Material Assessment Score:		3
Priority Assessment Score:		Negligible
Action:	Manage	
Comments:	N/A

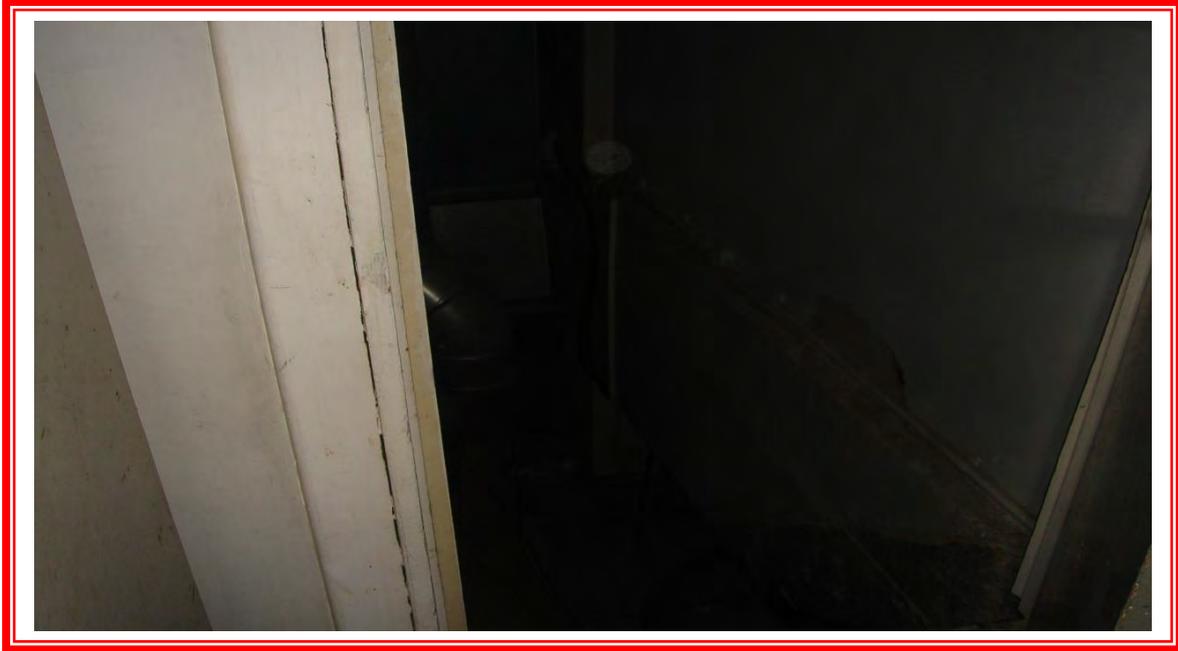
Material Description:	No Access Due to No Floor	
Identification:	Presumed to Contain Asbestos	
Approx. quantity:	Unknown	
Accessibility	Low	Assessment Score
Product type:	No Access	3
Extent of Damage:	No Access	3
Surface Treatment:	No Access	3
Asbestos type:	No Access	3
Material Assessment Score:		12
Priority Assessment Score:		High
Action:	Further Investigation Required	
Comments:	Unable to gain access as there is no floor

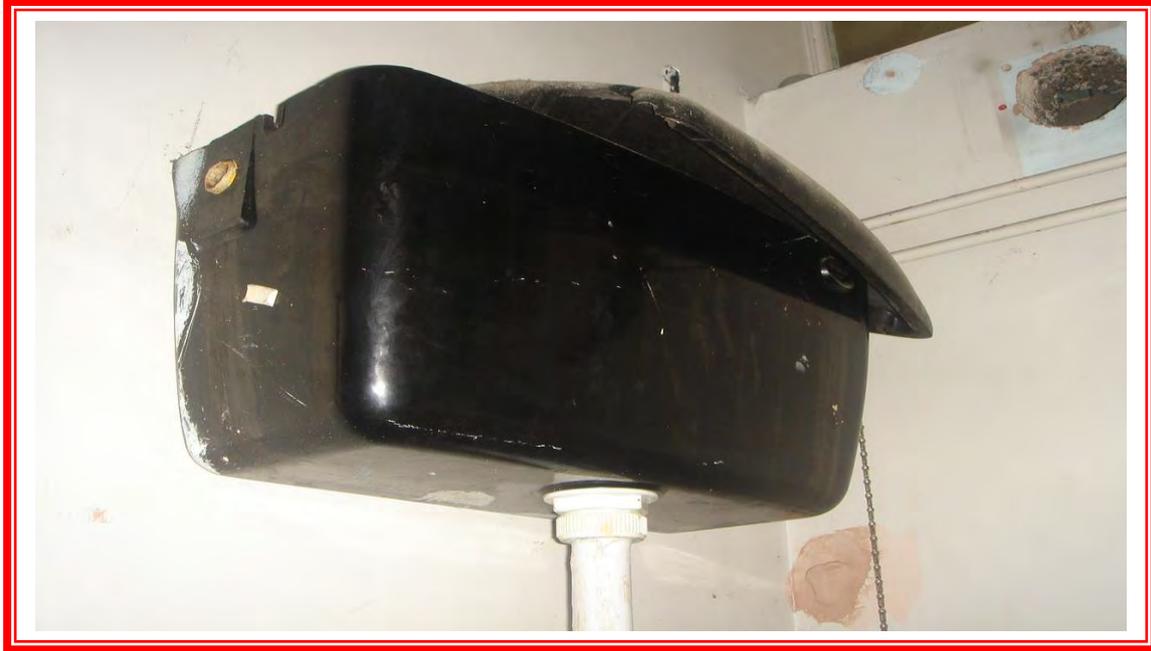
Material Description:	Toilet Cistern	
Identification:	As Per Sample 1 – Asbestos Detected	
Approx. quantity:	X 1	
Accessibility	Low	Assessment Score
Product type:	Composite	1
Extent of Damage:	Minor	1
Surface Treatment:	Non-Friable	0
Asbestos type:	Amosite	2
Material Assessment Score:		4
Priority Assessment Score:		Negligible
Action:	Manage	
Comments:	N/A

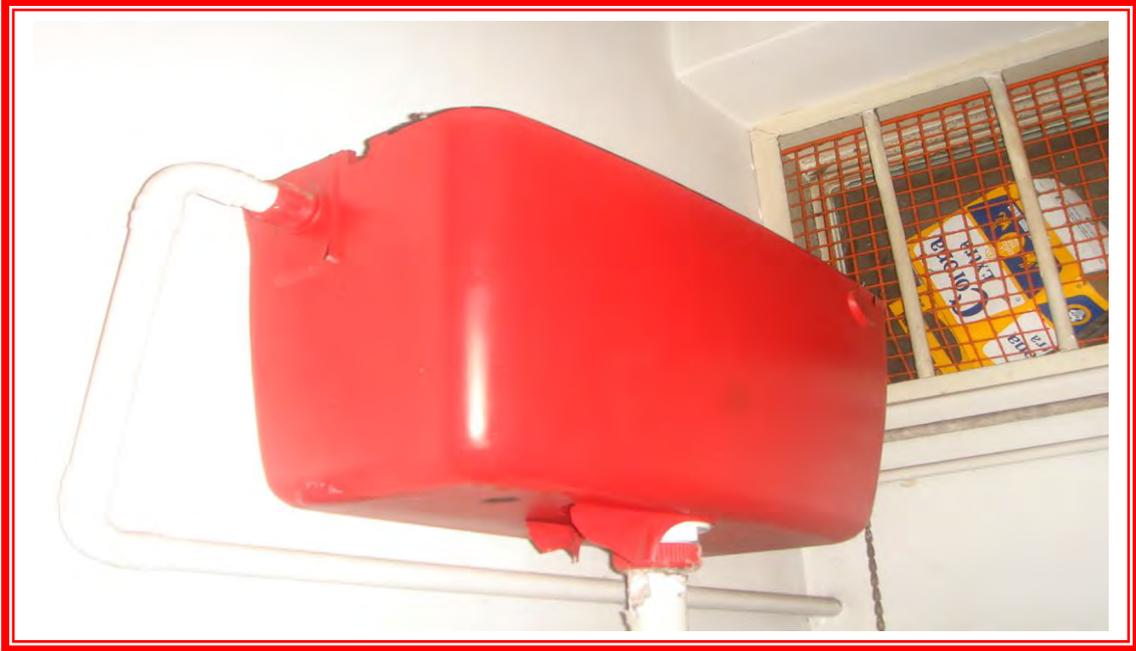
Material Description:	Toilet Cistern	
Identification:	As Per Sample 1 – Asbestos Detected	
Approx. quantity:	X 1	
Accessibility	Low	Assessment Score
Product type:	Composite	1
Extent of Damage:	Minor	1
Surface Treatment:	Non-Friable	0
Asbestos type:	Amosite	2
Material Assessment Score:		4
Priority Assessment Score:		Negligible
Action:	Manage	
Comments:	N/A

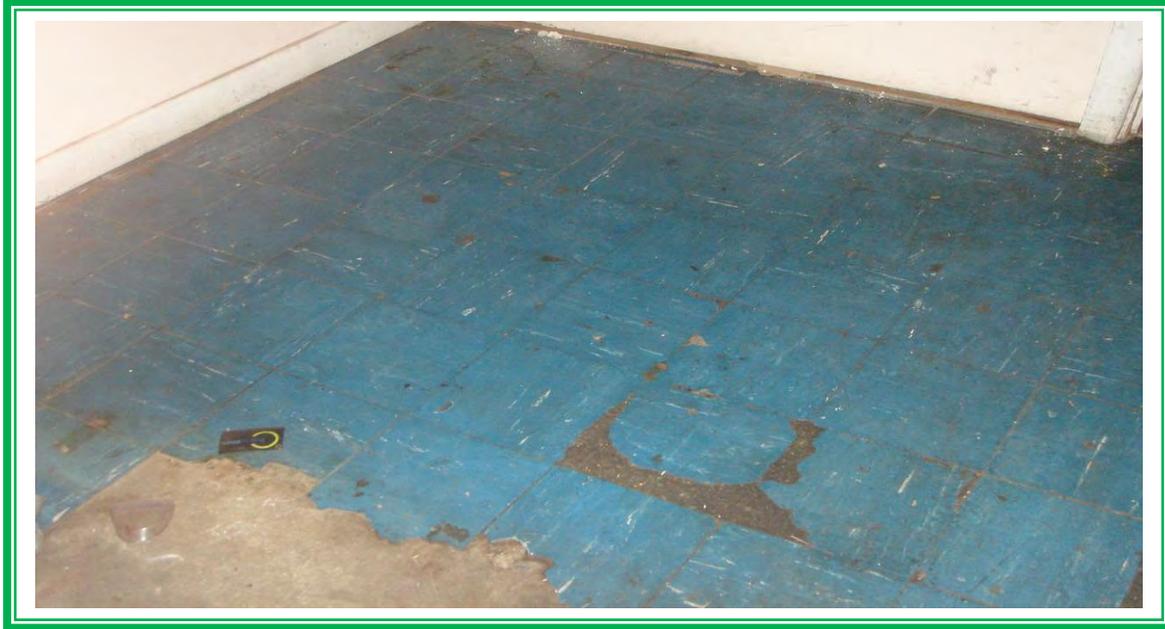
Material Description:	Vinyl Floor Tiles	
Identification:	Sampled – No Asbestos Detected	
Approx. quantity:	6M2	
Accessibility	N/A	Assessment Score
Product type:	N/A	N/A
Extent of Damage:	N/A	N/A
Surface Treatment:	N/A	N/A
Asbestos type:	N/A	N/A
Material Assessment Score:		N/A
Priority Assessment Score:		N/A
Action:	N/A	
Comments:	N/A

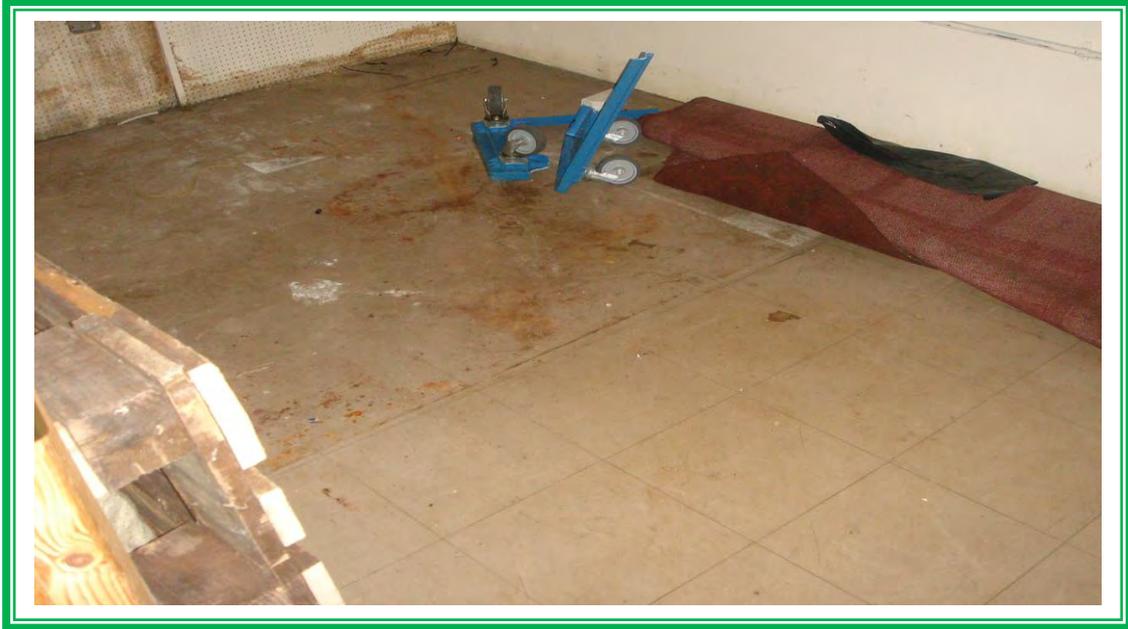
Material Description:	Vinyl Floor Tiles	
Identification:	As Per Sample 3 – No Asbestos Detected	
Approx. quantity:	8M2	
Accessibility	N/A	Assessment Score
Product type:	N/A	N/A
Extent of Damage:	N/A	N/A
Surface Treatment:	N/A	N/A
Asbestos type:	N/A	N/A
Material Assessment Score:		N/A
Priority Assessment Score:		N/A
Action:	N/A	
Comments:	N/A
