Project Number 3113

Management
Asbestos Survey Report

Kennet Centre, Market Street, Newbury,
Berkshire, RG14 5EN

1-3 The Mall

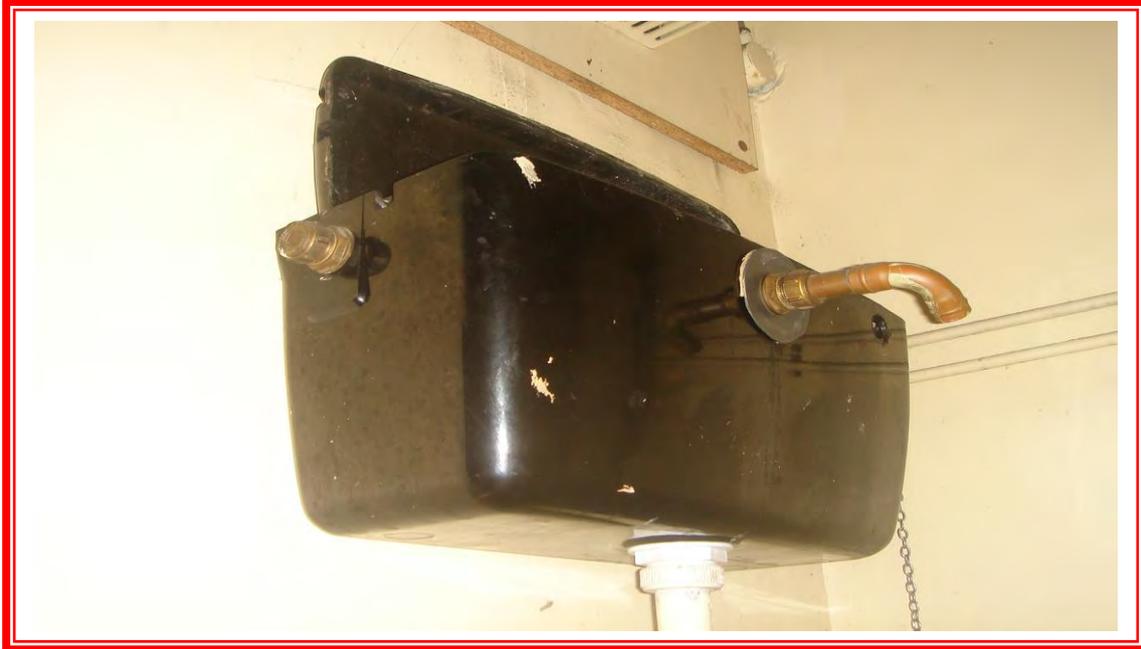
Location: 1/004 WC

Material Description:	Toilet Cistern	
Identification:	Sampled - Asbestos Detected	
Approx. quantity:	1 X Item	
Accessibility	Low	Assessment Score
Product type:	Composite	1
Extent of Damage:	Good	0
Surface Treatment:	Non-Friable	0
Asbestos type:	Amosite	2
Material Assessment Score:		3
Priority Assessment Score:		Negligible
Action:	Manage	
Comments:	N/A

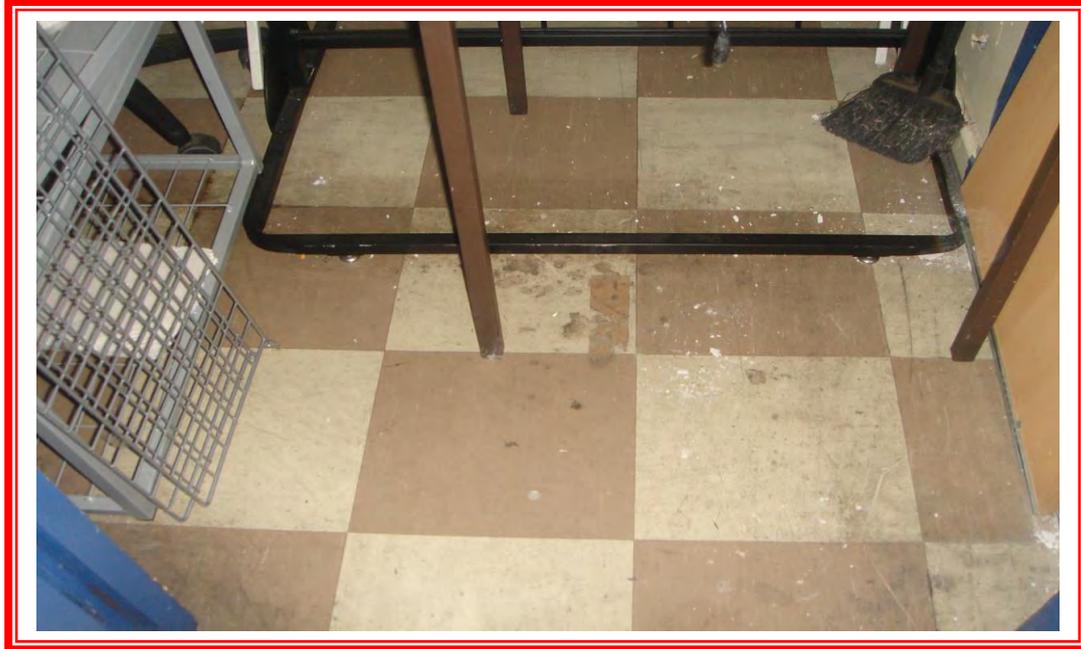
Location: 1/007

Material Description:	Vinyl Floor Tiles	
Identification:	As Per Sample NE/1 - Asbestos Detected	
Approx. quantity:	6M2	
Accessibility	Low	Assessment Score
Product type:	Vinyl	1
Extent of Damage:	Minor	1
Surface Treatment:	Non-Friable	0
Asbestos type:	Chrysotile	1
Material Assessment Score:		3
Priority Assessment Score:		Negligible
Action:	Manage	
Comments:	N/A

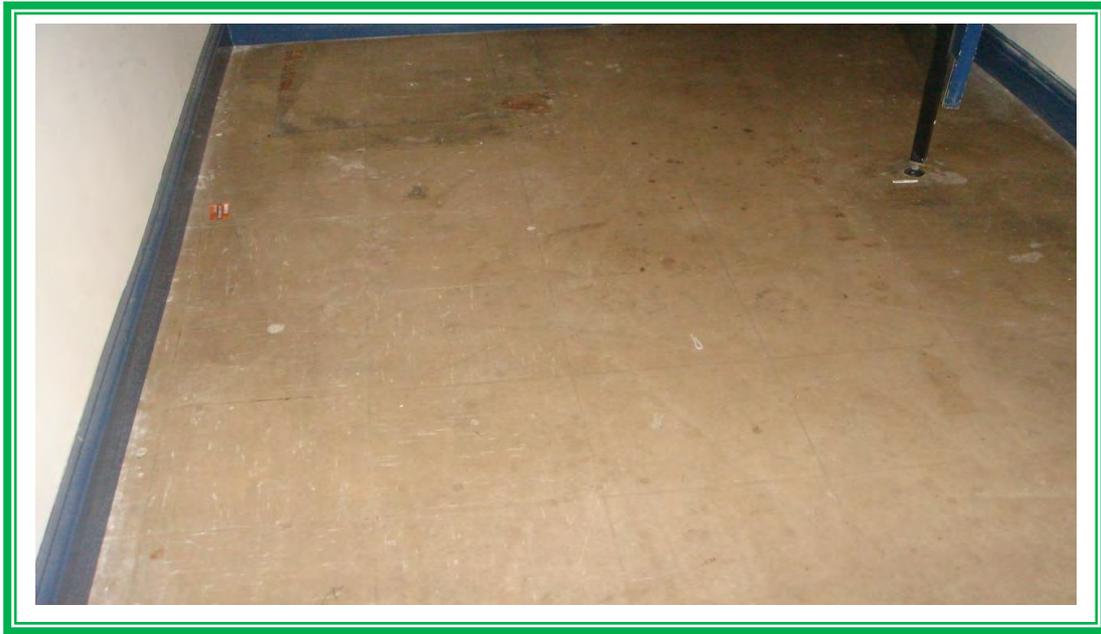
Location: 1/002

Material Description:	Vinyl Floor Tiles	
Identification:	Sampled – No Asbestos Detected	
Approx. quantity:	4M2	
Accessibility	N/A	Assessment Score
Product type:	N/A	N/A
Extent of Damage:	N/A	N/A
Surface Treatment:	N/A	N/A
Asbestos type:	N/A	N/A
Material Assessment Score:		N/A
Priority Assessment Score:		N/A
Action:	N/A	
Comments:	N/A

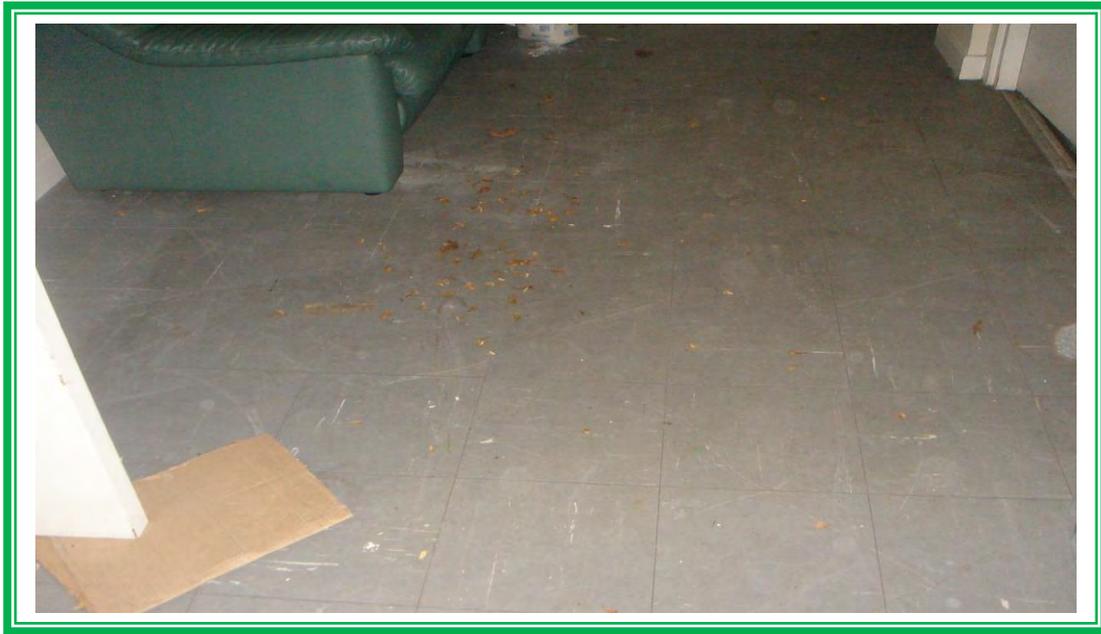
Item No: 1	Sample No: NE/1
Location: 1/001 Kitchen

Material Description:	Vinyl Floor Tiles	
Identification:	Sampled – No Asbestos Detected	
Approx. quantity:	15M2	
Accessibility	N/A	Assessment Score
Product type:	N/A	N/A
Extent of Damage:	N/A	N/A
Surface Treatment:	N/A	N/A
Asbestos type:	N/A	N/A
Material Assessment Score:		N/A
Priority Assessment Score:		N/A
Action:	N/A	
Comments:	N/A

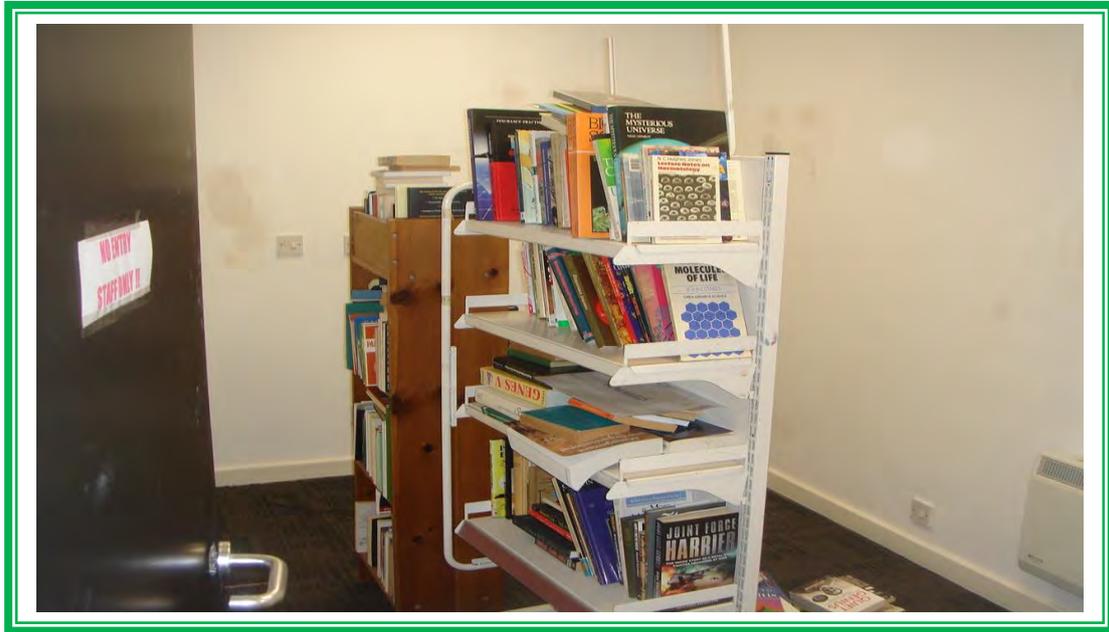
Location: 0/002 Store

Material Description:	Visual Inspection – No Suspect Materials Found	
Identification:	N/A	
Approx. quantity:	N/A	
Accessibility	N/A	Assessment Score
Product type:	N/A	N/A
Extent of Damage:	N/A	N/A
Surface Treatment:	N/A	N/A
Asbestos type:	N/A	N/A
Material Assessment Score:		N/A
Priority Assessment Score:		N/A
Action:	N/A	
Comments:	N/A

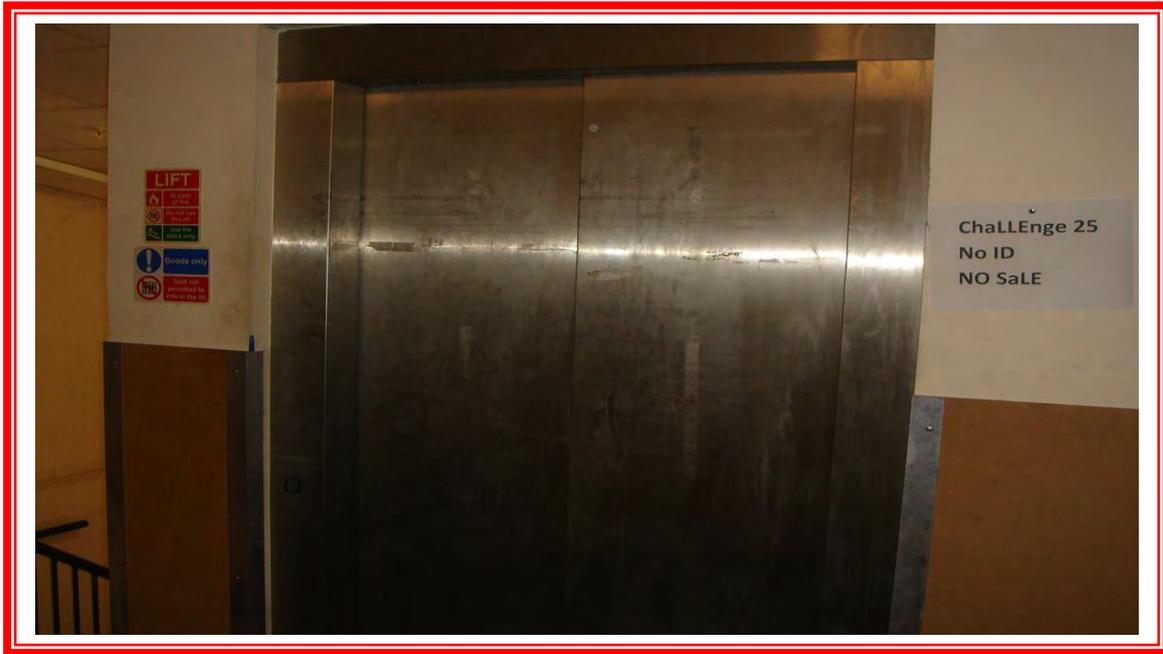
Material Description:	No Access	
Identification:	Presumed to Contain Asbestos	
Approx. quantity:	Unknown	
Accessibility	Low	Assessment Score
Product type:	No Access	3
Extent of Damage:	No Access	3
Surface Treatment:	No Access	3
Asbestos type:	No Access	3
Material Assessment Score:		12
Priority Assessment Score:		High
Action:	Further Inspection Required	
Comments:	No access as no lift engineer onsite

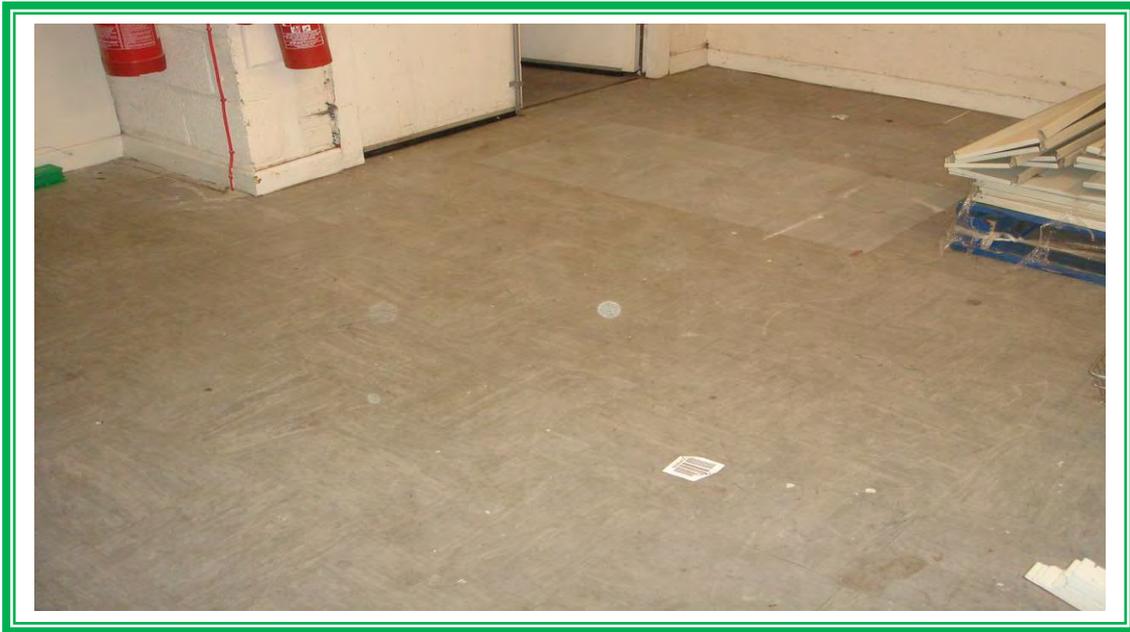
Location: 1/001 Corridor

Material Description:	Vinyl Floor Tiles	
Identification:	Sampled – No Asbestos Detected	
Approx. quantity:	6M2	
Accessibility	N/A	Assessment Score
Product type:	N/A	N/A
Extent of Damage:	N/A	N/A
Surface Treatment:	N/A	N/A
Asbestos type:	N/A	N/A
Material Assessment Score:		N/A
Priority Assessment Score:		N/A
Action:	N/A	
Comments:	N/A

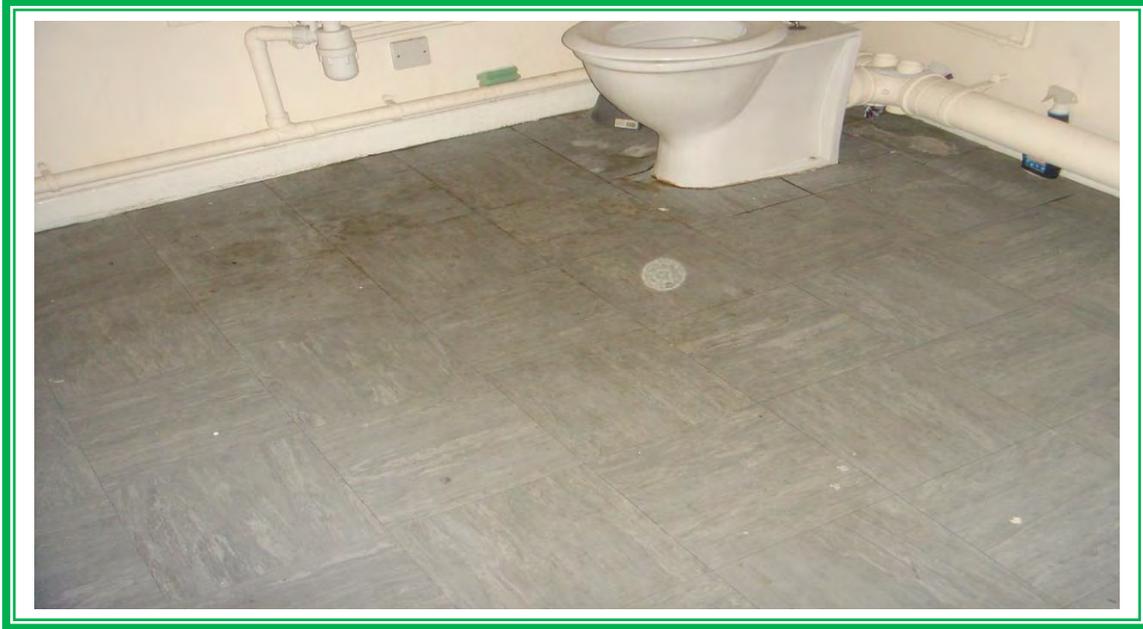
Material Description:	Vinyl Floor Tiles	
Identification:	As Per Sample NE/1 – No Asbestos Detected	
Approx. quantity:	6M2	
Accessibility	N/A	Assessment Score
Product type:	N/A	N/A
Extent of Damage:	N/A	N/A
Surface Treatment:	N/A	N/A
Asbestos type:	N/A	N/A
Material Assessment Score:		N/A
Priority Assessment Score:		N/A
Action:	N/A	
Comments:	N/A

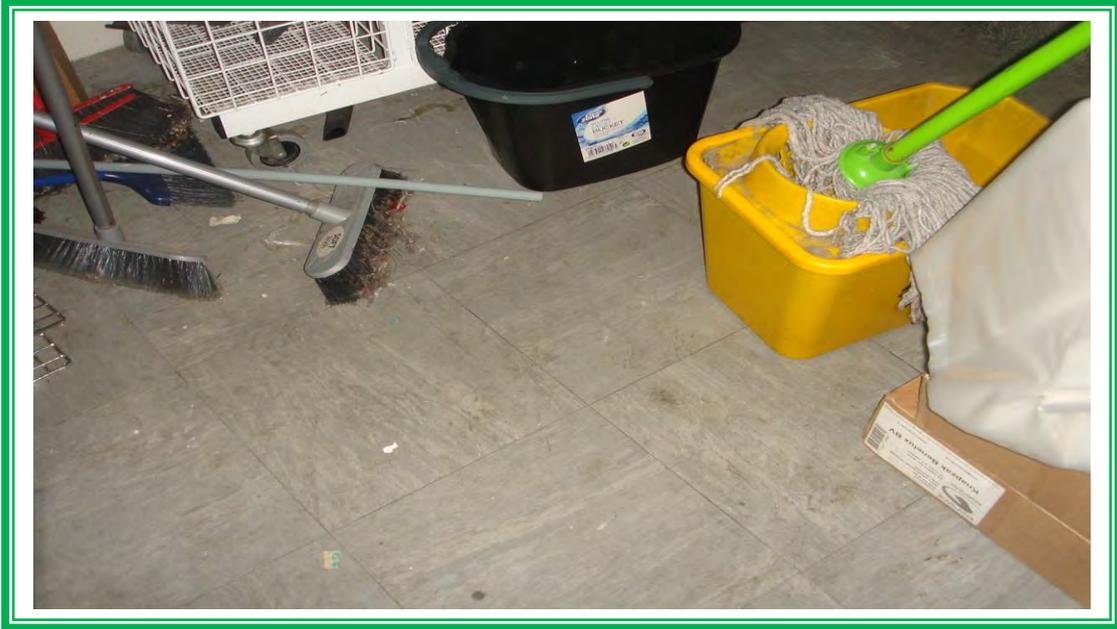
Material Description:	Vinyl Floor Tiles	
Identification:	As Per Sample NE/1 – No Asbestos Detected	
Approx. quantity:	3M2	
Accessibility	N/A	Assessment Score
Product type:	N/A	N/A
Extent of Damage:	N/A	N/A
Surface Treatment:	N/A	N/A
Asbestos type:	N/A	N/A
Material Assessment Score:		N/A
Priority Assessment Score:		N/A
Action:	N/A	
Comments:	N/A

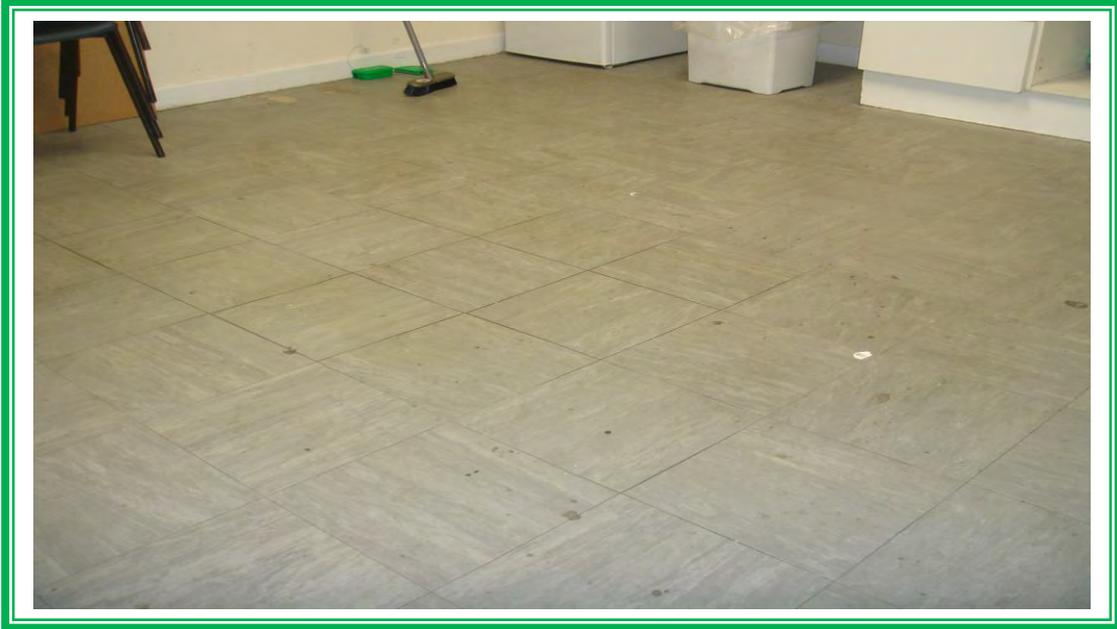
Material Description:	Vinyl Floor Tiles	
Identification:	As Per Sample NE/1 – No Asbestos Detected	
Approx. quantity:	16M2	
Accessibility	N/A	Assessment Score
Product type:	N/A	N/A
Extent of Damage:	N/A	N/A
Surface Treatment:	N/A	N/A
Asbestos type:	N/A	N/A
Material Assessment Score:		N/A
Priority Assessment Score:		N/A
Action:	N/A	
Comments:	N/A

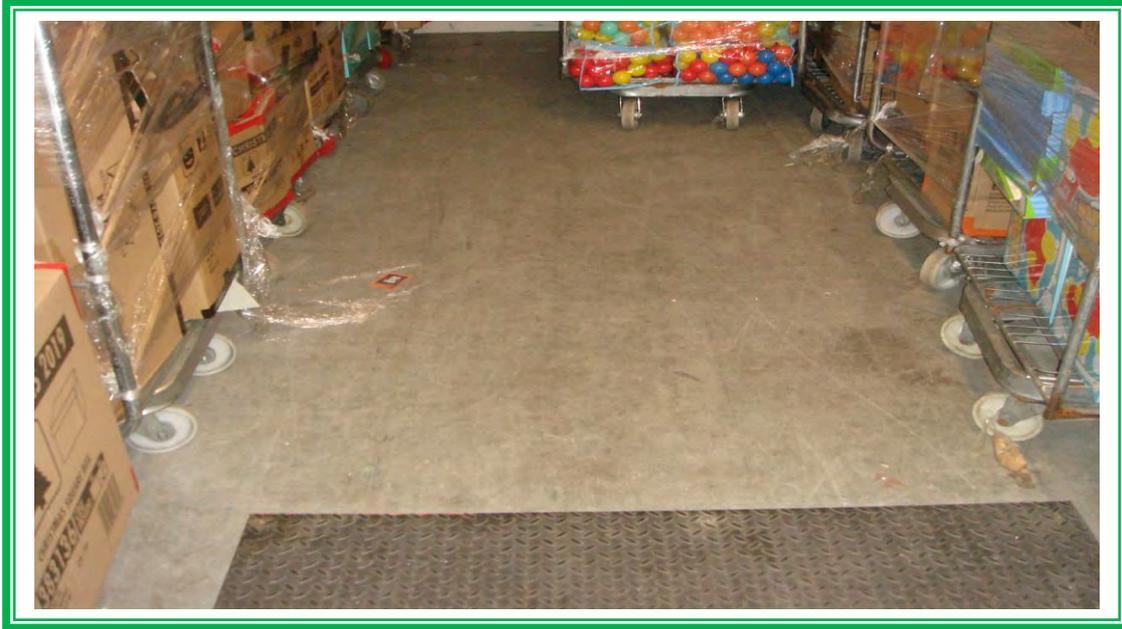
Material Description:	Vinyl Floor Tiles	
Identification:	As Per Sample NE/2 – No Asbestos Detected	
Approx. quantity:	30M2	
Accessibility	N/A	Assessment Score
Product type:	N/A	N/A
Extent of Damage:	N/A	N/A
Surface Treatment:	N/A	N/A
Asbestos type:	N/A	N/A
Material Assessment Score:		N/A
Priority Assessment Score:		N/A
Action:	N/A	
Comments:	N/A

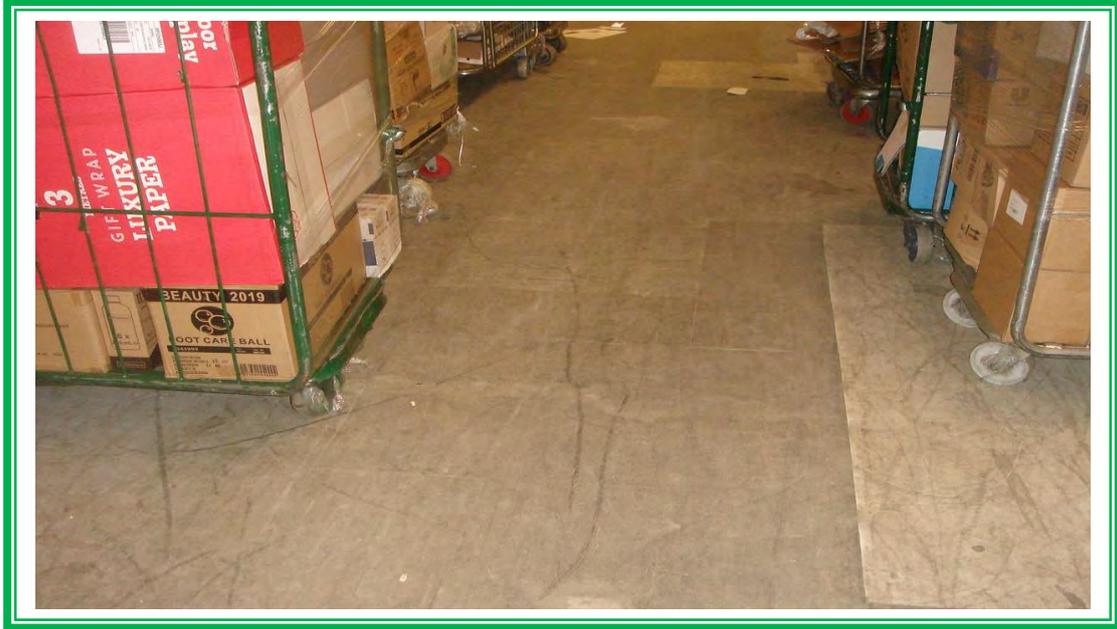
Material Description:	Vinyl Floor Tiles	
Identification:	As Per Sample NE/2 – No Asbestos Detected	
Approx. quantity:	60M2	
Accessibility	N/A	Assessment Score
Product type:	N/A	N/A
Extent of Damage:	N/A	N/A
Surface Treatment:	N/A	N/A
Asbestos type:	N/A	N/A
Material Assessment Score:		N/A
Priority Assessment Score:		N/A
Action:	N/A	
Comments:	N/A

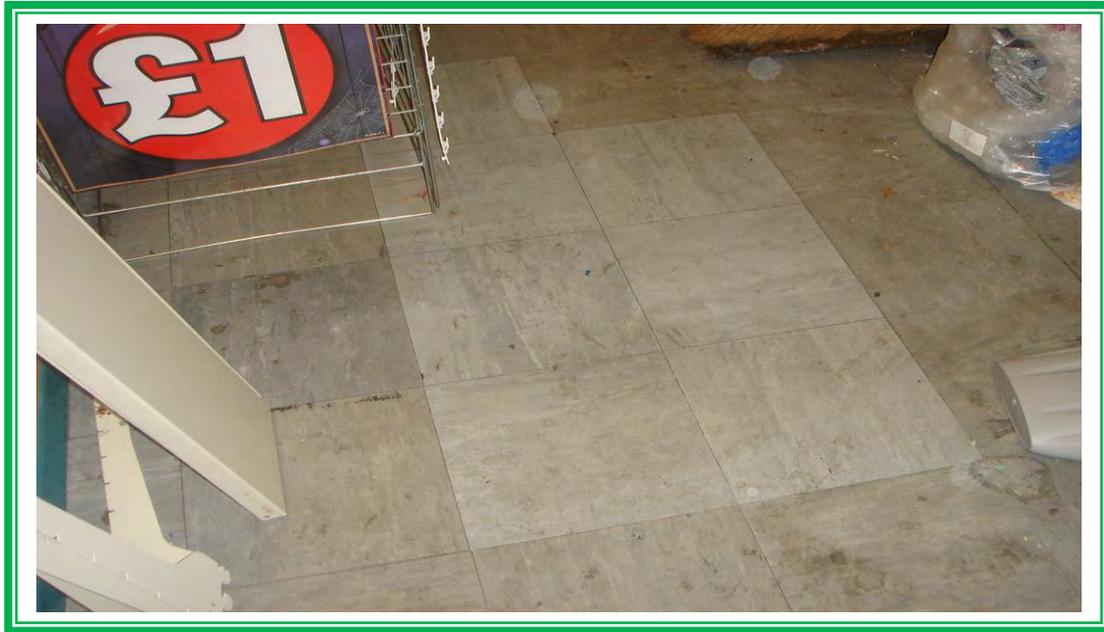
Material Description:	Vinyl Floor Tiles	
Identification:	Sampled - No Asbestos Detected	
Approx. quantity:	16M2	
Accessibility	N/A	Assessment Score
Product type:	N/A	N/A
Extent of Damage:	N/A	N/A
Surface Treatment:	N/A	N/A
Asbestos type:	N/A	N/A
Material Assessment Score:		N/A
Priority Assessment Score:		N/A
Action:	N/A	
Comments:	N/A

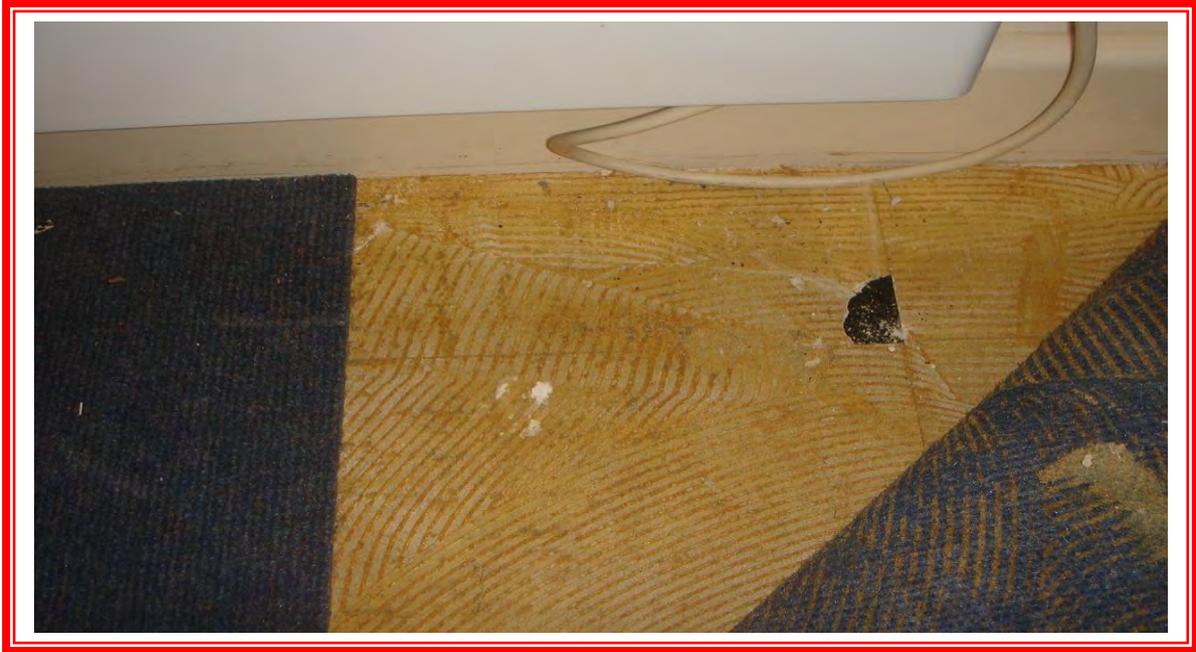
Material Description:	Vinyl Floor Tiles	
Identification:	Sampled – Asbestos Detected	
Approx. quantity:	40M2	
Accessibility	Low	Assessment Score
Product type:	Vinyl	1
Extent of Damage:	Minor	1
Surface Treatment:	Non-Friable	0
Asbestos type:	Chrysotile	1
Material Assessment Score:		3
Priority Assessment Score:		Negligible
Action:	Manage	
Comments:	N/A

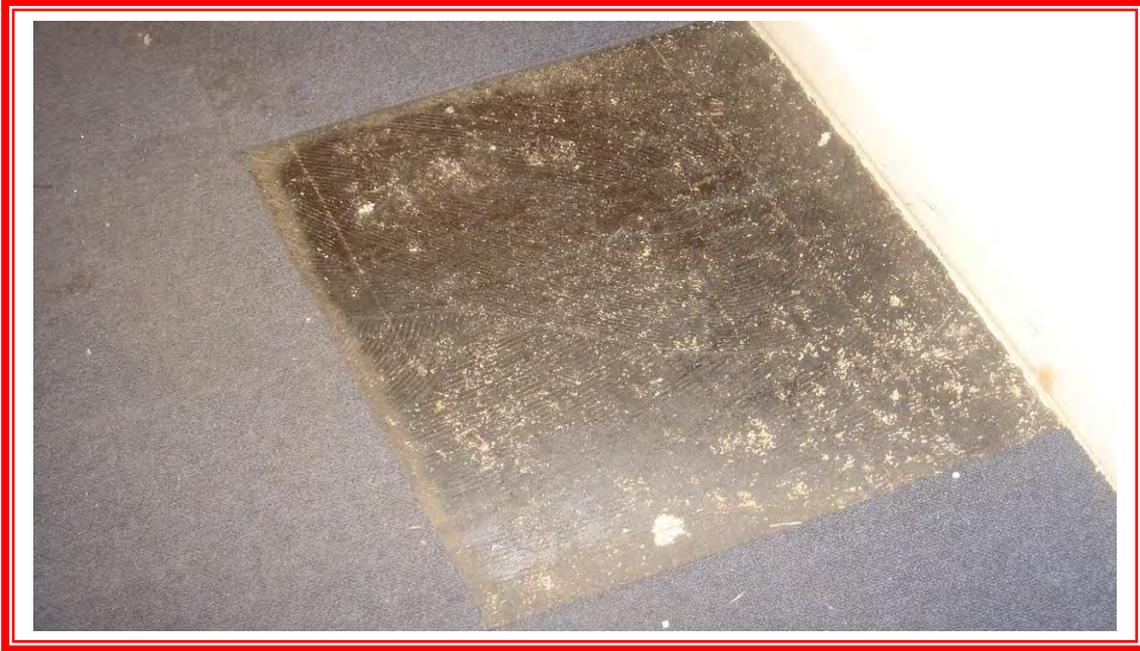
Material Description:	Bitumen Adhesive	
Identification:	Sampled - Asbestos Detected	
Approx. quantity:	6M2	
Accessibility	Low	Assessment Score
Product type:	Bitumen	1
Extent of Damage:	Good	0
Surface Treatment:	Non-Friable	0
Asbestos type:	Chrysotile	1
Material Assessment Score:		2
Priority Assessment Score:		Negligible
Action:	Manage	
Comments:	N/A

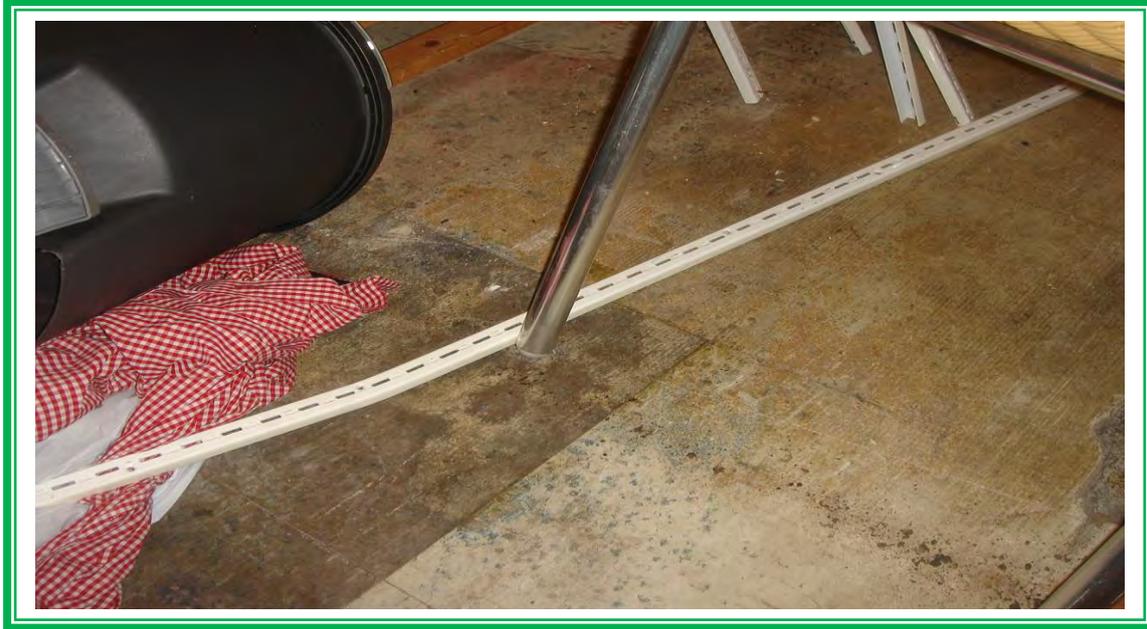
Material Description:	Vinyl Floor Tiles	
Identification:	Sampled - No Asbestos Detected	
Approx. quantity:	8M2	
Accessibility	N/A	Assessment Score
Product type:	N/A	N/A
Extent of Damage:	N/A	N/A
Surface Treatment:	N/A	N/A
Asbestos type:	N/A	N/A
Material Assessment Score:		N/A
Priority Assessment Score:		N/A
Action:	N/A	
Comments:	N/A

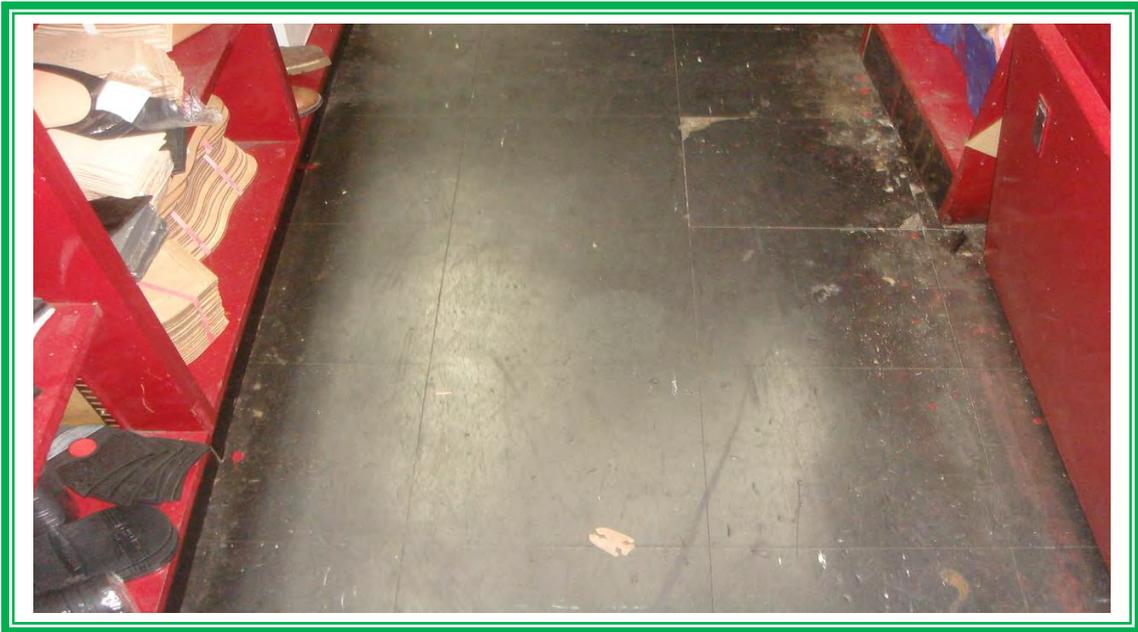
Material Description:	Vinyl Floor Tiles	
Identification:	Sampled – No Asbestos Detected	
Approx. quantity:	16M2	
Accessibility	N/A	Assessment Score
Product type:	N/A	N/A
Extent of Damage:	N/A	N/A
Surface Treatment:	N/A	N/A
Asbestos type:	N/A	N/A
Material Assessment Score:		N/A
Priority Assessment Score:		N/A
Action:	N/A	
Comments:	N/A

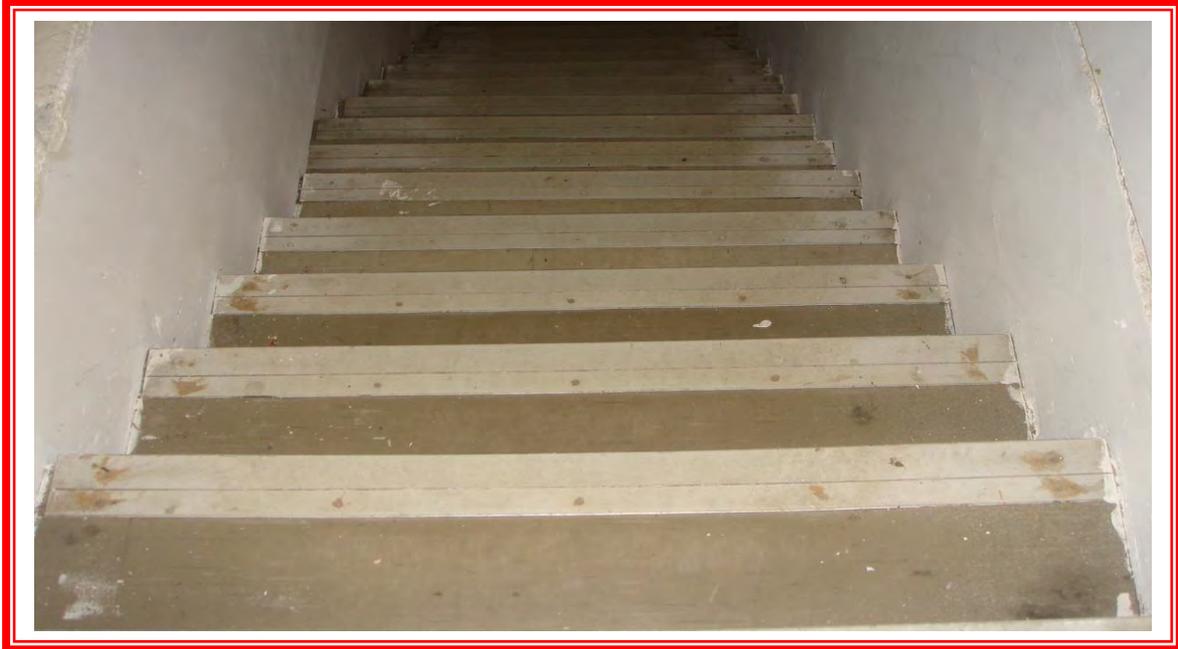
Material Description:	Vinyl Floor Tiles	
Identification:	Sampled – Asbestos Detected	
Approx. quantity:	30M2	
Accessibility	Medium	Assessment Score
Product type:	Vinyl	1
Extent of Damage:	Minor	1
Surface Treatment:	Non-Friable	0
Asbestos type:	Chrysotile	1
Material Assessment Score:		3
Priority Assessment Score:		Negligible
Action:	Manage	
Comments:	N/A

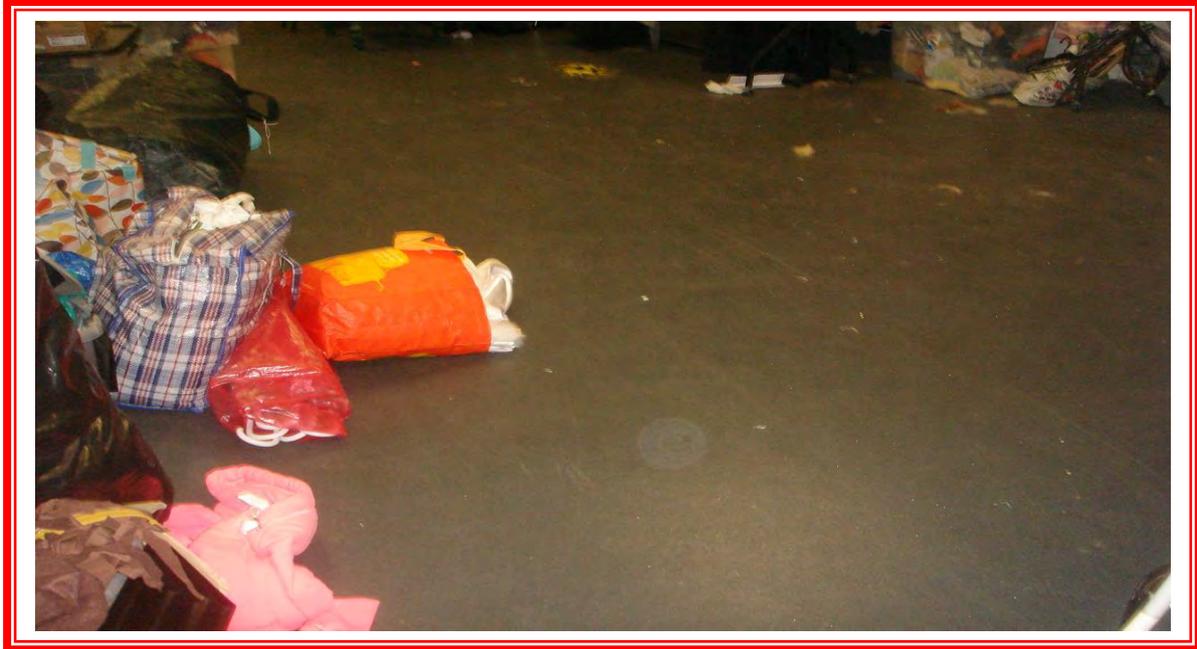
Material Description:	Vinyl Floor Tiles	
Identification:	As Per Sample NE/ - Asbestos Detected	
Approx. quantity:	75M2	
Accessibility	Low	Assessment Score
Product type:	Vinyl	1
Extent of Damage:	Minor	1
Surface Treatment:	Non-Friable	0
Asbestos type:	Chrysotile	1
Material Assessment Score:		3
Priority Assessment Score:		Negligible
Action:	Manage	
Comments:	Below Modern Vinyl

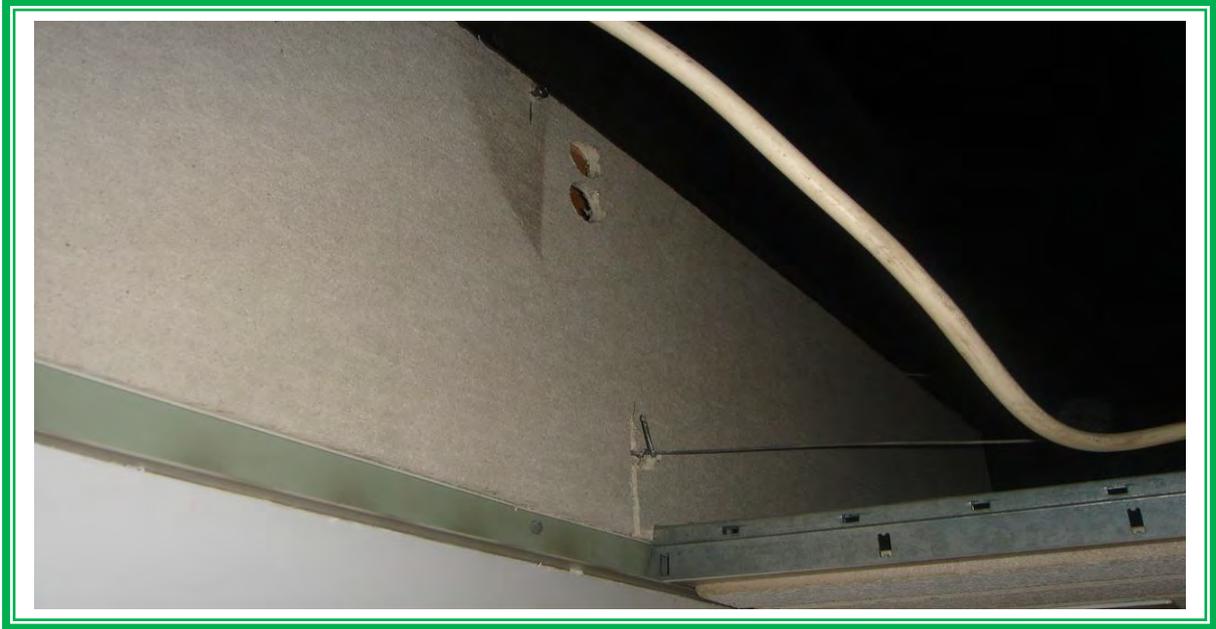
Material Description:	Insulating Board – Above Entrance	
Identification:	Sampled – No Asbestos Detected	
Approx. quantity:	5M2	
Accessibility	N/A	<i>Assessment Score</i>
Product type:	N/A	N/A
Extent of Damage:	N/A	N/A
Surface Treatment:	N/A	N/A
Asbestos type:	N/A	N/A
Material Assessment Score:		N/A
Priority Assessment Score:		N/A
Action:	N/A	
Comments:	N/A

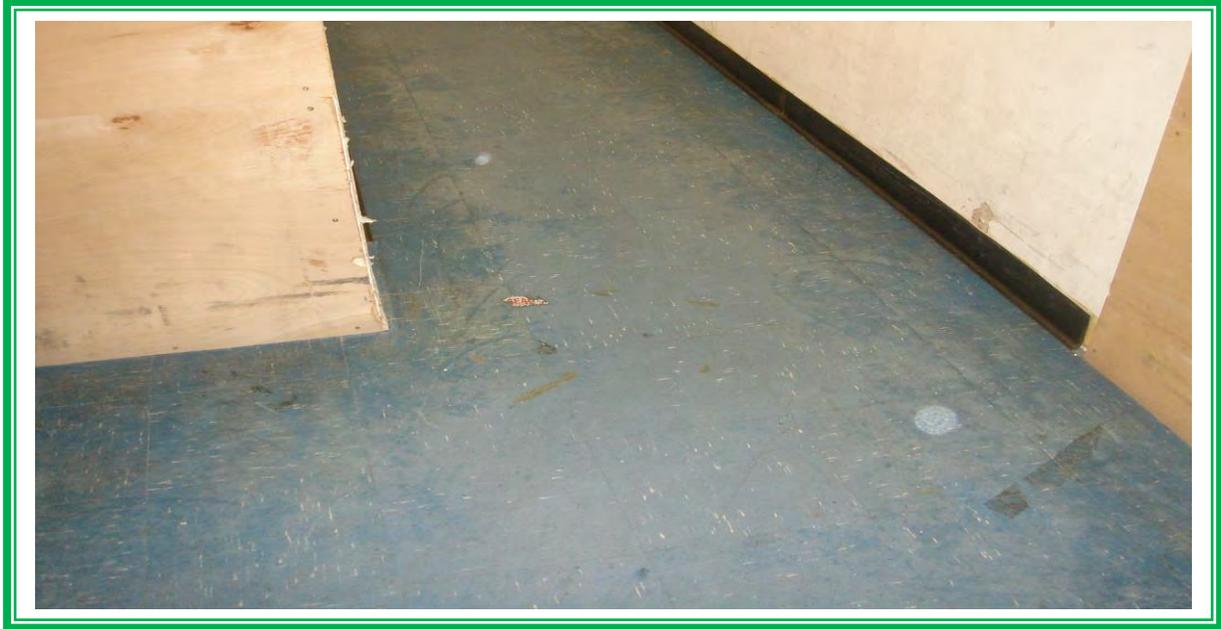
Material Description:	Vinyl Floor Tiles	
Identification:	As Per Sample NE/1 – No Asbestos Detected	
Approx. quantity:	10M2	
Accessibility	N/A	Assessment Score
Product type:	N/A	N/A
Extent of Damage:	N/A	N/A
Surface Treatment:	N/A	N/A
Asbestos type:	N/A	N/A
Material Assessment Score:		N/A
Priority Assessment Score:		N/A
Action:	N/A	
Comments:	N/A

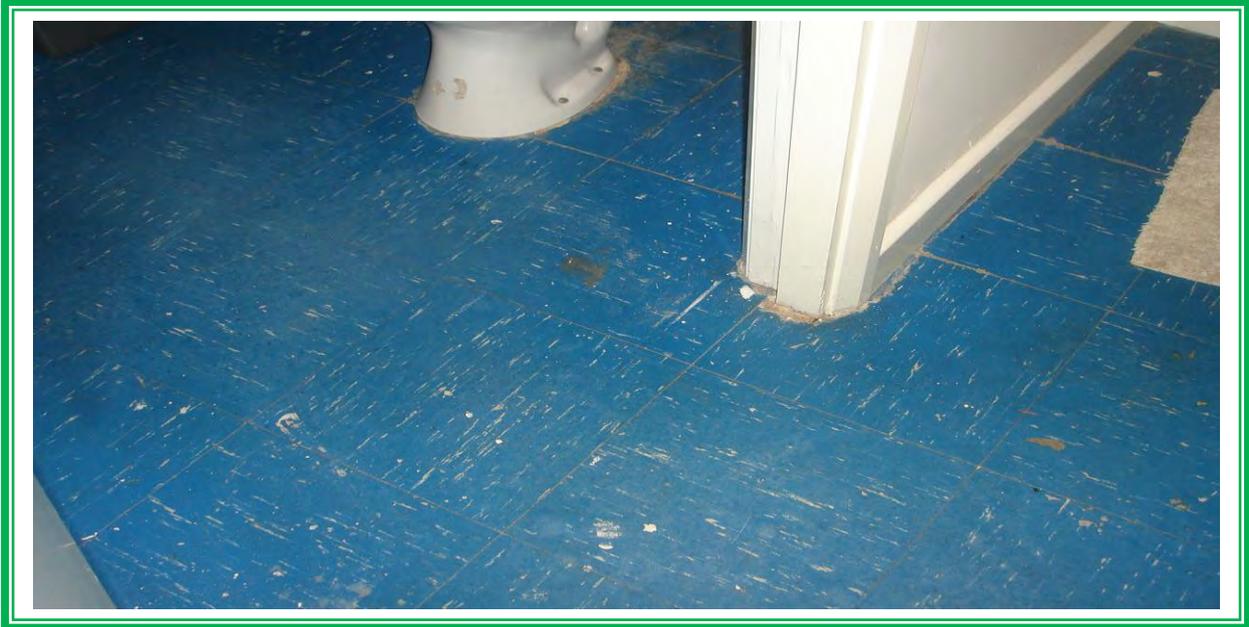
Material Description:	Vinyl Floor Tiles	
Identification:	As Per Sampled NE/1 – No Asbestos Detected	
Approx. quantity:	2M2	
Accessibility	N/A	Assessment Score
Product type:	N/A	N/A
Extent of Damage:	N/A	N/A
Surface Treatment:	N/A	N/A
Asbestos type:	N/A	N/A
Material Assessment Score:		N/A
Priority Assessment Score:		N/A
Action:	N/A	
Comments:	N/A

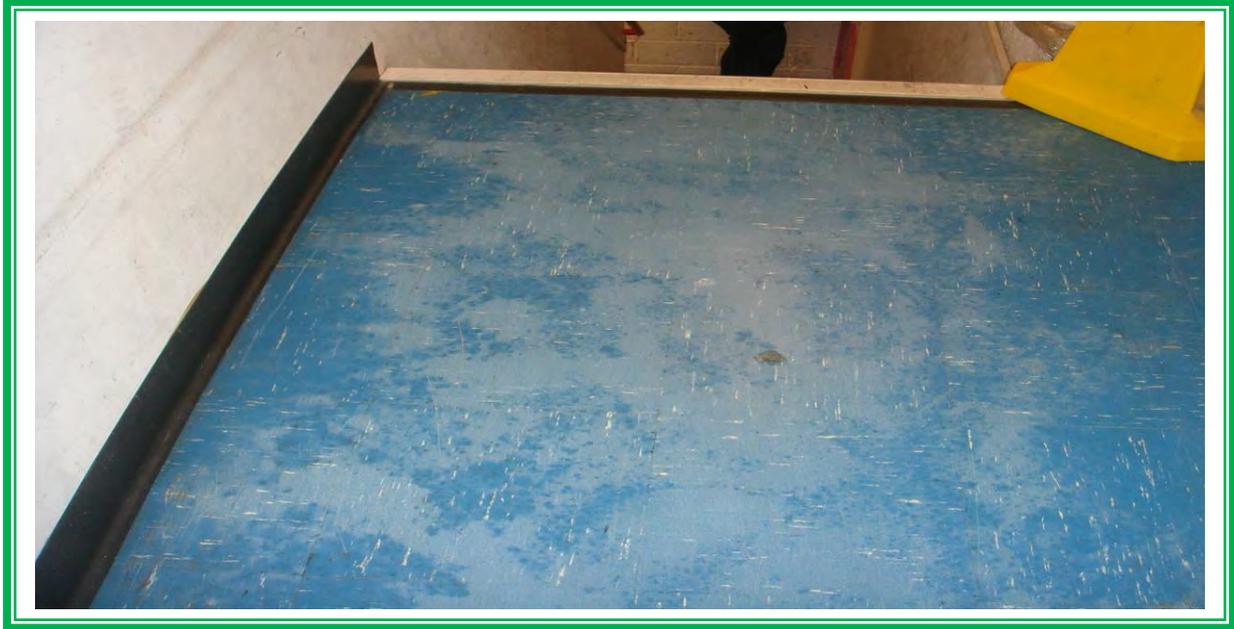
Material Description:	Vinyl Floor Tiles	
Identification:	As Per Sample NE/1 – No Asbestos Detected	
Approx. quantity:	26M2	
Accessibility	N/A	Assessment Score
Product type:	N/A	N/A
Extent of Damage:	N/A	N/A
Surface Treatment:	N/A	N/A
Asbestos type:	N/A	N/A
Material Assessment Score:		N/A
Priority Assessment Score:		N/A
Action:	N/A	
Comments:	N/A

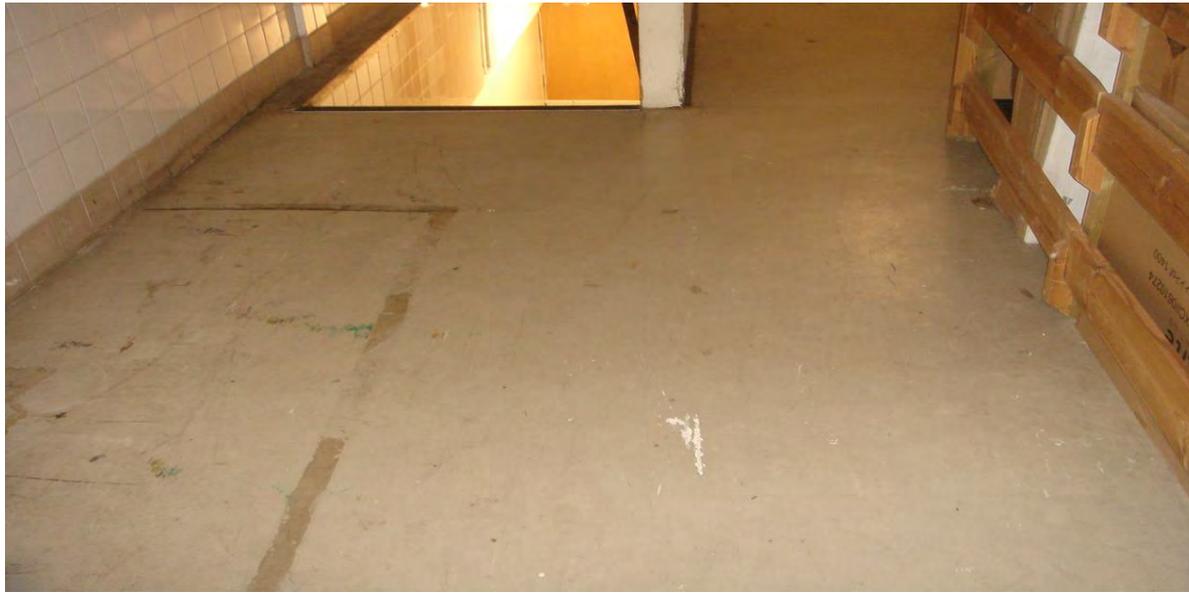
Material Description:	Vinyl Floor Sheets	
Identification:	Sampled – No Asbestos Detected	
Approx. quantity:	36M2	
Accessibility	N/A	Assessment Score
Product type:	N/A	N/A
Extent of Damage:	N/A	N/A
Surface Treatment:	N/A	N/A
Asbestos type:	N/A	N/A
Material Assessment Score:		N/A
Priority Assessment Score:		N/A
Action:	N/A	
Comments:	N/A
