Section 6: Survey Objectives

Instructions were received from James Croucher of Lochailort Newbury Ltd to carry out a Management asbestos survey at Kennet Centre, Market Street, Newbury, Berkshire, RG14 5EN in accordance with HSG264 and Armour Analytical's quality procedures.

The survey was carried out on 22nd – 25th October 2019 by Neale Evans with the objective of facilitating a Management report.

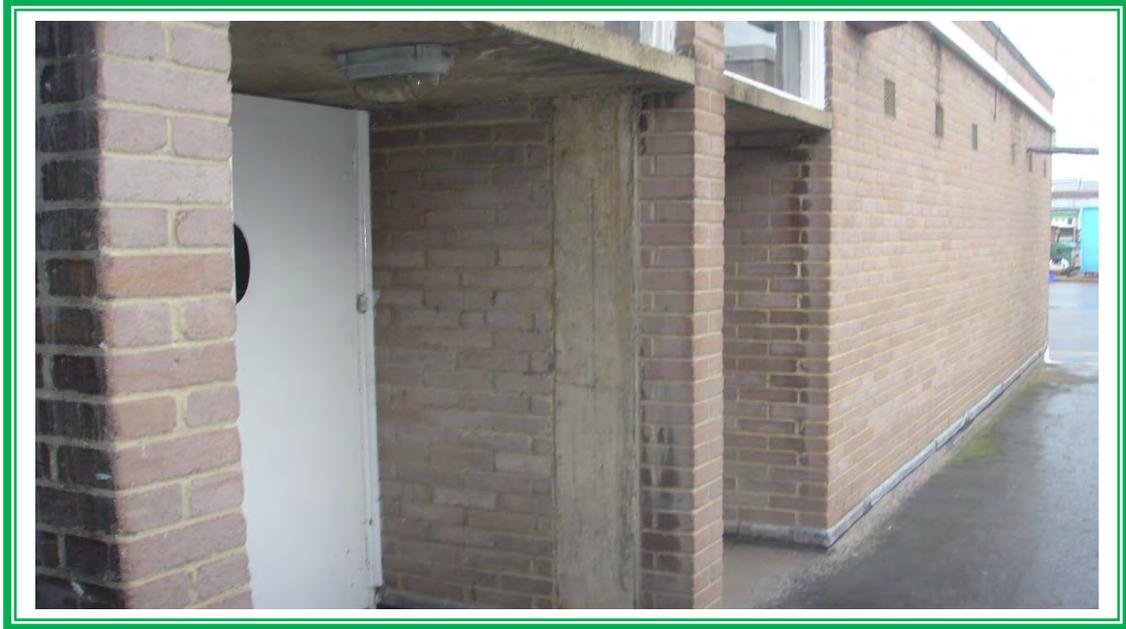
Location: 99/001 External

Material Description:	Visual Inspection – No Suspect Materials Found	
Identification:	N/A	
Approx. quantity:	N/A	
Accessibility	N/A	Assessment Score
Product type:	N/A	N/A
Extent of Damage:	N/A	N/A
Surface Treatment:	N/A	N/A
Asbestos type:	N/A	N/A
Material Assessment Score:		N/A
Priority Assessment Score:		N/A
Action:	N/A	
Comments:	N/A

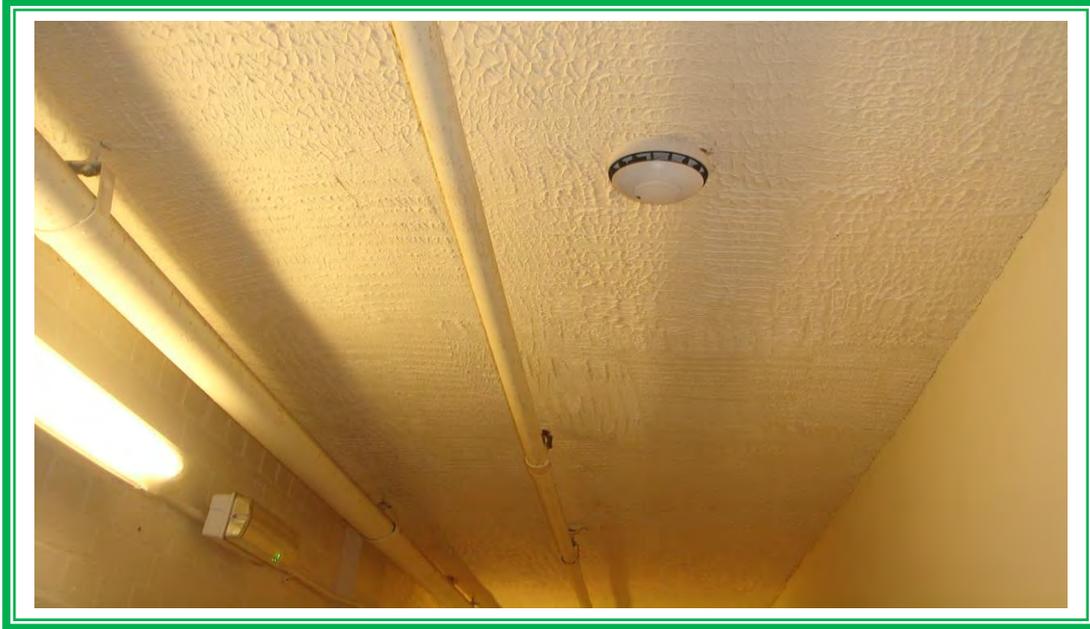
Location: 1/006 Stairs

Material Description:	Textured Coating to Ceiling	
Identification:	Sampled - No Asbestos Detected	
Approx. quantity:	15M2	
Accessibility	N/A	<i>Assessment Score</i>
Product type:	N/A	N/A
Extent of Damage:	N/A	N/A
Surface Treatment:	N/A	N/A
Asbestos type:	N/A	N/A
Material Assessment Score:		N/A
Priority Assessment Score:		N/A
Action:	N/A	
Comments:	N/A

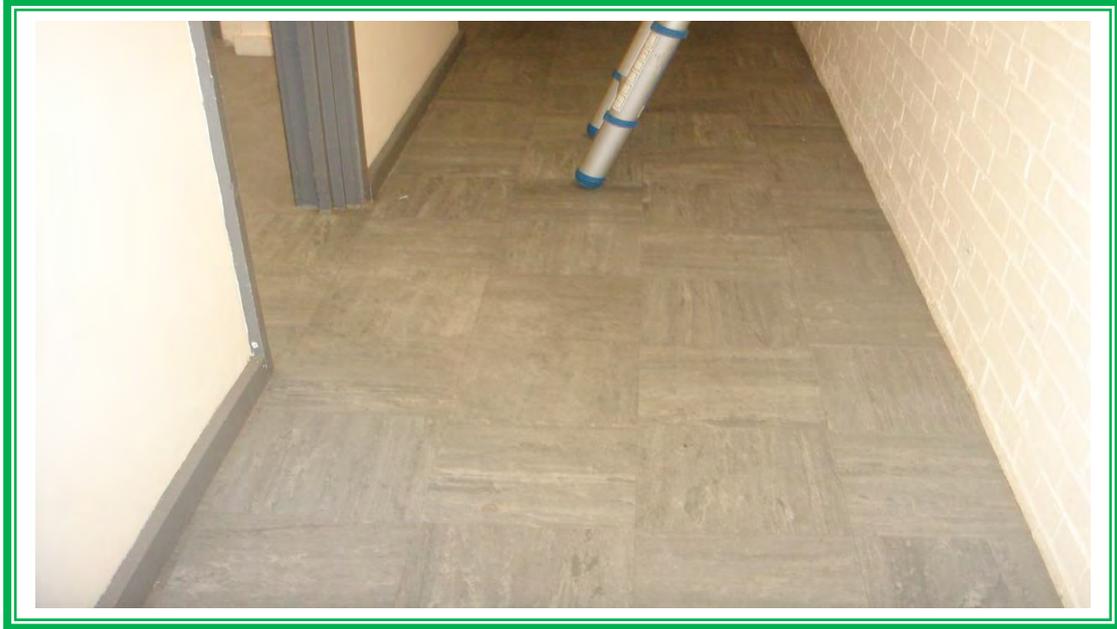
Location: 1/006 Stairs

Material Description:	Vinyl Floor Tiles	
Identification:	As Per Sample NE/1 – No Asbestos Detected	
Approx. quantity:	6M2	
Accessibility	N/A	Assessment Score
Product type:	N/A	N/A
Extent of Damage:	N/A	N/A
Surface Treatment:	N/A	N/A
Asbestos type:	N/A	N/A
Material Assessment Score:		N/A
Priority Assessment Score:		N/A
Action:	N/A	
Comments:	N/A

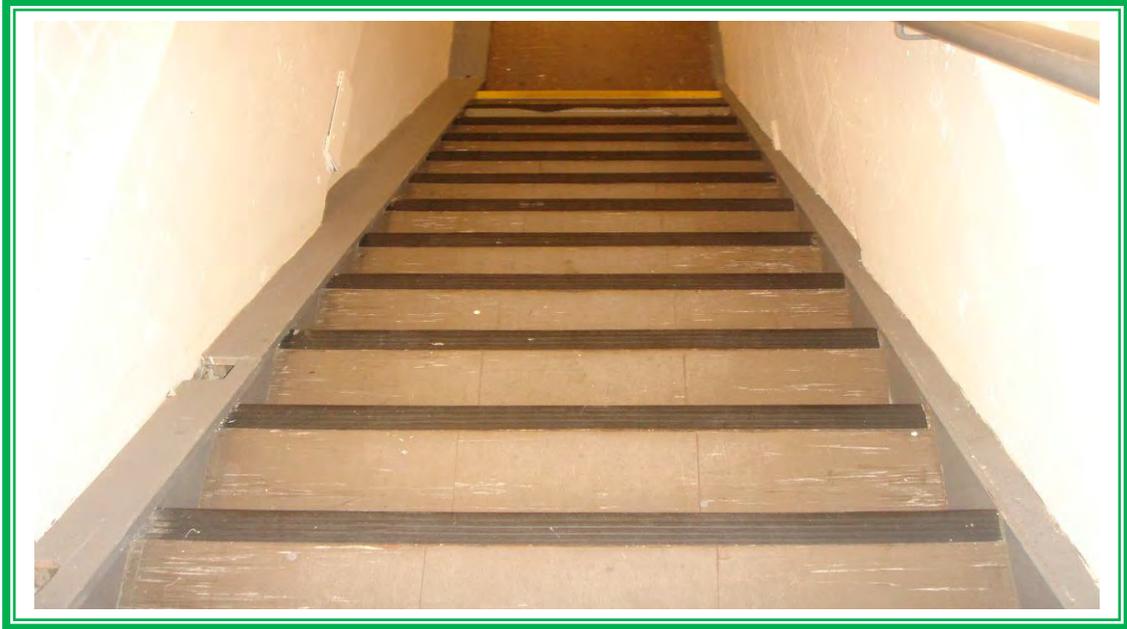
Location: 1/006 Stairs

Material Description:	Vinyl Floor Tiles	
Identification:	Sampled - No Asbestos Detected	
Approx. quantity:	10M2	
Accessibility	N/A	Assessment Score
Product type:	N/A	N/A
Extent of Damage:	N/A	N/A
Surface Treatment:	N/A	N/A
Asbestos type:	N/A	N/A
Material Assessment Score:		N/A
Priority Assessment Score:		N/A
Action:	N/A	
Comments:	N/A

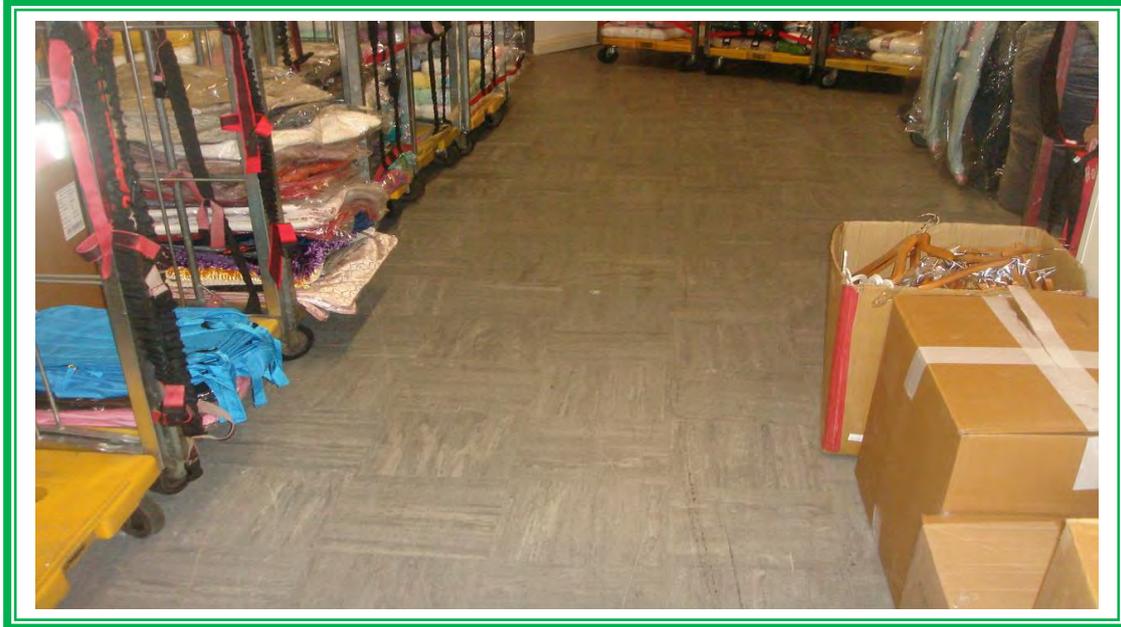
Location: 0/002 Stores

Material Description:	Vinyl Floor Tiles	
Identification:	As Per Sample NE/4 – No Asbestos Detected	
Approx. quantity:	40M2	
Accessibility	N/A	Assessment Score
Product type:	N/A	N/A
Extent of Damage:	N/A	N/A
Surface Treatment:	N/A	N/A
Asbestos type:	N/A	N/A
Material Assessment Score:		N/A
Priority Assessment Score:		N/A
Action:	N/A	
Comments:	N/A

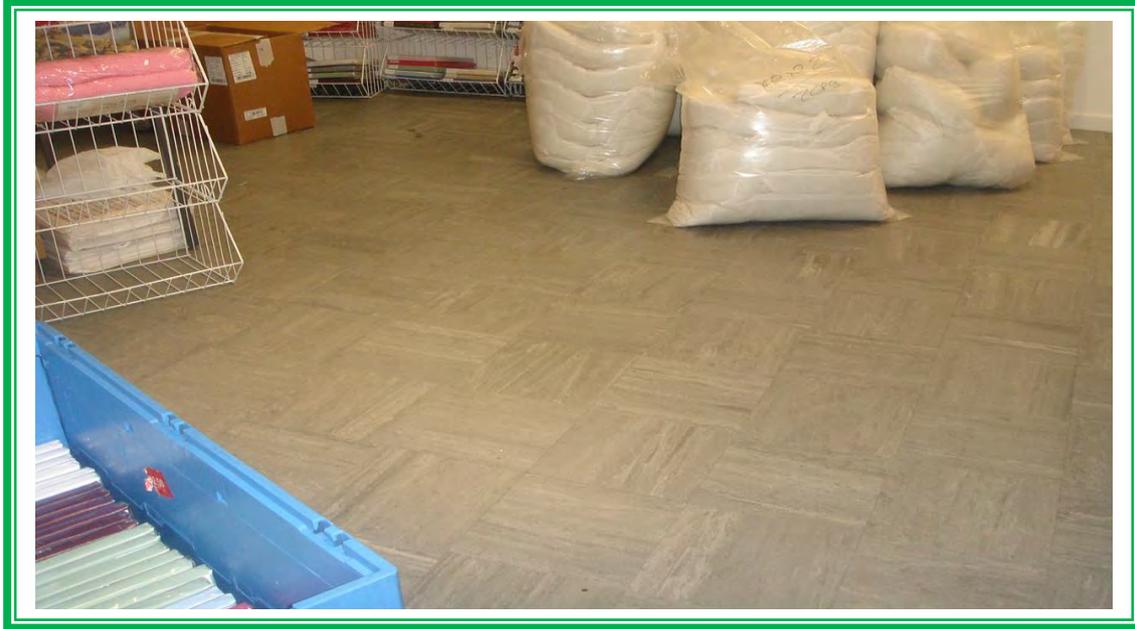
Location: 0/003 Stores

Material Description:	Vinyl Floor Tiles	
Identification:	As Per Sample NE/4 – No Asbestos Detected	
Approx. quantity:	30M2	
Accessibility	N/A	Assessment Score
Product type:	N/A	N/A
Extent of Damage:	N/A	N/A
Surface Treatment:	N/A	N/A
Asbestos type:	N/A	N/A
Material Assessment Score:		N/A
Priority Assessment Score:		N/A
Action:	N/A	
Comments:	N/A

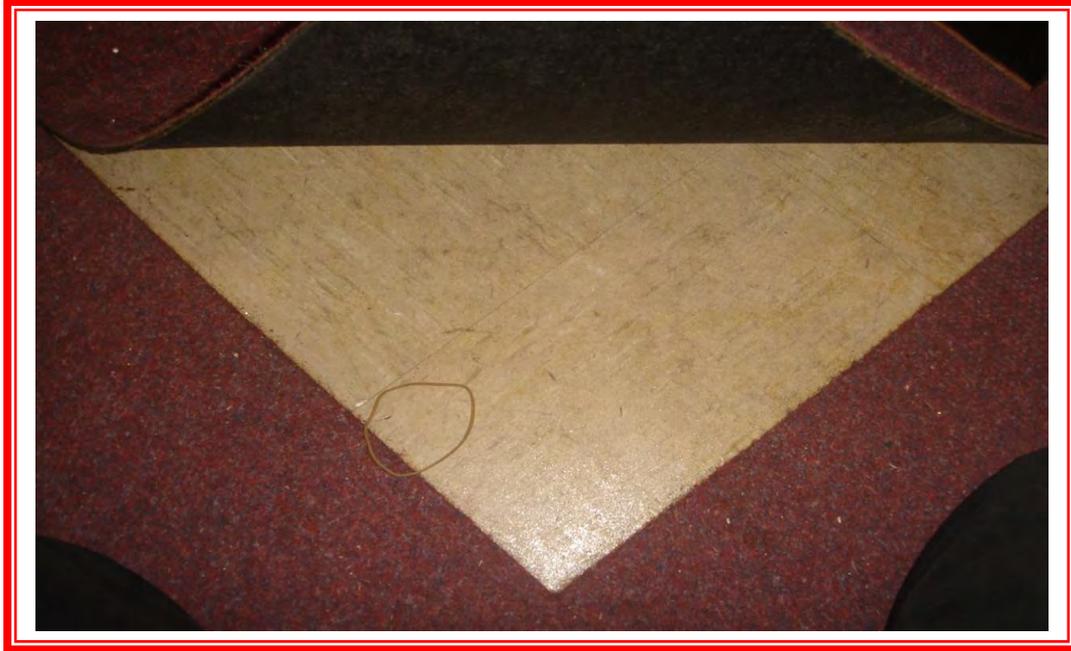
Material Description:	Vinyl Floor Tiles	
Identification:	Sampled - Asbestos Detected	
Approx. quantity:	2M2	
Accessibility	Low	Assessment Score
Product type:	Vinyl	1
Extent of Damage:	Good	0
Surface Treatment:	Non-Friable	0
Asbestos type:	Chrysotile	1
Material Assessment Score:		2
Priority Assessment Score:		Negligible
Action:	Manage	
Comments:	N/A

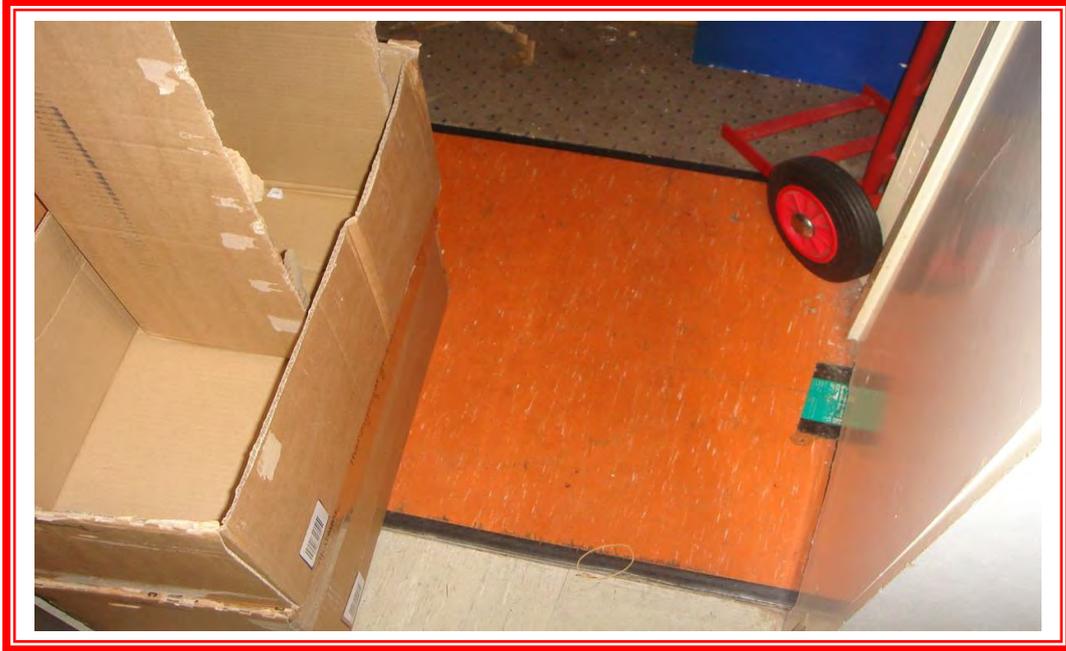
Material Description:	Vinyl Floor Tiles (Orange)	
Identification:	Sampled - Asbestos Detected	
Approx. quantity:	1M2	
Accessibility	Low	Assessment Score
Product type:	Vinyl	1
Extent of Damage:	Minor	1
Surface Treatment:	Non-Friable	0
Asbestos type:	Chrysotile	1
Material Assessment Score:		3
Priority Assessment Score:		Negligible
Action:	Manage	
Comments:	N/A

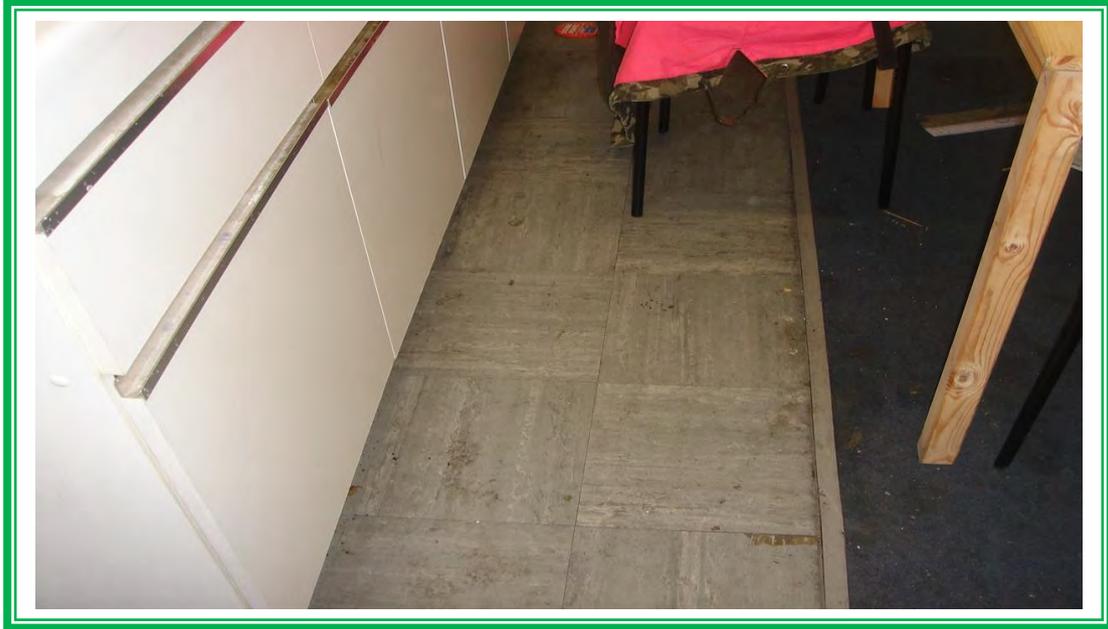
Material Description:	Vinyl Floor Tiles	
Identification:	Sampled - No Asbestos Detected	
Approx. quantity:	1M2	
Accessibility	N/A	Assessment Score
Product type:	N/A	N/A
Extent of Damage:	N/A	N/A
Surface Treatment:	N/A	N/A
Asbestos type:	N/A	N/A
Material Assessment Score:		N/A
Priority Assessment Score:		N/A
Action:	N/A	
Comments:	N/A

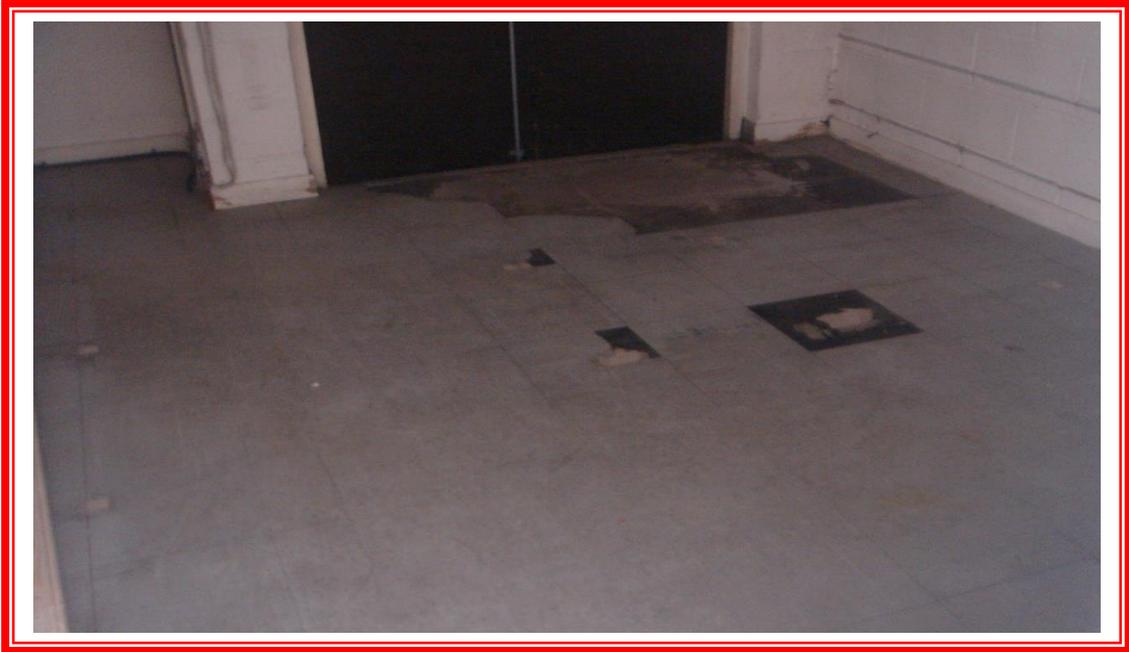
Material Description:	Vinyl Floor Tiles	
Identification:	Sampled – Asbestos Detected	
Approx. quantity:	20M2	
Accessibility	Low	Assessment Score
Product type:	Vinyl	1
Extent of Damage:	Moderate	2
Surface Treatment:	Non-Friable	0
Asbestos type:	Chrysotile	1
Material Assessment Score:		4
Priority Assessment Score:		Negligible
Action:	Manage	
Comments:	N/A

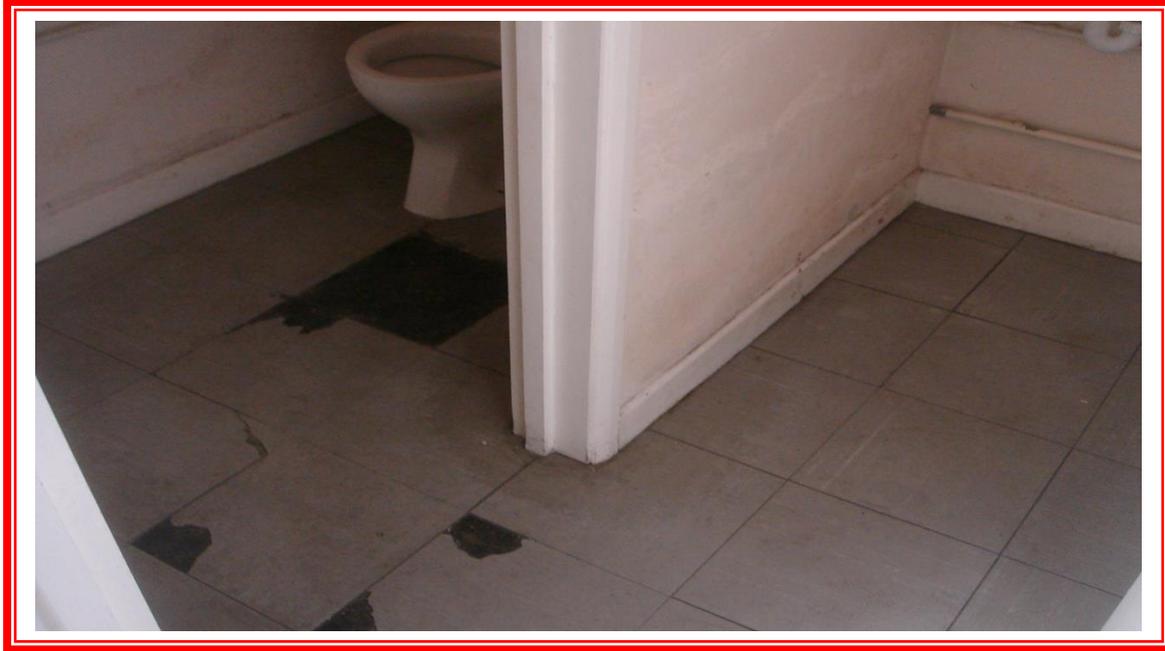
Material Description:	Vinyl Floor Tiles	
Identification:	As Per Sample NE/1 - Asbestos Detected	
Approx. quantity:	2M2	
Accessibility	Low	Assessment Score
Product type:	Vinyl	1
Extent of Damage:	Low	1
Surface Treatment:	Non-Friable	0
Asbestos type:	Chrysotile	1
Material Assessment Score:		3
Priority Assessment Score:		Negligible
Action:	Manage	
Comments:	N/A

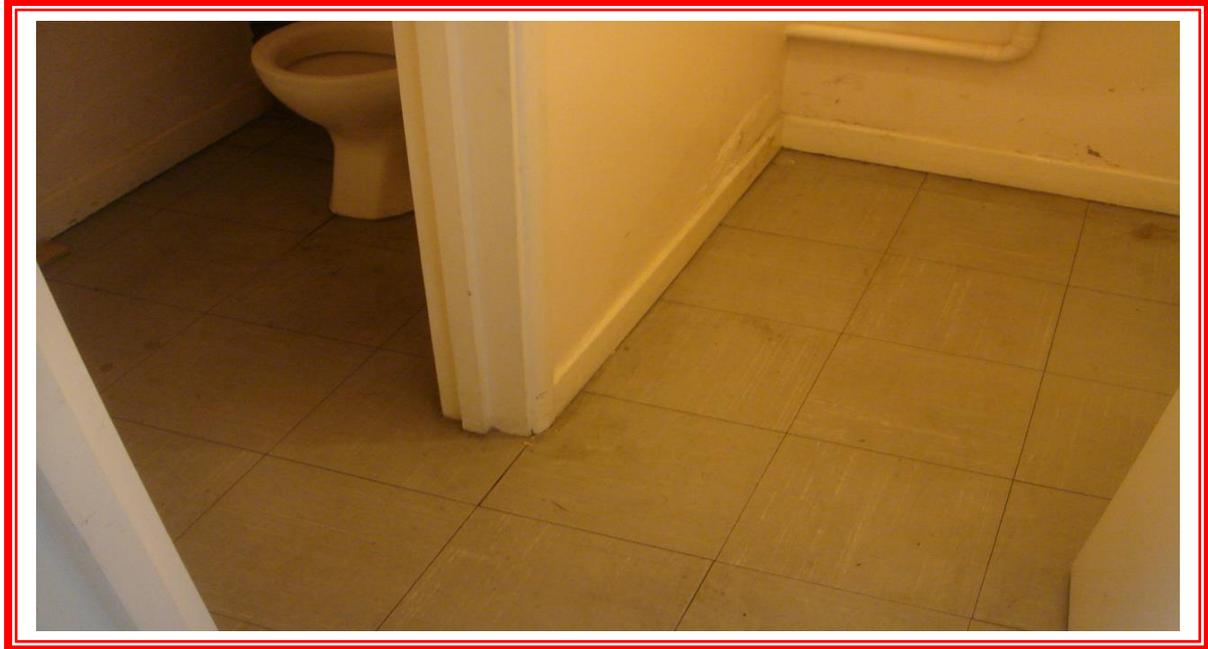
Material Description:	Vinyl floor Tiles	
Identification:	As Per Sample NE/1 - Asbestos Detected	
Approx. quantity:	2M2	
Accessibility	Low	Assessment Score
Product type:	Vinyl	1
Extent of Damage:	Low	1
Surface Treatment:	Non-Friable	0
Asbestos type:	Chrysotile	1
Material Assessment Score:		3
Priority Assessment Score:		Negligible
Action:	Manage	
Comments:	N/A

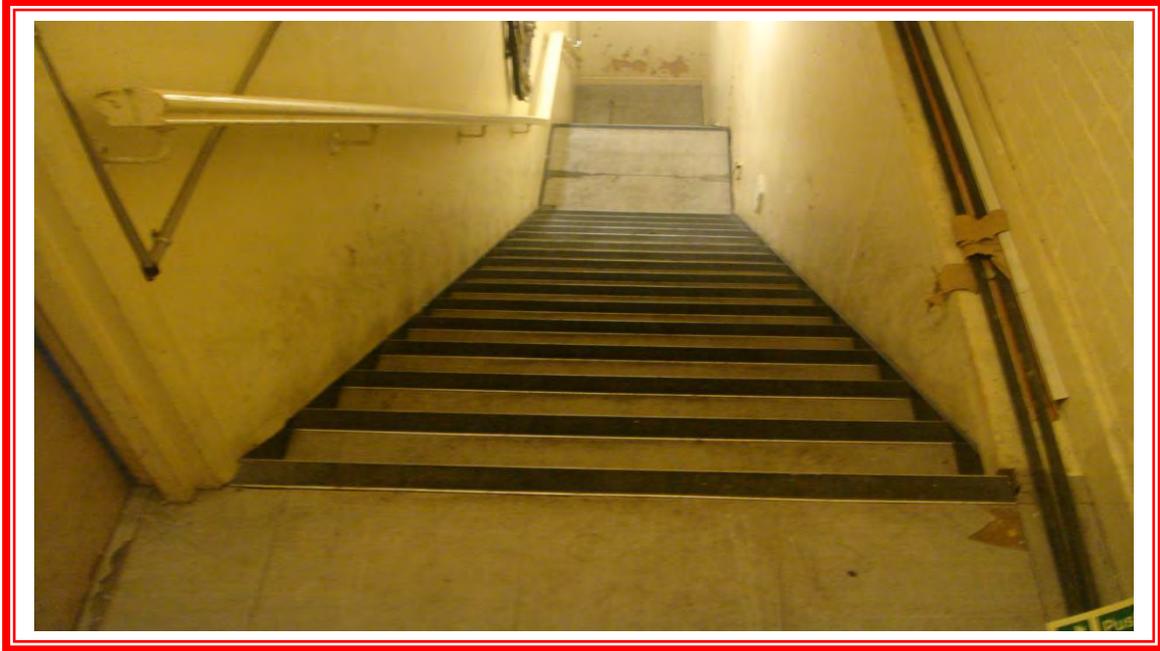
Material Description:	Vinyl Floor Tiles	
Identification:	As per Sample NE/1- Asbestos Detected	
Approx. quantity:	20M2	
Accessibility	Low	Assessment Score
Product type:	Vinyl	1
Extent of Damage:	Low	1
Surface Treatment:	Non-Friable	0
Asbestos type:	Chrysotile	1
Material Assessment Score:		3
Priority Assessment Score:		Negligible
Action:	Manage	
Comments:	N/A

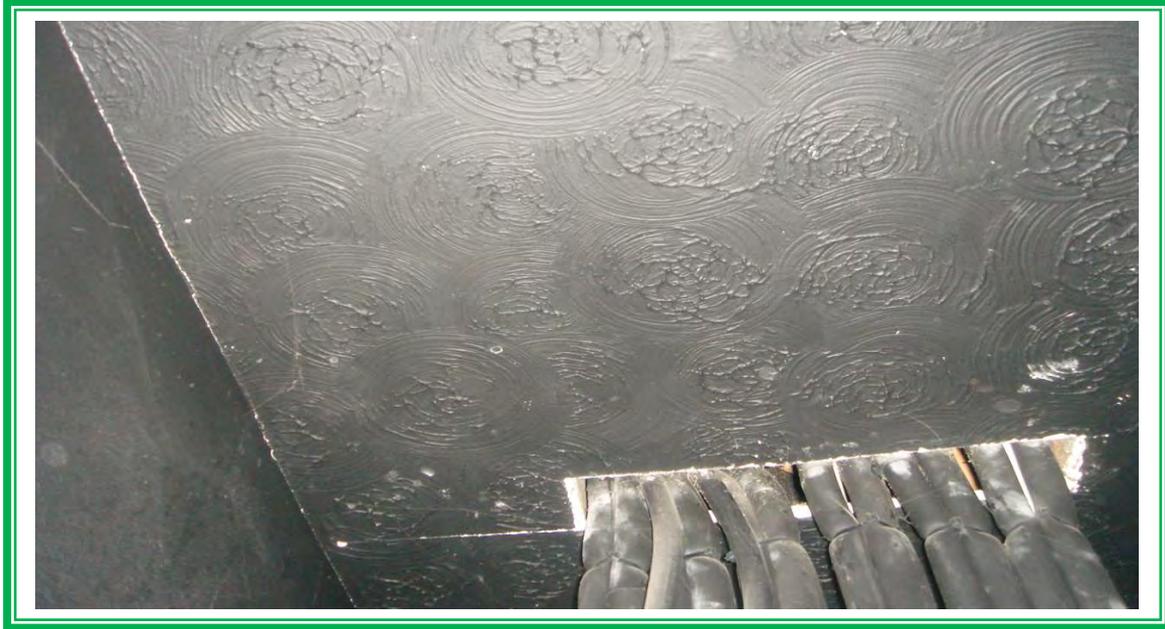
Material Description:	Textured Coating	
Identification:	Sampled – No Asbestos Detected	
Approx. quantity:	4M2	
Accessibility	N/A	Assessment Score
Product type:	N/A	N/A
Extent of Damage:	N/A	N/A
Surface Treatment:	N/A	N/A
Asbestos type:	N/A	N/A
Material Assessment Score:		N/A
Priority Assessment Score:		N/A
Action:	N/A	
Comments:	N/A

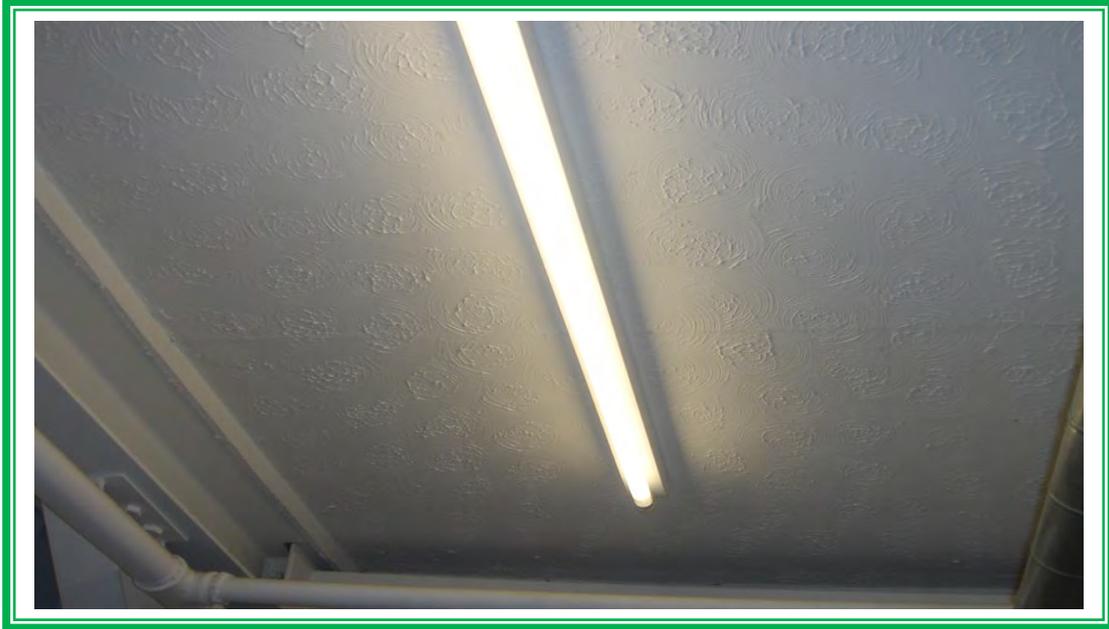
Material Description:	Textured Coating	
Identification:	As Per Sample NE/2 – No Asbestos Detected	
Approx. quantity:	2M2	
Accessibility	N/A	Assessment Score
Product type:	N/A	N/A
Extent of Damage:	N/A	N/A
Surface Treatment:	N/A	N/A
Asbestos type:	N/A	N/A
Material Assessment Score:		N/A
Priority Assessment Score:		N/A
Action:	N/A	
Comments:	N/A

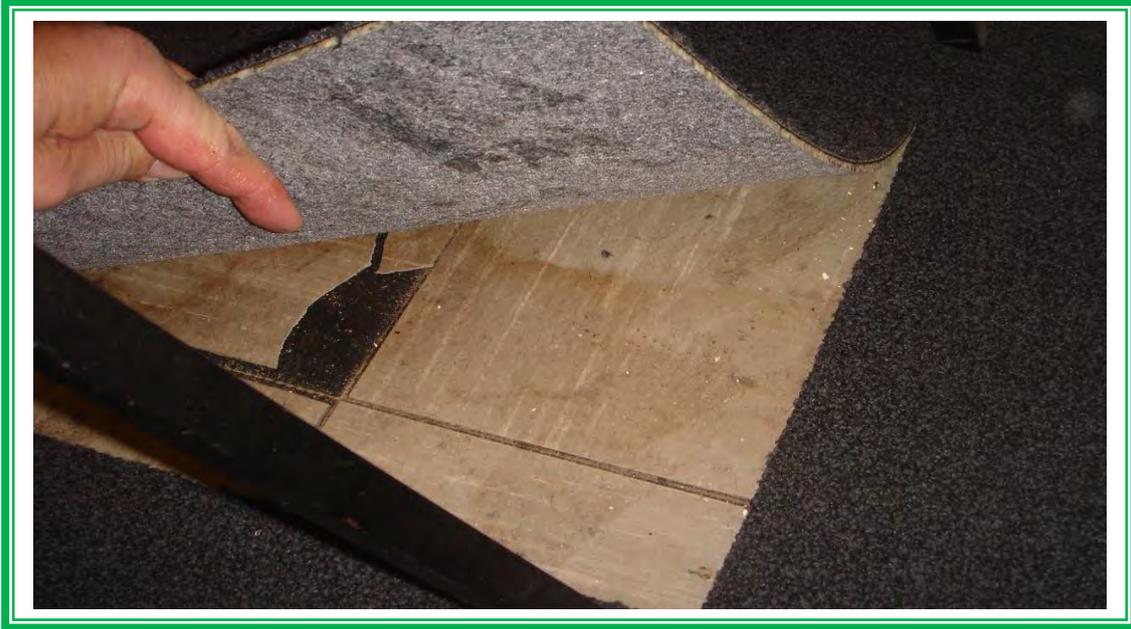
Material Description:	Vinyl Floor Tiles	
Identification:	Sampled - No Asbestos Detected	
Approx. quantity:	12M2	
Accessibility	N/A	Assessment Score
Product type:	N/A	N/A
Extent of Damage:	N/A	N/A
Surface Treatment:	N/A	N/A
Asbestos type:	N/A	N/A
Material Assessment Score:		N/A
Priority Assessment Score:		N/A
Action:	N/A	
Comments:	N/A

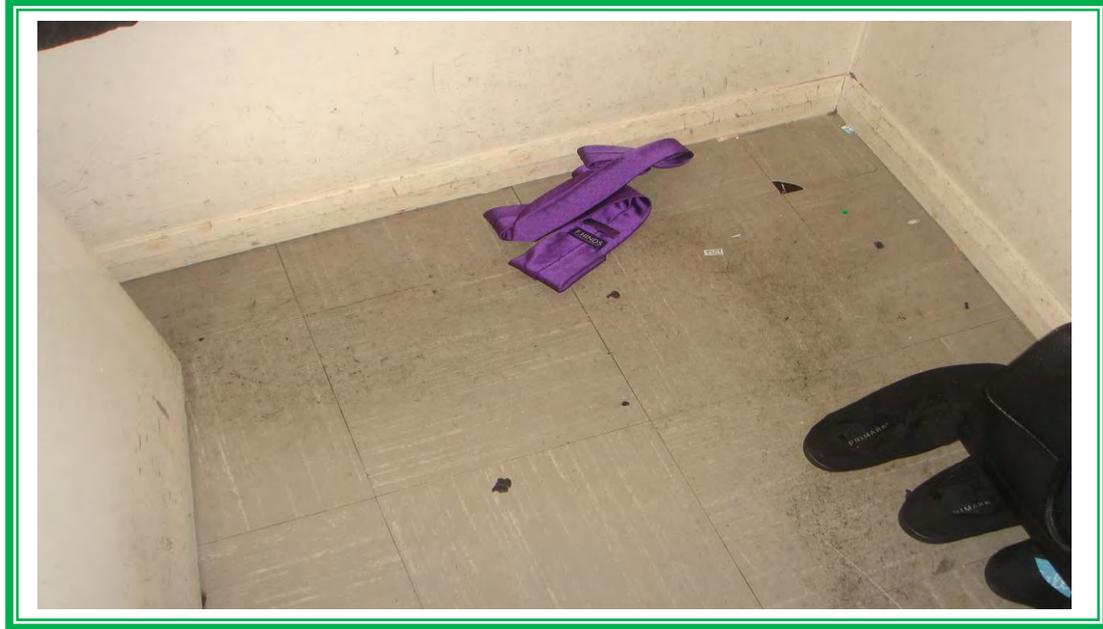
Material Description:	Vinyl Floor Tiles	
Identification:	Sampled – No Asbestos Detected	
Approx. quantity:	2M2	
Accessibility	N/A	Assessment Score
Product type:	N/A	N/A
Extent of Damage:	N/A	N/A
Surface Treatment:	N/A	N/A
Asbestos type:	N/A	N/A
Material Assessment Score:		N/A
Priority Assessment Score:		N/A
Action:	N/A	
Comments:	N/A

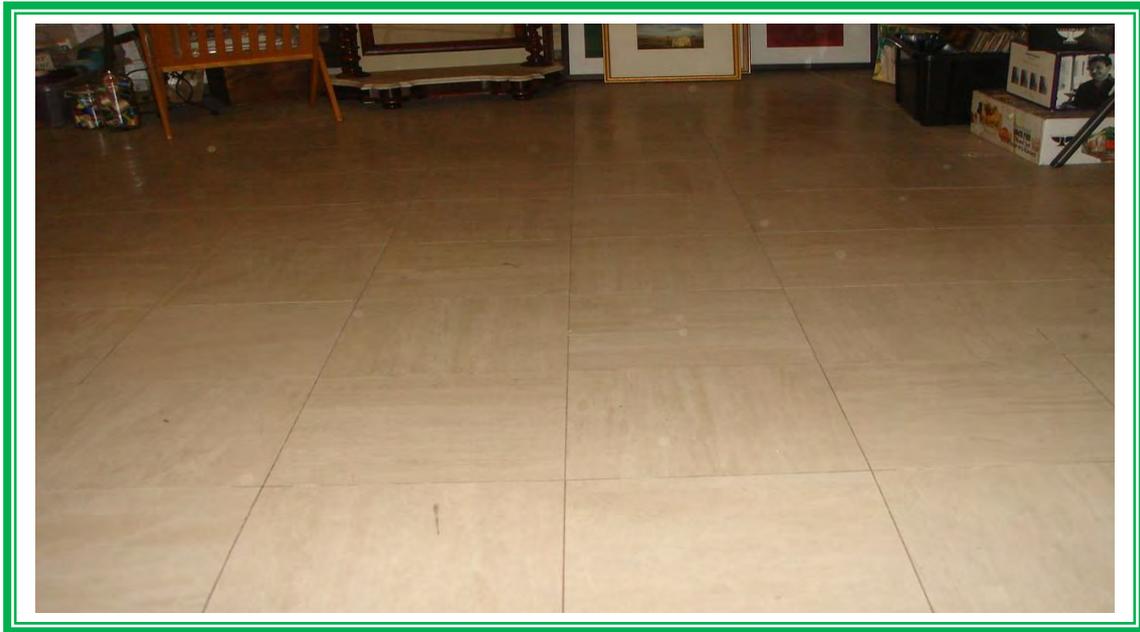
Material Description:	Vinyl Floor Tiles	
Identification:	Sampled – No Asbestos Detected	
Approx. quantity:	40M2	
Accessibility	N/A	Assessment Score
Product type:	N/A	N/A
Extent of Damage:	N/A	N/A
Surface Treatment:	N/A	N/A
Asbestos type:	N/A	N/A
Material Assessment Score:		N/A
Priority Assessment Score:		N/A
Action:	N/A	
Comments:	N/A

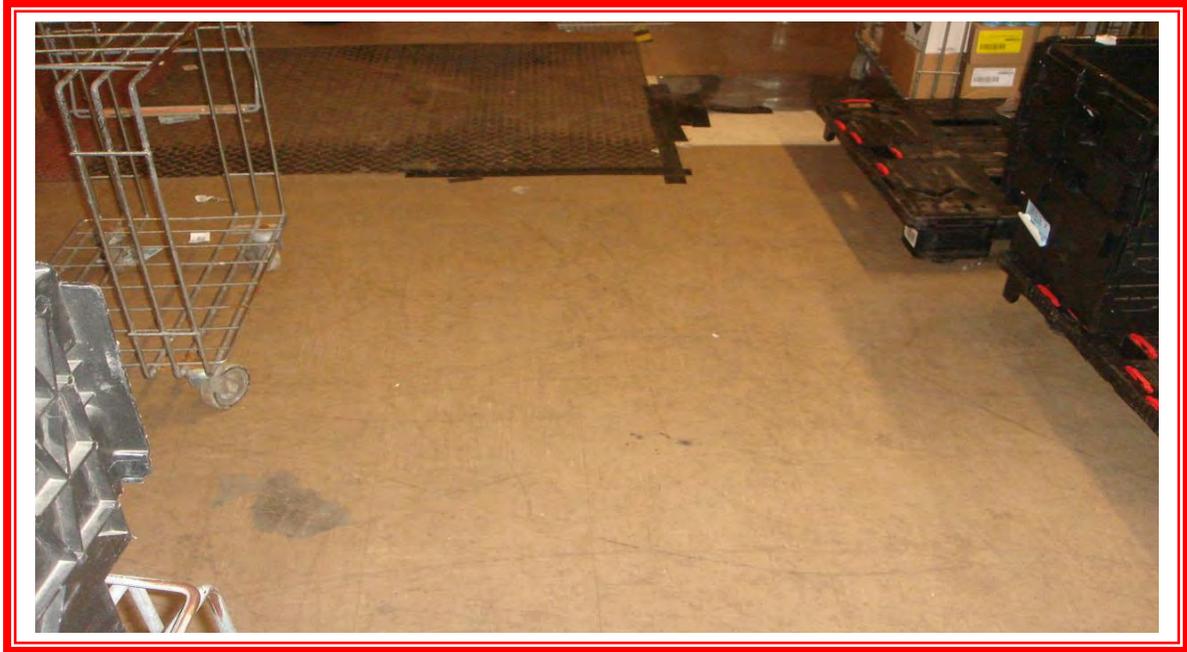
Material Description:	Vinyl Floor Tiles	
Identification:	Sampled – Asbestos Detected	
Approx. quantity:	50M2	
Accessibility	Low	Assessment Score
Product type:	Vinyl	1
Extent of Damage:	Low	1
Surface Treatment:	Non-Friable	0
Asbestos type:	Chrysotile	1
Material Assessment Score:		3
Priority Assessment Score:		Negligible
Action:	Manage	
Comments:	N/A

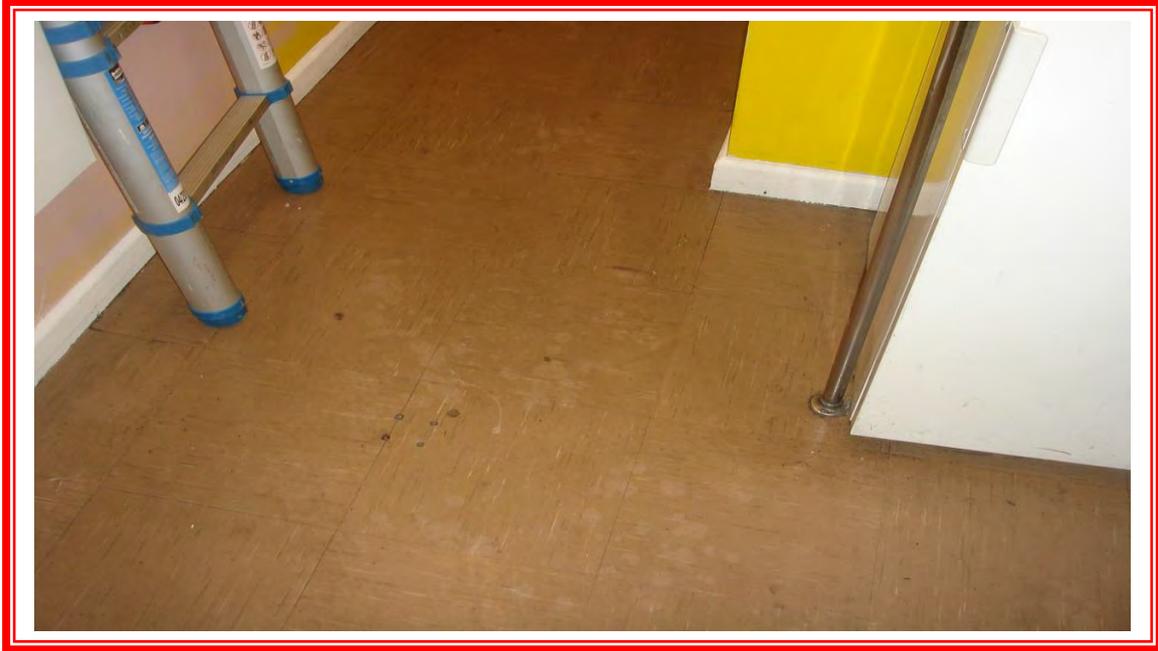
Material Description:	Vinyl Floor Tiles	
Identification:	As Per Sample NE/1 - Asbestos Detected	
Approx. quantity:	10M2	
Accessibility	Low	Assessment Score
Product type:	Vinyl	1
Extent of Damage:	Low	1
Surface Treatment:	Non-Friable	0
Asbestos type:	Chrysotile	1
Material Assessment Score:		3
Priority Assessment Score:		Negligible
Action:	Manage	
Comments:	N/A

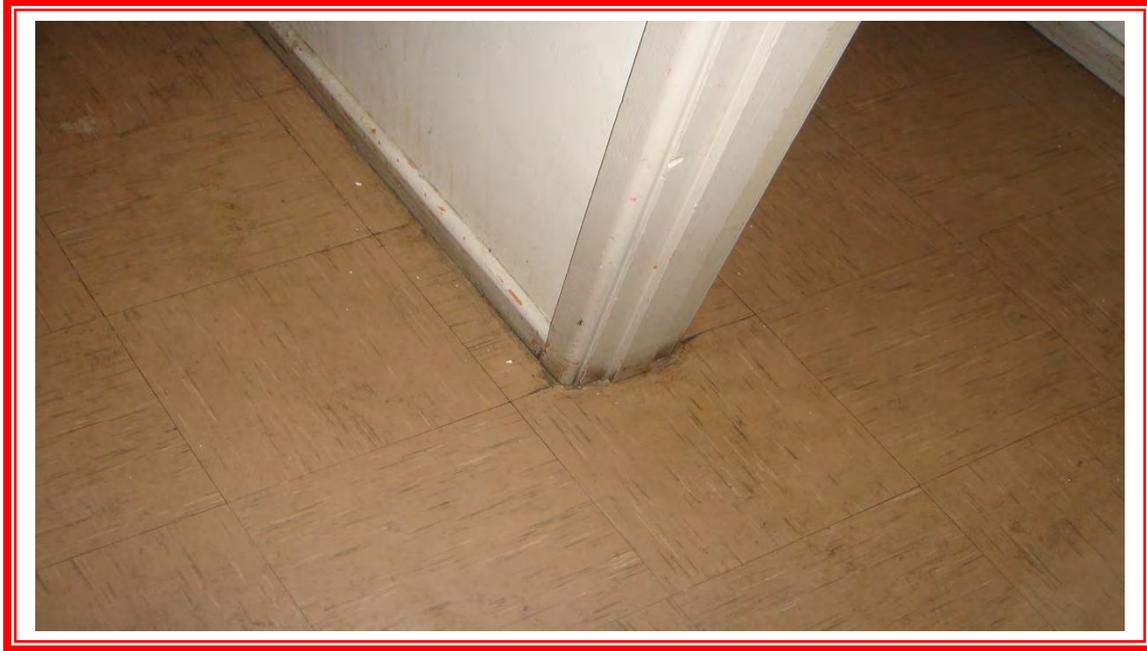
Material Description:	Vinyl Floor Tiles	
Identification:	As Per Sample NE/1 - Asbestos Detected	
Approx. quantity:	2M2	
Accessibility	Low	Assessment Score
Product type:	Vinyl	1
Extent of Damage:	Low	1
Surface Treatment:	Non-Friable	0
Asbestos type:	Chrysotile	1
Material Assessment Score:		3
Priority Assessment Score:		Negligible
Action:	Manage	
Comments:	N/A

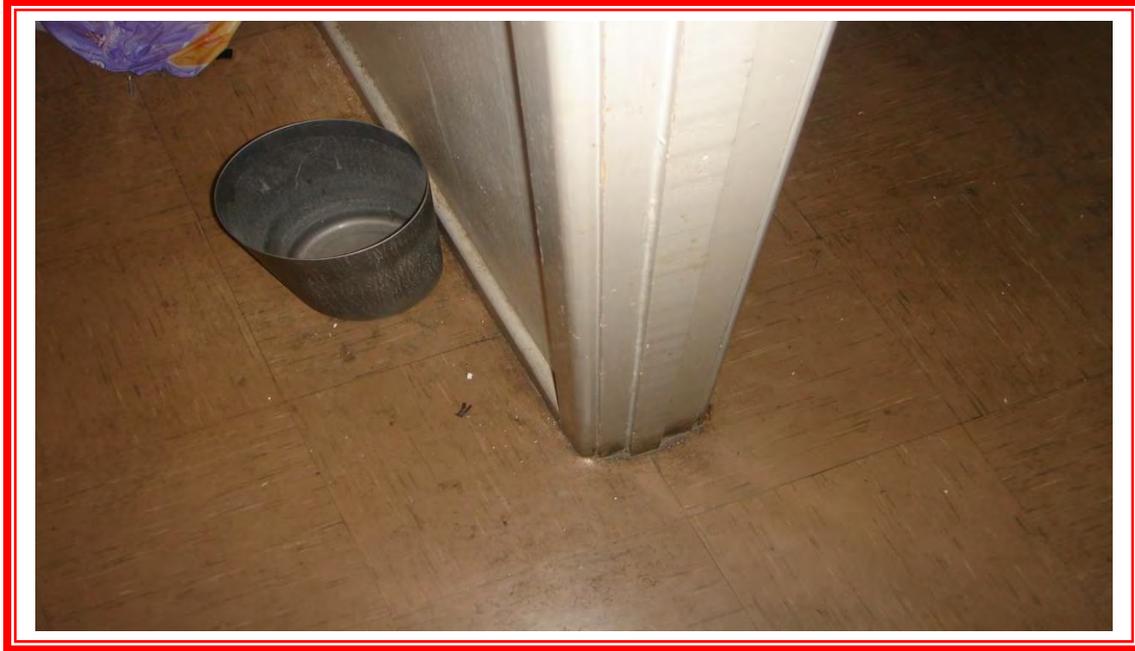
Material Description:	Vinyl Floor Tiles	
Identification:	As Per Sample NE/1 - Asbestos Detected	
Approx. quantity:	2M2	
Accessibility	Low	Assessment Score
Product type:	Vinyl	1
Extent of Damage:	Low	1
Surface Treatment:	Non-Friable	0
Asbestos type:	Chrysotile	1
Material Assessment Score:		3
Priority Assessment Score:		Negligible
Action:	Manage	
Comments:	N/A

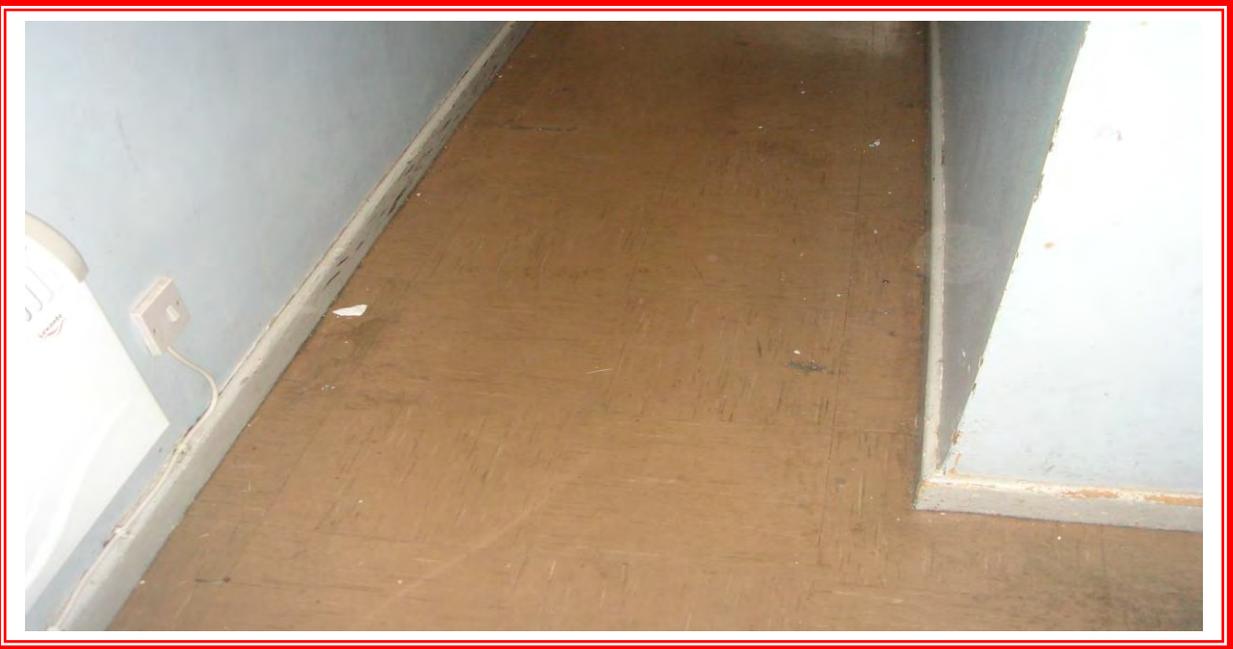
Material Description:	Vinyl Floor Tiles	
Identification:	Sampled - Asbestos Detected	
Approx. quantity:	6M2	
Accessibility	Low	Assessment Score
Product type:	Vinyl	1
Extent of Damage:	Low	1
Surface Treatment:	Non-Friable	0
Asbestos type:	Chrysotile	1
Material Assessment Score:		3
Priority Assessment Score:		Negligible
Action:	Manage	
Comments:	N/A

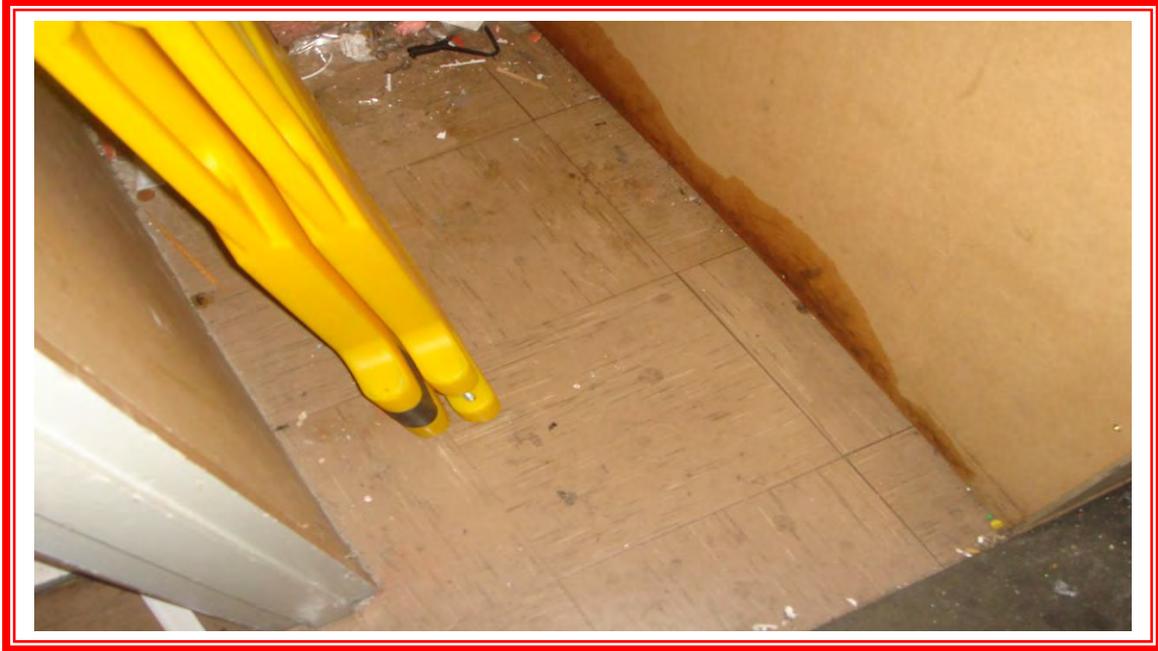
Material Description:	Vinyl Floor Tiles	
Identification:	As Per Sample NE/2 - Asbestos Detected	
Approx. quantity:	1M2	
Accessibility	Low	Assessment Score
Product type:	Vinyl	1
Extent of Damage:	Low	1
Surface Treatment:	Non-Friable	0
Asbestos type:	Chrysotile	1
Material Assessment Score:		3
Priority Assessment Score:		Negligible
Action:	Manage	
Comments:	N/A

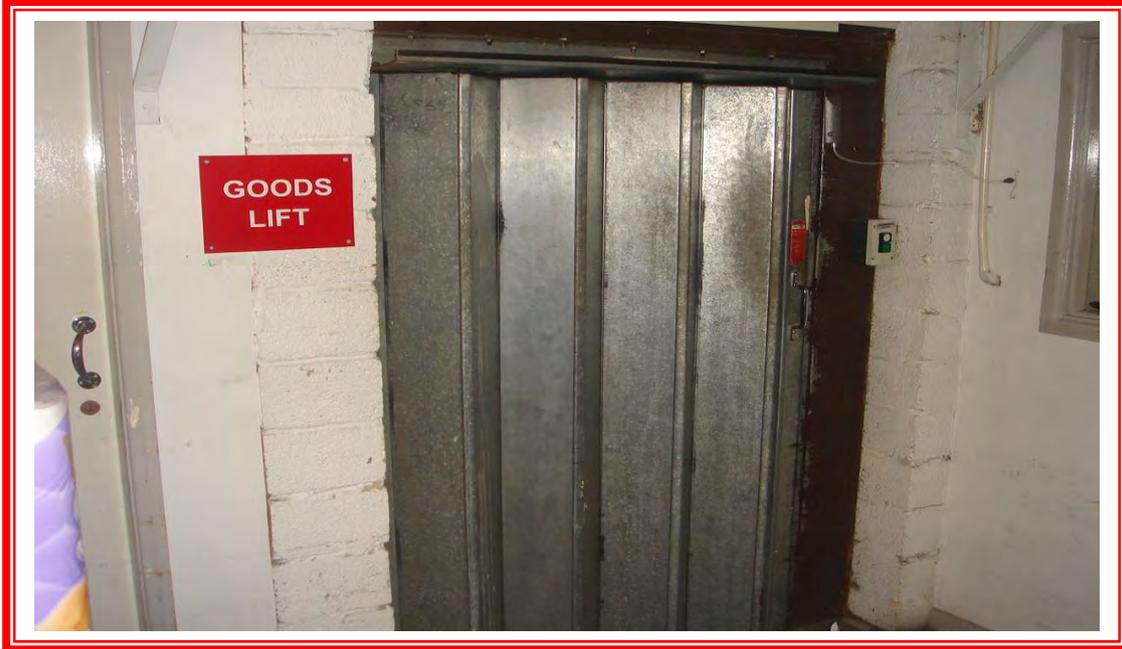
Material Description:	No Access	
Identification:	Presumed to Contain Asbestos	
Approx. quantity:	Unknown	
Accessibility	Low	Assessment Score
Product type:	No Access	3
Extent of Damage:	No Access	3
Surface Treatment:	No Access	3
Asbestos type:	No Access	3
Material Assessment Score:		12
Priority Assessment Score:		High
Action:	Further Investigation Required	
Comments:	No access as no lift engineer was onsite

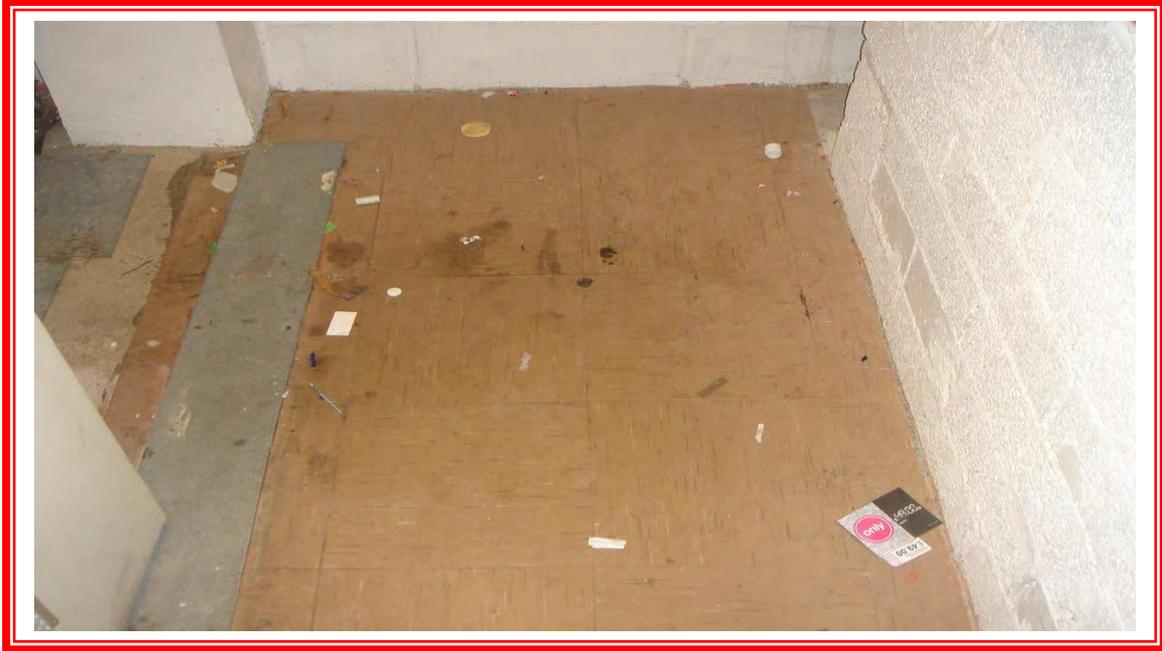
Material Description:	Vinyl Floor Tiles	
Identification:	As Per Sample NE/2 - Asbestos Detected	
Approx. quantity:	2M2	
Accessibility	Low	Assessment Score
Product type:	Vinyl	1
Extent of Damage:	Low	1
Surface Treatment:	Non-Friable	0
Asbestos type:	Chrysotile	1
Material Assessment Score:		3
Priority Assessment Score:		Negligible
Action:	Manage	
Comments:	N/A

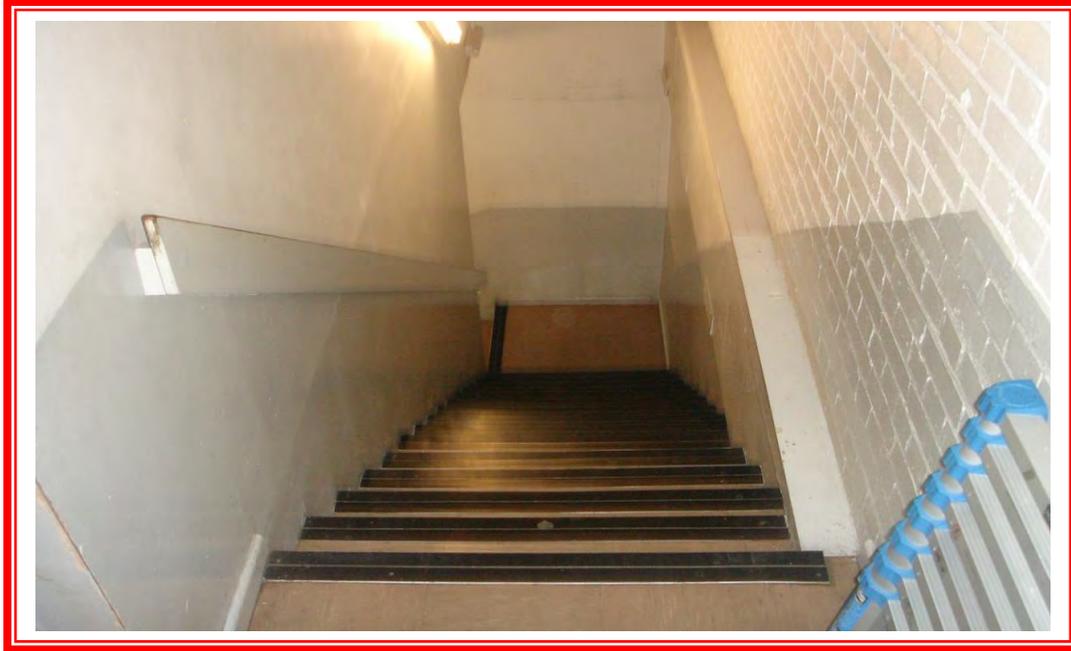
Material Description:	Vinyl Floor Tiles	
Identification:	As Per Sample NE/2 - Asbestos Detected	
Approx. quantity:	30M2	
Accessibility	Low	Assessment Score
Product type:	Vinyl	1
Extent of Damage:	Low	1
Surface Treatment:	Non-Friable	0
Asbestos type:	Chrysotile	1
Material Assessment Score:		3
Priority Assessment Score:		Negligible
Action:	Manage	
Comments:	N/A
