Section 6: Survey Objectives

Instructions were received from James Croucher of Lochailort Newbury Ltd to carry out a Management asbestos survey at Kennet Centre, Market Street, Newbury, Berkshire, RG14 5EN in accordance with HSG264 and Armour Analytical's quality procedures.

The survey was carried out on 22nd – 25th October 2019 by Neale Evans with the objective of facilitating a Management report.

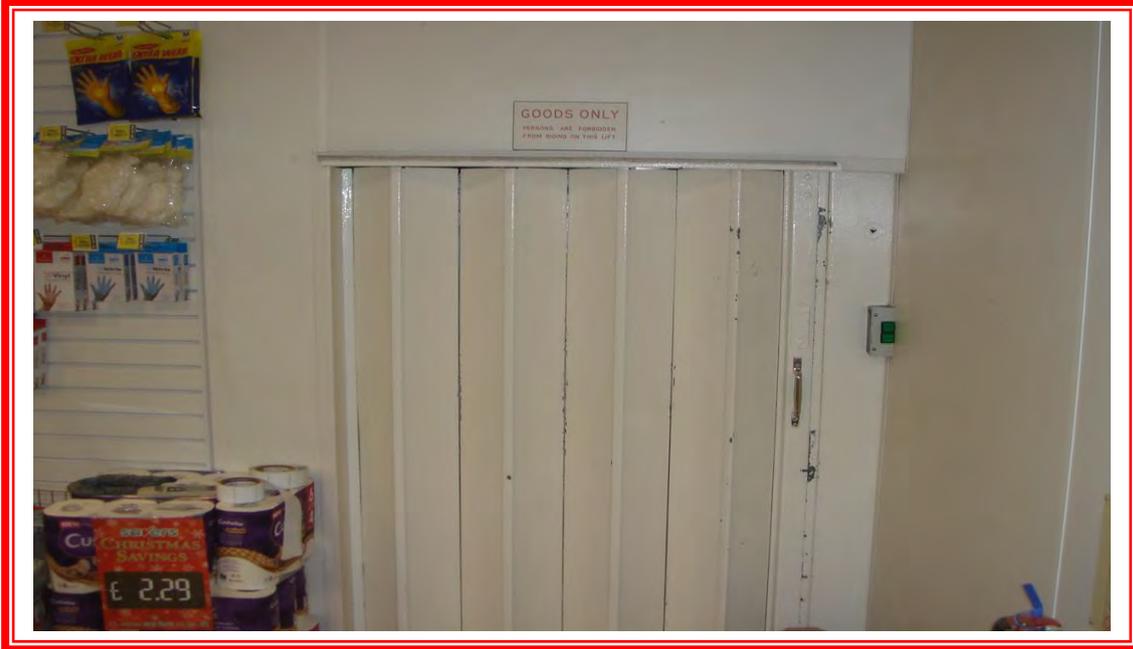
Material Description:	No Access	
Identification:	Presumed to Contain Asbestos	
Approx. quantity:	Unknown	
Accessibility	Low	Assessment Score
Product type:	No Access	3
Extent of Damage:	No Access	3
Surface Treatment:	No Access	3
Asbestos type:	No Access	3
Material Assessment Score:		12
Priority Assessment Score:		High
Action:	Further Investigation Required	
Comments:	No access as no lift engineer was onsite

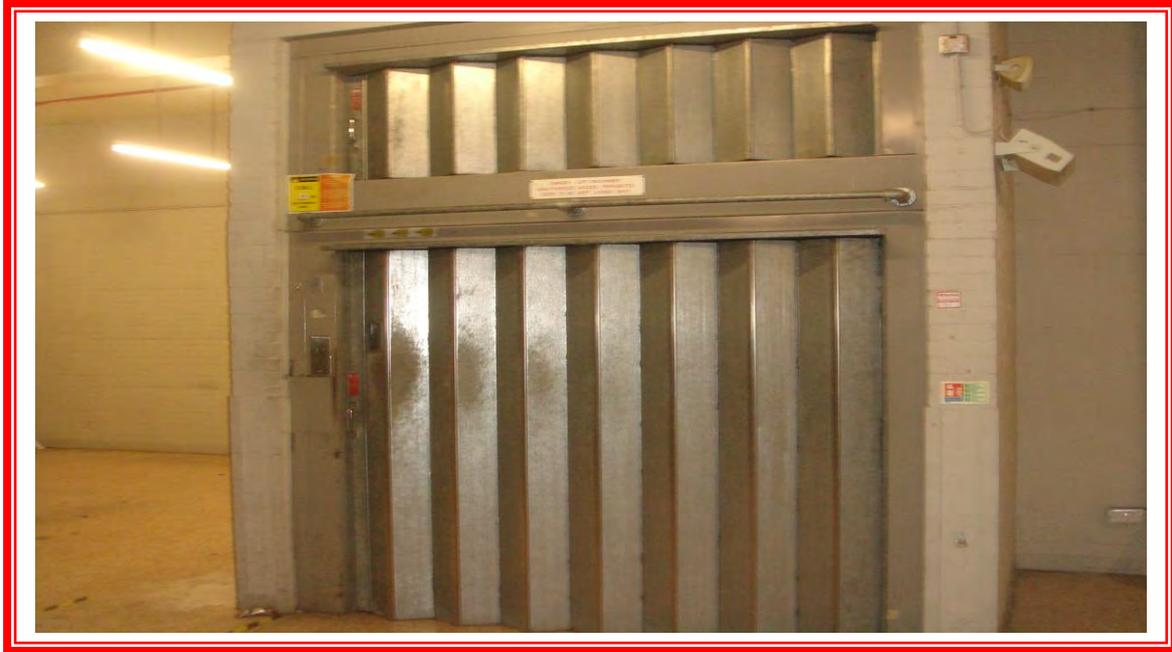
Material Description:	No Access	
Identification:	Presumed to Contain Asbestos	
Approx. quantity:	Unknown	
Accessibility	Low	Assessment Score
Product type:	No Access	3
Extent of Damage:	No Access	3
Surface Treatment:	No Access	3
Asbestos type:	No Access	3
Material Assessment Score:		12
Priority Assessment Score:		High
Action:	Further Investigation Required	
Comments:	No Access to inspect as there was no lift engineer onsite

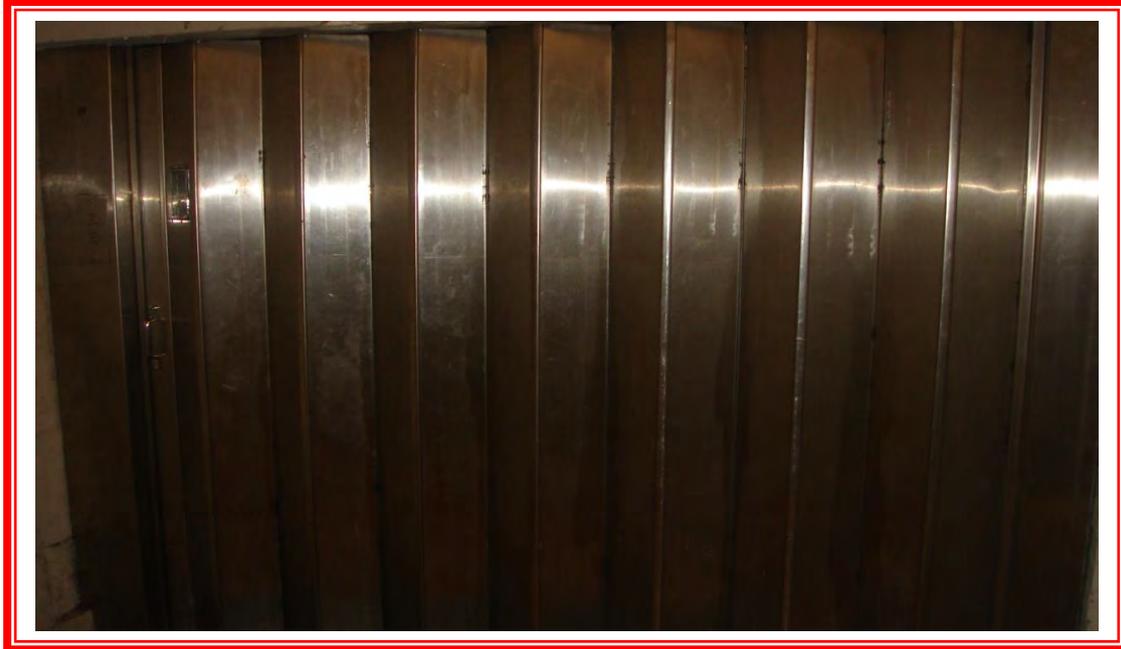
Material Description:	No Access to Lift or Shaft	
Identification:	Presumed to Contain Asbestos	
Approx. quantity:	Unknown	
Accessibility	Low	Assessment Score
Product type:	No Access	3
Extent of Damage:	No Access	3
Surface Treatment:	No Access	3
Asbestos type:	No Access	3
Material Assessment Score:		12
Priority Assessment Score:		High
Action:	Further Investigation Required	
Comments:	No Access to inspect as there was no lift engineer onsite

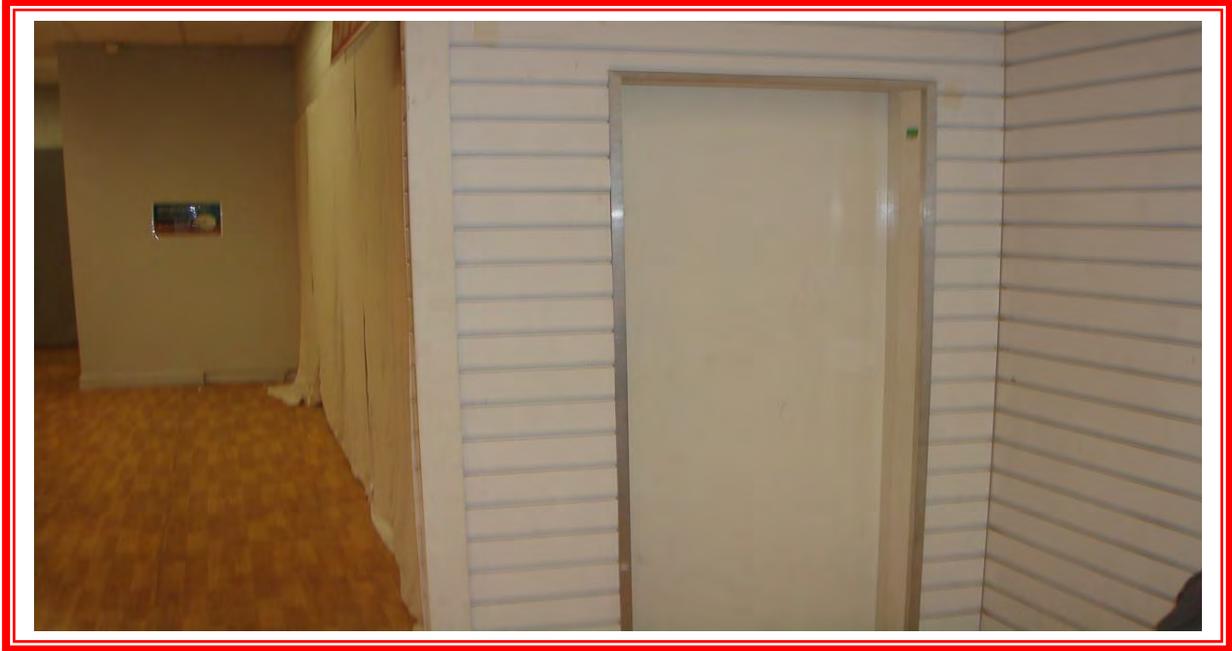
Material Description:	No Access	
Identification:	Presumed to Contain Asbestos	
Approx. quantity:	Unknown	
Accessibility	Low	Assessment Score
Product type:	No Access	3
Extent of Damage:	No Access	3
Surface Treatment:	No Access	3
Asbestos type:	No Access	3
Material Assessment Score:		12
Priority Assessment Score:		High
Action:	Further Investigation Required	
Comments:	No Access, no Keys at Time of Survey
