# EAGLE QUARTER II NEWBURY

ASBESTOS SURVEY

Management  
Asbestos Survey Report

Kennet Centre, Market Street, Newbury,  
Berkshire, RG14 5EN

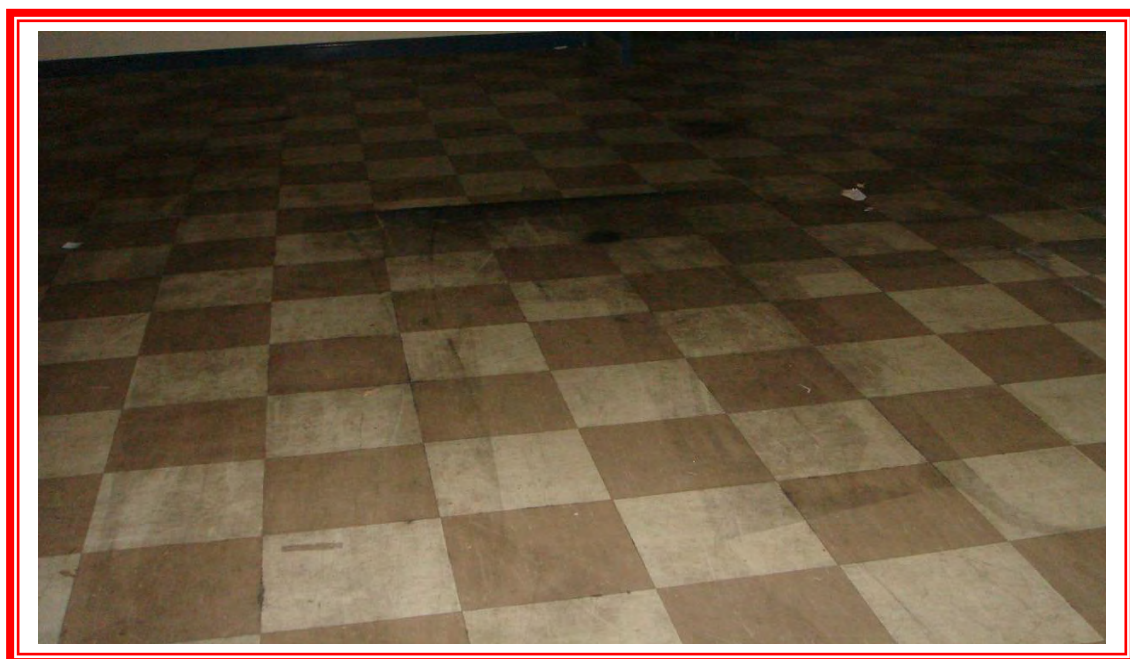
Material Description:	Vinyl Floor Tiles	
Identification:	Sampled – Asbestos Detected	
Approx. quantity:	64M2	
Accessibility	Low	Assessment Score
Product type:	Vinyl	1
Extent of Damage:	Minor	1
Surface Treatment:	Non-Friable	0
Asbestos type:	Chrysotile	1
Material Assessment Score:		3
Priority Assessment Score:		Negligible
Action:	Manage	
Comments:	N/A

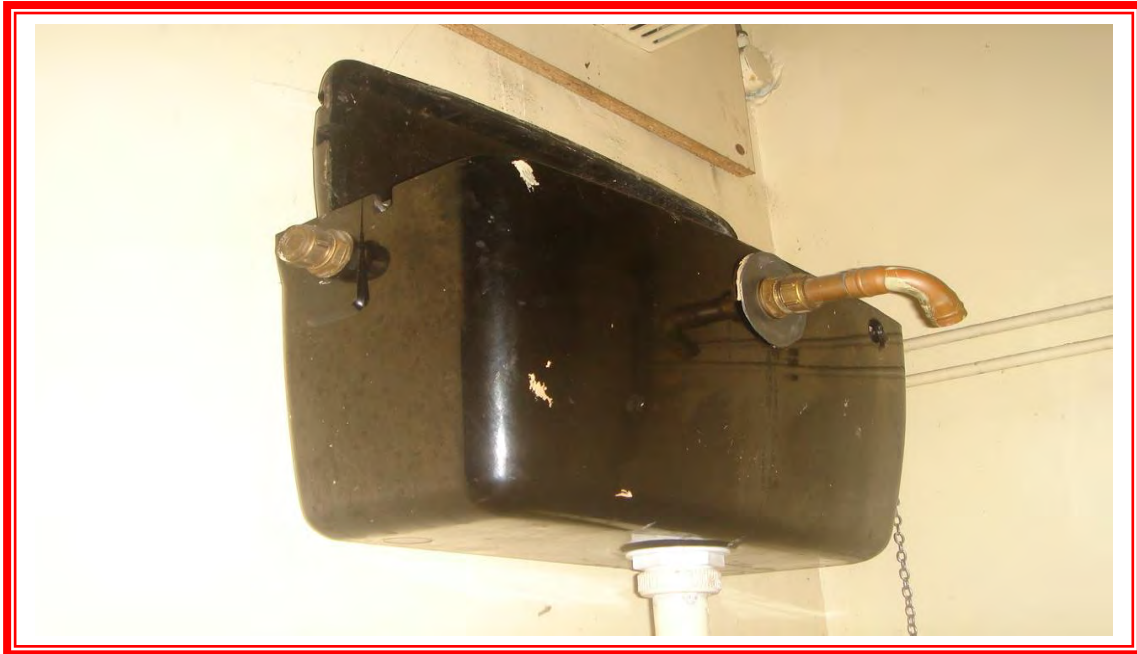
Material Description:	Toilet Cistern	
Identification:	Sampled – Asbestos Detected	
Approx. quantity:	1 X Item	
Accessibility	Low	Assessment Score
Product type:	Composite	1
Extent of Damage:	Good	0
Surface Treatment:	Non-Friable	0
Asbestos type:	Amosite	2
Material Assessment Score:		3
Priority Assessment Score:		Negligible
Action:	Manage	
Comments:	N/A

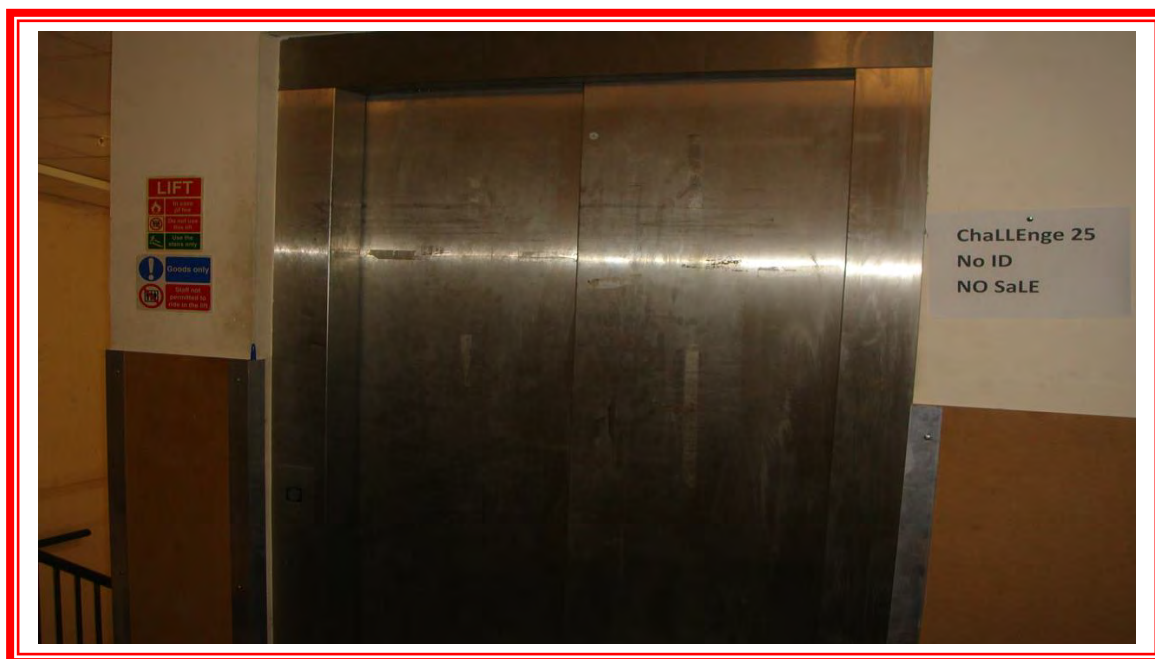
Material Description:	No Access	
Identification:	Presumed to Contain Asbestos	
Approx. quantity:	Unknown	
Accessibility	Low	Assessment Score
Product type:	No Access	3
Extent of Damage:	No Access	3
Surface Treatment:	No Access	3
Asbestos type:	No Access	3
Material Assessment Score:		12
Priority Assessment Score:		High
Action:	Further Inspection Required	
Comments:	No access as no lift engineer onsite

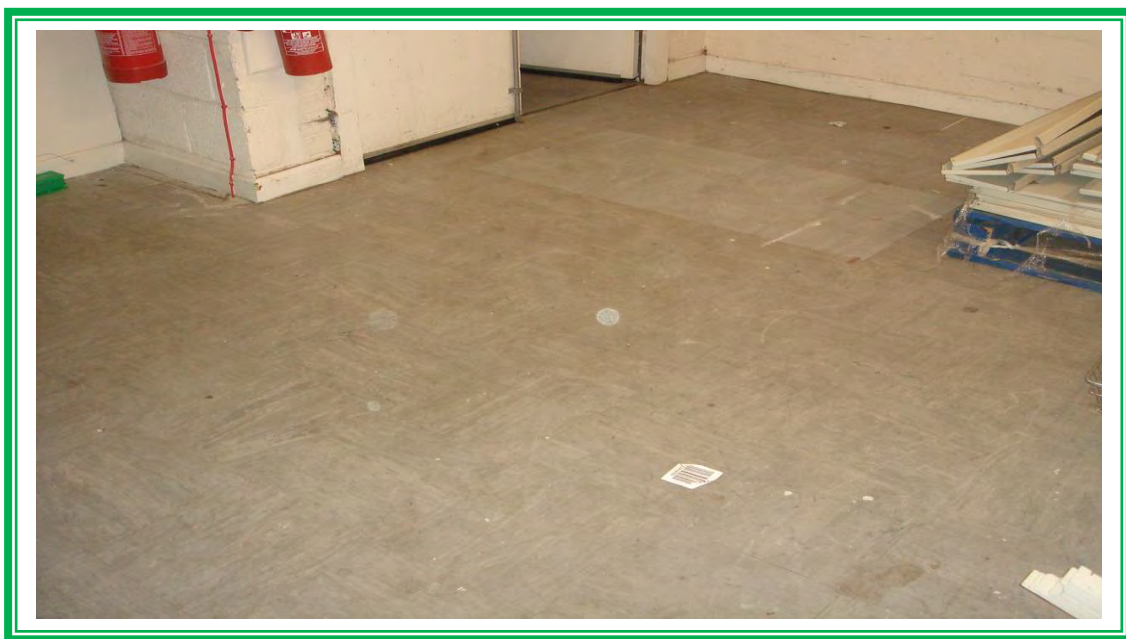
Material Description:	Vinyl Floor Tiles	
Identification:	Sampled – No Asbestos Detected	
Approx. quantity:	6M2	
Accessibility	N/A	Assessment Score
Product type:	N/A	N/A
Extent of Damage:	N/A	N/A
Surface Treatment:	N/A	N/A
Asbestos type:	N/A	N/A
Material Assessment Score:		N/A
Priority Assessment Score:		N/A
Action:	N/A	
Comments:	N/A

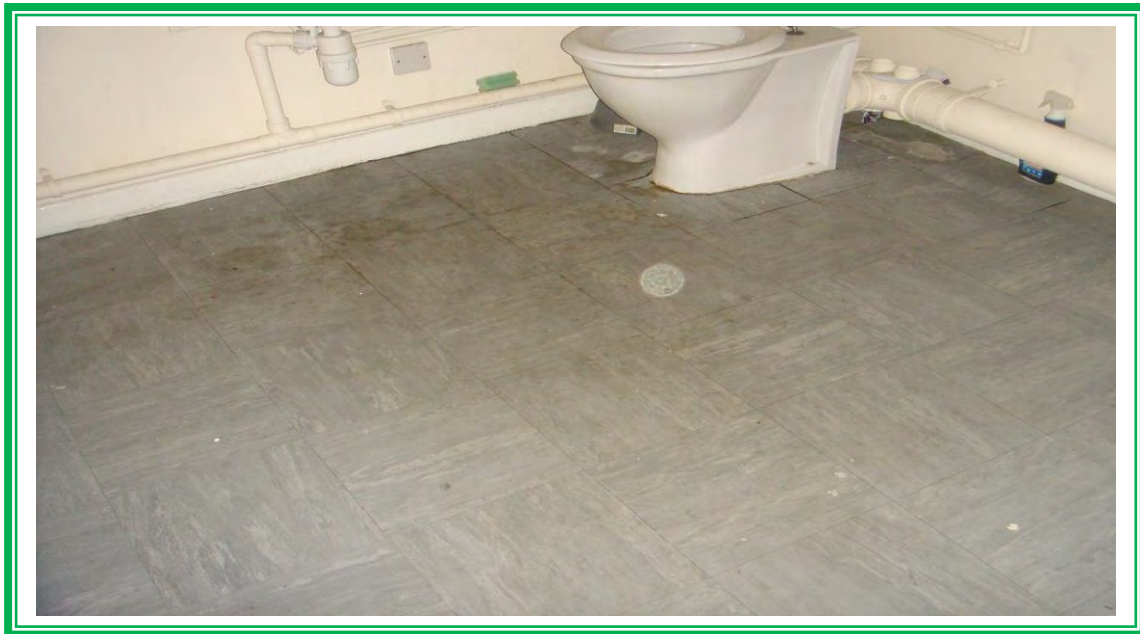
Material Description:	Vinyl Floor Tiles	
Identification:	As Per Sample NE/1 – No Asbestos Detected	
Approx. quantity:	6M2	
Accessibility	N/A	Assessment Score
Product type:	N/A	N/A
Extent of Damage:	N/A	N/A
Surface Treatment:	N/A	N/A
Asbestos type:	N/A	N/A
Material Assessment Score:		N/A
Priority Assessment Score:		N/A
Action:	N/A	
Comments:	N/A

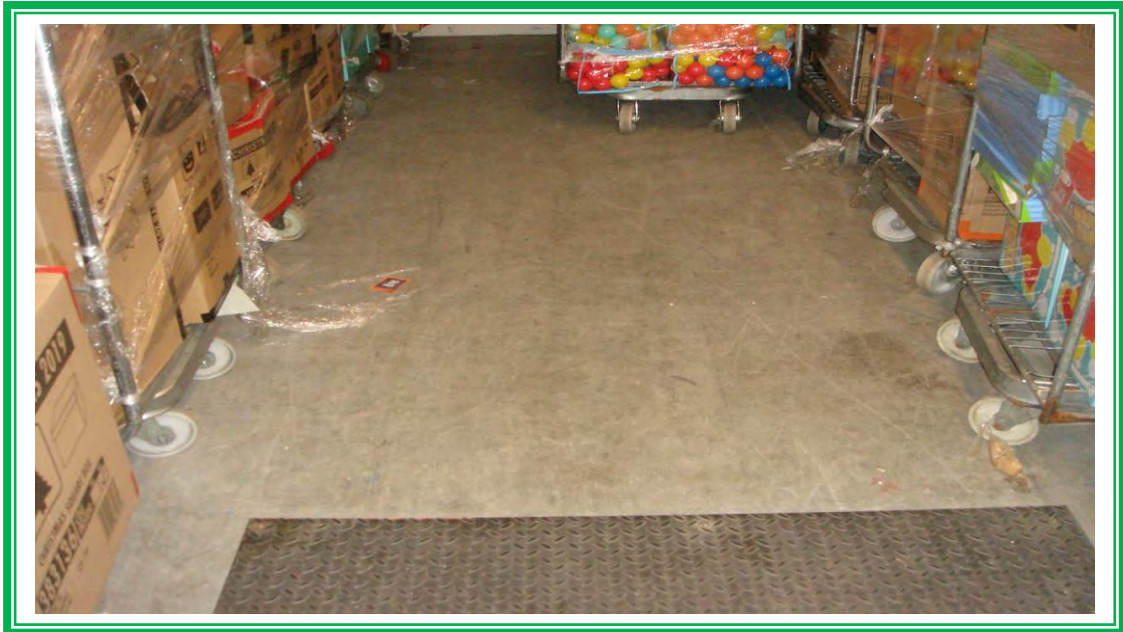
Material Description:	Vinyl Floor Tiles	
Identification:	As Per Sample NE/2 – No Asbestos Detected	
Approx. quantity:	30M2	
Accessibility	N/A	Assessment Score
Product type:	N/A	N/A
Extent of Damage:	N/A	N/A
Surface Treatment:	N/A	N/A
Asbestos type:	N/A	N/A
Material Assessment Score:		N/A
Priority Assessment Score:		N/A
Action:	N/A	
Comments:	N/A

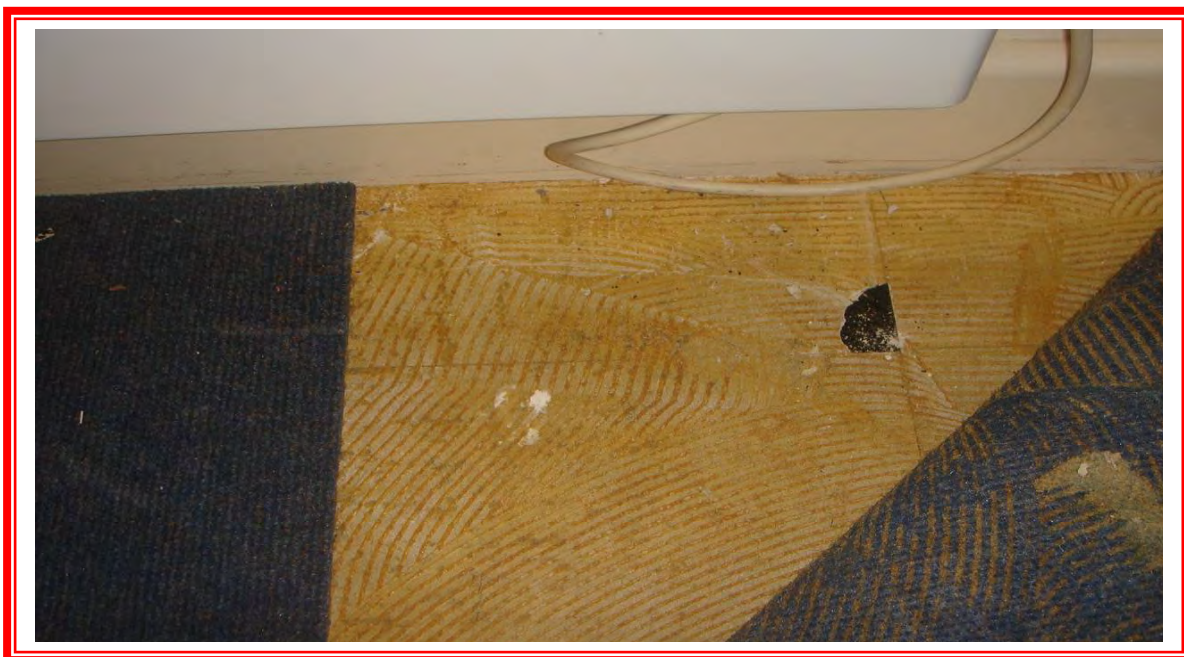
Material Description:	Vinyl Floor Tiles	
Identification:	Sampled – Asbestos Detected	
Approx. quantity:	40M2	
Accessibility	Low	Assessment Score
Product type:	Vinyl	1
Extent of Damage:	Minor	1
Surface Treatment:	Non-Friable	0
Asbestos type:	Chrysotile	1
Material Assessment Score:		3
Priority Assessment Score:		Negligible
Action:	Manage	
Comments:	N/A

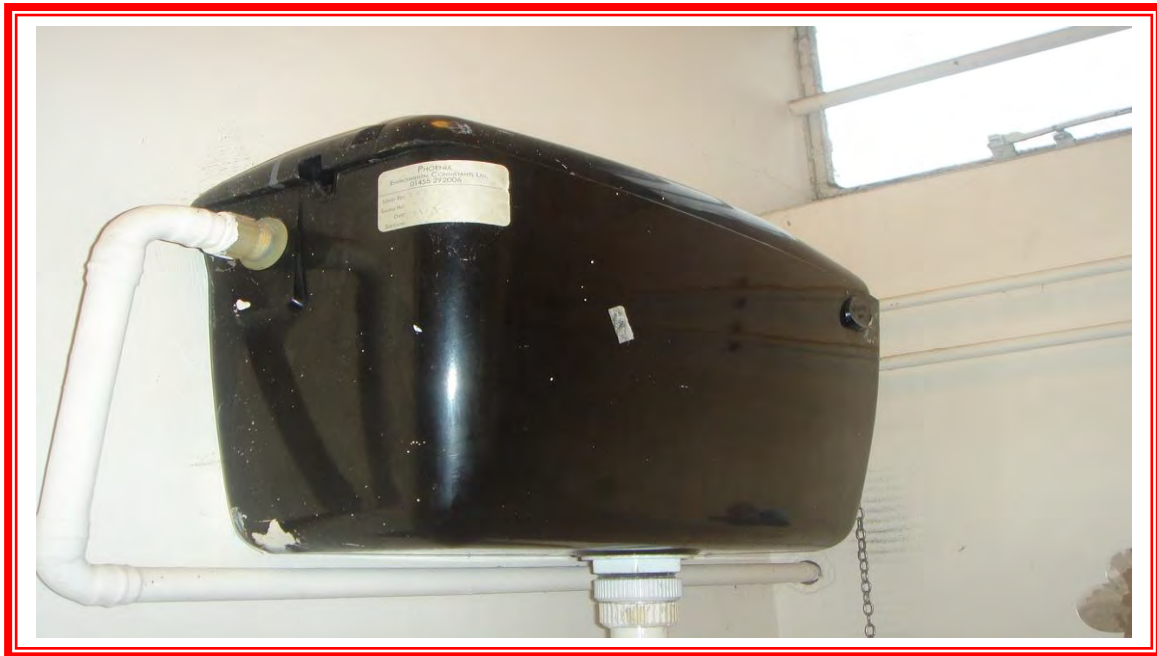
Material Description:	Toilet Cistern	
Identification:	Sampled – Asbestos Detected	
Approx. quantity:	1 X Cistern	
Accessibility	Low	Assessment Score
Product type:	Bakelite	1
Extent of Damage:	Good	0
Surface Treatment:	Non-Friable	0
Asbestos type:	Amosite	2
Material Assessment Score:		3
Priority Assessment Score:		Negligible
Action:	Manage	
Comments:	N/A

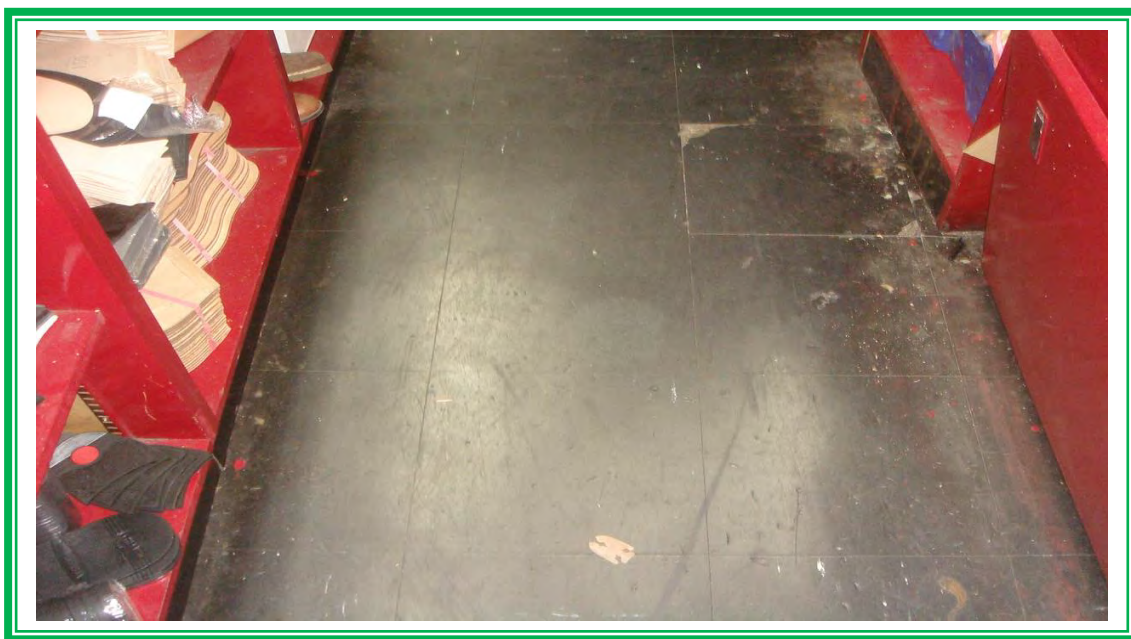
Material Description:	Vinyl Floor Tiles	
Identification:	Sampled – No Asbestos Detected	
Approx. quantity:	16M2	
Accessibility	N/A	Assessment Score
Product type:	N/A	N/A
Extent of Damage:	N/A	N/A
Surface Treatment:	N/A	N/A
Asbestos type:	N/A	N/A
Material Assessment Score:		N/A
Priority Assessment Score:		N/A
Action:	N/A	
Comments:	N/A

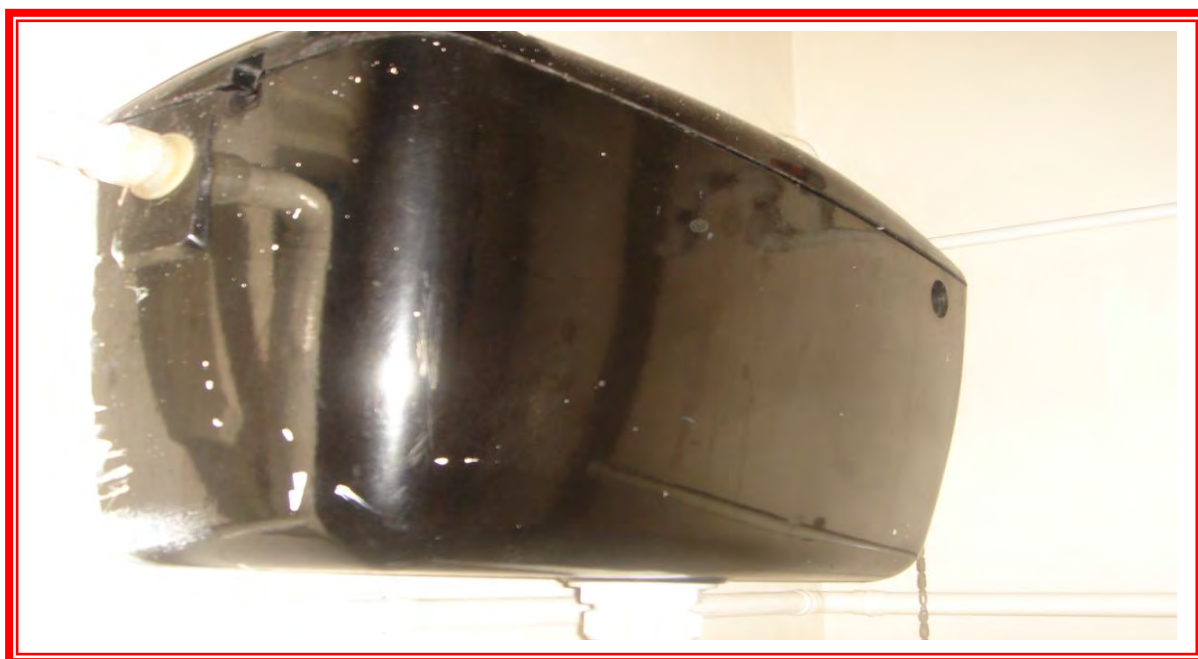
Material Description:	Toilet Cistern	
Identification:	Sampled – Asbestos Detected	
Approx. quantity:	1 X Item	
Accessibility	Low	Assessment Score
Product type:	Composite	1
Extent of Damage:	Good	0
Surface Treatment:	Non-Friable	0
Asbestos type:	Amosite	2
Material Assessment Score:		3
Priority Assessment Score:		Negligible
Action:	Manage	
Comments:	N/A

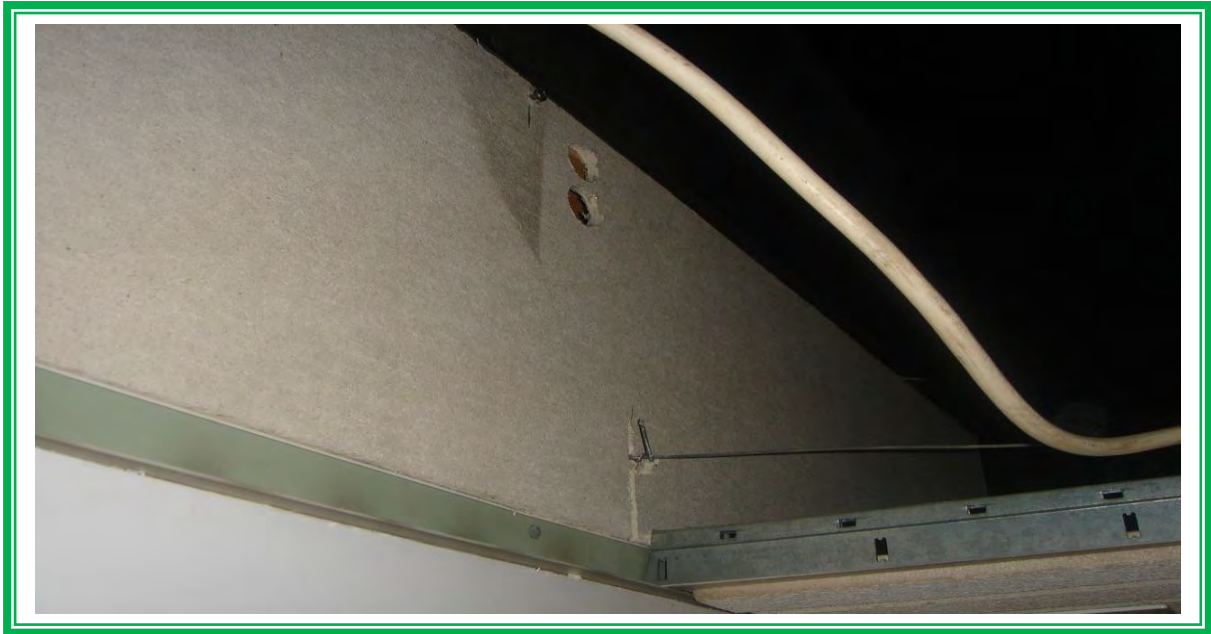
Material Description:	Insulating Board – Above Entrance	
Identification:	Sampled – No Asbestos Detected	
Approx. quantity:	5M2	
Accessibility	N/A	Assessment Score
Product type:	N/A	N/A
Extent of Damage:	N/A	N/A
Surface Treatment:	N/A	N/A
Asbestos type:	N/A	N/A
Material Assessment Score:		N/A
Priority Assessment Score:		N/A
Action:	N/A	
Comments:	N/A

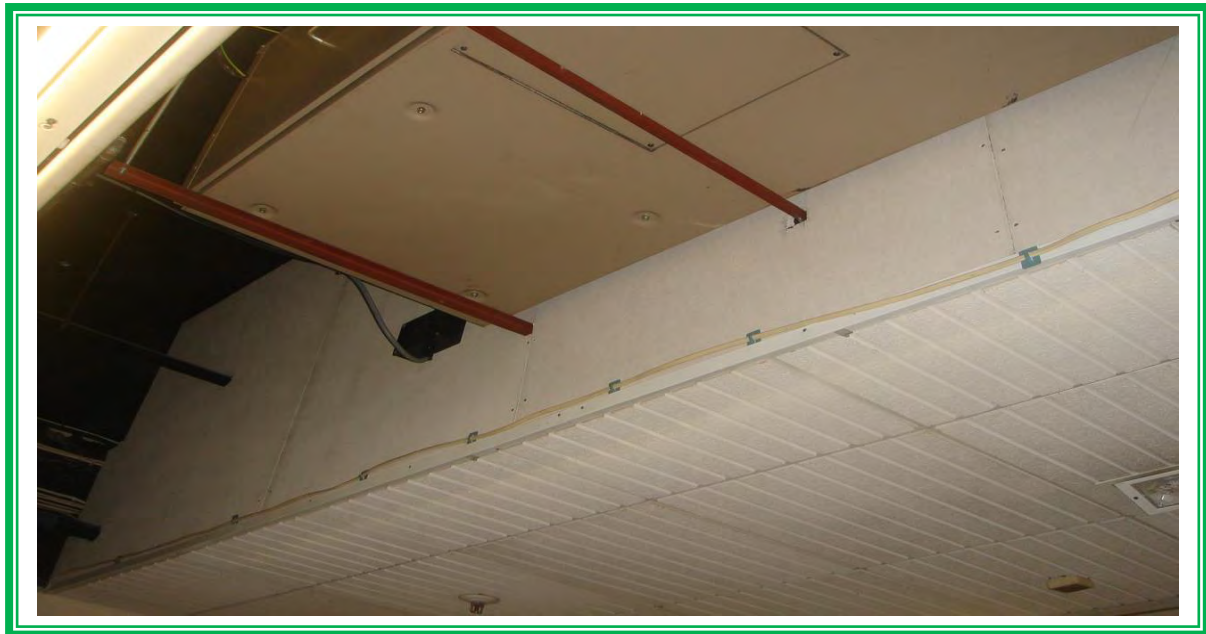
Material Description:	Insulating Board – High Level to Air Con Unit	
Identification:	As Per Sampled NE/3 – No Asbestos Detected	
Approx. quantity:	10M2	
Accessibility	N/A	Assessment Score
Product type:	N/A	N/A
Extent of Damage:	N/A	N/A
Surface Treatment:	N/A	N/A
Asbestos type:	N/A	N/A
Material Assessment Score:		N/A
Priority Assessment Score:		N/A
Action:	N/A	
Comments:	N/A

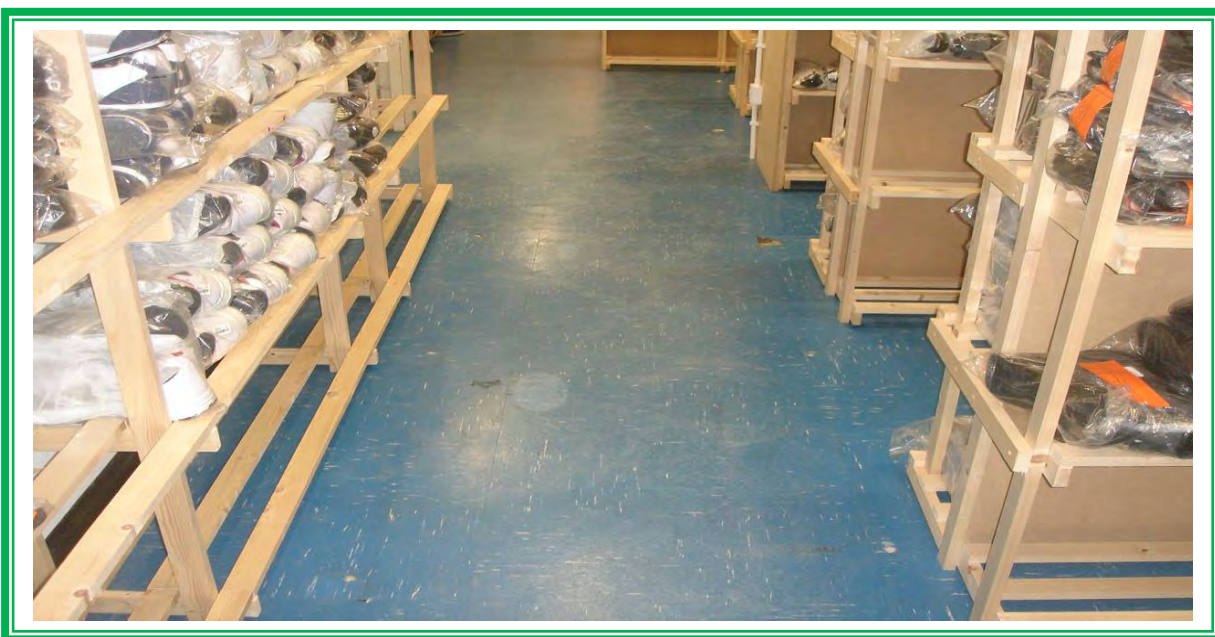
Material Description:	Vinyl Floor Tiles	
Identification:	Sampled – No Asbestos Detected	
Approx. quantity:	60M2	
Accessibility	N/A	Assessment Score
Product type:	N/A	N/A
Extent of Damage:	N/A	N/A
Surface Treatment:	N/A	N/A
Asbestos type:	N/A	N/A
Material Assessment Score:		N/A
Priority Assessment Score:		N/A
Action:	N/A	
Comments:	N/A

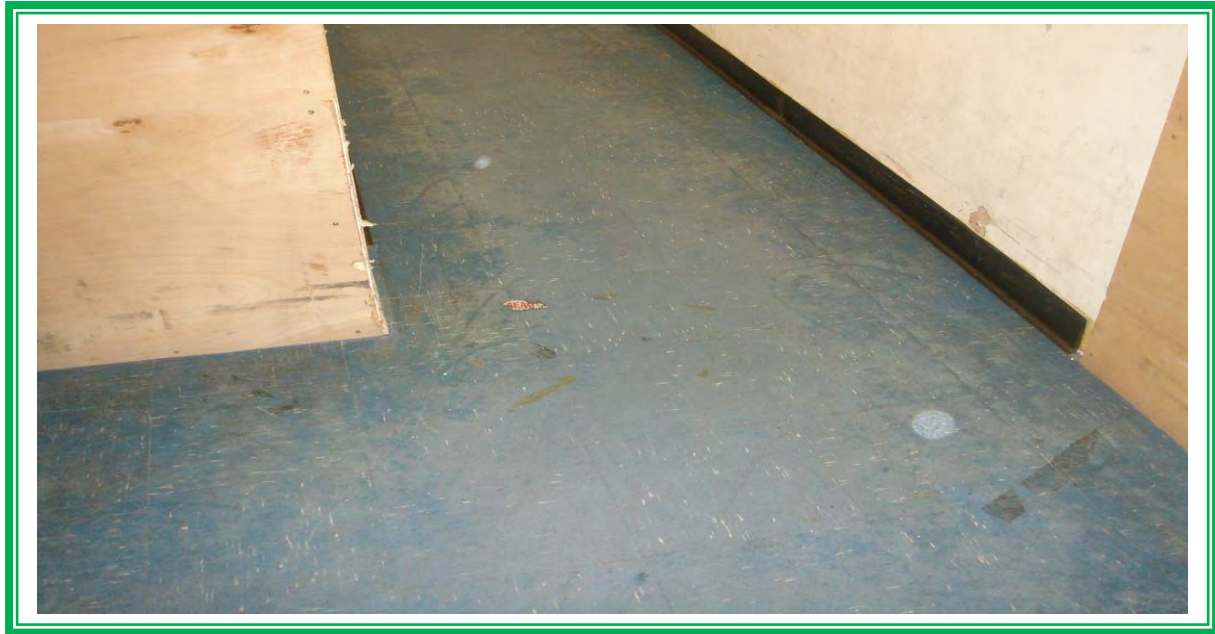
Material Description:	Vinyl Floor Tiles	
Identification:	As Per Sample NE/1 – No Asbestos Detected	
Approx. quantity:	10M2	
Accessibility	N/A	Assessment Score
Product type:	N/A	N/A
Extent of Damage:	N/A	N/A
Surface Treatment:	N/A	N/A
Asbestos type:	N/A	N/A
Material Assessment Score:		N/A
Priority Assessment Score:		N/A
Action:	N/A	
Comments:	N/A

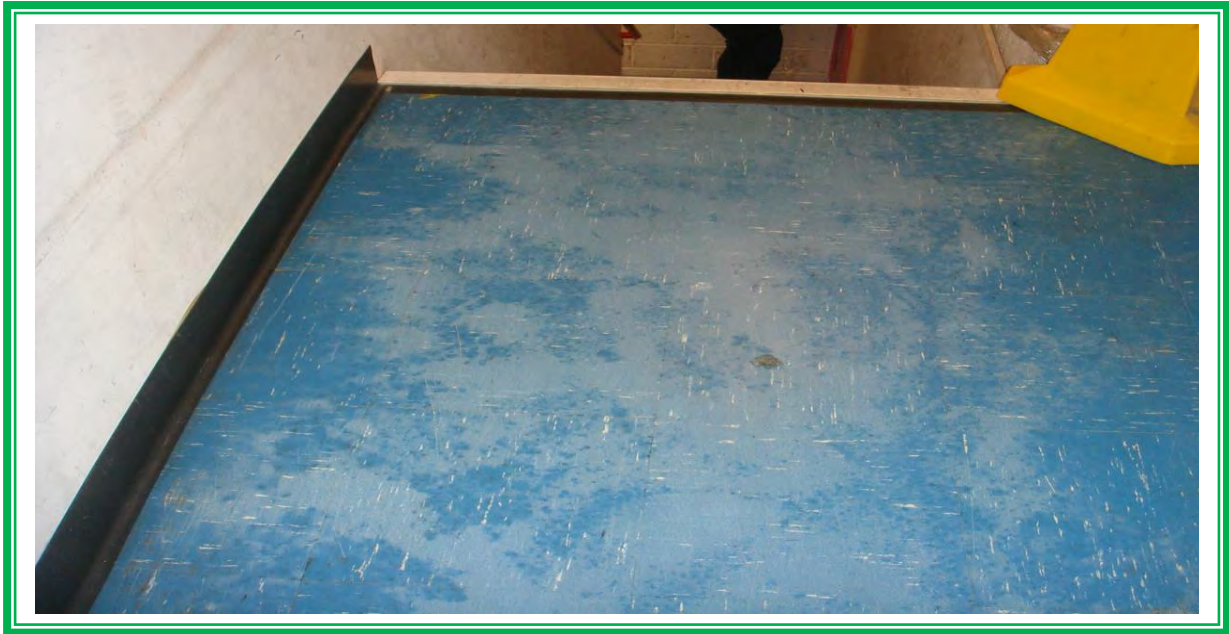
Material Description:	Vinyl Floor Tiles	
Identification:	As Per Sample NE/1 – No Asbestos Detected	
Approx. quantity:	26M2	
Accessibility	N/A	Assessment Score
Product type:	N/A	N/A
Extent of Damage:	N/A	N/A
Surface Treatment:	N/A	N/A
Asbestos type:	N/A	N/A
Material Assessment Score:		N/A
Priority Assessment Score:		N/A
Action:	N/A	
Comments:	N/A

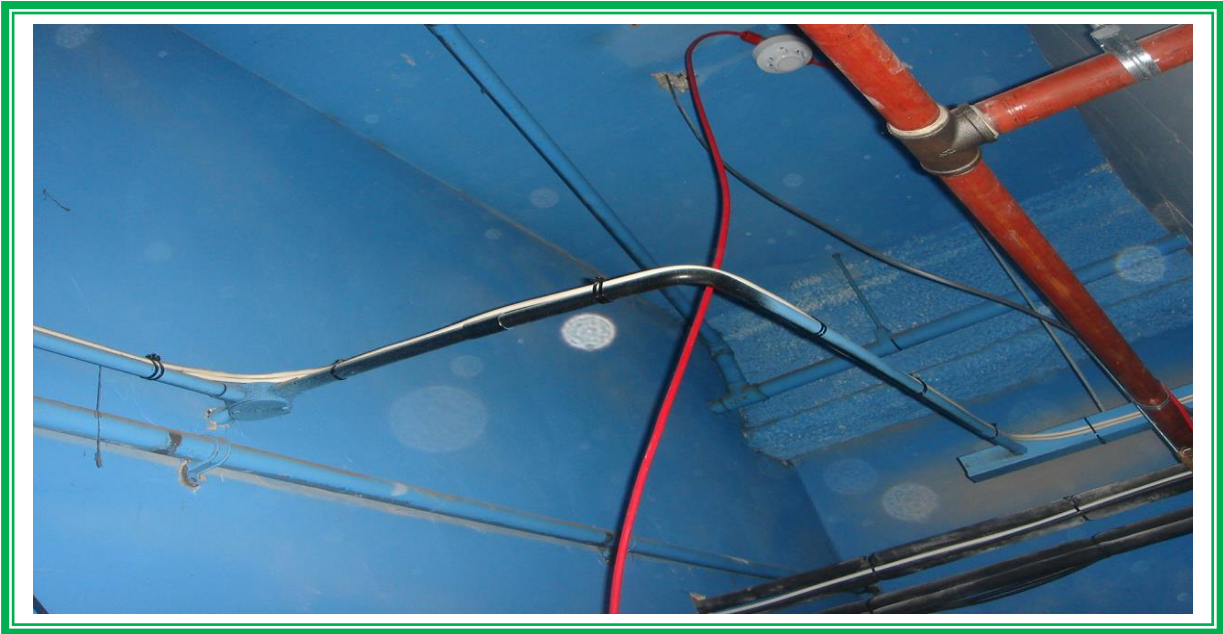
Material Description:	Sprayed Coating to Beams	
Identification:	As Per Sampled NE/2 – No Asbestos Detected	
Approx. quantity:	4M2	
Accessibility	N/A	Assessment Score
Product type:	N/A	N/A
Extent of Damage:	N/A	N/A
Surface Treatment:	N/A	N/A
Asbestos type:	N/A	N/A
Material Assessment Score:		N/A
Priority Assessment Score:		N/A
Action:	N/A	
Comments:	N/A

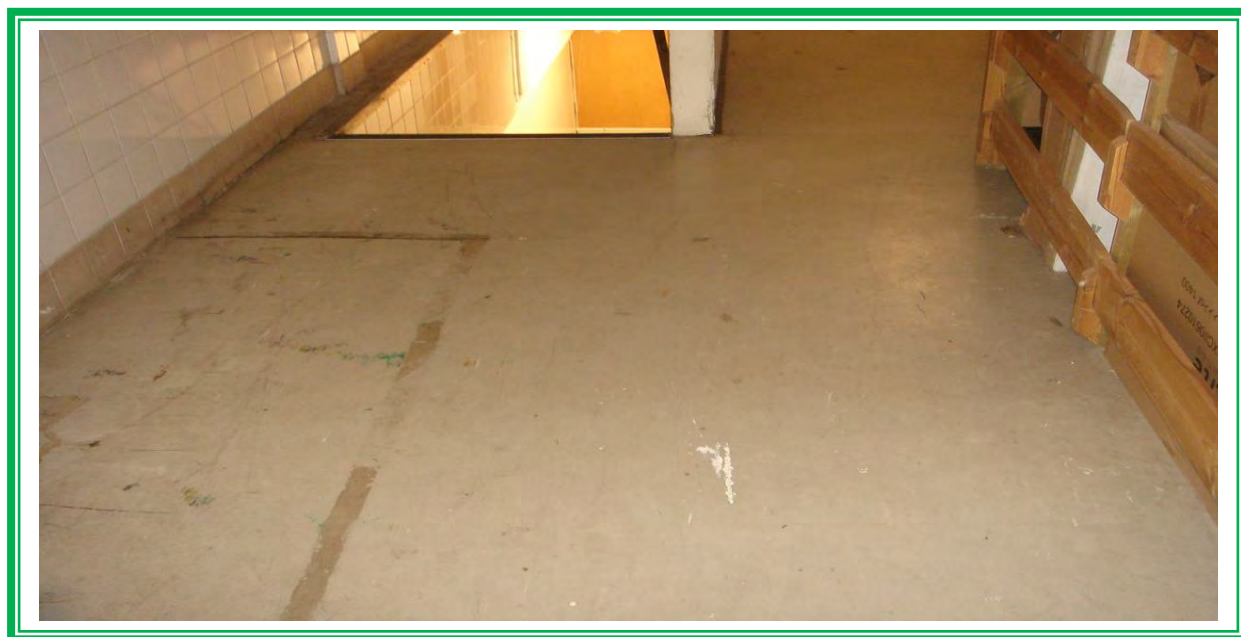
Material Description:	Vinyl Floor Sheets	
Identification:	Sampled – No Asbestos Detected	
Approx. quantity:	36M2	
Accessibility	N/A	Assessment Score
Product type:	N/A	N/A
Extent of Damage:	N/A	N/A
Surface Treatment:	N/A	N/A
Asbestos type:	N/A	N/A
Material Assessment Score:		N/A
Priority Assessment Score:		N/A
Action:	N/A	
Comments:	N/A

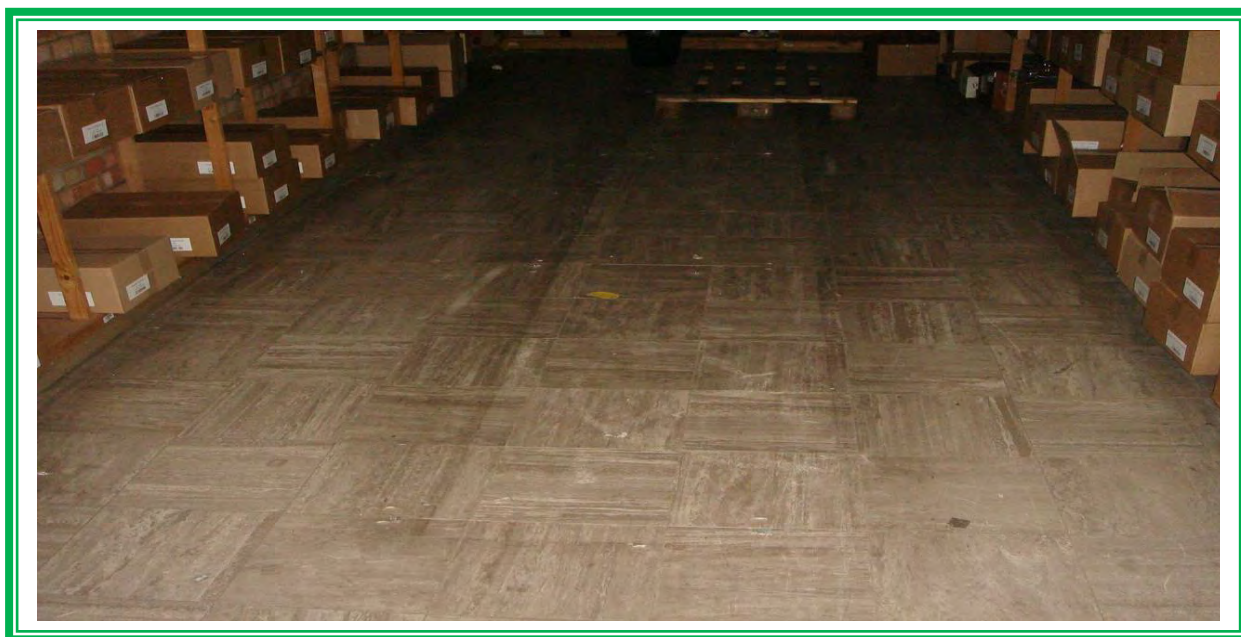
Material Description:	Vinyl Floor Tiles	
Identification:	Sampled – No Asbestos Detected	
Approx. quantity:	50M2	
Accessibility	N/A	Assessment Score
Product type:	N/A	N/A
Extent of Damage:	N/A	N/A
Surface Treatment:	N/A	N/A
Asbestos type:	N/A	N/A
Material Assessment Score:		N/A
Priority Assessment Score:		N/A
Action:	N/A	
Comments:	N/A

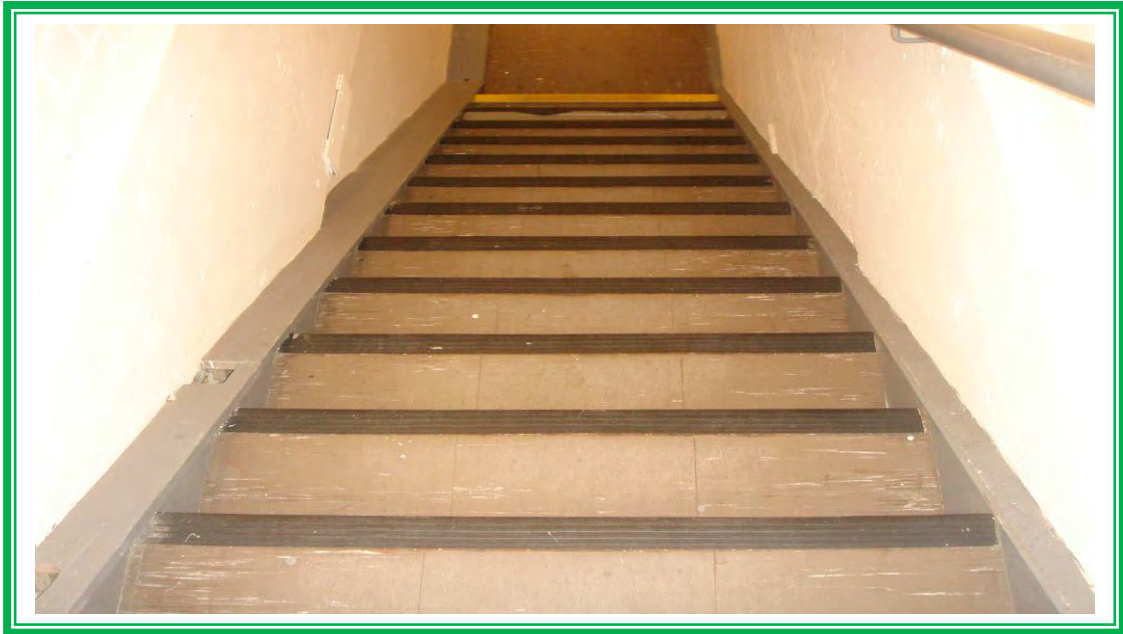
Material Description:	Vinyl Floor Tiles	
Identification:	Sampled – No Asbestos Detected	
Approx. quantity:	10M2	
Accessibility	N/A	Assessment Score
Product type:	N/A	N/A
Extent of Damage:	N/A	N/A
Surface Treatment:	N/A	N/A
Asbestos type:	N/A	N/A
Material Assessment Score:		N/A
Priority Assessment Score:		N/A
Action:	N/A	
Comments:	N/A

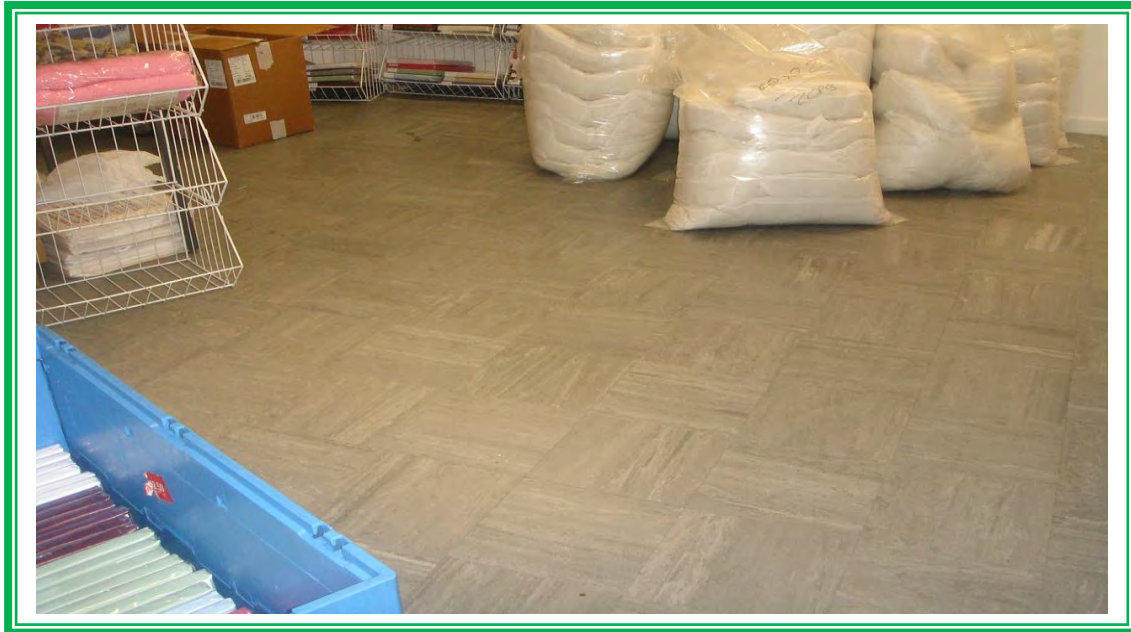
Material Description:	Vinyl Floor Tiles	
Identification:	As Per Sample NE/4 – No Asbestos Detected	
Approx. quantity:	30M2	
Accessibility	N/A	Assessment Score
Product type:	N/A	N/A
Extent of Damage:	N/A	N/A
Surface Treatment:	N/A	N/A
Asbestos type:	N/A	N/A
Material Assessment Score:		N/A
Priority Assessment Score:		N/A
Action:	N/A	
Comments:	N/A

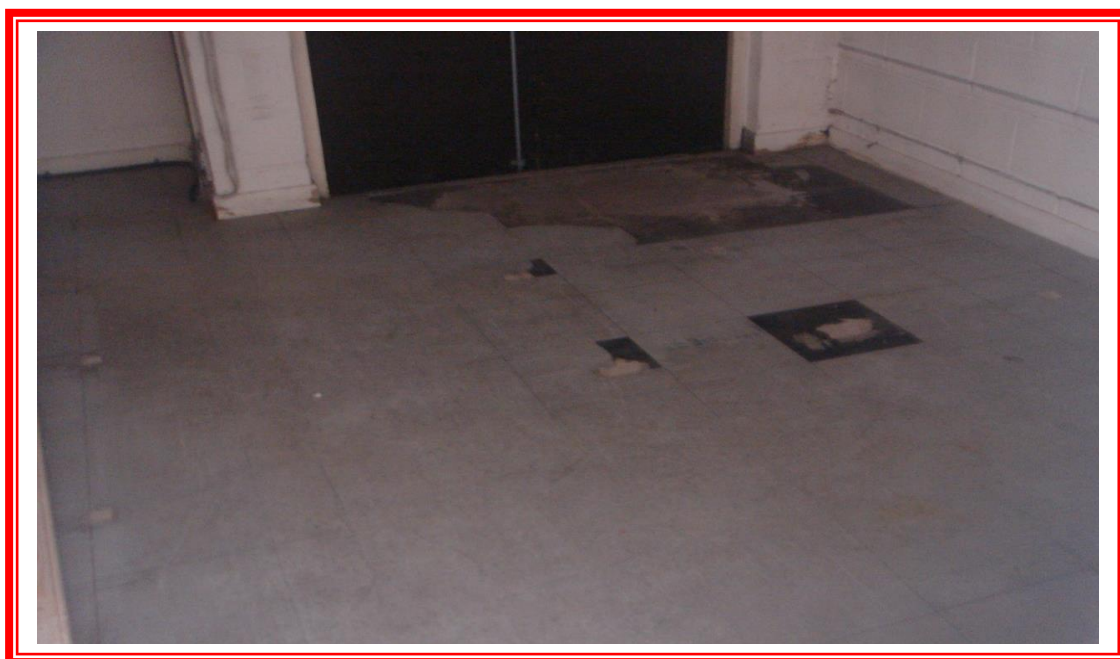
Material Description:	Vinyl Floor Tiles	
Identification:	Sampled – Asbestos Detected	
Approx. quantity:	20M2	
Accessibility	Low	Assessment Score
Product type:	Vinyl	1
Extent of Damage:	Moderate	2
Surface Treatment:	Non-Friable	0
Asbestos type:	Chrysotile	1
Material Assessment Score:		4
Priority Assessment Score:		Negligible
Action:	Manage	
Comments:	N/A

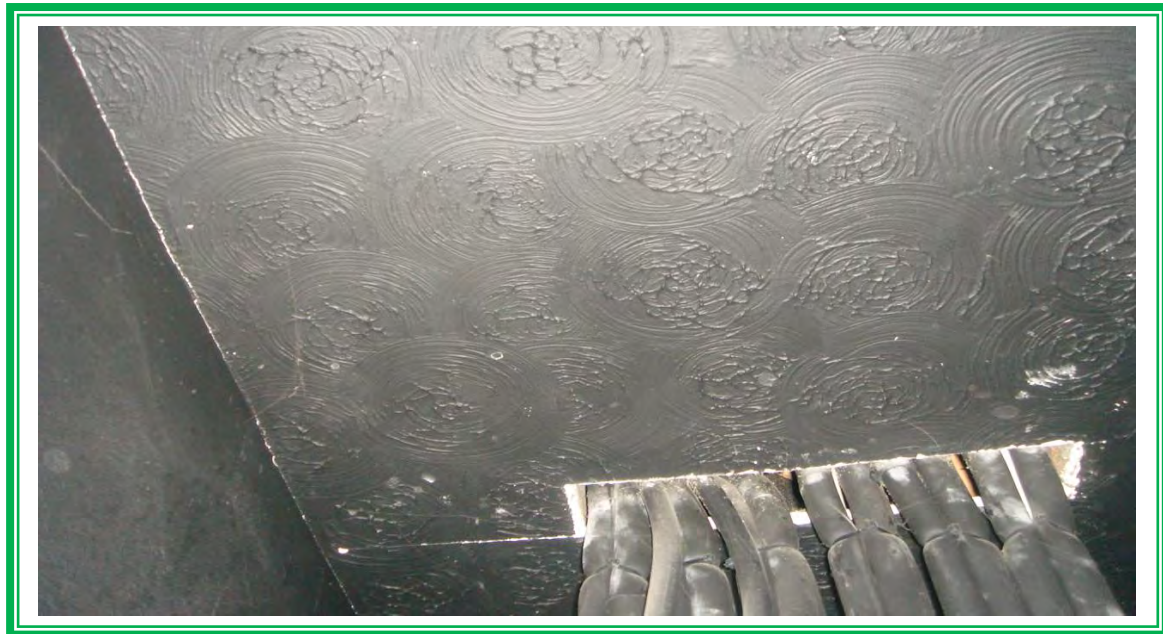
Material Description:	Textured Coating	
Identification:	Sampled – No Asbestos Detected	
Approx. quantity:	4M2	
Accessibility	N/A	Assessment Score
Product type:	N/A	N/A
Extent of Damage:	N/A	N/A
Surface Treatment:	N/A	N/A
Asbestos type:	N/A	N/A
Material Assessment Score:		N/A
Priority Assessment Score:		N/A
Action:	N/A	
Comments:	N/A

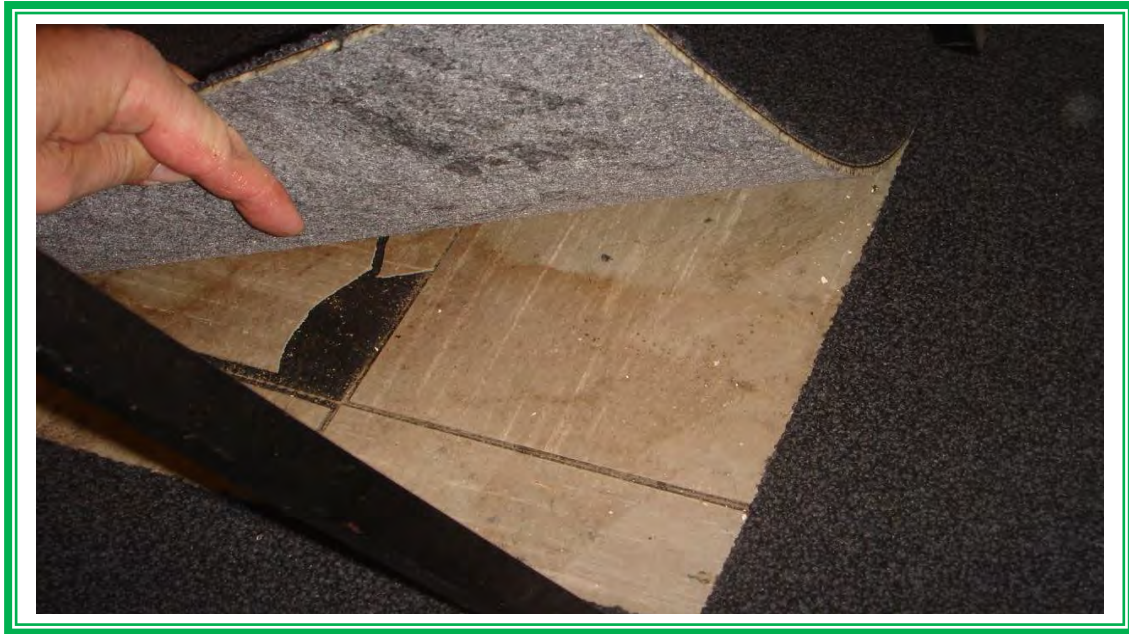
Material Description:	Vinyl Floor Tiles	
Identification:	Sampled – No Asbestos Detected	
Approx. quantity:	12M2	
Accessibility	N/A	Assessment Score
Product type:	N/A	N/A
Extent of Damage:	N/A	N/A
Surface Treatment:	N/A	N/A
Asbestos type:	N/A	N/A
Material Assessment Score:		N/A
Priority Assessment Score:		N/A
Action:	N/A	
Comments:	N/A
