Project Number 3113

Management
Asbestos Survey Report

Kennet Centre, Market Street, Newbury,
Berkshire, RG14 5EN

1-3 The Mall

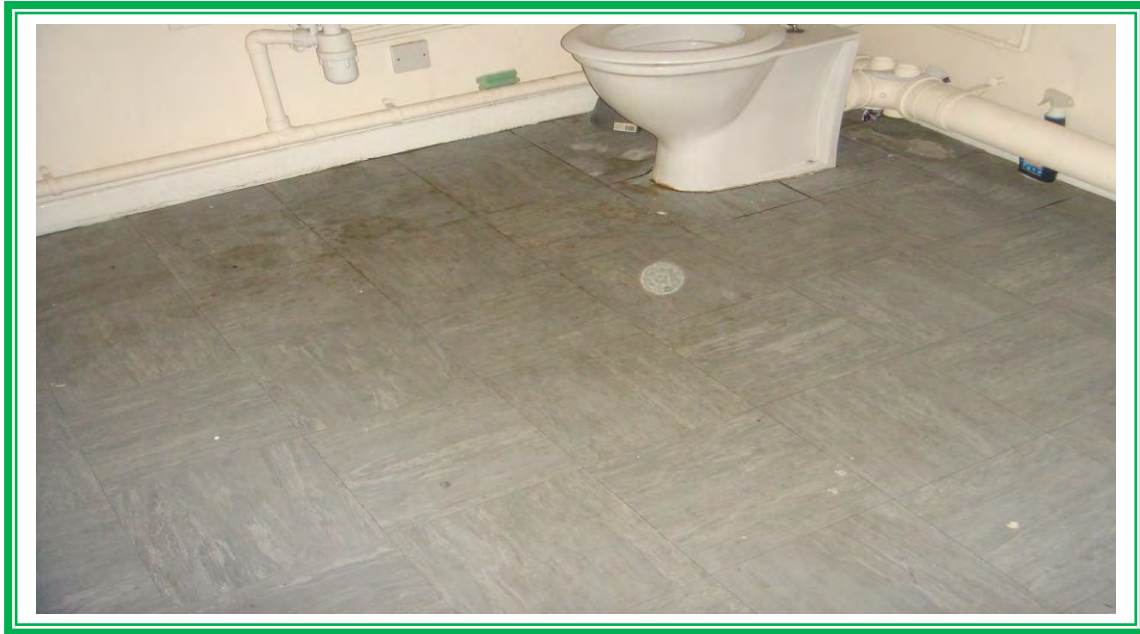
Material Description:	Vinyl Floor Tiles	
Identification:	As Per Sample NE/1 – No Asbestos Detected	
Approx. quantity:	6M2	
Accessibility	N/A	Assessment Score
Product type:	N/A	N/A
Extent of Damage:	N/A	N/A
Surface Treatment:	N/A	N/A
Asbestos type:	N/A	N/A
Material Assessment Score:		N/A
Priority Assessment Score:		N/A
Action:	N/A	
Comments:	N/A

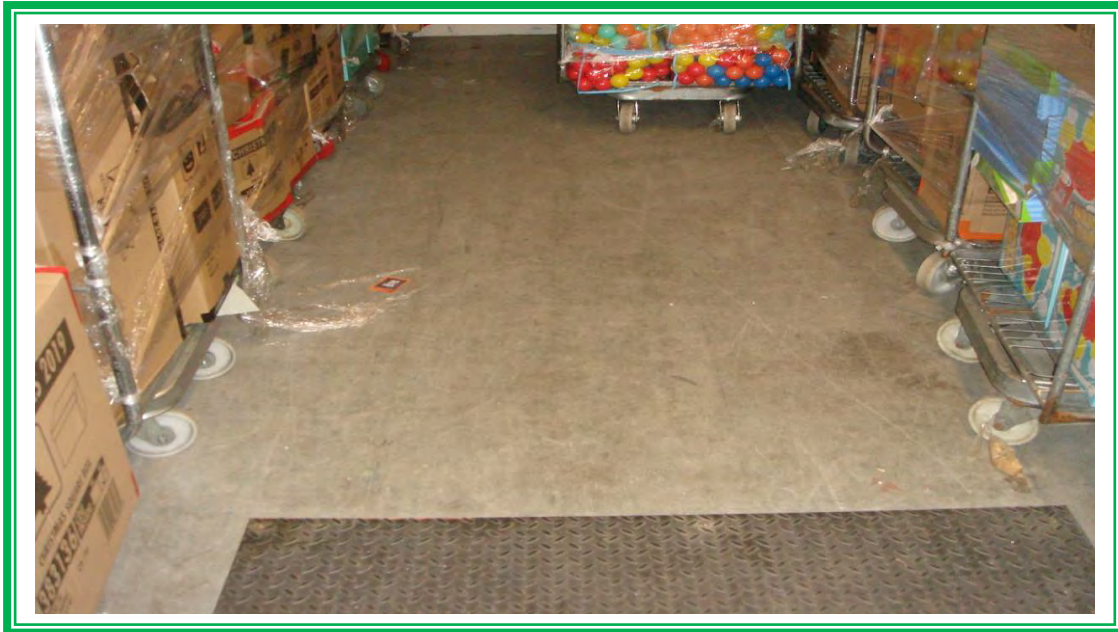
Material Description:	Vinyl Floor Tiles	
Identification:	As Per Sample NE/2 – No Asbestos Detected	
Approx. quantity:	30M2	
Accessibility	N/A	Assessment Score
Product type:	N/A	N/A
Extent of Damage:	N/A	N/A
Surface Treatment:	N/A	N/A
Asbestos type:	N/A	N/A
Material Assessment Score:		N/A
Priority Assessment Score:		N/A
Action:	N/A	
Comments:	N/A

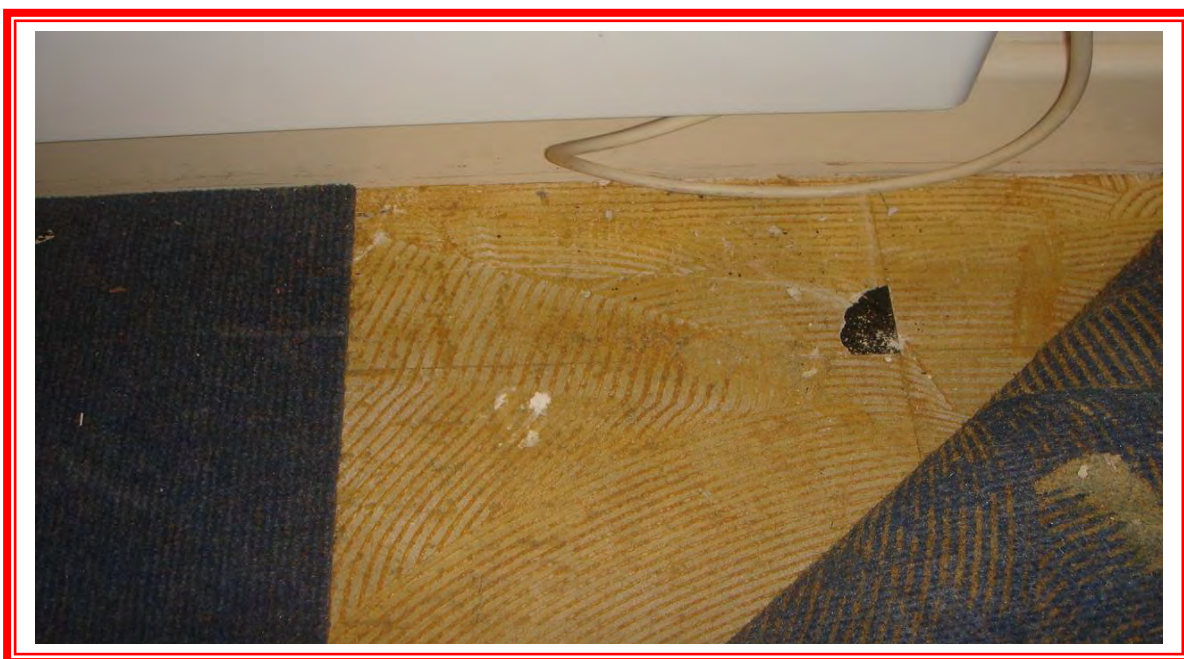
Material Description:	Vinyl Floor Tiles	
Identification:	Sampled – Asbestos Detected	
Approx. quantity:	40M2	
Accessibility	Low	Assessment Score
Product type:	Vinyl	1
Extent of Damage:	Minor	1
Surface Treatment:	Non-Friable	0
Asbestos type:	Chrysotile	1
Material Assessment Score:		3
Priority Assessment Score:		Negligible
Action:	Manage	
Comments:	N/A

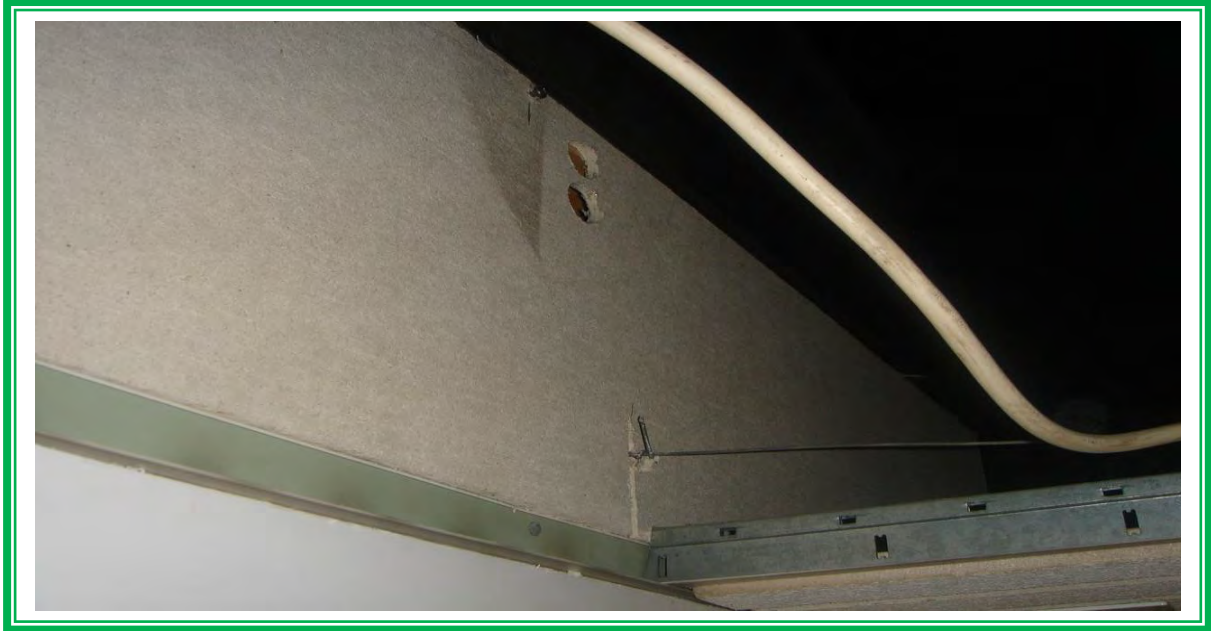
Material Description:	Insulating Board – Above Entrance	
Identification:	Sampled – No Asbestos Detected	
Approx. quantity:	5M2	
Accessibility	N/A	Assessment Score
Product type:	N/A	N/A
Extent of Damage:	N/A	N/A
Surface Treatment:	N/A	N/A
Asbestos type:	N/A	N/A
Material Assessment Score:		N/A
Priority Assessment Score:		N/A
Action:	N/A	
Comments:	N/A

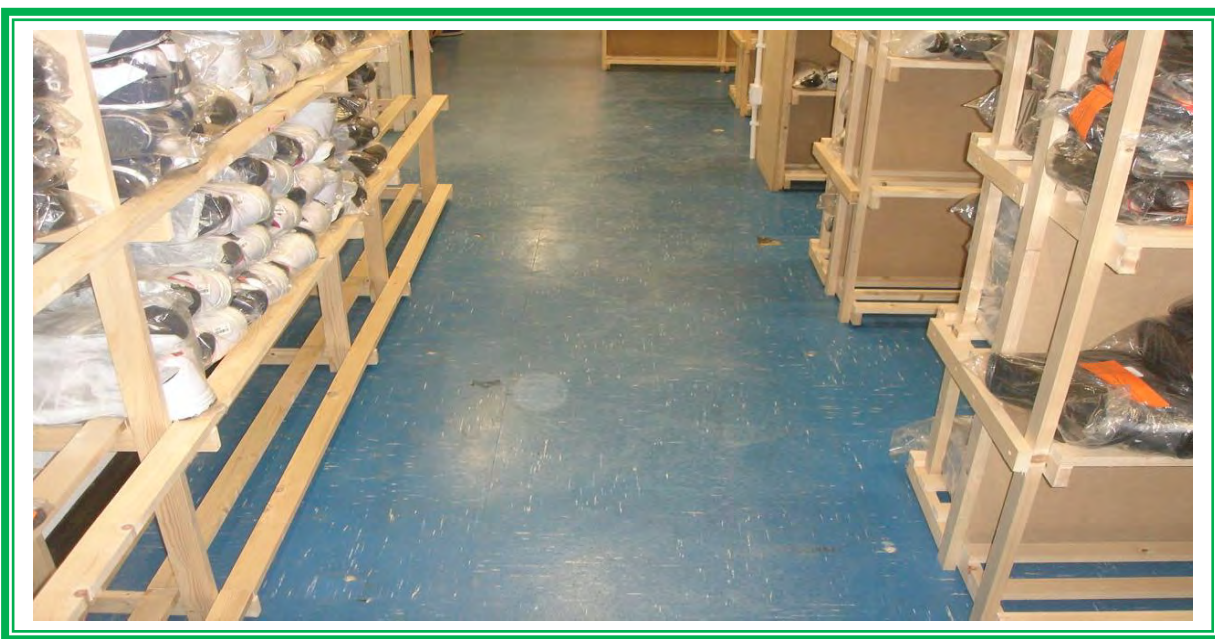
Material Description:	Vinyl Floor Tiles	
Identification:	Sampled – No Asbestos Detected	
Approx. quantity:	60M2	
Accessibility	N/A	Assessment Score
Product type:	N/A	N/A
Extent of Damage:	N/A	N/A
Surface Treatment:	N/A	N/A
Asbestos type:	N/A	N/A
Material Assessment Score:		N/A
Priority Assessment Score:		N/A
Action:	N/A	
Comments:	N/A

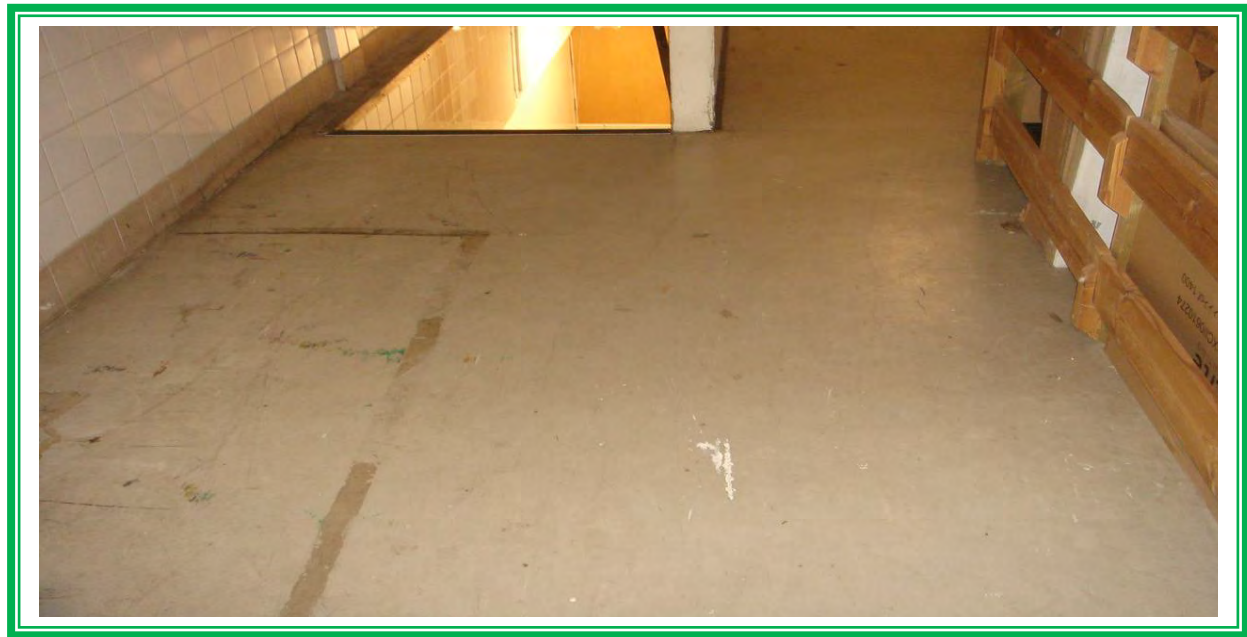
Material Description:	Vinyl Floor Sheets	
Identification:	Sampled – No Asbestos Detected	
Approx. quantity:	36M2	
Accessibility	N/A	Assessment Score
Product type:	N/A	N/A
Extent of Damage:	N/A	N/A
Surface Treatment:	N/A	N/A
Asbestos type:	N/A	N/A
Material Assessment Score:		N/A
Priority Assessment Score:		N/A
Action:	N/A	
Comments:	N/A
