Project Number 3113

Management Asbestos Survey Report

Kennet Centre, Market Street, Newbury,
Berkshire, RG14 5EN

3 Market Place and Associated Store

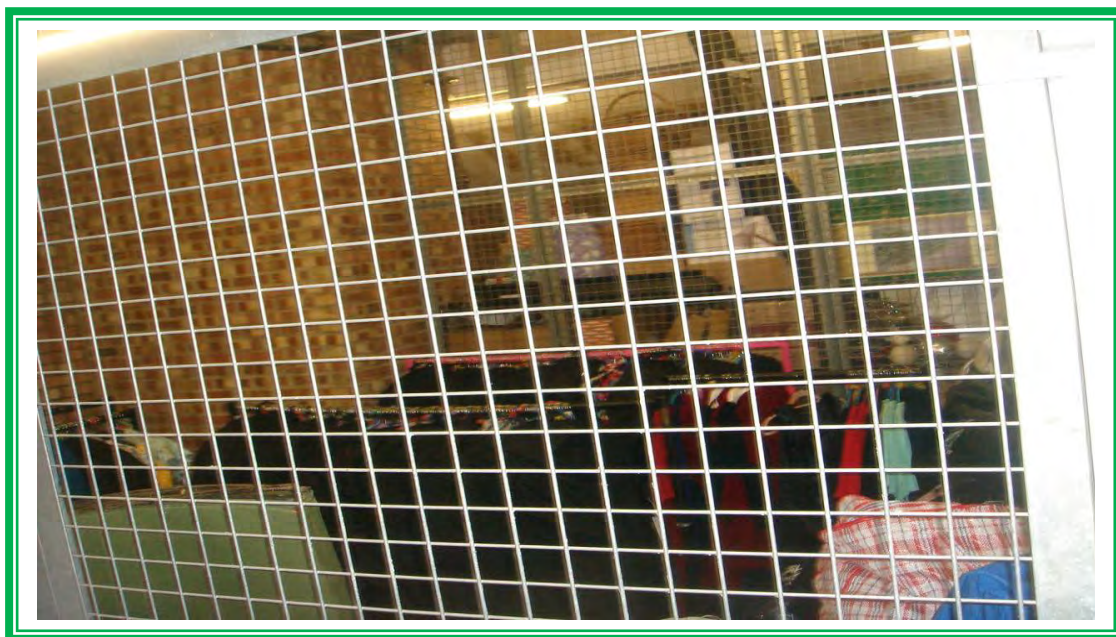
Location: 1/001 Store

Material Description:	Visual Inspection – No Suspect Materials Found	
Identification:	N/A	
Approx. quantity:	N/A	
Accessibility	N/A	Assessment Score
Product type:	N/A	N/A
Extent of Damage:	N/A	N/A
Surface Treatment:	N/A	N/A
Asbestos type:	N/A	N/A
Material Assessment Score:		N/A
Priority Assessment Score:		N/A
Action:	N/A	
Comments:	N/A

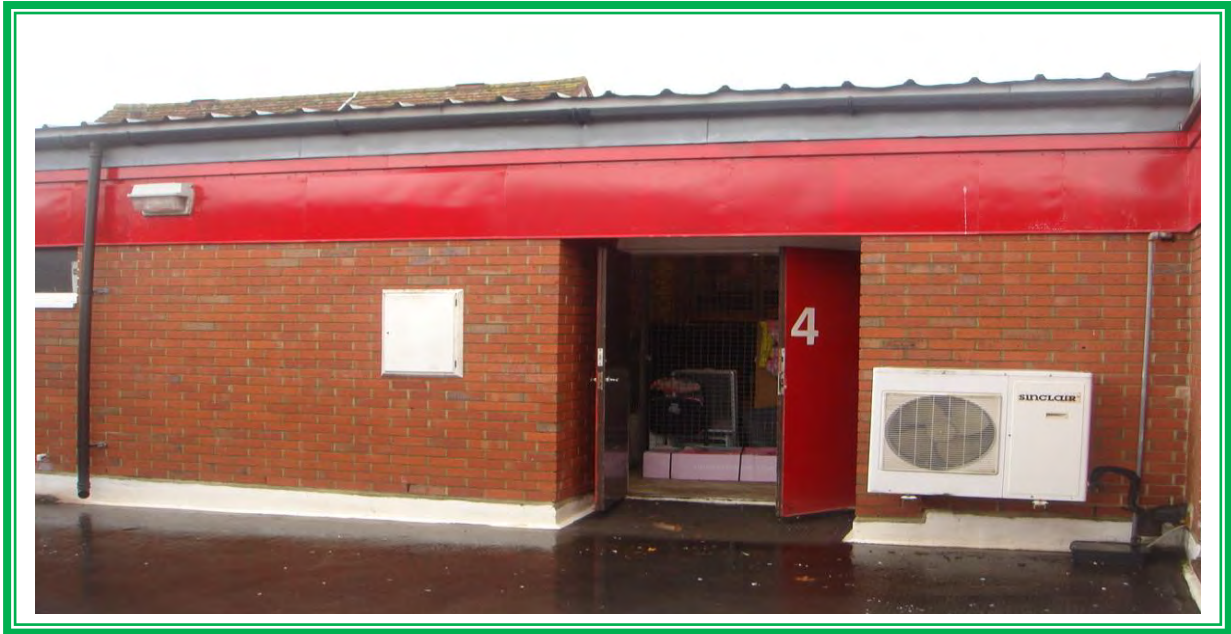
Location: 99/001 External

Material Description:	Visual Inspection – No Suspect Materials Found	
Identification:	N/A	
Approx. quantity:	N/A	
Accessibility	N/A	Assessment Score
Product type:	N/A	N/A
Extent of Damage:	N/A	N/A
Surface Treatment:	N/A	N/A
Asbestos type:	N/A	N/A
Material Assessment Score:		N/A
Priority Assessment Score:		N/A
Action:	N/A	
Comments:	N/A

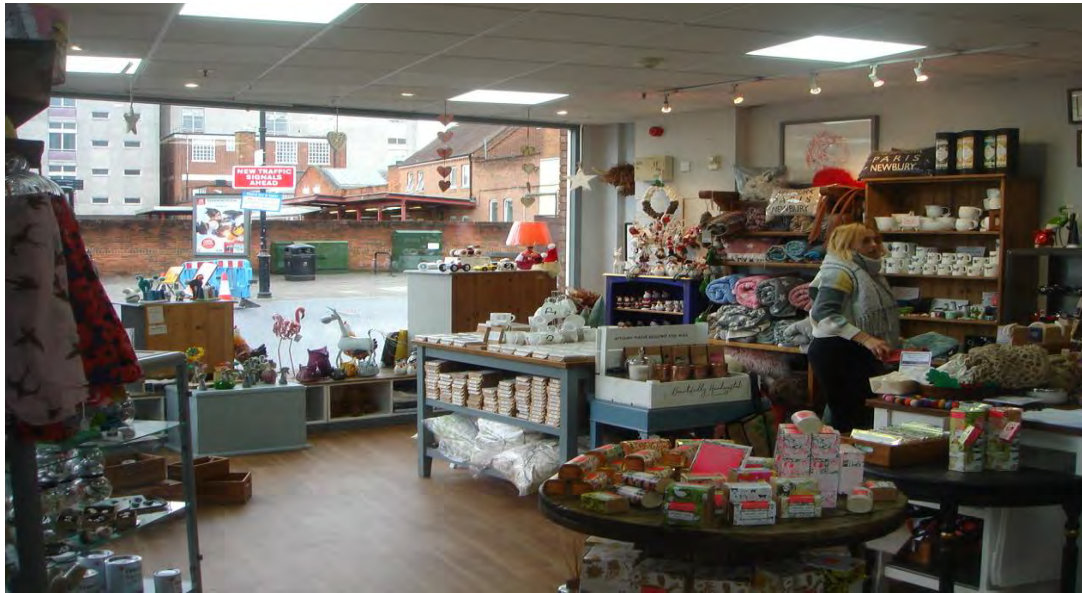
Location: 0/001 Shop Floor

Material Description:	Visual Inspection – No Suspect Materials Found	
Identification:	N/A	
Approx. quantity:	N/A	
Accessibility	N/A	Assessment Score
Product type:	N/A	N/A
Extent of Damage:	N/A	N/A
Surface Treatment:	N/A	N/A
Asbestos type:	N/A	N/A
Material Assessment Score:		N/A
Priority Assessment Score:		N/A
Action:	N/A	
Comments:	N/A

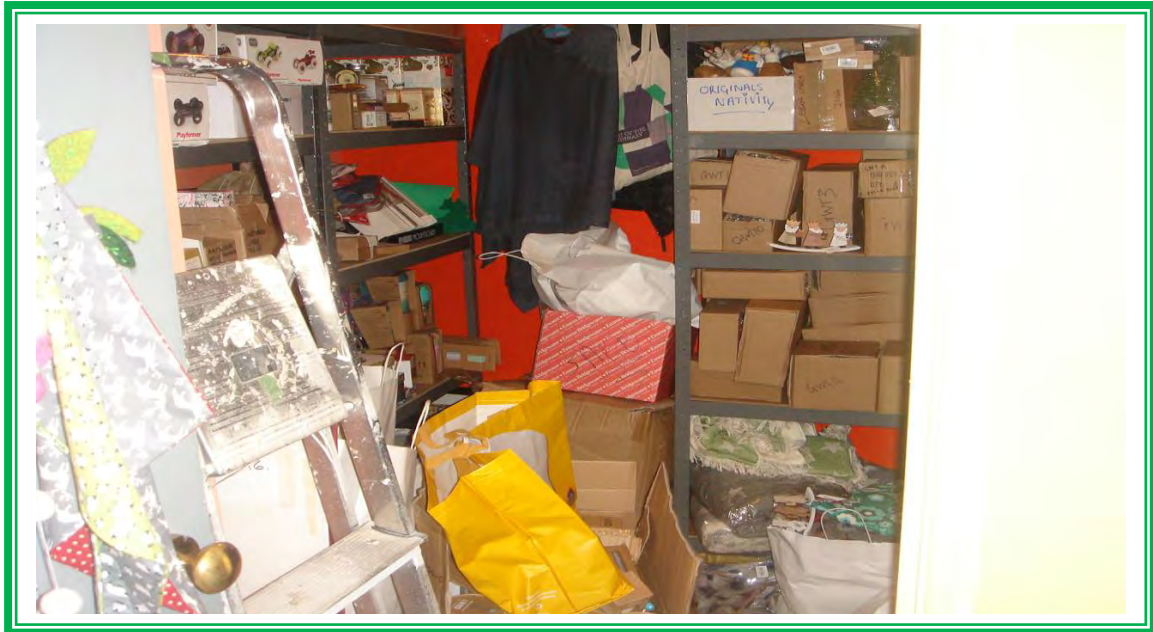
Location: 0/002 Store

Material Description:	Visual Inspection – No Suspect Materials Found	
Identification:	N/A	
Approx. quantity:	N/A	
Accessibility	N/A	Assessment Score
Product type:	N/A	N/A
Extent of Damage:	N/A	N/A
Surface Treatment:	N/A	N/A
Asbestos type:	N/A	N/A
Material Assessment Score:		N/A
Priority Assessment Score:		N/A
Action:	N/A	
Comments:	N/A

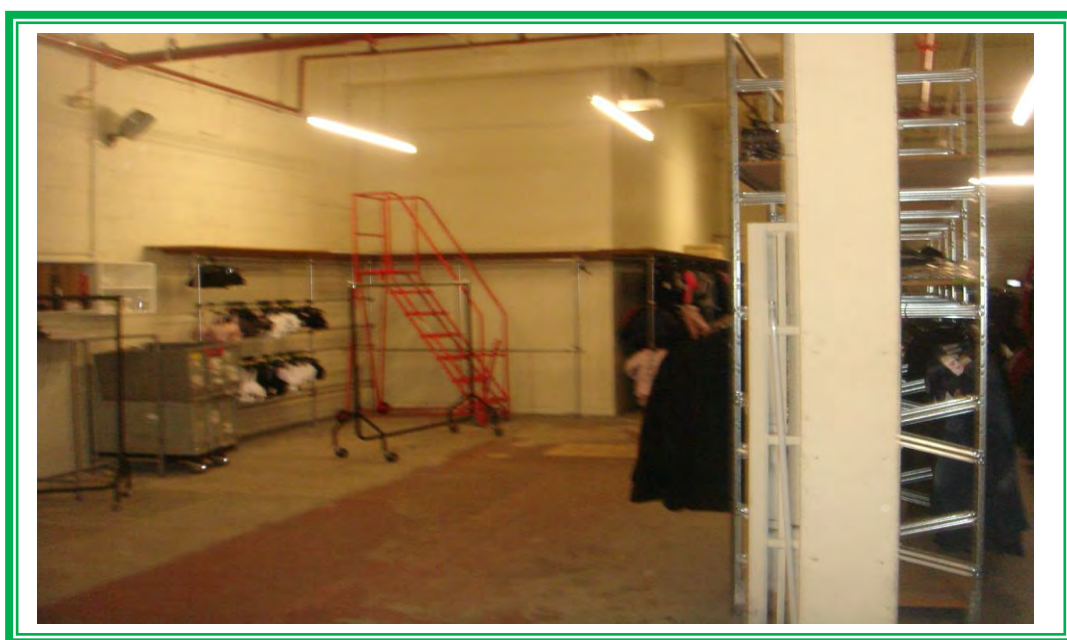
Item No: 1	Sample No: N/A
Location: 1/001 Stock Room

Material Description:	Visual Inspection – No Suspect Materials Found	
Identification:	N/A	
Approx. quantity:	N/A	
Accessibility	N/A	Assessment Score
Product type:	N/A	N/A
Extent of Damage:	N/A	N/A
Surface Treatment:	N/A	N/A
Asbestos type:	N/A	N/A
Material Assessment Score:		N/A
Priority Assessment Score:		N/A
Action:	N/A	
Comments:	N/A

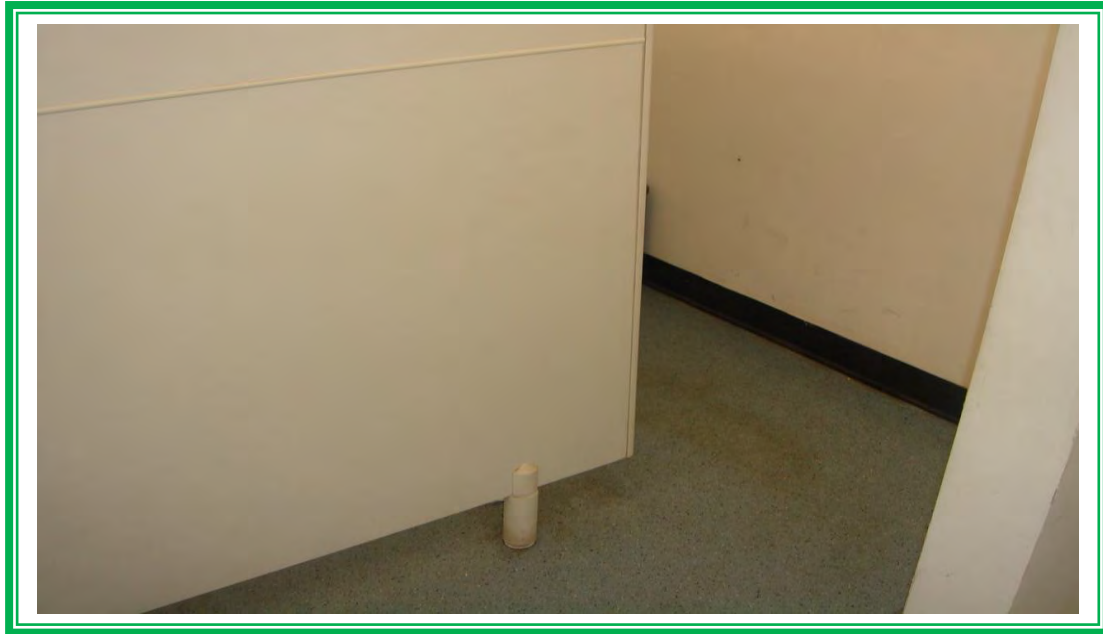
Location: 1/002 WC

Material Description:	Visual Inspection – No Suspect Materials Found	
Identification:	N/A	
Approx. quantity:	N/A	
Accessibility	N/A	Assessment Score
Product type:	N/A	N/A
Extent of Damage:	N/A	N/A
Surface Treatment:	N/A	N/A
Asbestos type:	N/A	N/A
Material Assessment Score:		N/A
Priority Assessment Score:		N/A
Action:	N/A	
Comments:	N/A

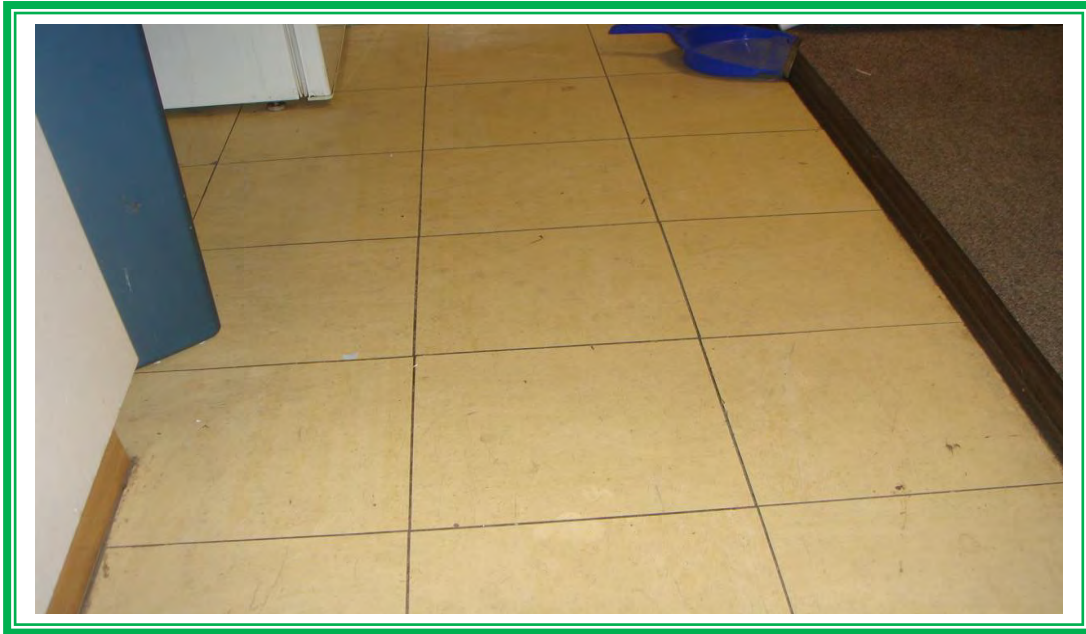
Location: 1/003 Canteen

Material Description:	Vinyl Floor Tiles	
Identification:	Sampled – No Asbestos Detected	
Approx. quantity:	3M2	
Accessibility	N/A	Assessment Score
Product type:	N/A	N/A
Extent of Damage:	N/A	N/A
Surface Treatment:	N/A	N/A
Asbestos type:	N/A	N/A
Material Assessment Score:		N/A
Priority Assessment Score:		N/A
Action:	N/A	
Comments:	N/A

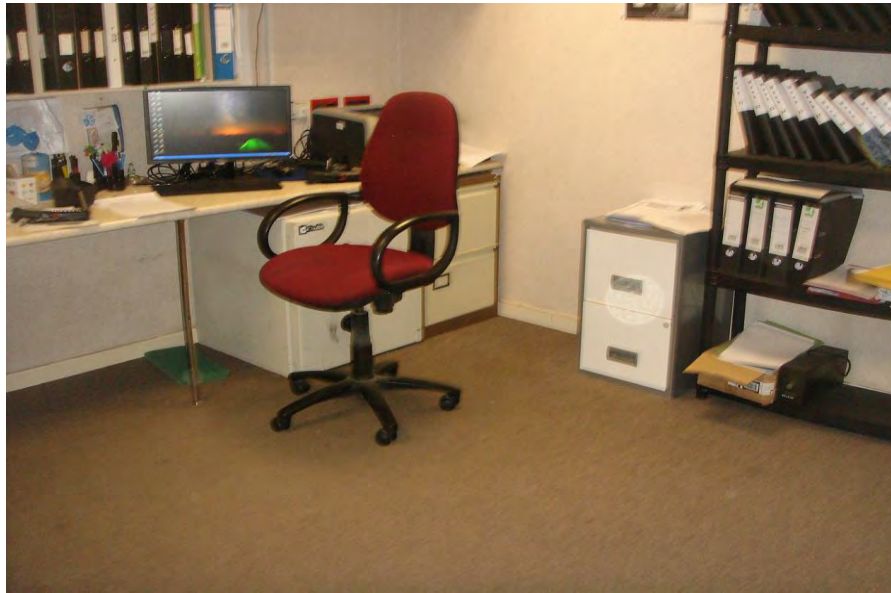
Location: 1/004 Office

Material Description:	Visual Inspection – No Suspect Materials Found	
Identification:	N/A	
Approx. quantity:	N/A	
Accessibility	N/A	Assessment Score
Product type:	N/A	N/A
Extent of Damage:	N/A	N/A
Surface Treatment:	N/A	N/A
Asbestos type:	N/A	N/A
Material Assessment Score:		N/A
Priority Assessment Score:		N/A
Action:	N/A	
Comments:	N/A

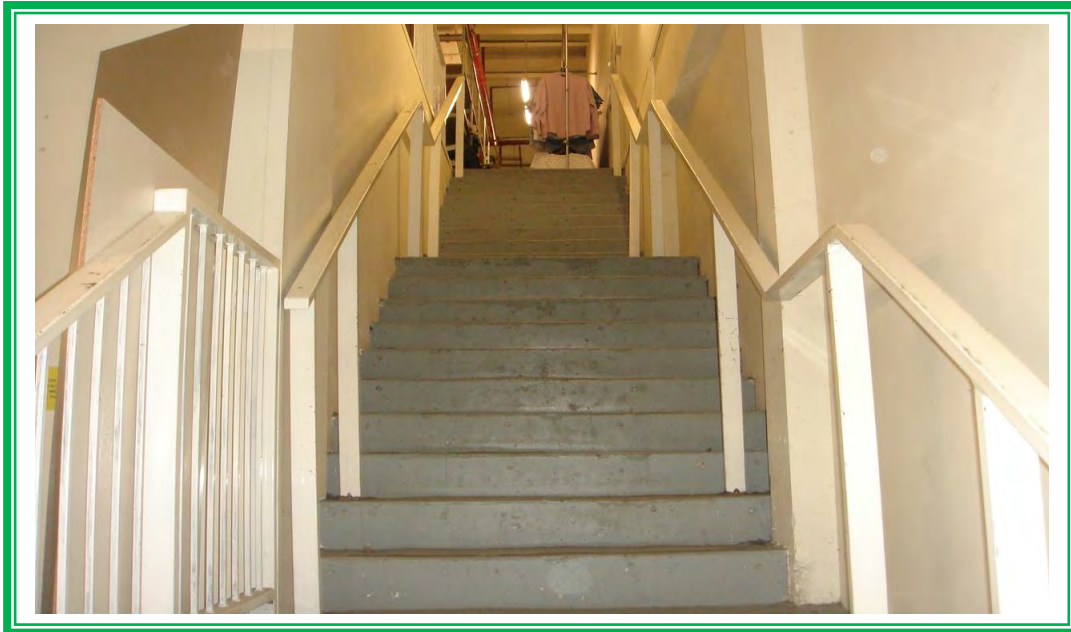
Location: 1/006 Stairs

Material Description:	Visual Inspection – No Suspect Materials Found	
Identification:	N/A	
Approx. quantity:	N/A	
Accessibility	N/A	Assessment Score
Product type:	N/A	N/A
Extent of Damage:	N/A	N/A
Surface Treatment:	N/A	N/A
Asbestos type:	N/A	N/A
Material Assessment Score:		N/A
Priority Assessment Score:		N/A
Action:	N/A	
Comments:	N/A

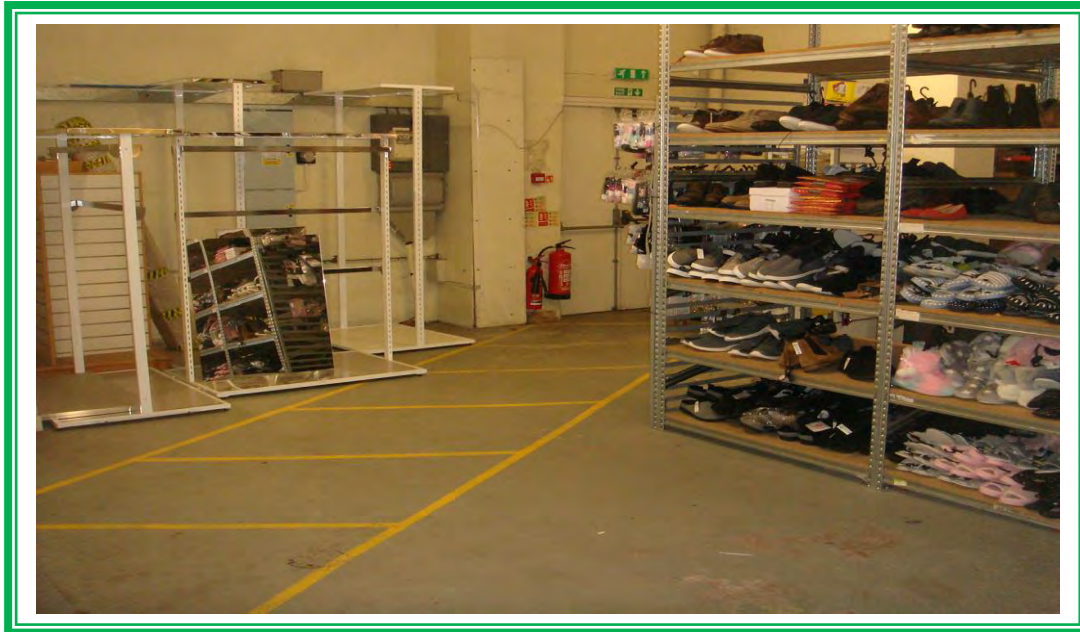
Location: 0/001 Store

Material Description:	Visual Inspection – No Suspect Materials Found	
Identification:	N/A	
Approx. quantity:	N/A	
Accessibility	N/A	Assessment Score
Product type:	N/A	N/A
Extent of Damage:	N/A	N/A
Surface Treatment:	N/A	N/A
Asbestos type:	N/A	N/A
Material Assessment Score:		N/A
Priority Assessment Score:		N/A
Action:	N/A	
Comments:	N/A

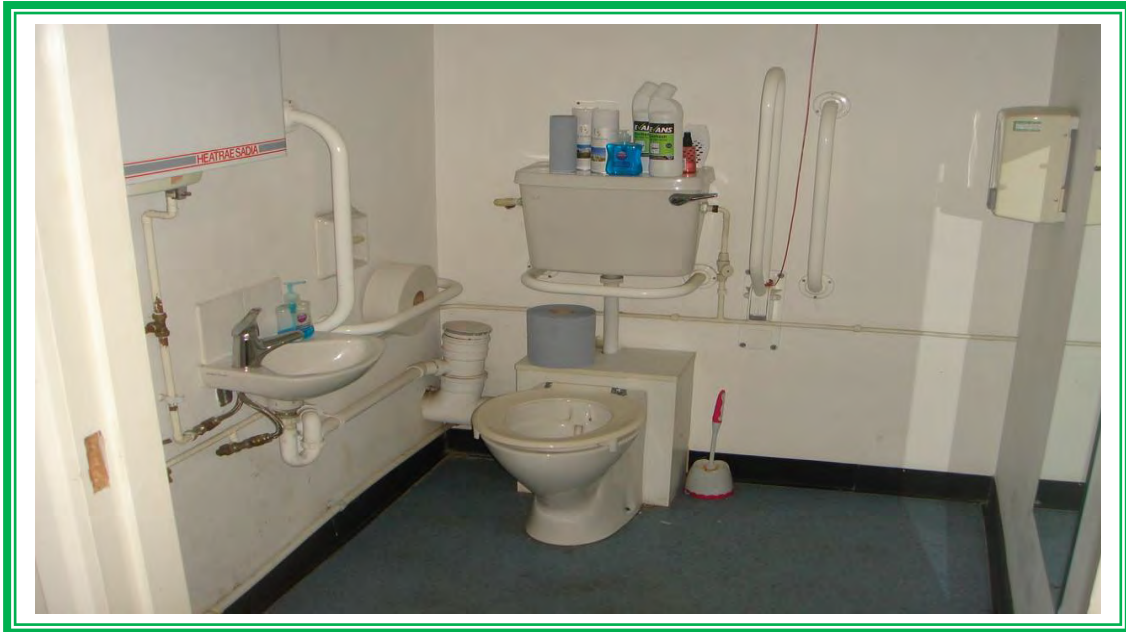
Location: 0/002 WC

Material Description:	Visual Inspection – No Suspect Materials Found	
Identification:	N/A	
Approx. quantity:	N/A	
Accessibility	N/A	Assessment Score
Product type:	N/A	N/A
Extent of Damage:	N/A	N/A
Surface Treatment:	N/A	N/A
Asbestos type:	N/A	N/A
Material Assessment Score:		N/A
Priority Assessment Score:		N/A
Action:	N/A	
Comments:	N/A

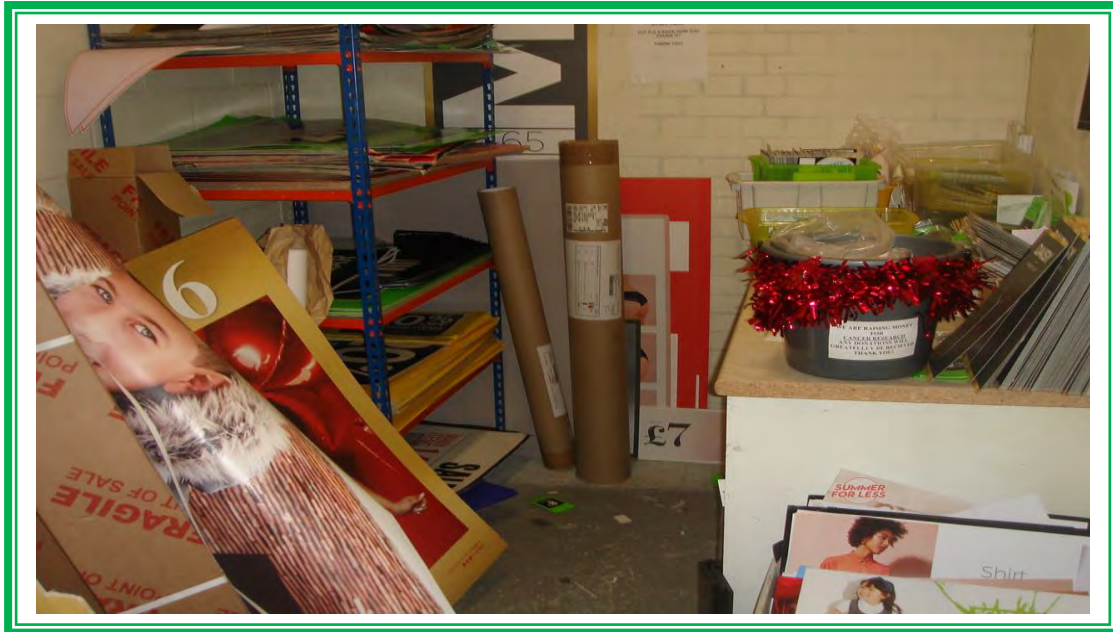
Location: 0/003 Store

Material Description:	Visual Inspection – No Suspect Materials Found	
Identification:	N/A	
Approx. quantity:	N/A	
Accessibility	N/A	Assessment Score
Product type:	N/A	N/A
Extent of Damage:	N/A	N/A
Surface Treatment:	N/A	N/A
Asbestos type:	N/A	N/A
Material Assessment Score:		N/A
Priority Assessment Score:		N/A
Action:	N/A	
Comments:	N/A

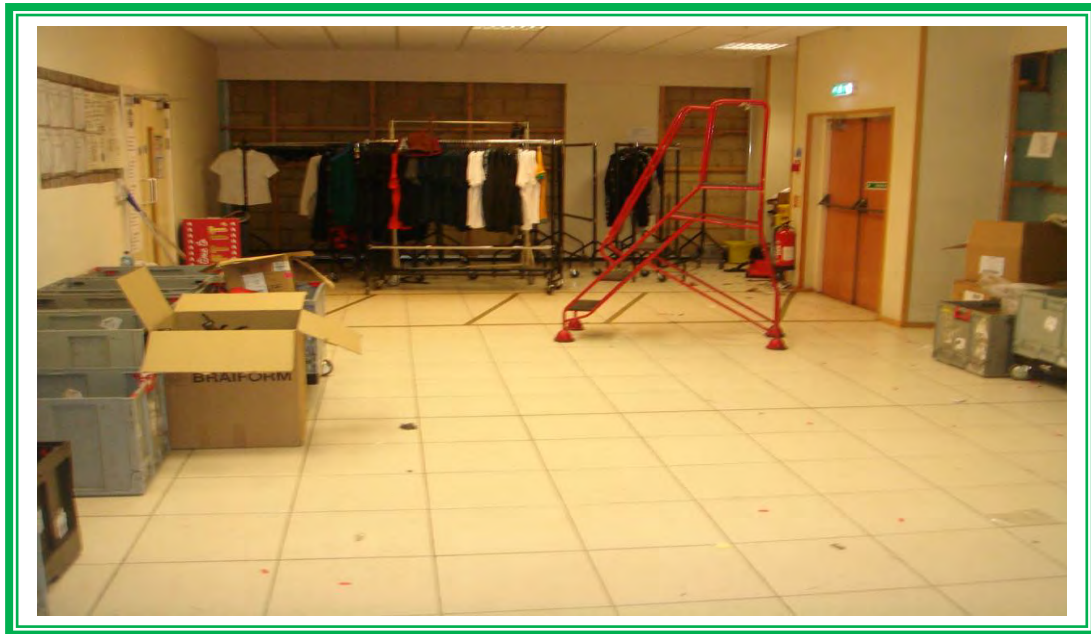
Location: 0/005 Store

Material Description:	Visual Inspection – No Suspect Materials Found	
Identification:	N/A	
Approx. quantity:	N/A	
Accessibility	N/A	Assessment Score
Product type:	N/A	N/A
Extent of Damage:	N/A	N/A
Surface Treatment:	N/A	N/A
Asbestos type:	N/A	N/A
Material Assessment Score:		N/A
Priority Assessment Score:		N/A
Action:	N/A	
Comments:	N/A

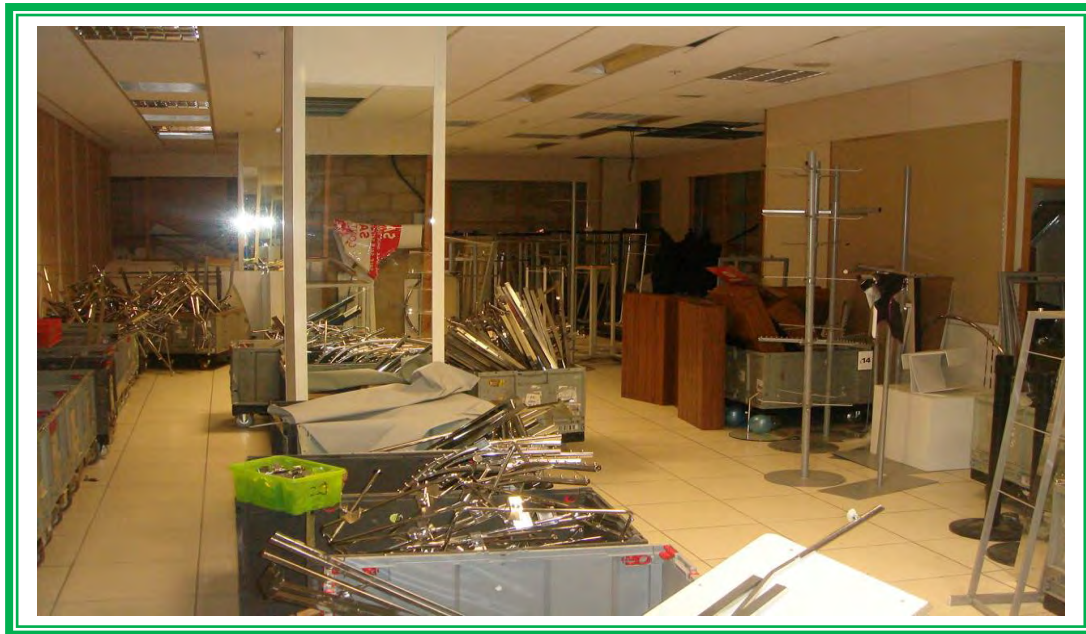
Location: 0/006 Store

Material Description:	Visual Inspection – No Suspect Materials Found	
Identification:	N/A	
Approx. quantity:	N/A	
Accessibility	N/A	Assessment Score
Product type:	N/A	N/A
Extent of Damage:	N/A	N/A
Surface Treatment:	N/A	N/A
Asbestos type:	N/A	N/A
Material Assessment Score:		N/A
Priority Assessment Score:		N/A
Action:	N/A	
Comments:	N/A

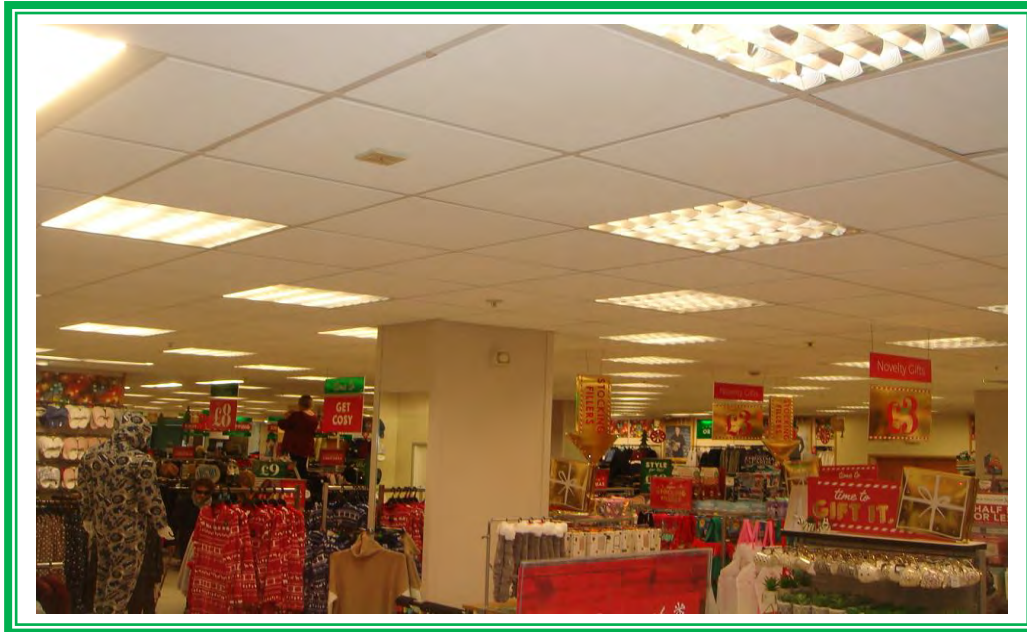
Location: 0/007 Shop Floor

Material Description:	Visual Inspection – No Suspect Materials Found	
Identification:	N/A	
Approx. quantity:	N/A	
Accessibility	N/A	Assessment Score
Product type:	N/A	N/A
Extent of Damage:	N/A	N/A
Surface Treatment:	N/A	N/A
Asbestos type:	N/A	N/A
Material Assessment Score:		N/A
Priority Assessment Score:		N/A
Action:	N/A	
Comments:	N/A

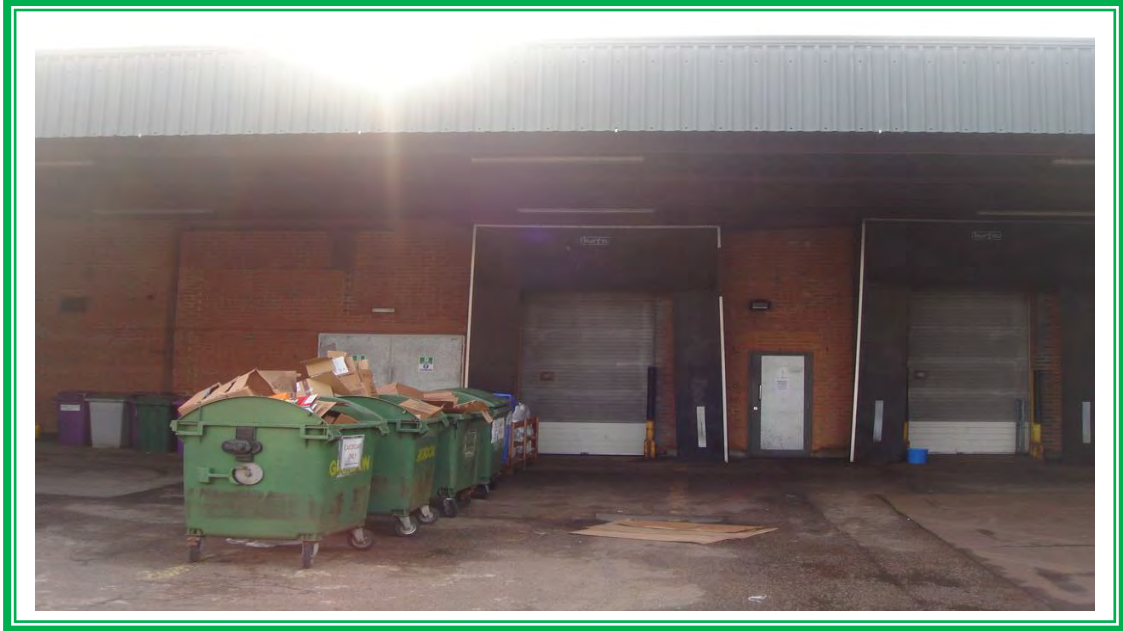
Location: 99/001 External

Material Description:	Visual Inspection – No Suspect Materials Found	
Identification:	N/A	
Approx. quantity:	N/A	
Accessibility	N/A	Assessment Score
Product type:	N/A	N/A
Extent of Damage:	N/A	N/A
Surface Treatment:	N/A	N/A
Asbestos type:	N/A	N/A
Material Assessment Score:		N/A
Priority Assessment Score:		N/A
Action:	N/A	
Comments:	N/A

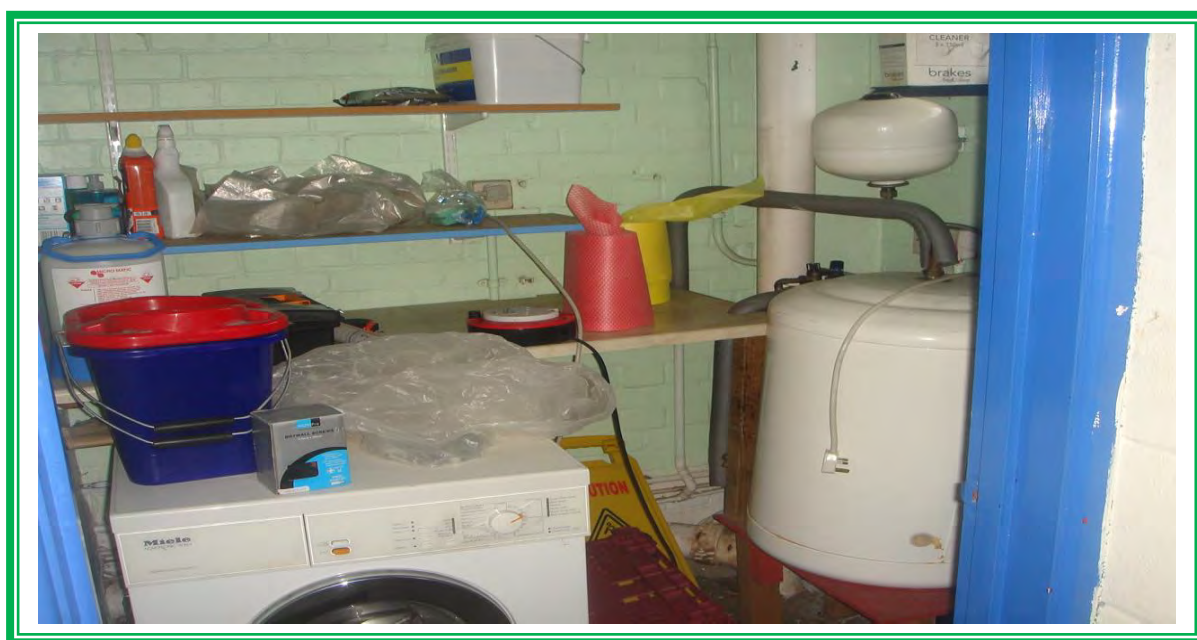
Location: Ground Floor - 1/001 Store

Material Description:	Visual Inspection – No Suspect Materials Found	
Identification:	N/A	
Approx. quantity:	N/A	
Accessibility	N/A	Assessment Score
Product type:	N/A	N/A
Extent of Damage:	N/A	N/A
Surface Treatment:	N/A	N/A
Asbestos type:	N/A	N/A
Material Assessment Score:		N/A
Priority Assessment Score:		N/A
Action:	N/A	
Comments:	N/A

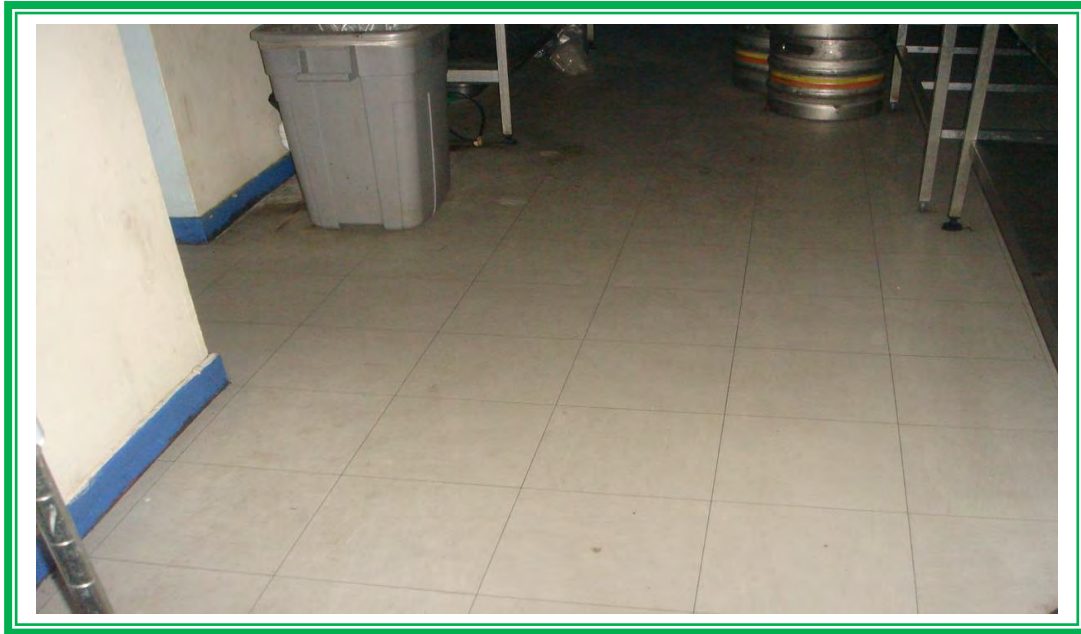
Location: Ground Floor – 1/002 Kitchen

Material Description:	Vinyl Floor Tiles	
Identification:	Sampled – No Asbestos Detected	
Approx. quantity:	40M2	
Accessibility	N/A	Assessment Score
Product type:	N/A	N/A
Extent of Damage:	N/A	N/A
Surface Treatment:	N/A	N/A
Asbestos type:	N/A	N/A
Material Assessment Score:		N/A
Priority Assessment Score:		N/A
Action:	N/A	
Comments:	N/A

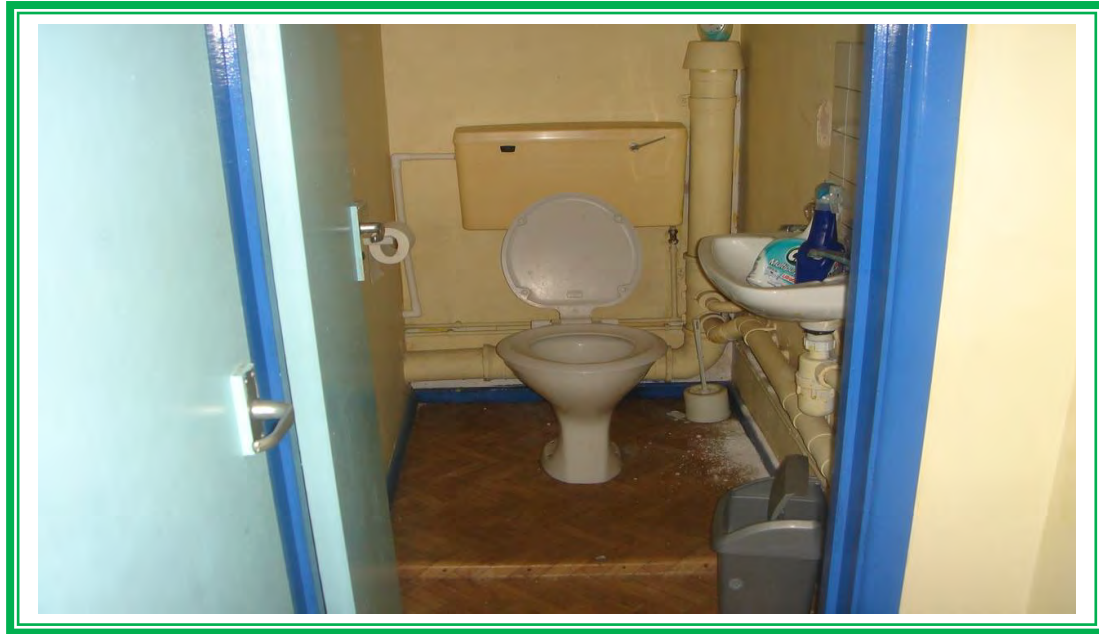
Location: 1/003 WC

Material Description:	Visual Inspection – No Suspect Materials Found	
Identification:	N/A	
Approx. quantity:	N/A	
Accessibility	N/A	Assessment Score
Product type:	N/A	N/A
Extent of Damage:	N/A	N/A
Surface Treatment:	N/A	N/A
Asbestos type:	N/A	N/A
Material Assessment Score:		N/A
Priority Assessment Score:		N/A
Action:	N/A	
Comments:	N/A

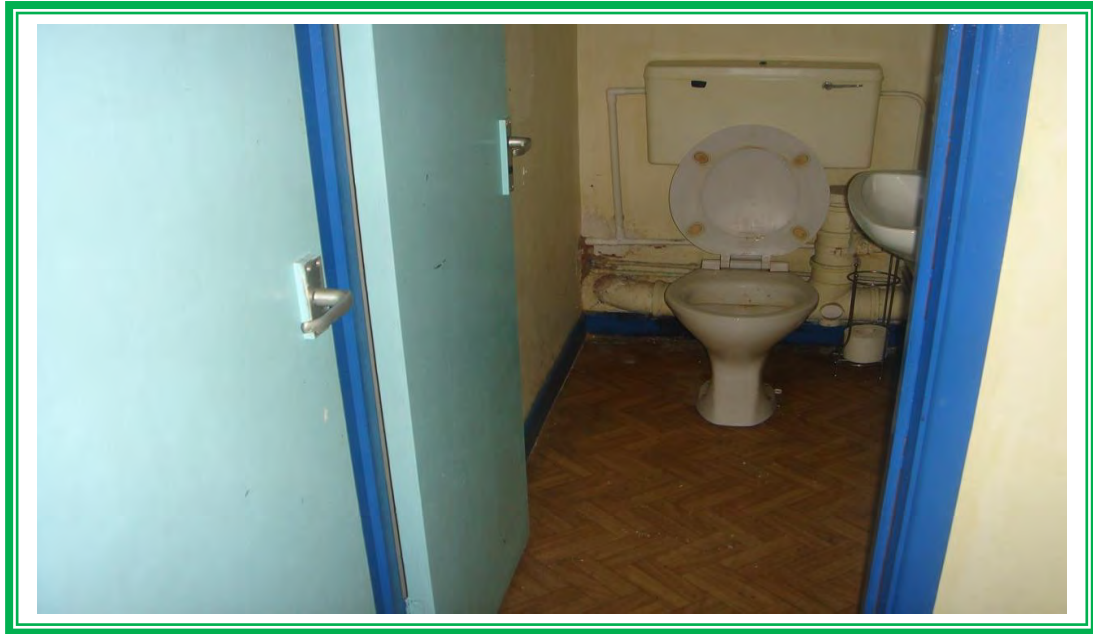
Location: 1/004

Material Description:	Visual Inspection – No Suspect Materials Found	
Identification:	N/A	
Approx. quantity:	N/A	
Accessibility	N/A	Assessment Score
Product type:	N/A	N/A
Extent of Damage:	N/A	N/A
Surface Treatment:	N/A	N/A
Asbestos type:	N/A	N/A
Material Assessment Score:		N/A
Priority Assessment Score:		N/A
Action:	N/A	
Comments:	N/A

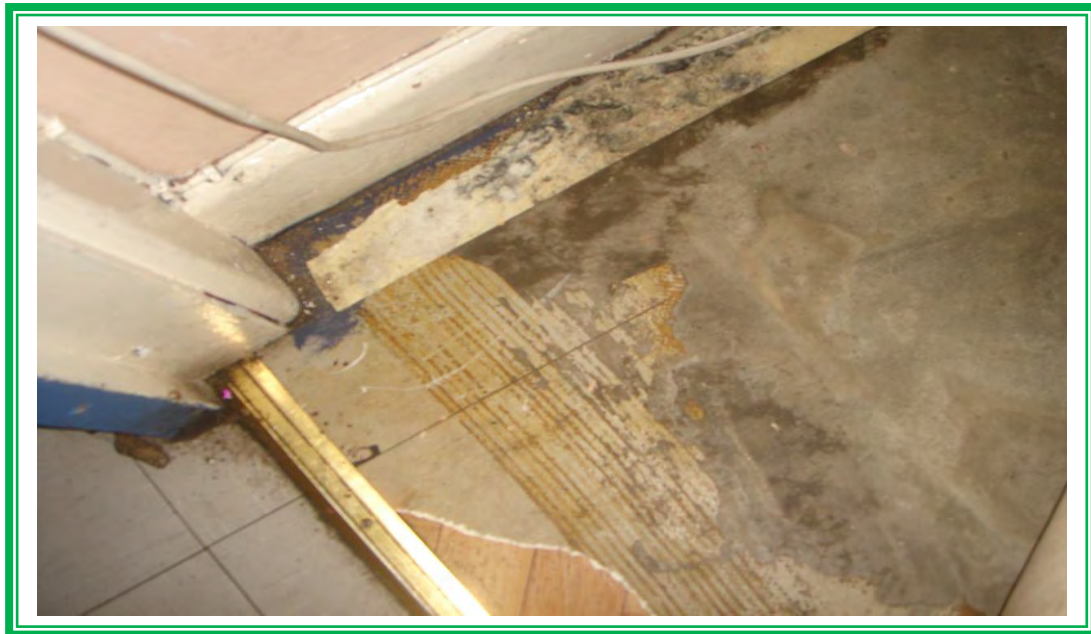
Location: 1/005 Office

Material Description:	Vinyl Floor Tiles	
Identification:	As Per Sample NE/1 – No Asbestos Detected	
Approx. quantity:	8M2	
Accessibility	N/A	Assessment Score
Product type:	N/A	N/A
Extent of Damage:	N/A	N/A
Surface Treatment:	N/A	N/A
Asbestos type:	N/A	N/A
Material Assessment Score:		N/A
Priority Assessment Score:		N/A
Action:	N/A	
Comments:	N/A

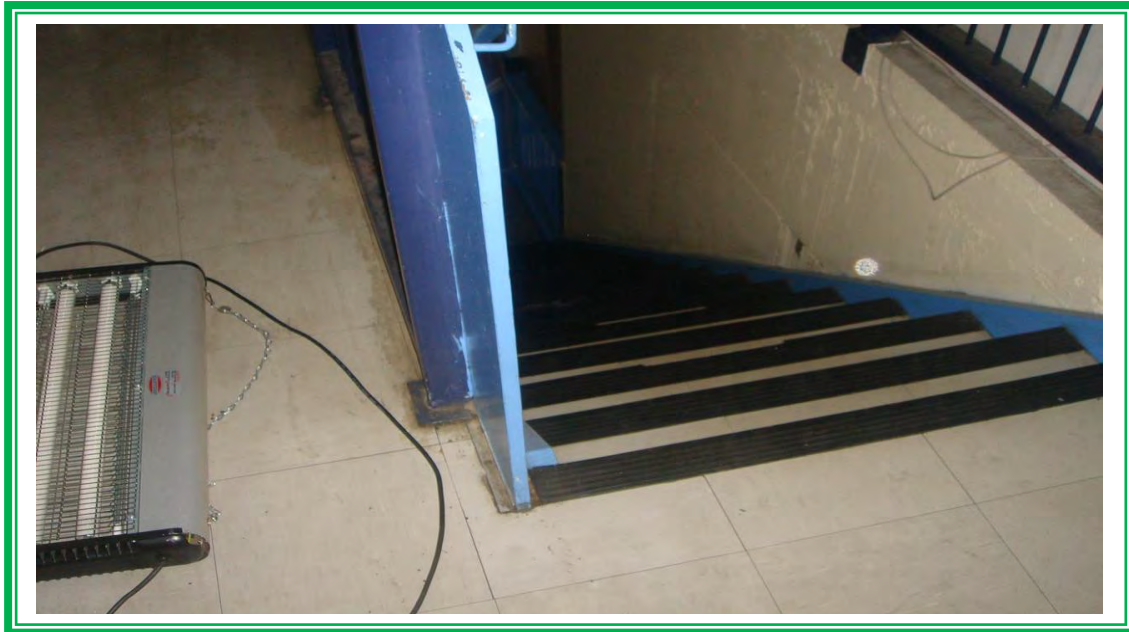
Location: 1/006 - Stairs

Material Description:	Vinyl Floor Tiles	
Identification:	As Per Sample NE/1 – No Asbestos Detected	
Approx. quantity:	10M2	
Accessibility	N/A	Assessment Score
Product type:	N/A	N/A
Extent of Damage:	N/A	N/A
Surface Treatment:	N/A	N/A
Asbestos type:	N/A	N/A
Material Assessment Score:		N/A
Priority Assessment Score:		N/A
Action:	N/A	
Comments:	N/A

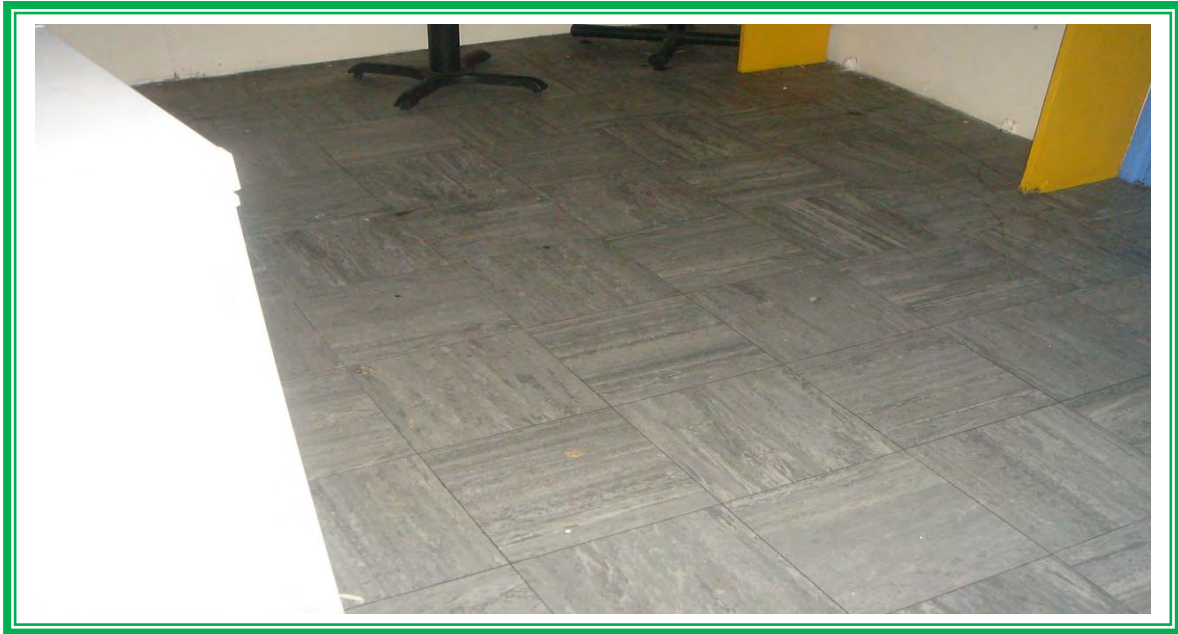
Location: 1/007

Material Description:	Vinyl Floor Tiles	
Identification:	Sampled – No Asbestos Detected	
Approx. quantity:	8M2	
Accessibility	N/A	Assessment Score
Product type:	N/A	N/A
Extent of Damage:	N/A	N/A
Surface Treatment:	N/A	N/A
Asbestos type:	N/A	N/A
Material Assessment Score:		N/A
Priority Assessment Score:		N/A
Action:	N/A	
Comments:	N/A

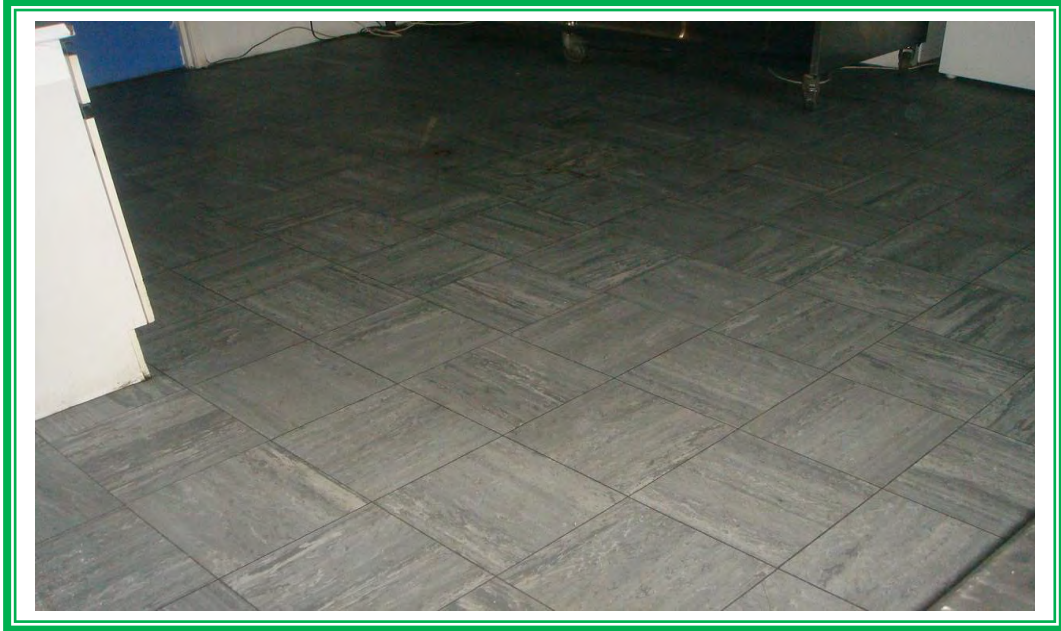
Location: 1/008

Material Description:	Vinyl Floor Tiles	
Identification:	As Per Sample NE/2 – No Asbestos Detected	
Approx. quantity:	28M2	
Accessibility	N/A	Assessment Score
Product type:	N/A	N/A
Extent of Damage:	N/A	N/A
Surface Treatment:	N/A	N/A
Asbestos type:	N/A	N/A
Material Assessment Score:		N/A
Priority Assessment Score:		N/A
Action:	N/A	
Comments:	N/A

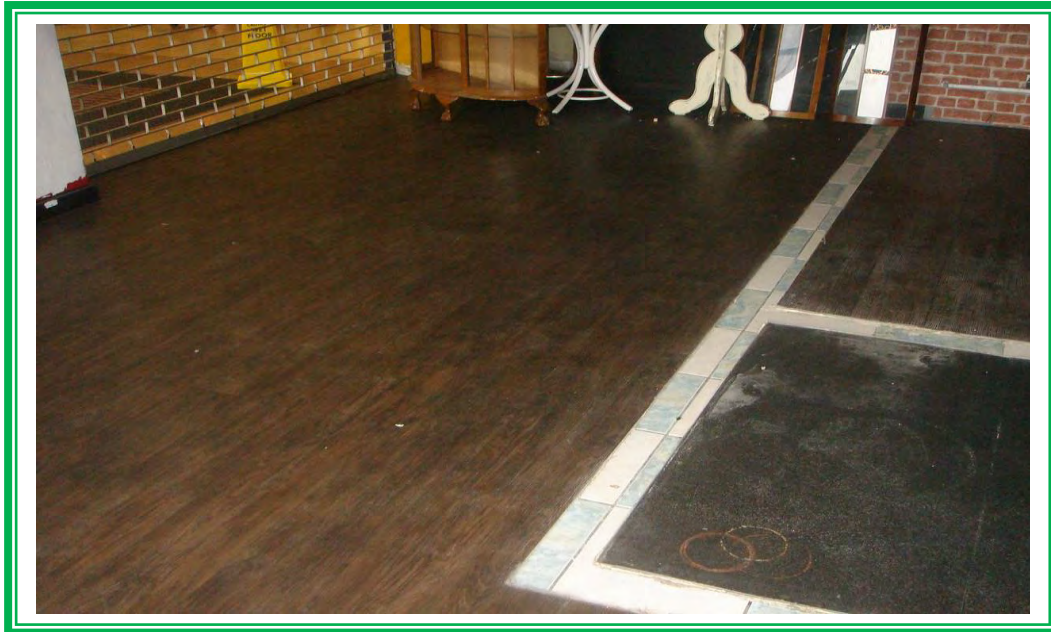
Location: 0/001

Material Description:	Visual Inspection – No Suspect Materials Found	
Identification:	N/A	
Approx. quantity:	N/A	
Accessibility	N/A	Assessment Score
Product type:	N/A	N/A
Extent of Damage:	N/A	N/A
Surface Treatment:	N/A	N/A
Asbestos type:	N/A	N/A
Material Assessment Score:		N/A
Priority Assessment Score:		N/A
Action:	N/A	
Comments:	N/A

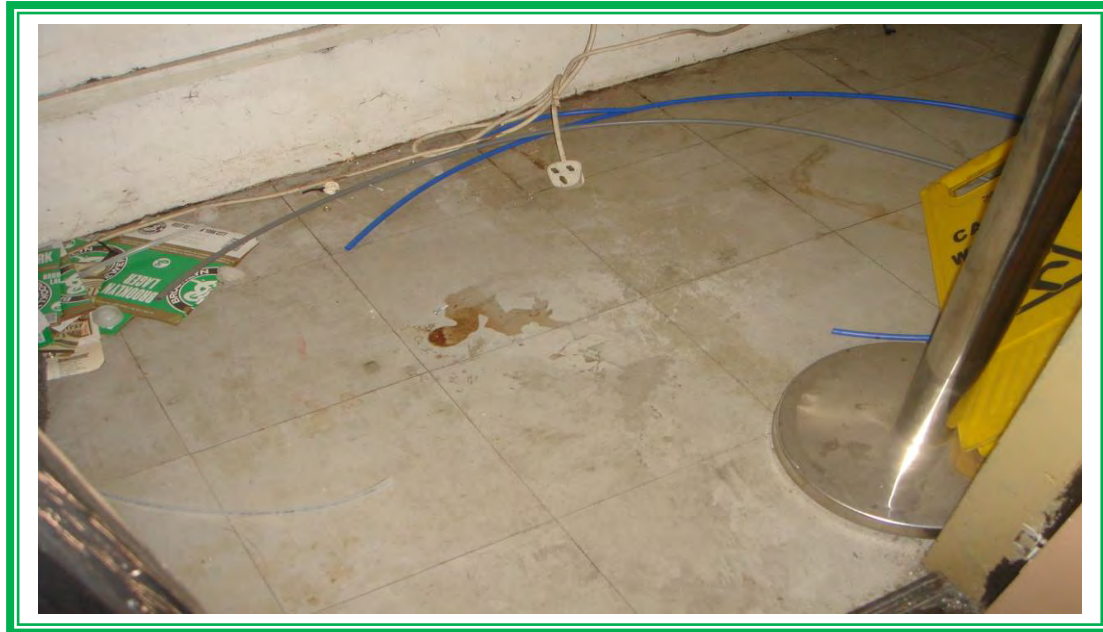
Location: 0/002 Cupboard

Material Description:	Vinyl Floor Tiles	
Identification:	Sampled – No Asbestos Detected	
Approx. quantity:	3M2	
Accessibility	N/A	Assessment Score
Product type:	N/A	N/A
Extent of Damage:	N/A	N/A
Surface Treatment:	N/A	N/A
Asbestos type:	N/A	N/A
Material Assessment Score:		N/A
Priority Assessment Score:		N/A
Action:	N/A	
Comments:	N/A

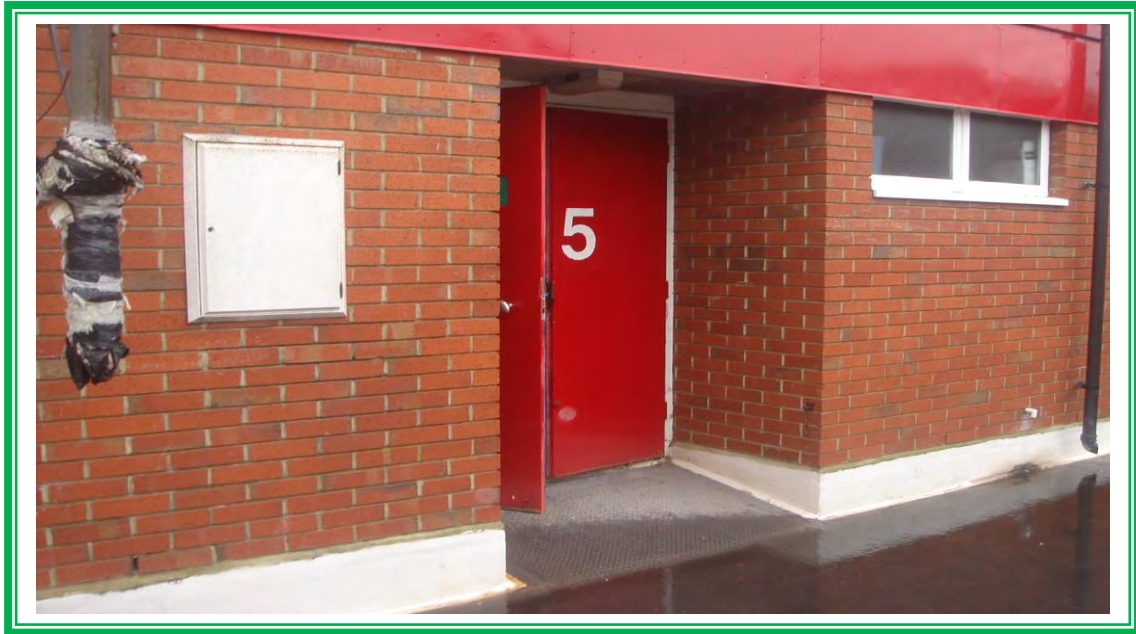
Location: 99/001

Material Description:	Visual Inspection – No Suspect Materials Found	
Identification:	N/A	
Approx. quantity:	N/A	
Accessibility	N/A	Assessment Score
Product type:	N/A	N/A
Extent of Damage:	N/A	N/A
Surface Treatment:	N/A	N/A
Asbestos type:	N/A	N/A
Material Assessment Score:		N/A
Priority Assessment Score:		N/A
Action:	N/A	
Comments:	N/A

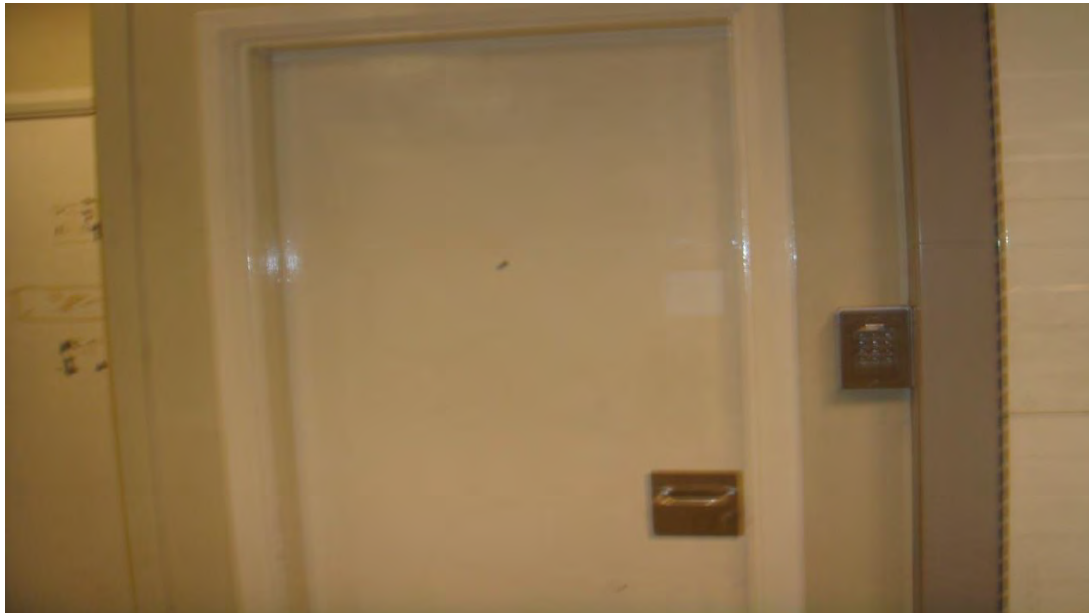
Location: 0/005 Strong Room

Material Description:	No Access as no Code Available	
Identification:	Presumed to Contain Asbestos	
Approx. quantity:	Unknown	
Accessibility	Low	Assessment Score
Product type:	No Access	3
Extent of Damage:	No Access	3
Surface Treatment:	No Access	3
Asbestos type:	No Access	3
Material Assessment Score:		12
Priority Assessment Score:		High
Action:	Further Inspection Required	
Comments:	No Code

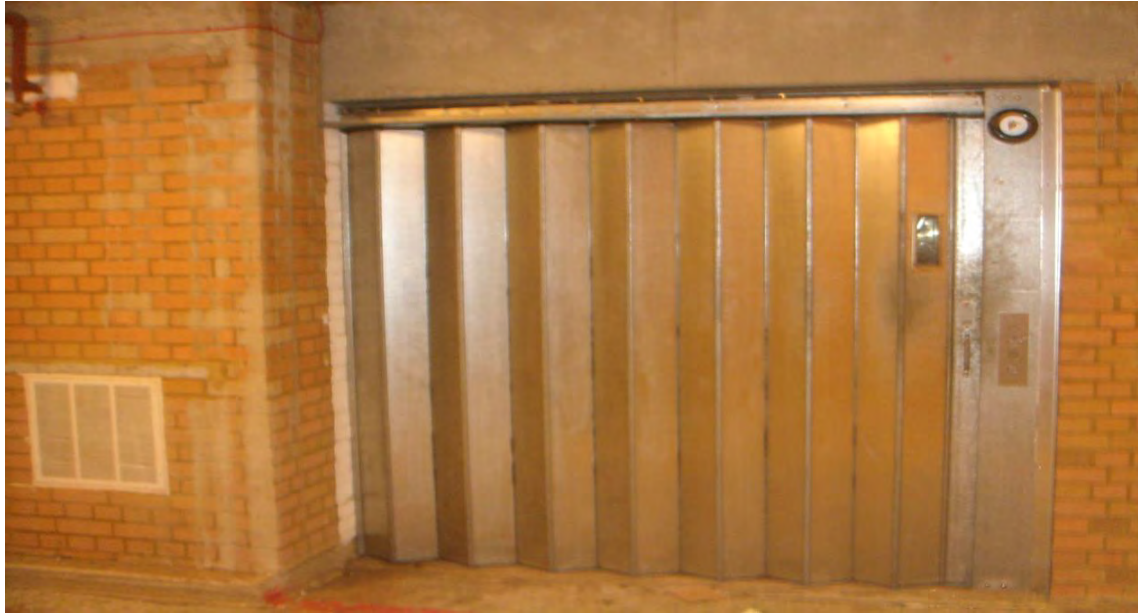
Location: 0/015 Lift

Material Description:	No Access to Lift or Shaft	
Identification:	Presumed to Contain Asbestos	
Approx. quantity:	Unknown	
Accessibility	Low	Assessment Score
Product type:	No Access	3
Extent of Damage:	No Access	3
Surface Treatment:	No Access	3
Asbestos type:	No Access	3
Material Assessment Score:		12
Priority Assessment Score:		High
Action:	Further Inspection Required	
Comments:	No Lift Engineer
