Project Number 3113

Management Asbestos Survey Report

Kennet Centre, Market Street, Newbury,
Berkshire, RG14 5EN

3 Market Place and Associated Store

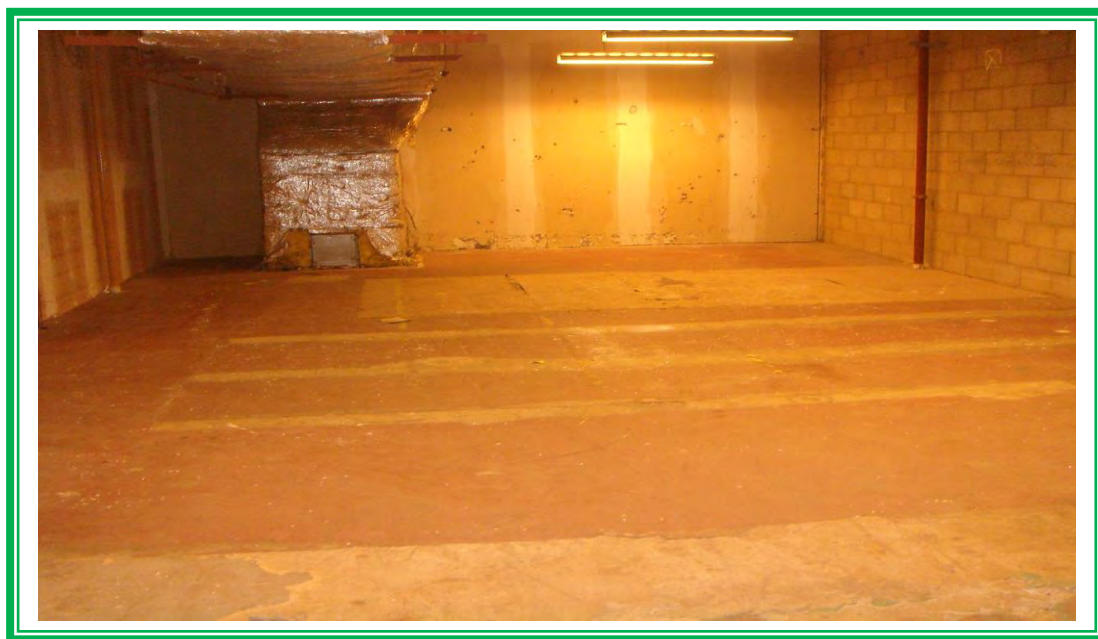
Item No: 1	Sample No: N/A
Location: 1/001 Store

Material Description:	Visual Inspection – No Suspect Materials Found	
Identification:	N/A	
Approx. quantity:	N/A	
Accessibility	N/A	Assessment Score
Product type:	N/A	N/A
Extent of Damage:	N/A	N/A
Surface Treatment:	N/A	N/A
Asbestos type:	N/A	N/A
Material Assessment Score:		N/A
Priority Assessment Score:		N/A
Action:	N/A	
Comments:	N/A

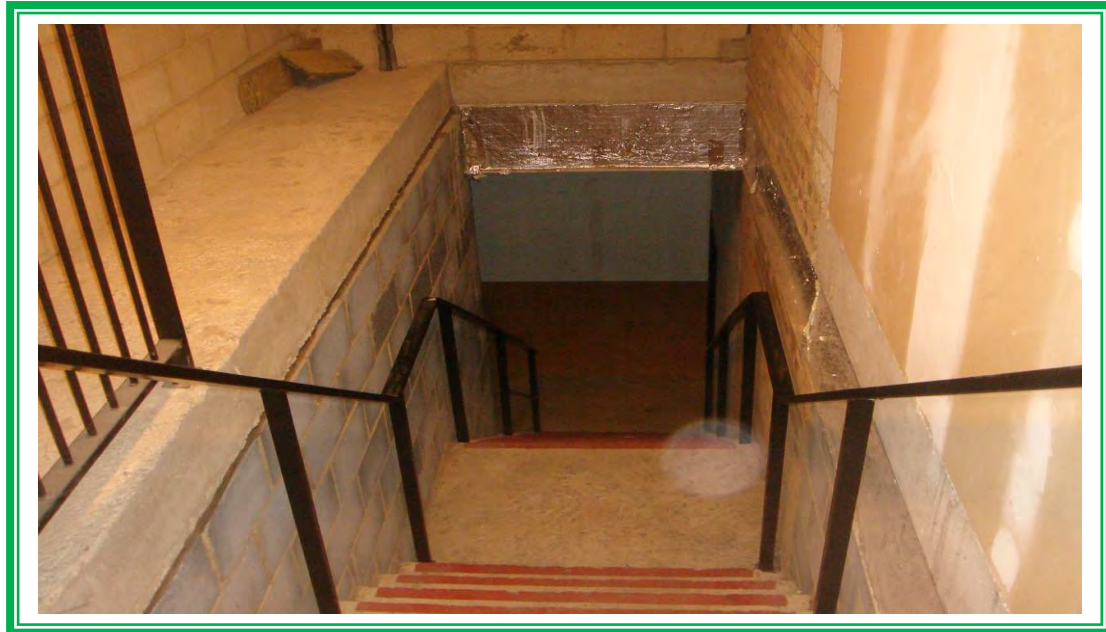
Location: 1/003 Stairs

Material Description:	Visual Inspection – No Suspect Materials Found	
Identification:	N/A	
Approx. quantity:	N/A	
Accessibility	N/A	Assessment Score
Product type:	N/A	N/A
Extent of Damage:	N/A	N/A
Surface Treatment:	N/A	N/A
Asbestos type:	N/A	N/A
Material Assessment Score:		N/A
Priority Assessment Score:		N/A
Action:	N/A	
Comments:	N/A

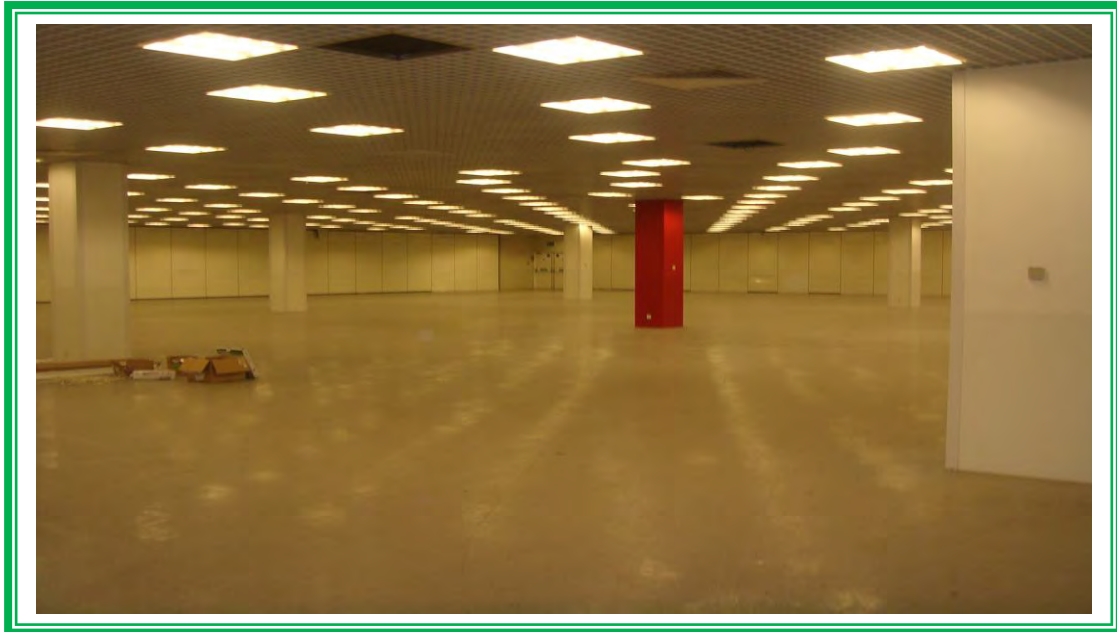
Location: 0/001 Shop Floor

Material Description:	Visual Inspection – No Suspect Materials Found	
Identification:	N/A	
Approx. quantity:	N/A	
Accessibility	N/A	Assessment Score
Product type:	N/A	N/A
Extent of Damage:	N/A	N/A
Surface Treatment:	N/A	N/A
Asbestos type:	N/A	N/A
Material Assessment Score:		N/A
Priority Assessment Score:		N/A
Action:	N/A	
Comments:	N/A

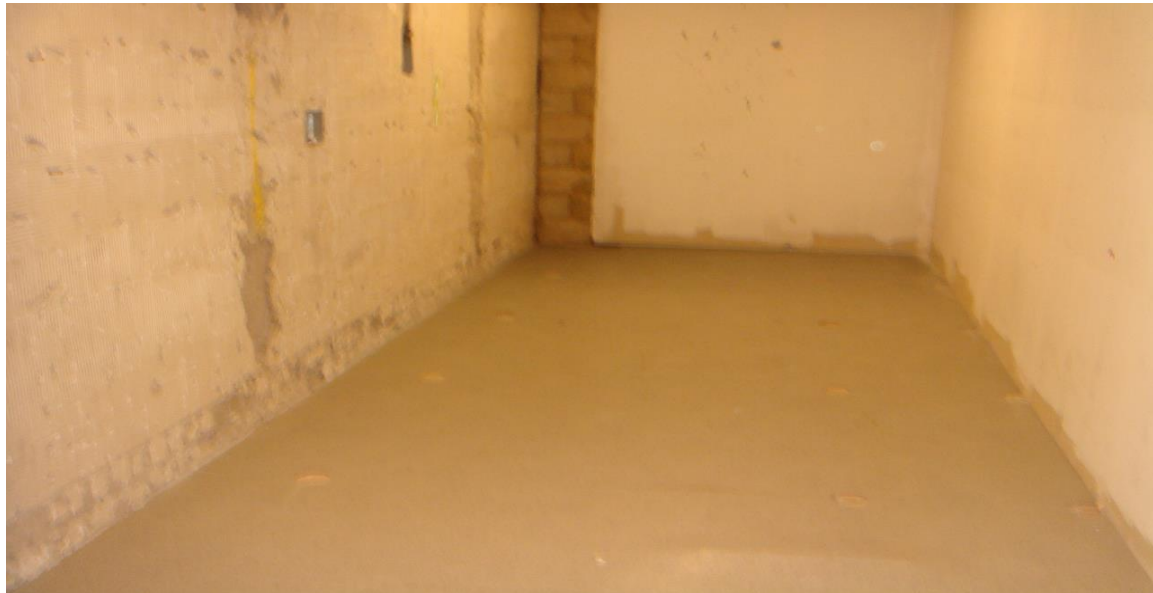
Location: 0/002 Store

Material Description:	Visual Inspection – No Suspect Materials Found	
Identification:	N/A	
Approx. quantity:	N/A	
Accessibility	N/A	Assessment Score
Product type:	N/A	N/A
Extent of Damage:	N/A	N/A
Surface Treatment:	N/A	N/A
Asbestos type:	N/A	N/A
Material Assessment Score:		N/A
Priority Assessment Score:		N/A
Action:	N/A	
Comments:	N/A

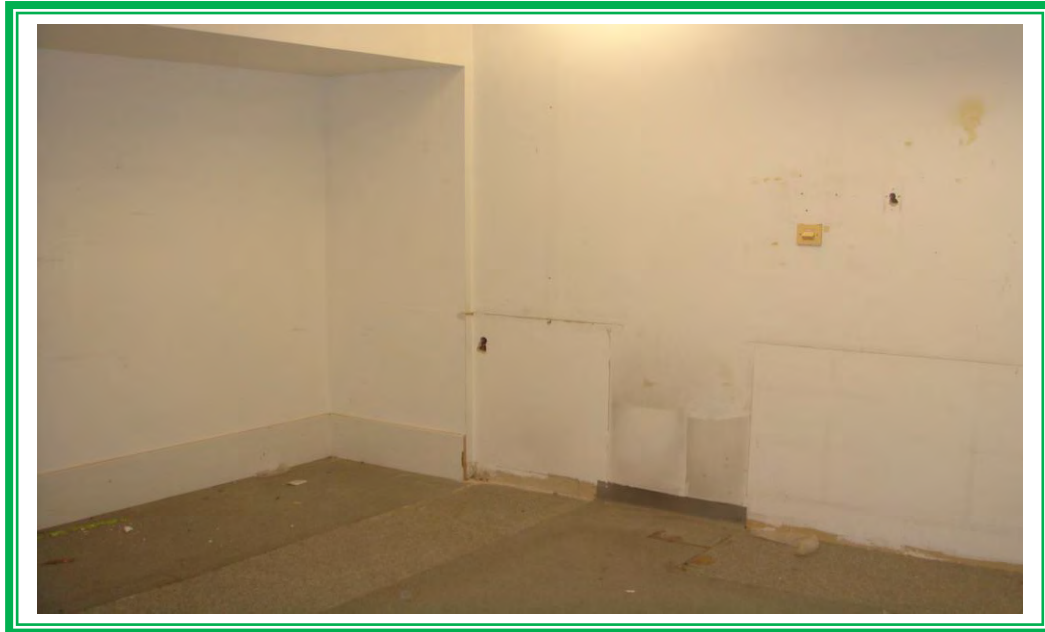
Location: 0/003 Office

Material Description:	Visual Inspection – No Suspect Materials Found	
Identification:	N/A	
Approx. quantity:	N/A	
Accessibility	N/A	Assessment Score
Product type:	N/A	N/A
Extent of Damage:	N/A	N/A
Surface Treatment:	N/A	N/A
Asbestos type:	N/A	N/A
Material Assessment Score:		N/A
Priority Assessment Score:		N/A
Action:	N/A	
Comments:	N/A

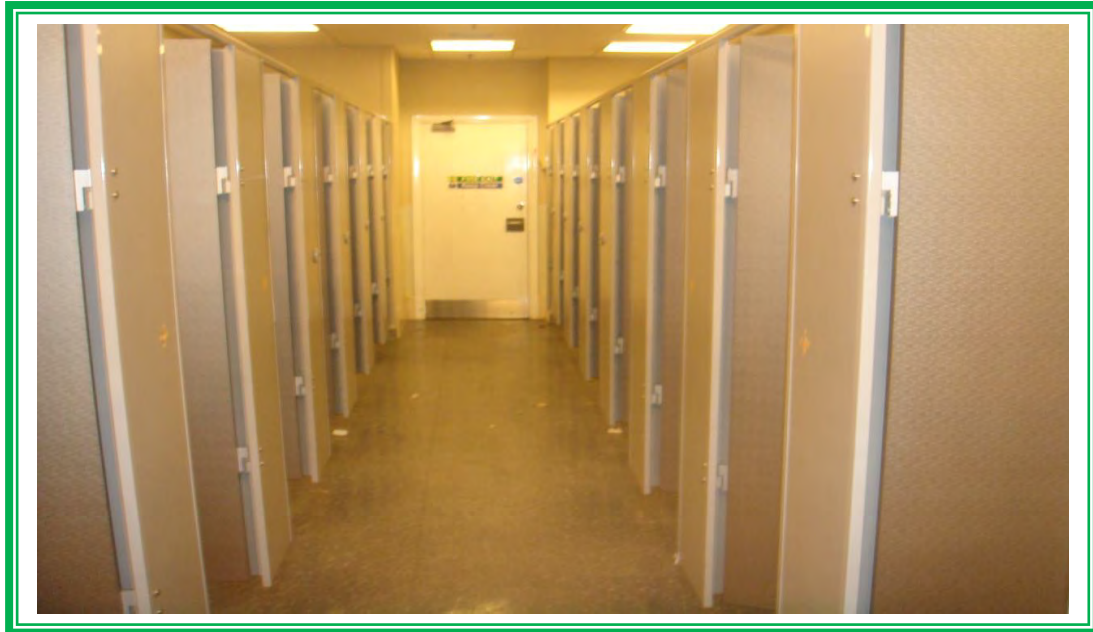
Location: 0/004

Material Description:	Visual Inspection – No Suspect Materials Found	
Identification:	N/A	
Approx. quantity:	N/A	
Accessibility	N/A	Assessment Score
Product type:	N/A	N/A
Extent of Damage:	N/A	N/A
Surface Treatment:	N/A	N/A
Asbestos type:	N/A	N/A
Material Assessment Score:		N/A
Priority Assessment Score:		N/A
Action:	N/A	
Comments:	N/A

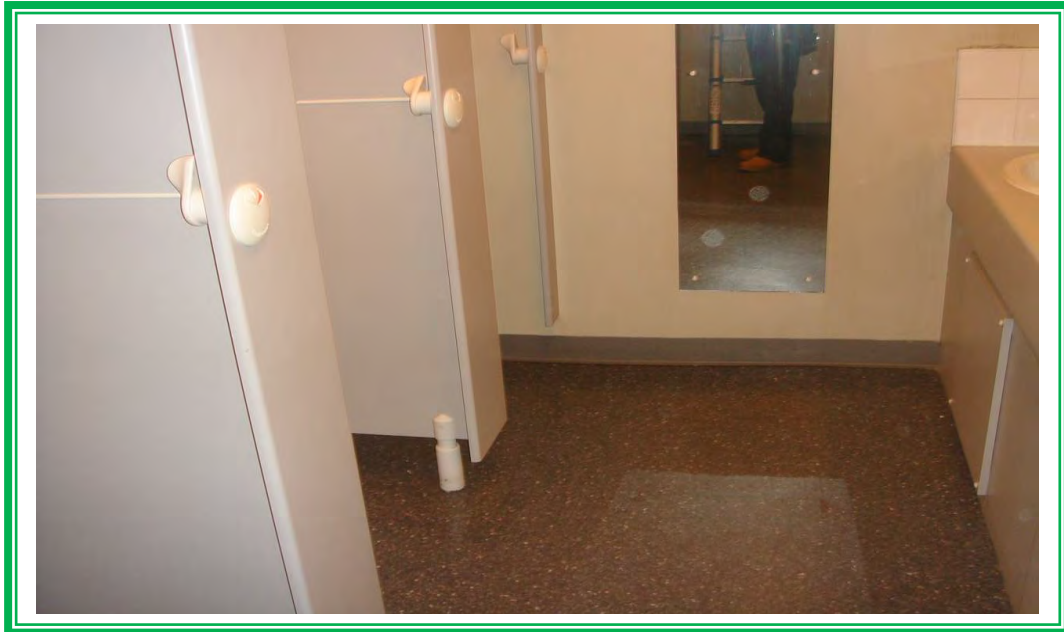
Location: 0/005A WC

Material Description:	Visual Inspection – No Suspect Materials Found	
Identification:	N/A	
Approx. quantity:	N/A	
Accessibility	N/A	Assessment Score
Product type:	N/A	N/A
Extent of Damage:	N/A	N/A
Surface Treatment:	N/A	N/A
Asbestos type:	N/A	N/A
Material Assessment Score:		N/A
Priority Assessment Score:		N/A
Action:	N/A	
Comments:	N/A

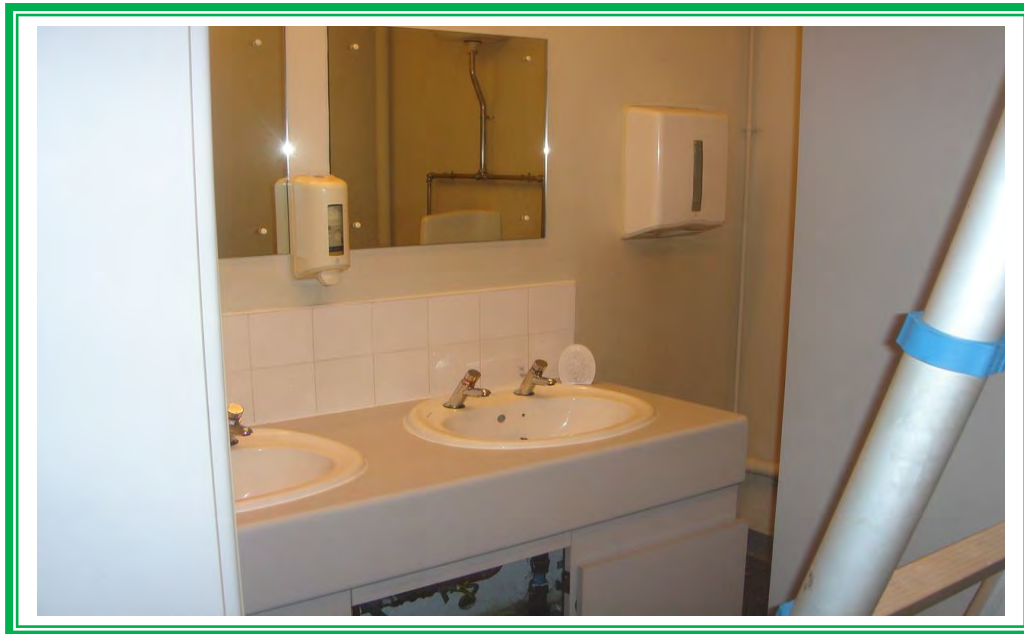
Location: 0/006 WC

Material Description:	Visual Inspection – No Suspect Materials Found	
Identification:	N/A	
Approx. quantity:	N/A	
Accessibility	N/A	Assessment Score
Product type:	N/A	N/A
Extent of Damage:	N/A	N/A
Surface Treatment:	N/A	N/A
Asbestos type:	N/A	N/A
Material Assessment Score:		N/A
Priority Assessment Score:		N/A
Action:	N/A	
Comments:	N/A

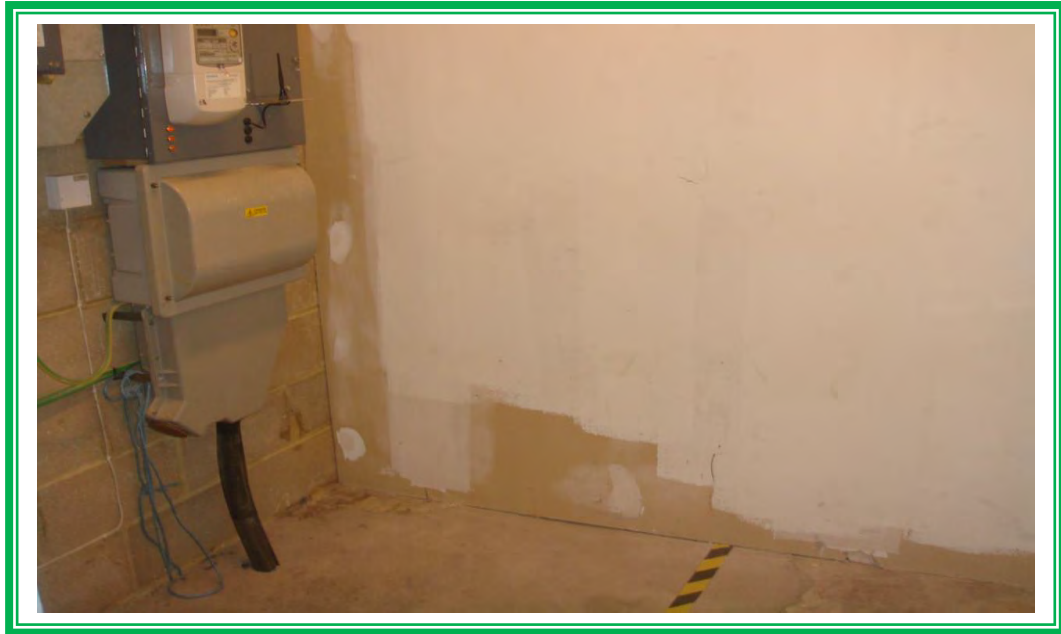
Location: 0/006A Electrics Room

Material Description:	Visual Inspection – No Suspect Materials Found	
Identification:	N/A	
Approx. quantity:	N/A	
Accessibility	N/A	Assessment Score
Product type:	N/A	N/A
Extent of Damage:	N/A	N/A
Surface Treatment:	N/A	N/A
Asbestos type:	N/A	N/A
Material Assessment Score:		N/A
Priority Assessment Score:		N/A
Action:	N/A	
Comments:	N/A

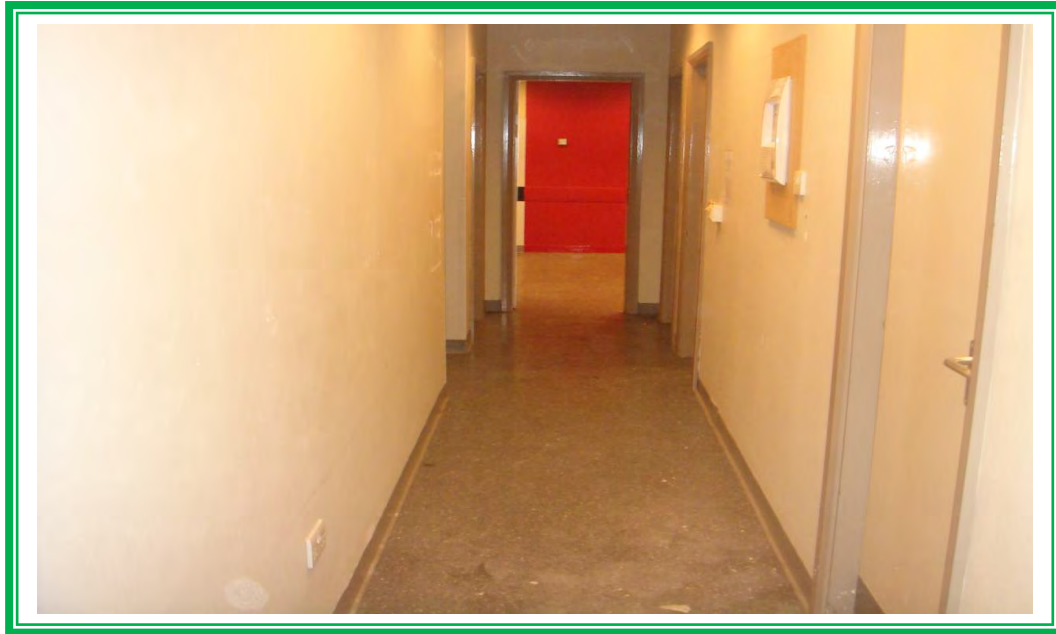
Location: 0/007 Corridor

Material Description:	Visual Inspection – No Suspect Materials Found	
Identification:	N/A	
Approx. quantity:	N/A	
Accessibility	N/A	Assessment Score
Product type:	N/A	N/A
Extent of Damage:	N/A	N/A
Surface Treatment:	N/A	N/A
Asbestos type:	N/A	N/A
Material Assessment Score:		N/A
Priority Assessment Score:		N/A
Action:	N/A	
Comments:	N/A

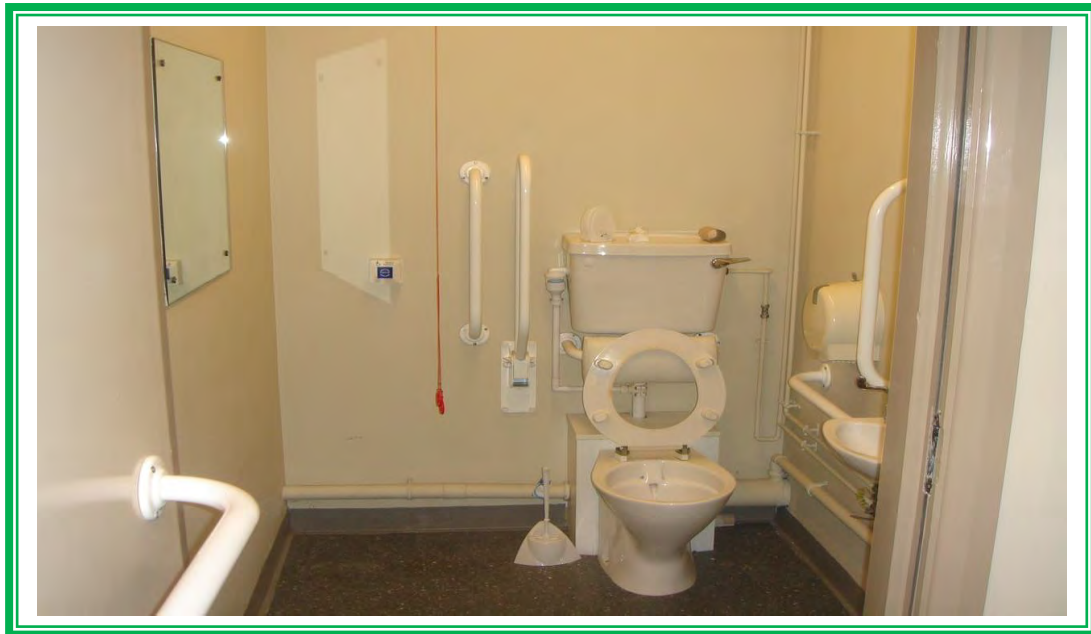
Location: 0/008 Disabled WC

Material Description:	Visual Inspection – No Suspect Materials Found	
Identification:	N/A	
Approx. quantity:	N/A	
Accessibility	N/A	Assessment Score
Product type:	N/A	N/A
Extent of Damage:	N/A	N/A
Surface Treatment:	N/A	N/A
Asbestos type:	N/A	N/A
Material Assessment Score:		N/A
Priority Assessment Score:		N/A
Action:	N/A	
Comments:	N/A

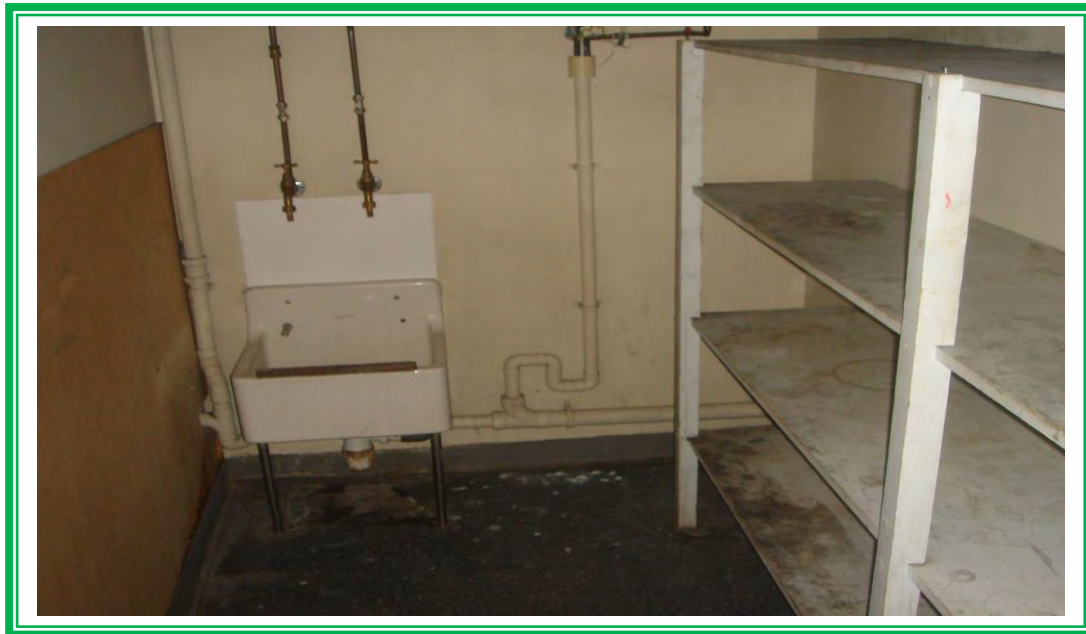
Location: 0/009 Store

Material Description:	Visual Inspection – No Suspect Materials Found	
Identification:	N/A	
Approx. quantity:	N/A	
Accessibility	N/A	Assessment Score
Product type:	N/A	N/A
Extent of Damage:	N/A	N/A
Surface Treatment:	N/A	N/A
Asbestos type:	N/A	N/A
Material Assessment Score:		N/A
Priority Assessment Score:		N/A
Action:	N/A	
Comments:	N/A

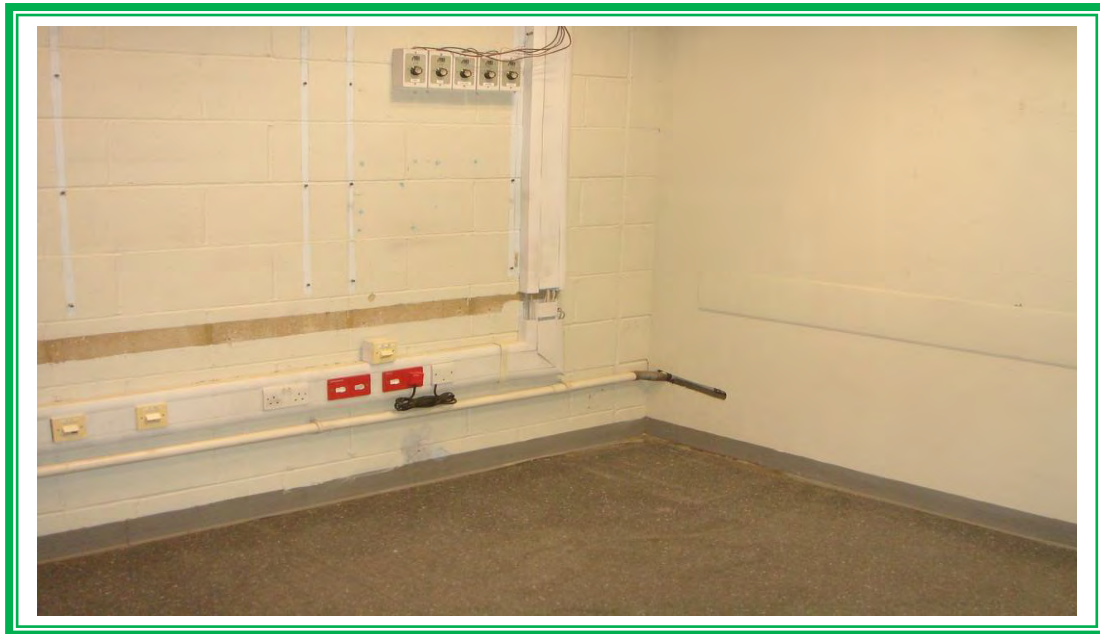
Location: 0/010 Store

Material Description:	Visual Inspection – No Suspect Materials Found	
Identification:	N/A	
Approx. quantity:	N/A	
Accessibility	N/A	Assessment Score
Product type:	N/A	N/A
Extent of Damage:	N/A	N/A
Surface Treatment:	N/A	N/A
Asbestos type:	N/A	N/A
Material Assessment Score:		N/A
Priority Assessment Score:		N/A
Action:	N/A	
Comments:	N/A

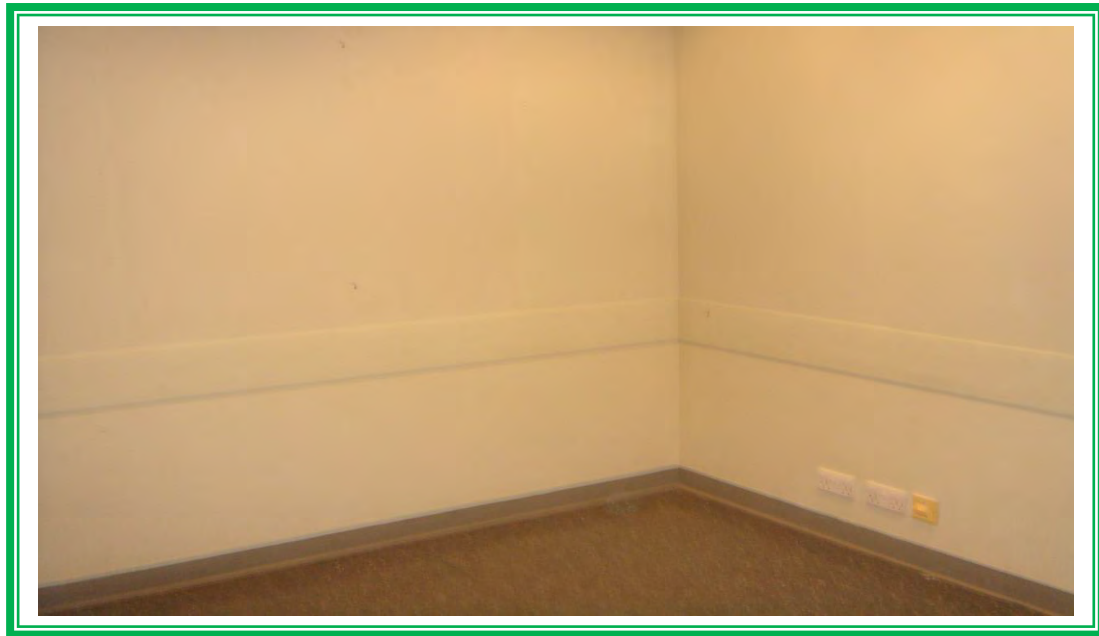
Location: 0/12 Office

Material Description:	Visual Inspection – No Suspect Materials Found	
Identification:	N/A	
Approx. quantity:	N/A	
Accessibility	N/A	Assessment Score
Product type:	N/A	N/A
Extent of Damage:	N/A	N/A
Surface Treatment:	N/A	N/A
Asbestos type:	N/A	N/A
Material Assessment Score:		N/A
Priority Assessment Score:		N/A
Action:	N/A	
Comments:	N/A

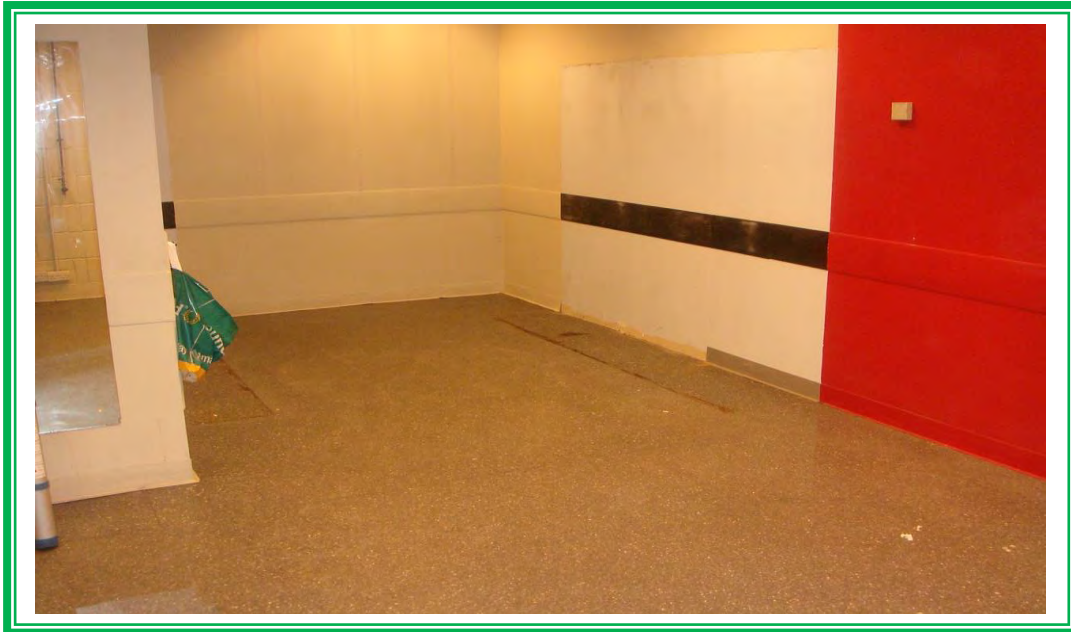
Location: 0/013 Canteen

Material Description:	Visual Inspection – No Suspect Materials Found	
Identification:	N/A	
Approx. quantity:	N/A	
Accessibility	N/A	Assessment Score
Product type:	N/A	N/A
Extent of Damage:	N/A	N/A
Surface Treatment:	N/A	N/A
Asbestos type:	N/A	N/A
Material Assessment Score:		N/A
Priority Assessment Score:		N/A
Action:	N/A	
Comments:	N/A

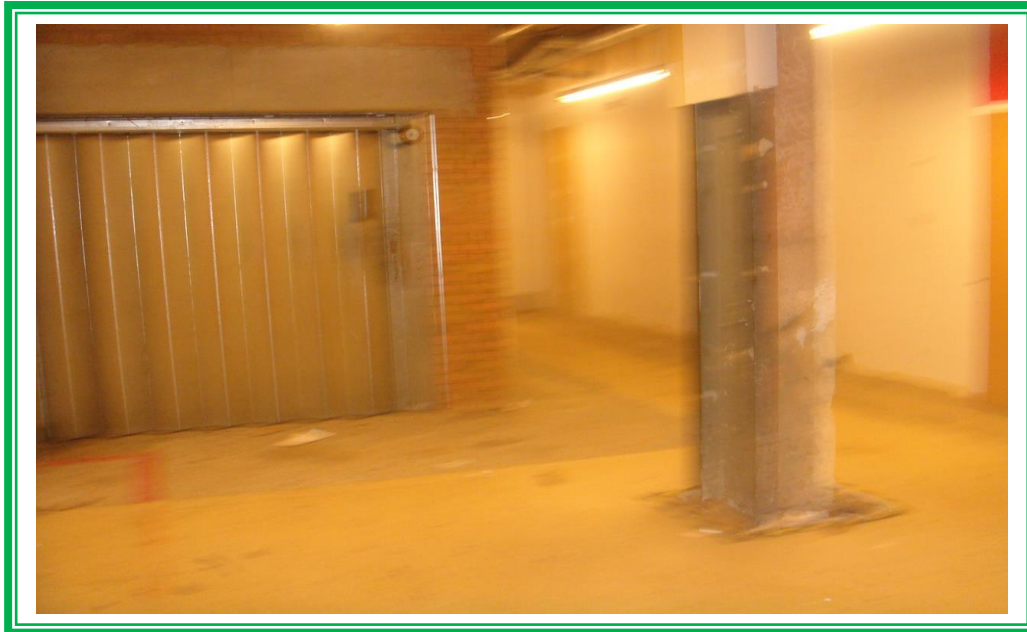
Location: 0/014 Lobby Lift

Material Description:	Visual Inspection – No Suspect Materials Found	
Identification:	N/A	
Approx. quantity:	N/A	
Accessibility	N/A	Assessment Score
Product type:	N/A	N/A
Extent of Damage:	N/A	N/A
Surface Treatment:	N/A	N/A
Asbestos type:	N/A	N/A
Material Assessment Score:		N/A
Priority Assessment Score:		N/A
Action:	N/A	
Comments:	N/A

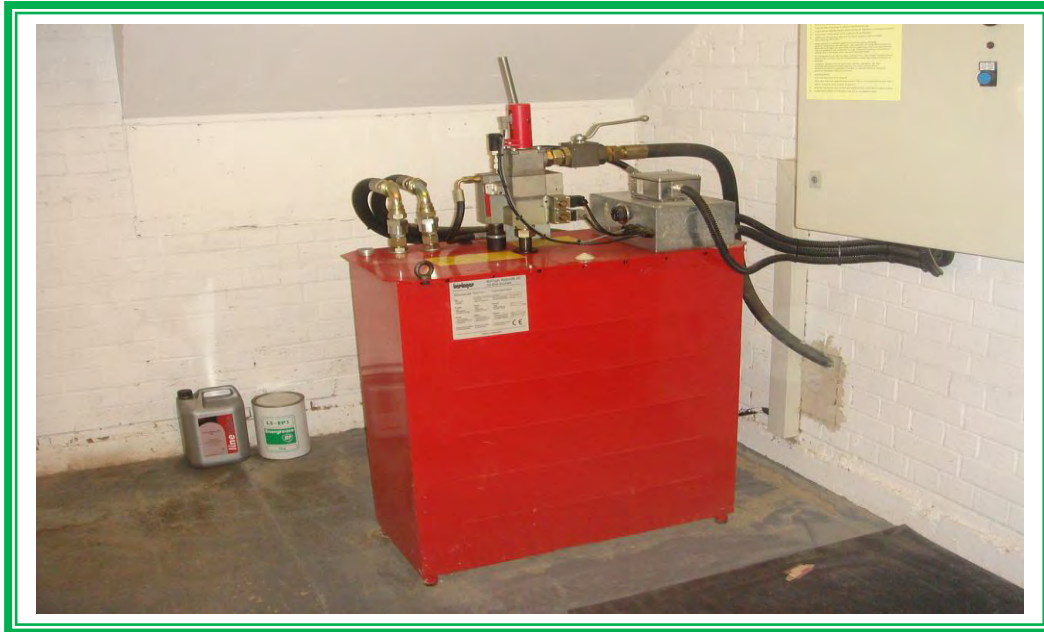
Location: 0/016 Lift Motor Room

Material Description:	Visual Inspection – No Suspect Materials Found	
Identification:	N/A	
Approx. quantity:	N/A	
Accessibility	N/A	Assessment Score
Product type:	N/A	N/A
Extent of Damage:	N/A	N/A
Surface Treatment:	N/A	N/A
Asbestos type:	N/A	N/A
Material Assessment Score:		N/A
Priority Assessment Score:		N/A
Action:	N/A	
Comments:	N/A

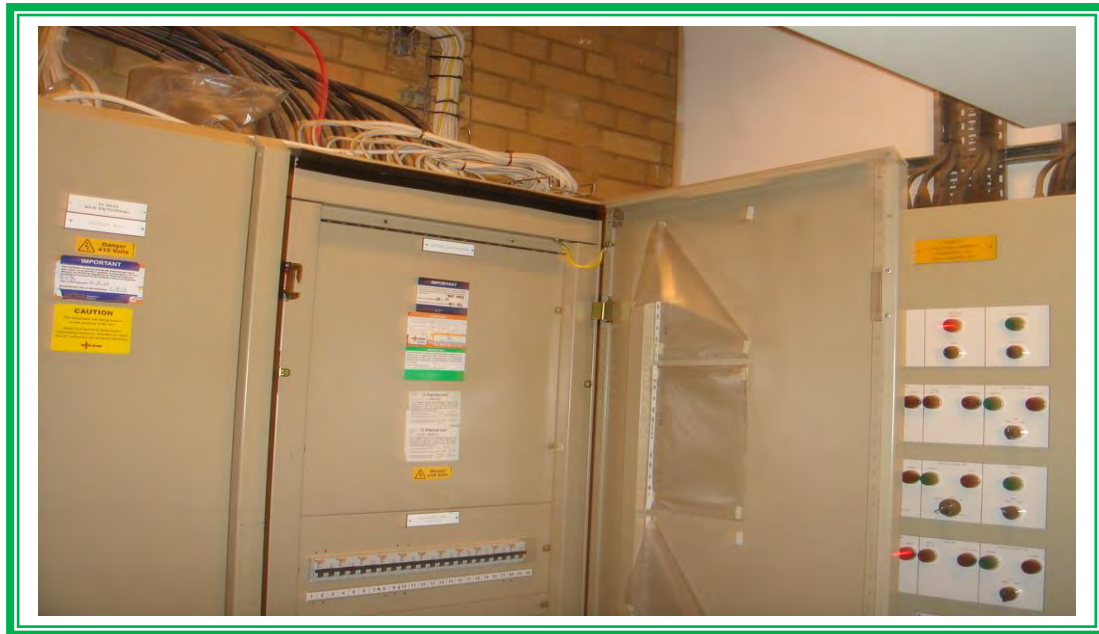
Location: 0/017

Material Description:	Visual Inspection – No Suspect Materials Found	
Identification:	N/A	
Approx. quantity:	N/A	
Accessibility	N/A	Assessment Score
Product type:	N/A	N/A
Extent of Damage:	N/A	N/A
Surface Treatment:	N/A	N/A
Asbestos type:	N/A	N/A
Material Assessment Score:		N/A
Priority Assessment Score:		N/A
Action:	N/A	
Comments:	N/A

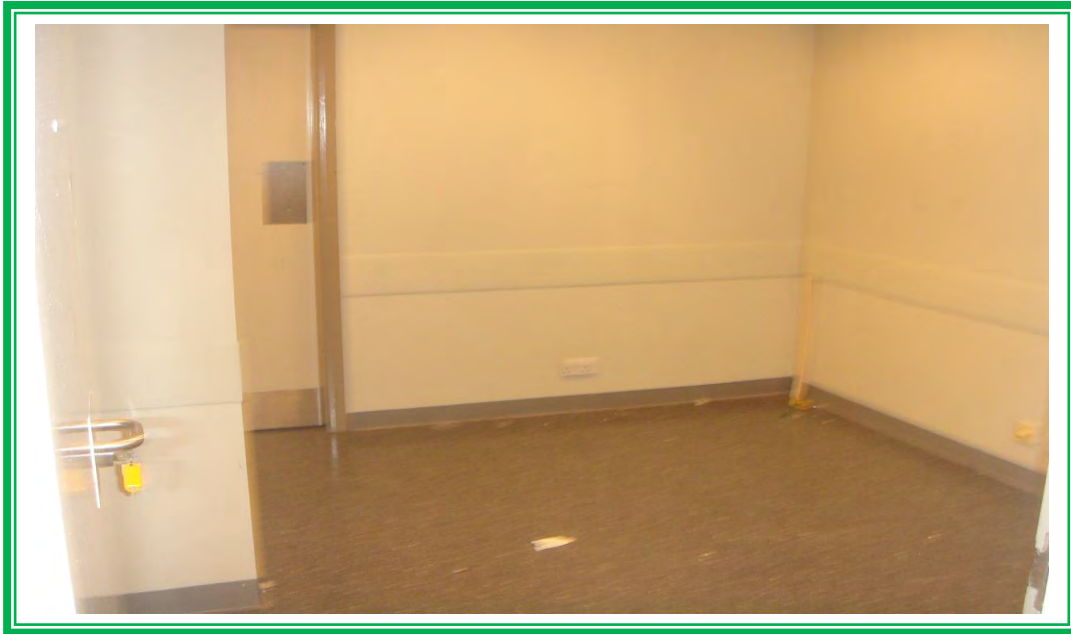
Location: 0/018

Material Description:	Visual Inspection – No Suspect Materials Found	
Identification:	N/A	
Approx. quantity:	N/A	
Accessibility	N/A	Assessment Score
Product type:	N/A	N/A
Extent of Damage:	N/A	N/A
Surface Treatment:	N/A	N/A
Asbestos type:	N/A	N/A
Material Assessment Score:		N/A
Priority Assessment Score:		N/A
Action:	N/A	
Comments:	N/A

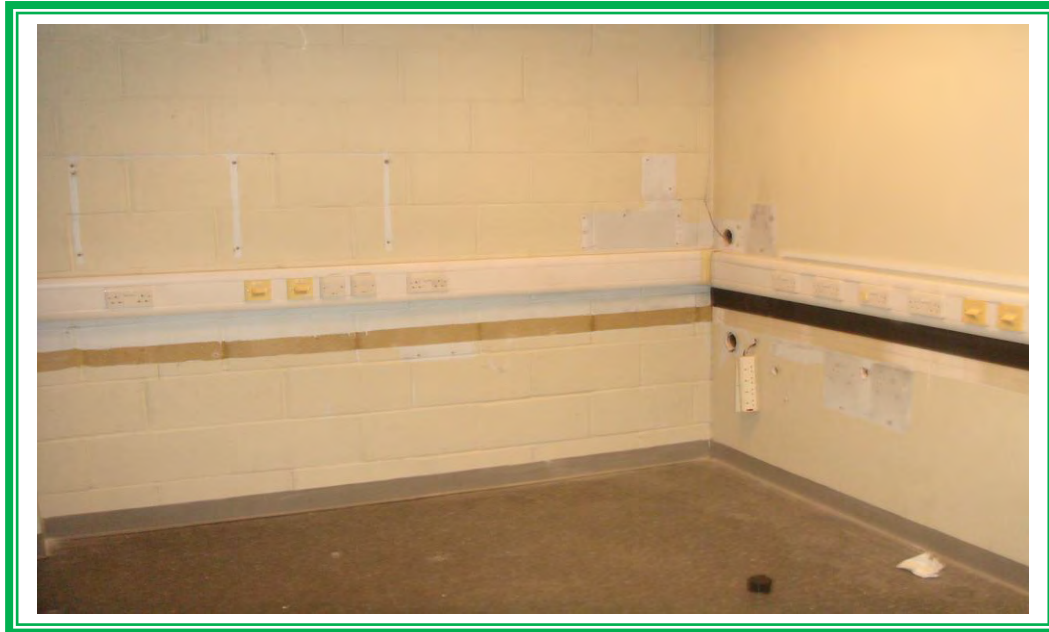
Location: 0/19

Material Description:	Visual Inspection – No Suspect Materials Found	
Identification:	N/A	
Approx. quantity:	N/A	
Accessibility	N/A	Assessment Score
Product type:	N/A	N/A
Extent of Damage:	N/A	N/A
Surface Treatment:	N/A	N/A
Asbestos type:	N/A	N/A
Material Assessment Score:		N/A
Priority Assessment Score:		N/A
Action:	N/A	
Comments:	N/A

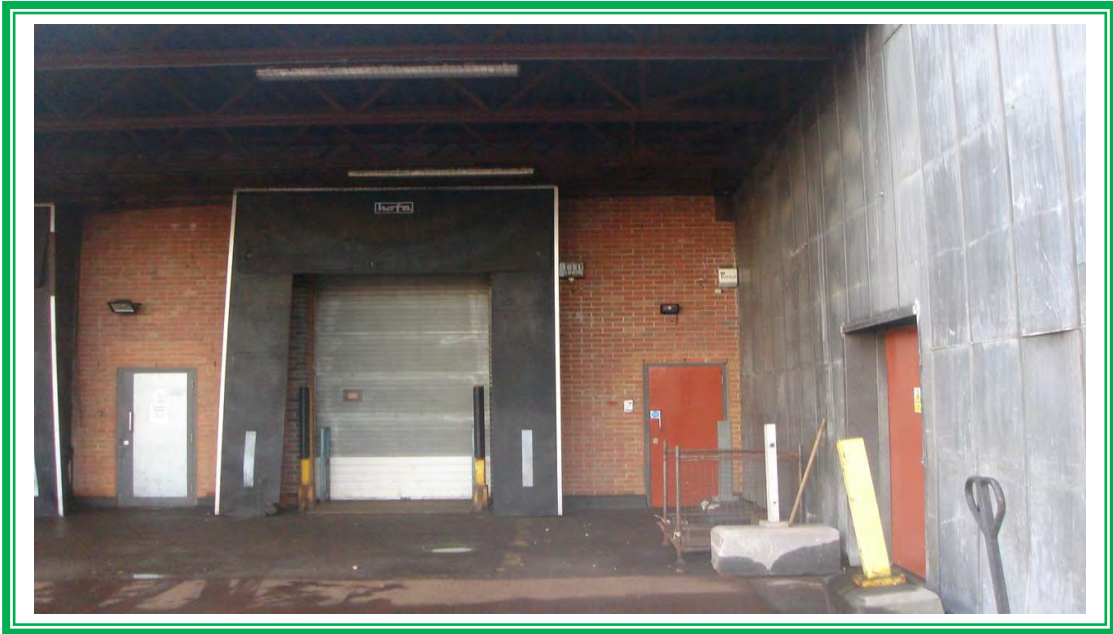
Location: 99/001 External

Material Description:	Visual Inspection – No Suspect Materials Found	
Identification:	N/A	
Approx. quantity:	N/A	
Accessibility	N/A	Assessment Score
Product type:	N/A	N/A
Extent of Damage:	N/A	N/A
Surface Treatment:	N/A	N/A
Asbestos type:	N/A	N/A
Material Assessment Score:		N/A
Priority Assessment Score:		N/A
Action:	N/A	
Comments:	N/A

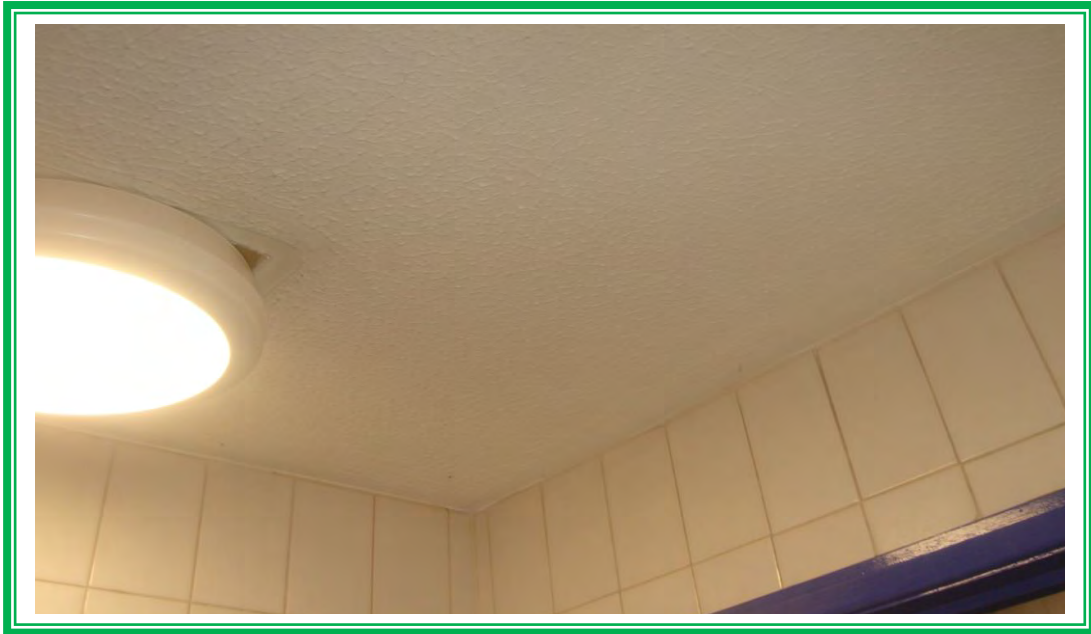
Location: 0/002 WC

Material Description:	Textured Coating Ceiling	
Identification:	Sampled – No Asbestos Detected	
Approx. quantity:	3M2	
Accessibility	N/A	Assessment Score
Product type:	N/A	N/A
Extent of Damage:	N/A	N/A
Surface Treatment:	N/A	N/A
Asbestos type:	N/A	N/A
Material Assessment Score:		N/A
Priority Assessment Score:		N/A
Action:	N/A	
Comments:	N/A

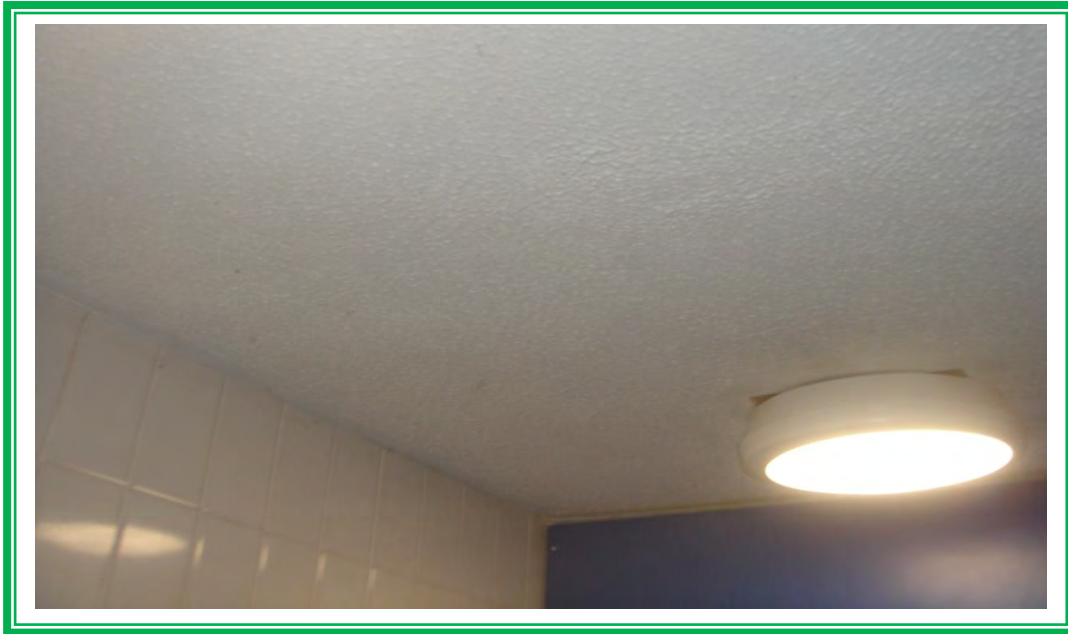
Location: 1/003 WC

Material Description:	Textured Coating Ceiling	
Identification:	As Per Sample NE/1 – No Asbestos Detected	
Approx. quantity:	3M2	
Accessibility	N/A	Assessment Score
Product type:	N/A	N/A
Extent of Damage:	N/A	N/A
Surface Treatment:	N/A	N/A
Asbestos type:	N/A	N/A
Material Assessment Score:		N/A
Priority Assessment Score:		N/A
Action:	N/A	
Comments:	N/A

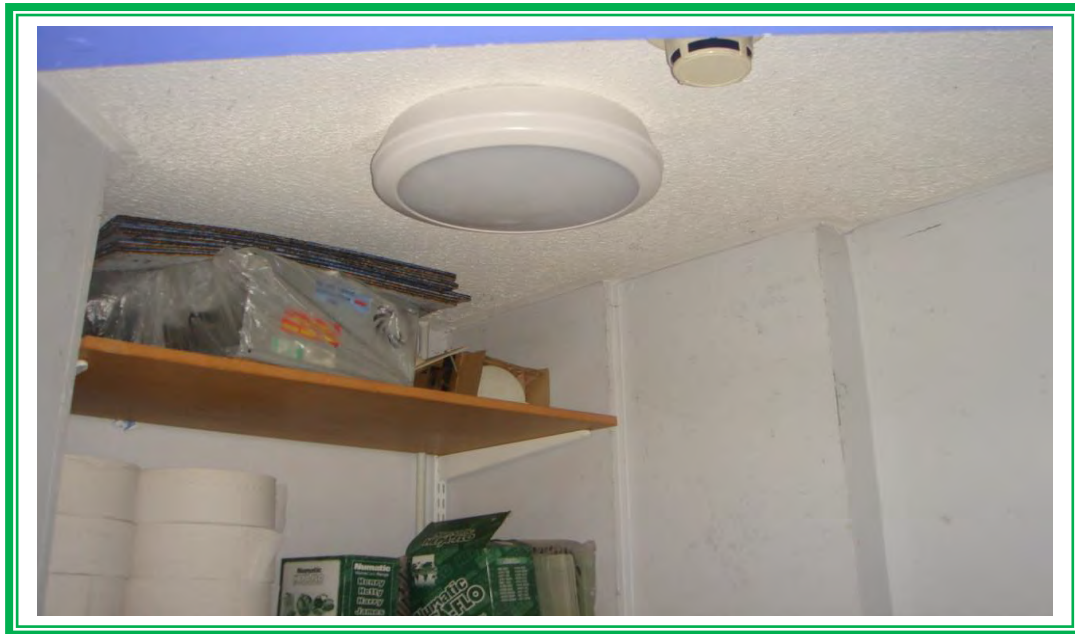
Location: 1/004 Cupboard

Material Description:	Textured Coating Ceiling	
Identification:	As Per Sample NE/1 – No Asbestos Detected	
Approx. quantity:	2M2	
Accessibility	N/A	Assessment Score
Product type:	N/A	N/A
Extent of Damage:	N/A	N/A
Surface Treatment:	N/A	N/A
Asbestos type:	N/A	N/A
Material Assessment Score:		N/A
Priority Assessment Score:		N/A
Action:	N/A	
Comments:	N/A

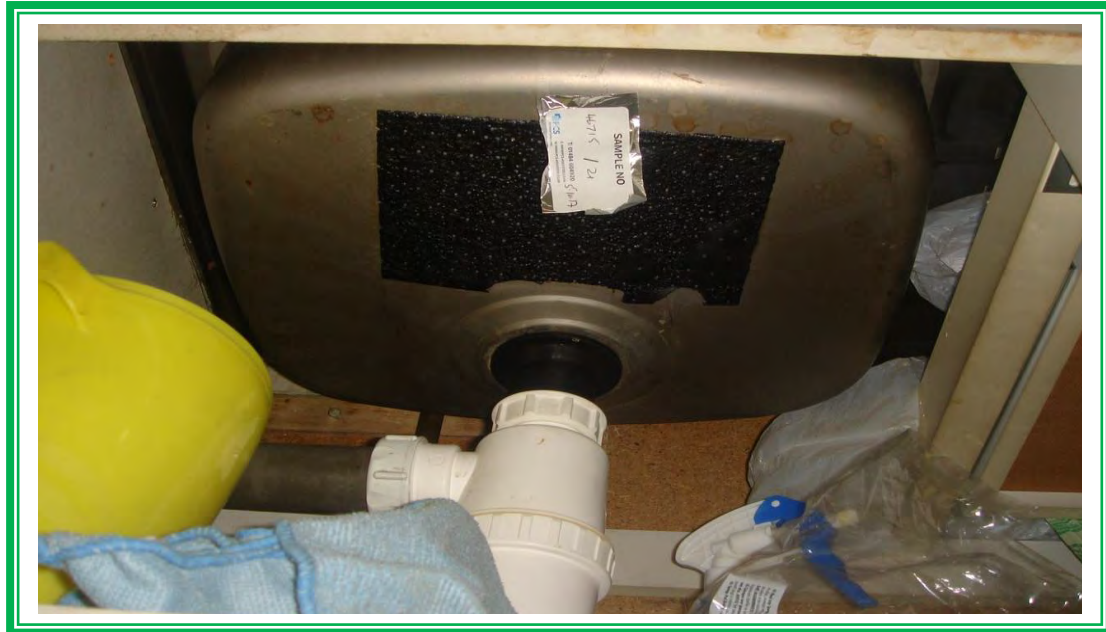
Location: 0/008 Kitchen

Material Description:	Sink Pad	
Identification:	Sampled – No Asbestos Detected	
Approx. quantity:	X 2	
Accessibility	N/A	Assessment Score
Product type:	N/A	N/A
Extent of Damage:	N/A	N/A
Surface Treatment:	N/A	N/A
Asbestos type:	N/A	N/A
Material Assessment Score:		N/A
Priority Assessment Score:		N/A
Action:	N/A	
Comments:	N/A

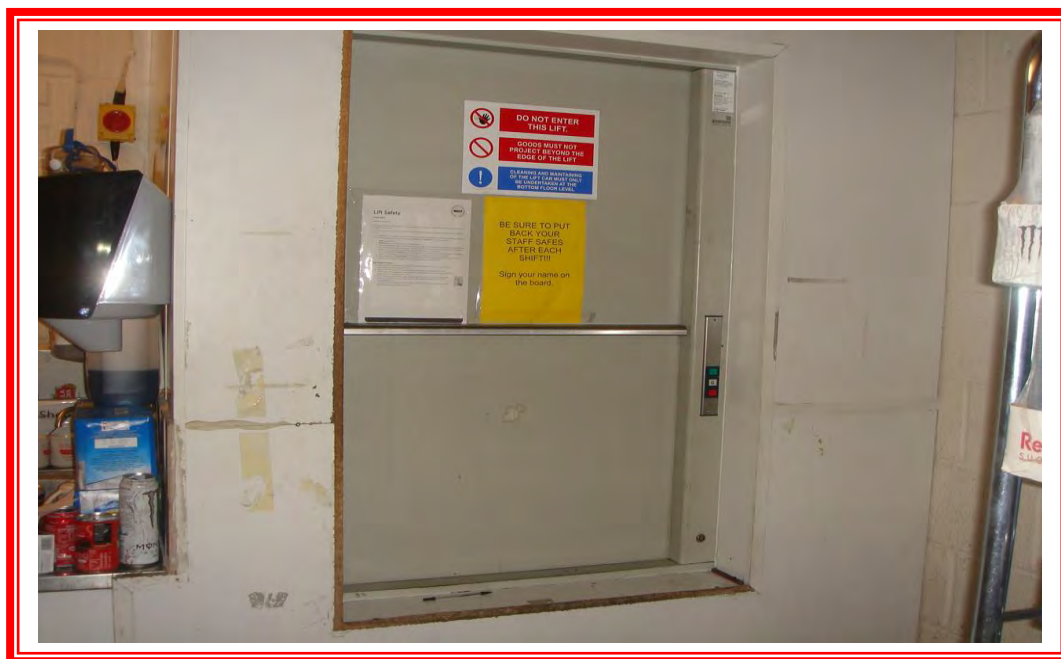
Location: 1/003 Lift and Shaft

Material Description:	No Access	
Identification:	Presumed to Contain Asbestos	
Approx. quantity:	Entire Lift and Shaft	
Accessibility	Low	Assessment Score
Product type:	No Access	3
Extent of Damage:	No Access	3
Surface Treatment:	No Access	3
Asbestos type:	No Access	3
Material Assessment Score:		12
Priority Assessment Score:		High
Action:	Further Investigation Needed	
Comments:	Unable to access as there was no lift engineer

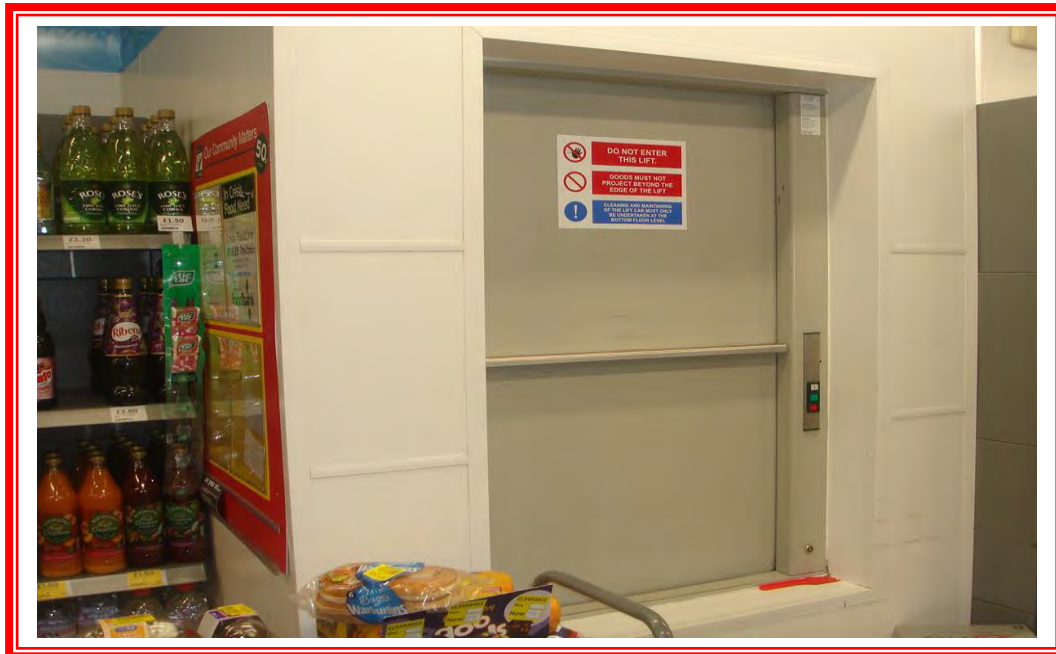
Location: 0/002 Lift and Shaft

Material Description:	No Access	
Identification:	Presumed to Contain Asbestos	
Approx. quantity:	Entire Lift and Shaft	
Accessibility	Low	Assessment Score
Product type:	No Access	3
Extent of Damage:	No Access	3
Surface Treatment:	No Access	3
Asbestos type:	No Access	3
Material Assessment Score:		12
Priority Assessment Score:		High
Action:	Further Investigation Needed	
Comments:	Unable to access as there was no lift engineer

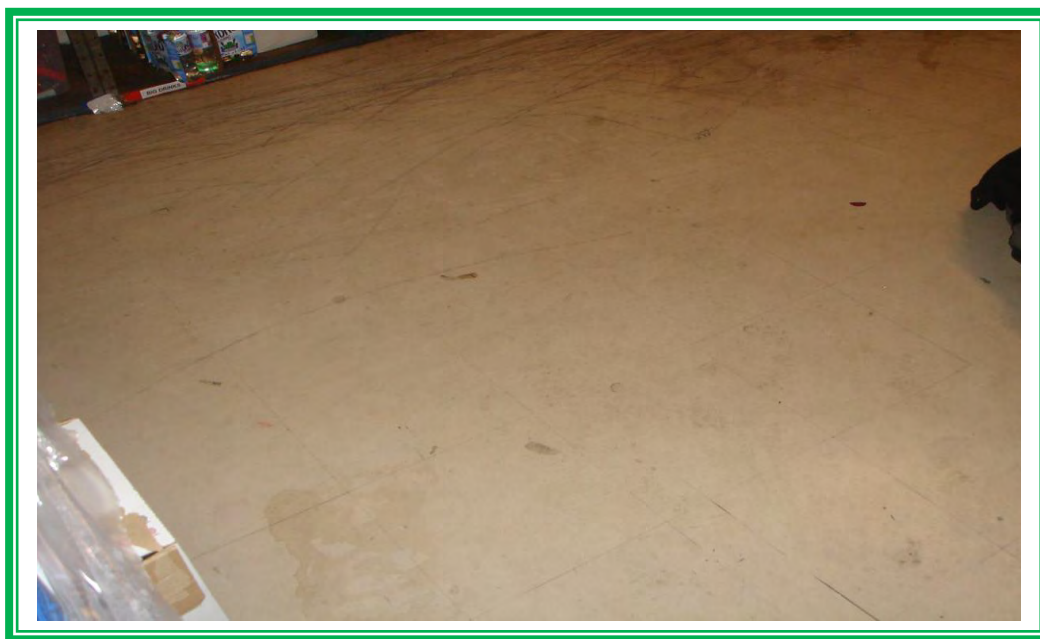
Item No: 1	Sample No: NE/1
Location: 1/001 Store

Material Description:	Vinyl Floor Tiles	
Identification:	Sampled – No Asbestos Detected	
Approx. quantity:	50M2	
Accessibility	N/A	Assessment Score
Product type:	N/A	N/A
Extent of Damage:	N/A	N/A
Surface Treatment:	N/A	N/A
Asbestos type:	N/A	N/A
Material Assessment Score:		N/A
Priority Assessment Score:		N/A
Action:	N/A	
Comments:	N/A

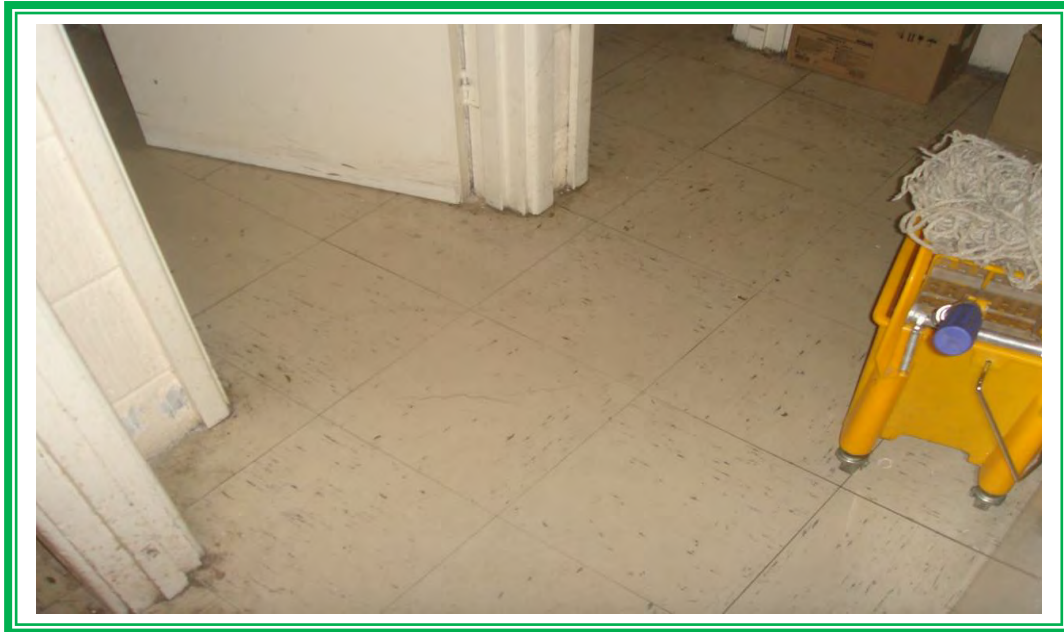
Location: 1/002 WC

Material Description:	Vinyl Floor Tiles	
Identification:	As Per Sample NE/1 – No Asbestos Detected	
Approx. quantity:	6M2	
Accessibility	N/A	Assessment Score
Product type:	N/A	N/A
Extent of Damage:	N/A	N/A
Surface Treatment:	N/A	N/A
Asbestos type:	N/A	N/A
Material Assessment Score:		N/A
Priority Assessment Score:		N/A
Action:	N/A	
Comments:	N/A
