Project Number 3113

Management Asbestos Survey Report

Kennet Centre, Market Street, Newbury,
Berkshire, RG14 5EN

3 Market Place and Associated Store

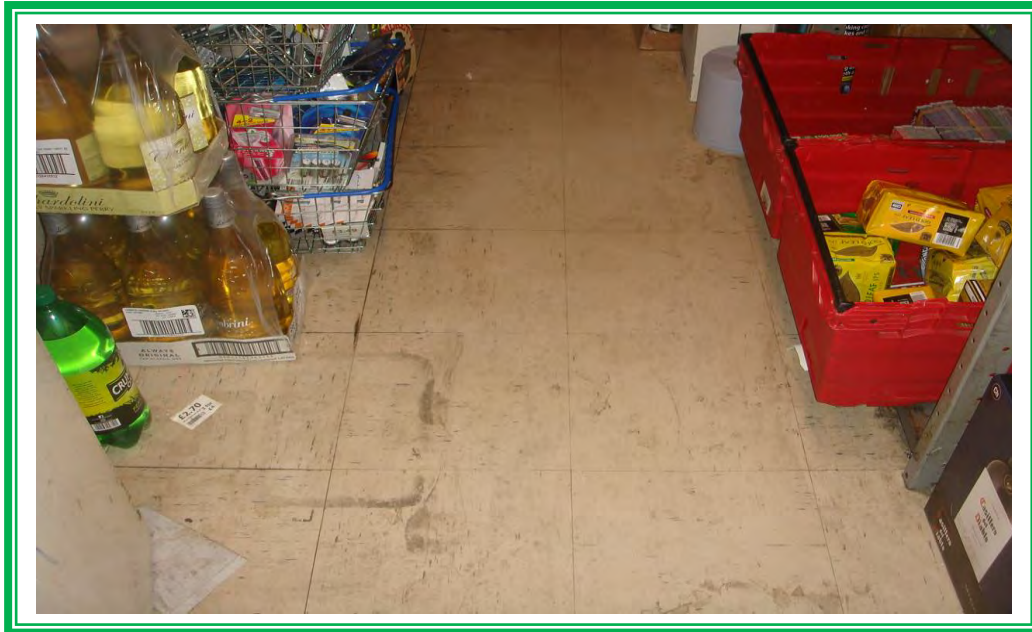
Location: 1/004 Stock Room

Material Description:	Vinyl Floor Tiles	
Identification:	As Per Sample NE/1 – No Asbestos Detected	
Approx. quantity:	2M2	
Accessibility	N/A	Assessment Score
Product type:	N/A	N/A
Extent of Damage:	N/A	N/A
Surface Treatment:	N/A	N/A
Asbestos type:	N/A	N/A
Material Assessment Score:		N/A
Priority Assessment Score:		N/A
Action:	N/A	
Comments:	N/A

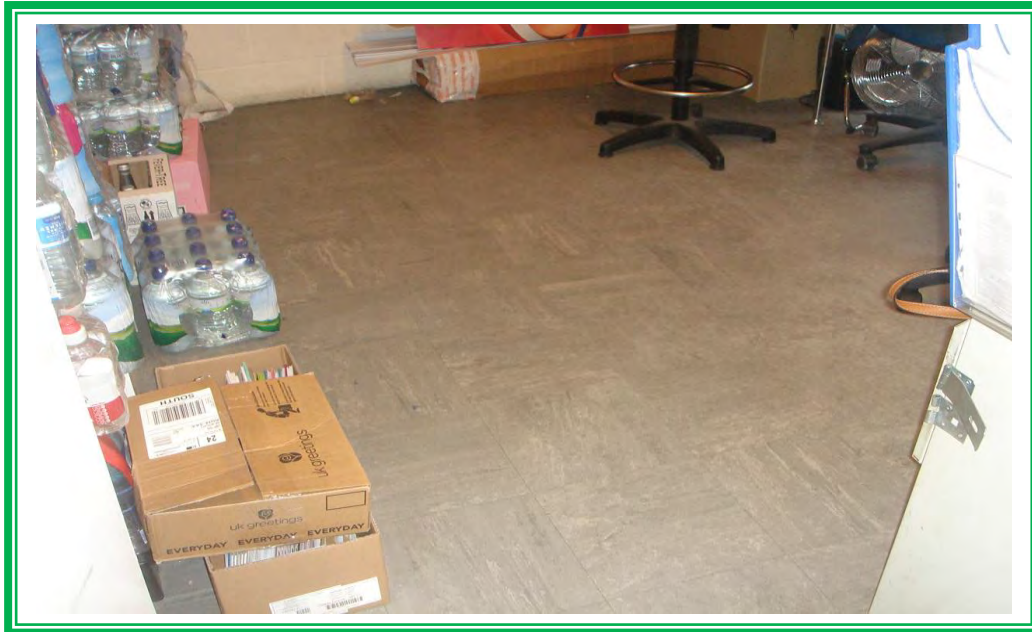
Location: 1/005 Office

Material Description:	Vinyl Floor Tiles	
Identification:	Sampled – No Asbestos Detected	
Approx. quantity:	8M2	
Accessibility	N/A	Assessment Score
Product type:	N/A	N/A
Extent of Damage:	N/A	N/A
Surface Treatment:	N/A	N/A
Asbestos type:	N/A	N/A
Material Assessment Score:		N/A
Priority Assessment Score:		N/A
Action:	N/A	
Comments:	N/A

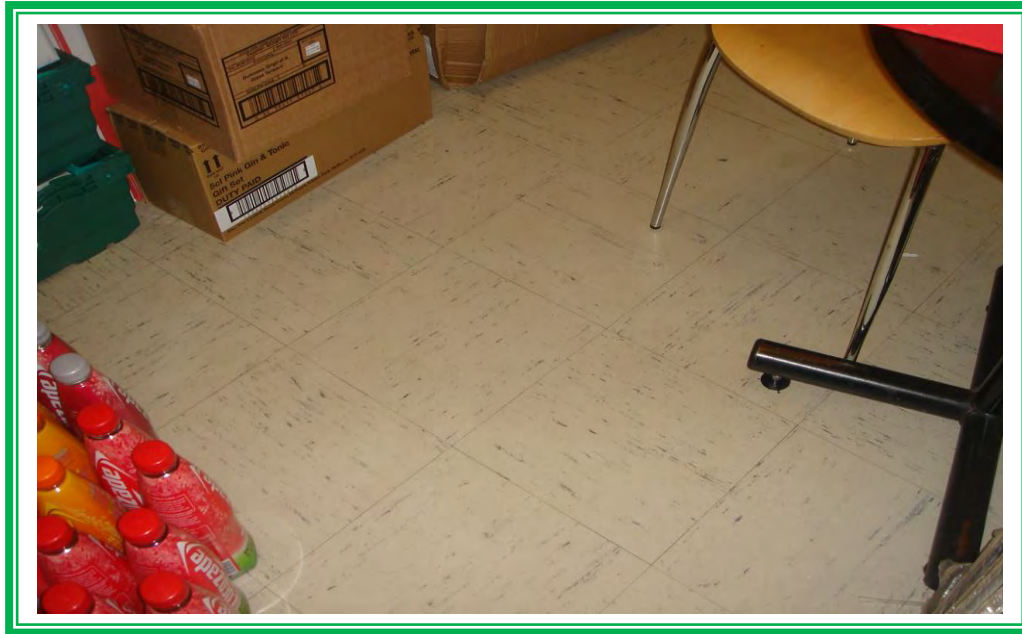
Location: 1/006 Kitchen/Store

Material Description:	Vinyl Floor Tiles	
Identification:	As Per Sample NE/1 – No Asbestos Detected	
Approx. quantity:	4M2	
Accessibility	N/A	Assessment Score
Product type:	N/A	N/A
Extent of Damage:	N/A	N/A
Surface Treatment:	N/A	N/A
Asbestos type:	N/A	N/A
Material Assessment Score:		N/A
Priority Assessment Score:		N/A
Action:	N/A	
Comments:	N/A

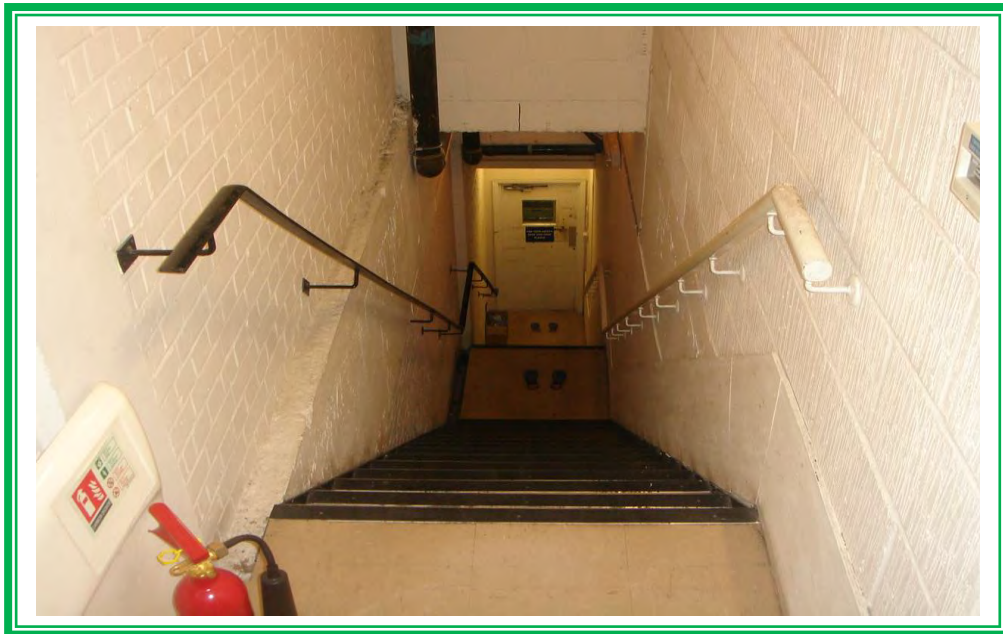
Location: 1/007 Stairs

Material Description:	Vinyl Floor Tiles	
Identification:	Sampled – No Asbestos Detected	
Approx. quantity:	15M2	
Accessibility	N/A	Assessment Score
Product type:	N/A	N/A
Extent of Damage:	N/A	N/A
Surface Treatment:	N/A	N/A
Asbestos type:	N/A	N/A
Material Assessment Score:		N/A
Priority Assessment Score:		N/A
Action:	N/A	
Comments:	N/A

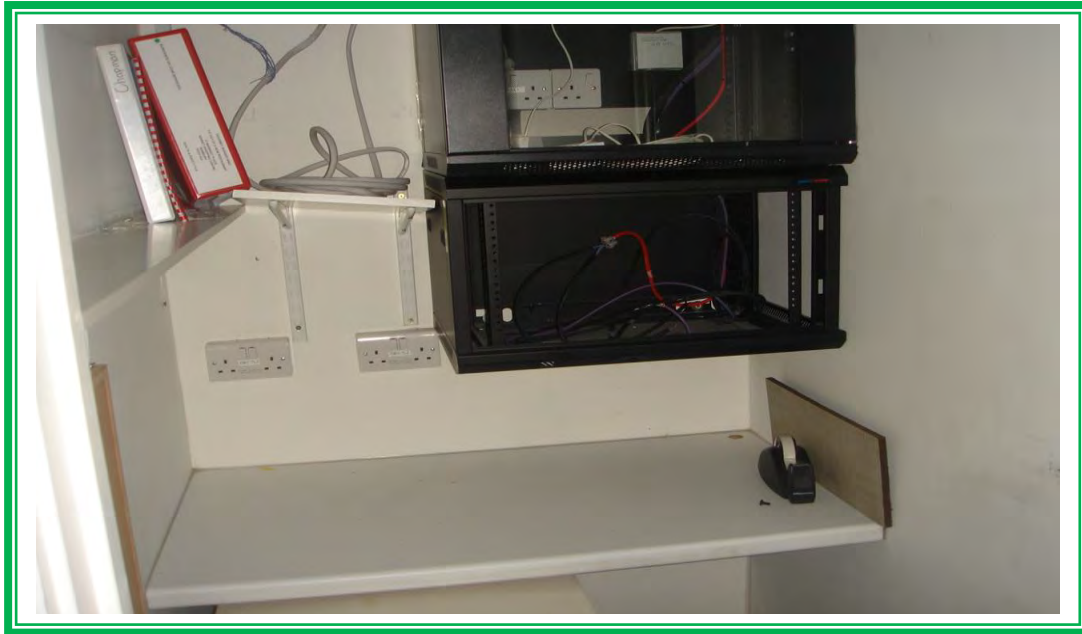
Location: 1/003 Cupboard

Material Description:	Visual Inspection – No Suspect Materials Found	
Identification:	N/A	
Approx. quantity:	N/A	
Accessibility	N/A	Assessment Score
Product type:	N/A	N/A
Extent of Damage:	N/A	N/A
Surface Treatment:	N/A	N/A
Asbestos type:	N/A	N/A
Material Assessment Score:		N/A
Priority Assessment Score:		N/A
Action:	N/A	
Comments:	N/A

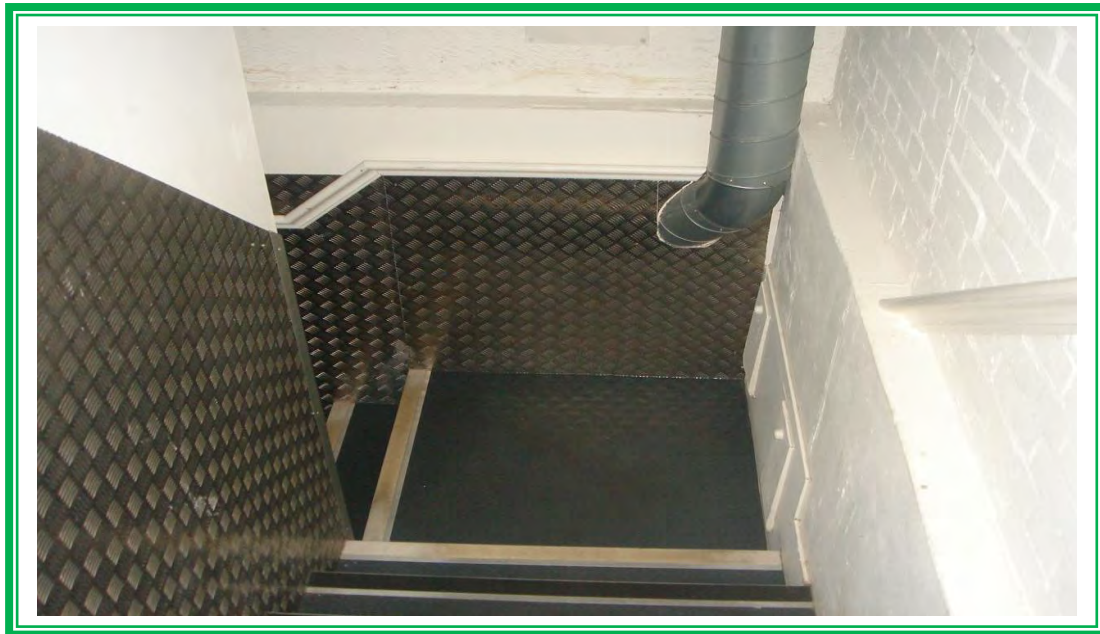
Location: 1/004 Stairs

Material Description:	Visual Inspection – No Suspect Materials Found	
Identification:	N/A	
Approx. quantity:	N/A	
Accessibility	N/A	Assessment Score
Product type:	N/A	N/A
Extent of Damage:	N/A	N/A
Surface Treatment:	N/A	N/A
Asbestos type:	N/A	N/A
Material Assessment Score:		N/A
Priority Assessment Score:		N/A
Action:	N/A	
Comments:	N/A

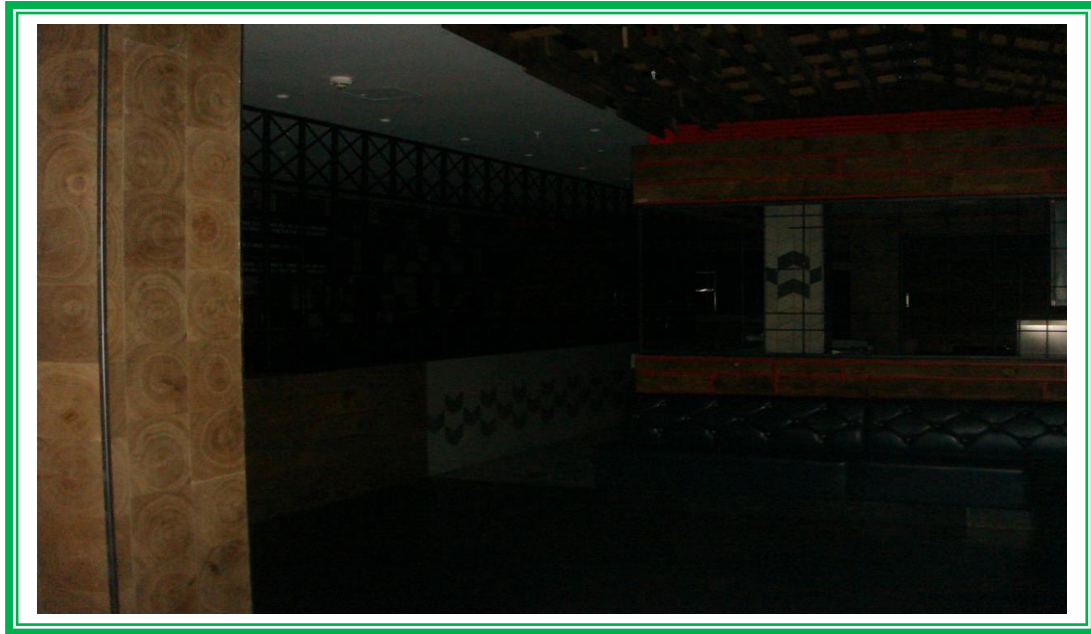
Location: 0/001 Bar and Seating

Material Description:	Visual Inspection – No Suspect Materials Found	
Identification:	N/A	
Approx. quantity:	N/A	
Accessibility	N/A	Assessment Score
Product type:	N/A	N/A
Extent of Damage:	N/A	N/A
Surface Treatment:	N/A	N/A
Asbestos type:	N/A	N/A
Material Assessment Score:		N/A
Priority Assessment Score:		N/A
Action:	N/A	
Comments:	N/A

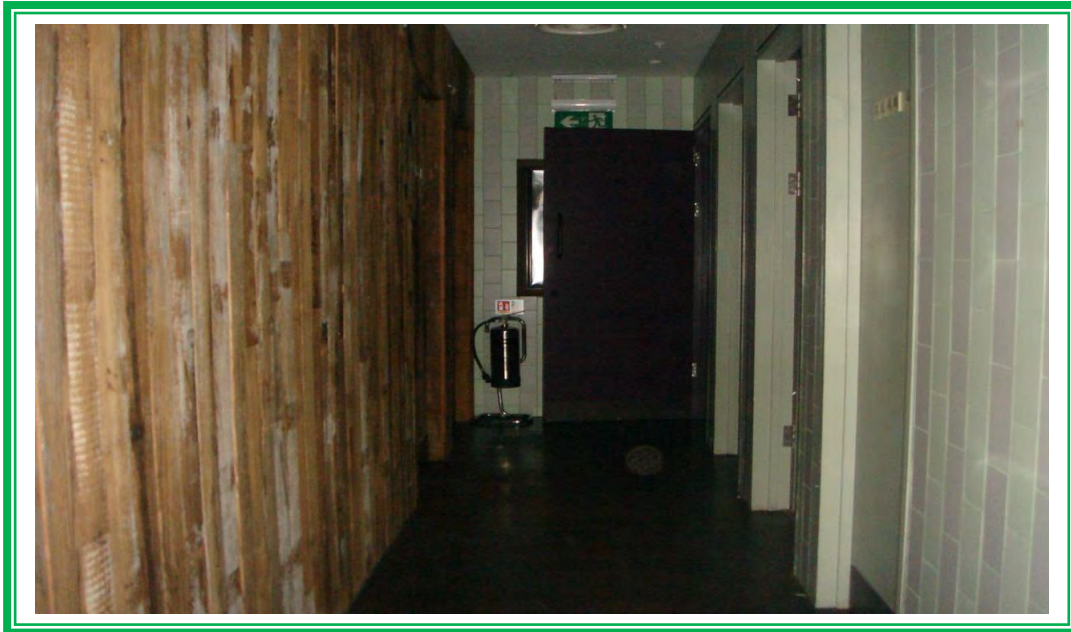
Location: 0/002 Lobby

Material Description:	Visual Inspection – No Suspect Materials Found	
Identification:	N/A	
Approx. quantity:	N/A	
Accessibility	N/A	Assessment Score
Product type:	N/A	N/A
Extent of Damage:	N/A	N/A
Surface Treatment:	N/A	N/A
Asbestos type:	N/A	N/A
Material Assessment Score:		N/A
Priority Assessment Score:		N/A
Action:	N/A	
Comments:	N/A

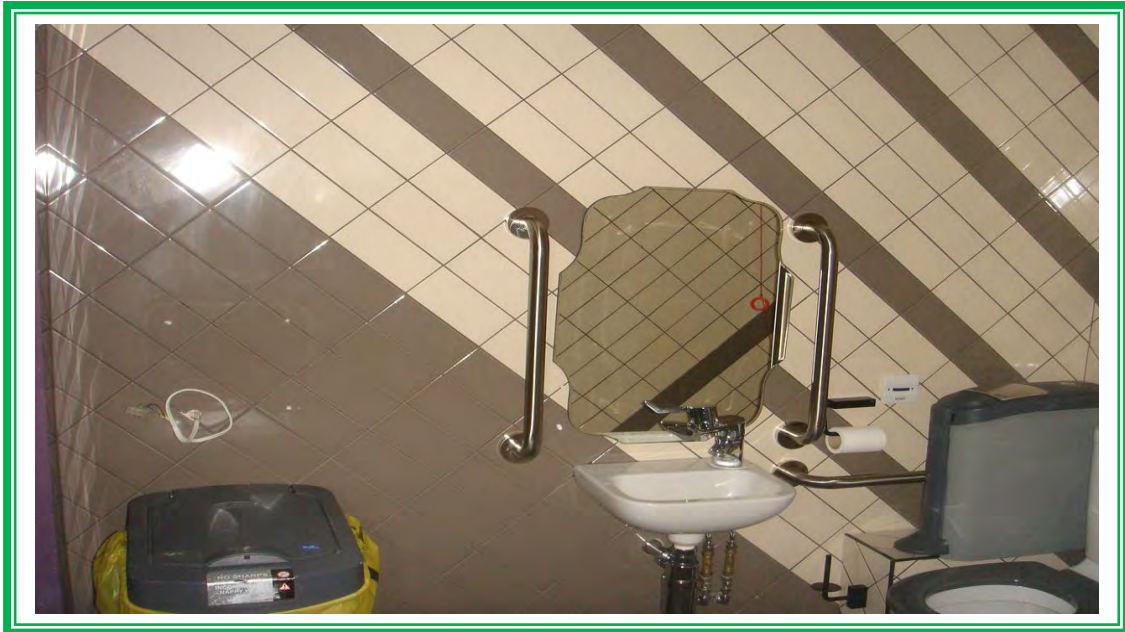
Location: 0/003 Disabled WC

Material Description:	Visual Inspection – No Suspect Materials Found	
Identification:	N/A	
Approx. quantity:	N/A	
Accessibility	N/A	Assessment Score
Product type:	N/A	N/A
Extent of Damage:	N/A	N/A
Surface Treatment:	N/A	N/A
Asbestos type:	N/A	N/A
Material Assessment Score:		N/A
Priority Assessment Score:		N/A
Action:	N/A	
Comments:	N/A

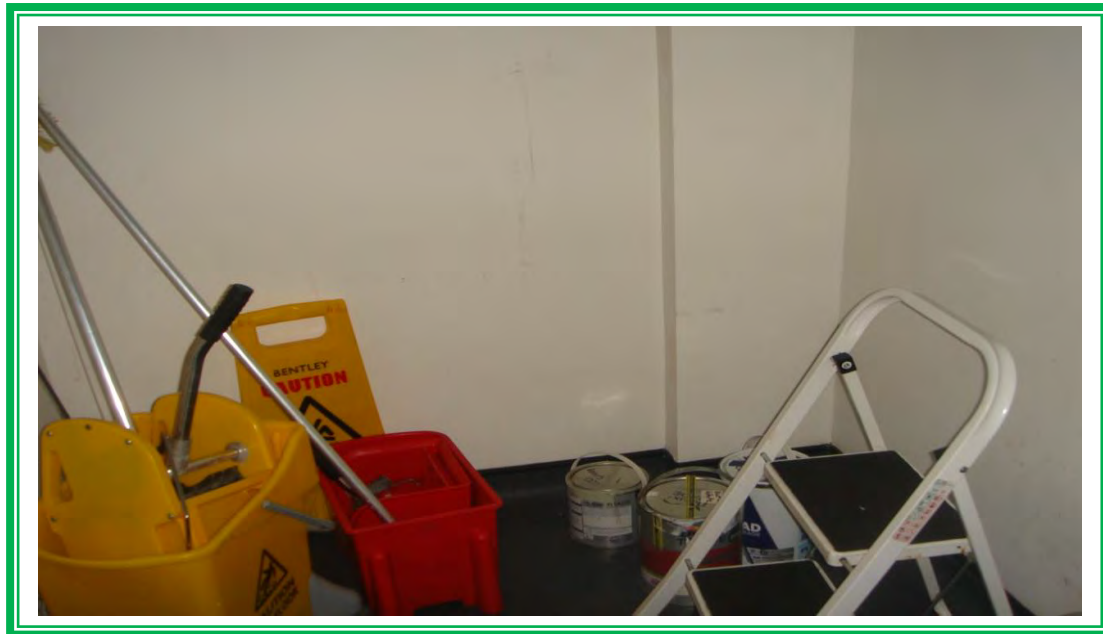
Location: 0/004 Store

Material Description:	Visual Inspection – No Suspect Materials Found	
Identification:	N/A	
Approx. quantity:	N/A	
Accessibility	N/A	Assessment Score
Product type:	N/A	N/A
Extent of Damage:	N/A	N/A
Surface Treatment:	N/A	N/A
Asbestos type:	N/A	N/A
Material Assessment Score:		N/A
Priority Assessment Score:		N/A
Action:	N/A	
Comments:	N/A

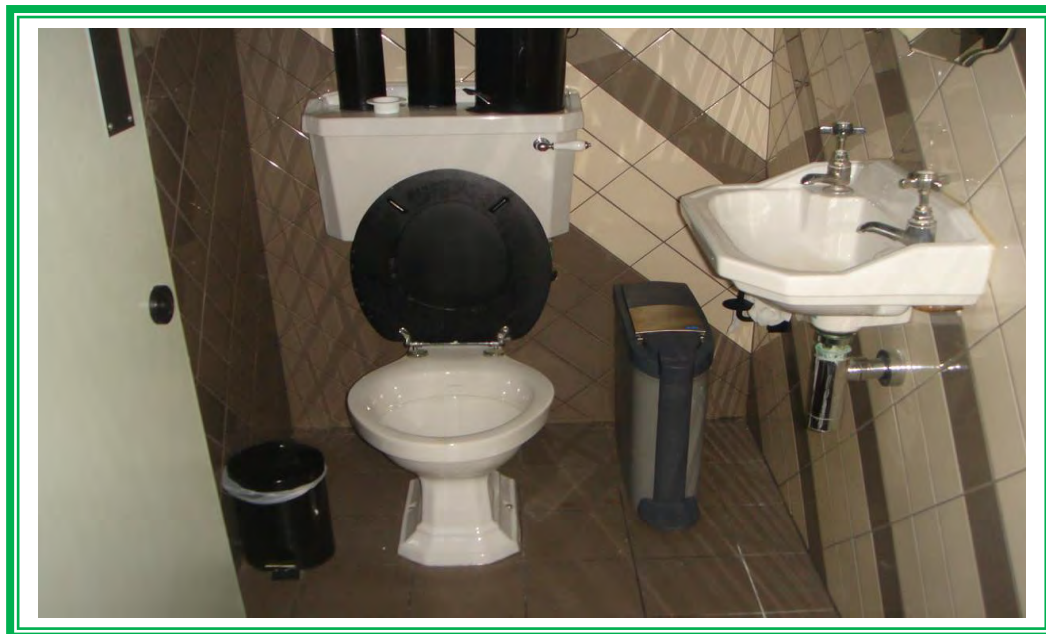
Location: 0/005 WC

Material Description:	Visual Inspection – No Suspect Materials Found	
Identification:	N/A	
Approx. quantity:	N/A	
Accessibility	N/A	Assessment Score
Product type:	N/A	N/A
Extent of Damage:	N/A	N/A
Surface Treatment:	N/A	N/A
Asbestos type:	N/A	N/A
Material Assessment Score:		N/A
Priority Assessment Score:		N/A
Action:	N/A	
Comments:	N/A

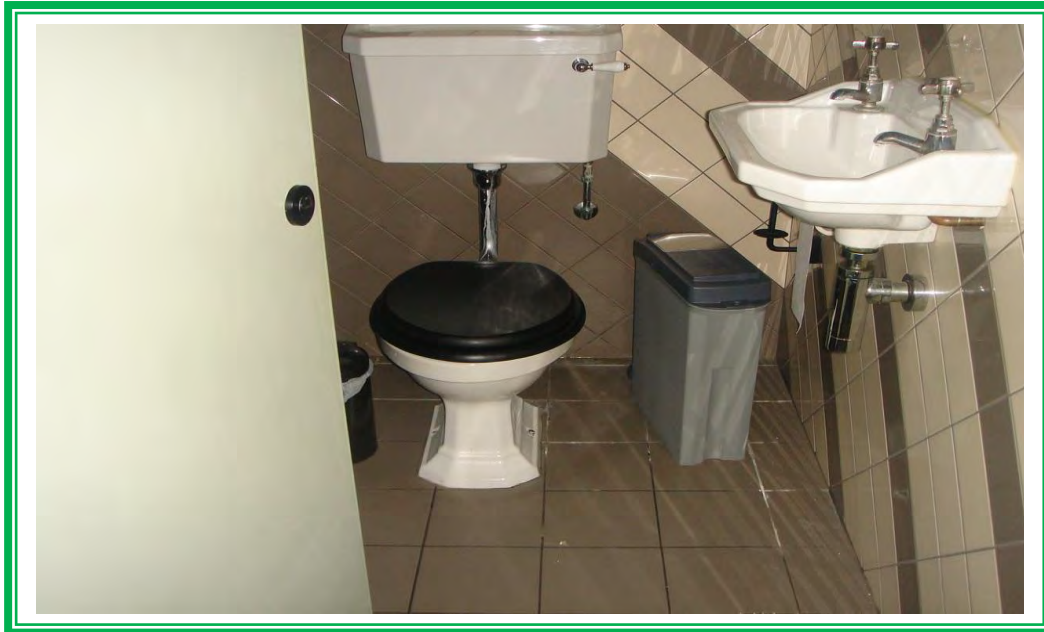
Location: 0/006 WC

Material Description:	Visual Inspection – No Suspect Materials Found	
Identification:	N/A	
Approx. quantity:	N/A	
Accessibility	N/A	Assessment Score
Product type:	N/A	N/A
Extent of Damage:	N/A	N/A
Surface Treatment:	N/A	N/A
Asbestos type:	N/A	N/A
Material Assessment Score:		N/A
Priority Assessment Score:		N/A
Action:	N/A	
Comments:	N/A

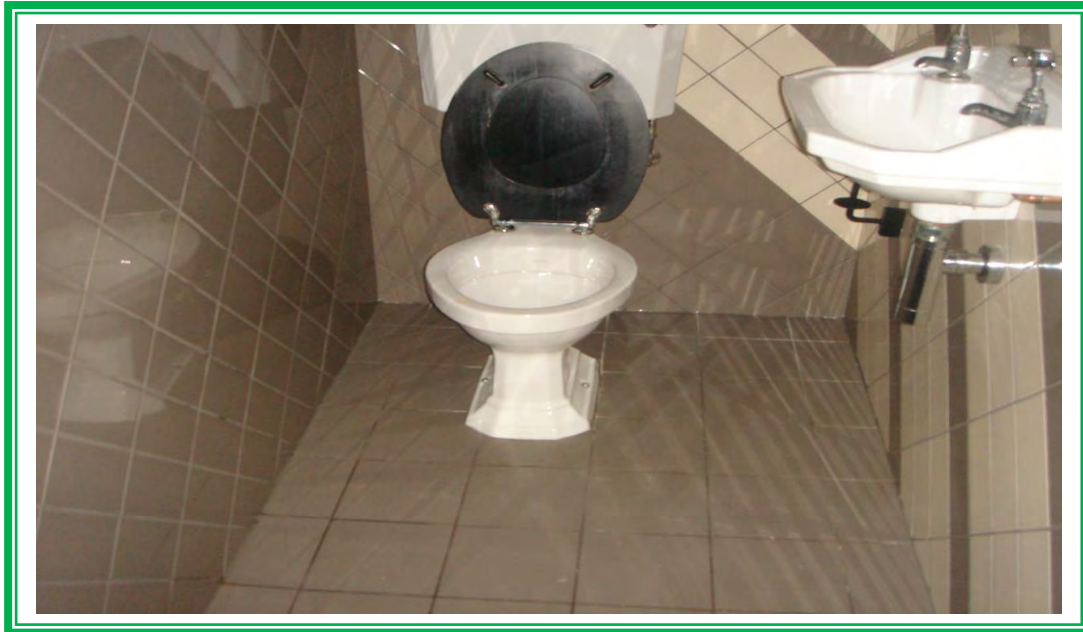
Location: 0/007

Material Description:	Visual Inspection – No Suspect Materials Found	
Identification:	N/A	
Approx. quantity:	N/A	
Accessibility	N/A	Assessment Score
Product type:	N/A	N/A
Extent of Damage:	N/A	N/A
Surface Treatment:	N/A	N/A
Asbestos type:	N/A	N/A
Material Assessment Score:		N/A
Priority Assessment Score:		N/A
Action:	N/A	
Comments:	N/A

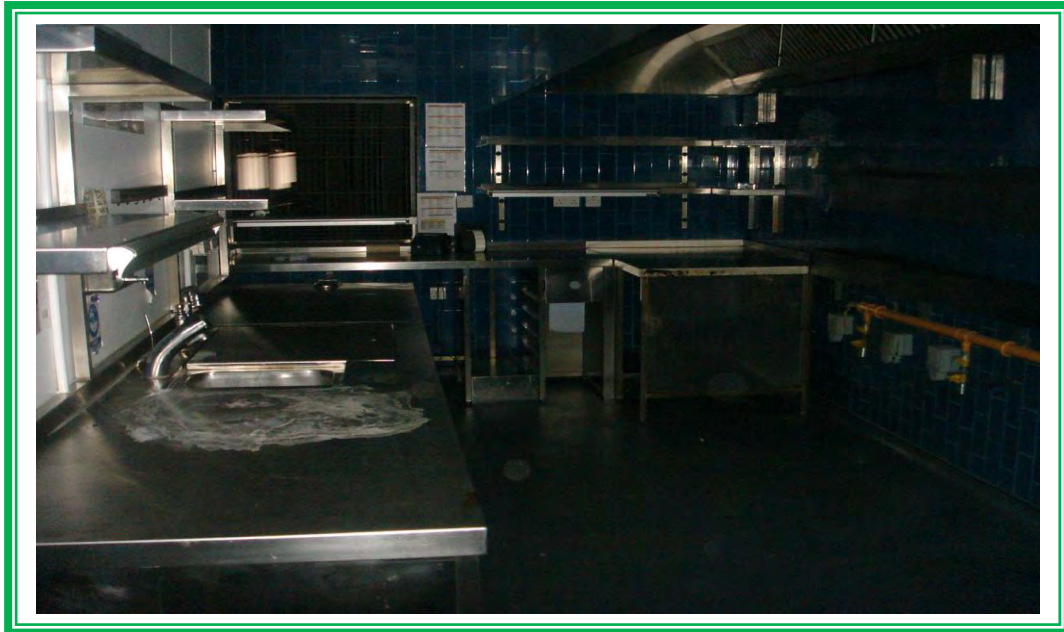
Location: 0/008 Kitchen

Material Description:	Visual Inspection – No Suspect Materials Found	
Identification:	N/A	
Approx. quantity:	N/A	
Accessibility	N/A	Assessment Score
Product type:	N/A	N/A
Extent of Damage:	N/A	N/A
Surface Treatment:	N/A	N/A
Asbestos type:	N/A	N/A
Material Assessment Score:		N/A
Priority Assessment Score:		N/A
Action:	N/A	
Comments:	N/A

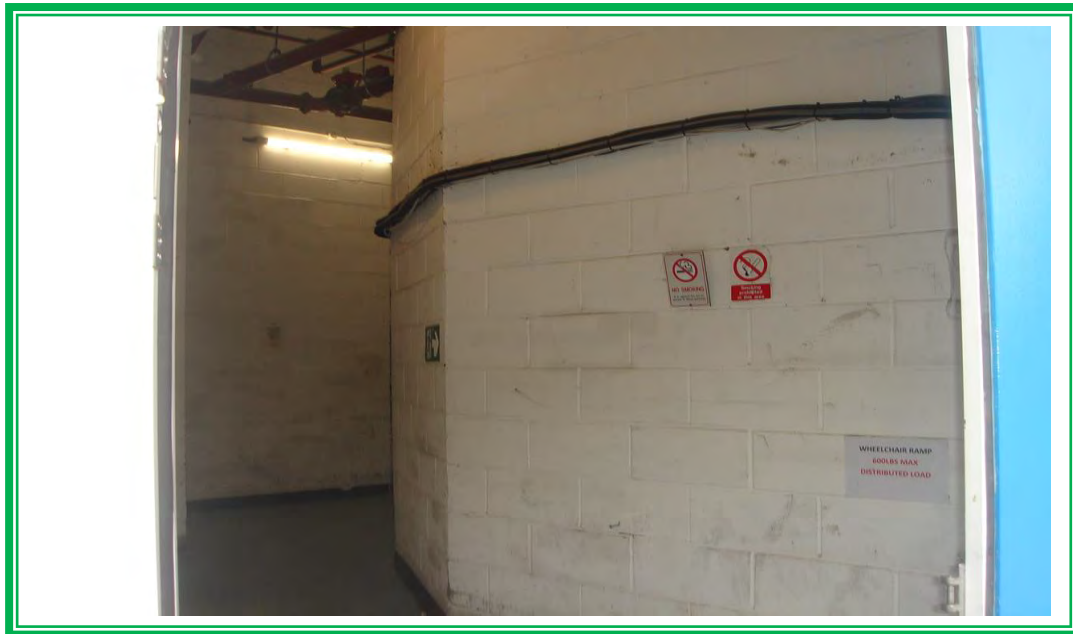
Location: 99/001 External

Material Description:	Visual Inspection – No Suspect Materials Found	
Identification:	N/A	
Approx. quantity:	N/A	
Accessibility	N/A	Assessment Score
Product type:	N/A	N/A
Extent of Damage:	N/A	N/A
Surface Treatment:	N/A	N/A
Asbestos type:	N/A	N/A
Material Assessment Score:		N/A
Priority Assessment Score:		N/A
Action:	N/A	
Comments:	N/A

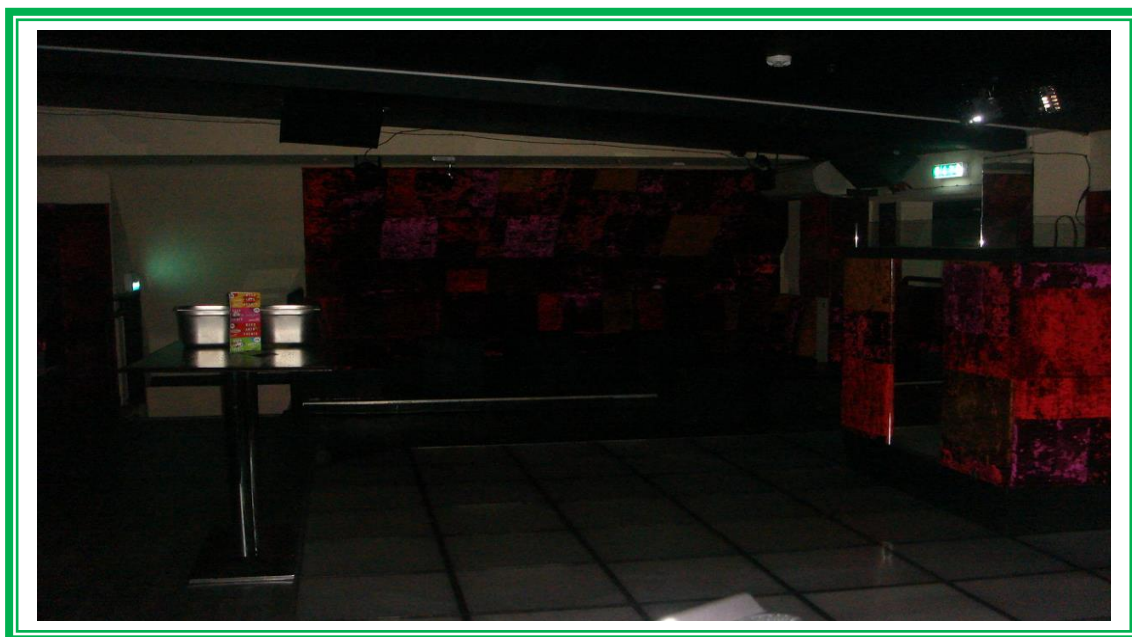
Item No: 1	Sample No: N/A
Location: 2/001 Club Bar

Material Description:	Visual Inspection – No Suspect Materials Found	
Identification:	N/A	
Approx. quantity:	N/A	
Accessibility	N/A	Assessment Score
Product type:	N/A	N/A
Extent of Damage:	N/A	N/A
Surface Treatment:	N/A	N/A
Asbestos type:	N/A	N/A
Material Assessment Score:		N/A
Priority Assessment Score:		N/A
Action:	N/A	
Comments:	N/A

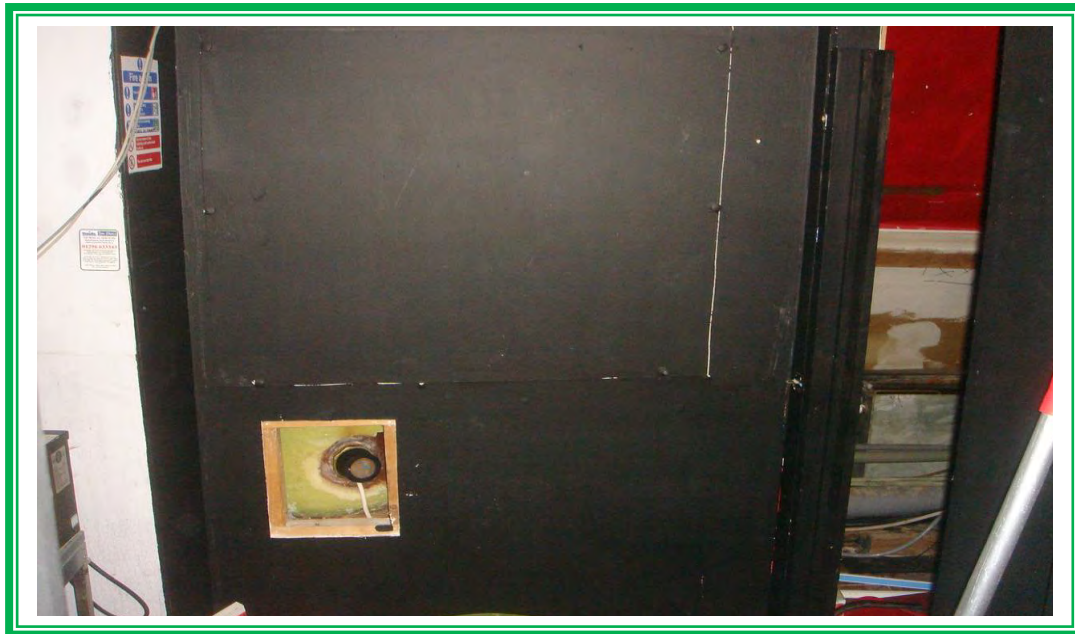
Location: 2/002 Store

Material Description:	Visual Inspection – No Suspect Materials Found	
Identification:	N/A	
Approx. quantity:	N/A	
Accessibility	N/A	Assessment Score
Product type:	N/A	N/A
Extent of Damage:	N/A	N/A
Surface Treatment:	N/A	N/A
Asbestos type:	N/A	N/A
Material Assessment Score:		N/A
Priority Assessment Score:		N/A
Action:	N/A	
Comments:	N/A

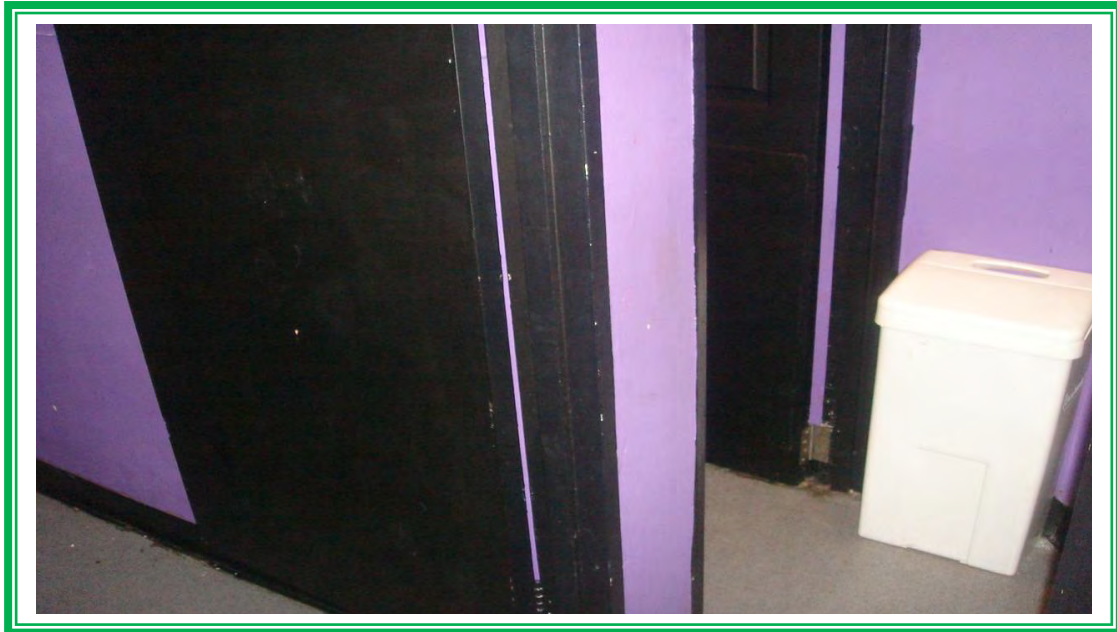
Location: 2/003 WC

Material Description:	Visual Inspection – No Suspect Materials Found	
Identification:	N/A	
Approx. quantity:	N/A	
Accessibility	N/A	Assessment Score
Product type:	N/A	N/A
Extent of Damage:	N/A	N/A
Surface Treatment:	N/A	N/A
Asbestos type:	N/A	N/A
Material Assessment Score:		N/A
Priority Assessment Score:		N/A
Action:	N/A	
Comments:	N/A

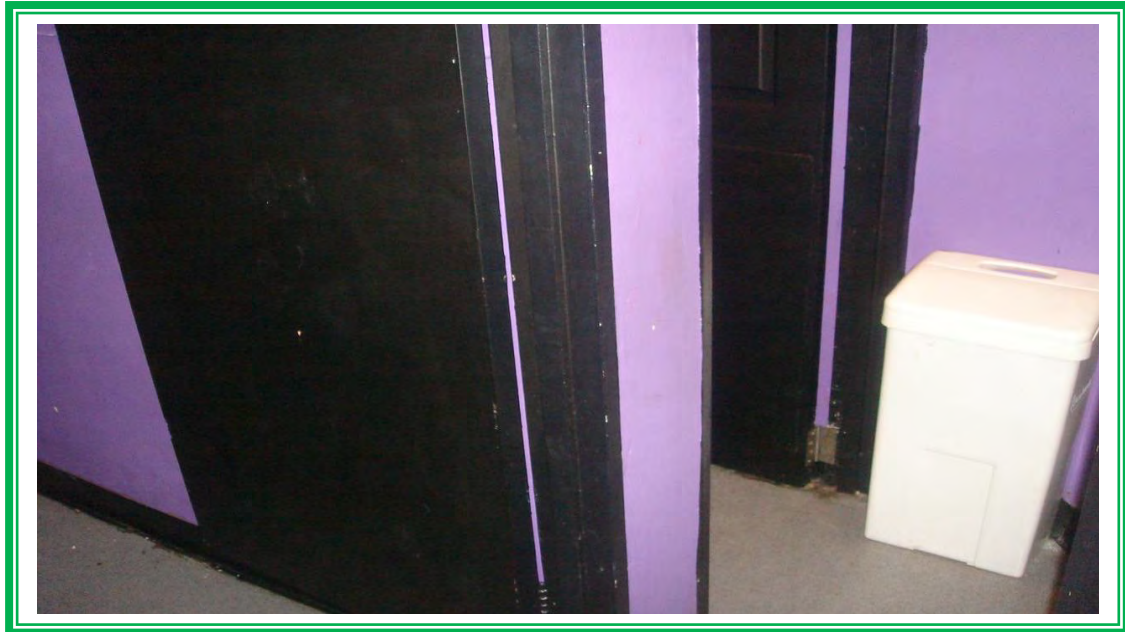
Location: 2/004 WC

Material Description:	Visual Inspection – No Suspect Materials Found	
Identification:	N/A	
Approx. quantity:	N/A	
Accessibility	N/A	Assessment Score
Product type:	N/A	N/A
Extent of Damage:	N/A	N/A
Surface Treatment:	N/A	N/A
Asbestos type:	N/A	N/A
Material Assessment Score:		N/A
Priority Assessment Score:		N/A
Action:	N/A	
Comments:	N/A

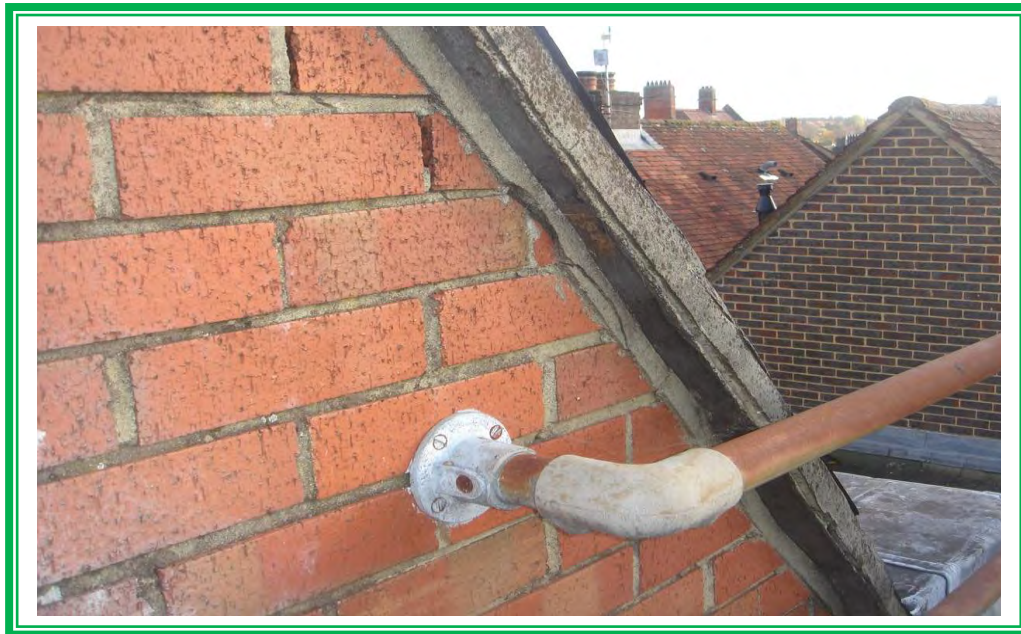
Location: 99/001 Externals

Material Description:	Roof Under cloak	
Identification:	Sampled – No Asbestos Detected	
Approx. quantity:	8LM	
Accessibility	N/A	Assessment Score
Product type:	N/A	N/A
Extent of Damage:	N/A	N/A
Surface Treatment:	N/A	N/A
Asbestos type:	N/A	N/A
Material Assessment Score:		N/A
Priority Assessment Score:		N/A
Action:	N/A	
Comments:	N/A

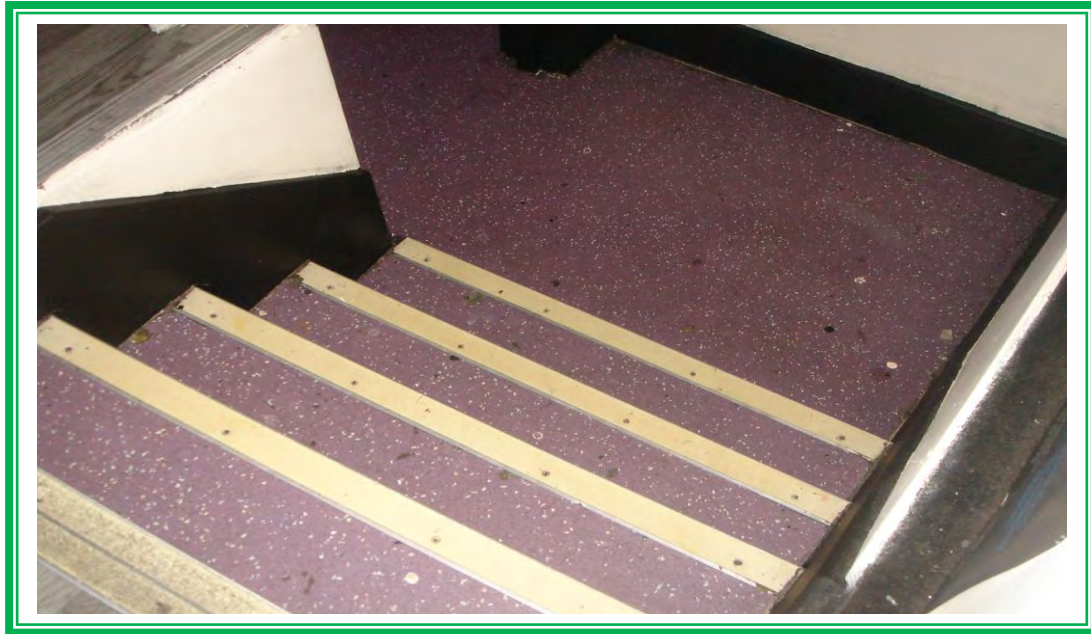
Location: 2/005 Stairs

Material Description:	Visual Inspection – No Suspect Materials Found	
Identification:	N/A	
Approx. quantity:	N/A	
Accessibility	N/A	Assessment Score
Product type:	N/A	N/A
Extent of Damage:	N/A	N/A
Surface Treatment:	N/A	N/A
Asbestos type:	N/A	N/A
Material Assessment Score:		N/A
Priority Assessment Score:		N/A
Action:	N/A	
Comments:	N/A

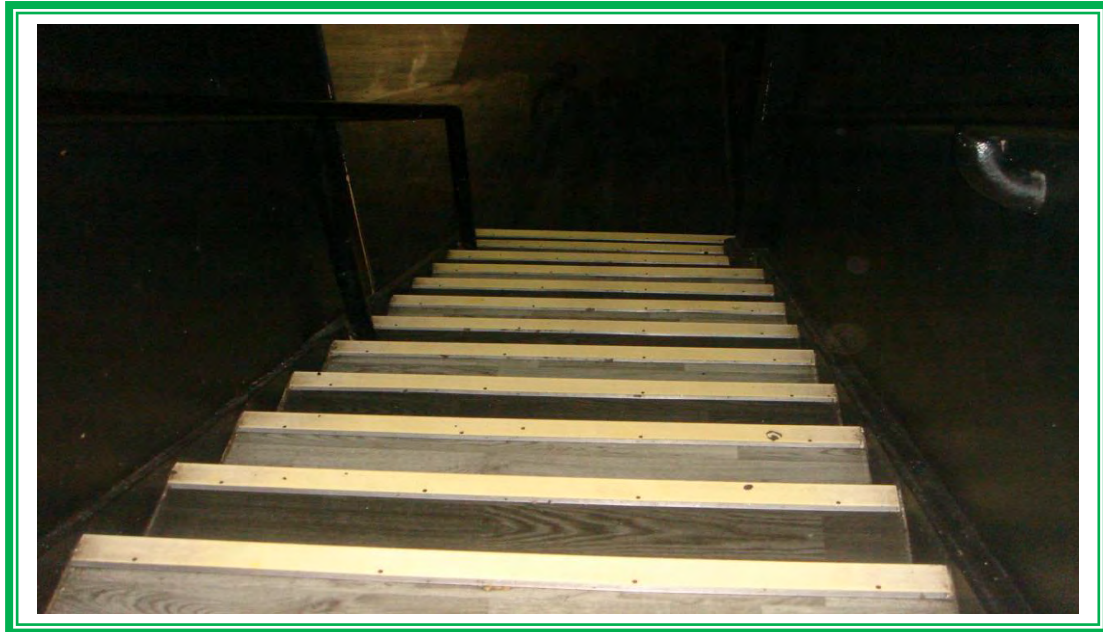
Location: M/001 Stairs and Lobby

Material Description:	Visual Inspection – No Suspect Materials Found	
Identification:	N/A	
Approx. quantity:	N/A	
Accessibility	N/A	Assessment Score
Product type:	N/A	N/A
Extent of Damage:	N/A	N/A
Surface Treatment:	N/A	N/A
Asbestos type:	N/A	N/A
Material Assessment Score:		N/A
Priority Assessment Score:		N/A
Action:	N/A	
Comments:	N/A

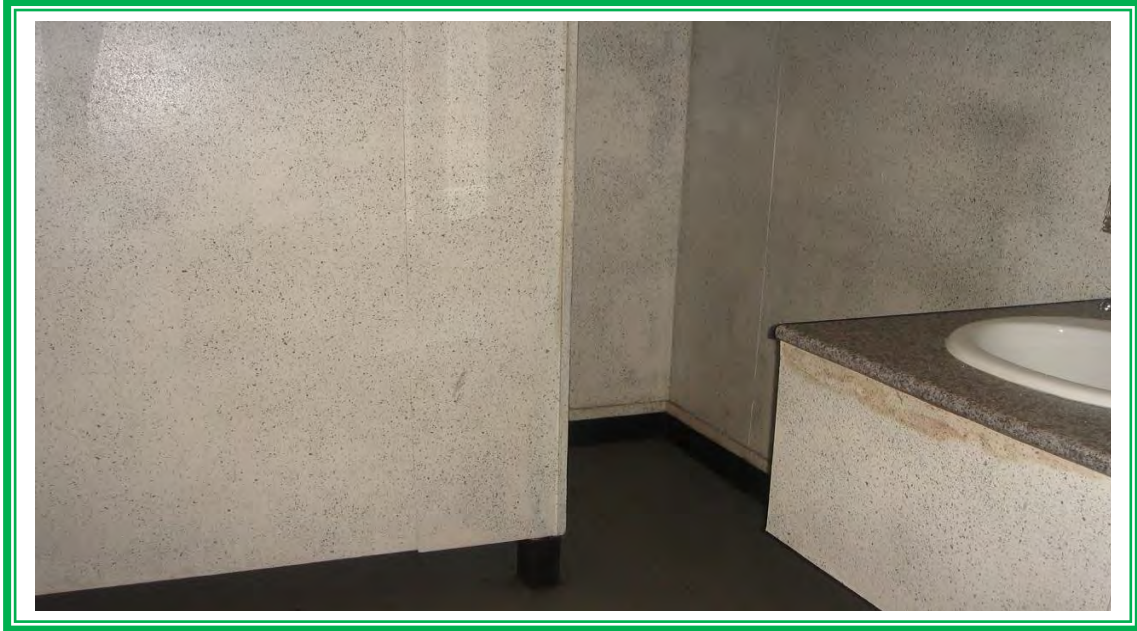
Location: M/002 WC

Material Description:	Visual Inspection – No Suspect Materials Found	
Identification:	N/A	
Approx. quantity:	N/A	
Accessibility	N/A	Assessment Score
Product type:	N/A	N/A
Extent of Damage:	N/A	N/A
Surface Treatment:	N/A	N/A
Asbestos type:	N/A	N/A
Material Assessment Score:		N/A
Priority Assessment Score:		N/A
Action:	N/A	
Comments:	N/A

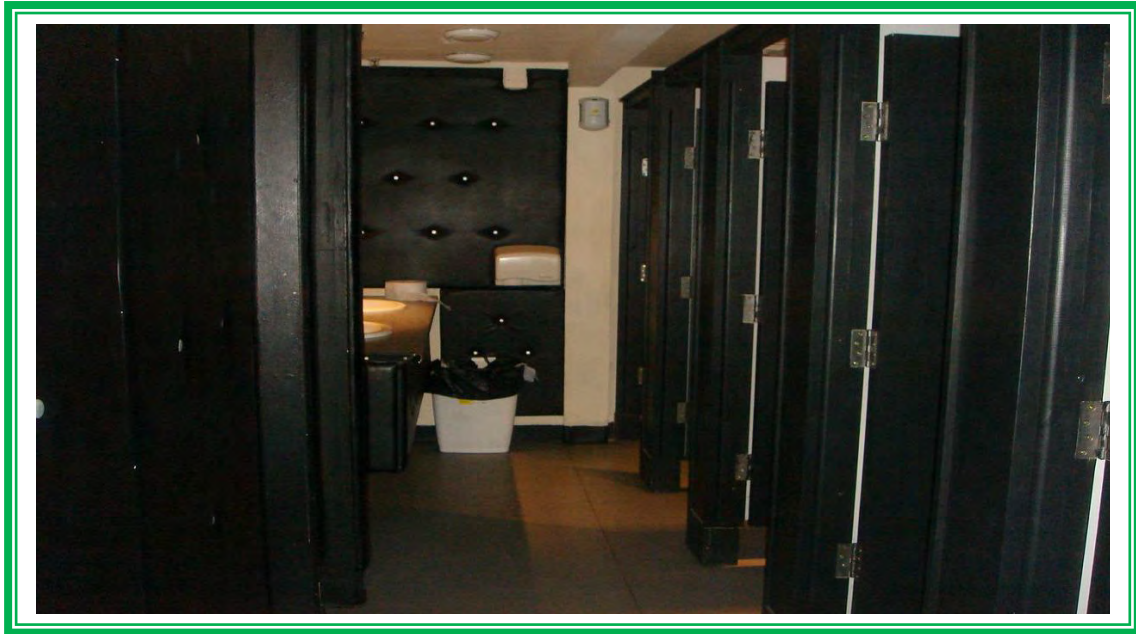
Location: M/003 WC

Material Description:	Visual Inspection – No Suspect Materials Found	
Identification:	N/A	
Approx. quantity:	N/A	
Accessibility	N/A	Assessment Score
Product type:	N/A	N/A
Extent of Damage:	N/A	N/A
Surface Treatment:	N/A	N/A
Asbestos type:	N/A	N/A
Material Assessment Score:		N/A
Priority Assessment Score:		N/A
Action:	N/A	
Comments:	N/A

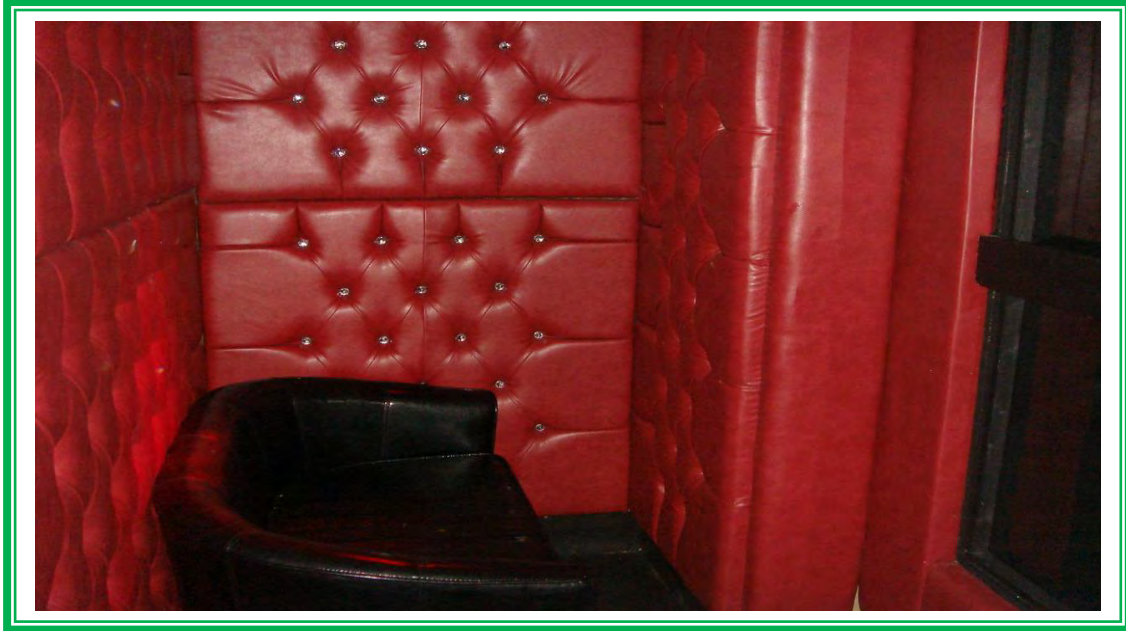
Location: M/004 Rest Room

Material Description:	Visual Inspection – No Suspect Materials Found	
Identification:	N/A	
Approx. quantity:	N/A	
Accessibility	N/A	Assessment Score
Product type:	N/A	N/A
Extent of Damage:	N/A	N/A
Surface Treatment:	N/A	N/A
Asbestos type:	N/A	N/A
Material Assessment Score:		N/A
Priority Assessment Score:		N/A
Action:	N/A	
Comments:	N/A

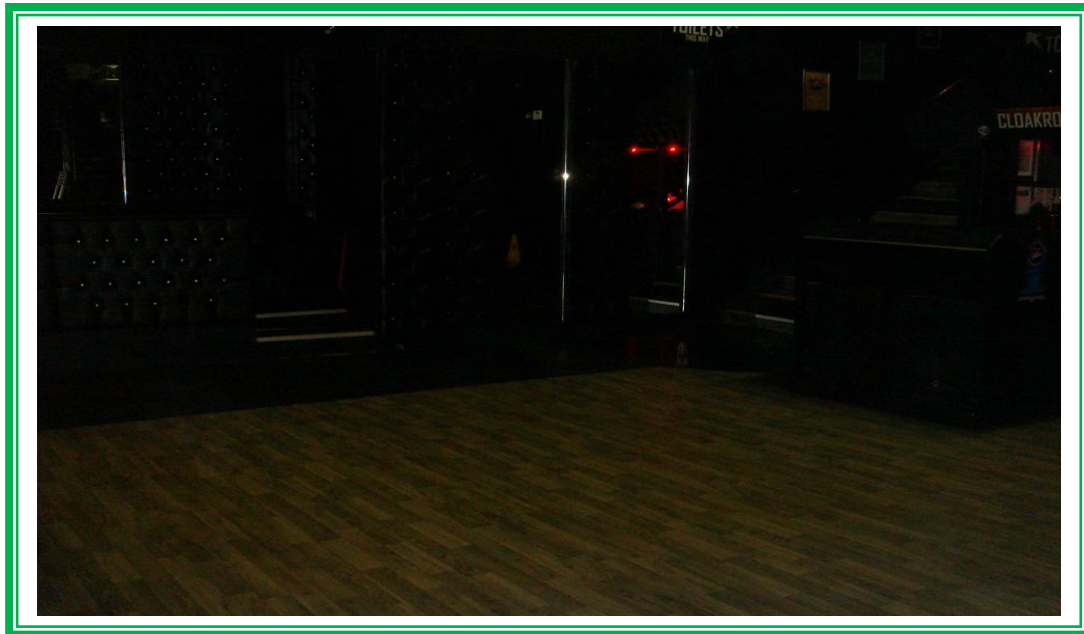
Location: 1/001 Club and Bars

Material Description:	Visual Inspection – No Suspect Materials Found	
Identification:	N/A	
Approx. quantity:	N/A	
Accessibility	N/A	Assessment Score
Product type:	N/A	N/A
Extent of Damage:	N/A	N/A
Surface Treatment:	N/A	N/A
Asbestos type:	N/A	N/A
Material Assessment Score:		N/A
Priority Assessment Score:		N/A
Action:	N/A	
Comments:	N/A

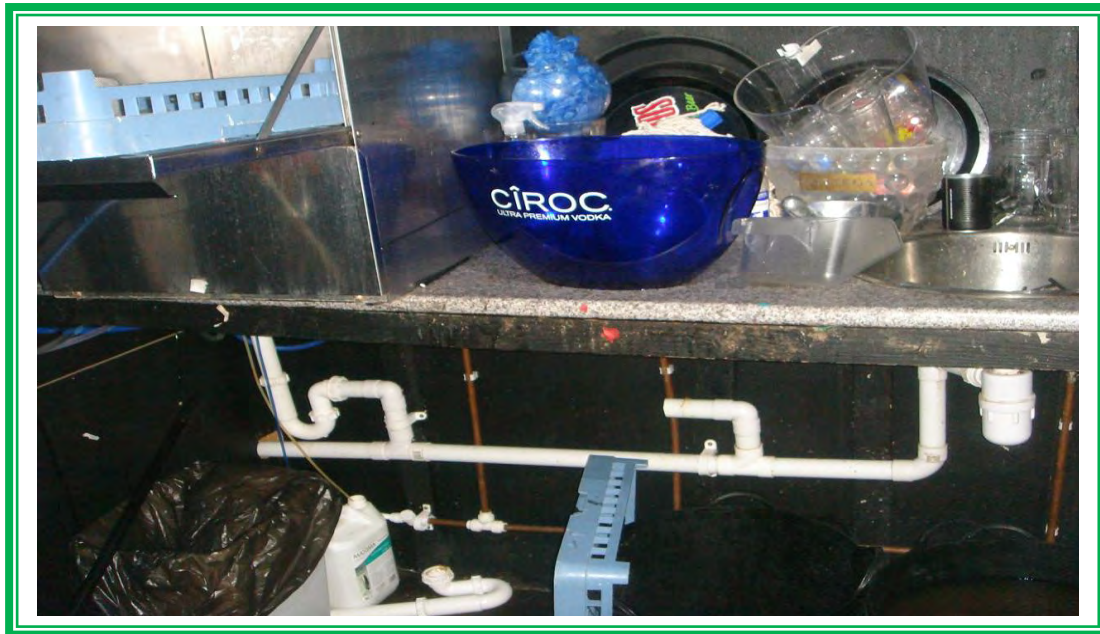
Location: 1/002 Store Room

Material Description:	Visual Inspection – No Suspect Materials Found	
Identification:	N/A	
Approx. quantity:	N/A	
Accessibility	N/A	Assessment Score
Product type:	N/A	N/A
Extent of Damage:	N/A	N/A
Surface Treatment:	N/A	N/A
Asbestos type:	N/A	N/A
Material Assessment Score:		N/A
Priority Assessment Score:		N/A
Action:	N/A	
Comments:	N/A

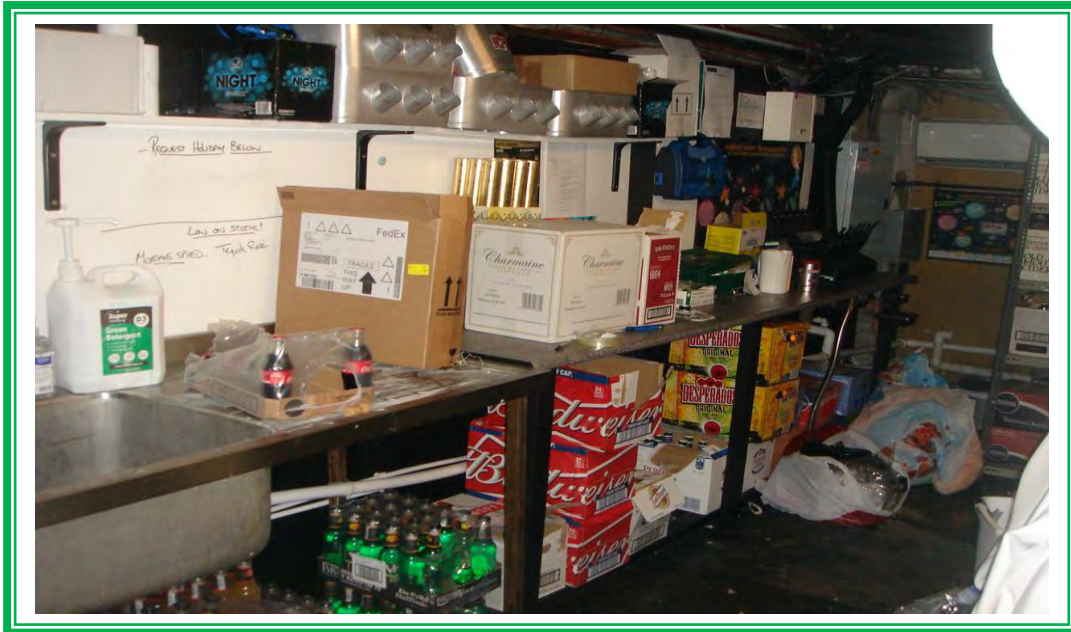
Location: 1/003 Store

Material Description:	Visual Inspection – No Suspect Materials Found	
Identification:	N/A	
Approx. quantity:	N/A	
Accessibility	N/A	Assessment Score
Product type:	N/A	N/A
Extent of Damage:	N/A	N/A
Surface Treatment:	N/A	N/A
Asbestos type:	N/A	N/A
Material Assessment Score:		N/A
Priority Assessment Score:		N/A
Action:	N/A	
Comments:	N/A

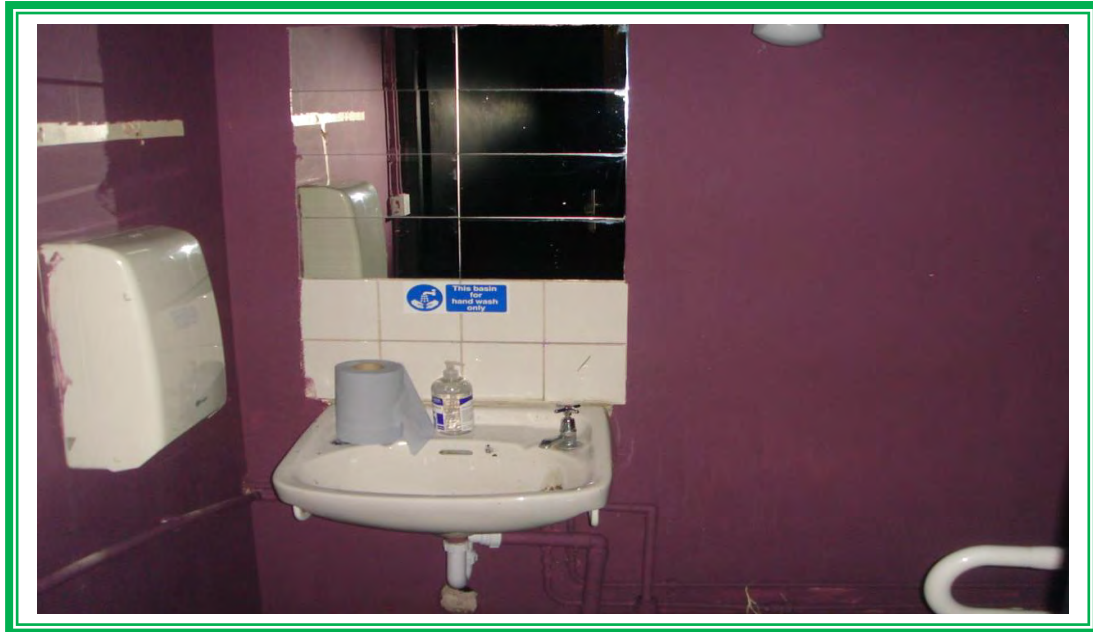
Location: 1/004 WC

Material Description:	Visual Inspection – No Suspect Materials Found	
Identification:	N/A	
Approx. quantity:	N/A	
Accessibility	N/A	Assessment Score
Product type:	N/A	N/A
Extent of Damage:	N/A	N/A
Surface Treatment:	N/A	N/A
Asbestos type:	N/A	N/A
Material Assessment Score:		N/A
Priority Assessment Score:		N/A
Action:	N/A	
Comments:	N/A
