Project Number 3113

Management Asbestos Survey Report

Kennet Centre, Market Street, Newbury,
Berkshire, RG14 5EN

3 Market Place and Associated Store

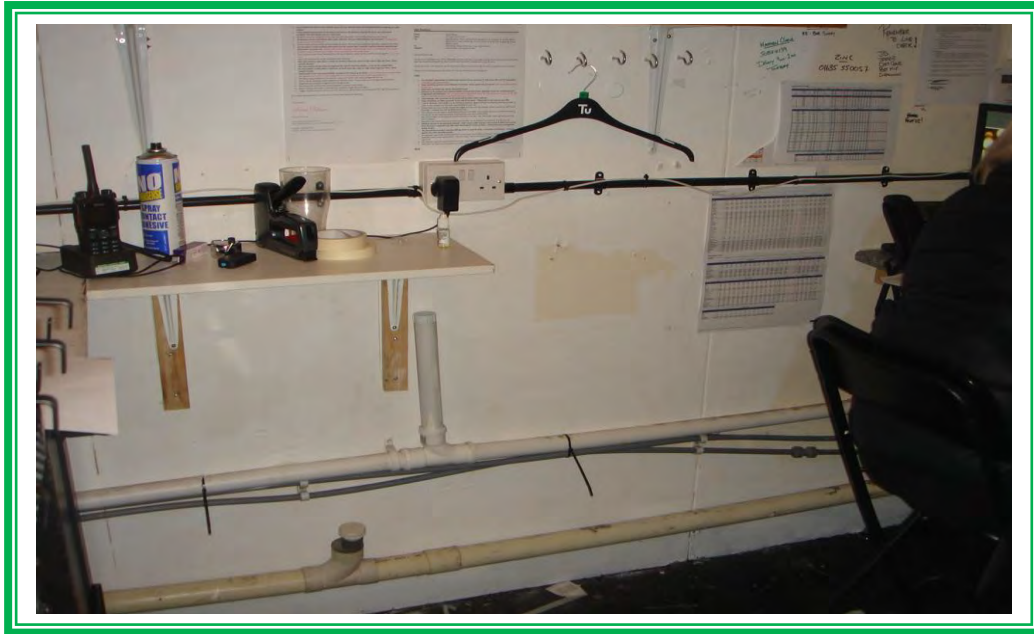
Location: 1/005 Office

Material Description:	Visual Inspection – No Suspect Materials Found	
Identification:	N/A	
Approx. quantity:	N/A	
Accessibility	N/A	Assessment Score
Product type:	N/A	N/A
Extent of Damage:	N/A	N/A
Surface Treatment:	N/A	N/A
Asbestos type:	N/A	N/A
Material Assessment Score:		N/A
Priority Assessment Score:		N/A
Action:	N/A	
Comments:	N/A

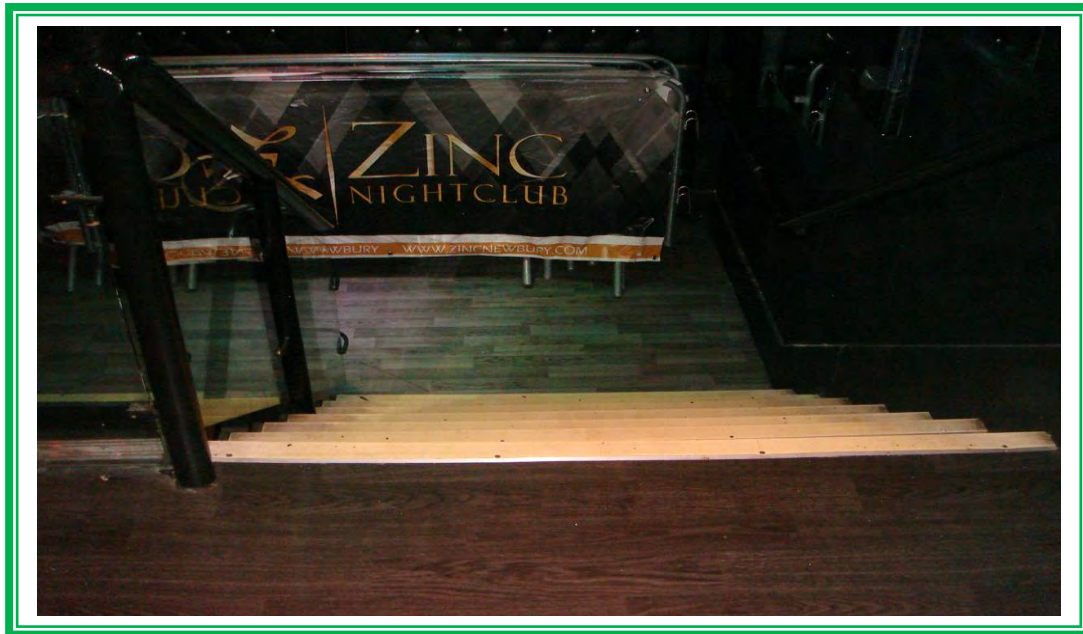
Location: 1/006 Stairs

Material Description:	Visual Inspection – No Suspect Materials Found	
Identification:	N/A	
Approx. quantity:	N/A	
Accessibility	N/A	Assessment Score
Product type:	N/A	N/A
Extent of Damage:	N/A	N/A
Surface Treatment:	N/A	N/A
Asbestos type:	N/A	N/A
Material Assessment Score:		N/A
Priority Assessment Score:		N/A
Action:	N/A	
Comments:	N/A

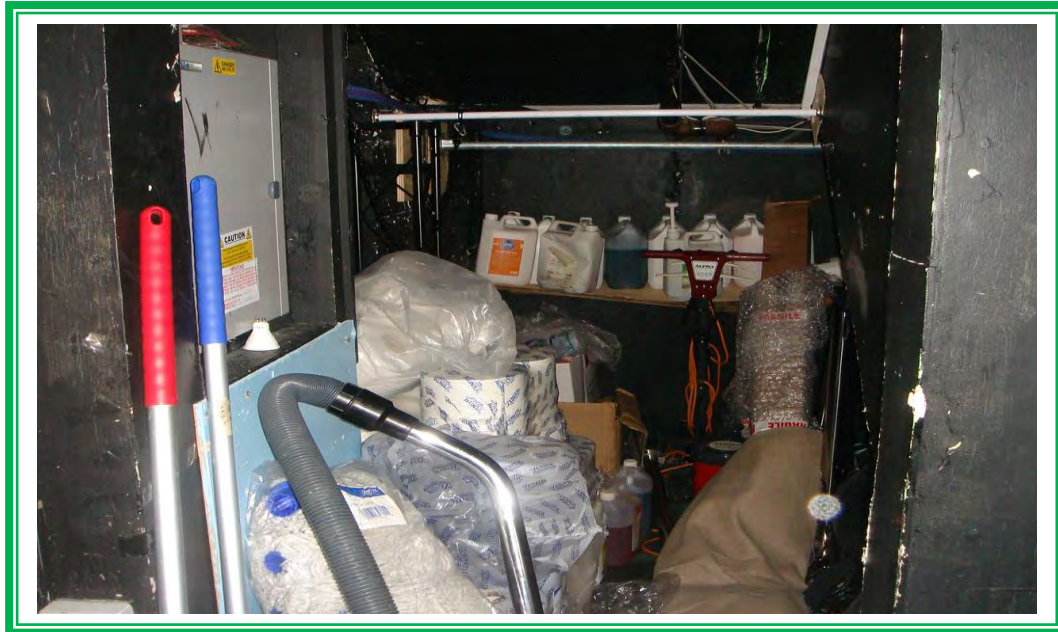
Location: 1/007 Cupboard

Material Description:	Visual Inspection – No Suspect Materials Found	
Identification:	N/A	
Approx. quantity:	N/A	
Accessibility	N/A	Assessment Score
Product type:	N/A	N/A
Extent of Damage:	N/A	N/A
Surface Treatment:	N/A	N/A
Asbestos type:	N/A	N/A
Material Assessment Score:		N/A
Priority Assessment Score:		N/A
Action:	N/A	
Comments:	N/A

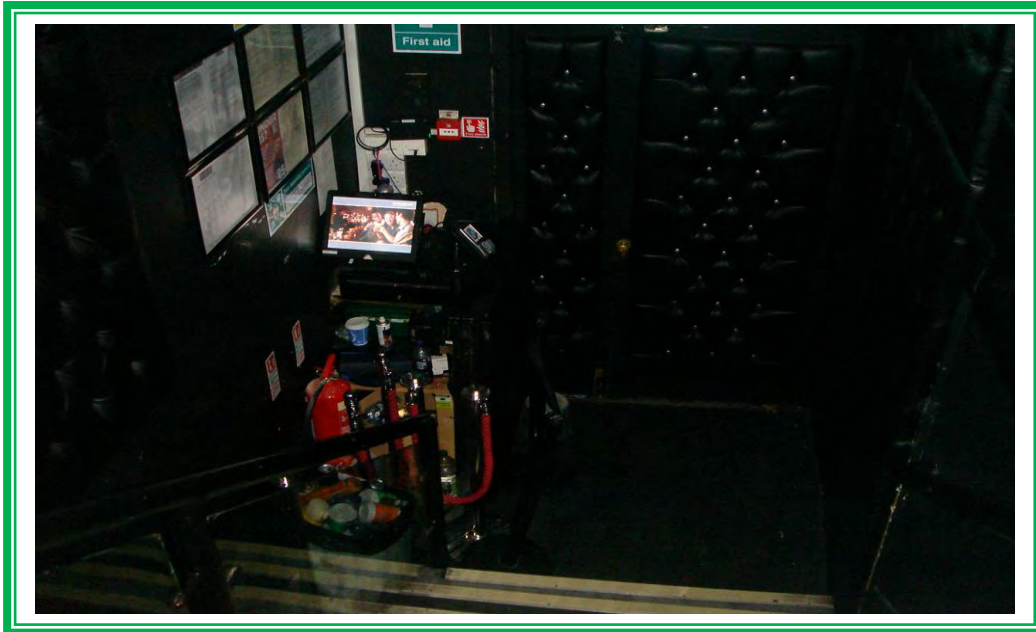
Location: 0/001 Entrance

Material Description:	Visual Inspection – No Suspect Materials Found	
Identification:	N/A	
Approx. quantity:	N/A	
Accessibility	N/A	Assessment Score
Product type:	N/A	N/A
Extent of Damage:	N/A	N/A
Surface Treatment:	N/A	N/A
Asbestos type:	N/A	N/A
Material Assessment Score:		N/A
Priority Assessment Score:		N/A
Action:	N/A	
Comments:	N/A

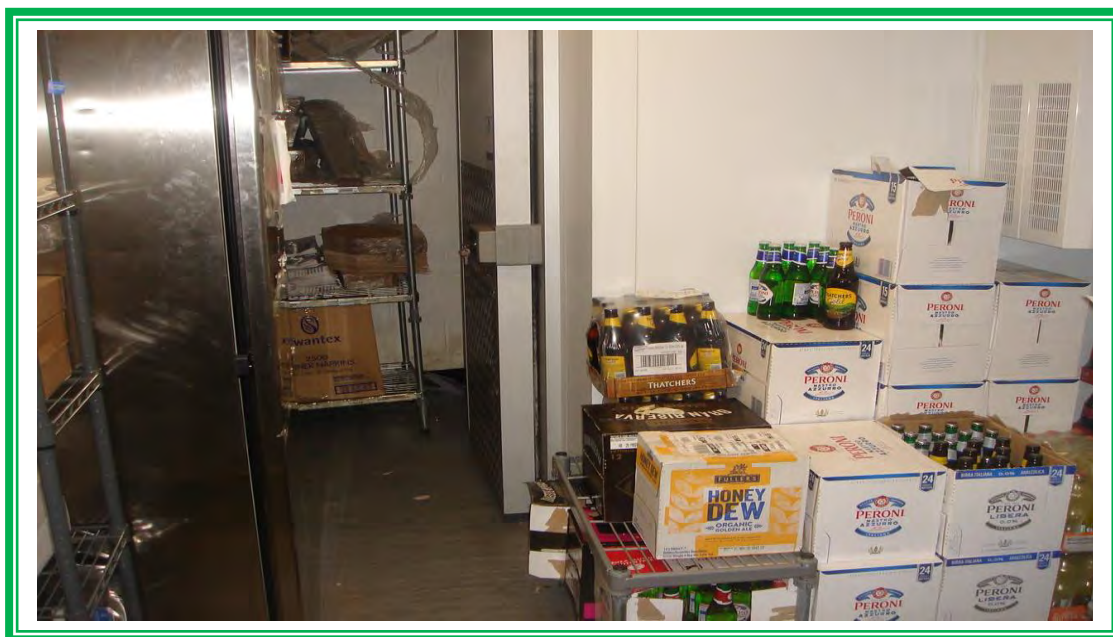
Location: 1/001 Store

Material Description:	Visual Inspection – No Suspect Materials Found	
Identification:	N/A	
Approx. quantity:	N/A	
Accessibility	N/A	Assessment Score
Product type:	N/A	N/A
Extent of Damage:	N/A	N/A
Surface Treatment:	N/A	N/A
Asbestos type:	N/A	N/A
Material Assessment Score:		N/A
Priority Assessment Score:		N/A
Action:	N/A	
Comments:	N/A

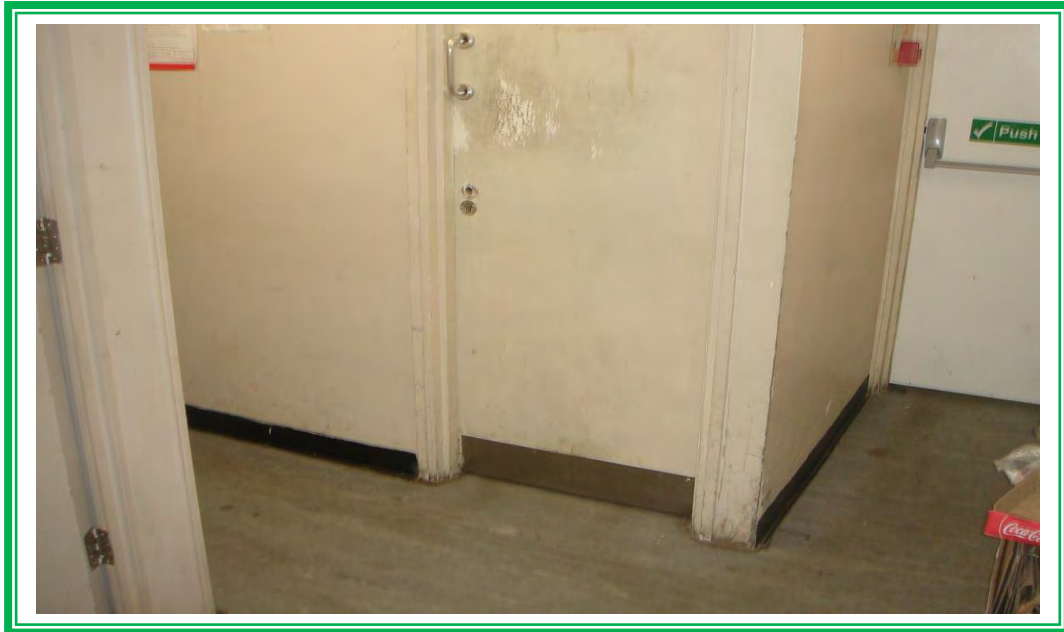
Location: 1/002 Lobby

Material Description:	Visual Inspection – No Suspect Materials Found	
Identification:	N/A	
Approx. quantity:	N/A	
Accessibility	N/A	Assessment Score
Product type:	N/A	N/A
Extent of Damage:	N/A	N/A
Surface Treatment:	N/A	N/A
Asbestos type:	N/A	N/A
Material Assessment Score:		N/A
Priority Assessment Score:		N/A
Action:	N/A	
Comments:	N/A

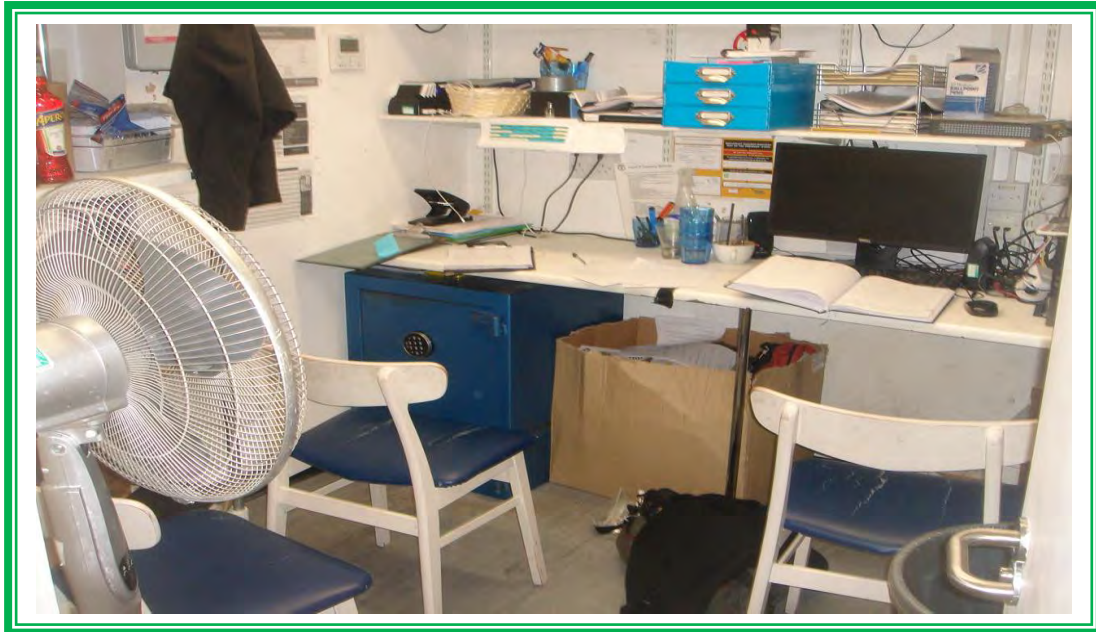
Location: 1/003 Office

Material Description:	Visual Inspection – No Suspect Materials Found	
Identification:	N/A	
Approx. quantity:	N/A	
Accessibility	N/A	Assessment Score
Product type:	N/A	N/A
Extent of Damage:	N/A	N/A
Surface Treatment:	N/A	N/A
Asbestos type:	N/A	N/A
Material Assessment Score:		N/A
Priority Assessment Score:		N/A
Action:	N/A	
Comments:	N/A

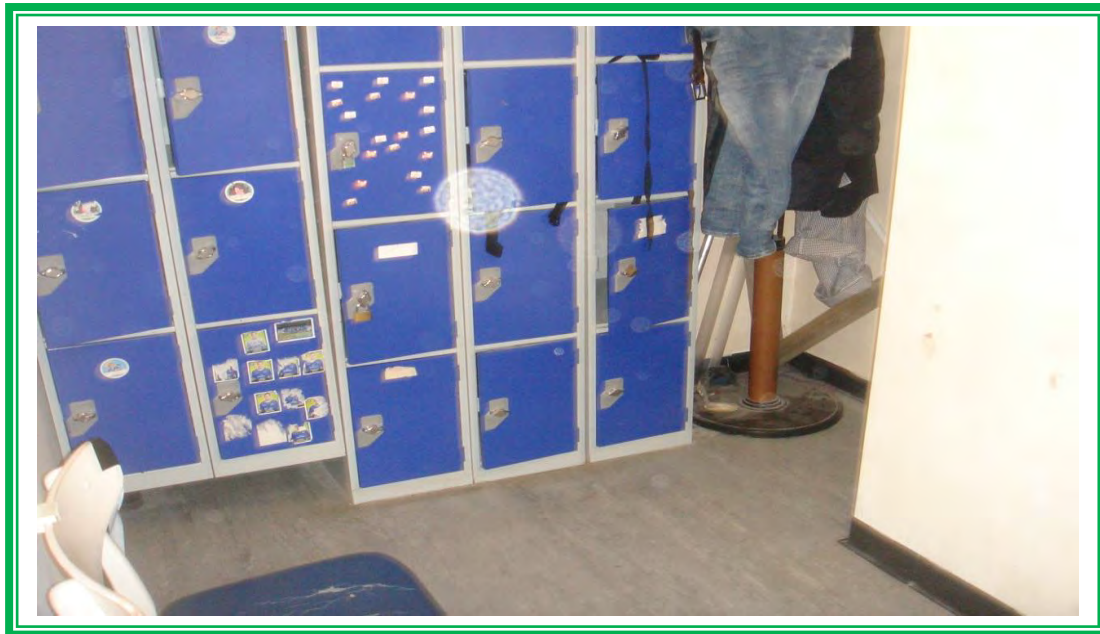
Location: 1/004 Staff Room

Material Description:	Visual Inspection – No Suspect Materials Found	
Identification:	N/A	
Approx. quantity:	N/A	
Accessibility	N/A	Assessment Score
Product type:	N/A	N/A
Extent of Damage:	N/A	N/A
Surface Treatment:	N/A	N/A
Asbestos type:	N/A	N/A
Material Assessment Score:		N/A
Priority Assessment Score:		N/A
Action:	N/A	
Comments:	N/A

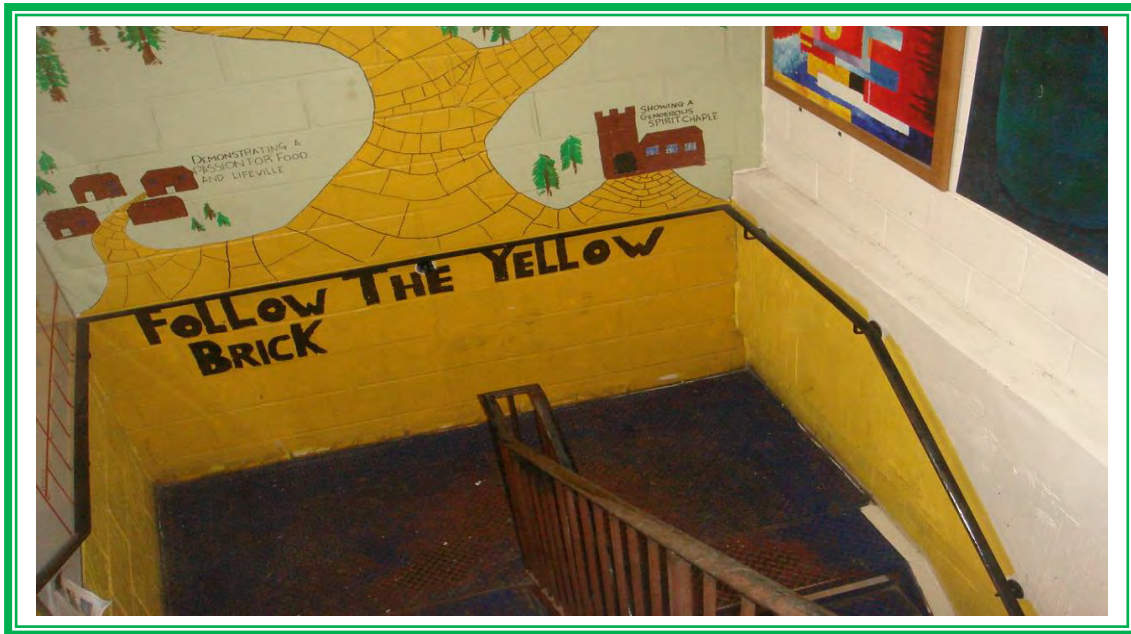
Location: 1/005 Stairwell

Material Description:	Visual Inspection – No Suspect Materials Found	
Identification:	N/A	
Approx. quantity:	N/A	
Accessibility	N/A	Assessment Score
Product type:	N/A	N/A
Extent of Damage:	N/A	N/A
Surface Treatment:	N/A	N/A
Asbestos type:	N/A	N/A
Material Assessment Score:		N/A
Priority Assessment Score:		N/A
Action:	N/A	
Comments:	N/A

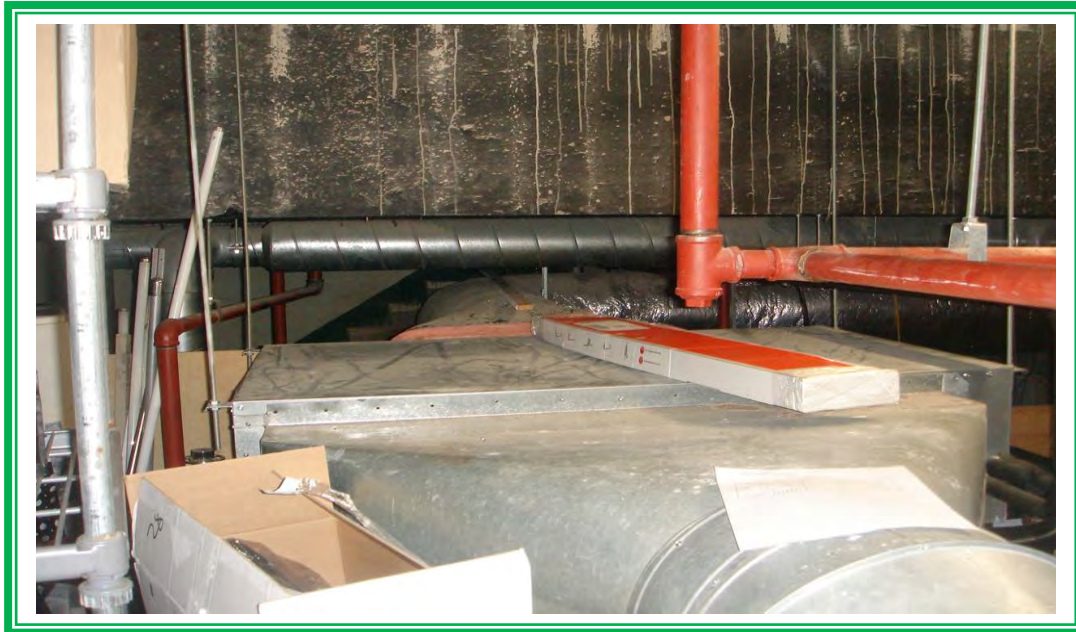
Location: M/001 Mezzanine Air Con Room

Material Description:	Visual Inspection – No Suspect Materials Found	
Identification:	N/A	
Approx. quantity:	N/A	
Accessibility	N/A	Assessment Score
Product type:	N/A	N/A
Extent of Damage:	N/A	N/A
Surface Treatment:	N/A	N/A
Asbestos type:	N/A	N/A
Material Assessment Score:		N/A
Priority Assessment Score:		N/A
Action:	N/A	
Comments:	N/A

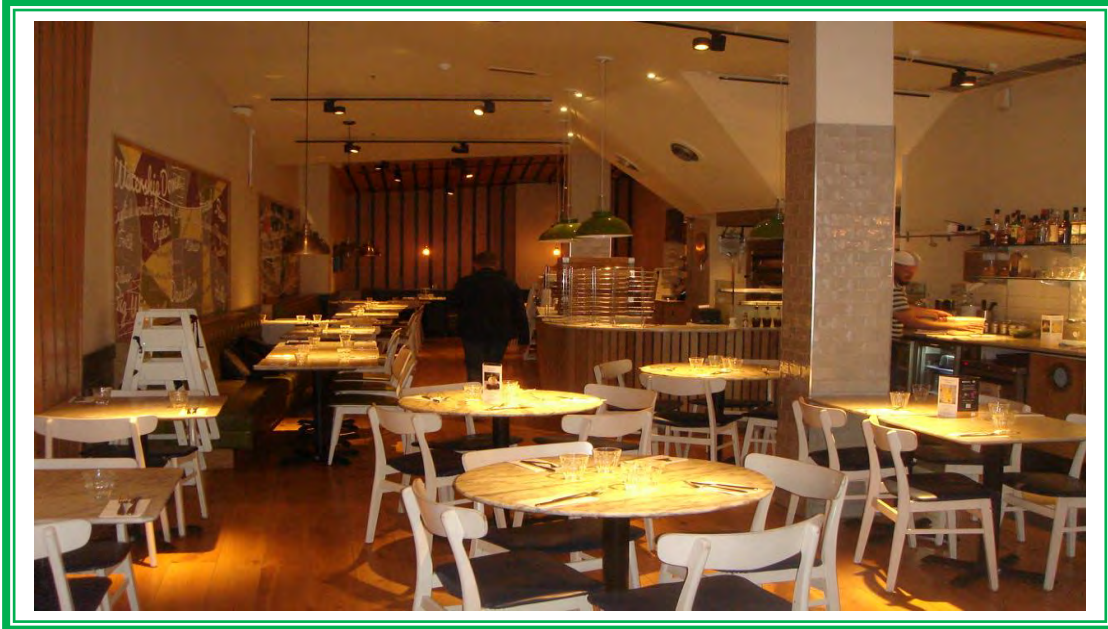
Location: 0/001 Restaurant and Servery

Material Description:	Visual Inspection – No Suspect Materials Found	
Identification:	N/A	
Approx. quantity:	N/A	
Accessibility	N/A	Assessment Score
Product type:	N/A	N/A
Extent of Damage:	N/A	N/A
Surface Treatment:	N/A	N/A
Asbestos type:	N/A	N/A
Material Assessment Score:		N/A
Priority Assessment Score:		N/A
Action:	N/A	
Comments:	N/A

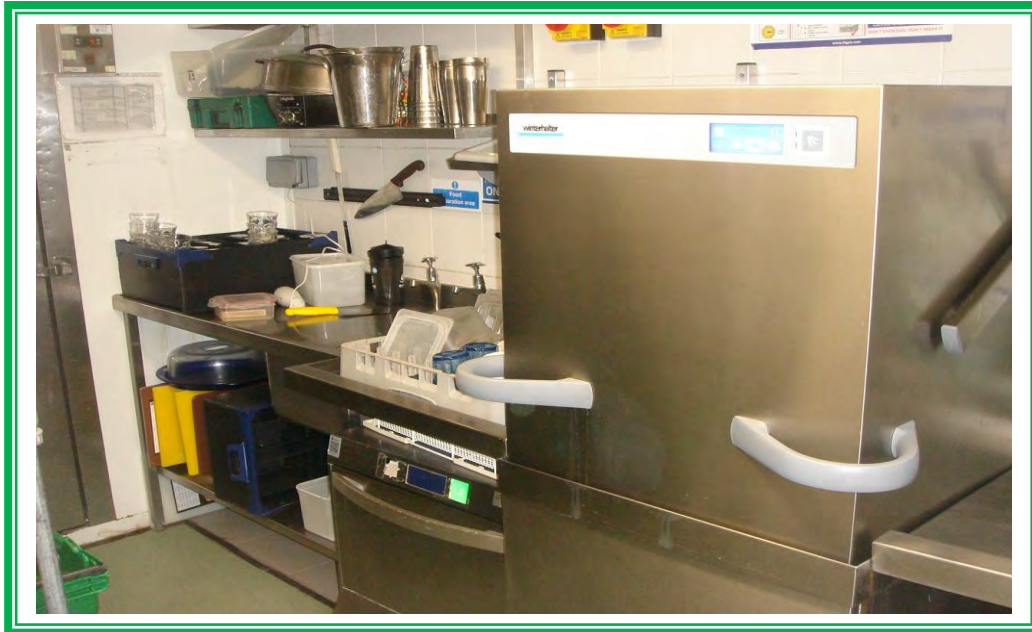
Location: 0/002 Prep Area

Material Description:	Visual Inspection – No Suspect Materials Found	
Identification:	N/A	
Approx. quantity:	N/A	
Accessibility	N/A	Assessment Score
Product type:	N/A	N/A
Extent of Damage:	N/A	N/A
Surface Treatment:	N/A	N/A
Asbestos type:	N/A	N/A
Material Assessment Score:		N/A
Priority Assessment Score:		N/A
Action:	N/A	
Comments:	N/A

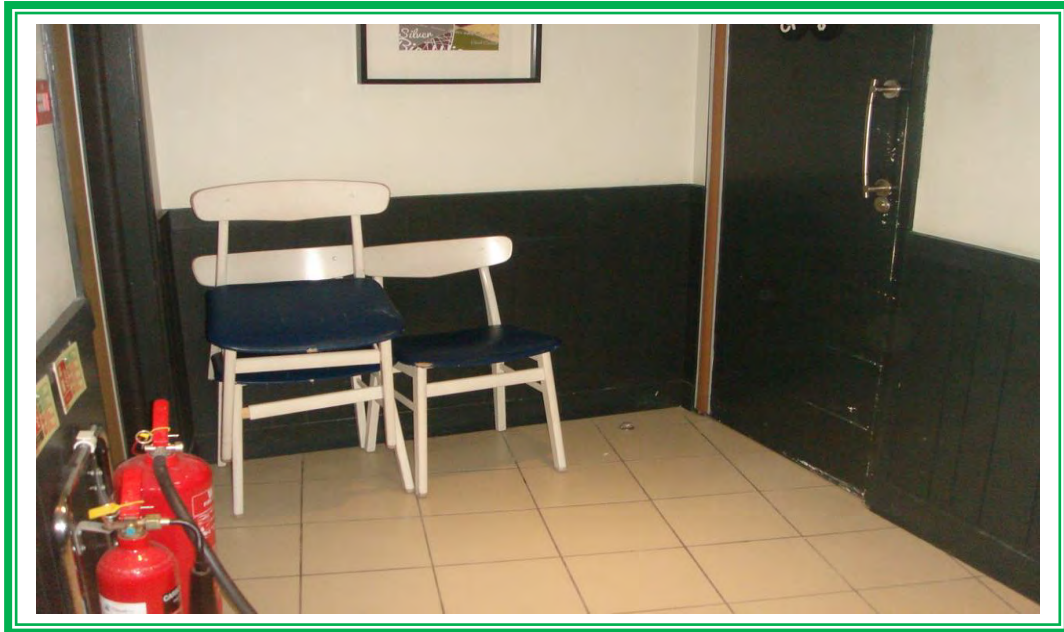
Location: 0/003 Lobby

Material Description:	Visual Inspection – No Suspect Materials Found	
Identification:	N/A	
Approx. quantity:	N/A	
Accessibility	N/A	Assessment Score
Product type:	N/A	N/A
Extent of Damage:	N/A	N/A
Surface Treatment:	N/A	N/A
Asbestos type:	N/A	N/A
Material Assessment Score:		N/A
Priority Assessment Score:		N/A
Action:	N/A	
Comments:	N/A

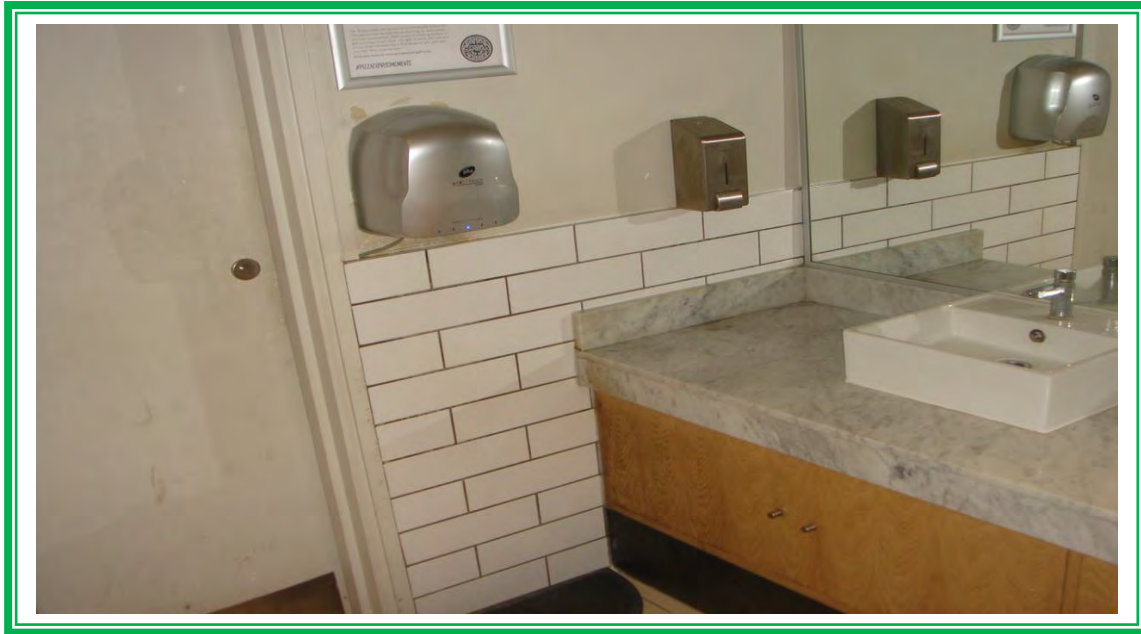
Location: 0/004 WC

Material Description:	Visual Inspection – No Suspect Materials Found	
Identification:	N/A	
Approx. quantity:	N/A	
Accessibility	N/A	Assessment Score
Product type:	N/A	N/A
Extent of Damage:	N/A	N/A
Surface Treatment:	N/A	N/A
Asbestos type:	N/A	N/A
Material Assessment Score:		N/A
Priority Assessment Score:		N/A
Action:	N/A	
Comments:	N/A

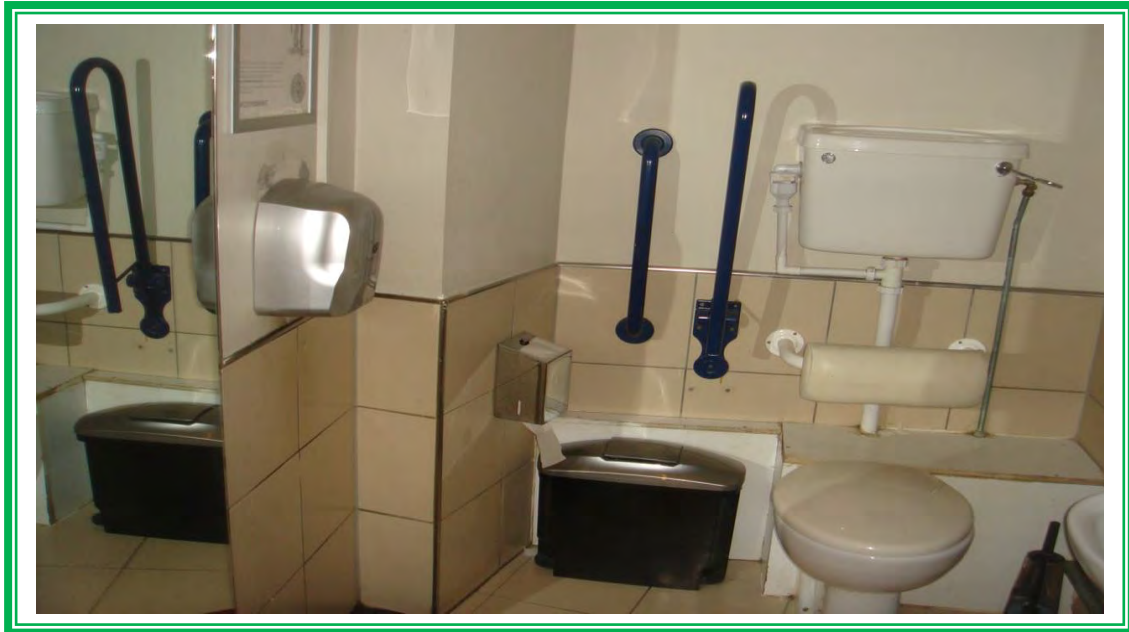
Location: 0/005 WC

Material Description:	Visual Inspection – No Suspect Materials Found	
Identification:	N/A	
Approx. quantity:	N/A	
Accessibility	N/A	Assessment Score
Product type:	N/A	N/A
Extent of Damage:	N/A	N/A
Surface Treatment:	N/A	N/A
Asbestos type:	N/A	N/A
Material Assessment Score:		N/A
Priority Assessment Score:		N/A
Action:	N/A	
Comments:	N/A

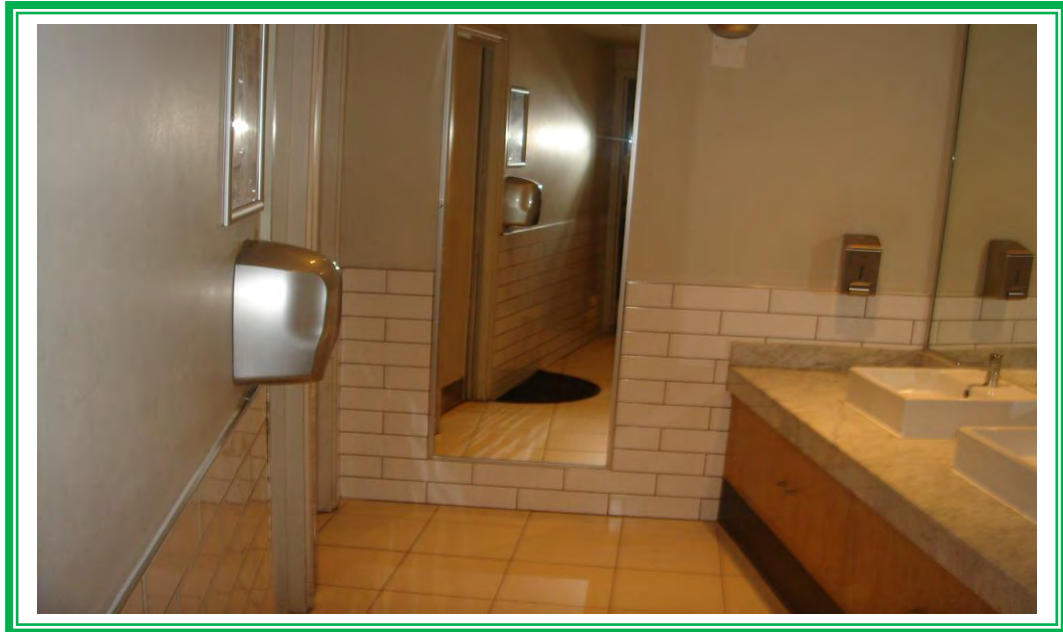
Location: 0/006 WC

Material Description:	Visual Inspection – No Suspect Materials Found	
Identification:	N/A	
Approx. quantity:	N/A	
Accessibility	N/A	Assessment Score
Product type:	N/A	N/A
Extent of Damage:	N/A	N/A
Surface Treatment:	N/A	N/A
Asbestos type:	N/A	N/A
Material Assessment Score:		N/A
Priority Assessment Score:		N/A
Action:	N/A	
Comments:	N/A

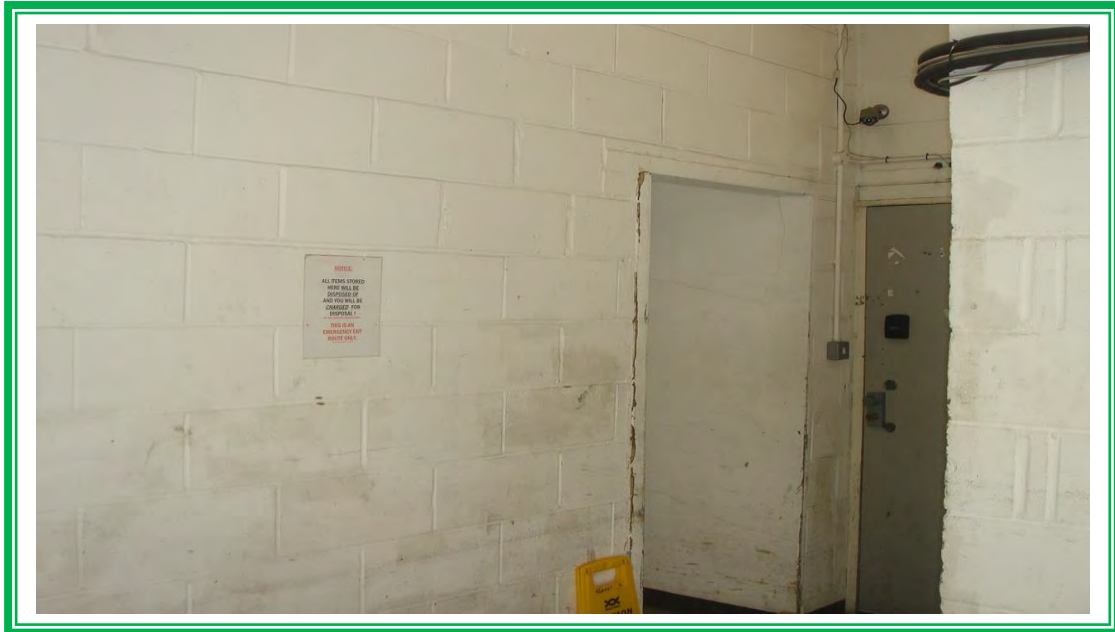
Location: 99/001 External

Material Description:	Visual Inspection – No Suspect Materials Found	
Identification:	N/A	
Approx. quantity:	N/A	
Accessibility	N/A	Assessment Score
Product type:	N/A	N/A
Extent of Damage:	N/A	N/A
Surface Treatment:	N/A	N/A
Asbestos type:	N/A	N/A
Material Assessment Score:		N/A
Priority Assessment Score:		N/A
Action:	N/A	
Comments:	N/A

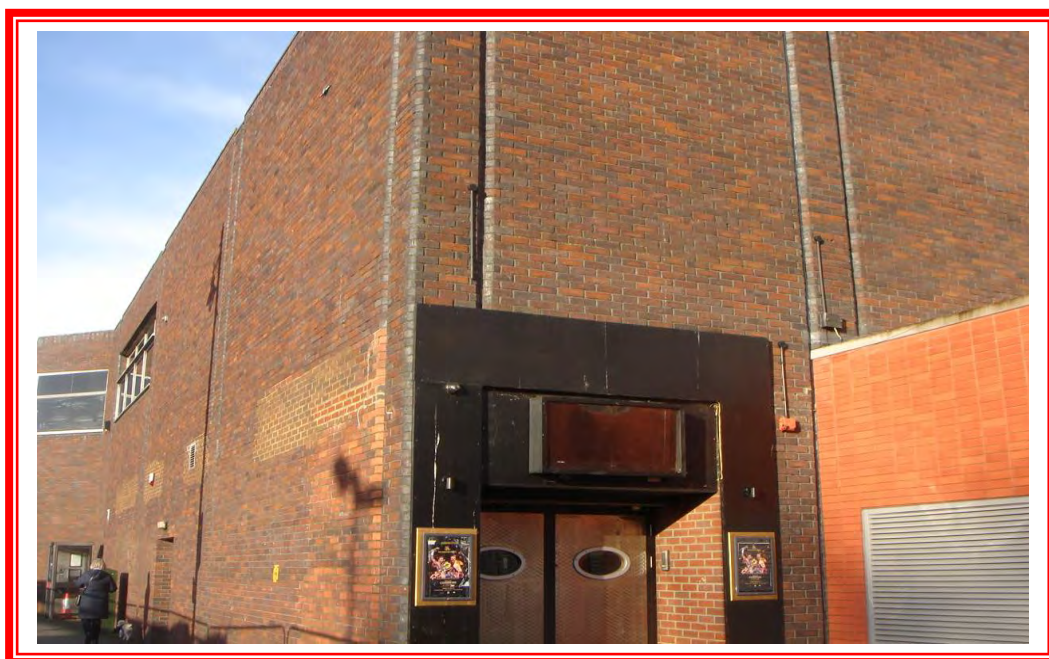
Location: 4A The Mall

Material Description:	No Access	
Identification:	Presumed to Contain Asbestos	
Approx. quantity:	Unknown	
Accessibility	Low	Assessment Score
Product type:	No Access	3
Extent of Damage:	No Access	3
Surface Treatment:	No Access	3
Asbestos type:	No Access	3
Material Assessment Score:		12
Priority Assessment Score:		High
Action:	Further Inspection Required	
Comments:	No Access as still in lease but vacant – No Keys (The Vacant Nightclub)

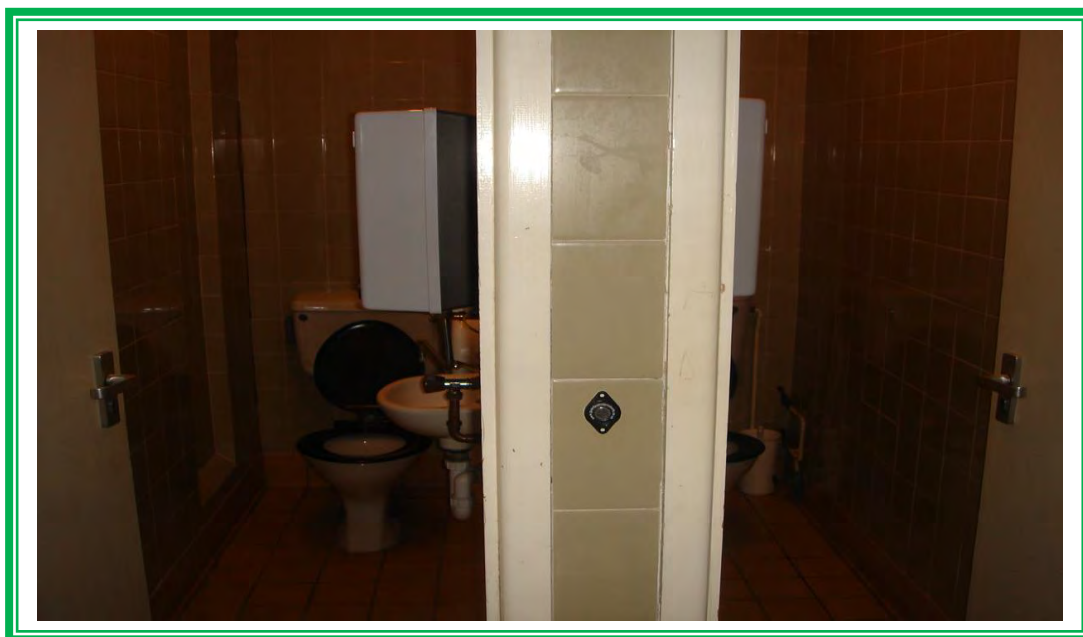
Item No: 1	Sample No: N/A
Location: 0/001 WC

Material Description:	Visual Inspection – No Suspect Materials Found	
Identification:	N/A	
Approx. quantity:	N/A	
Accessibility	N/A	Assessment Score
Product type:	N/A	N/A
Extent of Damage:	N/A	N/A
Surface Treatment:	N/A	N/A
Asbestos type:	N/A	N/A
Material Assessment Score:		N/A
Priority Assessment Score:		N/A
Action:	N/A	
Comments:	N/A

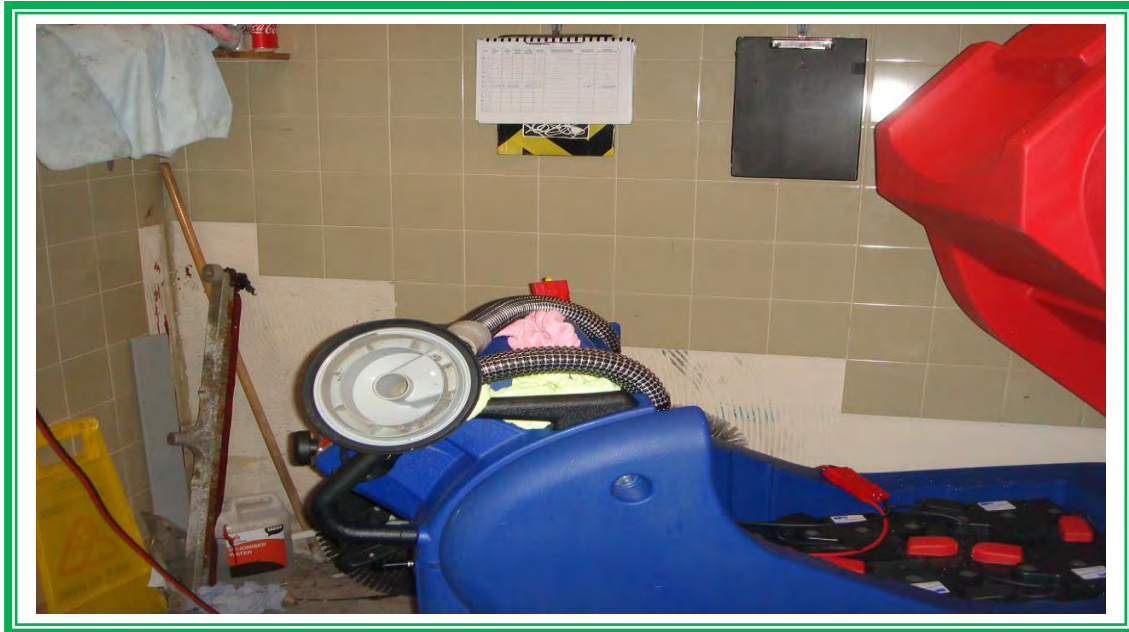
Location: 0/002 Store

Material Description:	Visual Inspection – No Suspect Materials Found	
Identification:	N/A	
Approx. quantity:	N/A	
Accessibility	N/A	Assessment Score
Product type:	N/A	N/A
Extent of Damage:	N/A	N/A
Surface Treatment:	N/A	N/A
Asbestos type:	N/A	N/A
Material Assessment Score:		N/A
Priority Assessment Score:		N/A
Action:	N/A	
Comments:	N/A

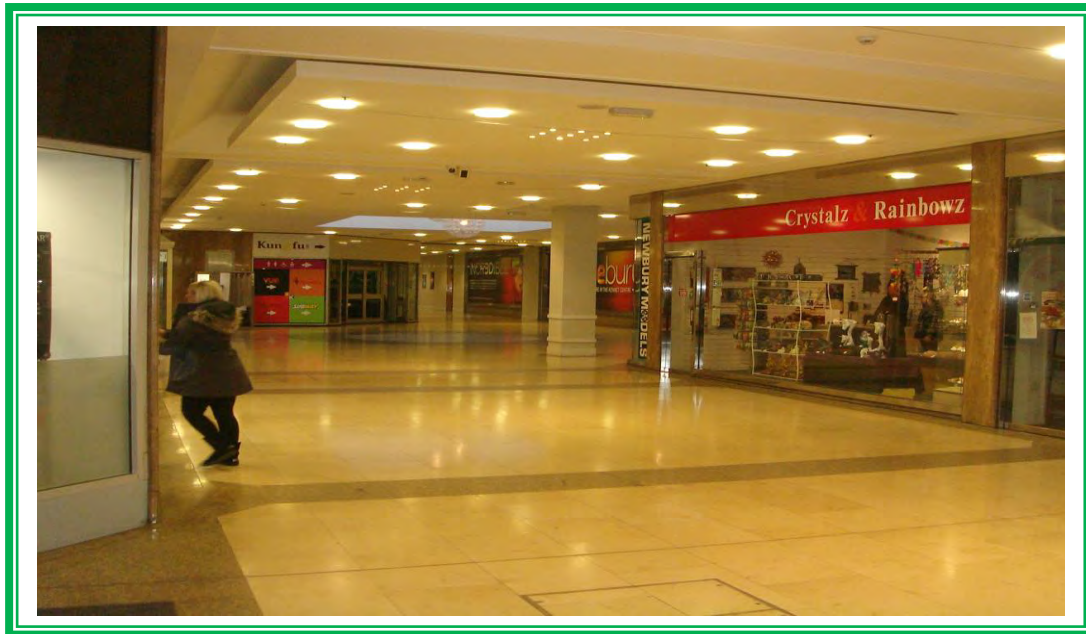
Location: 0/003 The Mall

Material Description:	Visual Inspection – No Suspect Materials Found	
Identification:	N/A	
Approx. quantity:	N/A	
Accessibility	N/A	Assessment Score
Product type:	N/A	N/A
Extent of Damage:	N/A	N/A
Surface Treatment:	N/A	N/A
Asbestos type:	N/A	N/A
Material Assessment Score:		N/A
Priority Assessment Score:		N/A
Action:	N/A	
Comments:	N/A

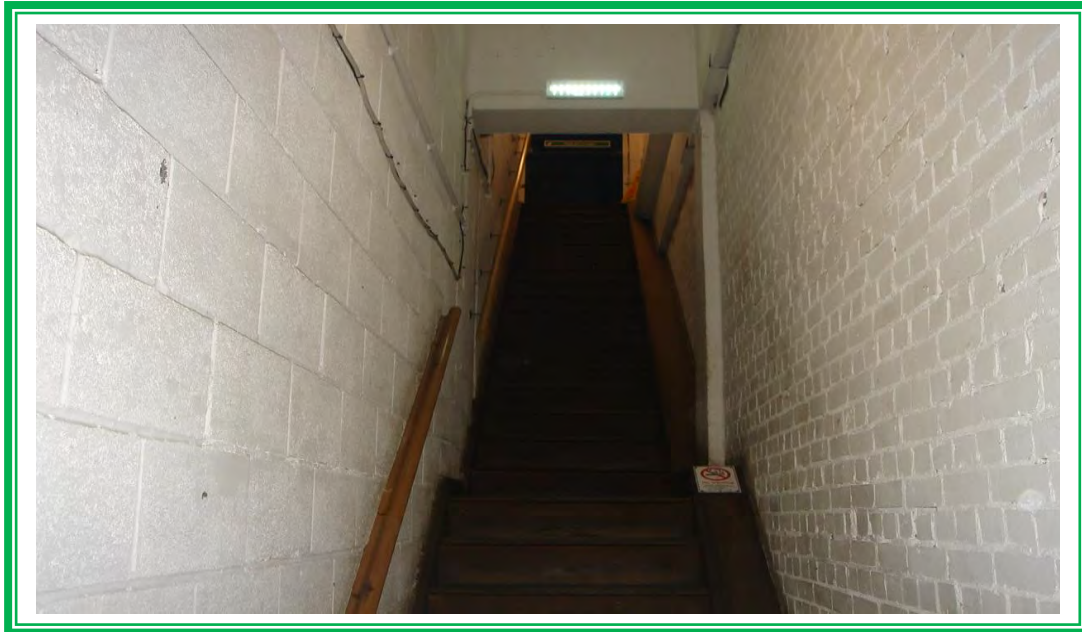
Location: 0/004 Corridor and Stairs

Material Description:	Visual Inspection – No Suspect Materials Found	
Identification:	N/A	
Approx. quantity:	N/A	
Accessibility	N/A	Assessment Score
Product type:	N/A	N/A
Extent of Damage:	N/A	N/A
Surface Treatment:	N/A	N/A
Asbestos type:	N/A	N/A
Material Assessment Score:		N/A
Priority Assessment Score:		N/A
Action:	N/A	
Comments:	N/A

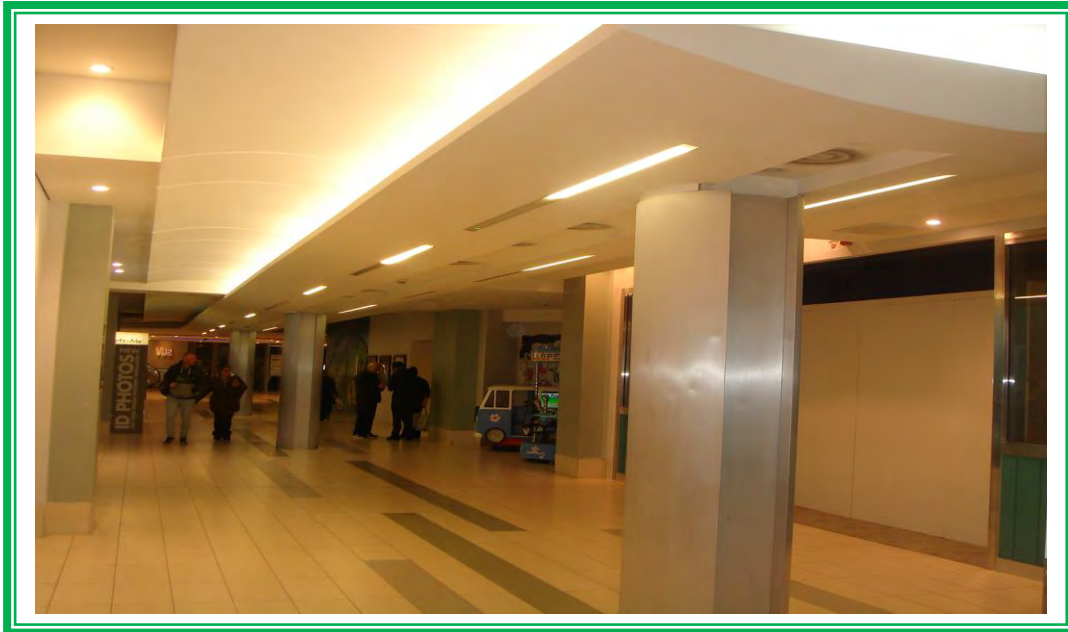
Location: Vue Cinema Area

Material Description:	Visual Inspection – No Suspect Materials Found	
Identification:	N/A	
Approx. quantity:	N/A	
Accessibility	N/A	Assessment Score
Product type:	N/A	N/A
Extent of Damage:	N/A	N/A
Surface Treatment:	N/A	N/A
Asbestos type:	N/A	N/A
Material Assessment Score:		N/A
Priority Assessment Score:		N/A
Action:	N/A	
Comments:	Built in 2009

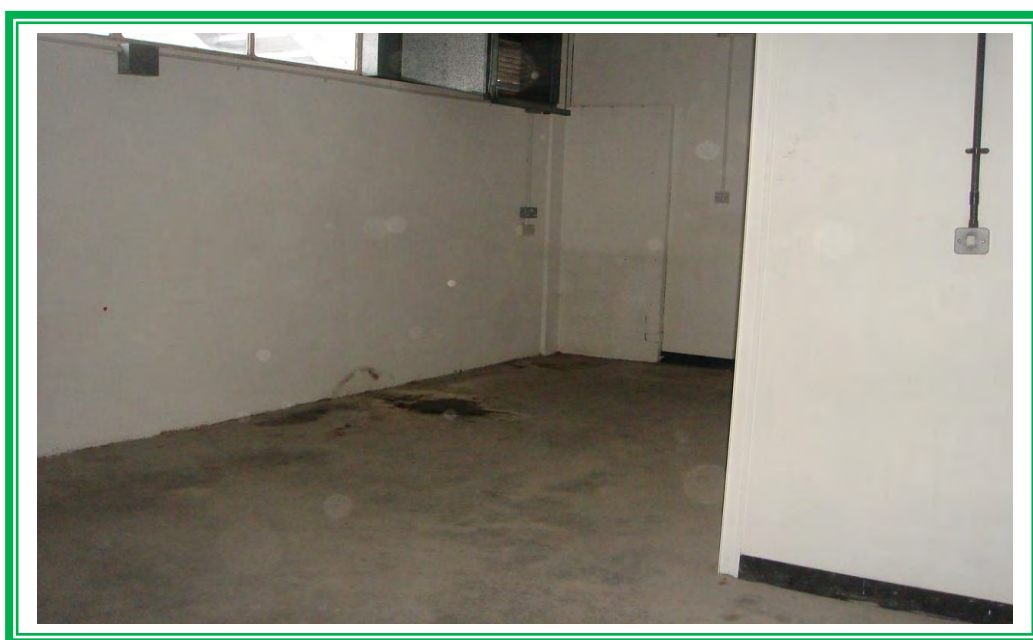
Item No: 1	Sample No: N/A
Location: 1/001

Material Description:	Visual Inspection – No Suspect Materials Found	
Identification:	N/A	
Approx. quantity:	N/A	
Accessibility	N/A	Assessment Score
Product type:	N/A	N/A
Extent of Damage:	N/A	N/A
Surface Treatment:	N/A	N/A
Asbestos type:	N/A	N/A
Material Assessment Score:		N/A
Priority Assessment Score:		N/A
Action:	N/A	
Comments:	N/A

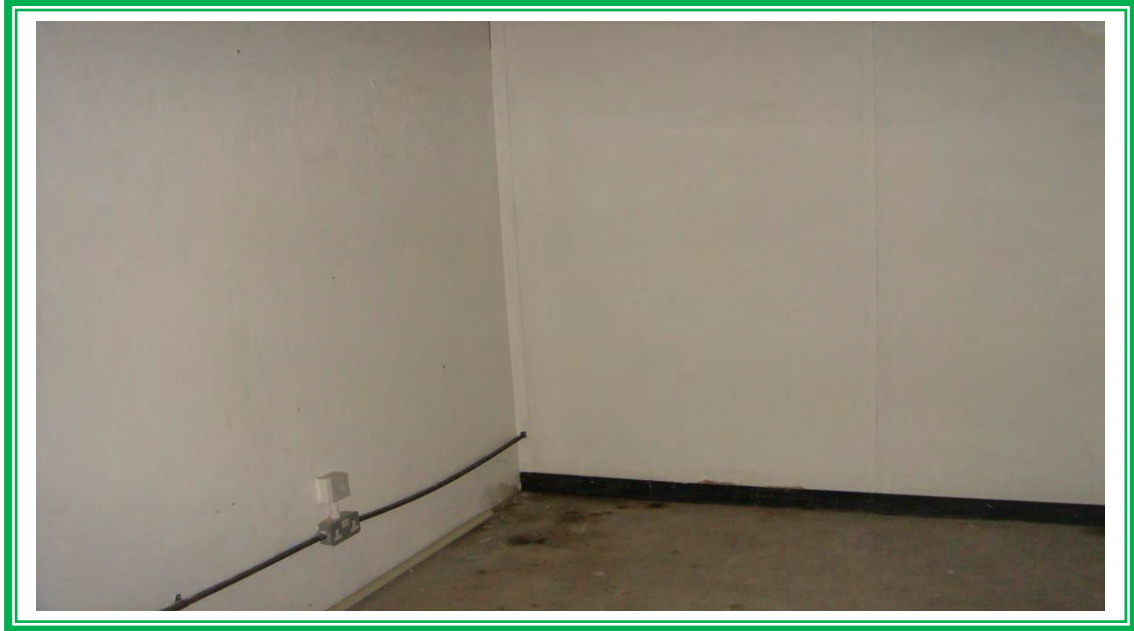
Location: 1/002

Material Description:	Visual Inspection – No Suspect Materials Found	
Identification:	N/A	
Approx. quantity:	N/A	
Accessibility	N/A	Assessment Score
Product type:	N/A	N/A
Extent of Damage:	N/A	N/A
Surface Treatment:	N/A	N/A
Asbestos type:	N/A	N/A
Material Assessment Score:		N/A
Priority Assessment Score:		N/A
Action:	N/A	
Comments:	N/A

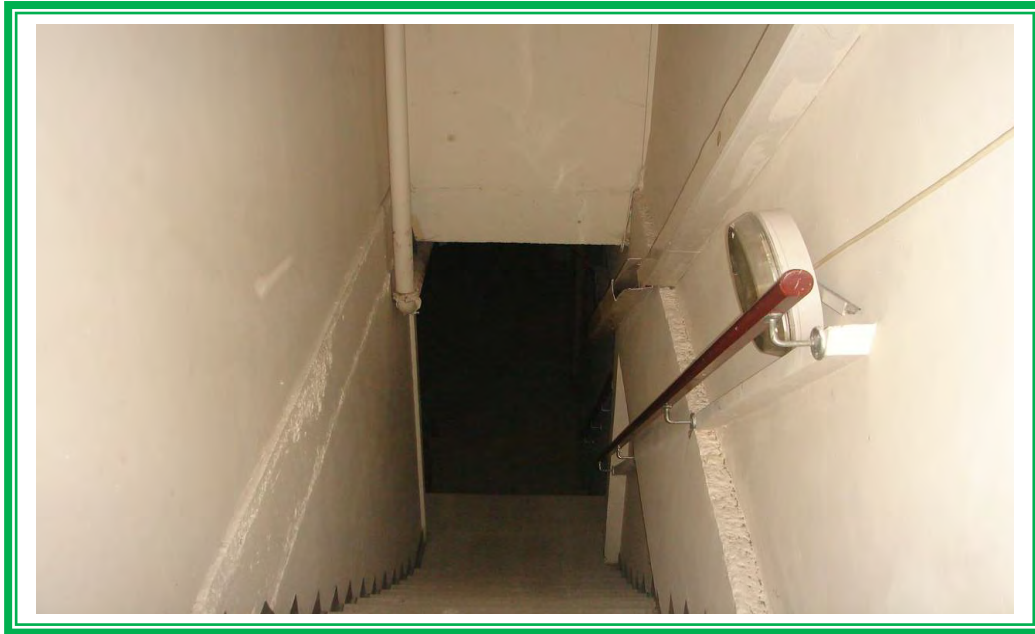
Location: 1/003 Lobby and Stairs

Material Description:	Visual Inspection – No Suspect Materials Found	
Identification:	N/A	
Approx. quantity:	N/A	
Accessibility	N/A	Assessment Score
Product type:	N/A	N/A
Extent of Damage:	N/A	N/A
Surface Treatment:	N/A	N/A
Asbestos type:	N/A	N/A
Material Assessment Score:		N/A
Priority Assessment Score:		N/A
Action:	N/A	
Comments:	N/A

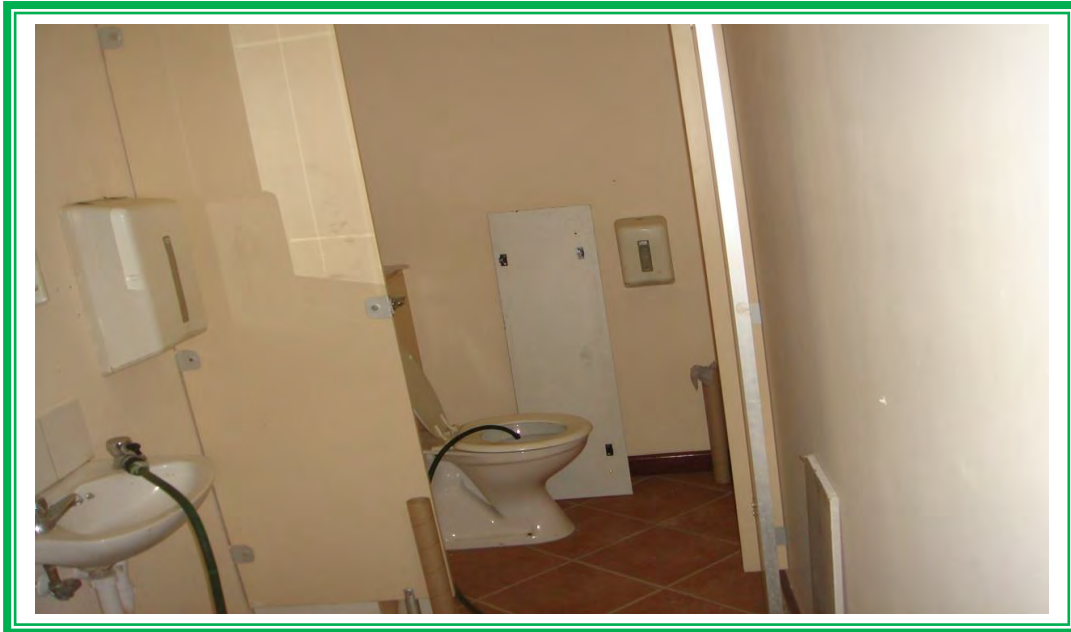
Location: 1/004 WC

Material Description:	Visual Inspection – No Suspect Materials Found	
Identification:	N/A	
Approx. quantity:	N/A	
Accessibility	N/A	Assessment Score
Product type:	N/A	N/A
Extent of Damage:	N/A	N/A
Surface Treatment:	N/A	N/A
Asbestos type:	N/A	N/A
Material Assessment Score:		N/A
Priority Assessment Score:		N/A
Action:	N/A	
Comments:	N/A

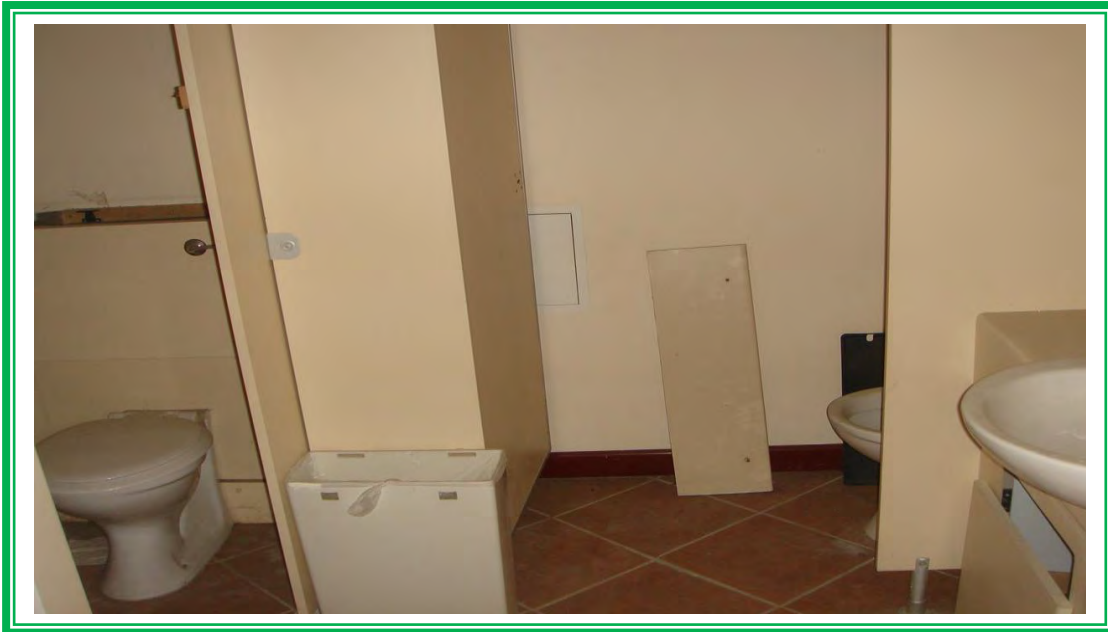
Location: 1/005 WC

Material Description:	Visual Inspection – No Suspect Materials Found	
Identification:	N/A	
Approx. quantity:	N/A	
Accessibility	N/A	Assessment Score
Product type:	N/A	N/A
Extent of Damage:	N/A	N/A
Surface Treatment:	N/A	N/A
Asbestos type:	N/A	N/A
Material Assessment Score:		N/A
Priority Assessment Score:		N/A
Action:	N/A	
Comments:	N/A

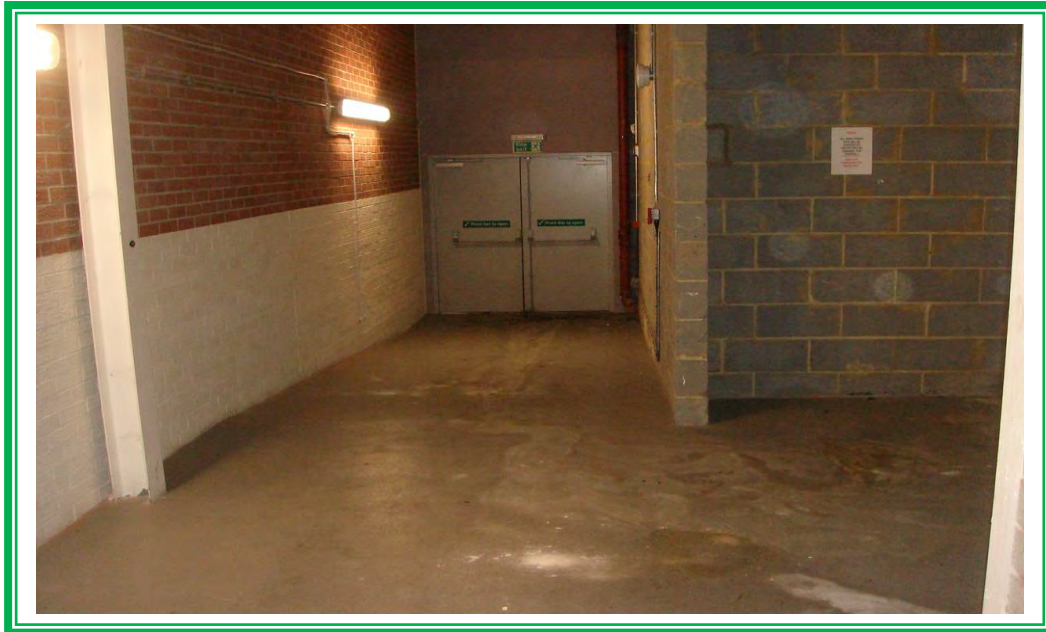
Location: 0/001 Walkway

Material Description:	Visual Inspection – No Suspect Materials Found	
Identification:	N/A	
Approx. quantity:	N/A	
Accessibility	N/A	Assessment Score
Product type:	N/A	N/A
Extent of Damage:	N/A	N/A
Surface Treatment:	N/A	N/A
Asbestos type:	N/A	N/A
Material Assessment Score:		N/A
Priority Assessment Score:		N/A
Action:	N/A	
Comments:	N/A
