Project Number 3113

Management Asbestos Survey Report

Kennet Centre, Market Street, Newbury,
Berkshire, RG14 5EN

3 Market Place and Associated Store

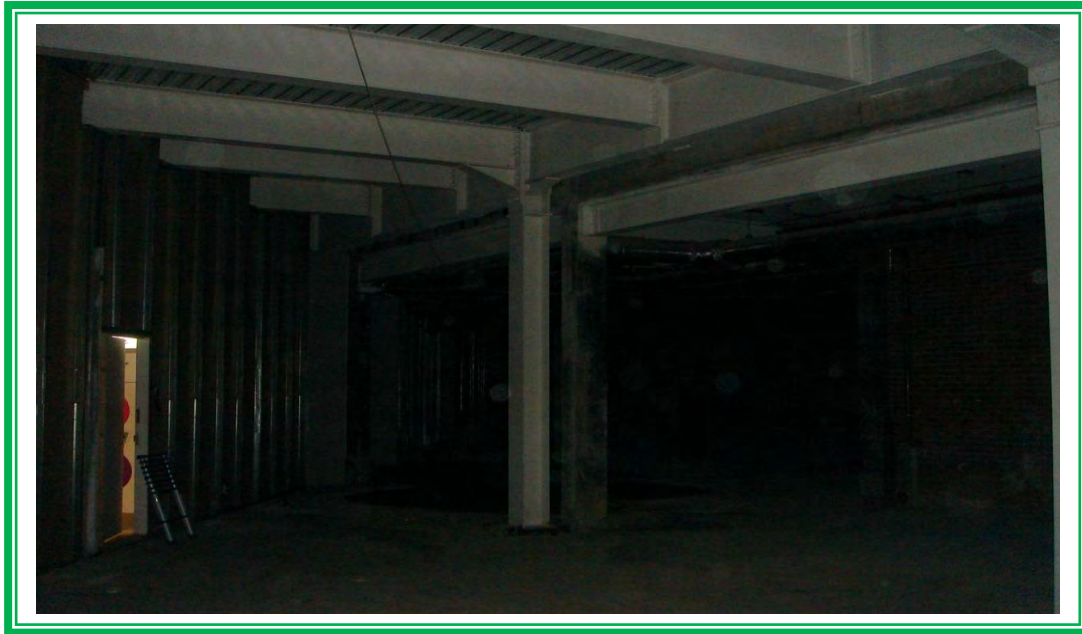
Location: 0/002 Ground Floor

Material Description:	Visual Inspection – No Suspect Materials Found	
Identification:	N/A	
Approx. quantity:	N/A	
Accessibility	N/A	Assessment Score
Product type:	N/A	N/A
Extent of Damage:	N/A	N/A
Surface Treatment:	N/A	N/A
Asbestos type:	N/A	N/A
Material Assessment Score:		N/A
Priority Assessment Score:		N/A
Action:	N/A	
Comments:	N/A

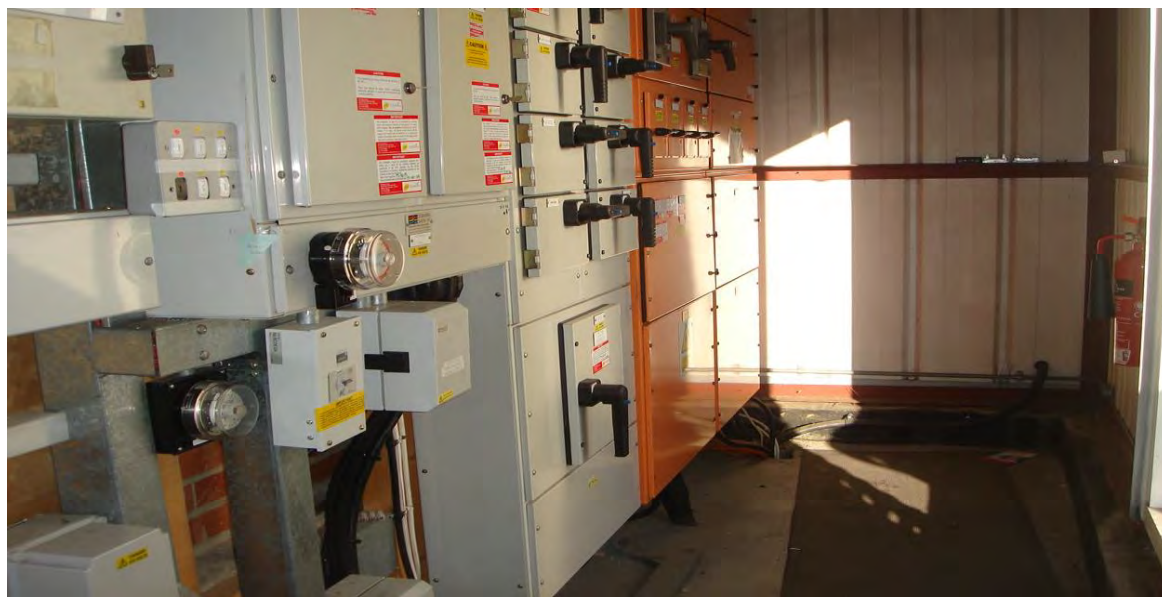
Location: 1/001 Plant Room 5

Material Description:	Visual Inspection – No Suspect Materials Found	
Identification:	N/A	
Approx. quantity:	N/A	
Accessibility	N/A	Assessment Score
Product type:	N/A	N/A
Extent of Damage:	N/A	N/A
Surface Treatment:	N/A	N/A
Asbestos type:	N/A	N/A
Material Assessment Score:		N/A
Priority Assessment Score:		N/A
Action:	N/A	
Comments:	N/A

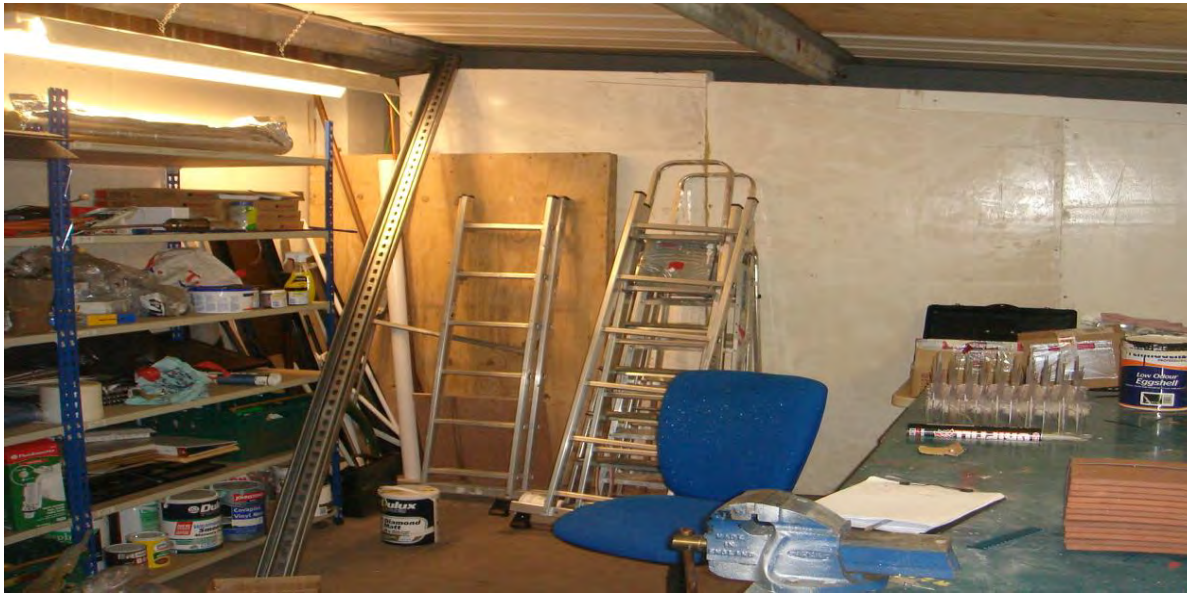
Location: 1/002 Workshop

Material Description:	Visual Inspection – No Suspect Materials Found	
Identification:	N/A	
Approx. quantity:	N/A	
Accessibility	N/A	Assessment Score
Product type:	N/A	N/A
Extent of Damage:	N/A	N/A
Surface Treatment:	N/A	N/A
Asbestos type:	N/A	N/A
Material Assessment Score:		N/A
Priority Assessment Score:		N/A
Action:	N/A	
Comments:	N/A

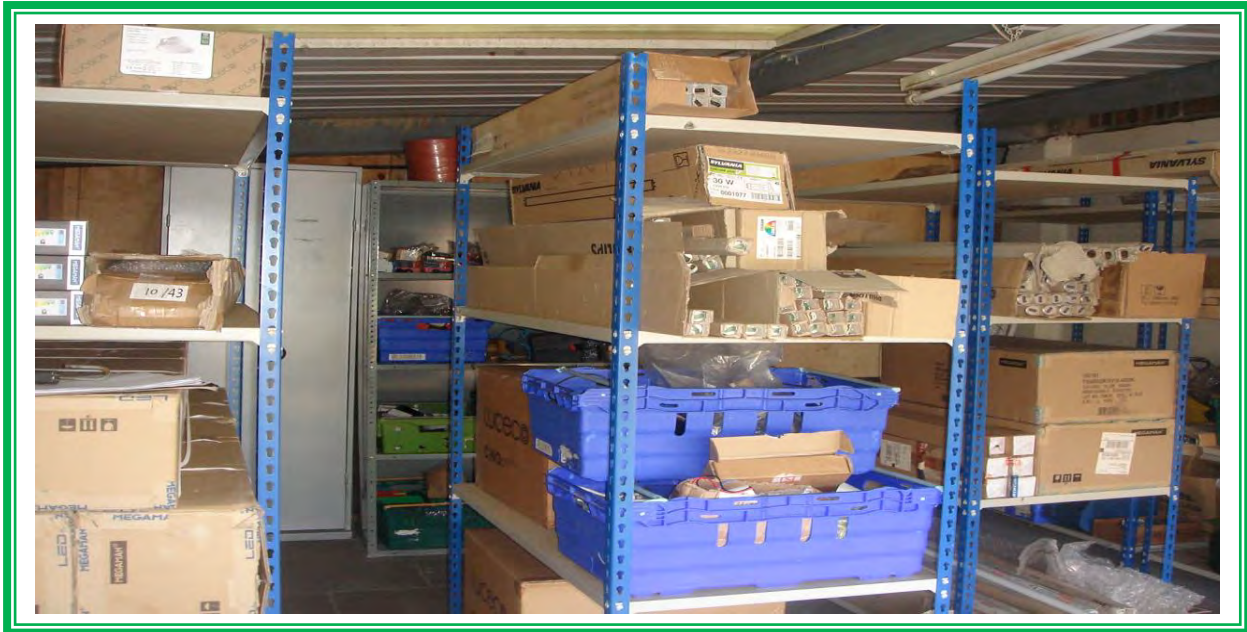
Location: 0/003 Garage

Material Description:	Visual Inspection – No Suspect Materials Found	
Identification:	N/A	
Approx. quantity:	N/A	
Accessibility	N/A	Assessment Score
Product type:	N/A	N/A
Extent of Damage:	N/A	N/A
Surface Treatment:	N/A	N/A
Asbestos type:	N/A	N/A
Material Assessment Score:		N/A
Priority Assessment Score:		N/A
Action:	N/A	
Comments:	N/A

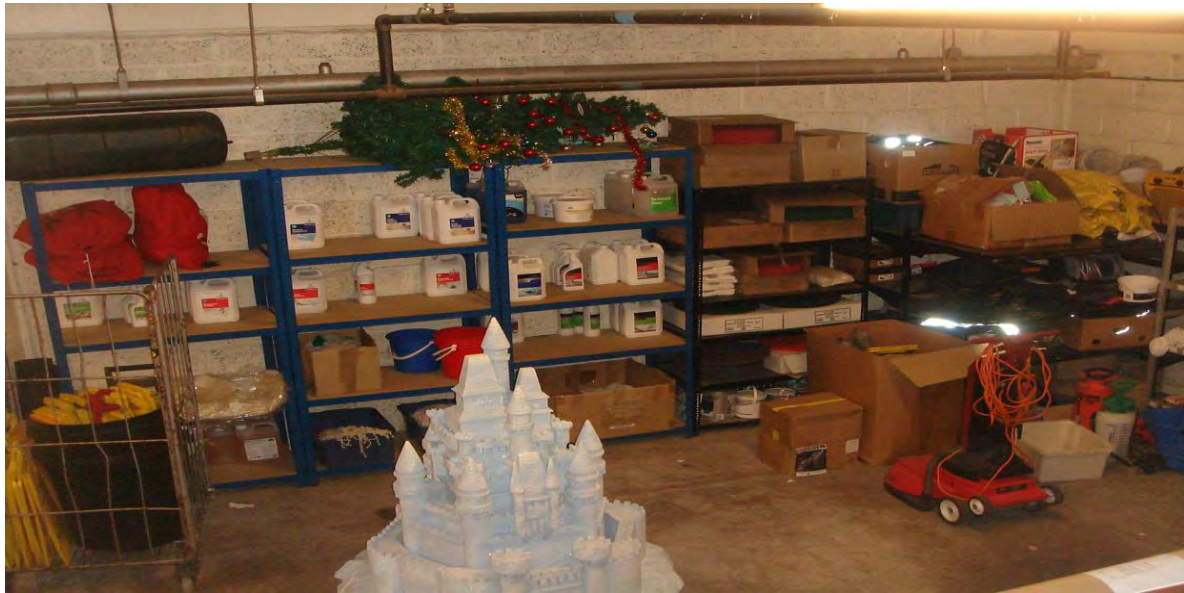
Location: 0/004 Mess Room and Clearance Store

Material Description:	Visual Inspection – No Suspect Materials Found	
Identification:	N/A	
Approx. quantity:	N/A	
Accessibility	N/A	Assessment Score
Product type:	N/A	N/A
Extent of Damage:	N/A	N/A
Surface Treatment:	N/A	N/A
Asbestos type:	N/A	N/A
Material Assessment Score:		N/A
Priority Assessment Score:		N/A
Action:	N/A	
Comments:	N/A

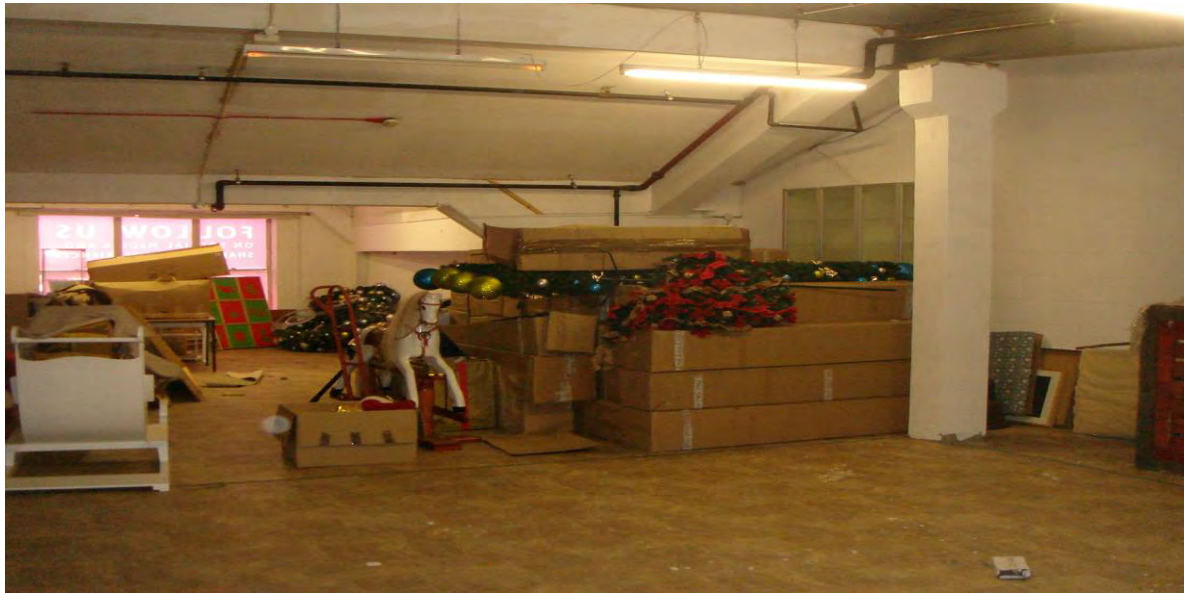
Location: 1/005 Event Store

Material Description:	Visual Inspection – No Suspect Materials Found	
Identification:	N/A	
Approx. quantity:	N/A	
Accessibility	N/A	Assessment Score
Product type:	N/A	N/A
Extent of Damage:	N/A	N/A
Surface Treatment:	N/A	N/A
Asbestos type:	N/A	N/A
Material Assessment Score:		N/A
Priority Assessment Score:		N/A
Action:	N/A	
Comments:	N/A

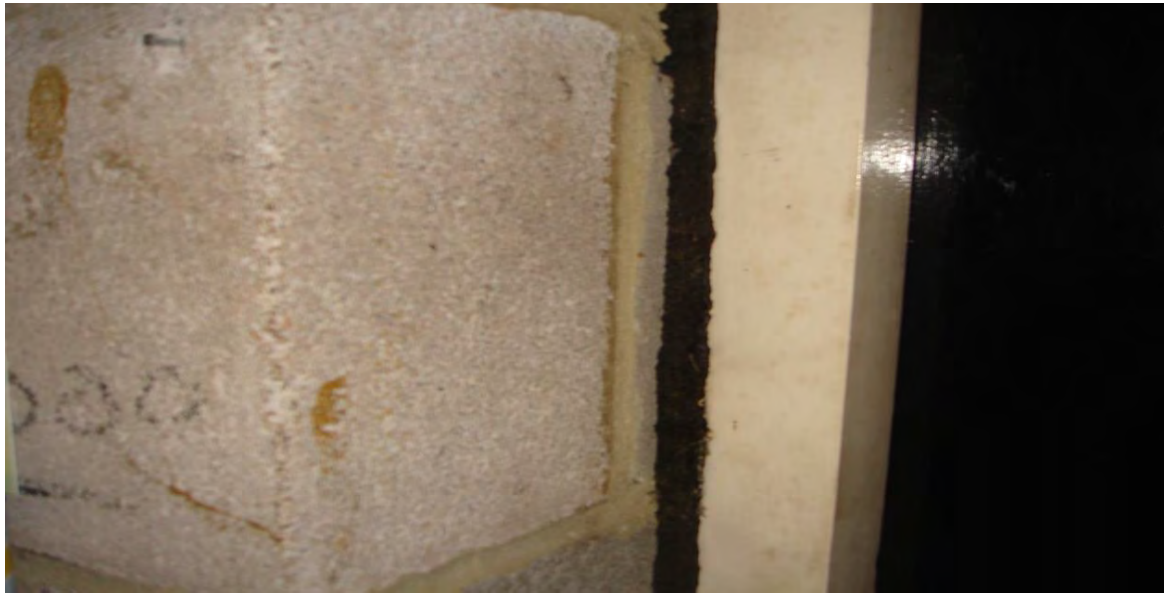
Location: 1/006 Plant Room 3

Material Description:	Damage Proof Courses	
Identification:	Sampled – No Asbestos Detected	
Approx. quantity:	Throughout Wall Cavity in Plant Room	
Accessibility	N/A	Assessment Score
Product type:	N/A	N/A
Extent of Damage:	N/A	N/A
Surface Treatment:	N/A	N/A
Asbestos type:	N/A	N/A
Material Assessment Score:		N/A
Priority Assessment Score:		N/A
Action:	N/A	
Comments:	N/A

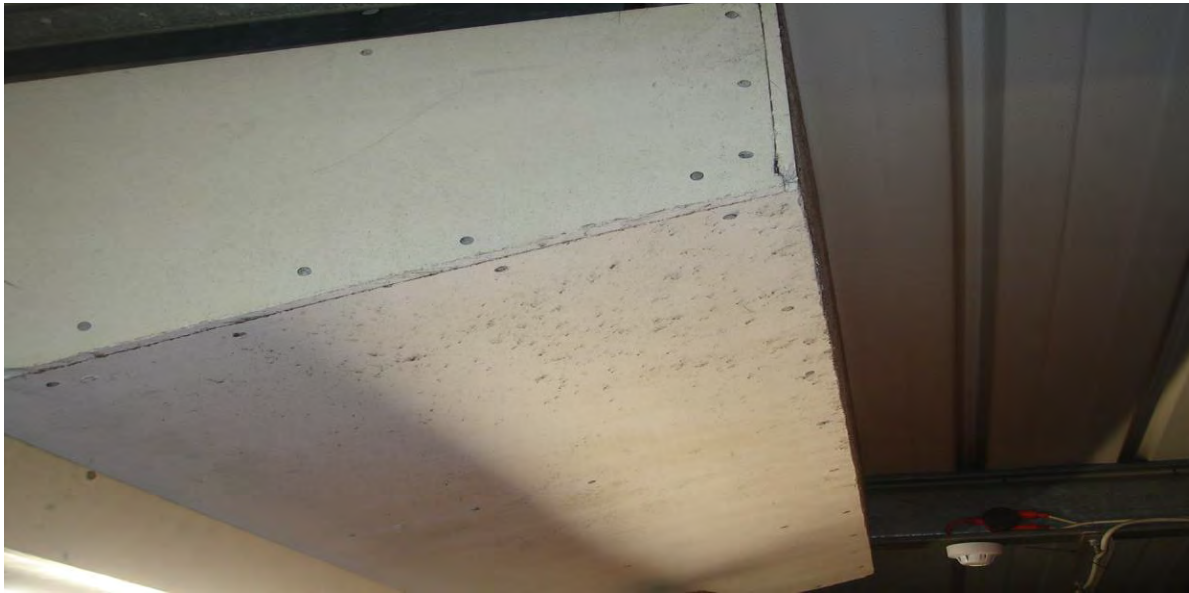
Location: 1/007 Plant Room 1

Material Description:	Insulating Board	
Identification:	Sampled – No Asbestos Detected	
Approx. quantity:	3M2	
Accessibility	N/A	Assessment Score
Product type:	N/A	N/A
Extent of Damage:	N/A	N/A
Surface Treatment:	N/A	N/A
Asbestos type:	N/A	N/A
Material Assessment Score:		N/A
Priority Assessment Score:		N/A
Action:	N/A	
Comments:	N/A

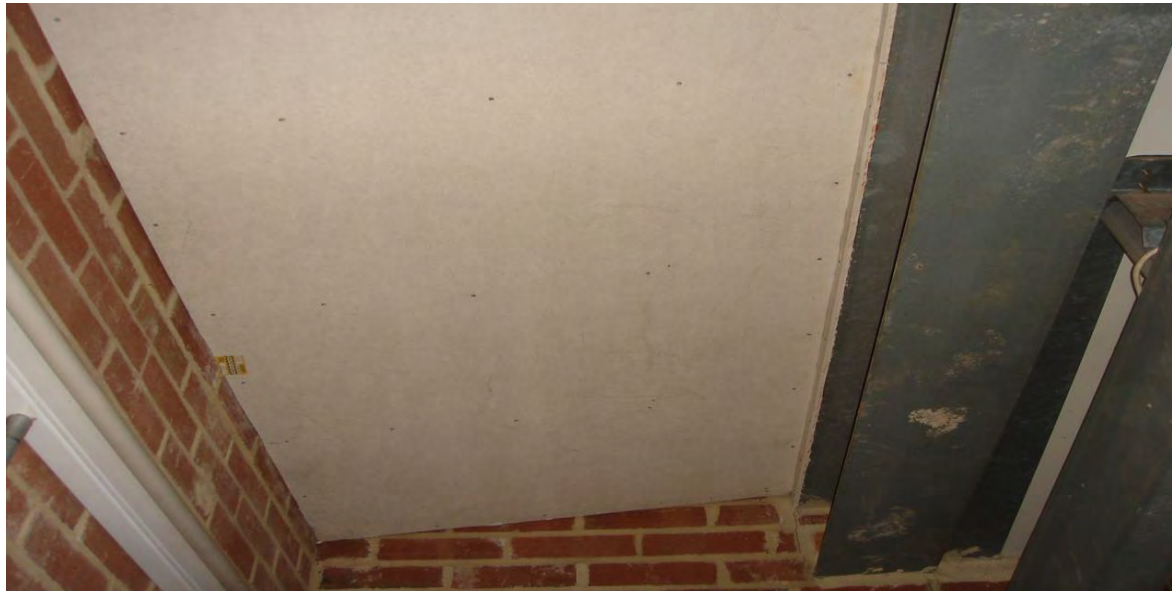
Location: 1/008 Plant Room 6

Material Description:	Insulating Board	
Identification:	As Per Sample 3 – No Asbestos Detected	
Approx. quantity:	2M2	
Accessibility	N/A	Assessment Score
Product type:	N/A	N/A
Extent of Damage:	N/A	N/A
Surface Treatment:	N/A	N/A
Asbestos type:	N/A	N/A
Material Assessment Score:		N/A
Priority Assessment Score:		N/A
Action:	N/A	
Comments:	N/A

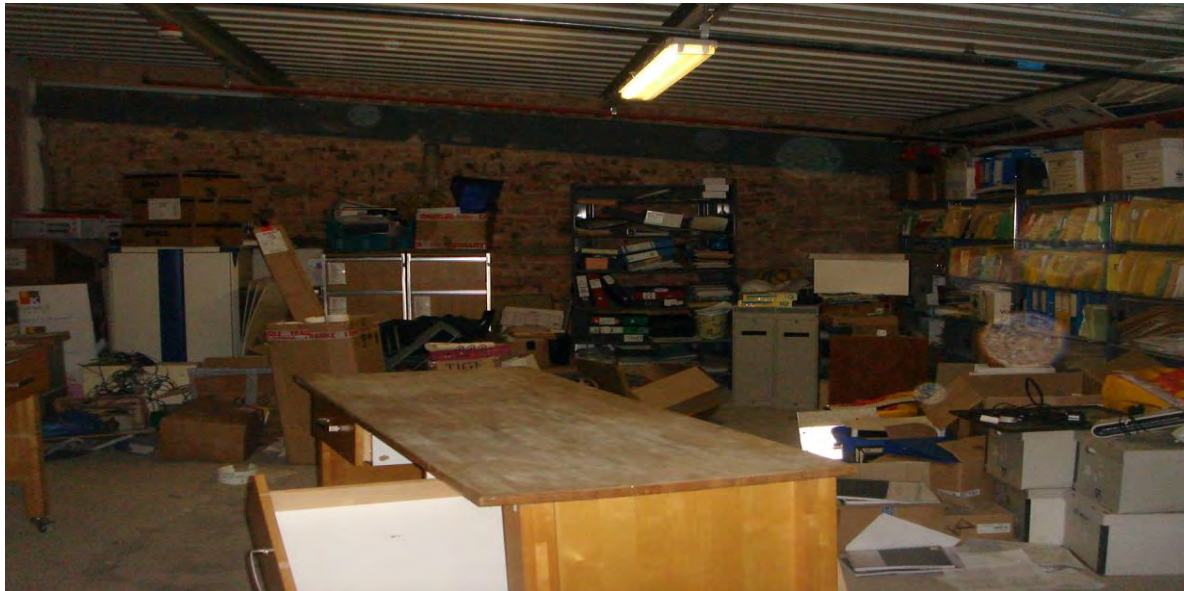
Location: 1/009 Store Green Room 9

Material Description:	Visual Inspection – No Suspect Materials Found	
Identification:	N/A	
Approx. quantity:	N/A	
Accessibility	N/A	Assessment Score
Product type:	N/A	N/A
Extent of Damage:	N/A	N/A
Surface Treatment:	N/A	N/A
Asbestos type:	N/A	N/A
Material Assessment Score:		N/A
Priority Assessment Score:		N/A
Action:	N/A	
Comments:	N/A

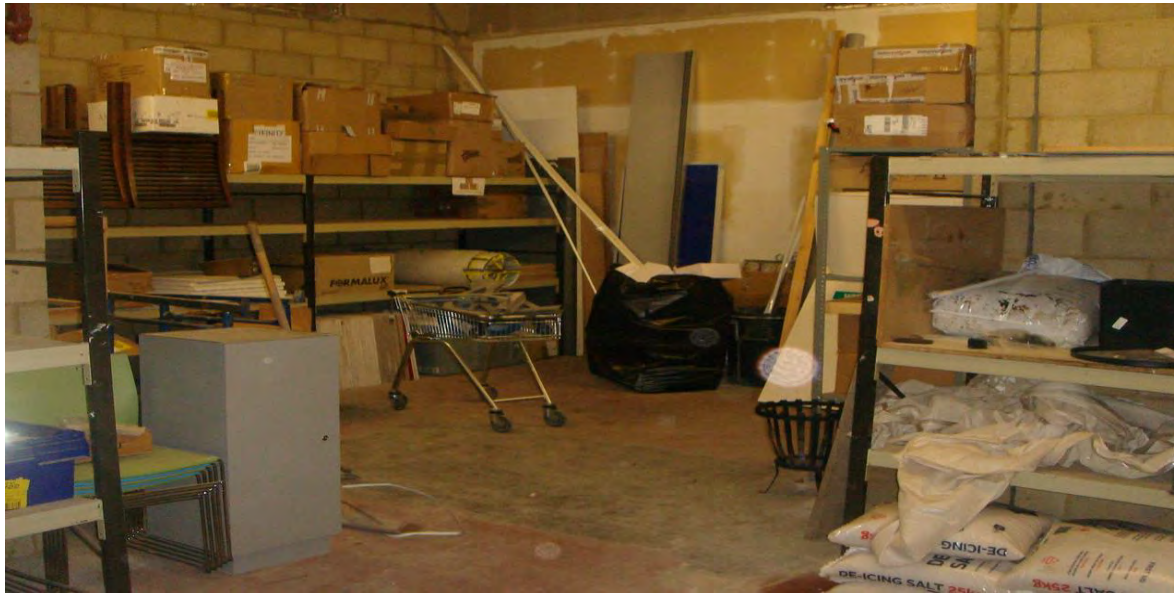
Location: 1/010 TK Maxx Store

Material Description:	Visual Inspection – No Suspect Materials Found	
Identification:	N/A	
Approx. quantity:	N/A	
Accessibility	N/A	Assessment Score
Product type:	N/A	N/A
Extent of Damage:	N/A	N/A
Surface Treatment:	N/A	N/A
Asbestos type:	N/A	N/A
Material Assessment Score:		N/A
Priority Assessment Score:		N/A
Action:	N/A	
Comments:	N/A

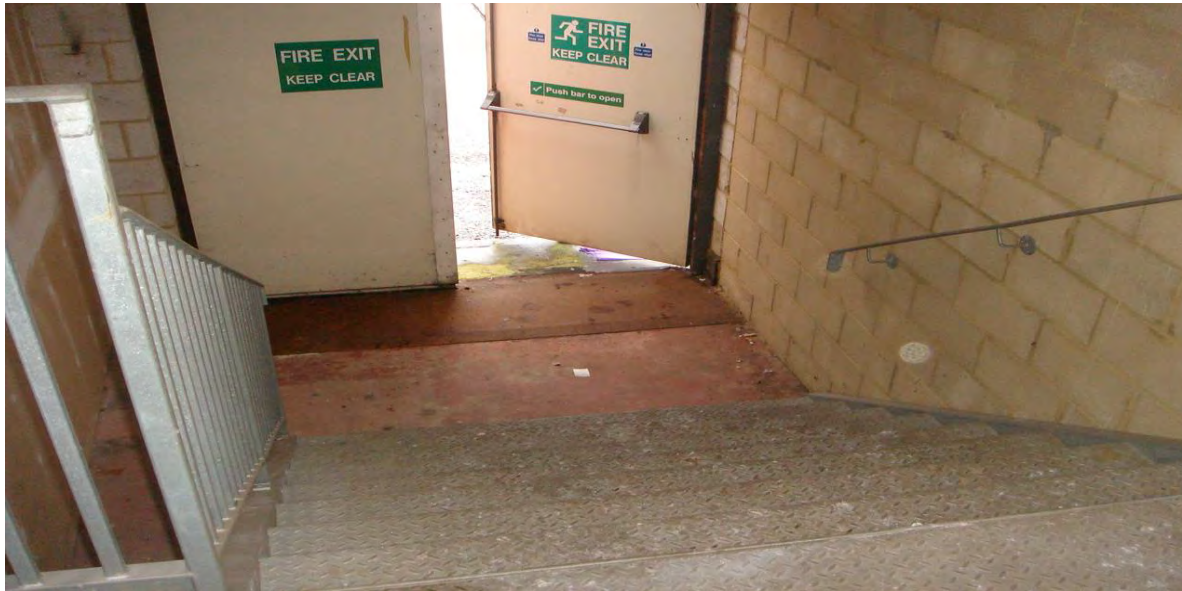
Location: 1/011 Liquid Fire Escape

Material Description:	Visual Inspection – No Suspect Materials Found	
Identification:	N/A	
Approx. quantity:	N/A	
Accessibility	N/A	Assessment Score
Product type:	N/A	N/A
Extent of Damage:	N/A	N/A
Surface Treatment:	N/A	N/A
Asbestos type:	N/A	N/A
Material Assessment Score:		N/A
Priority Assessment Score:		N/A
Action:	N/A	
Comments:	N/A

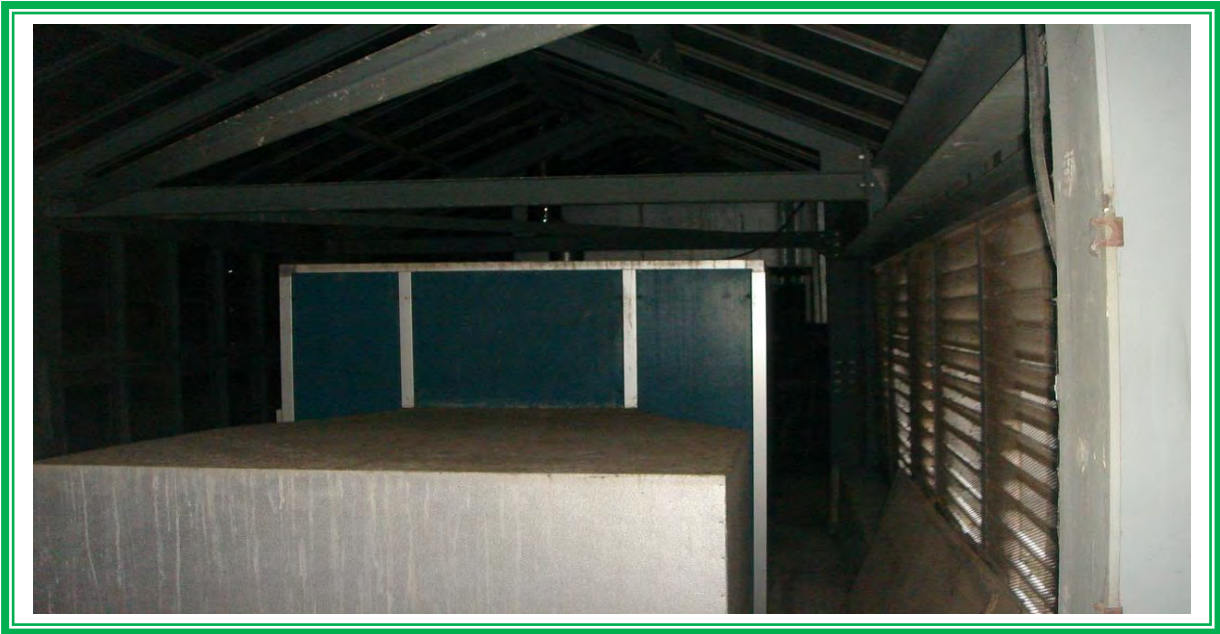
Location: 2/012 TK Maxx Air Conditioning

Material Description:	Visual Inspection – No Suspect Materials Found	
Identification:	N/A	
Approx. quantity:	N/A	
Accessibility	N/A	Assessment Score
Product type:	N/A	N/A
Extent of Damage:	N/A	N/A
Surface Treatment:	N/A	N/A
Asbestos type:	N/A	N/A
Material Assessment Score:		N/A
Priority Assessment Score:		N/A
Action:	N/A	
Comments:	N/A

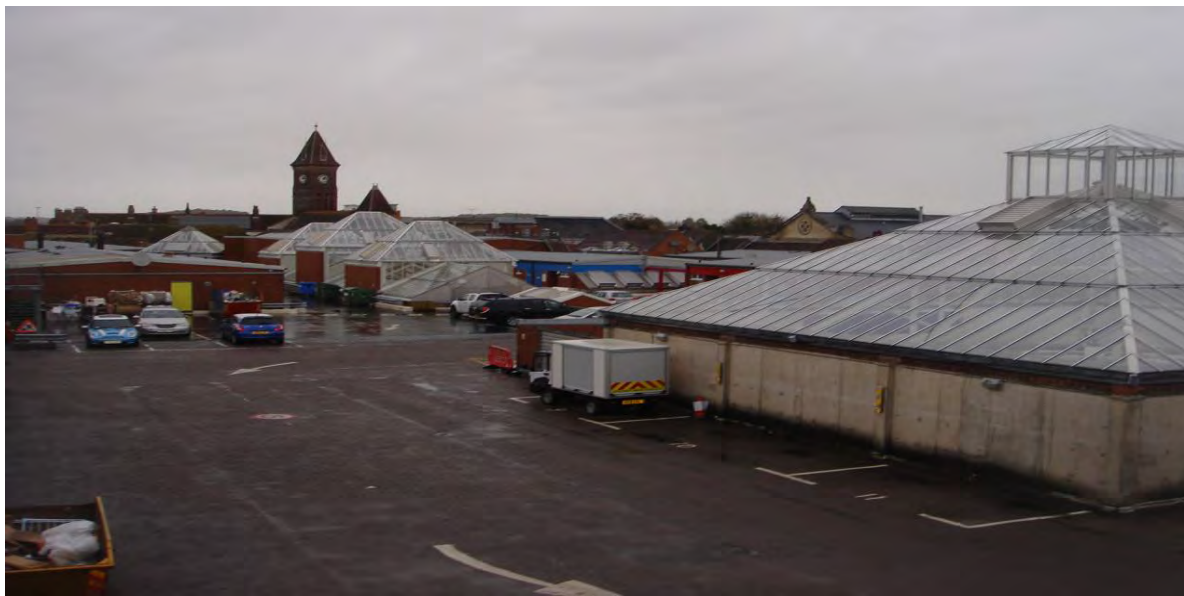
Location: 99/001 Externals

Material Description:	Visual Inspection – No Suspect Materials Found	
Identification:	N/A	
Approx. quantity:	N/A	
Accessibility	N/A	Assessment Score
Product type:	N/A	N/A
Extent of Damage:	N/A	N/A
Surface Treatment:	N/A	N/A
Asbestos type:	N/A	N/A
Material Assessment Score:		N/A
Priority Assessment Score:		N/A
Action:	N/A	
Comments:	N/A

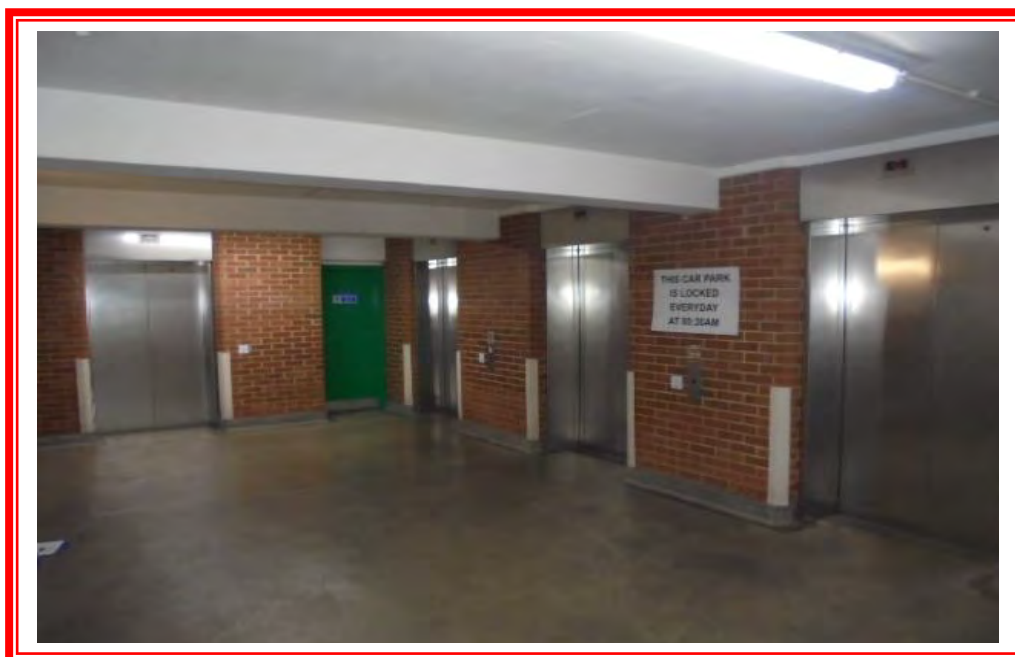
Location: Lift/Lift Shaft

Material Description:	No Access within Lift Shaft	
Identification:	Presumed to Contain Asbestos	
Approx. quantity:	X 4 Lifts	
Accessibility	Low	Assessment Score
Product type:	No Access	3
Extent of Damage:	No Access	3
Surface Treatment:	No Access	3
Asbestos type:	No Access	3
Material Assessment Score:		12
Priority Assessment Score:		High
Action:	Manage	
Comments:	No Access as no lift engineer was onsite

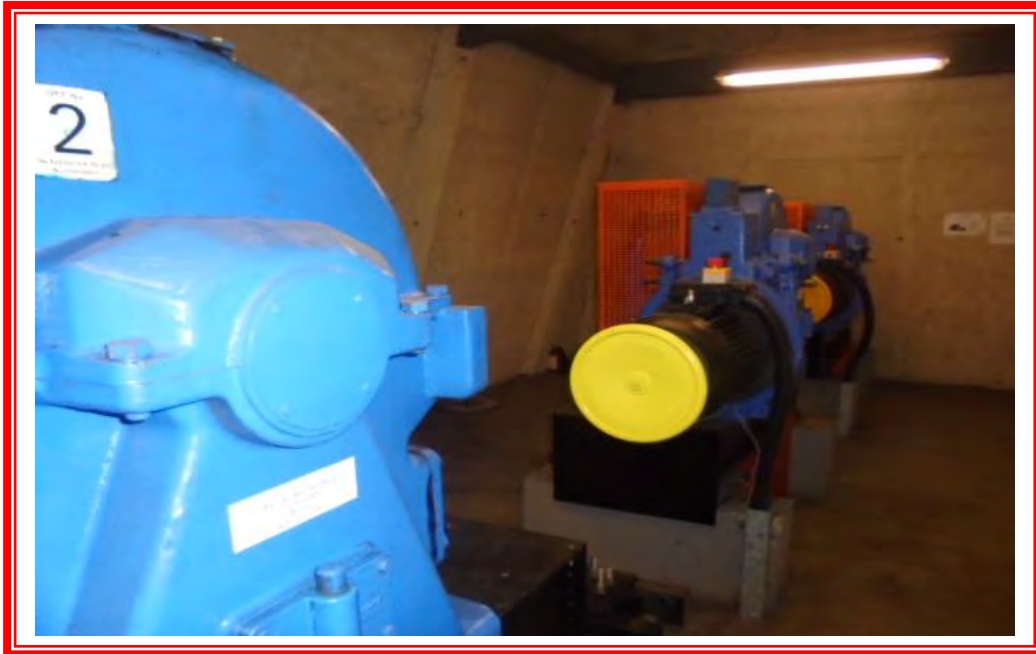
Location: 4/001 Lift Engineer Room

Material Description:	No Access within Lift Motors	
Identification:	Presumed to Contain Asbestos	
Approx. quantity:	X 4 Units	
Accessibility	Low	Assessment Score
Product type:	No Access	2
Extent of Damage:	No Access	1
Surface Treatment:	No Access	1
Asbestos type:	No Access	1
Material Assessment Score:		5
Priority Assessment Score:		Low
Action:	Manage	
Comments:	No Access as Live

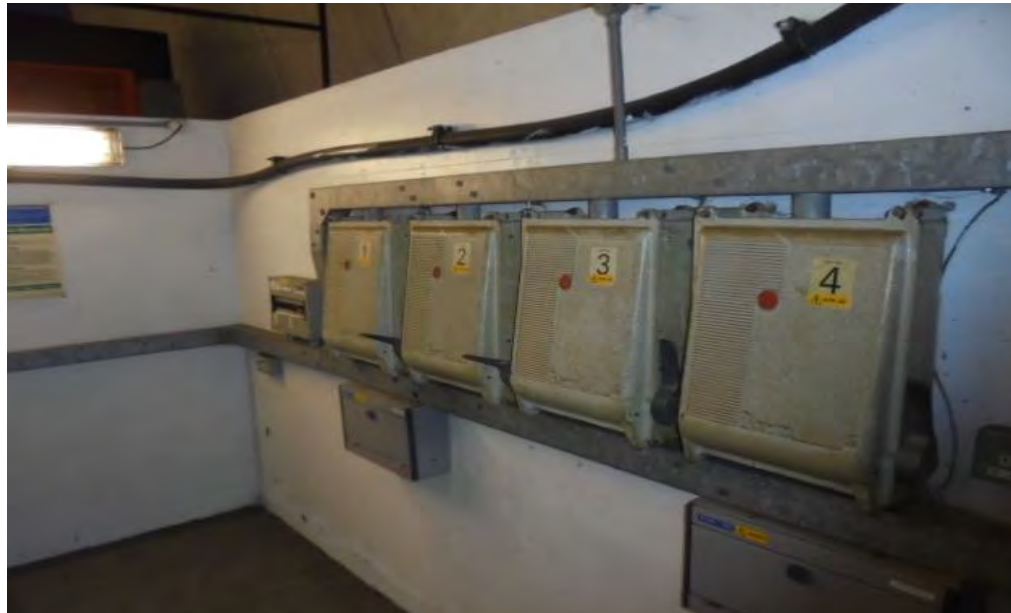
Location: 4/001 Lift Motor Room

Material Description:	No Access within Live Electrics	
Identification:	Presumed to Contain Asbestos	
Approx. quantity:	X 4 Panels	
Accessibility	Low	Assessment Score
Product type:	No Access	2
Extent of Damage:	No Access	1
Surface Treatment:	No Access	1
Asbestos type:	No Access	1
Material Assessment Score:		5
Priority Assessment Score:		Low
Action:	Manage	
Comments:	No Access as Live

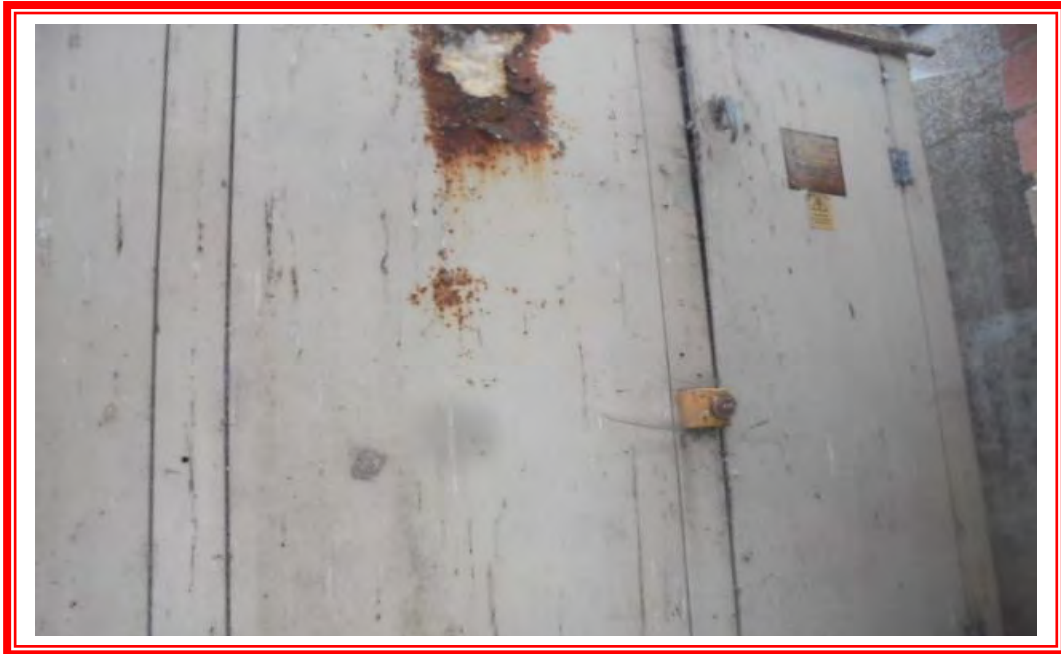
Location: 3/006 Fan Room

Material Description:	No Access within Live Unit	
Identification:	Presumed to Contain Asbestos	
Approx. quantity:	X 1 Unit	
Accessibility	Low	Assessment Score
Product type:	No Access	3
Extent of Damage:	No Access	3
Surface Treatment:	No Access	3
Asbestos type:	No Access	3
Material Assessment Score:		12
Priority Assessment Score:		High
Action:	Manage	
Comments:	No Access as Live

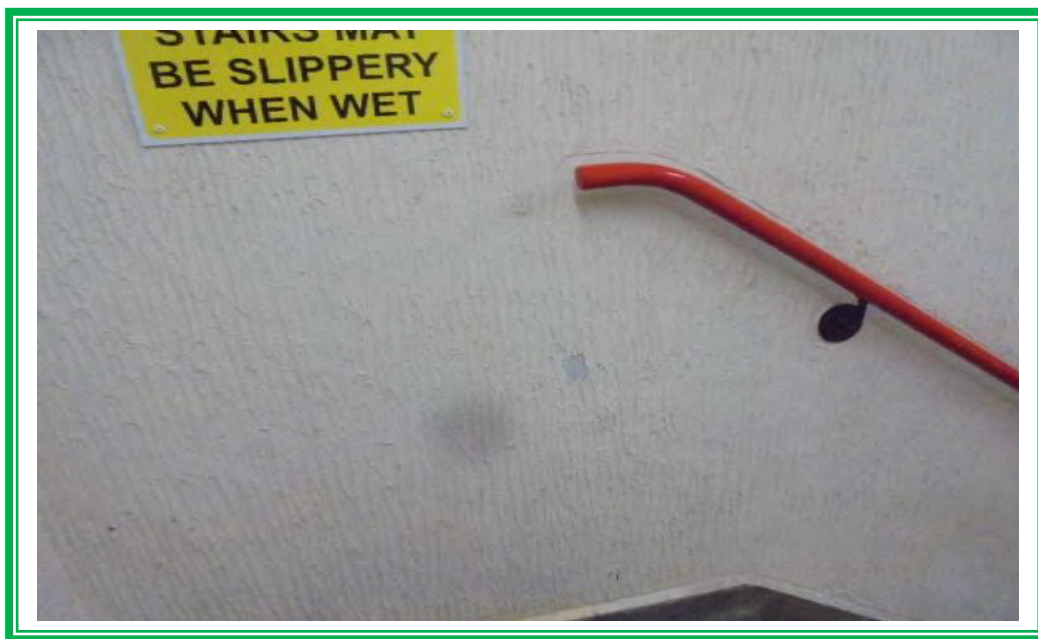
Location: 3/001 South East Stairwell

Material Description:	Textured Coating to Walls	
Identification:	Sampled – No Asbestos Detected	
Approx. quantity:	25M2	
Accessibility	N/A	Assessment Score
Product type:	N/A	N/A
Extent of Damage:	N/A	N/A
Surface Treatment:	N/A	N/A
Asbestos type:	N/A	N/A
Material Assessment Score:		N/A
Priority Assessment Score:		N/A
Action:	N/A	
Comments:	N/A

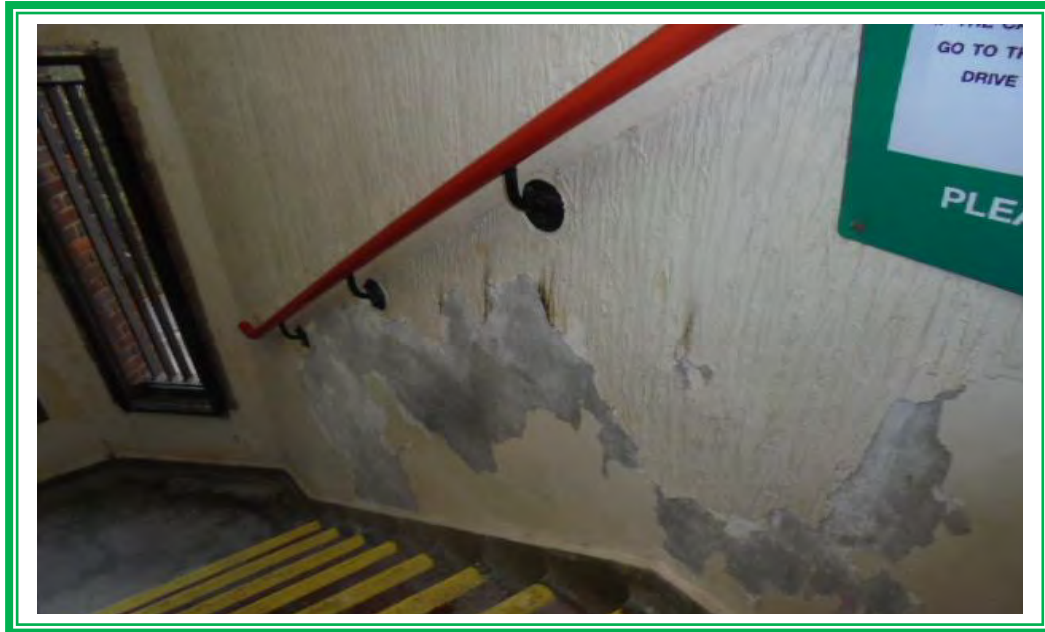
Location: 3/002 South West Stairwell – Level 2 and 3

Material Description:	Textured Coating to Walls	
Identification:	As Per Sample NE/1 – No Asbestos Detected	
Approx. quantity:	25M2	
Accessibility	N/A	Assessment Score
Product type:	N/A	N/A
Extent of Damage:	N/A	N/A
Surface Treatment:	N/A	N/A
Asbestos type:	N/A	N/A
Material Assessment Score:		N/A
Priority Assessment Score:		N/A
Action:	N/A	
Comments:	N/A

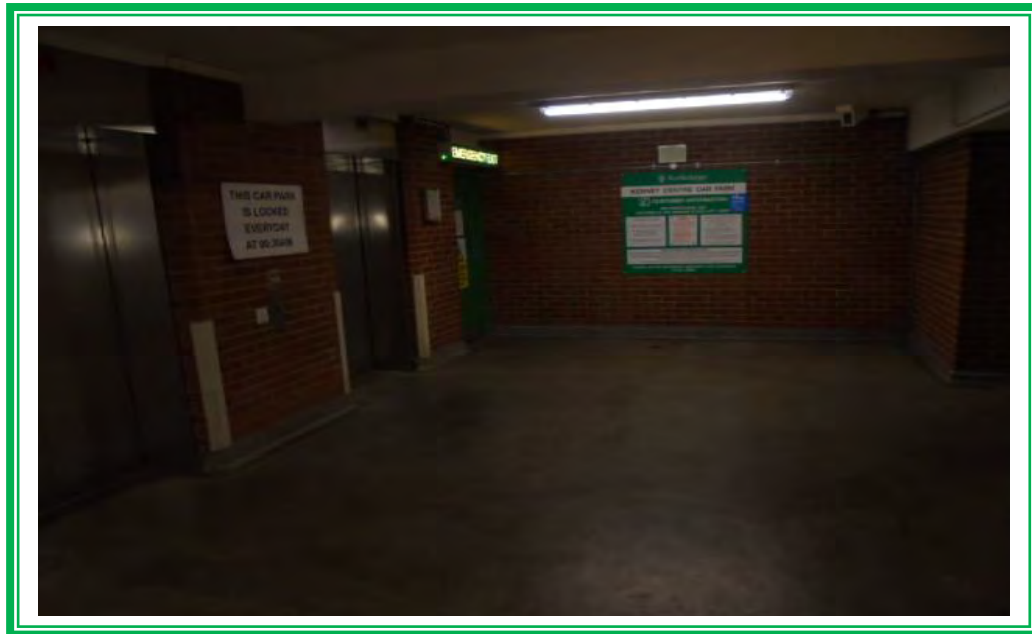
Location: 3/003 Lift Lobby

Material Description:	Visual Inspection – No Suspect Materials Found	
Identification:	N/A	
Approx. quantity:	N/A	
Accessibility	N/A	Assessment Score
Product type:	N/A	N/A
Extent of Damage:	N/A	N/A
Surface Treatment:	N/A	N/A
Asbestos type:	N/A	N/A
Material Assessment Score:		N/A
Priority Assessment Score:		N/A
Action:	N/A	
Comments:	N/A

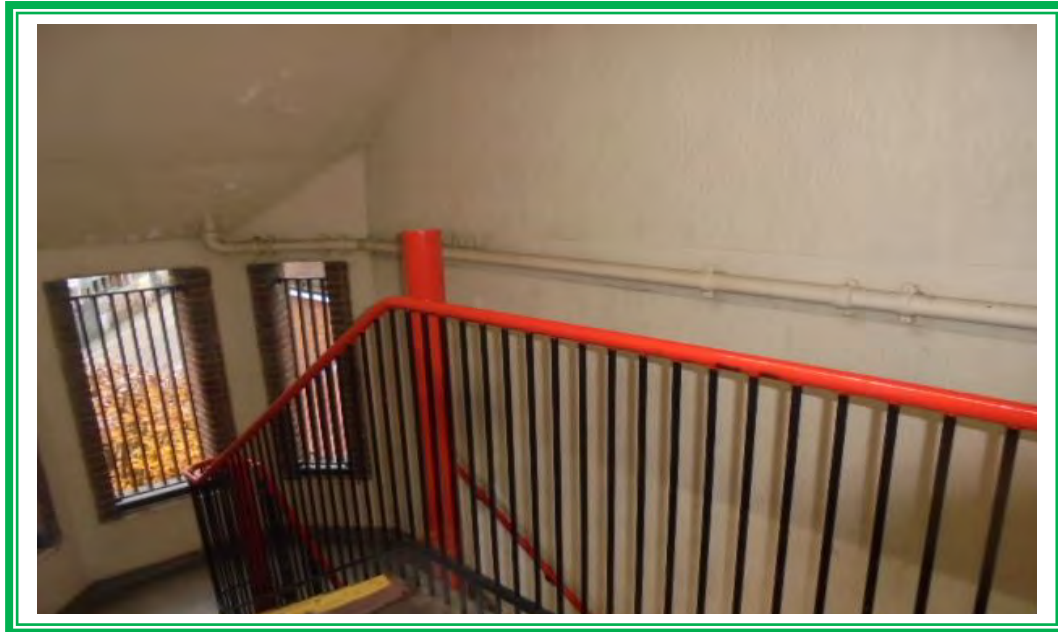
Location: 3/004 North Stairwell

Material Description:	Textured Coating to Walls	
Identification:	As Per Sample NE/1 – No Asbestos Detected	
Approx. quantity:	40M2	
Accessibility	N/A	Assessment Score
Product type:	N/A	N/A
Extent of Damage:	N/A	N/A
Surface Treatment:	N/A	N/A
Asbestos type:	N/A	N/A
Material Assessment Score:		N/A
Priority Assessment Score:		N/A
Action:	N/A	
Comments:	N/A

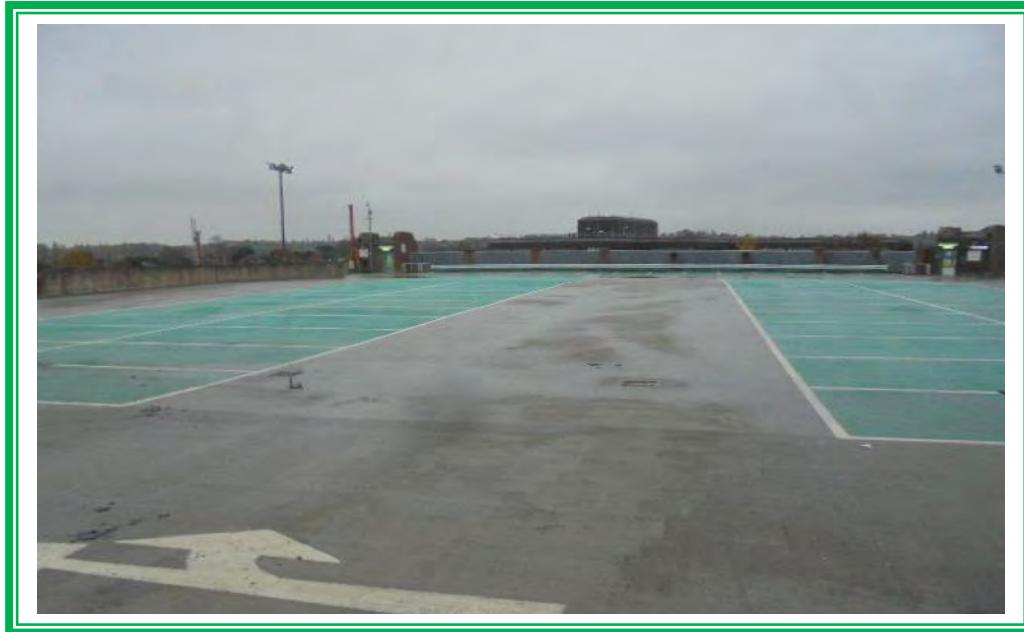
Location: 3/005 External Car Park

Material Description:	Visual Inspection – No Suspect Materials Found	
Identification:	N/A	
Approx. quantity:	N/A	
Accessibility	N/A	Assessment Score
Product type:	N/A	N/A
Extent of Damage:	N/A	N/A
Surface Treatment:	N/A	N/A
Asbestos type:	N/A	N/A
Material Assessment Score:		N/A
Priority Assessment Score:		N/A
Action:	N/A	
Comments:	N/A

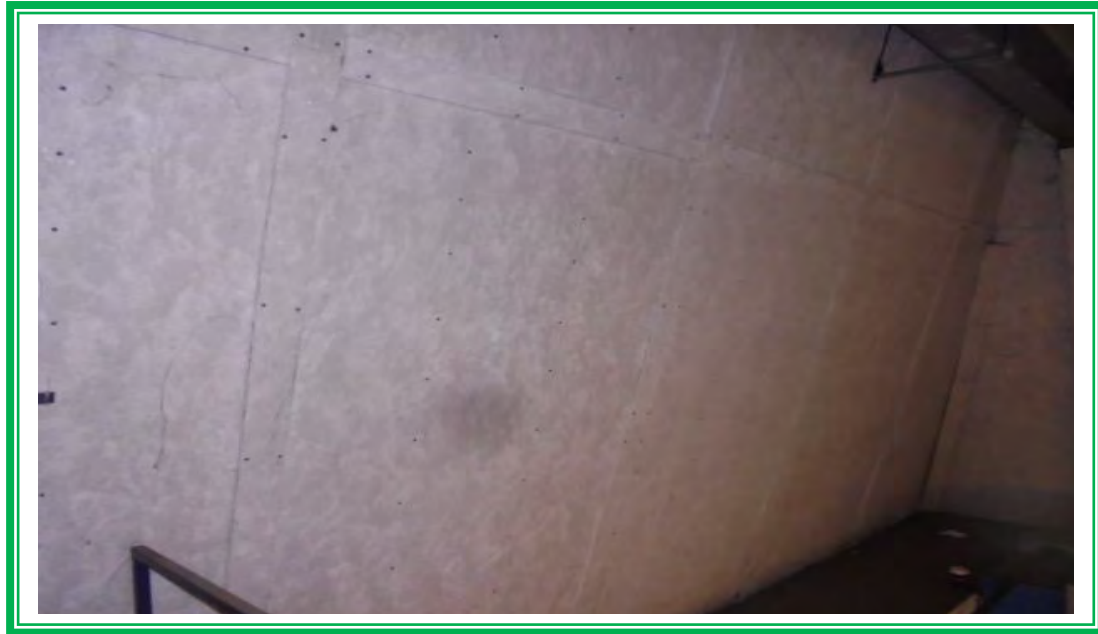
Location: 4/001 Lift Motor Room

Material Description:	Insulation Board Wall Panels	
Identification:	Sampled – No Asbestos Detected	
Approx. quantity:	60M2	
Accessibility	N/A	Assessment Score
Product type:	N/A	N/A
Extent of Damage:	N/A	N/A
Surface Treatment:	N/A	N/A
Asbestos type:	N/A	N/A
Material Assessment Score:		N/A
Priority Assessment Score:		N/A
Action:	N/A	
Comments:	N/A

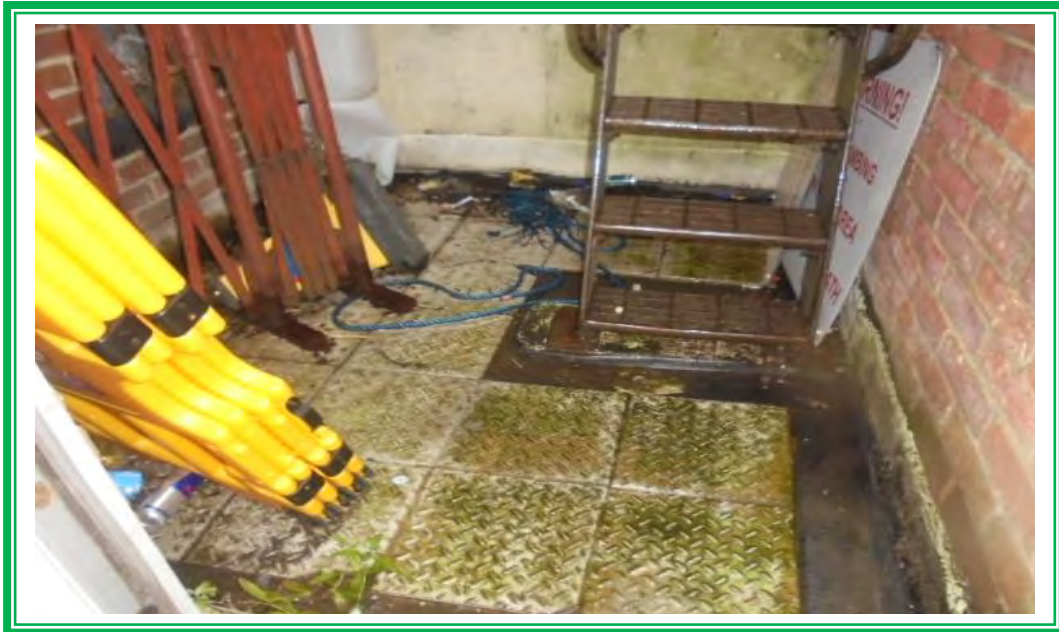
Location: 4/002 Ladder Landing and Lobby

Material Description:	Prominade Tiles	
Identification:	Sampled – No Asbestos Detected	
Approx. quantity:	6M2	
Accessibility	N/A	Assessment Score
Product type:	N/A	N/A
Extent of Damage:	N/A	N/A
Surface Treatment:	N/A	N/A
Asbestos type:	N/A	N/A
Material Assessment Score:		N/A
Priority Assessment Score:		N/A
Action:	N/A	
Comments:	N/A

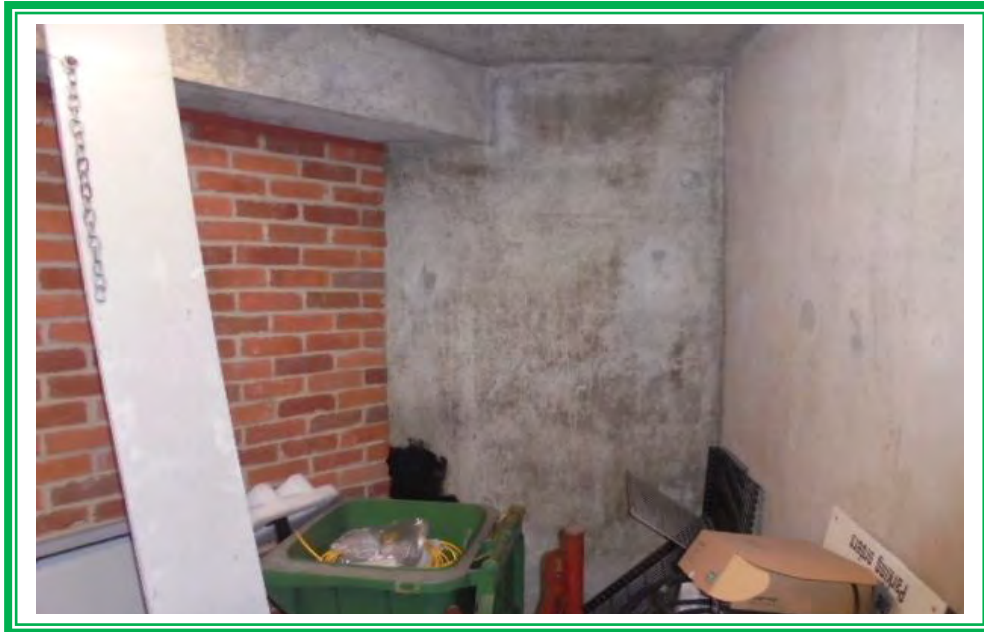
Location: 2/001 Comms Room

Material Description:	Visual Inspection – No Suspect Materials Found	
Identification:	N/A	
Approx. quantity:	N/A	
Accessibility	N/A	Assessment Score
Product type:	N/A	N/A
Extent of Damage:	N/A	N/A
Surface Treatment:	N/A	N/A
Asbestos type:	N/A	N/A
Material Assessment Score:		N/A
Priority Assessment Score:		N/A
Action:	N/A	
Comments:	N/A

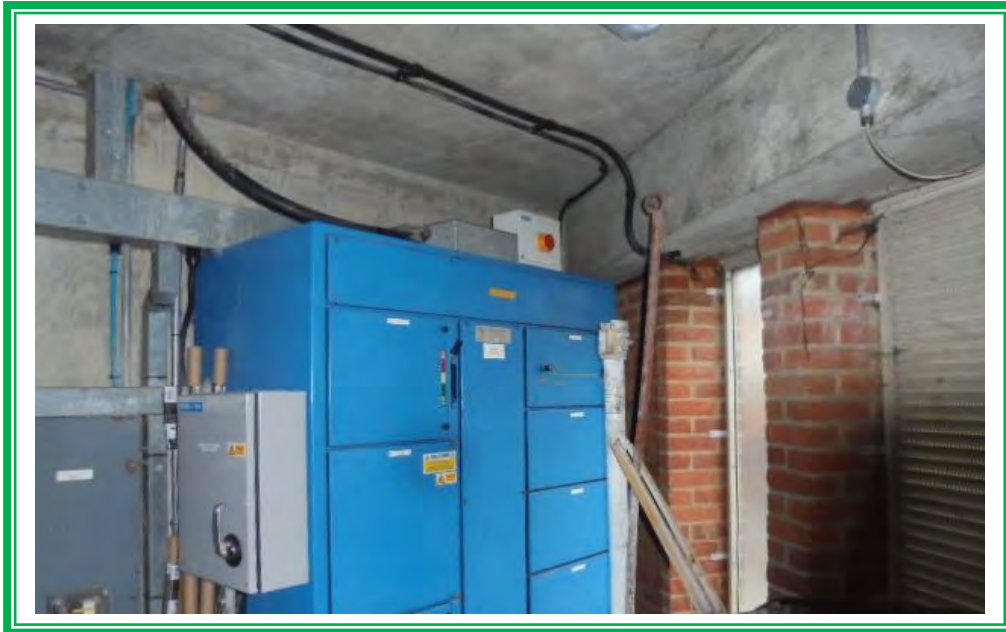
Location: 1/001 Switch Room

Material Description:	Visual Inspection – No Suspect Materials Found	
Identification:	N/A	
Approx. quantity:	N/A	
Accessibility	N/A	Assessment Score
Product type:	N/A	N/A
Extent of Damage:	N/A	N/A
Surface Treatment:	N/A	N/A
Asbestos type:	N/A	N/A
Material Assessment Score:		N/A
Priority Assessment Score:		N/A
Action:	N/A	
Comments:	No access within live electrics

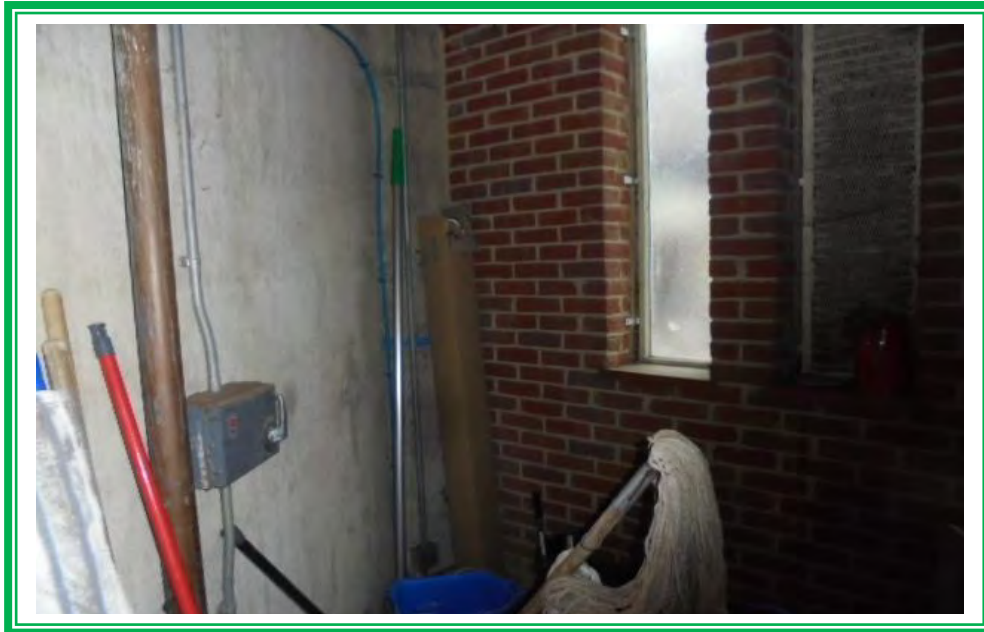
Location: 0/001 Cleaners Cupboard

Material Description:	Visual Inspection – No Suspect Materials Found	
Identification:	N/A	
Approx. quantity:	N/A	
Accessibility	N/A	Assessment Score
Product type:	N/A	N/A
Extent of Damage:	N/A	N/A
Surface Treatment:	N/A	N/A
Asbestos type:	N/A	N/A
Material Assessment Score:		N/A
Priority Assessment Score:		N/A
Action:	N/A	
Comments:	N/A

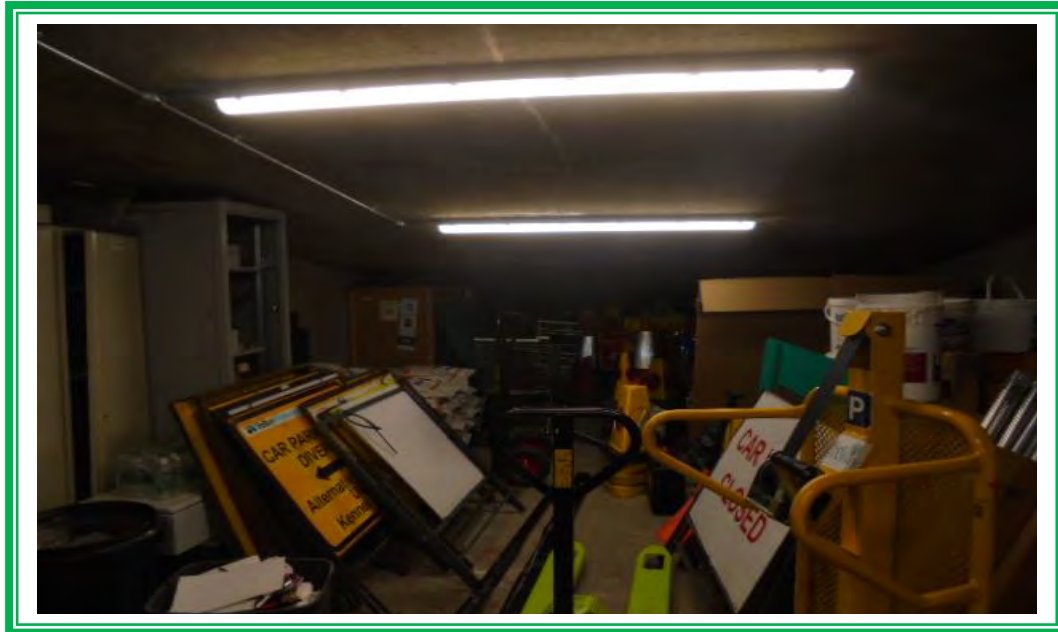
Location: 0/002 Under Ramp Store

Material Description:	Visual Inspection – No Suspect Materials Found	
Identification:	N/A	
Approx. quantity:	N/A	
Accessibility	N/A	Assessment Score
Product type:	N/A	N/A
Extent of Damage:	N/A	N/A
Surface Treatment:	N/A	N/A
Asbestos type:	N/A	N/A
Material Assessment Score:		N/A
Priority Assessment Score:		N/A
Action:	N/A	
Comments:	N/A
