Project Number 3113

Management Asbestos Survey Report

Kennet Centre, Market Street, Newbury,
Berkshire, RG14 5EN

3 Market Place and Associated Store

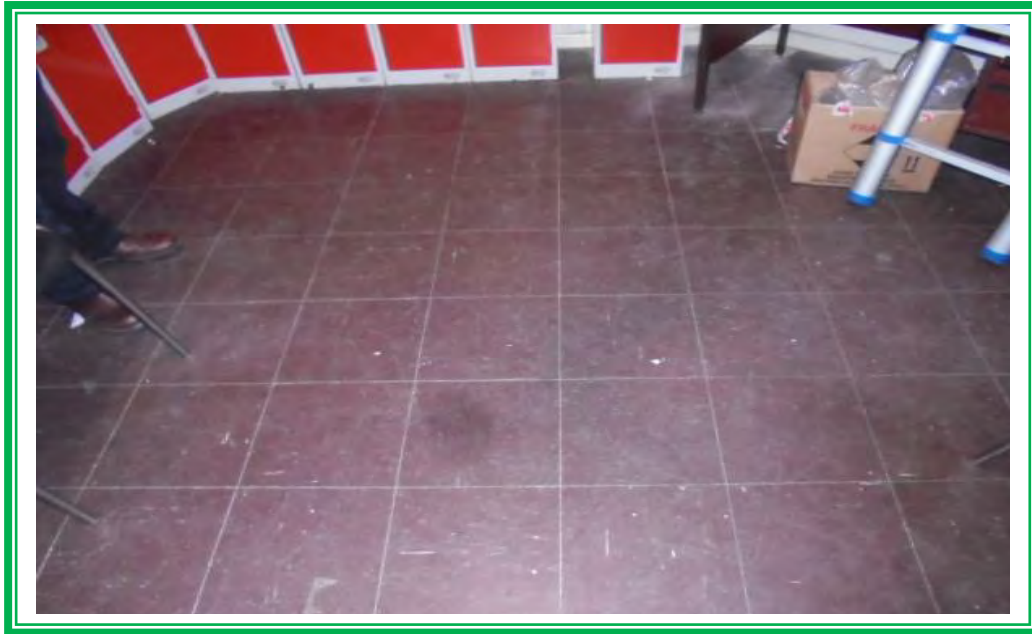
Location: 0/003 Lobby and Locker Room

Material Description:	Floor Tiles	
Identification:	Sampled – No Asbestos Detected	
Approx. quantity:	18M2	
Accessibility	N/A	Assessment Score
Product type:	N/A	N/A
Extent of Damage:	N/A	N/A
Surface Treatment:	N/A	N/A
Asbestos type:	N/A	N/A
Material Assessment Score:		N/A
Priority Assessment Score:		N/A
Action:	N/A	
Comments:	N/A

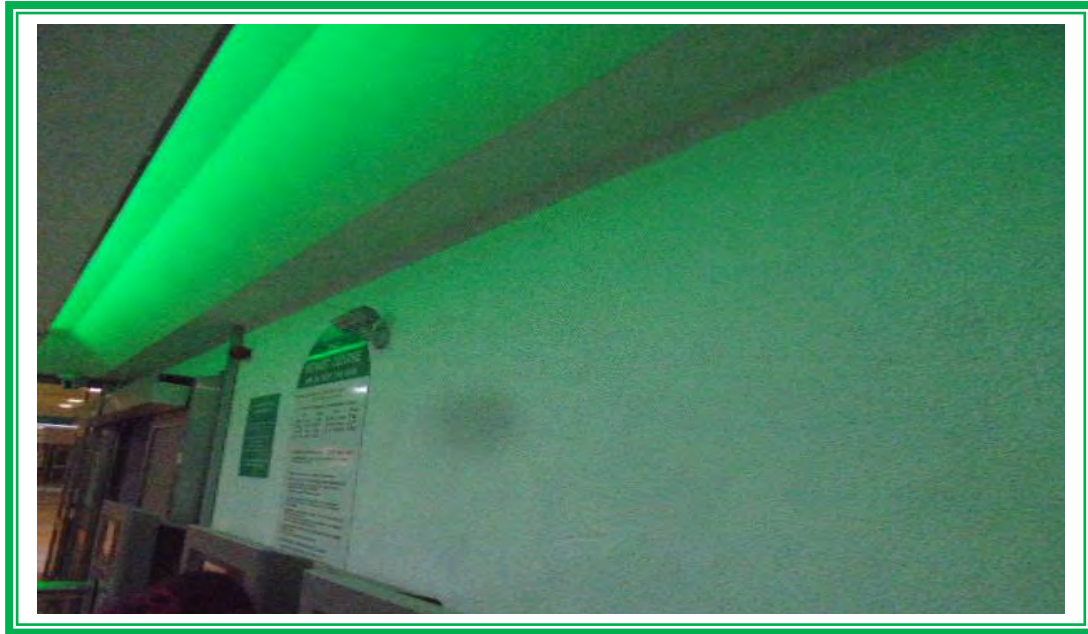
Location: 0/004 Lift Lobby

Material Description:	Textured Coating to Walls	
Identification:	Sampled – No Asbestos Detected	
Approx. quantity:	20M2	
Accessibility	N/A	Assessment Score
Product type:	N/A	N/A
Extent of Damage:	N/A	N/A
Surface Treatment:	N/A	N/A
Asbestos type:	N/A	N/A
Material Assessment Score:		N/A
Priority Assessment Score:		N/A
Action:	N/A	
Comments:	N/A

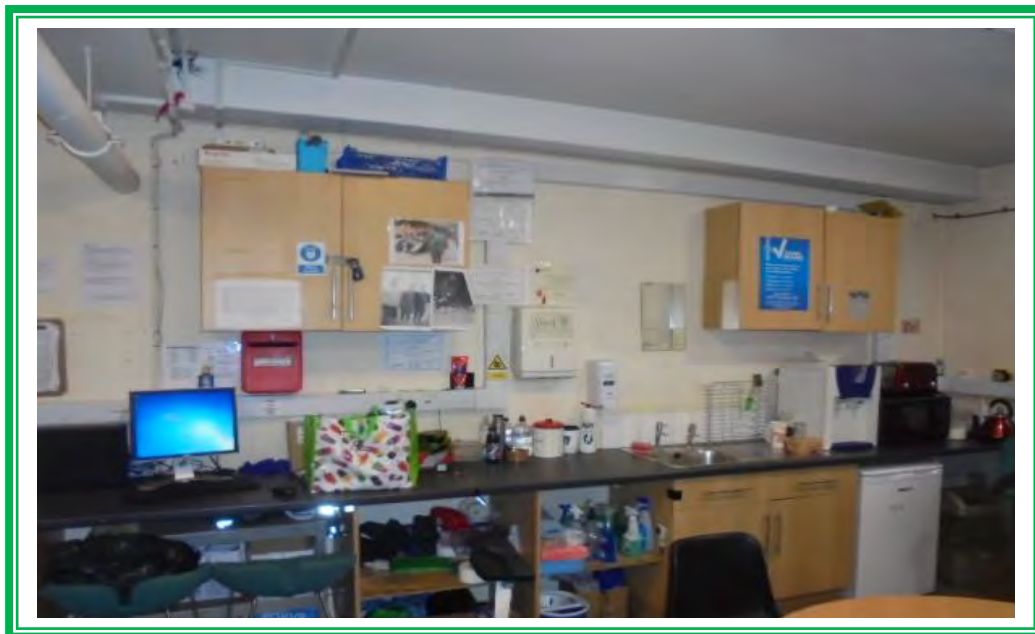
Location: **0/004 Staff Room and WC's x 2**

Material Description:	Visual Inspection – No Suspect Materials Found	
Identification:	N/A	
Approx. quantity:	N/A	
Accessibility	N/A	Assessment Score
Product type:	N/A	N/A
Extent of Damage:	N/A	N/A
Surface Treatment:	N/A	N/A
Asbestos type:	N/A	N/A
Material Assessment Score:		N/A
Priority Assessment Score:		N/A
Action:	N/A	
Comments:	N/A

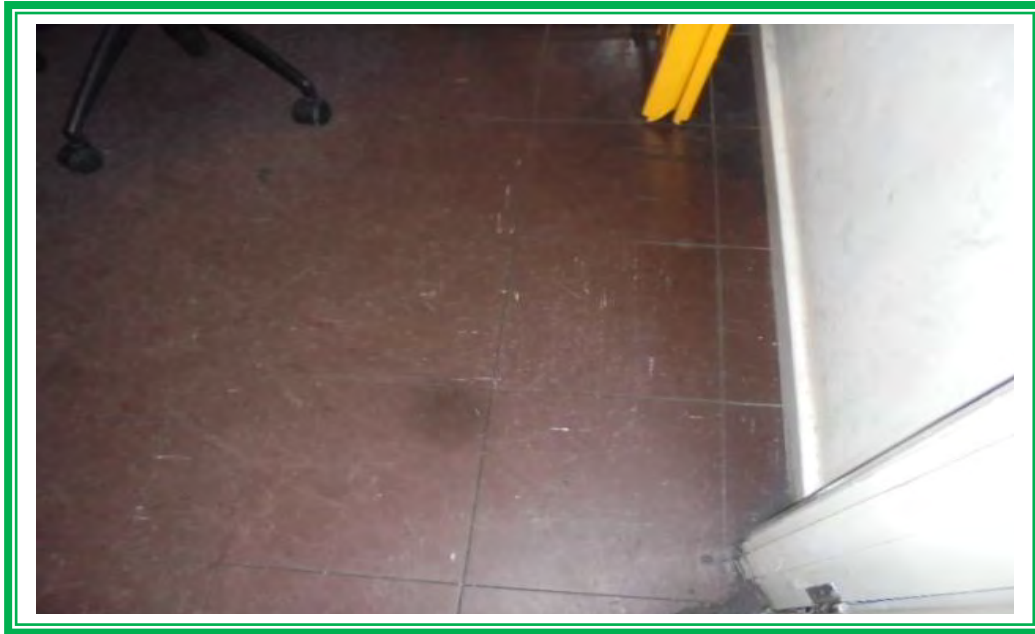
Location: 0/005 Comms Room

Material Description:	Floor Tiles	
Identification:	As Per Sample NE/4 – No Asbestos Detected	
Approx. quantity:	4M2	
Accessibility	N/A	Assessment Score
Product type:	N/A	N/A
Extent of Damage:	N/A	N/A
Surface Treatment:	N/A	N/A
Asbestos type:	N/A	N/A
Material Assessment Score:		N/A
Priority Assessment Score:		N/A
Action:	N/A	
Comments:	N/A

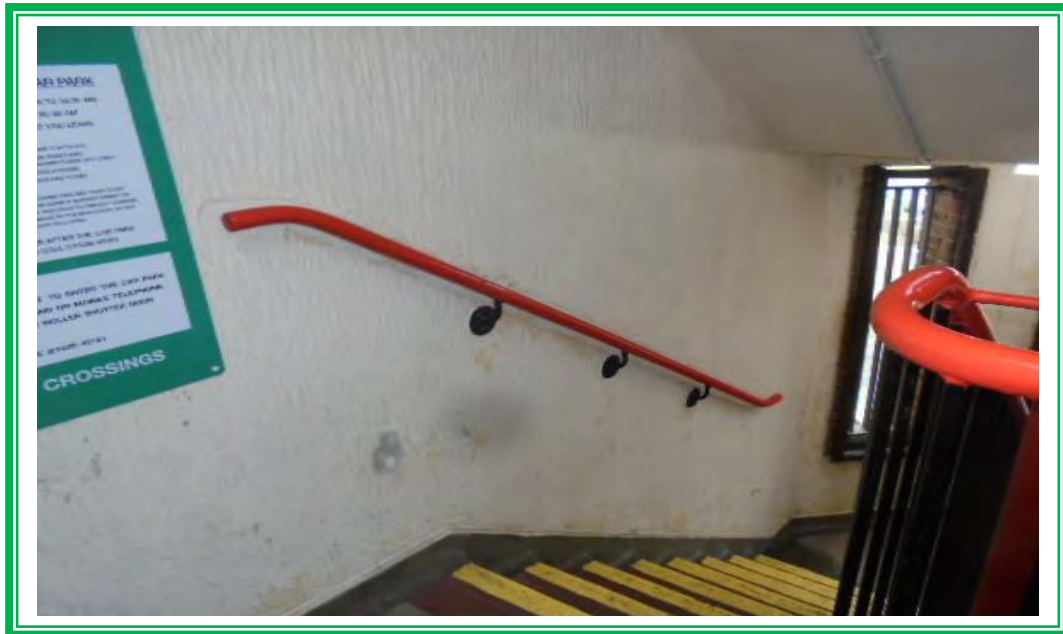
Location: 2/002 South East Stairwell – Level 1 and 2

Material Description:	Textured Coating to Walls	
Identification:	As Per Sample NE/6 – No Asbestos Detected	
Approx. quantity:	25M2	
Accessibility	N/A	Assessment Score
Product type:	N/A	N/A
Extent of Damage:	N/A	N/A
Surface Treatment:	N/A	N/A
Asbestos type:	N/A	N/A
Material Assessment Score:		N/A
Priority Assessment Score:		N/A
Action:	N/A	
Comments:	N/A

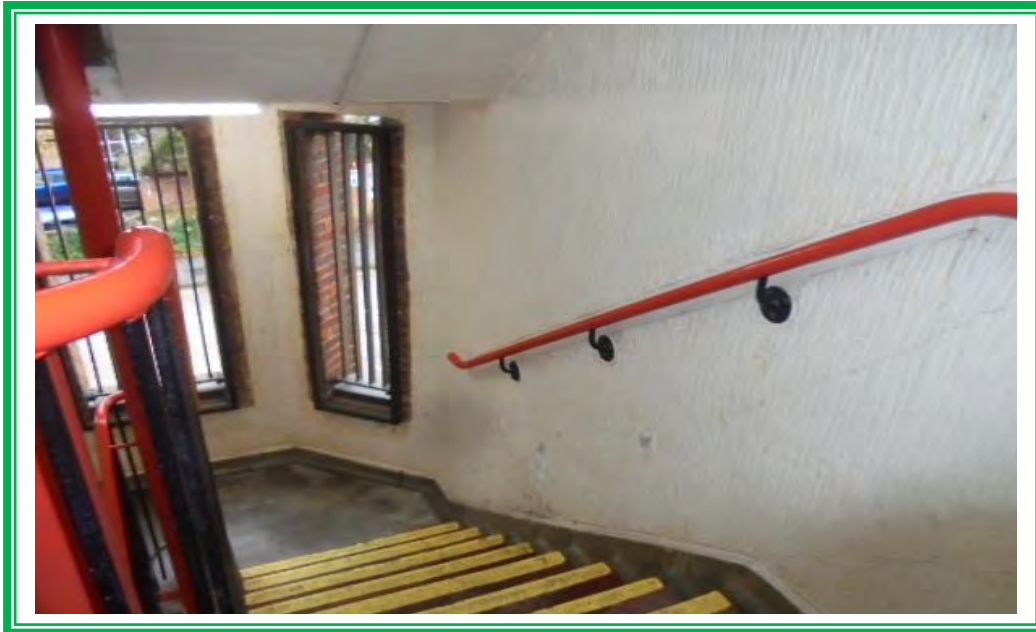
Location: 2/003 South West Stairwell – Level 1 and 2

Material Description:	Textured Coating to Walls	
Identification:	Sampled – No Asbestos Detected	
Approx. quantity:	25M2	
Accessibility	N/A	Assessment Score
Product type:	N/A	N/A
Extent of Damage:	N/A	N/A
Surface Treatment:	N/A	N/A
Asbestos type:	N/A	N/A
Material Assessment Score:		N/A
Priority Assessment Score:		N/A
Action:	N/A	
Comments:	N/A

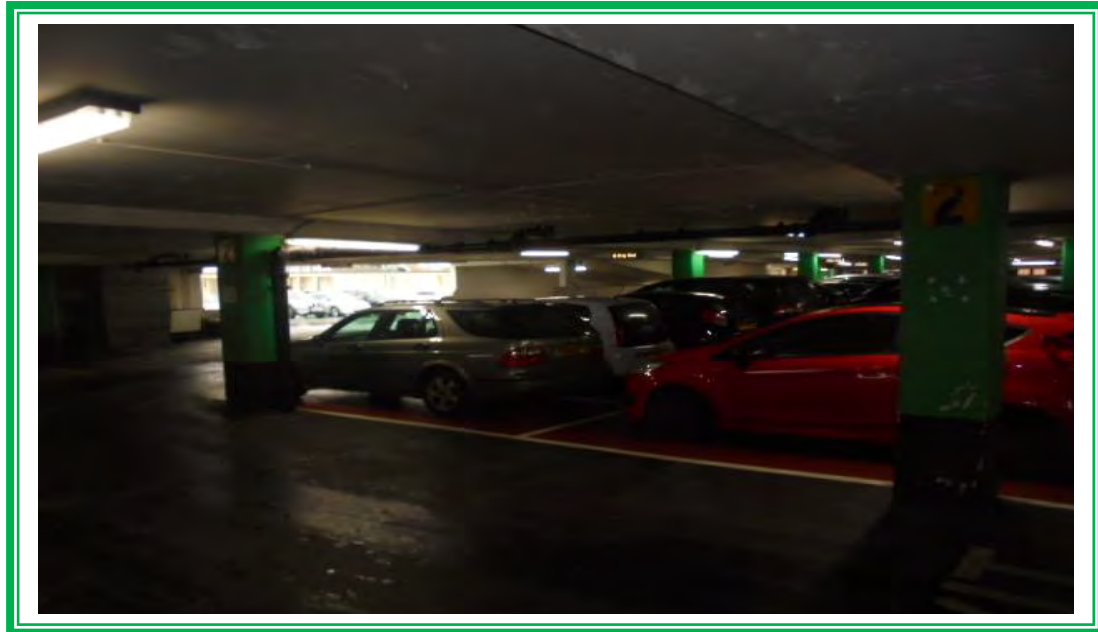
Location: 2/004 Car Park

Material Description:	Visual Inspection – No Suspect Materials Found	
Identification:	N/A	
Approx. quantity:	N/A	
Accessibility	N/A	Assessment Score
Product type:	N/A	N/A
Extent of Damage:	N/A	N/A
Surface Treatment:	N/A	N/A
Asbestos type:	N/A	N/A
Material Assessment Score:		N/A
Priority Assessment Score:		N/A
Action:	N/A	
Comments:	N/A

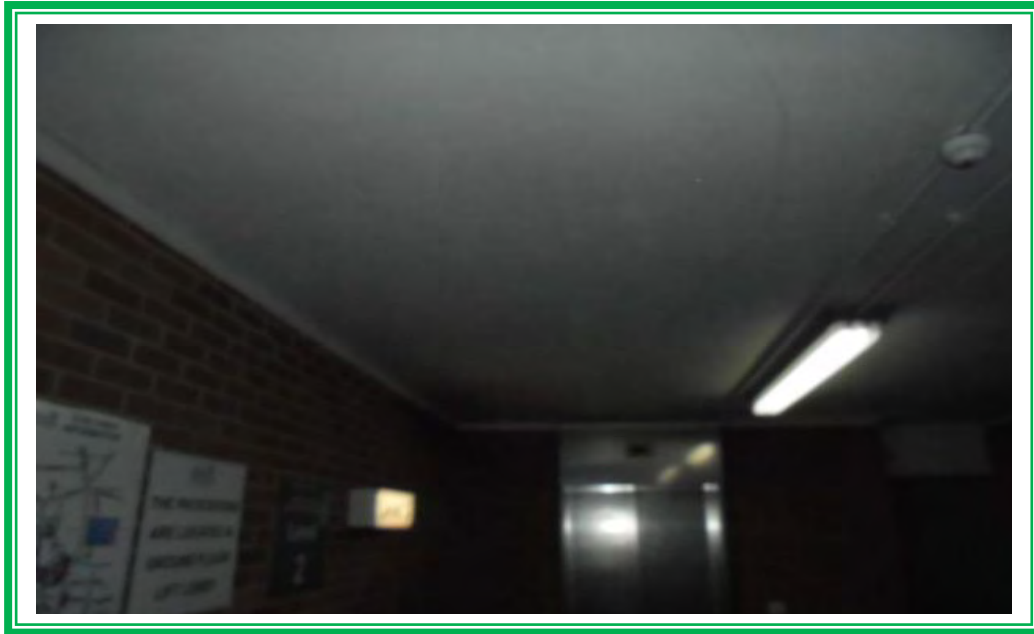
Location: 2/005 Lift Lobby

Material Description:	Visual Inspection – No Suspect Materials Found	
Identification:	N/A	
Approx. quantity:	N/A	
Accessibility	N/A	Assessment Score
Product type:	N/A	N/A
Extent of Damage:	N/A	N/A
Surface Treatment:	N/A	N/A
Asbestos type:	N/A	N/A
Material Assessment Score:		N/A
Priority Assessment Score:		N/A
Action:	N/A	
Comments:	N/A

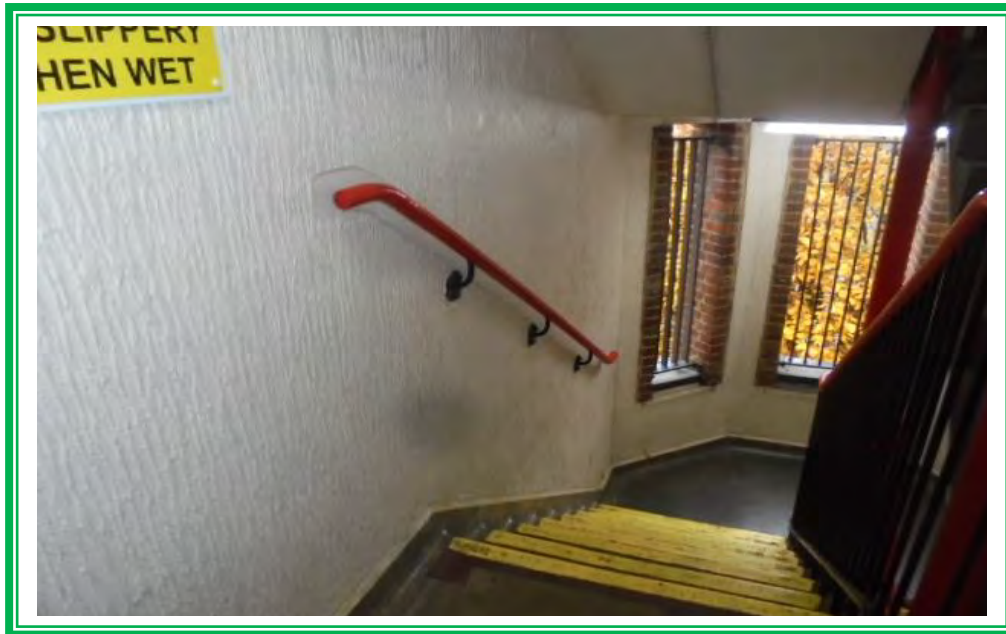
Location: 2/006 North Stairwell – Level 1 and 2

Material Description:	Textured Coating to Walls	
Identification:	As Per Sample NE/6 – No Asbestos Detected	
Approx. quantity:	40M2	
Accessibility	N/A	Assessment Score
Product type:	N/A	N/A
Extent of Damage:	N/A	N/A
Surface Treatment:	N/A	N/A
Asbestos type:	N/A	N/A
Material Assessment Score:		N/A
Priority Assessment Score:		N/A
Action:	N/A	
Comments:	N/A

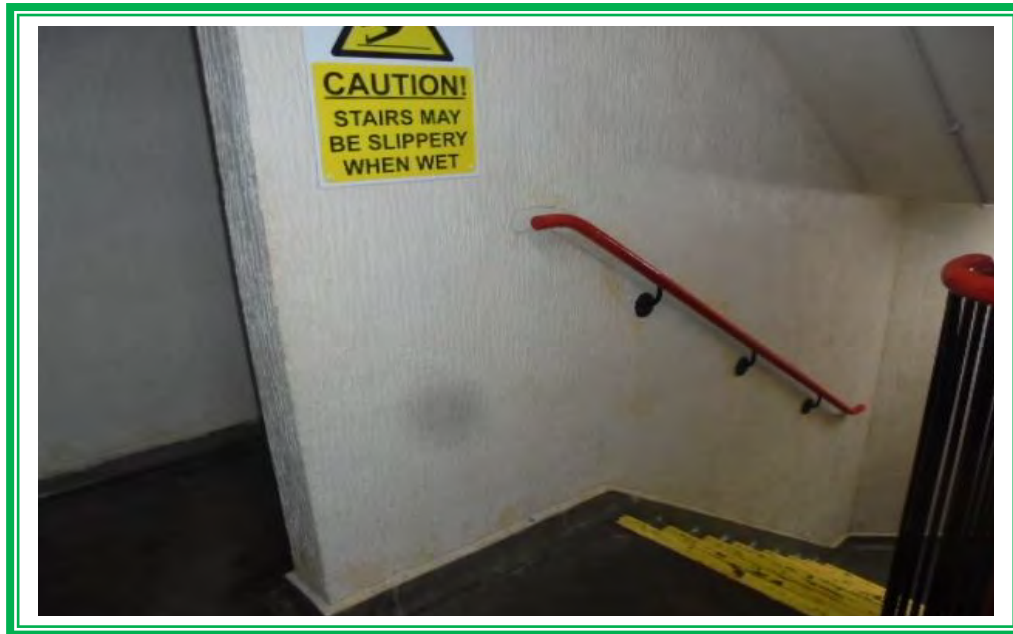
Location: 1/002 North Stairwell – Level 1 - 0

Material Description:	Textured Coating to Walls	
Identification:	Sampled – No Asbestos Detected	
Approx. quantity:	40M2	
Accessibility	N/A	Assessment Score
Product type:	N/A	N/A
Extent of Damage:	N/A	N/A
Surface Treatment:	N/A	N/A
Asbestos type:	N/A	N/A
Material Assessment Score:		N/A
Priority Assessment Score:		N/A
Action:	N/A	
Comments:	N/A

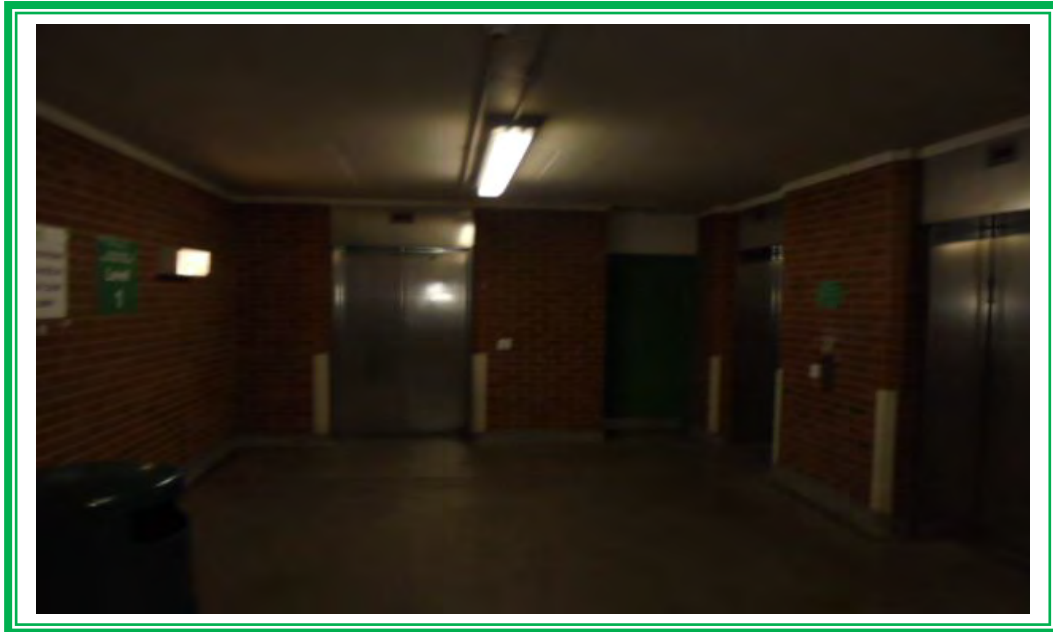
Location: 1/003 Lift Lobby

Material Description:	Visual Inspection – No Suspect Materials Found	
Identification:	N/A	
Approx. quantity:	N/A	
Accessibility	N/A	Assessment Score
Product type:	N/A	N/A
Extent of Damage:	N/A	N/A
Surface Treatment:	N/A	N/A
Asbestos type:	N/A	N/A
Material Assessment Score:		N/A
Priority Assessment Score:		N/A
Action:	N/A	
Comments:	N/A

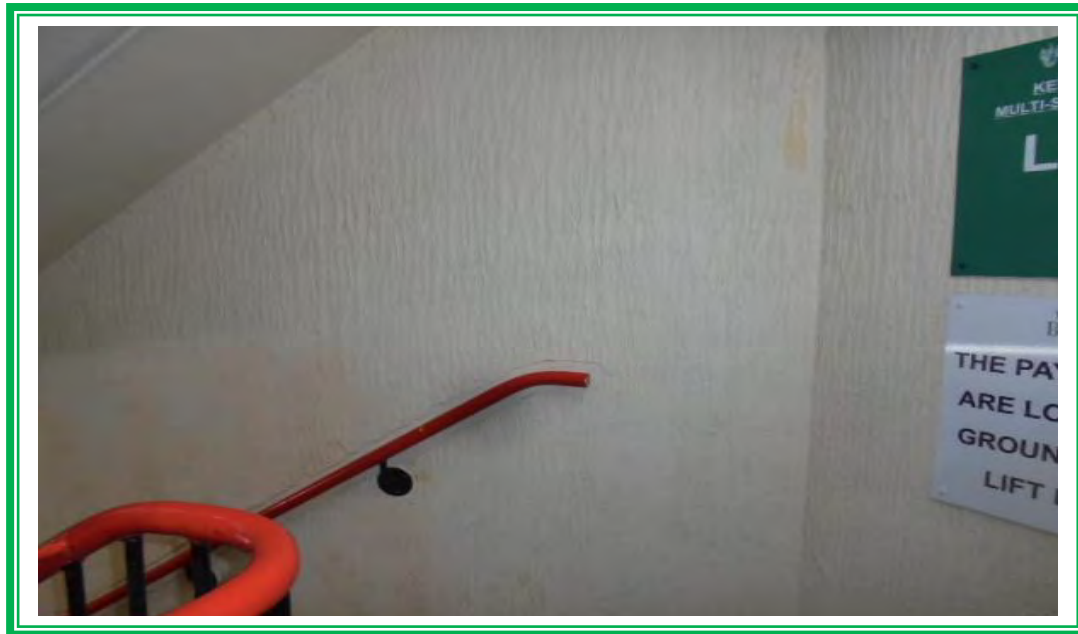
Location: 1/004 South West Stairwell - Level 1 - 0

Material Description:	Textured Coating to Walls	
Identification:	As Per Sample NE/7 – No Asbestos Detected	
Approx. quantity:	25M2	
Accessibility	N/A	Assessment Score
Product type:	N/A	N/A
Extent of Damage:	N/A	N/A
Surface Treatment:	N/A	N/A
Asbestos type:	N/A	N/A
Material Assessment Score:		N/A
Priority Assessment Score:		N/A
Action:	N/A	
Comments:	N/A

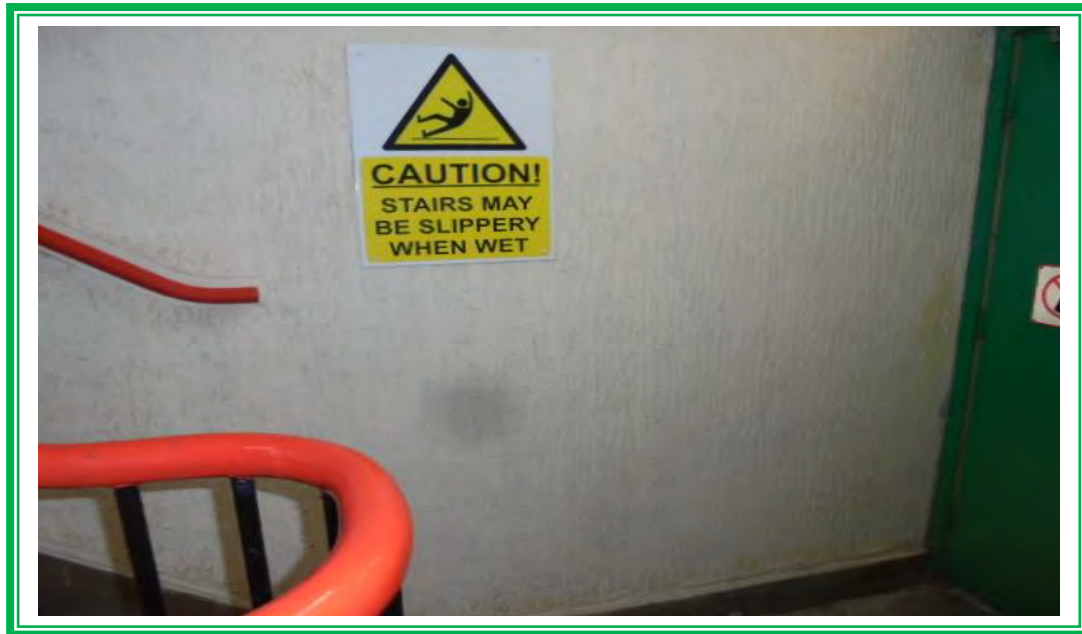
Location: 1/005 South East Stairwell – Level 1 - 0

Material Description:	Visual Inspection – No Suspect Materials Found	
Identification:	N/A	
Approx. quantity:	N/A	
Accessibility	N/A	Assessment Score
Product type:	N/A	N/A
Extent of Damage:	N/A	N/A
Surface Treatment:	N/A	N/A
Asbestos type:	N/A	N/A
Material Assessment Score:		N/A
Priority Assessment Score:		N/A
Action:	N/A	
Comments:	N/A

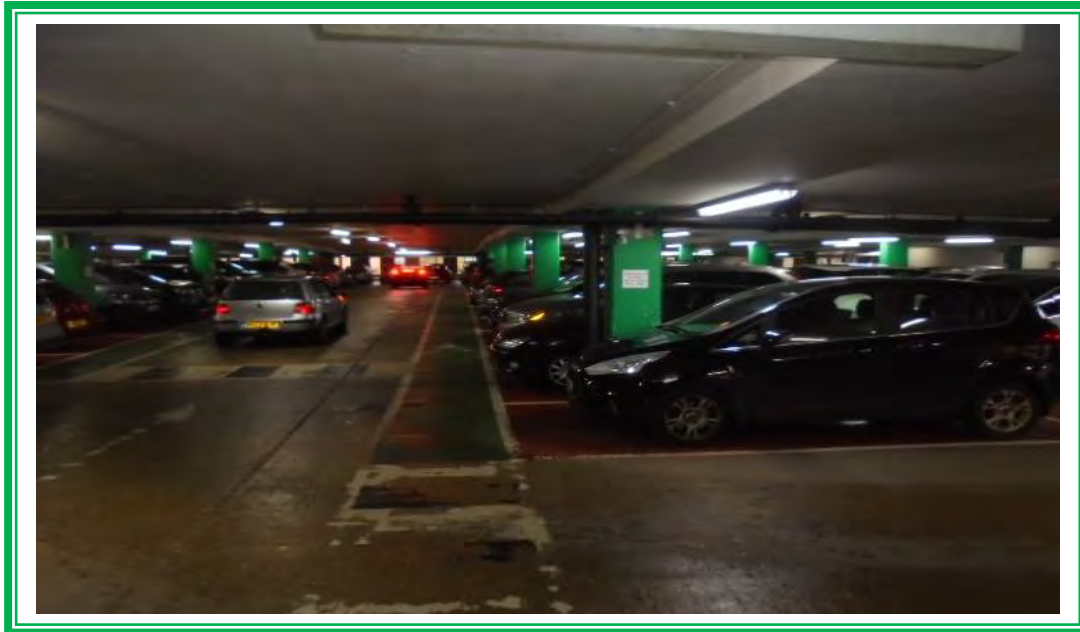
Location: 1/006 Car Park

Material Description:	Visual Inspection – No Suspect Materials Found	
Identification:	N/A	
Approx. quantity:	N/A	
Accessibility	N/A	Assessment Score
Product type:	N/A	N/A
Extent of Damage:	N/A	N/A
Surface Treatment:	N/A	N/A
Asbestos type:	N/A	N/A
Material Assessment Score:		N/A
Priority Assessment Score:		N/A
Action:	N/A	
Comments:	N/A

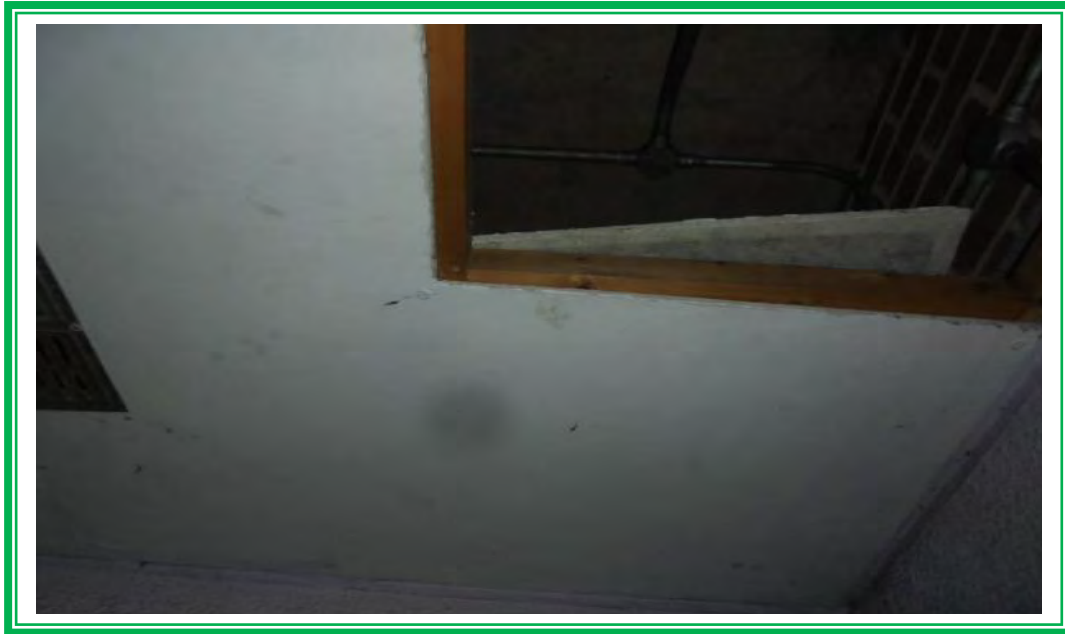
Location: 0/004 Lift Lobby

Material Description:	Insulation Board Ceiling and Hatch	
Identification:	Sampled – No Asbestos Detected	
Approx. quantity:	3M2	
Accessibility	N/A	Assessment Score
Product type:	N/A	N/A
Extent of Damage:	N/A	N/A
Surface Treatment:	N/A	N/A
Asbestos type:	N/A	N/A
Material Assessment Score:		N/A
Priority Assessment Score:		N/A
Action:	N/A	
Comments:	N/A

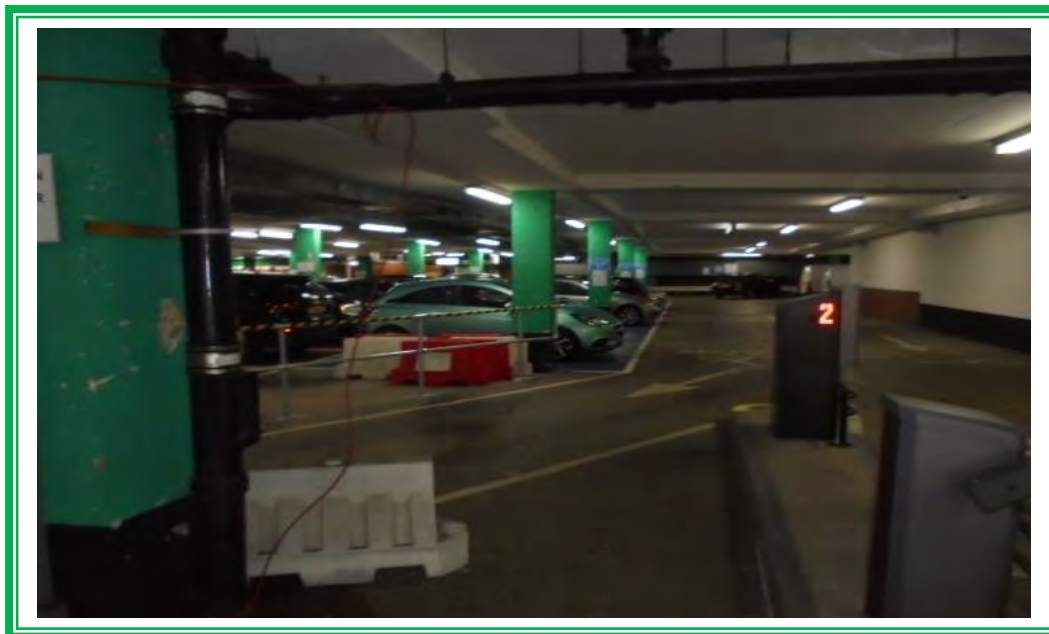
Location: 0/007 Car Park

Material Description:	Visual Inspection – No Suspect Materials Found	
Identification:	N/A	
Approx. quantity:	N/A	
Accessibility	N/A	Assessment Score
Product type:	N/A	N/A
Extent of Damage:	N/A	N/A
Surface Treatment:	N/A	N/A
Asbestos type:	N/A	N/A
Material Assessment Score:		N/A
Priority Assessment Score:		N/A
Action:	N/A	
Comments:	N/A

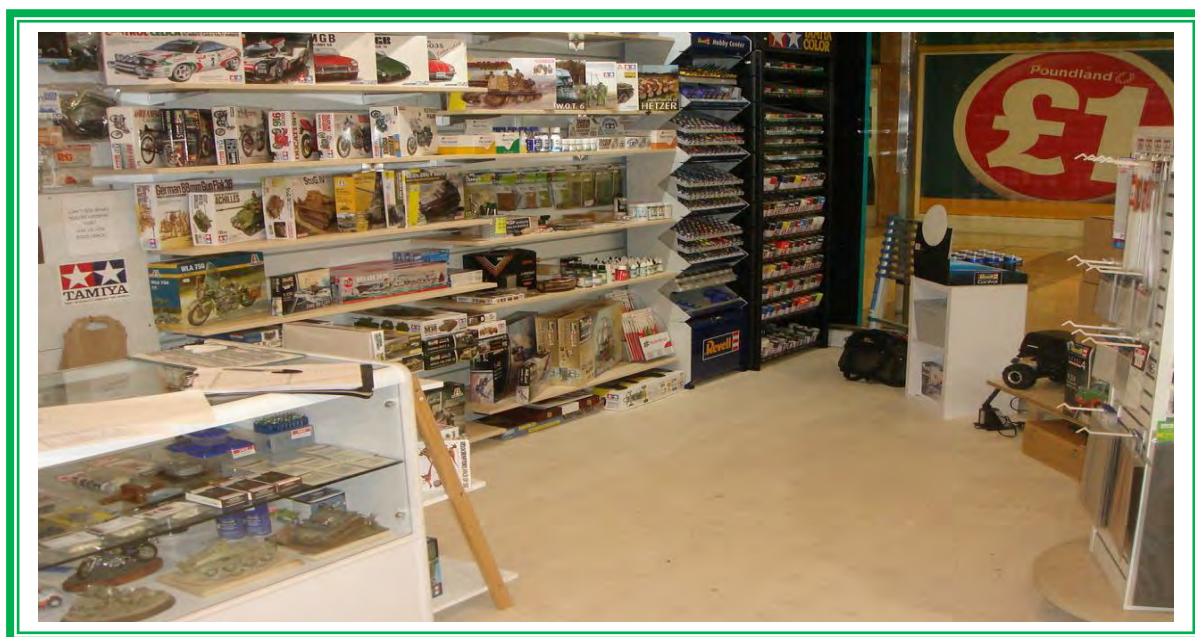
Location: 0/001 Shop Floor

Material Description:	Visual Inspection – No Suspect Materials Found	
Identification:	N/A	
Approx. quantity:	N/A	
Accessibility	N/A	Assessment Score
Product type:	N/A	N/A
Extent of Damage:	N/A	N/A
Surface Treatment:	N/A	N/A
Asbestos type:	N/A	N/A
Material Assessment Score:		N/A
Priority Assessment Score:		N/A
Action:	N/A	
Comments:	N/A

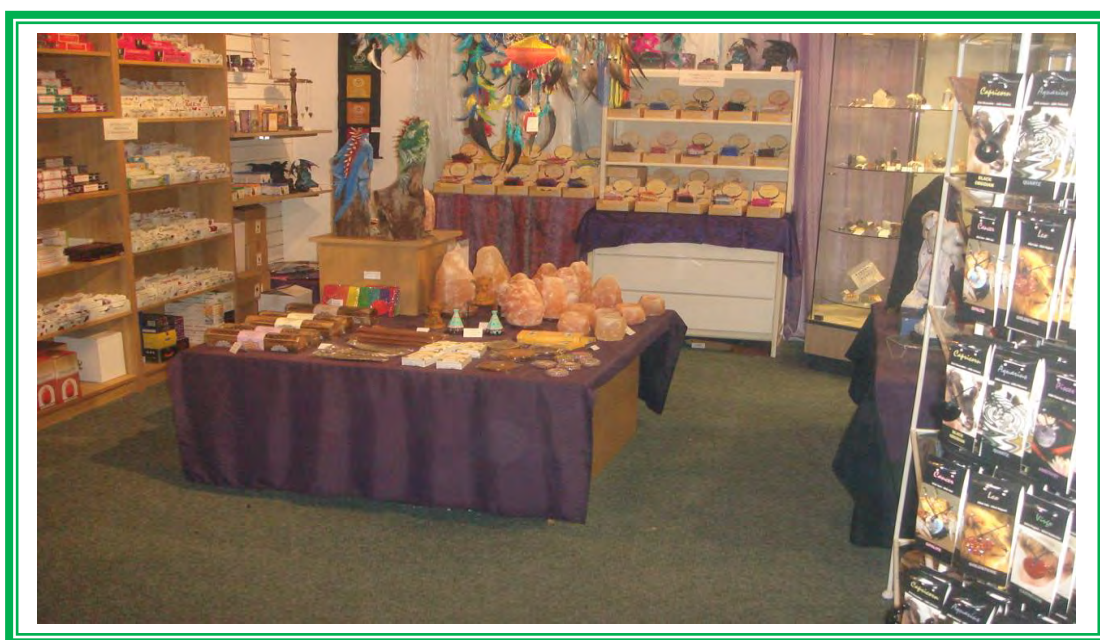
Location: 0/001

Material Description:	Visual Inspection – No Suspect Materials Found	
Identification:	N/A	
Approx. quantity:	N/A	
Accessibility	N/A	Assessment Score
Product type:	N/A	N/A
Extent of Damage:	N/A	N/A
Surface Treatment:	N/A	N/A
Asbestos type:	N/A	N/A
Material Assessment Score:		N/A
Priority Assessment Score:		N/A
Action:	N/A	
Comments:	N/A

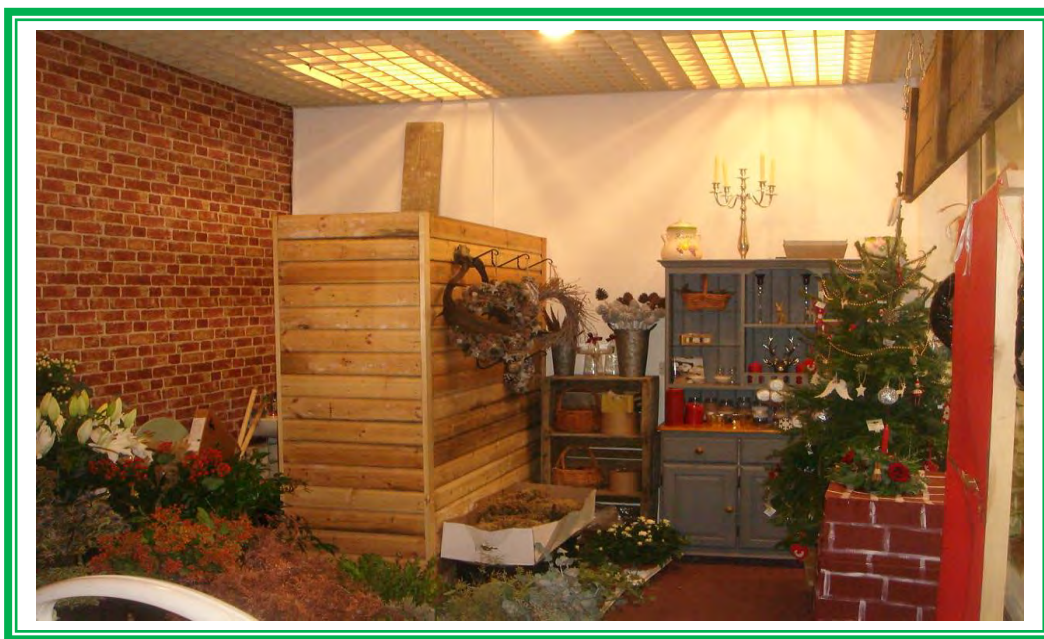
Location: 0/001 Shop

Material Description:	Visual Inspection – No Suspect Materials Found	
Identification:	N/A	
Approx. quantity:	N/A	
Accessibility	N/A	Assessment Score
Product type:	N/A	N/A
Extent of Damage:	N/A	N/A
Surface Treatment:	N/A	N/A
Asbestos type:	N/A	N/A
Material Assessment Score:		N/A
Priority Assessment Score:		N/A
Action:	N/A	
Comments:	N/A

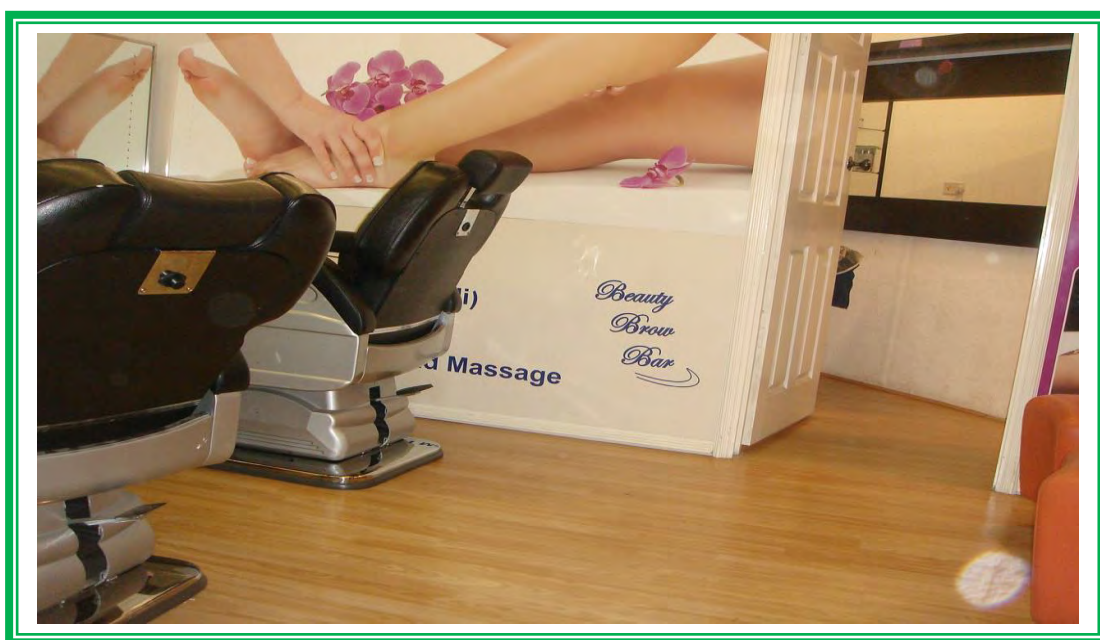
Location: 0/001

Material Description:	Visual Inspection – No Suspect Materials Found	
Identification:	N/A	
Approx. quantity:	N/A	
Accessibility	N/A	Assessment Score
Product type:	N/A	N/A
Extent of Damage:	N/A	N/A
Surface Treatment:	N/A	N/A
Asbestos type:	N/A	N/A
Material Assessment Score:		N/A
Priority Assessment Score:		N/A
Action:	N/A	
Comments:	N/A

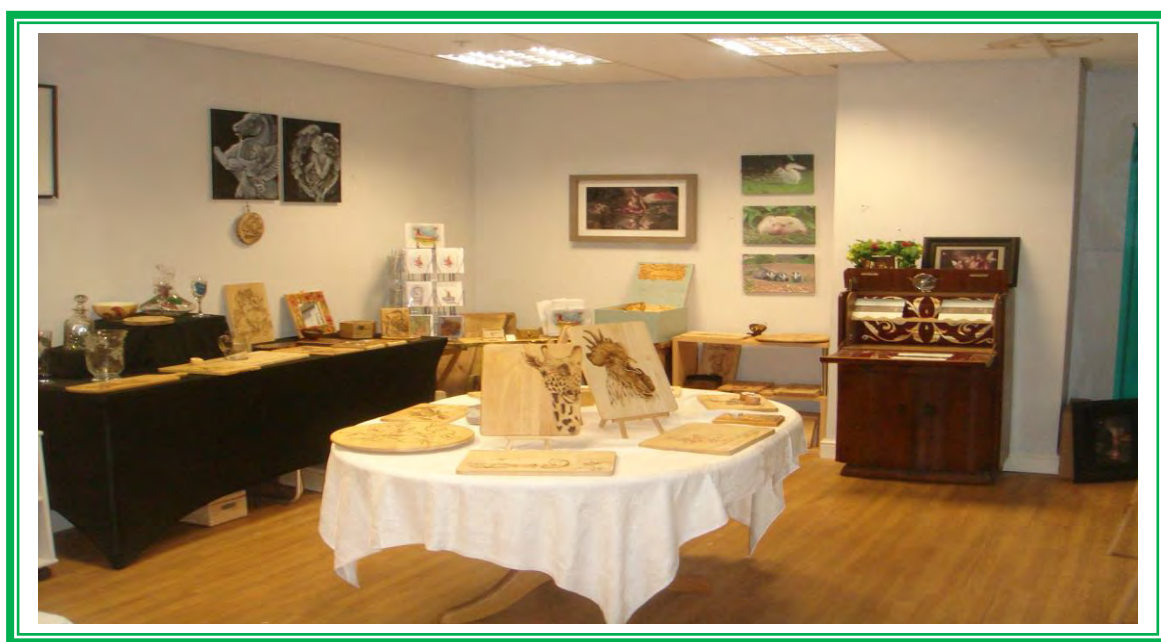
Location: 0/001

Material Description:	Visual Inspection – No Suspect Materials Found	
Identification:	N/A	
Approx. quantity:	N/A	
Accessibility	N/A	Assessment Score
Product type:	N/A	N/A
Extent of Damage:	N/A	N/A
Surface Treatment:	N/A	N/A
Asbestos type:	N/A	N/A
Material Assessment Score:		N/A
Priority Assessment Score:		N/A
Action:	N/A	
Comments:	N/A

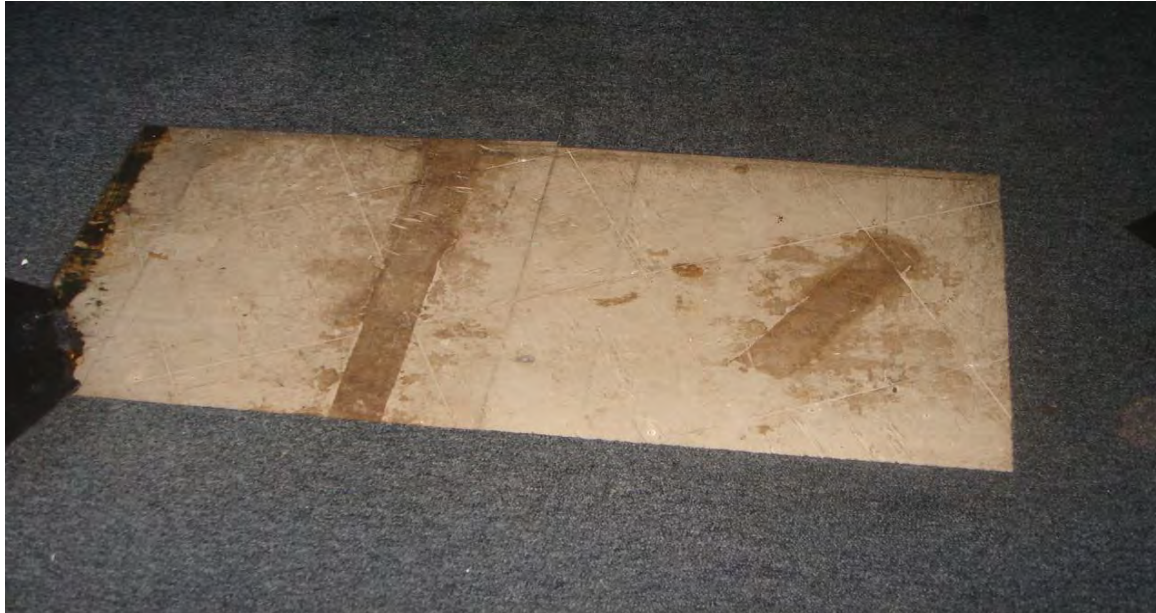
Location: 2/005 Office

Material Description:	Vinyl Floor Tiles	
Identification:	As Per Sample NE/5 – Asbestos Detected	
Approx. quantity:	24M2	
Accessibility	Low	Assessment Score
Product type:	Vinyl	1
Extent of Damage:	Minor	1
Surface Treatment:	Non-Friable	0
Asbestos type:	Chrysotile	1
Material Assessment Score:		3
Priority Assessment Score:		Negligible
Action:	Manage	
Comments:	N/A

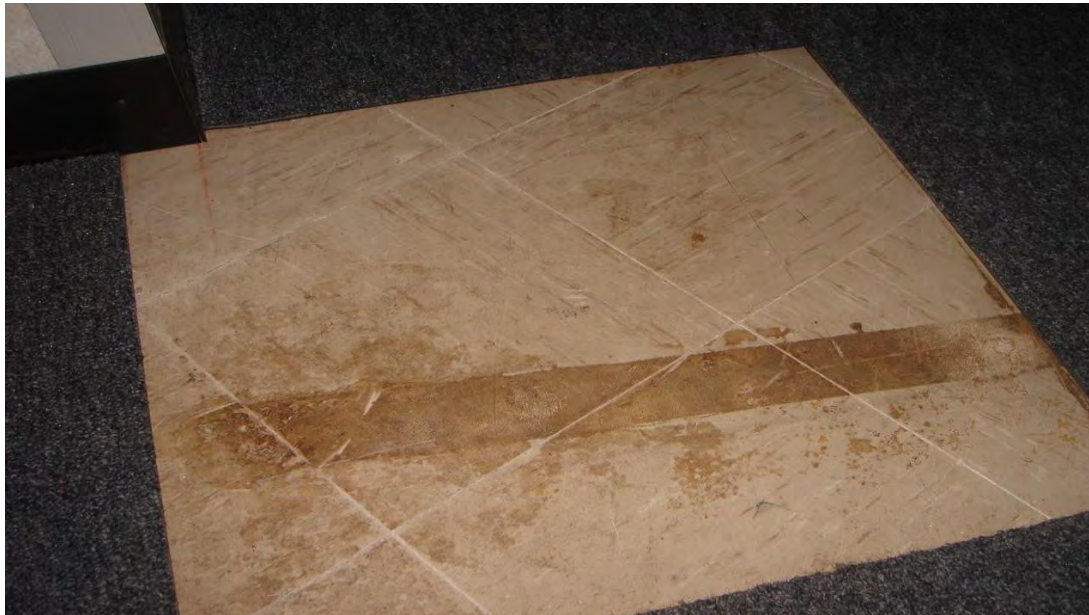
Location: 2/006 Office

Material Description:	Vinyl Floor Tiles	
Identification:	As Per Sample NE/5 – Asbestos Detected	
Approx. quantity:	20M2	
Accessibility	Low	Assessment Score
Product type:	Vinyl	1
Extent of Damage:	Minor	1
Surface Treatment:	Non-Friable	0
Asbestos type:	Chrysotile	1
Material Assessment Score:		3
Priority Assessment Score:		Negligible
Action:	Manage	
Comments:	N/A

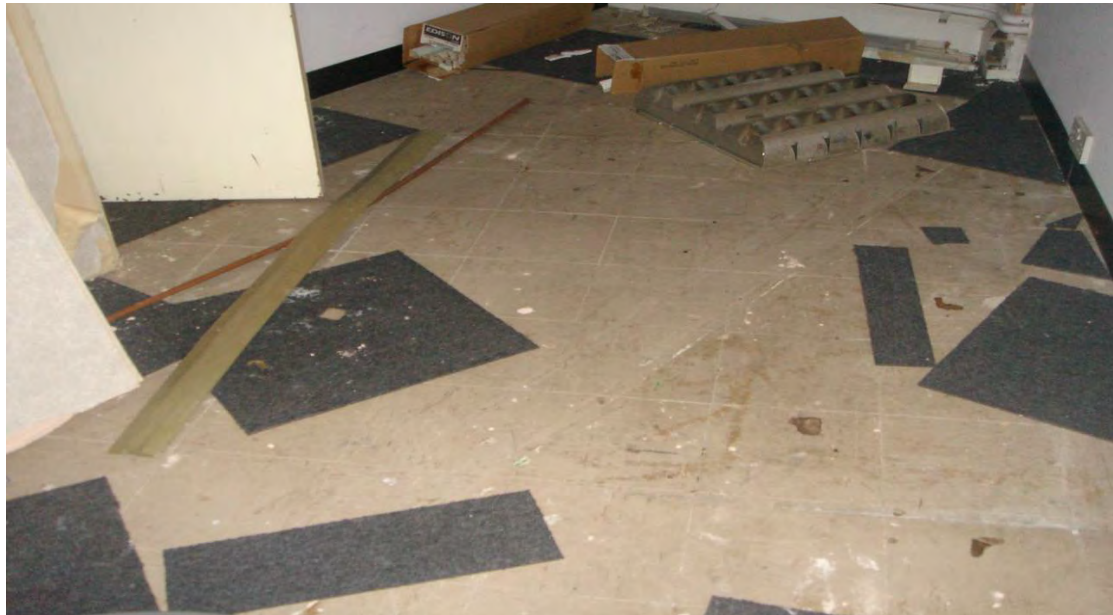
Location: 2/012 Office

Material Description:	Vinyl Floor Tiles	
Identification:	As Per Sample NE/5 – Asbestos Detected	
Approx. quantity:	10M2	
Accessibility	Low	Assessment Score
Product type:	Vinyl	1
Extent of Damage:	Minor	1
Surface Treatment:	Non-Friable	0
Asbestos type:	Chrysotile	1
Material Assessment Score:		3
Priority Assessment Score:		Negligible
Action:	Manage	
Comments:	N/A

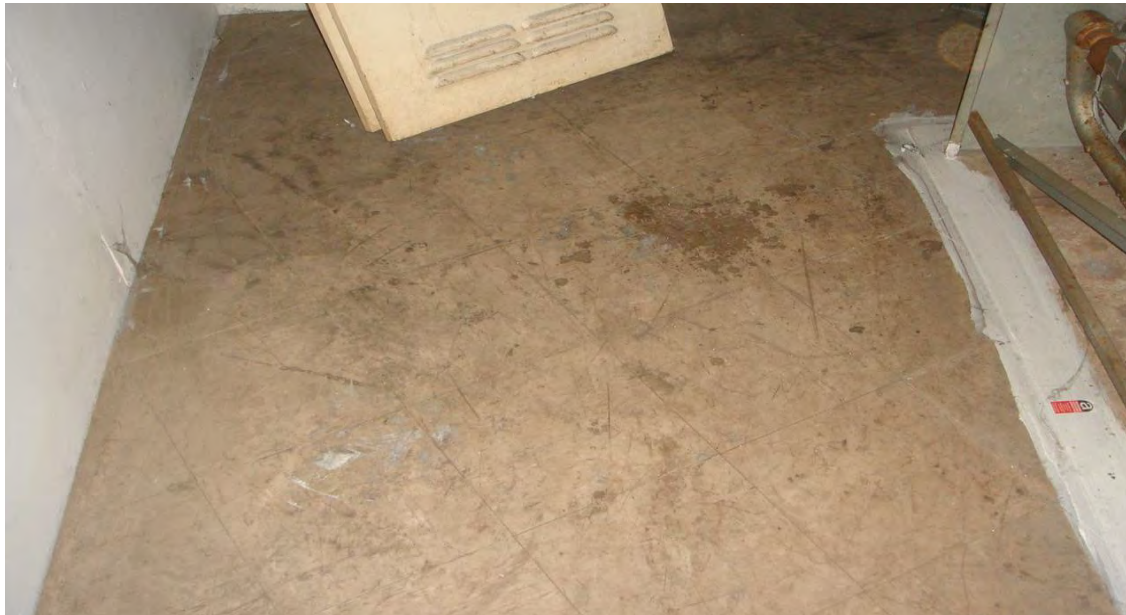
Location: 2/013 Boiler Room

Material Description:	Vinyl Floor Tiles	
Identification:	As Per Sample NE/5 – Asbestos Detected	
Approx. quantity:	8M2	
Accessibility	Medium	Assessment Score
Product type:	Vinyl	1
Extent of Damage:	Minor	1
Surface Treatment:	Non-Friable	0
Asbestos type:	Chrysotile	1
Material Assessment Score:		3
Priority Assessment Score:		Negligible
Action:	Manage	
Comments:	N/A

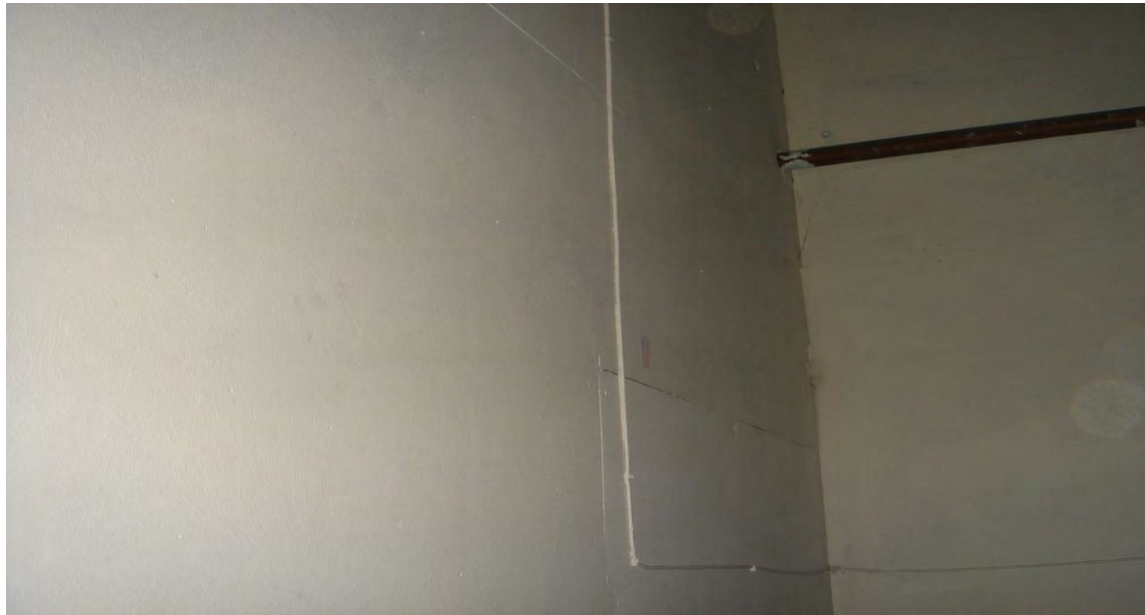
Location: 2/013 Boiler Room

Material Description:	Asbestos Insulating Board to Walls	
Identification:	Sampled – Asbestos Detected	
Approx. quantity:	50M2	
Accessibility	Medium	Assessment Score
Product type:	Asbestos Insulating Board	2
Extent of Damage:	Minor	1
Surface Treatment:	Encapsulated	1
Asbestos type:	Amosite	2
Material Assessment Score:		6
Priority Assessment Score:		Low
Action:	Manage	
Comments:	All Four Walls

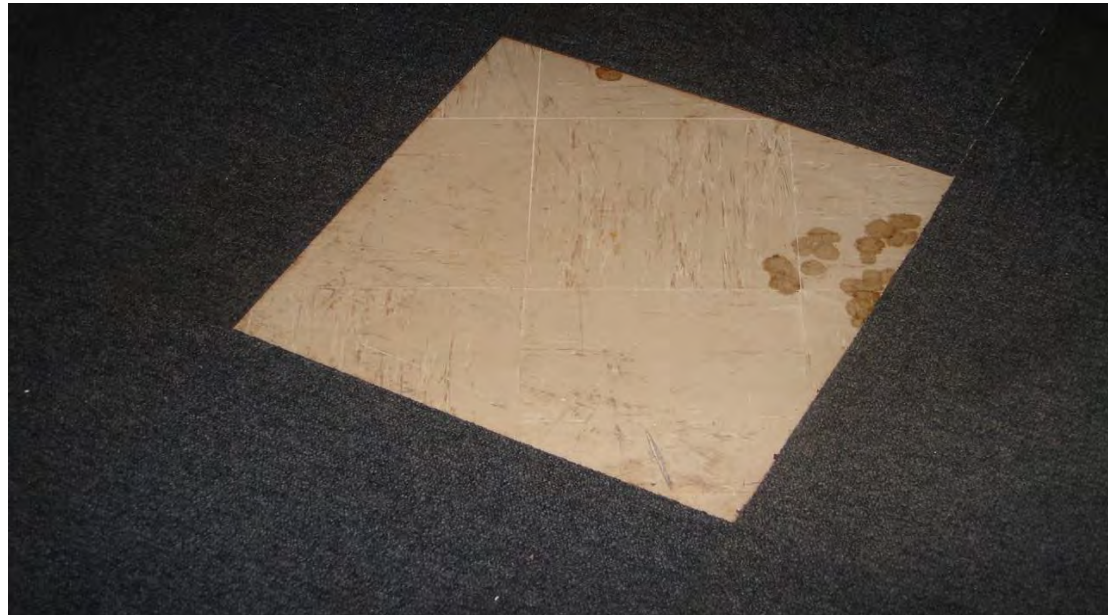
Location: 2/013A Office

Material Description:	Vinyl Floor Tiles	
Identification:	As Per Sample NE/5 – Asbestos Detected	
Approx. quantity:	10M2	
Accessibility	Low	Assessment Score
Product type:	Vinyl	1
Extent of Damage:	Minor	1
Surface Treatment:	Non-Friable	0
Asbestos type:	Chrysotile	1
Material Assessment Score:		3
Priority Assessment Score:		Negligible
Action:	Manage	
Comments:	N/A

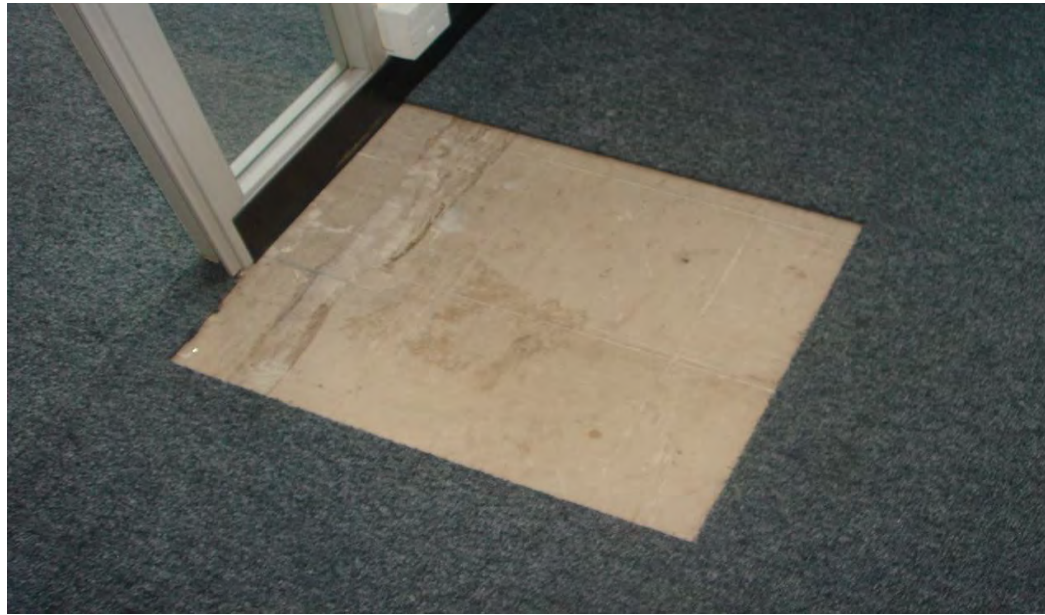
Location: 2/016 Office

Material Description:	Vinyl Floor Tiles	
Identification:	As Per Sample NE/8 – Asbestos Detected	
Approx. quantity:	15M2	
Accessibility	Low	Assessment Score
Product type:	Vinyl	1
Extent of Damage:	Minor	1
Surface Treatment:	Non-Friable	0
Asbestos type:	Chrysotile	1
Material Assessment Score:		3
Priority Assessment Score:		Negligible
Action:	Manage	
Comments:	N/A

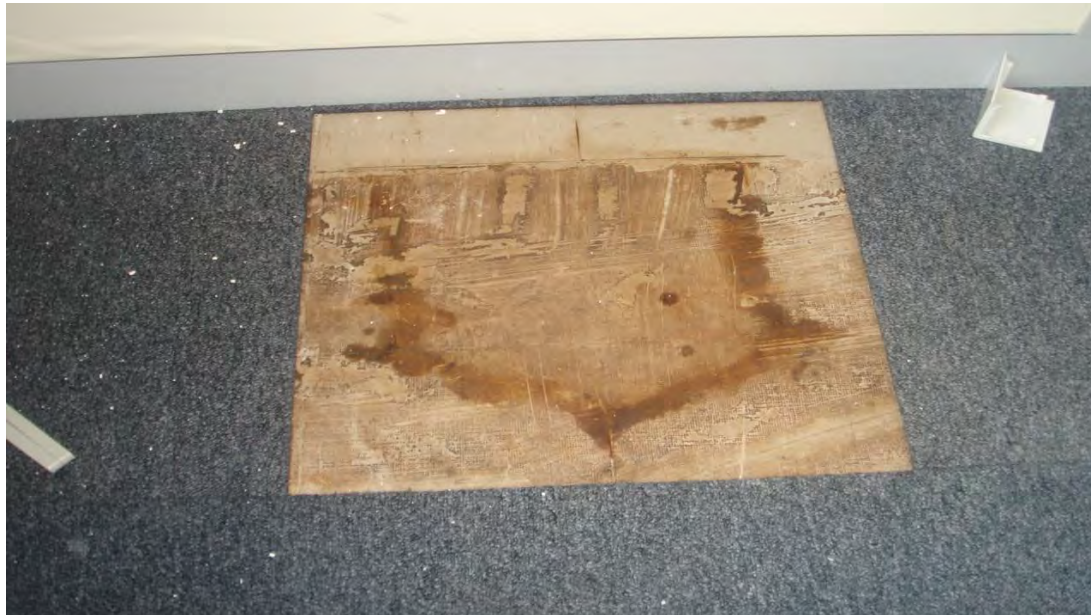
Location: 2/018

Material Description:	Vinyl Floor Tiles	
Identification:	As Per Sample NE/8 – Asbestos Detected	
Approx. quantity:	24M2	
Accessibility	Low	Assessment Score
Product type:	Vinyl	1
Extent of Damage:	Minor	1
Surface Treatment:	Non-Friable	0
Asbestos type:	Chrysotile	1
Material Assessment Score:		3
Priority Assessment Score:		Negligible
Action:	Manage	
Comments:	N/A
