Project Number 3113

Management Asbestos Survey Report

Kennet Centre, Market Street, Newbury,
Berkshire, RG14 5EN

3 Market Place and Associated Store

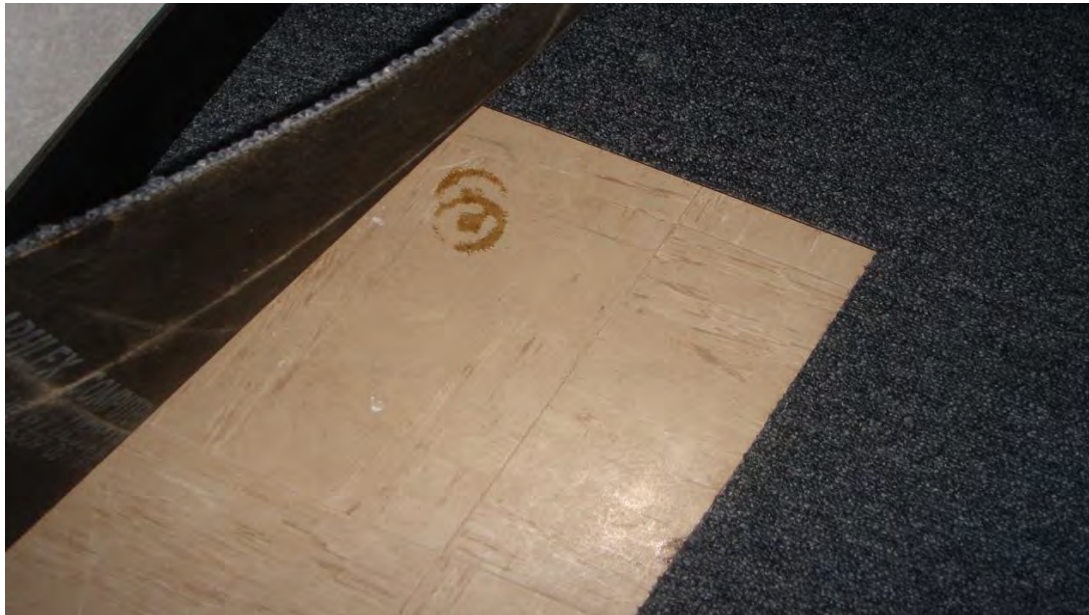
Location: 2/019

Material Description:	Vinyl Floor Tiles	
Identification:	As Per Sample NE/8 – Asbestos Detected	
Approx. quantity:	15M2	
Accessibility	Low	Assessment Score
Product type:	Vinyl	1
Extent of Damage:	Minor	1
Surface Treatment:	Non-Friable	0
Asbestos type:	Chrysotile	1
Material Assessment Score:		3
Priority Assessment Score:		Negligible
Action:	Manage	
Comments:	N/A

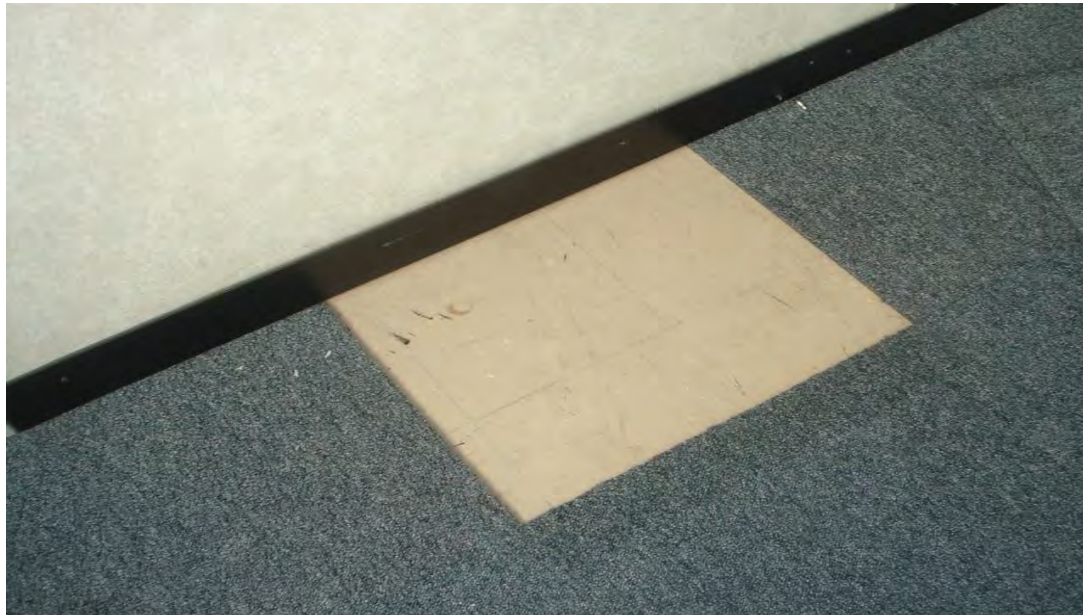
Location: 2/022

Material Description:	Vinyl Floor Tiles	
Identification:	As Per Sample NE/9 – Asbestos Detected	
Approx. quantity:	30M2	
Accessibility	Low	Assessment Score
Product type:	Vinyl	1
Extent of Damage:	Minor	1
Surface Treatment:	Non-Friable	0
Asbestos type:	Chrysotile	1
Material Assessment Score:		3
Priority Assessment Score:		Negligible
Action:	Manage	
Comments:	N/A

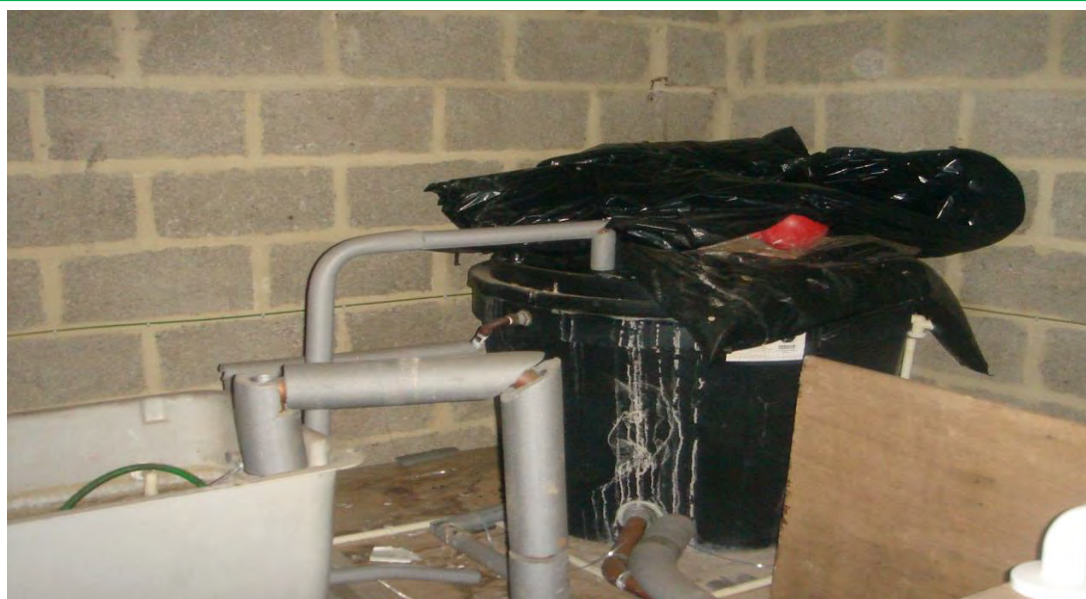
Location: 3/001 Tank Room

Material Description:	Visual Inspection – No Suspect Materials Found	
Identification:	N/A	
Approx. quantity:	N/A	
Accessibility	N/A	Assessment Score
Product type:	N/A	N/A
Extent of Damage:	N/A	N/A
Surface Treatment:	N/A	N/A
Asbestos type:	N/A	N/A
Material Assessment Score:		N/A
Priority Assessment Score:		N/A
Action:	N/A	
Comments:	N/A

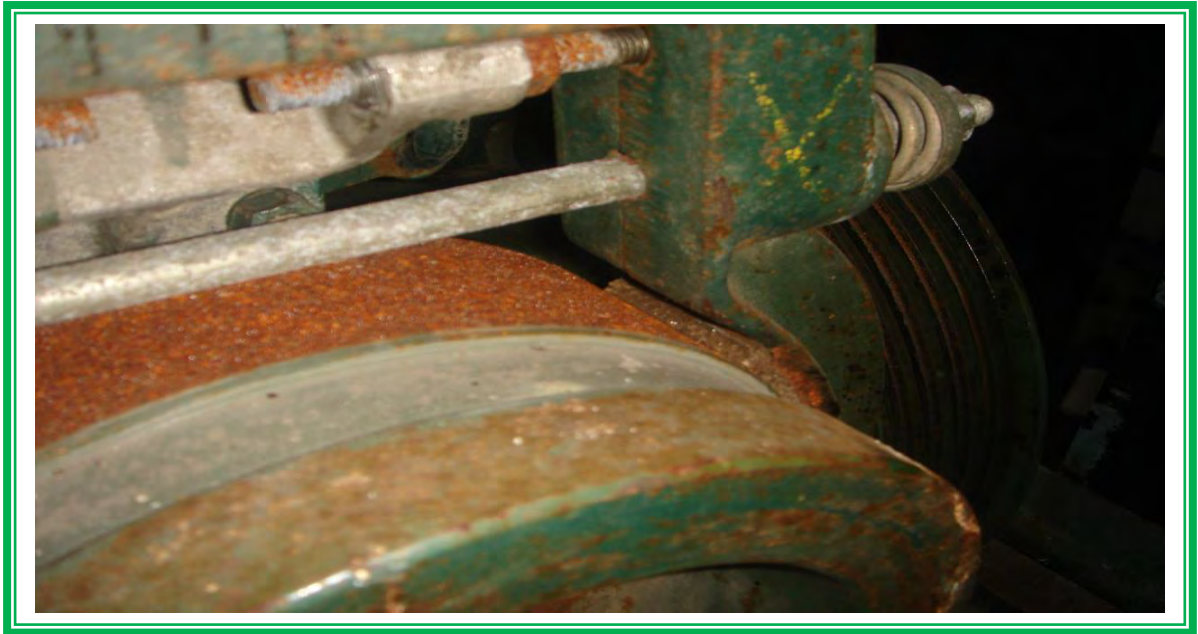
Location: 3/002 Lift Motor Room

Material Description:	Lift Brake Shoes/Lining Textile	
Identification:	Sampled – No Asbestos Detected	
Approx. quantity:	<0.5M2	
Accessibility	N/A	Assessment Score
Product type:	N/A	N/A
Extent of Damage:	N/A	N/A
Surface Treatment:	N/A	N/A
Asbestos type:	N/A	N/A
Material Assessment Score:		N/A
Priority Assessment Score:		N/A
Action:	N/A	
Comments:	N/A

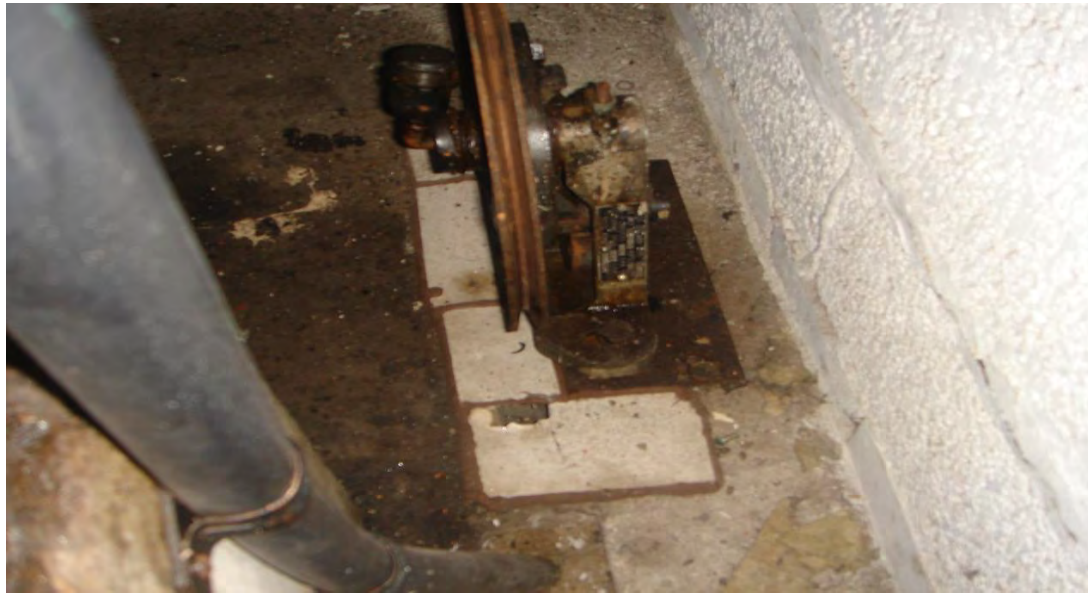
Location: 3/002 Lift motor Room

Material Description:	Insulating Board	
Identification:	Sampled – No Asbestos Detected	
Approx. quantity:	1M2	
Accessibility	N/A	Assessment Score
Product type:	N/A	N/A
Extent of Damage:	N/A	N/A
Surface Treatment:	N/A	N/A
Asbestos type:	N/A	N/A
Material Assessment Score:		N/A
Priority Assessment Score:		N/A
Action:	N/A	
Comments:	To Floor as Debris

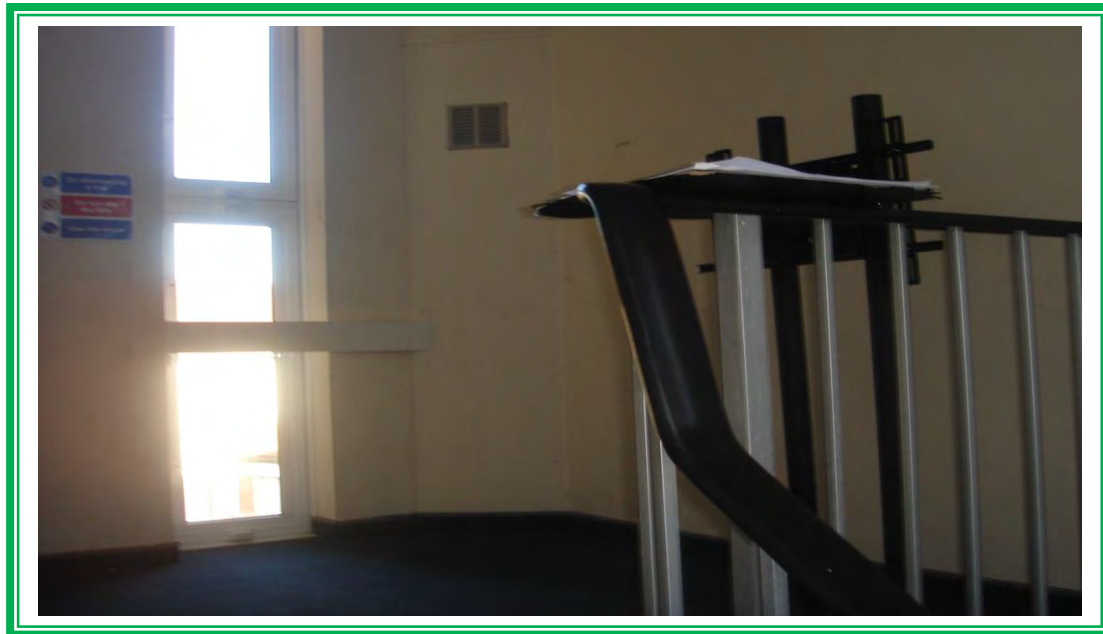
Location: 2/001 Stairs

Material Description:	Visual Inspection – No Suspect Materials Found	
Identification:	N/A	
Approx. quantity:	N/A	
Accessibility	N/A	Assessment Score
Product type:	N/A	N/A
Extent of Damage:	N/A	N/A
Surface Treatment:	N/A	N/A
Asbestos type:	N/A	N/A
Material Assessment Score:		N/A
Priority Assessment Score:		N/A
Action:	N/A	
Comments:	N/A

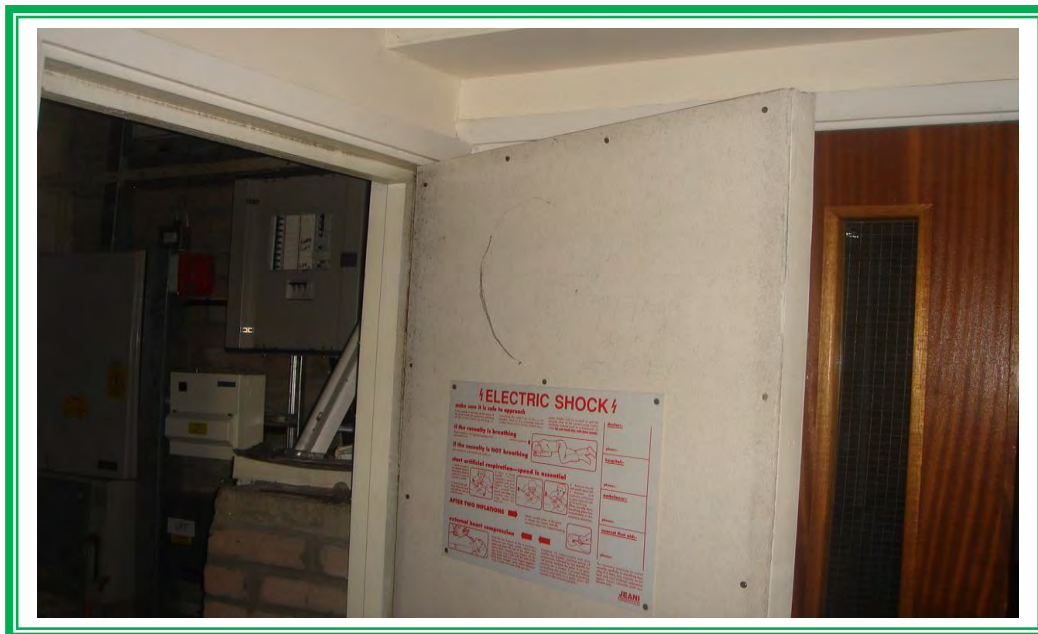
Location: 2/003

Material Description:	Insulating Board to Door	
Identification:	Sampled – No Asbestos Detected	
Approx. quantity:	2M2	
Accessibility	N/A	Assessment Score
Product type:	N/A	N/A
Extent of Damage:	N/A	N/A
Surface Treatment:	N/A	N/A
Asbestos type:	N/A	N/A
Material Assessment Score:		N/A
Priority Assessment Score:		N/A
Action:	N/A	
Comments:	N/A

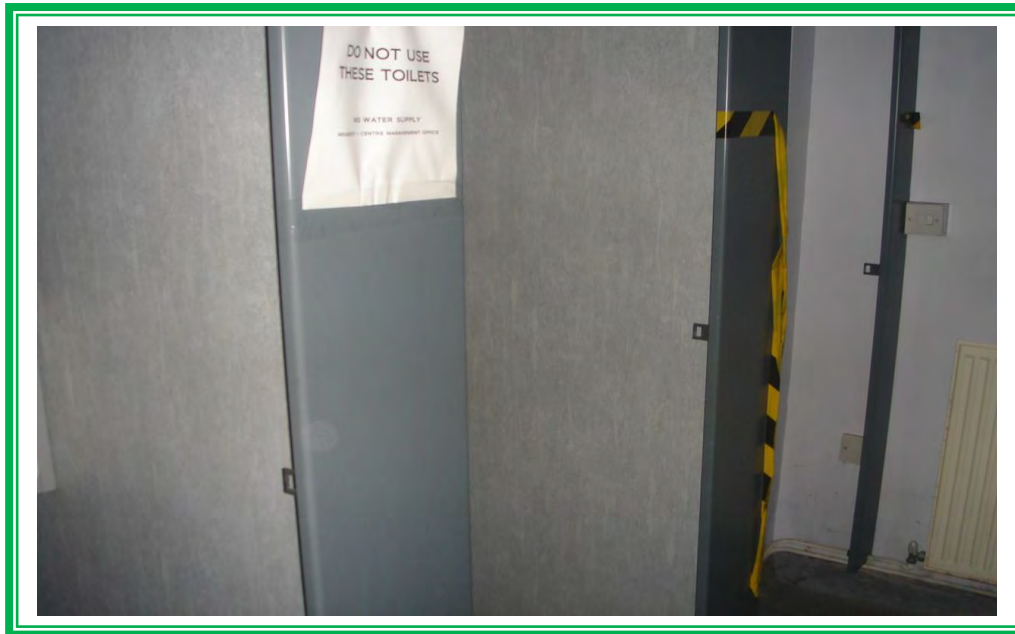
Location: 2/007 Male WC

Material Description:	Visual Inspection – No Suspect Materials Found	
Identification:	N/A	
Approx. quantity:	N/A	
Accessibility	N/A	Assessment Score
Product type:	N/A	N/A
Extent of Damage:	N/A	N/A
Surface Treatment:	N/A	N/A
Asbestos type:	N/A	N/A
Material Assessment Score:		N/A
Priority Assessment Score:		N/A
Action:	N/A	
Comments:	N/A

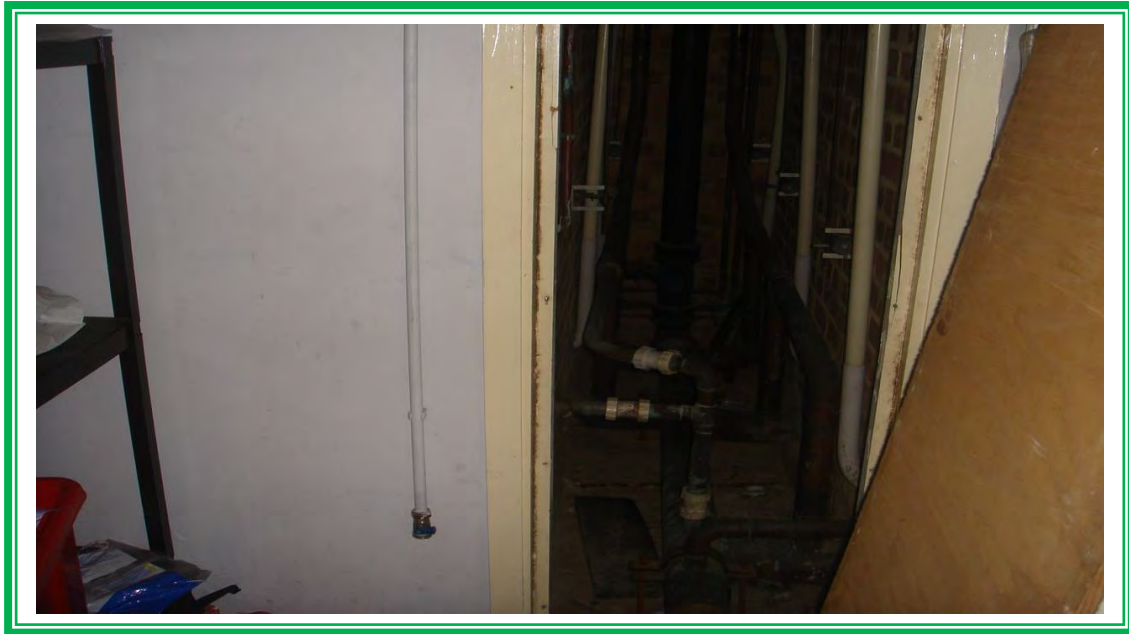
Location: 2/008 and 2/009 Water Closet

Material Description:	Visual Inspection – No Suspect Materials Found	
Identification:	N/A	
Approx. quantity:	N/A	
Accessibility	N/A	Assessment Score
Product type:	N/A	N/A
Extent of Damage:	N/A	N/A
Surface Treatment:	N/A	N/A
Asbestos type:	N/A	N/A
Material Assessment Score:		N/A
Priority Assessment Score:		N/A
Action:	N/A	
Comments:	N/A

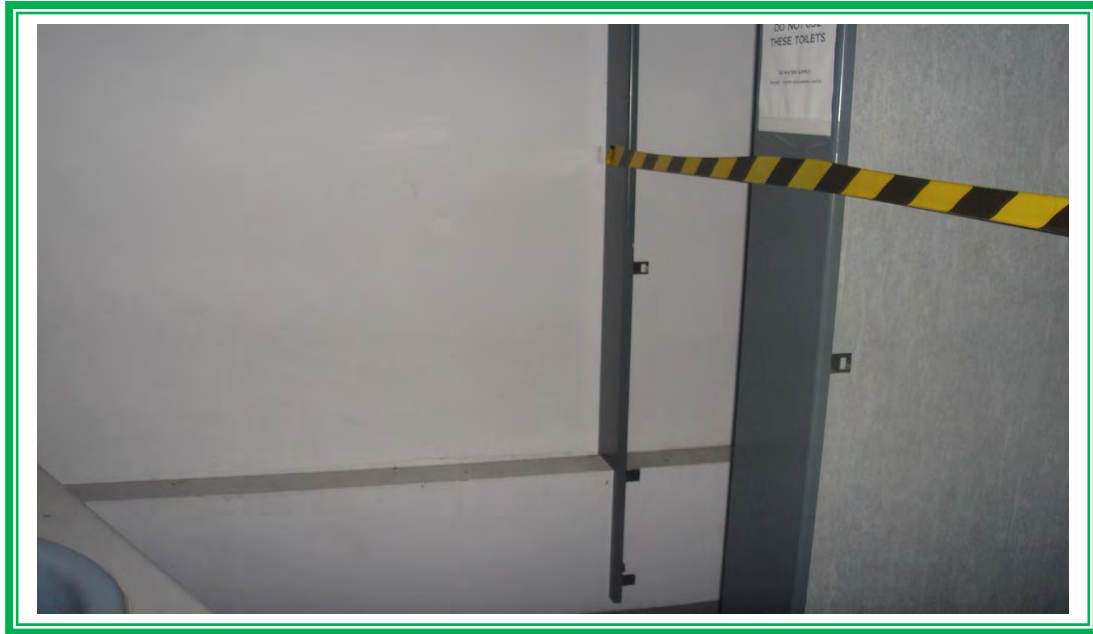
Location: 2/010 Female WC

Material Description:	Visual Inspection – No Suspect Materials Found	
Identification:	N/A	
Approx. quantity:	N/A	
Accessibility	N/A	Assessment Score
Product type:	N/A	N/A
Extent of Damage:	N/A	N/A
Surface Treatment:	N/A	N/A
Asbestos type:	N/A	N/A
Material Assessment Score:		N/A
Priority Assessment Score:		N/A
Action:	N/A	
Comments:	N/A

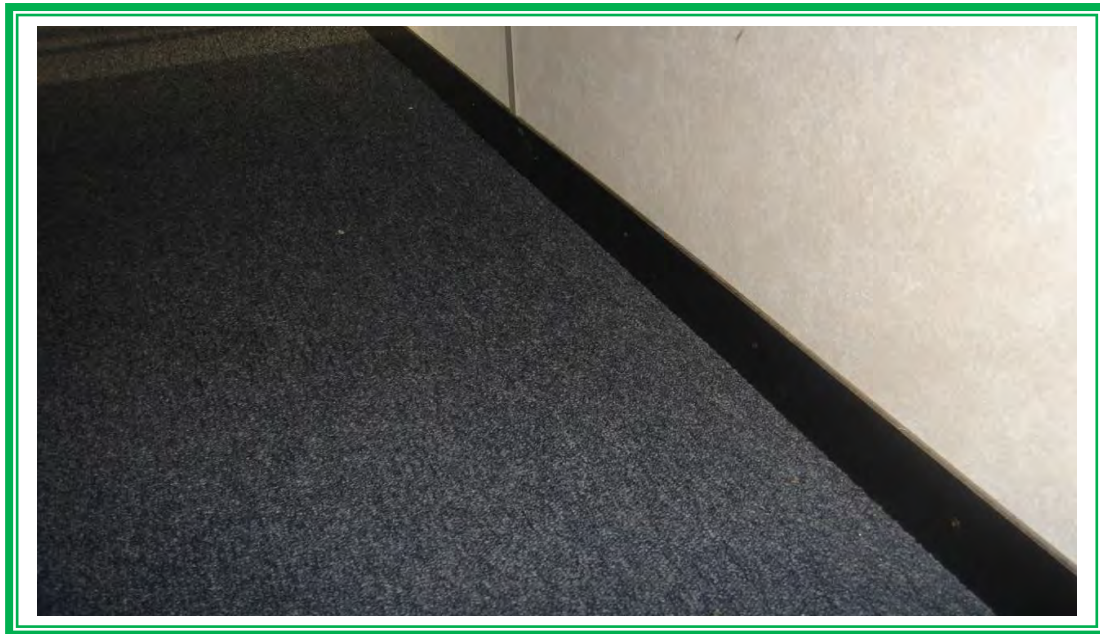
Location: 2/004 Corridor

Material Description:	Black Skirting Board	
Identification:	Sampled – No Asbestos Detected	
Approx. quantity:	>300LM	
Accessibility	N/A	Assessment Score
Product type:	N/A	N/A
Extent of Damage:	N/A	N/A
Surface Treatment:	N/A	N/A
Asbestos type:	N/A	N/A
Material Assessment Score:		N/A
Priority Assessment Score:		N/A
Action:	N/A	
Comments:	Skirting Board Are to Every Wall on Second Floor (Every Room)

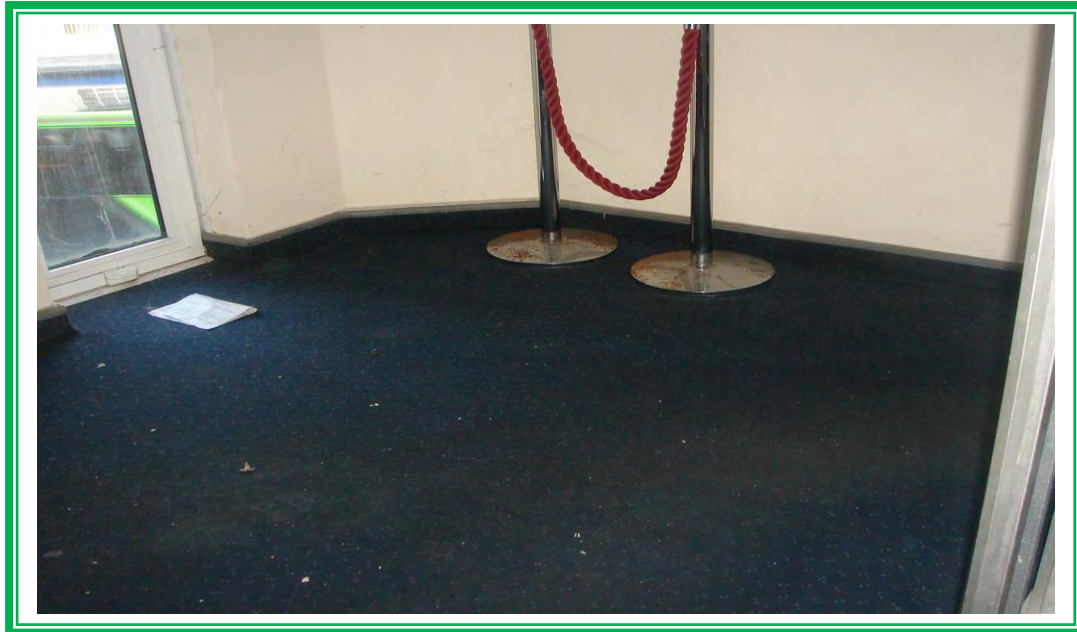
Location: 1/001 Stairs

Material Description:	Visual Inspection – No Suspect Materials Found	
Identification:	N/A	
Approx. quantity:	N/A	
Accessibility	N/A	Assessment Score
Product type:	N/A	N/A
Extent of Damage:	N/A	N/A
Surface Treatment:	N/A	N/A
Asbestos type:	N/A	N/A
Material Assessment Score:		N/A
Priority Assessment Score:		N/A
Action:	N/A	
Comments:	N/A

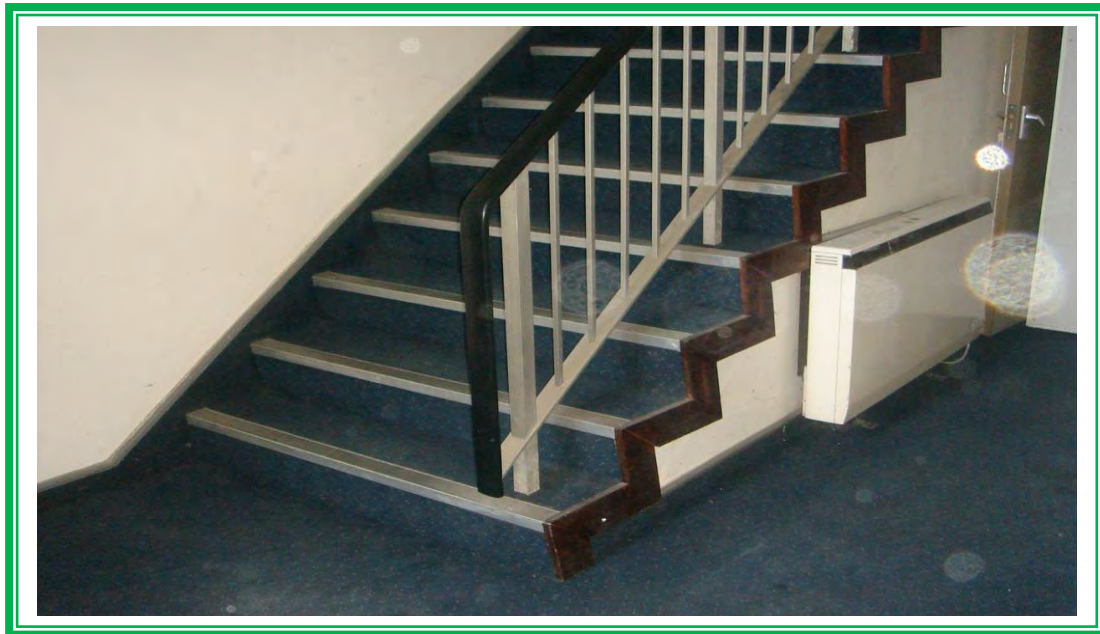
Location: 0/001 Stairs

Material Description:	Visual Inspection – No Suspect Materials Found	
Identification:	N/A	
Approx. quantity:	N/A	
Accessibility	N/A	Assessment Score
Product type:	N/A	N/A
Extent of Damage:	N/A	N/A
Surface Treatment:	N/A	N/A
Asbestos type:	N/A	N/A
Material Assessment Score:		N/A
Priority Assessment Score:		N/A
Action:	N/A	
Comments:	N/A

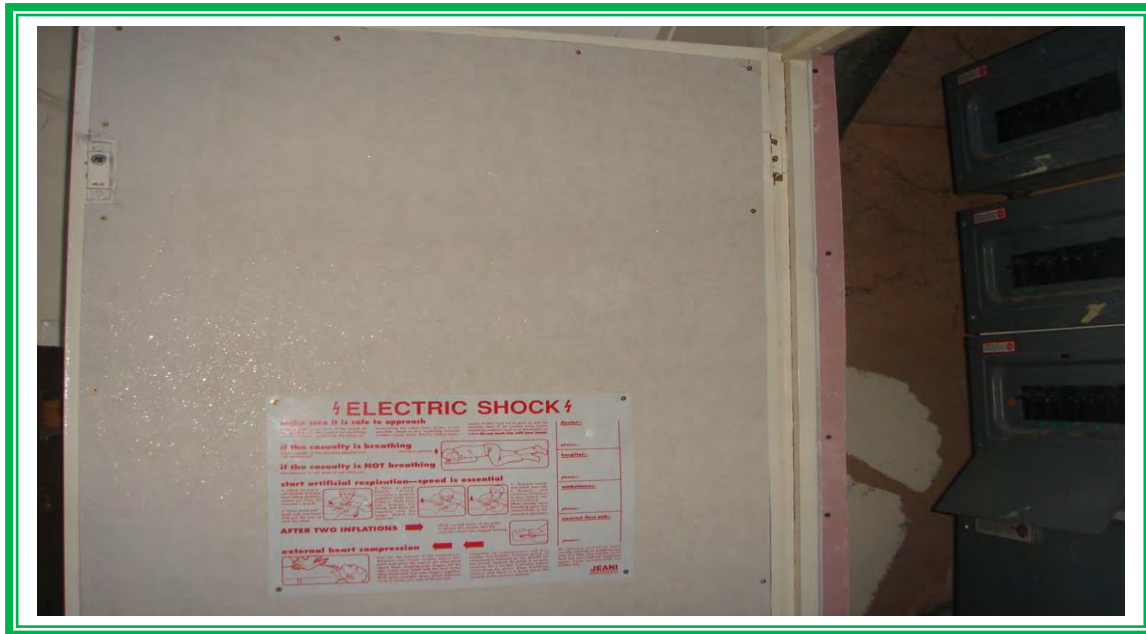
Location: 0/003 Electrics

Material Description:	Insulating Board to Doors	
Identification:	Sampled – No Asbestos Detected	
Approx. quantity:	4M2	
Accessibility	N/A	Assessment Score
Product type:	N/A	N/A
Extent of Damage:	N/A	N/A
Surface Treatment:	N/A	N/A
Asbestos type:	N/A	N/A
Material Assessment Score:		N/A
Priority Assessment Score:		N/A
Action:	N/A	
Comments:	N/A

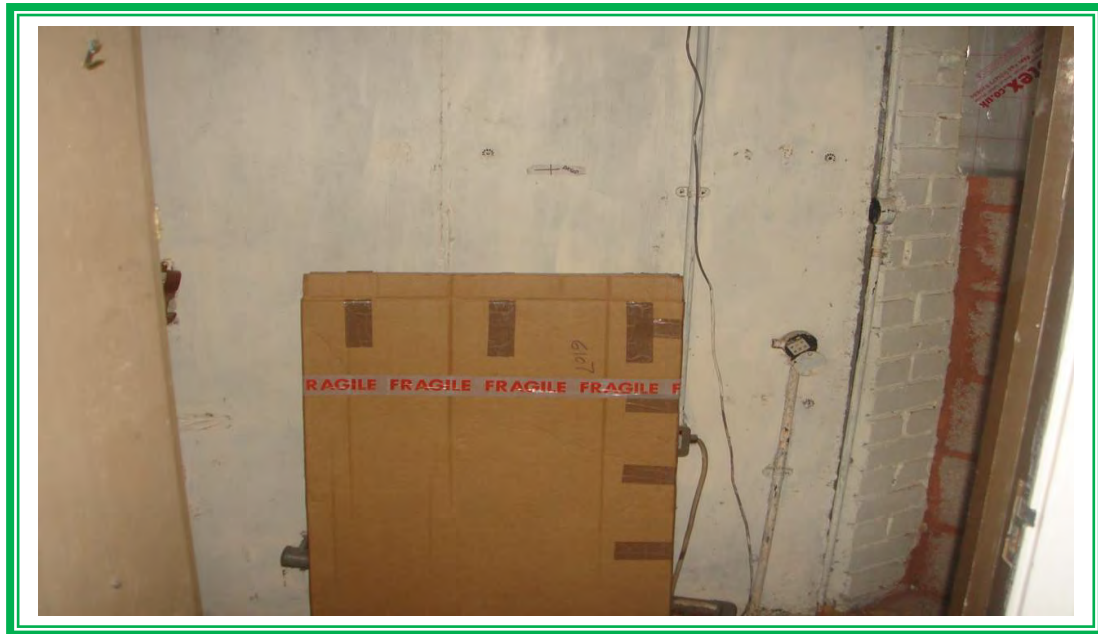
Location: 0/004

Material Description:	Visual Inspection – No Suspect Materials Found	
Identification:	N/A	
Approx. quantity:	N/A	
Accessibility	N/A	Assessment Score
Product type:	N/A	N/A
Extent of Damage:	N/A	N/A
Surface Treatment:	N/A	N/A
Asbestos type:	N/A	N/A
Material Assessment Score:		N/A
Priority Assessment Score:		N/A
Action:	N/A	
Comments:	N/A

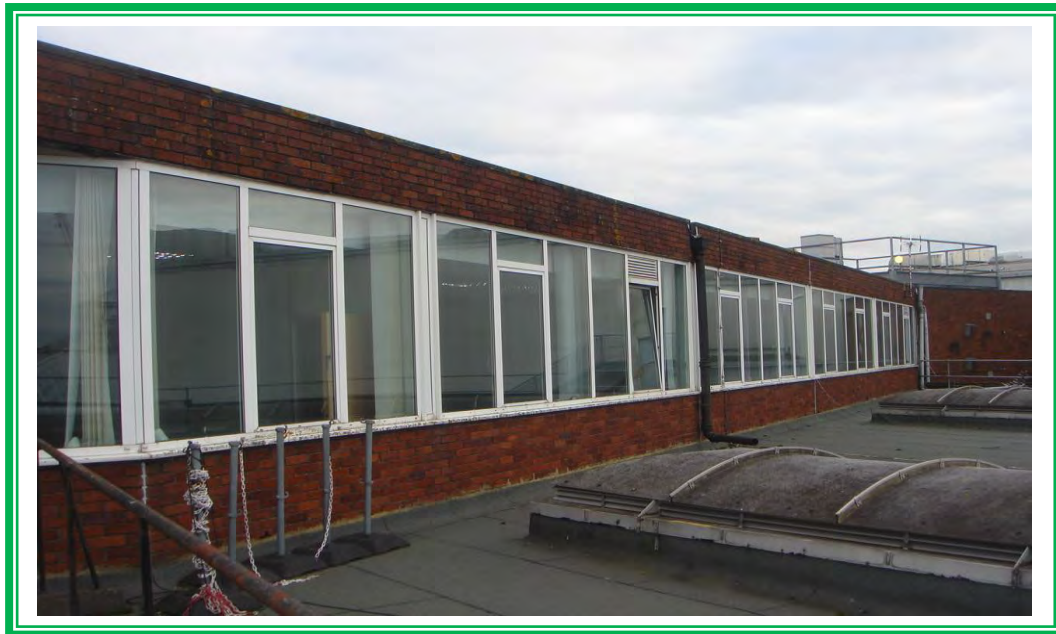
Location: 99/001 External

Material Description:	Visual Inspection – No Suspect Materials Found	
Identification:	N/A	
Approx. quantity:	N/A	
Accessibility	N/A	Assessment Score
Product type:	N/A	N/A
Extent of Damage:	N/A	N/A
Surface Treatment:	N/A	N/A
Asbestos type:	N/A	N/A
Material Assessment Score:		N/A
Priority Assessment Score:		N/A
Action:	N/A	
Comments:	N/A

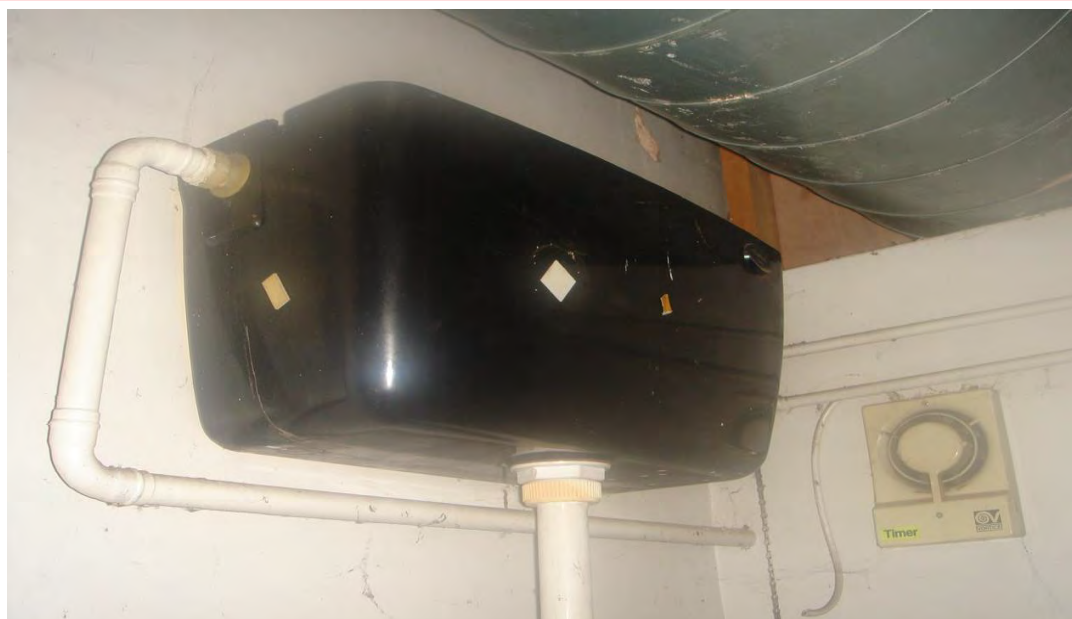
Location: 1/001 WC

Material Description:	Toilet Cistern	
Identification:	Sampled – Asbestos Detected	
Approx. quantity:	X 1	
Accessibility	Low	Assessment Score
Product type:	Composite	1
Extent of Damage:	Minor	1
Surface Treatment:	Non-Friable	0
Asbestos type:	Amosite	2
Material Assessment Score:		4
Priority Assessment Score:		Negligible
Action:	Manage	
Comments:	N/A

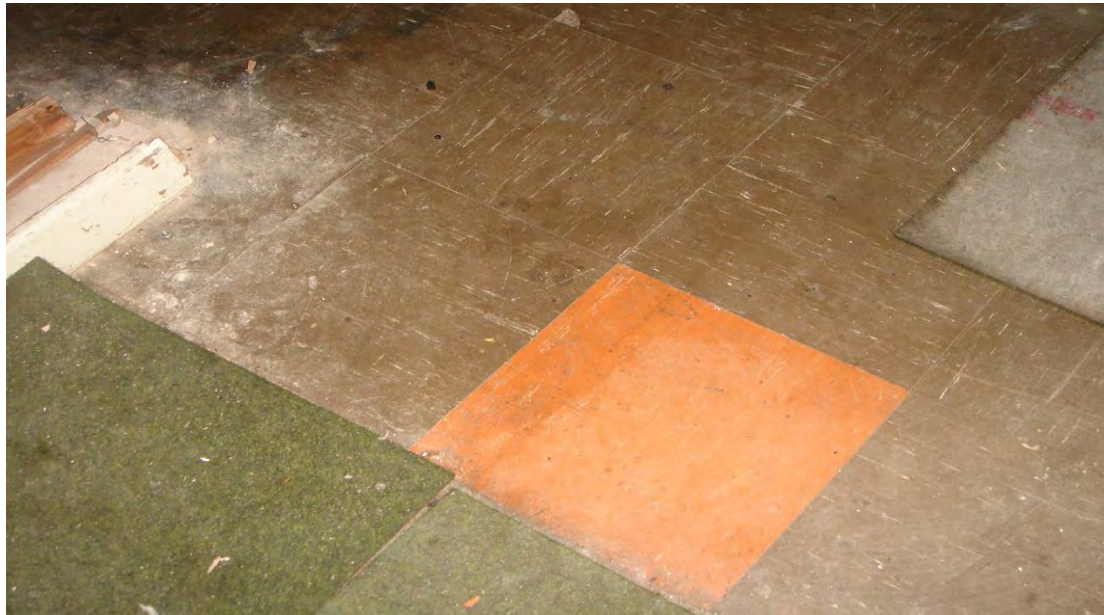
Location: 1/002 Kitchen

Material Description:	Vinyl Floor Tiles	
Identification:	Sampled – Asbestos Detected	
Approx. quantity:	8M2	
Accessibility	Low	Assessment Score
Product type:	Vinyl	1
Extent of Damage:	Minor	1
Surface Treatment:	Non-Friable	0
Asbestos type:	Chrysotile	1
Material Assessment Score:		3
Priority Assessment Score:		Negligible
Action:	Manage	
Comments:	N/A

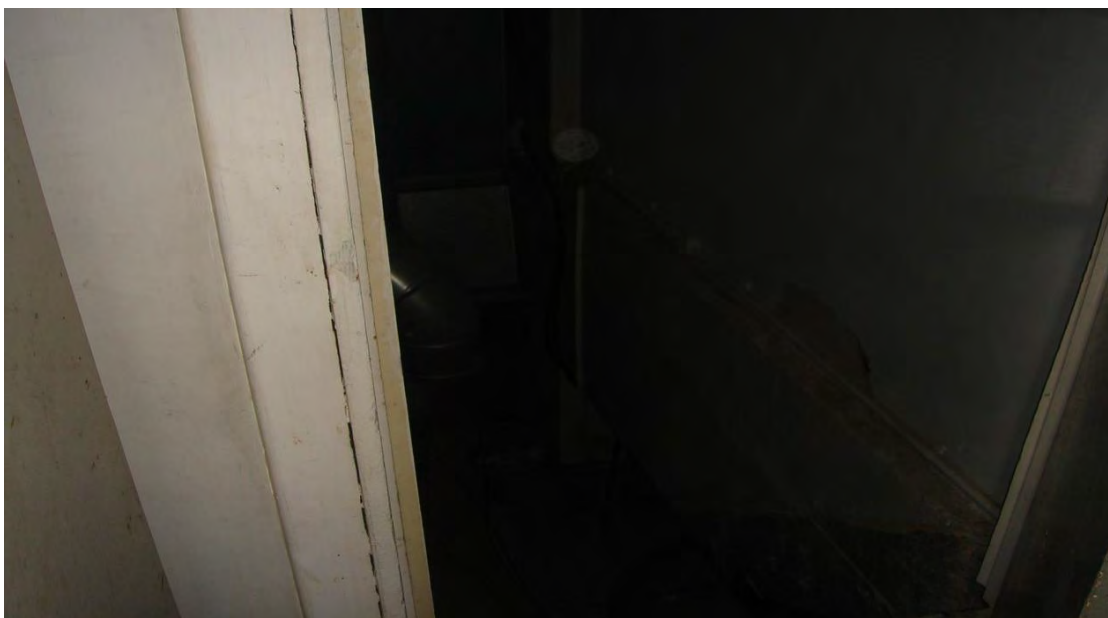
Location: 1/004

Material Description:	No Access Due to No Floor	
Identification:	Presumed to Contain Asbestos	
Approx. quantity:	Unknown	
Accessibility	Low	Assessment Score
Product type:	No Access	3
Extent of Damage:	No Access	3
Surface Treatment:	No Access	3
Asbestos type:	No Access	3
Material Assessment Score:		12
Priority Assessment Score:		High
Action:	Further Investigation Required	
Comments:	Unable to gain access as there is no floor

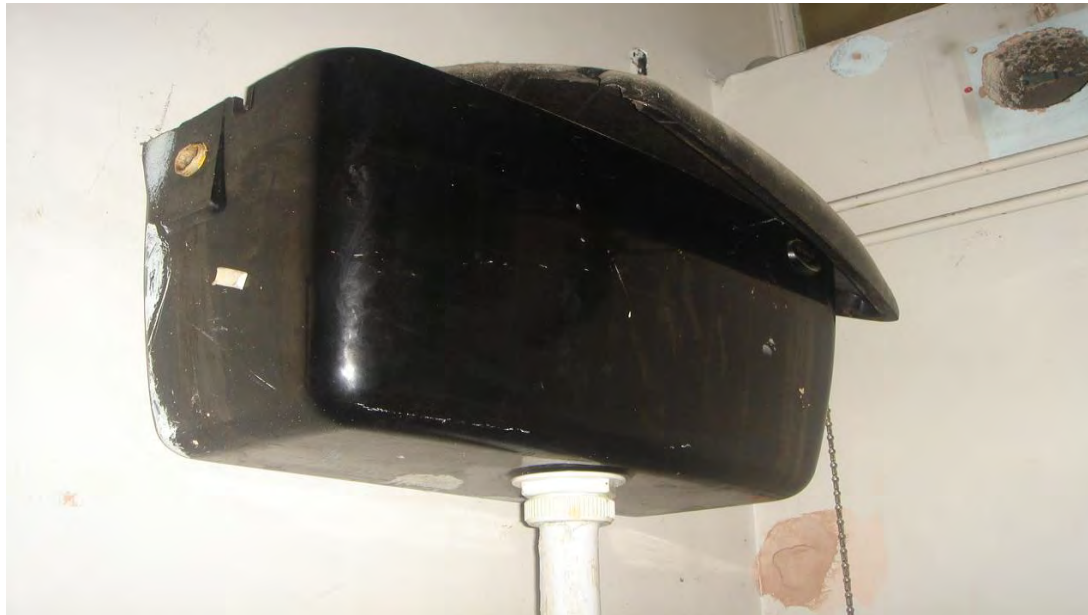
Location: 1/009 WC

Material Description:	Toilet Cistern	
Identification:	As Per Sample 1 – Asbestos Detected	
Approx. quantity:	X 1	
Accessibility	Low	Assessment Score
Product type:	Composite	1
Extent of Damage:	Minor	1
Surface Treatment:	Non-Friable	0
Asbestos type:	Amosite	2
Material Assessment Score:		4
Priority Assessment Score:		Negligible
Action:	Manage	
Comments:	N/A

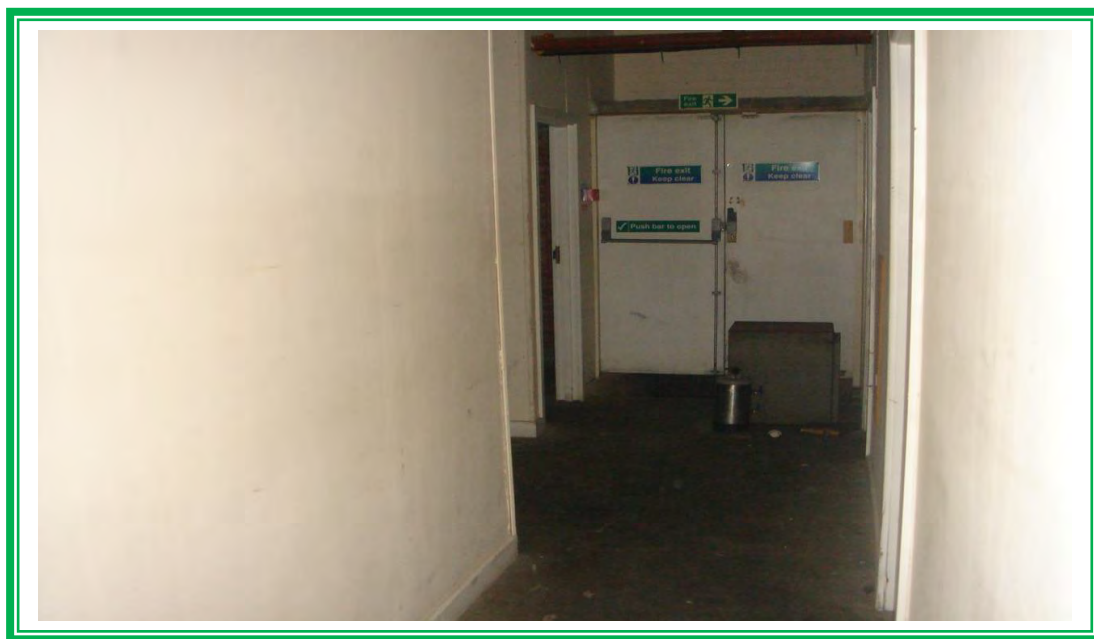
Location: 1/005 Corridor

Material Description:	Visual Inspection – No Suspect Materials Found	
Identification:	N/A	
Approx. quantity:	N/A	
Accessibility	N/A	Assessment Score
Product type:	N/A	N/A
Extent of Damage:	N/A	N/A
Surface Treatment:	N/A	N/A
Asbestos type:	N/A	N/A
Material Assessment Score:		N/A
Priority Assessment Score:		N/A
Action:	N/A	
Comments:	N/A

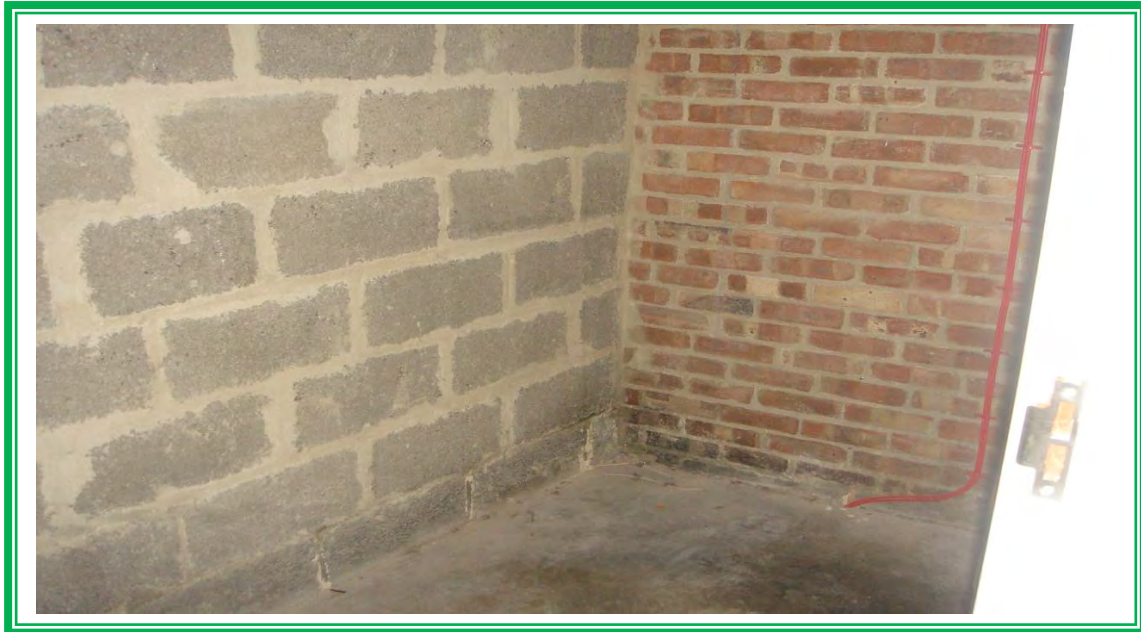
Location: 1/006 Store

Material Description:	Visual Inspection – No Suspect Materials Found	
Identification:	N/A	
Approx. quantity:	N/A	
Accessibility	N/A	Assessment Score
Product type:	N/A	N/A
Extent of Damage:	N/A	N/A
Surface Treatment:	N/A	N/A
Asbestos type:	N/A	N/A
Material Assessment Score:		N/A
Priority Assessment Score:		N/A
Action:	N/A	
Comments:	N/A

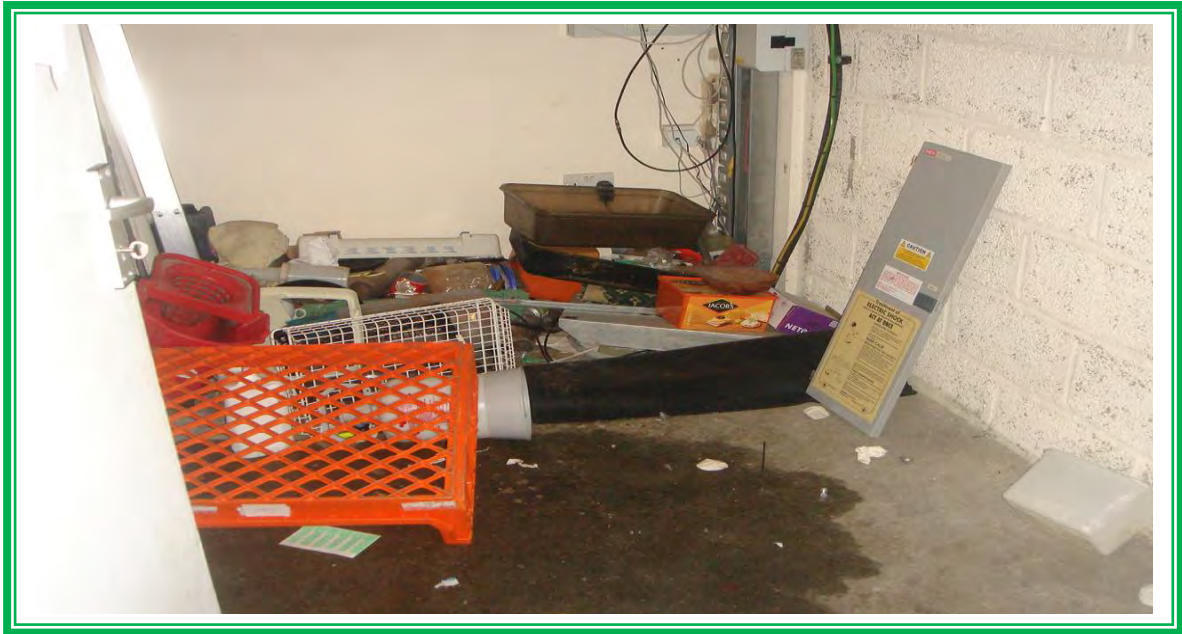
Location: 1/007

Material Description:	Visual Inspection – No Suspect Materials Found	
Identification:	N/A	
Approx. quantity:	N/A	
Accessibility	N/A	Assessment Score
Product type:	N/A	N/A
Extent of Damage:	N/A	N/A
Surface Treatment:	N/A	N/A
Asbestos type:	N/A	N/A
Material Assessment Score:		N/A
Priority Assessment Score:		N/A
Action:	N/A	
Comments:	N/A

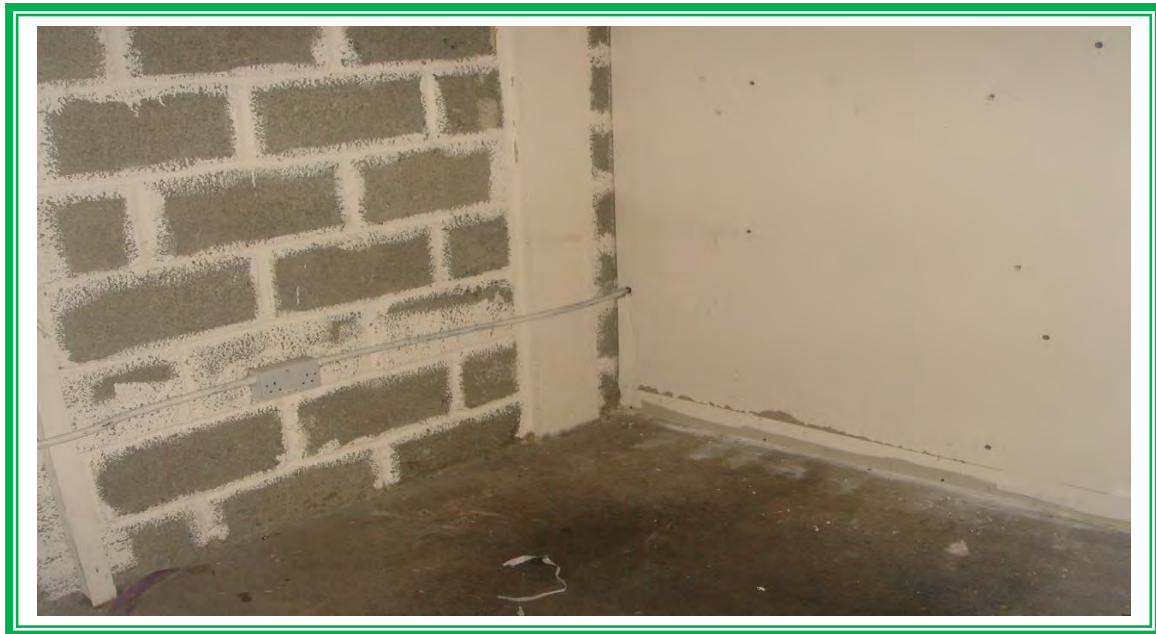
Location: 1/008

Material Description:	Visual Inspection – No Suspect Materials Found	
Identification:	N/A	
Approx. quantity:	N/A	
Accessibility	N/A	Assessment Score
Product type:	N/A	N/A
Extent of Damage:	N/A	N/A
Surface Treatment:	N/A	N/A
Asbestos type:	N/A	N/A
Material Assessment Score:		N/A
Priority Assessment Score:		N/A
Action:	N/A	
Comments:	N/A

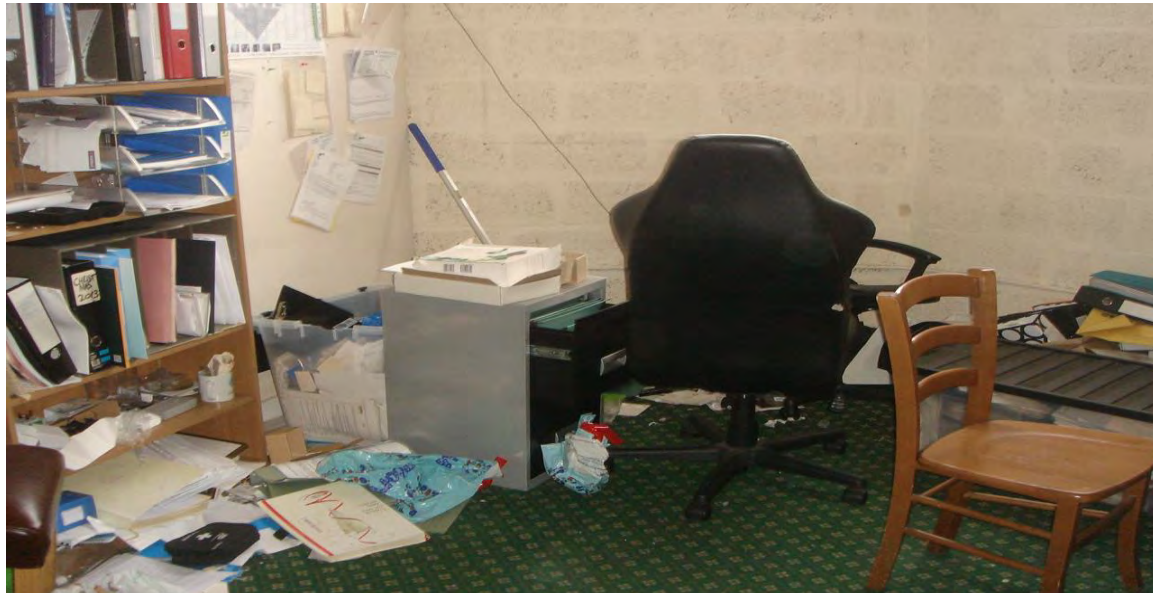
Location: 1/010 Store

Material Description:	Visual Inspection – No Suspect Materials Found	
Identification:	N/A	
Approx. quantity:	N/A	
Accessibility	N/A	Assessment Score
Product type:	N/A	N/A
Extent of Damage:	N/A	N/A
Surface Treatment:	N/A	N/A
Asbestos type:	N/A	N/A
Material Assessment Score:		N/A
Priority Assessment Score:		N/A
Action:	N/A	
Comments:	N/A

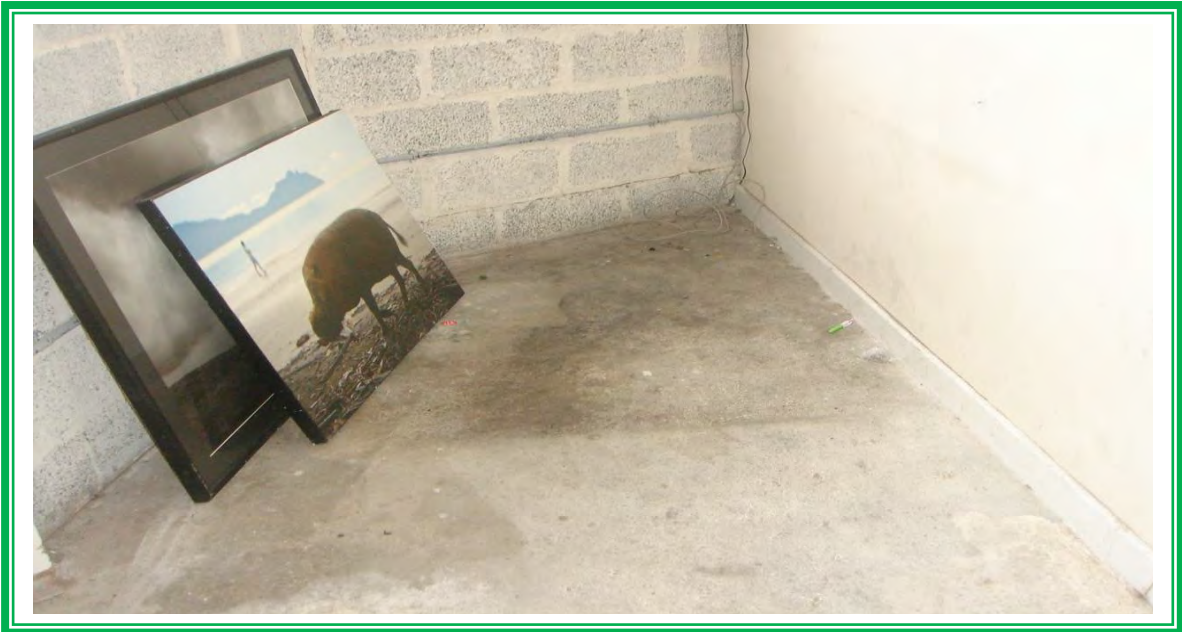
Location: 1/011 Store

Material Description:	Visual Inspection – No Suspect Materials Found	
Identification:	N/A	
Approx. quantity:	N/A	
Accessibility	N/A	Assessment Score
Product type:	N/A	N/A
Extent of Damage:	N/A	N/A
Surface Treatment:	N/A	N/A
Asbestos type:	N/A	N/A
Material Assessment Score:		N/A
Priority Assessment Score:		N/A
Action:	N/A	
Comments:	N/A

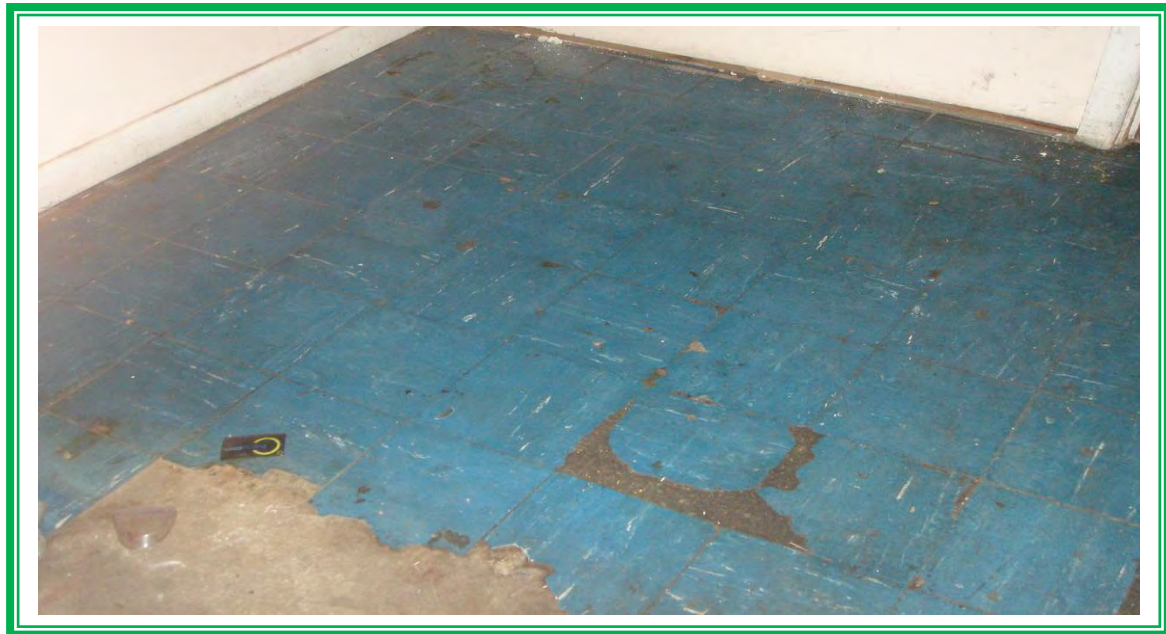
Location: 1/012 Corridor

Material Description:	Vinyl Floor Tiles	
Identification:	Sampled – No Asbestos Detected	
Approx. quantity:	6M2	
Accessibility	N/A	Assessment Score
Product type:	N/A	N/A
Extent of Damage:	N/A	N/A
Surface Treatment:	N/A	N/A
Asbestos type:	N/A	N/A
Material Assessment Score:		N/A
Priority Assessment Score:		N/A
Action:	N/A	
Comments:	N/A

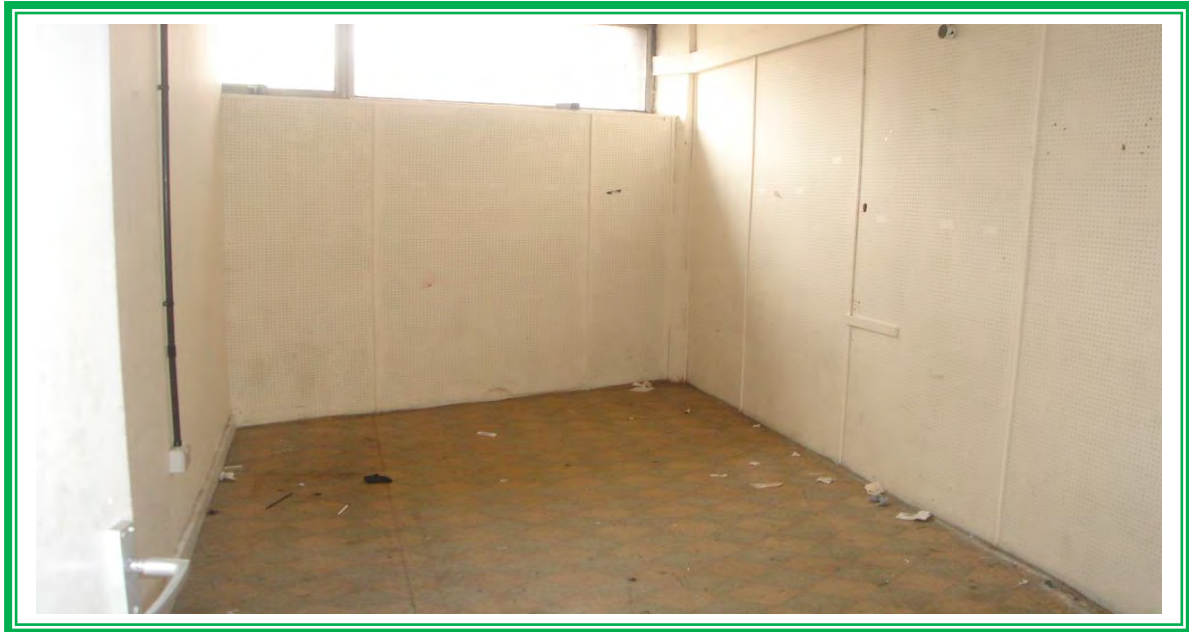
Location: 1/013

Material Description:	Visual Inspection – No Suspect Materials Found	
Identification:	N/A	
Approx. quantity:	N/A	
Accessibility	N/A	Assessment Score
Product type:	N/A	N/A
Extent of Damage:	N/A	N/A
Surface Treatment:	N/A	N/A
Asbestos type:	N/A	N/A
Material Assessment Score:		N/A
Priority Assessment Score:		N/A
Action:	N/A	
Comments:	N/A
