Project Number 3113

Management Asbestos Survey Report

Kennet Centre, Market Street, Newbury,
Berkshire, RG14 5EN

3 Market Place and Associated Store

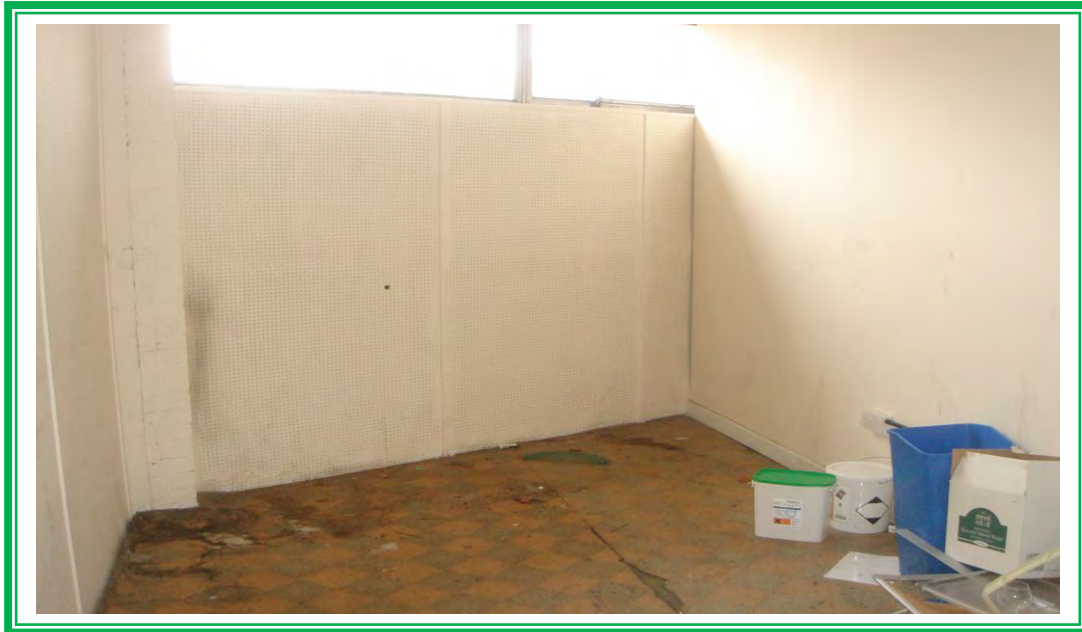
Location: 1/014

Material Description:	Visual Inspection – No Suspect Materials Found	
Identification:	N/A	
Approx. quantity:	N/A	
Accessibility	N/A	Assessment Score
Product type:	N/A	N/A
Extent of Damage:	N/A	N/A
Surface Treatment:	N/A	N/A
Asbestos type:	N/A	N/A
Material Assessment Score:		N/A
Priority Assessment Score:		N/A
Action:	N/A	
Comments:	N/A

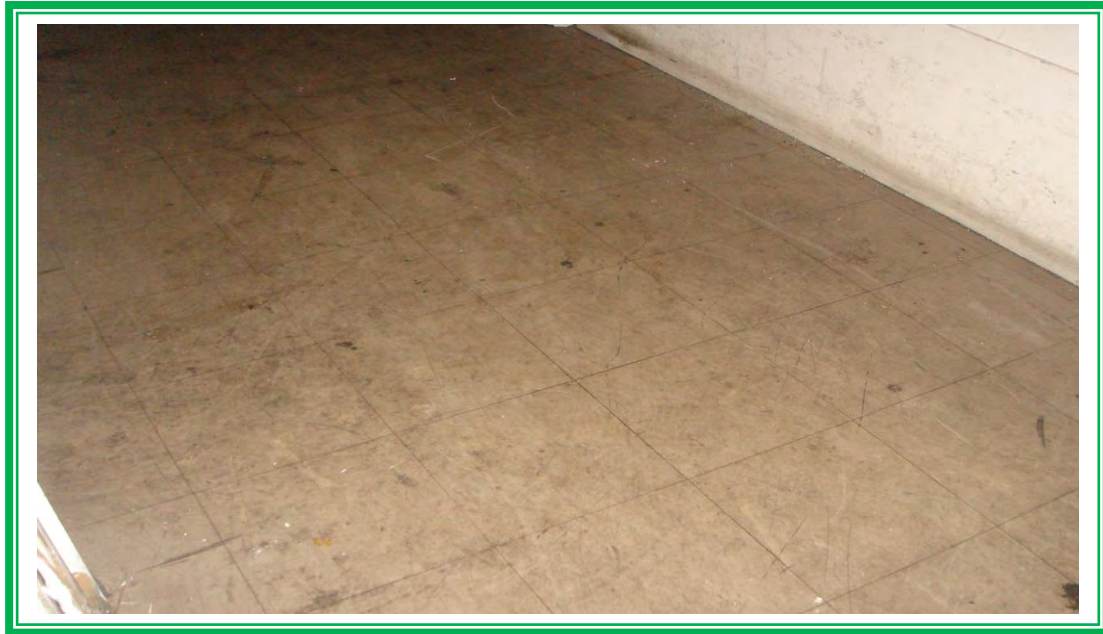
Location: 1/015

Material Description:	Vinyl Floor Tiles	
Identification:	Sampled – No Asbestos Detected	
Approx. quantity:	8M2	
Accessibility	N/A	Assessment Score
Product type:	N/A	N/A
Extent of Damage:	N/A	N/A
Surface Treatment:	N/A	N/A
Asbestos type:	N/A	N/A
Material Assessment Score:		N/A
Priority Assessment Score:		N/A
Action:	N/A	
Comments:	N/A

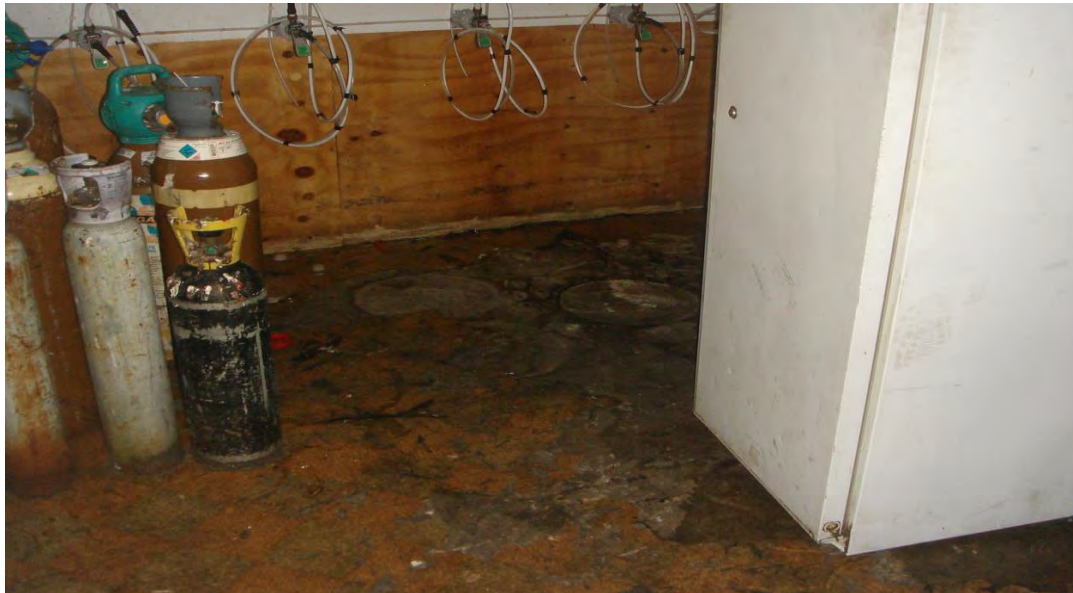
Location: 1/016

Material Description:	Visual Inspection – No Suspect Materials Found	
Identification:	N/A	
Approx. quantity:	N/A	
Accessibility	N/A	Assessment Score
Product type:	N/A	N/A
Extent of Damage:	N/A	N/A
Surface Treatment:	N/A	N/A
Asbestos type:	N/A	N/A
Material Assessment Score:		N/A
Priority Assessment Score:		N/A
Action:	N/A	
Comments:	N/A

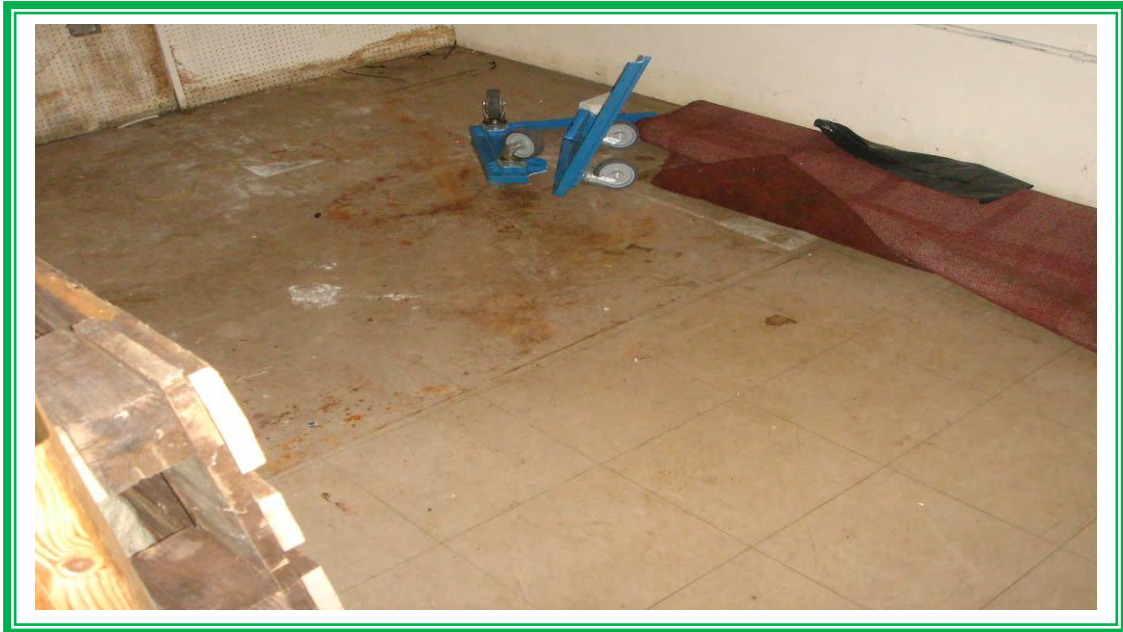
Location: 1/017

Material Description:	Vinyl Floor Tiles	
Identification:	As Per Sample 3 – No Asbestos Detected	
Approx. quantity:	8M2	
Accessibility	N/A	Assessment Score
Product type:	N/A	N/A
Extent of Damage:	N/A	N/A
Surface Treatment:	N/A	N/A
Asbestos type:	N/A	N/A
Material Assessment Score:		N/A
Priority Assessment Score:		N/A
Action:	N/A	
Comments:	N/A

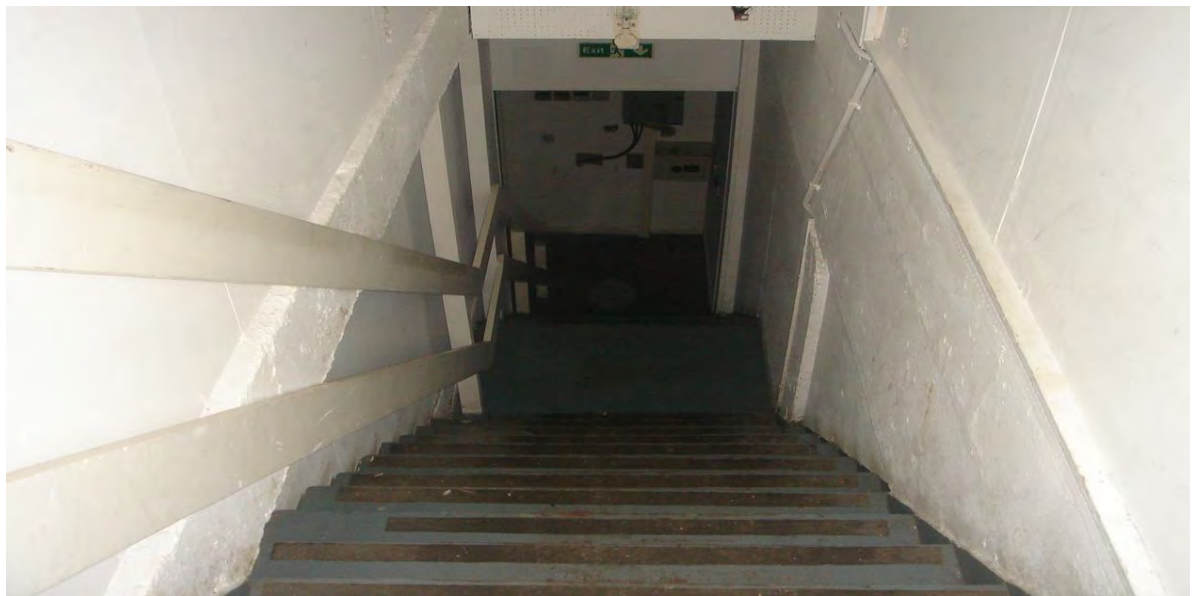
Location: 1/019 Stairs

Material Description:	Visual Inspection – No Suspect Materials Found	
Identification:	N/A	
Approx. quantity:	N/A	
Accessibility	N/A	Assessment Score
Product type:	N/A	N/A
Extent of Damage:	N/A	N/A
Surface Treatment:	N/A	N/A
Asbestos type:	N/A	N/A
Material Assessment Score:		N/A
Priority Assessment Score:		N/A
Action:	N/A	
Comments:	N/A

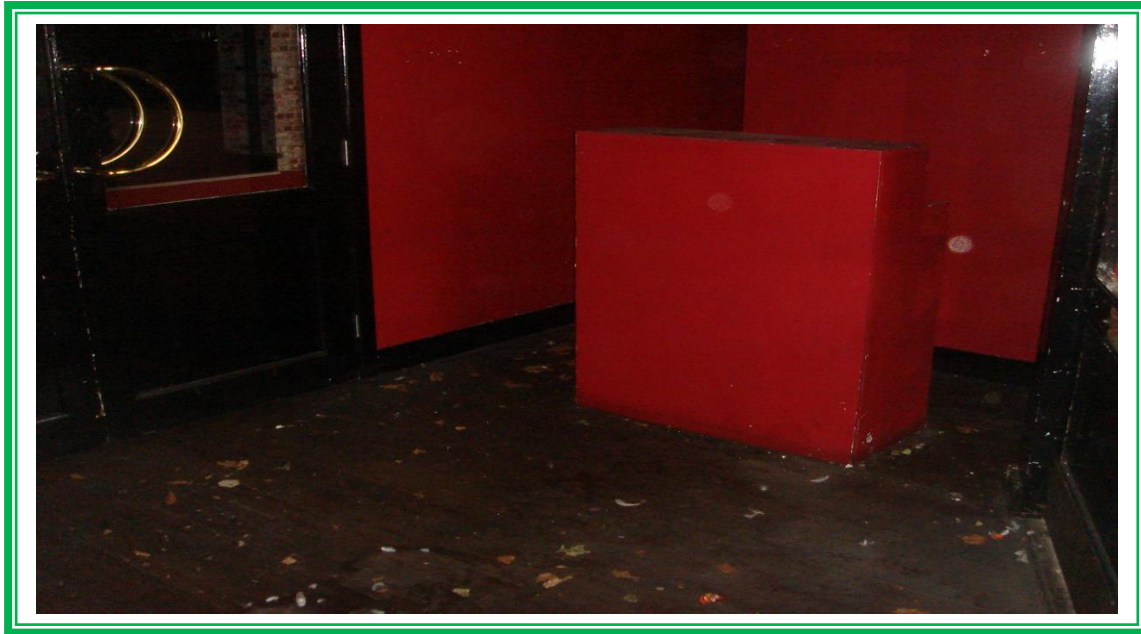
Location: 0/001 Entrance Lobby

Material Description:	Visual Inspection – No Suspect Materials Found	
Identification:	N/A	
Approx. quantity:	N/A	
Accessibility	N/A	Assessment Score
Product type:	N/A	N/A
Extent of Damage:	N/A	N/A
Surface Treatment:	N/A	N/A
Asbestos type:	N/A	N/A
Material Assessment Score:		N/A
Priority Assessment Score:		N/A
Action:	N/A	
Comments:	N/A

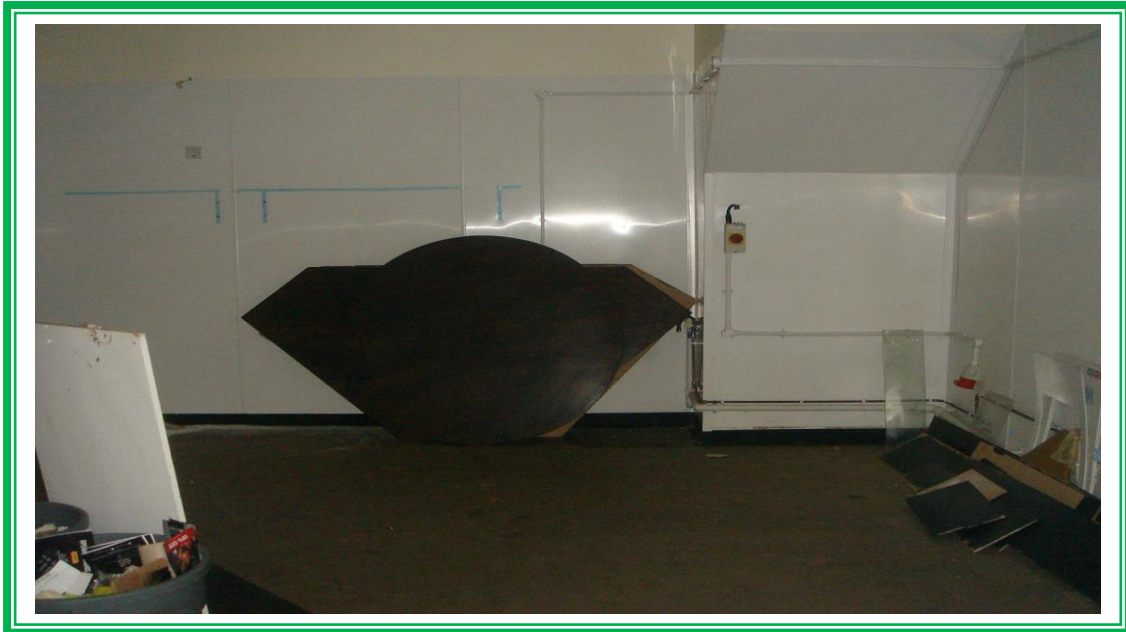
Location: 0/014

Material Description:	Visual Inspection – No Suspect Materials Found	
Identification:	N/A	
Approx. quantity:	N/A	
Accessibility	N/A	Assessment Score
Product type:	N/A	N/A
Extent of Damage:	N/A	N/A
Surface Treatment:	N/A	N/A
Asbestos type:	N/A	N/A
Material Assessment Score:		N/A
Priority Assessment Score:		N/A
Action:	N/A	
Comments:	Plastic Wall Sheets

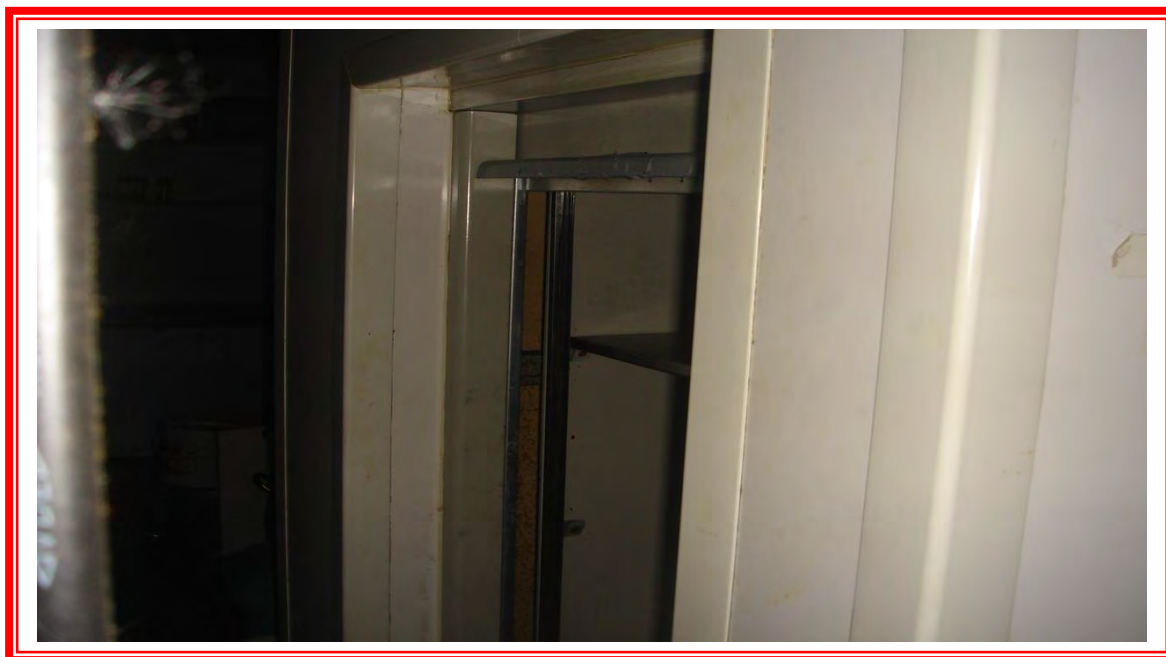
Location: 1/003 Dumbwaiter

Material Description:	No Access to Dumb Waiter and Lift Shafts	
Identification:	Presumed to Contain Asbestos	
Approx. quantity:	Unknown	
Accessibility	Low	Assessment Score
Product type:	No Access	3
Extent of Damage:	No Access	3
Surface Treatment:	No Access	3
Asbestos type:	No Access	3
Material Assessment Score:		12
Priority Assessment Score:		High
Action:	Further Inspection Required	
Comments:	No Access as Presumed Live

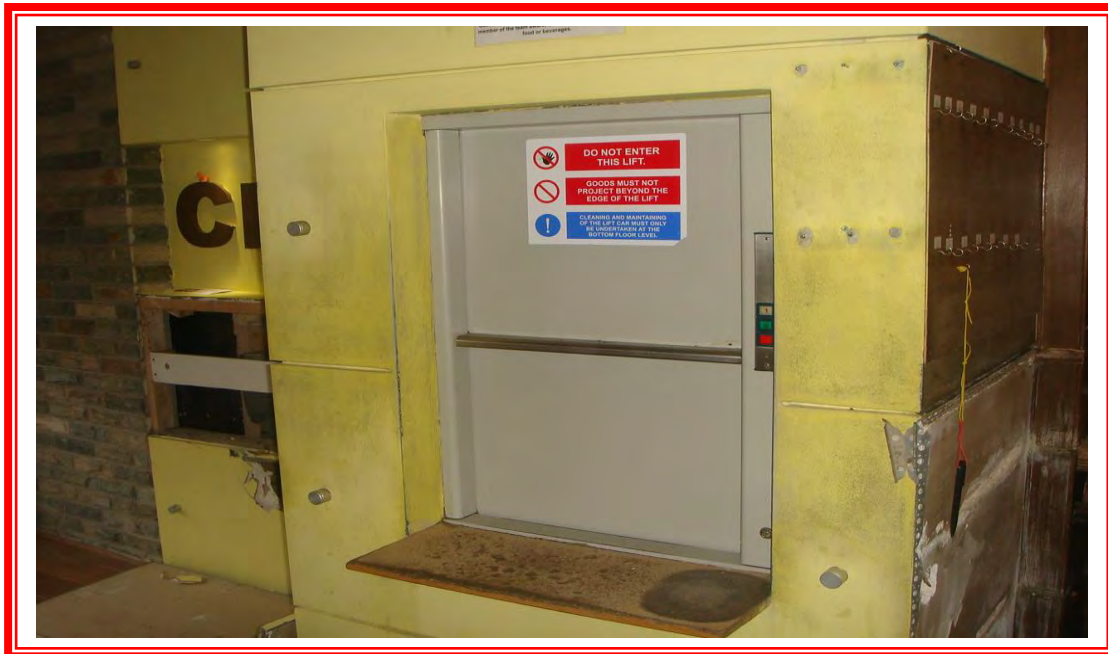
Location: 0/002

Material Description:	No Access to Dumb Waiter and Shaft	
Identification:	Presumed to Contain Asbestos	
Approx. quantity:	Unknown	
Accessibility	Low	Assessment Score
Product type:	No Access	3
Extent of Damage:	No Access	3
Surface Treatment:	No Access	3
Asbestos type:	No Access	3
Material Assessment Score:		12
Priority Assessment Score:		High
Action:	Further Inspection Required	
Comments:	No Access as Presumed to be Live

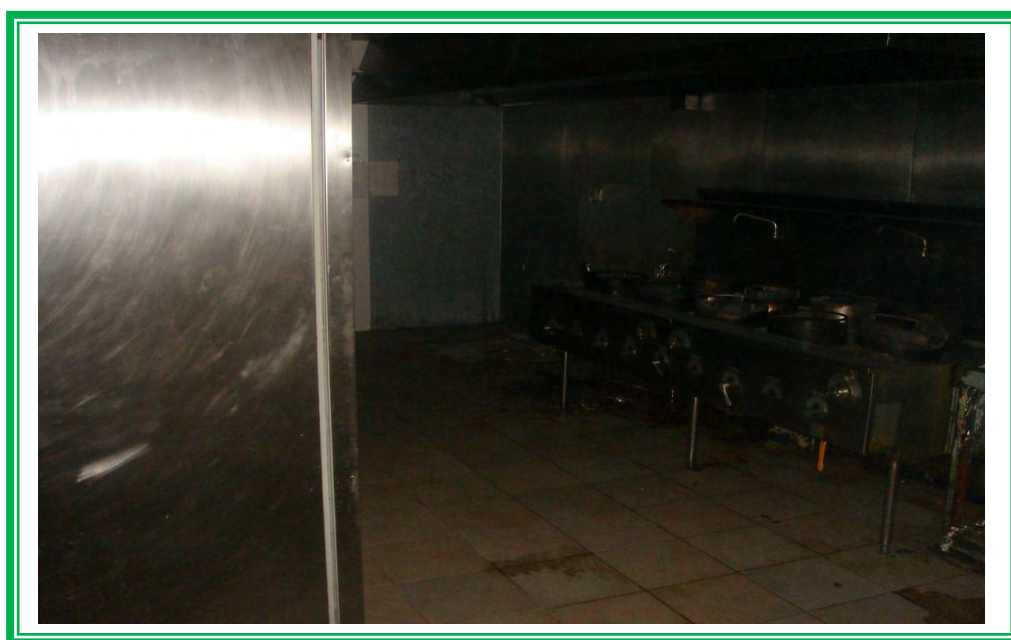
Item No: 1	Sample No: N/A
Location: 1/001 Kitchen

Material Description:	Visual Inspection – No Suspect Materials Found	
Identification:	N/A	
Approx. quantity:	N/A	
Accessibility	N/A	Assessment Score
Product type:	N/A	N/A
Extent of Damage:	N/A	N/A
Surface Treatment:	N/A	N/A
Asbestos type:	N/A	N/A
Material Assessment Score:		N/A
Priority Assessment Score:		N/A
Action:	N/A	
Comments:	N/A

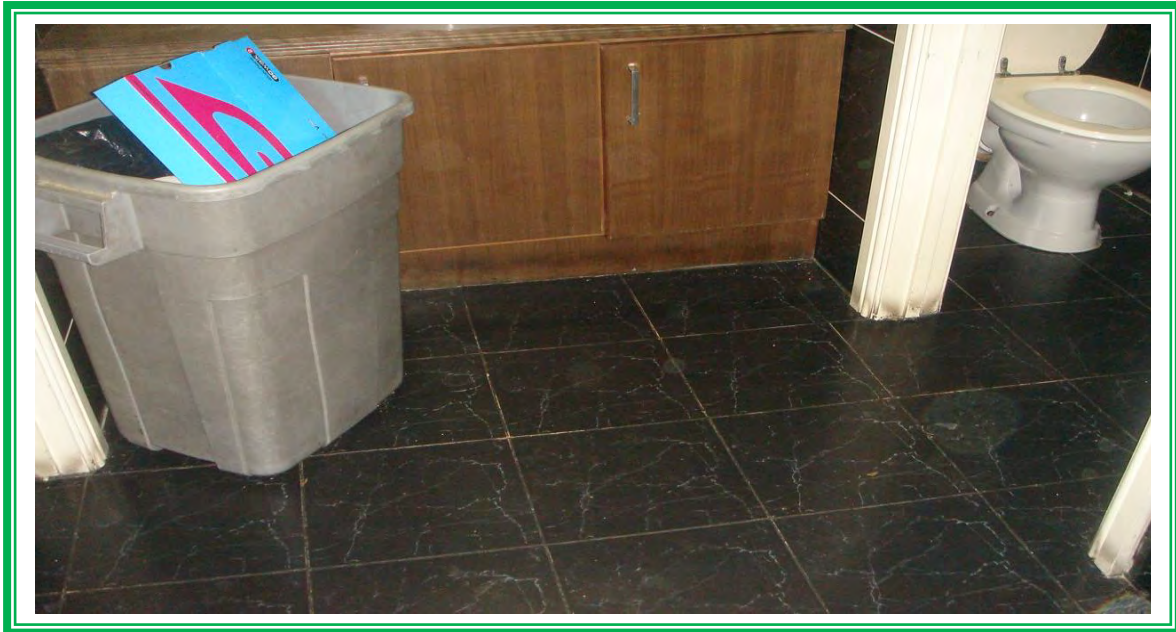
Location: 0/004 Toilet Lobby

Material Description:	Visual Inspection – No Suspect Materials Found	
Identification:	N/A	
Approx. quantity:	N/A	
Accessibility	N/A	Assessment Score
Product type:	N/A	N/A
Extent of Damage:	N/A	N/A
Surface Treatment:	N/A	N/A
Asbestos type:	N/A	N/A
Material Assessment Score:		N/A
Priority Assessment Score:		N/A
Action:	N/A	
Comments:	N/A

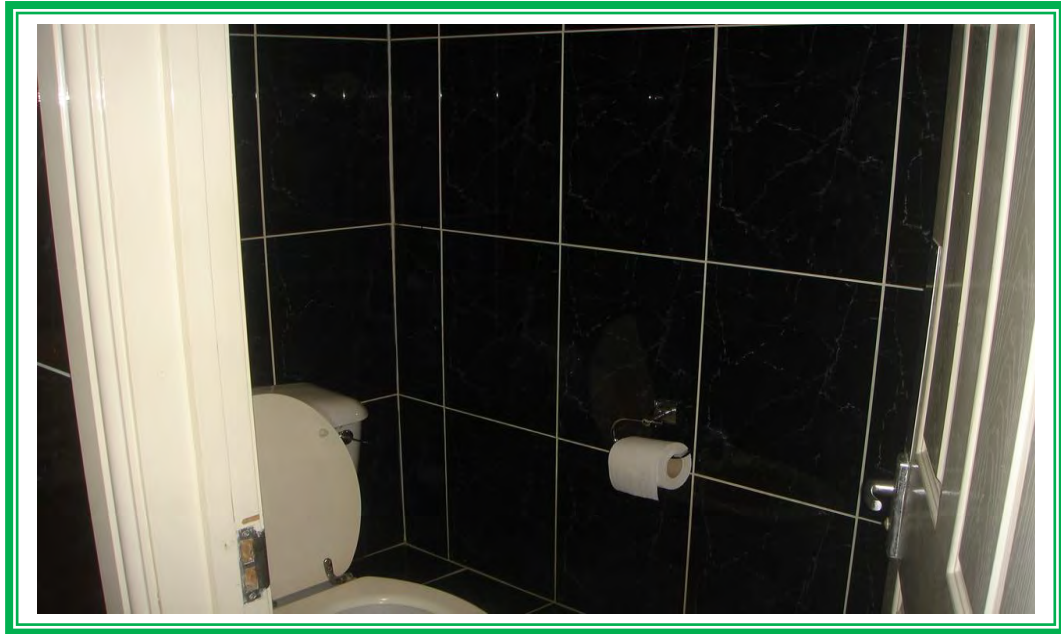
Location: 0/005 Male WC

Material Description:	Visual Inspection – No Suspect Materials Found	
Identification:	N/A	
Approx. quantity:	N/A	
Accessibility	N/A	Assessment Score
Product type:	N/A	N/A
Extent of Damage:	N/A	N/A
Surface Treatment:	N/A	N/A
Asbestos type:	N/A	N/A
Material Assessment Score:		N/A
Priority Assessment Score:		N/A
Action:	N/A	
Comments:	N/A

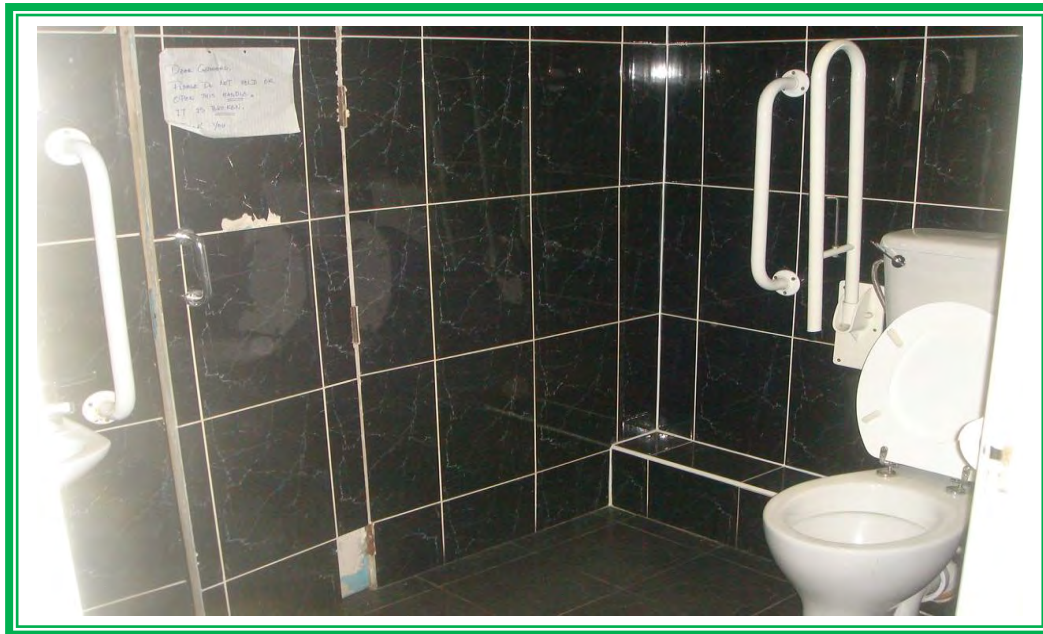
Location: 0/006 Female WC

Material Description:	Visual Inspection – No Suspect Materials Found	
Identification:	N/A	
Approx. quantity:	N/A	
Accessibility	N/A	Assessment Score
Product type:	N/A	N/A
Extent of Damage:	N/A	N/A
Surface Treatment:	N/A	N/A
Asbestos type:	N/A	N/A
Material Assessment Score:		N/A
Priority Assessment Score:		N/A
Action:	N/A	
Comments:	N/A

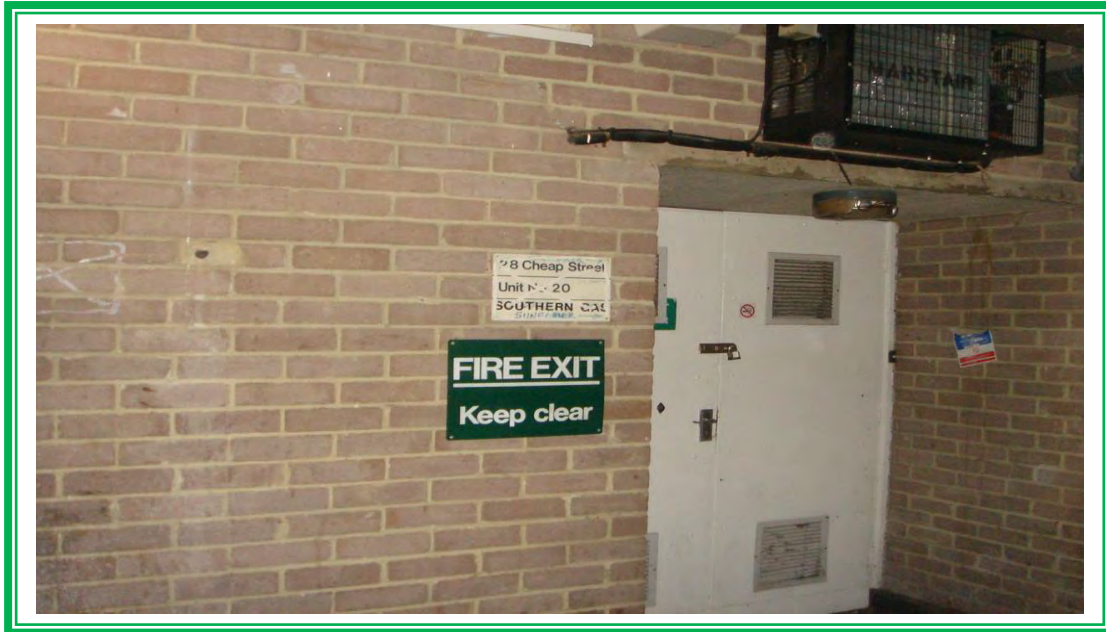
Location: 99/001 External

Material Description:	Visual Inspection – No Suspect Materials Found	
Identification:	N/A	
Approx. quantity:	N/A	
Accessibility	N/A	Assessment Score
Product type:	N/A	N/A
Extent of Damage:	N/A	N/A
Surface Treatment:	N/A	N/A
Asbestos type:	N/A	N/A
Material Assessment Score:		N/A
Priority Assessment Score:		N/A
Action:	N/A	
Comments:	N/A

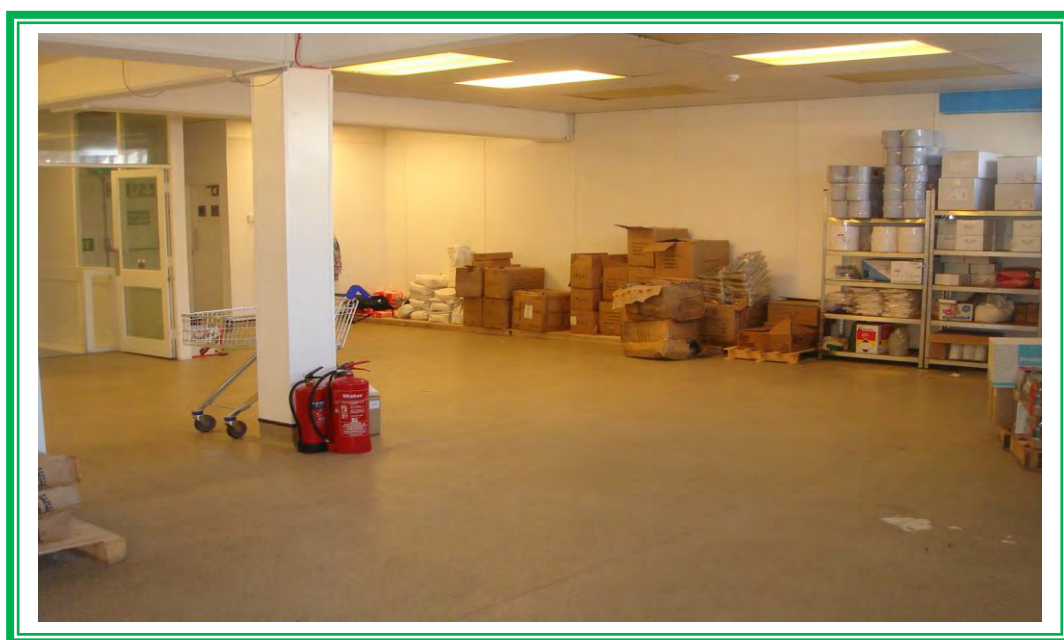
Location: 1/001 Store

Material Description:	Visual Inspection – No Suspect Materials Found	
Identification:	N/A	
Approx. quantity:	N/A	
Accessibility	N/A	Assessment Score
Product type:	N/A	N/A
Extent of Damage:	N/A	N/A
Surface Treatment:	N/A	N/A
Asbestos type:	N/A	N/A
Material Assessment Score:		N/A
Priority Assessment Score:		N/A
Action:	N/A	
Comments:	N/A

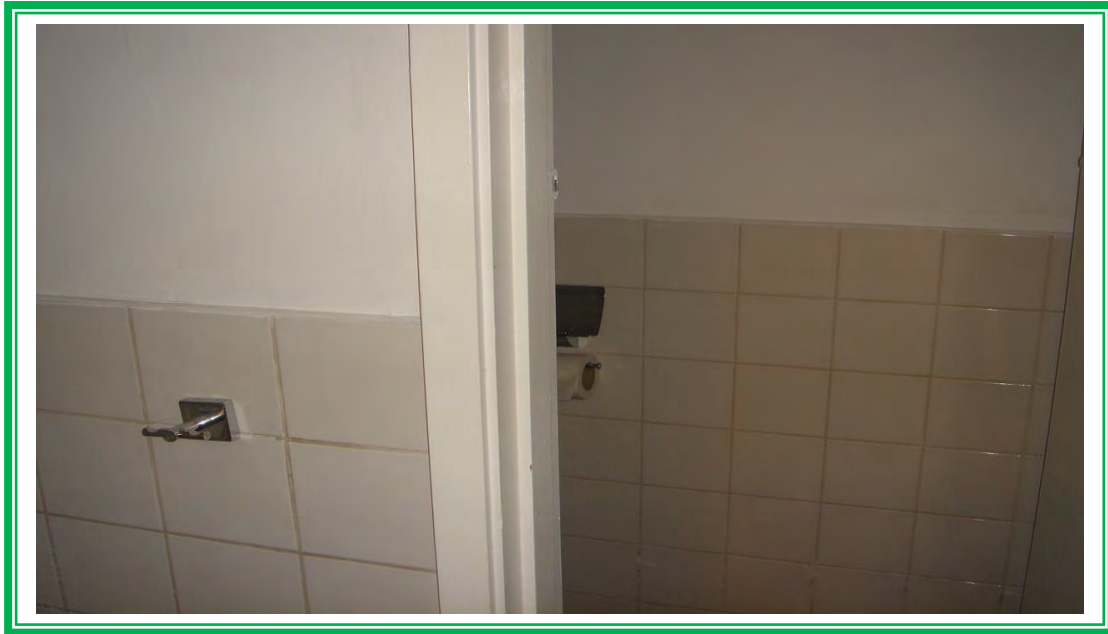
Location: 1/002 WC

Material Description:	Visual Inspection – No Suspect Materials Found	
Identification:	N/A	
Approx. quantity:	N/A	
Accessibility	N/A	Assessment Score
Product type:	N/A	N/A
Extent of Damage:	N/A	N/A
Surface Treatment:	N/A	N/A
Asbestos type:	N/A	N/A
Material Assessment Score:		N/A
Priority Assessment Score:		N/A
Action:	N/A	
Comments:	N/A

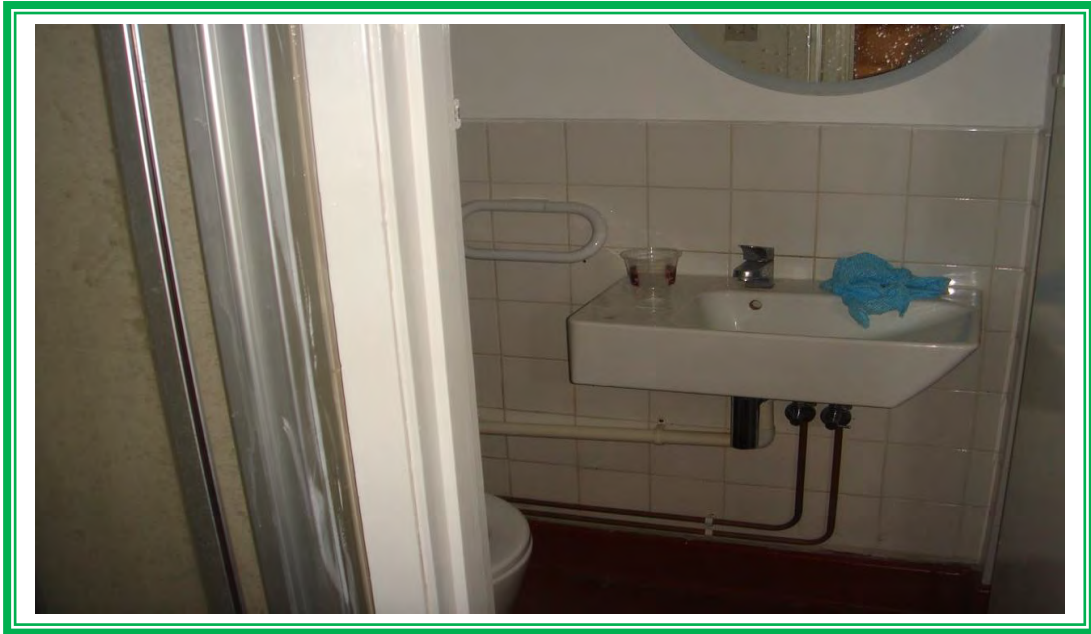
Location: 1/003 WC

Material Description:	Visual Inspection – No Suspect Materials Found	
Identification:	N/A	
Approx. quantity:	N/A	
Accessibility	N/A	Assessment Score
Product type:	N/A	N/A
Extent of Damage:	N/A	N/A
Surface Treatment:	N/A	N/A
Asbestos type:	N/A	N/A
Material Assessment Score:		N/A
Priority Assessment Score:		N/A
Action:	N/A	
Comments:	N/A

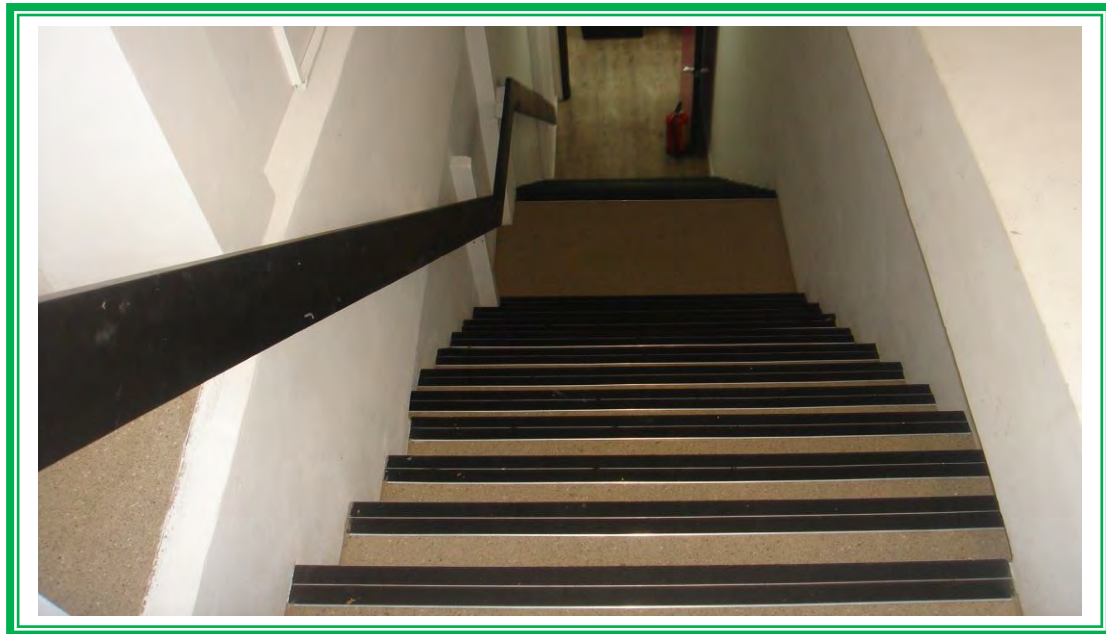
Location: 1/004 Stairs

Material Description:	Visual Inspection – No Suspect Materials Found	
Identification:	N/A	
Approx. quantity:	N/A	
Accessibility	N/A	Assessment Score
Product type:	N/A	N/A
Extent of Damage:	N/A	N/A
Surface Treatment:	N/A	N/A
Asbestos type:	N/A	N/A
Material Assessment Score:		N/A
Priority Assessment Score:		N/A
Action:	N/A	
Comments:	N/A

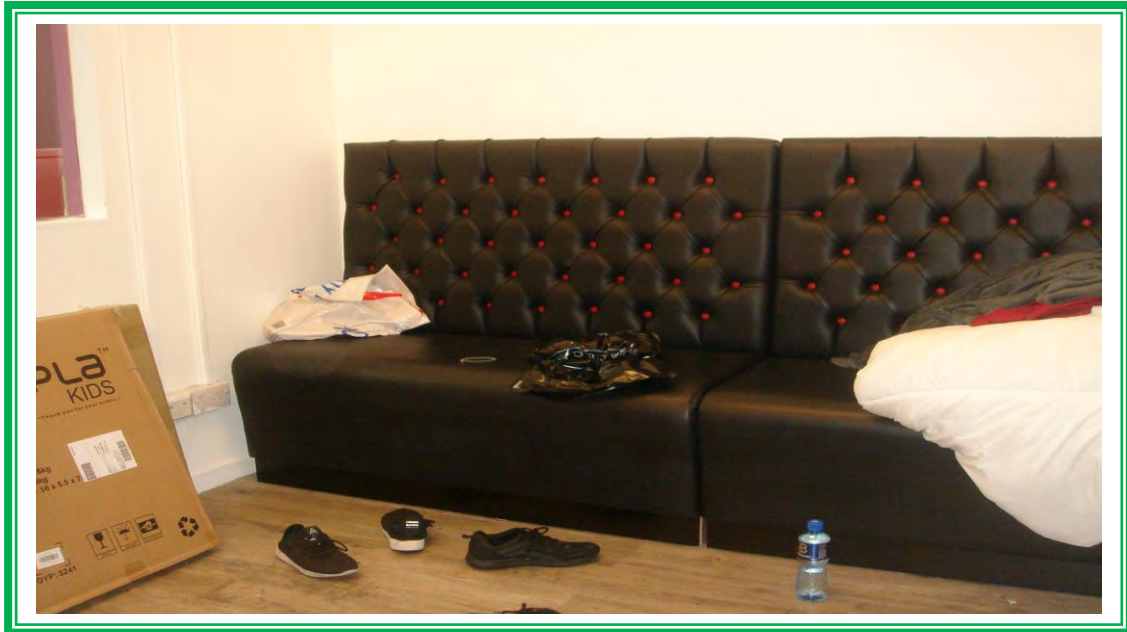
Location: 0/001 Office

Material Description:	Visual Inspection – No Suspect Materials Found	
Identification:	N/A	
Approx. quantity:	N/A	
Accessibility	N/A	Assessment Score
Product type:	N/A	N/A
Extent of Damage:	N/A	N/A
Surface Treatment:	N/A	N/A
Asbestos type:	N/A	N/A
Material Assessment Score:		N/A
Priority Assessment Score:		N/A
Action:	N/A	
Comments:	N/A

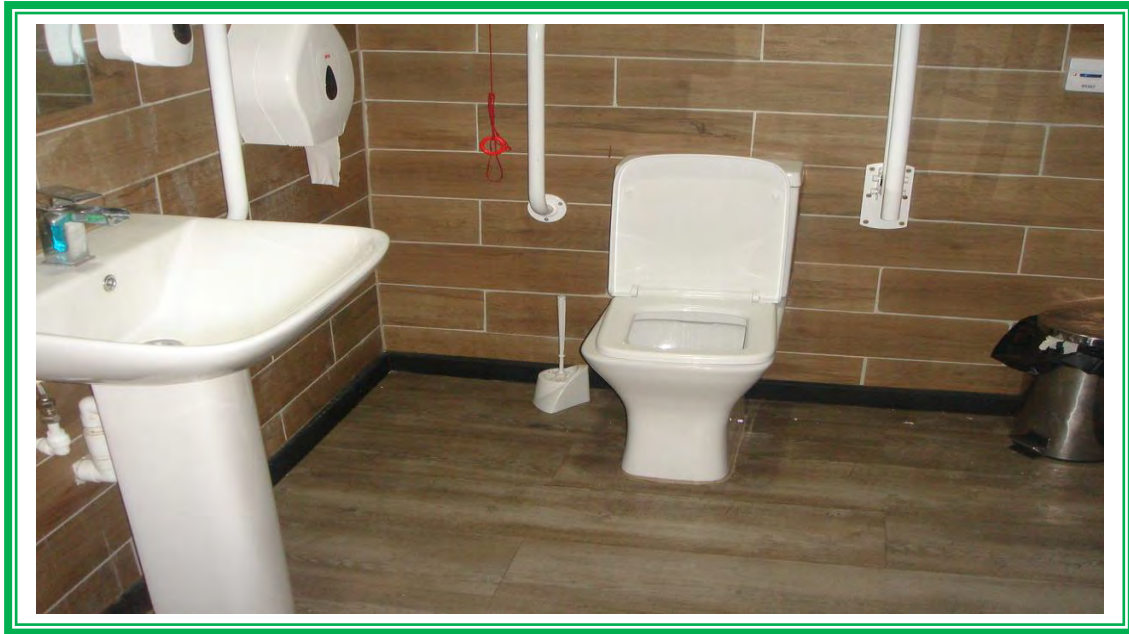
Location: 0/002 WC

Material Description:	Visual Inspection – No Suspect Materials Found	
Identification:	N/A	
Approx. quantity:	N/A	
Accessibility	N/A	Assessment Score
Product type:	N/A	N/A
Extent of Damage:	N/A	N/A
Surface Treatment:	N/A	N/A
Asbestos type:	N/A	N/A
Material Assessment Score:		N/A
Priority Assessment Score:		N/A
Action:	N/A	
Comments:	N/A

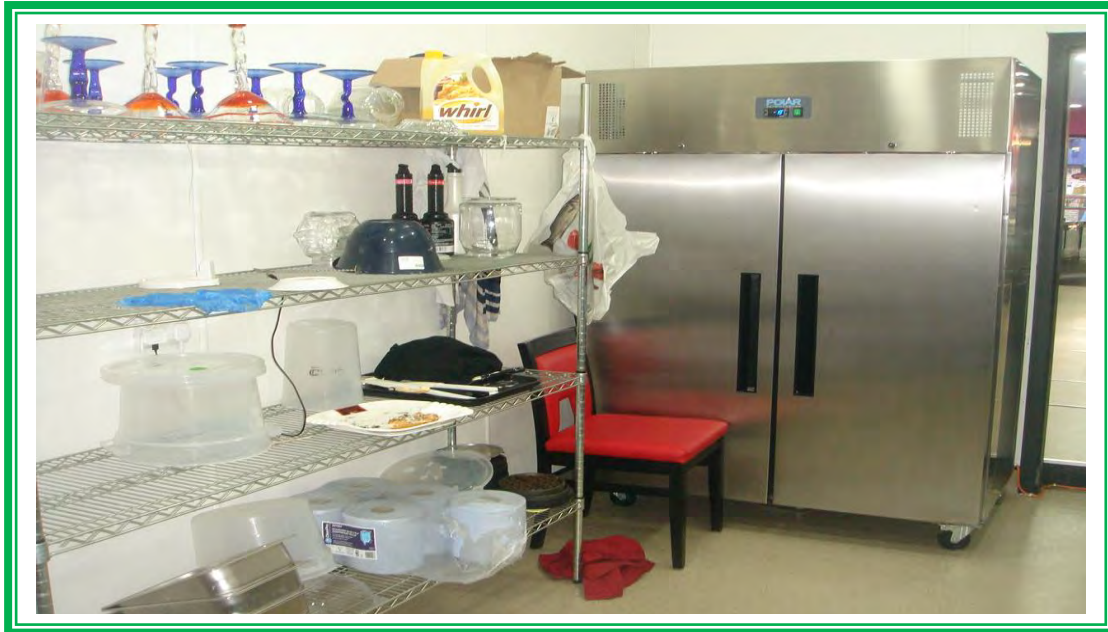
Location: 0/003 Kitchen

Material Description:	Visual Inspection – No Suspect Materials Found	
Identification:	N/A	
Approx. quantity:	N/A	
Accessibility	N/A	Assessment Score
Product type:	N/A	N/A
Extent of Damage:	N/A	N/A
Surface Treatment:	N/A	N/A
Asbestos type:	N/A	N/A
Material Assessment Score:		N/A
Priority Assessment Score:		N/A
Action:	N/A	
Comments:	N/A

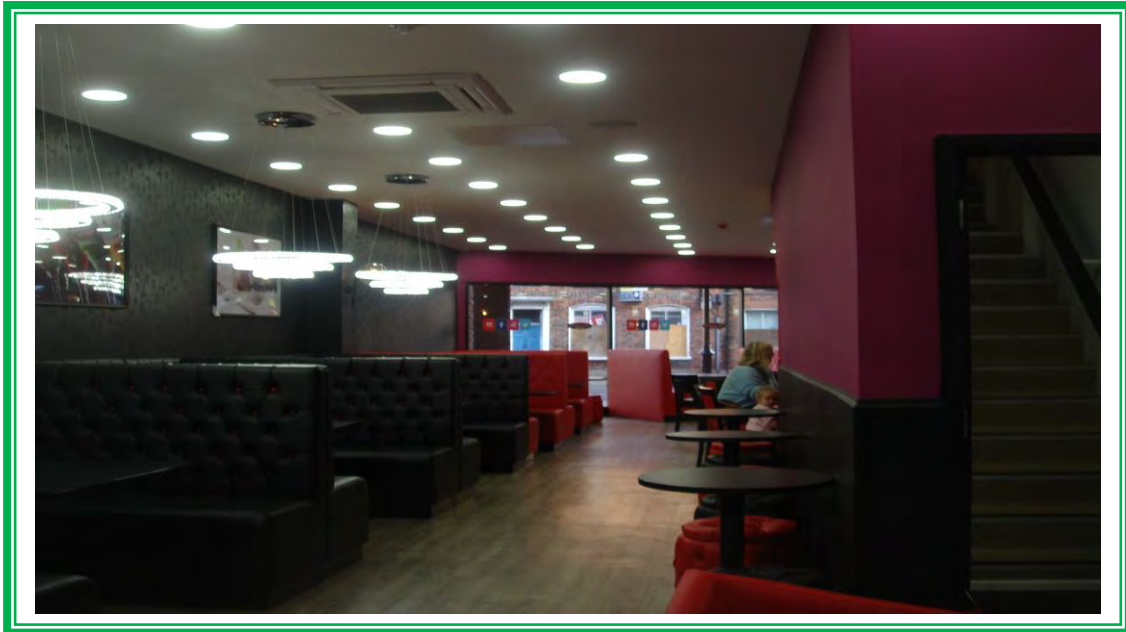
Location: 0/004 Restaurant/Servery

Material Description:	Visual Inspection – No Suspect Materials Found	
Identification:	N/A	
Approx. quantity:	N/A	
Accessibility	N/A	Assessment Score
Product type:	N/A	N/A
Extent of Damage:	N/A	N/A
Surface Treatment:	N/A	N/A
Asbestos type:	N/A	N/A
Material Assessment Score:		N/A
Priority Assessment Score:		N/A
Action:	N/A	
Comments:	N/A

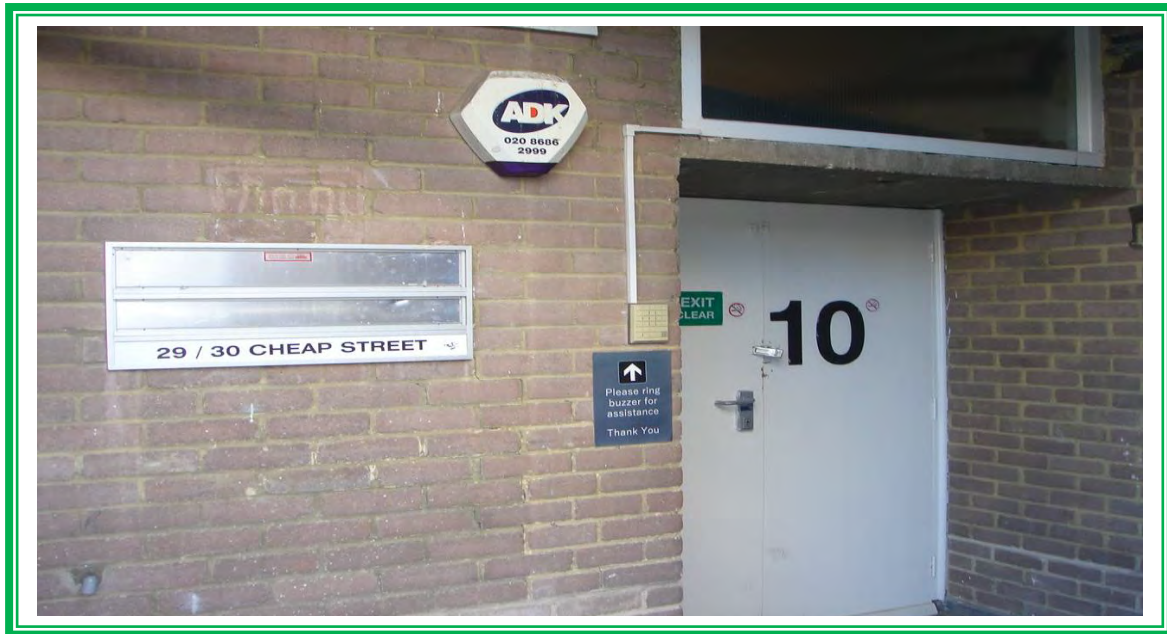
Location: 99/001 External

Material Description:	Visual Inspection – No Suspect Materials Found	
Identification:	N/A	
Approx. quantity:	N/A	
Accessibility	N/A	Assessment Score
Product type:	N/A	N/A
Extent of Damage:	N/A	N/A
Surface Treatment:	N/A	N/A
Asbestos type:	N/A	N/A
Material Assessment Score:		N/A
Priority Assessment Score:		N/A
Action:	N/A	
Comments:	N/A
