Project Number 3113

Management
Asbestos Survey Report

Kennet Centre, Market Street, Newbury,
Berkshire, RG14 5EN

3 Market Place and Associated Store

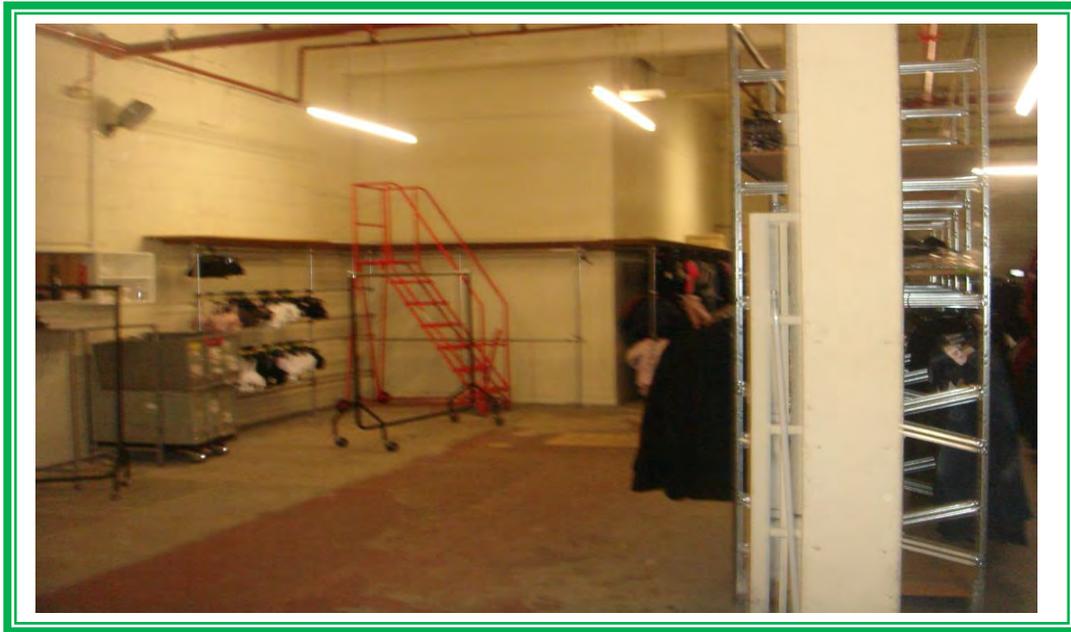
Item No: 1	Sample No: N/A
Location: 1/001 Stock Room

Material Description:	Visual Inspection – No Suspect Materials Found	
Identification:	N/A	
Approx. quantity:	N/A	
Accessibility	N/A	Assessment Score
Product type:	N/A	N/A
Extent of Damage:	N/A	N/A
Surface Treatment:	N/A	N/A
Asbestos type:	N/A	N/A
Material Assessment Score:		N/A
Priority Assessment Score:		N/A
Action:	N/A	
Comments:	N/A

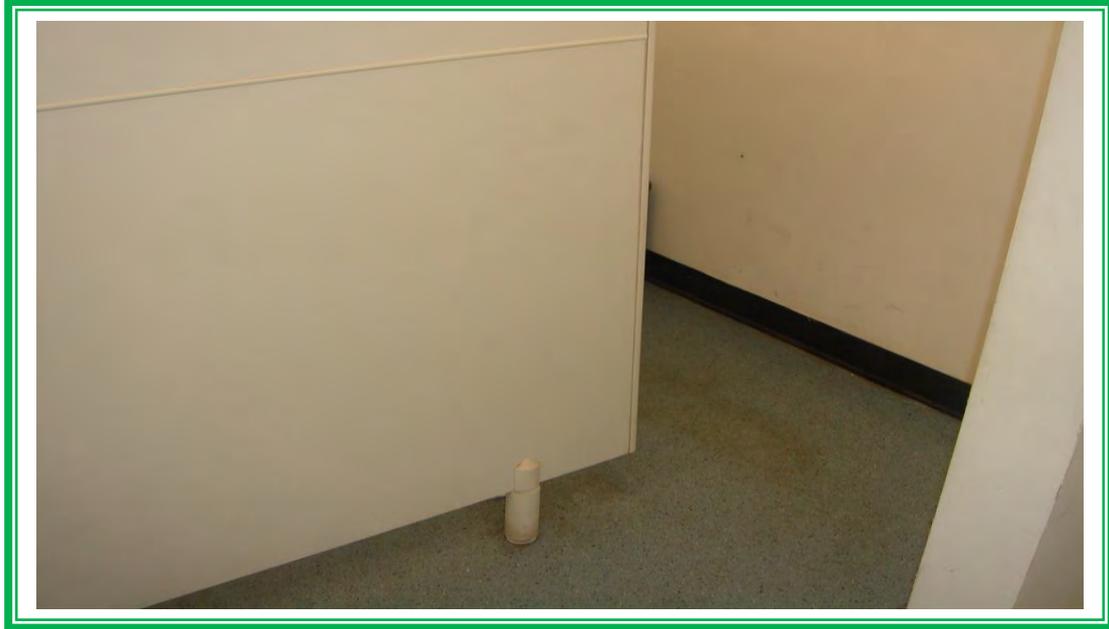
Location: 1/002 WC

Material Description:	Visual Inspection – No Suspect Materials Found	
Identification:	N/A	
Approx. quantity:	N/A	
Accessibility	N/A	Assessment Score
Product type:	N/A	N/A
Extent of Damage:	N/A	N/A
Surface Treatment:	N/A	N/A
Asbestos type:	N/A	N/A
Material Assessment Score:		N/A
Priority Assessment Score:		N/A
Action:	N/A	
Comments:	N/A

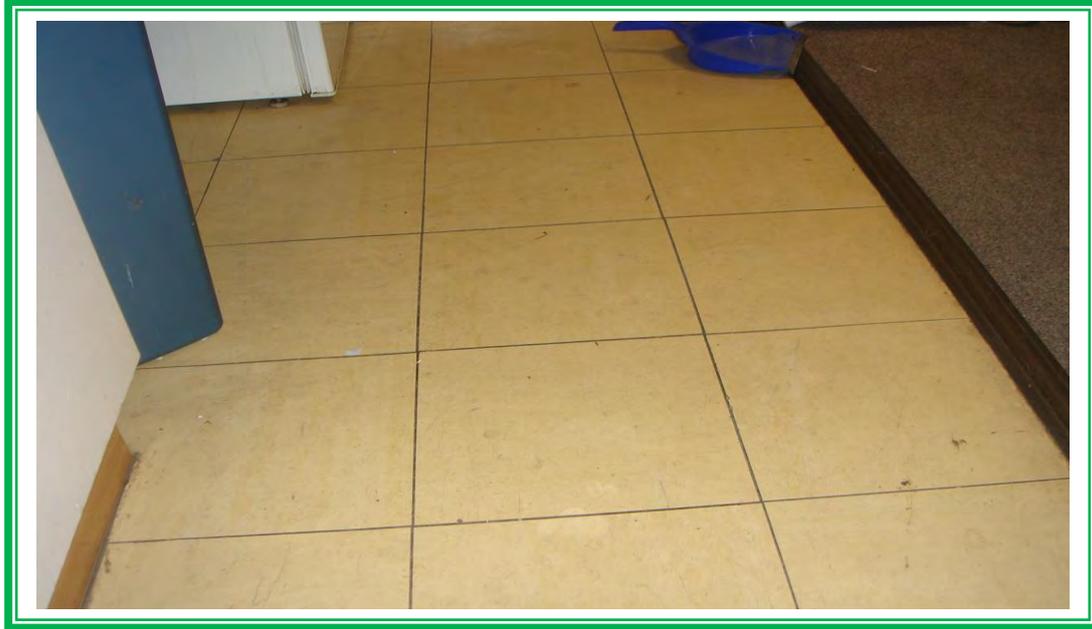
Location: 1/003 Canteen

Material Description:	Vinyl Floor Tiles	
Identification:	Sampled - No Asbestos Detected	
Approx. quantity:	3M2	
Accessibility	N/A	Assessment Score
Product type:	N/A	N/A
Extent of Damage:	N/A	N/A
Surface Treatment:	N/A	N/A
Asbestos type:	N/A	N/A
Material Assessment Score:		N/A
Priority Assessment Score:		N/A
Action:	N/A	
Comments:	N/A

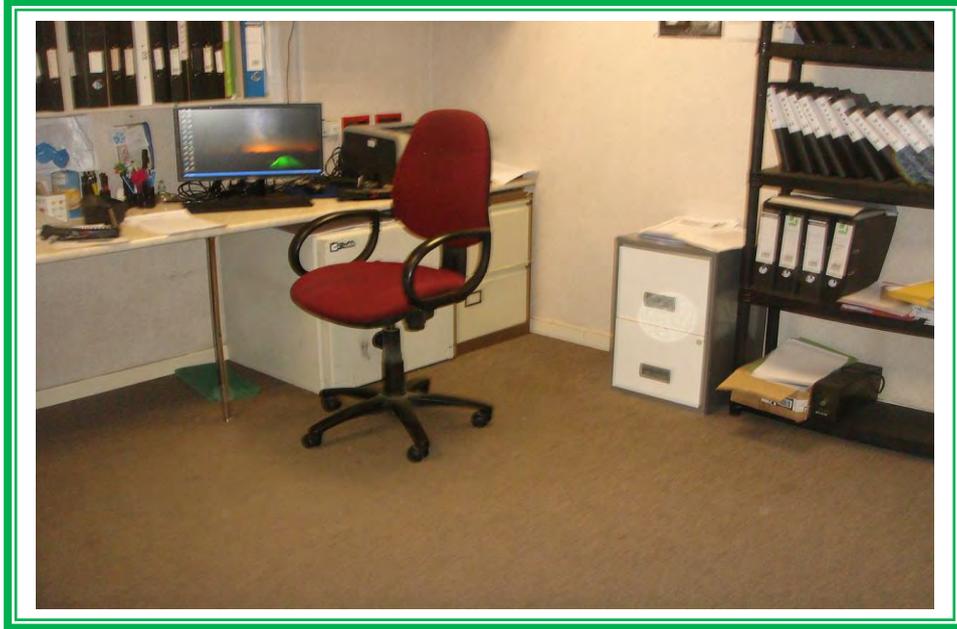
Location: 1/004 Office

Material Description:	Visual Inspection – No Suspect Materials Found	
Identification:	N/A	
Approx. quantity:	N/A	
Accessibility	N/A	Assessment Score
Product type:	N/A	N/A
Extent of Damage:	N/A	N/A
Surface Treatment:	N/A	N/A
Asbestos type:	N/A	N/A
Material Assessment Score:		N/A
Priority Assessment Score:		N/A
Action:	N/A	
Comments:	N/A

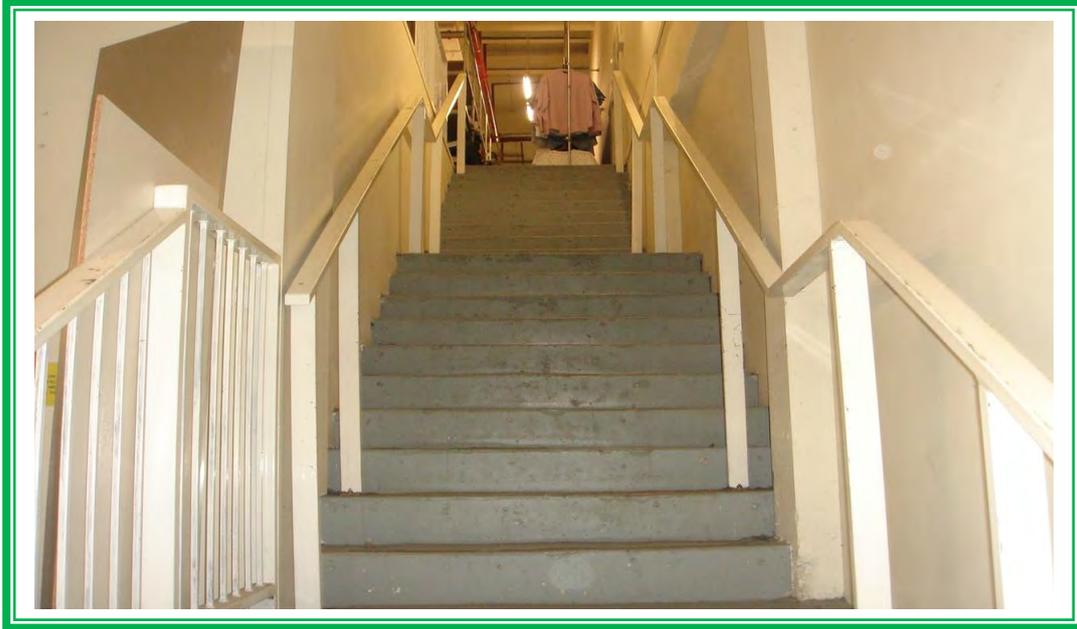
Location: 1/006 Stairs

Material Description:	Visual Inspection – No Suspect Materials Found	
Identification:	N/A	
Approx. quantity:	N/A	
Accessibility	N/A	Assessment Score
Product type:	N/A	N/A
Extent of Damage:	N/A	N/A
Surface Treatment:	N/A	N/A
Asbestos type:	N/A	N/A
Material Assessment Score:		N/A
Priority Assessment Score:		N/A
Action:	N/A	
Comments:	N/A

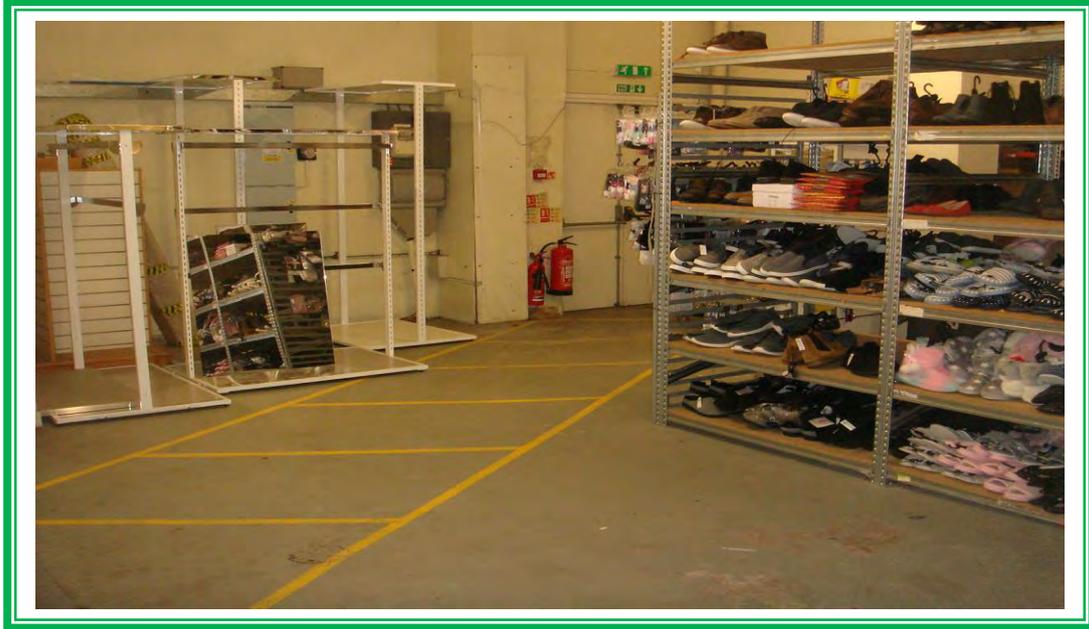
Location: 0/001 Store

Material Description:	Visual Inspection – No Suspect Materials Found	
Identification:	N/A	
Approx. quantity:	N/A	
Accessibility	N/A	Assessment Score
Product type:	N/A	N/A
Extent of Damage:	N/A	N/A
Surface Treatment:	N/A	N/A
Asbestos type:	N/A	N/A
Material Assessment Score:		N/A
Priority Assessment Score:		N/A
Action:	N/A	
Comments:	N/A

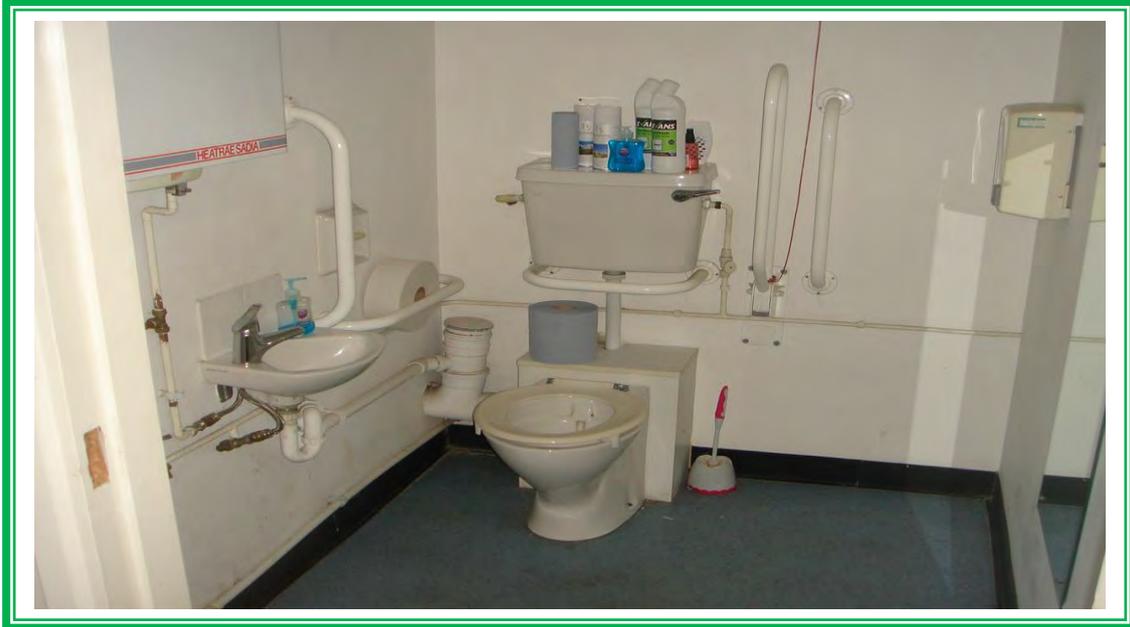
Location: 0/002 WC

Material Description:	Visual Inspection – No Suspect Materials Found	
Identification:	N/A	
Approx. quantity:	N/A	
Accessibility	N/A	Assessment Score
Product type:	N/A	N/A
Extent of Damage:	N/A	N/A
Surface Treatment:	N/A	N/A
Asbestos type:	N/A	N/A
Material Assessment Score:		N/A
Priority Assessment Score:		N/A
Action:	N/A	
Comments:	N/A

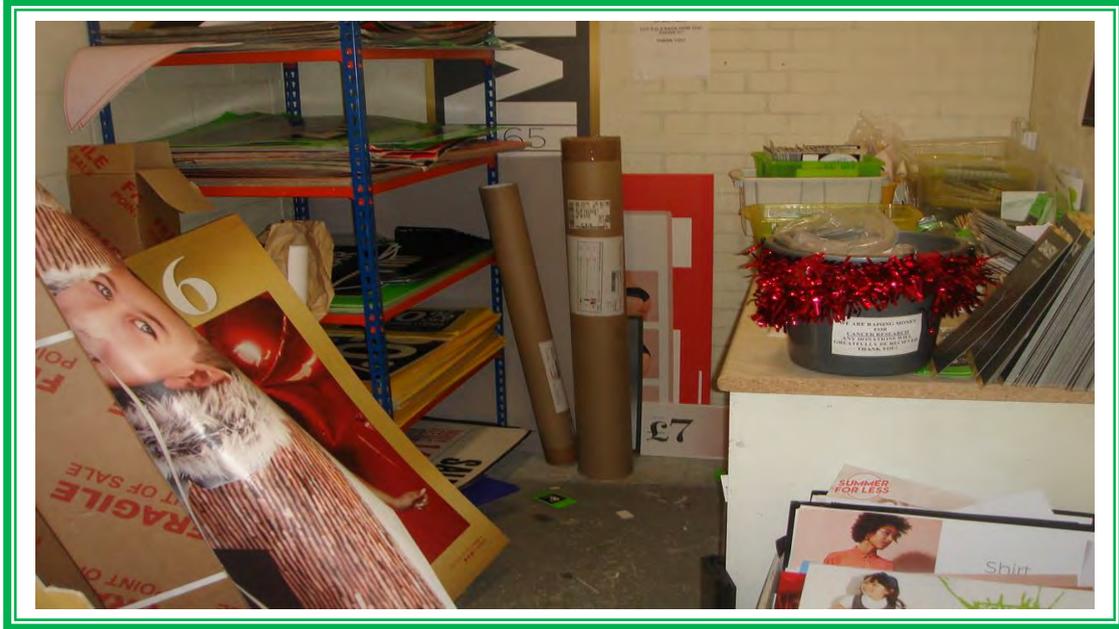
Location: 0/003 Store

Material Description:	Visual Inspection – No Suspect Materials Found	
Identification:	N/A	
Approx. quantity:	N/A	
Accessibility	N/A	Assessment Score
Product type:	N/A	N/A
Extent of Damage:	N/A	N/A
Surface Treatment:	N/A	N/A
Asbestos type:	N/A	N/A
Material Assessment Score:		N/A
Priority Assessment Score:		N/A
Action:	N/A	
Comments:	N/A

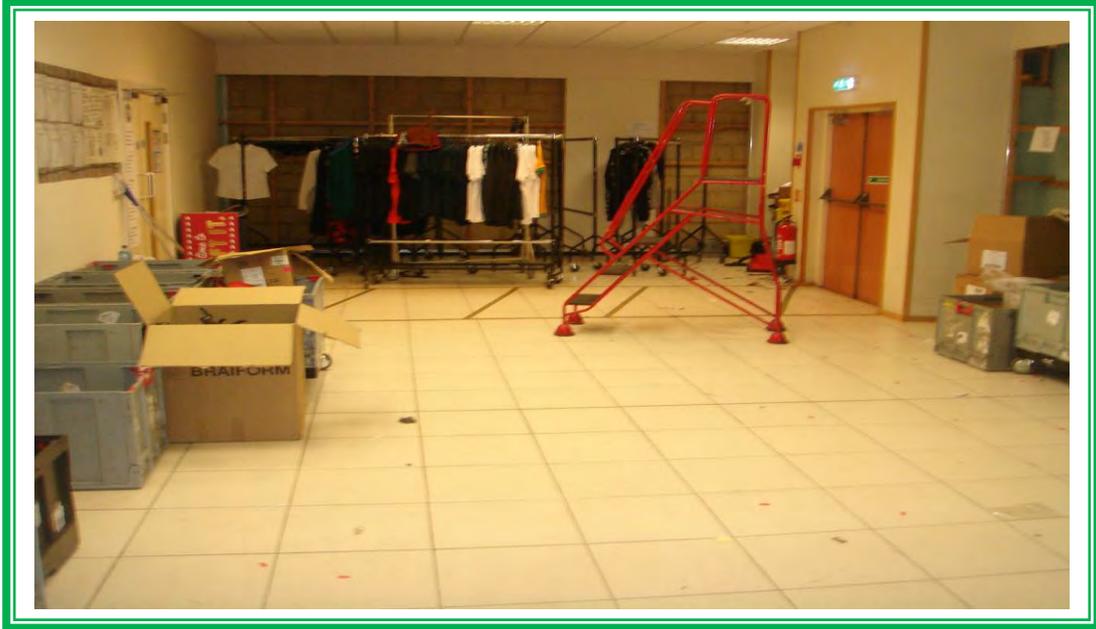
Location: 0/005 Store

Material Description:	Visual Inspection – No Suspect Materials Found	
Identification:	N/A	
Approx. quantity:	N/A	
Accessibility	N/A	Assessment Score
Product type:	N/A	N/A
Extent of Damage:	N/A	N/A
Surface Treatment:	N/A	N/A
Asbestos type:	N/A	N/A
Material Assessment Score:		N/A
Priority Assessment Score:		N/A
Action:	N/A	
Comments:	N/A

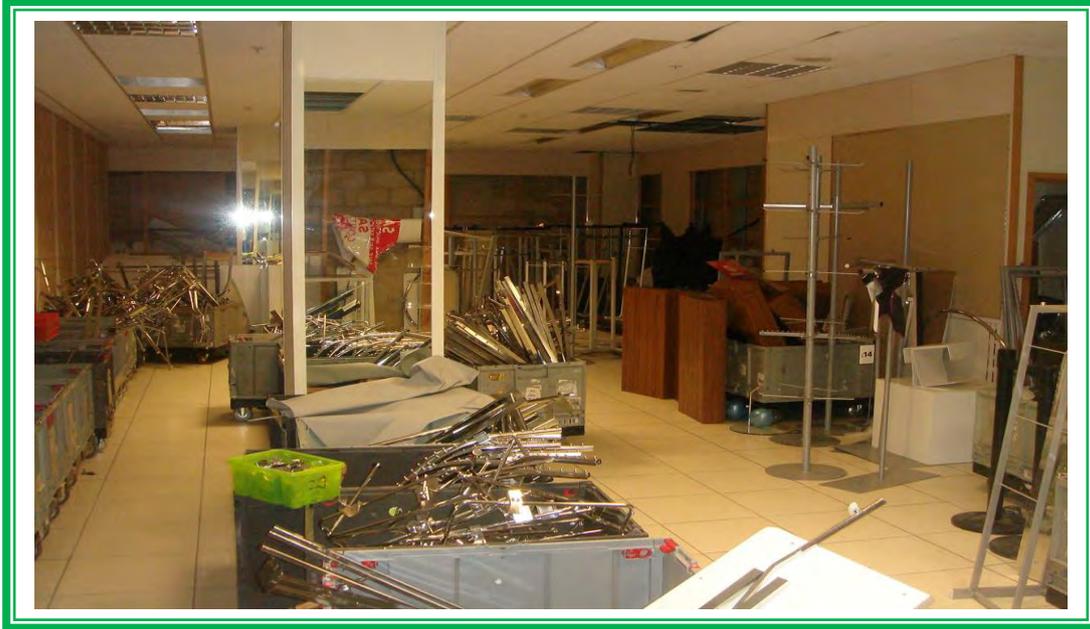
Location: 0/006 Store

Material Description:	Visual Inspection – No Suspect Materials Found	
Identification:	N/A	
Approx. quantity:	N/A	
Accessibility	N/A	Assessment Score
Product type:	N/A	N/A
Extent of Damage:	N/A	N/A
Surface Treatment:	N/A	N/A
Asbestos type:	N/A	N/A
Material Assessment Score:		N/A
Priority Assessment Score:		N/A
Action:	N/A	
Comments:	N/A

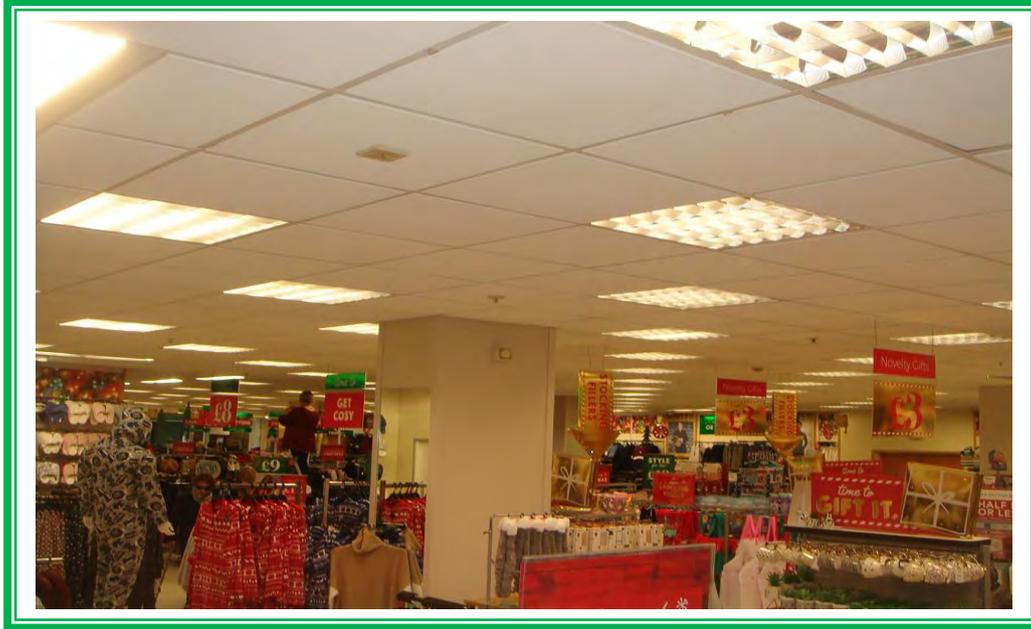
Location: 0/007 Shop Floor

Material Description:	Visual Inspection – No Suspect Materials Found	
Identification:	N/A	
Approx. quantity:	N/A	
Accessibility	N/A	Assessment Score
Product type:	N/A	N/A
Extent of Damage:	N/A	N/A
Surface Treatment:	N/A	N/A
Asbestos type:	N/A	N/A
Material Assessment Score:		N/A
Priority Assessment Score:		N/A
Action:	N/A	
Comments:	N/A

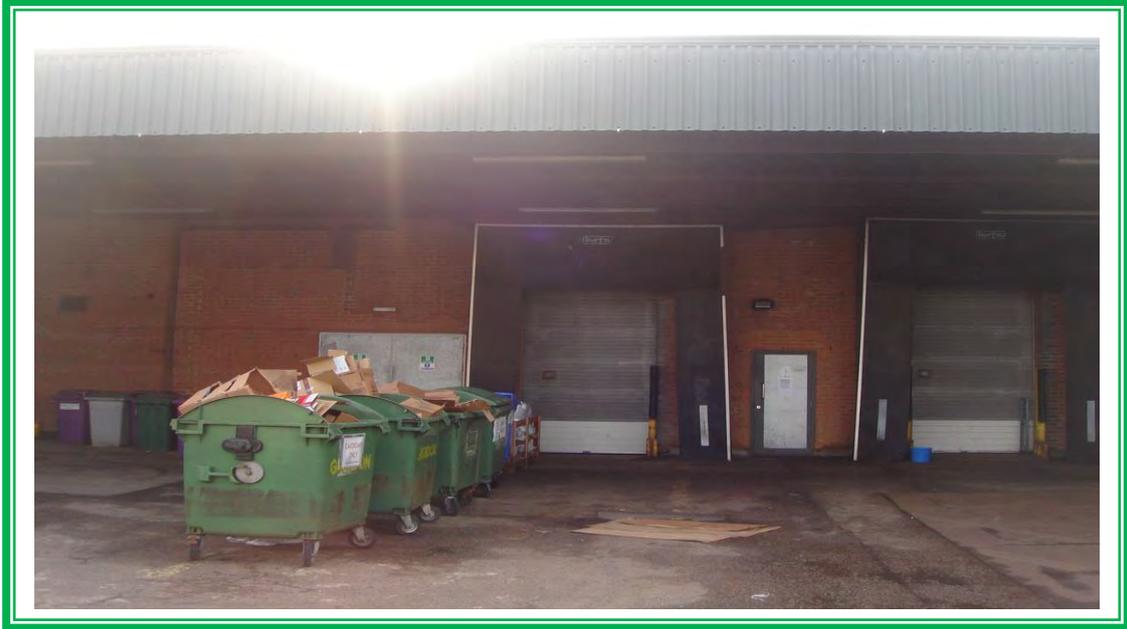
Location: 99/001 External

Material Description:	Visual Inspection – No Suspect Materials Found	
Identification:	N/A	
Approx. quantity:	N/A	
Accessibility	N/A	Assessment Score
Product type:	N/A	N/A
Extent of Damage:	N/A	N/A
Surface Treatment:	N/A	N/A
Asbestos type:	N/A	N/A
Material Assessment Score:		N/A
Priority Assessment Score:		N/A
Action:	N/A	
Comments:	N/A

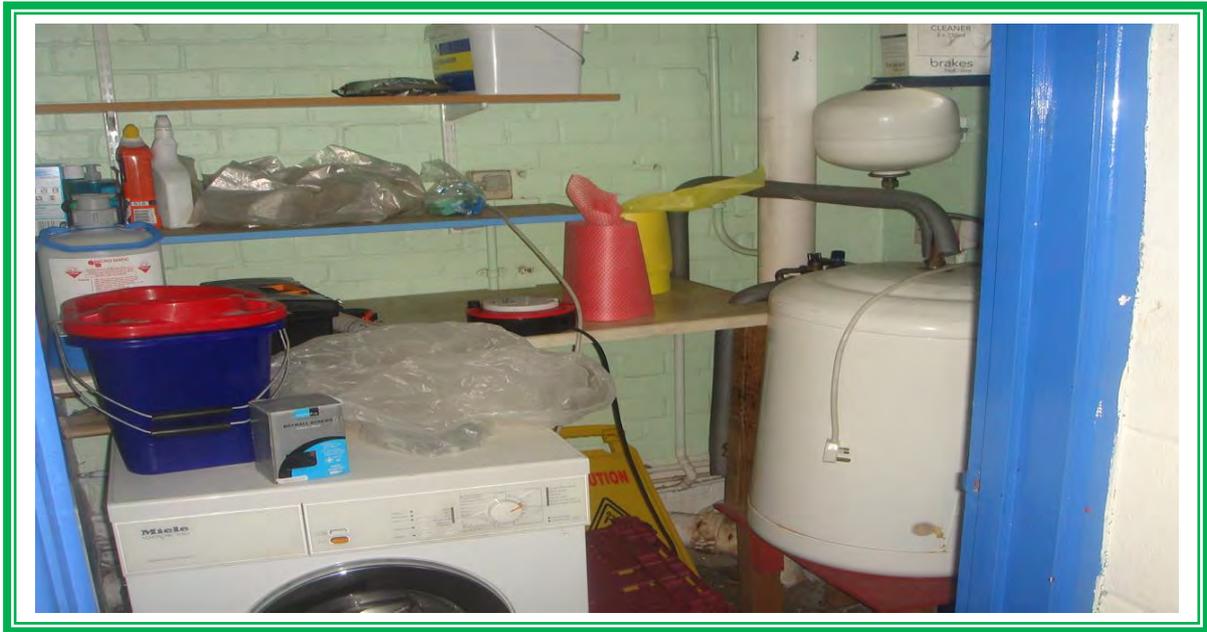
Item No: 1	Sample No: N/A
Location: Ground Floor - 1/001 Store

Material Description:	Visual Inspection – No Suspect Materials Found	
Identification:	N/A	
Approx. quantity:	N/A	
Accessibility	N/A	Assessment Score
Product type:	N/A	N/A
Extent of Damage:	N/A	N/A
Surface Treatment:	N/A	N/A
Asbestos type:	N/A	N/A
Material Assessment Score:		N/A
Priority Assessment Score:		N/A
Action:	N/A	
Comments:	N/A

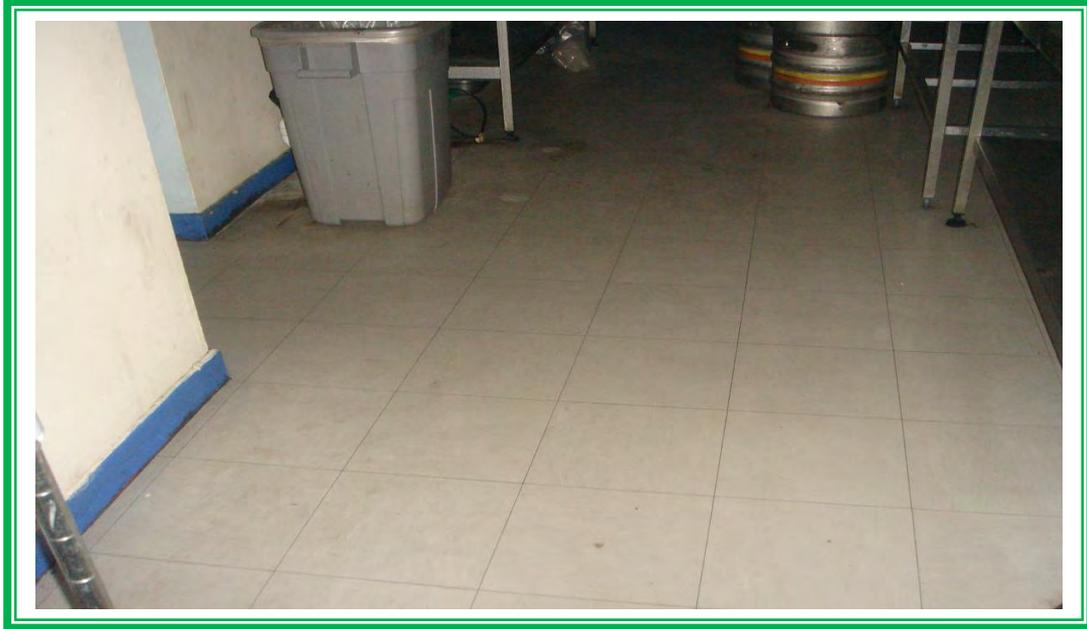
Location: Ground Floor – 1/002 Kitchen

Material Description:	Vinyl Floor Tiles	
Identification:	Sampled – No Asbestos Detected	
Approx. quantity:	40M2	
Accessibility	N/A	Assessment Score
Product type:	N/A	N/A
Extent of Damage:	N/A	N/A
Surface Treatment:	N/A	N/A
Asbestos type:	N/A	N/A
Material Assessment Score:		N/A
Priority Assessment Score:		N/A
Action:	N/A	
Comments:	N/A

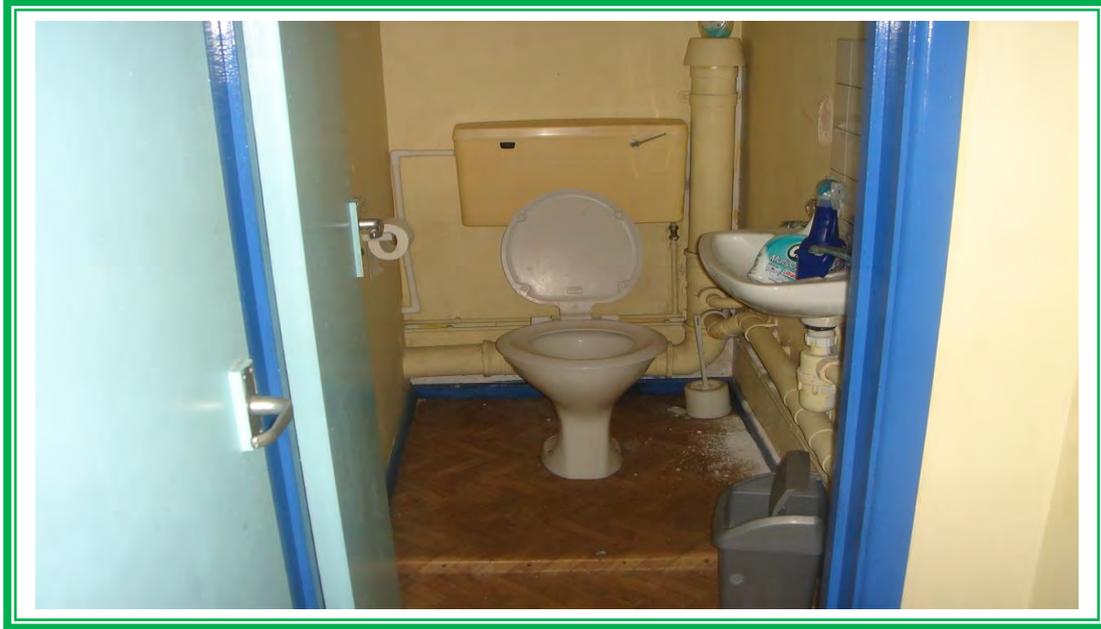
Location: 1/003 WC

Material Description:	Visual Inspection – No Suspect Materials Found	
Identification:	N/A	
Approx. quantity:	N/A	
Accessibility	N/A	Assessment Score
Product type:	N/A	N/A
Extent of Damage:	N/A	N/A
Surface Treatment:	N/A	N/A
Asbestos type:	N/A	N/A
Material Assessment Score:		N/A
Priority Assessment Score:		N/A
Action:	N/A	
Comments:	N/A

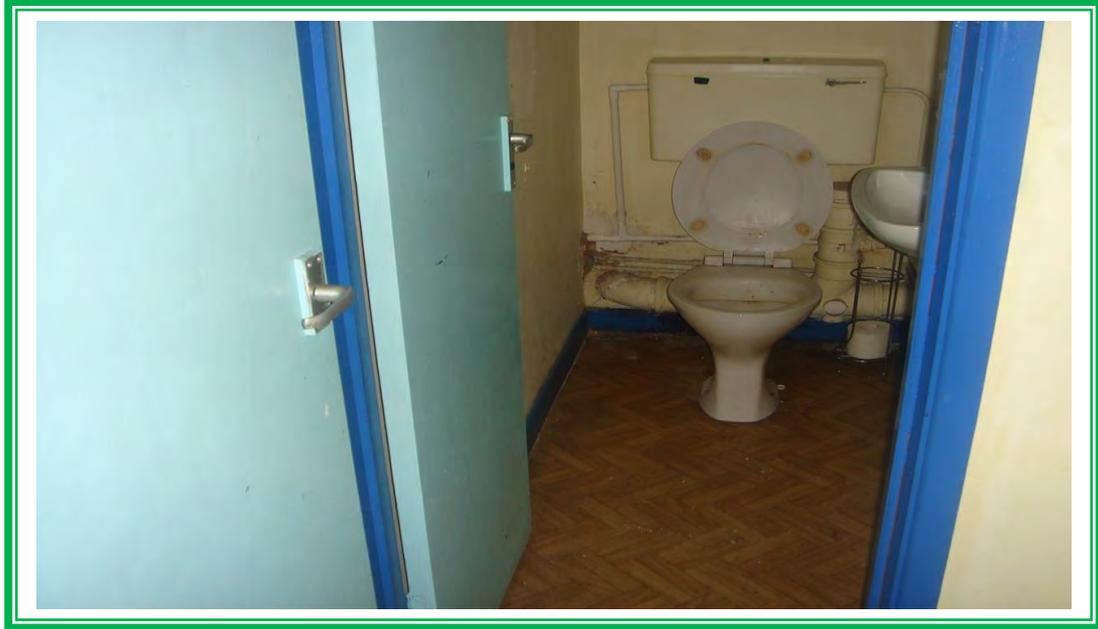
Location: 1/004

Material Description:	Visual Inspection – No Suspect Materials Found	
Identification:	N/A	
Approx. quantity:	N/A	
Accessibility	N/A	Assessment Score
Product type:	N/A	N/A
Extent of Damage:	N/A	N/A
Surface Treatment:	N/A	N/A
Asbestos type:	N/A	N/A
Material Assessment Score:		N/A
Priority Assessment Score:		N/A
Action:	N/A	
Comments:	N/A

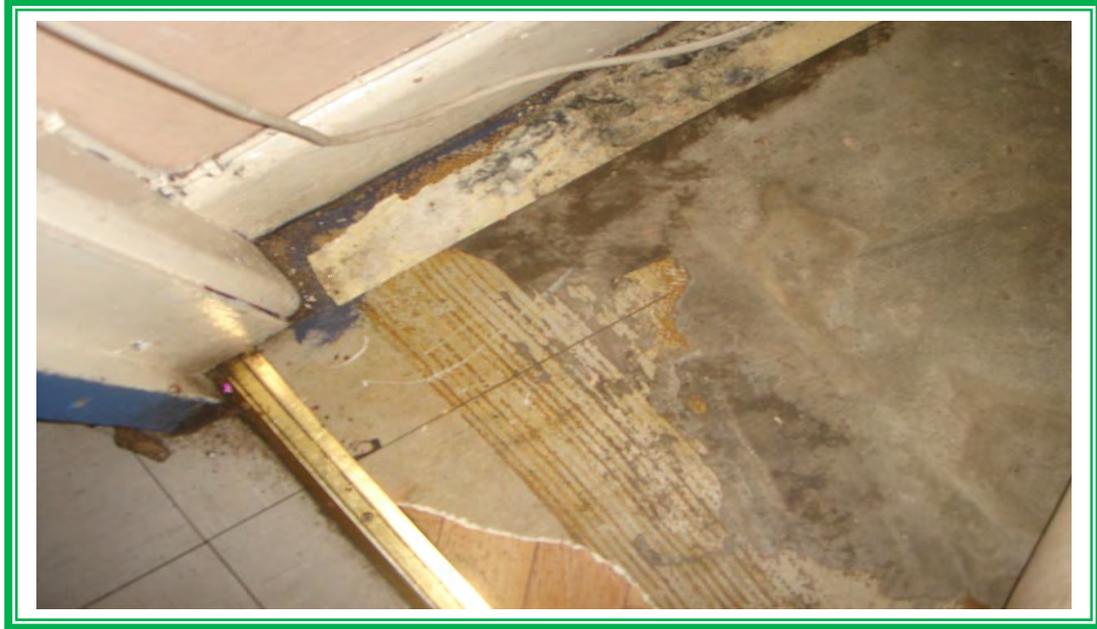
Location: 1/005 Office

Material Description:	Vinyl Floor Tiles	
Identification:	As Per Sample NE/1 – No Asbestos Detected	
Approx. quantity:	8M2	
Accessibility	N/A	Assessment Score
Product type:	N/A	N/A
Extent of Damage:	N/A	N/A
Surface Treatment:	N/A	N/A
Asbestos type:	N/A	N/A
Material Assessment Score:		N/A
Priority Assessment Score:		N/A
Action:	N/A	
Comments:	N/A

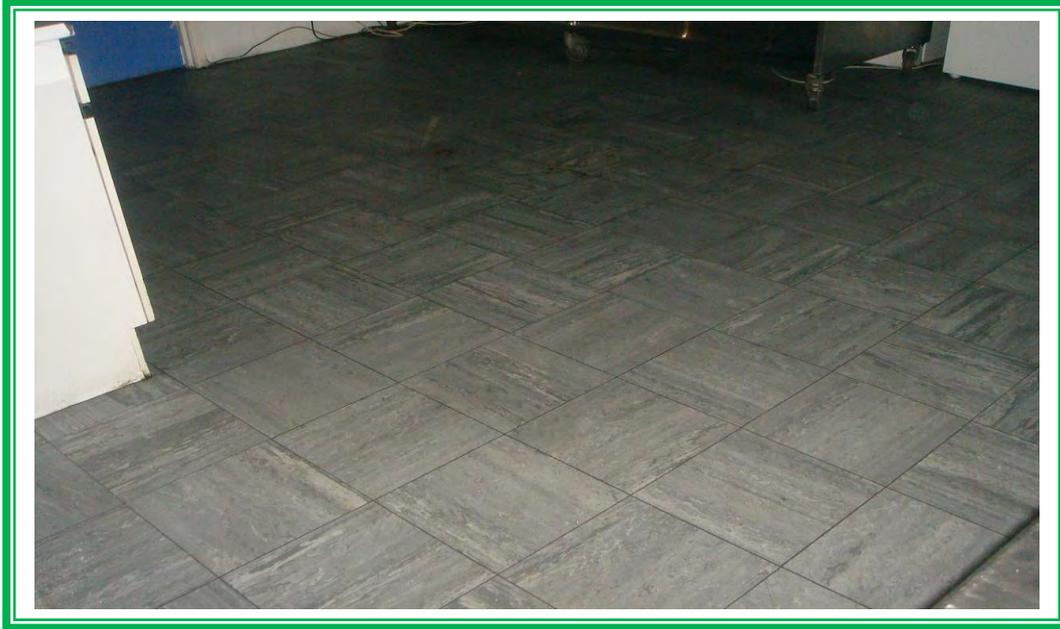
Location: 1/008

Material Description:	Vinyl Floor Tiles	
Identification:	As Per Sample NE/2 – No Asbestos Detected	
Approx. quantity:	28M2	
Accessibility	N/A	Assessment Score
Product type:	N/A	N/A
Extent of Damage:	N/A	N/A
Surface Treatment:	N/A	N/A
Asbestos type:	N/A	N/A
Material Assessment Score:		N/A
Priority Assessment Score:		N/A
Action:	N/A	
Comments:	N/A

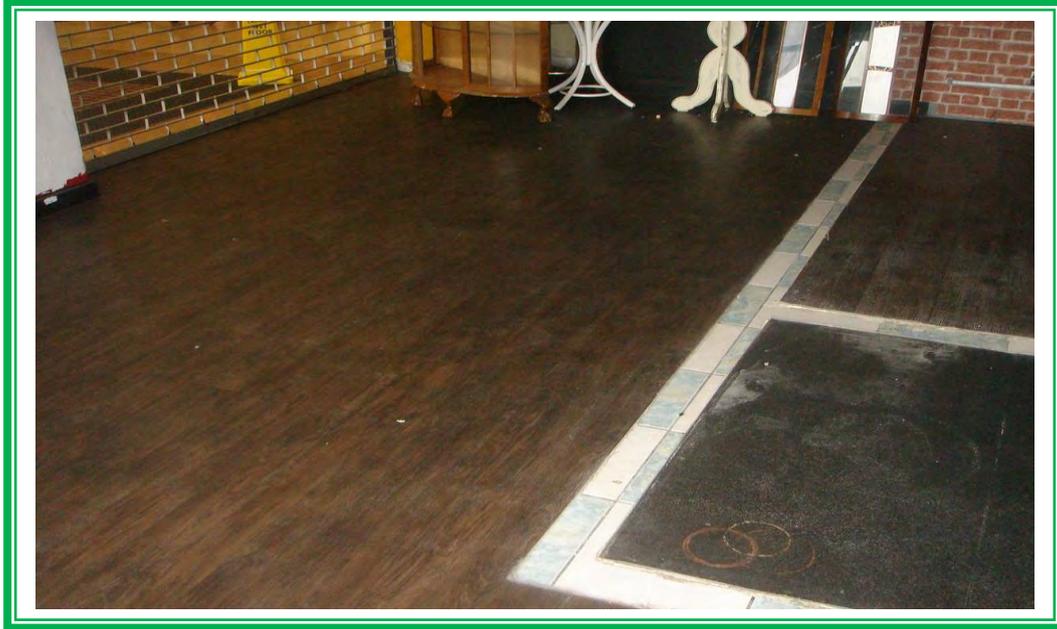
Location: 0/001

Material Description:	Visual Inspection – No Suspect Materials Found	
Identification:	N/A	
Approx. quantity:	N/A	
Accessibility	N/A	Assessment Score
Product type:	N/A	N/A
Extent of Damage:	N/A	N/A
Surface Treatment:	N/A	N/A
Asbestos type:	N/A	N/A
Material Assessment Score:		N/A
Priority Assessment Score:		N/A
Action:	N/A	
Comments:	N/A

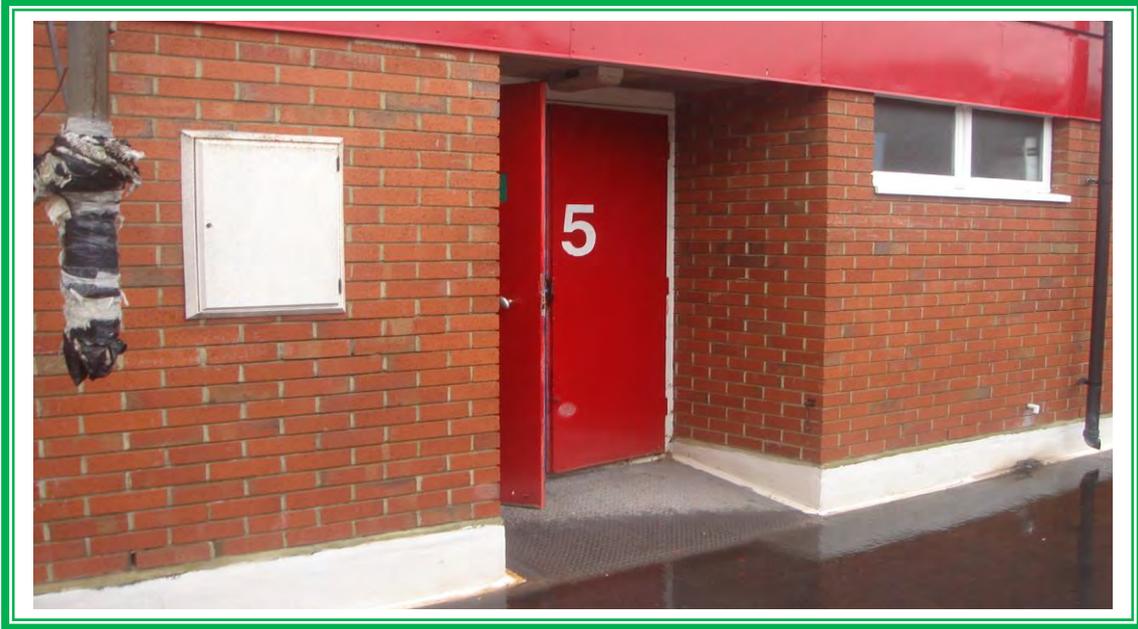
Location: 99/001

Material Description:	Visual Inspection – No Suspect Materials Found	
Identification:	N/A	
Approx. quantity:	N/A	
Accessibility	N/A	Assessment Score
Product type:	N/A	N/A
Extent of Damage:	N/A	N/A
Surface Treatment:	N/A	N/A
Asbestos type:	N/A	N/A
Material Assessment Score:		N/A
Priority Assessment Score:		N/A
Action:	N/A	
Comments:	N/A

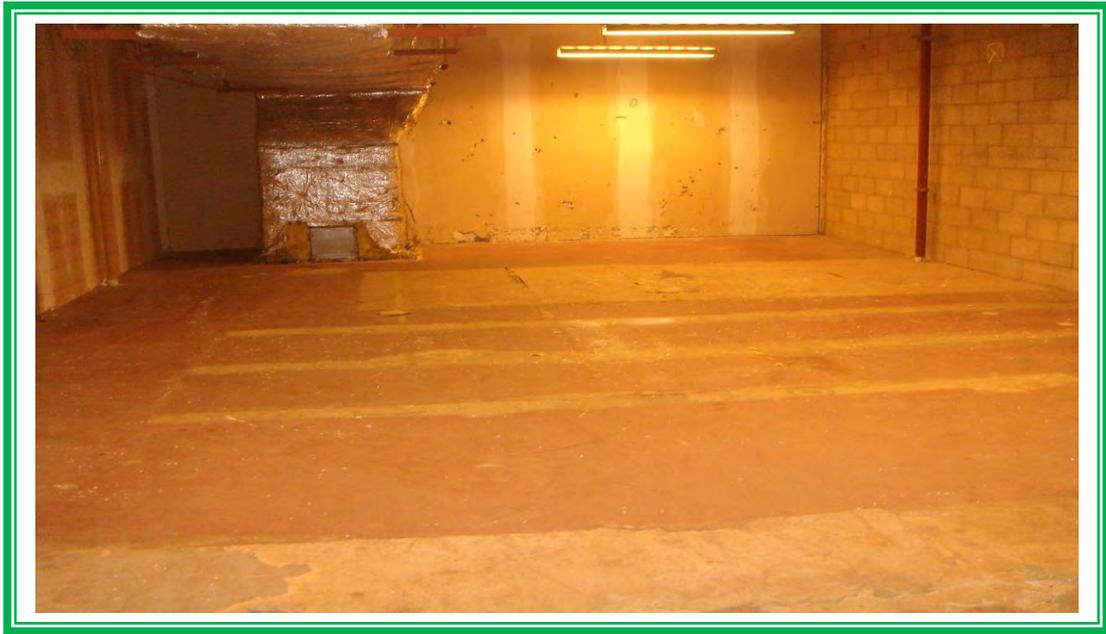
Item No: 1	Sample No: N/A
Location: 1/001 Store

Material Description:	Visual Inspection – No Suspect Materials Found	
Identification:	N/A	
Approx. quantity:	N/A	
Accessibility	N/A	Assessment Score
Product type:	N/A	N/A
Extent of Damage:	N/A	N/A
Surface Treatment:	N/A	N/A
Asbestos type:	N/A	N/A
Material Assessment Score:		N/A
Priority Assessment Score:		N/A
Action:	N/A	
Comments:	N/A

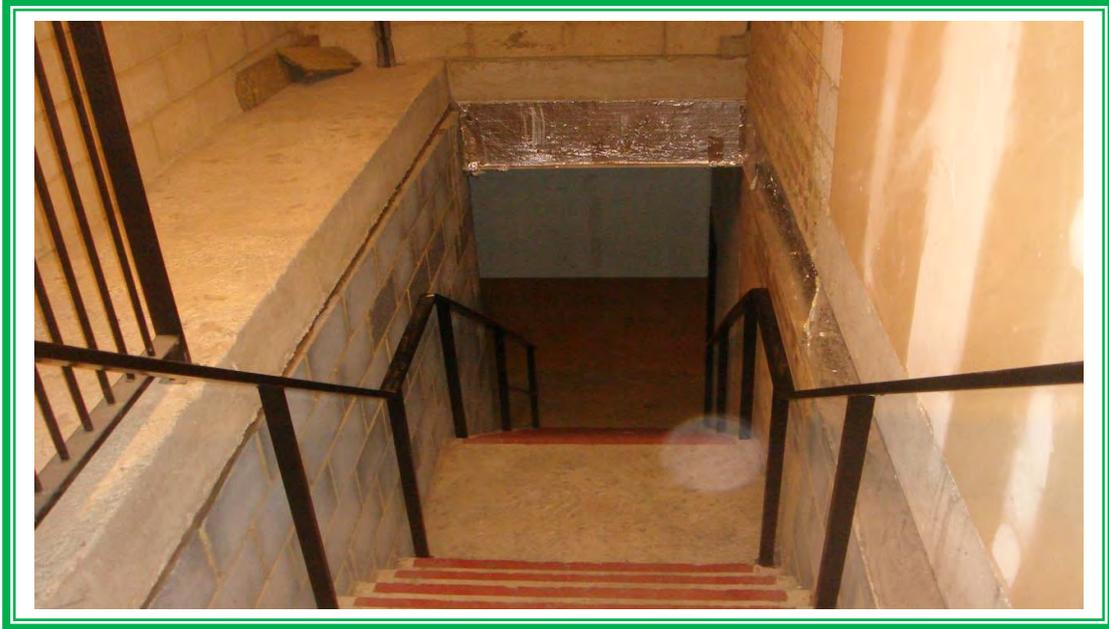
Location: 1/003 Stairs

Material Description:	Visual Inspection – No Suspect Materials Found	
Identification:	N/A	
Approx. quantity:	N/A	
Accessibility	N/A	Assessment Score
Product type:	N/A	N/A
Extent of Damage:	N/A	N/A
Surface Treatment:	N/A	N/A
Asbestos type:	N/A	N/A
Material Assessment Score:		N/A
Priority Assessment Score:		N/A
Action:	N/A	
Comments:	N/A

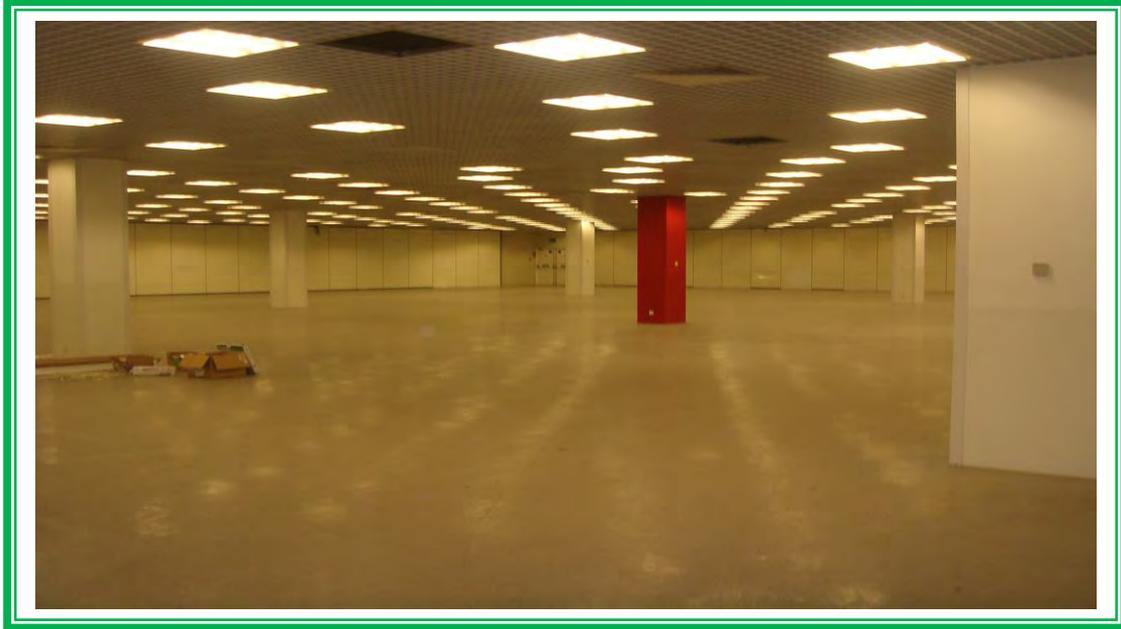
Location: 0/001 Shop Floor

Material Description:	Visual Inspection – No Suspect Materials Found	
Identification:	N/A	
Approx. quantity:	N/A	
Accessibility	N/A	Assessment Score
Product type:	N/A	N/A
Extent of Damage:	N/A	N/A
Surface Treatment:	N/A	N/A
Asbestos type:	N/A	N/A
Material Assessment Score:		N/A
Priority Assessment Score:		N/A
Action:	N/A	
Comments:	N/A

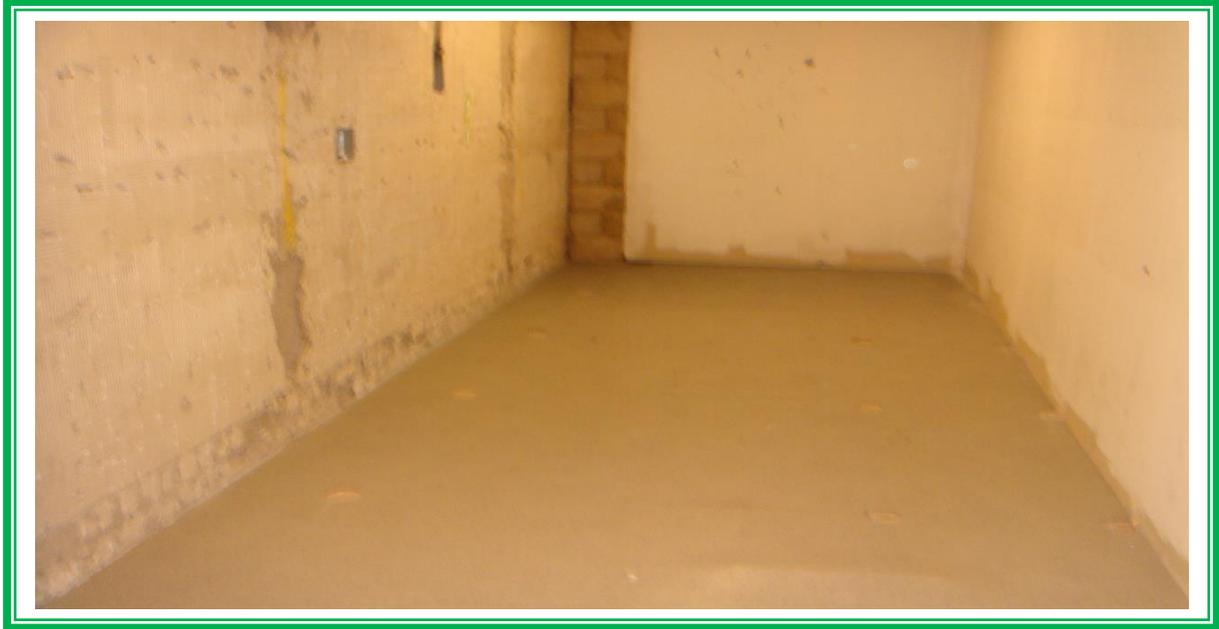
Location: 0/002 Store

Material Description:	Visual Inspection – No Suspect Materials Found	
Identification:	N/A	
Approx. quantity:	N/A	
Accessibility	N/A	Assessment Score
Product type:	N/A	N/A
Extent of Damage:	N/A	N/A
Surface Treatment:	N/A	N/A
Asbestos type:	N/A	N/A
Material Assessment Score:		N/A
Priority Assessment Score:		N/A
Action:	N/A	
Comments:	N/A

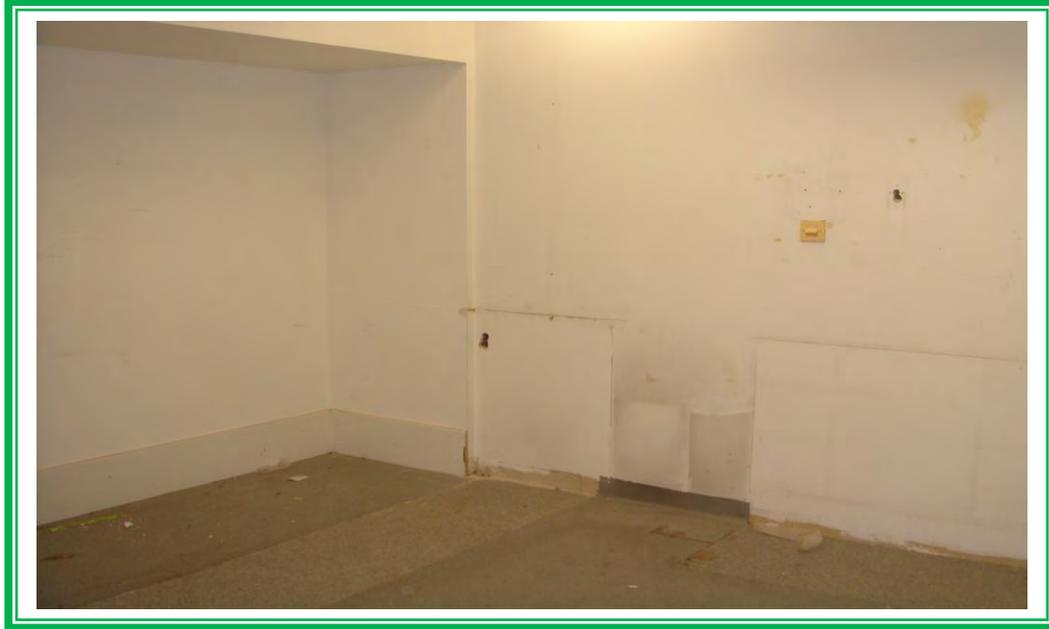
Location: 0/003 Office

Material Description:	Visual Inspection – No Suspect Materials Found	
Identification:	N/A	
Approx. quantity:	N/A	
Accessibility	N/A	Assessment Score
Product type:	N/A	N/A
Extent of Damage:	N/A	N/A
Surface Treatment:	N/A	N/A
Asbestos type:	N/A	N/A
Material Assessment Score:		N/A
Priority Assessment Score:		N/A
Action:	N/A	
Comments:	N/A

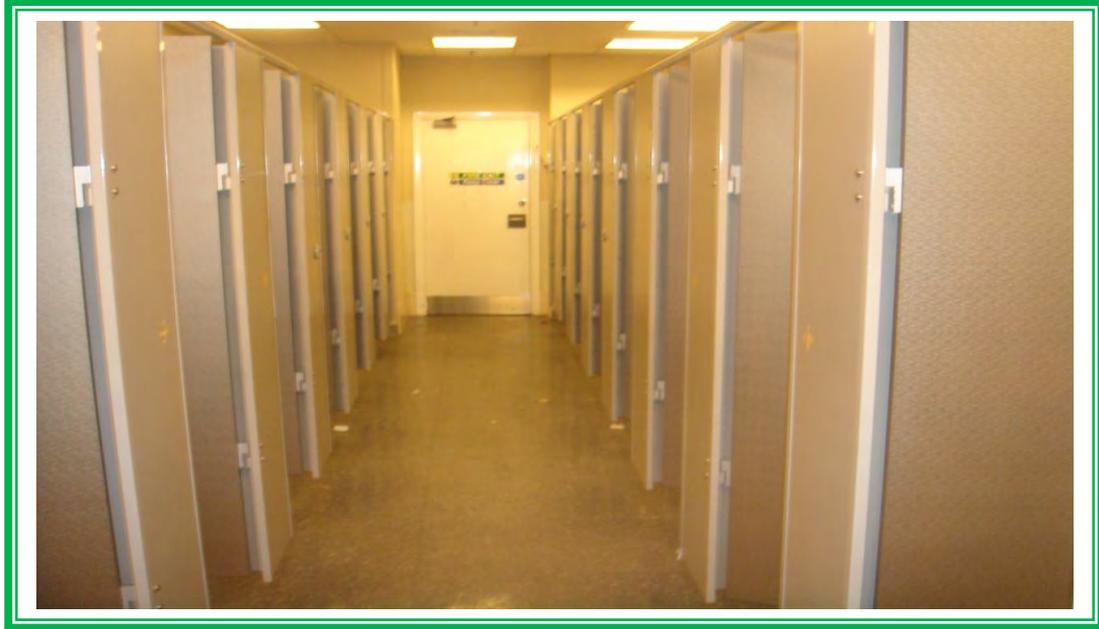
Location: 0/004

Material Description:	Visual Inspection – No Suspect Materials Found	
Identification:	N/A	
Approx. quantity:	N/A	
Accessibility	N/A	Assessment Score
Product type:	N/A	N/A
Extent of Damage:	N/A	N/A
Surface Treatment:	N/A	N/A
Asbestos type:	N/A	N/A
Material Assessment Score:		N/A
Priority Assessment Score:		N/A
Action:	N/A	
Comments:	N/A

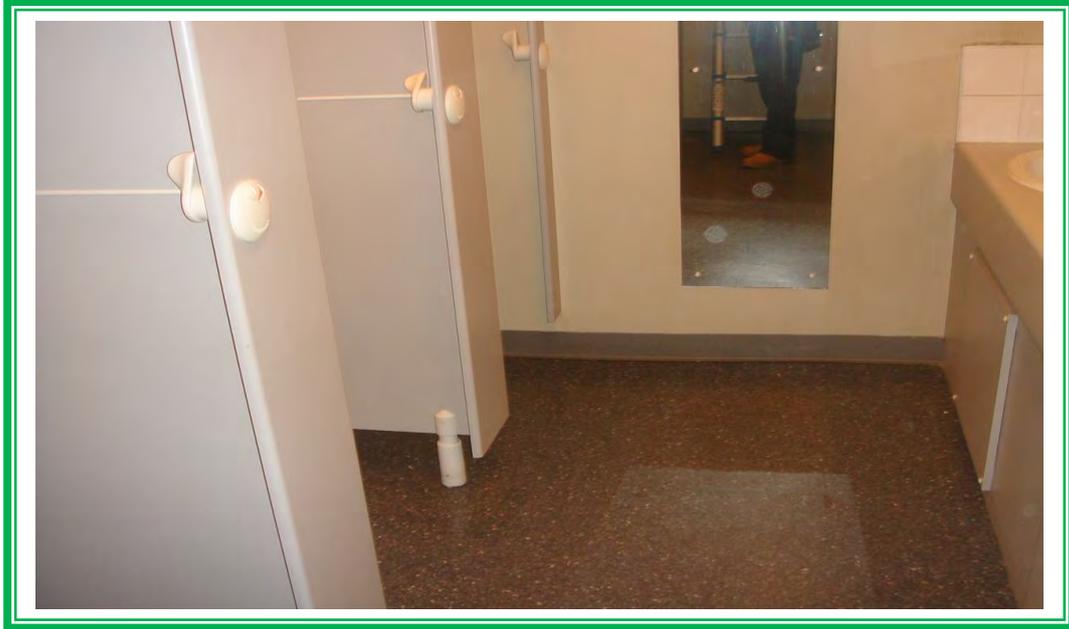
Location: 0/005A WC

Material Description:	Visual Inspection – No Suspect Materials Found	
Identification:	N/A	
Approx. quantity:	N/A	
Accessibility	N/A	Assessment Score
Product type:	N/A	N/A
Extent of Damage:	N/A	N/A
Surface Treatment:	N/A	N/A
Asbestos type:	N/A	N/A
Material Assessment Score:		N/A
Priority Assessment Score:		N/A
Action:	N/A	
Comments:	N/A

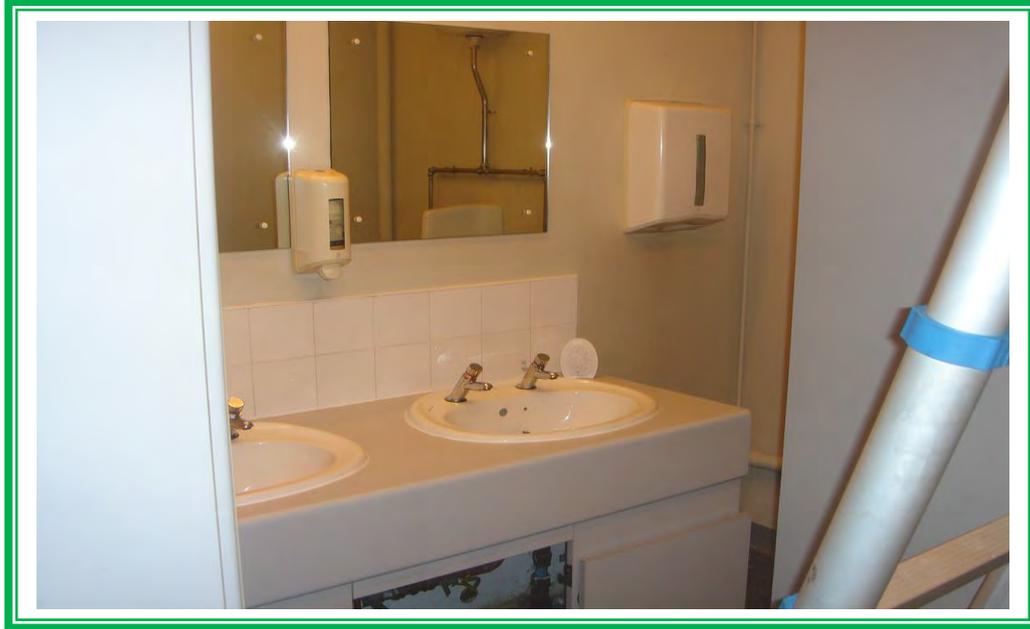
Location: 0/006 WC

Material Description:	Visual Inspection – No Suspect Materials Found	
Identification:	N/A	
Approx. quantity:	N/A	
Accessibility	N/A	Assessment Score
Product type:	N/A	N/A
Extent of Damage:	N/A	N/A
Surface Treatment:	N/A	N/A
Asbestos type:	N/A	N/A
Material Assessment Score:		N/A
Priority Assessment Score:		N/A
Action:	N/A	
Comments:	N/A

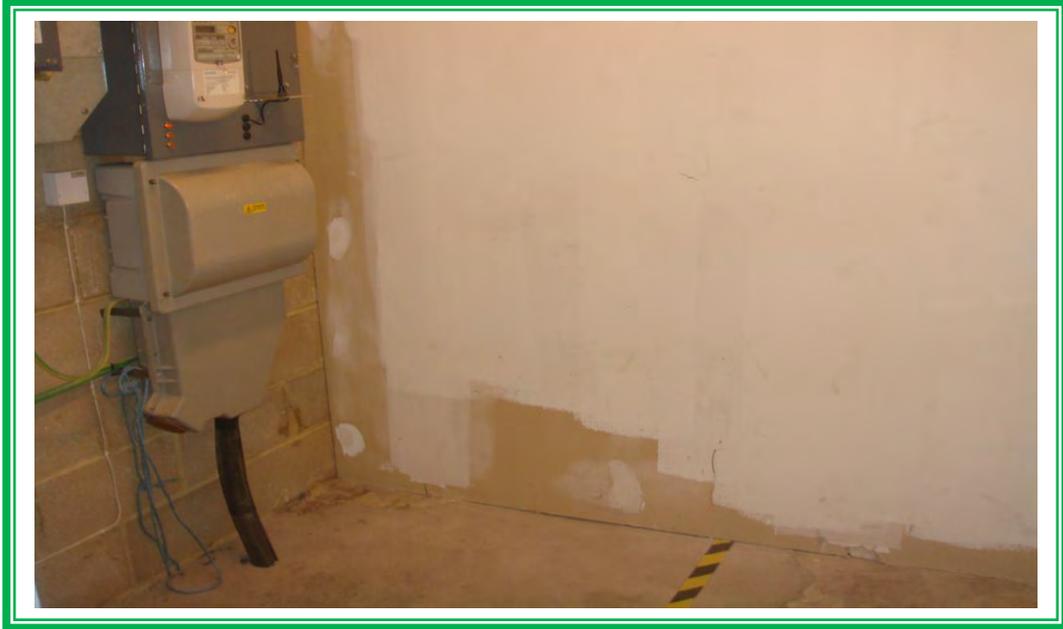
Location: 0/006A Electrics Room

Material Description:	Visual Inspection – No Suspect Materials Found	
Identification:	N/A	
Approx. quantity:	N/A	
Accessibility	N/A	Assessment Score
Product type:	N/A	N/A
Extent of Damage:	N/A	N/A
Surface Treatment:	N/A	N/A
Asbestos type:	N/A	N/A
Material Assessment Score:		N/A
Priority Assessment Score:		N/A
Action:	N/A	
Comments:	N/A
