Project Number 3113

Management
Asbestos Survey Report

Kennet Centre, Market Street, Newbury,
Berkshire, RG14 5EN

3 Market Place and Associated Store

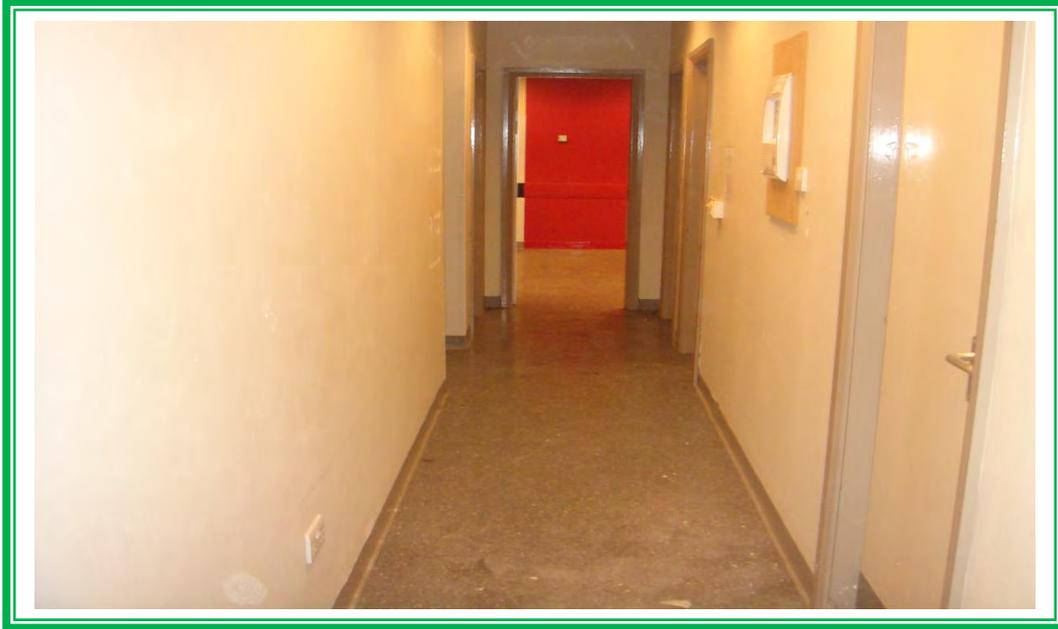
Location: 0/007 Corridor

Material Description:	Visual Inspection – No Suspect Materials Found	
Identification:	N/A	
Approx. quantity:	N/A	
Accessibility	N/A	Assessment Score
Product type:	N/A	N/A
Extent of Damage:	N/A	N/A
Surface Treatment:	N/A	N/A
Asbestos type:	N/A	N/A
Material Assessment Score:		N/A
Priority Assessment Score:		N/A
Action:	N/A	
Comments:	N/A

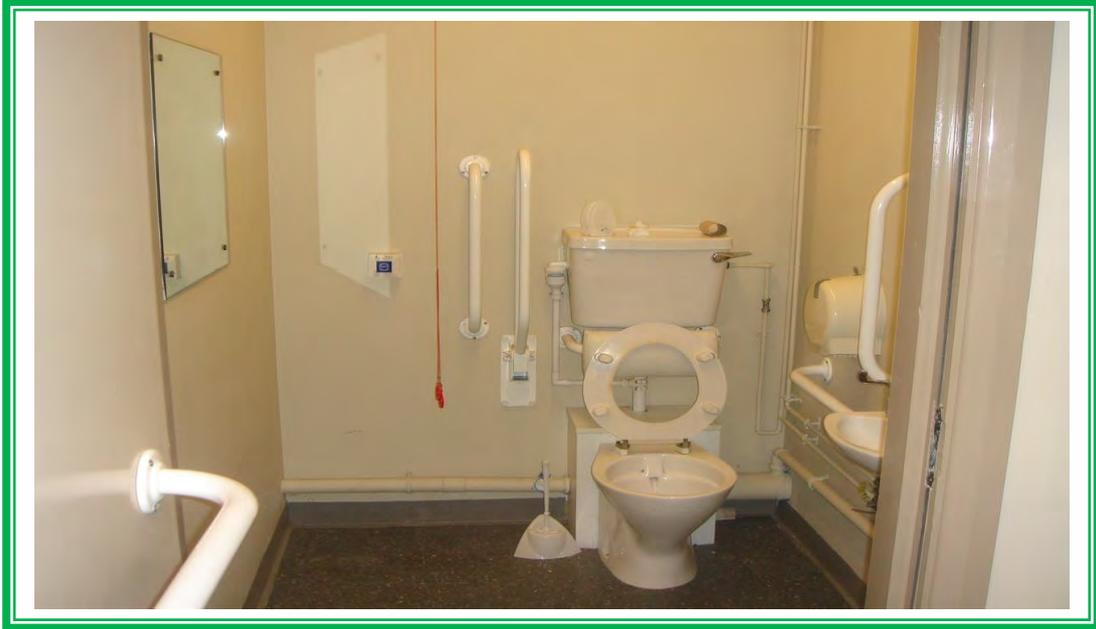
Location: 0/008 Disabled WC

Material Description:	Visual Inspection – No Suspect Materials Found	
Identification:	N/A	
Approx. quantity:	N/A	
Accessibility	N/A	Assessment Score
Product type:	N/A	N/A
Extent of Damage:	N/A	N/A
Surface Treatment:	N/A	N/A
Asbestos type:	N/A	N/A
Material Assessment Score:		N/A
Priority Assessment Score:		N/A
Action:	N/A	
Comments:	N/A

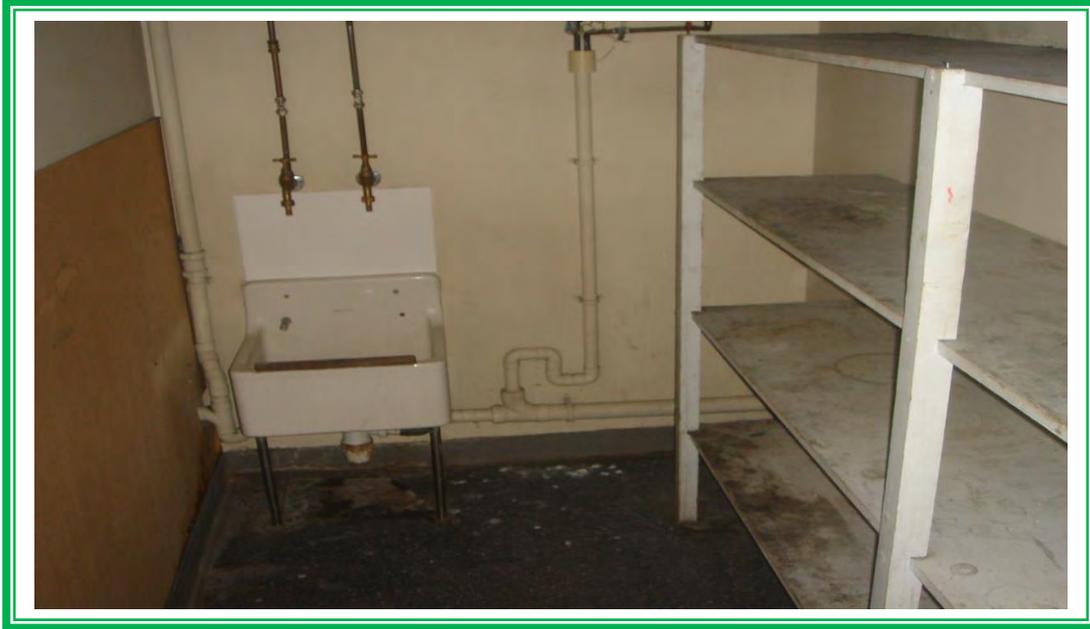
Location: 0/009 Store

Material Description:	Visual Inspection – No Suspect Materials Found	
Identification:	N/A	
Approx. quantity:	N/A	
Accessibility	N/A	Assessment Score
Product type:	N/A	N/A
Extent of Damage:	N/A	N/A
Surface Treatment:	N/A	N/A
Asbestos type:	N/A	N/A
Material Assessment Score:		N/A
Priority Assessment Score:		N/A
Action:	N/A	
Comments:	N/A

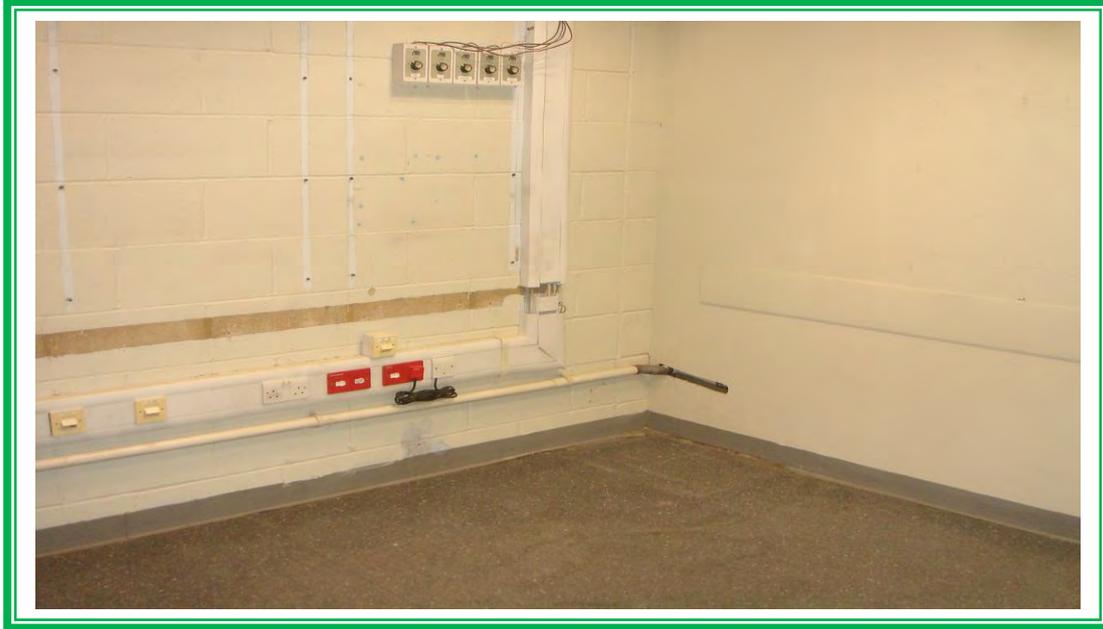
Location: 0/010 Store

Material Description:	Visual Inspection – No Suspect Materials Found	
Identification:	N/A	
Approx. quantity:	N/A	
Accessibility	N/A	Assessment Score
Product type:	N/A	N/A
Extent of Damage:	N/A	N/A
Surface Treatment:	N/A	N/A
Asbestos type:	N/A	N/A
Material Assessment Score:		N/A
Priority Assessment Score:		N/A
Action:	N/A	
Comments:	N/A

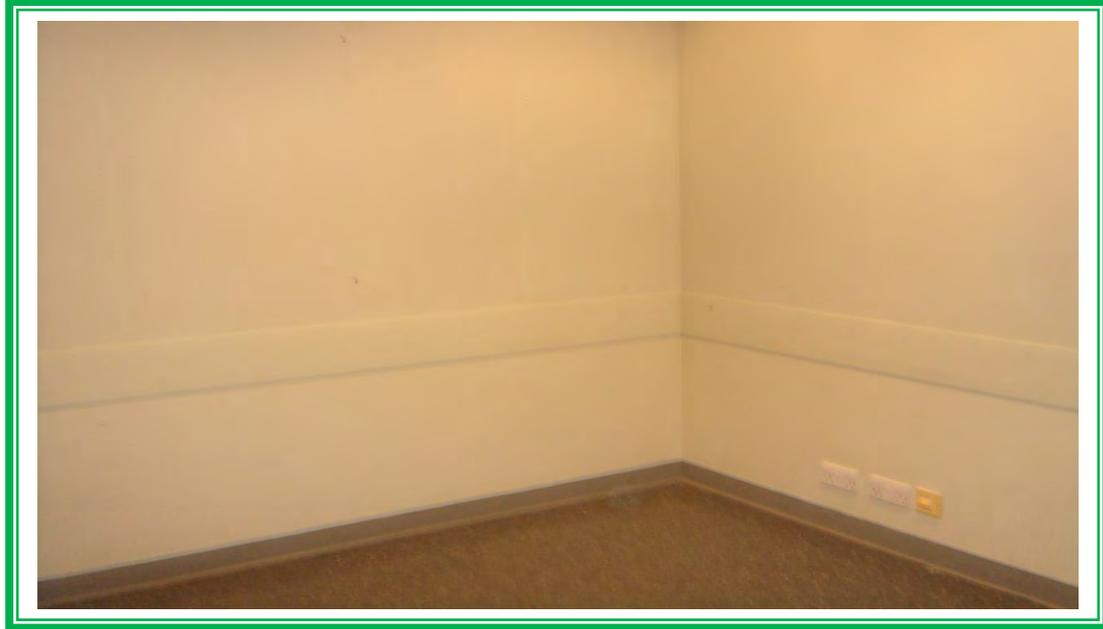
Location: 0/12 Office

Material Description:	Visual Inspection – No Suspect Materials Found	
Identification:	N/A	
Approx. quantity:	N/A	
Accessibility	N/A	Assessment Score
Product type:	N/A	N/A
Extent of Damage:	N/A	N/A
Surface Treatment:	N/A	N/A
Asbestos type:	N/A	N/A
Material Assessment Score:		N/A
Priority Assessment Score:		N/A
Action:	N/A	
Comments:	N/A

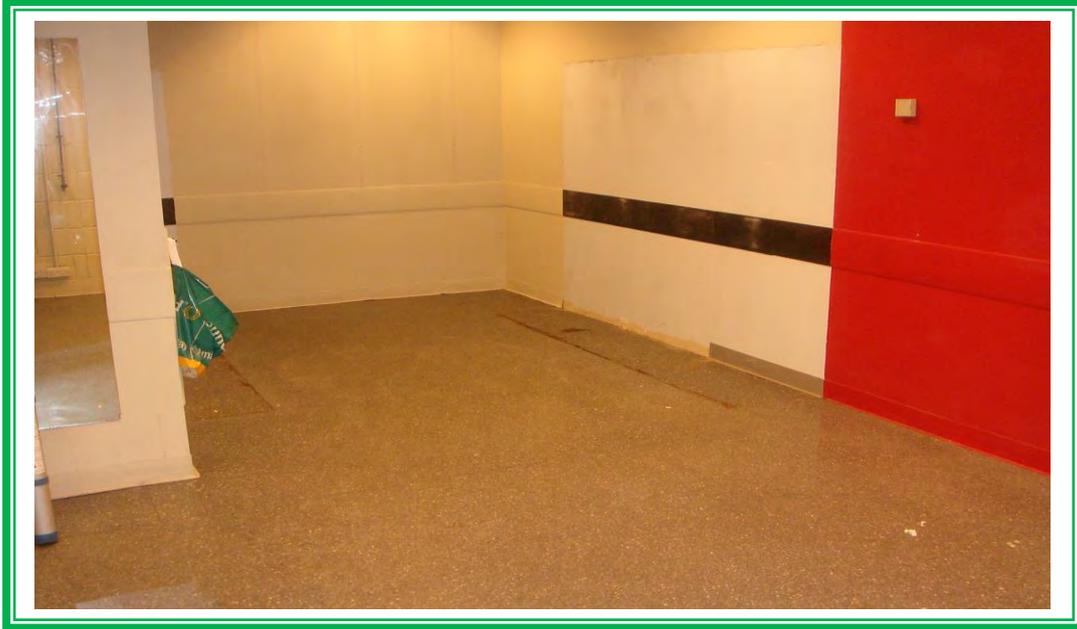
Location: 0/013 Canteen

Material Description:	Visual Inspection – No Suspect Materials Found	
Identification:	N/A	
Approx. quantity:	N/A	
Accessibility	N/A	Assessment Score
Product type:	N/A	N/A
Extent of Damage:	N/A	N/A
Surface Treatment:	N/A	N/A
Asbestos type:	N/A	N/A
Material Assessment Score:		N/A
Priority Assessment Score:		N/A
Action:	N/A	
Comments:	N/A

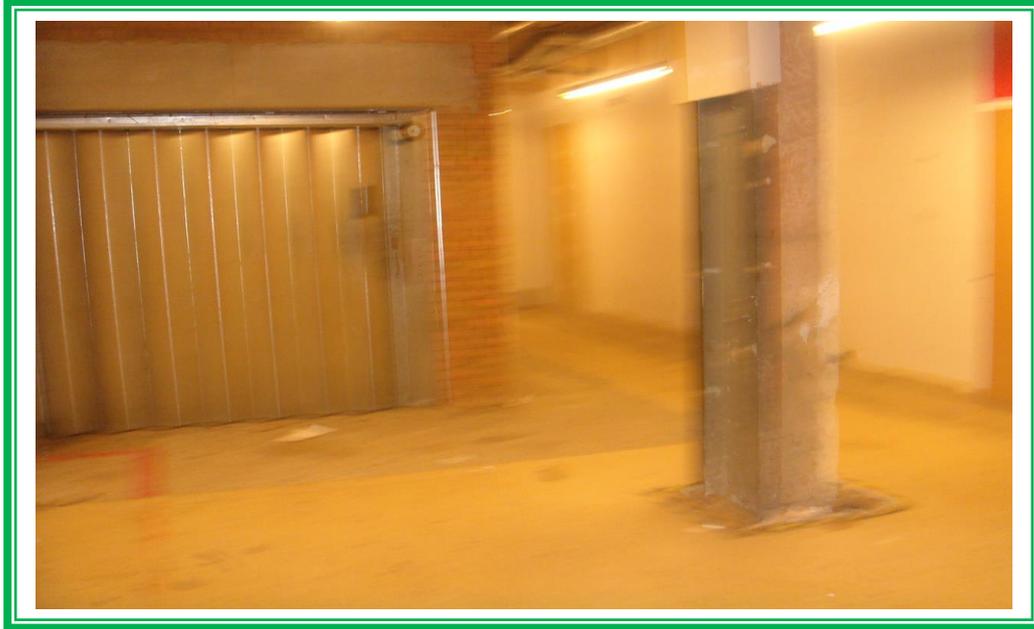
Location: 0/014 Lobby Lift

Material Description:	Visual Inspection – No Suspect Materials Found	
Identification:	N/A	
Approx. quantity:	N/A	
Accessibility	N/A	Assessment Score
Product type:	N/A	N/A
Extent of Damage:	N/A	N/A
Surface Treatment:	N/A	N/A
Asbestos type:	N/A	N/A
Material Assessment Score:		N/A
Priority Assessment Score:		N/A
Action:	N/A	
Comments:	N/A

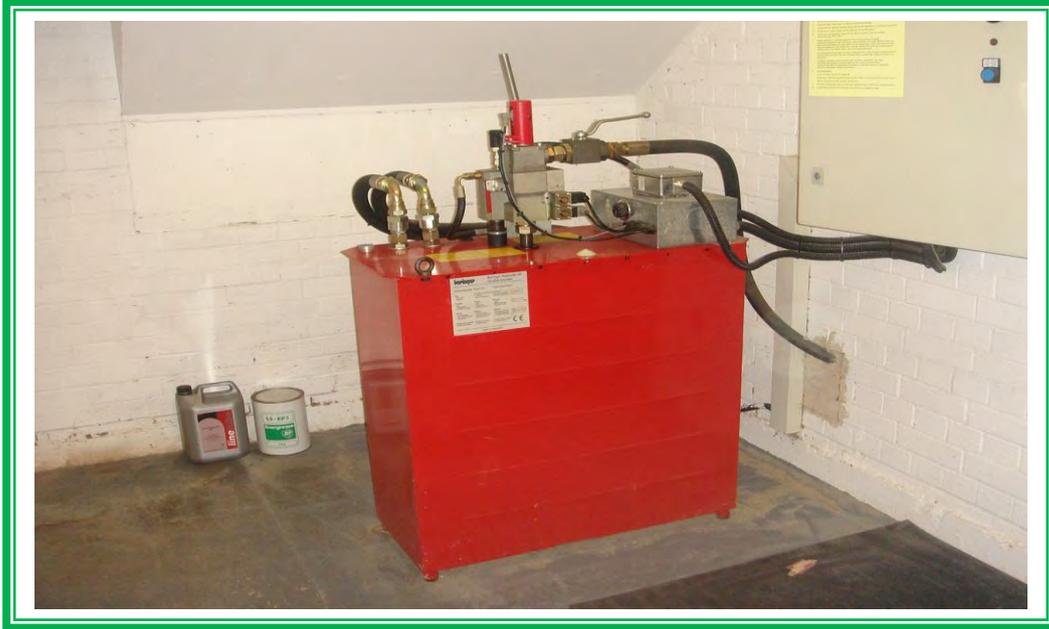
Location: 0/016 Lift Motor Room

Material Description:	Visual Inspection – No Suspect Materials Found	
Identification:	N/A	
Approx. quantity:	N/A	
Accessibility	N/A	Assessment Score
Product type:	N/A	N/A
Extent of Damage:	N/A	N/A
Surface Treatment:	N/A	N/A
Asbestos type:	N/A	N/A
Material Assessment Score:		N/A
Priority Assessment Score:		N/A
Action:	N/A	
Comments:	N/A

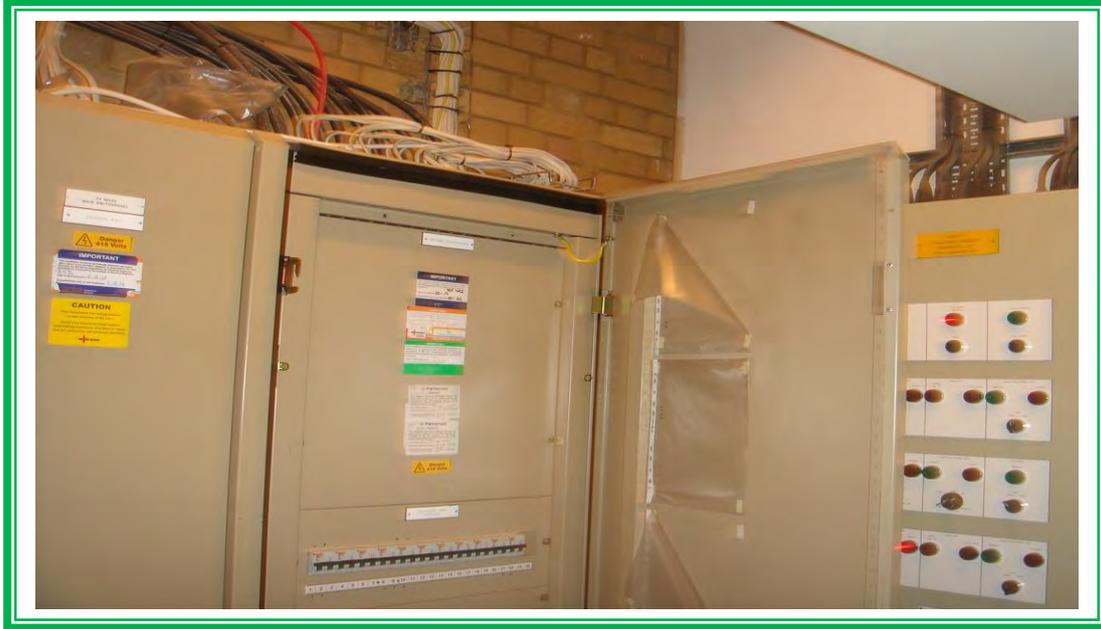
Location: 0/017

Material Description:	Visual Inspection – No Suspect Materials Found	
Identification:	N/A	
Approx. quantity:	N/A	
Accessibility	N/A	Assessment Score
Product type:	N/A	N/A
Extent of Damage:	N/A	N/A
Surface Treatment:	N/A	N/A
Asbestos type:	N/A	N/A
Material Assessment Score:		N/A
Priority Assessment Score:		N/A
Action:	N/A	
Comments:	N/A

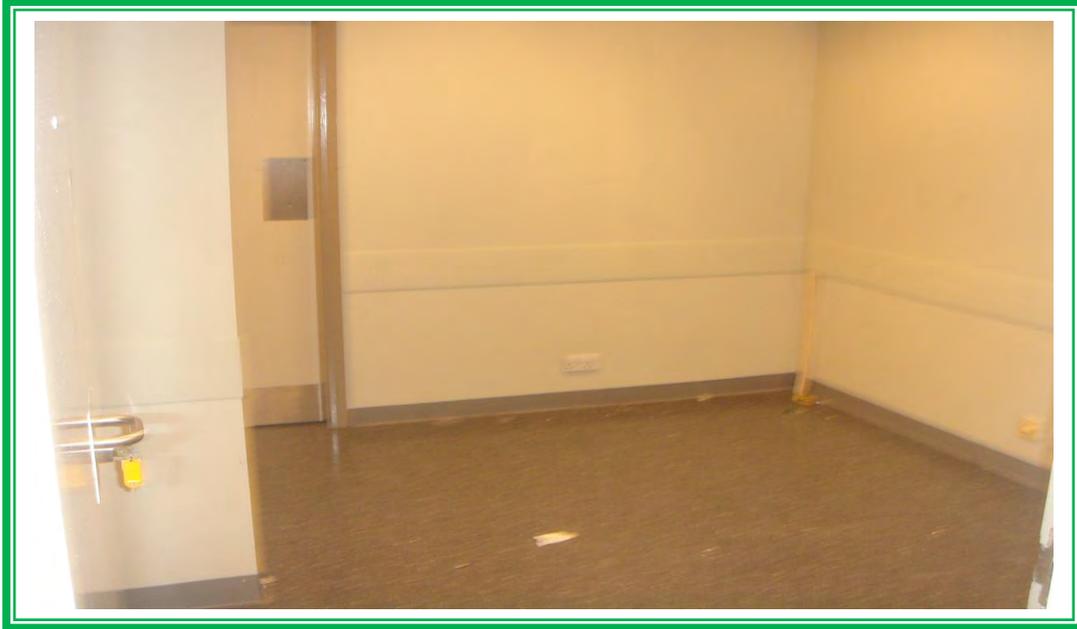
Location: 0/018

Material Description:	Visual Inspection – No Suspect Materials Found	
Identification:	N/A	
Approx. quantity:	N/A	
Accessibility	N/A	Assessment Score
Product type:	N/A	N/A
Extent of Damage:	N/A	N/A
Surface Treatment:	N/A	N/A
Asbestos type:	N/A	N/A
Material Assessment Score:		N/A
Priority Assessment Score:		N/A
Action:	N/A	
Comments:	N/A

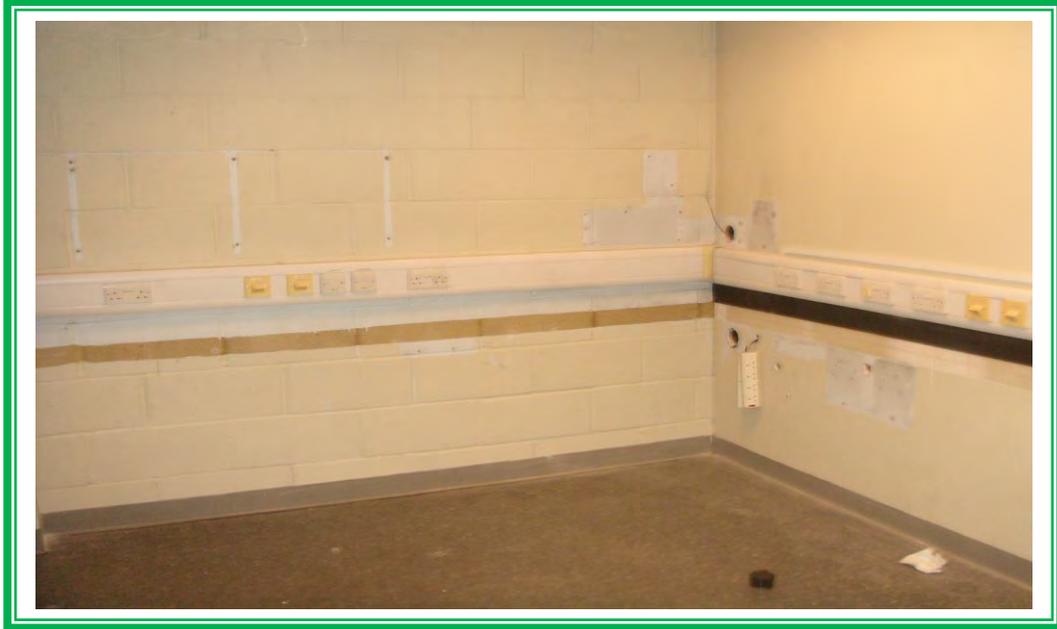
Location: 0/19

Material Description:	Visual Inspection – No Suspect Materials Found	
Identification:	N/A	
Approx. quantity:	N/A	
Accessibility	N/A	Assessment Score
Product type:	N/A	N/A
Extent of Damage:	N/A	N/A
Surface Treatment:	N/A	N/A
Asbestos type:	N/A	N/A
Material Assessment Score:		N/A
Priority Assessment Score:		N/A
Action:	N/A	
Comments:	N/A

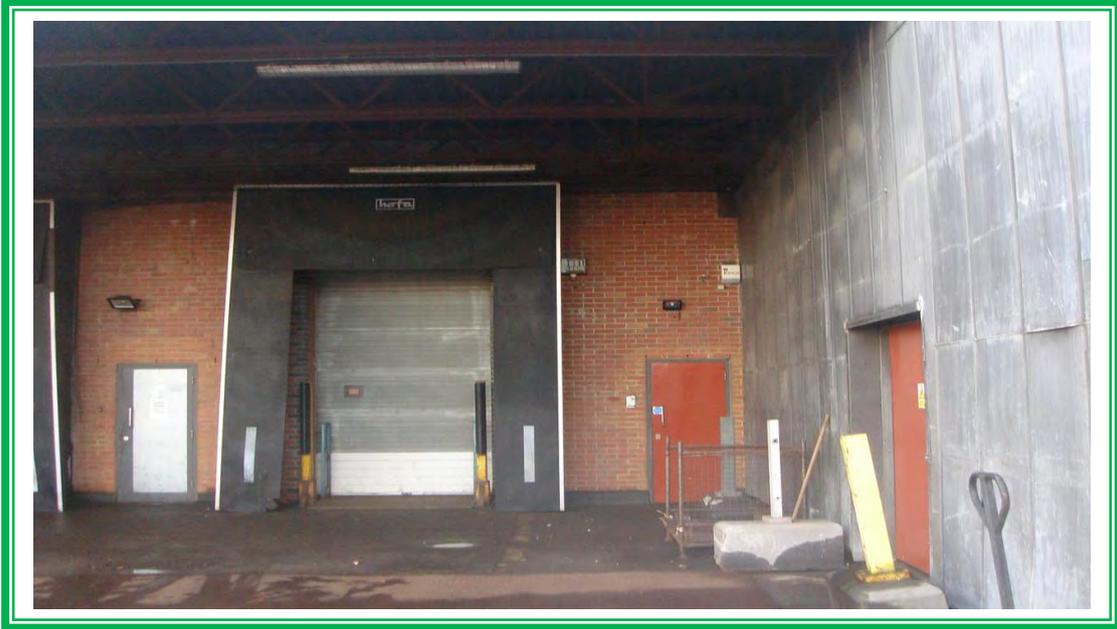
Location: 99/001 External

Material Description:	Visual Inspection – No Suspect Materials Found	
Identification:	N/A	
Approx. quantity:	N/A	
Accessibility	N/A	Assessment Score
Product type:	N/A	N/A
Extent of Damage:	N/A	N/A
Surface Treatment:	N/A	N/A
Asbestos type:	N/A	N/A
Material Assessment Score:		N/A
Priority Assessment Score:		N/A
Action:	N/A	
Comments:	N/A

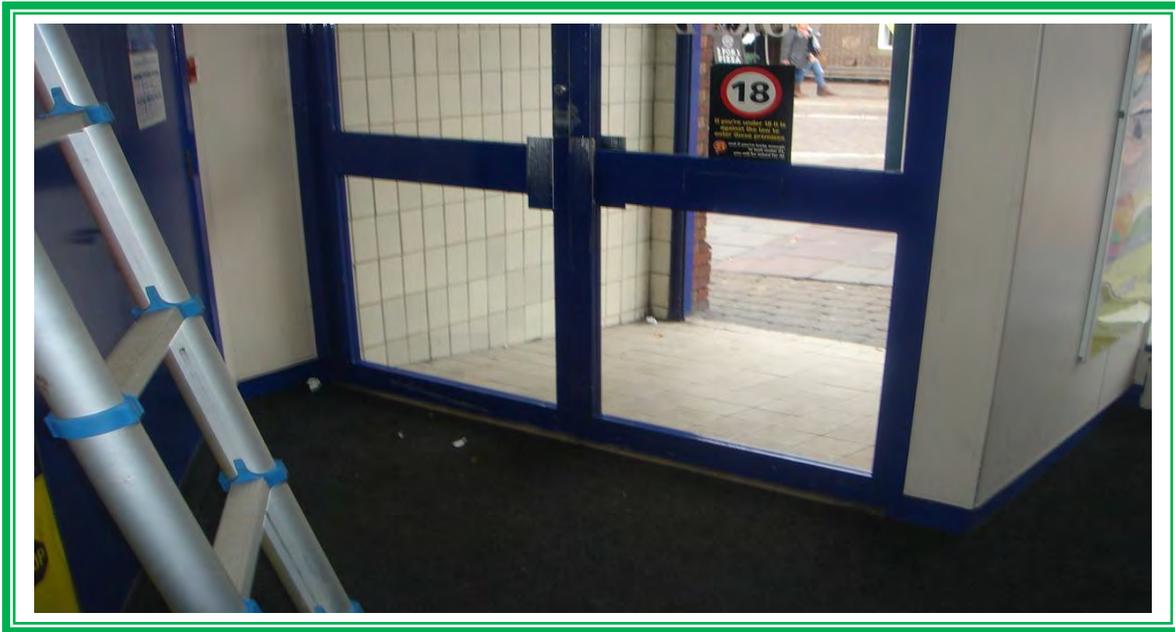
Location: 0/001 Lobby

Material Description:	Visual Inspection – No Suspect Materials Found	
Identification:	N/A	
Approx. quantity:	N/A	
Accessibility	N/A	Assessment Score
Product type:	N/A	N/A
Extent of Damage:	N/A	N/A
Surface Treatment:	N/A	N/A
Asbestos type:	N/A	N/A
Material Assessment Score:		N/A
Priority Assessment Score:		N/A
Action:	N/A	
Comments:	N/A

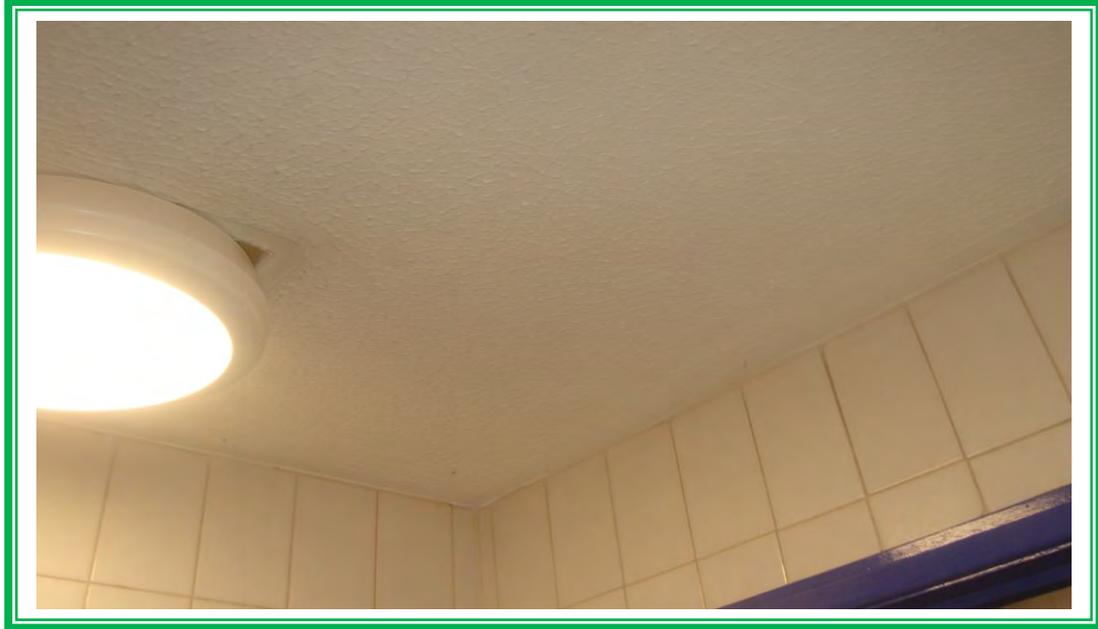
Location: 0/002 WC

Material Description:	Textured Coating Ceiling	
Identification:	Sampled - No Asbestos Detected	
Approx. quantity:	3M2	
Accessibility	N/A	Assessment Score
Product type:	N/A	N/A
Extent of Damage:	N/A	N/A
Surface Treatment:	N/A	N/A
Asbestos type:	N/A	N/A
Material Assessment Score:		N/A
Priority Assessment Score:		N/A
Action:	N/A	
Comments:	N/A

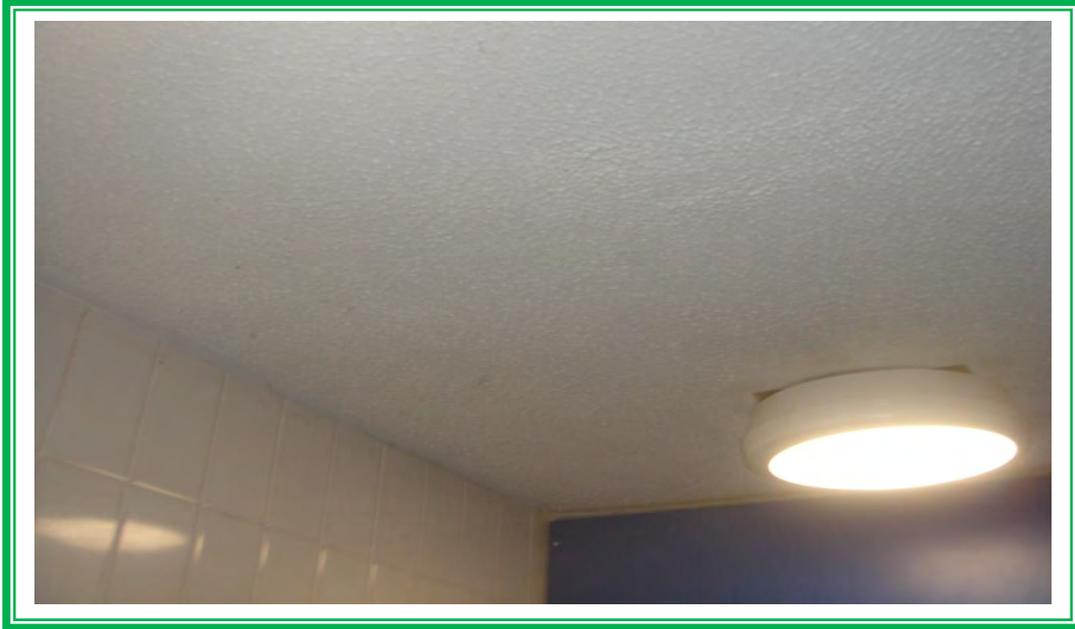
Location: 1/003 WC

Material Description:	Textured Coating Ceiling	
Identification:	As Per Sample NE/1 – No Asbestos Detected	
Approx. quantity:	3M2	
Accessibility	N/A	Assessment Score
Product type:	N/A	N/A
Extent of Damage:	N/A	N/A
Surface Treatment:	N/A	N/A
Asbestos type:	N/A	N/A
Material Assessment Score:		N/A
Priority Assessment Score:		N/A
Action:	N/A	
Comments:	N/A

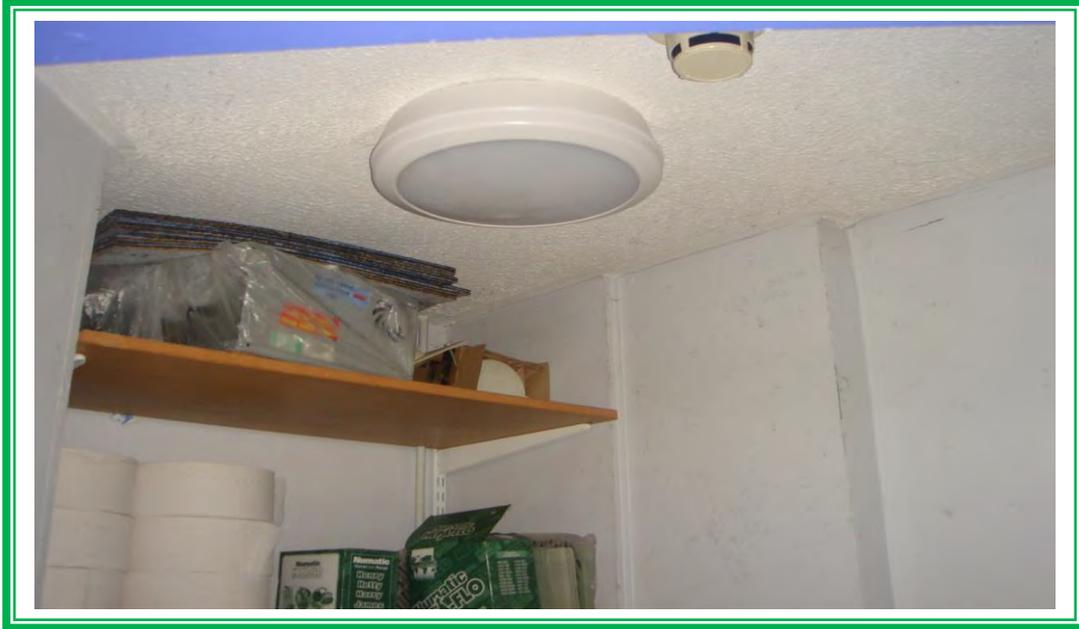
Location: 1/004 Cupboard

Material Description:	Textured Coating Ceiling	
Identification:	As Per Sample NE/1 – No Asbestos Detected	
Approx. quantity:	2M2	
Accessibility	N/A	Assessment Score
Product type:	N/A	N/A
Extent of Damage:	N/A	N/A
Surface Treatment:	N/A	N/A
Asbestos type:	N/A	N/A
Material Assessment Score:		N/A
Priority Assessment Score:		N/A
Action:	N/A	
Comments:	N/A

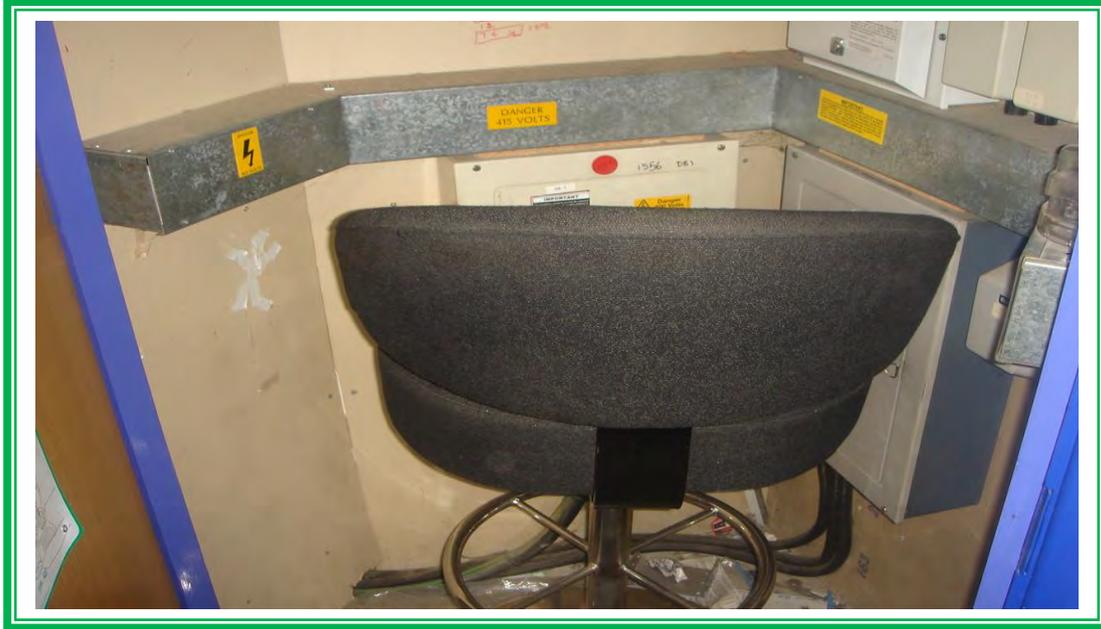
Location: 0/005 Cupboard

Material Description:	Visual Inspection – No Suspect Materials Found	
Identification:	N/A	
Approx. quantity:	N/A	
Accessibility	N/A	Assessment Score
Product type:	N/A	N/A
Extent of Damage:	N/A	N/A
Surface Treatment:	N/A	N/A
Asbestos type:	N/A	N/A
Material Assessment Score:		N/A
Priority Assessment Score:		N/A
Action:	N/A	
Comments:	N/A

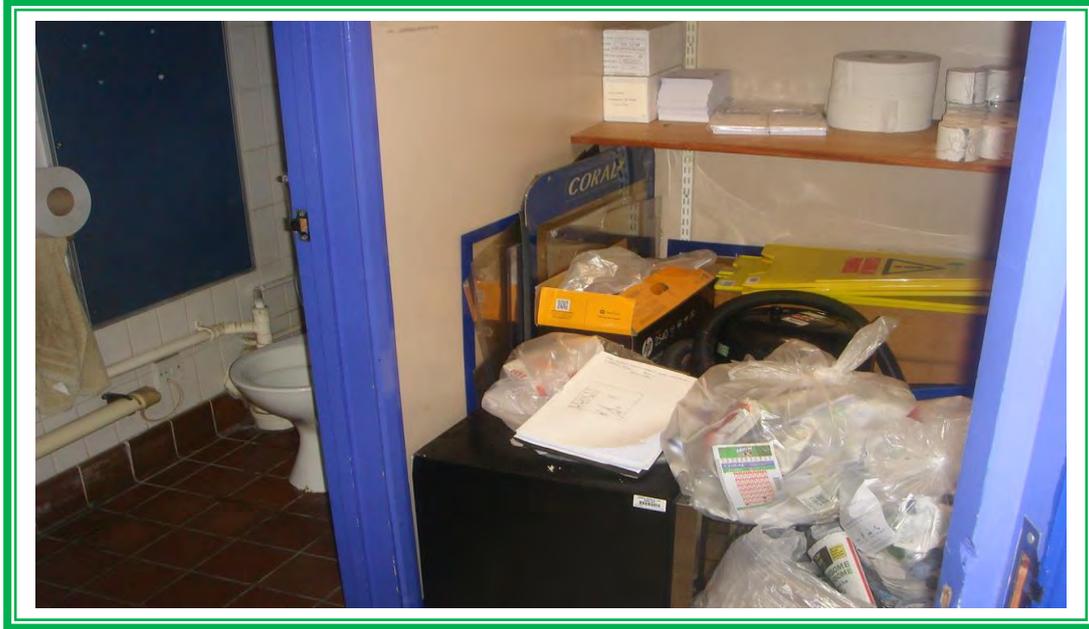
Location: 0/006 Office

Material Description:	Visual Inspection – No Suspect Materials Found	
Identification:	N/A	
Approx. quantity:	N/A	
Accessibility	N/A	Assessment Score
Product type:	N/A	N/A
Extent of Damage:	N/A	N/A
Surface Treatment:	N/A	N/A
Asbestos type:	N/A	N/A
Material Assessment Score:		N/A
Priority Assessment Score:		N/A
Action:	N/A	
Comments:	N/A

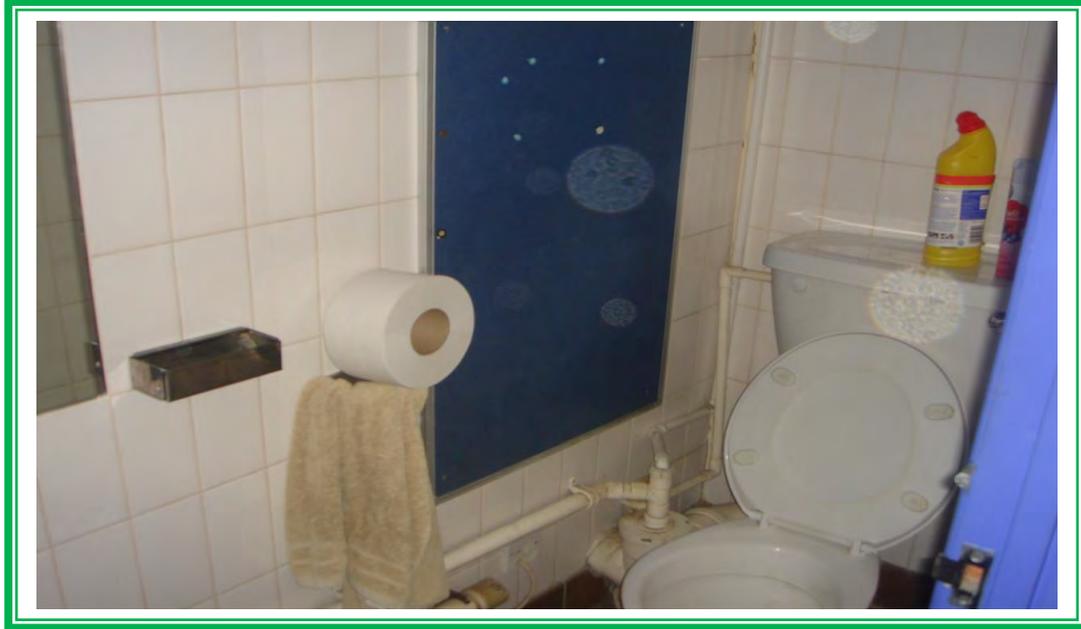
Location: 0/007 WC

Material Description:	Visual Inspection – No Suspect Materials Found	
Identification:	N/A	
Approx. quantity:	N/A	
Accessibility	N/A	Assessment Score
Product type:	N/A	N/A
Extent of Damage:	N/A	N/A
Surface Treatment:	N/A	N/A
Asbestos type:	N/A	N/A
Material Assessment Score:		N/A
Priority Assessment Score:		N/A
Action:	N/A	
Comments:	N/A

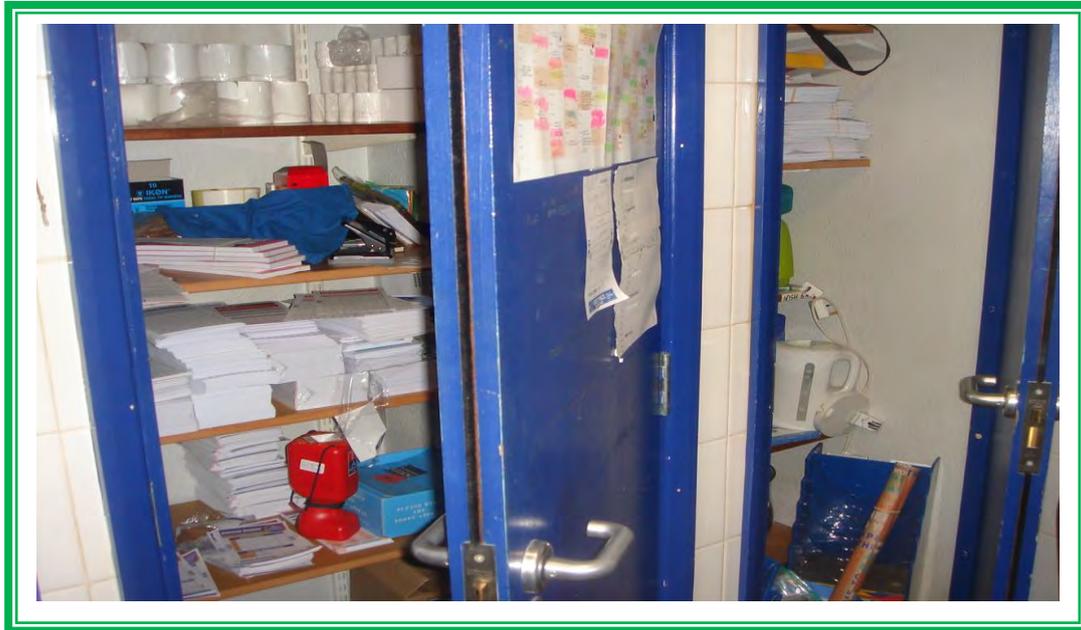
Location: 0/009 Cupboard

Material Description:	Visual Inspection – No Suspect Materials Found	
Identification:	N/A	
Approx. quantity:	N/A	
Accessibility	N/A	Assessment Score
Product type:	N/A	N/A
Extent of Damage:	N/A	N/A
Surface Treatment:	N/A	N/A
Asbestos type:	N/A	N/A
Material Assessment Score:		N/A
Priority Assessment Score:		N/A
Action:	N/A	
Comments:	N/A

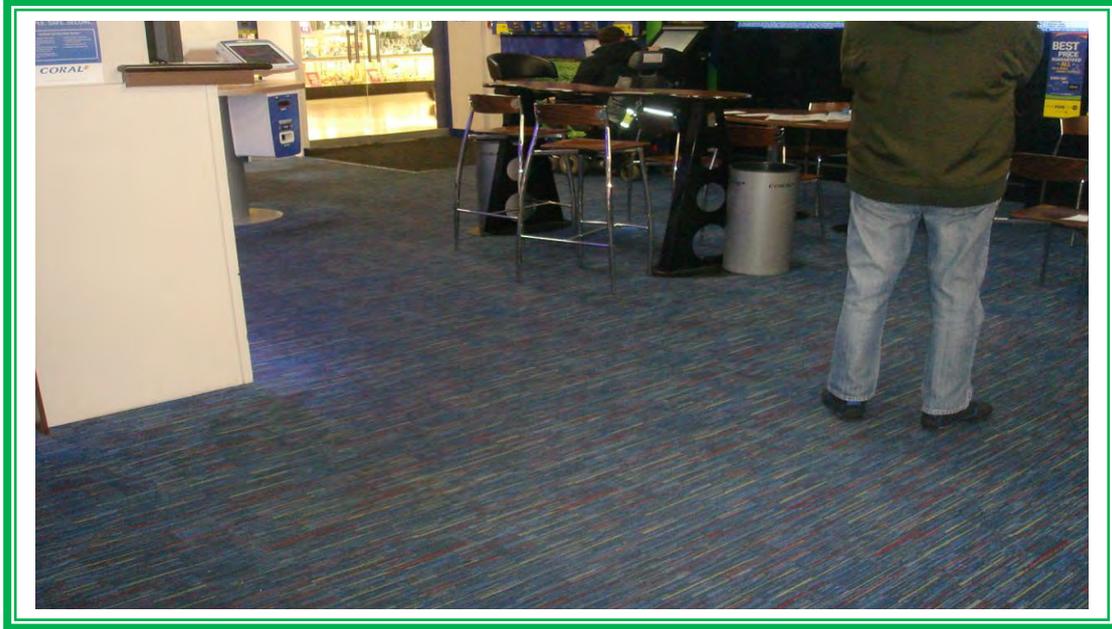
Location: 0/010 Shop Floor

Material Description:	Visual Inspection – No Suspect Materials Found	
Identification:	N/A	
Approx. quantity:	N/A	
Accessibility	N/A	Assessment Score
Product type:	N/A	N/A
Extent of Damage:	N/A	N/A
Surface Treatment:	N/A	N/A
Asbestos type:	N/A	N/A
Material Assessment Score:		N/A
Priority Assessment Score:		N/A
Action:	N/A	
Comments:	N/A

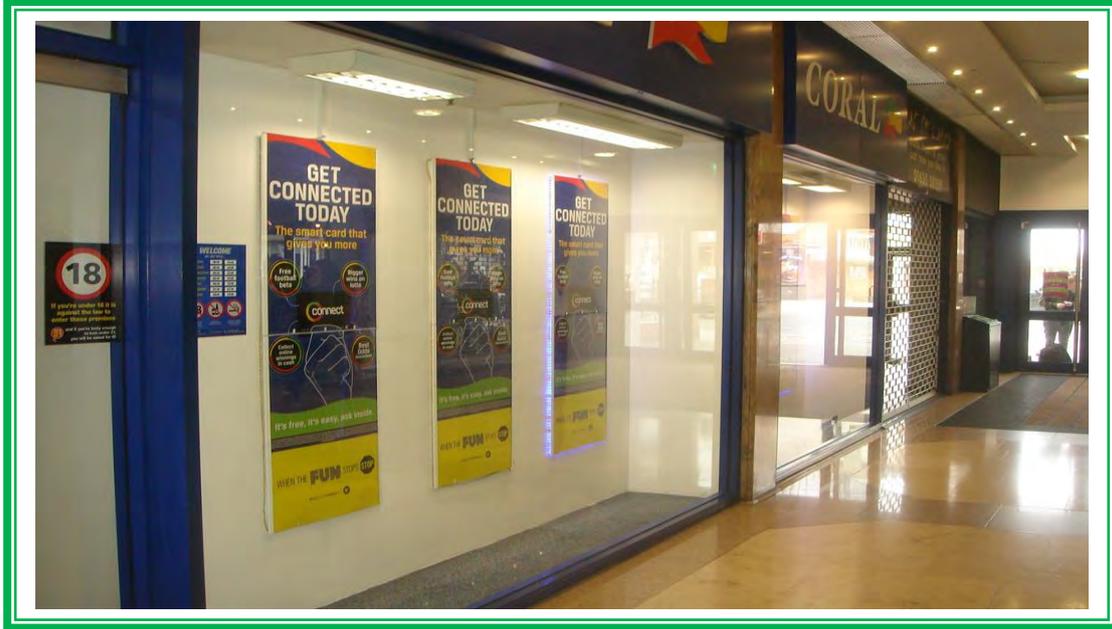
Location: 99/001

Material Description:	Visual Inspection – No Suspect Materials Found	
Identification:	N/A	
Approx. quantity:	N/A	
Accessibility	N/A	Assessment Score
Product type:	N/A	N/A
Extent of Damage:	N/A	N/A
Surface Treatment:	N/A	N/A
Asbestos type:	N/A	N/A
Material Assessment Score:		N/A
Priority Assessment Score:		N/A
Action:	N/A	
Comments:	N/A

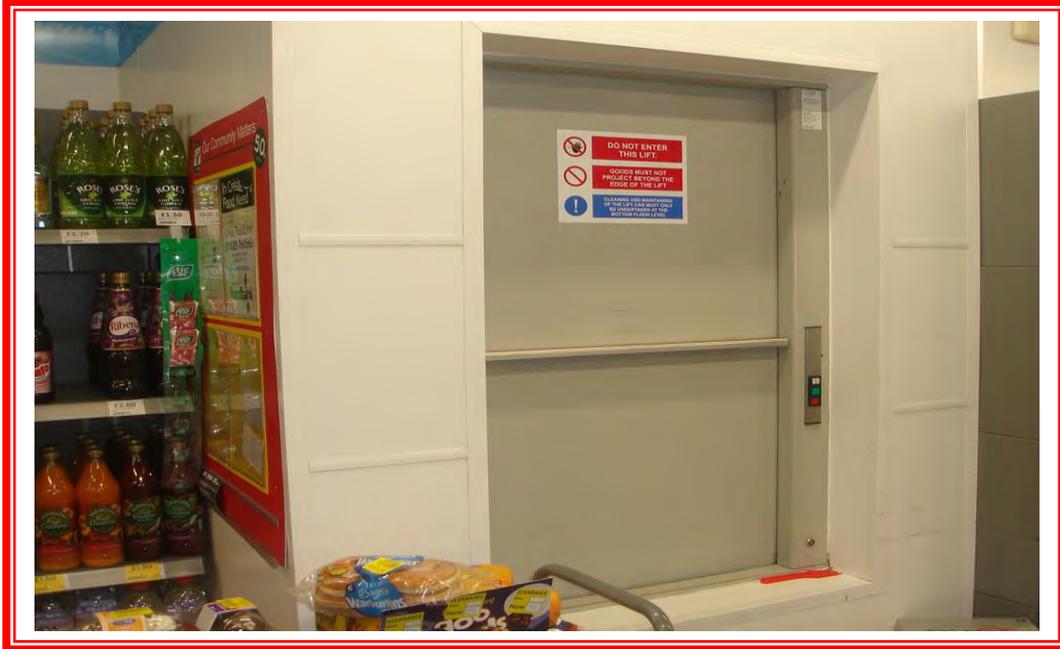
Location: 0/002 Lift and Shaft

Material Description:	No Access	
Identification:	Presumed to Contain Asbestos	
Approx. quantity:	Entire Lift and Shaft	
Accessibility	Low	Assessment Score
Product type:	No Access	3
Extent of Damage:	No Access	3
Surface Treatment:	No Access	3
Asbestos type:	No Access	3
Material Assessment Score:		12
Priority Assessment Score:		High
Action:	Further Investigation Needed	
Comments:	Unable to access as there was no lift engineer

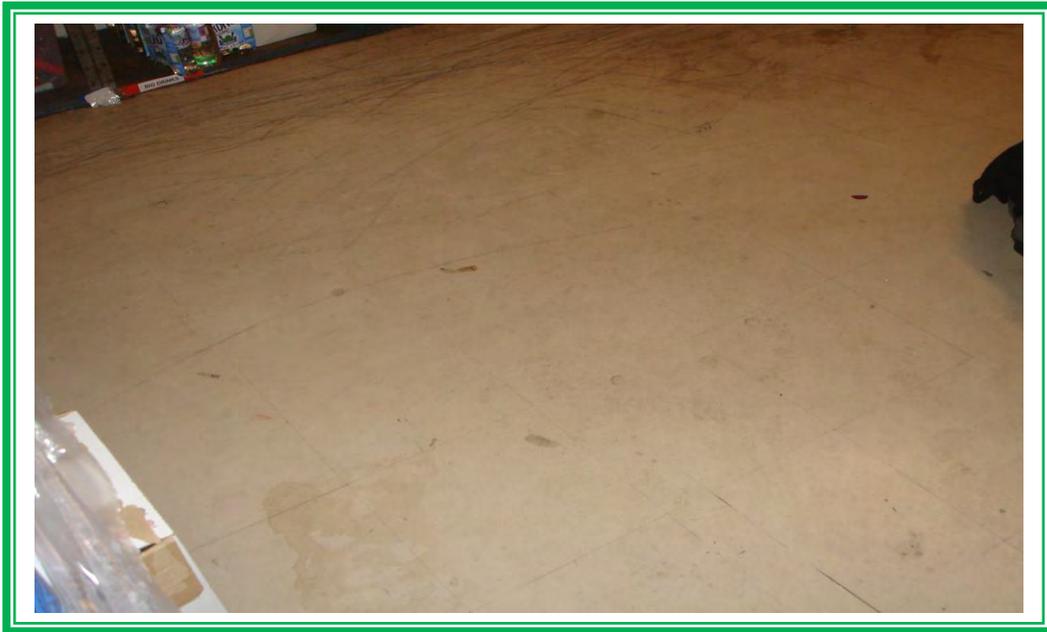
Item No: 1	Sample No: NE/1
Location: 1/001 Store

Material Description:	Vinyl Floor Tiles	
Identification:	Sampled – No Asbestos Detected	
Approx. quantity:	50M2	
Accessibility	N/A	Assessment Score
Product type:	N/A	N/A
Extent of Damage:	N/A	N/A
Surface Treatment:	N/A	N/A
Asbestos type:	N/A	N/A
Material Assessment Score:		N/A
Priority Assessment Score:		N/A
Action:	N/A	
Comments:	N/A

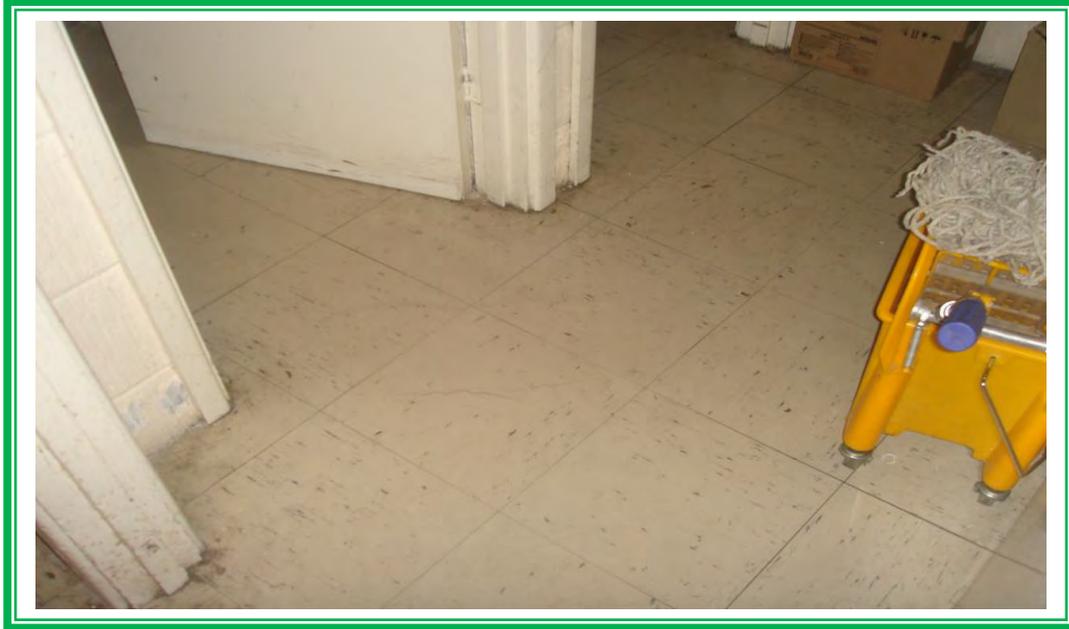
Location: 1/002 WC

Material Description:	Vinyl Floor Tiles	
Identification:	As Per Sample NE/1 – No Asbestos Detected	
Approx. quantity:	6M2	
Accessibility	N/A	Assessment Score
Product type:	N/A	N/A
Extent of Damage:	N/A	N/A
Surface Treatment:	N/A	N/A
Asbestos type:	N/A	N/A
Material Assessment Score:		N/A
Priority Assessment Score:		N/A
Action:	N/A	
Comments:	N/A

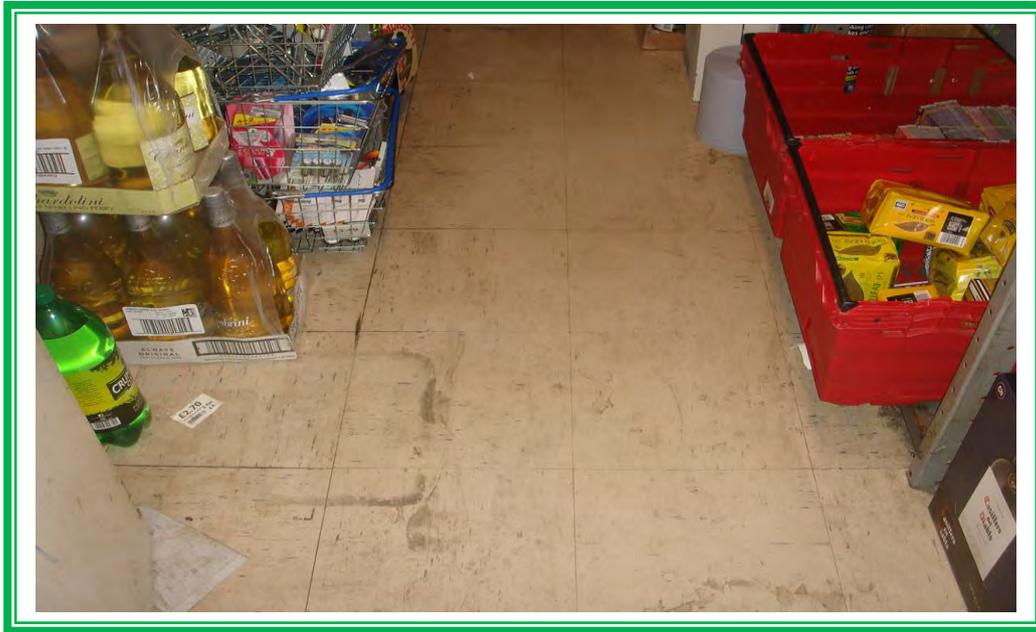
Location: 1/004 Stock Room

Material Description:	Vinyl Floor Tiles	
Identification:	As Per Sample NE/1 – No Asbestos Detected	
Approx. quantity:	2M2	
Accessibility	N/A	Assessment Score
Product type:	N/A	N/A
Extent of Damage:	N/A	N/A
Surface Treatment:	N/A	N/A
Asbestos type:	N/A	N/A
Material Assessment Score:		N/A
Priority Assessment Score:		N/A
Action:	N/A	
Comments:	N/A

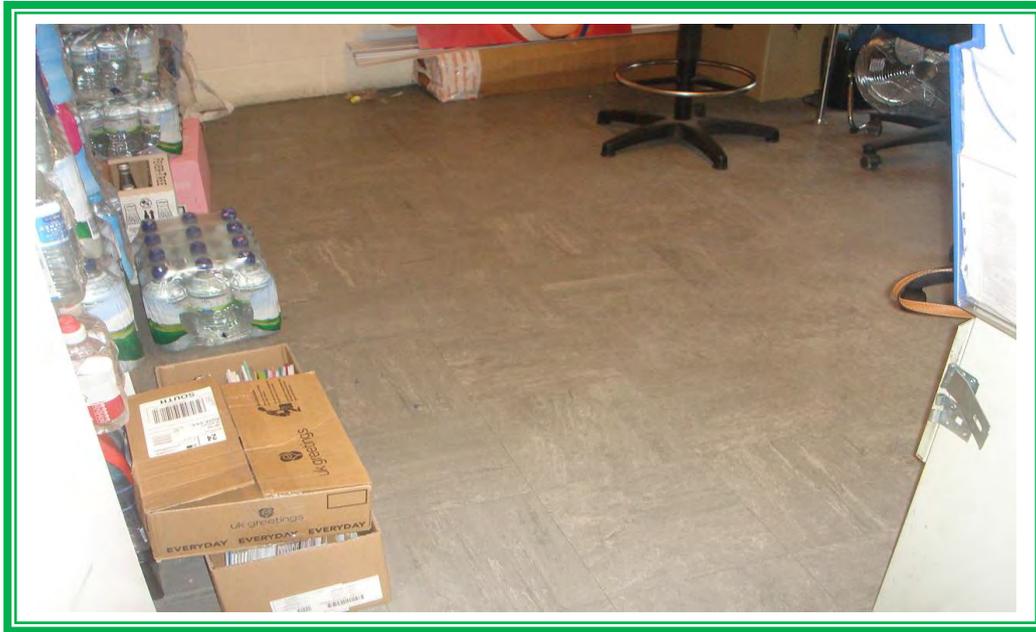
Location: 1/005 Office

Material Description:	Vinyl Floor Tiles	
Identification:	Sampled – No Asbestos Detected	
Approx. quantity:	8M2	
Accessibility	N/A	Assessment Score
Product type:	N/A	N/A
Extent of Damage:	N/A	N/A
Surface Treatment:	N/A	N/A
Asbestos type:	N/A	N/A
Material Assessment Score:		N/A
Priority Assessment Score:		N/A
Action:	N/A	
Comments:	N/A

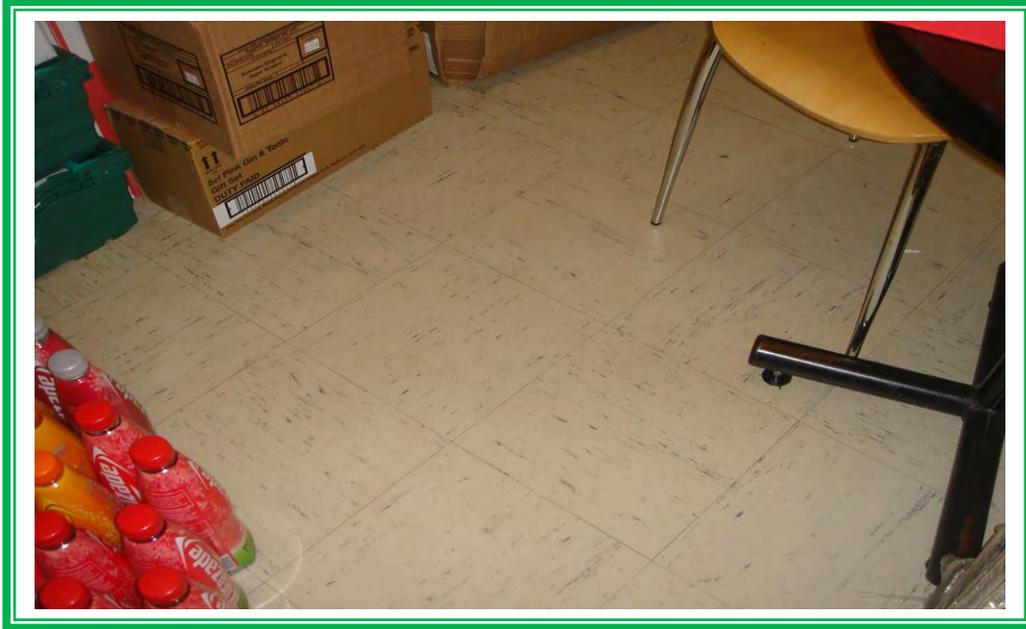
Location: 1/006 Kitchen/Store

Material Description:	Vinyl Floor Tiles	
Identification:	As Per Sample NE/1 – No Asbestos Detected	
Approx. quantity:	4M2	
Accessibility	N/A	Assessment Score
Product type:	N/A	N/A
Extent of Damage:	N/A	N/A
Surface Treatment:	N/A	N/A
Asbestos type:	N/A	N/A
Material Assessment Score:		N/A
Priority Assessment Score:		N/A
Action:	N/A	
Comments:	N/A

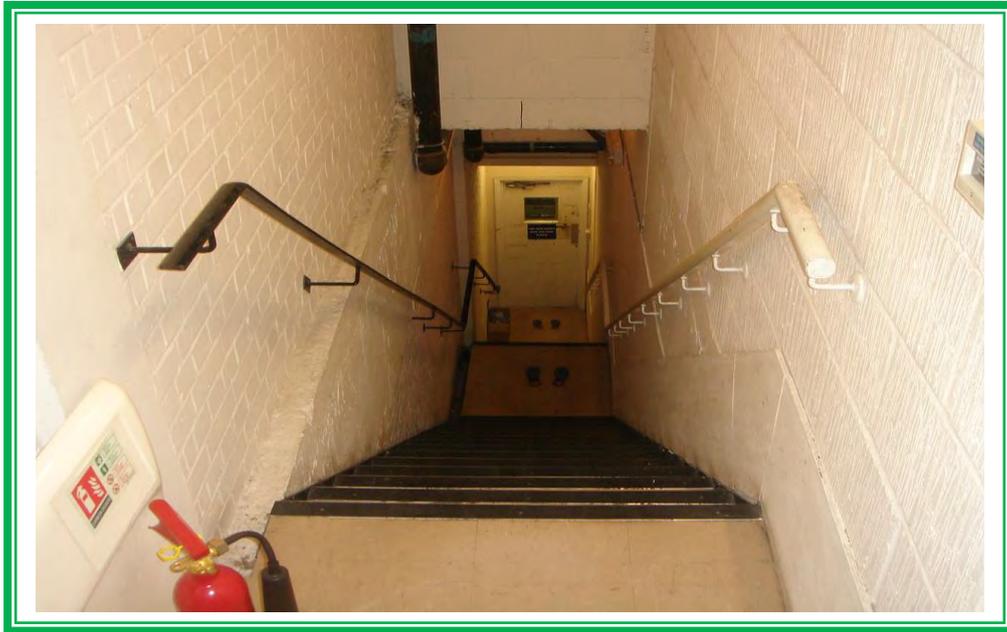
Location: 1/007 Stairs

Material Description:	Vinyl Floor Tiles	
Identification:	Sampled – No Asbestos Detected	
Approx. quantity:	15M2	
Accessibility	N/A	Assessment Score
Product type:	N/A	N/A
Extent of Damage:	N/A	N/A
Surface Treatment:	N/A	N/A
Asbestos type:	N/A	N/A
Material Assessment Score:		N/A
Priority Assessment Score:		N/A
Action:	N/A	
Comments:	N/A
