Project Number 3113

Management
Asbestos Survey Report

Kennet Centre, Market Street, Newbury,
Berkshire, RG14 5EN

3 Market Place and Associated Store

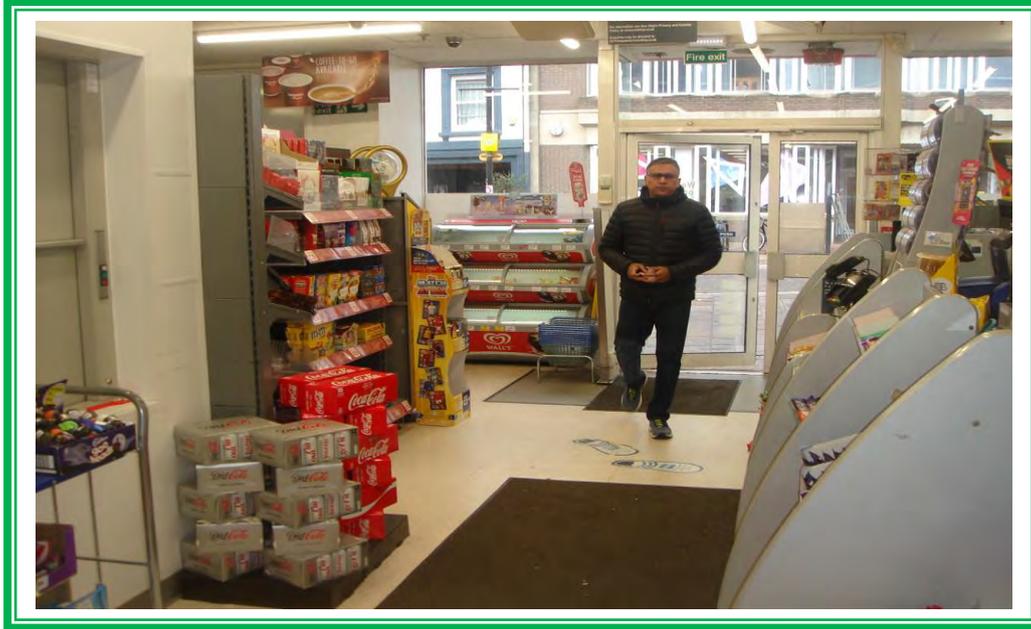
Location: 0/001 Shop Floor

Material Description:	Visual Inspection – No Suspect Materials Found	
Identification:	N/A	
Approx. quantity:	N/A	
Accessibility	N/A	Assessment Score
Product type:	N/A	N/A
Extent of Damage:	N/A	N/A
Surface Treatment:	N/A	N/A
Asbestos type:	N/A	N/A
Material Assessment Score:		N/A
Priority Assessment Score:		N/A
Action:	N/A	
Comments:	N/A

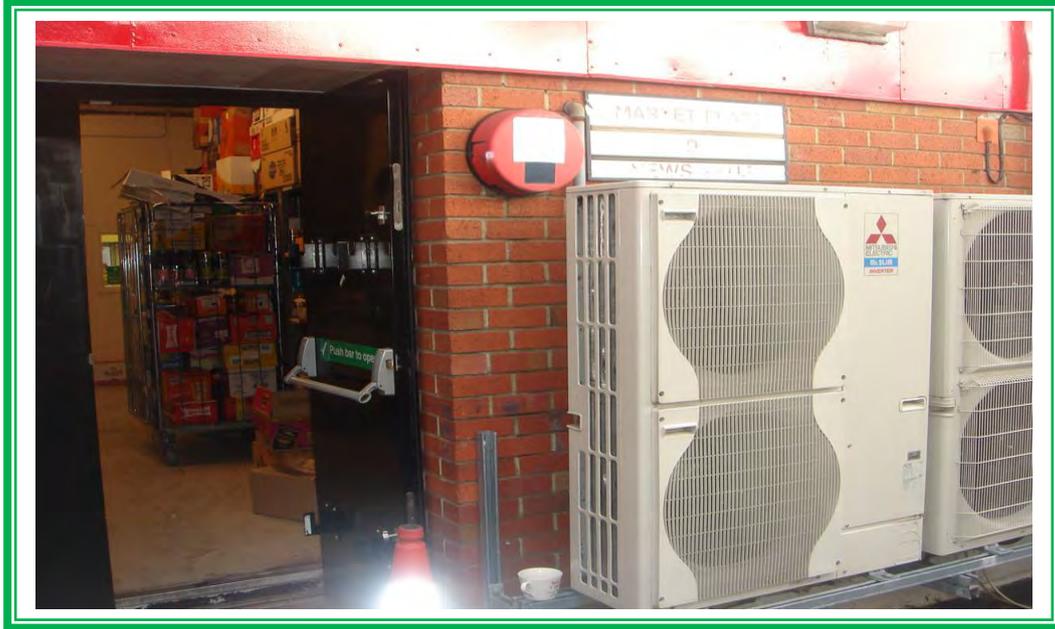
Location: 99/001 External

Material Description:	Visual Inspection – No Suspect Materials Found	
Identification:	N/A	
Approx. quantity:	N/A	
Accessibility	N/A	Assessment Score
Product type:	N/A	N/A
Extent of Damage:	N/A	N/A
Surface Treatment:	N/A	N/A
Asbestos type:	N/A	N/A
Material Assessment Score:		N/A
Priority Assessment Score:		N/A
Action:	N/A	
Comments:	N/A

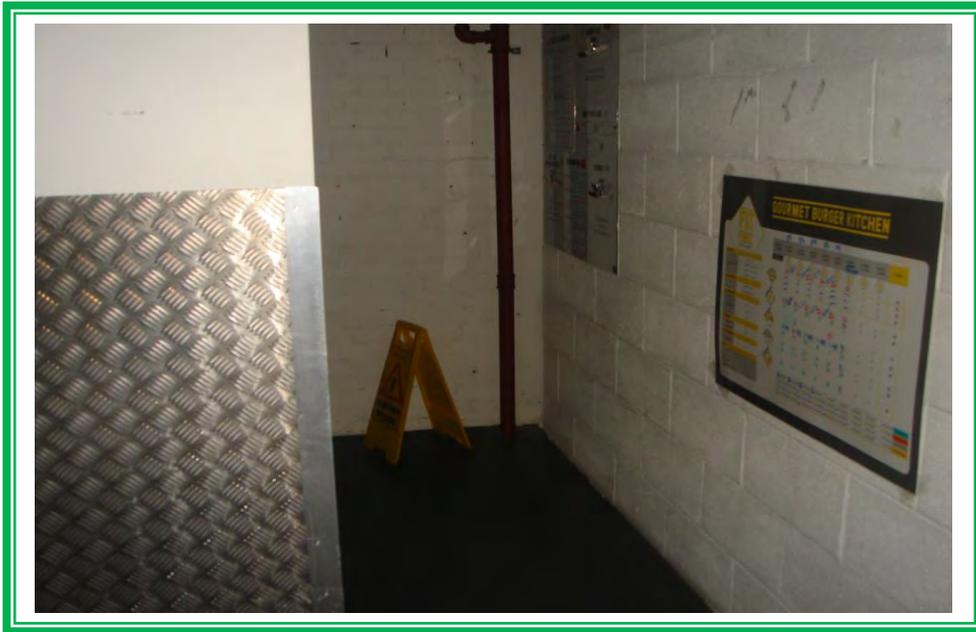
Item No: 1	Sample No: N/A
Location: 1/001 Lobby

Material Description:	Visual Inspection – No Suspect Materials Found	
Identification:	N/A	
Approx. quantity:	N/A	
Accessibility	N/A	Assessment Score
Product type:	N/A	N/A
Extent of Damage:	N/A	N/A
Surface Treatment:	N/A	N/A
Asbestos type:	N/A	N/A
Material Assessment Score:		N/A
Priority Assessment Score:		N/A
Action:	N/A	
Comments:	N/A

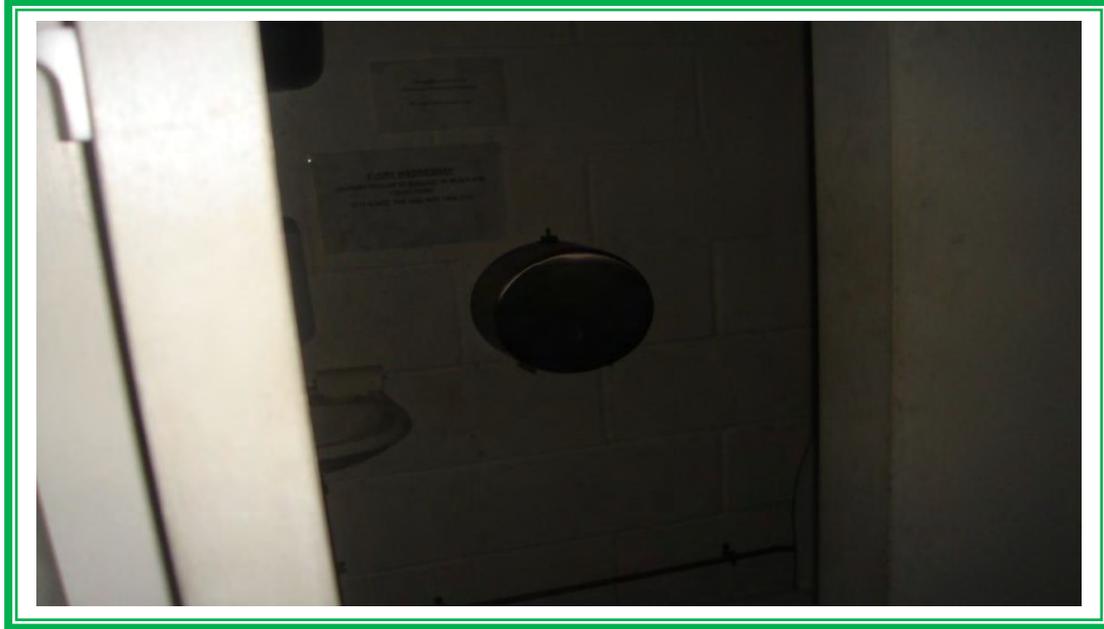
Location: 1/002 WC

Material Description:	Visual Inspection – No Suspect Materials Found	
Identification:	N/A	
Approx. quantity:	N/A	
Accessibility	N/A	Assessment Score
Product type:	N/A	N/A
Extent of Damage:	N/A	N/A
Surface Treatment:	N/A	N/A
Asbestos type:	N/A	N/A
Material Assessment Score:		N/A
Priority Assessment Score:		N/A
Action:	N/A	
Comments:	N/A

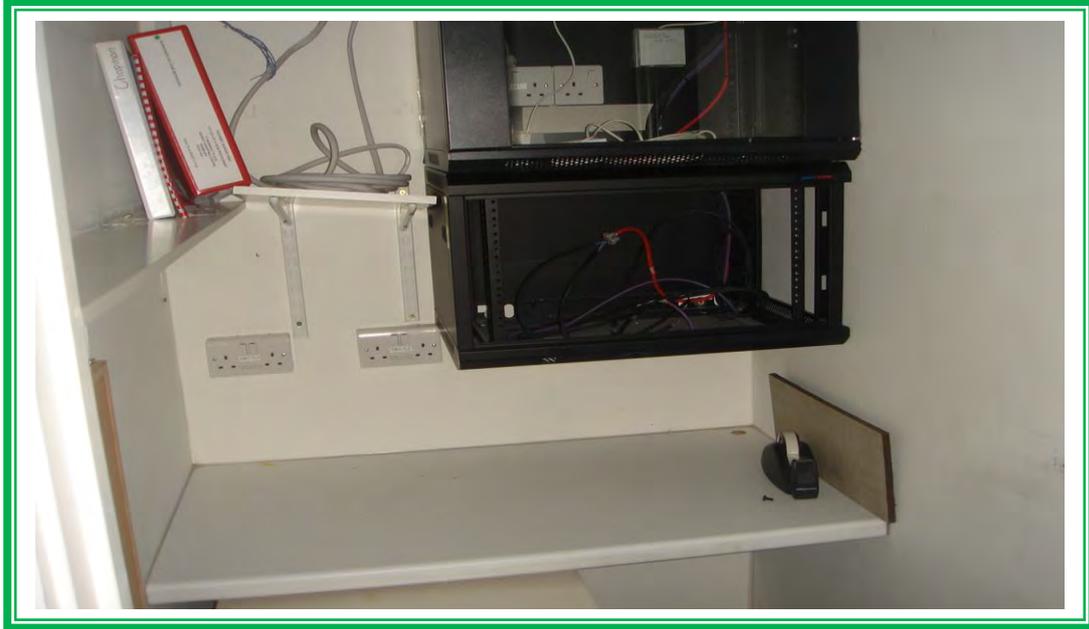
Location: 1/003 Cupboard

Material Description:	Visual Inspection – No Suspect Materials Found	
Identification:	N/A	
Approx. quantity:	N/A	
Accessibility	N/A	Assessment Score
Product type:	N/A	N/A
Extent of Damage:	N/A	N/A
Surface Treatment:	N/A	N/A
Asbestos type:	N/A	N/A
Material Assessment Score:		N/A
Priority Assessment Score:		N/A
Action:	N/A	
Comments:	N/A

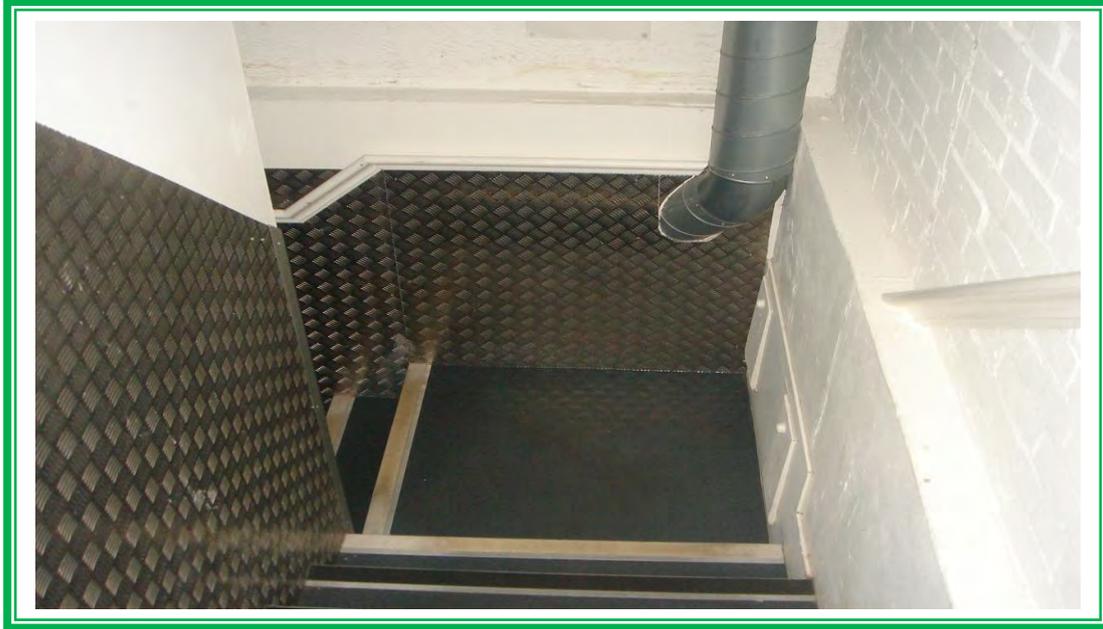
Location: 1/004 Stairs

Material Description:	Visual Inspection – No Suspect Materials Found	
Identification:	N/A	
Approx. quantity:	N/A	
Accessibility	N/A	Assessment Score
Product type:	N/A	N/A
Extent of Damage:	N/A	N/A
Surface Treatment:	N/A	N/A
Asbestos type:	N/A	N/A
Material Assessment Score:		N/A
Priority Assessment Score:		N/A
Action:	N/A	
Comments:	N/A

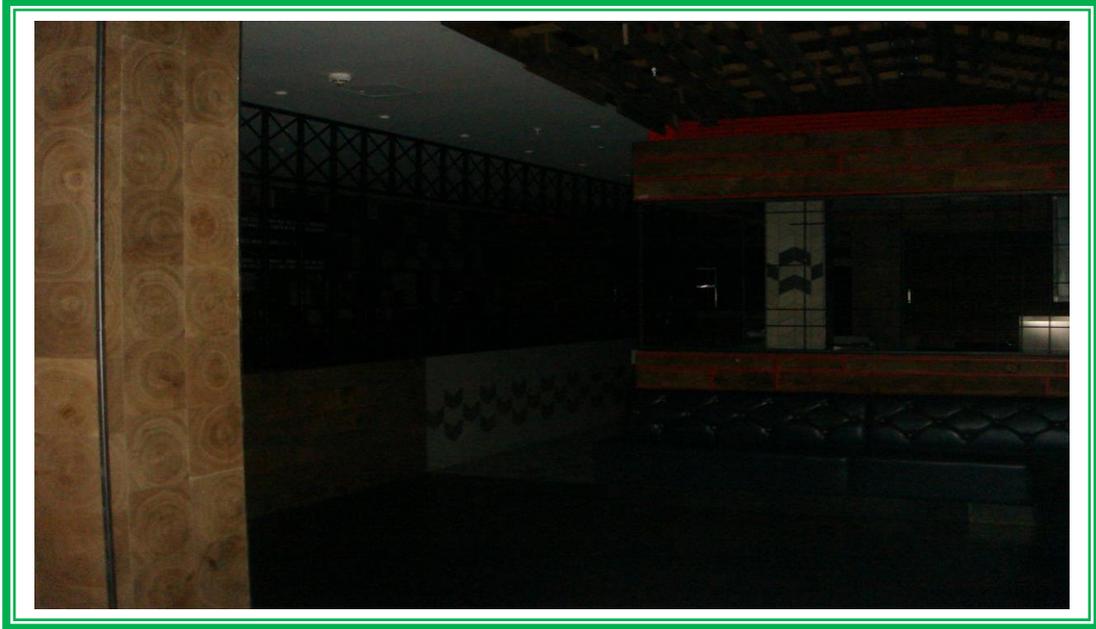
Location: 0/001 Bar and Seating

Material Description:	Visual Inspection – No Suspect Materials Found	
Identification:	N/A	
Approx. quantity:	N/A	
Accessibility	N/A	Assessment Score
Product type:	N/A	N/A
Extent of Damage:	N/A	N/A
Surface Treatment:	N/A	N/A
Asbestos type:	N/A	N/A
Material Assessment Score:		N/A
Priority Assessment Score:		N/A
Action:	N/A	
Comments:	N/A

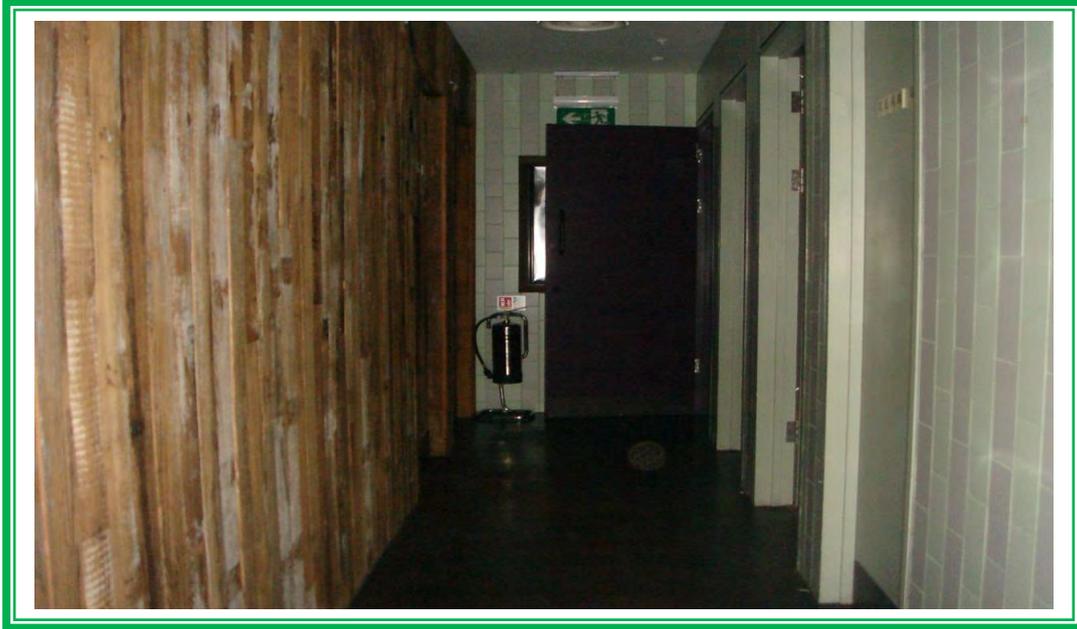
Location: 0/002 Lobby

Material Description:	Visual Inspection – No Suspect Materials Found	
Identification:	N/A	
Approx. quantity:	N/A	
Accessibility	N/A	Assessment Score
Product type:	N/A	N/A
Extent of Damage:	N/A	N/A
Surface Treatment:	N/A	N/A
Asbestos type:	N/A	N/A
Material Assessment Score:		N/A
Priority Assessment Score:		N/A
Action:	N/A	
Comments:	N/A

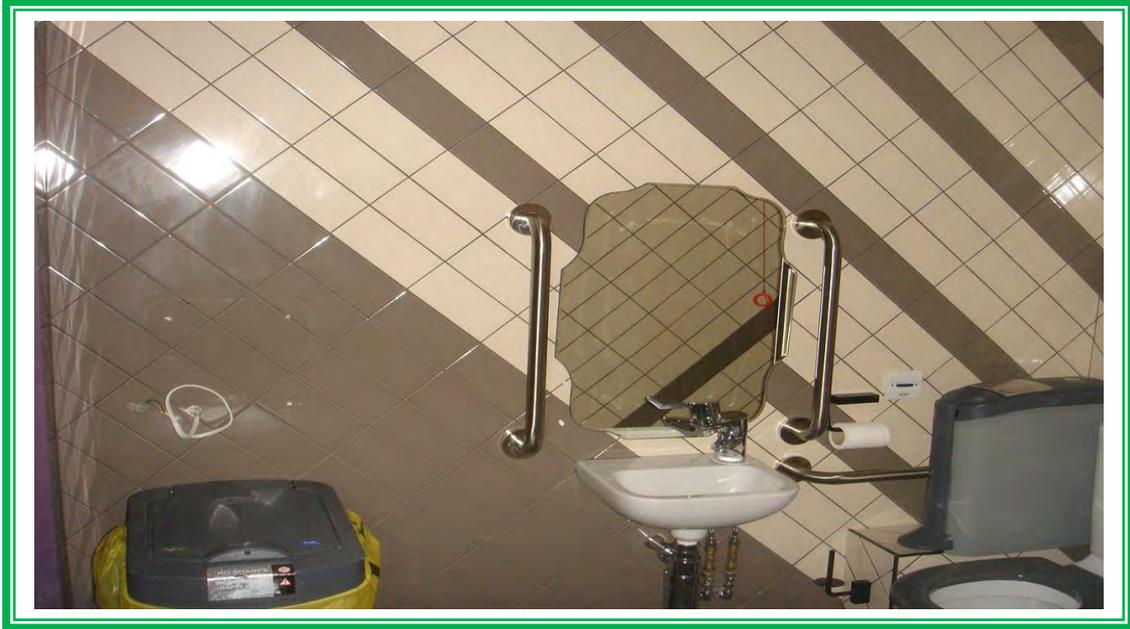
Location: 0/003 Disabled WC

Material Description:	Visual Inspection – No Suspect Materials Found	
Identification:	N/A	
Approx. quantity:	N/A	
Accessibility	N/A	Assessment Score
Product type:	N/A	N/A
Extent of Damage:	N/A	N/A
Surface Treatment:	N/A	N/A
Asbestos type:	N/A	N/A
Material Assessment Score:		N/A
Priority Assessment Score:		N/A
Action:	N/A	
Comments:	N/A

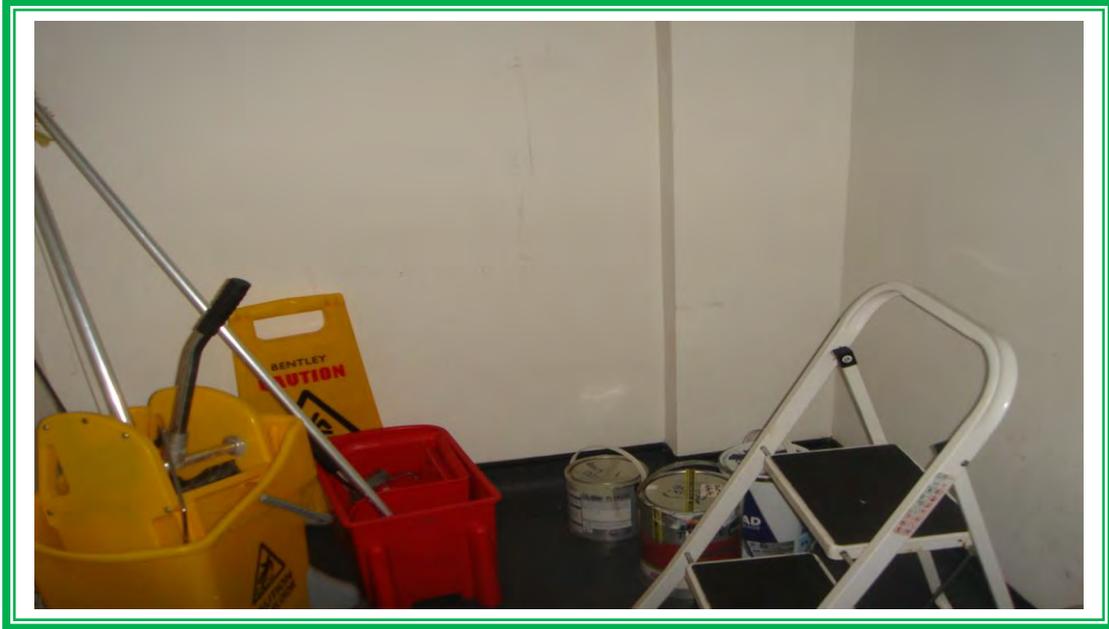
Location: 0/004 Store

Material Description:	Visual Inspection – No Suspect Materials Found	
Identification:	N/A	
Approx. quantity:	N/A	
Accessibility	N/A	Assessment Score
Product type:	N/A	N/A
Extent of Damage:	N/A	N/A
Surface Treatment:	N/A	N/A
Asbestos type:	N/A	N/A
Material Assessment Score:		N/A
Priority Assessment Score:		N/A
Action:	N/A	
Comments:	N/A

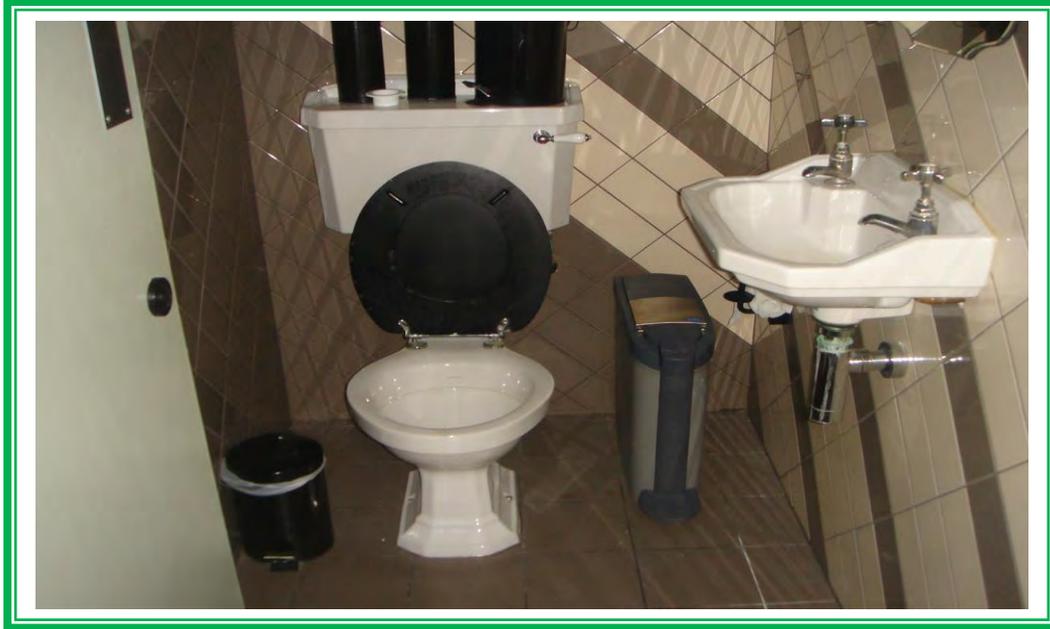
Location: 0/005 WC

Material Description:	Visual Inspection – No Suspect Materials Found	
Identification:	N/A	
Approx. quantity:	N/A	
Accessibility	N/A	Assessment Score
Product type:	N/A	N/A
Extent of Damage:	N/A	N/A
Surface Treatment:	N/A	N/A
Asbestos type:	N/A	N/A
Material Assessment Score:		N/A
Priority Assessment Score:		N/A
Action:	N/A	
Comments:	N/A

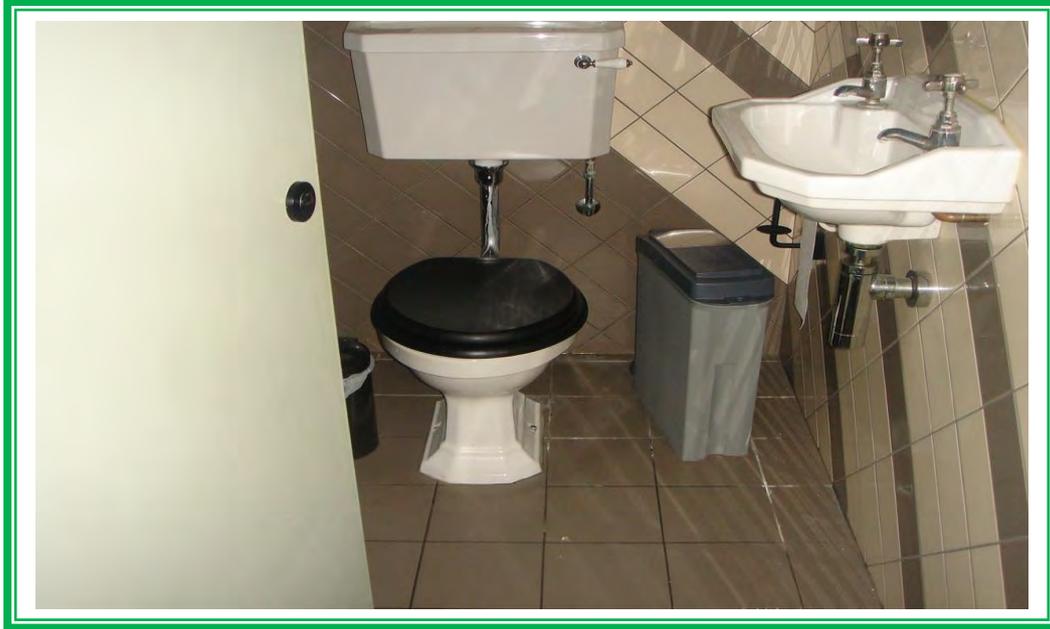
Location: 0/006 WC

Material Description:	Visual Inspection – No Suspect Materials Found	
Identification:	N/A	
Approx. quantity:	N/A	
Accessibility	N/A	Assessment Score
Product type:	N/A	N/A
Extent of Damage:	N/A	N/A
Surface Treatment:	N/A	N/A
Asbestos type:	N/A	N/A
Material Assessment Score:		N/A
Priority Assessment Score:		N/A
Action:	N/A	
Comments:	N/A

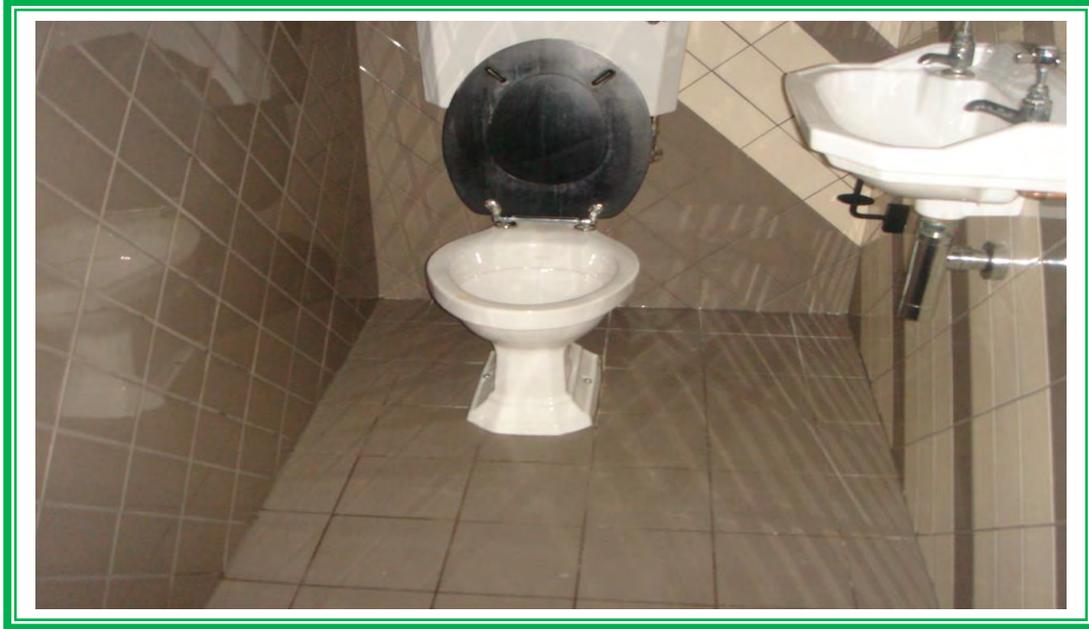
Location: 0/007

Material Description:	Visual Inspection – No Suspect Materials Found	
Identification:	N/A	
Approx. quantity:	N/A	
Accessibility	N/A	Assessment Score
Product type:	N/A	N/A
Extent of Damage:	N/A	N/A
Surface Treatment:	N/A	N/A
Asbestos type:	N/A	N/A
Material Assessment Score:		N/A
Priority Assessment Score:		N/A
Action:	N/A	
Comments:	N/A

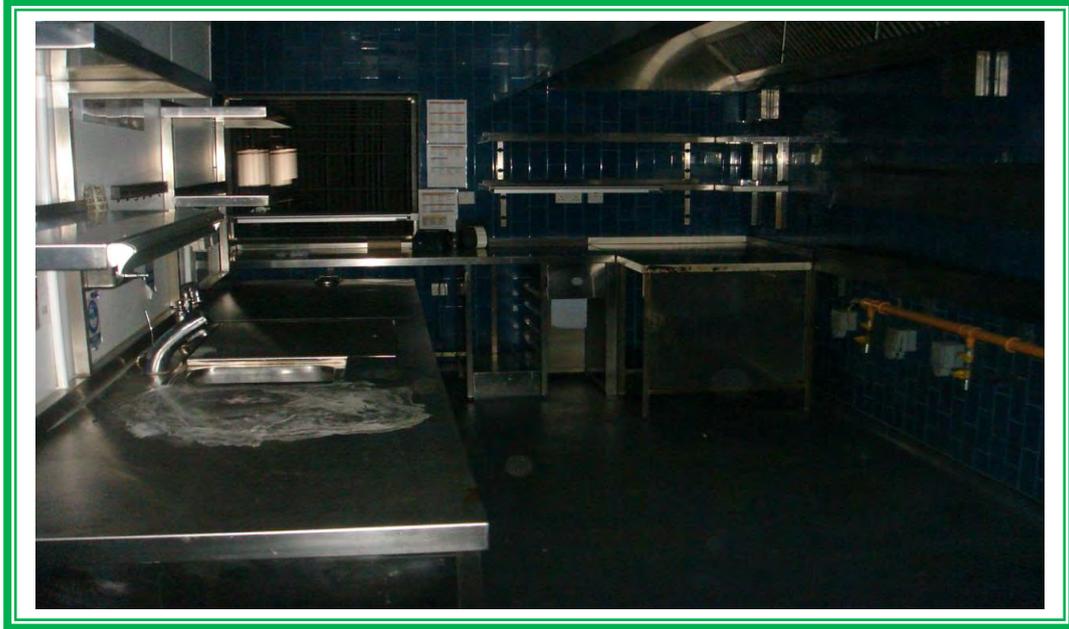
Location: 0/008 Kitchen

Material Description:	Visual Inspection – No Suspect Materials Found	
Identification:	N/A	
Approx. quantity:	N/A	
Accessibility	N/A	Assessment Score
Product type:	N/A	N/A
Extent of Damage:	N/A	N/A
Surface Treatment:	N/A	N/A
Asbestos type:	N/A	N/A
Material Assessment Score:		N/A
Priority Assessment Score:		N/A
Action:	N/A	
Comments:	N/A

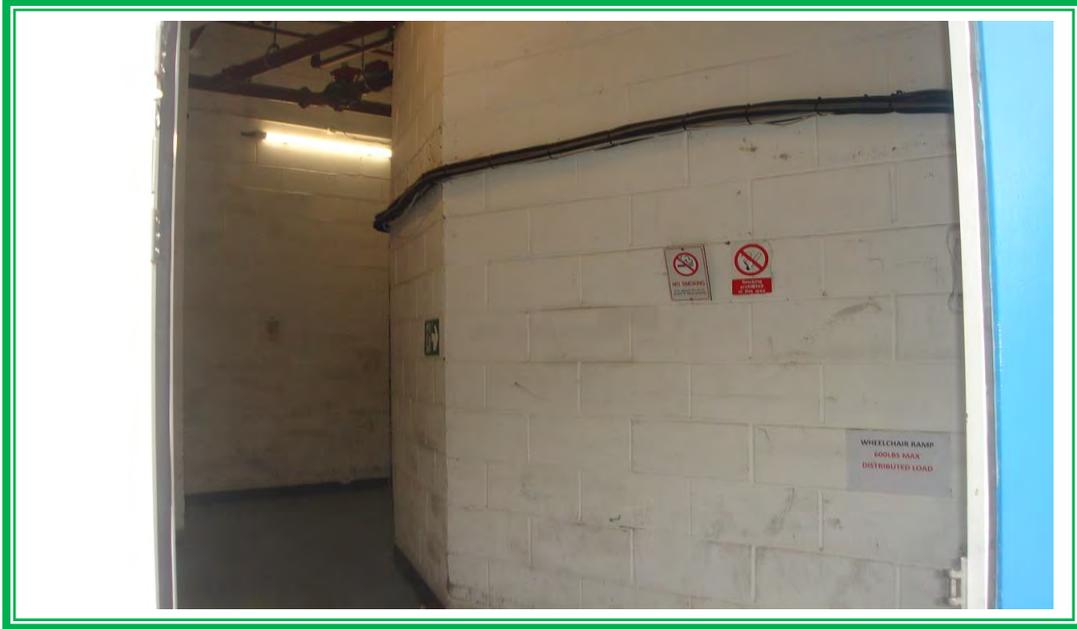
Location: 99/001 External

Material Description:	Visual Inspection – No Suspect Materials Found	
Identification:	N/A	
Approx. quantity:	N/A	
Accessibility	N/A	Assessment Score
Product type:	N/A	N/A
Extent of Damage:	N/A	N/A
Surface Treatment:	N/A	N/A
Asbestos type:	N/A	N/A
Material Assessment Score:		N/A
Priority Assessment Score:		N/A
Action:	N/A	
Comments:	N/A

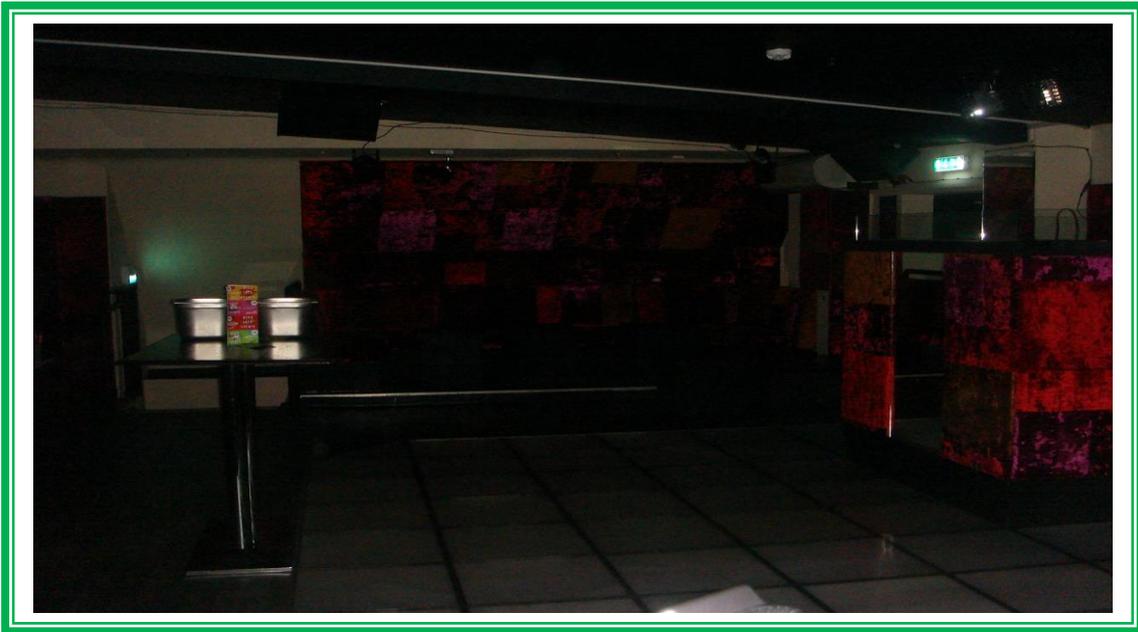
Item No: 1	Sample No: N/A
Location: 2/001 Club Bar

Material Description:	Visual Inspection – No Suspect Materials Found	
Identification:	N/A	
Approx. quantity:	N/A	
Accessibility	N/A	Assessment Score
Product type:	N/A	N/A
Extent of Damage:	N/A	N/A
Surface Treatment:	N/A	N/A
Asbestos type:	N/A	N/A
Material Assessment Score:		N/A
Priority Assessment Score:		N/A
Action:	N/A	
Comments:	N/A

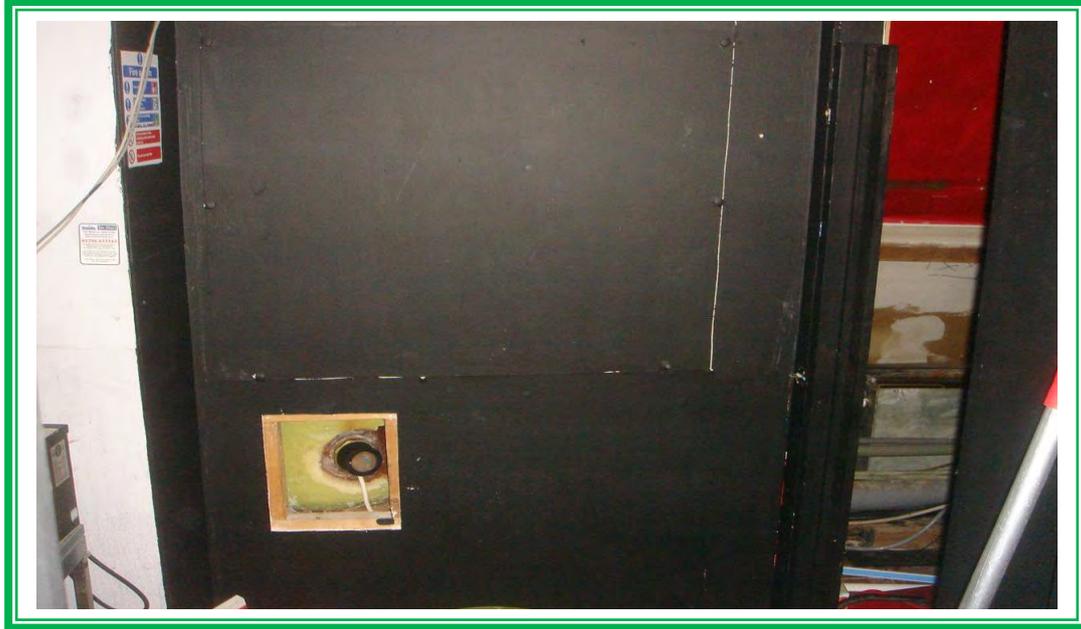
Location: 2/002 Store

Material Description:	Visual Inspection – No Suspect Materials Found	
Identification:	N/A	
Approx. quantity:	N/A	
Accessibility	N/A	Assessment Score
Product type:	N/A	N/A
Extent of Damage:	N/A	N/A
Surface Treatment:	N/A	N/A
Asbestos type:	N/A	N/A
Material Assessment Score:		N/A
Priority Assessment Score:		N/A
Action:	N/A	
Comments:	N/A

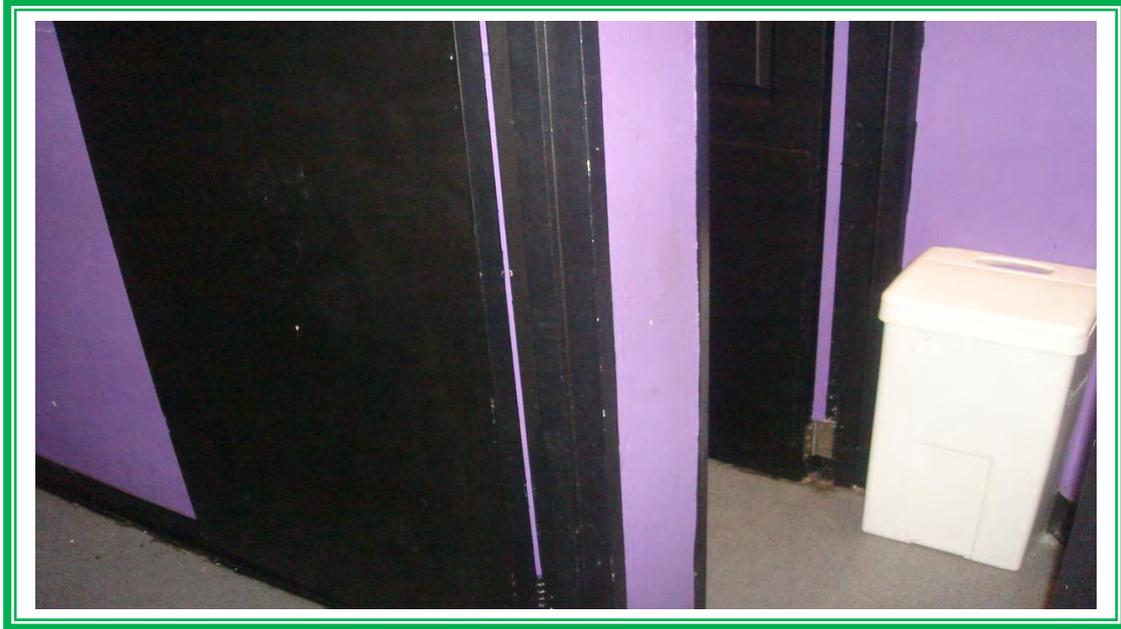
Location: 2/003 WC

Material Description:	Visual Inspection – No Suspect Materials Found	
Identification:	N/A	
Approx. quantity:	N/A	
Accessibility	N/A	Assessment Score
Product type:	N/A	N/A
Extent of Damage:	N/A	N/A
Surface Treatment:	N/A	N/A
Asbestos type:	N/A	N/A
Material Assessment Score:		N/A
Priority Assessment Score:		N/A
Action:	N/A	
Comments:	N/A

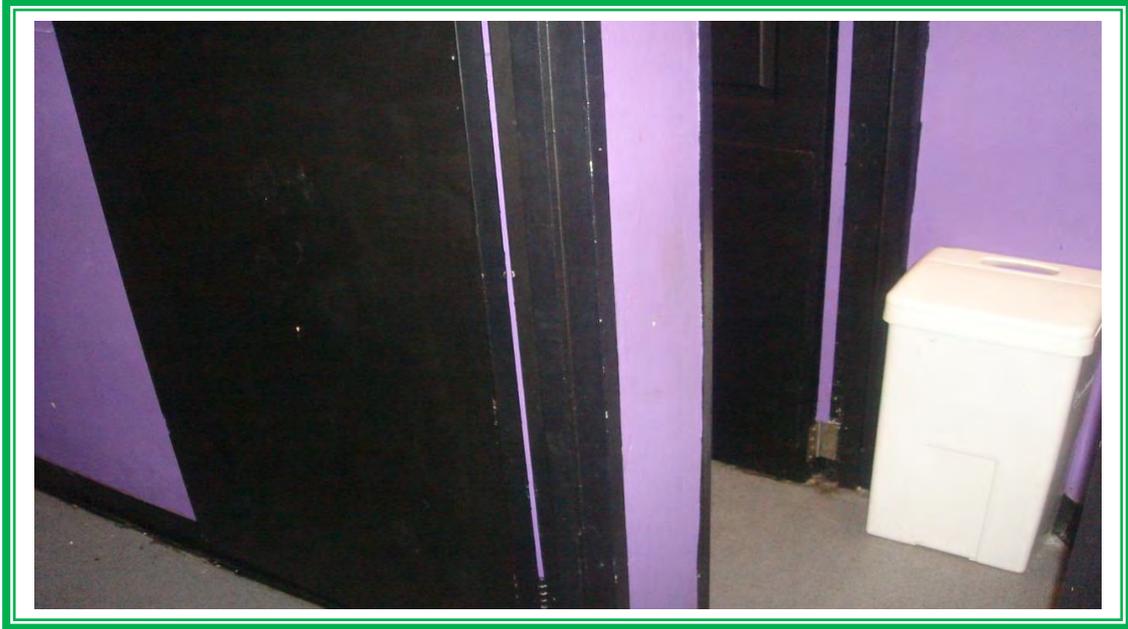
Location: 2/004 WC

Material Description:	Visual Inspection – No Suspect Materials Found	
Identification:	N/A	
Approx. quantity:	N/A	
Accessibility	N/A	Assessment Score
Product type:	N/A	N/A
Extent of Damage:	N/A	N/A
Surface Treatment:	N/A	N/A
Asbestos type:	N/A	N/A
Material Assessment Score:		N/A
Priority Assessment Score:		N/A
Action:	N/A	
Comments:	N/A

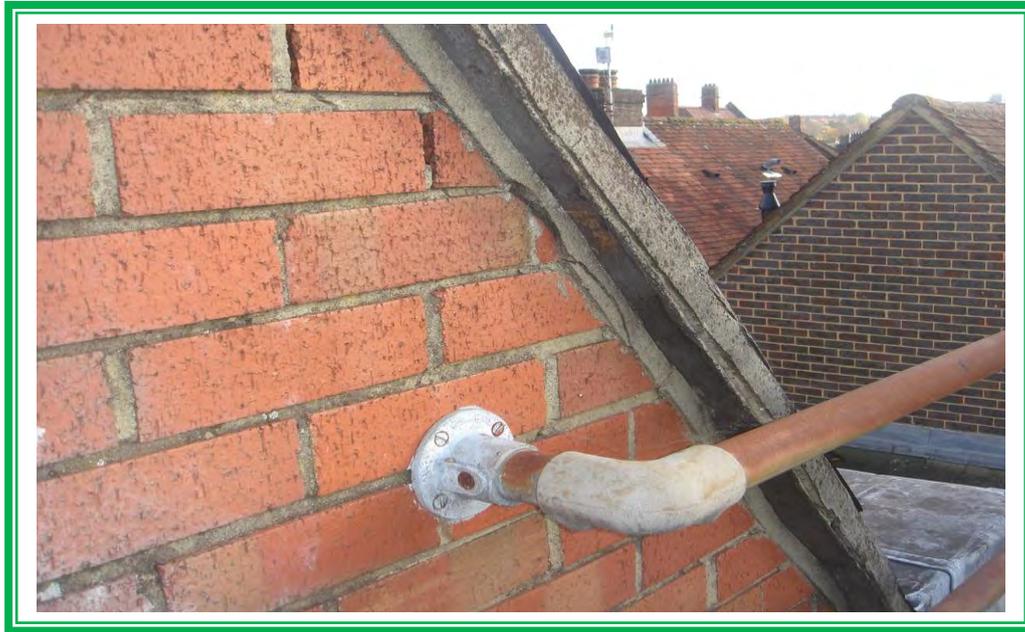
Location: 99/001 Externals

Material Description:	Roof Under cloak	
Identification:	Sampled – No Asbestos Detected	
Approx. quantity:	8LM	
Accessibility	N/A	Assessment Score
Product type:	N/A	N/A
Extent of Damage:	N/A	N/A
Surface Treatment:	N/A	N/A
Asbestos type:	N/A	N/A
Material Assessment Score:		N/A
Priority Assessment Score:		N/A
Action:	N/A	
Comments:	N/A

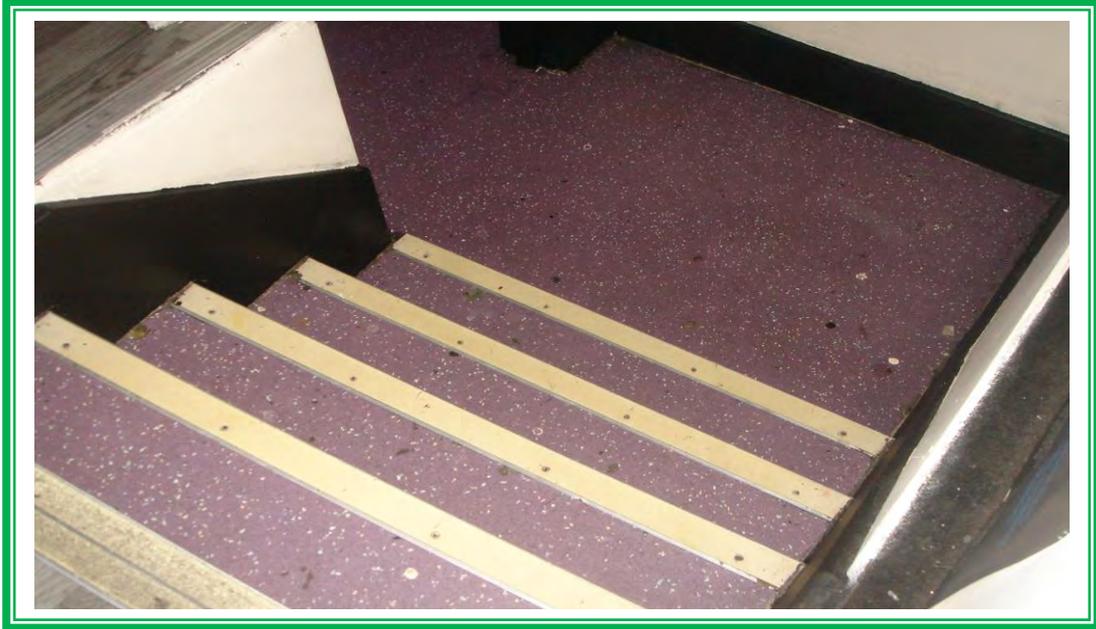
Location: 2/005 Stairs

Material Description:	Visual Inspection – No Suspect Materials Found	
Identification:	N/A	
Approx. quantity:	N/A	
Accessibility	N/A	Assessment Score
Product type:	N/A	N/A
Extent of Damage:	N/A	N/A
Surface Treatment:	N/A	N/A
Asbestos type:	N/A	N/A
Material Assessment Score:		N/A
Priority Assessment Score:		N/A
Action:	N/A	
Comments:	N/A

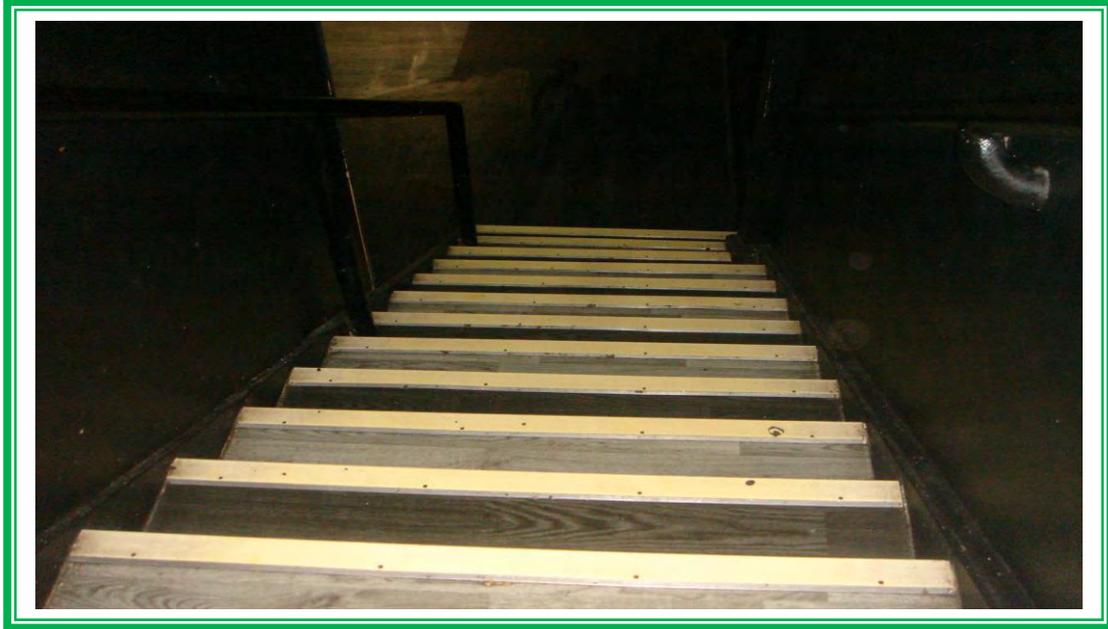
Location: M/001 Stairs and Lobby

Material Description:	Visual Inspection – No Suspect Materials Found	
Identification:	N/A	
Approx. quantity:	N/A	
Accessibility	N/A	Assessment Score
Product type:	N/A	N/A
Extent of Damage:	N/A	N/A
Surface Treatment:	N/A	N/A
Asbestos type:	N/A	N/A
Material Assessment Score:		N/A
Priority Assessment Score:		N/A
Action:	N/A	
Comments:	N/A

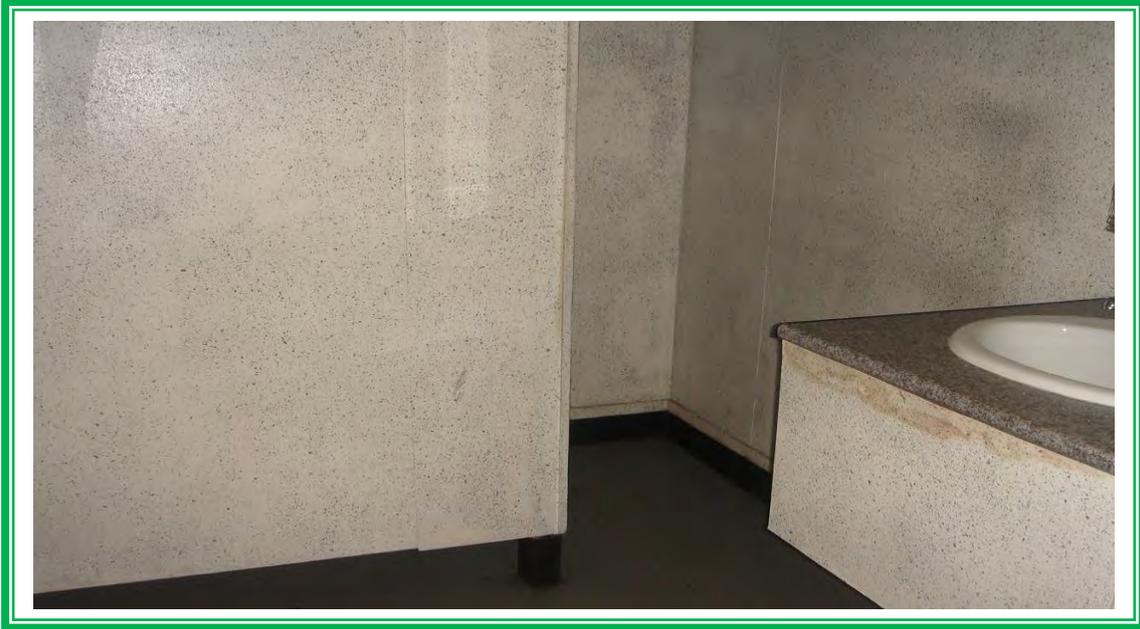
Location: M/002 WC

Material Description:	Visual Inspection – No Suspect Materials Found	
Identification:	N/A	
Approx. quantity:	N/A	
Accessibility	N/A	Assessment Score
Product type:	N/A	N/A
Extent of Damage:	N/A	N/A
Surface Treatment:	N/A	N/A
Asbestos type:	N/A	N/A
Material Assessment Score:		N/A
Priority Assessment Score:		N/A
Action:	N/A	
Comments:	N/A

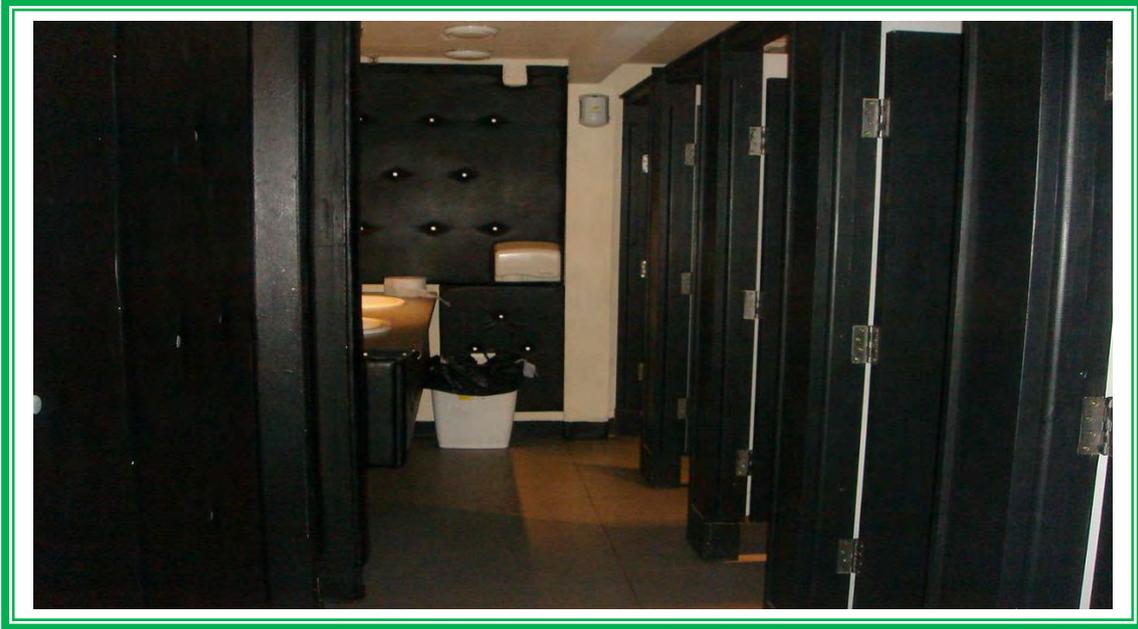
Location: M/003 WC

Material Description:	Visual Inspection – No Suspect Materials Found	
Identification:	N/A	
Approx. quantity:	N/A	
Accessibility	N/A	Assessment Score
Product type:	N/A	N/A
Extent of Damage:	N/A	N/A
Surface Treatment:	N/A	N/A
Asbestos type:	N/A	N/A
Material Assessment Score:		N/A
Priority Assessment Score:		N/A
Action:	N/A	
Comments:	N/A

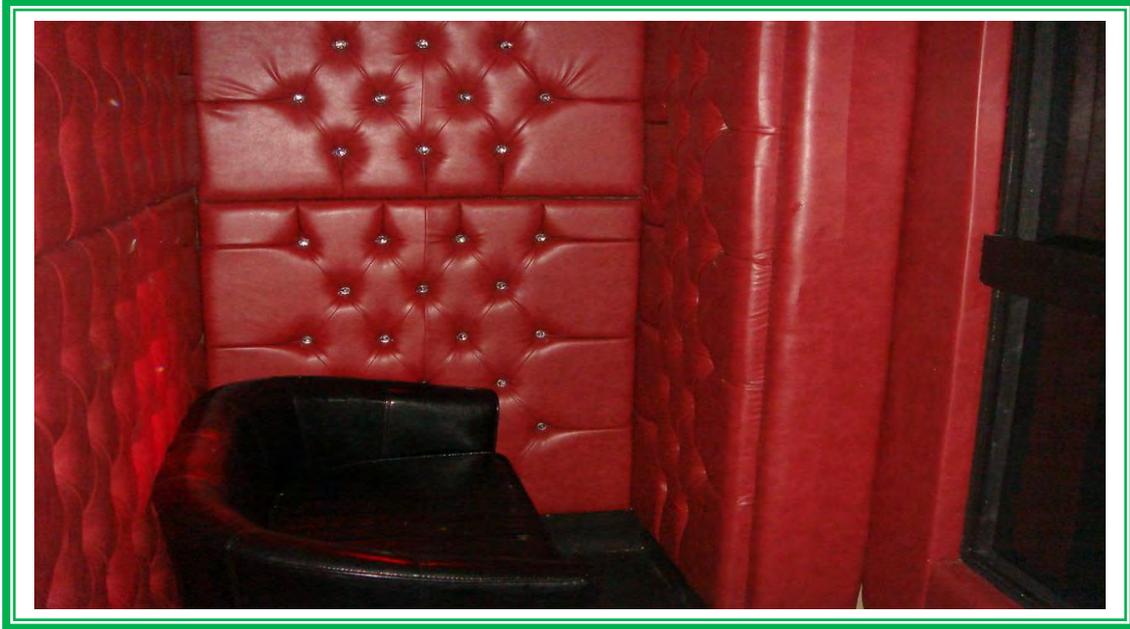
Location: M/004 Rest Room

Material Description:	Visual Inspection – No Suspect Materials Found	
Identification:	N/A	
Approx. quantity:	N/A	
Accessibility	N/A	Assessment Score
Product type:	N/A	N/A
Extent of Damage:	N/A	N/A
Surface Treatment:	N/A	N/A
Asbestos type:	N/A	N/A
Material Assessment Score:		N/A
Priority Assessment Score:		N/A
Action:	N/A	
Comments:	N/A

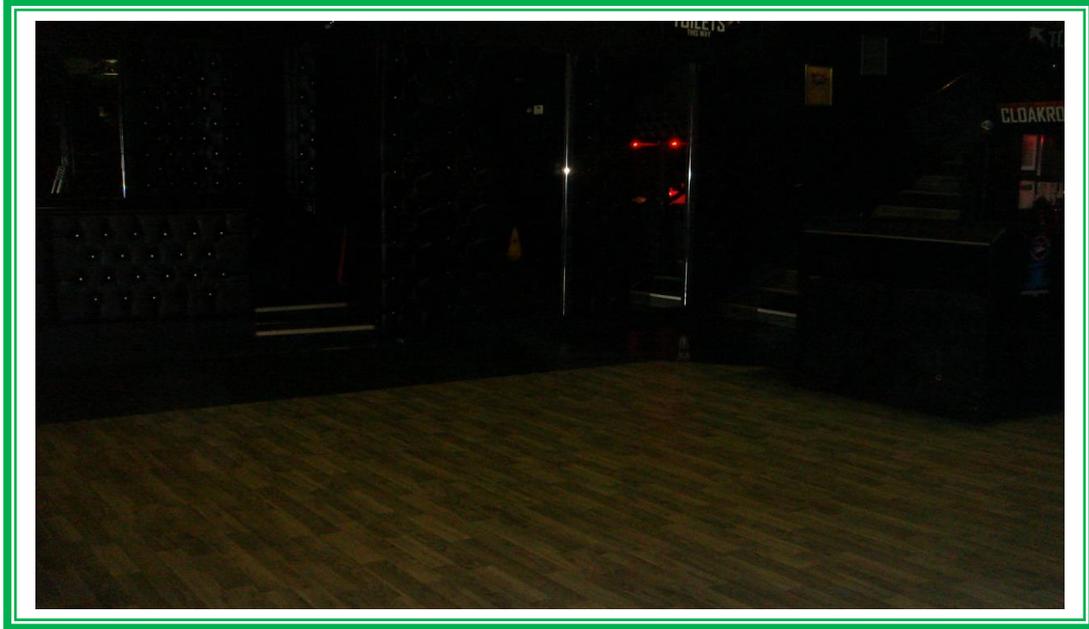
Location: 1/001 Club and Bars

Material Description:	Visual Inspection – No Suspect Materials Found	
Identification:	N/A	
Approx. quantity:	N/A	
Accessibility	N/A	Assessment Score
Product type:	N/A	N/A
Extent of Damage:	N/A	N/A
Surface Treatment:	N/A	N/A
Asbestos type:	N/A	N/A
Material Assessment Score:		N/A
Priority Assessment Score:		N/A
Action:	N/A	
Comments:	N/A

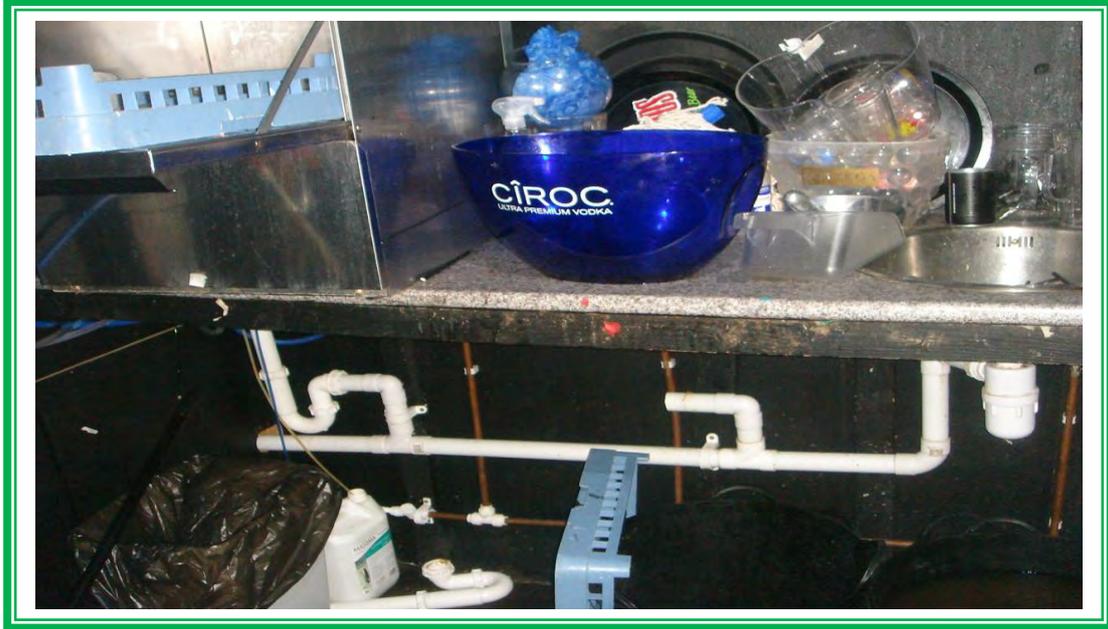
Location: 1/002 Store Room

Material Description:	Visual Inspection – No Suspect Materials Found	
Identification:	N/A	
Approx. quantity:	N/A	
Accessibility	N/A	Assessment Score
Product type:	N/A	N/A
Extent of Damage:	N/A	N/A
Surface Treatment:	N/A	N/A
Asbestos type:	N/A	N/A
Material Assessment Score:		N/A
Priority Assessment Score:		N/A
Action:	N/A	
Comments:	N/A

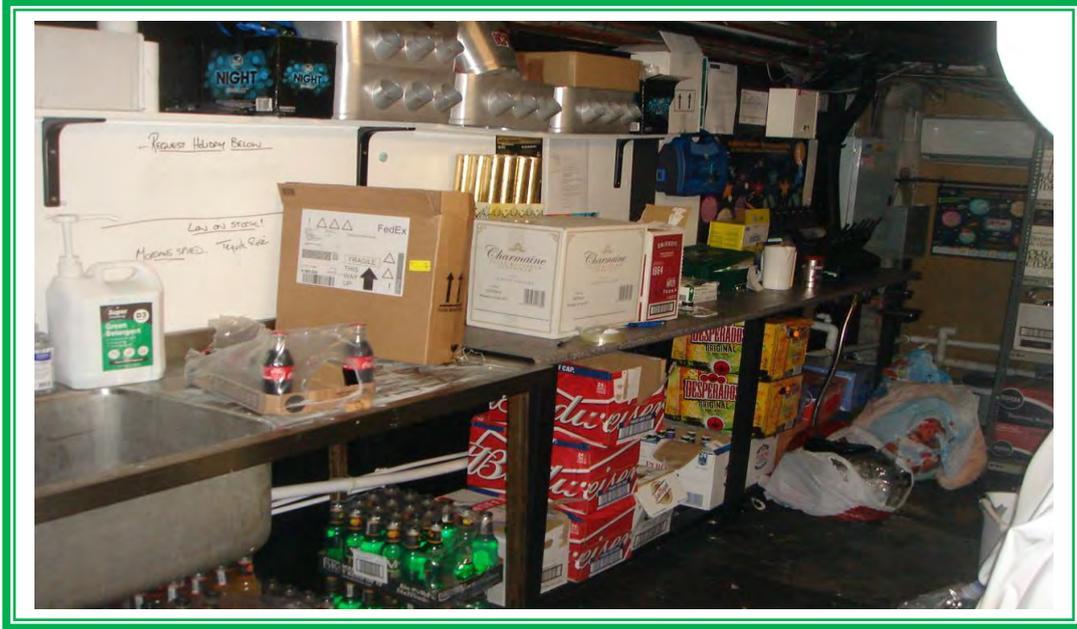
Location: 1/003 Store

Material Description:	Visual Inspection – No Suspect Materials Found	
Identification:	N/A	
Approx. quantity:	N/A	
Accessibility	N/A	Assessment Score
Product type:	N/A	N/A
Extent of Damage:	N/A	N/A
Surface Treatment:	N/A	N/A
Asbestos type:	N/A	N/A
Material Assessment Score:		N/A
Priority Assessment Score:		N/A
Action:	N/A	
Comments:	N/A

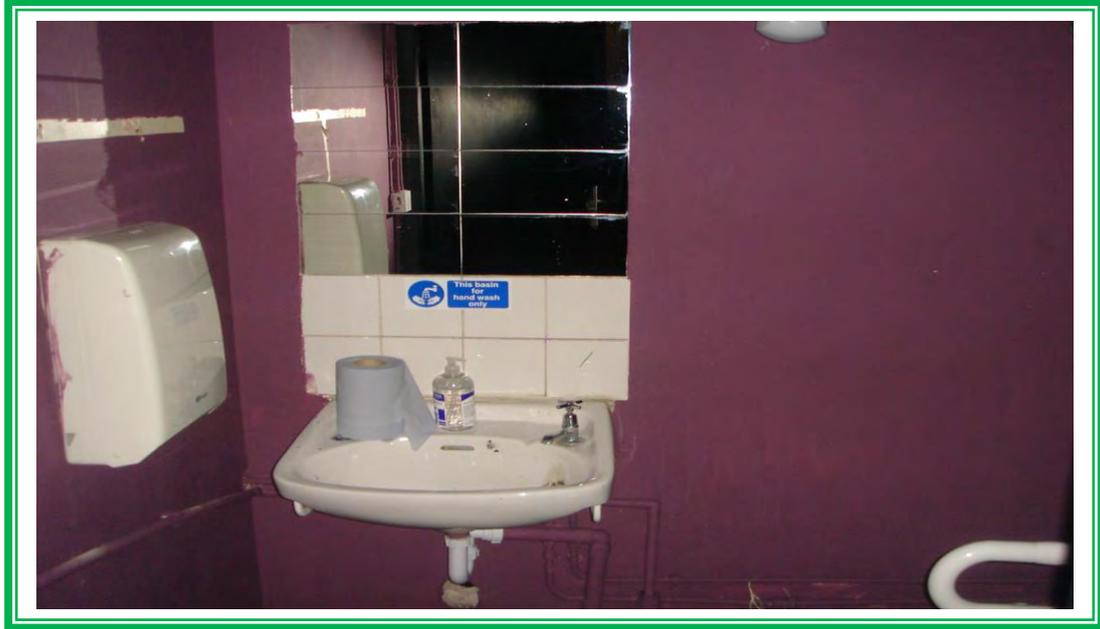
Location: 1/004 WC

Material Description:	Visual Inspection – No Suspect Materials Found	
Identification:	N/A	
Approx. quantity:	N/A	
Accessibility	N/A	Assessment Score
Product type:	N/A	N/A
Extent of Damage:	N/A	N/A
Surface Treatment:	N/A	N/A
Asbestos type:	N/A	N/A
Material Assessment Score:		N/A
Priority Assessment Score:		N/A
Action:	N/A	
Comments:	N/A
