Project Number 3113

Management
Asbestos Survey Report

Kennet Centre, Market Street, Newbury,
Berkshire, RG14 5EN

3 Market Place and Associated Store

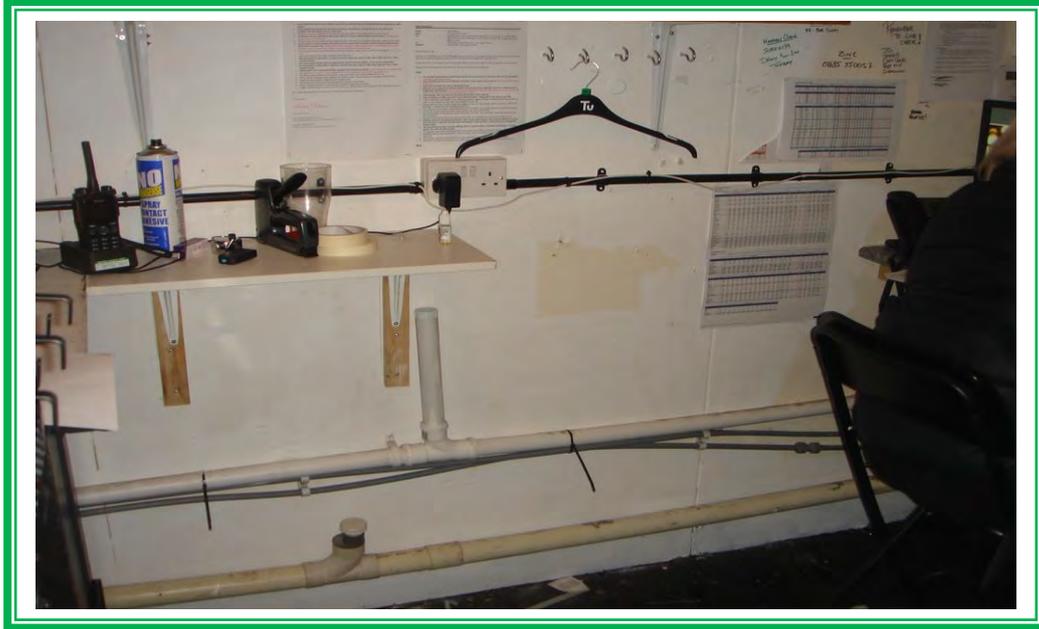
Location: 1/005 Office

Material Description:	Visual Inspection – No Suspect Materials Found	
Identification:	N/A	
Approx. quantity:	N/A	
Accessibility	N/A	Assessment Score
Product type:	N/A	N/A
Extent of Damage:	N/A	N/A
Surface Treatment:	N/A	N/A
Asbestos type:	N/A	N/A
Material Assessment Score:		N/A
Priority Assessment Score:		N/A
Action:	N/A	
Comments:	N/A

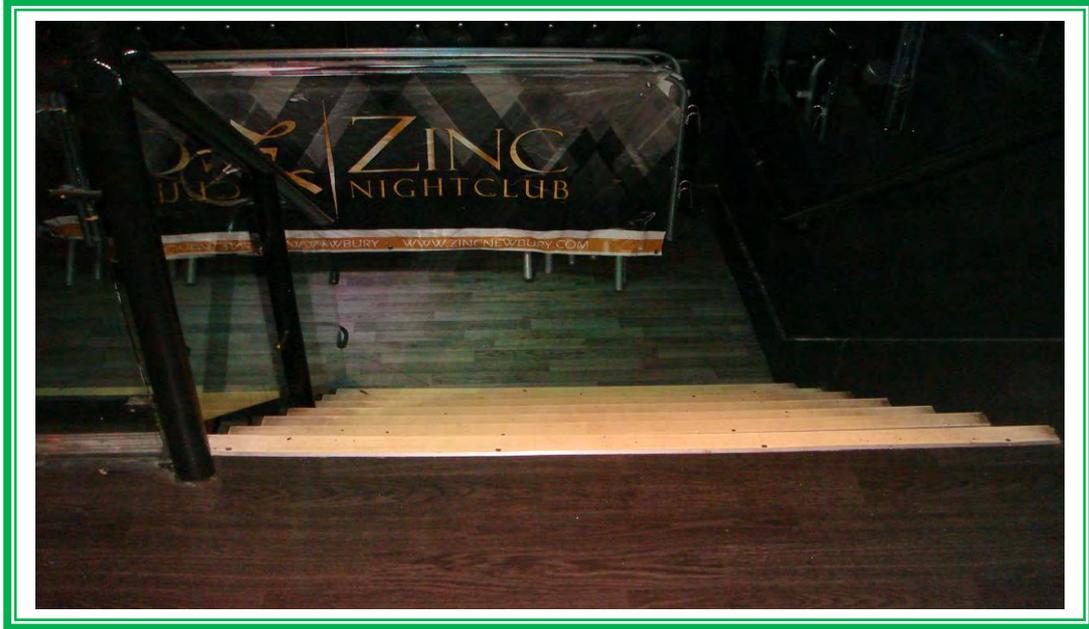
Location: 1/006 Stairs

Material Description:	Visual Inspection – No Suspect Materials Found	
Identification:	N/A	
Approx. quantity:	N/A	
Accessibility	N/A	Assessment Score
Product type:	N/A	N/A
Extent of Damage:	N/A	N/A
Surface Treatment:	N/A	N/A
Asbestos type:	N/A	N/A
Material Assessment Score:		N/A
Priority Assessment Score:		N/A
Action:	N/A	
Comments:	N/A

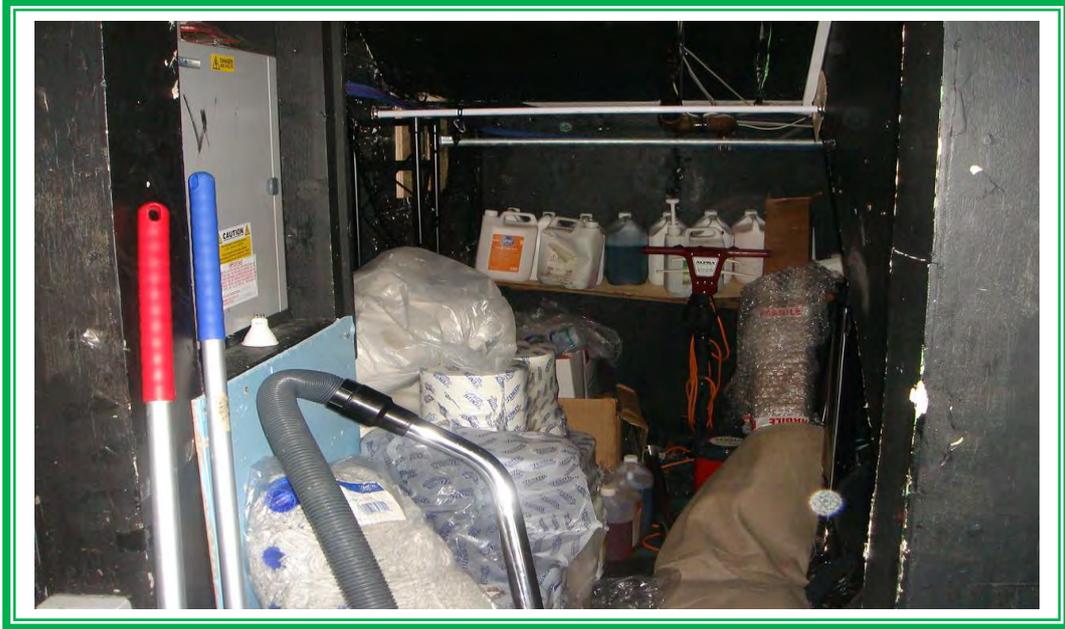
Location: 1/007 Cupboard

Material Description:	Visual Inspection – No Suspect Materials Found	
Identification:	N/A	
Approx. quantity:	N/A	
Accessibility	N/A	Assessment Score
Product type:	N/A	N/A
Extent of Damage:	N/A	N/A
Surface Treatment:	N/A	N/A
Asbestos type:	N/A	N/A
Material Assessment Score:		N/A
Priority Assessment Score:		N/A
Action:	N/A	
Comments:	N/A

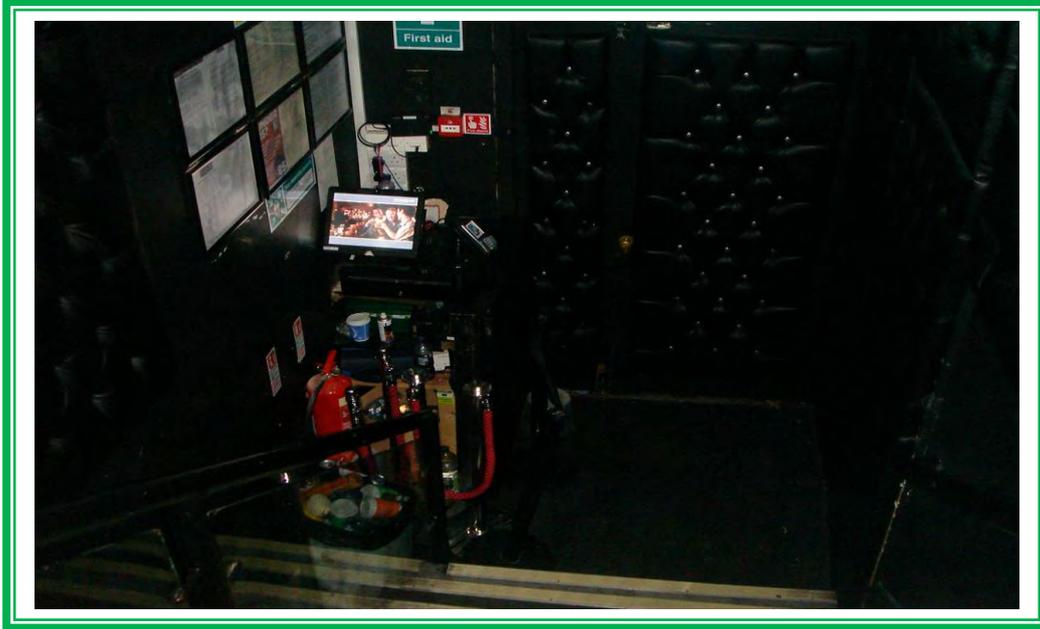
Location: 0/001 Entrance

Material Description:	Visual Inspection – No Suspect Materials Found	
Identification:	N/A	
Approx. quantity:	N/A	
Accessibility	N/A	Assessment Score
Product type:	N/A	N/A
Extent of Damage:	N/A	N/A
Surface Treatment:	N/A	N/A
Asbestos type:	N/A	N/A
Material Assessment Score:		N/A
Priority Assessment Score:		N/A
Action:	N/A	
Comments:	N/A

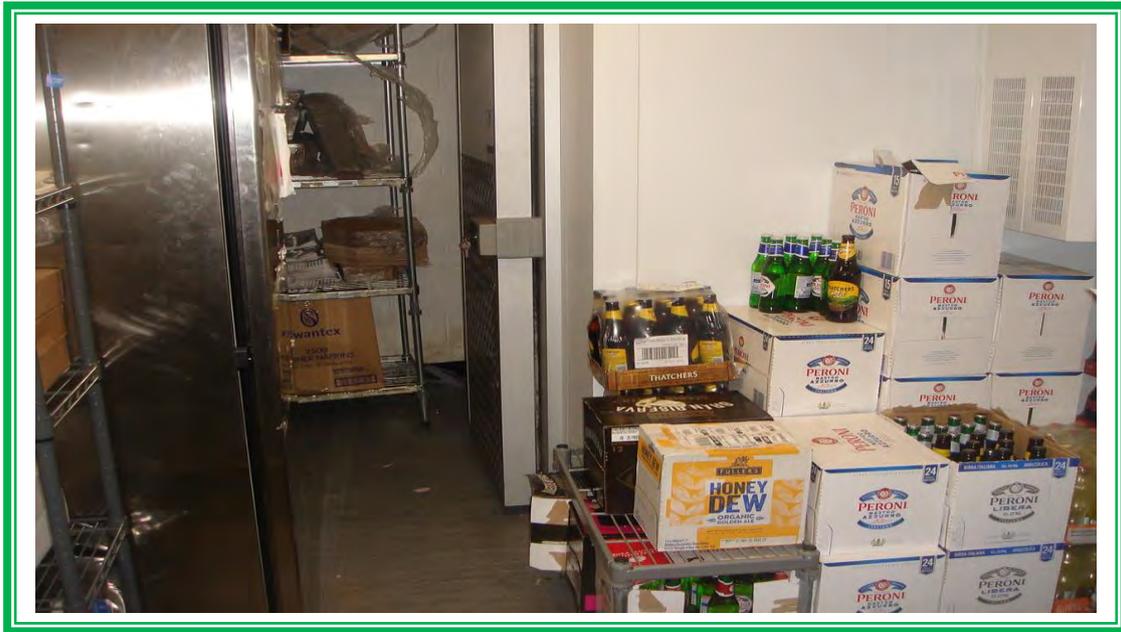
Item No: 1	Sample No: N/A
Location: 1/001 Store

Material Description:	Visual Inspection – No Suspect Materials Found	
Identification:	N/A	
Approx. quantity:	N/A	
Accessibility	N/A	<i>Assessment Score</i>
Product type:	N/A	N/A
Extent of Damage:	N/A	N/A
Surface Treatment:	N/A	N/A
Asbestos type:	N/A	N/A
Material Assessment Score:		N/A
Priority Assessment Score:		N/A
Action:	N/A	
Comments:	N/A

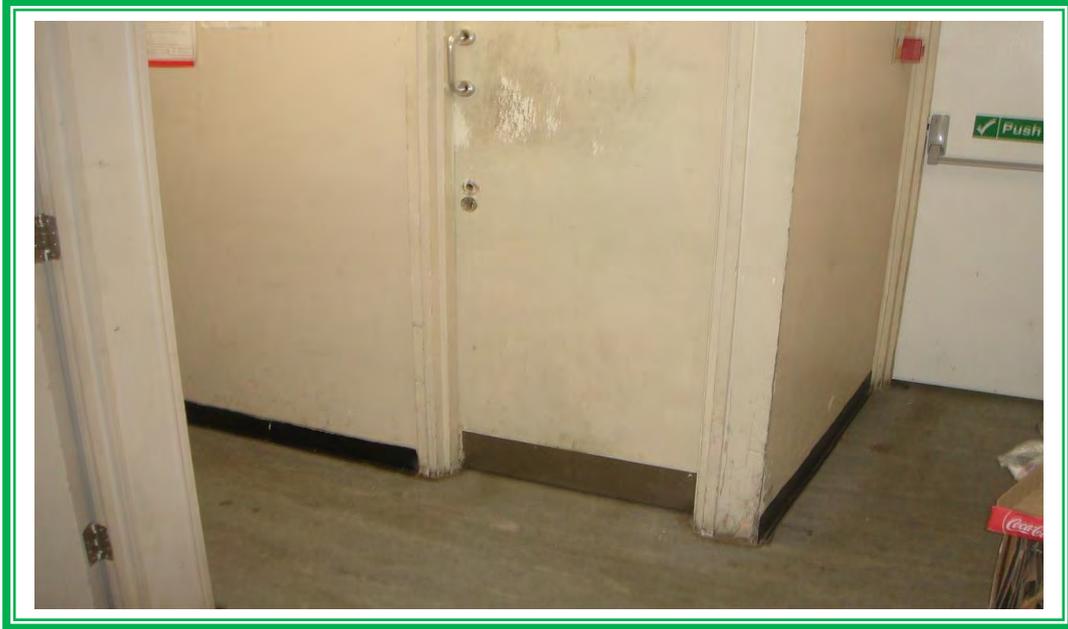
Location: 1/002 Lobby

Material Description:	Visual Inspection – No Suspect Materials Found	
Identification:	N/A	
Approx. quantity:	N/A	
Accessibility	N/A	Assessment Score
Product type:	N/A	N/A
Extent of Damage:	N/A	N/A
Surface Treatment:	N/A	N/A
Asbestos type:	N/A	N/A
Material Assessment Score:		N/A
Priority Assessment Score:		N/A
Action:	N/A	
Comments:	N/A

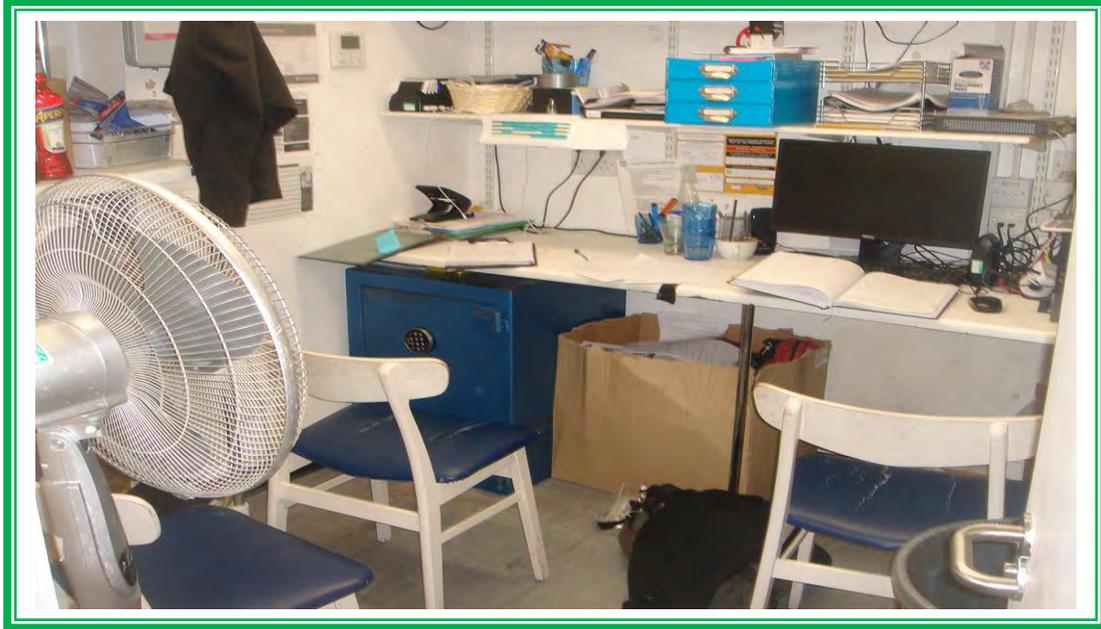
Location: 1/003 Office

Material Description:	Visual Inspection – No Suspect Materials Found	
Identification:	N/A	
Approx. quantity:	N/A	
Accessibility	N/A	Assessment Score
Product type:	N/A	N/A
Extent of Damage:	N/A	N/A
Surface Treatment:	N/A	N/A
Asbestos type:	N/A	N/A
Material Assessment Score:		N/A
Priority Assessment Score:		N/A
Action:	N/A	
Comments:	N/A

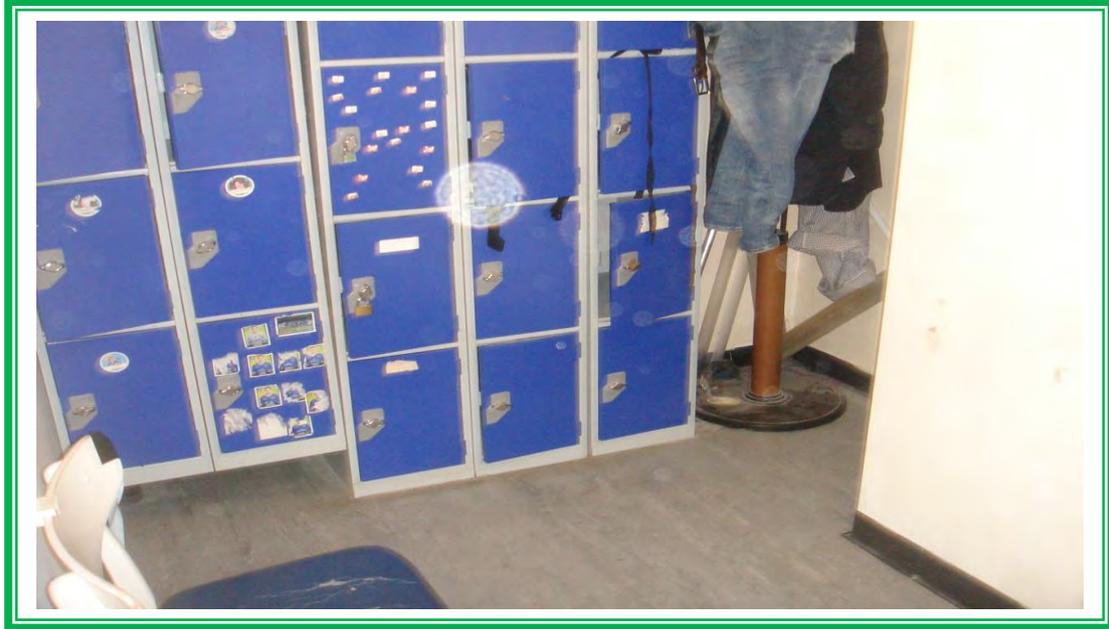
Location: 1/004 Staff Room

Material Description:	Visual Inspection – No Suspect Materials Found	
Identification:	N/A	
Approx. quantity:	N/A	
Accessibility	N/A	Assessment Score
Product type:	N/A	N/A
Extent of Damage:	N/A	N/A
Surface Treatment:	N/A	N/A
Asbestos type:	N/A	N/A
Material Assessment Score:		N/A
Priority Assessment Score:		N/A
Action:	N/A	
Comments:	N/A

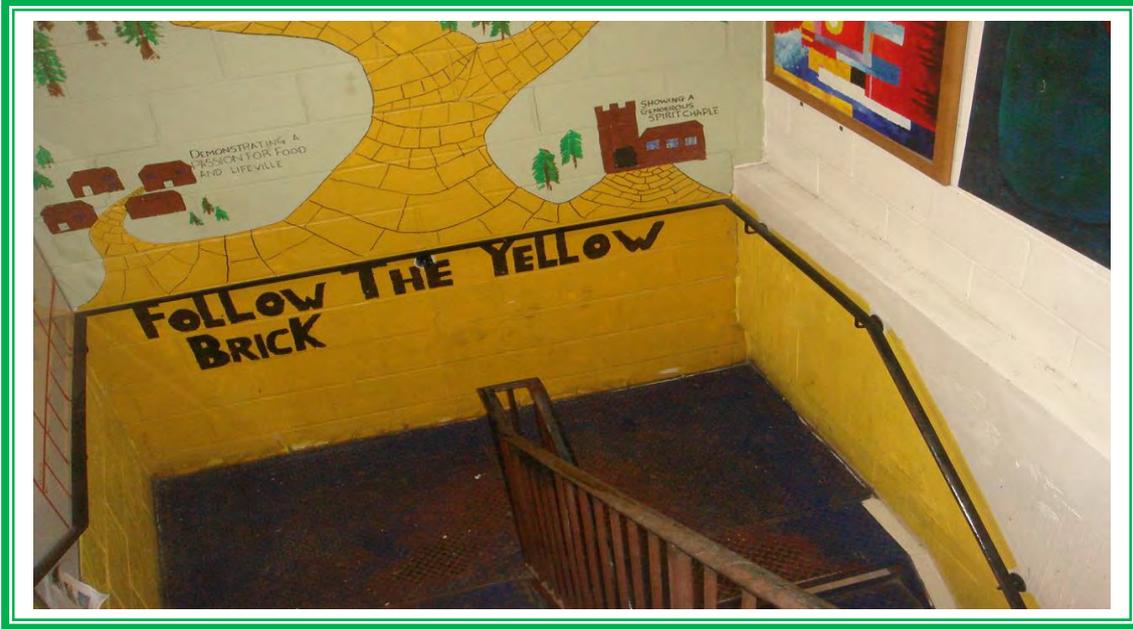
Location: 1/005 Stairwell

Material Description:	Visual Inspection – No Suspect Materials Found	
Identification:	N/A	
Approx. quantity:	N/A	
Accessibility	N/A	Assessment Score
Product type:	N/A	N/A
Extent of Damage:	N/A	N/A
Surface Treatment:	N/A	N/A
Asbestos type:	N/A	N/A
Material Assessment Score:		N/A
Priority Assessment Score:		N/A
Action:	N/A	
Comments:	N/A

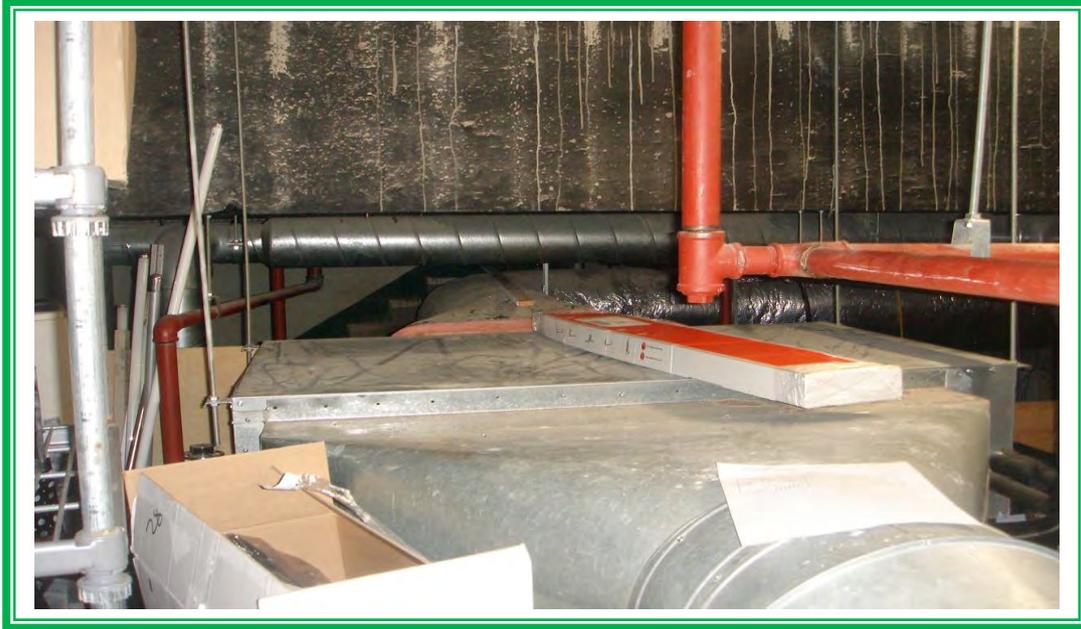
Location: M/001 Mezzanine Air Con Room

Material Description:	Visual Inspection – No Suspect Materials Found	
Identification:	N/A	
Approx. quantity:	N/A	
Accessibility	N/A	Assessment Score
Product type:	N/A	N/A
Extent of Damage:	N/A	N/A
Surface Treatment:	N/A	N/A
Asbestos type:	N/A	N/A
Material Assessment Score:		N/A
Priority Assessment Score:		N/A
Action:	N/A	
Comments:	N/A

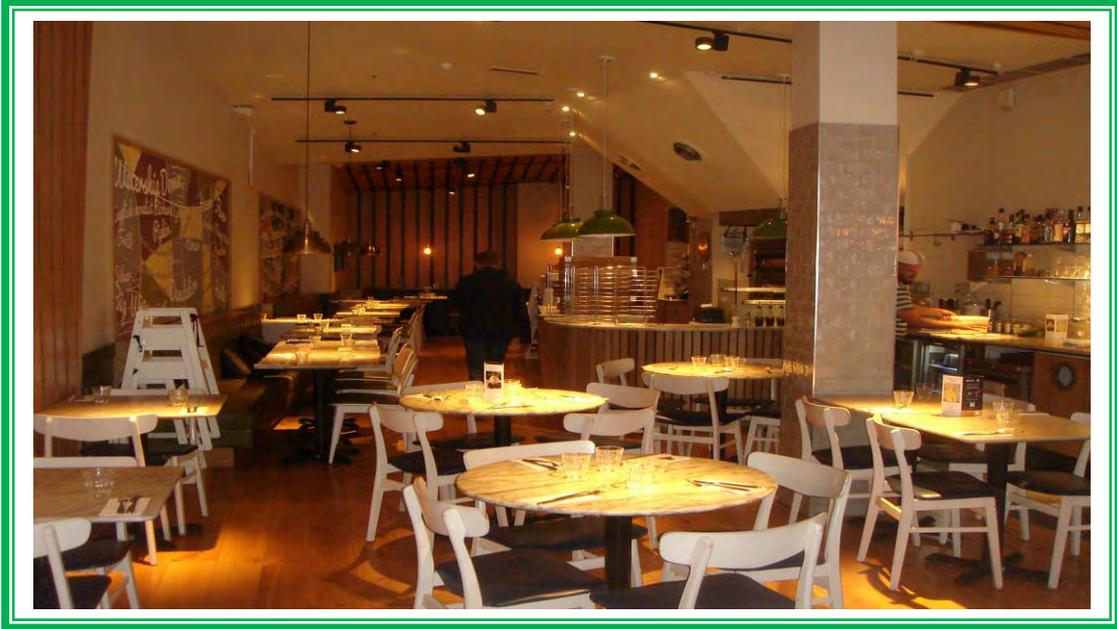
Location: 0/001 Restaurant and Servery

Material Description:	Visual Inspection – No Suspect Materials Found	
Identification:	N/A	
Approx. quantity:	N/A	
Accessibility	N/A	Assessment Score
Product type:	N/A	N/A
Extent of Damage:	N/A	N/A
Surface Treatment:	N/A	N/A
Asbestos type:	N/A	N/A
Material Assessment Score:		N/A
Priority Assessment Score:		N/A
Action:	N/A	
Comments:	N/A

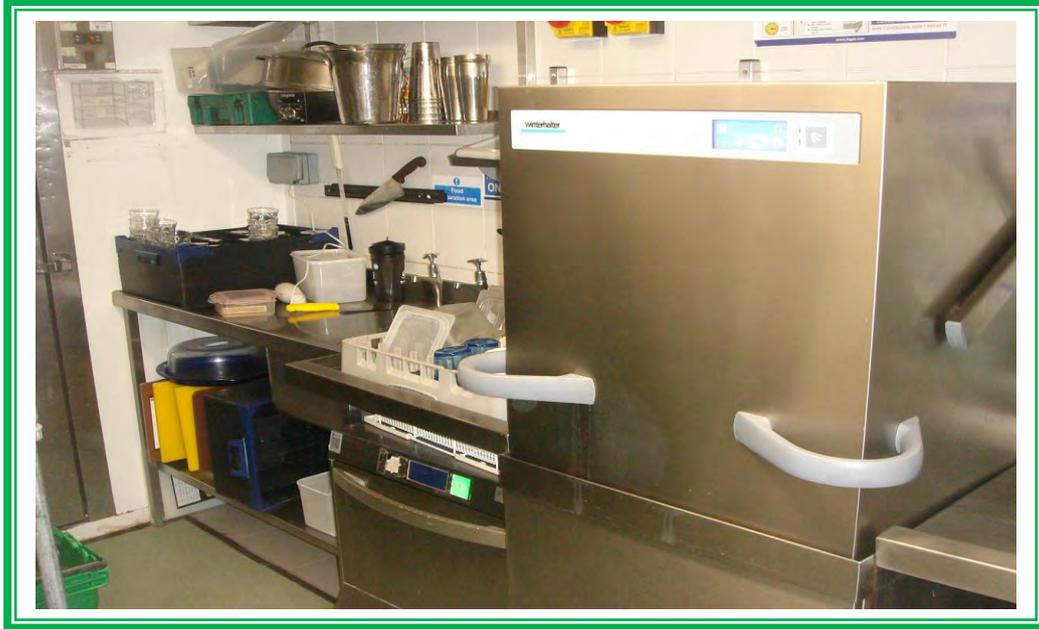
Location: 0/002 Prep Area

Material Description:	Visual Inspection – No Suspect Materials Found	
Identification:	N/A	
Approx. quantity:	N/A	
Accessibility	N/A	Assessment Score
Product type:	N/A	N/A
Extent of Damage:	N/A	N/A
Surface Treatment:	N/A	N/A
Asbestos type:	N/A	N/A
Material Assessment Score:		N/A
Priority Assessment Score:		N/A
Action:	N/A	
Comments:	N/A

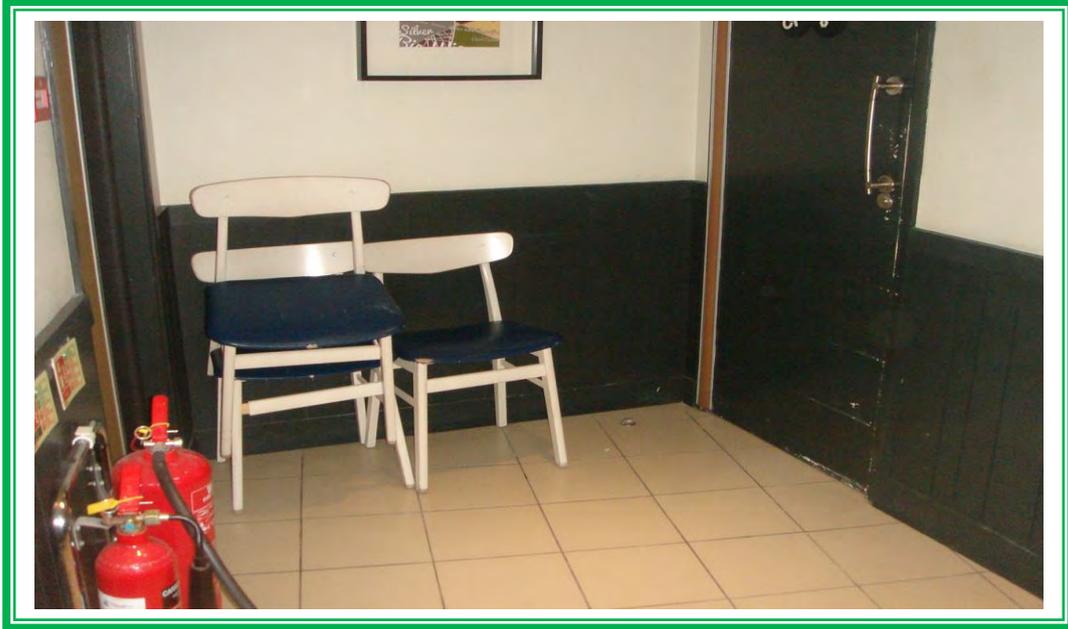
Location: 0/003 Lobby

Material Description:	Visual Inspection – No Suspect Materials Found	
Identification:	N/A	
Approx. quantity:	N/A	
Accessibility	N/A	Assessment Score
Product type:	N/A	N/A
Extent of Damage:	N/A	N/A
Surface Treatment:	N/A	N/A
Asbestos type:	N/A	N/A
Material Assessment Score:		N/A
Priority Assessment Score:		N/A
Action:	N/A	
Comments:	N/A

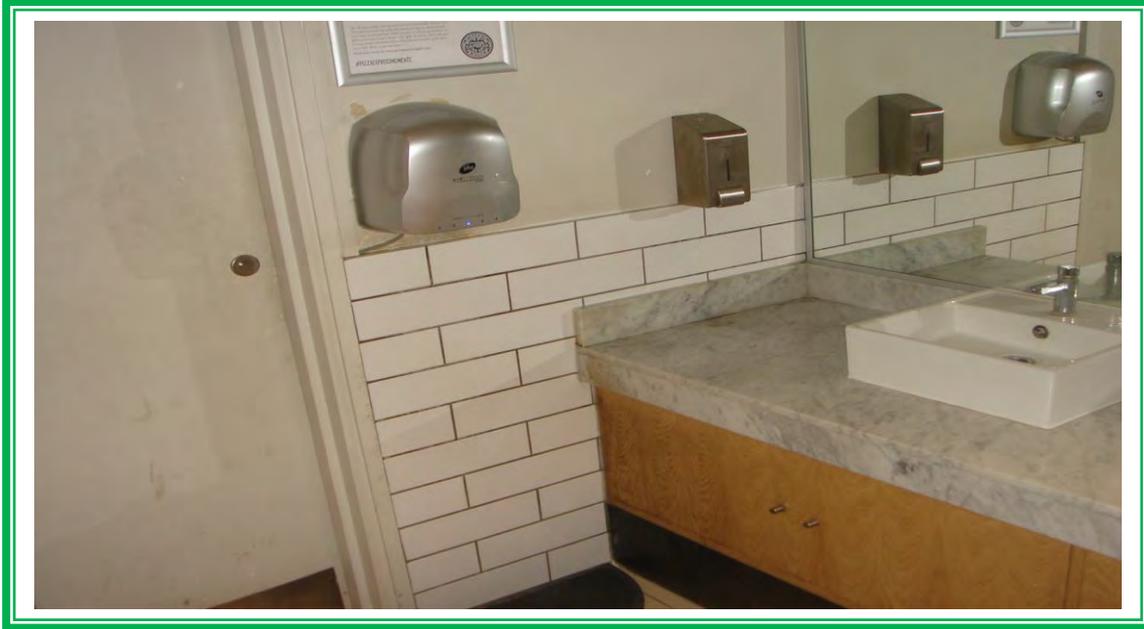
Location: 0/004 WC

Material Description:	Visual Inspection – No Suspect Materials Found	
Identification:	N/A	
Approx. quantity:	N/A	
Accessibility	N/A	Assessment Score
Product type:	N/A	N/A
Extent of Damage:	N/A	N/A
Surface Treatment:	N/A	N/A
Asbestos type:	N/A	N/A
Material Assessment Score:		N/A
Priority Assessment Score:		N/A
Action:	N/A	
Comments:	N/A

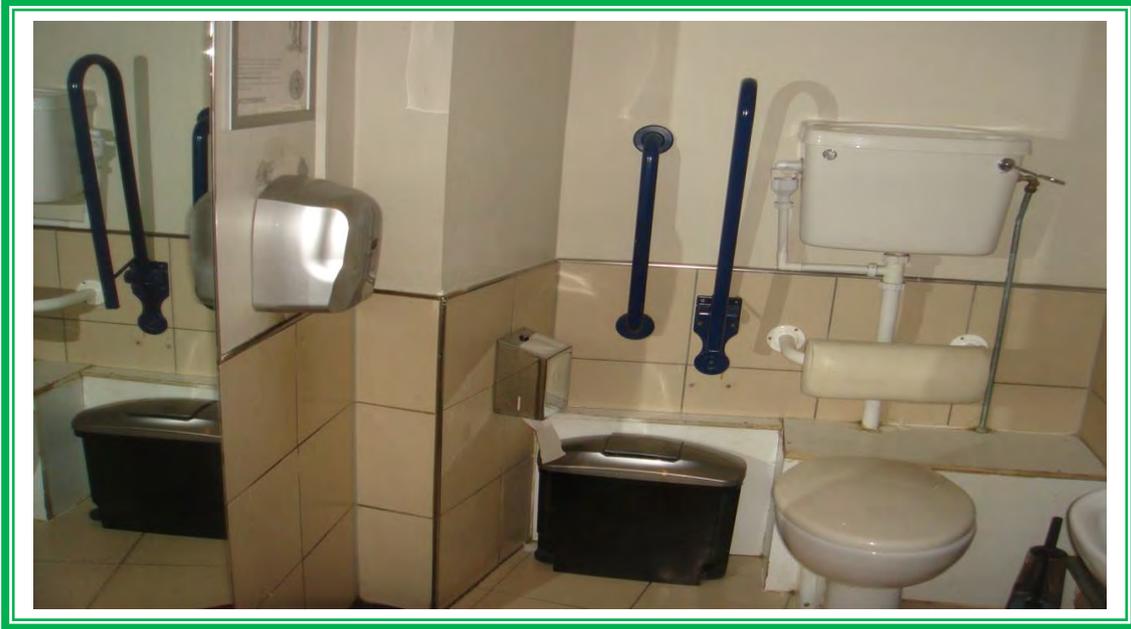
Location: 0/005 WC

Material Description:	Visual Inspection – No Suspect Materials Found	
Identification:	N/A	
Approx. quantity:	N/A	
Accessibility	N/A	Assessment Score
Product type:	N/A	N/A
Extent of Damage:	N/A	N/A
Surface Treatment:	N/A	N/A
Asbestos type:	N/A	N/A
Material Assessment Score:		N/A
Priority Assessment Score:		N/A
Action:	N/A	
Comments:	N/A

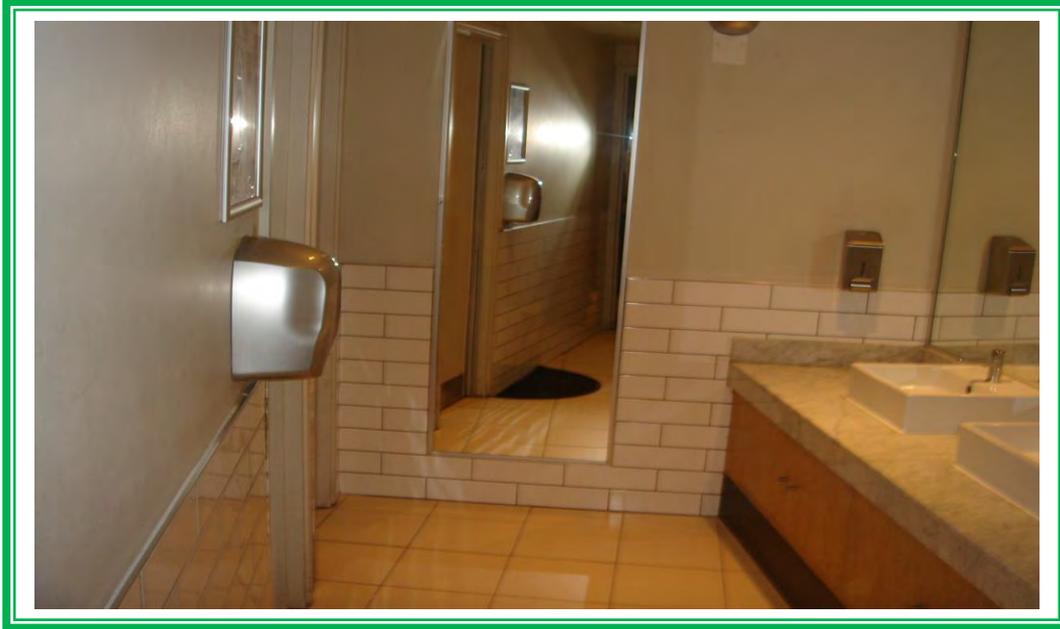
Location: 0/006 WC

Material Description:	Visual Inspection – No Suspect Materials Found	
Identification:	N/A	
Approx. quantity:	N/A	
Accessibility	N/A	Assessment Score
Product type:	N/A	N/A
Extent of Damage:	N/A	N/A
Surface Treatment:	N/A	N/A
Asbestos type:	N/A	N/A
Material Assessment Score:		N/A
Priority Assessment Score:		N/A
Action:	N/A	
Comments:	N/A

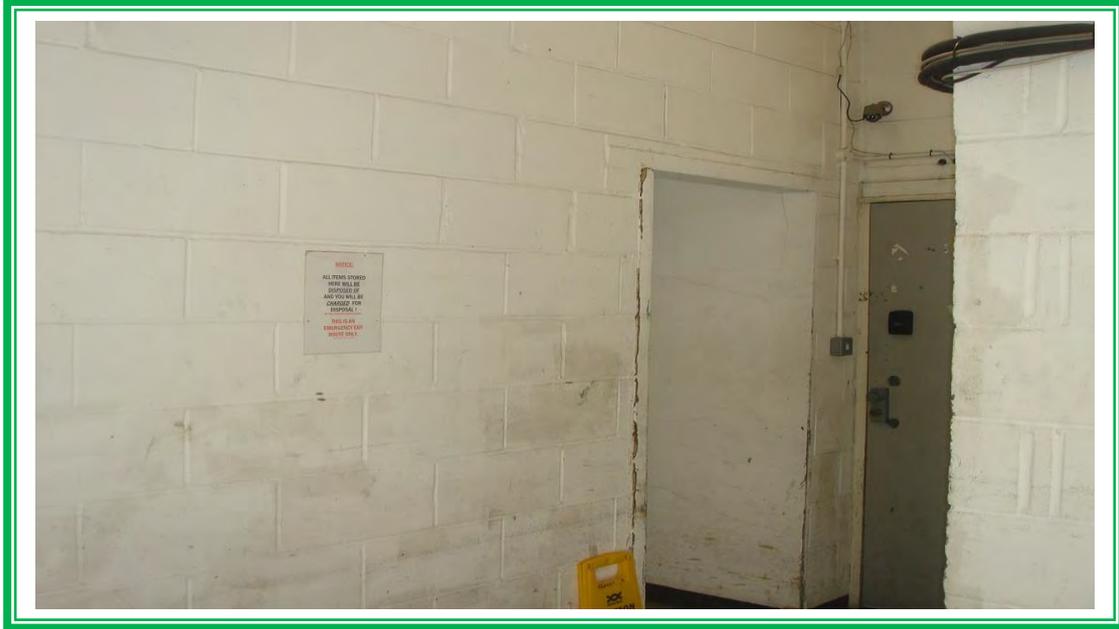
Location: 99/001 External

Material Description:	Visual Inspection – No Suspect Materials Found	
Identification:	N/A	
Approx. quantity:	N/A	
Accessibility	N/A	Assessment Score
Product type:	N/A	N/A
Extent of Damage:	N/A	N/A
Surface Treatment:	N/A	N/A
Asbestos type:	N/A	N/A
Material Assessment Score:		N/A
Priority Assessment Score:		N/A
Action:	N/A	
Comments:	N/A

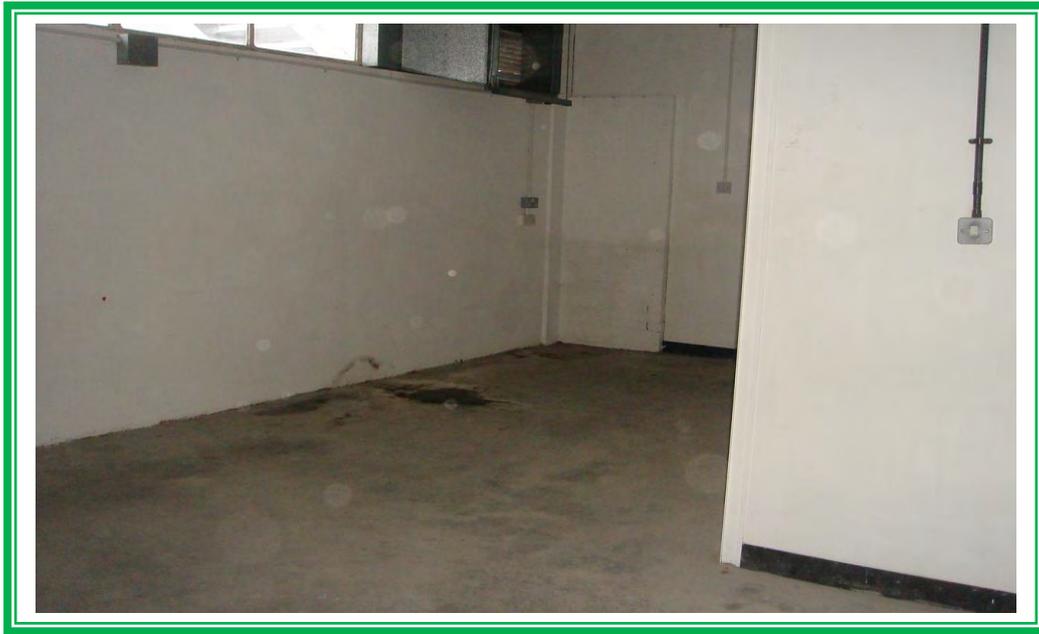
Location: 1/001

Material Description:	Visual Inspection – No Suspect Materials Found	
Identification:	N/A	
Approx. quantity:	N/A	
Accessibility	N/A	Assessment Score
Product type:	N/A	N/A
Extent of Damage:	N/A	N/A
Surface Treatment:	N/A	N/A
Asbestos type:	N/A	N/A
Material Assessment Score:		N/A
Priority Assessment Score:		N/A
Action:	N/A	
Comments:	N/A

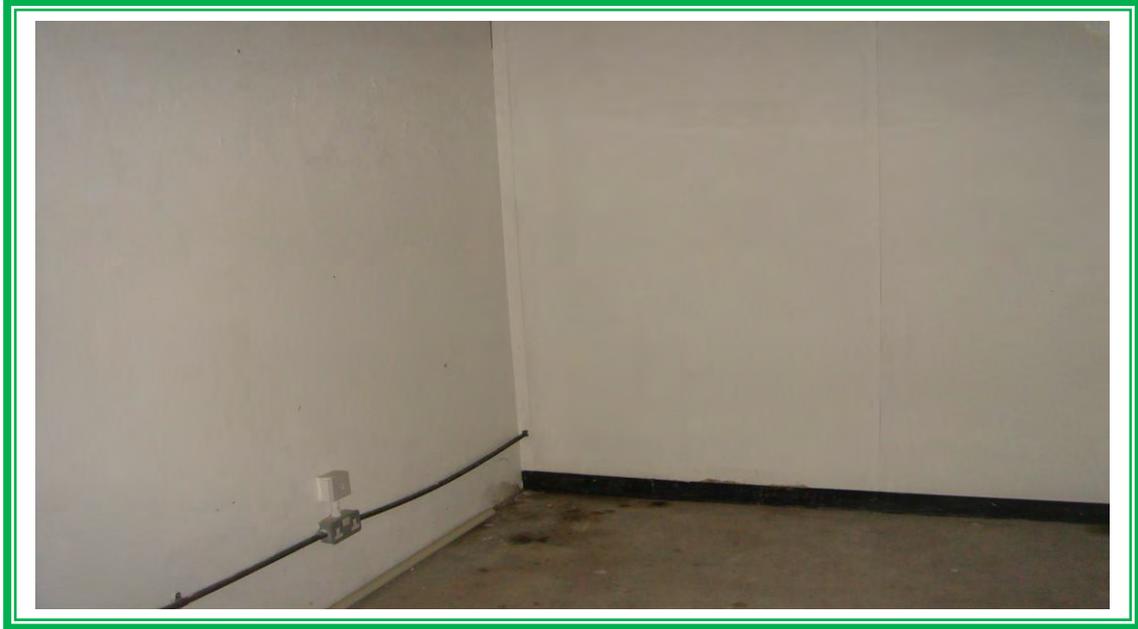
Location: 1/002

Material Description:	Visual Inspection – No Suspect Materials Found	
Identification:	N/A	
Approx. quantity:	N/A	
Accessibility	N/A	Assessment Score
Product type:	N/A	N/A
Extent of Damage:	N/A	N/A
Surface Treatment:	N/A	N/A
Asbestos type:	N/A	N/A
Material Assessment Score:		N/A
Priority Assessment Score:		N/A
Action:	N/A	
Comments:	N/A

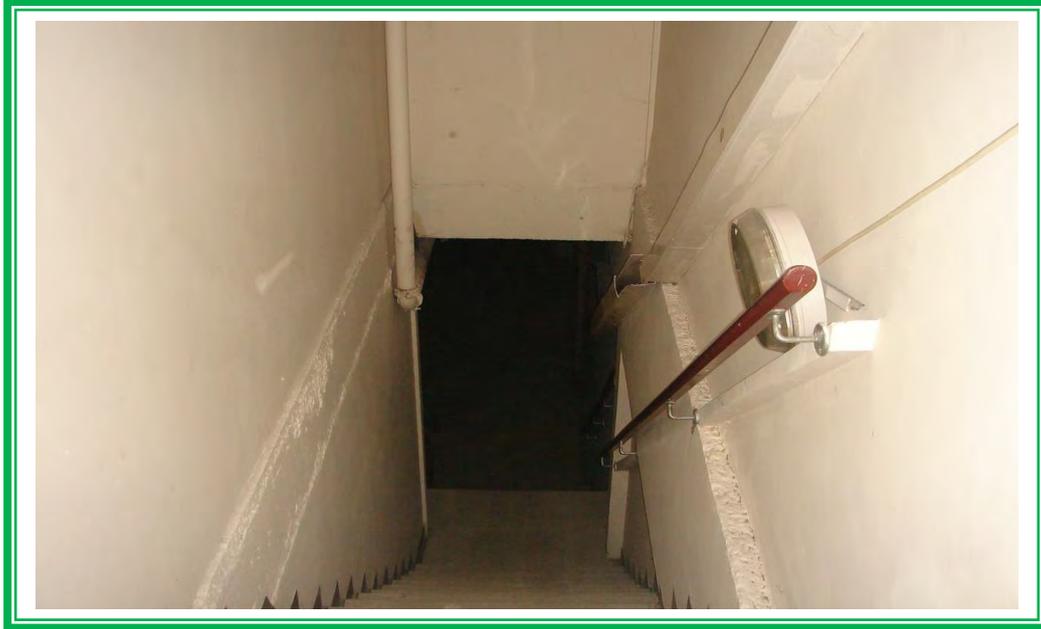
Location: 1/003 Lobby and Stairs

Material Description:	Visual Inspection – No Suspect Materials Found	
Identification:	N/A	
Approx. quantity:	N/A	
Accessibility	N/A	Assessment Score
Product type:	N/A	N/A
Extent of Damage:	N/A	N/A
Surface Treatment:	N/A	N/A
Asbestos type:	N/A	N/A
Material Assessment Score:		N/A
Priority Assessment Score:		N/A
Action:	N/A	
Comments:	N/A

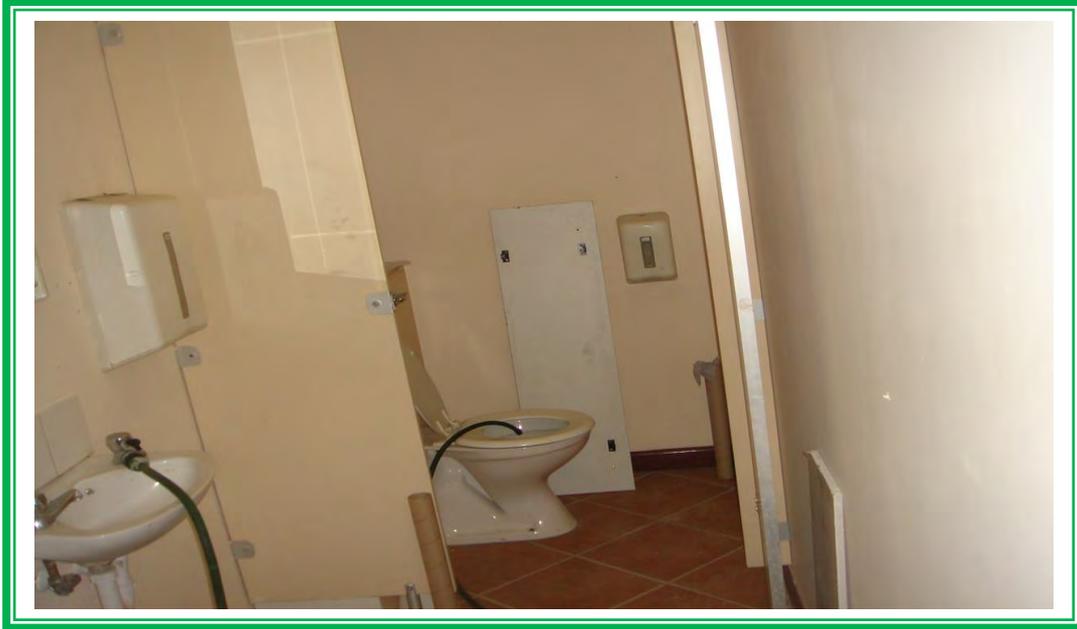
Location: 1/004 WC

Material Description:	Visual Inspection – No Suspect Materials Found	
Identification:	N/A	
Approx. quantity:	N/A	
Accessibility	N/A	Assessment Score
Product type:	N/A	N/A
Extent of Damage:	N/A	N/A
Surface Treatment:	N/A	N/A
Asbestos type:	N/A	N/A
Material Assessment Score:		N/A
Priority Assessment Score:		N/A
Action:	N/A	
Comments:	N/A

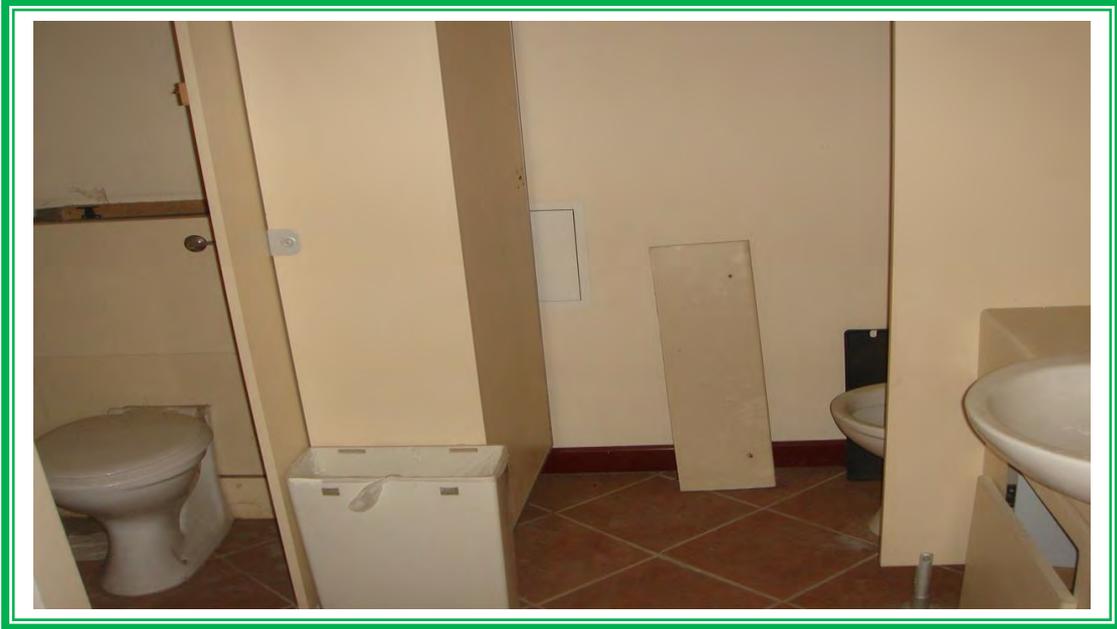
Location: 1/005 WC

Material Description:	Visual Inspection – No Suspect Materials Found	
Identification:	N/A	
Approx. quantity:	N/A	
Accessibility	N/A	Assessment Score
Product type:	N/A	N/A
Extent of Damage:	N/A	N/A
Surface Treatment:	N/A	N/A
Asbestos type:	N/A	N/A
Material Assessment Score:		N/A
Priority Assessment Score:		N/A
Action:	N/A	
Comments:	N/A

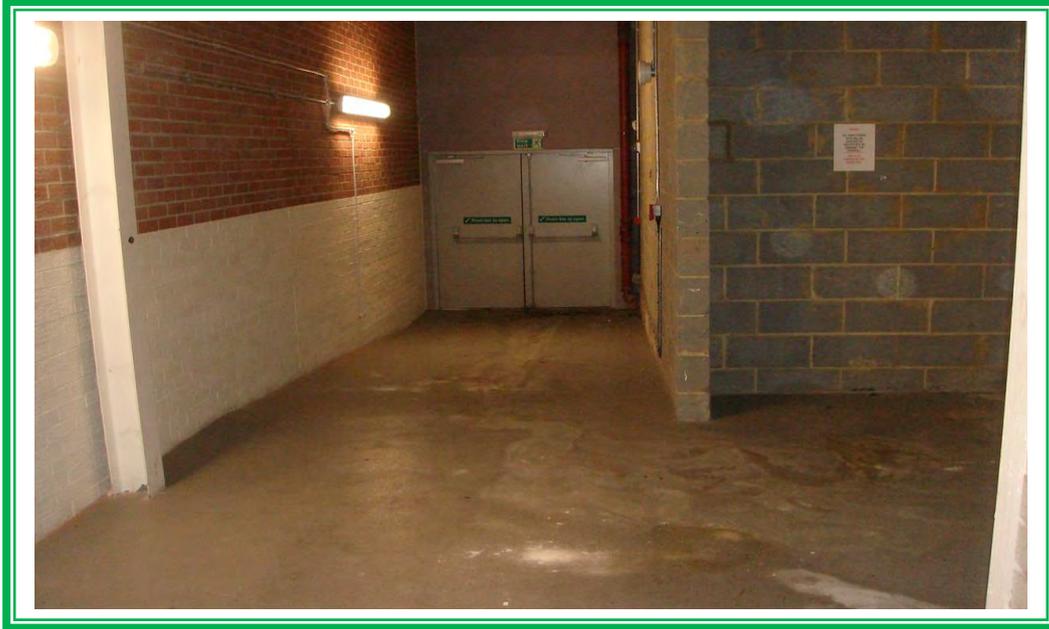
Location: 0/001 Walkway

Material Description:	Visual Inspection – No Suspect Materials Found	
Identification:	N/A	
Approx. quantity:	N/A	
Accessibility	N/A	Assessment Score
Product type:	N/A	N/A
Extent of Damage:	N/A	N/A
Surface Treatment:	N/A	N/A
Asbestos type:	N/A	N/A
Material Assessment Score:		N/A
Priority Assessment Score:		N/A
Action:	N/A	
Comments:	N/A

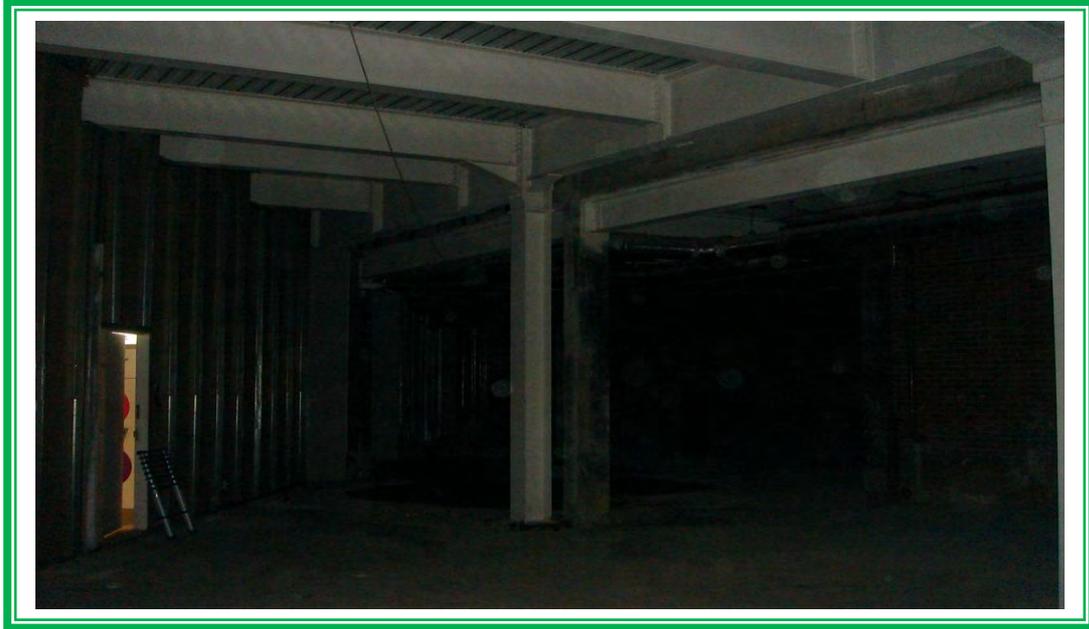
Location: 0/002 Ground Floor

Material Description:	Visual Inspection – No Suspect Materials Found	
Identification:	N/A	
Approx. quantity:	N/A	
Accessibility	N/A	Assessment Score
Product type:	N/A	N/A
Extent of Damage:	N/A	N/A
Surface Treatment:	N/A	N/A
Asbestos type:	N/A	N/A
Material Assessment Score:		N/A
Priority Assessment Score:		N/A
Action:	N/A	
Comments:	N/A

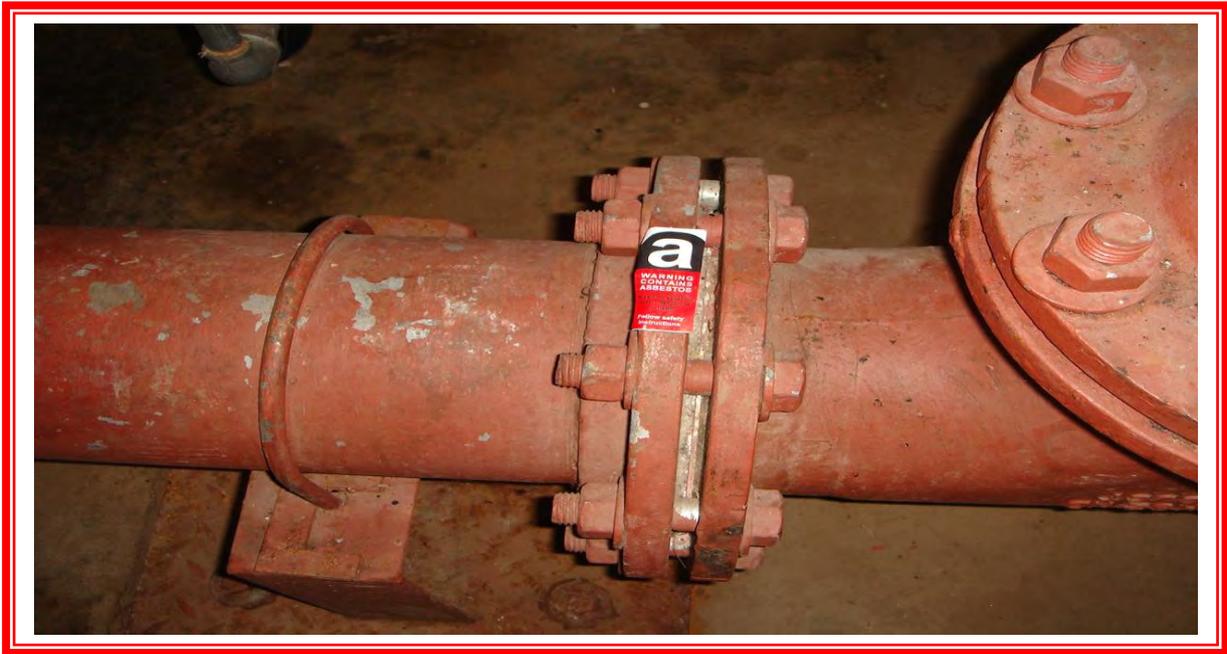
Item No: 6	Sample No: 1
Location: 1/006 Plant Room 3

Material Description:	Pipe Gasket	
Identification:	Sampled – Asbestos Detected	
Approx. quantity:	All Gaskets	
Accessibility	Low	<i>Assessment Score</i>
Product type:	Gasket	2
Extent of Damage:	Good	0
Surface Treatment:	Gasket	1
Asbestos type:	Chrysotile	1
Material Assessment Score:		4
Priority Assessment Score:		Negligible
Action:	Manage	
Comments:	N/A

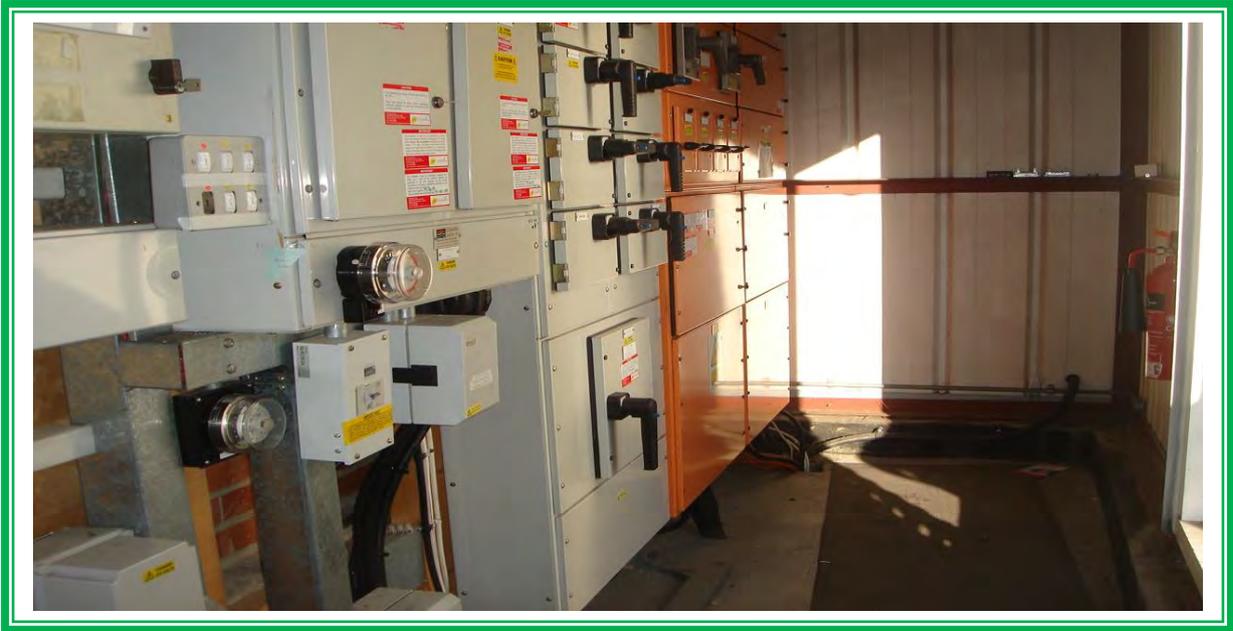
Item No: 1	Sample No: N/A
Location: 1/001 Plant Room 5

Material Description:	Visual Inspection – No Suspect Materials Found	
Identification:	N/A	
Approx. quantity:	N/A	
Accessibility	N/A	Assessment Score
Product type:	N/A	N/A
Extent of Damage:	N/A	N/A
Surface Treatment:	N/A	N/A
Asbestos type:	N/A	N/A
Material Assessment Score:		N/A
Priority Assessment Score:		N/A
Action:	N/A	
Comments:	N/A

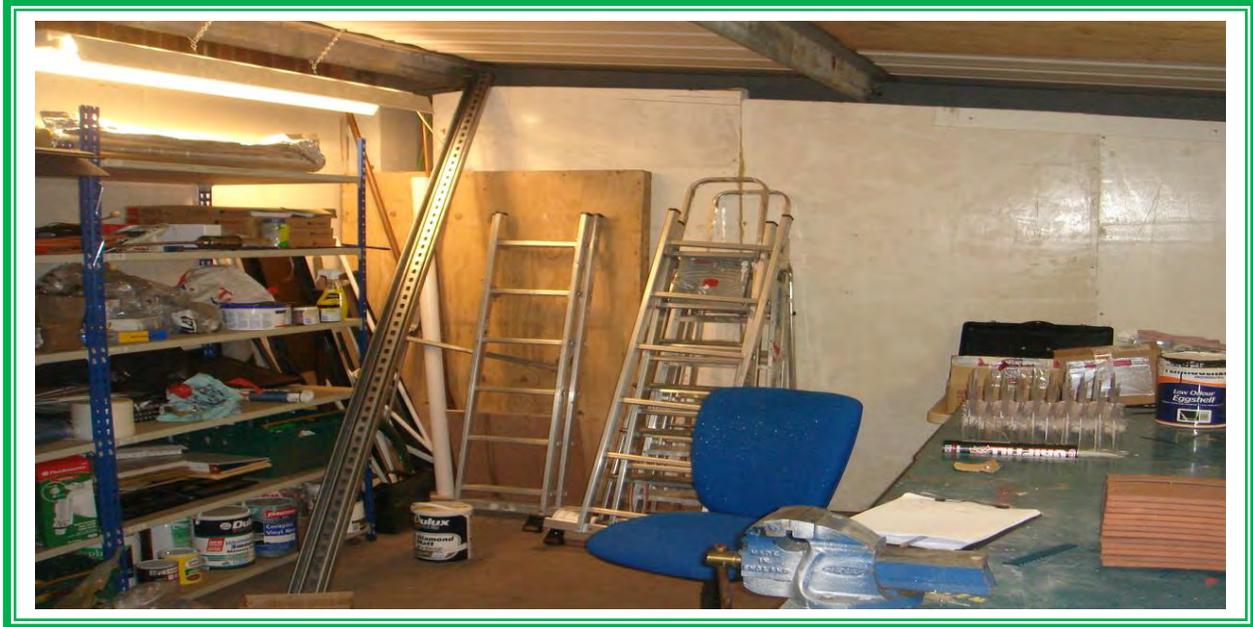
Location: 1/002 Workshop

Material Description:	Visual Inspection – No Suspect Materials Found	
Identification:	N/A	
Approx. quantity:	N/A	
Accessibility	N/A	Assessment Score
Product type:	N/A	N/A
Extent of Damage:	N/A	N/A
Surface Treatment:	N/A	N/A
Asbestos type:	N/A	N/A
Material Assessment Score:		N/A
Priority Assessment Score:		N/A
Action:	N/A	
Comments:	N/A

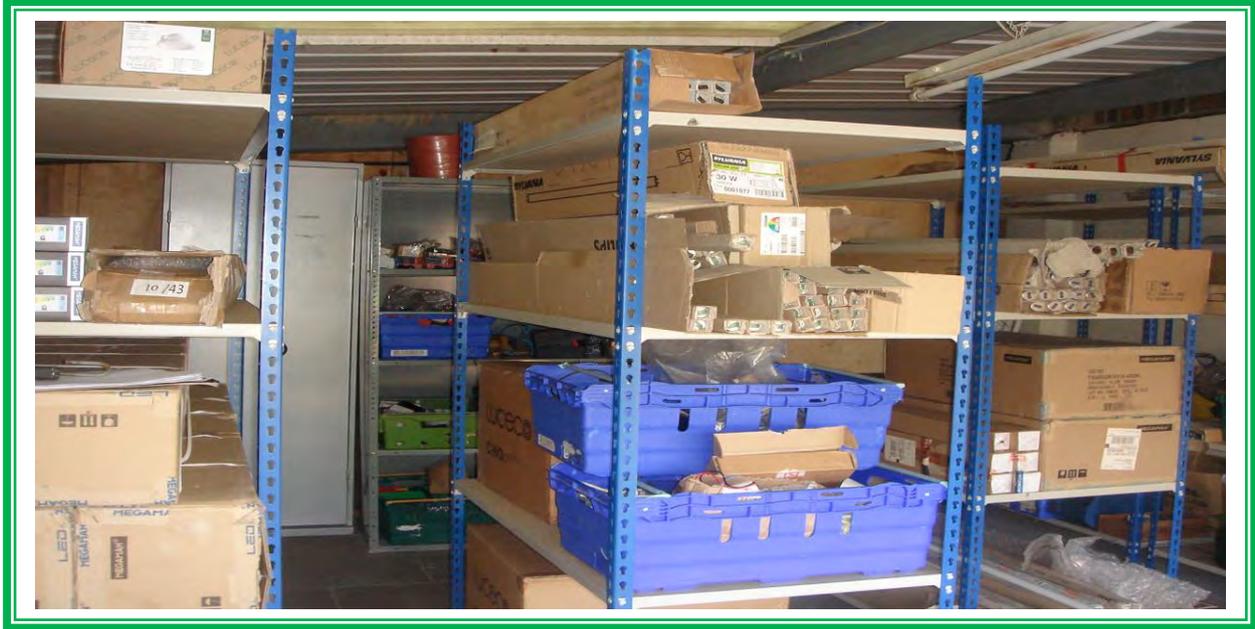
Location: 0/003 Garage

Material Description:	Visual Inspection – No Suspect Materials Found	
Identification:	N/A	
Approx. quantity:	N/A	
Accessibility	N/A	Assessment Score
Product type:	N/A	N/A
Extent of Damage:	N/A	N/A
Surface Treatment:	N/A	N/A
Asbestos type:	N/A	N/A
Material Assessment Score:		N/A
Priority Assessment Score:		N/A
Action:	N/A	
Comments:	N/A
