Project Number 3113

Management
Asbestos Survey Report

Kennet Centre, Market Street, Newbury,
Berkshire, RG14 5EN

3 Market Place and Associated Store

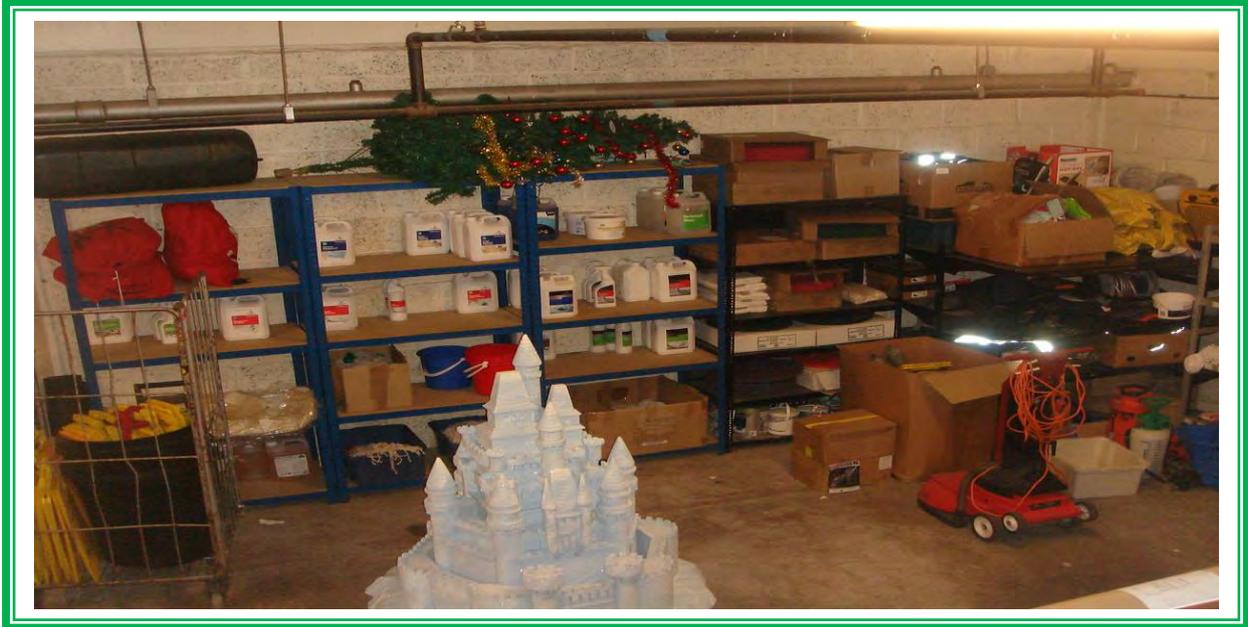
Location: 0/004 Mess Room and Clearance Store

Material Description:	Visual Inspection – No Suspect Materials Found	
Identification:	N/A	
Approx. quantity:	N/A	
Accessibility	N/A	Assessment Score
Product type:	N/A	N/A
Extent of Damage:	N/A	N/A
Surface Treatment:	N/A	N/A
Asbestos type:	N/A	N/A
Material Assessment Score:		N/A
Priority Assessment Score:		N/A
Action:	N/A	
Comments:	N/A

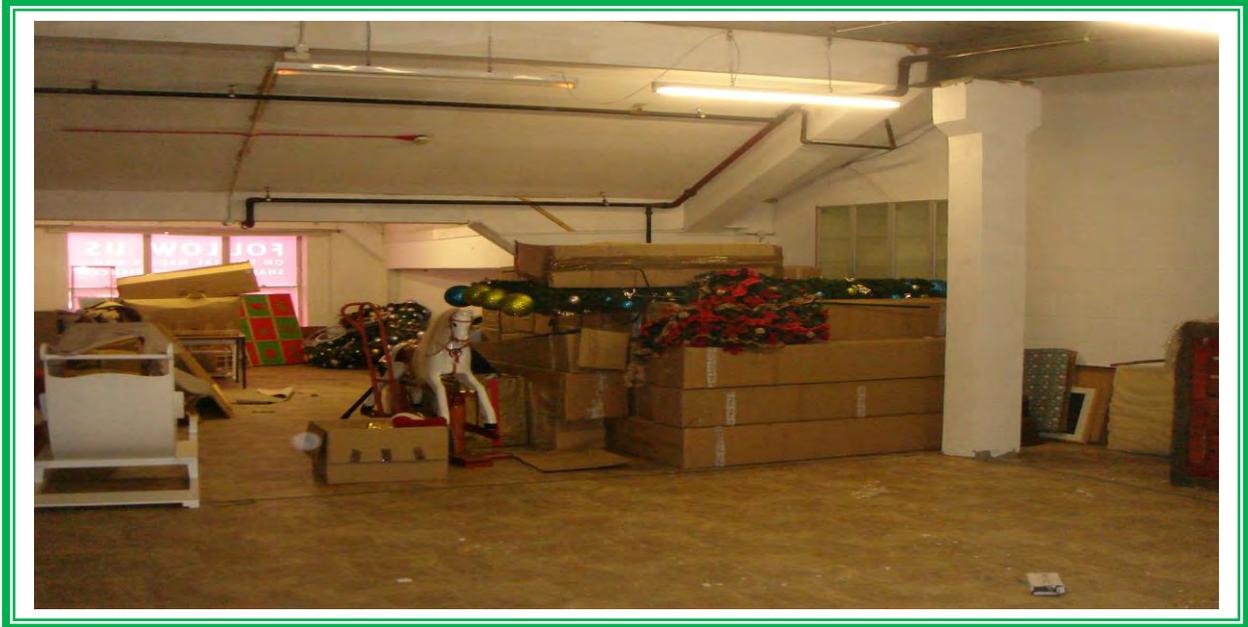
Location: 1/005 Event Store

Material Description:	Visual Inspection – No Suspect Materials Found	
Identification:	N/A	
Approx. quantity:	N/A	
Accessibility	N/A	Assessment Score
Product type:	N/A	N/A
Extent of Damage:	N/A	N/A
Surface Treatment:	N/A	N/A
Asbestos type:	N/A	N/A
Material Assessment Score:		N/A
Priority Assessment Score:		N/A
Action:	N/A	
Comments:	N/A

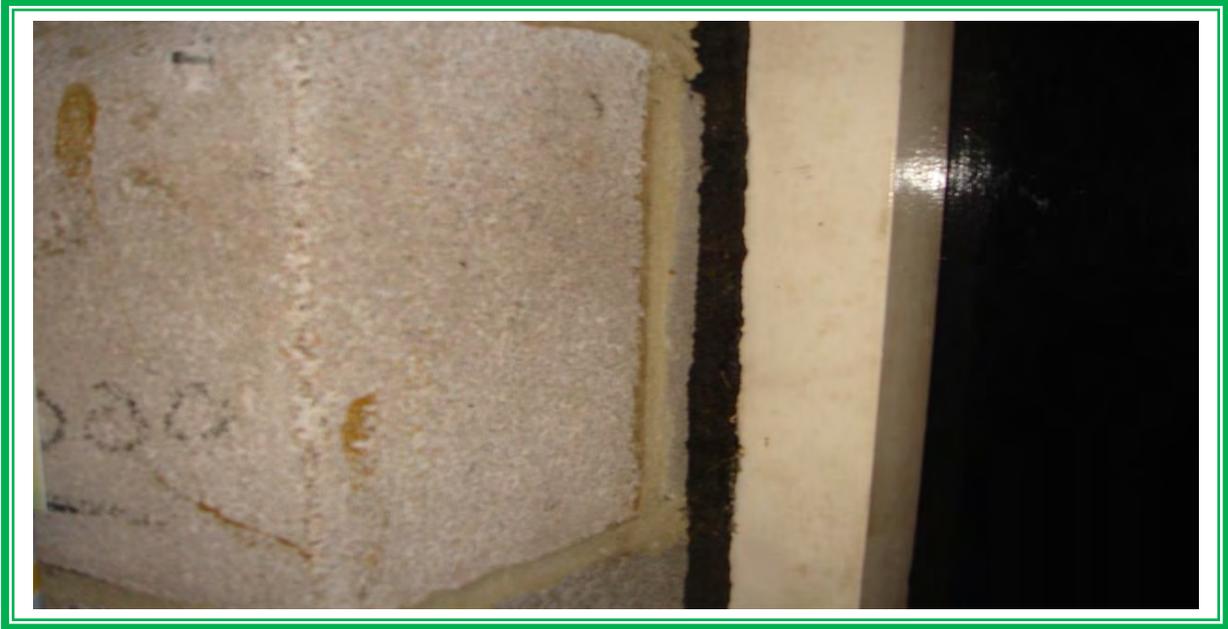
Location: 1/006 Plant Room 3

Material Description:	Damage Proof Courses	
Identification:	Sampled - No Asbestos Detected	
Approx. quantity:	Throughout Wall Cavity in Plant Room	
Accessibility	N/A	Assessment Score
Product type:	N/A	N/A
Extent of Damage:	N/A	N/A
Surface Treatment:	N/A	N/A
Asbestos type:	N/A	N/A
Material Assessment Score:		N/A
Priority Assessment Score:		N/A
Action:	N/A	
Comments:	N/A

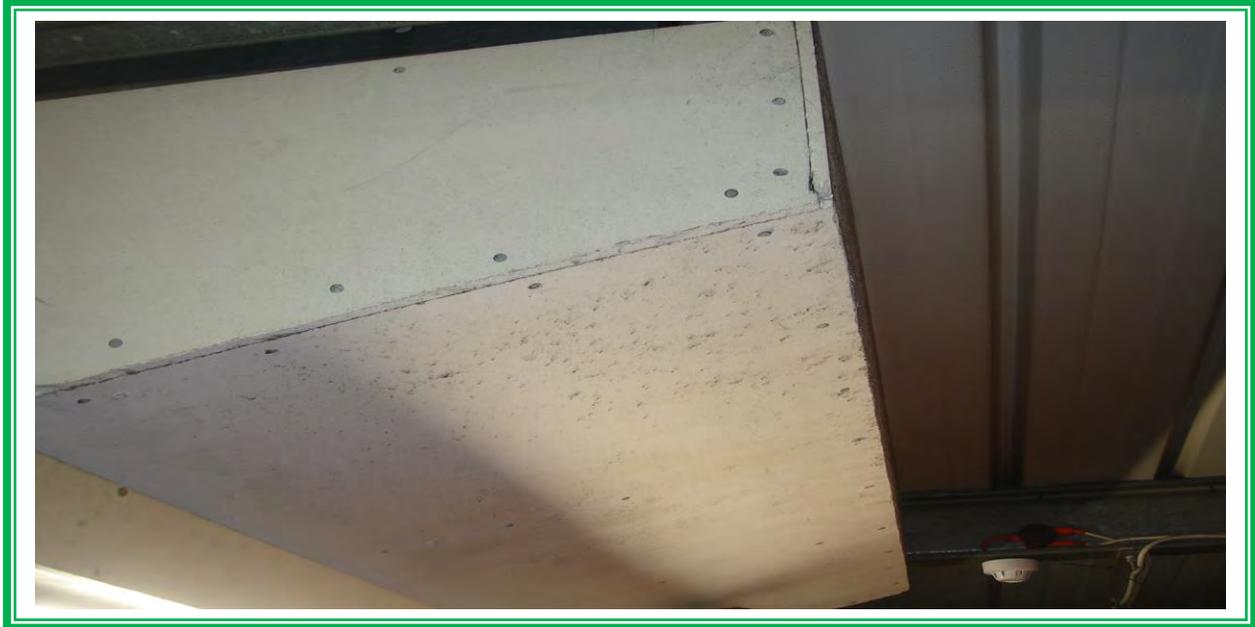
Location: 1/007 Plant Room 1

Material Description:	Insulating Board	
Identification:	Sampled - No Asbestos Detected	
Approx. quantity:	3M2	
Accessibility	N/A	Assessment Score
Product type:	N/A	N/A
Extent of Damage:	N/A	N/A
Surface Treatment:	N/A	N/A
Asbestos type:	N/A	N/A
Material Assessment Score:		N/A
Priority Assessment Score:		N/A
Action:	N/A	
Comments:	N/A

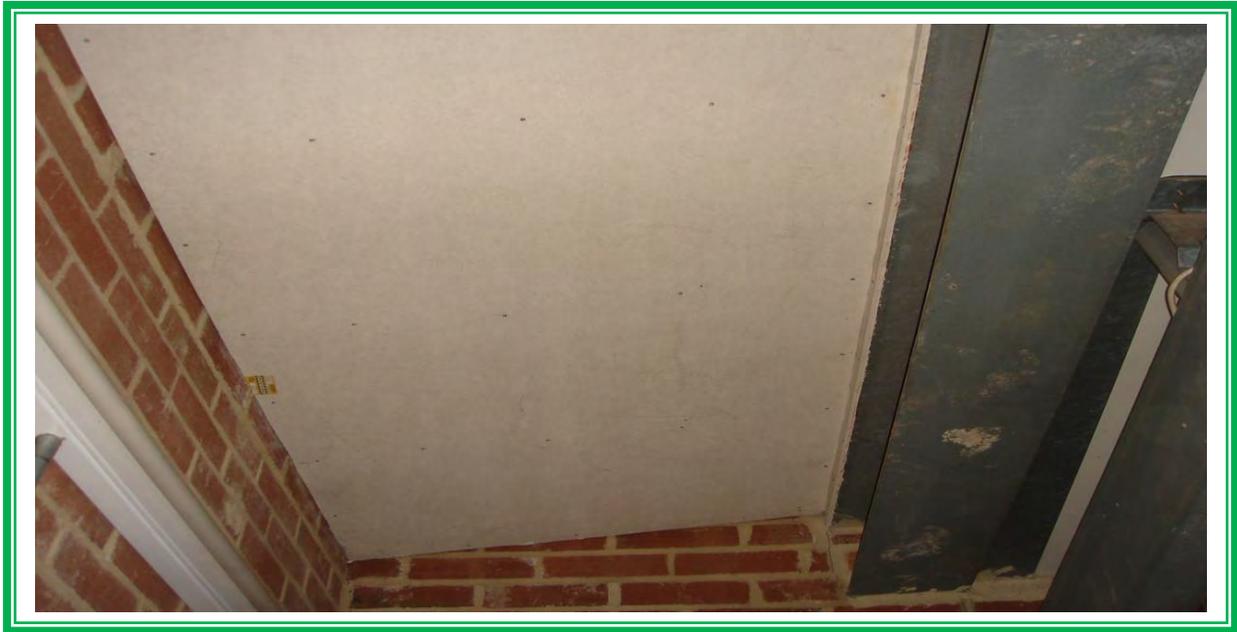
Location: 1/008 Plant Room 6

Material Description:	Insulating Board	
Identification:	As Per Sample 3 – No Asbestos Detected	
Approx. quantity:	2M2	
Accessibility	N/A	Assessment Score
Product type:	N/A	N/A
Extent of Damage:	N/A	N/A
Surface Treatment:	N/A	N/A
Asbestos type:	N/A	N/A
Material Assessment Score:		N/A
Priority Assessment Score:		N/A
Action:	N/A	
Comments:	N/A

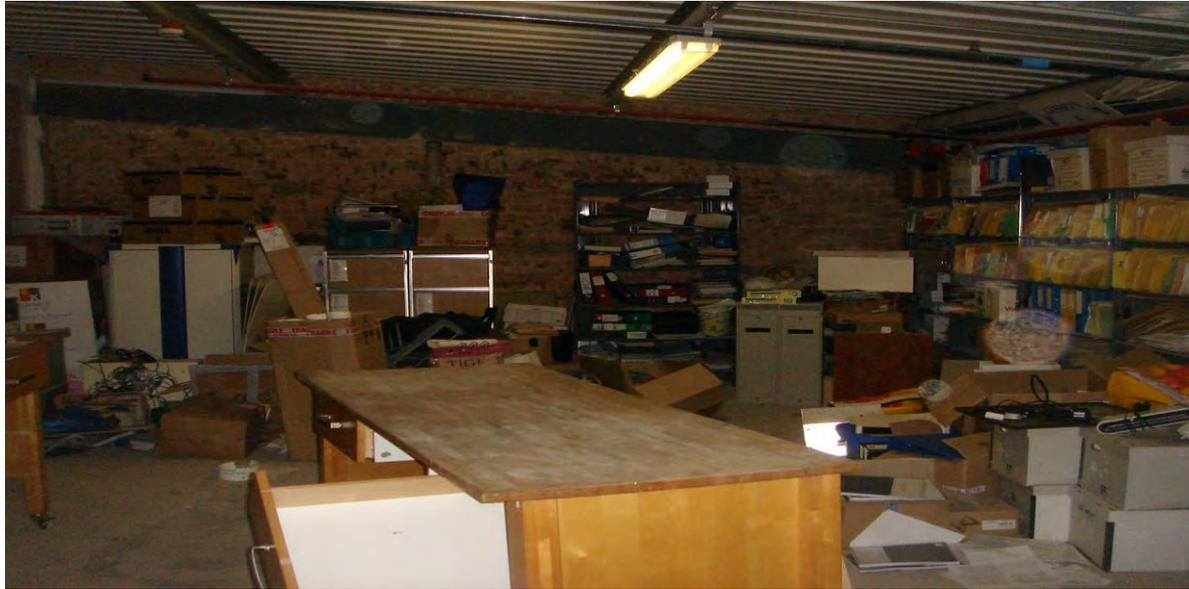
Location: 1/009 Store Green Room 9

Material Description:	Visual Inspection – No Suspect Materials Found	
Identification:	N/A	
Approx. quantity:	N/A	
Accessibility	N/A	Assessment Score
Product type:	N/A	N/A
Extent of Damage:	N/A	N/A
Surface Treatment:	N/A	N/A
Asbestos type:	N/A	N/A
Material Assessment Score:		N/A
Priority Assessment Score:		N/A
Action:	N/A	
Comments:	N/A

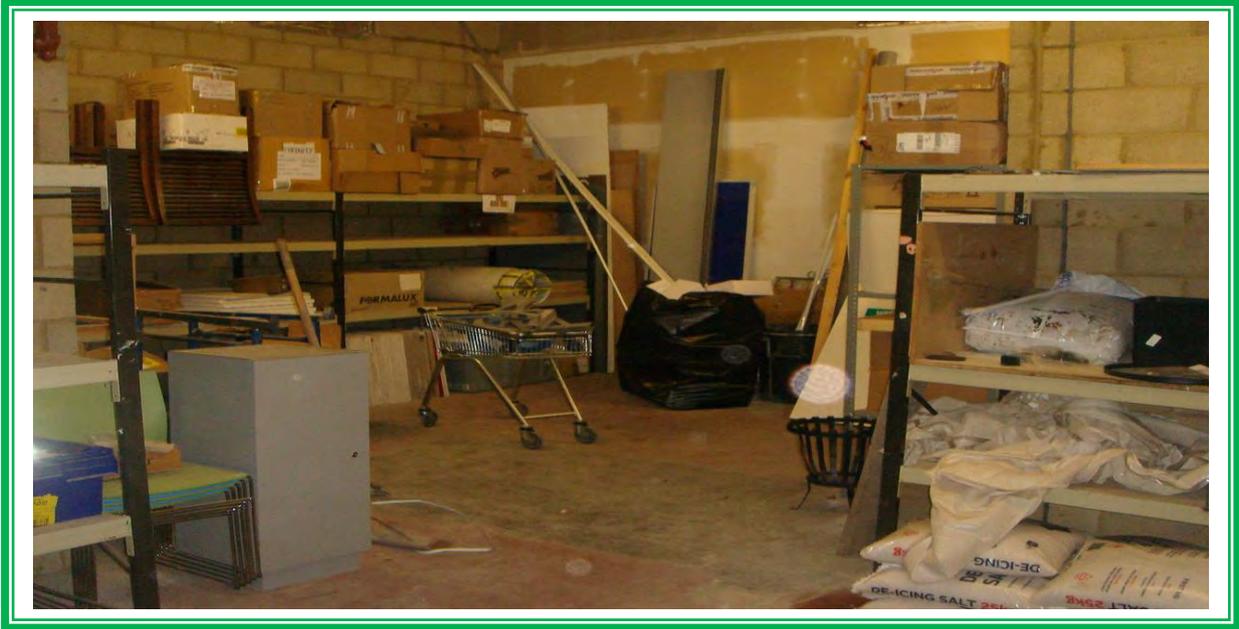
Location: 1/010 TK Maxx Store

Material Description:	Visual Inspection – No Suspect Materials Found	
Identification:	N/A	
Approx. quantity:	N/A	
Accessibility	N/A	Assessment Score
Product type:	N/A	N/A
Extent of Damage:	N/A	N/A
Surface Treatment:	N/A	N/A
Asbestos type:	N/A	N/A
Material Assessment Score:		N/A
Priority Assessment Score:		N/A
Action:	N/A	
Comments:	N/A

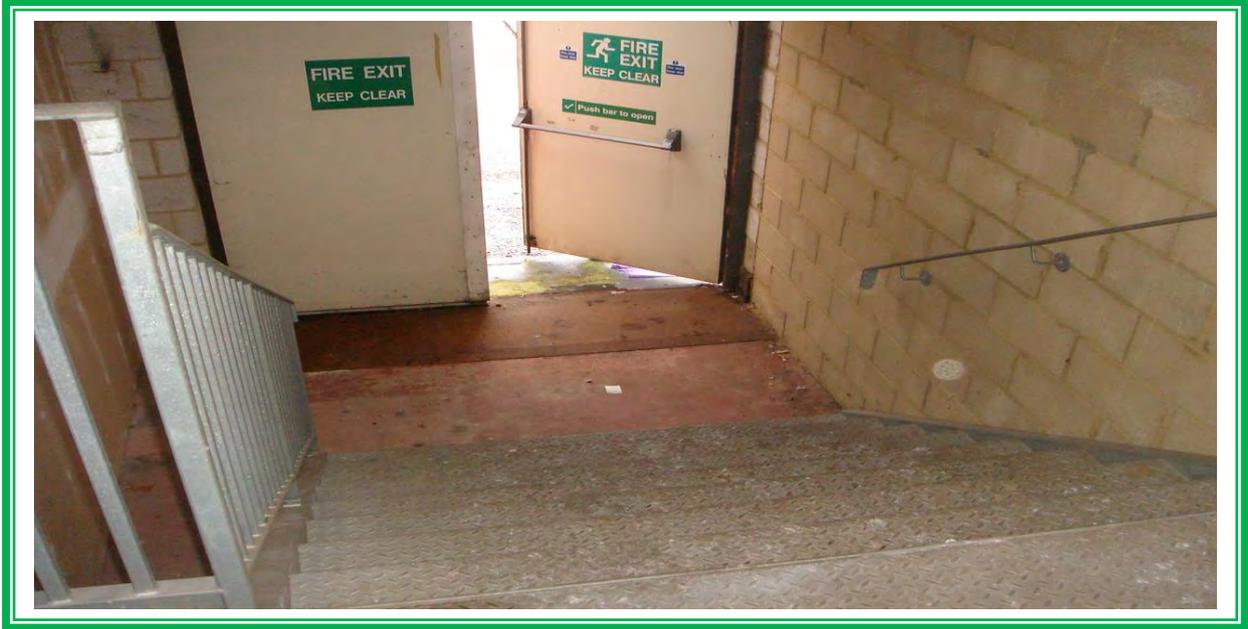
Location: 1/011 Liquid Fire Escape

Material Description:	Visual Inspection – No Suspect Materials Found	
Identification:	N/A	
Approx. quantity:	N/A	
Accessibility	N/A	Assessment Score
Product type:	N/A	N/A
Extent of Damage:	N/A	N/A
Surface Treatment:	N/A	N/A
Asbestos type:	N/A	N/A
Material Assessment Score:		N/A
Priority Assessment Score:		N/A
Action:	N/A	
Comments:	N/A

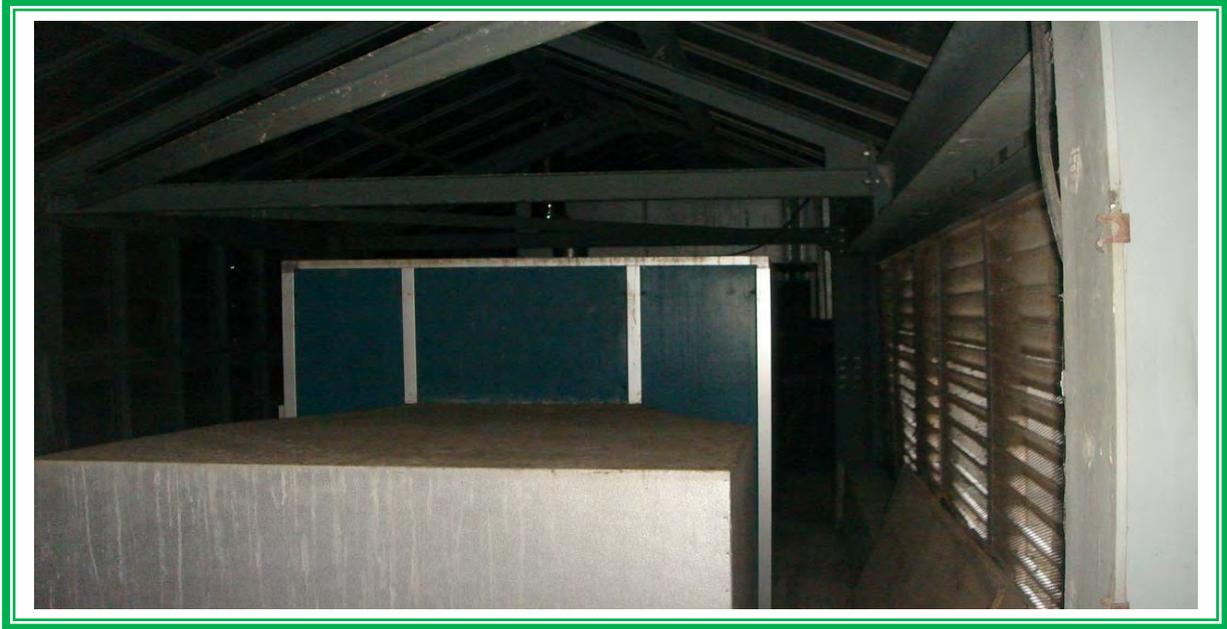
Location: 2/012 TK Maxx Air Conditioning

Material Description:	Visual Inspection – No Suspect Materials Found	
Identification:	N/A	
Approx. quantity:	N/A	
Accessibility	N/A	Assessment Score
Product type:	N/A	N/A
Extent of Damage:	N/A	N/A
Surface Treatment:	N/A	N/A
Asbestos type:	N/A	N/A
Material Assessment Score:		N/A
Priority Assessment Score:		N/A
Action:	N/A	
Comments:	N/A

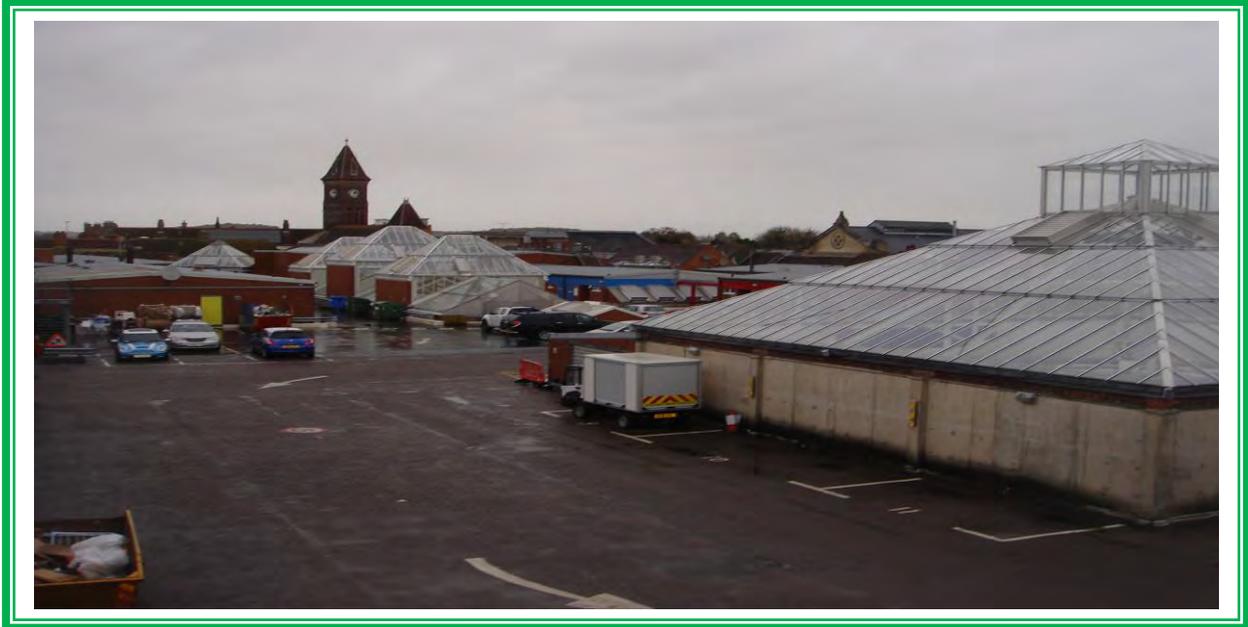
Location: 99/001 Externals

Material Description:	Visual Inspection – No Suspect Materials Found	
Identification:	N/A	
Approx. quantity:	N/A	
Accessibility	N/A	Assessment Score
Product type:	N/A	N/A
Extent of Damage:	N/A	N/A
Surface Treatment:	N/A	N/A
Asbestos type:	N/A	N/A
Material Assessment Score:		N/A
Priority Assessment Score:		N/A
Action:	N/A	
Comments:	N/A

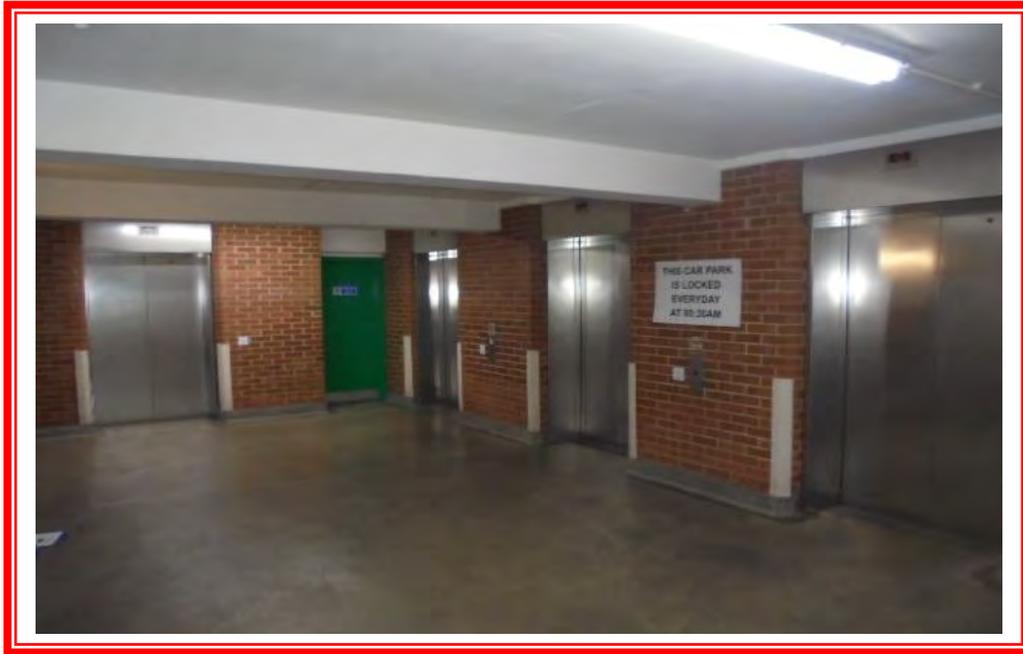
Location: Lift/Lift Shaft

Material Description:	No Access within Lift Shaft	
Identification:	Presumed to Contain Asbestos	
Approx. quantity:	X 4 Lifts	
Accessibility	Low	Assessment Score
Product type:	No Access	3
Extent of Damage:	No Access	3
Surface Treatment:	No Access	3
Asbestos type:	No Access	3
Material Assessment Score:		12
Priority Assessment Score:		High
Action:	Manage	
Comments:	No Access as no lift engineer was onsite

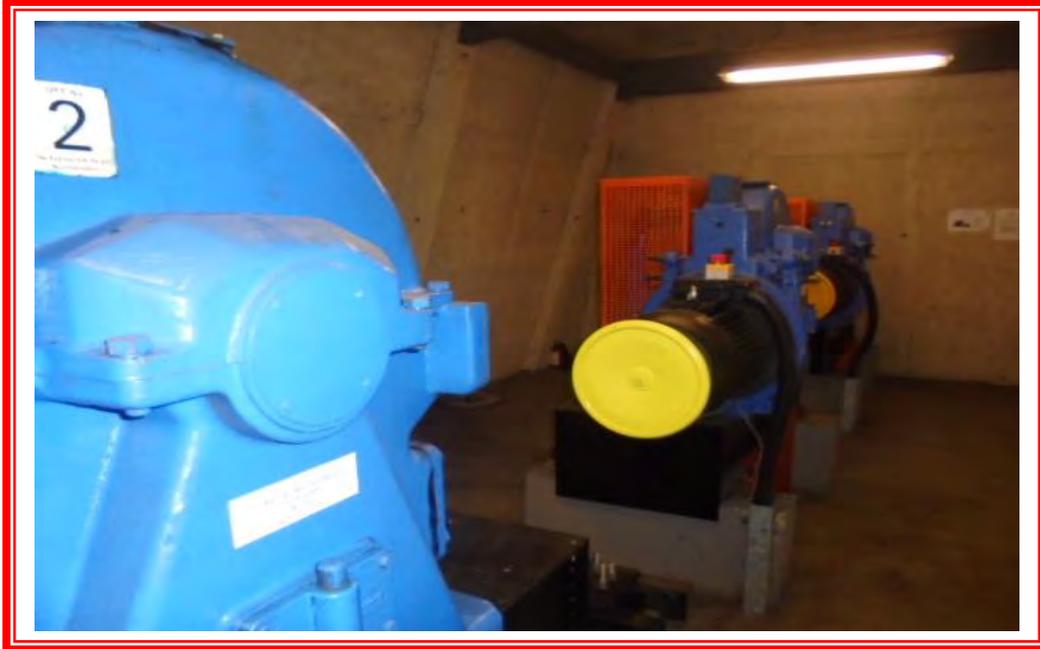
Location: 4/001 Lift Engineer Room

Material Description:	No Access within Lift Motors	
Identification:	Presumed to Contain Asbestos	
Approx. quantity:	X 4 Units	
Accessibility	Low	Assessment Score
Product type:	No Access	2
Extent of Damage:	No Access	1
Surface Treatment:	No Access	1
Asbestos type:	No Access	1
Material Assessment Score:		5
Priority Assessment Score:		Low
Action:	Manage	
Comments:	No Access as Live

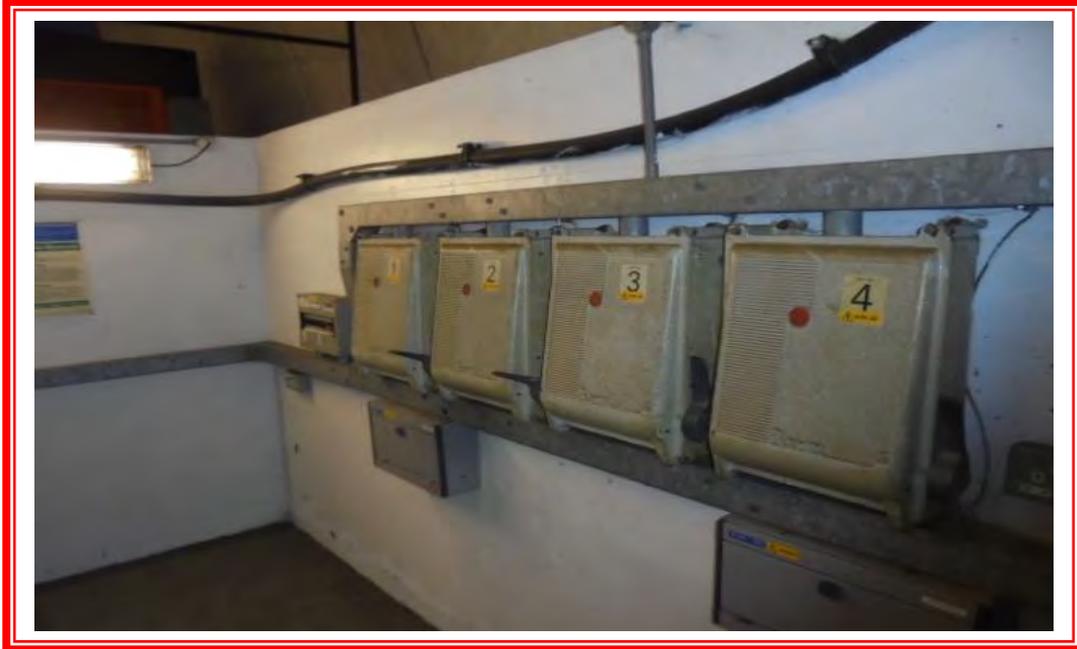
Location: 4/001 Lift Motor Room

Material Description:	No Access within Live Electrics	
Identification:	Presumed to Contain Asbestos	
Approx. quantity:	X 4 Panels	
Accessibility	Low	Assessment Score
Product type:	No Access	2
Extent of Damage:	No Access	1
Surface Treatment:	No Access	1
Asbestos type:	No Access	1
Material Assessment Score:		5
Priority Assessment Score:		Low
Action:	Manage	
Comments:	No Access as Live

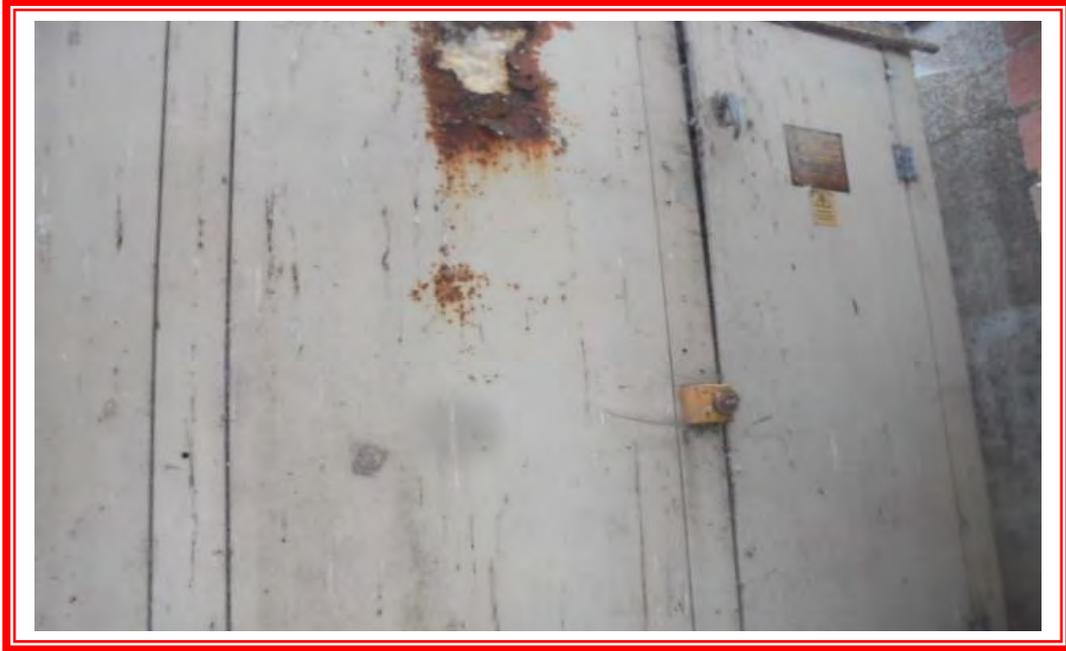
Location: 3/006 Fan Room

Material Description:	No Access within Live Unit	
Identification:	Presumed to Contain Asbestos	
Approx. quantity:	X 1 Unit	
Accessibility	Low	Assessment Score
Product type:	No Access	3
Extent of Damage:	No Access	3
Surface Treatment:	No Access	3
Asbestos type:	No Access	3
Material Assessment Score:		12
Priority Assessment Score:		High
Action:	Manage	
Comments:	No Access as Live

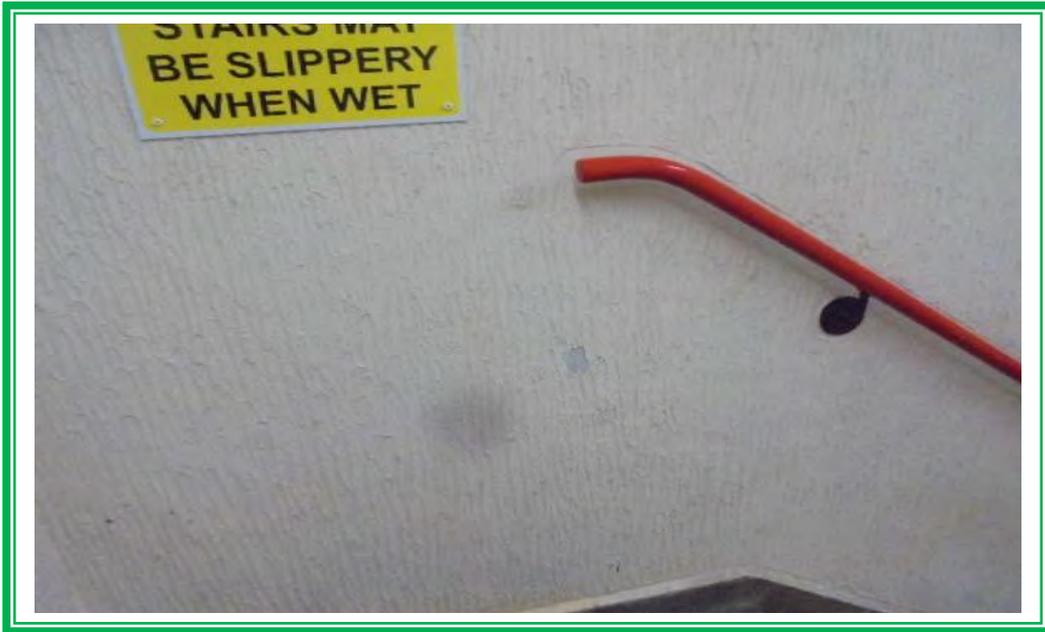
Item No: 1	Sample No: NE/01
Location: 3/001 South East Stairwell

Material Description:	Textured Coating to Walls	
Identification:	Sampled – No Asbestos Detected	
Approx. quantity:	25M2	
Accessibility	N/A	Assessment Score
Product type:	N/A	N/A
Extent of Damage:	N/A	N/A
Surface Treatment:	N/A	N/A
Asbestos type:	N/A	N/A
Material Assessment Score:		N/A
Priority Assessment Score:		N/A
Action:	N/A	
Comments:	N/A

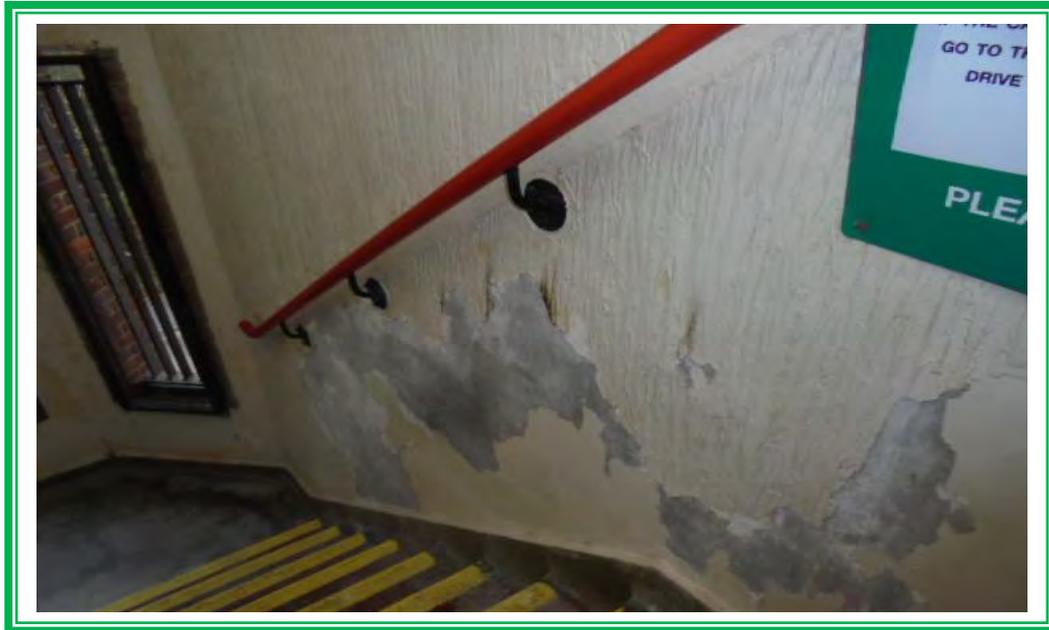
Location: 3/002 South West Stairwell – Level 2 and 3

Material Description:	Textured Coating to Walls	
Identification:	As Per Sample NE/1 – No Asbestos Detected	
Approx. quantity:	25M2	
Accessibility	N/A	Assessment Score
Product type:	N/A	N/A
Extent of Damage:	N/A	N/A
Surface Treatment:	N/A	N/A
Asbestos type:	N/A	N/A
Material Assessment Score:		N/A
Priority Assessment Score:		N/A
Action:	N/A	
Comments:	N/A

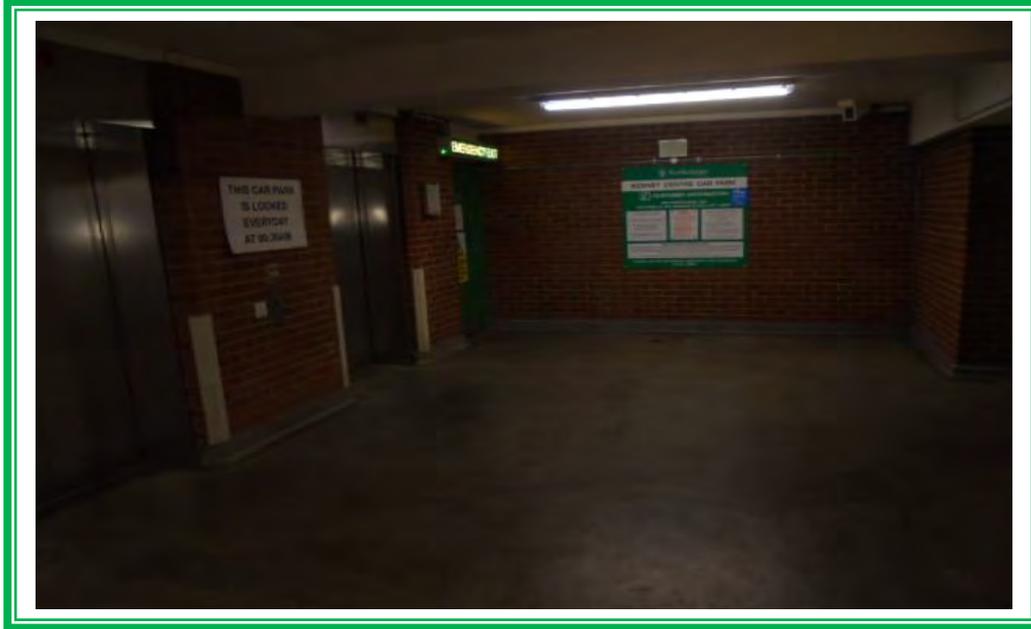
Location: 3/003 Lift Lobby

Material Description:	Visual Inspection – No Suspect Materials Found	
Identification:	N/A	
Approx. quantity:	N/A	
Accessibility	N/A	Assessment Score
Product type:	N/A	N/A
Extent of Damage:	N/A	N/A
Surface Treatment:	N/A	N/A
Asbestos type:	N/A	N/A
Material Assessment Score:		N/A
Priority Assessment Score:		N/A
Action:	N/A	
Comments:	N/A

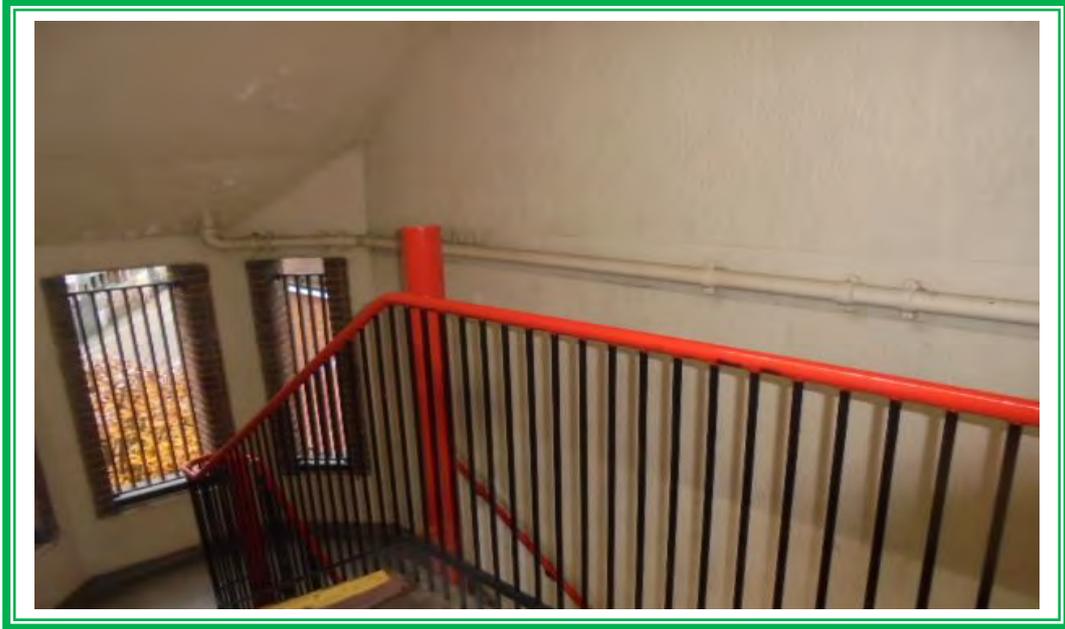
Location: 3/004 North Stairwell

Material Description:	Textured Coating to Walls	
Identification:	As Per Sample NE/1 – No Asbestos Detected	
Approx. quantity:	40M2	
Accessibility	N/A	Assessment Score
Product type:	N/A	N/A
Extent of Damage:	N/A	N/A
Surface Treatment:	N/A	N/A
Asbestos type:	N/A	N/A
Material Assessment Score:		N/A
Priority Assessment Score:		N/A
Action:	N/A	
Comments:	N/A

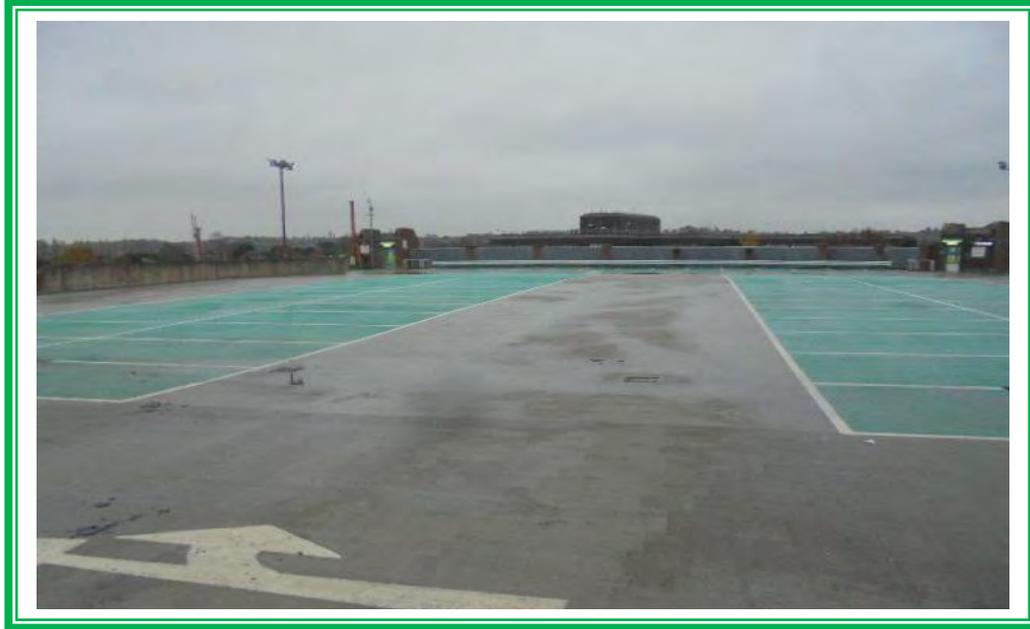
Location: 3/005 External Car Park

Material Description:	Visual Inspection – No Suspect Materials Found	
Identification:	N/A	
Approx. quantity:	N/A	
Accessibility	N/A	Assessment Score
Product type:	N/A	N/A
Extent of Damage:	N/A	N/A
Surface Treatment:	N/A	N/A
Asbestos type:	N/A	N/A
Material Assessment Score:		N/A
Priority Assessment Score:		N/A
Action:	N/A	
Comments:	N/A

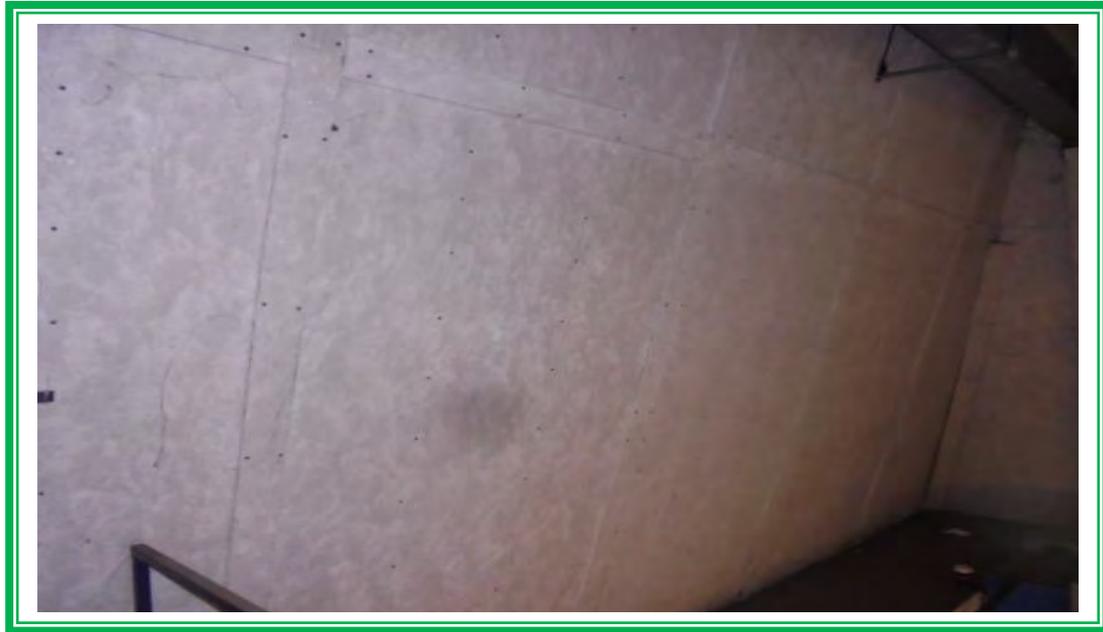
Location: 4/001 Lift Motor Room

Material Description:	Insulation Board Wall Panels	
Identification:	Sampled - No Asbestos Detected	
Approx. quantity:	60M2	
Accessibility	N/A	Assessment Score
Product type:	N/A	N/A
Extent of Damage:	N/A	N/A
Surface Treatment:	N/A	N/A
Asbestos type:	N/A	N/A
Material Assessment Score:		N/A
Priority Assessment Score:		N/A
Action:	N/A	
Comments:	N/A

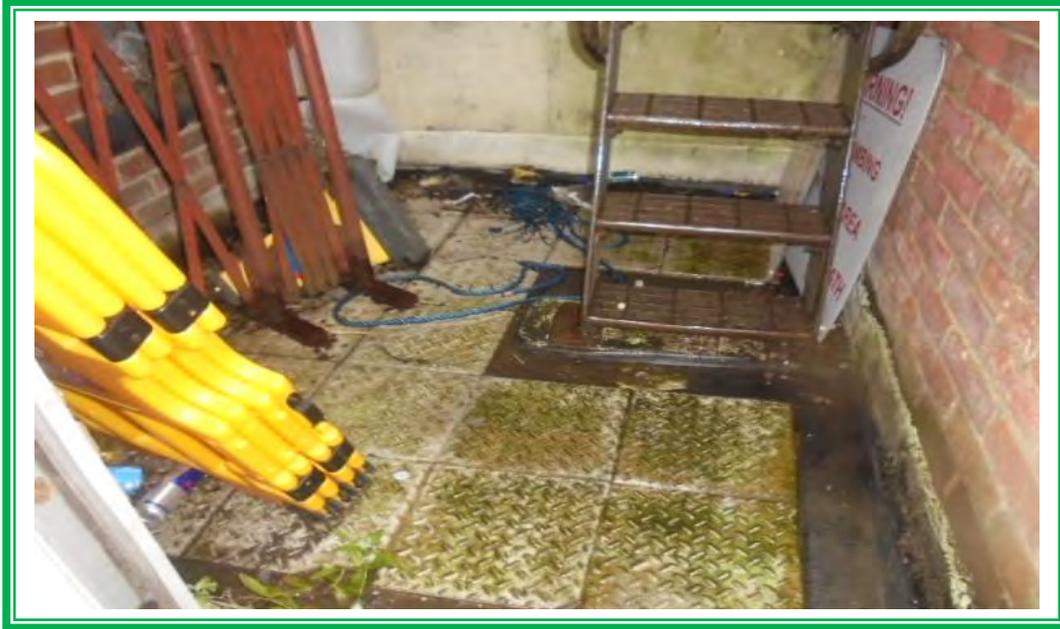
Location: 4/002 Ladder Landing and Lobby

Material Description:	Prominade Tiles	
Identification:	Sampled – No Asbestos Detected	
Approx. quantity:	6M2	
Accessibility	N/A	Assessment Score
Product type:	N/A	N/A
Extent of Damage:	N/A	N/A
Surface Treatment:	N/A	N/A
Asbestos type:	N/A	N/A
Material Assessment Score:		N/A
Priority Assessment Score:		N/A
Action:	N/A	
Comments:	N/A

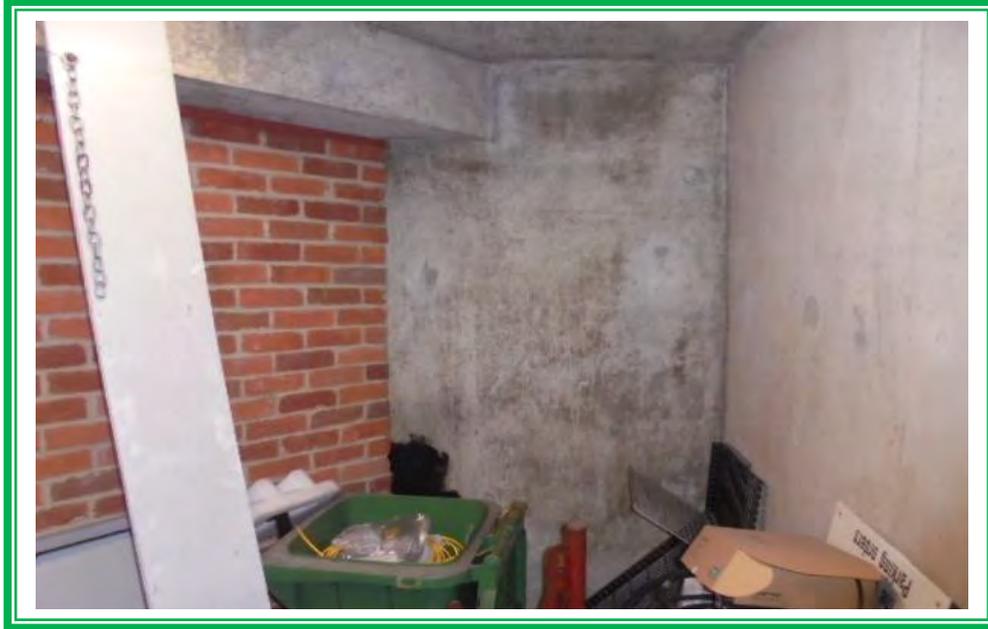
Location: 2/001 Comms Room

Material Description:	Visual Inspection – No Suspect Materials Found	
Identification:	N/A	
Approx. quantity:	N/A	
Accessibility	N/A	Assessment Score
Product type:	N/A	N/A
Extent of Damage:	N/A	N/A
Surface Treatment:	N/A	N/A
Asbestos type:	N/A	N/A
Material Assessment Score:		N/A
Priority Assessment Score:		N/A
Action:	N/A	
Comments:	N/A

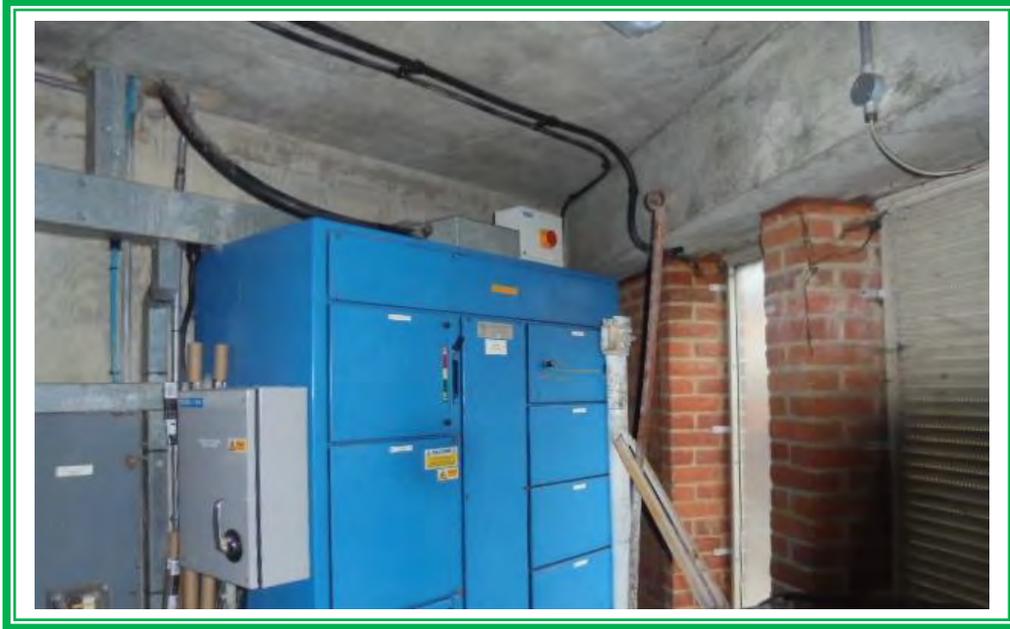
Location: 1/001 Switch Room

Material Description:	Visual Inspection – No Suspect Materials Found	
Identification:	N/A	
Approx. quantity:	N/A	
Accessibility	N/A	Assessment Score
Product type:	N/A	N/A
Extent of Damage:	N/A	N/A
Surface Treatment:	N/A	N/A
Asbestos type:	N/A	N/A
Material Assessment Score:		N/A
Priority Assessment Score:		N/A
Action:	N/A	
Comments:	No access within live electrics

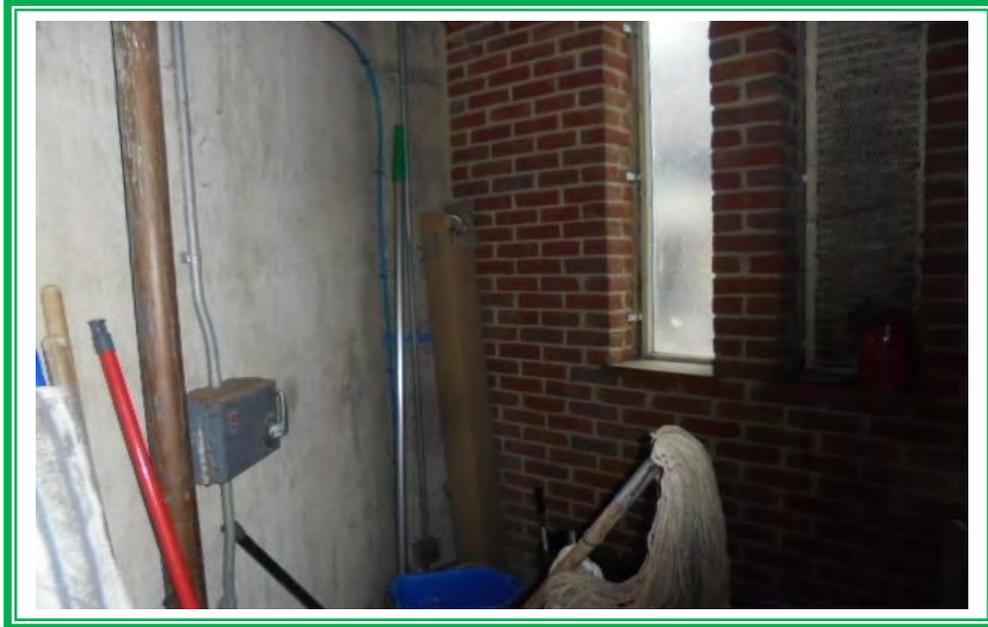
Location: 0/001 Cleaners Cupboard

Material Description:	Visual Inspection – No Suspect Materials Found	
Identification:	N/A	
Approx. quantity:	N/A	
Accessibility	N/A	Assessment Score
Product type:	N/A	N/A
Extent of Damage:	N/A	N/A
Surface Treatment:	N/A	N/A
Asbestos type:	N/A	N/A
Material Assessment Score:		N/A
Priority Assessment Score:		N/A
Action:	N/A	
Comments:	N/A

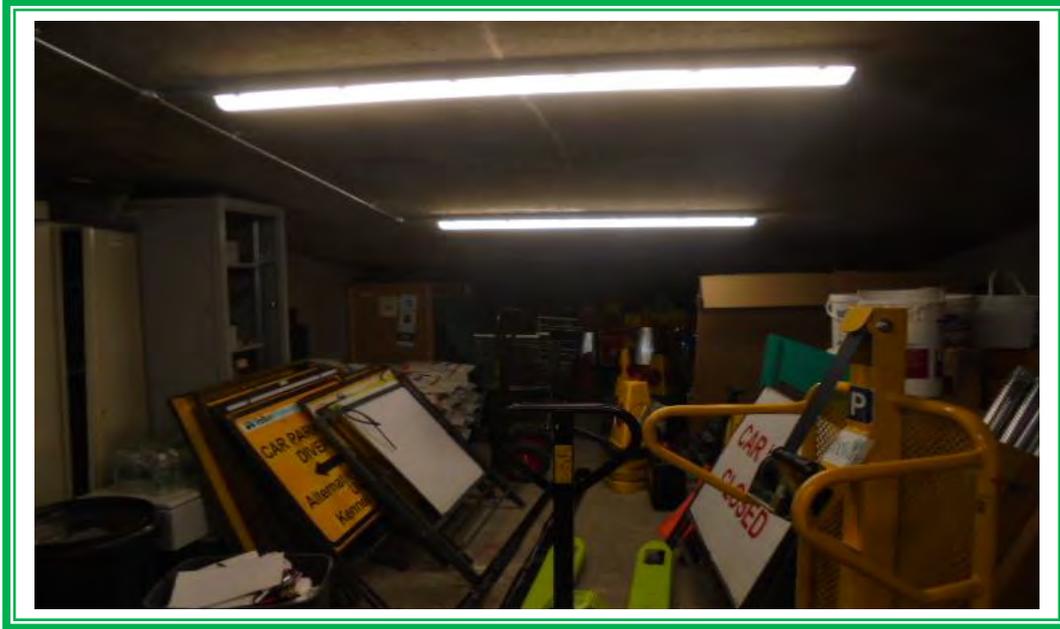
Location: 0/002 Under Ramp Store

Material Description:	Visual Inspection – No Suspect Materials Found	
Identification:	N/A	
Approx. quantity:	N/A	
Accessibility	N/A	Assessment Score
Product type:	N/A	N/A
Extent of Damage:	N/A	N/A
Surface Treatment:	N/A	N/A
Asbestos type:	N/A	N/A
Material Assessment Score:		N/A
Priority Assessment Score:		N/A
Action:	N/A	
Comments:	N/A

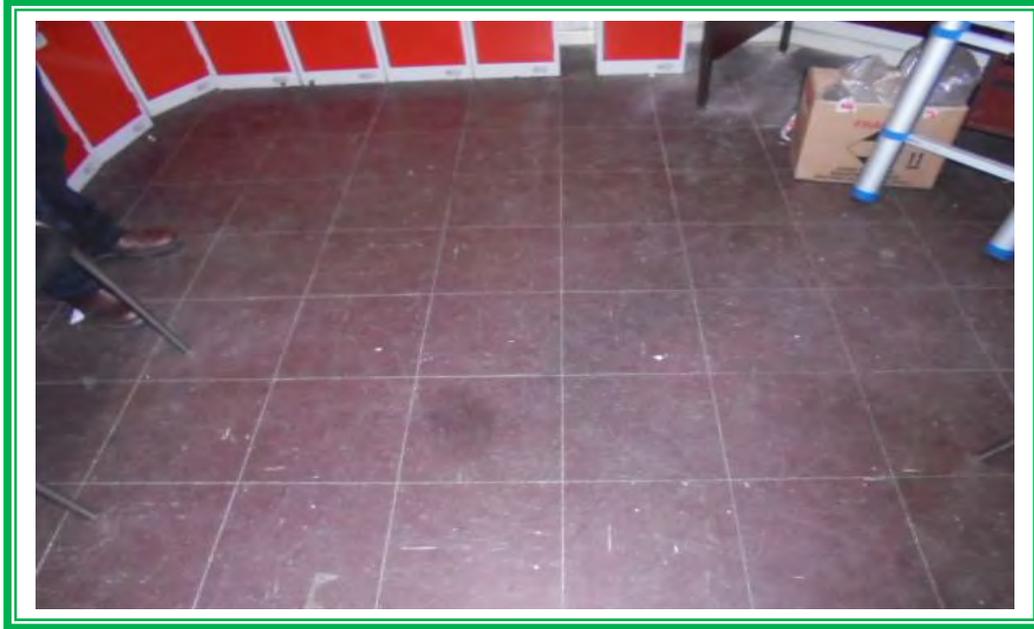
Location: 0/003 Lobby and Locker Room

Material Description:	Floor Tiles	
Identification:	Sampled – No Asbestos Detected	
Approx. quantity:	18M2	
Accessibility	N/A	Assessment Score
Product type:	N/A	N/A
Extent of Damage:	N/A	N/A
Surface Treatment:	N/A	N/A
Asbestos type:	N/A	N/A
Material Assessment Score:		N/A
Priority Assessment Score:		N/A
Action:	N/A	
Comments:	N/A

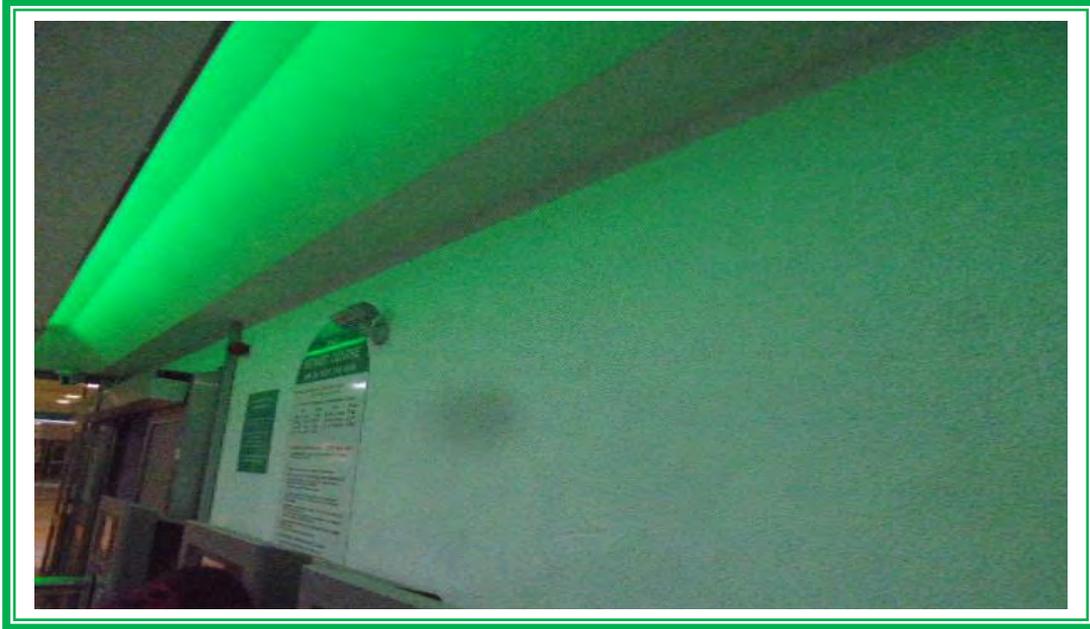
Location: 0/004 Lift Lobby

Material Description:	Textured Coating to Walls	
Identification:	Sampled - No Asbestos Detected	
Approx. quantity:	20M2	
Accessibility	N/A	Assessment Score
Product type:	N/A	N/A
Extent of Damage:	N/A	N/A
Surface Treatment:	N/A	N/A
Asbestos type:	N/A	N/A
Material Assessment Score:		N/A
Priority Assessment Score:		N/A
Action:	N/A	
Comments:	N/A

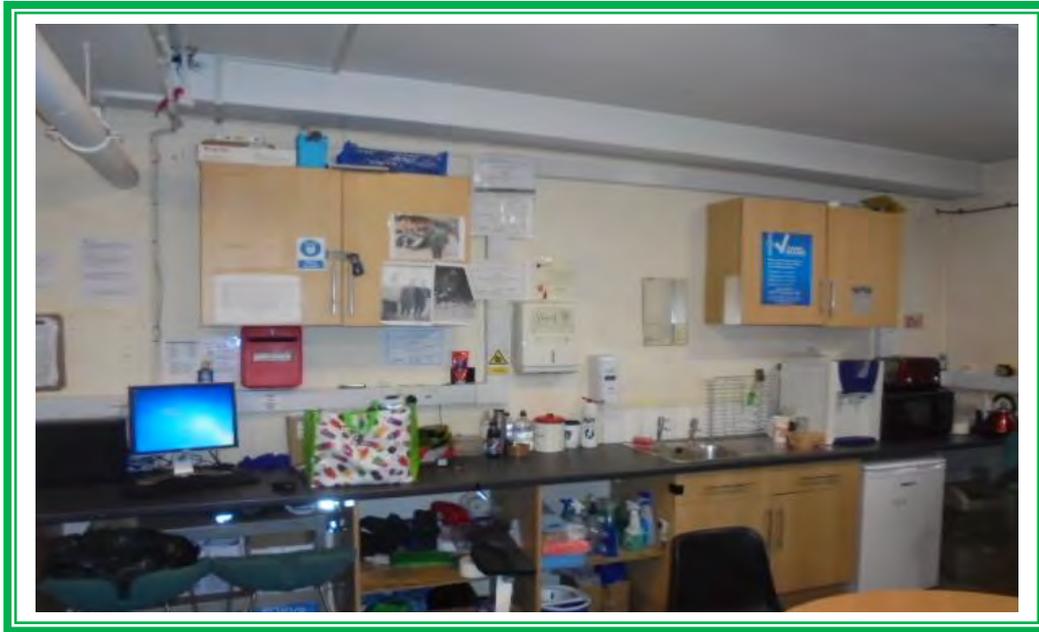
Location: **0/004 Staff Room and WC's x 2**

Material Description:	Visual Inspection – No Suspect Materials Found	
Identification:	N/A	
Approx. quantity:	N/A	
Accessibility	N/A	Assessment Score
Product type:	N/A	N/A
Extent of Damage:	N/A	N/A
Surface Treatment:	N/A	N/A
Asbestos type:	N/A	N/A
Material Assessment Score:		N/A
Priority Assessment Score:		N/A
Action:	N/A	
Comments:	N/A
