Project Number 3113

Management
Asbestos Survey Report

Kennet Centre, Market Street, Newbury,
Berkshire, RG14 5EN

3 Market Place and Associated Store

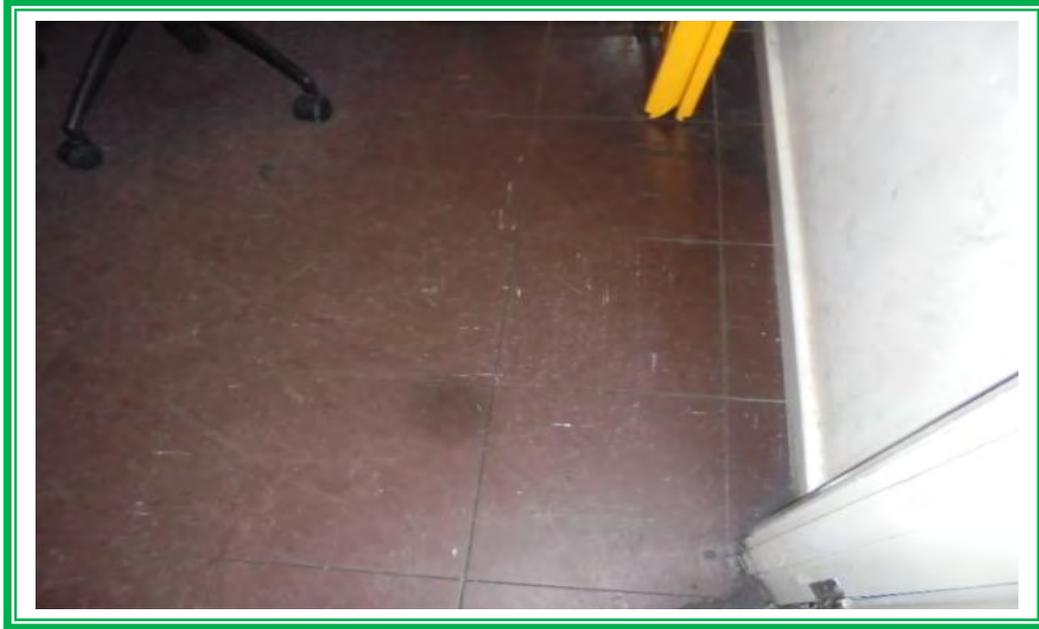
Location: 0/005 Comms Room

Material Description:	Floor Tiles	
Identification:	As Per Sample NE/4 – No Asbestos Detected	
Approx. quantity:	4M2	
Accessibility	N/A	Assessment Score
Product type:	N/A	N/A
Extent of Damage:	N/A	N/A
Surface Treatment:	N/A	N/A
Asbestos type:	N/A	N/A
Material Assessment Score:		N/A
Priority Assessment Score:		N/A
Action:	N/A	
Comments:	N/A
