Document Name	Author	Issued by	Revision Number	Issue Date	Page No
2019	Emma Humphreys	Armour AS	0	29/11/2019	25

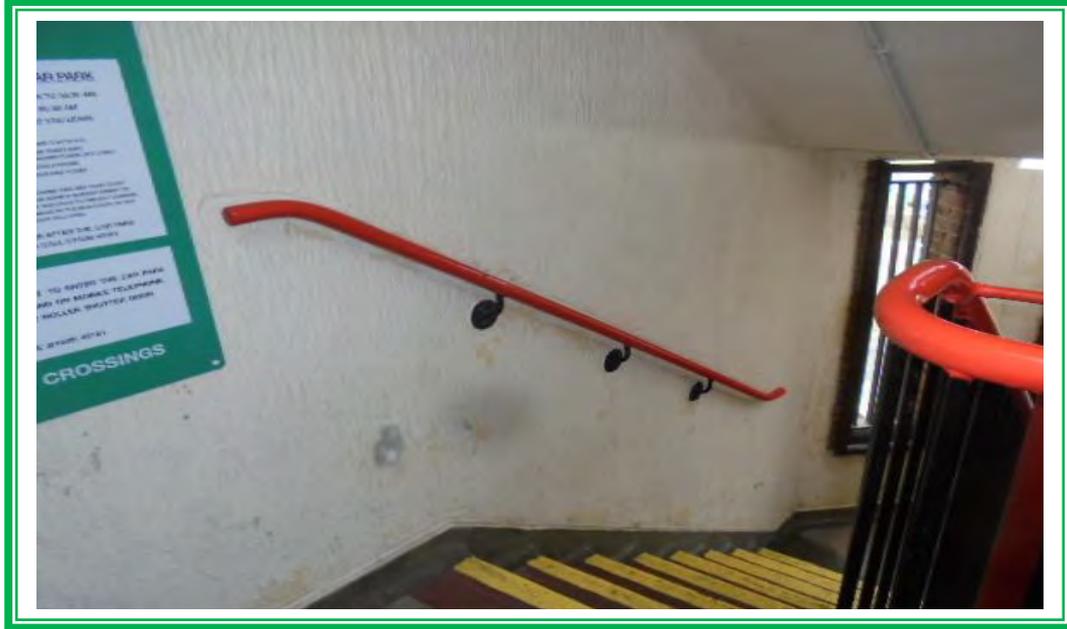
Item No: 20

Location: 2/002 South East Stairwell – Level 1 and 2

Material Description:	Textured Coating to Walls	
Identification:	As Per Sample NE/6 – No Asbestos Detected	
Approx. quantity:	25M2	
Accessibility	N/A	Assessment Score
Product type:	N/A	N/A
Extent of Damage:	N/A	N/A
Surface Treatment:	N/A	N/A
Asbestos type:	N/A	N/A
Material Assessment Score:		N/A
Priority Assessment Score:		N/A
Action:	N/A	
Comments:	N/A

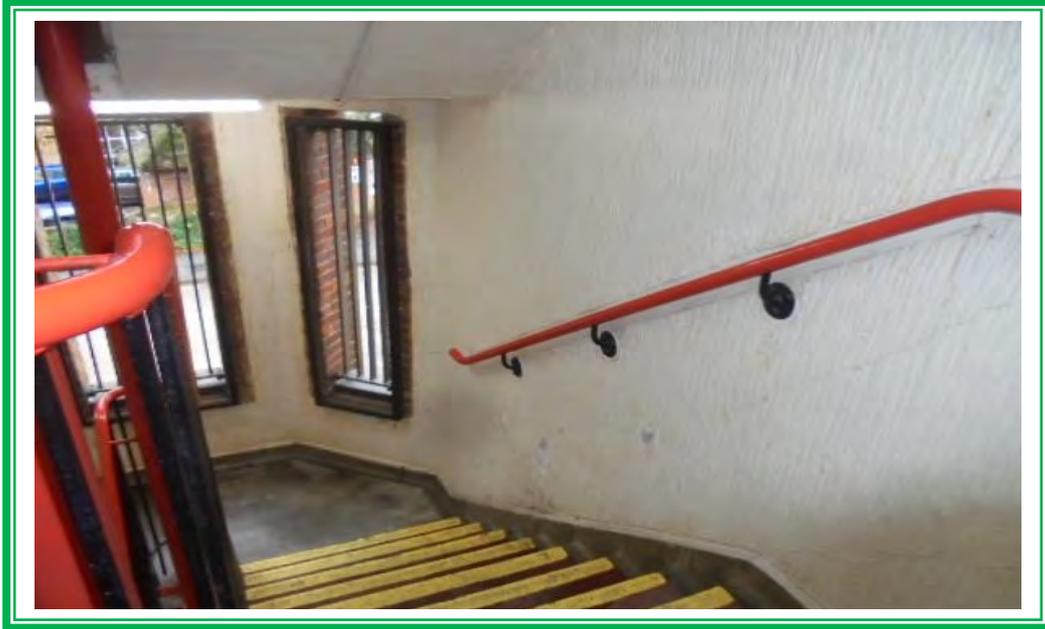
Item No: 21

Location: 2/003 South West Stairwell – Level 1 and 2

Material Description:	Textured Coating to Walls	
Identification:	Sampled – No Asbestos Detected	
Approx. quantity:	25M2	
Accessibility	N/A	Assessment Score
Product type:	N/A	N/A
Extent of Damage:	N/A	N/A
Surface Treatment:	N/A	N/A
Asbestos type:	N/A	N/A
Material Assessment Score:		N/A
Priority Assessment Score:		N/A
Action:	N/A	
Comments:	N/A

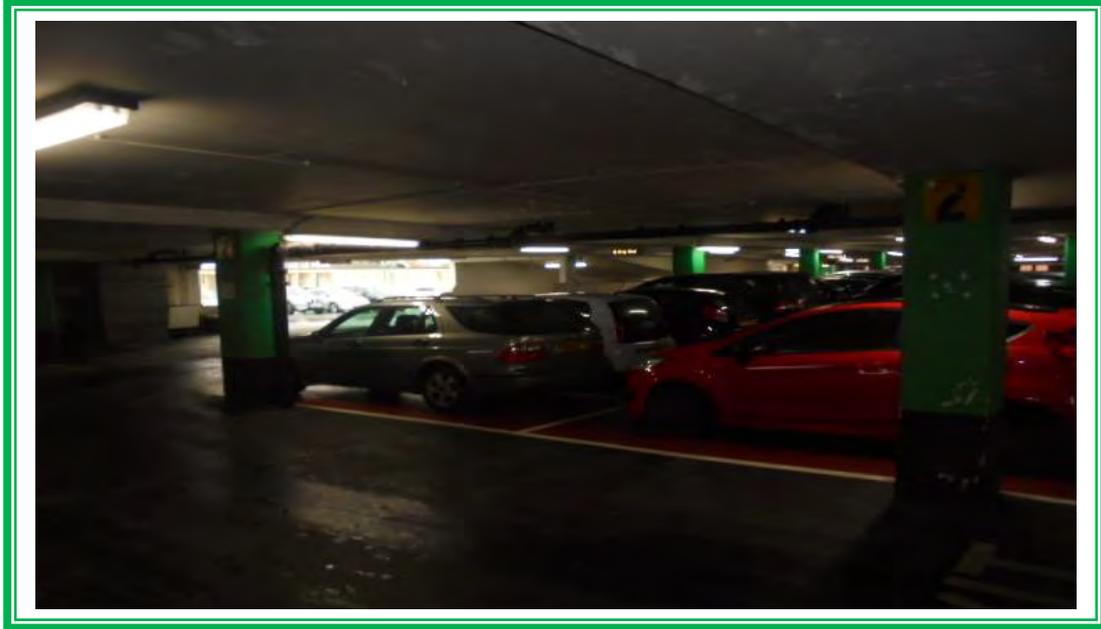
Item No: 22

Location: 2/004 Car Park

Material Description:	Visual Inspection – No Suspect Materials Found	
Identification:	N/A	
Approx. quantity:	N/A	
Accessibility	N/A	Assessment Score
Product type:	N/A	N/A
Extent of Damage:	N/A	N/A
Surface Treatment:	N/A	N/A
Asbestos type:	N/A	N/A
Material Assessment Score:		N/A
Priority Assessment Score:		N/A
Action:	N/A	
Comments:	N/A

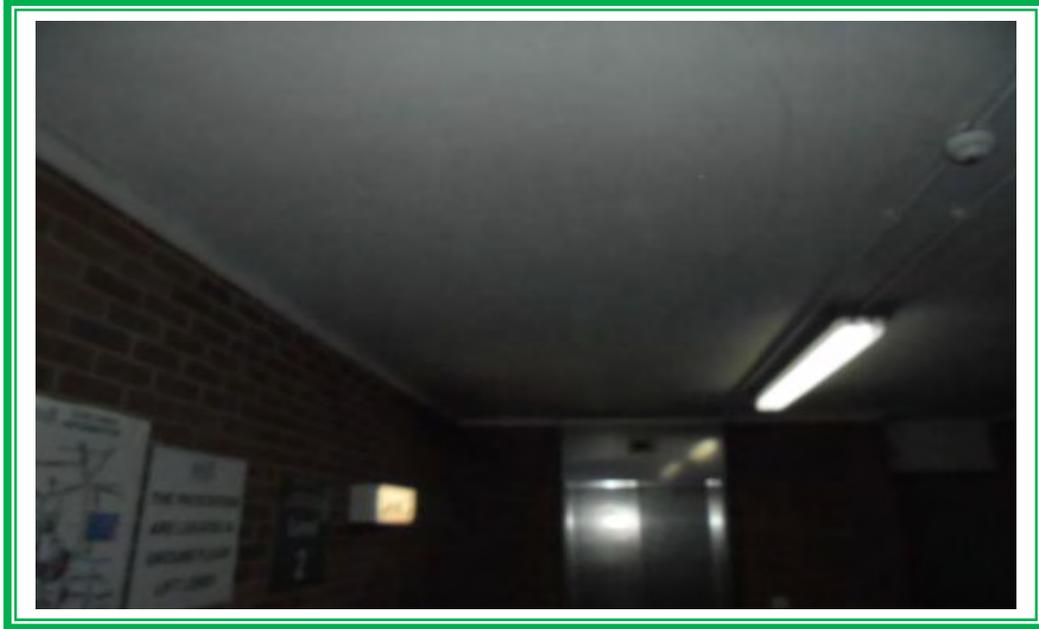
Item No: 23

Location: 2/005 Lift Lobby

Material Description:	Visual Inspection – No Suspect Materials Found	
Identification:	N/A	
Approx. quantity:	N/A	
Accessibility	N/A	Assessment Score
Product type:	N/A	N/A
Extent of Damage:	N/A	N/A
Surface Treatment:	N/A	N/A
Asbestos type:	N/A	N/A
Material Assessment Score:		N/A
Priority Assessment Score:		N/A
Action:	N/A	
Comments:	N/A

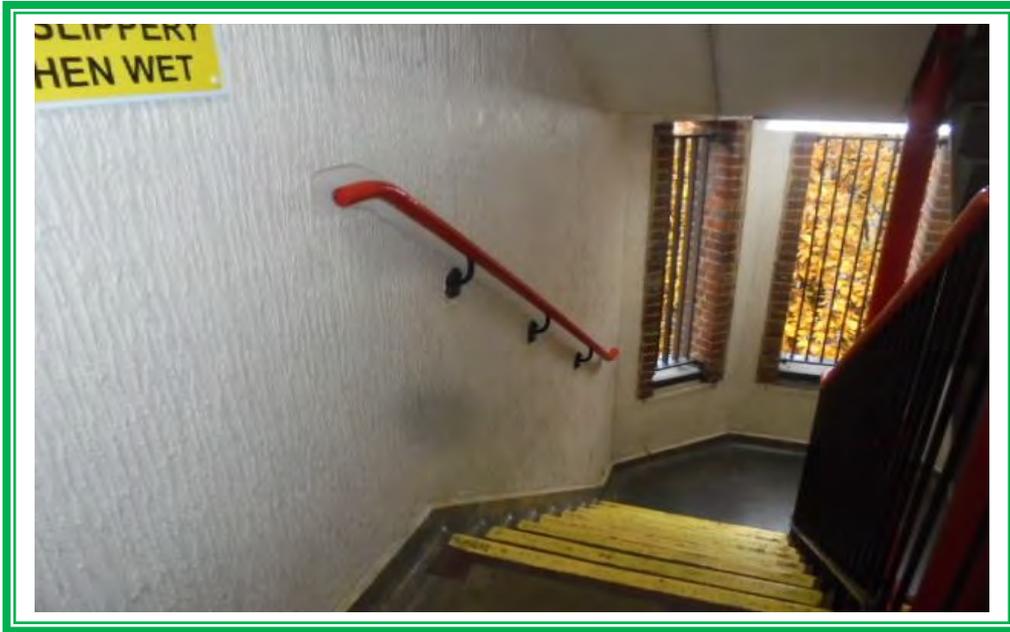
Item No: 24

Location: 2/006 North Stairwell – Level 1 and 2

Material Description:	Textured Coating to Walls	
Identification:	As Per Sample NE/6 – No Asbestos Detected	
Approx. quantity:	40M2	
Accessibility	N/A	Assessment Score
Product type:	N/A	N/A
Extent of Damage:	N/A	N/A
Surface Treatment:	N/A	N/A
Asbestos type:	N/A	N/A
Material Assessment Score:		N/A
Priority Assessment Score:		N/A
Action:	N/A	
Comments:	N/A

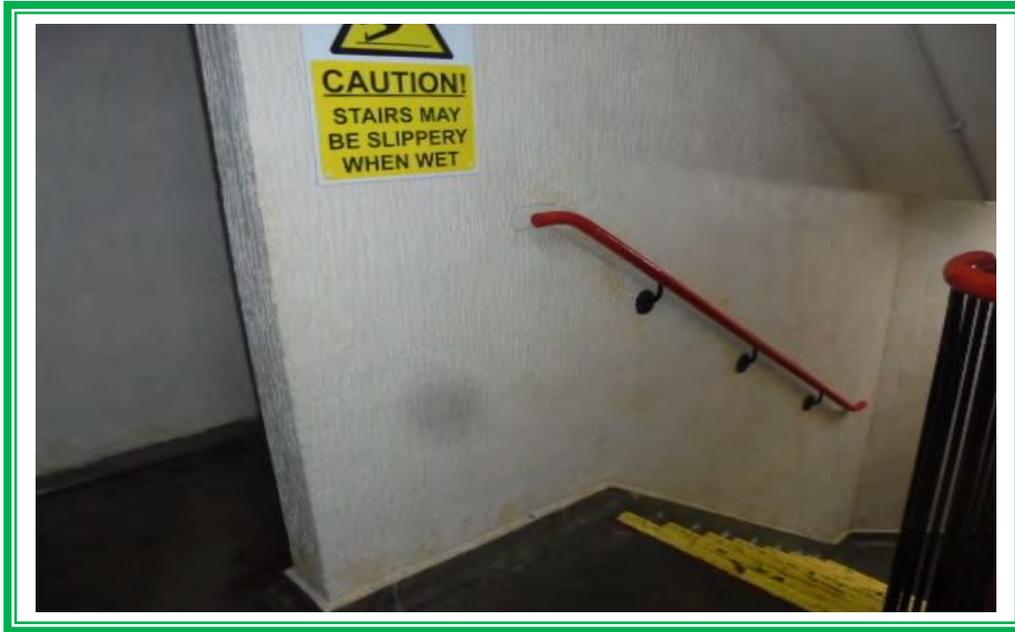
Item No: 25

Location: 1/002 North Stairwell – Level 1 - 0

Material Description:	Textured Coating to Walls	
Identification:	Sampled – No Asbestos Detected	
Approx. quantity:	40M2	
Accessibility	N/A	Assessment Score
Product type:	N/A	N/A
Extent of Damage:	N/A	N/A
Surface Treatment:	N/A	N/A
Asbestos type:	N/A	N/A
Material Assessment Score:		N/A
Priority Assessment Score:		N/A
Action:	N/A	
Comments:	N/A

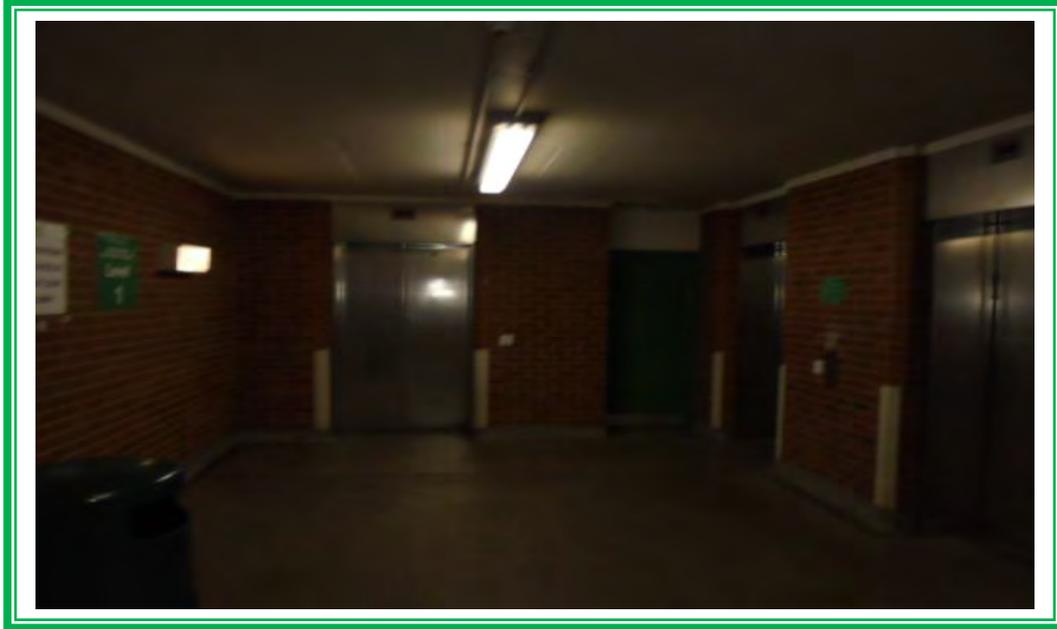
Location: 1/003 Lift Lobby

Material Description:	Visual Inspection – No Suspect Materials Found	
Identification:	N/A	
Approx. quantity:	N/A	
Accessibility	N/A	Assessment Score
Product type:	N/A	N/A
Extent of Damage:	N/A	N/A
Surface Treatment:	N/A	N/A
Asbestos type:	N/A	N/A
Material Assessment Score:		N/A
Priority Assessment Score:		N/A
Action:	N/A	
Comments:	N/A

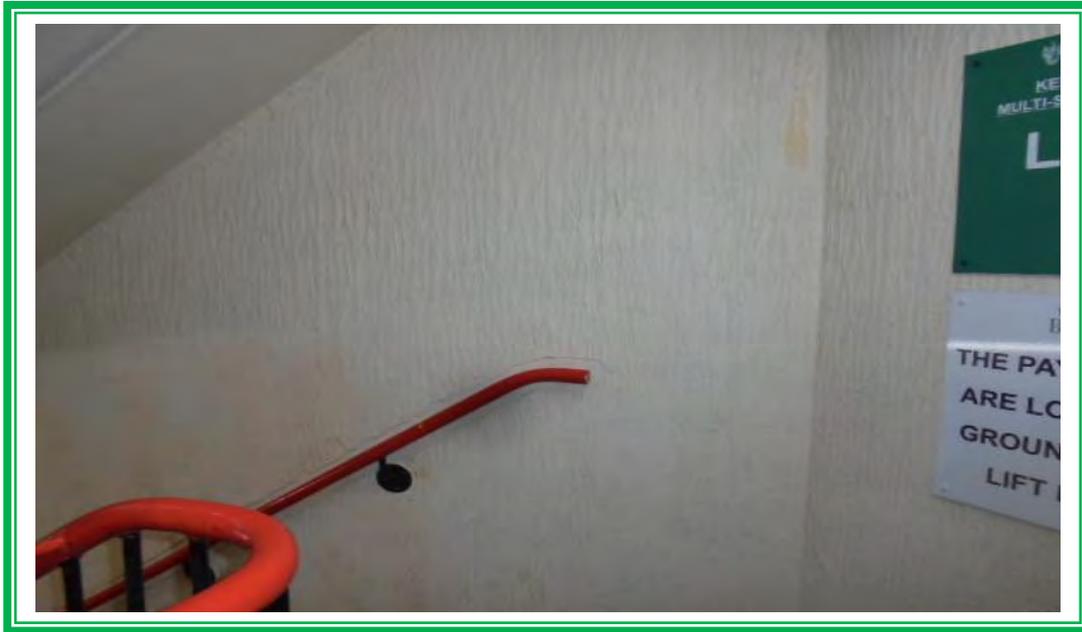
Location: 1/004 South West Stairwell - Level 1 - 0

Material Description:	Textured Coating to Walls	
Identification:	As Per Sample NE/7 – No Asbestos Detected	
Approx. quantity:	25M2	
Accessibility	N/A	Assessment Score
Product type:	N/A	N/A
Extent of Damage:	N/A	N/A
Surface Treatment:	N/A	N/A
Asbestos type:	N/A	N/A
Material Assessment Score:		N/A
Priority Assessment Score:		N/A
Action:	N/A	
Comments:	N/A

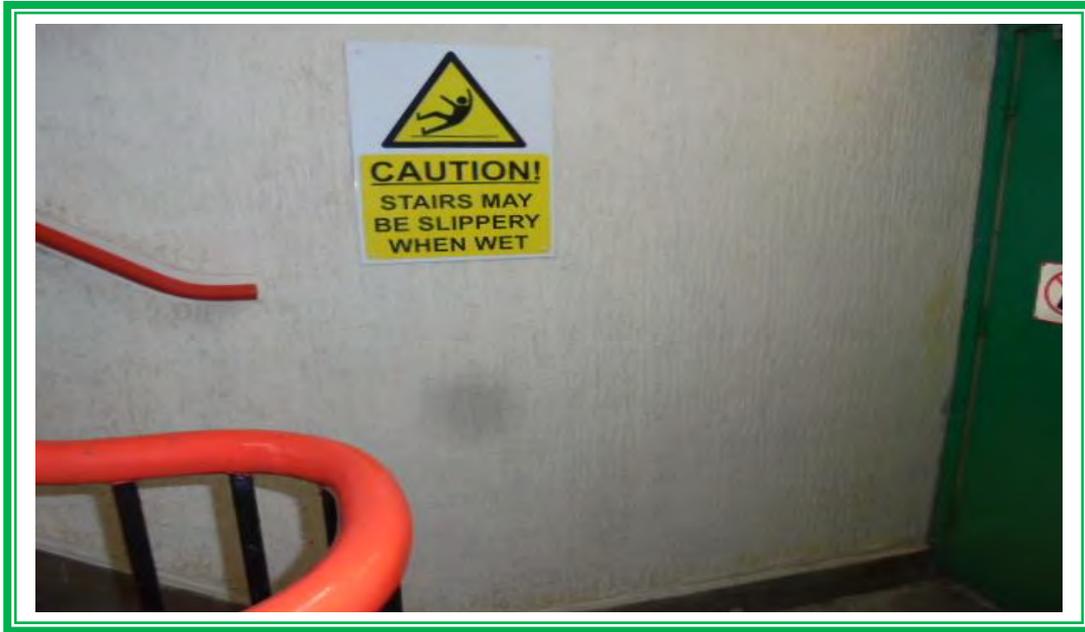
Location: 1/005 South East Stairwell – Level 1 - 0

Material Description:	Visual Inspection – No Suspect Materials Found	
Identification:	N/A	
Approx. quantity:	N/A	
Accessibility	N/A	Assessment Score
Product type:	N/A	N/A
Extent of Damage:	N/A	N/A
Surface Treatment:	N/A	N/A
Asbestos type:	N/A	N/A
Material Assessment Score:		N/A
Priority Assessment Score:		N/A
Action:	N/A	
Comments:	N/A

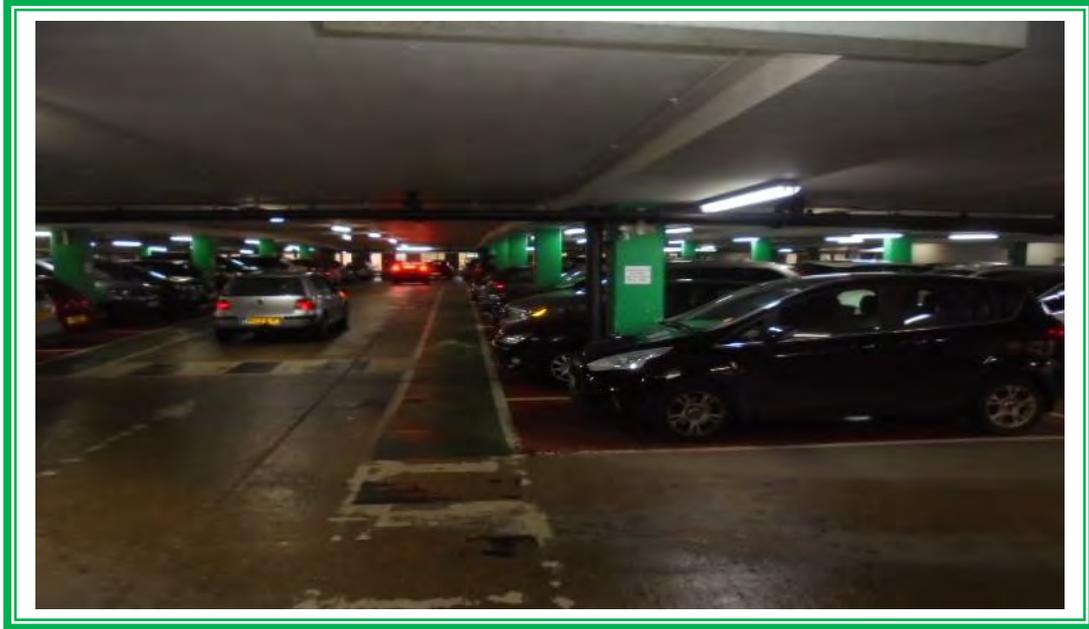
Location: 1/006 Car Park

Material Description:	Visual Inspection – No Suspect Materials Found	
Identification:	N/A	
Approx. quantity:	N/A	
Accessibility	N/A	Assessment Score
Product type:	N/A	N/A
Extent of Damage:	N/A	N/A
Surface Treatment:	N/A	N/A
Asbestos type:	N/A	N/A
Material Assessment Score:		N/A
Priority Assessment Score:		N/A
Action:	N/A	
Comments:	N/A

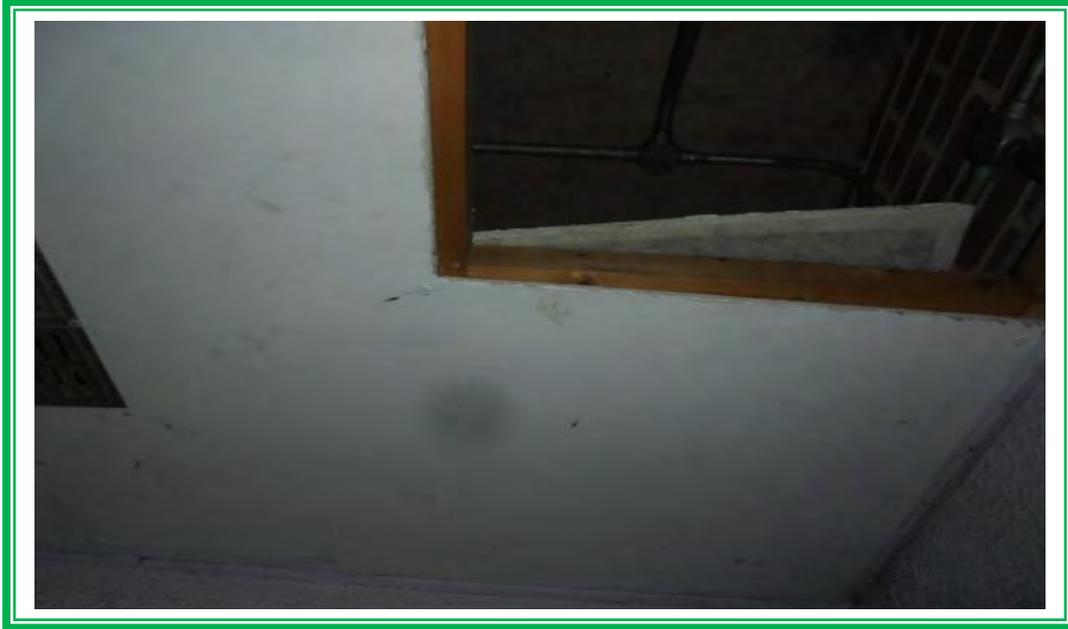
Location: 0/004 Lift Lobby

Material Description:	Insulation Board Ceiling and Hatch	
Identification:	Sampled – No Asbestos Detected	
Approx. quantity:	3M2	
Accessibility	N/A	Assessment Score
Product type:	N/A	N/A
Extent of Damage:	N/A	N/A
Surface Treatment:	N/A	N/A
Asbestos type:	N/A	N/A
Material Assessment Score:		N/A
Priority Assessment Score:		N/A
Action:	N/A	
Comments:	N/A

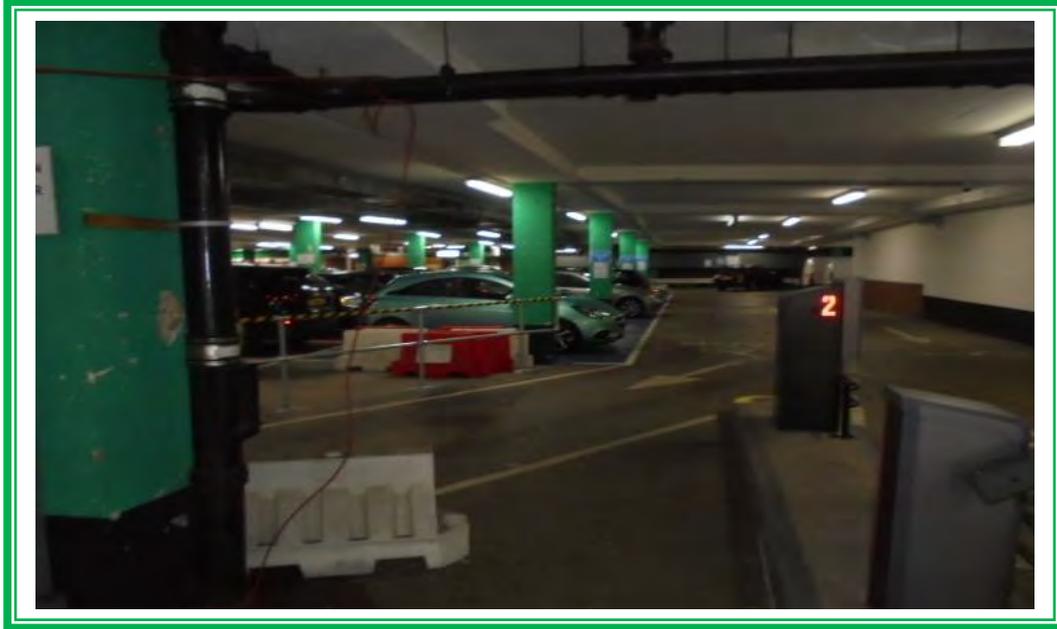
Location: 0/007 Car Park

Material Description:	Visual Inspection – No Suspect Materials Found	
Identification:	N/A	
Approx. quantity:	N/A	
Accessibility	N/A	Assessment Score
Product type:	N/A	N/A
Extent of Damage:	N/A	N/A
Surface Treatment:	N/A	N/A
Asbestos type:	N/A	N/A
Material Assessment Score:		N/A
Priority Assessment Score:		N/A
Action:	N/A	
Comments:	N/A

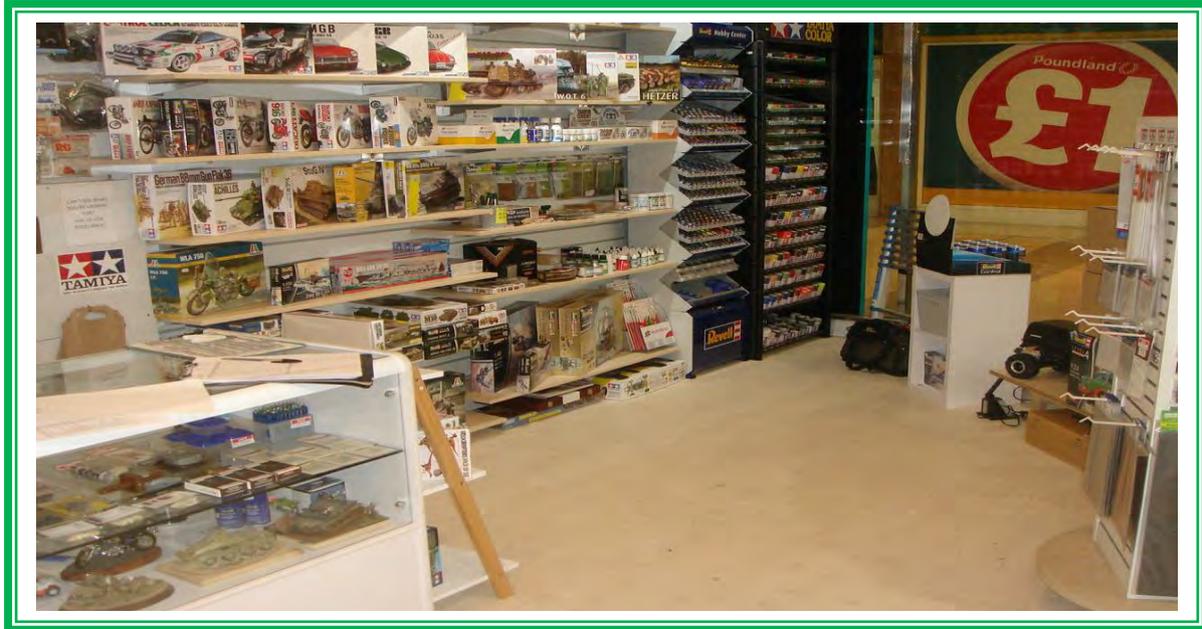
Location: 0/001 Shop Floor

Material Description:	Visual Inspection – No Suspect Materials Found	
Identification:	N/A	
Approx. quantity:	N/A	
Accessibility	N/A	Assessment Score
Product type:	N/A	N/A
Extent of Damage:	N/A	N/A
Surface Treatment:	N/A	N/A
Asbestos type:	N/A	N/A
Material Assessment Score:		N/A
Priority Assessment Score:		N/A
Action:	N/A	
Comments:	N/A

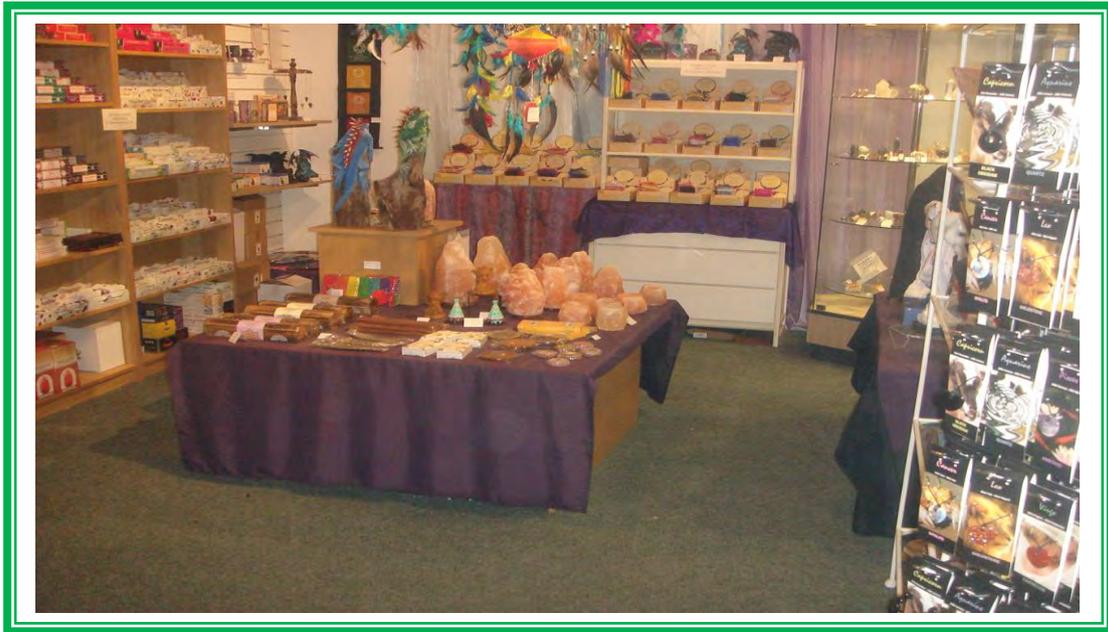
Item No: 1	Sample No: N/A
Location: 0/001

Material Description:	Visual Inspection – No Suspect Materials Found	
Identification:	N/A	
Approx. quantity:	N/A	
Accessibility	N/A	Assessment Score
Product type:	N/A	N/A
Extent of Damage:	N/A	N/A
Surface Treatment:	N/A	N/A
Asbestos type:	N/A	N/A
Material Assessment Score:		N/A
Priority Assessment Score:		N/A
Action:	N/A	
Comments:	N/A

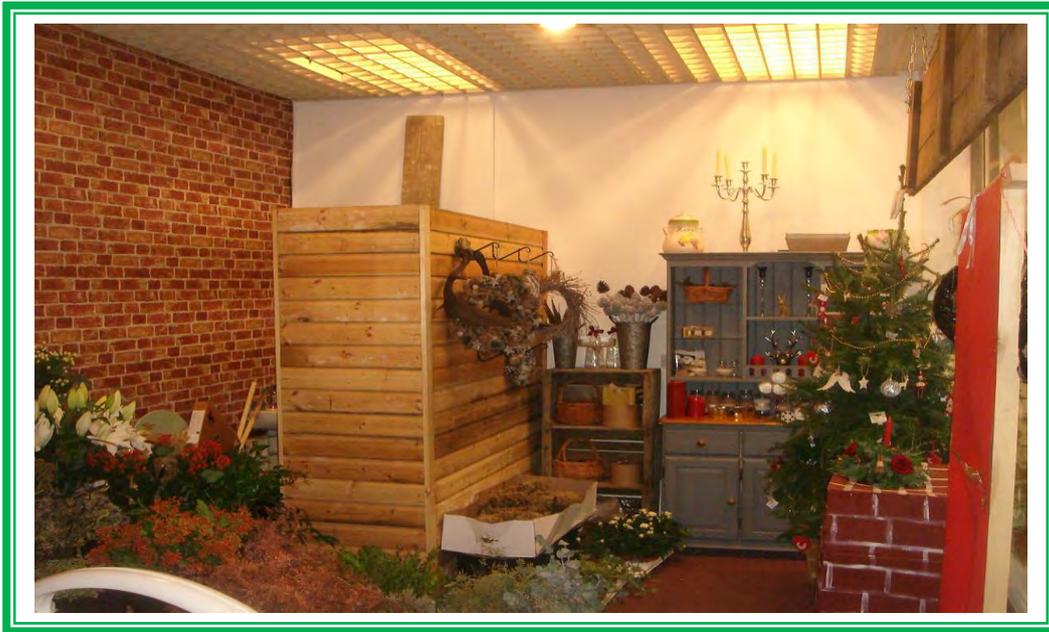
Location: 0/001 Shop

Material Description:	Visual Inspection – No Suspect Materials Found	
Identification:	N/A	
Approx. quantity:	N/A	
Accessibility	N/A	Assessment Score
Product type:	N/A	N/A
Extent of Damage:	N/A	N/A
Surface Treatment:	N/A	N/A
Asbestos type:	N/A	N/A
Material Assessment Score:		N/A
Priority Assessment Score:		N/A
Action:	N/A	
Comments:	N/A

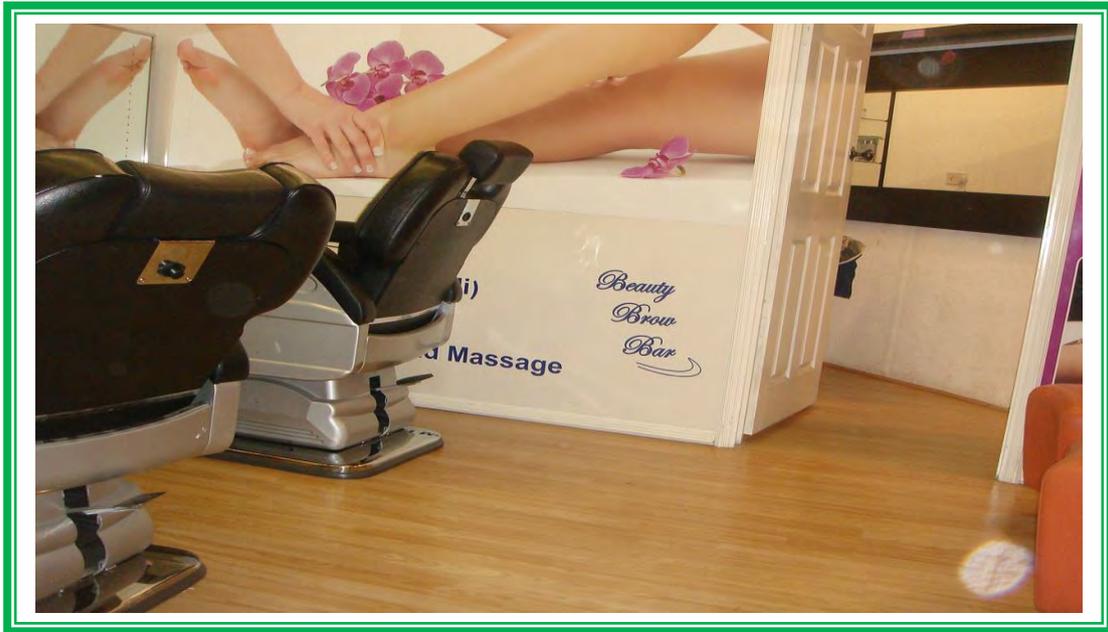
Item No: 1	Sample No: N/A
Location: 0/001

Material Description:	Visual Inspection – No Suspect Materials Found	
Identification:	N/A	
Approx. quantity:	N/A	
Accessibility	N/A	Assessment Score
Product type:	N/A	N/A
Extent of Damage:	N/A	N/A
Surface Treatment:	N/A	N/A
Asbestos type:	N/A	N/A
Material Assessment Score:		N/A
Priority Assessment Score:		N/A
Action:	N/A	
Comments:	N/A

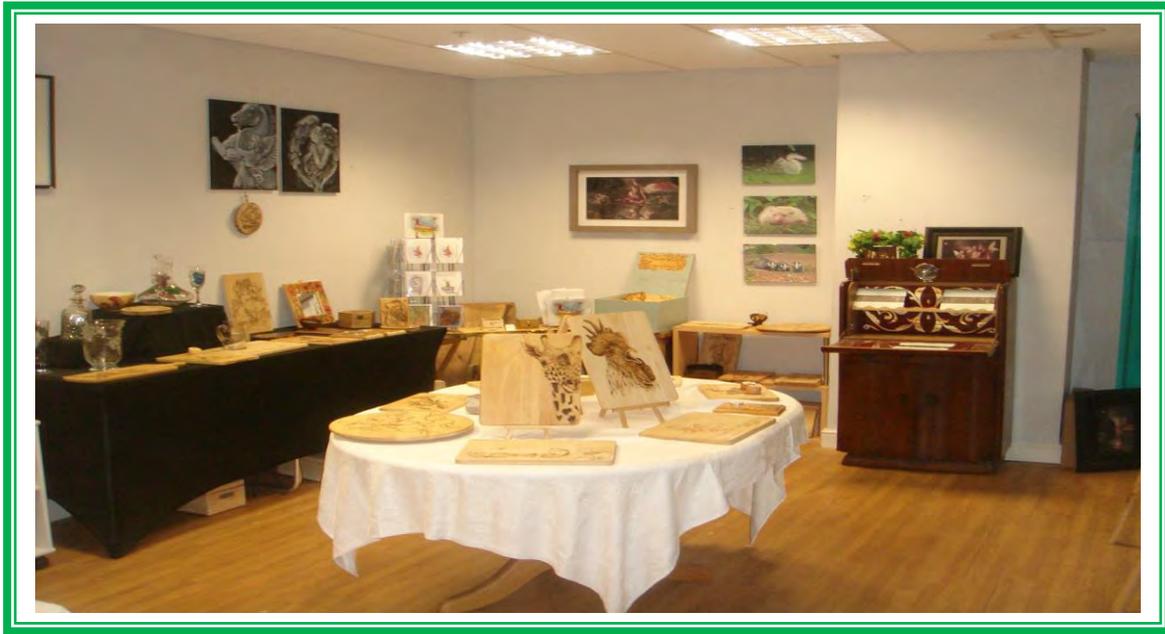
Location: 0/001

Material Description:	Visual Inspection – No Suspect Materials Found	
Identification:	N/A	
Approx. quantity:	N/A	
Accessibility	N/A	Assessment Score
Product type:	N/A	N/A
Extent of Damage:	N/A	N/A
Surface Treatment:	N/A	N/A
Asbestos type:	N/A	N/A
Material Assessment Score:		N/A
Priority Assessment Score:		N/A
Action:	N/A	
Comments:	N/A

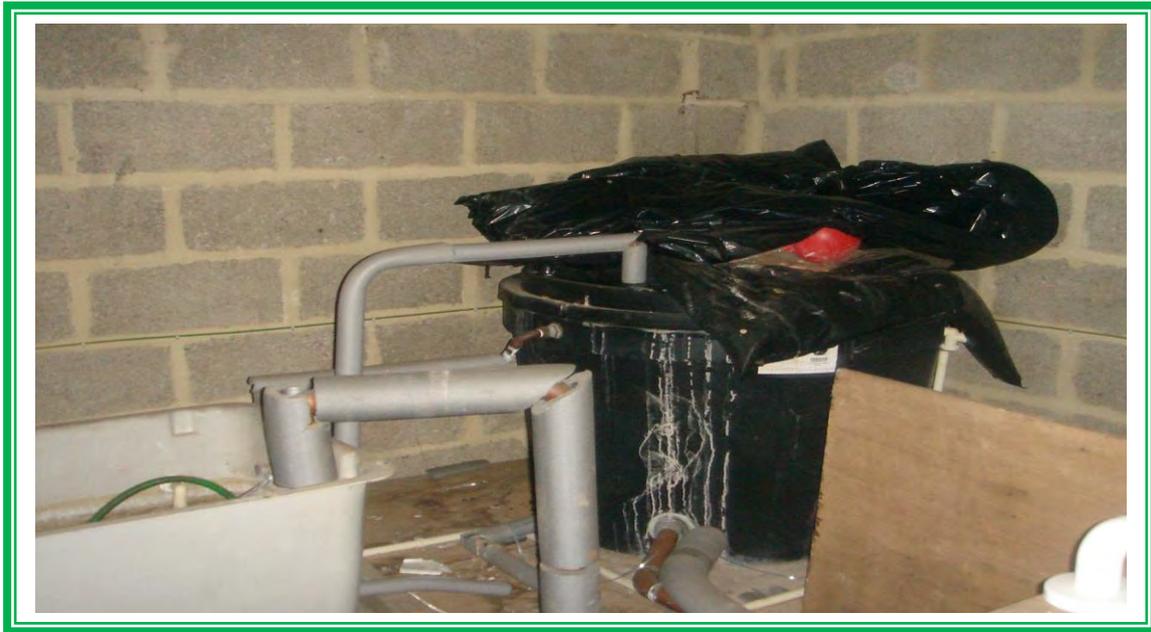
Item No: 1	Sample No: N/A
Location: 3/001 Tank Room

Material Description:	Visual Inspection – No Suspect Materials Found	
Identification:	N/A	
Approx. quantity:	N/A	
Accessibility	N/A	Assessment Score
Product type:	N/A	N/A
Extent of Damage:	N/A	N/A
Surface Treatment:	N/A	N/A
Asbestos type:	N/A	N/A
Material Assessment Score:		N/A
Priority Assessment Score:		N/A
Action:	N/A	
Comments:	N/A

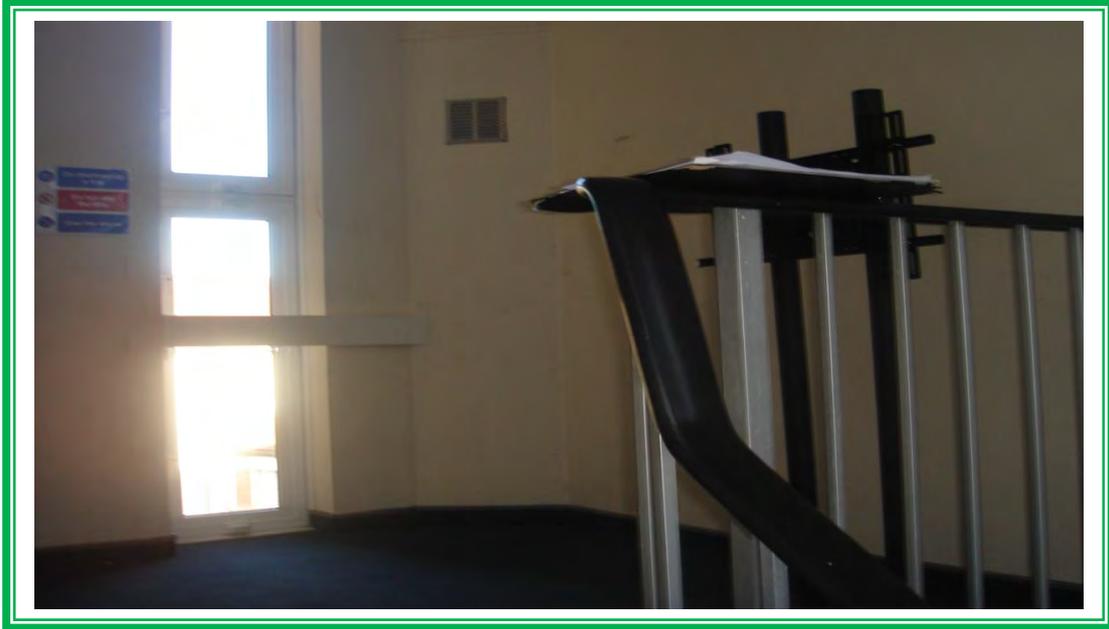
Location: 2/001 Stairs

Material Description:	Visual Inspection – No Suspect Materials Found	
Identification:	N/A	
Approx. quantity:	N/A	
Accessibility	N/A	Assessment Score
Product type:	N/A	N/A
Extent of Damage:	N/A	N/A
Surface Treatment:	N/A	N/A
Asbestos type:	N/A	N/A
Material Assessment Score:		N/A
Priority Assessment Score:		N/A
Action:	N/A	
Comments:	N/A

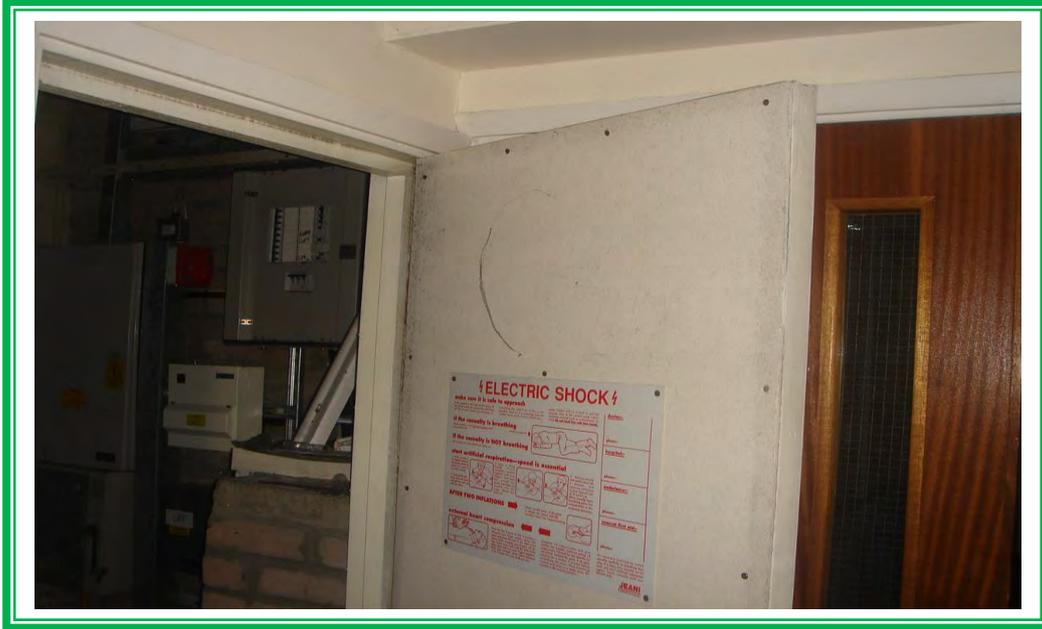
Location: 2/003

Material Description:	Insulating Board to Door	
Identification:	Sampled – No Asbestos Detected	
Approx. quantity:	2M2	
Accessibility	N/A	Assessment Score
Product type:	N/A	N/A
Extent of Damage:	N/A	N/A
Surface Treatment:	N/A	N/A
Asbestos type:	N/A	N/A
Material Assessment Score:		N/A
Priority Assessment Score:		N/A
Action:	N/A	
Comments:	N/A

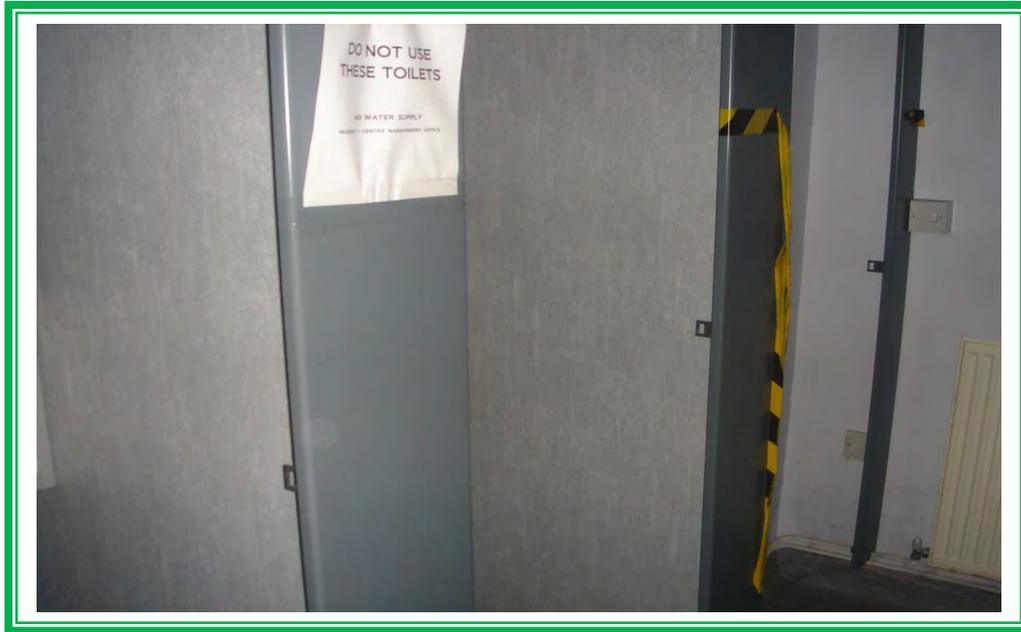
Location: 2/007 Male WC

Material Description:	Visual Inspection – No Suspect Materials Found	
Identification:	N/A	
Approx. quantity:	N/A	
Accessibility	N/A	Assessment Score
Product type:	N/A	N/A
Extent of Damage:	N/A	N/A
Surface Treatment:	N/A	N/A
Asbestos type:	N/A	N/A
Material Assessment Score:		N/A
Priority Assessment Score:		N/A
Action:	N/A	
Comments:	N/A

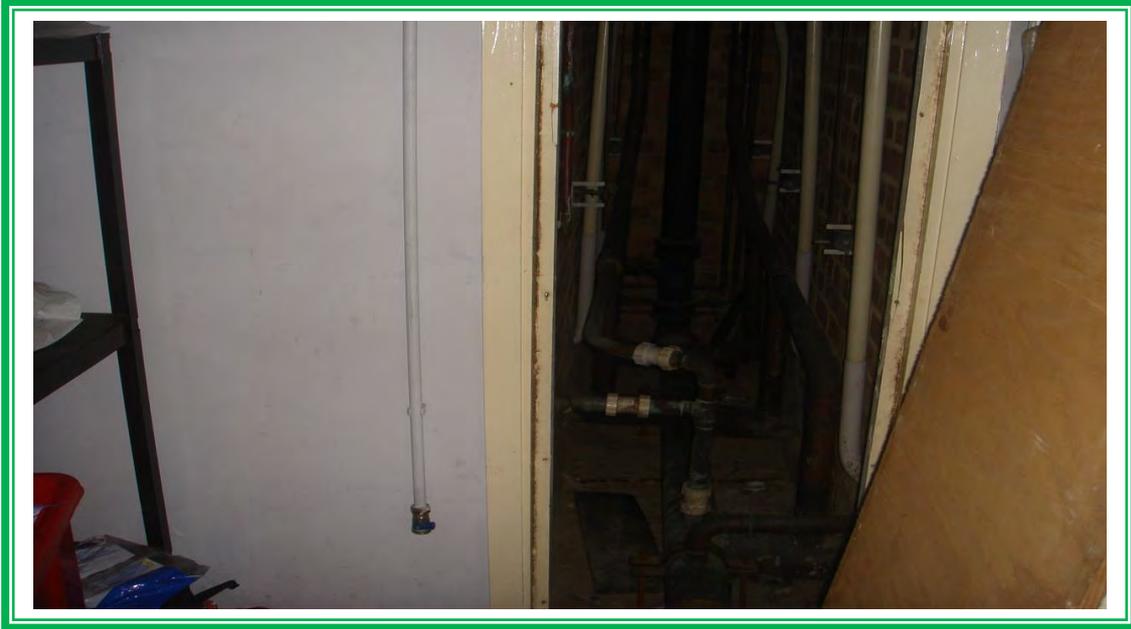
Location: 2/008 and 2/009 Water Closet

Material Description:	Visual Inspection – No Suspect Materials Found	
Identification:	N/A	
Approx. quantity:	N/A	
Accessibility	N/A	Assessment Score
Product type:	N/A	N/A
Extent of Damage:	N/A	N/A
Surface Treatment:	N/A	N/A
Asbestos type:	N/A	N/A
Material Assessment Score:		N/A
Priority Assessment Score:		N/A
Action:	N/A	
Comments:	N/A

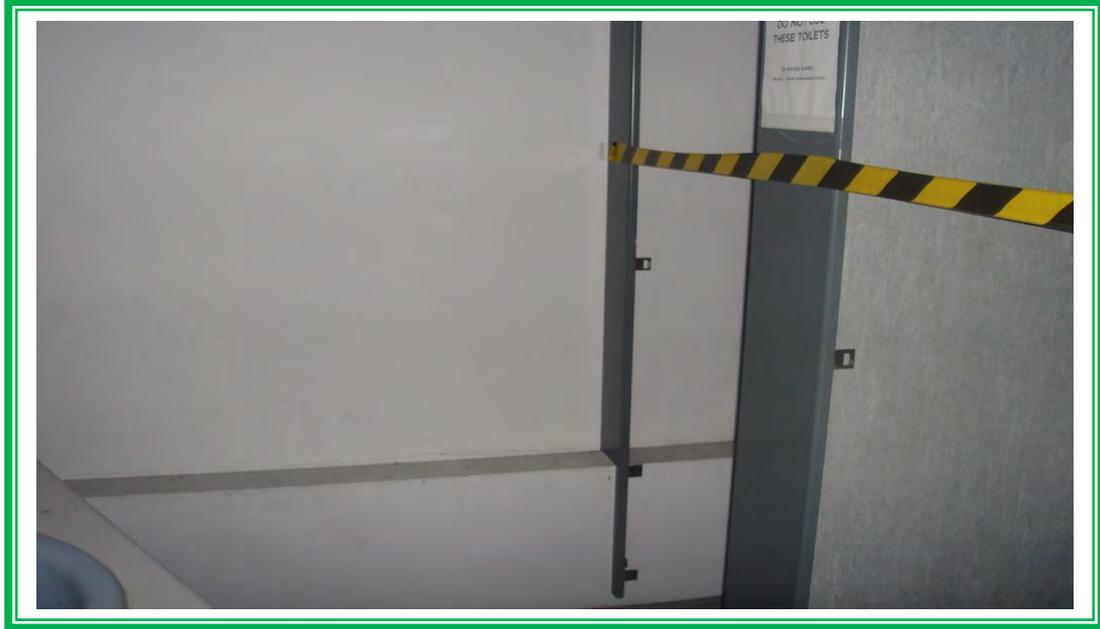
Location: 2/010 Female WC

Material Description:	Visual Inspection – No Suspect Materials Found	
Identification:	N/A	
Approx. quantity:	N/A	
Accessibility	N/A	Assessment Score
Product type:	N/A	N/A
Extent of Damage:	N/A	N/A
Surface Treatment:	N/A	N/A
Asbestos type:	N/A	N/A
Material Assessment Score:		N/A
Priority Assessment Score:		N/A
Action:	N/A	
Comments:	N/A

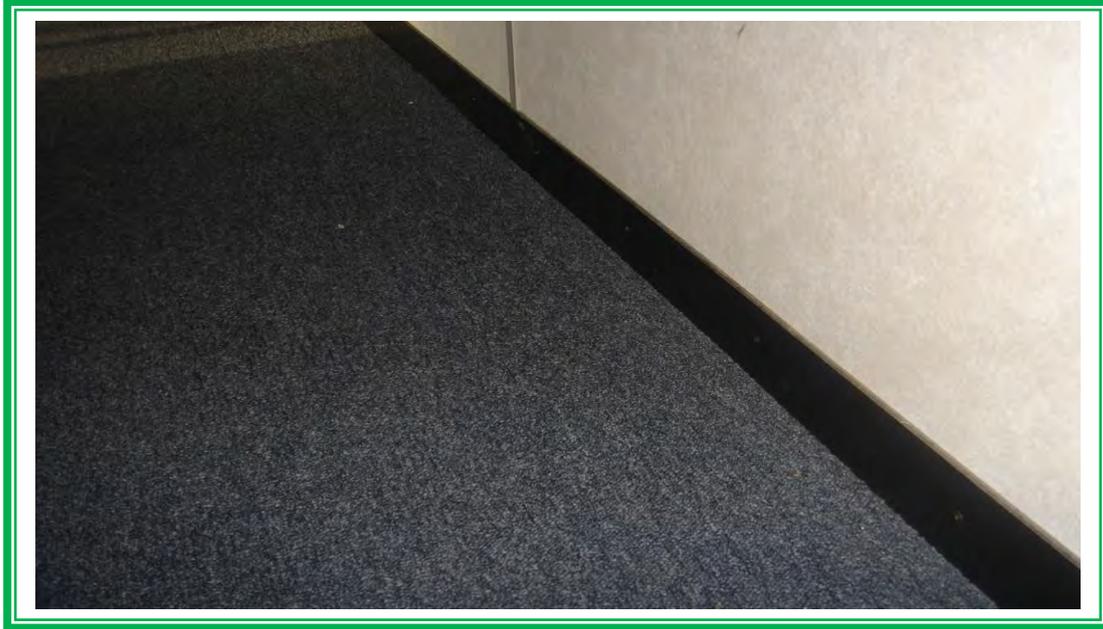
Location: 2/004 Corridor

Material Description:	Black Skirting Board	
Identification:	Sampled - No Asbestos Detected	
Approx. quantity:	> 300LM	
Accessibility	N/A	Assessment Score
Product type:	N/A	N/A
Extent of Damage:	N/A	N/A
Surface Treatment:	N/A	N/A
Asbestos type:	N/A	N/A
Material Assessment Score:		N/A
Priority Assessment Score:		N/A
Action:	N/A	
Comments:	Skirting Board Are to Every Wall on Second Floor (Every Room)

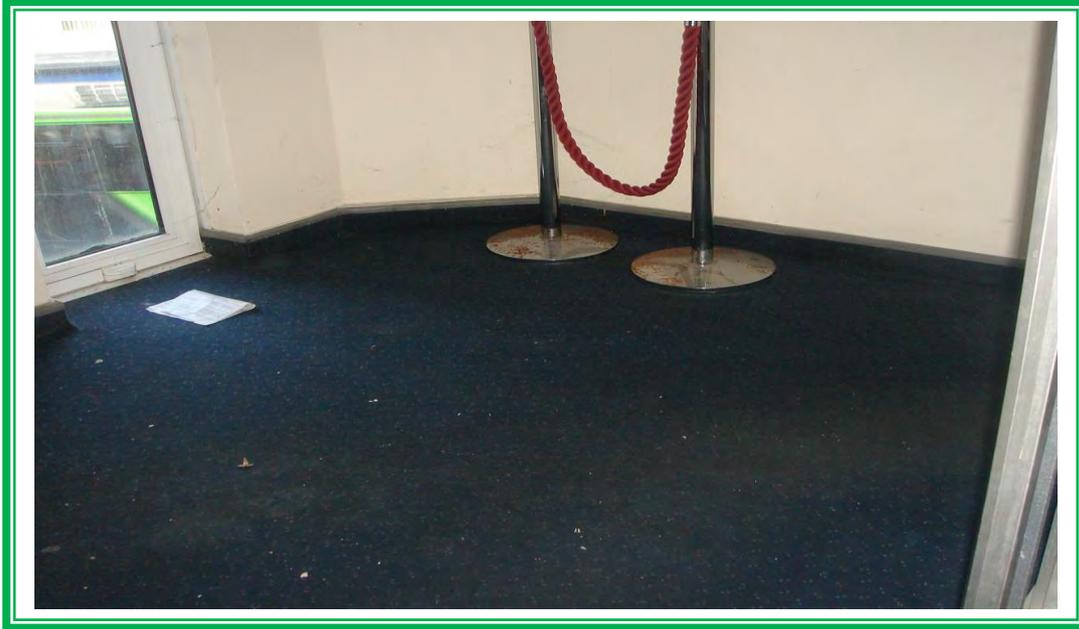
Location: 1/001 Stairs

Material Description:	Visual Inspection – No Suspect Materials Found	
Identification:	N/A	
Approx. quantity:	N/A	
Accessibility	N/A	Assessment Score
Product type:	N/A	N/A
Extent of Damage:	N/A	N/A
Surface Treatment:	N/A	N/A
Asbestos type:	N/A	N/A
Material Assessment Score:		N/A
Priority Assessment Score:		N/A
Action:	N/A	
Comments:	N/A

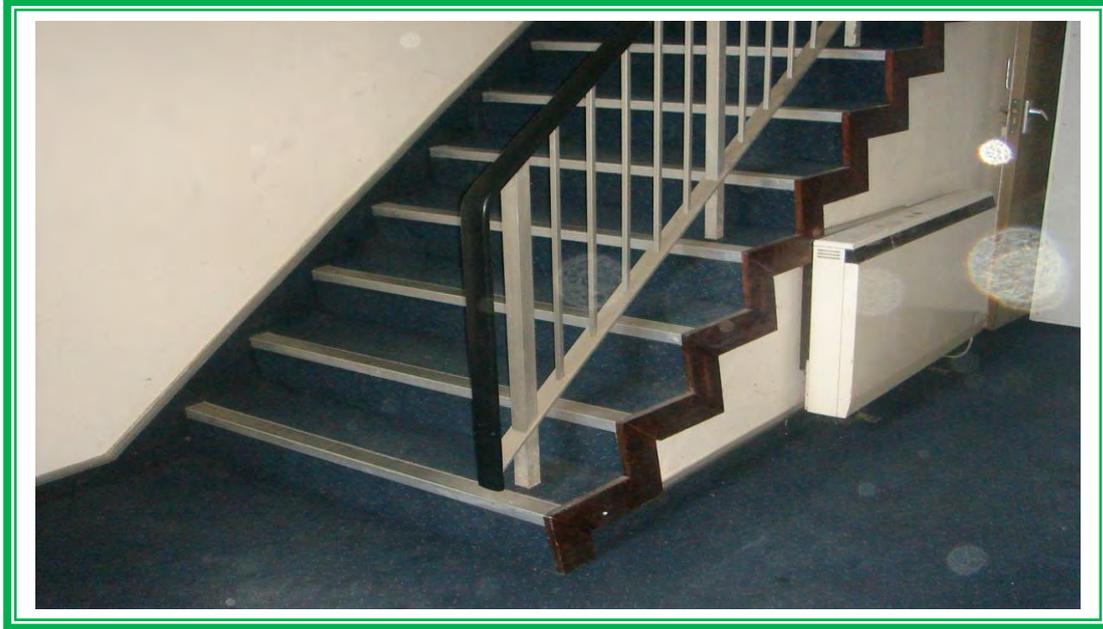
Location: 0/001 Stairs

Material Description:	Visual Inspection – No Suspect Materials Found	
Identification:	N/A	
Approx. quantity:	N/A	
Accessibility	N/A	Assessment Score
Product type:	N/A	N/A
Extent of Damage:	N/A	N/A
Surface Treatment:	N/A	N/A
Asbestos type:	N/A	N/A
Material Assessment Score:		N/A
Priority Assessment Score:		N/A
Action:	N/A	
Comments:	N/A

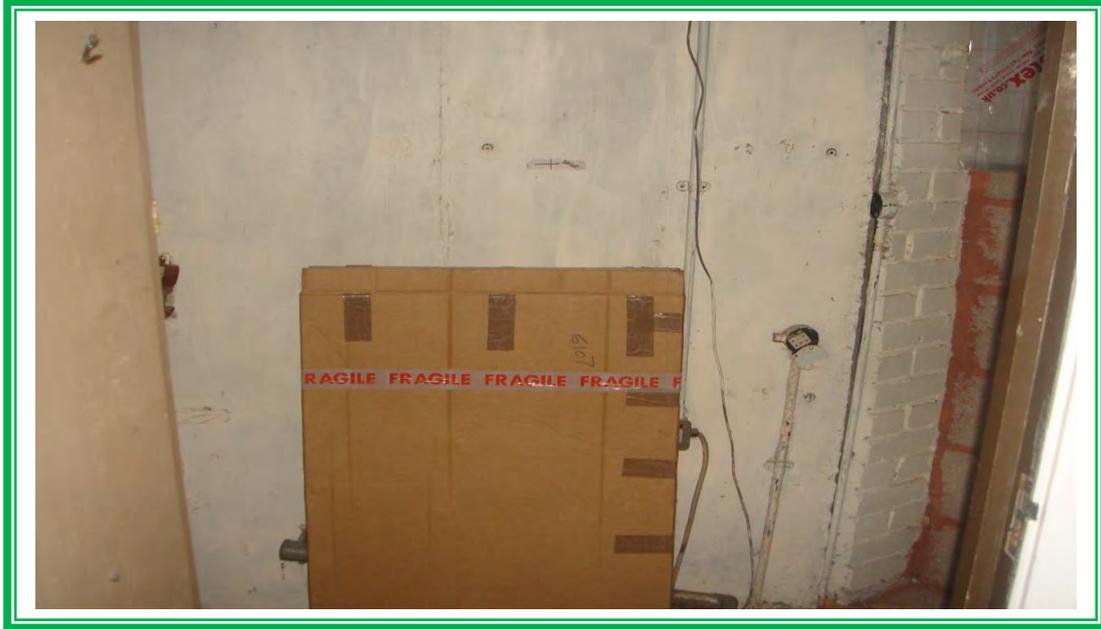
Location: 0/004

Material Description:	Visual Inspection – No Suspect Materials Found	
Identification:	N/A	
Approx. quantity:	N/A	
Accessibility	N/A	Assessment Score
Product type:	N/A	N/A
Extent of Damage:	N/A	N/A
Surface Treatment:	N/A	N/A
Asbestos type:	N/A	N/A
Material Assessment Score:		N/A
Priority Assessment Score:		N/A
Action:	N/A	
Comments:	N/A

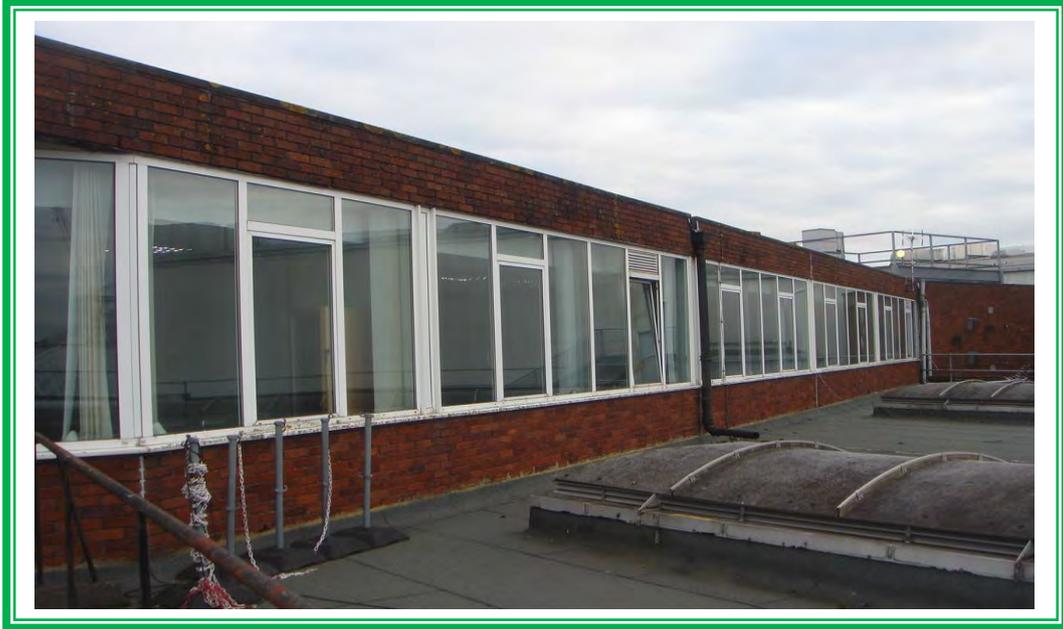
Location: 99/001 External

Material Description:	Visual Inspection – No Suspect Materials Found	
Identification:	N/A	
Approx. quantity:	N/A	
Accessibility	N/A	Assessment Score
Product type:	N/A	N/A
Extent of Damage:	N/A	N/A
Surface Treatment:	N/A	N/A
Asbestos type:	N/A	N/A
Material Assessment Score:		N/A
Priority Assessment Score:		N/A
Action:	N/A	
Comments:	N/A

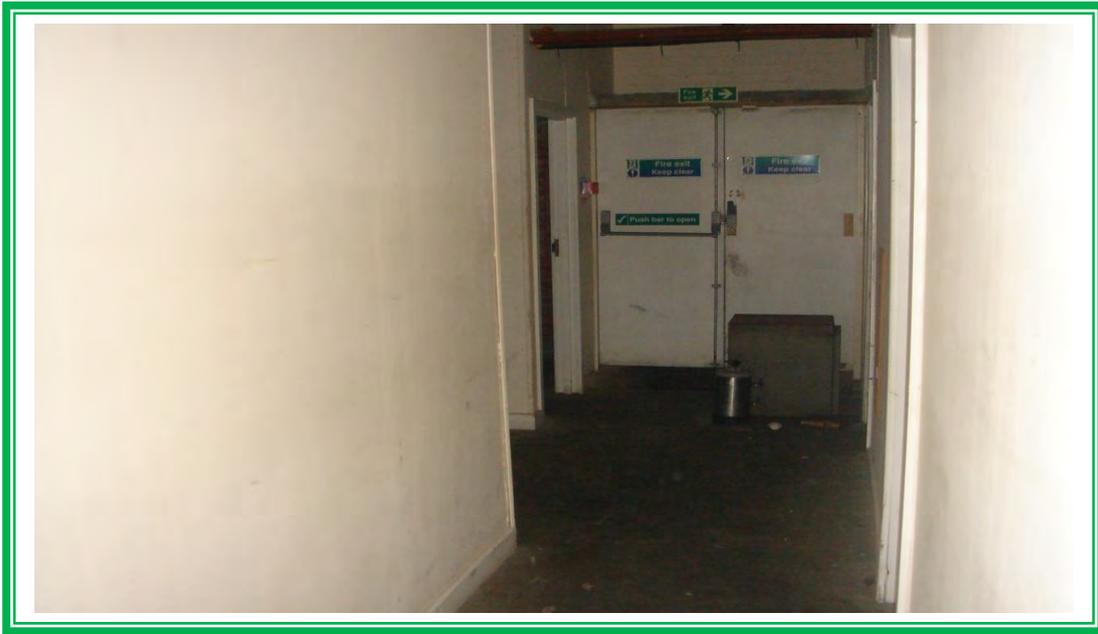
Location: 1/005 Corridor

Material Description:	Visual Inspection – No Suspect Materials Found	
Identification:	N/A	
Approx. quantity:	N/A	
Accessibility	N/A	Assessment Score
Product type:	N/A	N/A
Extent of Damage:	N/A	N/A
Surface Treatment:	N/A	N/A
Asbestos type:	N/A	N/A
Material Assessment Score:		N/A
Priority Assessment Score:		N/A
Action:	N/A	
Comments:	N/A
