Document Name	Author	Issued by	Revision Number	Issue Date	Page No
2019	Emma Humphreys	Armour AS	0	29/11/2019	25

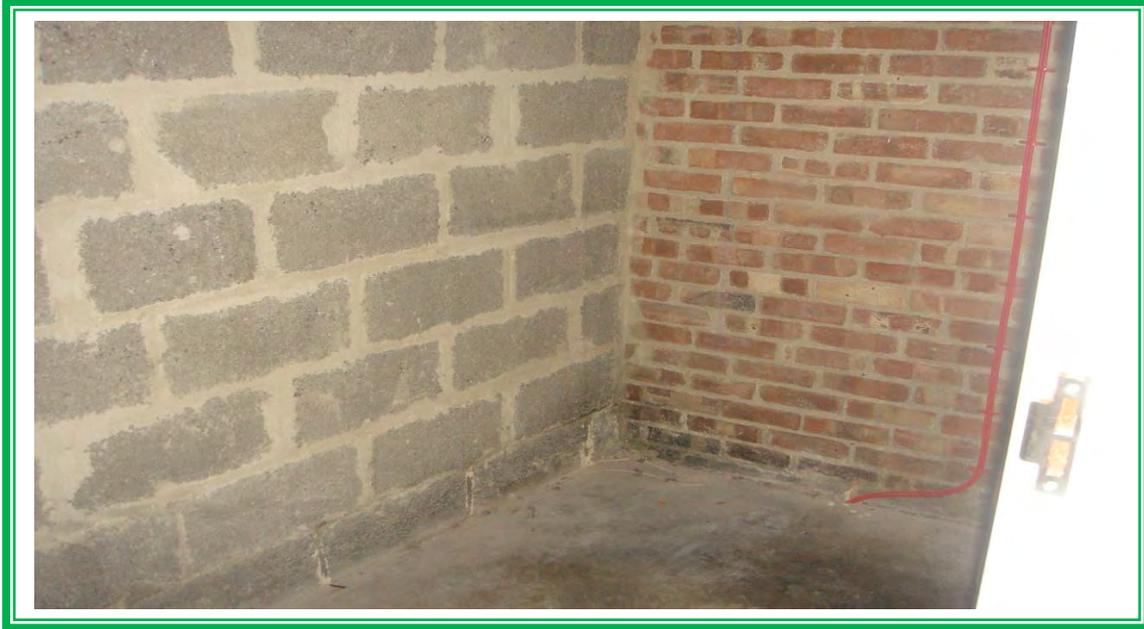
Location: 1/006 Store

Material Description:	Visual Inspection – No Suspect Materials Found	
Identification:	N/A	
Approx. quantity:	N/A	
Accessibility	N/A	Assessment Score
Product type:	N/A	N/A
Extent of Damage:	N/A	N/A
Surface Treatment:	N/A	N/A
Asbestos type:	N/A	N/A
Material Assessment Score:		N/A
Priority Assessment Score:		N/A
Action:	N/A	
Comments:	N/A

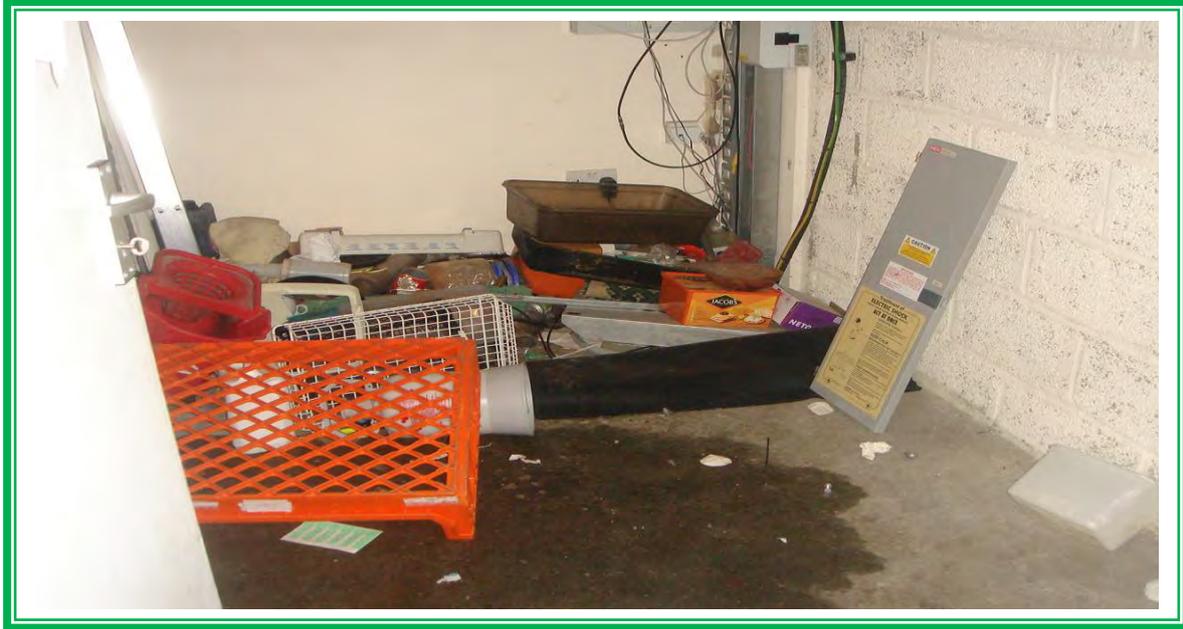
Location: 1/007

Material Description:	Visual Inspection – No Suspect Materials Found	
Identification:	N/A	
Approx. quantity:	N/A	
Accessibility	N/A	Assessment Score
Product type:	N/A	N/A
Extent of Damage:	N/A	N/A
Surface Treatment:	N/A	N/A
Asbestos type:	N/A	N/A
Material Assessment Score:		N/A
Priority Assessment Score:		N/A
Action:	N/A	
Comments:	N/A

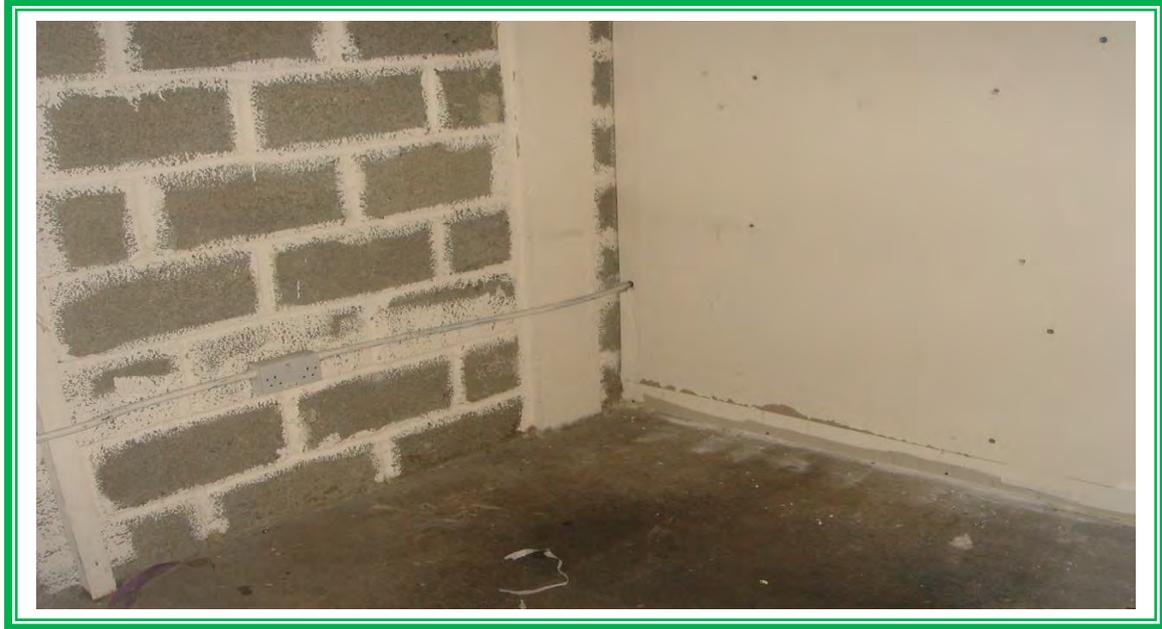
Location: 1/008

Material Description:	Visual Inspection – No Suspect Materials Found	
Identification:	N/A	
Approx. quantity:	N/A	
Accessibility	N/A	Assessment Score
Product type:	N/A	N/A
Extent of Damage:	N/A	N/A
Surface Treatment:	N/A	N/A
Asbestos type:	N/A	N/A
Material Assessment Score:		N/A
Priority Assessment Score:		N/A
Action:	N/A	
Comments:	N/A

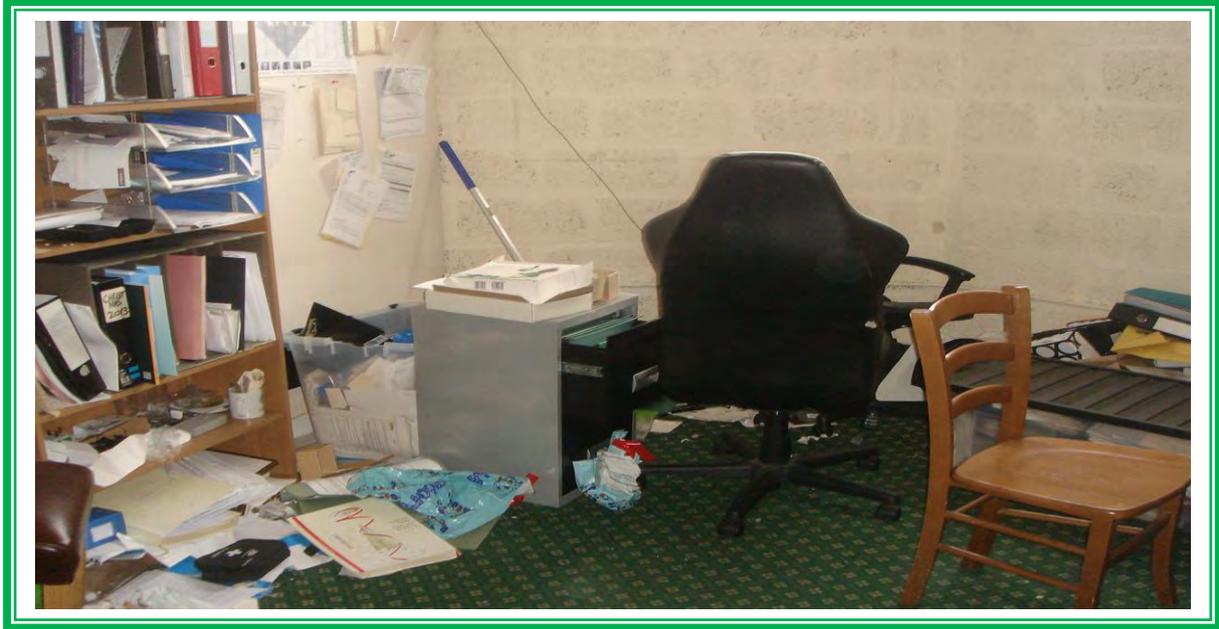
Location: 1/010 Store

Material Description:	Visual Inspection – No Suspect Materials Found	
Identification:	N/A	
Approx. quantity:	N/A	
Accessibility	N/A	Assessment Score
Product type:	N/A	N/A
Extent of Damage:	N/A	N/A
Surface Treatment:	N/A	N/A
Asbestos type:	N/A	N/A
Material Assessment Score:		N/A
Priority Assessment Score:		N/A
Action:	N/A	
Comments:	N/A

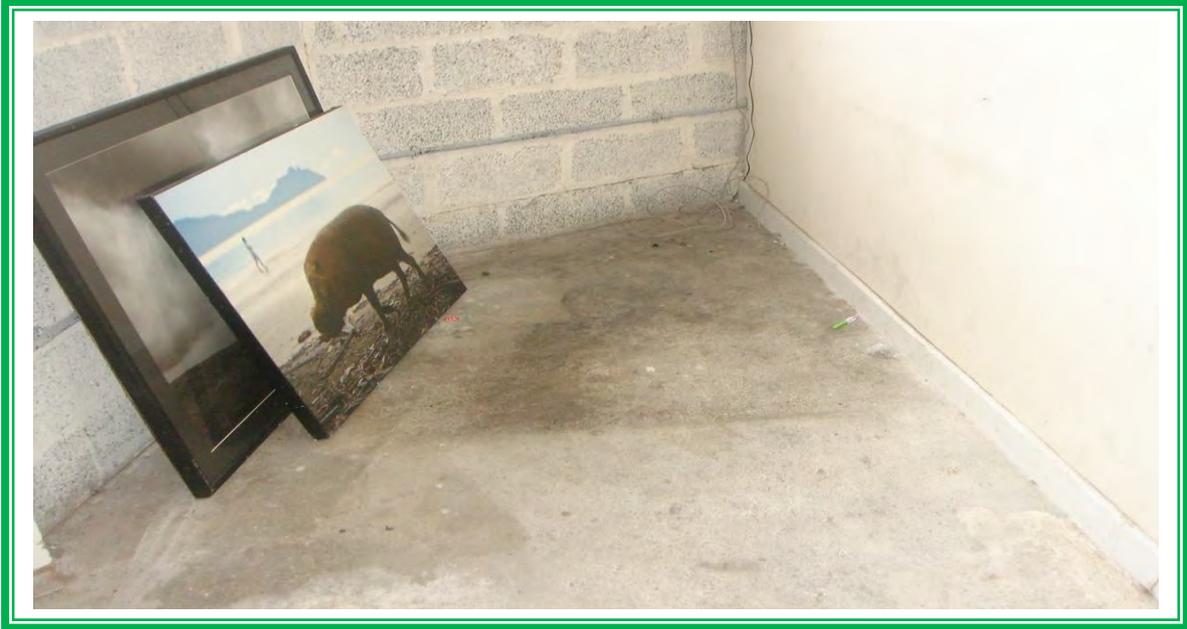
Location: 1/011 Store

Material Description:	Visual Inspection – No Suspect Materials Found	
Identification:	N/A	
Approx. quantity:	N/A	
Accessibility	N/A	Assessment Score
Product type:	N/A	N/A
Extent of Damage:	N/A	N/A
Surface Treatment:	N/A	N/A
Asbestos type:	N/A	N/A
Material Assessment Score:		N/A
Priority Assessment Score:		N/A
Action:	N/A	
Comments:	N/A

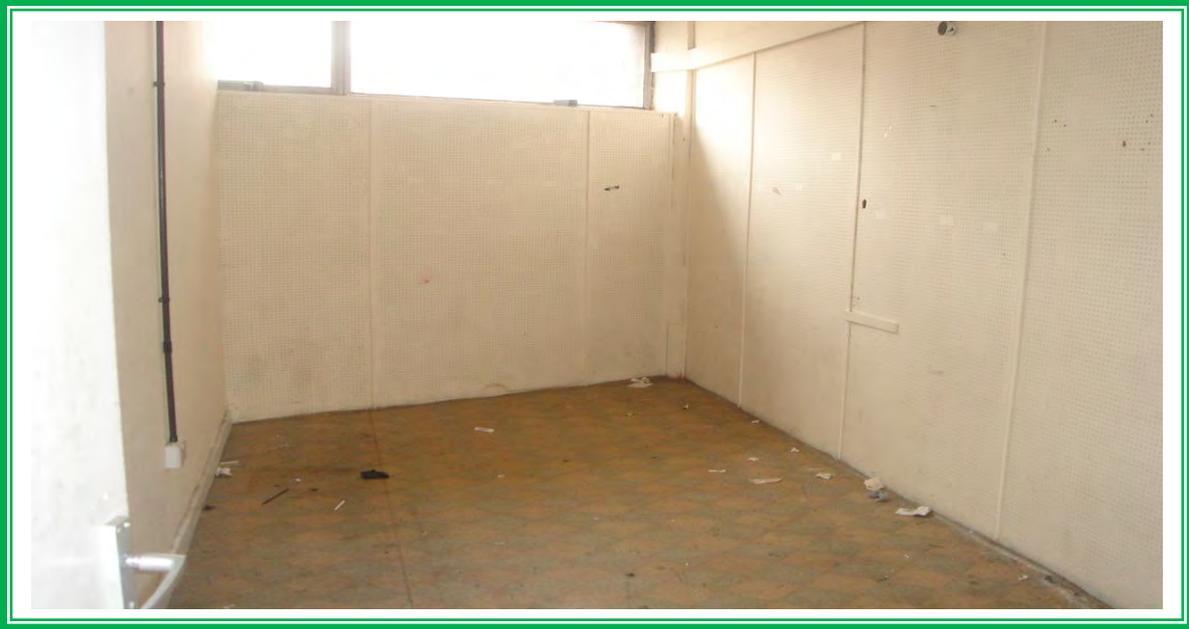
Location: 1/013

Material Description:	Visual Inspection – No Suspect Materials Found	
Identification:	N/A	
Approx. quantity:	N/A	
Accessibility	N/A	Assessment Score
Product type:	N/A	N/A
Extent of Damage:	N/A	N/A
Surface Treatment:	N/A	N/A
Asbestos type:	N/A	N/A
Material Assessment Score:		N/A
Priority Assessment Score:		N/A
Action:	N/A	
Comments:	N/A

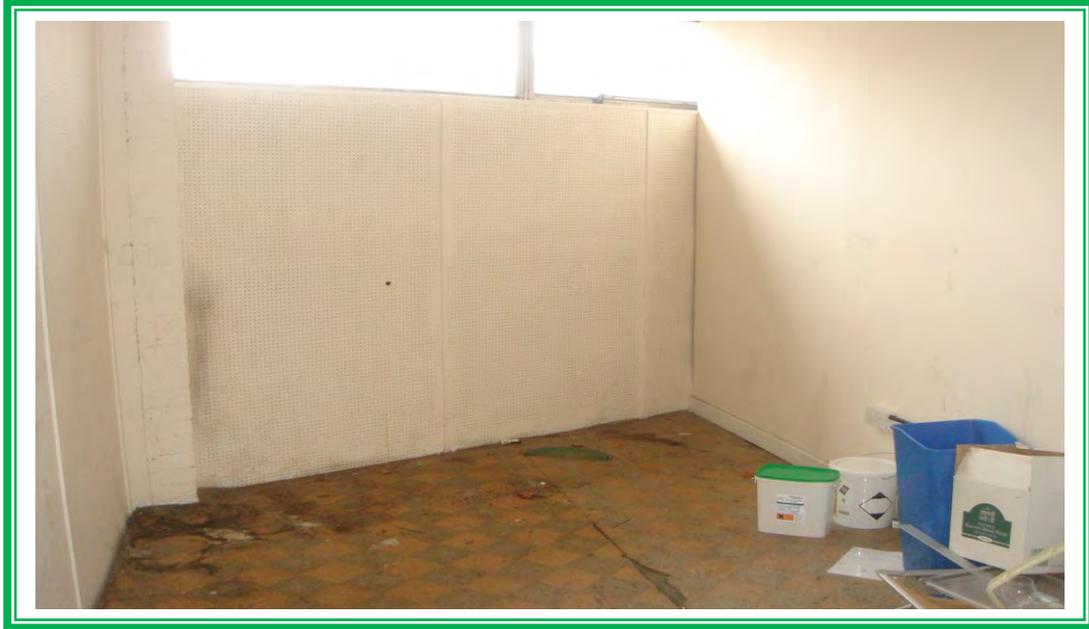
Location: 1/014

Material Description:	Visual Inspection – No Suspect Materials Found	
Identification:	N/A	
Approx. quantity:	N/A	
Accessibility	N/A	Assessment Score
Product type:	N/A	N/A
Extent of Damage:	N/A	N/A
Surface Treatment:	N/A	N/A
Asbestos type:	N/A	N/A
Material Assessment Score:		N/A
Priority Assessment Score:		N/A
Action:	N/A	
Comments:	N/A

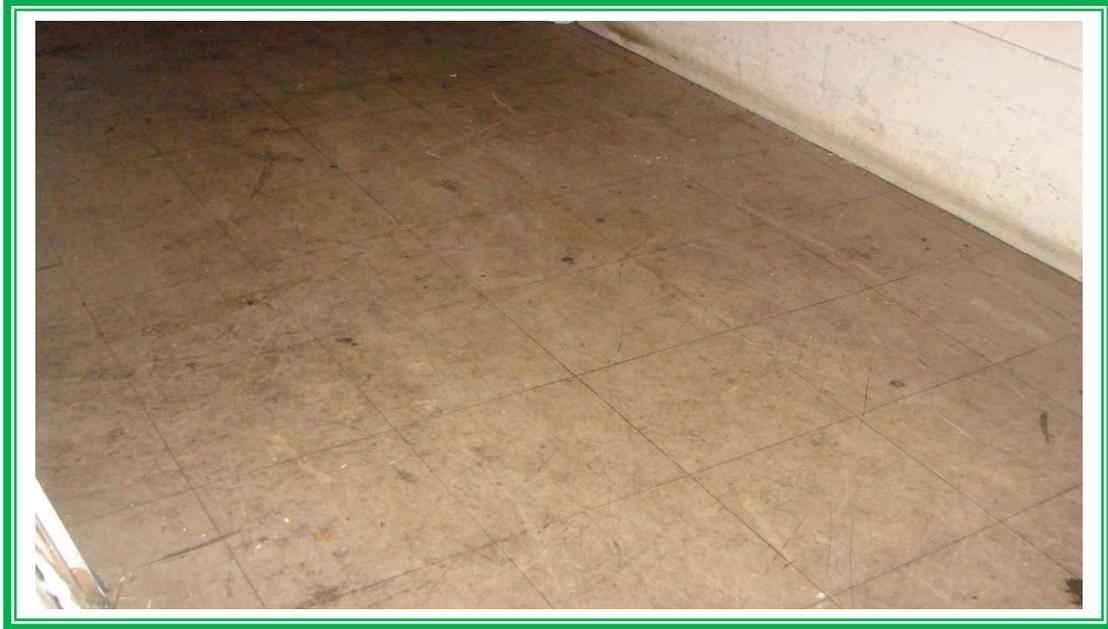
Location: 1/015

Material Description:	Vinyl Floor Tiles	
Identification:	Sampled - No Asbestos Detected	
Approx. quantity:	8M2	
Accessibility	N/A	Assessment Score
Product type:	N/A	N/A
Extent of Damage:	N/A	N/A
Surface Treatment:	N/A	N/A
Asbestos type:	N/A	N/A
Material Assessment Score:		N/A
Priority Assessment Score:		N/A
Action:	N/A	
Comments:	N/A

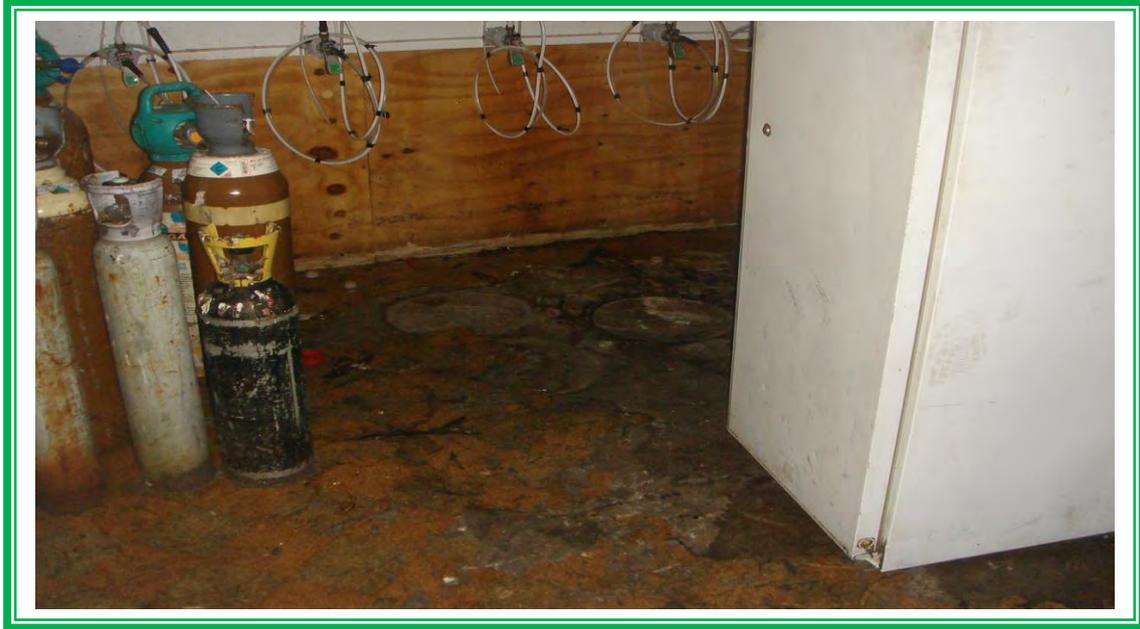
Location: 1/016

Material Description:	Visual Inspection – No Suspect Materials Found	
Identification:	N/A	
Approx. quantity:	N/A	
Accessibility	N/A	Assessment Score
Product type:	N/A	N/A
Extent of Damage:	N/A	N/A
Surface Treatment:	N/A	N/A
Asbestos type:	N/A	N/A
Material Assessment Score:		N/A
Priority Assessment Score:		N/A
Action:	N/A	
Comments:	N/A

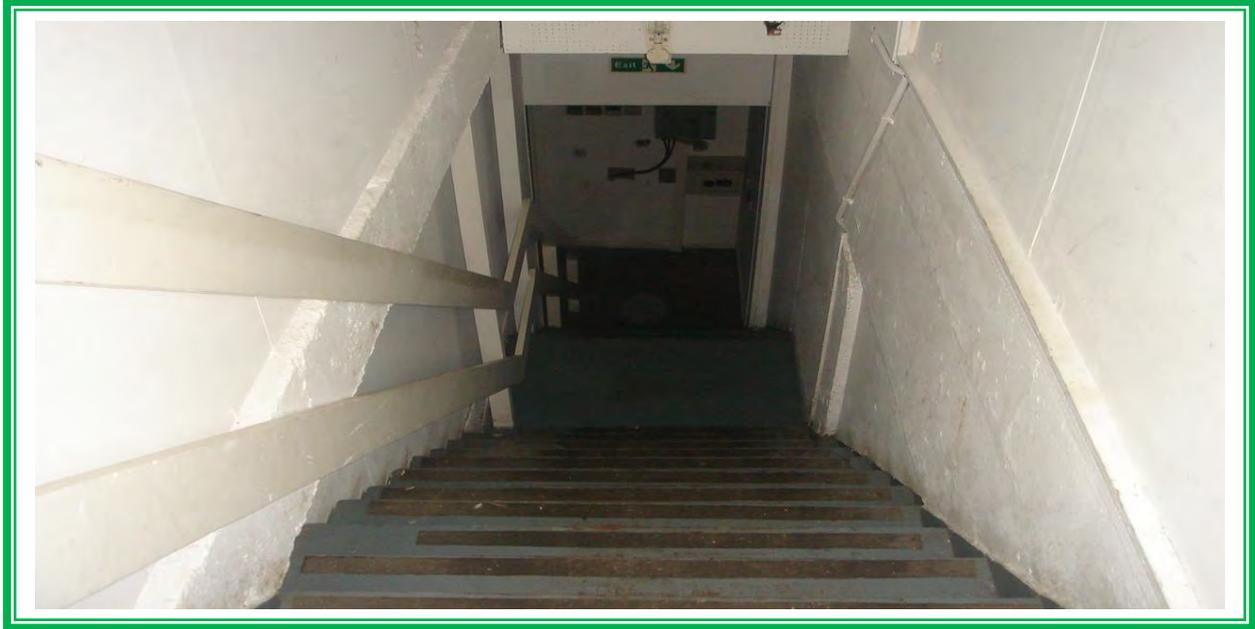
Location: 1/019 Stairs

Material Description:	Visual Inspection – No Suspect Materials Found	
Identification:	N/A	
Approx. quantity:	N/A	
Accessibility	N/A	Assessment Score
Product type:	N/A	N/A
Extent of Damage:	N/A	N/A
Surface Treatment:	N/A	N/A
Asbestos type:	N/A	N/A
Material Assessment Score:		N/A
Priority Assessment Score:		N/A
Action:	N/A	
Comments:	N/A

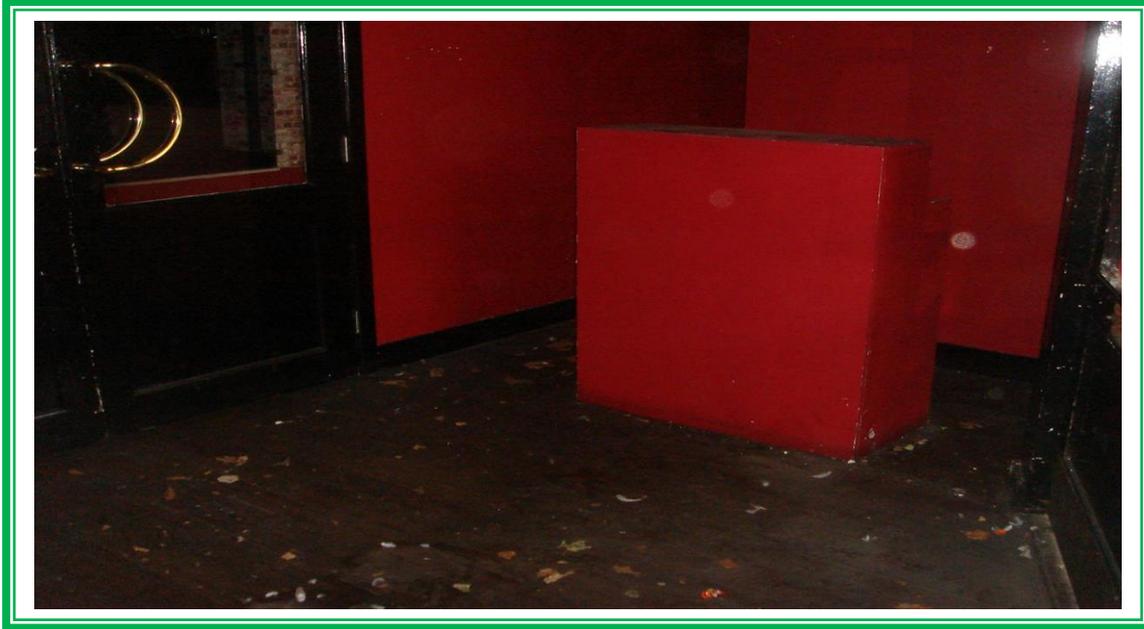
Location: 0/001 Entrance Lobby

Material Description:	Visual Inspection – No Suspect Materials Found	
Identification:	N/A	
Approx. quantity:	N/A	
Accessibility	N/A	Assessment Score
Product type:	N/A	N/A
Extent of Damage:	N/A	N/A
Surface Treatment:	N/A	N/A
Asbestos type:	N/A	N/A
Material Assessment Score:		N/A
Priority Assessment Score:		N/A
Action:	N/A	
Comments:	N/A

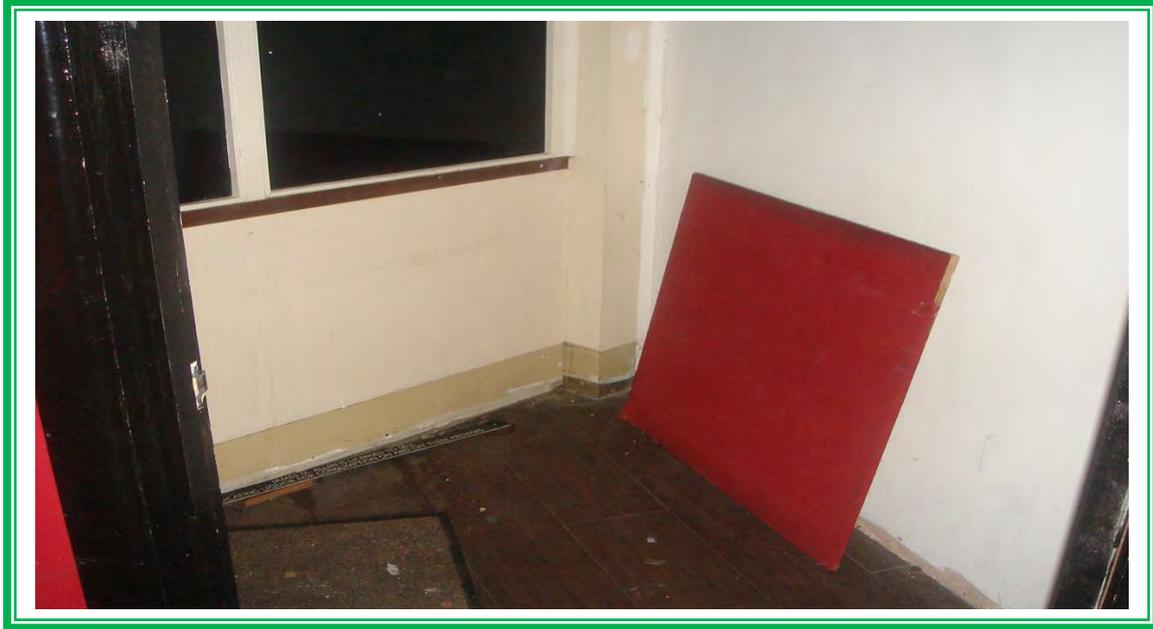
Location: 0/002 Store

Material Description:	Visual Inspection – No Suspect Materials Found	
Identification:	N/A	
Approx. quantity:	N/A	
Accessibility	N/A	Assessment Score
Product type:	N/A	N/A
Extent of Damage:	N/A	N/A
Surface Treatment:	N/A	N/A
Asbestos type:	N/A	N/A
Material Assessment Score:		N/A
Priority Assessment Score:		N/A
Action:	N/A	
Comments:	N/A

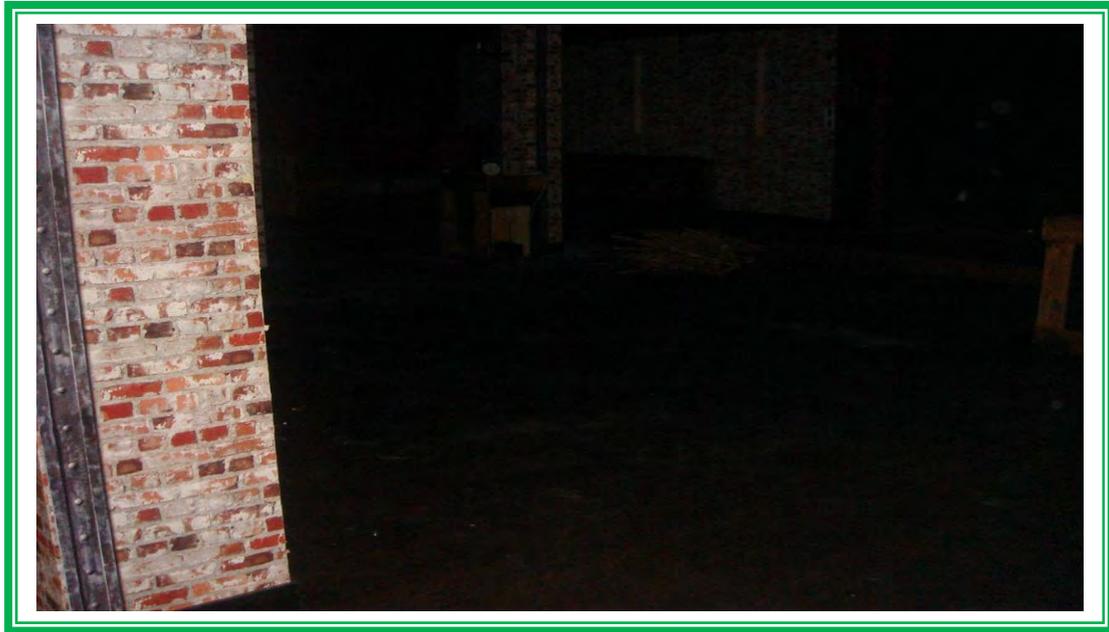
Location: 0/003 Bar Area

Material Description:	Visual Inspection – No Suspect Materials Found	
Identification:	N/A	
Approx. quantity:	N/A	
Accessibility	N/A	Assessment Score
Product type:	N/A	N/A
Extent of Damage:	N/A	N/A
Surface Treatment:	N/A	N/A
Asbestos type:	N/A	N/A
Material Assessment Score:		N/A
Priority Assessment Score:		N/A
Action:	N/A	
Comments:	N/A

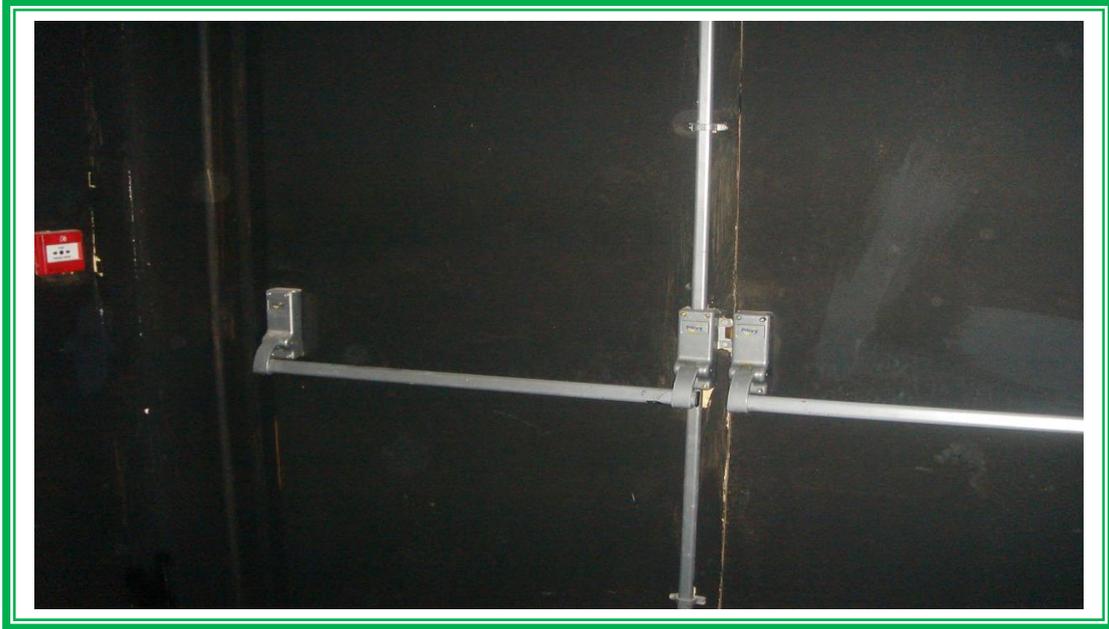
Location: 0/004 Fire Exit

Material Description:	Visual Inspection – No Suspect Materials Found	
Identification:	N/A	
Approx. quantity:	N/A	
Accessibility	N/A	Assessment Score
Product type:	N/A	N/A
Extent of Damage:	N/A	N/A
Surface Treatment:	N/A	N/A
Asbestos type:	N/A	N/A
Material Assessment Score:		N/A
Priority Assessment Score:		N/A
Action:	N/A	
Comments:	N/A

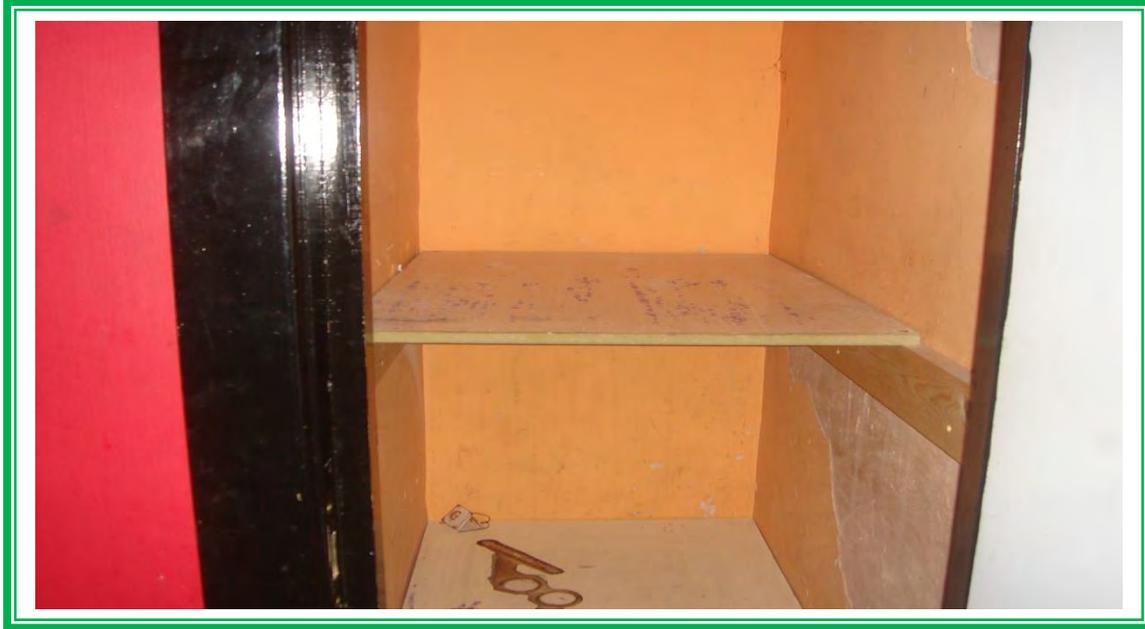
Location: 0/005 Cupboard

Material Description:	Visual Inspection – No Suspect Materials Found	
Identification:	N/A	
Approx. quantity:	N/A	
Accessibility	N/A	Assessment Score
Product type:	N/A	N/A
Extent of Damage:	N/A	N/A
Surface Treatment:	N/A	N/A
Asbestos type:	N/A	N/A
Material Assessment Score:		N/A
Priority Assessment Score:		N/A
Action:	N/A	
Comments:	N/A

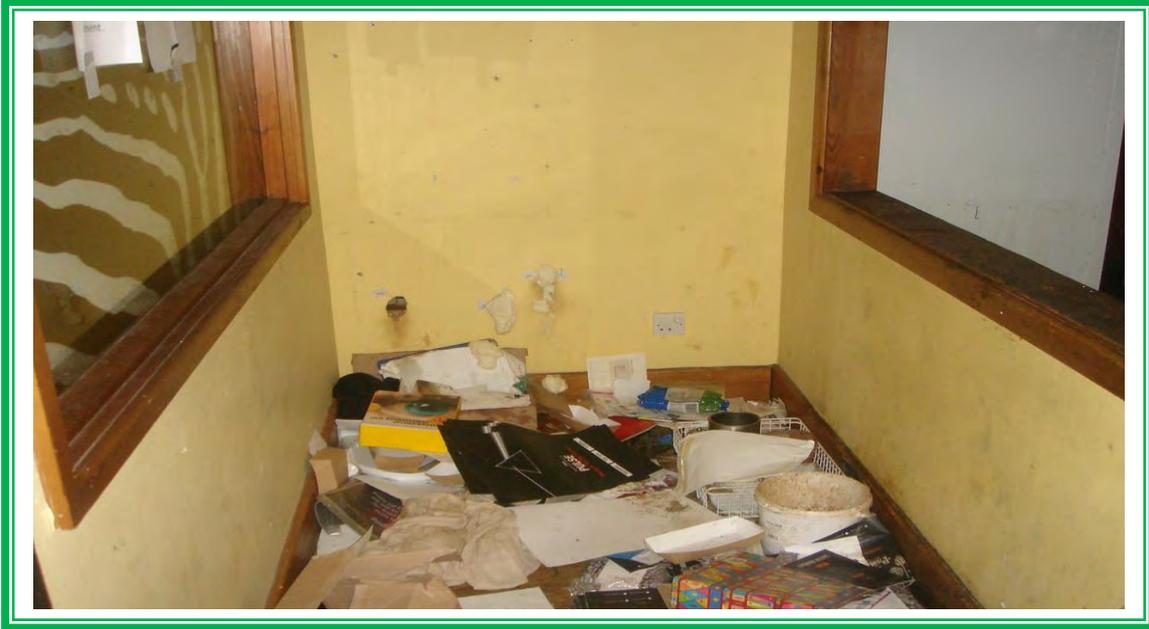
Location: 0/006

Material Description:	Visual Inspection – No Suspect Materials Found	
Identification:	N/A	
Approx. quantity:	N/A	
Accessibility	N/A	Assessment Score
Product type:	N/A	N/A
Extent of Damage:	N/A	N/A
Surface Treatment:	N/A	N/A
Asbestos type:	N/A	N/A
Material Assessment Score:		N/A
Priority Assessment Score:		N/A
Action:	N/A	
Comments:	N/A

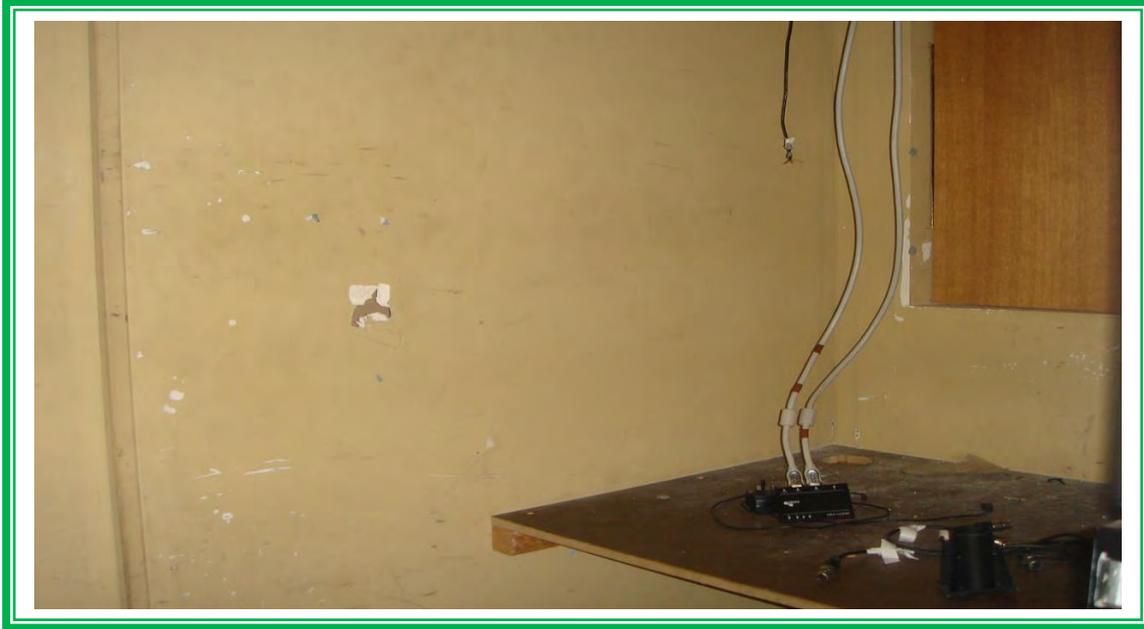
Location: 0/007

Material Description:	Visual Inspection – No Suspect Materials Found	
Identification:	N/A	
Approx. quantity:	N/A	
Accessibility	N/A	Assessment Score
Product type:	N/A	N/A
Extent of Damage:	N/A	N/A
Surface Treatment:	N/A	N/A
Asbestos type:	N/A	N/A
Material Assessment Score:		N/A
Priority Assessment Score:		N/A
Action:	N/A	
Comments:	N/A

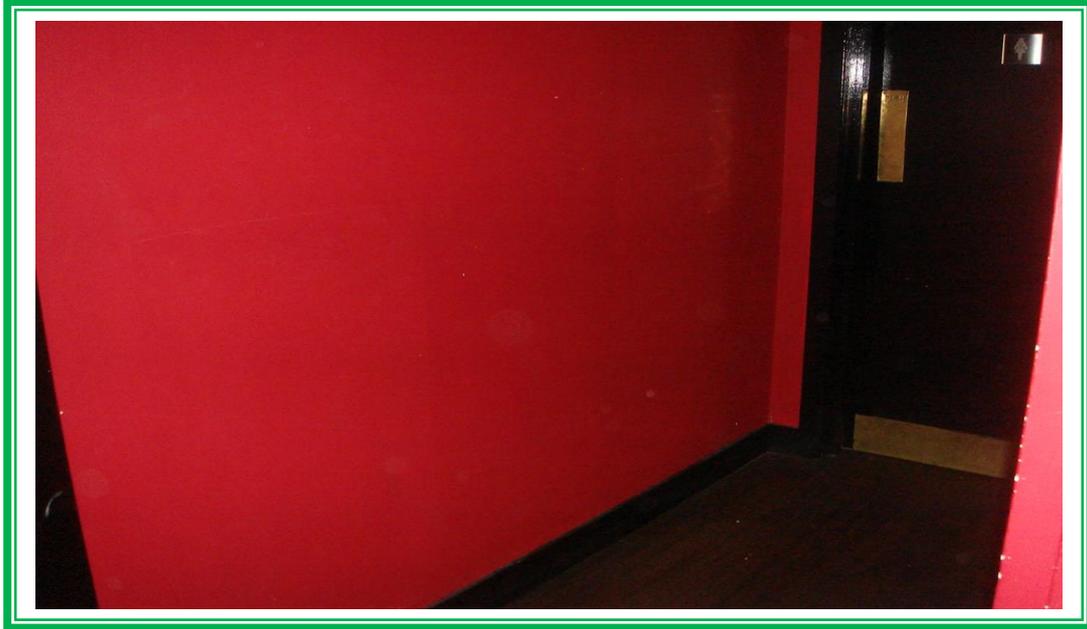
Location: 0/008 Corridor

Material Description:	Visual Inspection – No Suspect Materials Found	
Identification:	N/A	
Approx. quantity:	N/A	
Accessibility	N/A	Assessment Score
Product type:	N/A	N/A
Extent of Damage:	N/A	N/A
Surface Treatment:	N/A	N/A
Asbestos type:	N/A	N/A
Material Assessment Score:		N/A
Priority Assessment Score:		N/A
Action:	N/A	
Comments:	N/A

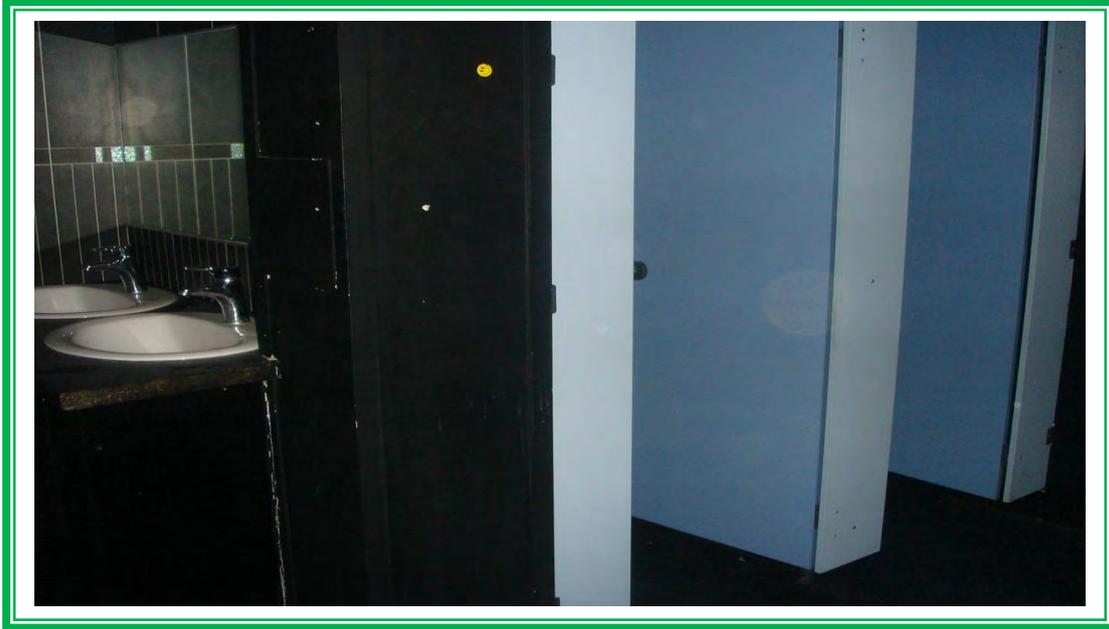
Location: 0/009 Male WC

Material Description:	Visual Inspection – No Suspect Materials Found	
Identification:	N/A	
Approx. quantity:	N/A	
Accessibility	N/A	Assessment Score
Product type:	N/A	N/A
Extent of Damage:	N/A	N/A
Surface Treatment:	N/A	N/A
Asbestos type:	N/A	N/A
Material Assessment Score:		N/A
Priority Assessment Score:		N/A
Action:	N/A	
Comments:	N/A

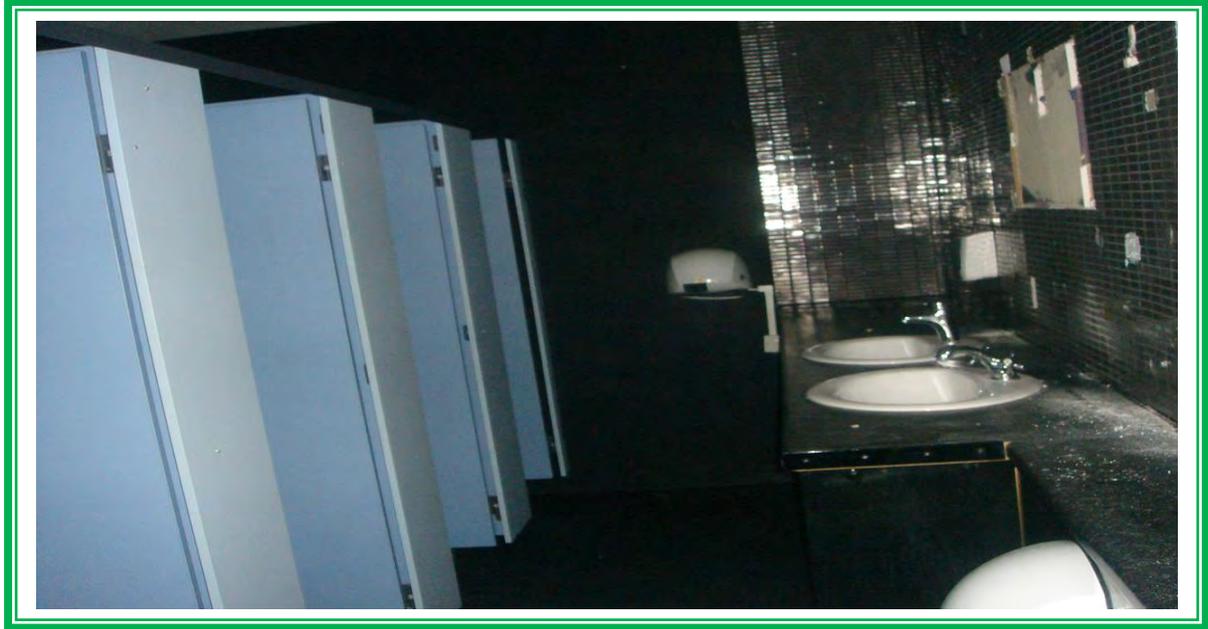
Location: 1/010 WC

Material Description:	Visual Inspection – No Suspect Materials Found	
Identification:	N/A	
Approx. quantity:	N/A	
Accessibility	N/A	Assessment Score
Product type:	N/A	N/A
Extent of Damage:	N/A	N/A
Surface Treatment:	N/A	N/A
Asbestos type:	N/A	N/A
Material Assessment Score:		N/A
Priority Assessment Score:		N/A
Action:	N/A	
Comments:	N/A

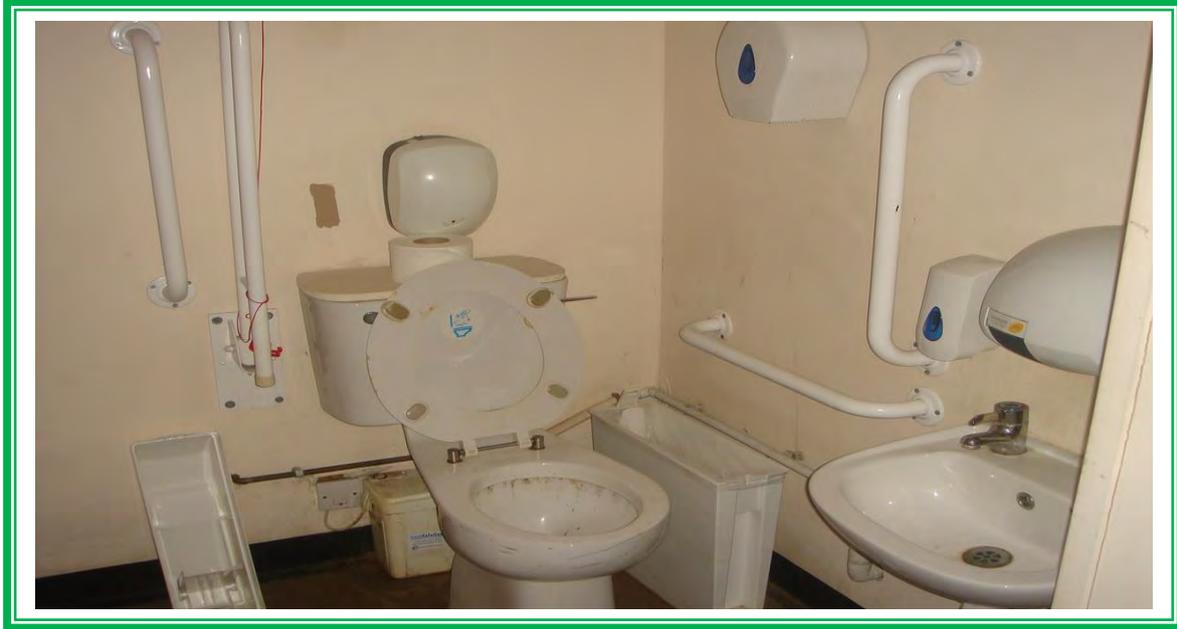
Location: 0/011 Disabled WC

Material Description:	Visual Inspection – No Suspect Materials Found	
Identification:	N/A	
Approx. quantity:	N/A	
Accessibility	N/A	Assessment Score
Product type:	N/A	N/A
Extent of Damage:	N/A	N/A
Surface Treatment:	N/A	N/A
Asbestos type:	N/A	N/A
Material Assessment Score:		N/A
Priority Assessment Score:		N/A
Action:	N/A	
Comments:	N/A

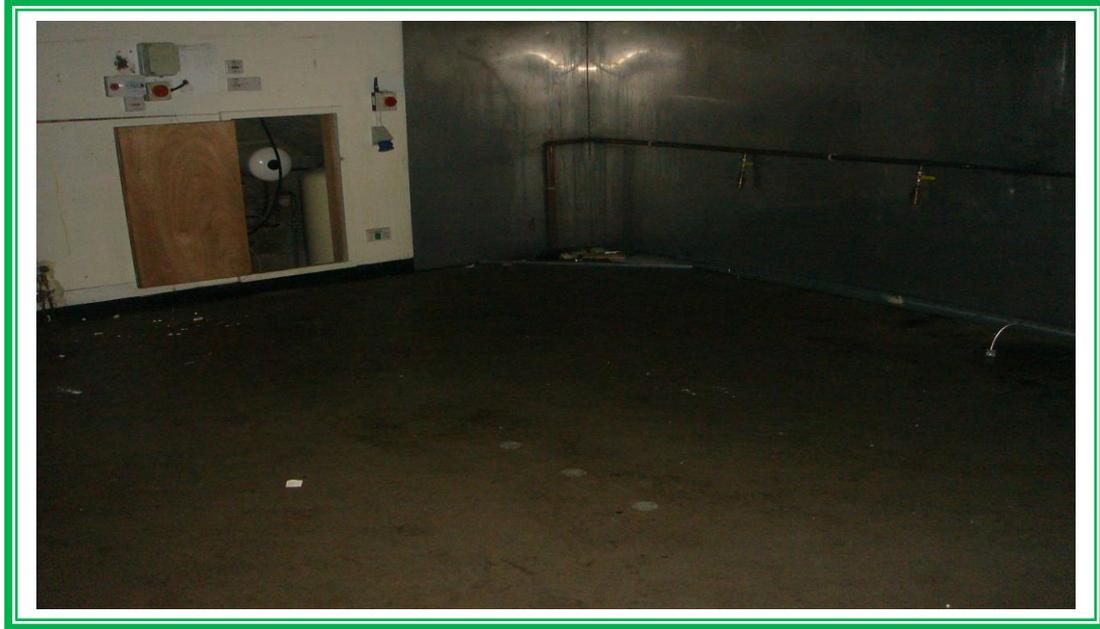
Location: 0/012

Material Description:	Visual Inspection – No Suspect Materials Found	
Identification:	N/A	
Approx. quantity:	N/A	
Accessibility	N/A	Assessment Score
Product type:	N/A	N/A
Extent of Damage:	N/A	N/A
Surface Treatment:	N/A	N/A
Asbestos type:	N/A	N/A
Material Assessment Score:		N/A
Priority Assessment Score:		N/A
Action:	N/A	
Comments:	N/A

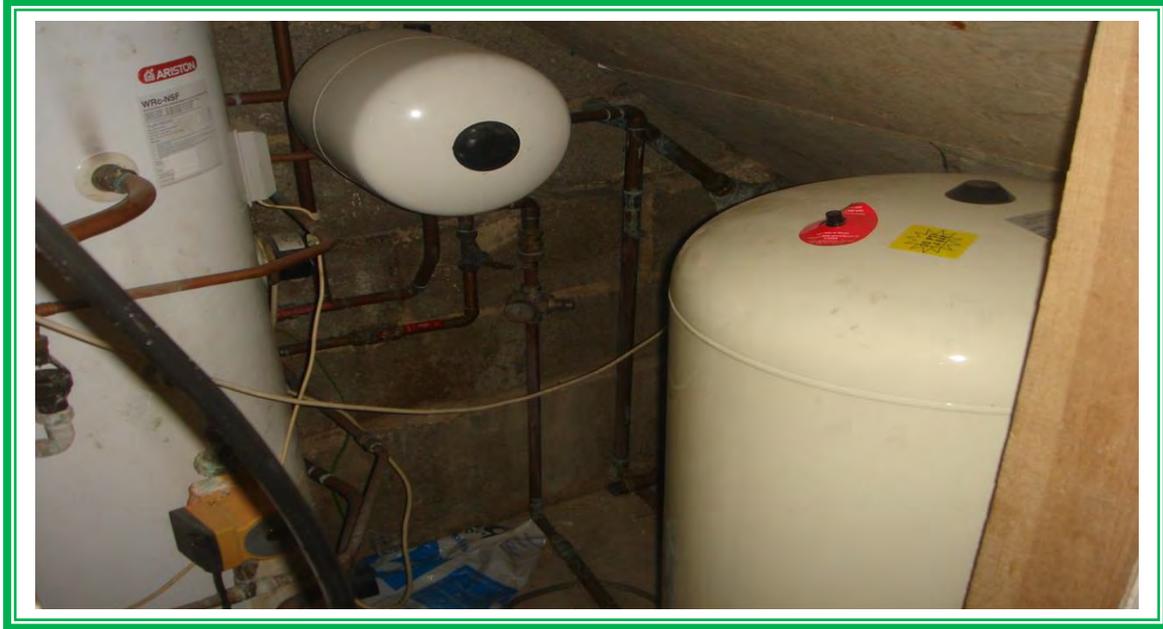
Location: 0/013 Understairs

Material Description:	Visual Inspection – No Suspect Materials Found	
Identification:	N/A	
Approx. quantity:	N/A	
Accessibility	N/A	Assessment Score
Product type:	N/A	N/A
Extent of Damage:	N/A	N/A
Surface Treatment:	N/A	N/A
Asbestos type:	N/A	N/A
Material Assessment Score:		N/A
Priority Assessment Score:		N/A
Action:	N/A	
Comments:	N/A

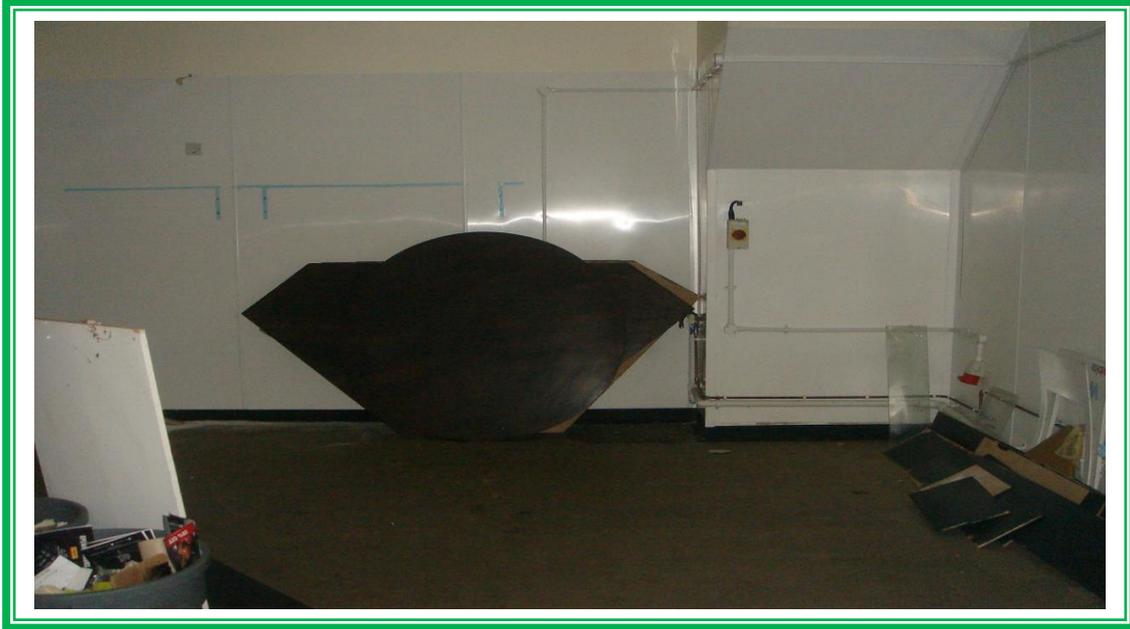
Location: 0/014

Material Description:	Visual Inspection – No Suspect Materials Found	
Identification:	N/A	
Approx. quantity:	N/A	
Accessibility	N/A	Assessment Score
Product type:	N/A	N/A
Extent of Damage:	N/A	N/A
Surface Treatment:	N/A	N/A
Asbestos type:	N/A	N/A
Material Assessment Score:		N/A
Priority Assessment Score:		N/A
Action:	N/A	
Comments:	Plastic Wall Sheets

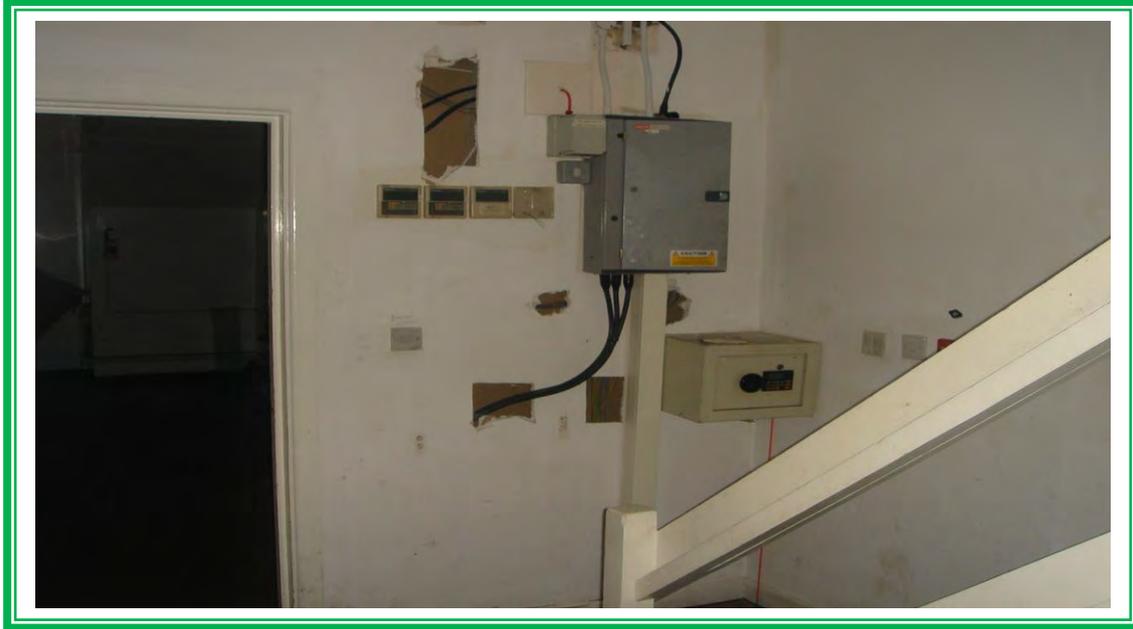
Location: 0/015 Stairs

Material Description:	Visual Inspection – No Suspect Materials Found	
Identification:	N/A	
Approx. quantity:	N/A	
Accessibility	N/A	Assessment Score
Product type:	N/A	N/A
Extent of Damage:	N/A	N/A
Surface Treatment:	N/A	N/A
Asbestos type:	N/A	N/A
Material Assessment Score:		N/A
Priority Assessment Score:		N/A
Action:	N/A	
Comments:	N/A

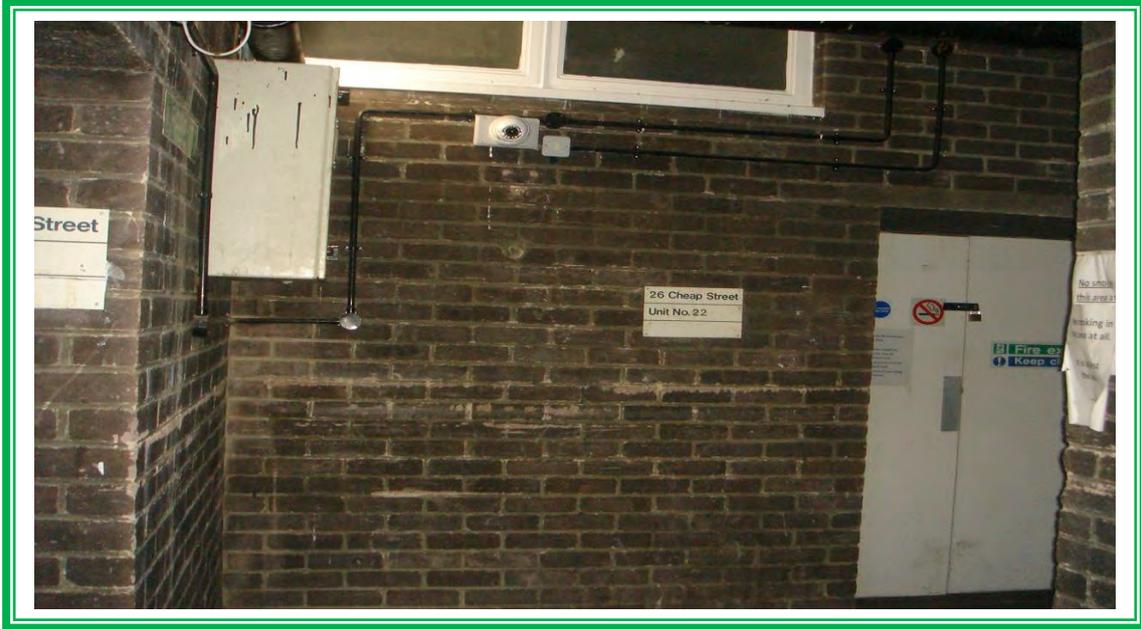
Location: 99/001 Externals

Material Description:	Visual Inspection – No Suspect Materials Found	
Identification:	N/A	
Approx. quantity:	N/A	
Accessibility	N/A	Assessment Score
Product type:	N/A	N/A
Extent of Damage:	N/A	N/A
Surface Treatment:	N/A	N/A
Asbestos type:	N/A	N/A
Material Assessment Score:		N/A
Priority Assessment Score:		N/A
Action:	N/A	
Comments:	N/A

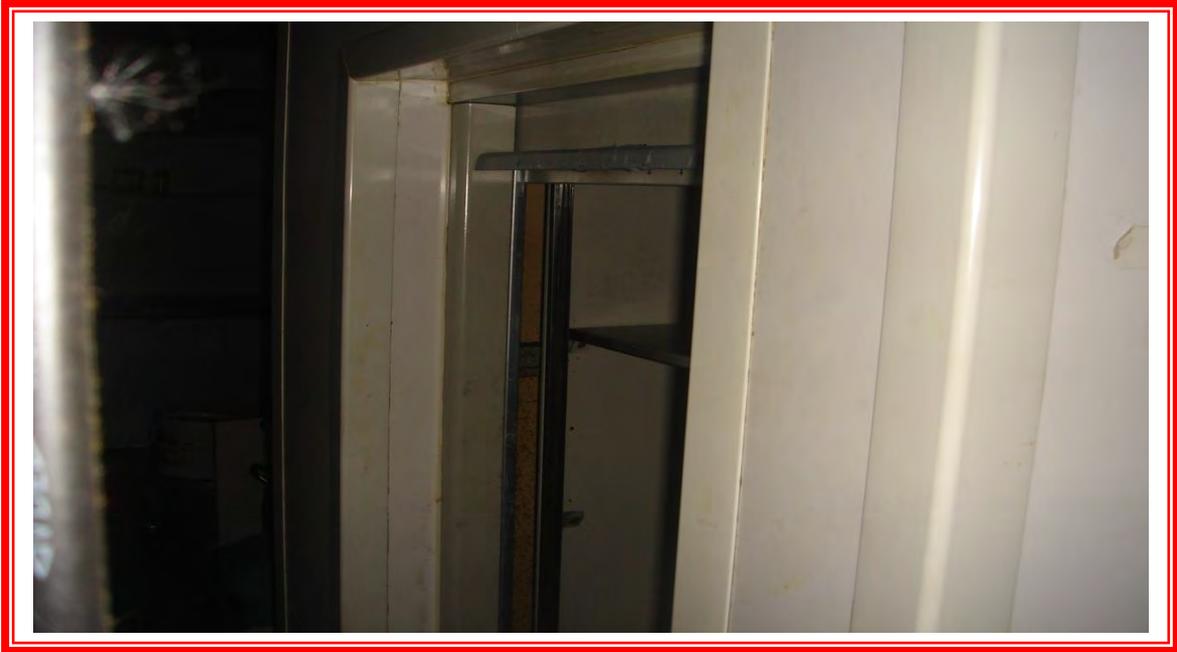
Location: 1/003 Dumbwaiter

Material Description:	No Access to Dumb Waiter and Lift Shafts	
Identification:	Presumed to Contain Asbestos	
Approx. quantity:	Unknown	
Accessibility	Low	Assessment Score
Product type:	No Access	3
Extent of Damage:	No Access	3
Surface Treatment:	No Access	3
Asbestos type:	No Access	3
Material Assessment Score:		12
Priority Assessment Score:		High
Action:	Further Inspection Required	
Comments:	No Access as Presumed Live
