Document Name	Author	Issued by	Revision Number	Issue Date	Page No
2019	Emma Humphreys	Armour AS	0	29/11/2019	25

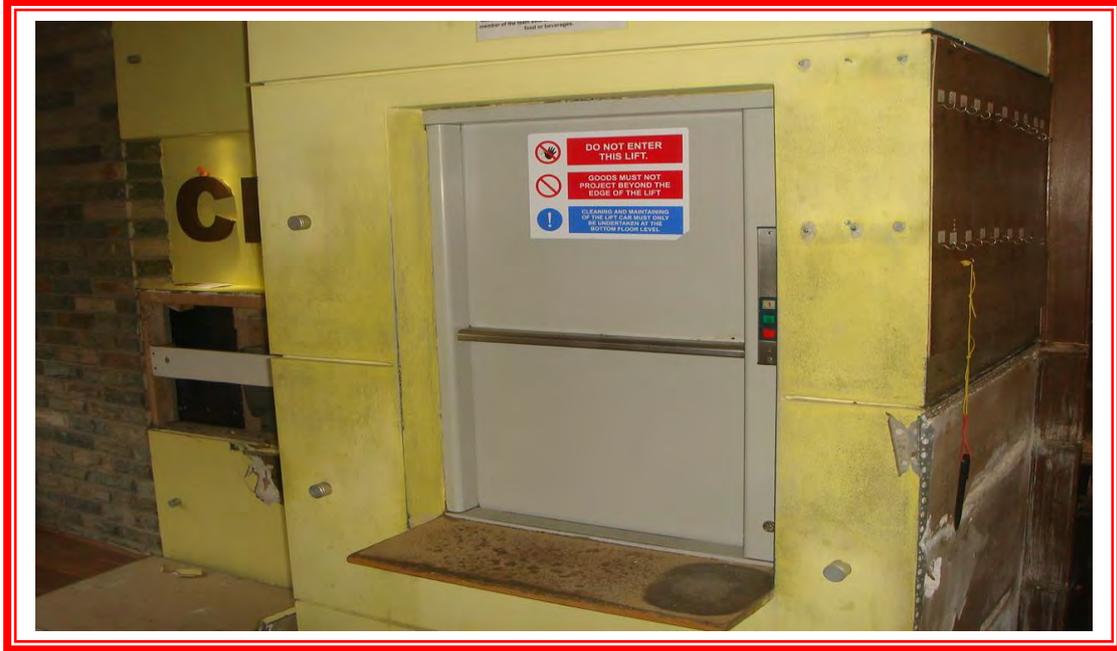
Location: 0/002

Material Description:	No Access to Dumb Waiter and Shaft	
Identification:	Presumed to Contain Asbestos	
Approx. quantity:	Unknown	
Accessibility	Low	Assessment Score
Product type:	No Access	3
Extent of Damage:	No Access	3
Surface Treatment:	No Access	3
Asbestos type:	No Access	3
Material Assessment Score:		12
Priority Assessment Score:		High
Action:	Further Inspection Required	
Comments:	No Access as Presumed to be Live

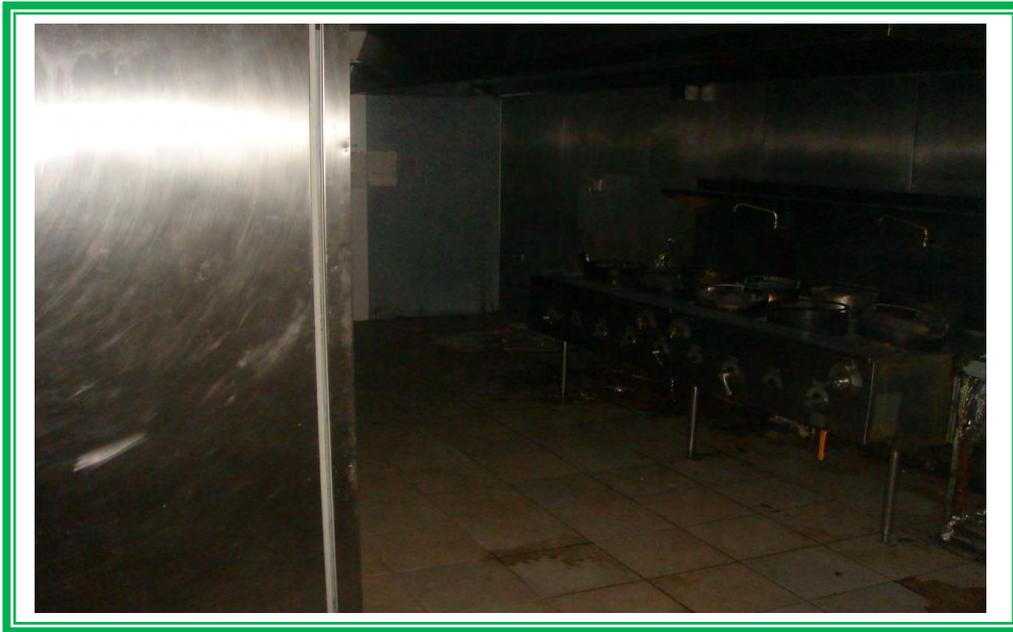
Location: 1/001 Kitchen

Material Description:	Visual Inspection – No Suspect Materials Found	
Identification:	N/A	
Approx. quantity:	N/A	
Accessibility	N/A	Assessment Score
Product type:	N/A	N/A
Extent of Damage:	N/A	N/A
Surface Treatment:	N/A	N/A
Asbestos type:	N/A	N/A
Material Assessment Score:		N/A
Priority Assessment Score:		N/A
Action:	N/A	
Comments:	N/A

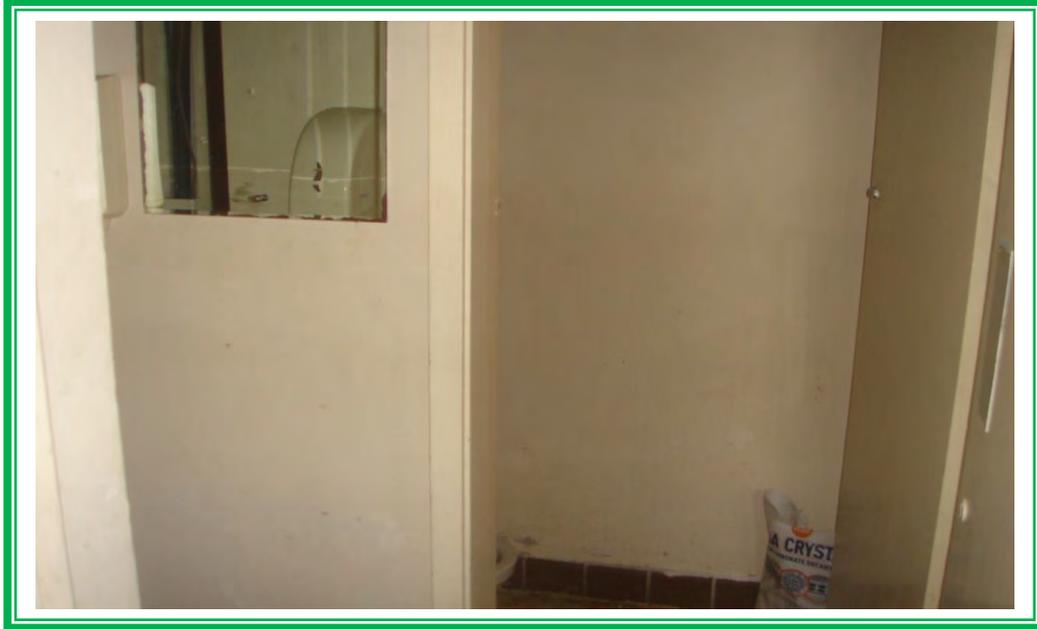
Location: 1/002 WC

Material Description:	Visual Inspection – No Suspect Materials Found	
Identification:	N/A	
Approx. quantity:	N/A	
Accessibility	N/A	Assessment Score
Product type:	N/A	N/A
Extent of Damage:	N/A	N/A
Surface Treatment:	N/A	N/A
Asbestos type:	N/A	N/A
Material Assessment Score:		N/A
Priority Assessment Score:		N/A
Action:	N/A	
Comments:	N/A

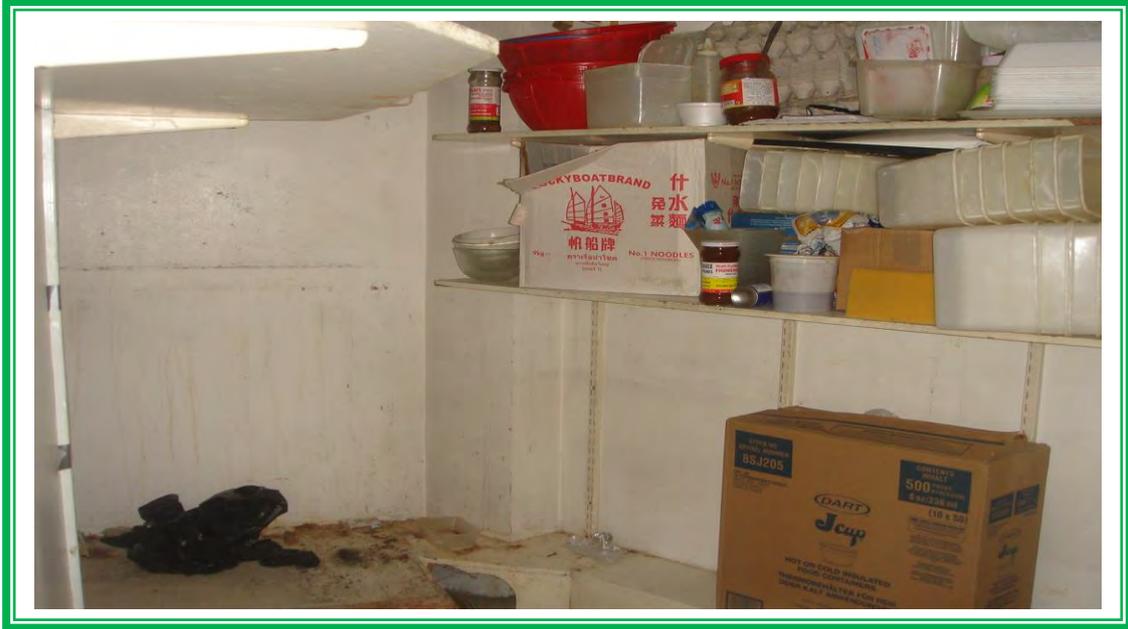
Location: 1/004 Store

Material Description:	Visual Inspection – No Suspect Materials Found	
Identification:	N/A	
Approx. quantity:	N/A	
Accessibility	N/A	Assessment Score
Product type:	N/A	N/A
Extent of Damage:	N/A	N/A
Surface Treatment:	N/A	N/A
Asbestos type:	N/A	N/A
Material Assessment Score:		N/A
Priority Assessment Score:		N/A
Action:	N/A	
Comments:	N/A

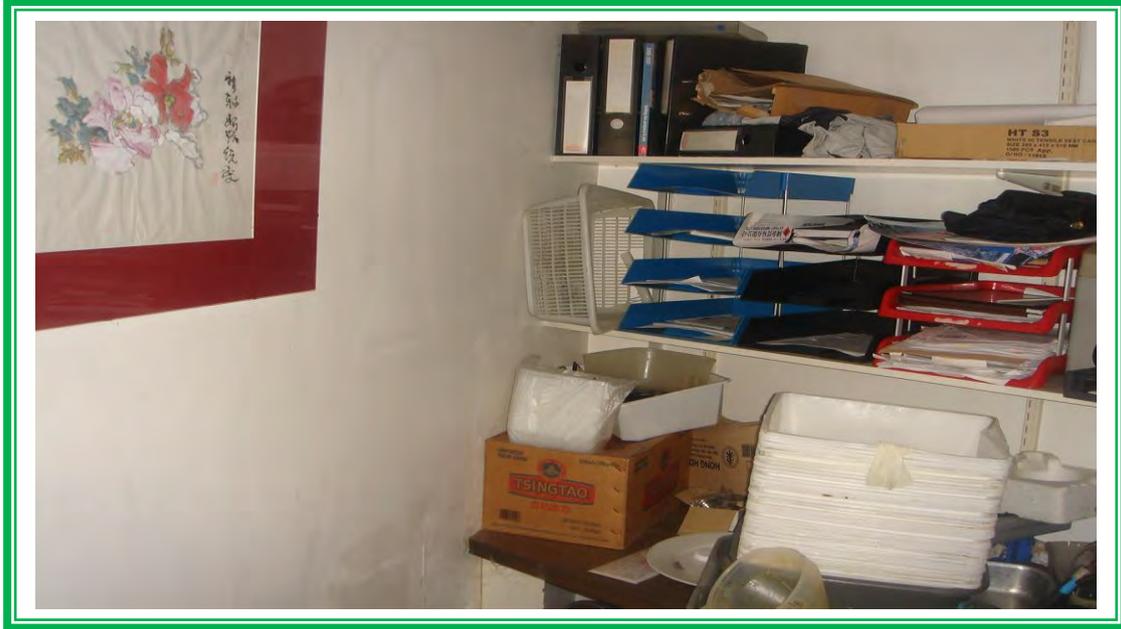
Location: 1/005 Store

Material Description:	Visual Inspection – No Suspect Materials Found	
Identification:	N/A	
Approx. quantity:	N/A	
Accessibility	N/A	Assessment Score
Product type:	N/A	N/A
Extent of Damage:	N/A	N/A
Surface Treatment:	N/A	N/A
Asbestos type:	N/A	N/A
Material Assessment Score:		N/A
Priority Assessment Score:		N/A
Action:	N/A	
Comments:	N/A

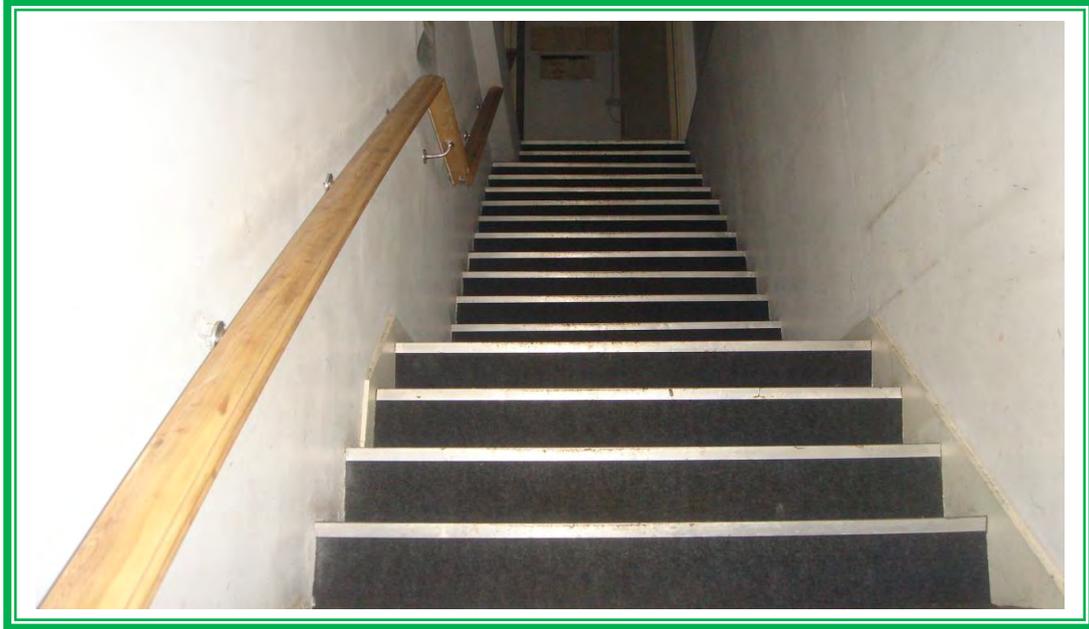
Location: 1/006 Stairs

Material Description:	Visual Inspection – No Suspect Materials Found	
Identification:	N/A	
Approx. quantity:	N/A	
Accessibility	N/A	Assessment Score
Product type:	N/A	N/A
Extent of Damage:	N/A	N/A
Surface Treatment:	N/A	N/A
Asbestos type:	N/A	N/A
Material Assessment Score:		N/A
Priority Assessment Score:		N/A
Action:	N/A	
Comments:	N/A

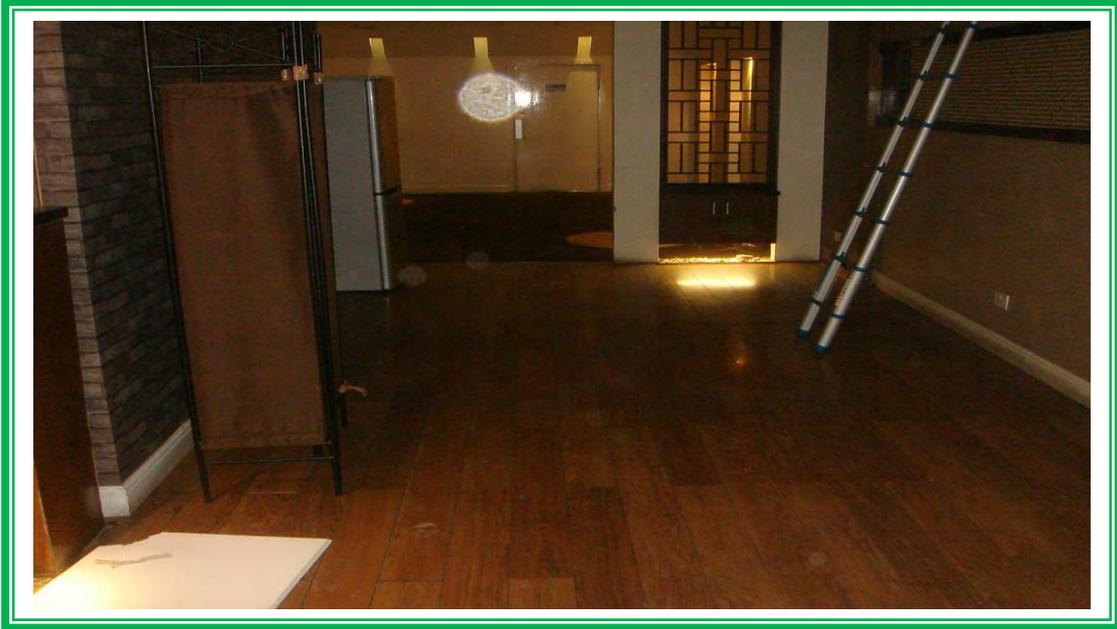
Location: 0/001 Restaurant

Material Description:	Visual Inspection – No Suspect Materials Found	
Identification:	N/A	
Approx. quantity:	N/A	
Accessibility	N/A	Assessment Score
Product type:	N/A	N/A
Extent of Damage:	N/A	N/A
Surface Treatment:	N/A	N/A
Asbestos type:	N/A	N/A
Material Assessment Score:		N/A
Priority Assessment Score:		N/A
Action:	N/A	
Comments:	N/A

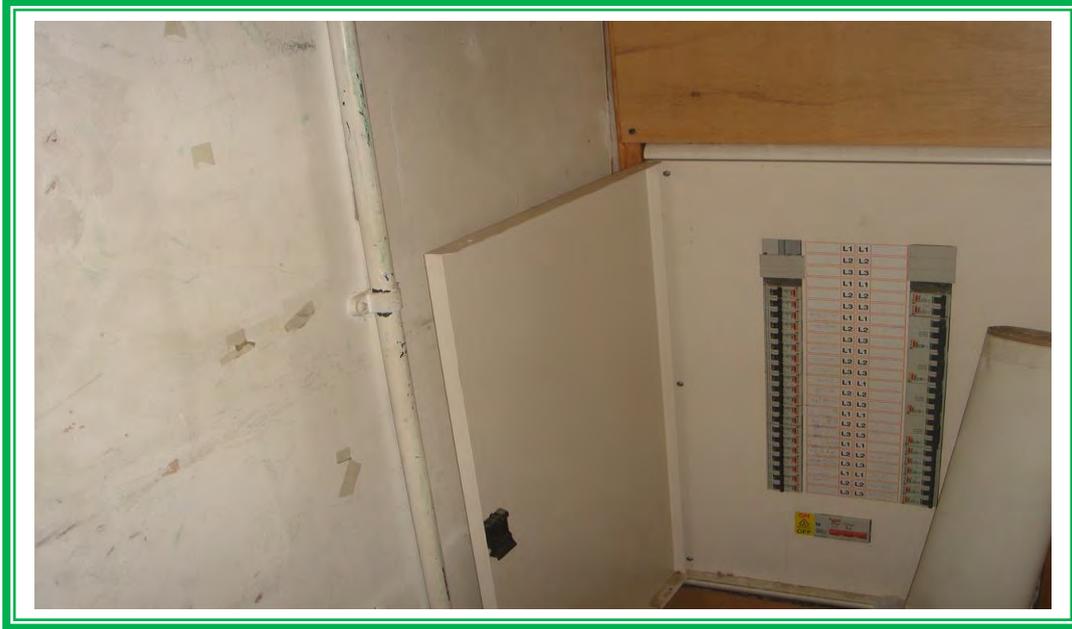
Location: 0/003 Cupboard

Material Description:	Visual Inspection – No Suspect Materials Found	
Identification:	N/A	
Approx. quantity:	N/A	
Accessibility	N/A	Assessment Score
Product type:	N/A	N/A
Extent of Damage:	N/A	N/A
Surface Treatment:	N/A	N/A
Asbestos type:	N/A	N/A
Material Assessment Score:		N/A
Priority Assessment Score:		N/A
Action:	N/A	
Comments:	N/A

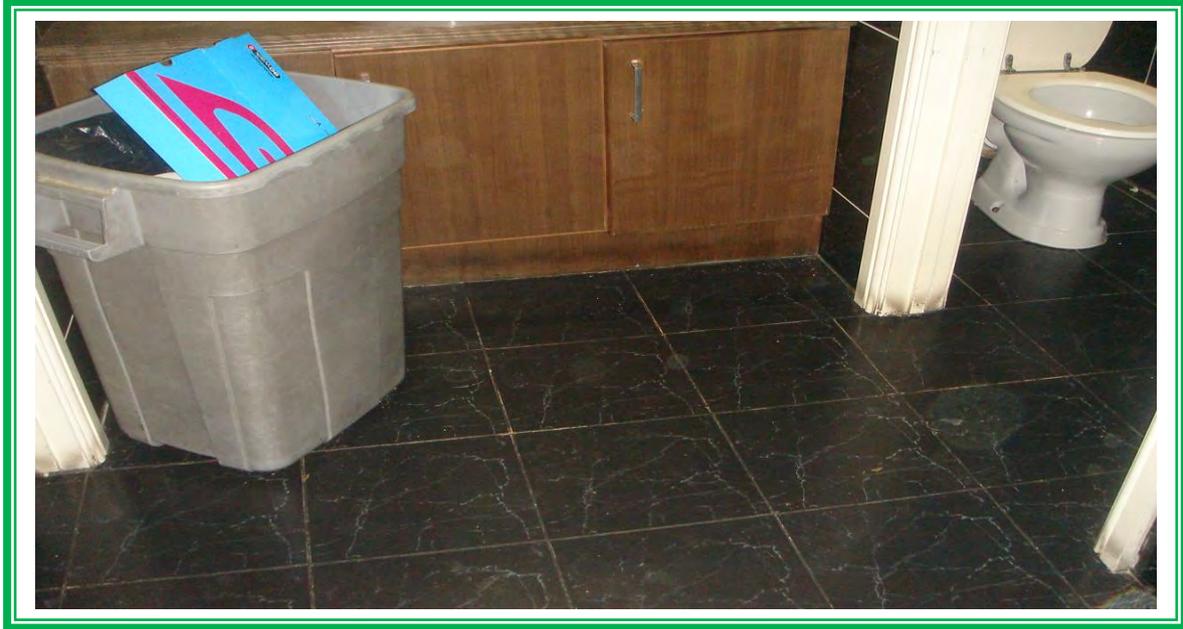
Location: 0/004 Toilet Lobby

Material Description:	Visual Inspection – No Suspect Materials Found	
Identification:	N/A	
Approx. quantity:	N/A	
Accessibility	N/A	Assessment Score
Product type:	N/A	N/A
Extent of Damage:	N/A	N/A
Surface Treatment:	N/A	N/A
Asbestos type:	N/A	N/A
Material Assessment Score:		N/A
Priority Assessment Score:		N/A
Action:	N/A	
Comments:	N/A

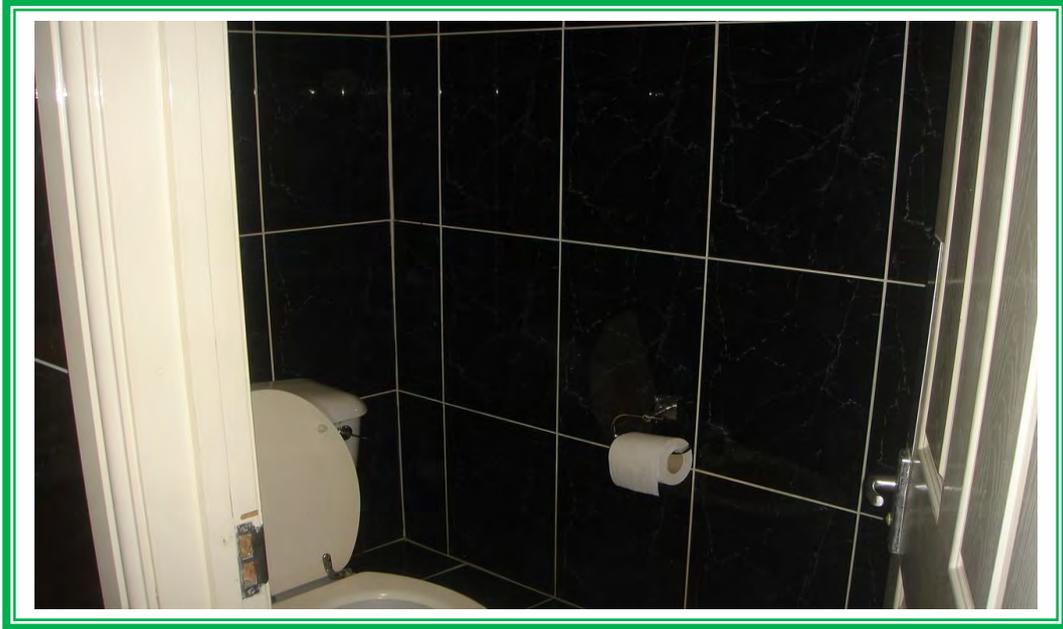
Location: 0/005 Male WC

Material Description:	Visual Inspection – No Suspect Materials Found	
Identification:	N/A	
Approx. quantity:	N/A	
Accessibility	N/A	Assessment Score
Product type:	N/A	N/A
Extent of Damage:	N/A	N/A
Surface Treatment:	N/A	N/A
Asbestos type:	N/A	N/A
Material Assessment Score:		N/A
Priority Assessment Score:		N/A
Action:	N/A	
Comments:	N/A

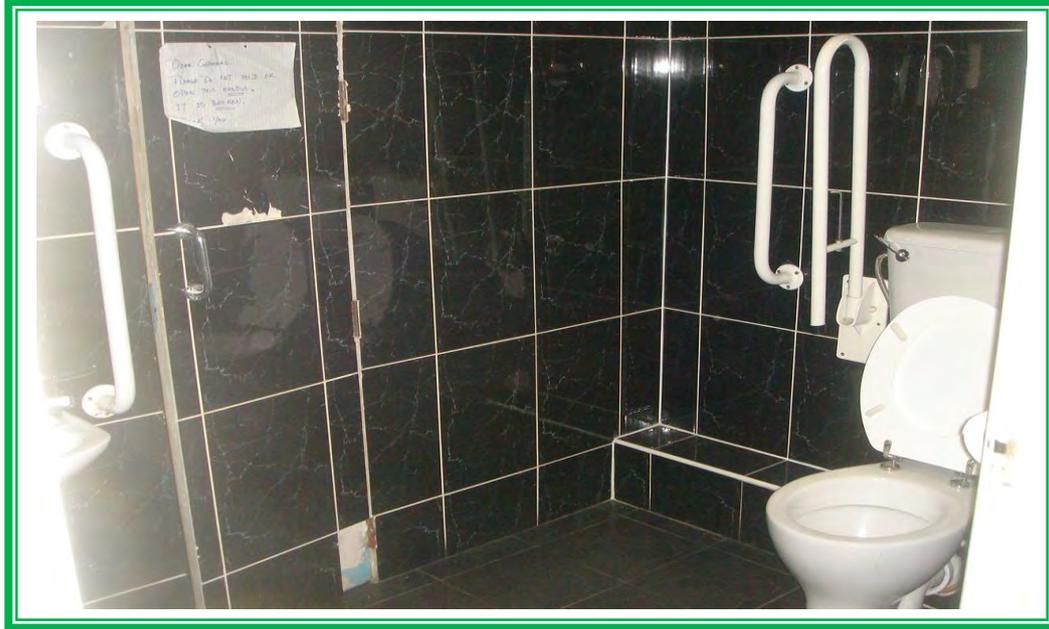
Location: 0/006 Female WC

Material Description:	Visual Inspection – No Suspect Materials Found	
Identification:	N/A	
Approx. quantity:	N/A	
Accessibility	N/A	Assessment Score
Product type:	N/A	N/A
Extent of Damage:	N/A	N/A
Surface Treatment:	N/A	N/A
Asbestos type:	N/A	N/A
Material Assessment Score:		N/A
Priority Assessment Score:		N/A
Action:	N/A	
Comments:	N/A

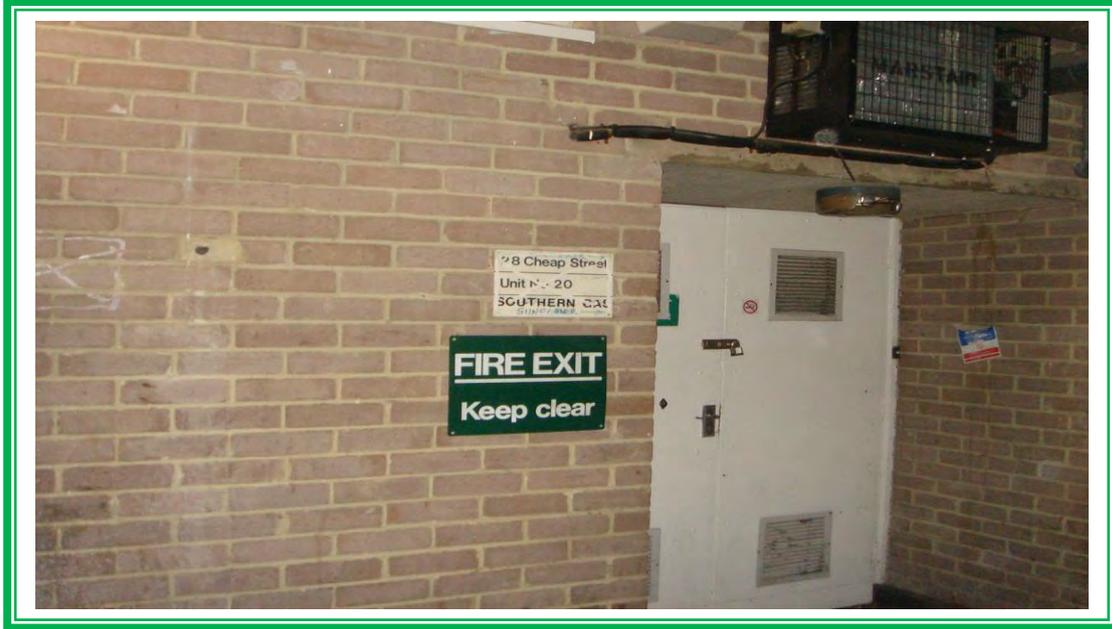
Location: 99/001 External

Material Description:	Visual Inspection – No Suspect Materials Found	
Identification:	N/A	
Approx. quantity:	N/A	
Accessibility	N/A	Assessment Score
Product type:	N/A	N/A
Extent of Damage:	N/A	N/A
Surface Treatment:	N/A	N/A
Asbestos type:	N/A	N/A
Material Assessment Score:		N/A
Priority Assessment Score:		N/A
Action:	N/A	
Comments:	N/A

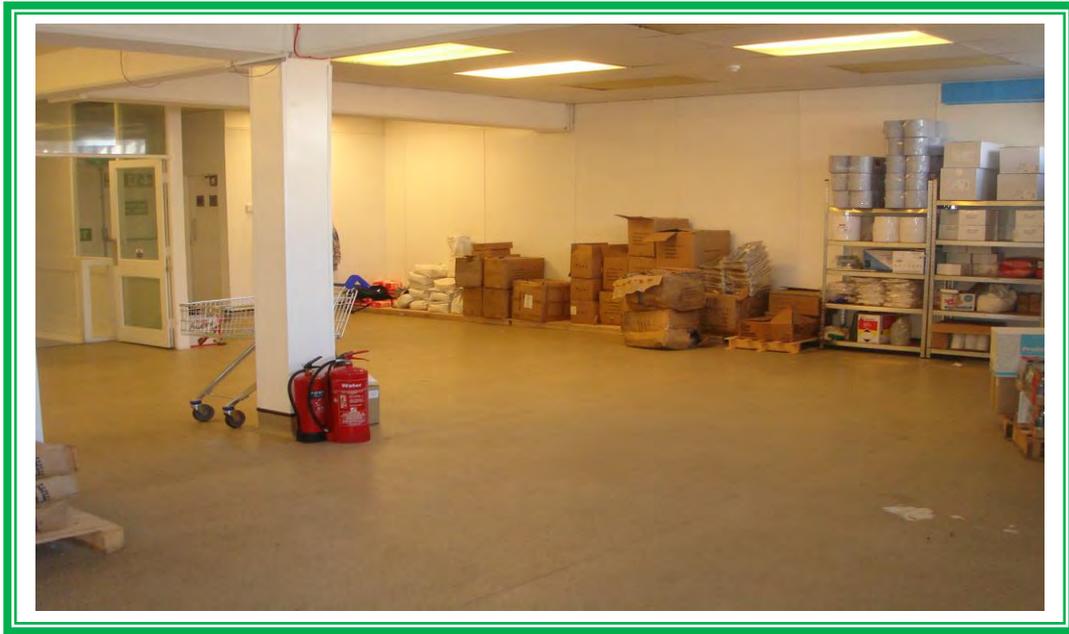
Item No: 1	Sample No: N/A
Location: 1/001 Store

Material Description:	Visual Inspection – No Suspect Materials Found	
Identification:	N/A	
Approx. quantity:	N/A	
Accessibility	N/A	Assessment Score
Product type:	N/A	N/A
Extent of Damage:	N/A	N/A
Surface Treatment:	N/A	N/A
Asbestos type:	N/A	N/A
Material Assessment Score:		N/A
Priority Assessment Score:		N/A
Action:	N/A	
Comments:	N/A

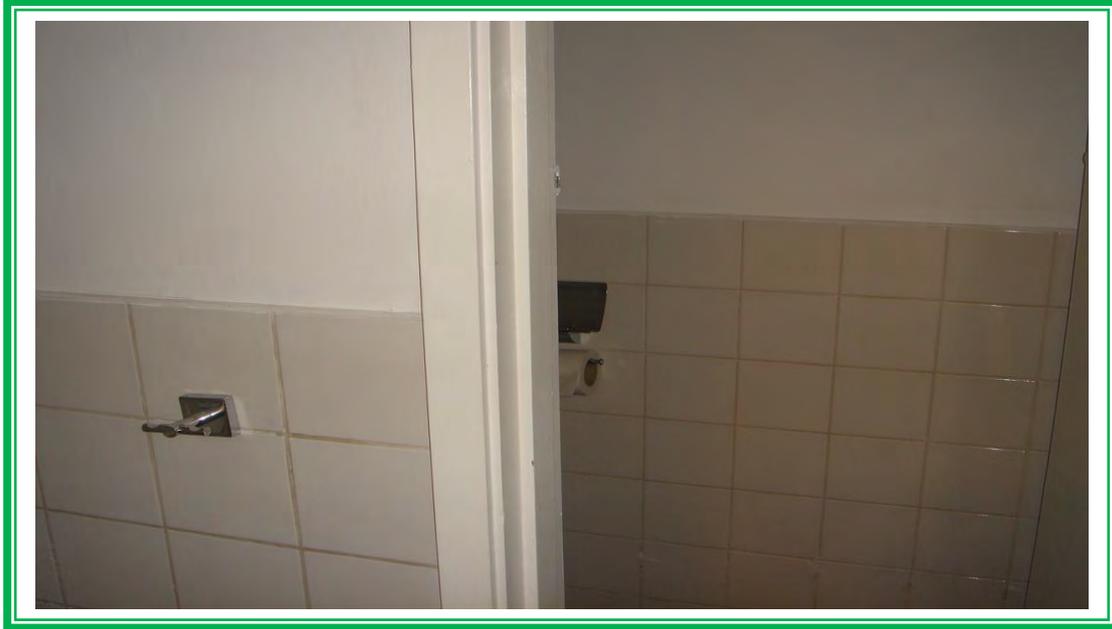
Location: 1/002 WC

Material Description:	Visual Inspection – No Suspect Materials Found	
Identification:	N/A	
Approx. quantity:	N/A	
Accessibility	N/A	<i>Assessment Score</i>
Product type:	N/A	N/A
Extent of Damage:	N/A	N/A
Surface Treatment:	N/A	N/A
Asbestos type:	N/A	N/A
Material Assessment Score:		N/A
Priority Assessment Score:		N/A
Action:	N/A	
Comments:	N/A

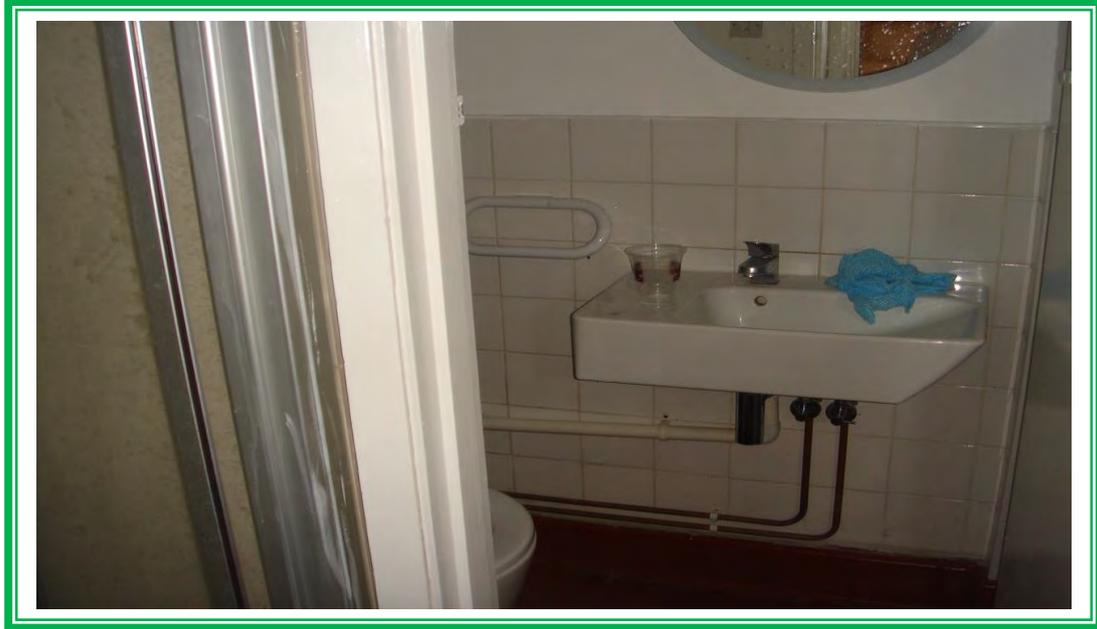
Location: 1/003 WC

Material Description:	Visual Inspection – No Suspect Materials Found	
Identification:	N/A	
Approx. quantity:	N/A	
Accessibility	N/A	Assessment Score
Product type:	N/A	N/A
Extent of Damage:	N/A	N/A
Surface Treatment:	N/A	N/A
Asbestos type:	N/A	N/A
Material Assessment Score:		N/A
Priority Assessment Score:		N/A
Action:	N/A	
Comments:	N/A

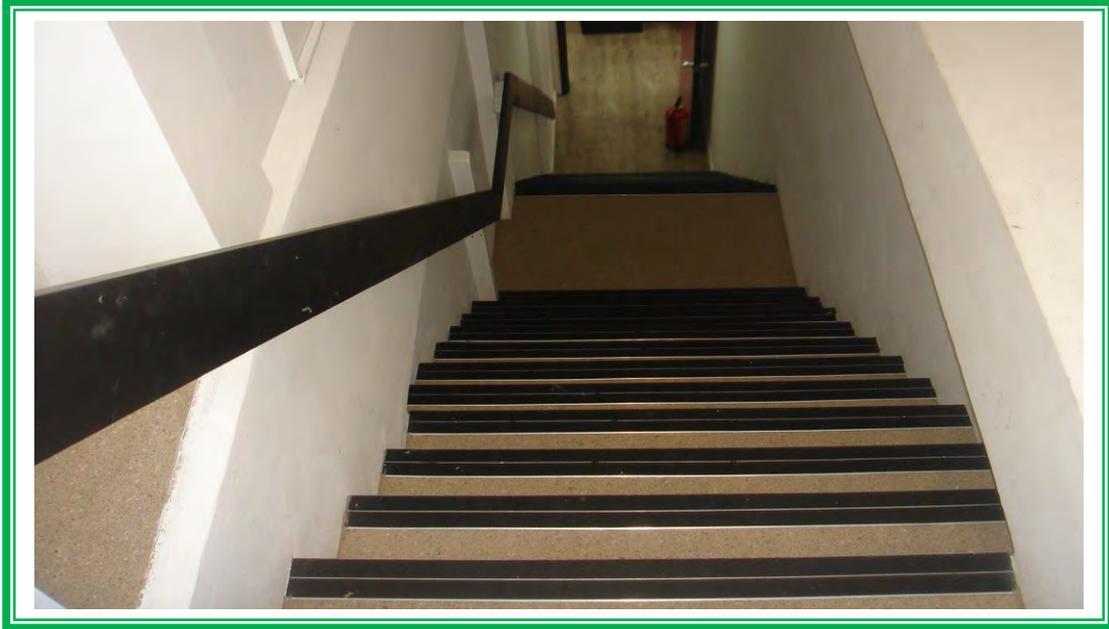
Location: 1/004 Stairs

Material Description:	Visual Inspection – No Suspect Materials Found	
Identification:	N/A	
Approx. quantity:	N/A	
Accessibility	N/A	Assessment Score
Product type:	N/A	N/A
Extent of Damage:	N/A	N/A
Surface Treatment:	N/A	N/A
Asbestos type:	N/A	N/A
Material Assessment Score:		N/A
Priority Assessment Score:		N/A
Action:	N/A	
Comments:	N/A

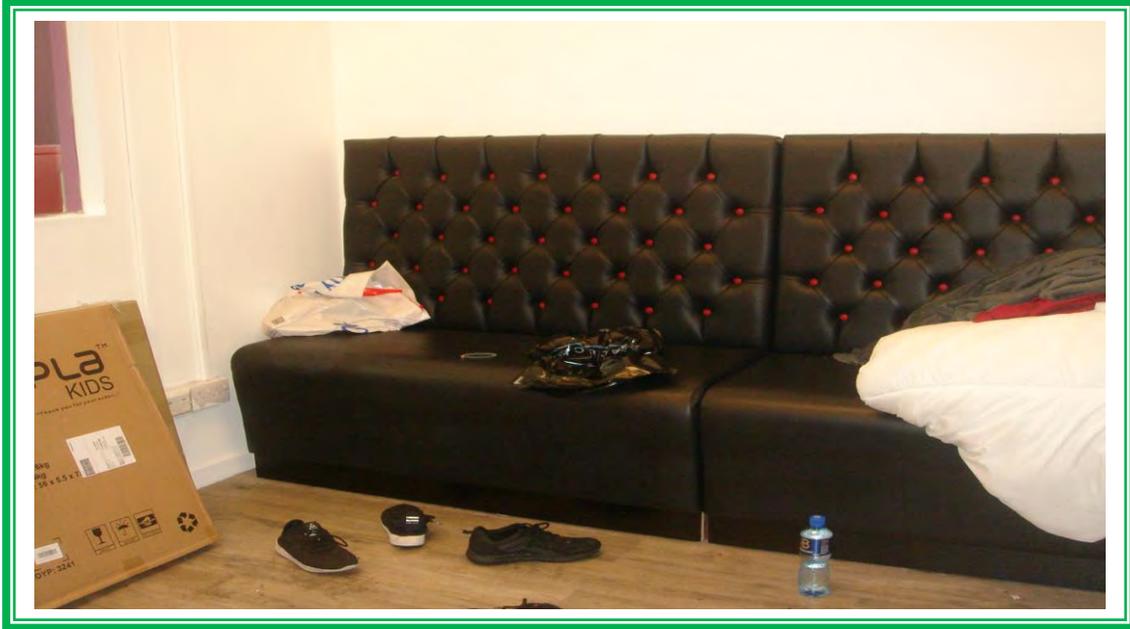
Location: 0/001 Office

Material Description:	Visual Inspection – No Suspect Materials Found	
Identification:	N/A	
Approx. quantity:	N/A	
Accessibility	N/A	Assessment Score
Product type:	N/A	N/A
Extent of Damage:	N/A	N/A
Surface Treatment:	N/A	N/A
Asbestos type:	N/A	N/A
Material Assessment Score:		N/A
Priority Assessment Score:		N/A
Action:	N/A	
Comments:	N/A

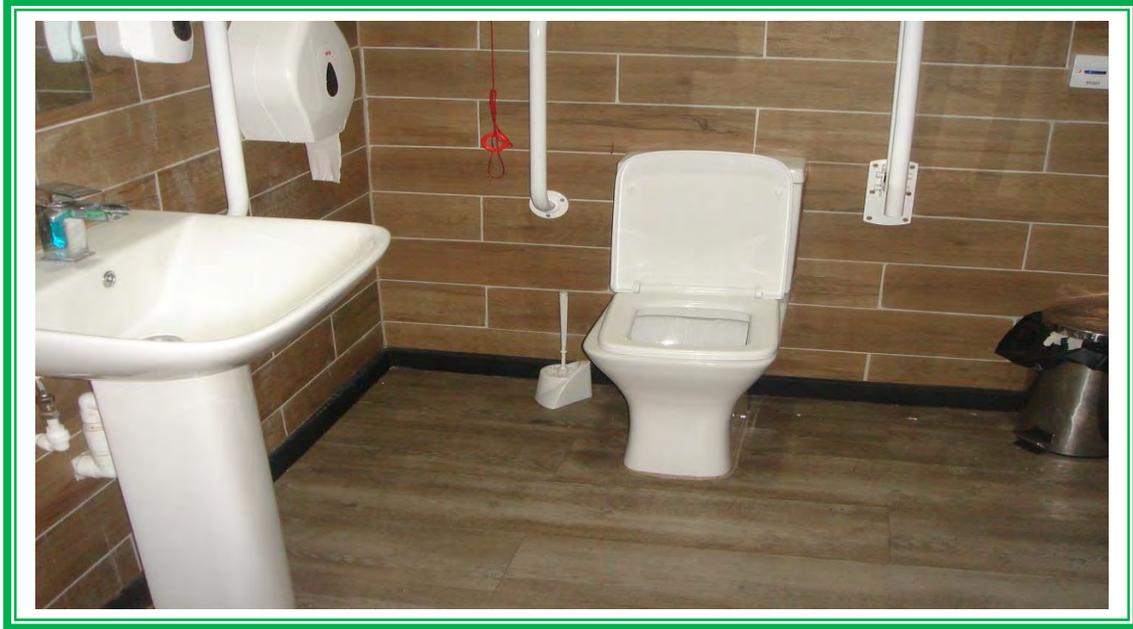
Location: 0/002 WC

Material Description:	Visual Inspection – No Suspect Materials Found	
Identification:	N/A	
Approx. quantity:	N/A	
Accessibility	N/A	Assessment Score
Product type:	N/A	N/A
Extent of Damage:	N/A	N/A
Surface Treatment:	N/A	N/A
Asbestos type:	N/A	N/A
Material Assessment Score:		N/A
Priority Assessment Score:		N/A
Action:	N/A	
Comments:	N/A

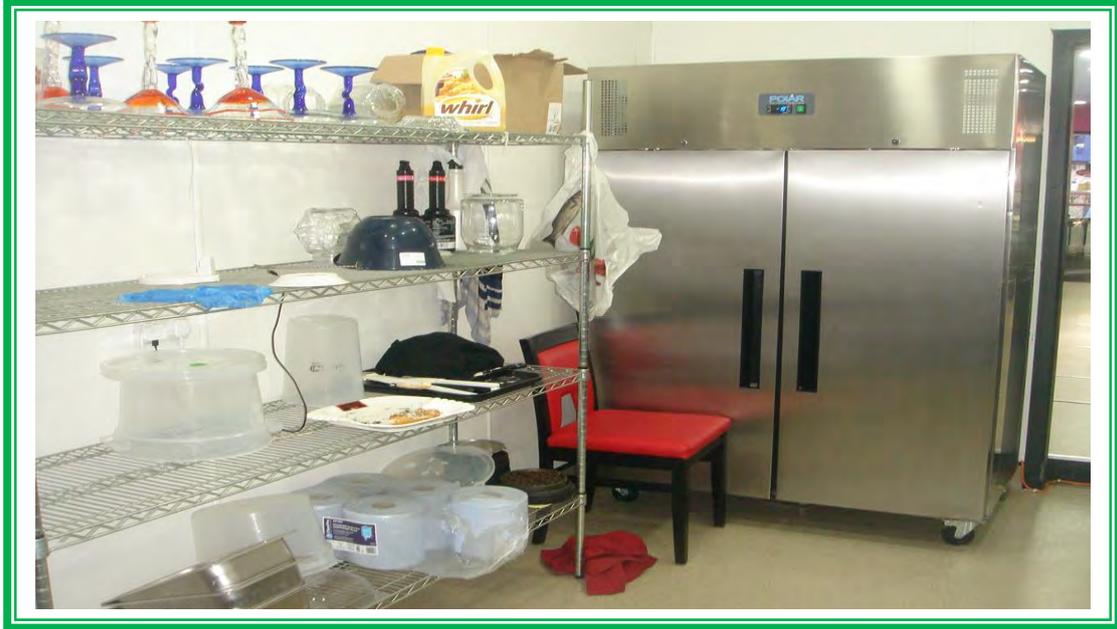
Location: 0/003 Kitchen

Material Description:	Visual Inspection – No Suspect Materials Found	
Identification:	N/A	
Approx. quantity:	N/A	
Accessibility	N/A	Assessment Score
Product type:	N/A	N/A
Extent of Damage:	N/A	N/A
Surface Treatment:	N/A	N/A
Asbestos type:	N/A	N/A
Material Assessment Score:		N/A
Priority Assessment Score:		N/A
Action:	N/A	
Comments:	N/A

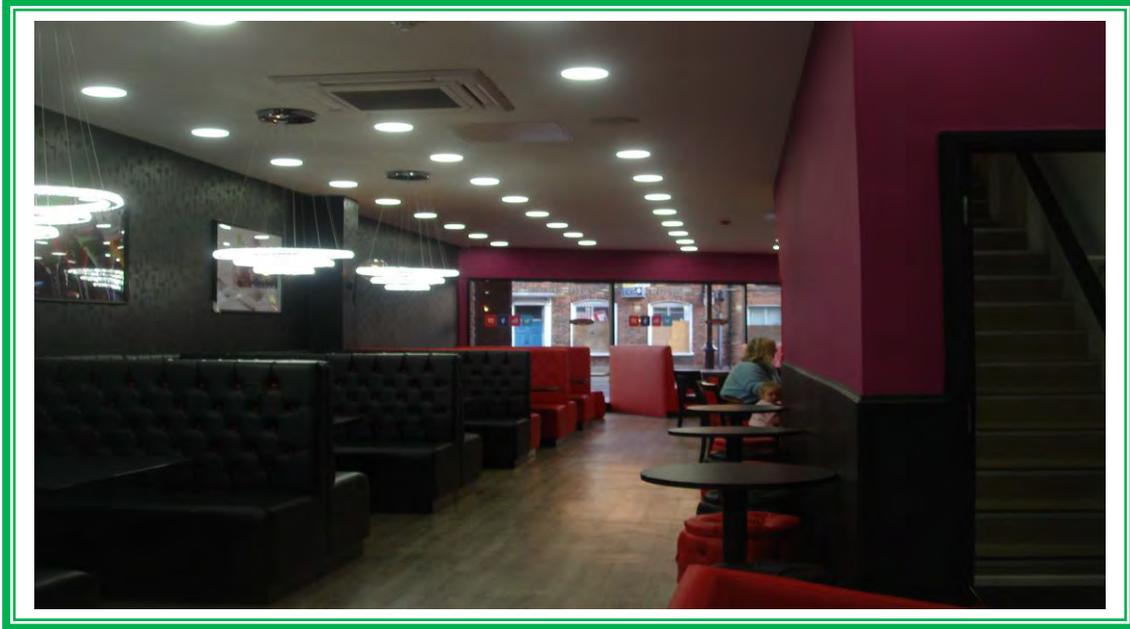
Location: 0/004 Restaurant/Servery

Material Description:	Visual Inspection – No Suspect Materials Found	
Identification:	N/A	
Approx. quantity:	N/A	
Accessibility	N/A	Assessment Score
Product type:	N/A	N/A
Extent of Damage:	N/A	N/A
Surface Treatment:	N/A	N/A
Asbestos type:	N/A	N/A
Material Assessment Score:		N/A
Priority Assessment Score:		N/A
Action:	N/A	
Comments:	N/A

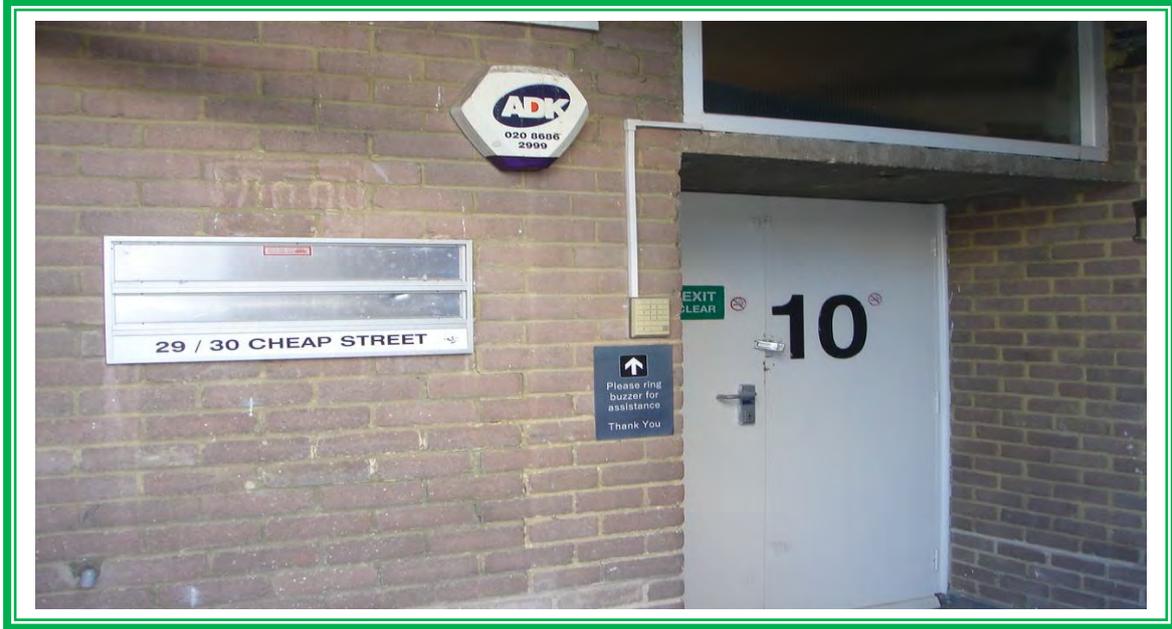
Location: 99/001 External

Material Description:	Visual Inspection – No Suspect Materials Found	
Identification:	N/A	
Approx. quantity:	N/A	
Accessibility	N/A	Assessment Score
Product type:	N/A	N/A
Extent of Damage:	N/A	N/A
Surface Treatment:	N/A	N/A
Asbestos type:	N/A	N/A
Material Assessment Score:		N/A
Priority Assessment Score:		N/A
Action:	N/A	
Comments:	N/A
