Project Number 3113

Management
Asbestos Survey Report

Kennet Centre, Market Street, Newbury,
Berkshire, RG14 5EN

1-3 The Mall

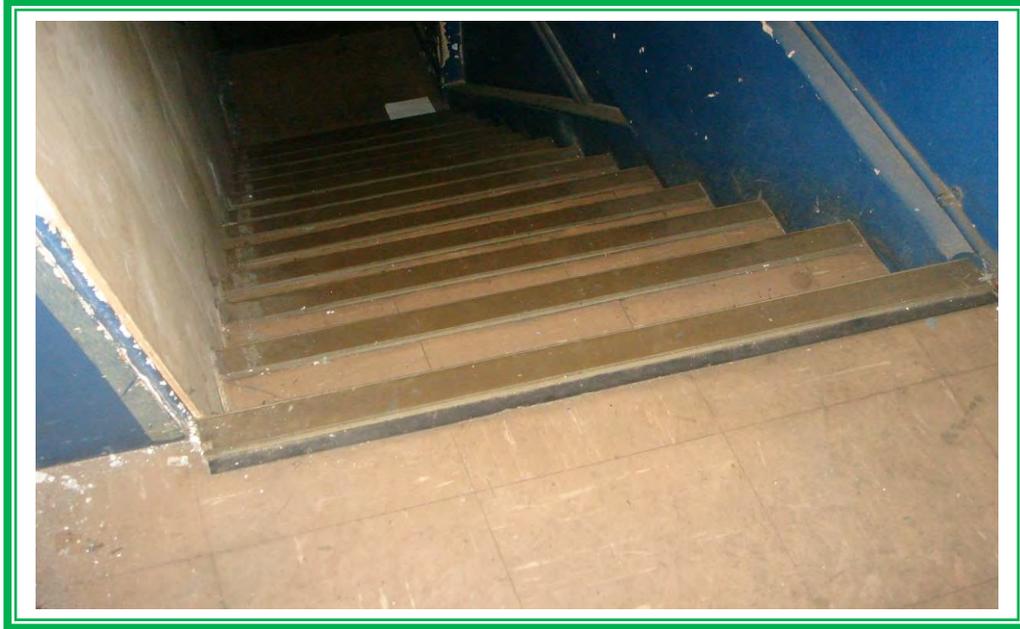
Location: 1/006 Stairs

Material Description:	Vinyl Floor Tiles	
Identification:	As Per Sample NE/2 – No Asbestos Detected	
Approx. quantity:	30M2	
Accessibility	N/A	Assessment Score
Product type:	N/A	N/A
Extent of Damage:	N/A	N/A
Surface Treatment:	N/A	N/A
Asbestos type:	N/A	N/A
Material Assessment Score:		N/A
Priority Assessment Score:		N/A
Action:	N/A	
Comments:	N/A

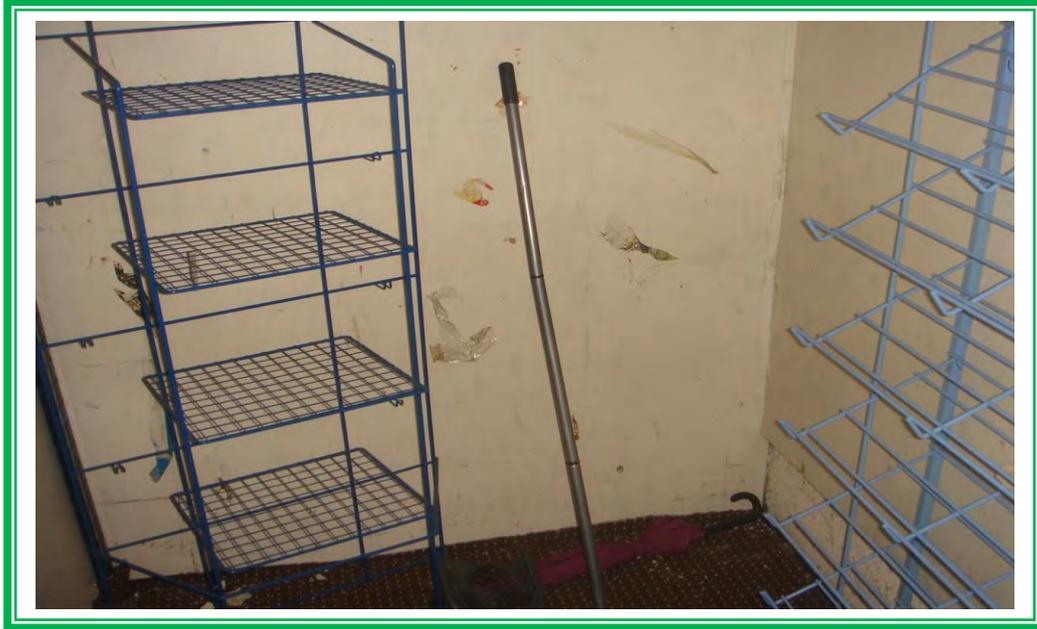
Location: 0/002 Cupboard

Material Description:	Visual Inspection – No Suspect Materials Found	
Identification:	N/A	
Approx. quantity:	N/A	
Accessibility	N/A	Assessment Score
Product type:	N/A	N/A
Extent of Damage:	N/A	N/A
Surface Treatment:	N/A	N/A
Asbestos type:	N/A	N/A
Material Assessment Score:		N/A
Priority Assessment Score:		N/A
Action:	N/A	
Comments:	N/A

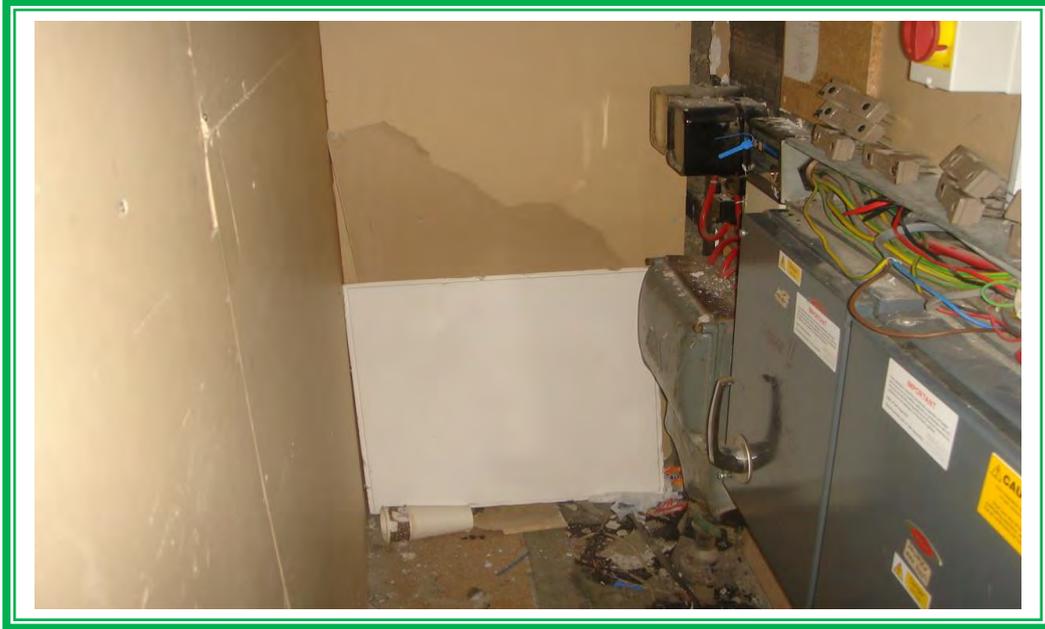
Location: 0/003 Electrics Cupboard

Material Description:	Visual Inspection – No Suspect Materials Found	
Identification:	N/A	
Approx. quantity:	N/A	
Accessibility	N/A	Assessment Score
Product type:	N/A	N/A
Extent of Damage:	N/A	N/A
Surface Treatment:	N/A	N/A
Asbestos type:	N/A	N/A
Material Assessment Score:		N/A
Priority Assessment Score:		N/A
Action:	N/A	
Comments:	N/A

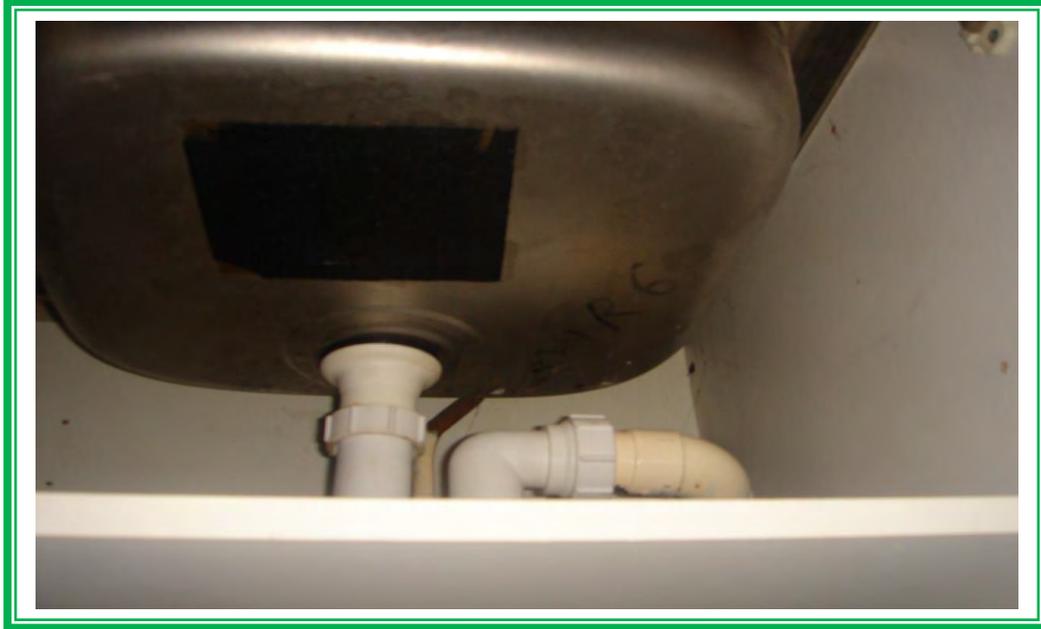
Location: 1/001 Kitchen

Material Description:	Sink Pads	
Identification:	Sampled- No Asbestos Detected	
Approx. quantity:	2 X Items	
Accessibility	N/A	<i>Assessment Score</i>
Product type:	N/A	N/A
Extent of Damage:	N/A	N/A
Surface Treatment:	N/A	N/A
Asbestos type:	N/A	N/A
Material Assessment Score:		N/A
Priority Assessment Score:		N/A
Action:	N/A	
Comments:	N/A

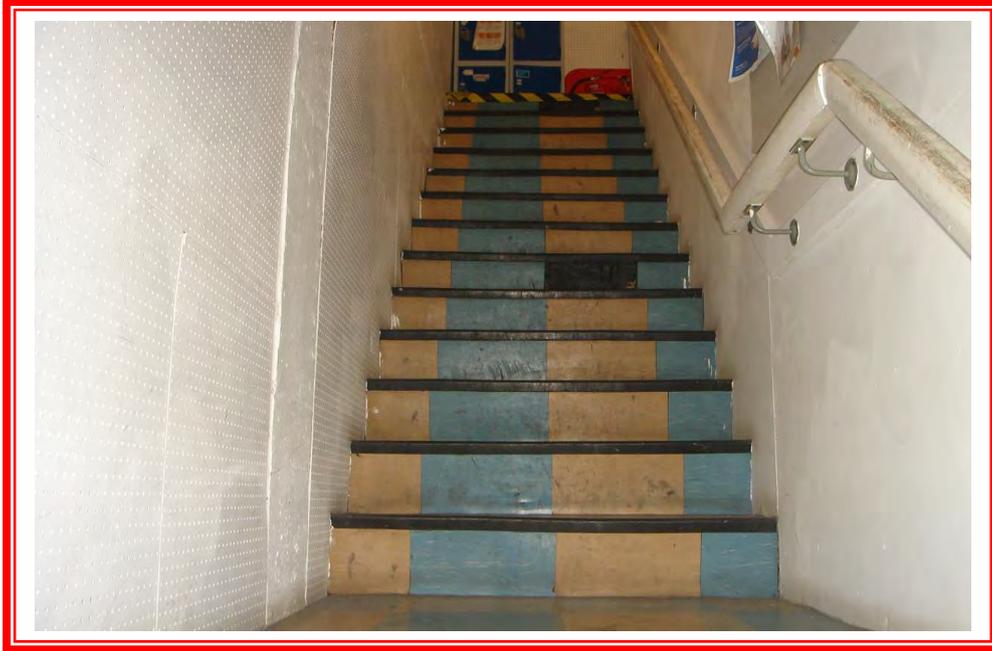
Location: 1/004 Stairs

Material Description:	Vinyl Floor Tiles	
Identification:	As Per Sample NE/1 - Asbestos Detected	
Approx. quantity:	15M2	
Accessibility	Low	Assessment Score
Product type:	Vinyl	1
Extent of Damage:	Moderate	2
Surface Treatment:	Non-Friable	0
Asbestos type:	Chrysotile	1
Material Assessment Score:		4
Priority Assessment Score:		Negligible
Action:	Manage/Repair/Seal	
Comments:	N/A

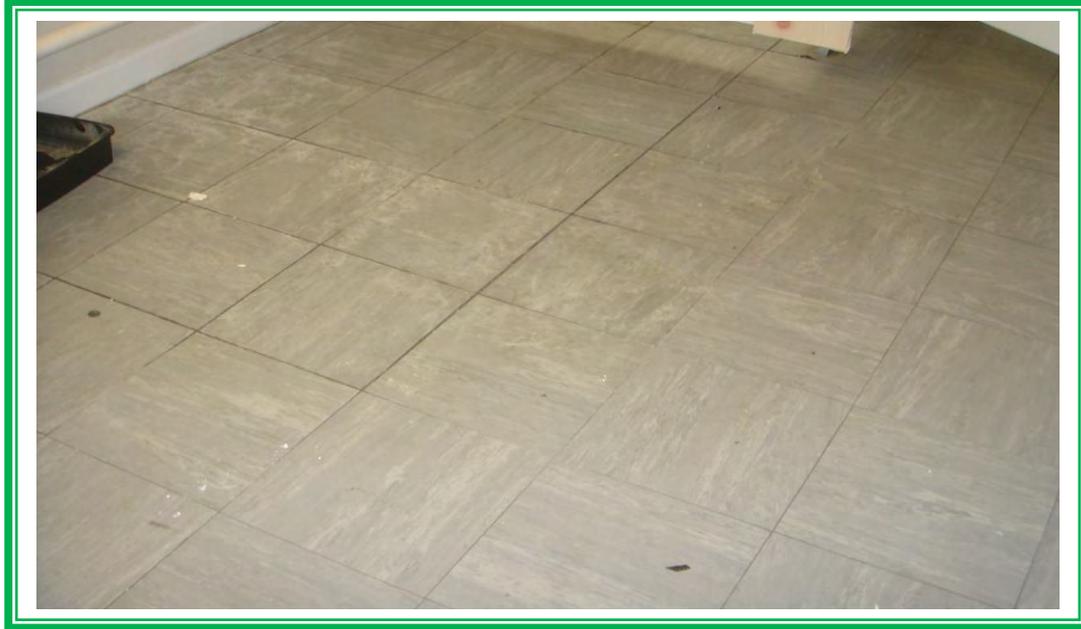
Location: 1/004 WC

Material Description:	Vinyl Floor Tiles	
Identification:	As Per Sample NE/1 – No Asbestos Detected	
Approx. quantity:	8M2	
Accessibility	N/A	Assessment Score
Product type:	N/A	N/A
Extent of Damage:	N/A	N/A
Surface Treatment:	N/A	N/A
Asbestos type:	N/A	N/A
Material Assessment Score:		N/A
Priority Assessment Score:		N/A
Action:	N/A	
Comments:	N/A

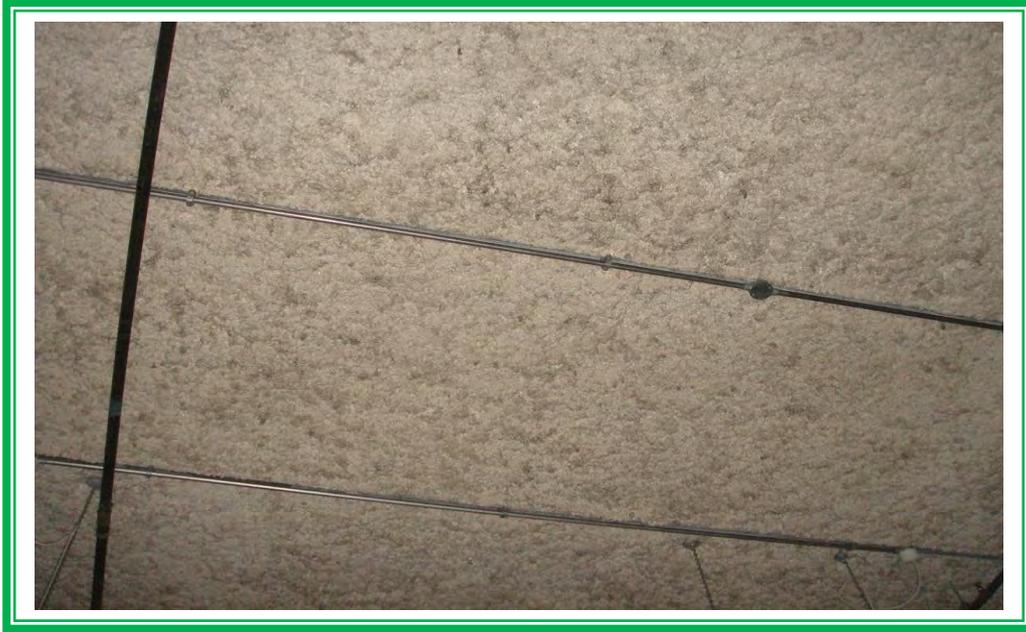
Location: 1/001, 1/002 and 1/003, Loading Bay and Stores x 2

Material Description:	Spray Coating to Ceiling/Beams	
Identification:	Sampled - No Asbestos Detected	
Approx. quantity:	Throughout Floor	
Accessibility	N/A	Assessment Score
Product type:	N/A	N/A
Extent of Damage:	N/A	N/A
Surface Treatment:	N/A	N/A
Asbestos type:	N/A	N/A
Material Assessment Score:		N/A
Priority Assessment Score:		N/A
Action:	N/A	
Comments:	N/A

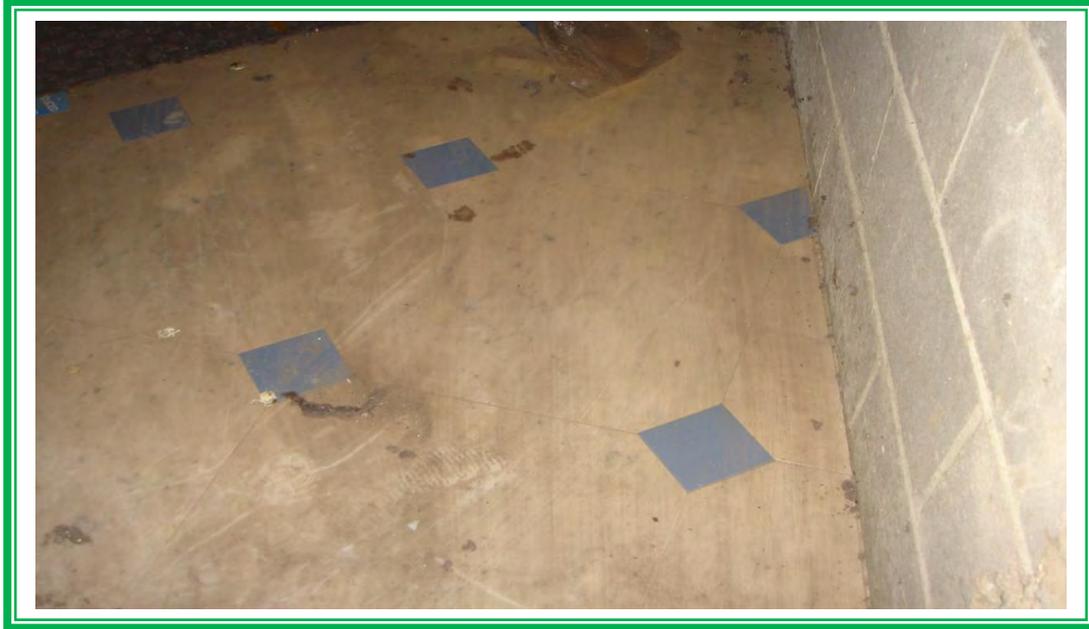
Location: 1/004 Main Shop Floor and Changing Rooms

Material Description:	Floor Tiles	
Identification:	Sampled – No Asbestos Detected	
Approx. quantity:	10M2 Visible – May be more under the carpet throughout	
Accessibility	N/A	Assessment Score
Product type:	N/A	N/A
Extent of Damage:	N/A	N/A
Surface Treatment:	N/A	N/A
Asbestos type:	N/A	N/A
Material Assessment Score:		N/A
Priority Assessment Score:		N/A
Action:	N/A	
Comments:	N/A

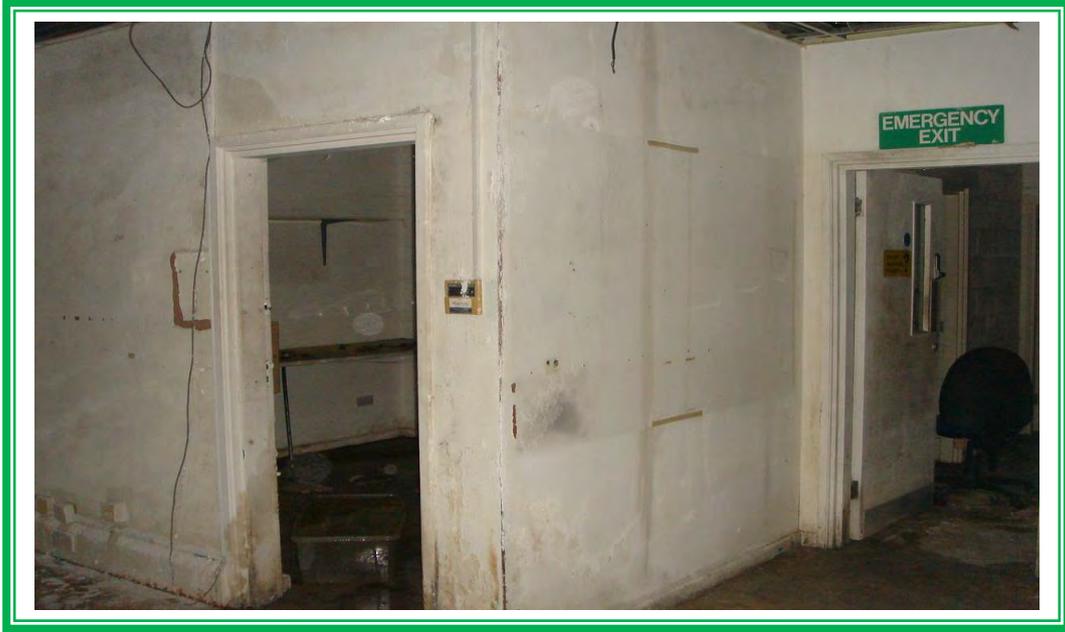
Location: 1/015 Cupboard, 1/016 Office and 1/017
Circulation

Material Description:	Visual Inspection – No Suspect Materials Found	
Identification:	N/A	
Approx. quantity:	N/A	
Accessibility	N/A	Assessment Score
Product type:	N/A	N/A
Extent of Damage:	N/A	N/A
Surface Treatment:	N/A	N/A
Asbestos type:	N/A	N/A
Material Assessment Score:		N/A
Priority Assessment Score:		N/A
Action:	N/A	
Comments:	N/A

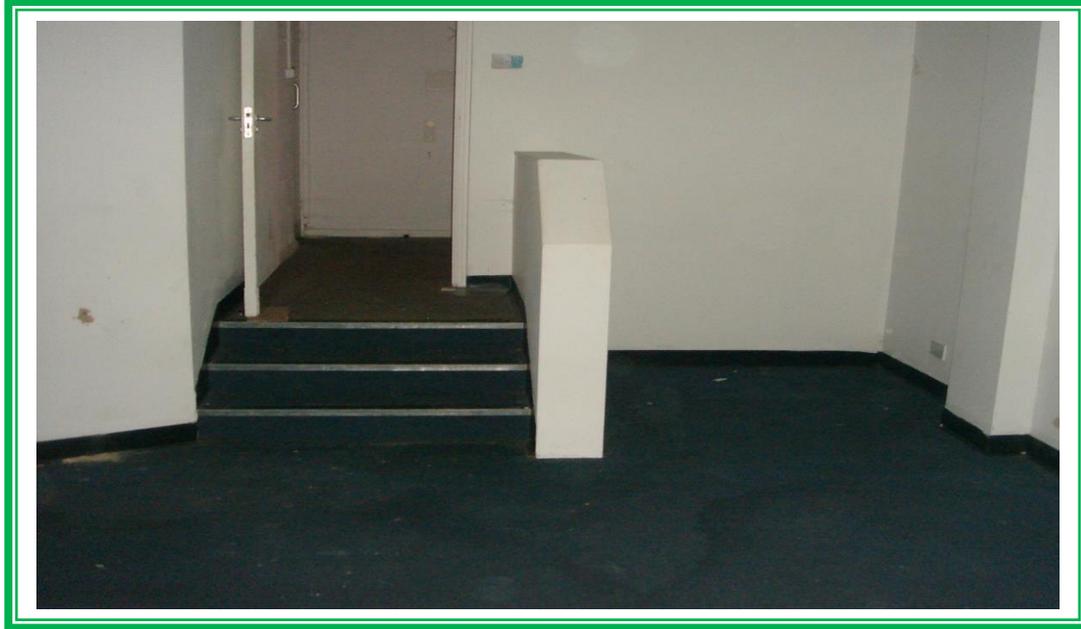
Location: 0/002 Store

Material Description:	Visual Inspection – No Suspect Materials Found	
Identification:	N/A	
Approx. quantity:	N/A	
Accessibility	N/A	Assessment Score
Product type:	N/A	N/A
Extent of Damage:	N/A	N/A
Surface Treatment:	N/A	N/A
Asbestos type:	N/A	N/A
Material Assessment Score:		N/A
Priority Assessment Score:		N/A
Action:	N/A	
Comments:	N/A

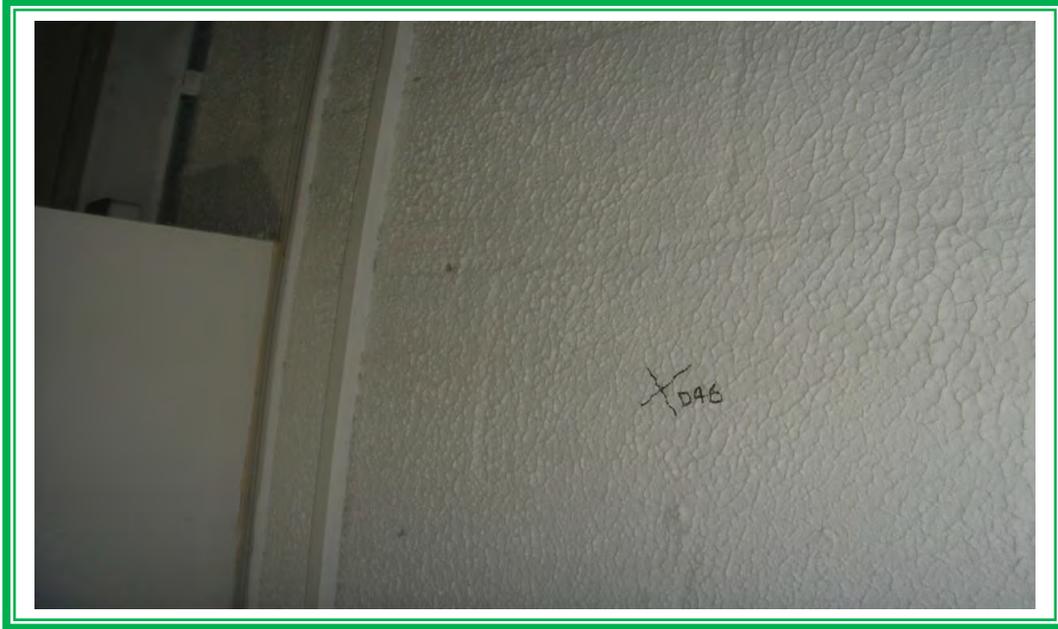
Location: 0/003 Office

Material Description:	Textured Coating to Walls	
Identification:	Sampled - No Asbestos Detected	
Approx. quantity:	22M2	
Accessibility	N/A	Assessment Score
Product type:	N/A	N/A
Extent of Damage:	N/A	N/A
Surface Treatment:	N/A	N/A
Asbestos type:	N/A	N/A
Material Assessment Score:		N/A
Priority Assessment Score:		N/A
Action:	N/A	
Comments:	Modern Electrics

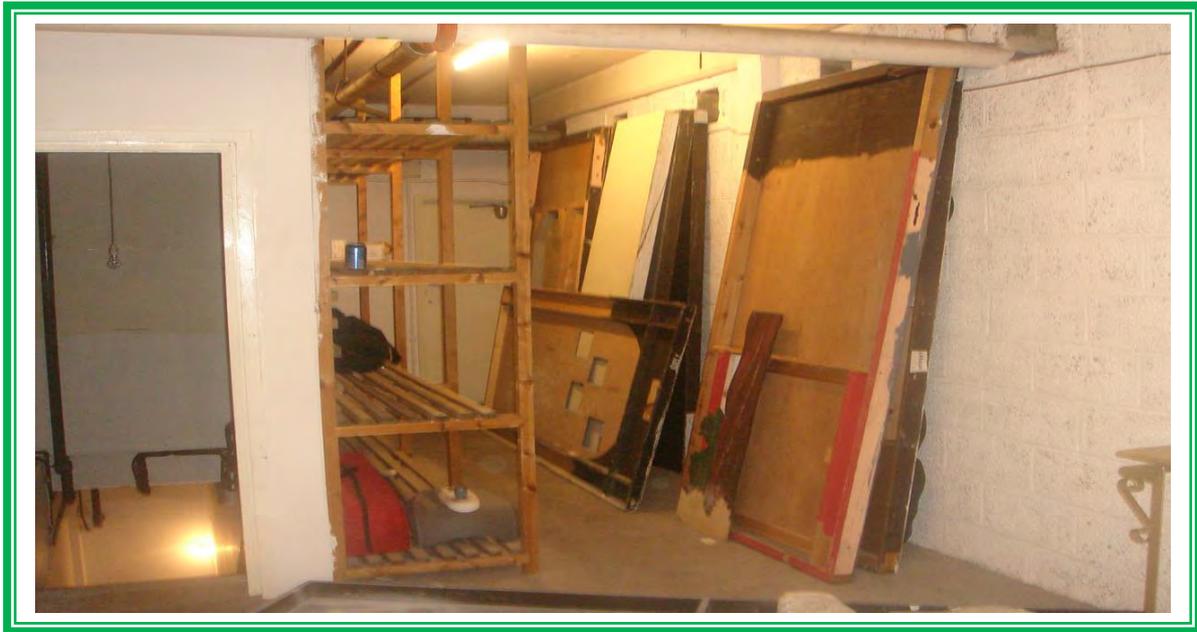
Location: 1/001 Store

Material Description:	Visual Inspection – No Suspect Materials Found	
Identification:	N/A	
Approx. quantity:	N/A	
Accessibility	N/A	Assessment Score
Product type:	N/A	N/A
Extent of Damage:	N/A	N/A
Surface Treatment:	N/A	N/A
Asbestos type:	N/A	N/A
Material Assessment Score:		N/A
Priority Assessment Score:		N/A
Action:	N/A	
Comments:	N/A

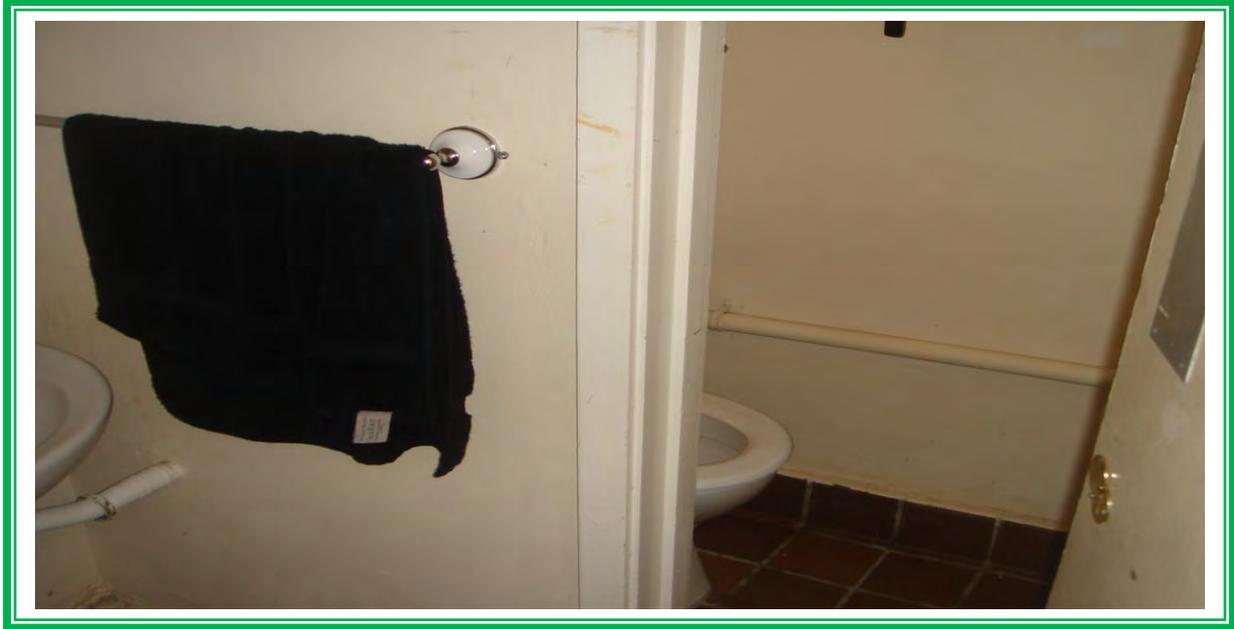
Location: 1/002 WC

Material Description:	Visual Inspection – No Suspect Materials Found	
Identification:	N/A	
Approx. quantity:	N/A	
Accessibility	N/A	Assessment Score
Product type:	N/A	N/A
Extent of Damage:	N/A	N/A
Surface Treatment:	N/A	N/A
Asbestos type:	N/A	N/A
Material Assessment Score:		N/A
Priority Assessment Score:		N/A
Action:	N/A	
Comments:	N/A

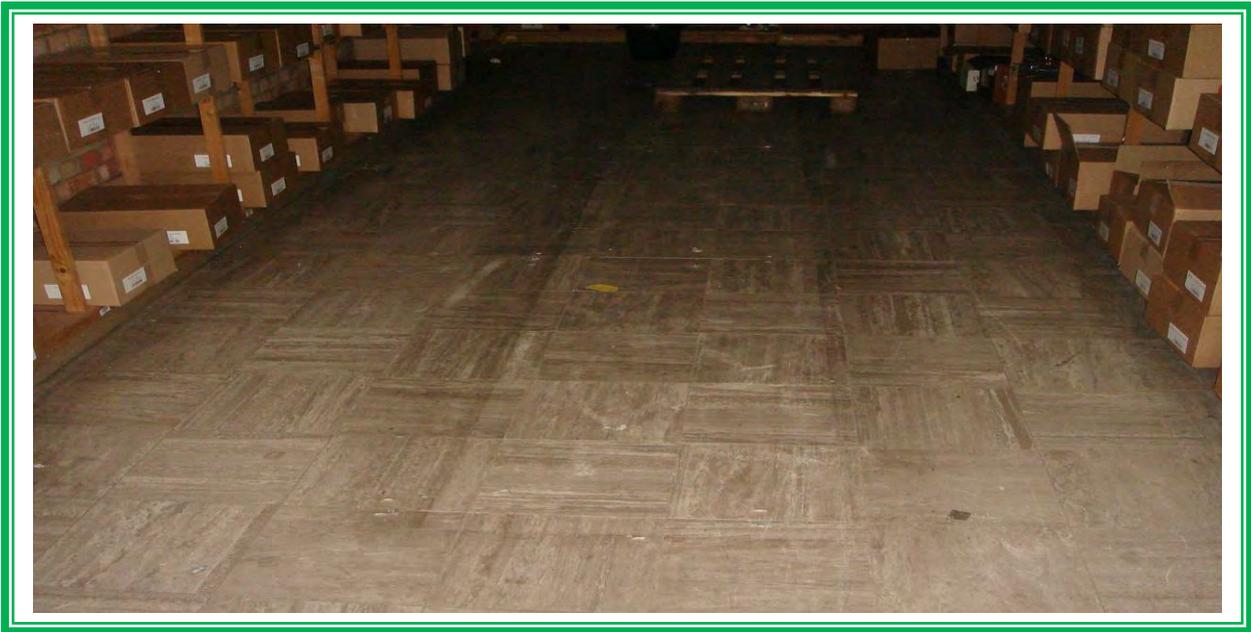
Item No: 1	Sample No: NE/1
Location: 1/001 Store

Material Description:	Vinyl Floor Tiles	
Identification:	Sampled – No Asbestos Detected	
Approx. quantity:	50M2	
Accessibility	N/A	Assessment Score
Product type:	N/A	N/A
Extent of Damage:	N/A	N/A
Surface Treatment:	N/A	N/A
Asbestos type:	N/A	N/A
Material Assessment Score:		N/A
Priority Assessment Score:		N/A
Action:	N/A	
Comments:	N/A

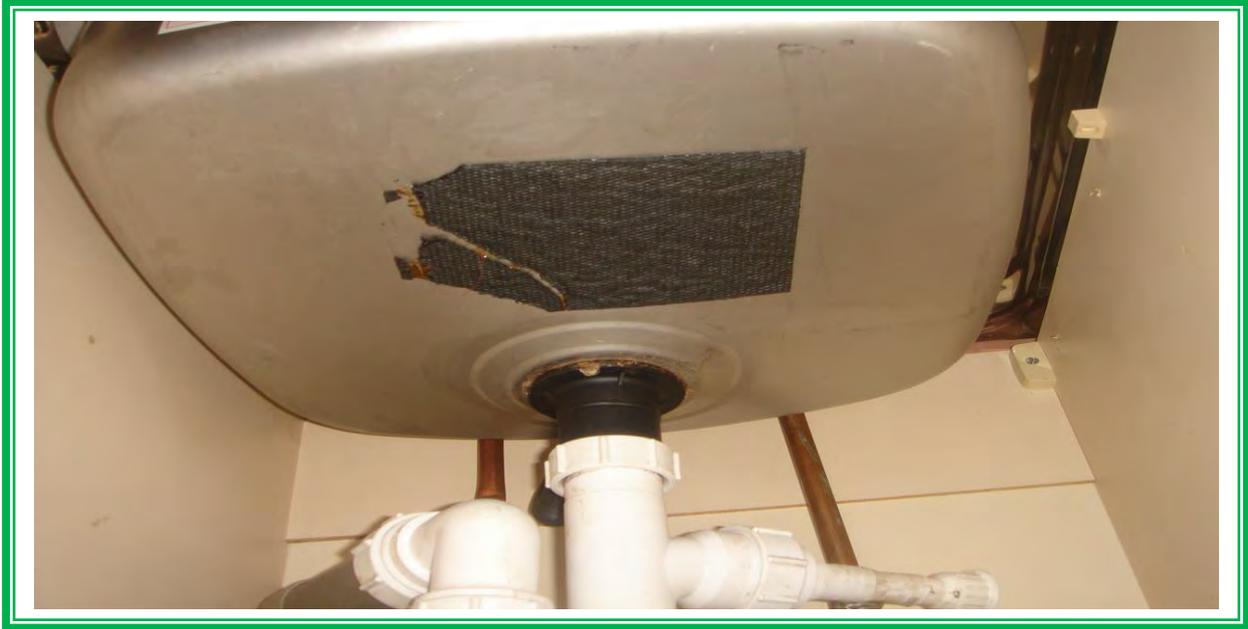
Location: 1/002 Kitchen

Material Description:	Sink Pad	
Identification:	Sampled - No Asbestos Detected	
Approx. quantity:	X 2	
Accessibility	N/A	Assessment Score
Product type:	N/A	N/A
Extent of Damage:	N/A	N/A
Surface Treatment:	N/A	N/A
Asbestos type:	N/A	N/A
Material Assessment Score:		N/A
Priority Assessment Score:		N/A
Action:	N/A	
Comments:	N/A

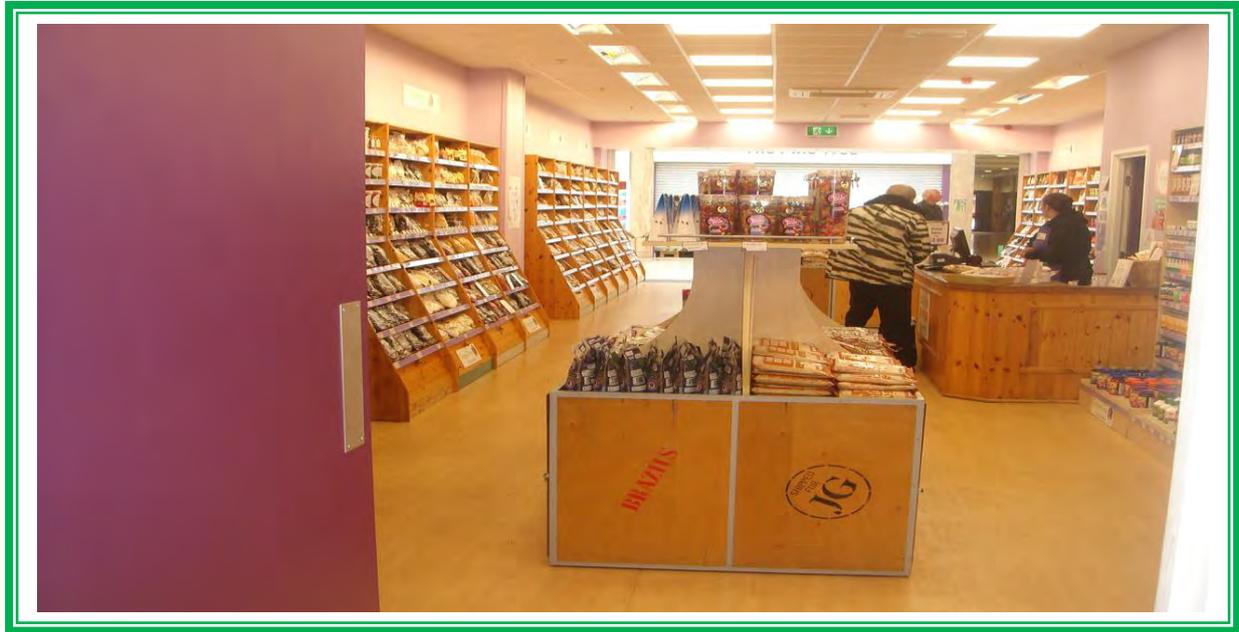
Location: 0/001 Shop Floor

Material Description:	Visual Inspection – No Suspect Materials Found	
Identification:	N/A	
Approx. quantity:	N/A	
Accessibility	N/A	Assessment Score
Product type:	N/A	N/A
Extent of Damage:	N/A	N/A
Surface Treatment:	N/A	N/A
Asbestos type:	N/A	N/A
Material Assessment Score:		N/A
Priority Assessment Score:		N/A
Action:	N/A	
Comments:	N/A

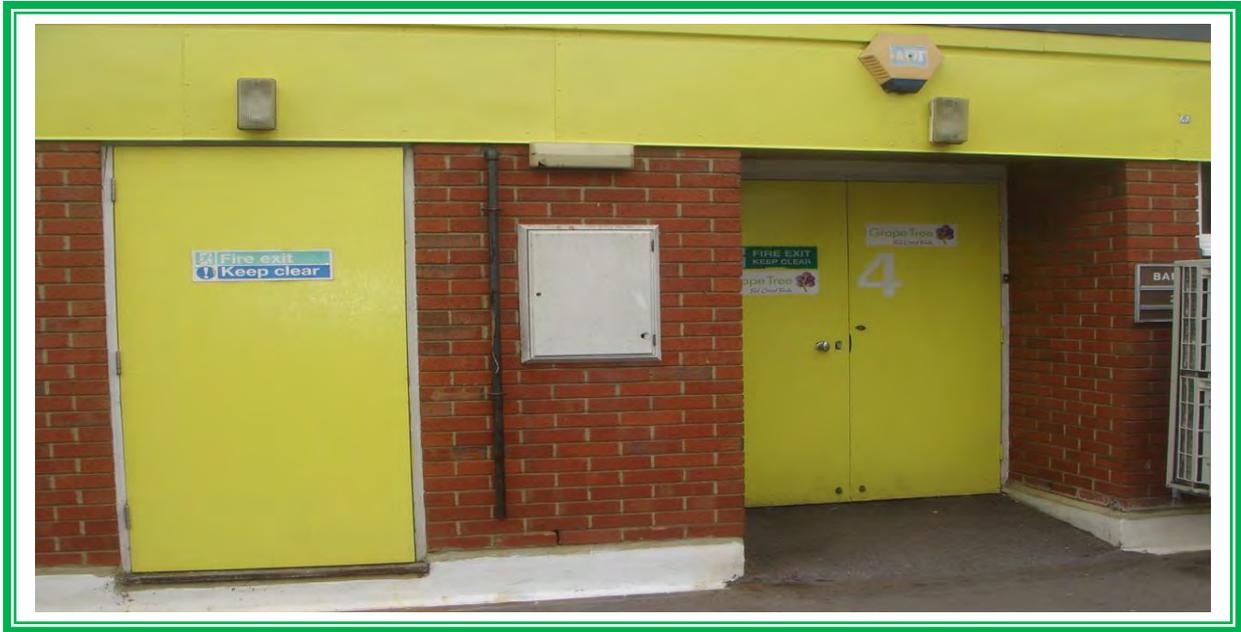
Location: 99/001

Material Description:	Visual Inspection – No Suspect Materials Found	
Identification:	N/A	
Approx. quantity:	N/A	
Accessibility	N/A	Assessment Score
Product type:	N/A	N/A
Extent of Damage:	N/A	N/A
Surface Treatment:	N/A	N/A
Asbestos type:	N/A	N/A
Material Assessment Score:		N/A
Priority Assessment Score:		N/A
Action:	N/A	
Comments:	N/A

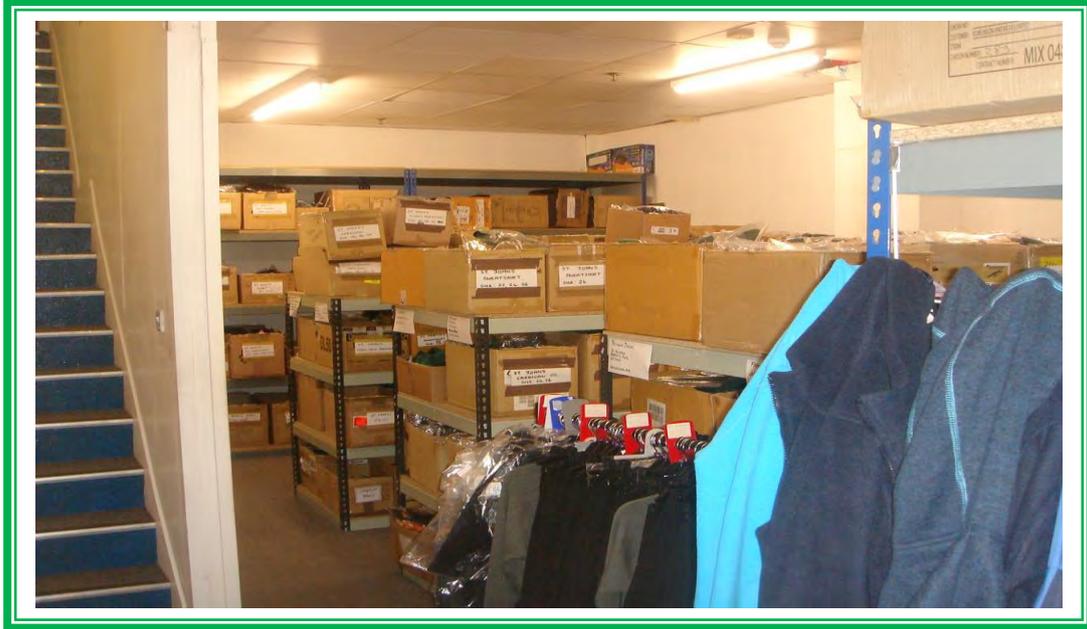
Location: 0/001 Store

Material Description:	Visual Inspection – No Suspect Materials Found	
Identification:	N/A	
Approx. quantity:	N/A	
Accessibility	N/A	Assessment Score
Product type:	N/A	N/A
Extent of Damage:	N/A	N/A
Surface Treatment:	N/A	N/A
Asbestos type:	N/A	N/A
Material Assessment Score:		N/A
Priority Assessment Score:		N/A
Action:	N/A	
Comments:	N/A

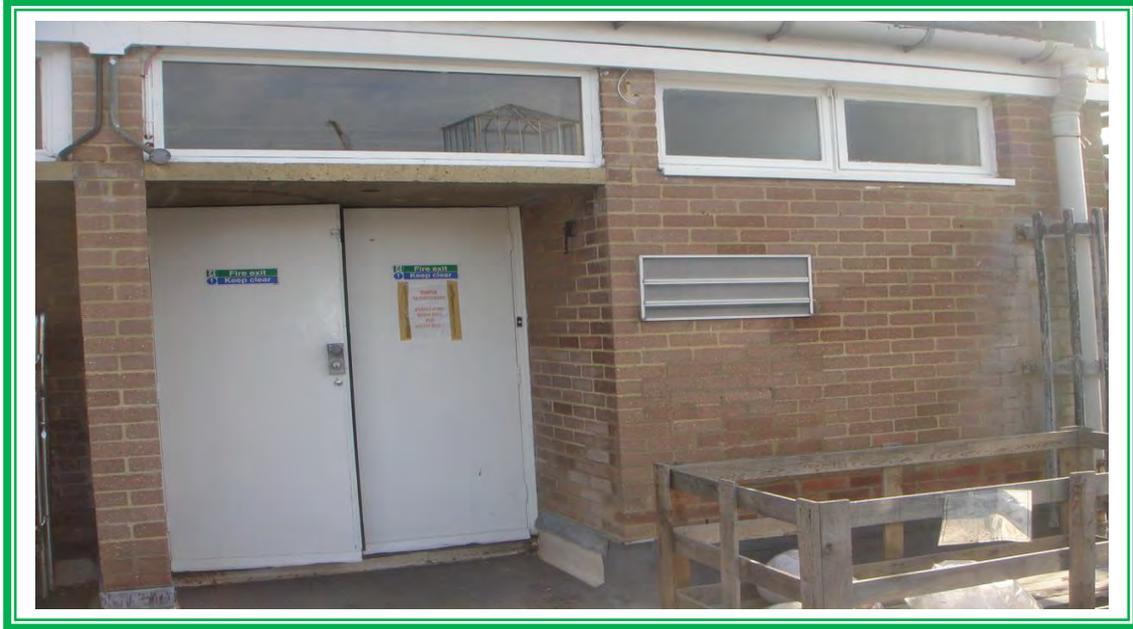
Location: 99/001 External

Material Description:	Visual Inspection – No Suspect Materials Found	
Identification:	N/A	
Approx. quantity:	N/A	
Accessibility	N/A	Assessment Score
Product type:	N/A	N/A
Extent of Damage:	N/A	N/A
Surface Treatment:	N/A	N/A
Asbestos type:	N/A	N/A
Material Assessment Score:		N/A
Priority Assessment Score:		N/A
Action:	N/A	
Comments:	N/A

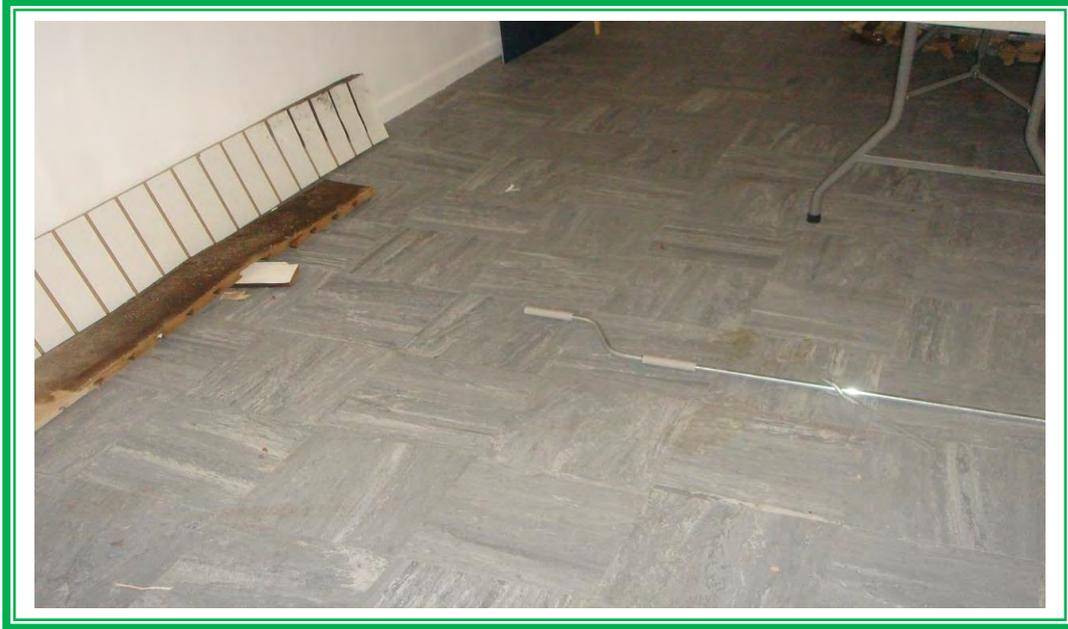
Location: 0/001 Store

Material Description:	Vinyl Floor Tiles	
Identification:	Sampled – No Asbestos Detected	
Approx. quantity:	12M2	
Accessibility	N/A	Assessment Score
Product type:	N/A	N/A
Extent of Damage:	N/A	N/A
Surface Treatment:	N/A	N/A
Asbestos type:	N/A	N/A
Material Assessment Score:		N/A
Priority Assessment Score:		N/A
Action:	N/A	
Comments:	N/A

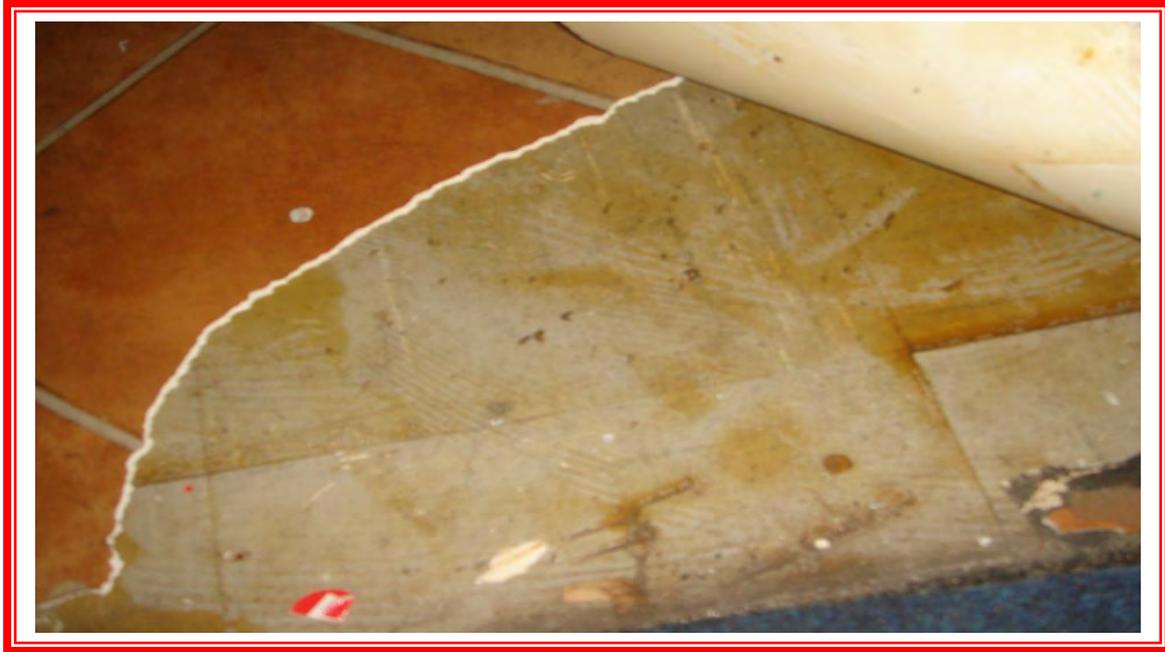
Location: 1/002 Kitchen

Material Description:	Vinyl Floor Tiles	
Identification:	Sampled – Asbestos Detected	
Approx. quantity:	10M2	
Accessibility	Low	Assessment Score
Product type:	Vinyl	1
Extent of Damage:	Minor	1
Surface Treatment:	Non-Friable	0
Asbestos type:	Chrysotile	1
Material Assessment Score:		3
Priority Assessment Score:		Negligible
Action:	Manage	
Comments:	N/A

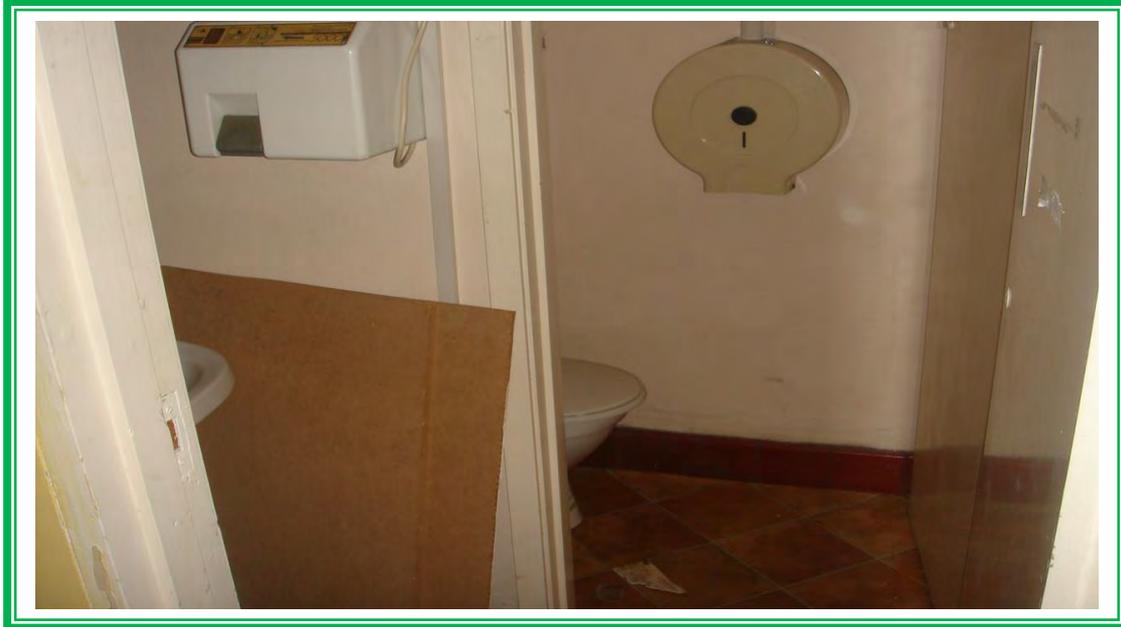
Location: 1/003 WC

Material Description:	Visual Inspection – No Suspect Materials Found	
Identification:	N/A	
Approx. quantity:	N/A	
Accessibility	N/A	Assessment Score
Product type:	N/A	N/A
Extent of Damage:	N/A	N/A
Surface Treatment:	N/A	N/A
Asbestos type:	N/A	N/A
Material Assessment Score:		N/A
Priority Assessment Score:		N/A
Action:	N/A	
Comments:	N/A

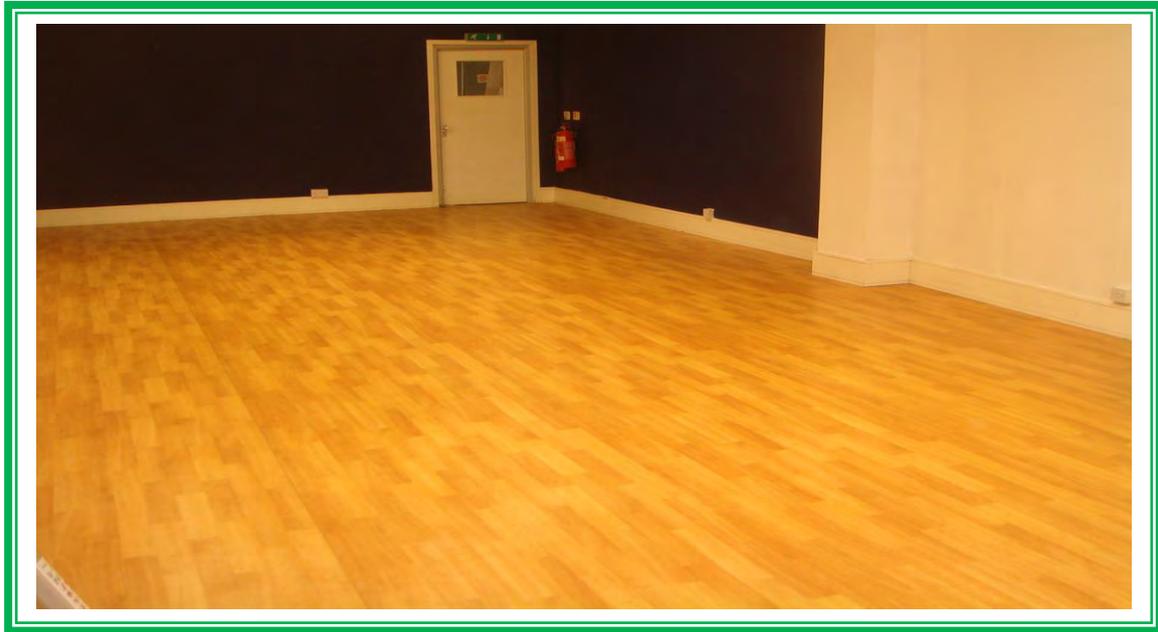
Location: 0/001 Shop Floor

Material Description:	Visual Inspection – No Suspect Materials Found	
Identification:	N/A	
Approx. quantity:	N/A	
Accessibility	N/A	Assessment Score
Product type:	N/A	N/A
Extent of Damage:	N/A	N/A
Surface Treatment:	N/A	N/A
Asbestos type:	N/A	N/A
Material Assessment Score:		N/A
Priority Assessment Score:		N/A
Action:	N/A	
Comments:	N/A

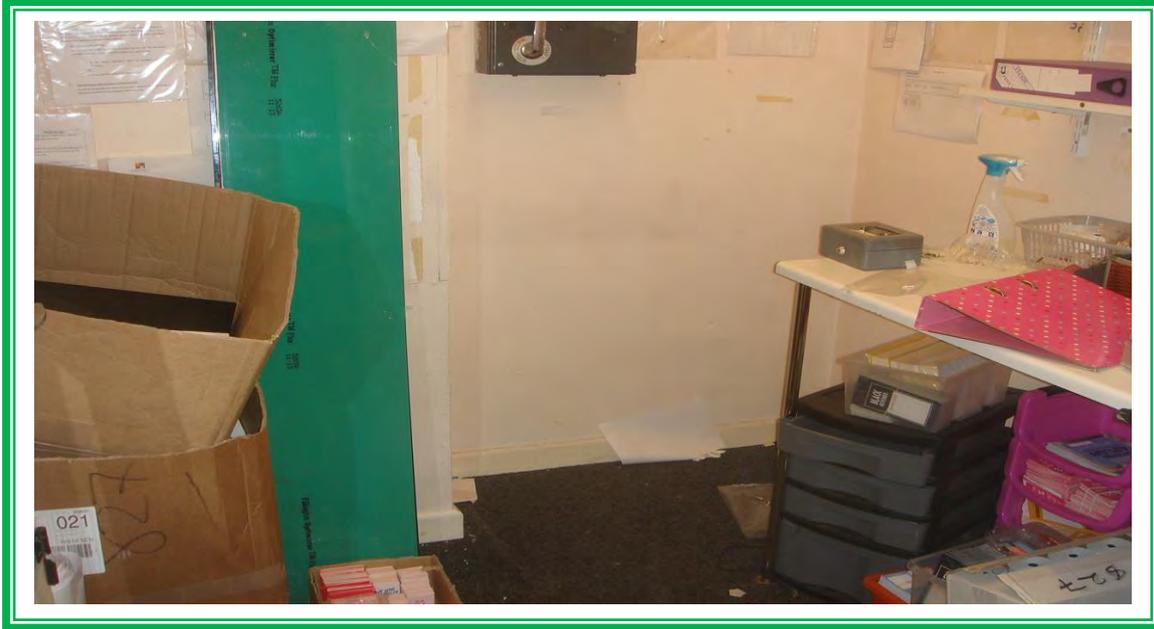
Location: 0/003 Office

Material Description:	Visual Inspection – No Suspect Materials Found	
Identification:	N/A	
Approx. quantity:	N/A	
Accessibility	N/A	Assessment Score
Product type:	N/A	N/A
Extent of Damage:	N/A	N/A
Surface Treatment:	N/A	N/A
Asbestos type:	N/A	N/A
Material Assessment Score:		N/A
Priority Assessment Score:		N/A
Action:	N/A	
Comments:	N/A
