Section 6: Survey Objectives

Instructions were received from James Croucher of Lochailort Newbury Ltd to carry out a Management asbestos survey at Kennet Centre, Market Street, Newbury, Berkshire, RG14 5EN in accordance with HSG264 and Armour Analytical's quality procedures.

The survey was carried out on 22nd – 25th October 2019 by Neale Evans with the objective of facilitating a Management report.

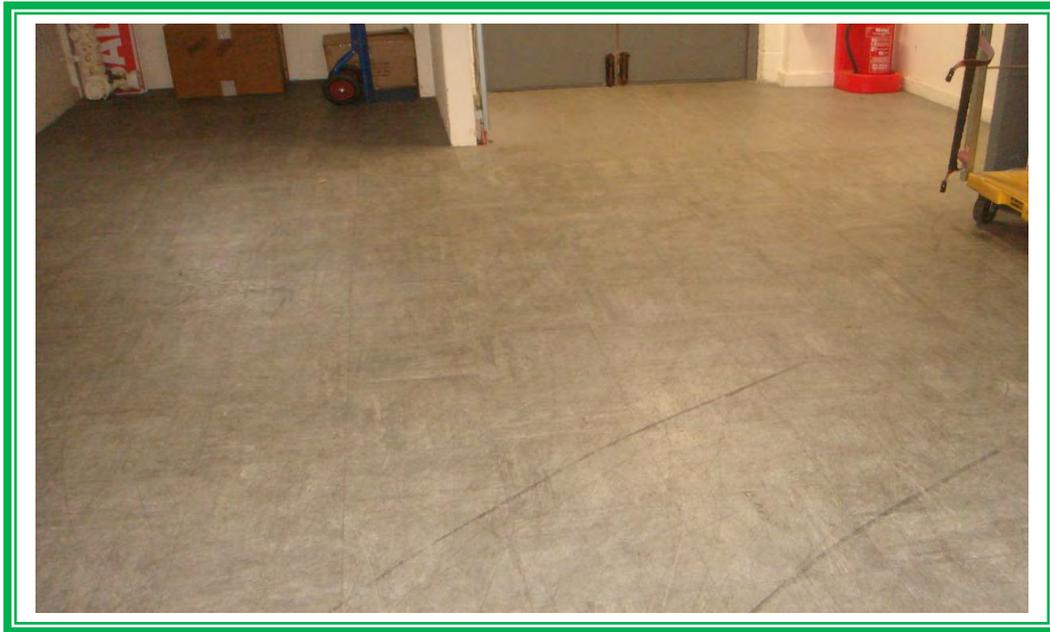
Item No: 1	Sample No: NE/1
Location: 1/001 Store Area

Material Description:	Vinyl Floor Tiles	
Identification:	Sampled – No Asbestos Detected	
Approx. quantity:	50M2	
Accessibility	N/A	Assessment Score
Product type:	N/A	N/A
Extent of Damage:	N/A	N/A
Surface Treatment:	N/A	N/A
Asbestos type:	N/A	N/A
Material Assessment Score:		N/A
Priority Assessment Score:		N/A
Action:	N/A	
Comments:	N/A

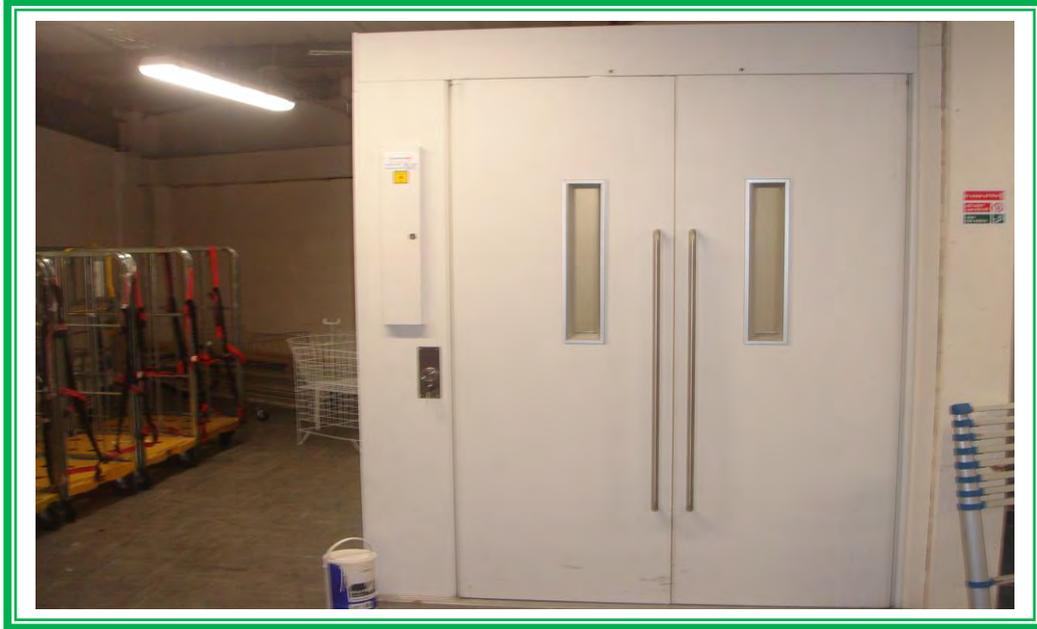
Location: 1/002 Lift and Shafts

Material Description:	Visual Inspection – No Suspect Materials Found	
Identification:	N/A	
Approx. quantity:	N/A	
Accessibility	N/A	Assessment Score
Product type:	N/A	N/A
Extent of Damage:	N/A	N/A
Surface Treatment:	N/A	N/A
Asbestos type:	N/A	N/A
Material Assessment Score:		N/A
Priority Assessment Score:		N/A
Action:	N/A	
Comments:	N/A

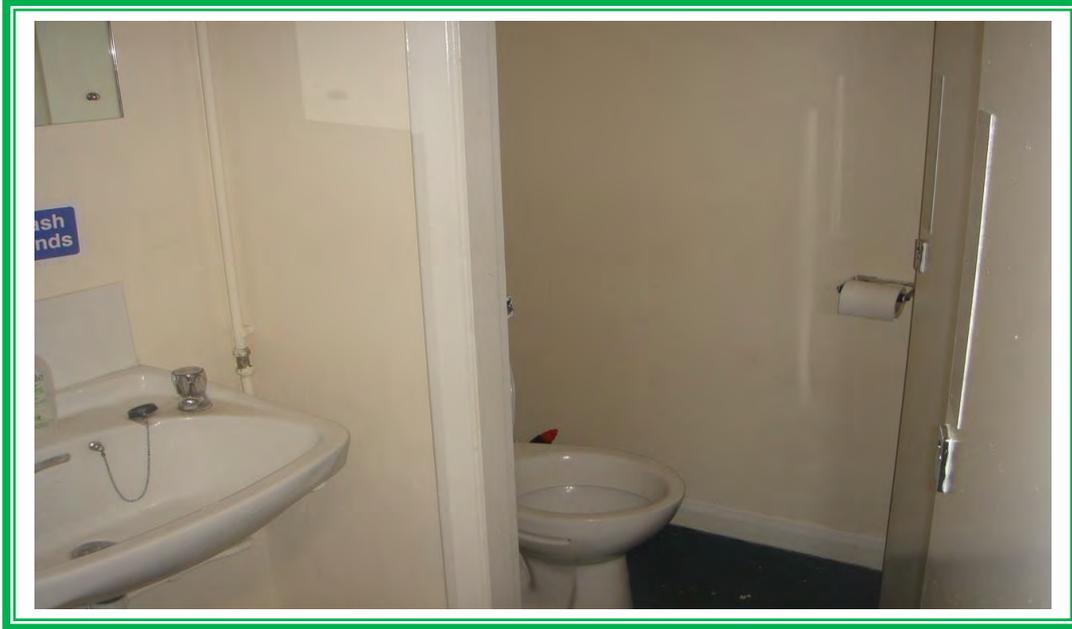
Location: 1/003 WC

Material Description:	Visual Inspection – No Suspect Materials Found	
Identification:	N/A	
Approx. quantity:	N/A	
Accessibility	N/A	Assessment Score
Product type:	N/A	N/A
Extent of Damage:	N/A	N/A
Surface Treatment:	N/A	N/A
Asbestos type:	N/A	N/A
Material Assessment Score:		N/A
Priority Assessment Score:		N/A
Action:	N/A	
Comments:	N/A

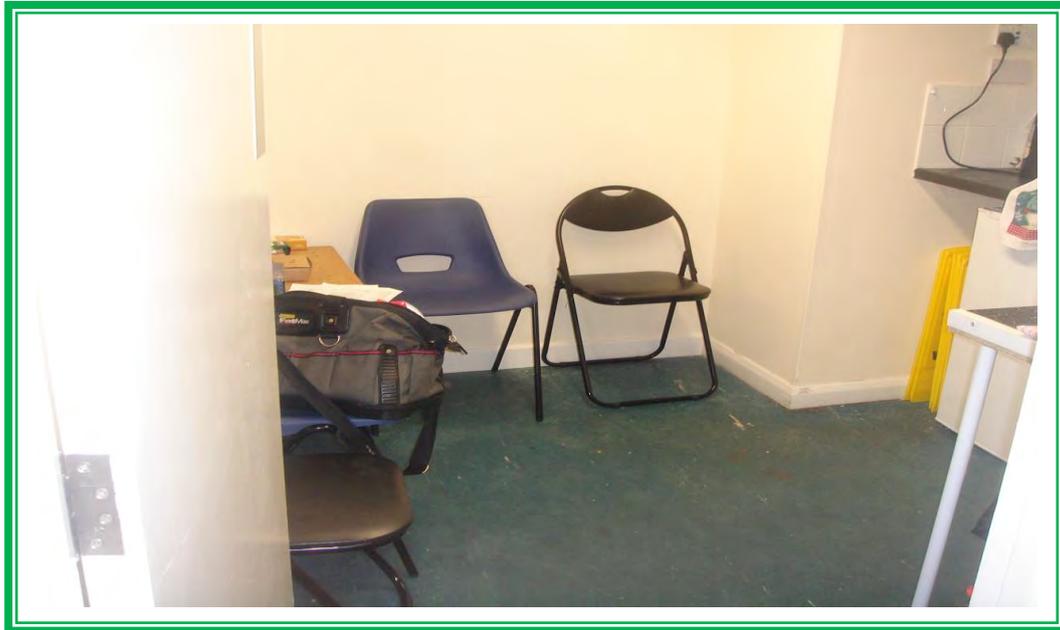
Location: 1/004 Kitchen

Material Description:	Visual Inspection – No Suspect Materials Found	
Identification:	N/A	
Approx. quantity:	N/A	
Accessibility	N/A	Assessment Score
Product type:	N/A	N/A
Extent of Damage:	N/A	N/A
Surface Treatment:	N/A	N/A
Asbestos type:	N/A	N/A
Material Assessment Score:		N/A
Priority Assessment Score:		N/A
Action:	N/A	
Comments:	N/A

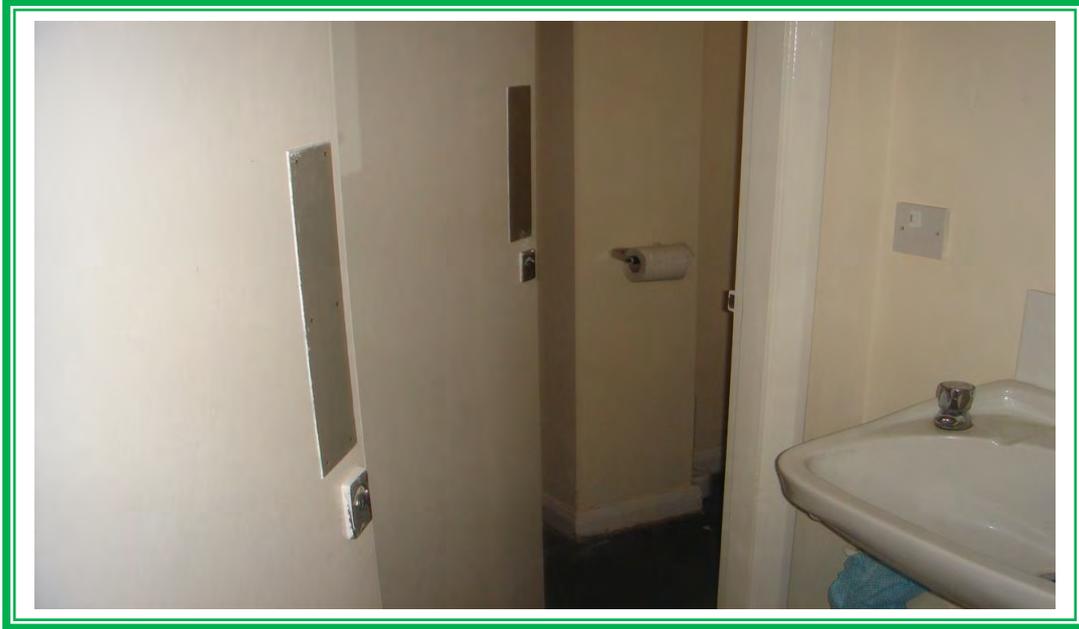
Location: 1/005 WC

Material Description:	Visual Inspection – No Suspect Materials Found	
Identification:	N/A	
Approx. quantity:	N/A	
Accessibility	N/A	Assessment Score
Product type:	N/A	N/A
Extent of Damage:	N/A	N/A
Surface Treatment:	N/A	N/A
Asbestos type:	N/A	N/A
Material Assessment Score:		N/A
Priority Assessment Score:		N/A
Action:	N/A	
Comments:	N/A

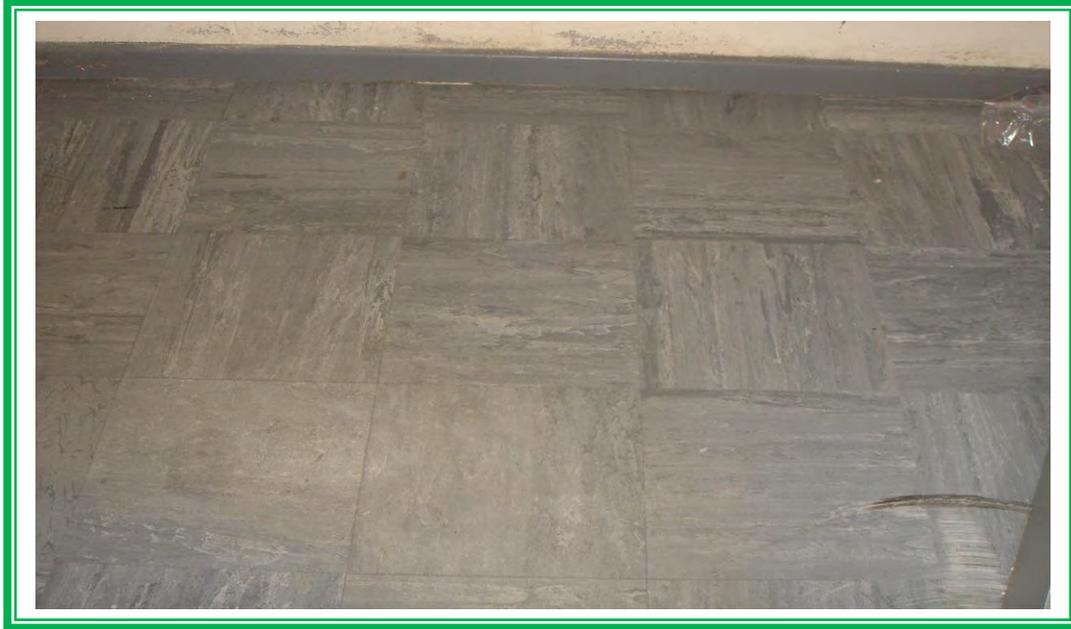
Location: 0/001 Lobby

Material Description:	Vinyl Floor Tiles	
Identification:	Sampled – No Asbestos Detected	
Approx. quantity:	4M2	
Accessibility	N/A	Assessment Score
Product type:	N/A	N/A
Extent of Damage:	N/A	N/A
Surface Treatment:	N/A	N/A
Asbestos type:	N/A	N/A
Material Assessment Score:		N/A
Priority Assessment Score:		N/A
Action:	N/A	
Comments:	N/A

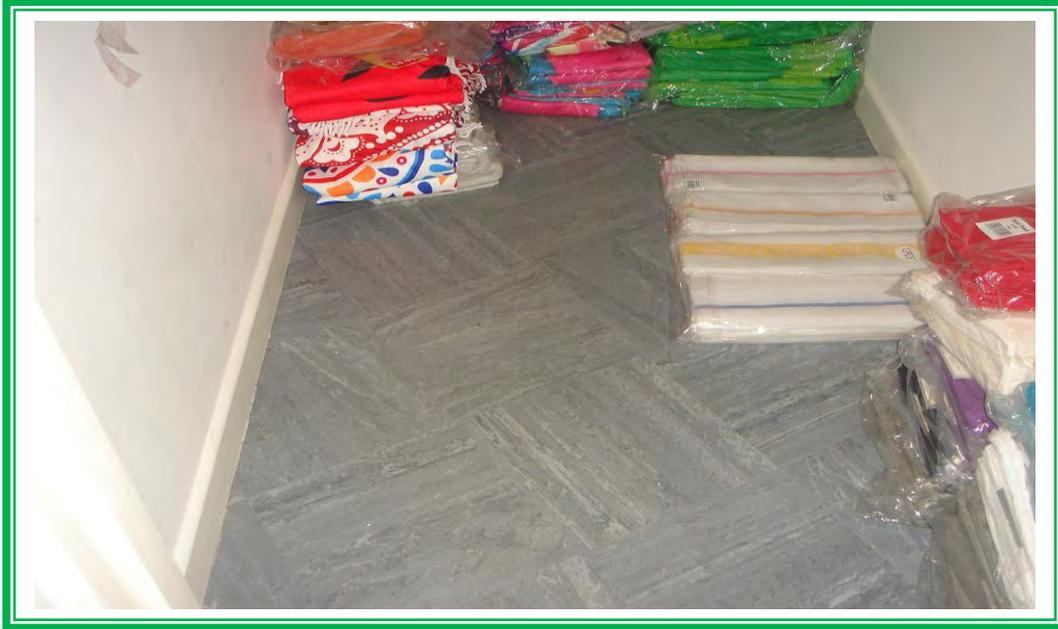
Location: 0/003A Cupboard

Material Description:	Vinyl Floor Tiles	
Identification:	As Per Sample NE/4 – No Asbestos Detected	
Approx. quantity:	2M2	
Accessibility	N/A	Assessment Score
Product type:	N/A	N/A
Extent of Damage:	N/A	N/A
Surface Treatment:	N/A	N/A
Asbestos type:	N/A	N/A
Material Assessment Score:		N/A
Priority Assessment Score:		N/A
Action:	N/A	
Comments:	N/A

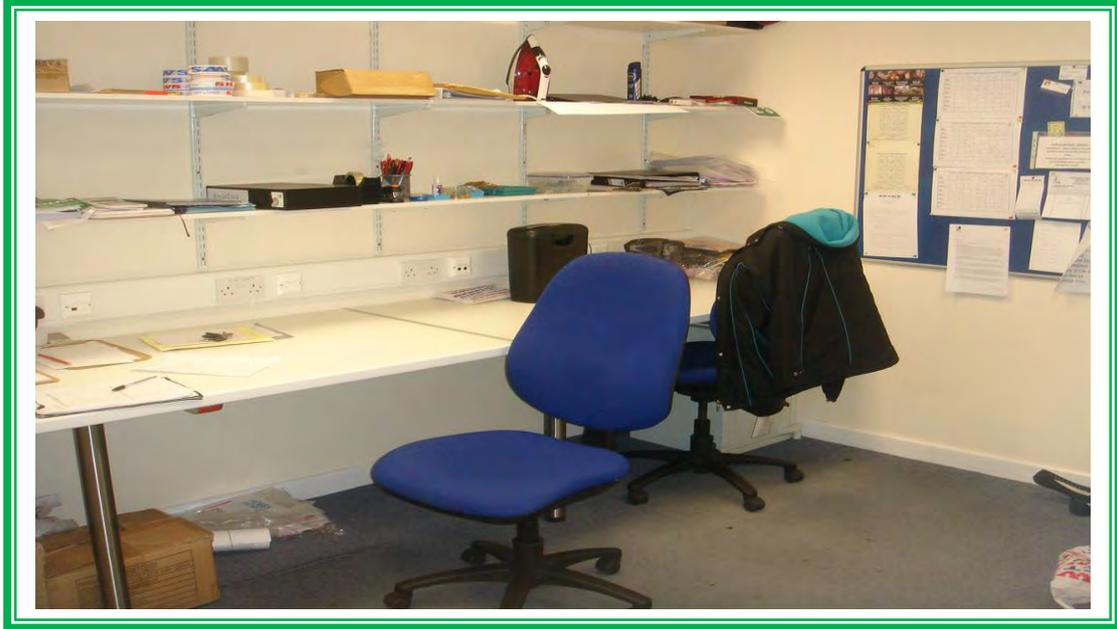
Location: 0/004 Office

Material Description:	Visual Inspection – No Suspect Materials Found	
Identification:	N/A	
Approx. quantity:	N/A	
Accessibility	N/A	Assessment Score
Product type:	N/A	N/A
Extent of Damage:	N/A	N/A
Surface Treatment:	N/A	N/A
Asbestos type:	N/A	N/A
Material Assessment Score:		N/A
Priority Assessment Score:		N/A
Action:	N/A	
Comments:	N/A

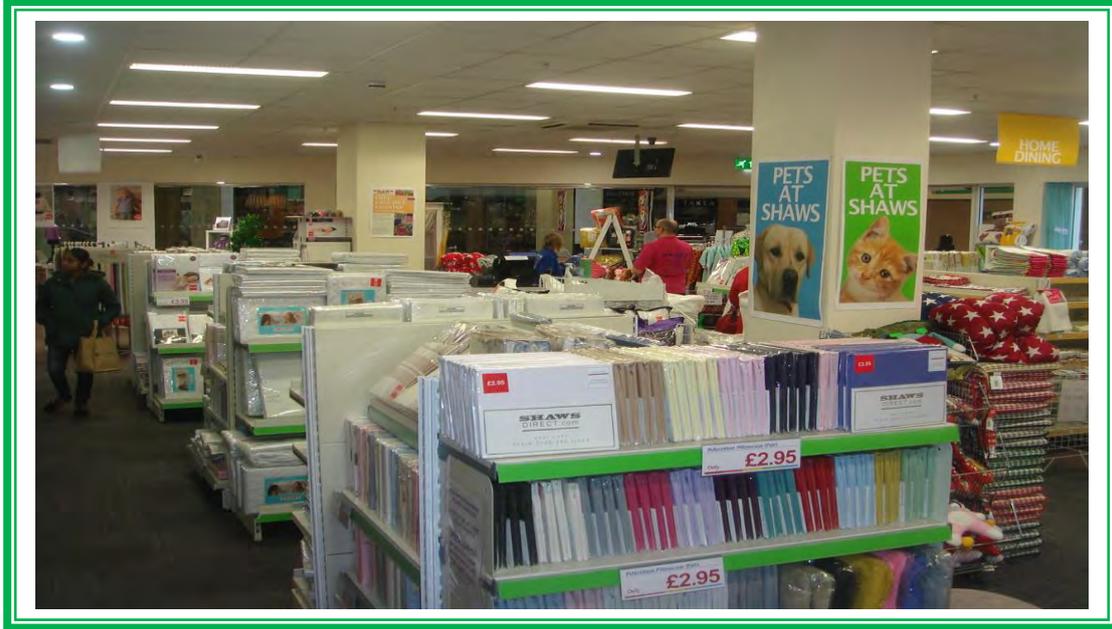
Location: 0/005 Shop Floor

Material Description:	Visual Inspection – No Suspect Materials Found	
Identification:	N/A	
Approx. quantity:	N/A	
Accessibility	N/A	Assessment Score
Product type:	N/A	N/A
Extent of Damage:	N/A	N/A
Surface Treatment:	N/A	N/A
Asbestos type:	N/A	N/A
Material Assessment Score:		N/A
Priority Assessment Score:		N/A
Action:	N/A	
Comments:	N/A

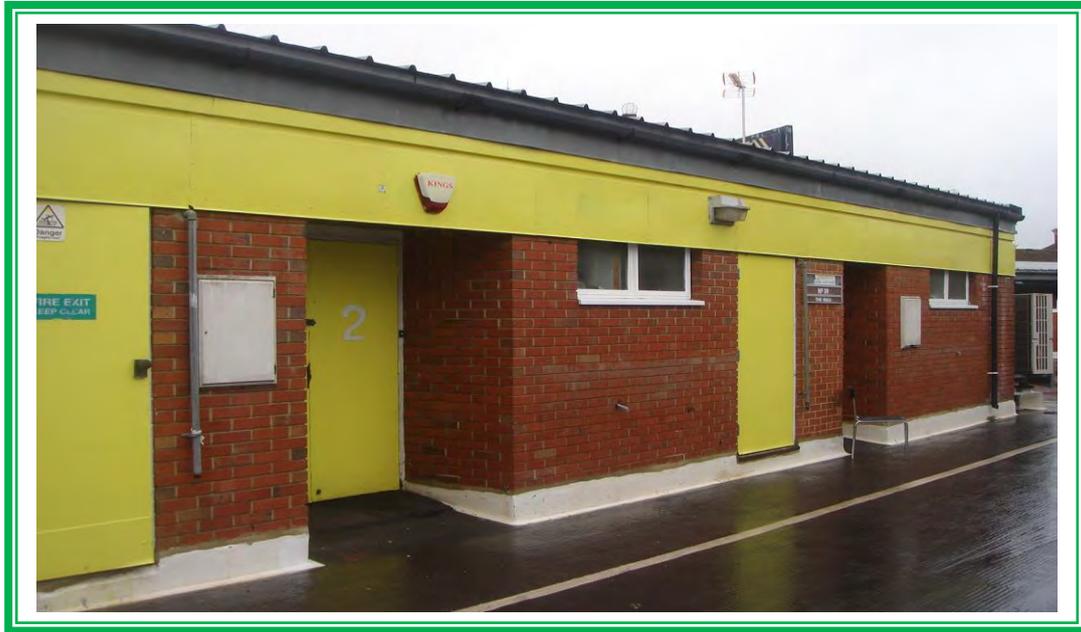
Location: 99/001 Externals

Material Description:	Visual Inspection – No Suspect Materials Found	
Identification:	N/A	
Approx. quantity:	N/A	
Accessibility	N/A	Assessment Score
Product type:	N/A	N/A
Extent of Damage:	N/A	N/A
Surface Treatment:	N/A	N/A
Asbestos type:	N/A	N/A
Material Assessment Score:		N/A
Priority Assessment Score:		N/A
Action:	N/A	
Comments:	N/A

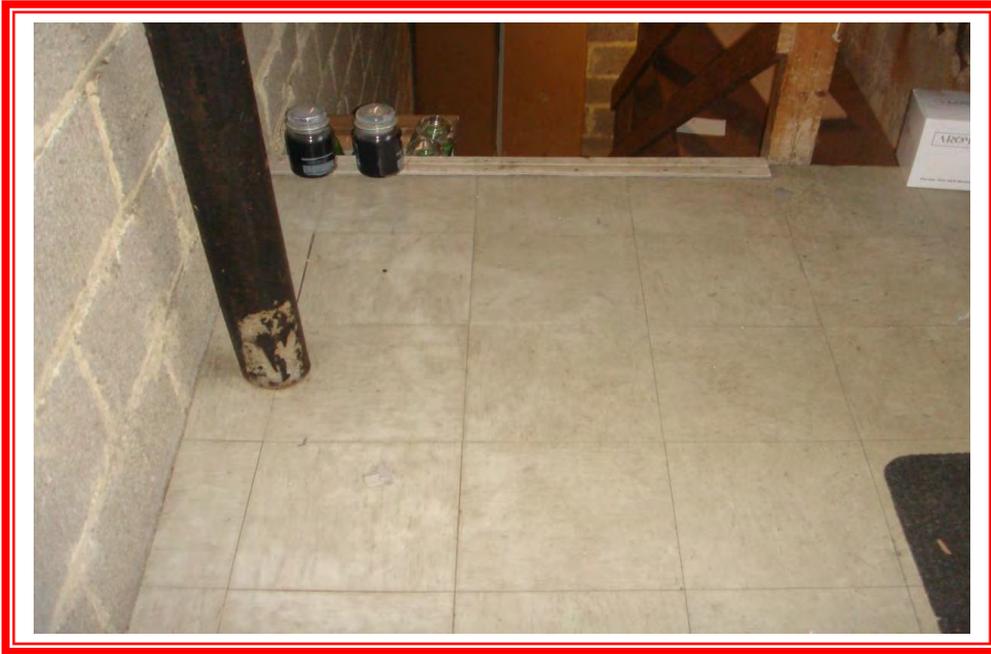
Item No: 1	Sample No: NE/1
Location: 1/001 Landing and Stairs

Material Description:	Vinyl Floor Tiles	
Identification:	Sampled - Asbestos Detected	
Approx. quantity:	20M2	
Accessibility	Low	Assessment Score
Product type:	Vinyl	1
Extent of Damage:	Minor	1
Surface Treatment:	Non-Friable	0
Asbestos type:	Chrysotile	1
Material Assessment Score:		3
Priority Assessment Score:		Negligible
Action:	Manage	
Comments:	N/A

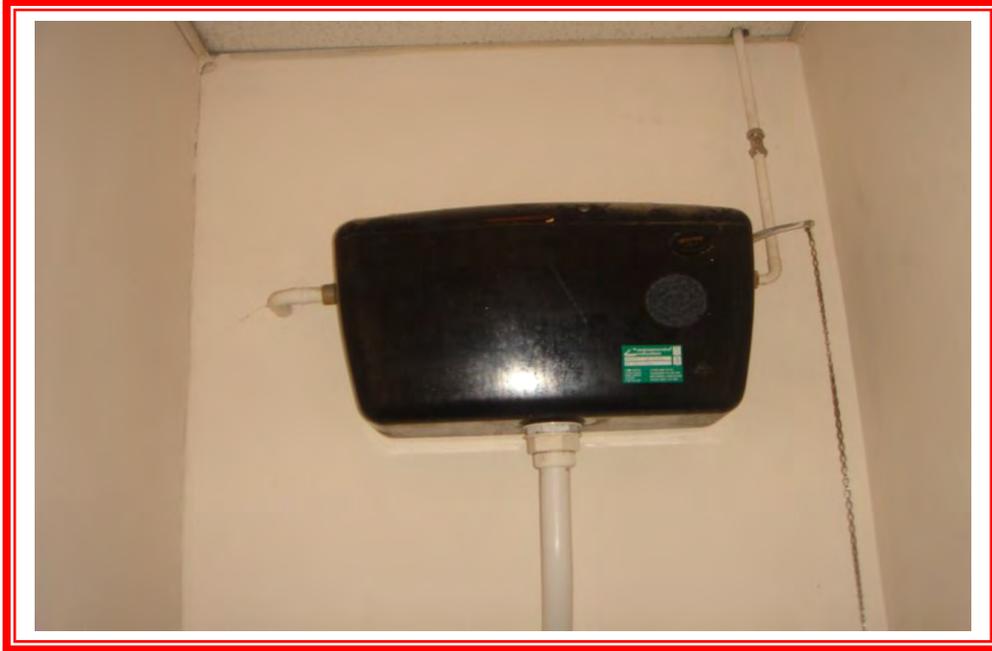
Location: 0/001 WC

Material Description:	Toilet Cistern	
Identification:	Sampled - Asbestos Detected	
Approx. quantity:	X 1	
Accessibility	Low	Assessment Score
Product type:	Bakelite	1
Extent of Damage:	Good	0
Surface Treatment:	Non-Friable	0
Asbestos type:	Amosite	2
Material Assessment Score:		3
Priority Assessment Score:		Negligible
Action:	Manage	
Comments:	N/A

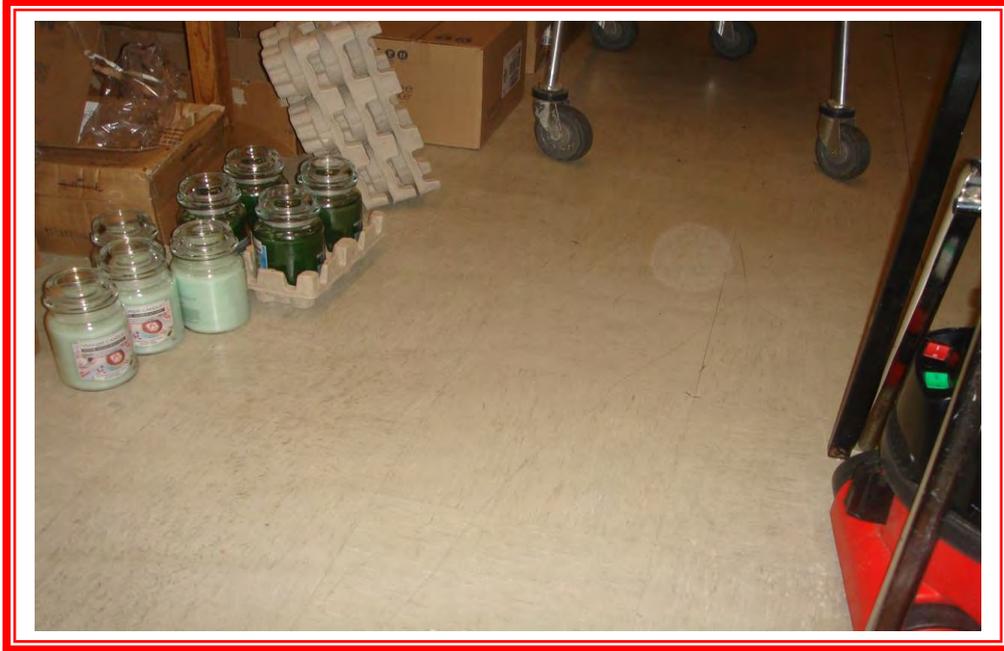
Location: 0/003 Store/Kitchen

Material Description:	Vinyl Floor Tiles	
Identification:	As Per Sample NE/3- Asbestos Detected	
Approx. quantity:	15M2	
Accessibility	Low	Assessment Score
Product type:	Vinyl	1
Extent of Damage:	Minor	1
Surface Treatment:	Non-Friable	0
Asbestos type:	Chrysotile	1
Material Assessment Score:		3
Priority Assessment Score:		Negligible
Action:	Manage	
Comments:	N/A

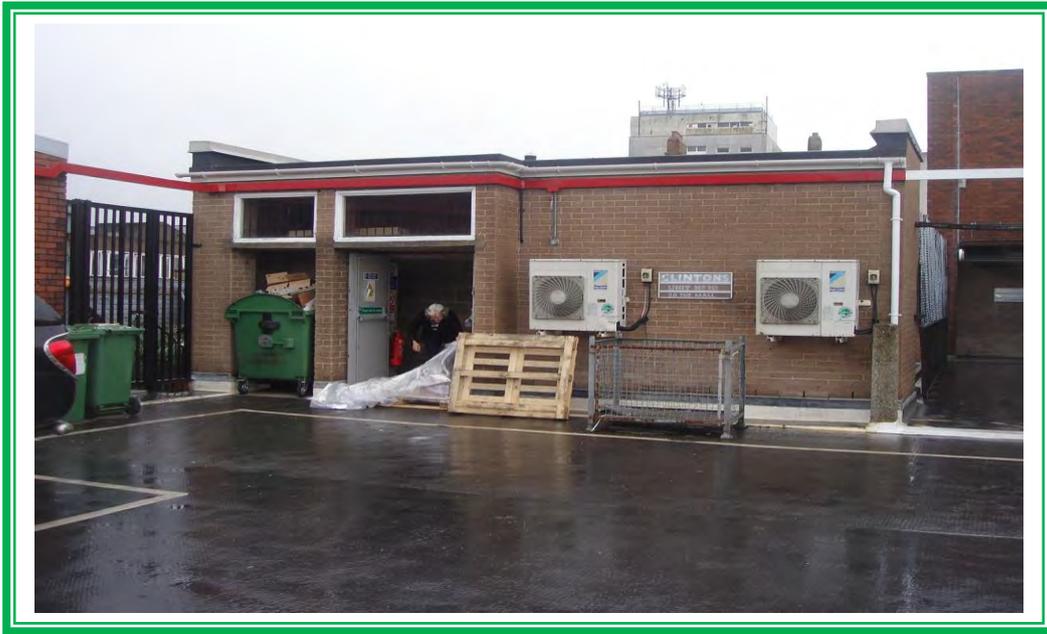
Item No: 2	Sample No: N/A
Location: 99/001 External

Material Description:	Visual Inspection – No Suspect Materials Found	
Identification:	N/A	
Approx. quantity:	N/A	
Accessibility	N/A	<i>Assessment Score</i>
Product type:	N/A	N/A
Extent of Damage:	N/A	N/A
Surface Treatment:	N/A	N/A
Asbestos type:	N/A	N/A
Material Assessment Score:		N/A
Priority Assessment Score:		N/A
Action:	N/A	
Comments:	N/A

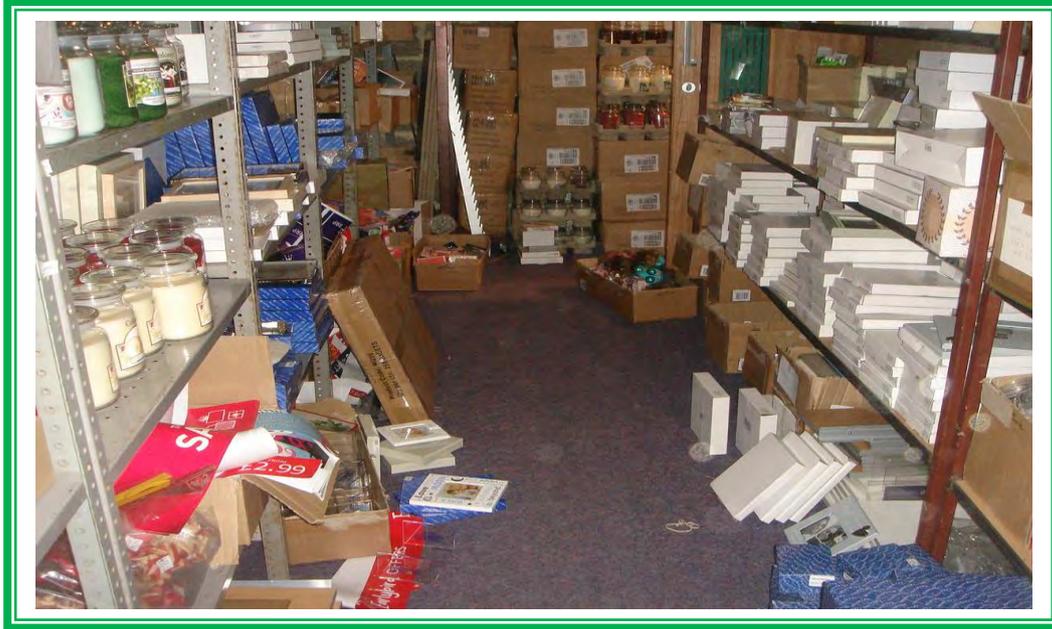
Location: 0/004 Store

Material Description:	Visual Inspection – No Suspect Materials Found	
Identification:	N/A	
Approx. quantity:	N/A	
Accessibility	N/A	Assessment Score
Product type:	N/A	N/A
Extent of Damage:	N/A	N/A
Surface Treatment:	N/A	N/A
Asbestos type:	N/A	N/A
Material Assessment Score:		N/A
Priority Assessment Score:		N/A
Action:	N/A	
Comments:	N/A

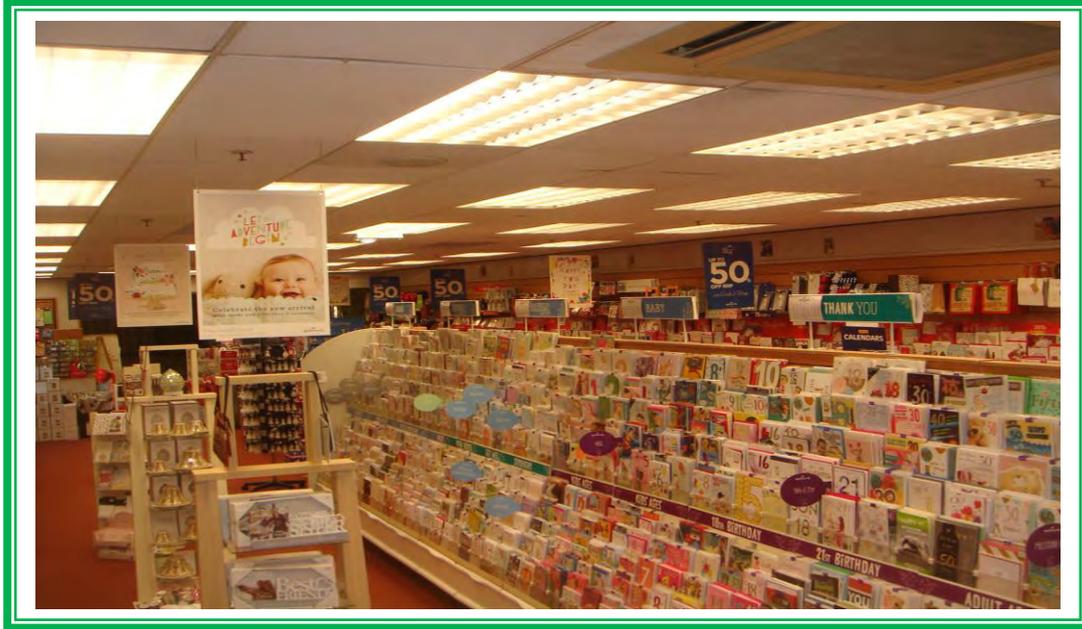
Location: 0/005 Shop Floor

Material Description:	Visual Inspection – No Suspect Materials Found	
Identification:	N/A	
Approx. quantity:	N/A	
Accessibility	N/A	Assessment Score
Product type:	N/A	N/A
Extent of Damage:	N/A	N/A
Surface Treatment:	N/A	N/A
Asbestos type:	N/A	N/A
Material Assessment Score:		N/A
Priority Assessment Score:		N/A
Action:	N/A	
Comments:	N/A

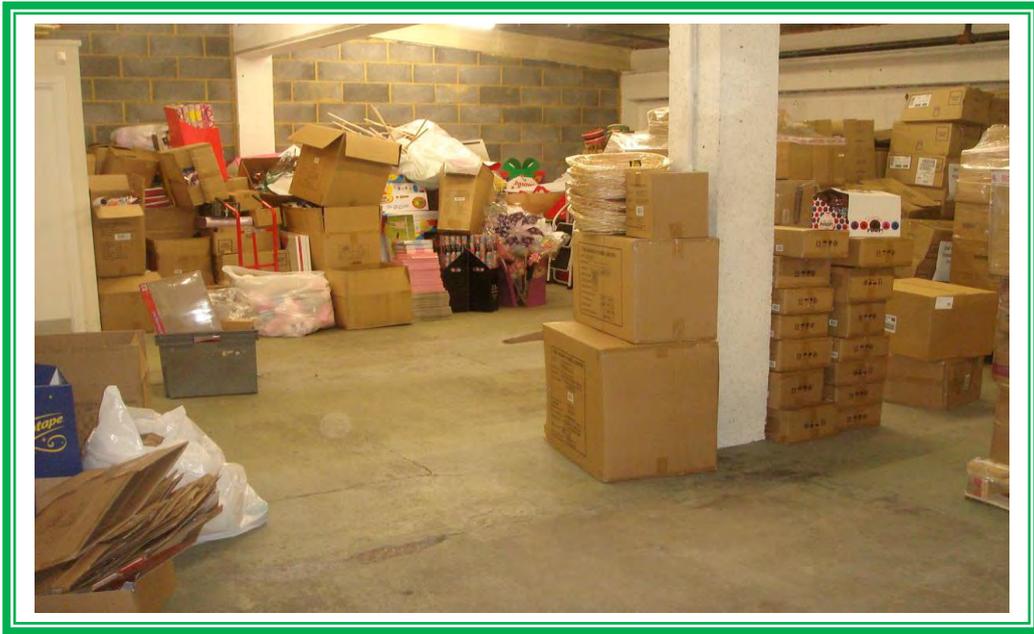
Item No: 1	Sample No: N/A
Location: 1/001 Store

Material Description:	Visual Inspection – No Suspect Materials Found	
Identification:	N/A	
Approx. quantity:	N/A	
Accessibility	N/A	Assessment Score
Product type:	N/A	N/A
Extent of Damage:	N/A	N/A
Surface Treatment:	N/A	N/A
Asbestos type:	N/A	N/A
Material Assessment Score:		N/A
Priority Assessment Score:		N/A
Action:	N/A	
Comments:	N/A

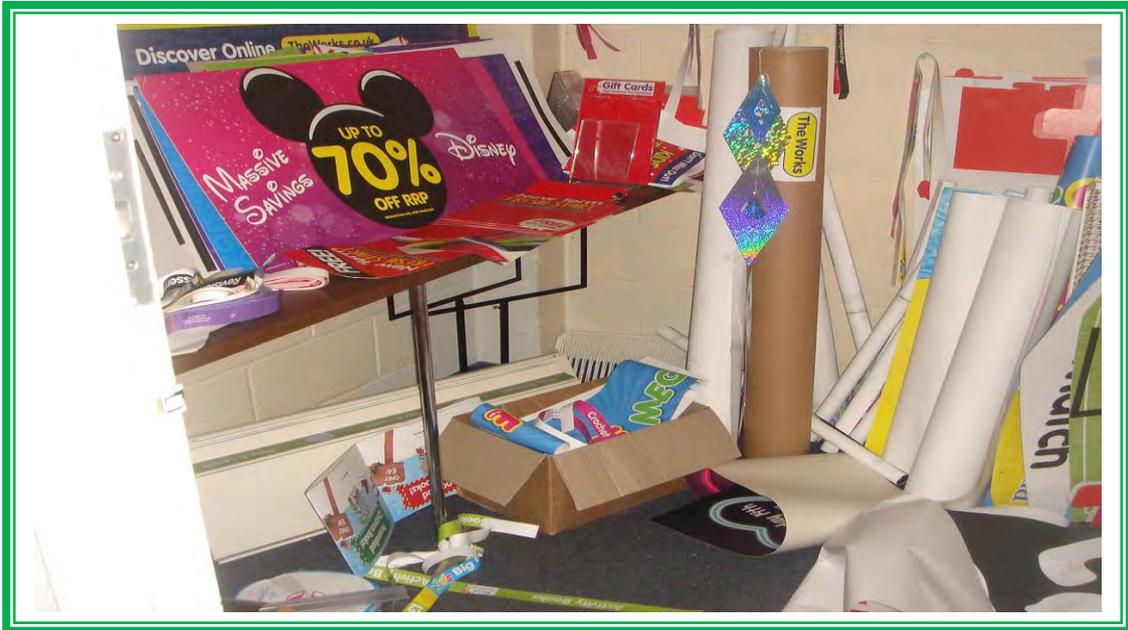
Location: 1/003 Store

Material Description:	Visual Inspection – No Suspect Materials Found	
Identification:	N/A	
Approx. quantity:	N/A	
Accessibility	N/A	Assessment Score
Product type:	N/A	N/A
Extent of Damage:	N/A	N/A
Surface Treatment:	N/A	N/A
Asbestos type:	N/A	N/A
Material Assessment Score:		N/A
Priority Assessment Score:		N/A
Action:	N/A	
Comments:	N/A

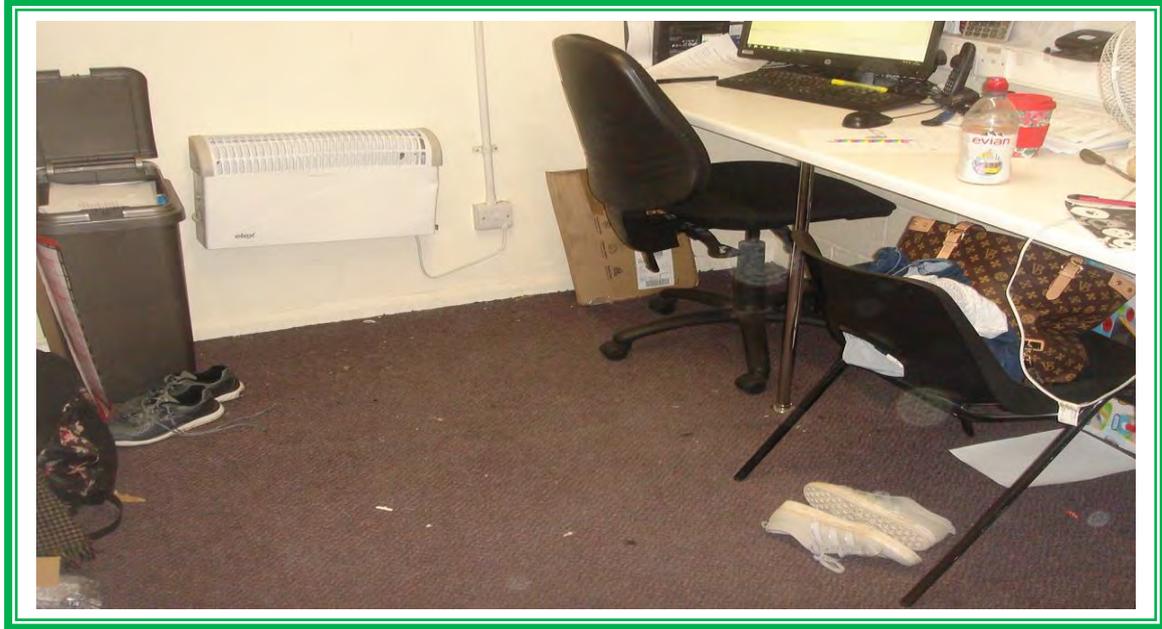
Location: 1/004 Office

Material Description:	Visual Inspection – No Suspect Materials Found	
Identification:	N/A	
Approx. quantity:	N/A	
Accessibility	N/A	Assessment Score
Product type:	N/A	N/A
Extent of Damage:	N/A	N/A
Surface Treatment:	N/A	N/A
Asbestos type:	N/A	N/A
Material Assessment Score:		N/A
Priority Assessment Score:		N/A
Action:	N/A	
Comments:	N/A

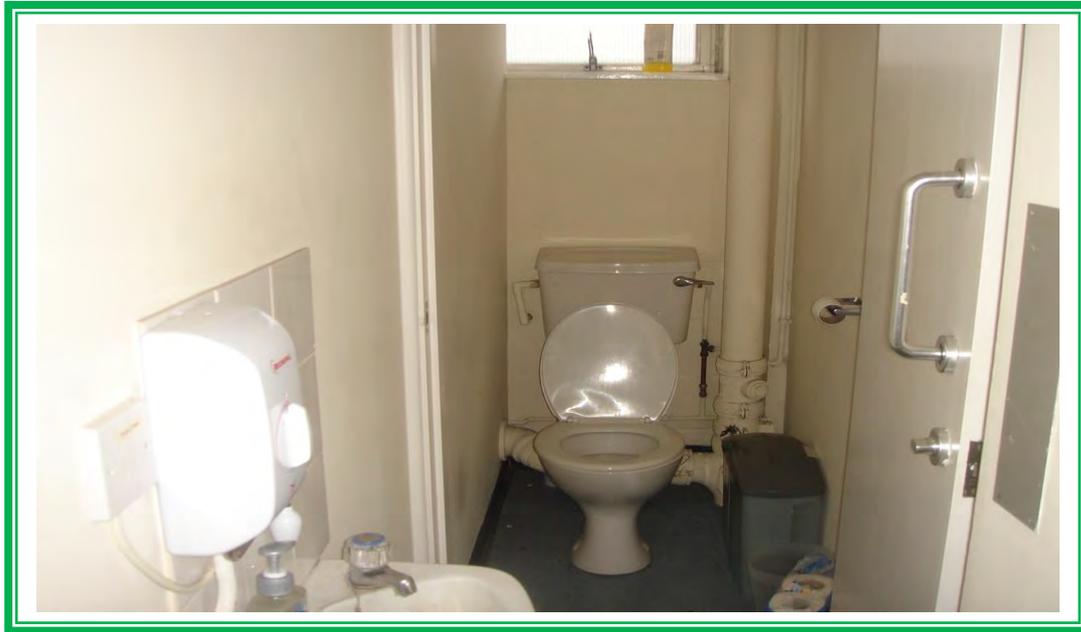
Location: 1/005 WC

Material Description:	Visual Inspection – No Suspect Materials Found	
Identification:	N/A	
Approx. quantity:	N/A	
Accessibility	N/A	Assessment Score
Product type:	N/A	N/A
Extent of Damage:	N/A	N/A
Surface Treatment:	N/A	N/A
Asbestos type:	N/A	N/A
Material Assessment Score:		N/A
Priority Assessment Score:		N/A
Action:	N/A	
Comments:	N/A

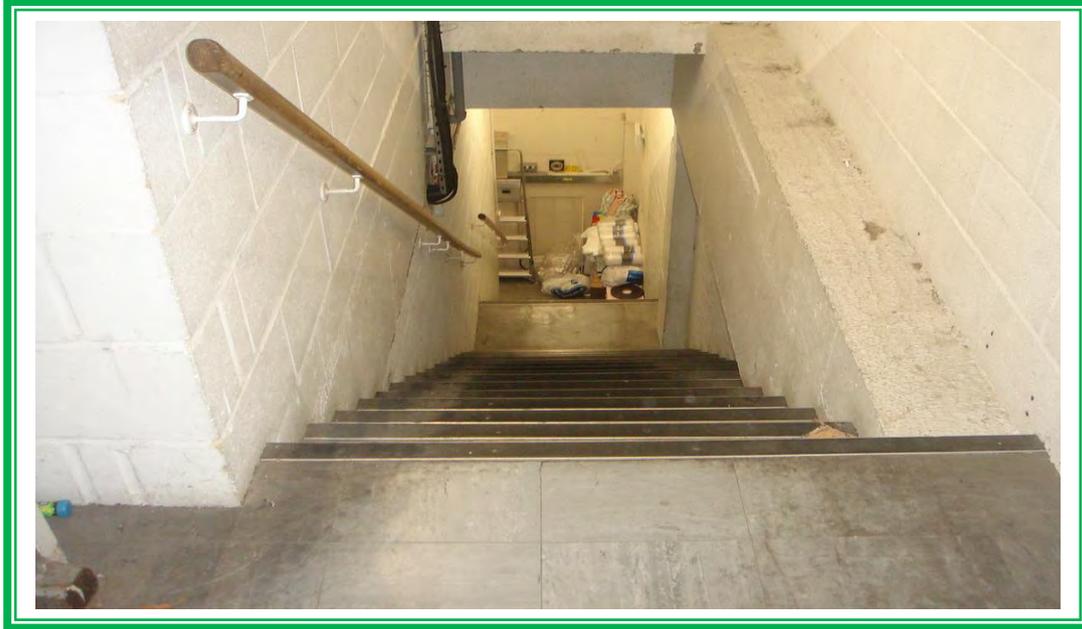
Location: 1/006 Stairwell

Material Description:	Vinyl Floor Tiles	
Identification:	As Per Sample NE/1 – No Asbestos Detected	
Approx. quantity:	20M2	
Accessibility	N/A	Assessment Score
Product type:	N/A	N/A
Extent of Damage:	N/A	N/A
Surface Treatment:	N/A	N/A
Asbestos type:	N/A	N/A
Material Assessment Score:		N/A
Priority Assessment Score:		N/A
Action:	N/A	
Comments:	N/A

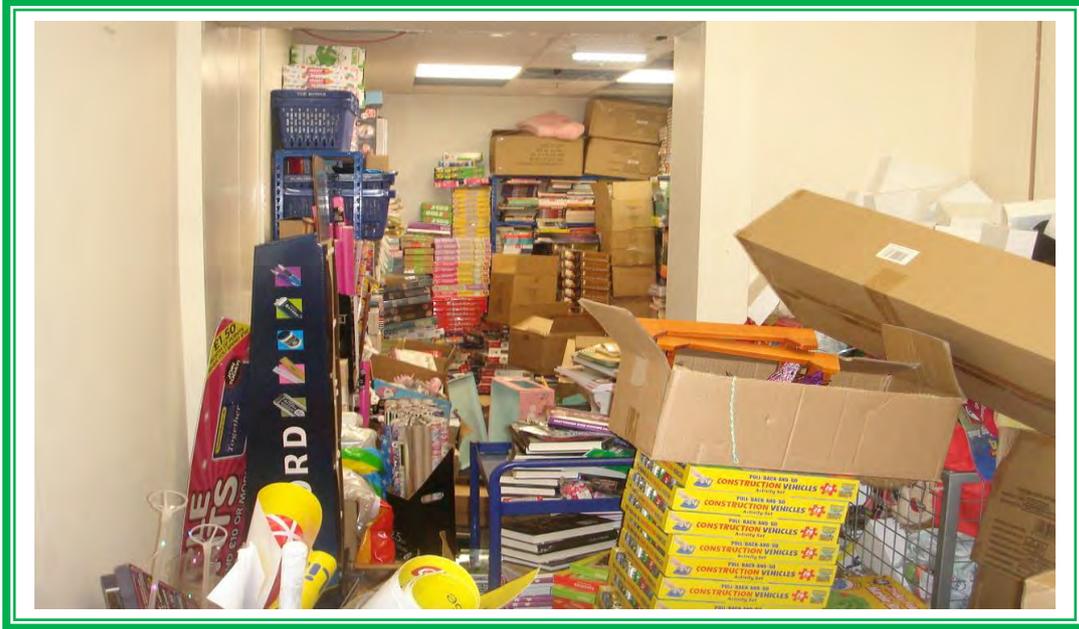
Location: 0/001 Store

Material Description:	Visual Inspection – No Suspect Materials Found	
Identification:	N/A	
Approx. quantity:	N/A	
Accessibility	N/A	Assessment Score
Product type:	N/A	N/A
Extent of Damage:	N/A	N/A
Surface Treatment:	N/A	N/A
Asbestos type:	N/A	N/A
Material Assessment Score:		N/A
Priority Assessment Score:		N/A
Action:	N/A	
Comments:	N/A

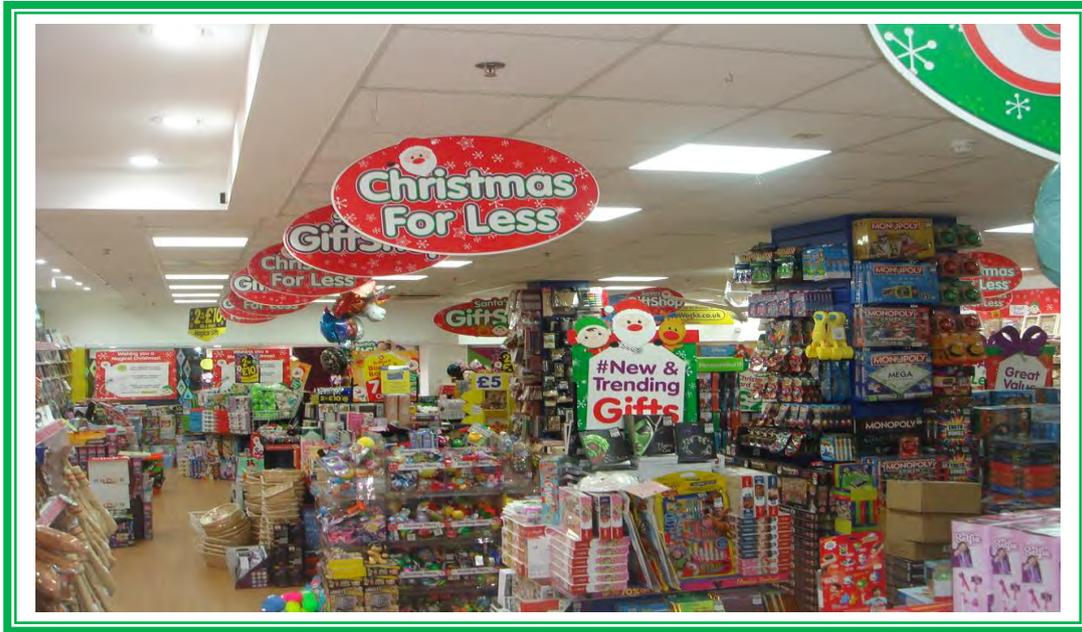
Location: 0/002 Shop Floor

Material Description:	Visual Inspection – No Suspect Materials Found	
Identification:	N/A	
Approx. quantity:	N/A	
Accessibility	N/A	Assessment Score
Product type:	N/A	N/A
Extent of Damage:	N/A	N/A
Surface Treatment:	N/A	N/A
Asbestos type:	N/A	N/A
Material Assessment Score:		N/A
Priority Assessment Score:		N/A
Action:	N/A	
Comments:	N/A

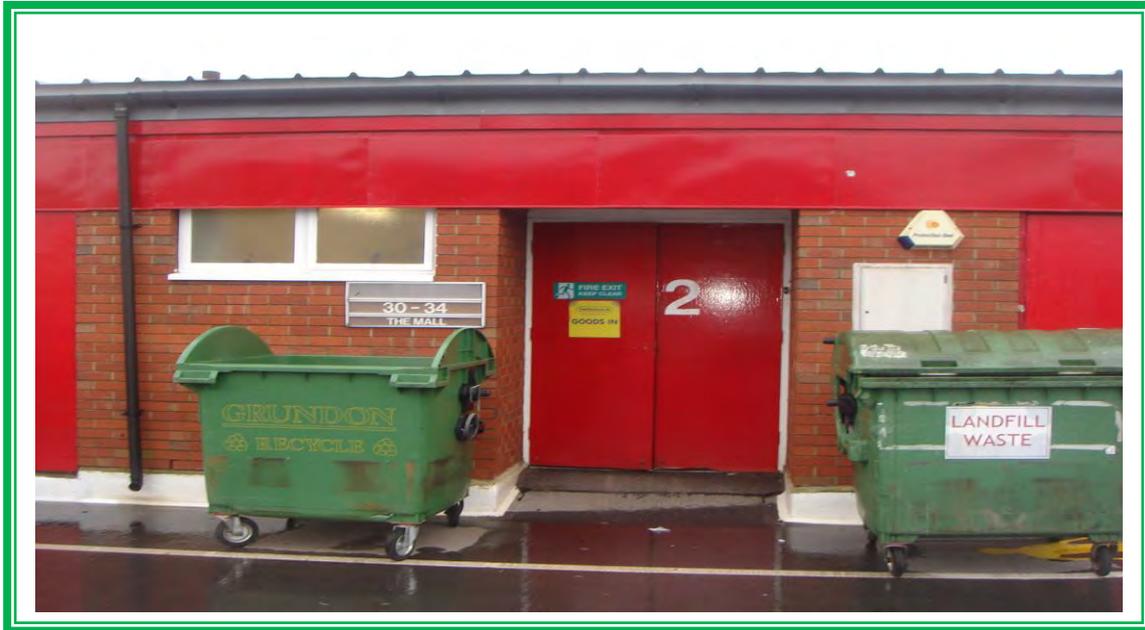
Location: 99/001 External

Material Description:	Visual Inspection – No Suspect Materials Found	
Identification:	N/A	
Approx. quantity:	N/A	
Accessibility	N/A	Assessment Score
Product type:	N/A	N/A
Extent of Damage:	N/A	N/A
Surface Treatment:	N/A	N/A
Asbestos type:	N/A	N/A
Material Assessment Score:		N/A
Priority Assessment Score:		N/A
Action:	N/A	
Comments:	N/A

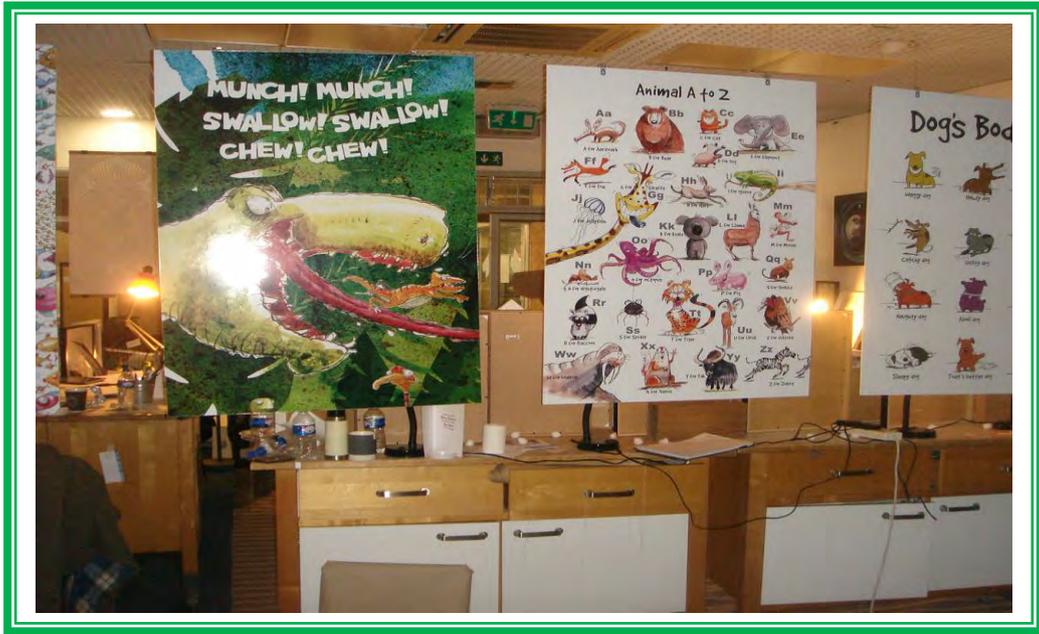
Item No: 5	Sample No: N/A
Location: 0/001 Shop Floor

Material Description:	Visual Inspection – No Suspect Materials Found	
Identification:	N/A	
Approx. quantity:	N/A	
Accessibility	N/A	Assessment Score
Product type:	N/A	N/A
Extent of Damage:	N/A	N/A
Surface Treatment:	N/A	N/A
Asbestos type:	N/A	N/A
Material Assessment Score:		N/A
Priority Assessment Score:		N/A
Action:	N/A	
Comments:	N/A

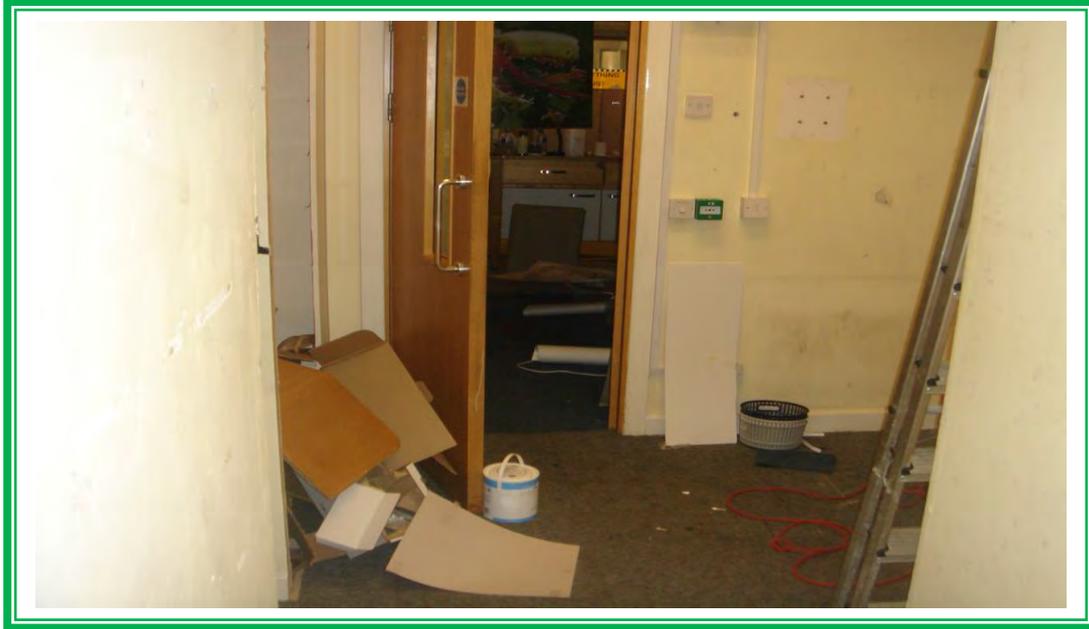
Location: 0/02 Stores

Material Description:	Visual Inspection – No Suspect Materials Found	
Identification:	N/A	
Approx. quantity:	N/A	
Accessibility	N/A	Assessment Score
Product type:	N/A	N/A
Extent of Damage:	N/A	N/A
Surface Treatment:	N/A	N/A
Asbestos type:	N/A	N/A
Material Assessment Score:		N/A
Priority Assessment Score:		N/A
Action:	N/A	
Comments:	N/A

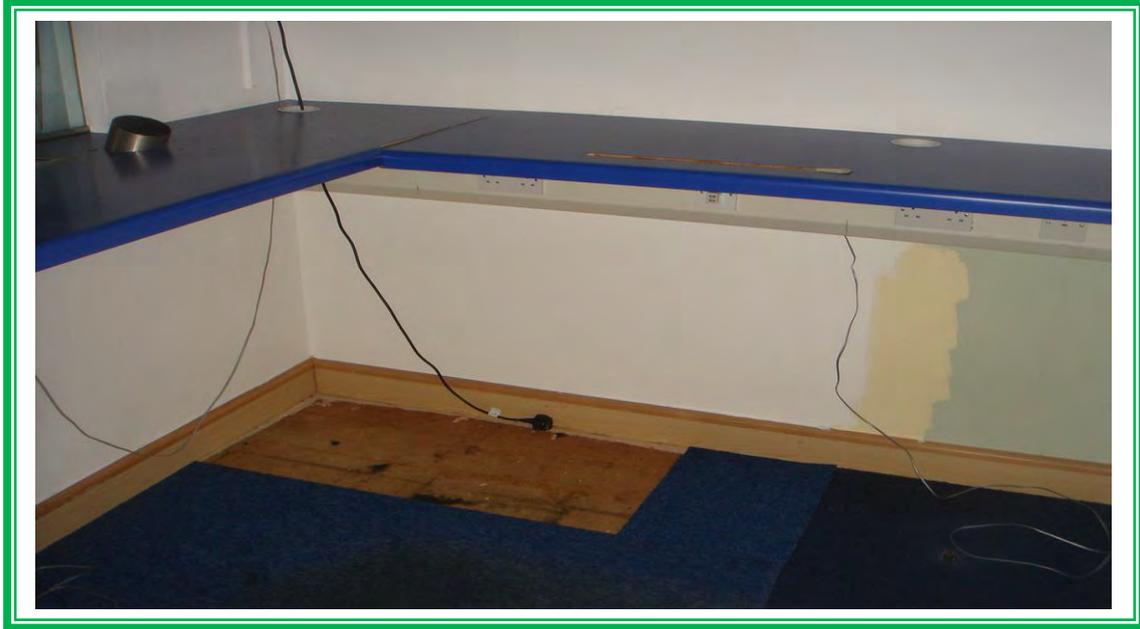
Location: 0/003 Office

Material Description:	Visual Inspection – No Suspect Materials Found	
Identification:	N/A	
Approx. quantity:	N/A	
Accessibility	N/A	Assessment Score
Product type:	N/A	N/A
Extent of Damage:	N/A	N/A
Surface Treatment:	N/A	N/A
Asbestos type:	N/A	N/A
Material Assessment Score:		N/A
Priority Assessment Score:		N/A
Action:	N/A	
Comments:	N/A

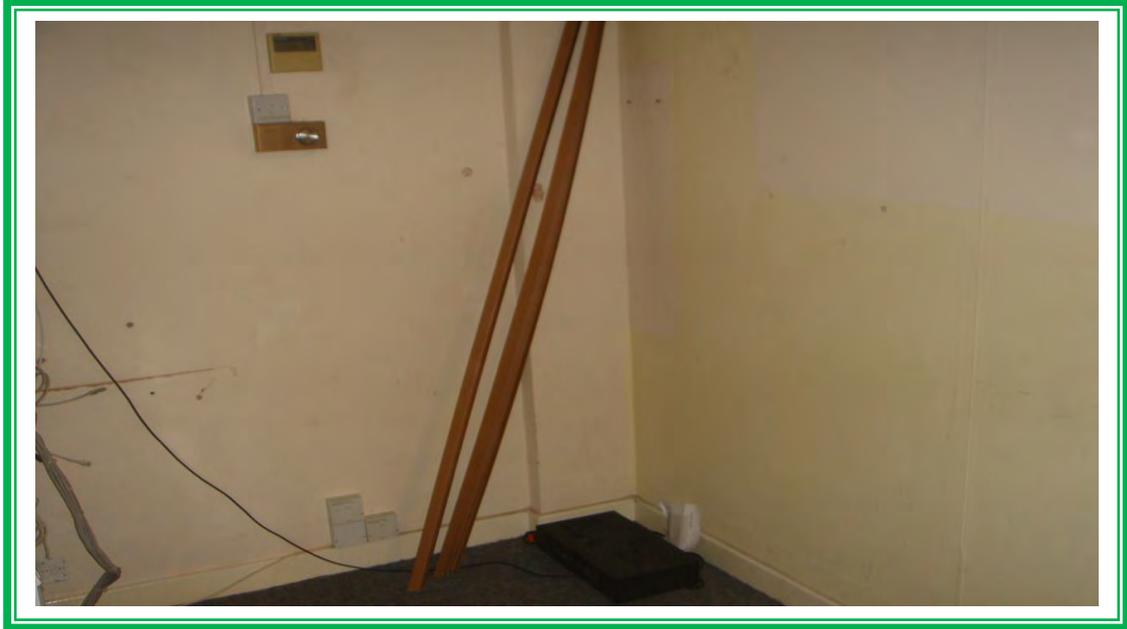
Location: 0/004 Office

Material Description:	Visual Inspection – No Suspect Materials Found	
Identification:	N/A	
Approx. quantity:	N/A	
Accessibility	N/A	Assessment Score
Product type:	N/A	N/A
Extent of Damage:	N/A	N/A
Surface Treatment:	N/A	N/A
Asbestos type:	N/A	N/A
Material Assessment Score:		N/A
Priority Assessment Score:		N/A
Action:	N/A	
Comments:	N/A

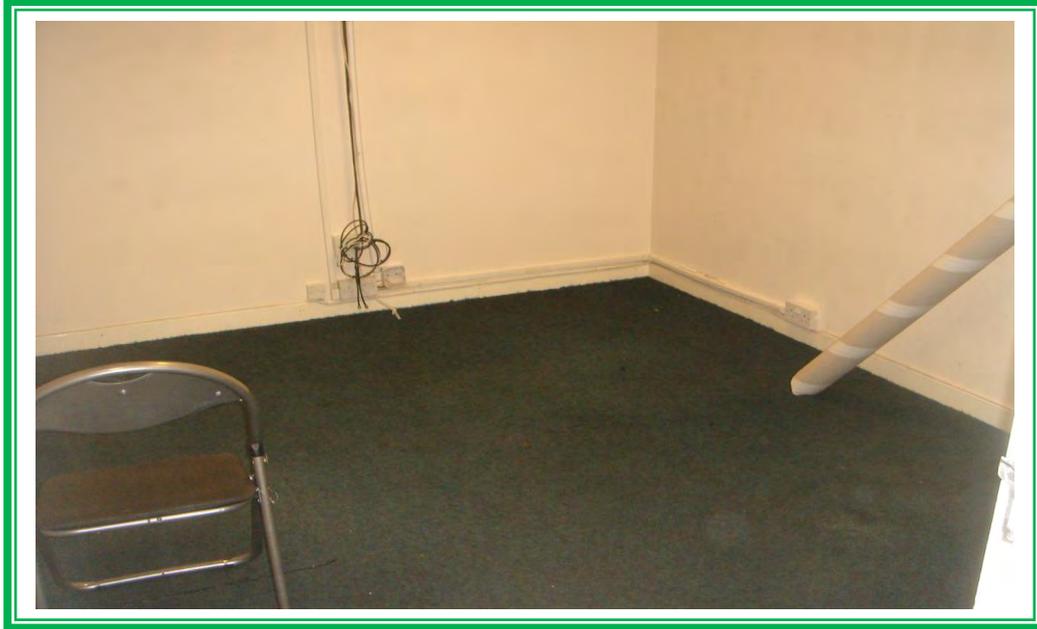
Location: 0/005 Office

Material Description:	Visual Inspection – No Suspect Materials Found	
Identification:	N/A	
Approx. quantity:	N/A	
Accessibility	N/A	Assessment Score
Product type:	N/A	N/A
Extent of Damage:	N/A	N/A
Surface Treatment:	N/A	N/A
Asbestos type:	N/A	N/A
Material Assessment Score:		N/A
Priority Assessment Score:		N/A
Action:	N/A	
Comments:	N/A
