Section 6: Survey Objectives

Instructions were received from James Croucher of Lochailort Newbury Ltd to carry out a Management asbestos survey at Kennet Centre, Market Street, Newbury, Berkshire, RG14 5EN in accordance with HSG264 and Armour Analytical's quality procedures.

The survey was carried out on 22nd – 25th October 2019 by Neale Evans with the objective of facilitating a Management report.

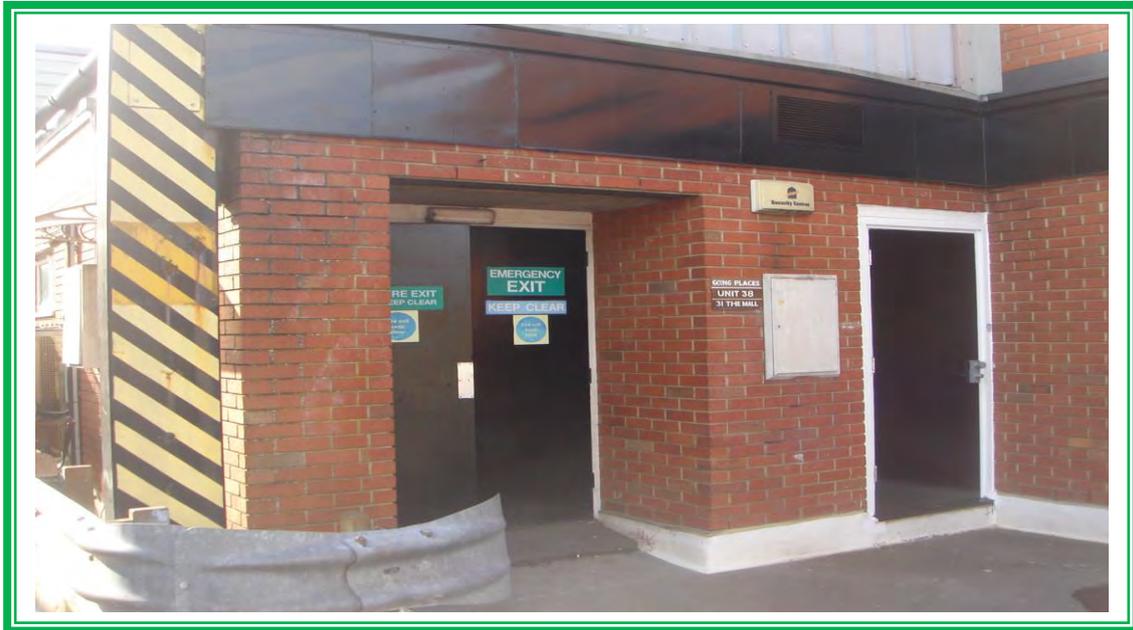
Location: 99/001 External

Material Description:	Visual Inspection – No Suspect Materials Found	
Identification:	N/A	
Approx. quantity:	N/A	
Accessibility	N/A	Assessment Score
Product type:	N/A	N/A
Extent of Damage:	N/A	N/A
Surface Treatment:	N/A	N/A
Asbestos type:	N/A	N/A
Material Assessment Score:		N/A
Priority Assessment Score:		N/A
Action:	N/A	
Comments:	N/A

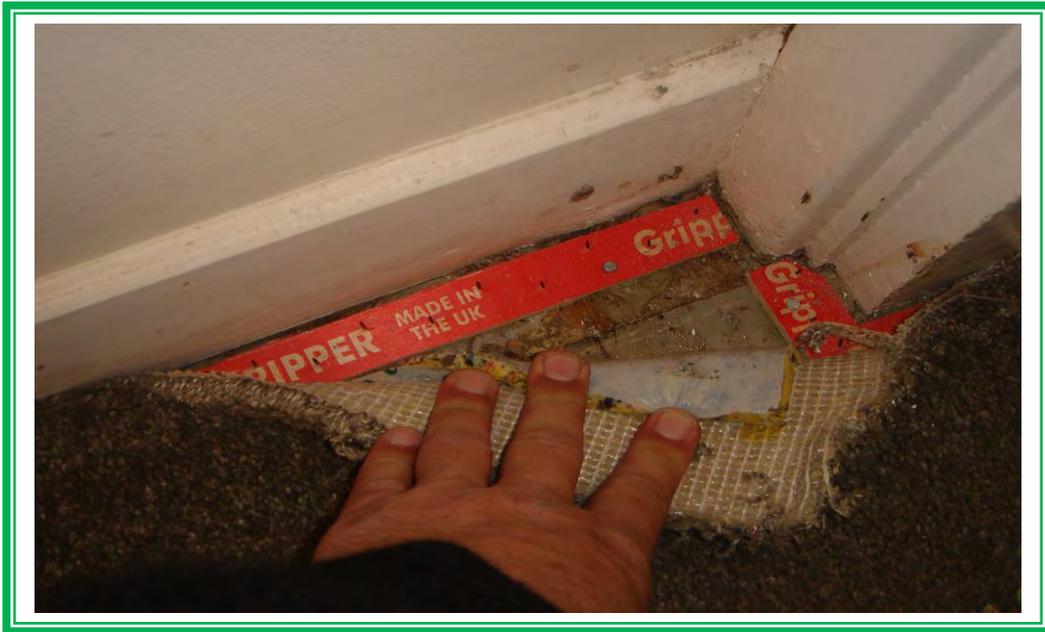
Item No: 1	Sample No: NE/1
Location: 1/001 Lobby

Material Description:	Vinyl Floor Tiles	
Identification:	Sampled – No Asbestos Detected	
Approx. quantity:	2M2	
Accessibility	N/A	Assessment Score
Product type:	N/A	N/A
Extent of Damage:	N/A	N/A
Surface Treatment:	N/A	N/A
Asbestos type:	N/A	N/A
Material Assessment Score:		N/A
Priority Assessment Score:		N/A
Action:	N/A	
Comments:	N/A

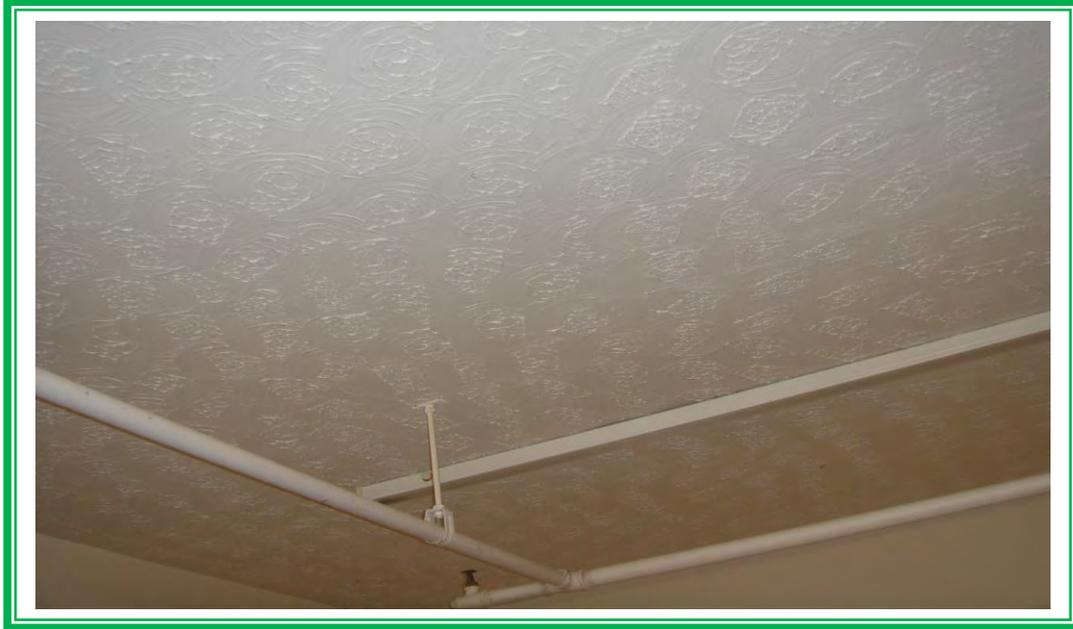
Location: 1/003 Kitchen

Material Description:	Textured Coating	
Identification:	As Per Sample NE/2- No Asbestos Detected	
Approx. quantity:	12M2	
Accessibility	N/A	Assessment Score
Product type:	N/A	N/A
Extent of Damage:	N/A	N/A
Surface Treatment:	N/A	N/A
Asbestos type:	N/A	N/A
Material Assessment Score:		N/A
Priority Assessment Score:		N/A
Action:	N/A	
Comments:	N/A

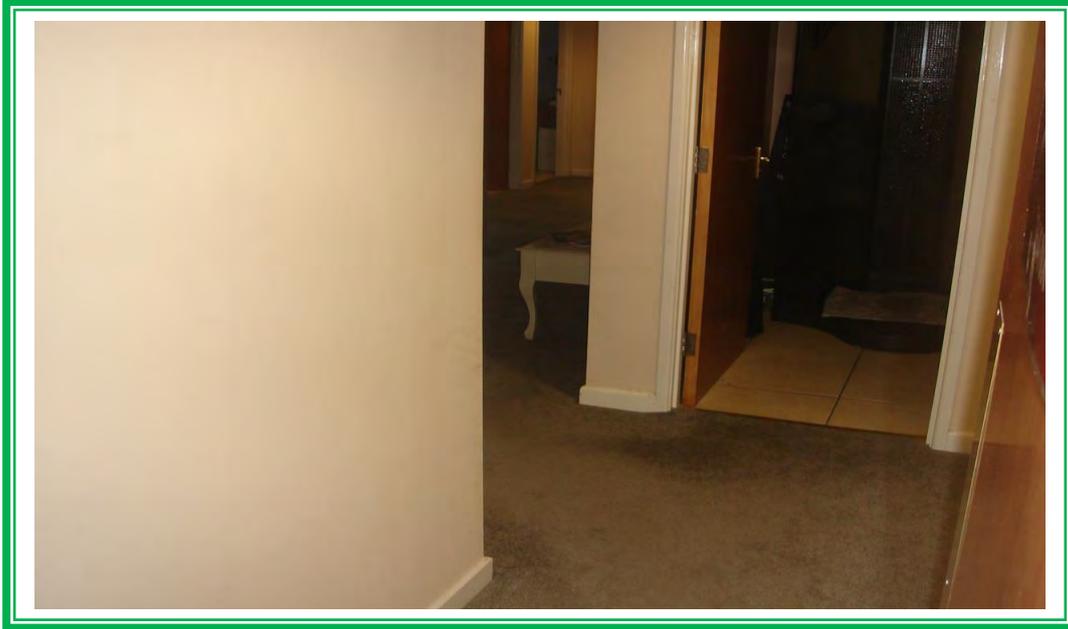
Location: 1/004 Corridor

Material Description:	Visual Inspection – No Suspect Materials Found	
Identification:	N/A	
Approx. quantity:	N/A	
Accessibility	N/A	Assessment Score
Product type:	N/A	N/A
Extent of Damage:	N/A	N/A
Surface Treatment:	N/A	N/A
Asbestos type:	N/A	N/A
Material Assessment Score:		N/A
Priority Assessment Score:		N/A
Action:	N/A	
Comments:	N/A

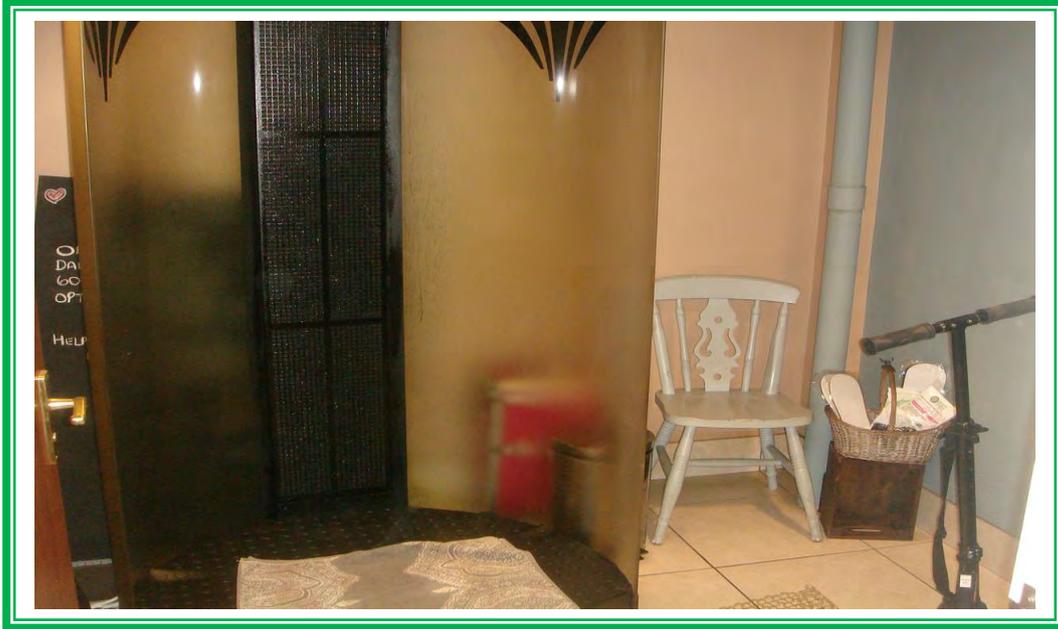
Location: 1/006 Tan Room

Material Description:	Visual Inspection – No Suspect Materials Found	
Identification:	N/A	
Approx. quantity:	N/A	
Accessibility	N/A	Assessment Score
Product type:	N/A	N/A
Extent of Damage:	N/A	N/A
Surface Treatment:	N/A	N/A
Asbestos type:	N/A	N/A
Material Assessment Score:		N/A
Priority Assessment Score:		N/A
Action:	N/A	
Comments:	N/A

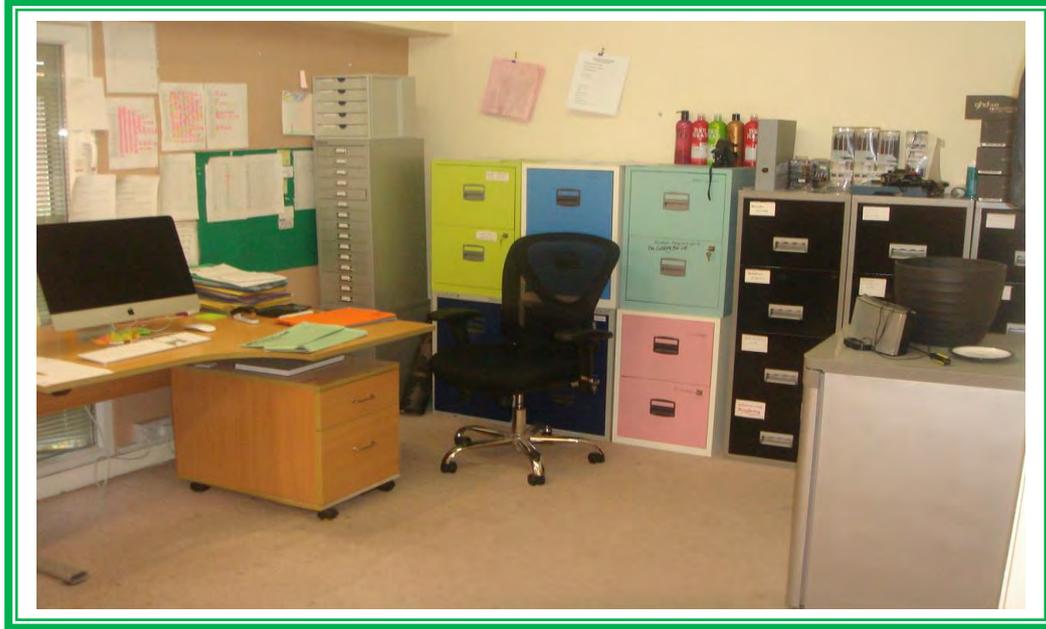
Location: 1/007 Office

Material Description:	Visual Inspection – No Suspect Materials Found	
Identification:	N/A	
Approx. quantity:	N/A	
Accessibility	N/A	Assessment Score
Product type:	N/A	N/A
Extent of Damage:	N/A	N/A
Surface Treatment:	N/A	N/A
Asbestos type:	N/A	N/A
Material Assessment Score:		N/A
Priority Assessment Score:		N/A
Action:	N/A	
Comments:	N/A

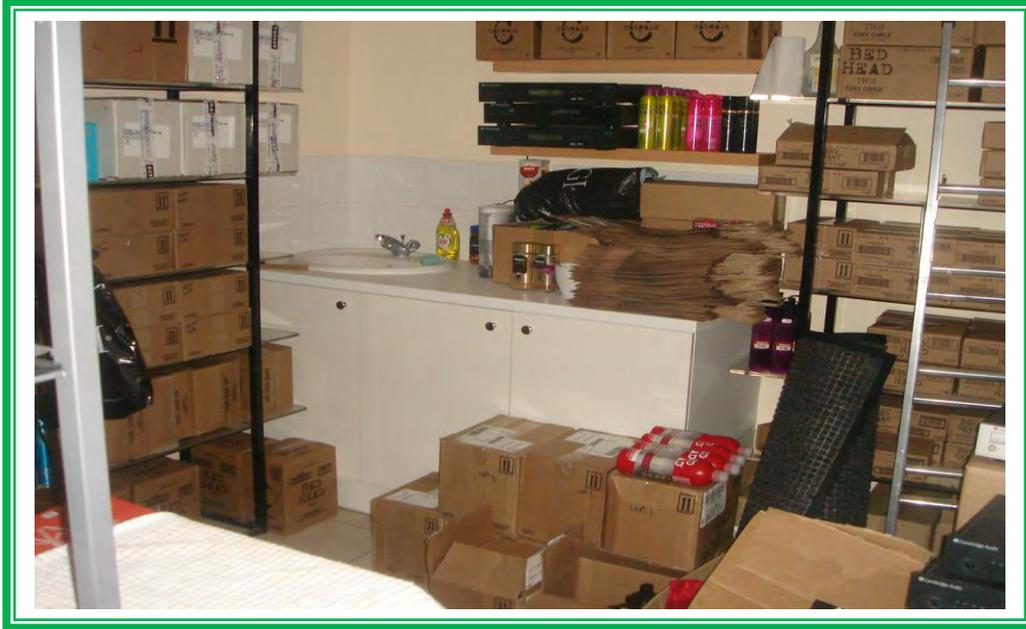
Location: 1/008 Store

Material Description:	Visual Inspection – No Suspect Materials Found	
Identification:	N/A	
Approx. quantity:	N/A	
Accessibility	N/A	Assessment Score
Product type:	N/A	N/A
Extent of Damage:	N/A	N/A
Surface Treatment:	N/A	N/A
Asbestos type:	N/A	N/A
Material Assessment Score:		N/A
Priority Assessment Score:		N/A
Action:	N/A	
Comments:	N/A

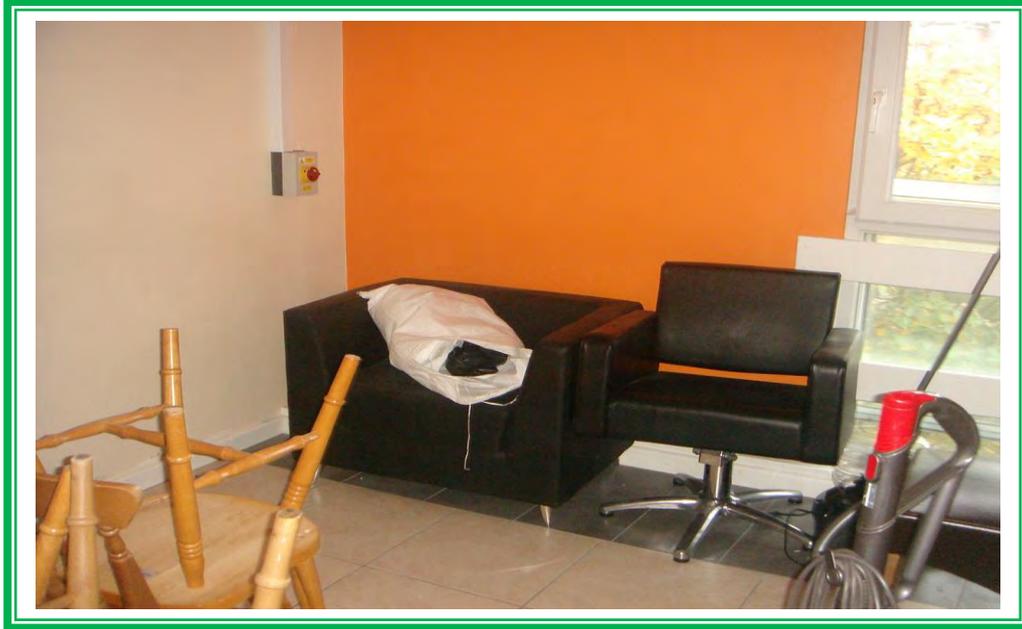
Location: 1/009 Treatment Room

Material Description:	Visual Inspection – No Suspect Materials Found	
Identification:	N/A	
Approx. quantity:	N/A	
Accessibility	N/A	Assessment Score
Product type:	N/A	N/A
Extent of Damage:	N/A	N/A
Surface Treatment:	N/A	N/A
Asbestos type:	N/A	N/A
Material Assessment Score:		N/A
Priority Assessment Score:		N/A
Action:	N/A	
Comments:	N/A

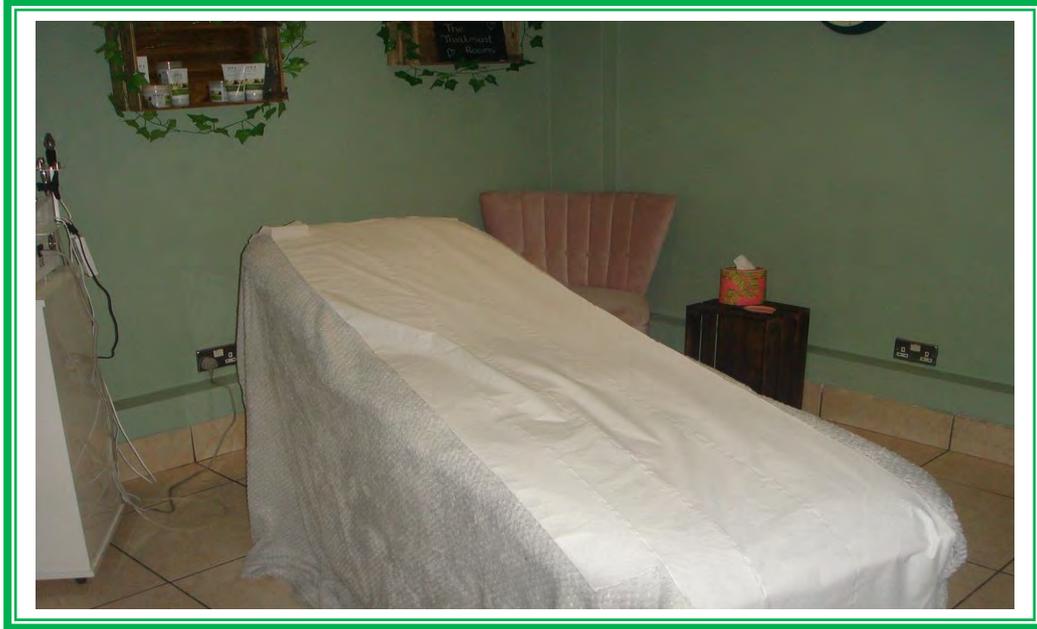
Location: 1/010 Treatment Room

Material Description:	Visual Inspection – No Suspect Materials Found	
Identification:	N/A	
Approx. quantity:	N/A	
Accessibility	N/A	Assessment Score
Product type:	N/A	N/A
Extent of Damage:	N/A	N/A
Surface Treatment:	N/A	N/A
Asbestos type:	N/A	N/A
Material Assessment Score:		N/A
Priority Assessment Score:		N/A
Action:	N/A	
Comments:	N/A

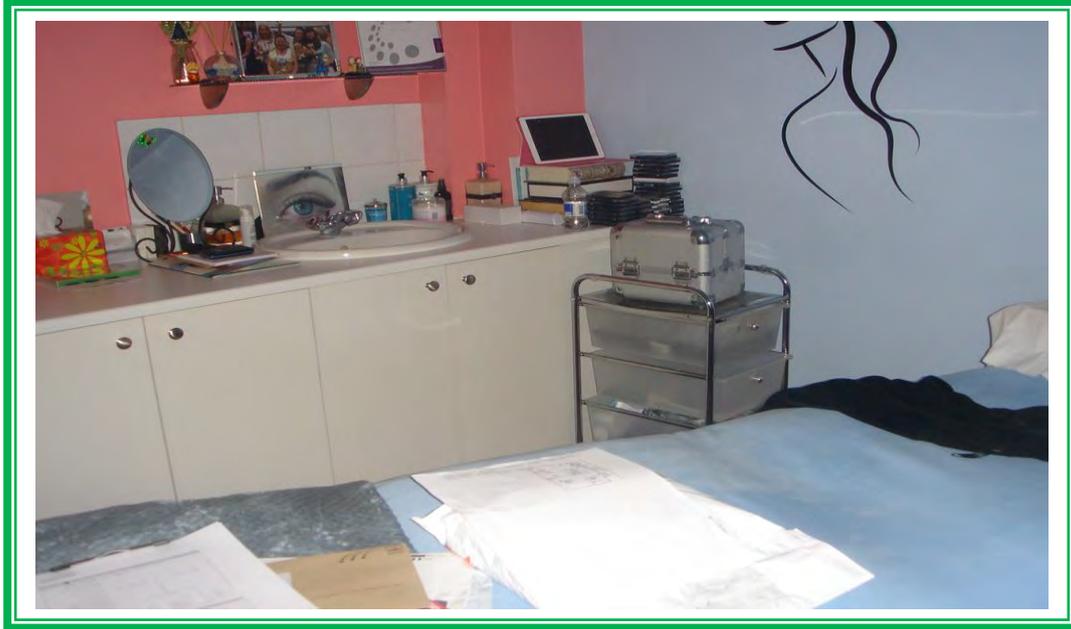
Location: 1/011 Treatment Room

Material Description:	Visual Inspection – No Suspect Materials Found	
Identification:	N/A	
Approx. quantity:	N/A	
Accessibility	N/A	Assessment Score
Product type:	N/A	N/A
Extent of Damage:	N/A	N/A
Surface Treatment:	N/A	N/A
Asbestos type:	N/A	N/A
Material Assessment Score:		N/A
Priority Assessment Score:		N/A
Action:	N/A	
Comments:	N/A

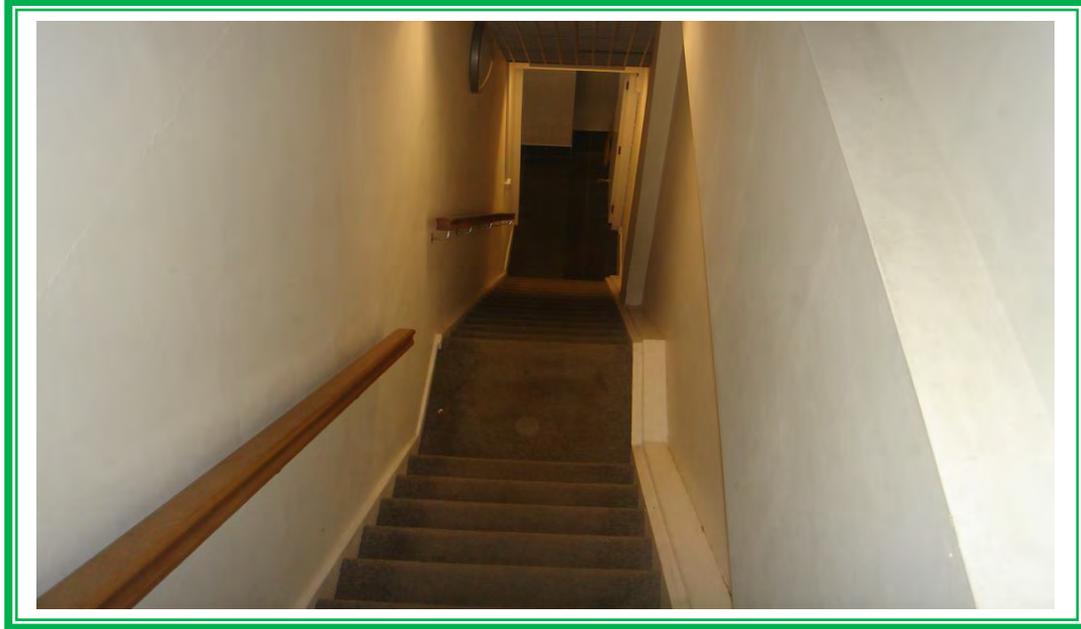
Location: 1/012 Stairs

Material Description:	Visual Inspection – No Suspect Materials Found	
Identification:	N/A	
Approx. quantity:	N/A	
Accessibility	N/A	Assessment Score
Product type:	N/A	N/A
Extent of Damage:	N/A	N/A
Surface Treatment:	N/A	N/A
Asbestos type:	N/A	N/A
Material Assessment Score:		N/A
Priority Assessment Score:		N/A
Action:	N/A	
Comments:	N/A

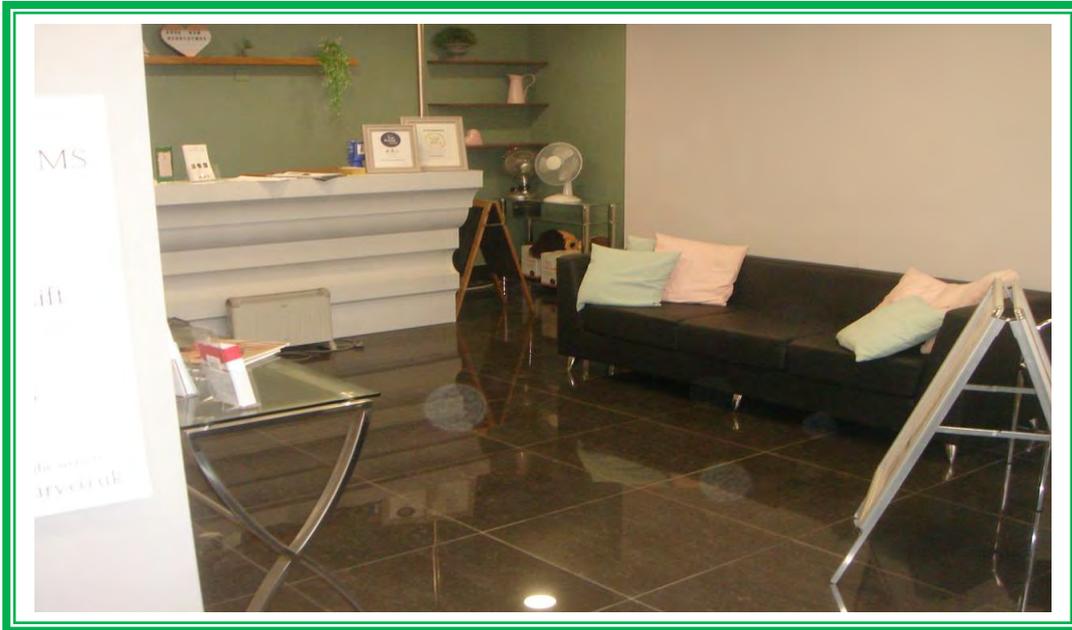
Location: 0/001 Reception

Material Description:	Visual Inspection – No Suspect Materials Found	
Identification:	N/A	
Approx. quantity:	N/A	
Accessibility	N/A	Assessment Score
Product type:	N/A	N/A
Extent of Damage:	N/A	N/A
Surface Treatment:	N/A	N/A
Asbestos type:	N/A	N/A
Material Assessment Score:		N/A
Priority Assessment Score:		N/A
Action:	N/A	
Comments:	N/A

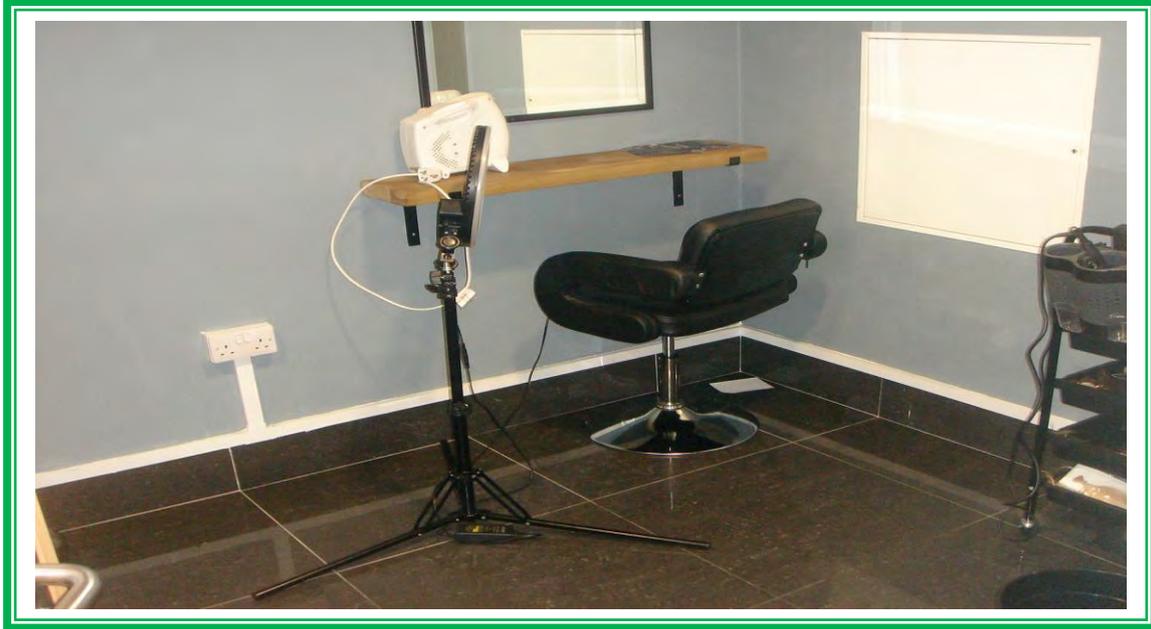
Location: 0/002 Treatment Room

Material Description:	Visual Inspection – No Suspect Materials Found	
Identification:	N/A	
Approx. quantity:	N/A	
Accessibility	N/A	Assessment Score
Product type:	N/A	N/A
Extent of Damage:	N/A	N/A
Surface Treatment:	N/A	N/A
Asbestos type:	N/A	N/A
Material Assessment Score:		N/A
Priority Assessment Score:		N/A
Action:	N/A	
Comments:	N/A

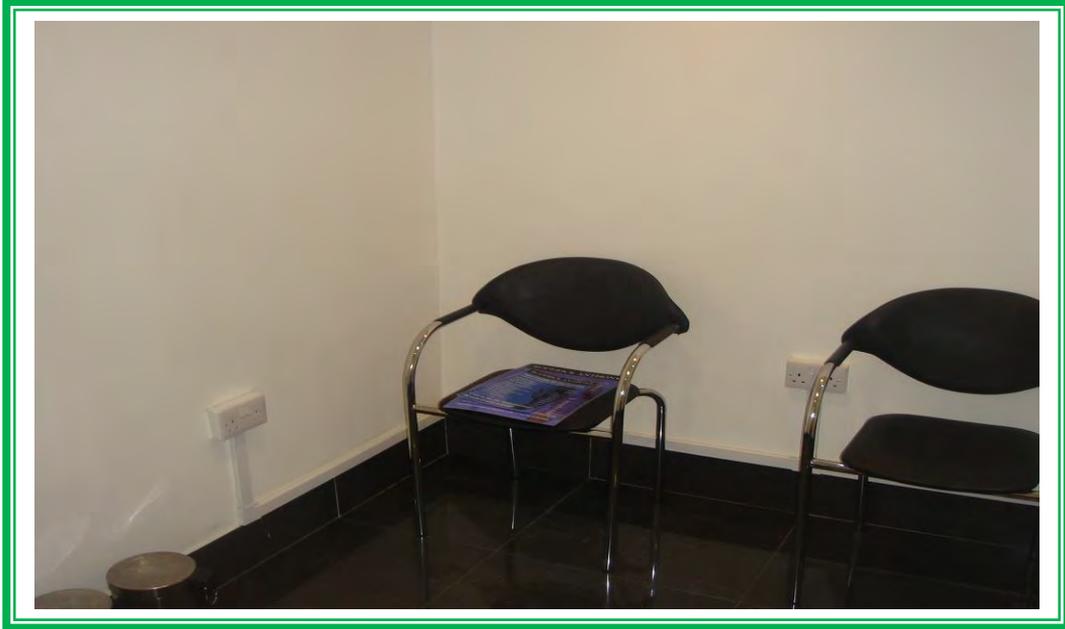
Location: 0/003 Treatment Room

Material Description:	Visual Inspection – No Suspect Materials Found	
Identification:	N/A	
Approx. quantity:	N/A	
Accessibility	N/A	Assessment Score
Product type:	N/A	N/A
Extent of Damage:	N/A	N/A
Surface Treatment:	N/A	N/A
Asbestos type:	N/A	N/A
Material Assessment Score:		N/A
Priority Assessment Score:		N/A
Action:	N/A	
Comments:	N/A

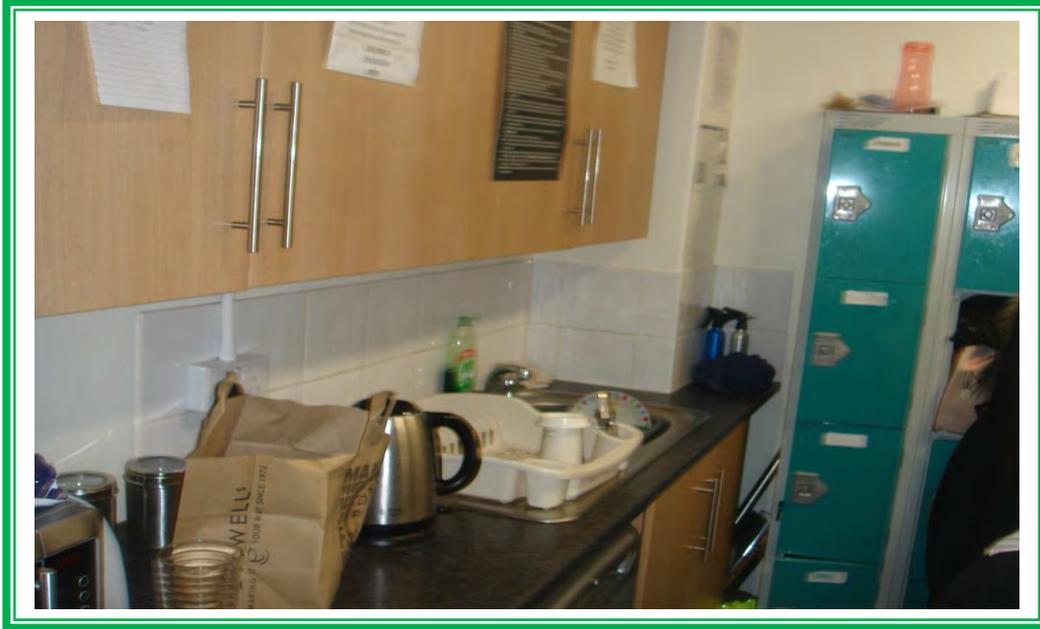
Location: 0/004 Kitchen

Material Description:	Visual Inspection – No Suspect Materials Found	
Identification:	N/A	
Approx. quantity:	N/A	
Accessibility	N/A	Assessment Score
Product type:	N/A	N/A
Extent of Damage:	N/A	N/A
Surface Treatment:	N/A	N/A
Asbestos type:	N/A	N/A
Material Assessment Score:		N/A
Priority Assessment Score:		N/A
Action:	N/A	
Comments:	N/A

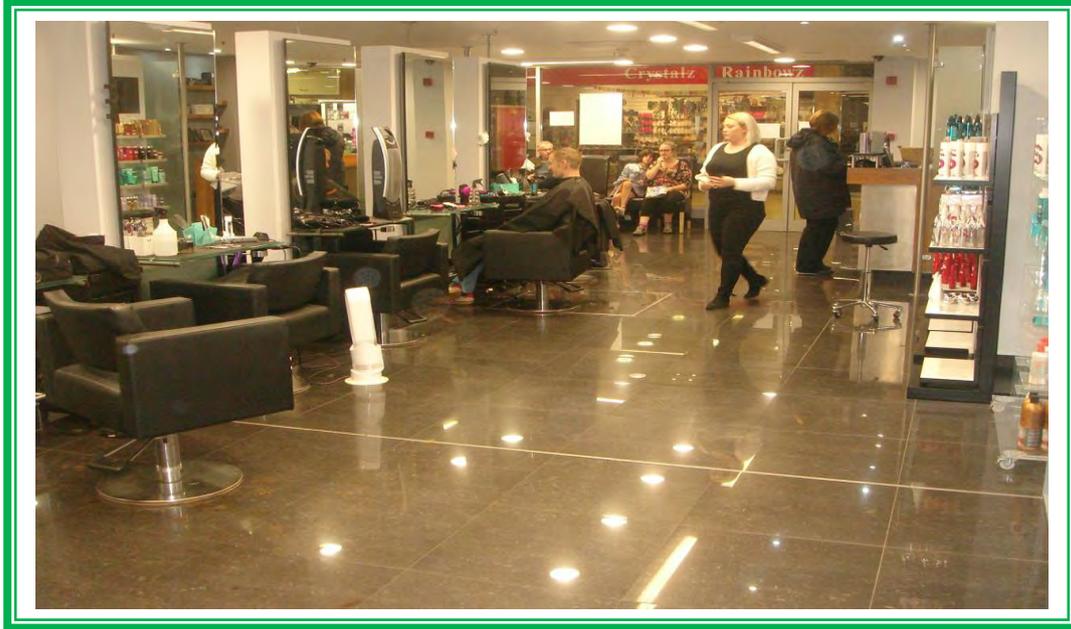
Location: 0/005 Shop Floor

Material Description:	Visual Inspection – No Suspect Materials Found	
Identification:	N/A	
Approx. quantity:	N/A	
Accessibility	N/A	Assessment Score
Product type:	N/A	N/A
Extent of Damage:	N/A	N/A
Surface Treatment:	N/A	N/A
Asbestos type:	N/A	N/A
Material Assessment Score:		N/A
Priority Assessment Score:		N/A
Action:	N/A	
Comments:	N/A

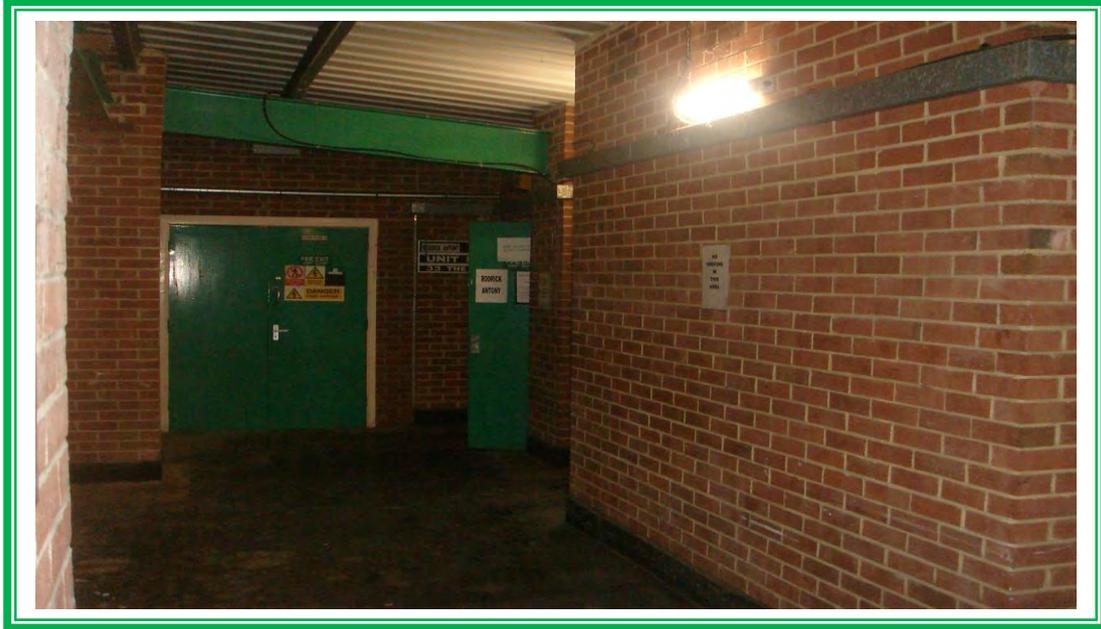
Location: 99/001

Material Description:	Visual Inspection – No Suspect Materials Found	
Identification:	N/A	
Approx. quantity:	N/A	
Accessibility	N/A	Assessment Score
Product type:	N/A	N/A
Extent of Damage:	N/A	N/A
Surface Treatment:	N/A	N/A
Asbestos type:	N/A	N/A
Material Assessment Score:		N/A
Priority Assessment Score:		N/A
Action:	N/A	
Comments:	N/A

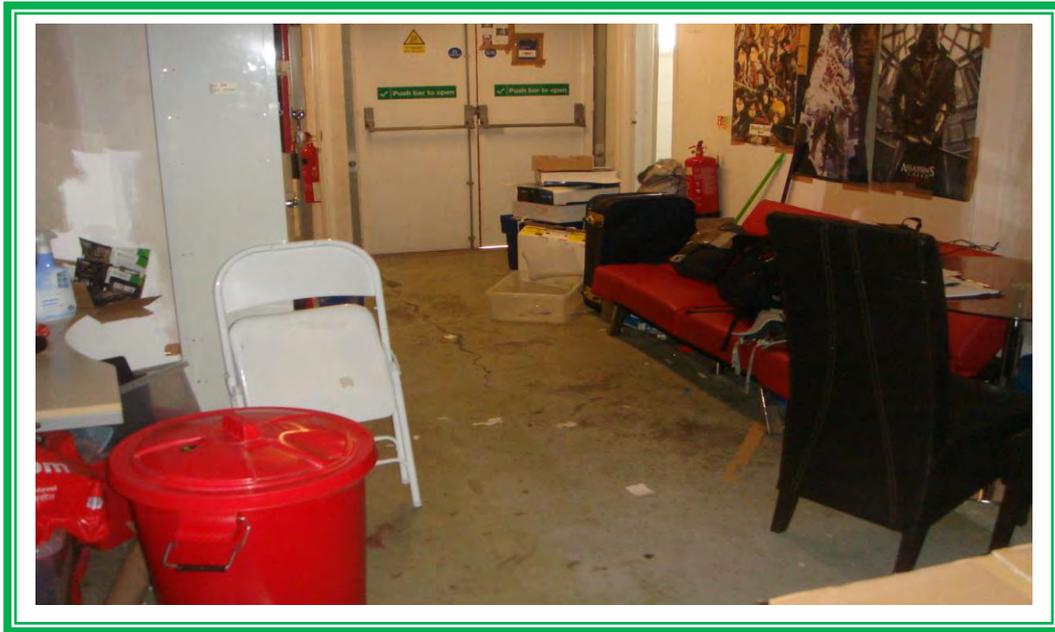
Item No: 1	Sample No: N/A
Location: 1/001 Store

Material Description:	Visual Inspection – No Suspect Materials Found	
Identification:	N/A	
Approx. quantity:	N/A	
Accessibility	N/A	Assessment Score
Product type:	N/A	N/A
Extent of Damage:	N/A	N/A
Surface Treatment:	N/A	N/A
Asbestos type:	N/A	N/A
Material Assessment Score:		N/A
Priority Assessment Score:		N/A
Action:	N/A	
Comments:	N/A

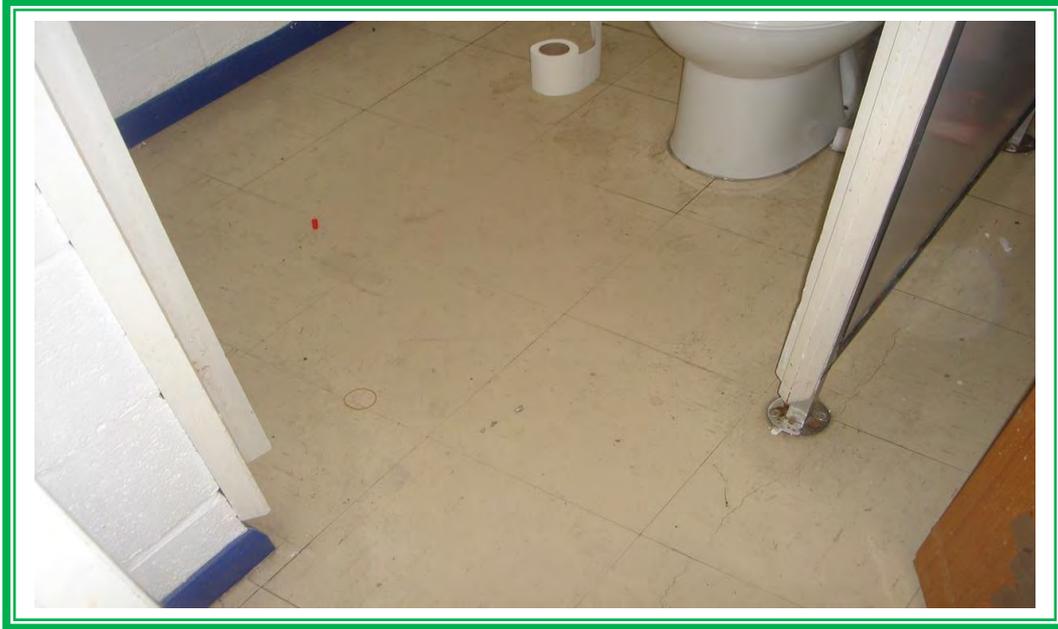
Location: 1/002 WC

Material Description:	Vinyl Floor Tiles	
Identification:	Sampled – No Asbestos Detected	
Approx. quantity:	6M2	
Accessibility	N/A	Assessment Score
Product type:	N/A	N/A
Extent of Damage:	N/A	N/A
Surface Treatment:	N/A	N/A
Asbestos type:	N/A	N/A
Material Assessment Score:		N/A
Priority Assessment Score:		N/A
Action:	N/A	
Comments:	N/A

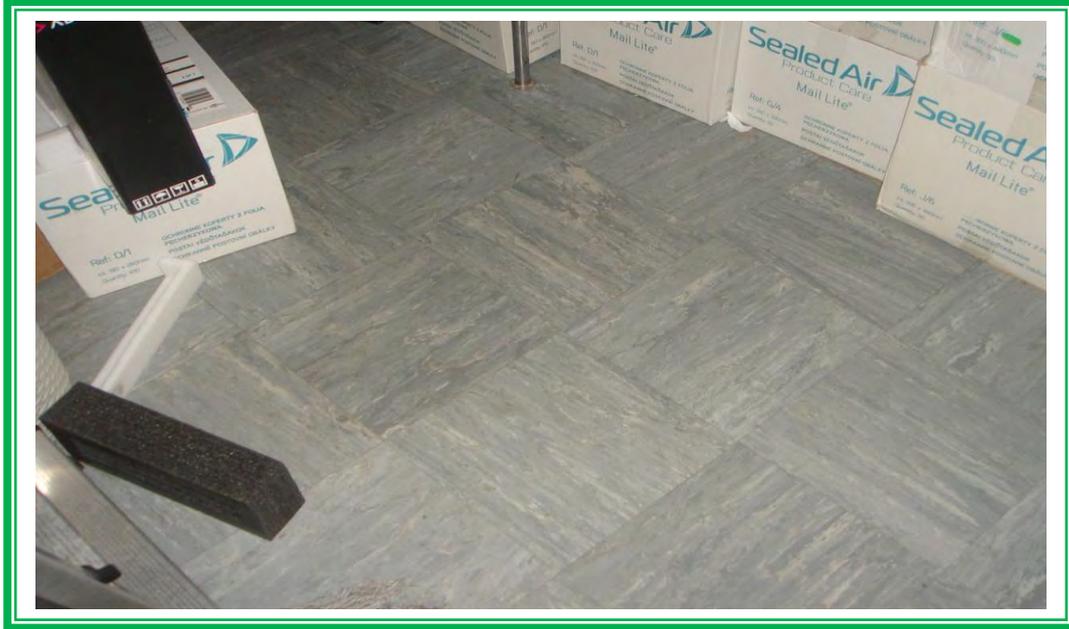
Location: 1/003 Kitchen

Material Description:	Vinyl Floor Tiles	
Identification:	Sampled – No Asbestos Detected	
Approx. quantity:	8M2	
Accessibility	N/A	Assessment Score
Product type:	N/A	N/A
Extent of Damage:	N/A	N/A
Surface Treatment:	N/A	N/A
Asbestos type:	N/A	N/A
Material Assessment Score:		N/A
Priority Assessment Score:		N/A
Action:	N/A	
Comments:	N/A

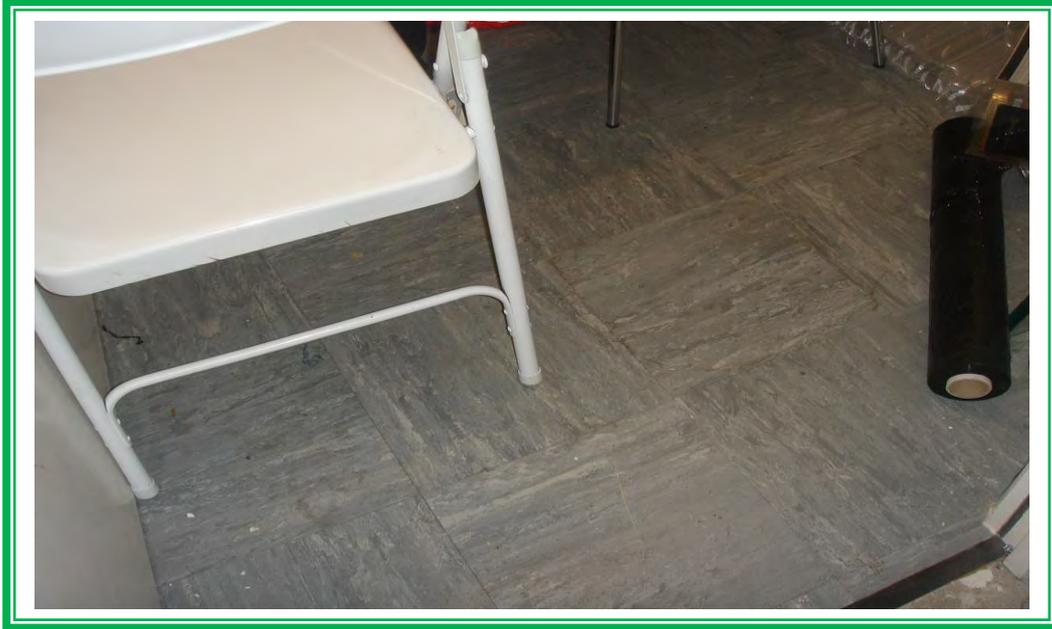
Location: 1/004 Office

Material Description:	Vinyl Floor Tiles	
Identification:	As Per Sample NE/2 – No Asbestos Detected	
Approx. quantity:	2M2	
Accessibility	N/A	Assessment Score
Product type:	N/A	N/A
Extent of Damage:	N/A	N/A
Surface Treatment:	N/A	N/A
Asbestos type:	N/A	N/A
Material Assessment Score:		N/A
Priority Assessment Score:		N/A
Action:	N/A	
Comments:	N/A

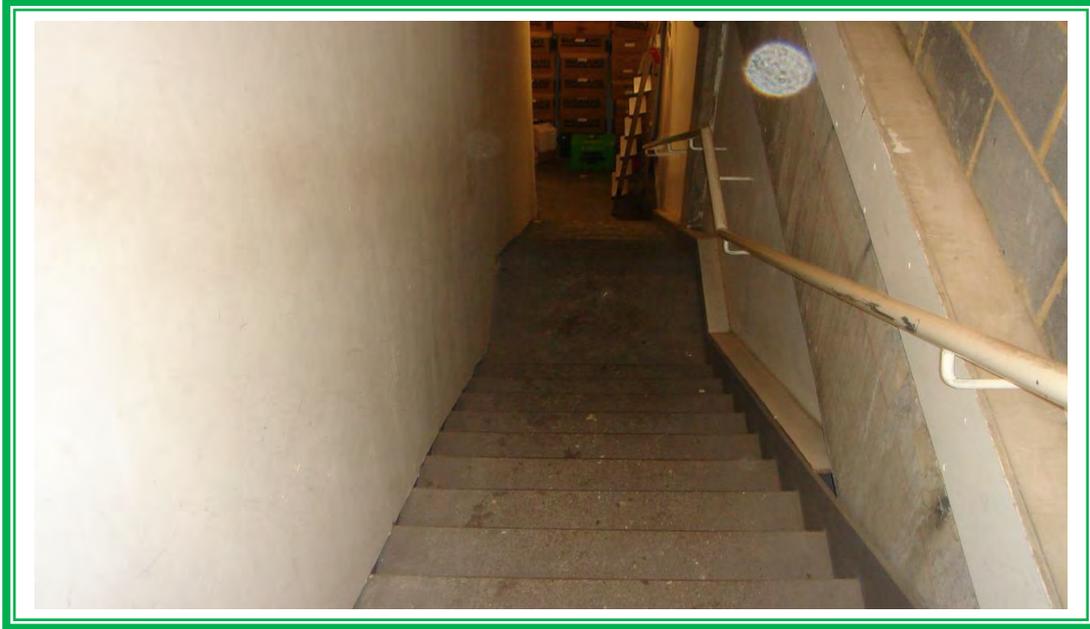
Location: 1/005 Stairs

Material Description:	Visual Inspection – No Suspect Materials Found	
Identification:	N/A	
Approx. quantity:	N/A	
Accessibility	N/A	Assessment Score
Product type:	N/A	N/A
Extent of Damage:	N/A	N/A
Surface Treatment:	N/A	N/A
Asbestos type:	N/A	N/A
Material Assessment Score:		N/A
Priority Assessment Score:		N/A
Action:	N/A	
Comments:	N/A

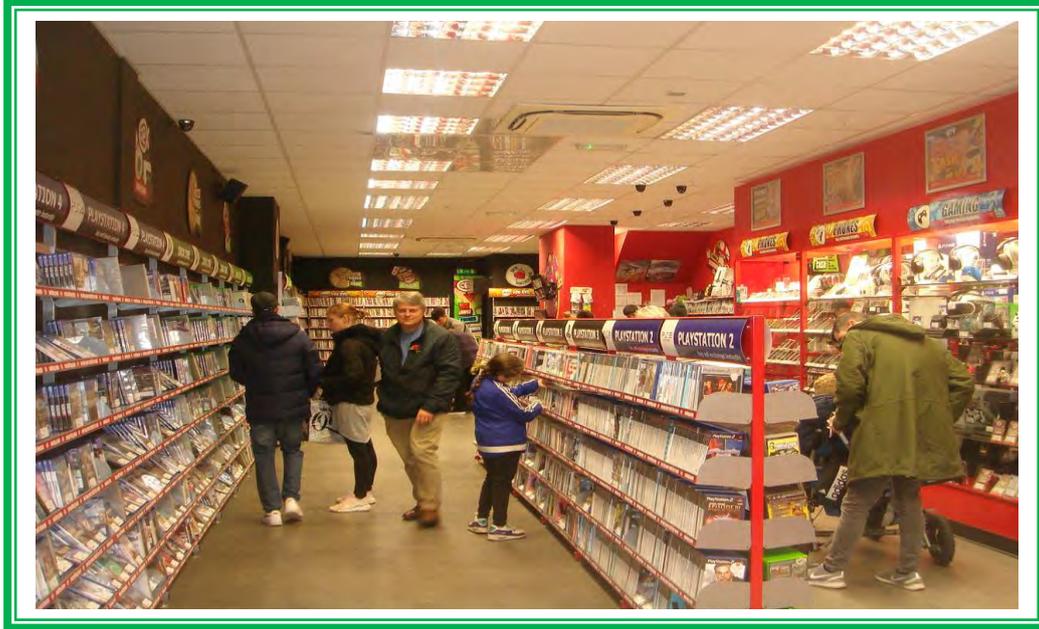
Location: 0/001 Shop Floor

Material Description:	Visual Inspection – No Suspect Materials Found	
Identification:	N/A	
Approx. quantity:	N/A	
Accessibility	N/A	Assessment Score
Product type:	N/A	N/A
Extent of Damage:	N/A	N/A
Surface Treatment:	N/A	N/A
Asbestos type:	N/A	N/A
Material Assessment Score:		N/A
Priority Assessment Score:		N/A
Action:	N/A	
Comments:	N/A

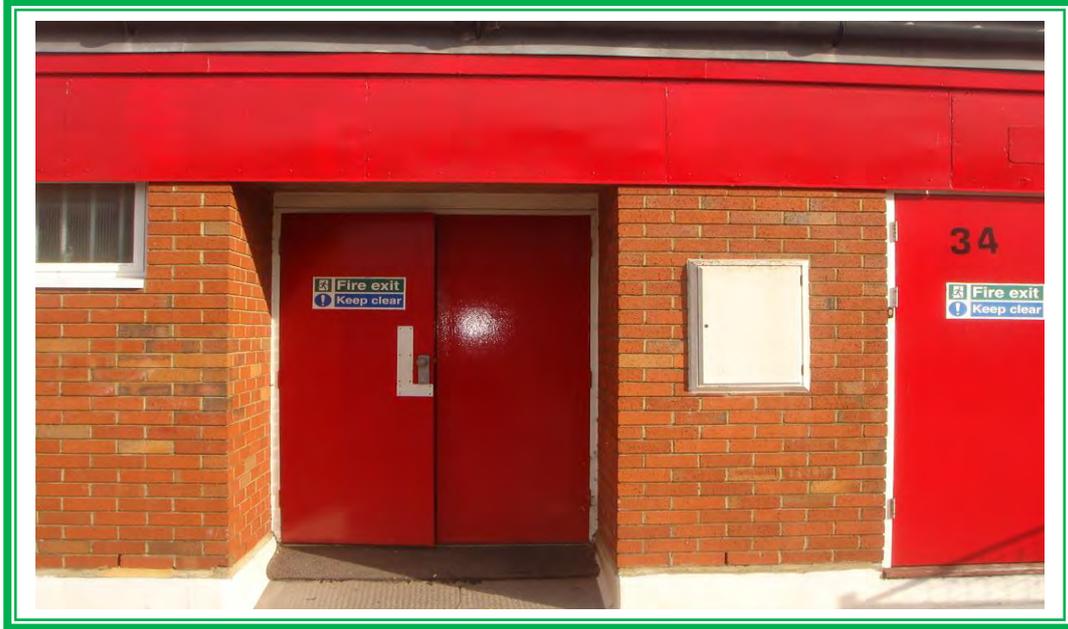
Location: 99/001

Material Description:	Visual Inspection – No Suspect Materials Found	
Identification:	N/A	
Approx. quantity:	N/A	
Accessibility	N/A	Assessment Score
Product type:	N/A	N/A
Extent of Damage:	N/A	N/A
Surface Treatment:	N/A	N/A
Asbestos type:	N/A	N/A
Material Assessment Score:		N/A
Priority Assessment Score:		N/A
Action:	N/A	
Comments:	N/A

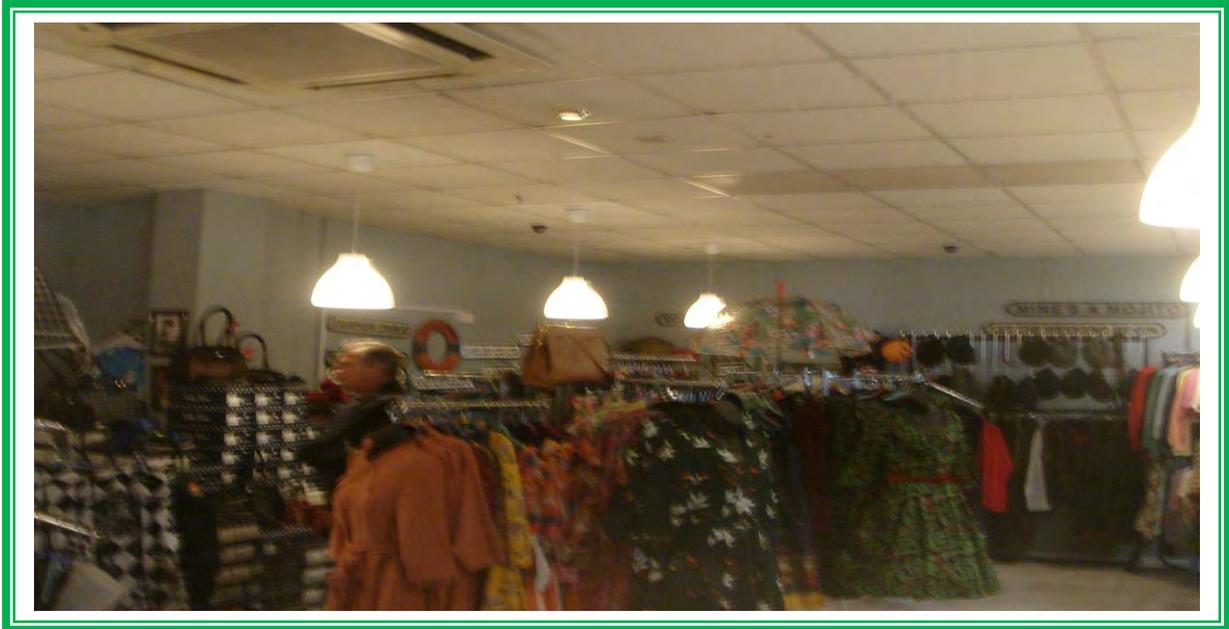
Item No: 1	Sample No: N/A
Location: 0/001 Shop Floor

Material Description:	Visual Inspection – No Suspect Materials Found	
Identification:	N/A	
Approx. quantity:	N/A	
Accessibility	N/A	Assessment Score
Product type:	N/A	N/A
Extent of Damage:	N/A	N/A
Surface Treatment:	N/A	N/A
Asbestos type:	N/A	N/A
Material Assessment Score:		N/A
Priority Assessment Score:		N/A
Action:	N/A	
Comments:	N/A

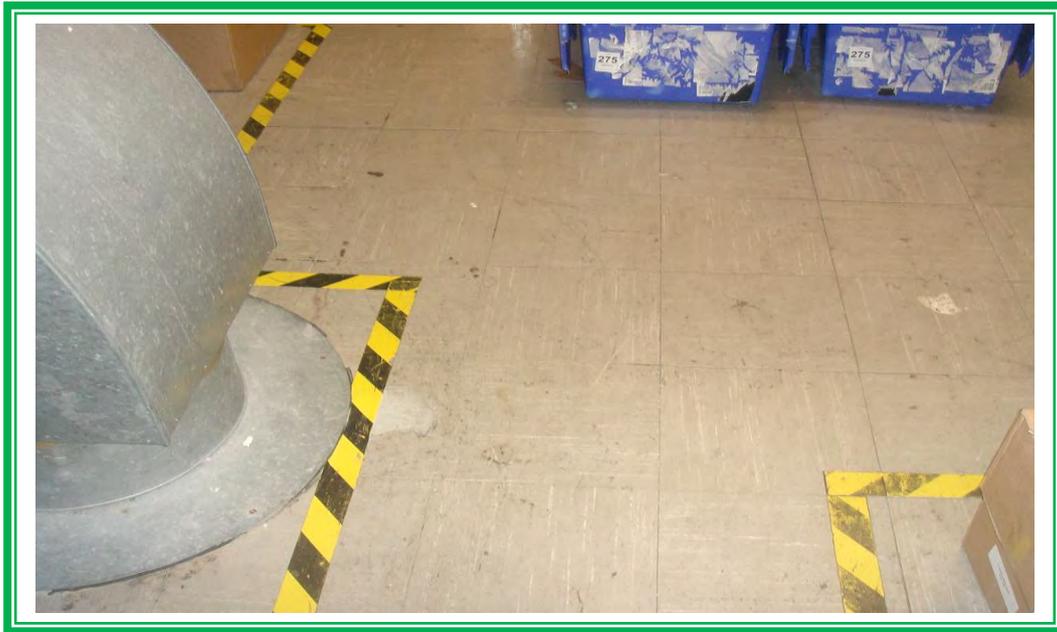
Item No: 1	Sample No: NE/1
Location: 1/001 Store

Material Description:	Vinyl Floor Tiles	
Identification:	Sampled – No Asbestos Detected	
Approx. quantity:	30M2	
Accessibility	N/A	Assessment Score
Product type:	N/A	N/A
Extent of Damage:	N/A	N/A
Surface Treatment:	N/A	N/A
Asbestos type:	N/A	N/A
Material Assessment Score:		N/A
Priority Assessment Score:		N/A
Action:	N/A	
Comments:	N/A

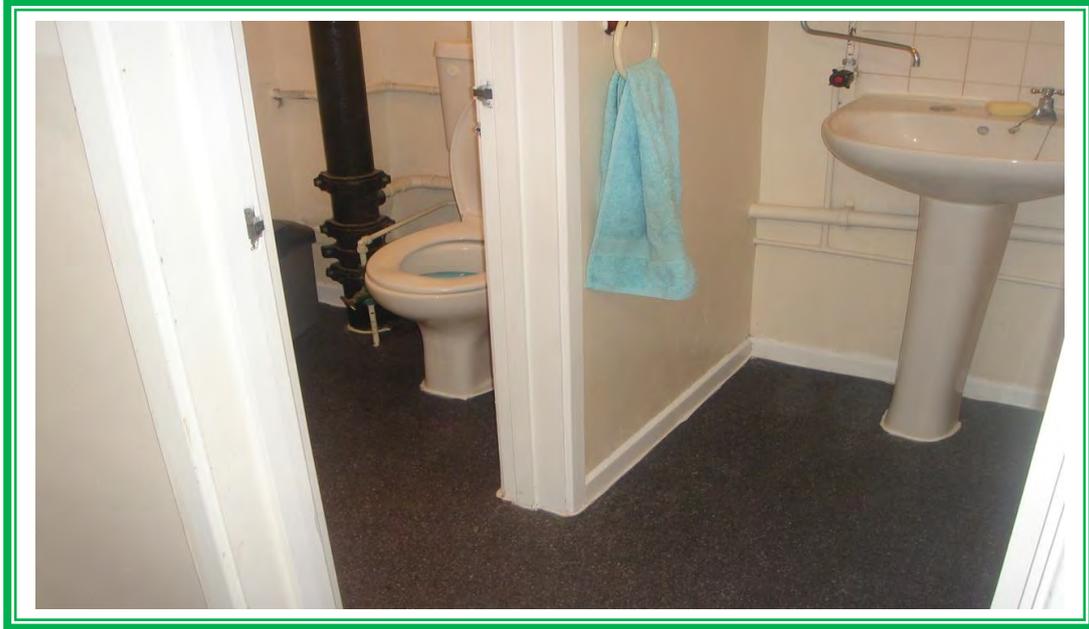
Location: 1/003 WC

Material Description:	Visual Inspection – No Suspect Materials Found	
Identification:	N/A	
Approx. quantity:	N/A	
Accessibility	N/A	Assessment Score
Product type:	N/A	N/A
Extent of Damage:	N/A	N/A
Surface Treatment:	N/A	N/A
Asbestos type:	N/A	N/A
Material Assessment Score:		N/A
Priority Assessment Score:		N/A
Action:	N/A	
Comments:	N/A

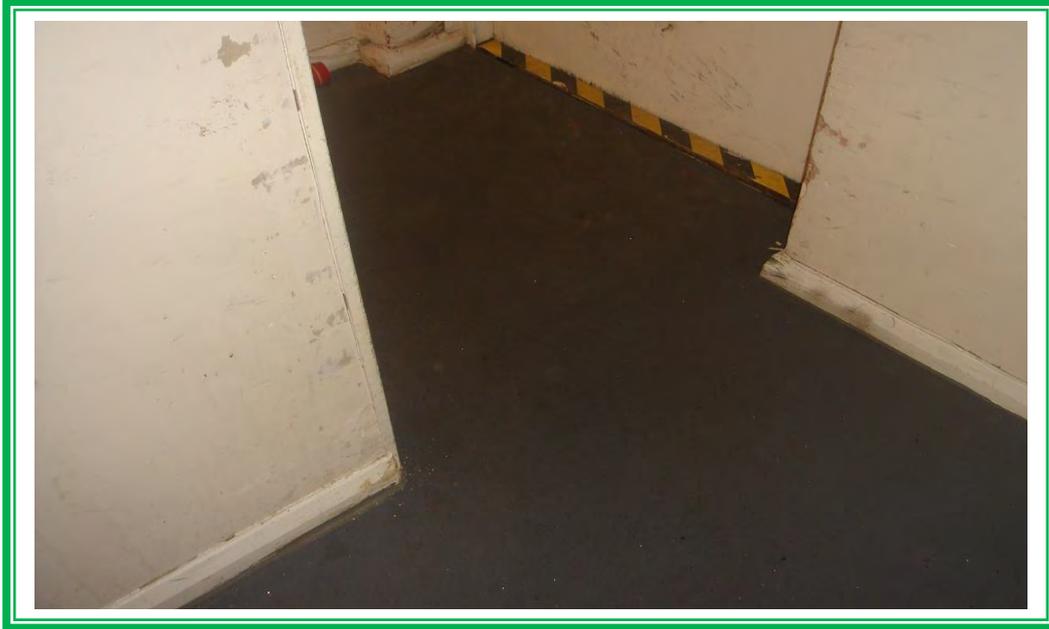
Location: 1/004 Stairs

Material Description:	Vinyl Floor Tiles	
Identification:	As Per Sample NE/2 – No Asbestos Detected	
Approx. quantity:	4M2	
Accessibility	N/A	Assessment Score
Product type:	N/A	N/A
Extent of Damage:	N/A	N/A
Surface Treatment:	N/A	N/A
Asbestos type:	N/A	N/A
Material Assessment Score:		N/A
Priority Assessment Score:		N/A
Action:	N/A	
Comments:	N/A

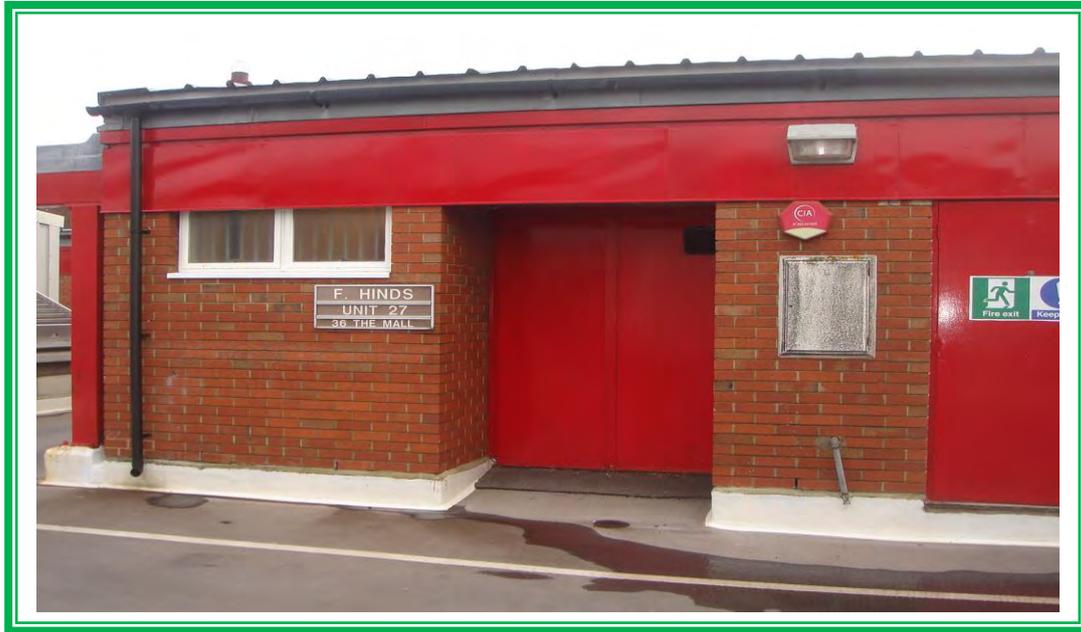
Location: 99/001 External

Material Description:	Visual Inspection – No Suspect Materials Found	
Identification:	N/A	
Approx. quantity:	N/A	
Accessibility	N/A	Assessment Score
Product type:	N/A	N/A
Extent of Damage:	N/A	N/A
Surface Treatment:	N/A	N/A
Asbestos type:	N/A	N/A
Material Assessment Score:		N/A
Priority Assessment Score:		N/A
Action:	N/A	
Comments:	N/A
