Section 6: Survey Objectives

Instructions were received from James Croucher of Lochailort Newbury Ltd to carry out a Management asbestos survey at Kennet Centre, Market Street, Newbury, Berkshire, RG14 5EN in accordance with HSG264 and Armour Analytical's quality procedures.

The survey was carried out on 22nd – 25th October 2019 by Neale Evans with the objective of facilitating a Management report.

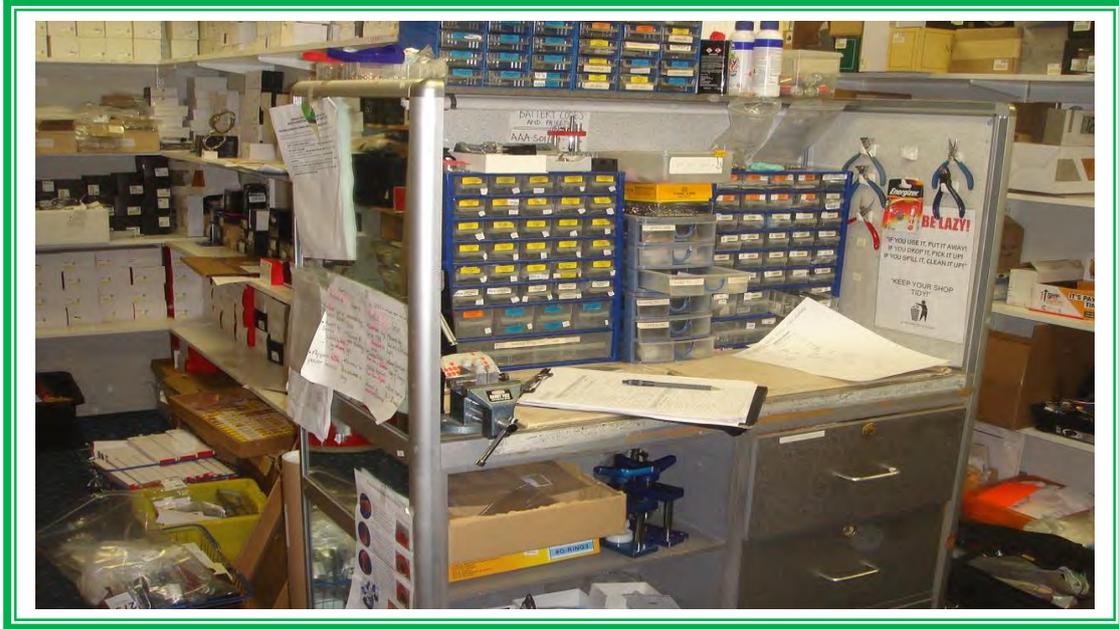
Location: 0/001 Office/Store

Material Description:	Visual Inspection – No Suspect Materials Found	
Identification:	N/A	
Approx. quantity:	N/A	
Accessibility	N/A	Assessment Score
Product type:	N/A	N/A
Extent of Damage:	N/A	N/A
Surface Treatment:	N/A	N/A
Asbestos type:	N/A	N/A
Material Assessment Score:		N/A
Priority Assessment Score:		N/A
Action:	N/A	
Comments:	N/A

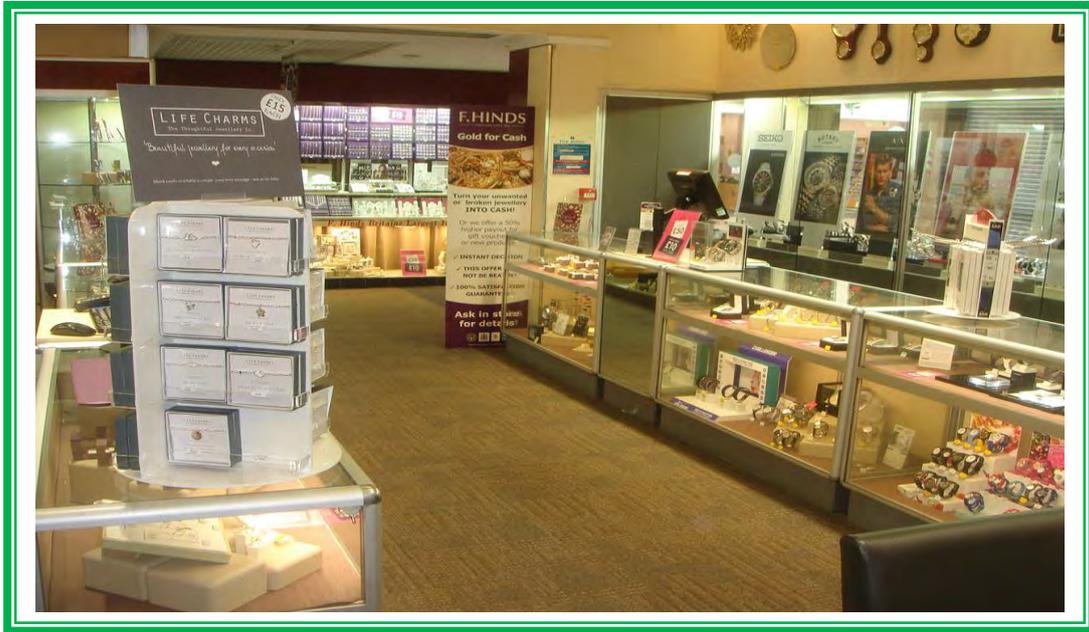
Location: 0/003 Shop Floor

Material Description:	Visual Inspection – No Suspect Materials Found	
Identification:	N/A	
Approx. quantity:	N/A	
Accessibility	N/A	Assessment Score
Product type:	N/A	N/A
Extent of Damage:	N/A	N/A
Surface Treatment:	N/A	N/A
Asbestos type:	N/A	N/A
Material Assessment Score:		N/A
Priority Assessment Score:		N/A
Action:	N/A	
Comments:	N/A

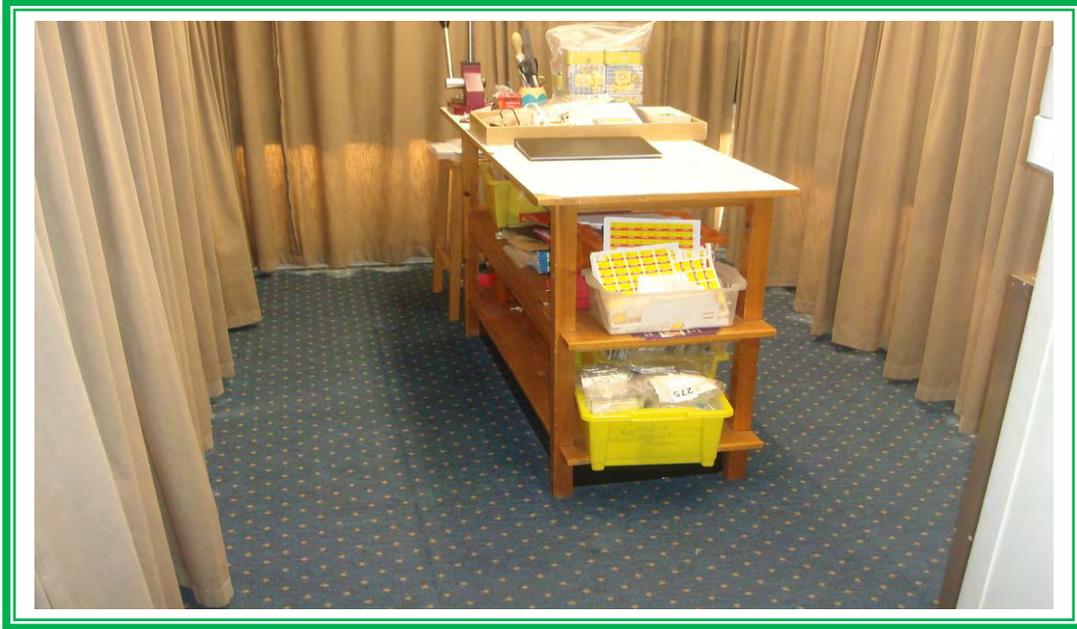
Location: 0/004 Gold Room

Material Description:	Visual Inspection – No Suspect Materials Found	
Identification:	N/A	
Approx. quantity:	N/A	
Accessibility	N/A	Assessment Score
Product type:	N/A	N/A
Extent of Damage:	N/A	N/A
Surface Treatment:	N/A	N/A
Asbestos type:	N/A	N/A
Material Assessment Score:		N/A
Priority Assessment Score:		N/A
Action:	N/A	
Comments:	N/A

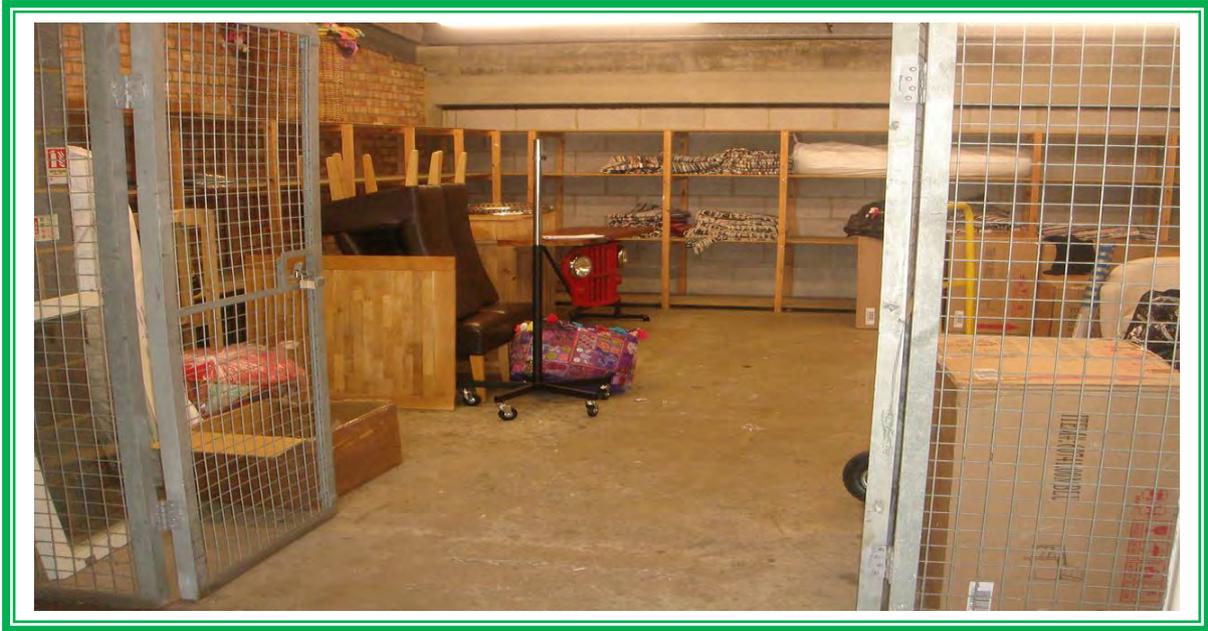
Item No: 1	Sample No: N/A
Location: 1/001 Store

Material Description:	Visual Inspection – No Suspect Materials Found	
Identification:	N/A	
Approx. quantity:	N/A	
Accessibility	N/A	Assessment Score
Product type:	N/A	N/A
Extent of Damage:	N/A	N/A
Surface Treatment:	N/A	N/A
Asbestos type:	N/A	N/A
Material Assessment Score:		N/A
Priority Assessment Score:		N/A
Action:	N/A	
Comments:	N/A

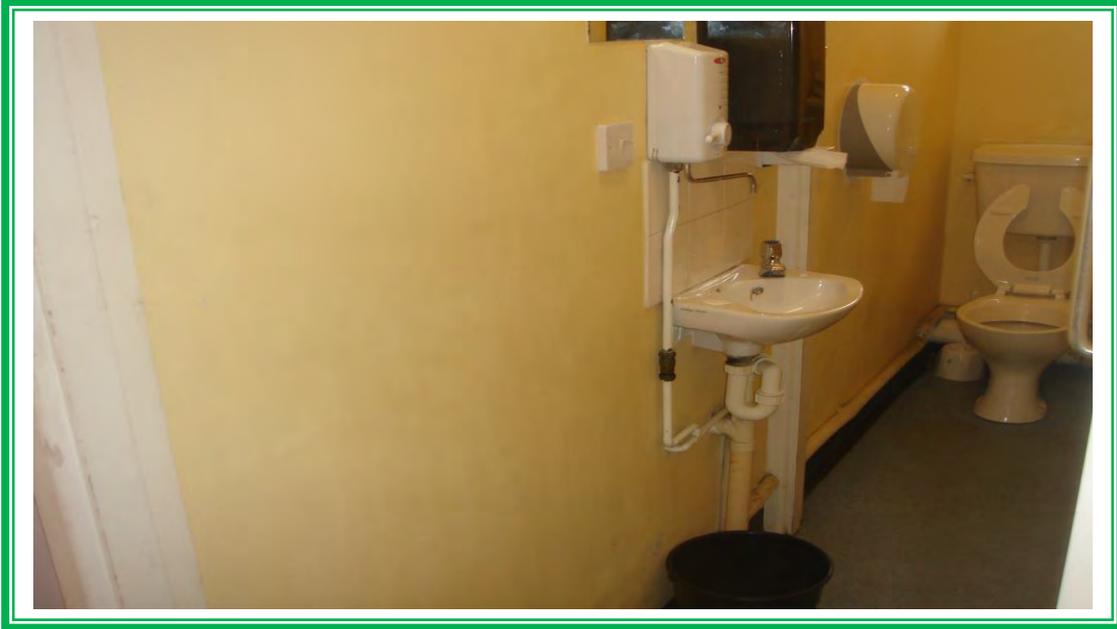
Location: 1/002 WC

Material Description:	Visual Inspection – No Suspect Materials Found	
Identification:	N/A	
Approx. quantity:	N/A	
Accessibility	N/A	Assessment Score
Product type:	N/A	N/A
Extent of Damage:	N/A	N/A
Surface Treatment:	N/A	N/A
Asbestos type:	N/A	N/A
Material Assessment Score:		N/A
Priority Assessment Score:		N/A
Action:	N/A	
Comments:	N/A

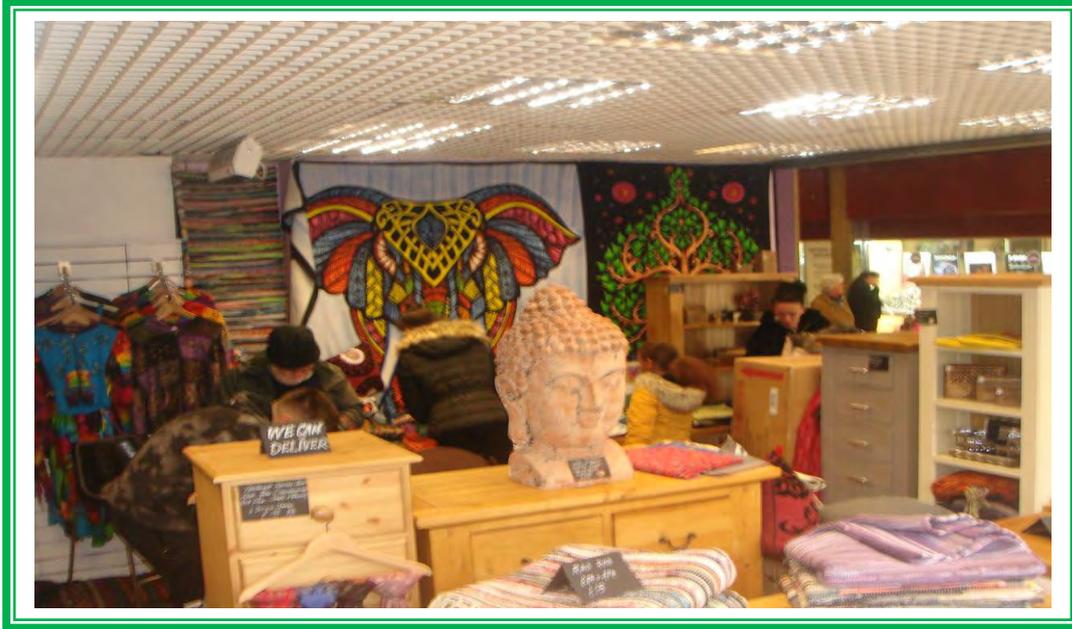
Location: 0/001 Shop Floor

Material Description:	Visual Inspection – No Suspect Materials Found	
Identification:	N/A	
Approx. quantity:	N/A	
Accessibility	N/A	Assessment Score
Product type:	N/A	N/A
Extent of Damage:	N/A	N/A
Surface Treatment:	N/A	N/A
Asbestos type:	N/A	N/A
Material Assessment Score:		N/A
Priority Assessment Score:		N/A
Action:	N/A	
Comments:	N/A

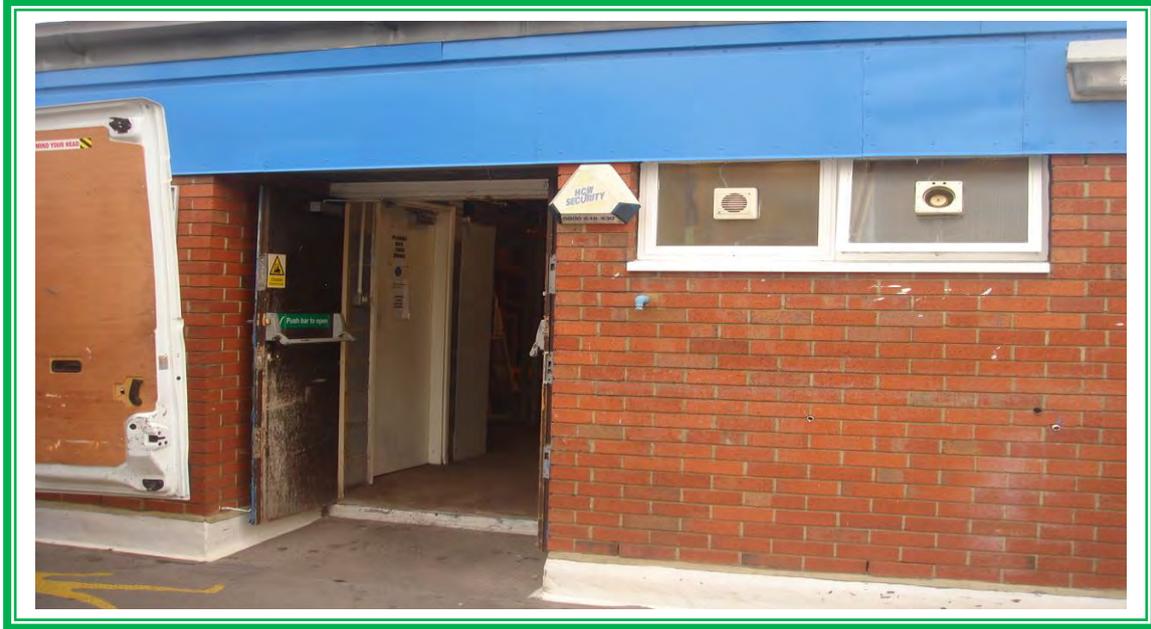
Location: 99/001 External

Material Description:	Visual Inspection – No Suspect Materials Found	
Identification:	N/A	
Approx. quantity:	N/A	
Accessibility	N/A	Assessment Score
Product type:	N/A	N/A
Extent of Damage:	N/A	N/A
Surface Treatment:	N/A	N/A
Asbestos type:	N/A	N/A
Material Assessment Score:		N/A
Priority Assessment Score:		N/A
Action:	N/A	
Comments:	N/A

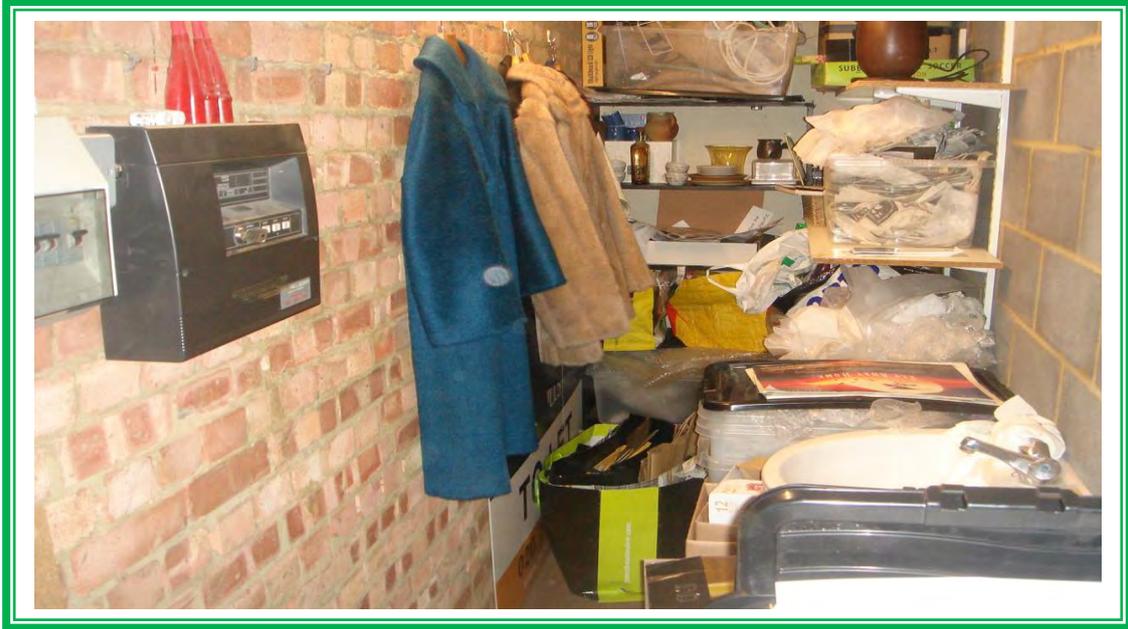
Location: 0/002 Store Cupboard

Material Description:	Visual Inspection – No Suspect Materials Found	
Identification:	N/A	
Approx. quantity:	N/A	
Accessibility	N/A	Assessment Score
Product type:	N/A	N/A
Extent of Damage:	N/A	N/A
Surface Treatment:	N/A	N/A
Asbestos type:	N/A	N/A
Material Assessment Score:		N/A
Priority Assessment Score:		N/A
Action:	N/A	
Comments:	N/A

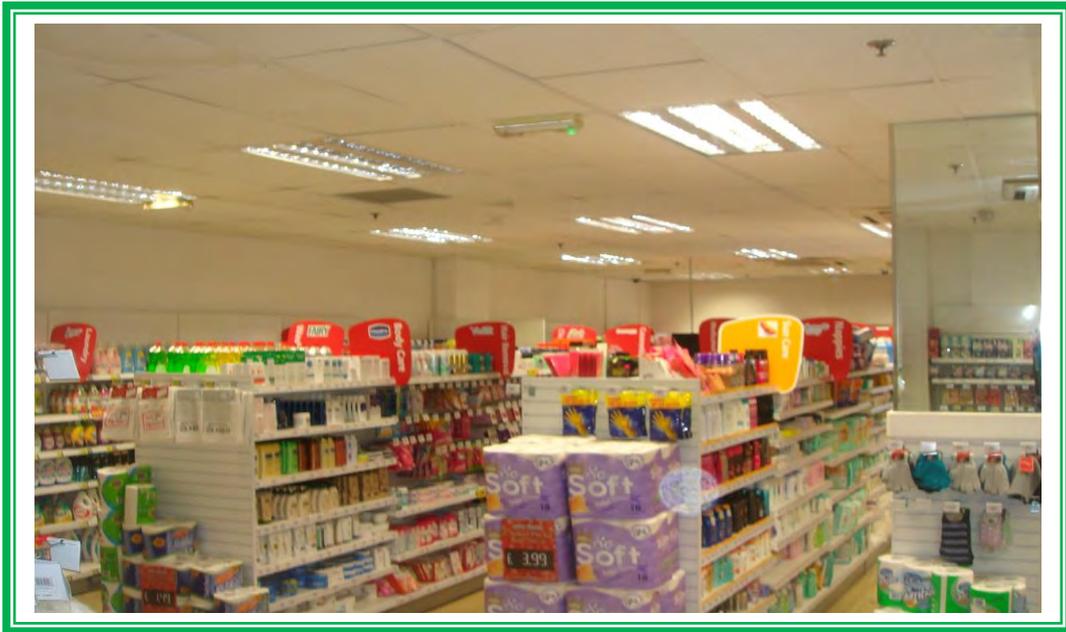
Item No: 10	Sample No: N/A
Location: 0/001 Shop Floor

Material Description:	Visual Inspection – No Suspect Materials Found	
Identification:	N/A	
Approx. quantity:	N/A	
Accessibility	N/A	Assessment Score
Product type:	N/A	N/A
Extent of Damage:	N/A	N/A
Surface Treatment:	N/A	N/A
Asbestos type:	N/A	N/A
Material Assessment Score:		N/A
Priority Assessment Score:		N/A
Action:	N/A	
Comments:	N/A

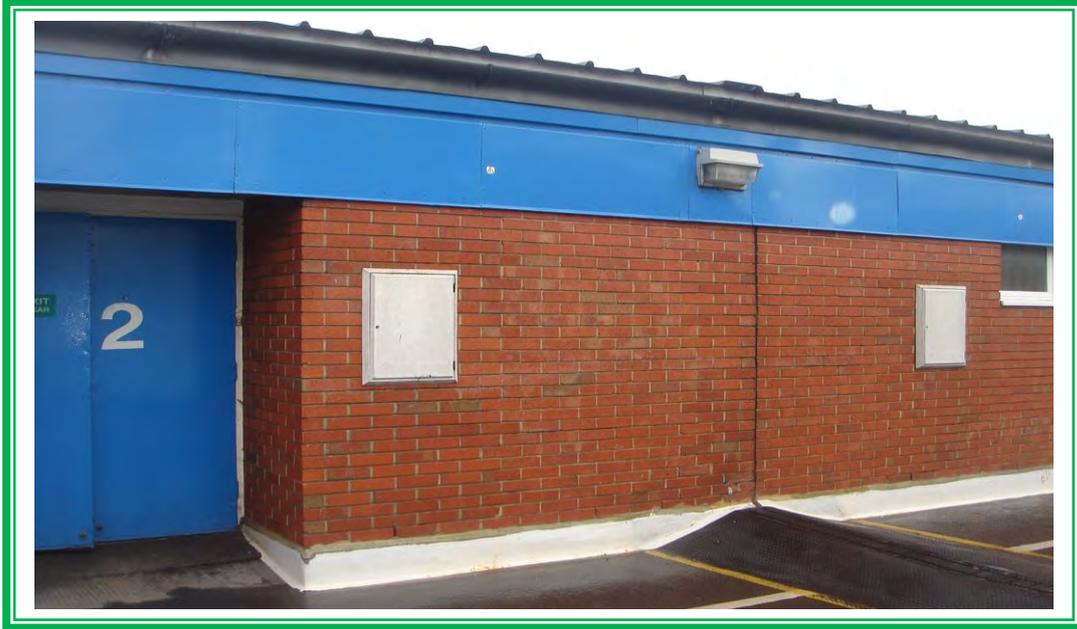
Location: 99/001

Material Description:	Visual Inspection – No Suspect Materials Found	
Identification:	N/A	
Approx. quantity:	N/A	
Accessibility	N/A	Assessment Score
Product type:	N/A	N/A
Extent of Damage:	N/A	N/A
Surface Treatment:	N/A	N/A
Asbestos type:	N/A	N/A
Material Assessment Score:		N/A
Priority Assessment Score:		N/A
Action:	N/A	
Comments:	N/A

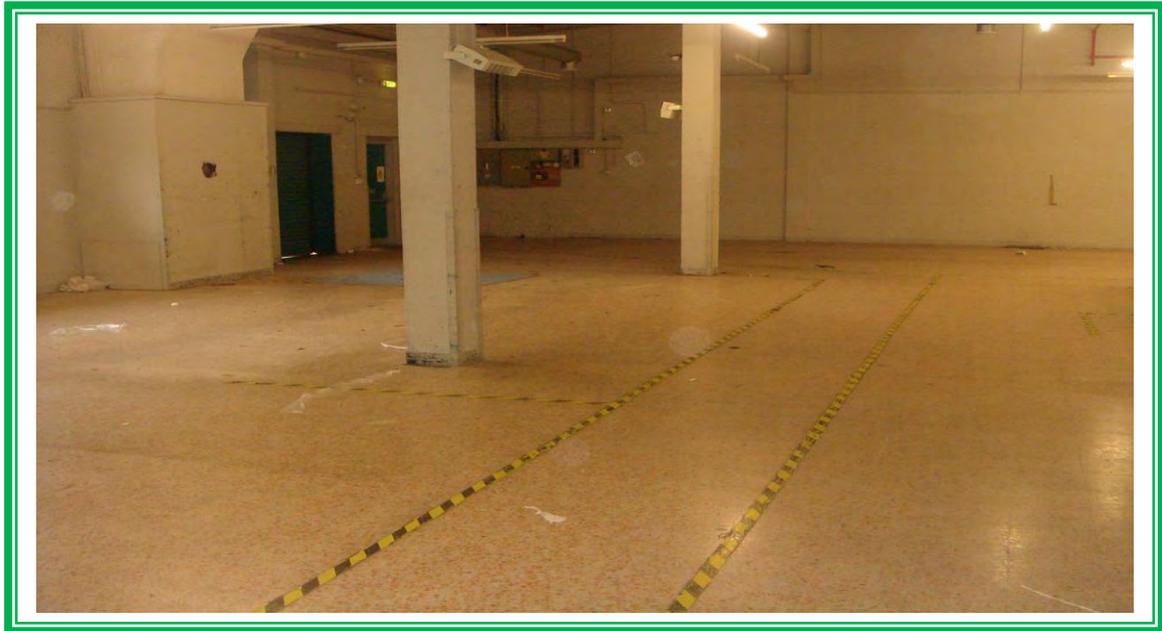
Item No: 1	Sample No: N/A
Location: 1/001

Material Description:	Visual Inspection – No Suspect Materials Found	
Identification:	N/A	
Approx. quantity:	N/A	
Accessibility	N/A	Assessment Score
Product type:	N/A	N/A
Extent of Damage:	N/A	N/A
Surface Treatment:	N/A	N/A
Asbestos type:	N/A	N/A
Material Assessment Score:		N/A
Priority Assessment Score:		N/A
Action:	N/A	
Comments:	N/A

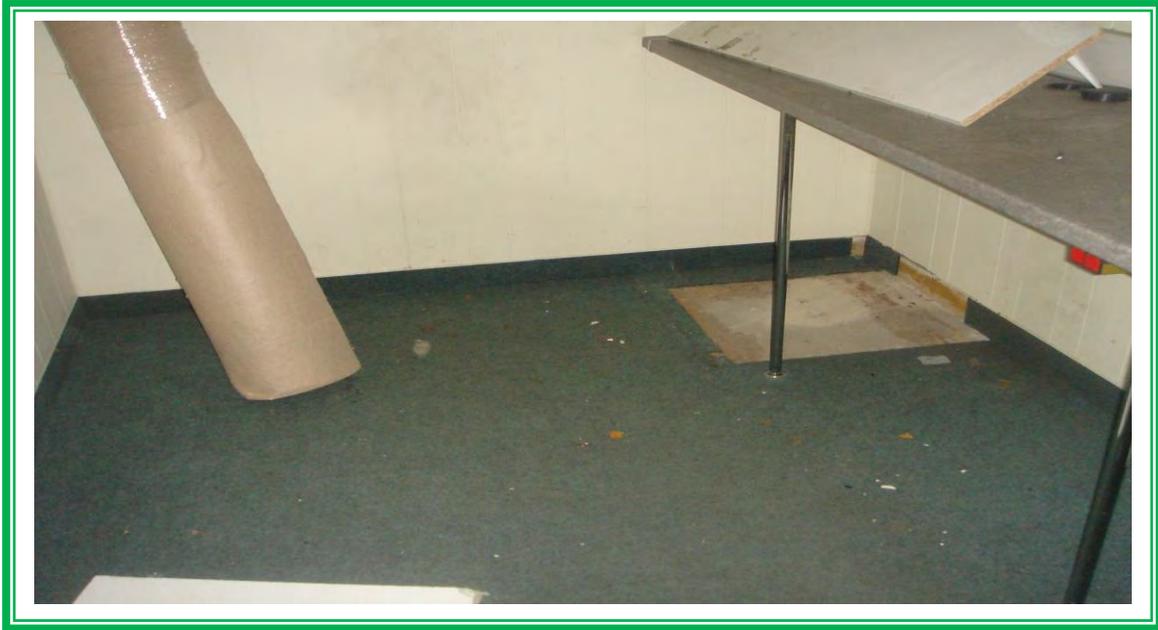
Location: 1/003 Office

Material Description:	Visual Inspection – No Suspect Materials Found	
Identification:	N/A	
Approx. quantity:	N/A	
Accessibility	N/A	Assessment Score
Product type:	N/A	N/A
Extent of Damage:	N/A	N/A
Surface Treatment:	N/A	N/A
Asbestos type:	N/A	N/A
Material Assessment Score:		N/A
Priority Assessment Score:		N/A
Action:	N/A	
Comments:	N/A

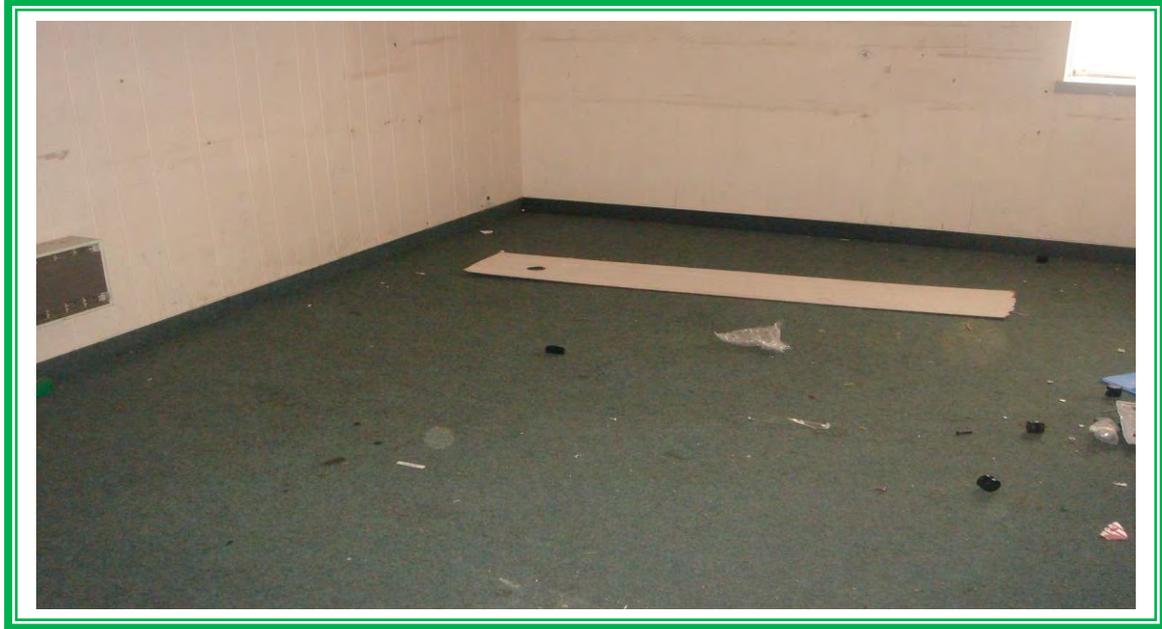
Location: 1/004 Mess Room

Material Description:	Visual Inspection – No Suspect Materials Found	
Identification:	N/A	
Approx. quantity:	N/A	
Accessibility	N/A	Assessment Score
Product type:	N/A	N/A
Extent of Damage:	N/A	N/A
Surface Treatment:	N/A	N/A
Asbestos type:	N/A	N/A
Material Assessment Score:		N/A
Priority Assessment Score:		N/A
Action:	N/A	
Comments:	N/A

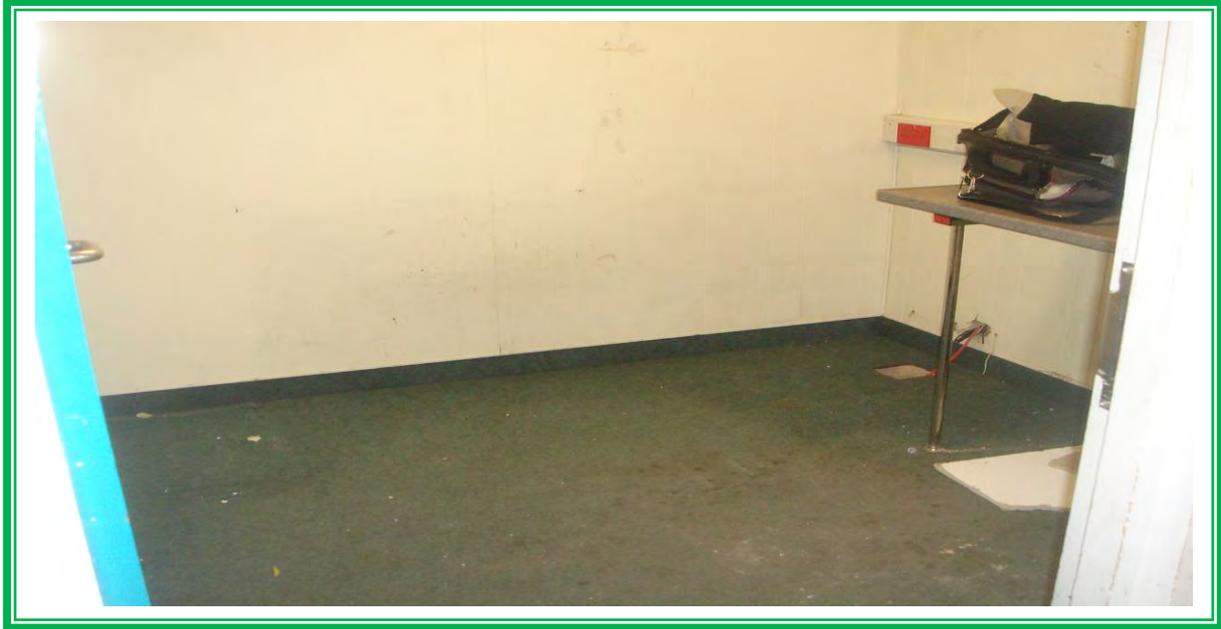
Location: 1/005 Office

Material Description:	Visual Inspection – No Suspect Materials Found	
Identification:	N/A	
Approx. quantity:	N/A	
Accessibility	N/A	Assessment Score
Product type:	N/A	N/A
Extent of Damage:	N/A	N/A
Surface Treatment:	N/A	N/A
Asbestos type:	N/A	N/A
Material Assessment Score:		N/A
Priority Assessment Score:		N/A
Action:	N/A	
Comments:	N/A

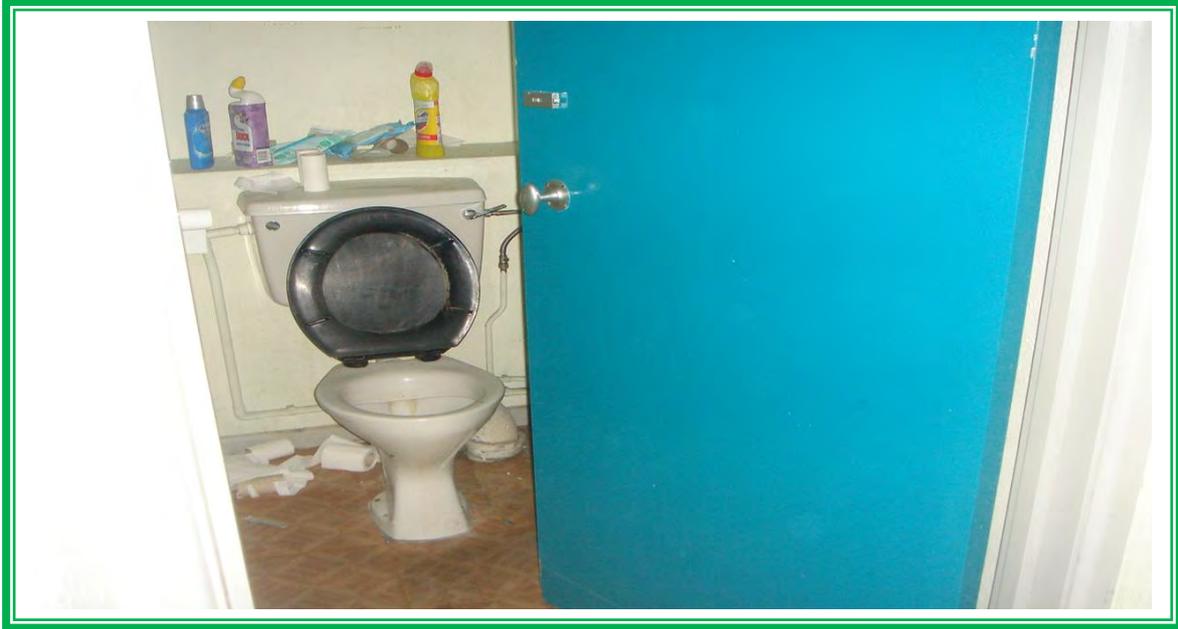
Location: 1/006 WC

Material Description:	Visual Inspection – No Suspect Materials Found	
Identification:	N/A	
Approx. quantity:	N/A	
Accessibility	N/A	Assessment Score
Product type:	N/A	N/A
Extent of Damage:	N/A	N/A
Surface Treatment:	N/A	N/A
Asbestos type:	N/A	N/A
Material Assessment Score:		N/A
Priority Assessment Score:		N/A
Action:	N/A	
Comments:	N/A

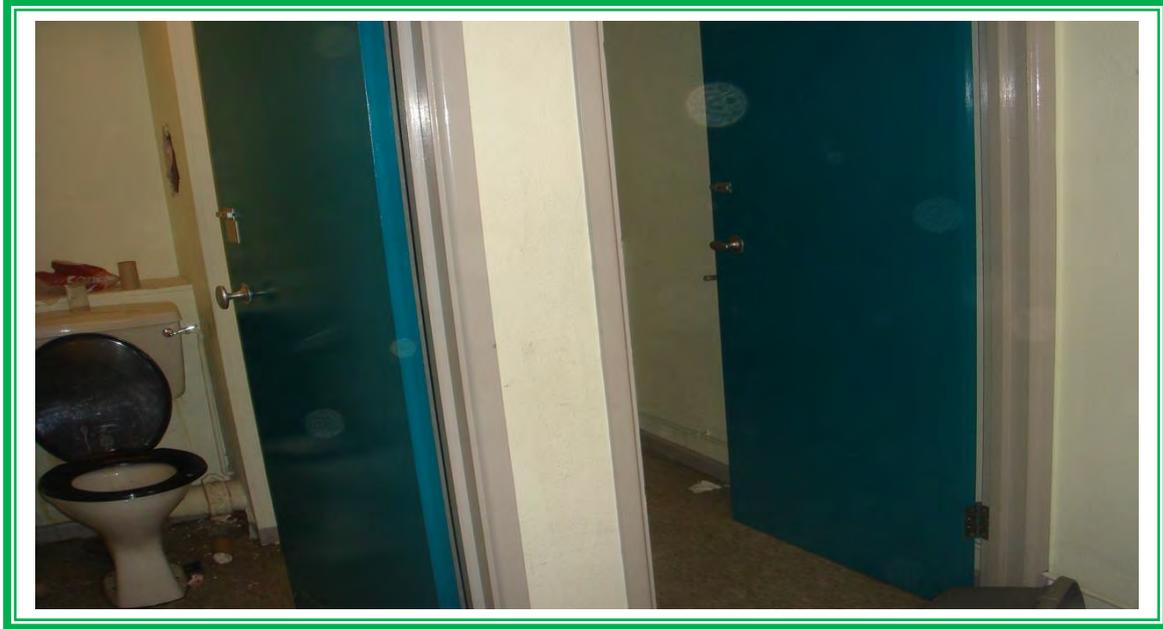
Location: 1/007 WC

Material Description:	Visual Inspection – No Suspect Materials Found	
Identification:	N/A	
Approx. quantity:	N/A	
Accessibility	N/A	Assessment Score
Product type:	N/A	N/A
Extent of Damage:	N/A	N/A
Surface Treatment:	N/A	N/A
Asbestos type:	N/A	N/A
Material Assessment Score:		N/A
Priority Assessment Score:		N/A
Action:	N/A	
Comments:	N/A

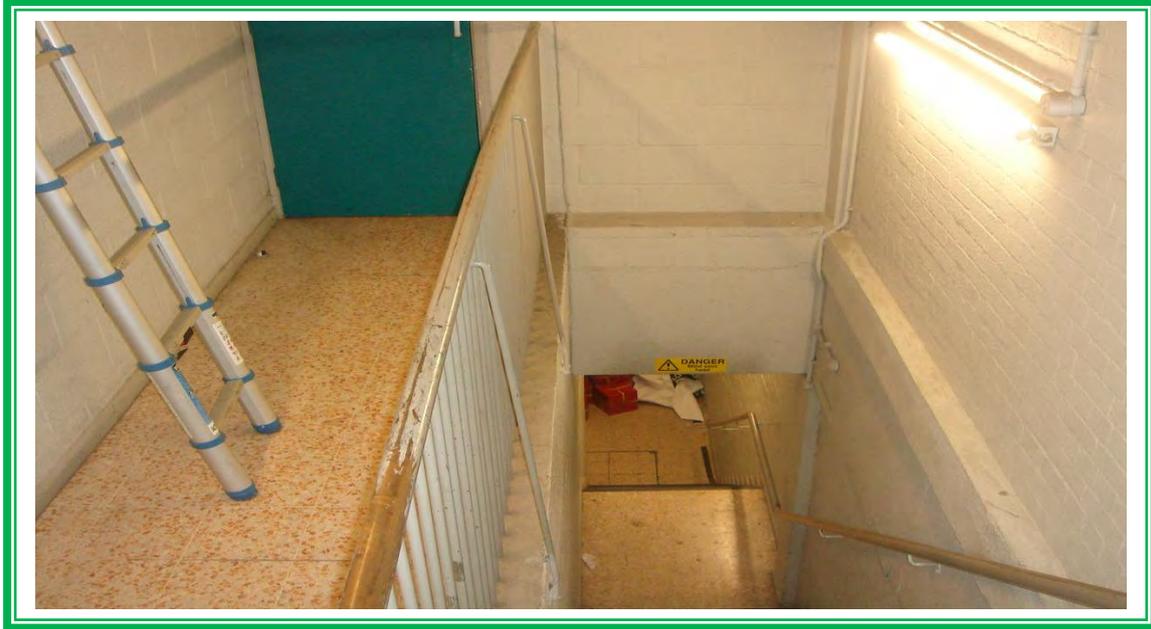
Location: 1/008 Stairs

Material Description:	Visual Inspection – No Suspect Materials Found	
Identification:	N/A	
Approx. quantity:	N/A	
Accessibility	N/A	Assessment Score
Product type:	N/A	N/A
Extent of Damage:	N/A	N/A
Surface Treatment:	N/A	N/A
Asbestos type:	N/A	N/A
Material Assessment Score:		N/A
Priority Assessment Score:		N/A
Action:	N/A	
Comments:	N/A

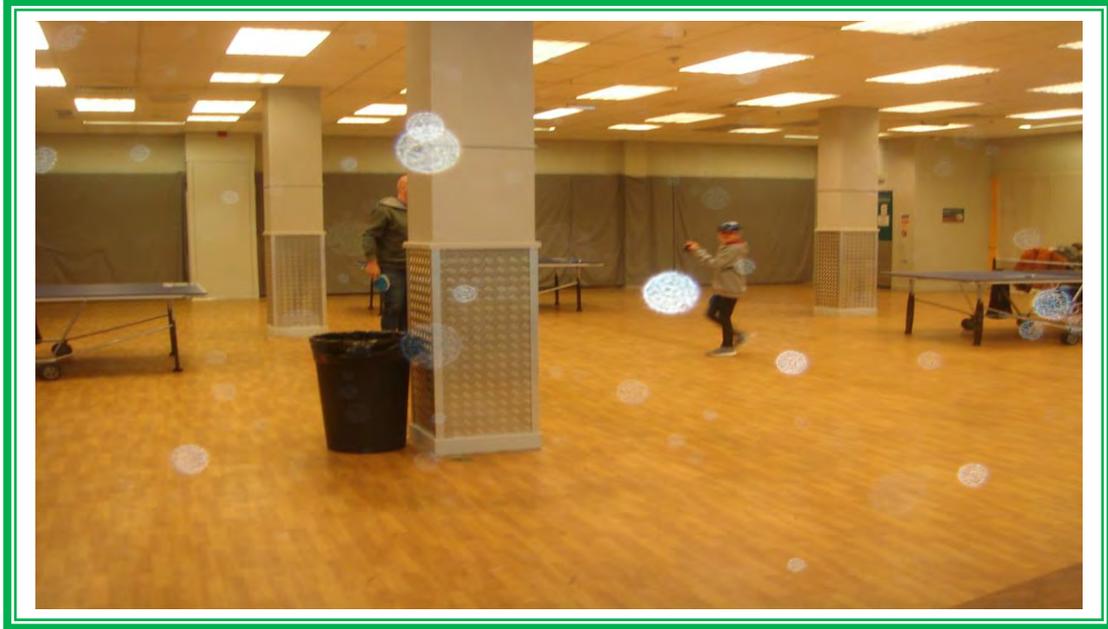
Location: 0/001 Shop Floor

Material Description:	Visual Inspection – No Suspect Materials Found	
Identification:	N/A	
Approx. quantity:	N/A	
Accessibility	N/A	Assessment Score
Product type:	N/A	N/A
Extent of Damage:	N/A	N/A
Surface Treatment:	N/A	N/A
Asbestos type:	N/A	N/A
Material Assessment Score:		N/A
Priority Assessment Score:		N/A
Action:	N/A	
Comments:	N/A

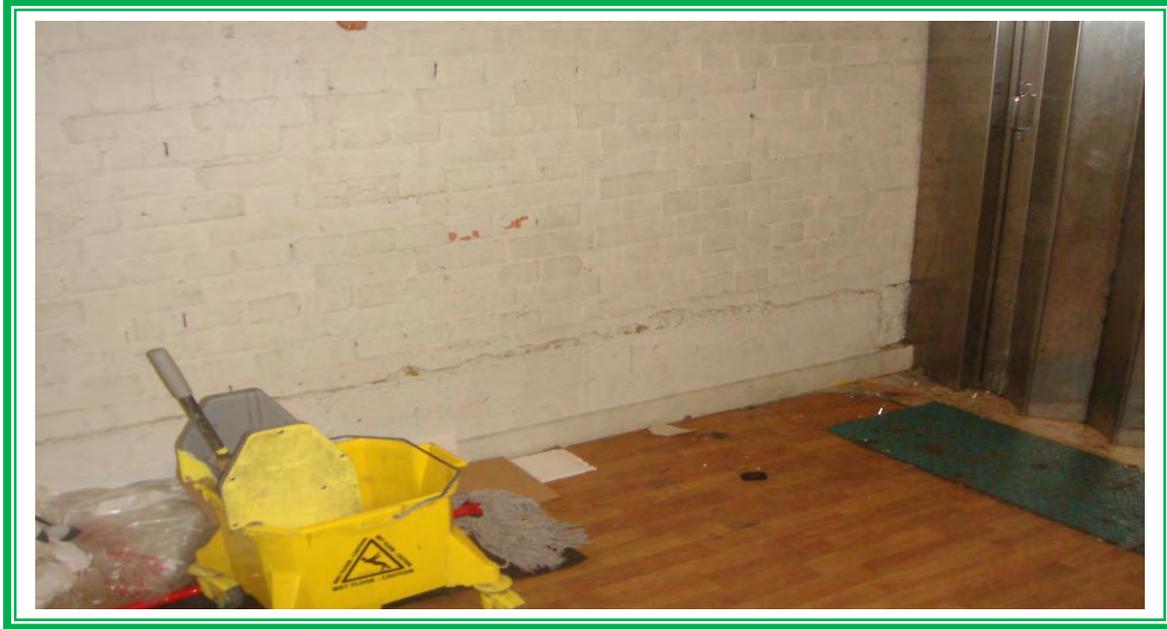
Location: 0/002 Lift Lobby

Material Description:	Visual Inspection – No Suspect Materials Found	
Identification:	N/A	
Approx. quantity:	N/A	
Accessibility	N/A	Assessment Score
Product type:	N/A	N/A
Extent of Damage:	N/A	N/A
Surface Treatment:	N/A	N/A
Asbestos type:	N/A	N/A
Material Assessment Score:		N/A
Priority Assessment Score:		N/A
Action:	N/A	
Comments:	N/A

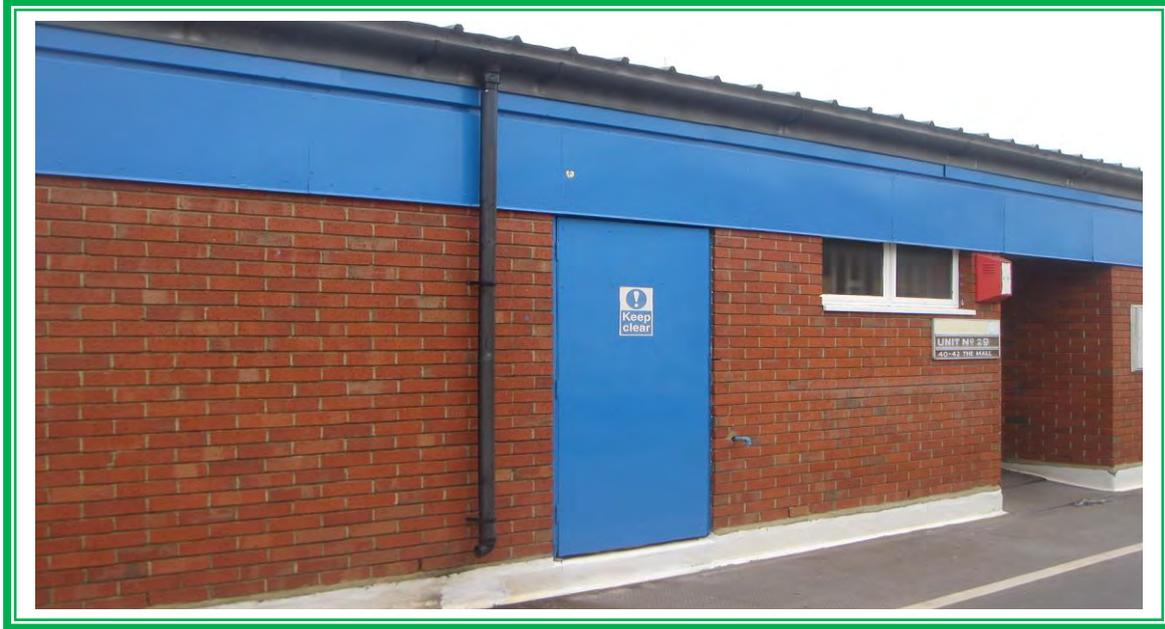
Location: 99/001

Material Description:	Visual Inspection – No Suspect Materials Found	
Identification:	N/A	
Approx. quantity:	N/A	
Accessibility	N/A	Assessment Score
Product type:	N/A	N/A
Extent of Damage:	N/A	N/A
Surface Treatment:	N/A	N/A
Asbestos type:	N/A	N/A
Material Assessment Score:		N/A
Priority Assessment Score:		N/A
Action:	N/A	
Comments:	N/A

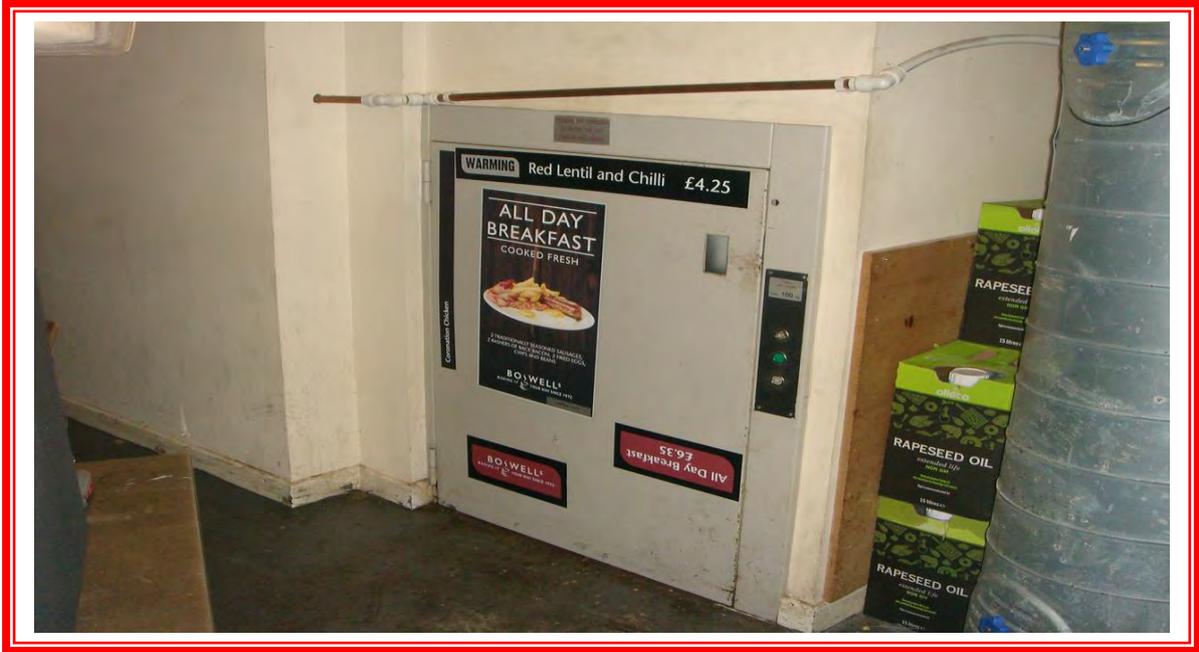
Item No: 4	Sample No: N/A
Location: 1/004 Lift and Shafts

Material Description:	No Access	
Identification:	Presumed to Contain Asbestos	
Approx. quantity:	Lift and Lift Shaft	
Accessibility	Low	<i>Assessment Score</i>
Product type:	No Access	3
Extent of Damage:	No Access	3
Surface Treatment:	No Access	3
Asbestos type:	No Access	3
Material Assessment Score:		12
Priority Assessment Score:		High
Action:	Further Inspection Required	
Comments:	Unable to gain access as no lift engineer was onsite

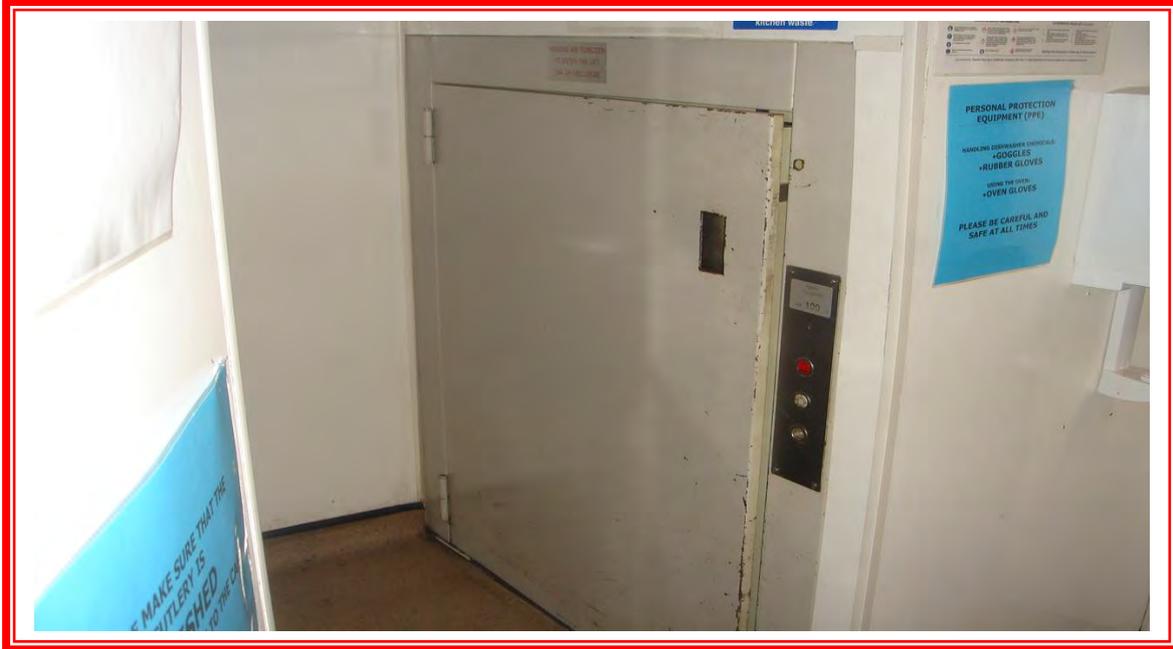
Location: 0/005 Lift and Shaft

Material Description:	No Access	
Identification:	Presumed to Contain Asbestos	
Approx. quantity:	Lift and Lift Shaft	
Accessibility	Low	Assessment Score
Product type:	No Access	3
Extent of Damage:	No Access	3
Surface Treatment:	No Access	3
Asbestos type:	No Access	3
Material Assessment Score:		12
Priority Assessment Score:		High
Action:	Further Inspection Required	
Comments:	Unable to gain access as no lift engineer was onsite

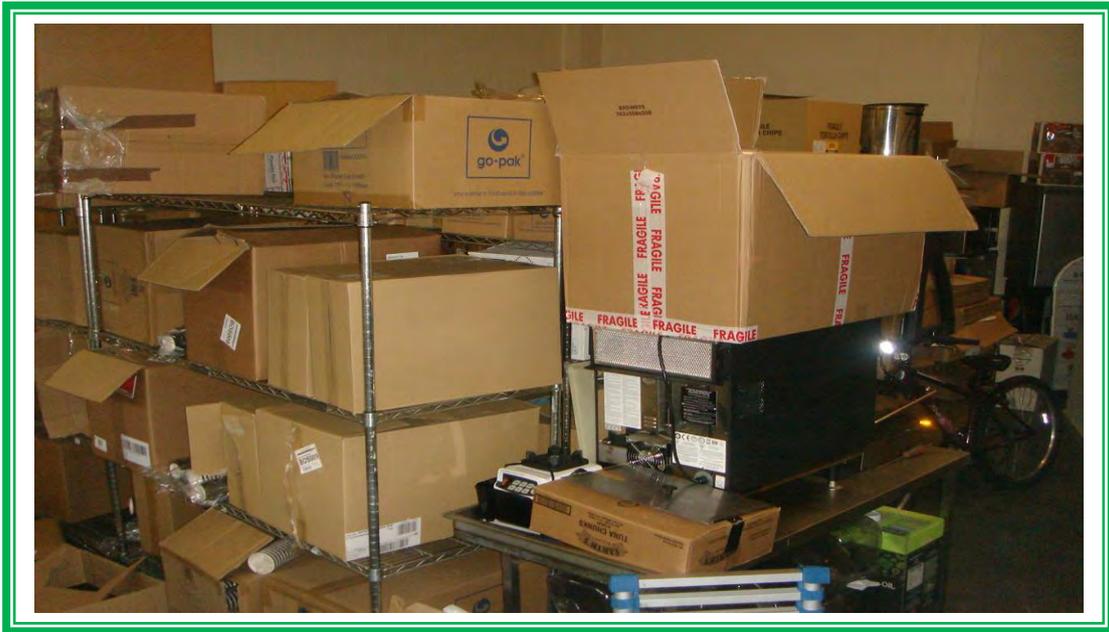
Item No: 1	Sample No: N/A
Location: 1/001 Store

Material Description:	Visual Inspection – No Suspect Materials Found	
Identification:	N/A	
Approx. quantity:	N/A	
Accessibility	N/A	Assessment Score
Product type:	N/A	N/A
Extent of Damage:	N/A	N/A
Surface Treatment:	N/A	N/A
Asbestos type:	N/A	N/A
Material Assessment Score:		N/A
Priority Assessment Score:		N/A
Action:	N/A	
Comments:	N/A

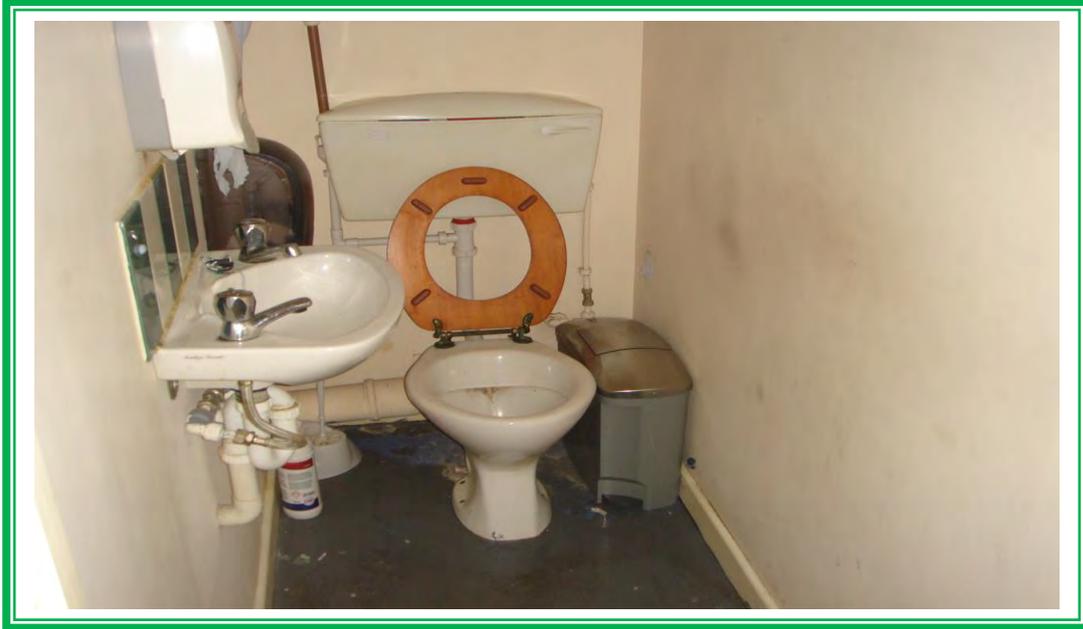
Location: 1/002 WC

Material Description:	Visual Inspection – No Suspect Materials Found	
Identification:	N/A	
Approx. quantity:	N/A	
Accessibility	N/A	Assessment Score
Product type:	N/A	N/A
Extent of Damage:	N/A	N/A
Surface Treatment:	N/A	N/A
Asbestos type:	N/A	N/A
Material Assessment Score:		N/A
Priority Assessment Score:		N/A
Action:	N/A	
Comments:	N/A

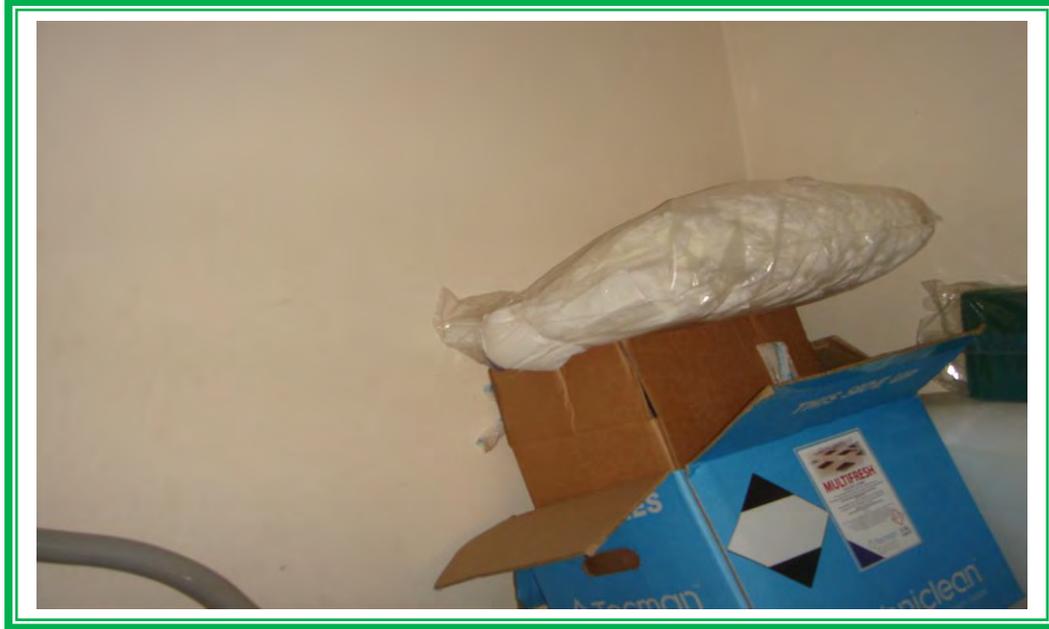
Location: 1/003

Material Description:	Visual Inspection – No Suspect Materials Found	
Identification:	N/A	
Approx. quantity:	N/A	
Accessibility	N/A	Assessment Score
Product type:	N/A	N/A
Extent of Damage:	N/A	N/A
Surface Treatment:	N/A	N/A
Asbestos type:	N/A	N/A
Material Assessment Score:		N/A
Priority Assessment Score:		N/A
Action:	N/A	
Comments:	N/A

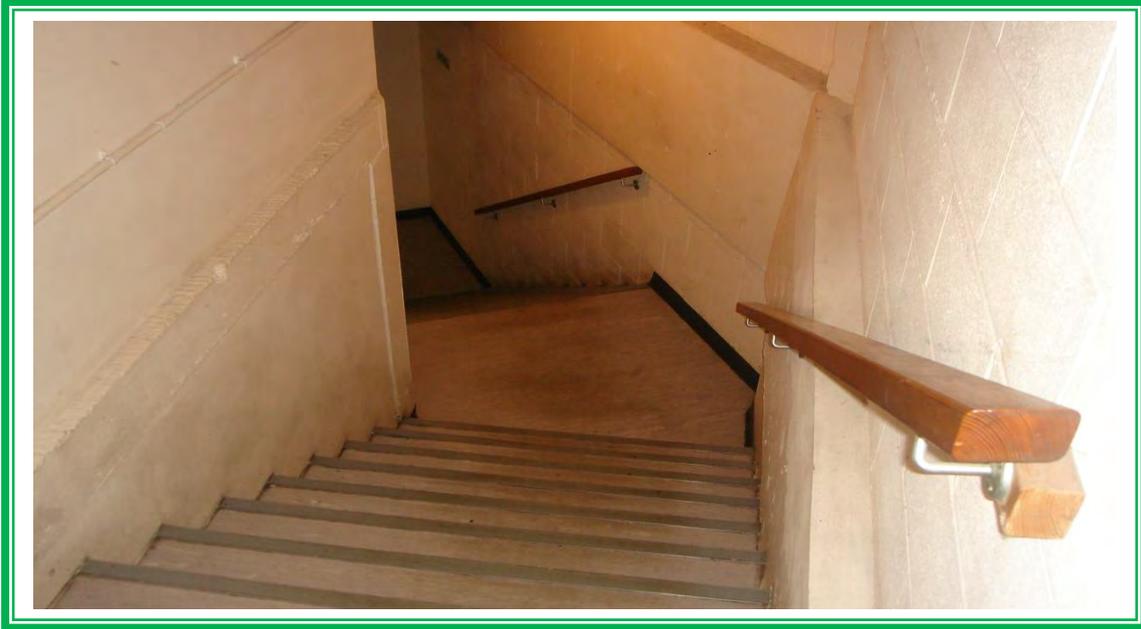
Location: 1/005 Stairs

Material Description:	Visual Inspection – No Suspect Materials Found	
Identification:	N/A	
Approx. quantity:	N/A	
Accessibility	N/A	Assessment Score
Product type:	N/A	N/A
Extent of Damage:	N/A	N/A
Surface Treatment:	N/A	N/A
Asbestos type:	N/A	N/A
Material Assessment Score:		N/A
Priority Assessment Score:		N/A
Action:	N/A	
Comments:	N/A

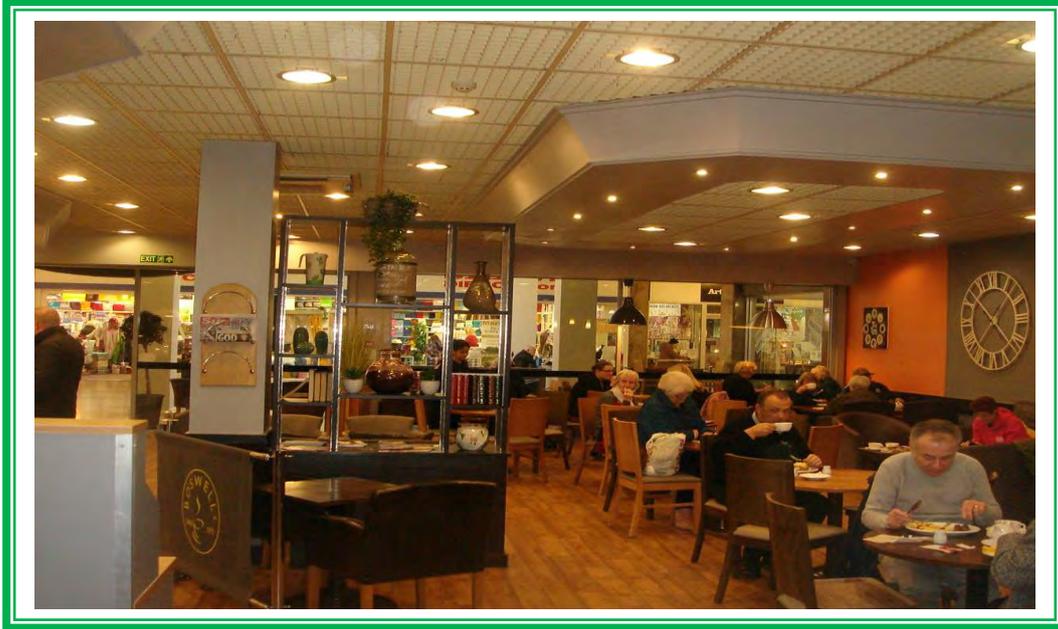
Location: 0/001 Café and Servery

Material Description:	Visual Inspection – No Suspect Materials Found	
Identification:	N/A	
Approx. quantity:	N/A	
Accessibility	N/A	Assessment Score
Product type:	N/A	N/A
Extent of Damage:	N/A	N/A
Surface Treatment:	N/A	N/A
Asbestos type:	N/A	N/A
Material Assessment Score:		N/A
Priority Assessment Score:		N/A
Action:	N/A	
Comments:	N/A

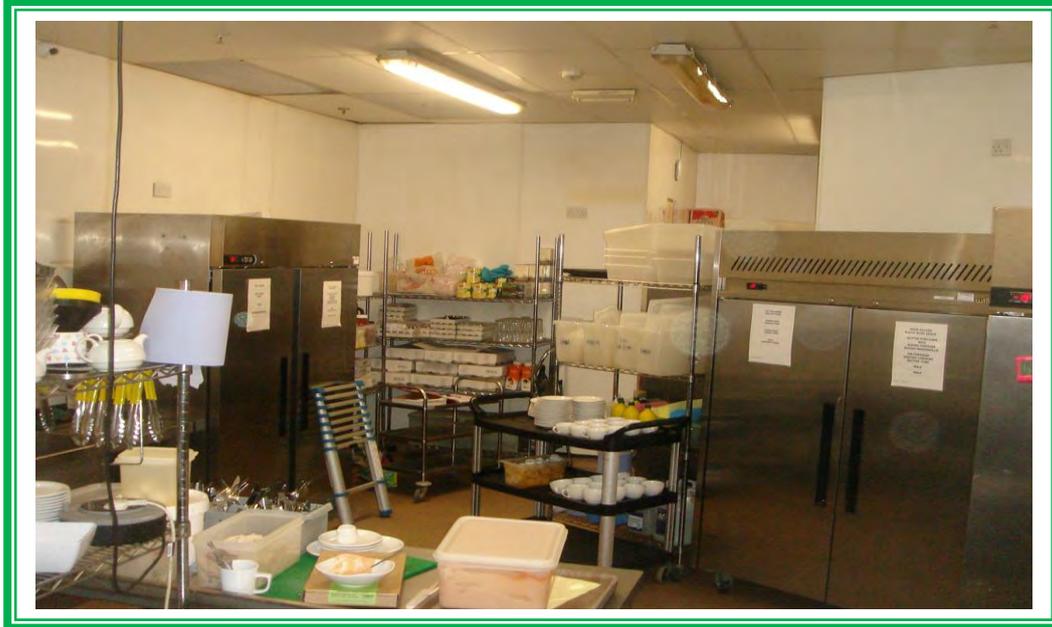
Location: 0/002 Kitchen

Material Description:	Visual Inspection – No Suspect Materials Found	
Identification:	N/A	
Approx. quantity:	N/A	
Accessibility	N/A	Assessment Score
Product type:	N/A	N/A
Extent of Damage:	N/A	N/A
Surface Treatment:	N/A	N/A
Asbestos type:	N/A	N/A
Material Assessment Score:		N/A
Priority Assessment Score:		N/A
Action:	N/A	
Comments:	N/A
