Section 6: Survey Objectives

Instructions were received from James Croucher of Lochailort Newbury Ltd to carry out a Management asbestos survey at Kennet Centre, Market Street, Newbury, Berkshire, RG14 5EN in accordance with HSG264 and Armour Analytical's quality procedures.

The survey was carried out on 22nd – 25th October 2019 by Neale Evans with the objective of facilitating a Management report.

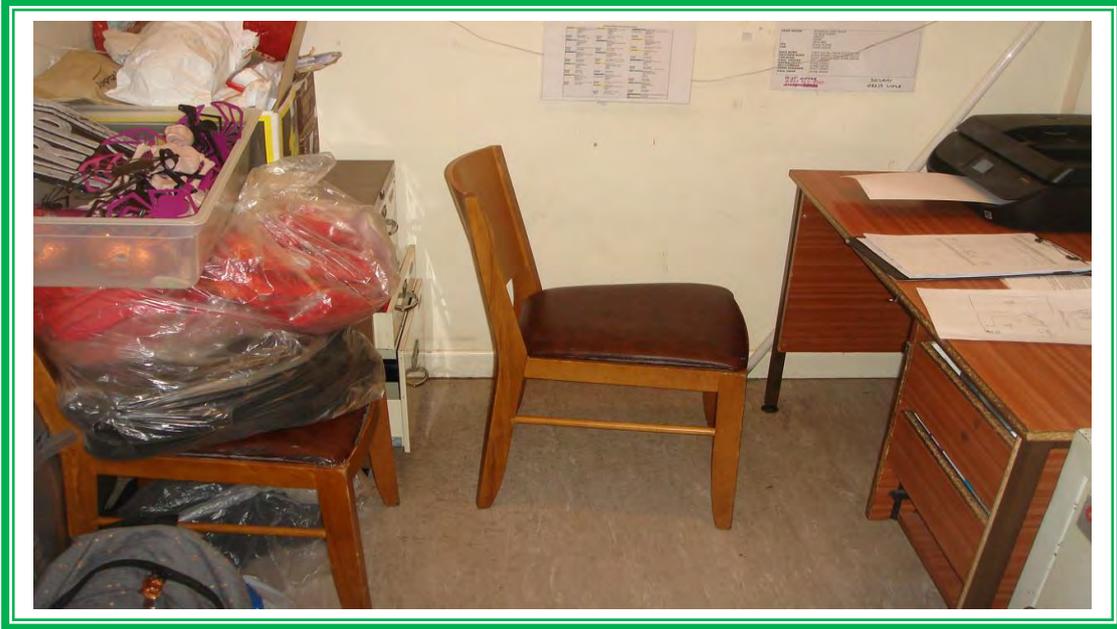
Location: 0/003 Office

Material Description:	Visual Inspection – No Suspect Materials Found	
Identification:	N/A	
Approx. quantity:	N/A	
Accessibility	N/A	Assessment Score
Product type:	N/A	N/A
Extent of Damage:	N/A	N/A
Surface Treatment:	N/A	N/A
Asbestos type:	N/A	N/A
Material Assessment Score:		N/A
Priority Assessment Score:		N/A
Action:	N/A	
Comments:	N/A

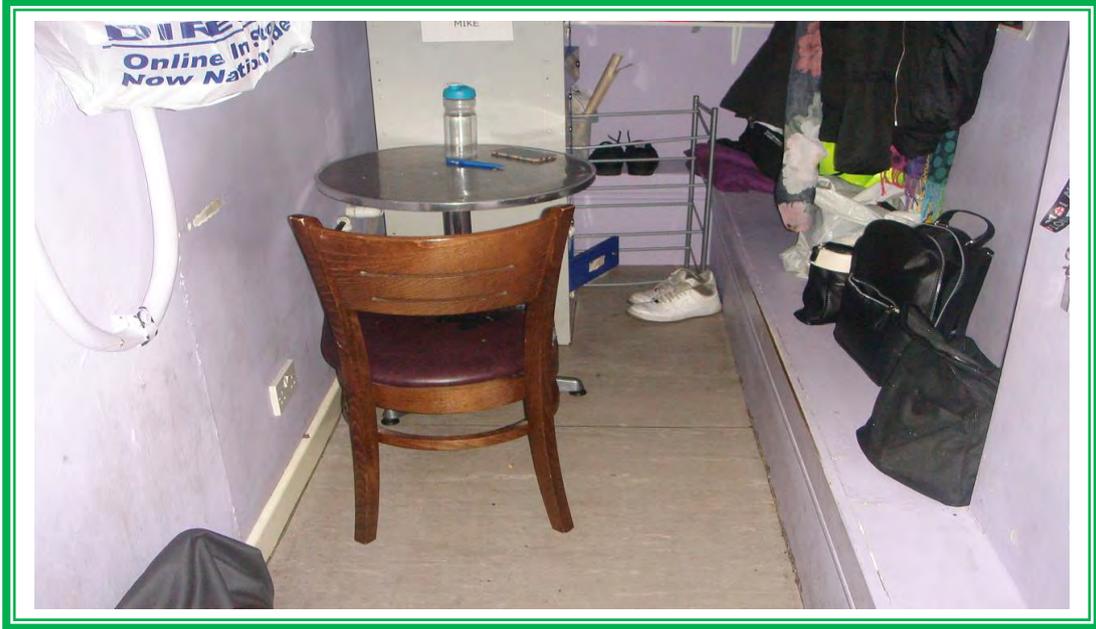
Location: 0/004 Cupboard

Material Description:	Visual Inspection – No Suspect Materials Found	
Identification:	N/A	
Approx. quantity:	N/A	
Accessibility	N/A	Assessment Score
Product type:	N/A	N/A
Extent of Damage:	N/A	N/A
Surface Treatment:	N/A	N/A
Asbestos type:	N/A	N/A
Material Assessment Score:		N/A
Priority Assessment Score:		N/A
Action:	N/A	
Comments:	N/A

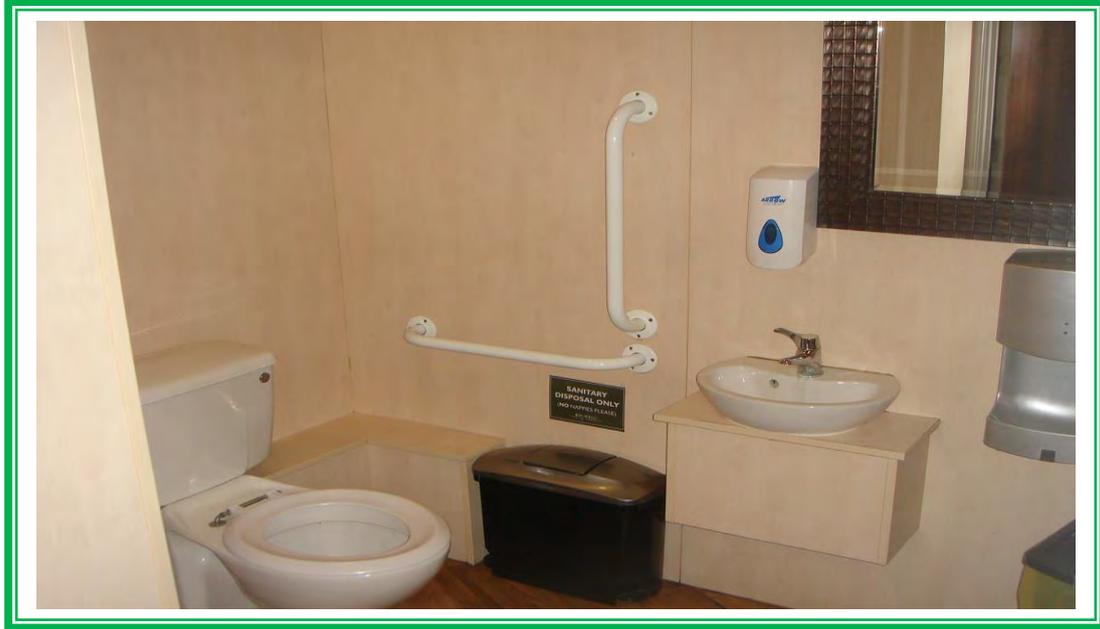
Location: 0/006 WC

Material Description:	Visual Inspection – No Suspect Materials Found	
Identification:	N/A	
Approx. quantity:	N/A	
Accessibility	N/A	Assessment Score
Product type:	N/A	N/A
Extent of Damage:	N/A	N/A
Surface Treatment:	N/A	N/A
Asbestos type:	N/A	N/A
Material Assessment Score:		N/A
Priority Assessment Score:		N/A
Action:	N/A	
Comments:	N/A

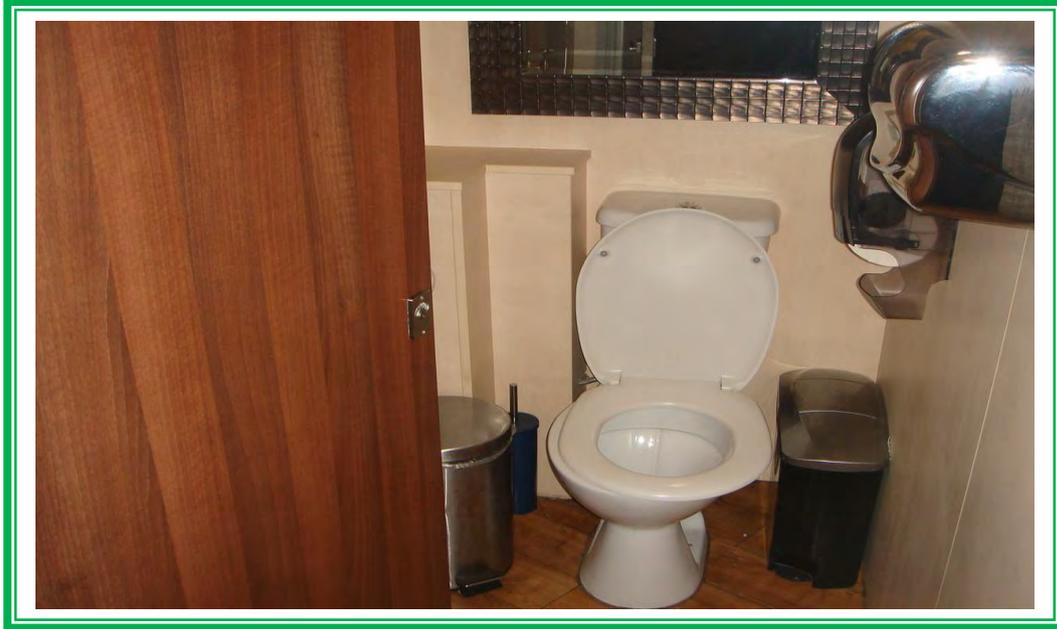
Location: 0/007 WC

Material Description:	Visual Inspection – No Suspect Materials Found	
Identification:	N/A	
Approx. quantity:	N/A	
Accessibility	N/A	Assessment Score
Product type:	N/A	N/A
Extent of Damage:	N/A	N/A
Surface Treatment:	N/A	N/A
Asbestos type:	N/A	N/A
Material Assessment Score:		N/A
Priority Assessment Score:		N/A
Action:	N/A	
Comments:	N/A

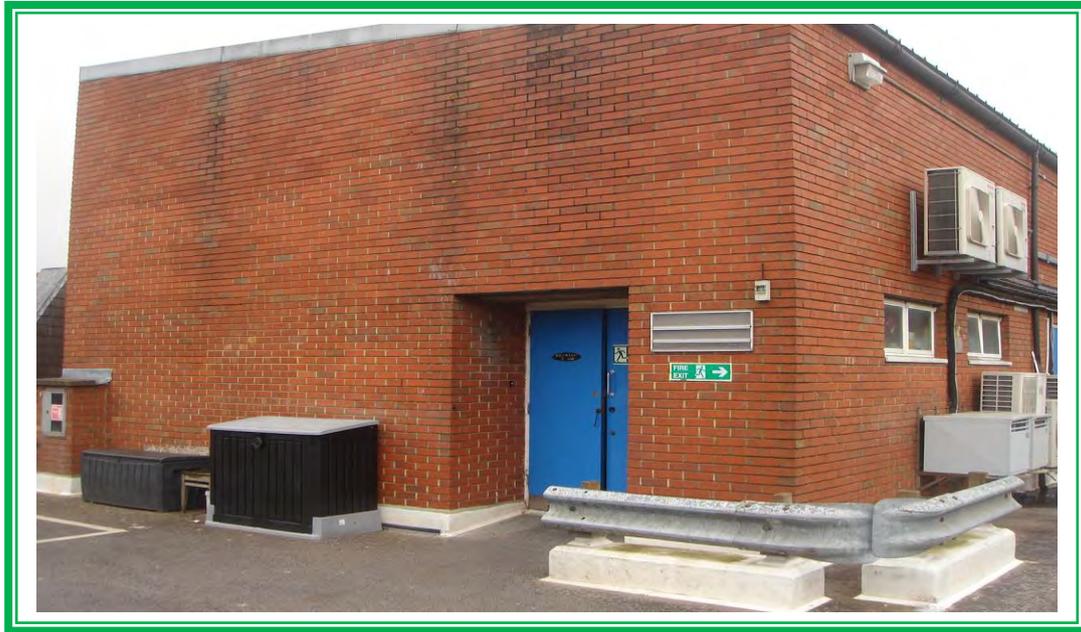
Location: 99/001 External

Material Description:	Visual Inspection – No Suspect Materials Found	
Identification:	N/A	
Approx. quantity:	N/A	
Accessibility	N/A	Assessment Score
Product type:	N/A	N/A
Extent of Damage:	N/A	N/A
Surface Treatment:	N/A	N/A
Asbestos type:	N/A	N/A
Material Assessment Score:		N/A
Priority Assessment Score:		N/A
Action:	N/A	
Comments:	N/A

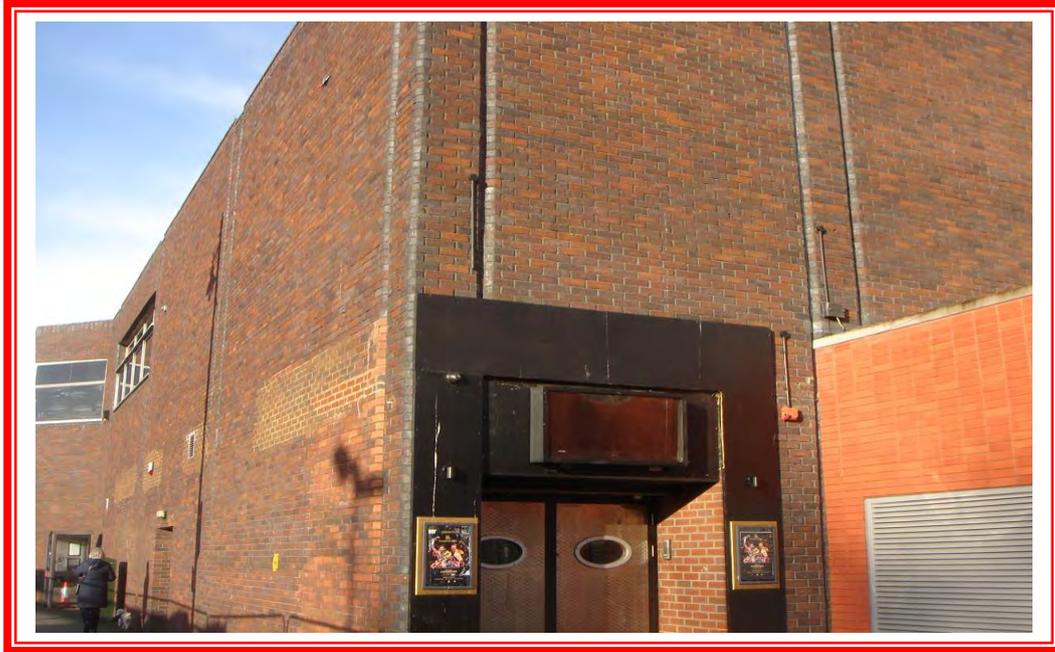
Location: 4A The Mall

Material Description:	No Access	
Identification:	Presumed to Contain Asbestos	
Approx. quantity:	Unknown	
Accessibility	Low	Assessment Score
Product type:	No Access	3
Extent of Damage:	No Access	3
Surface Treatment:	No Access	3
Asbestos type:	No Access	3
Material Assessment Score:		12
Priority Assessment Score:		High
Action:	Further Inspection Required	
Comments:	No Access as still in lease but vacant – No Keys (The Vacant Nightclub)

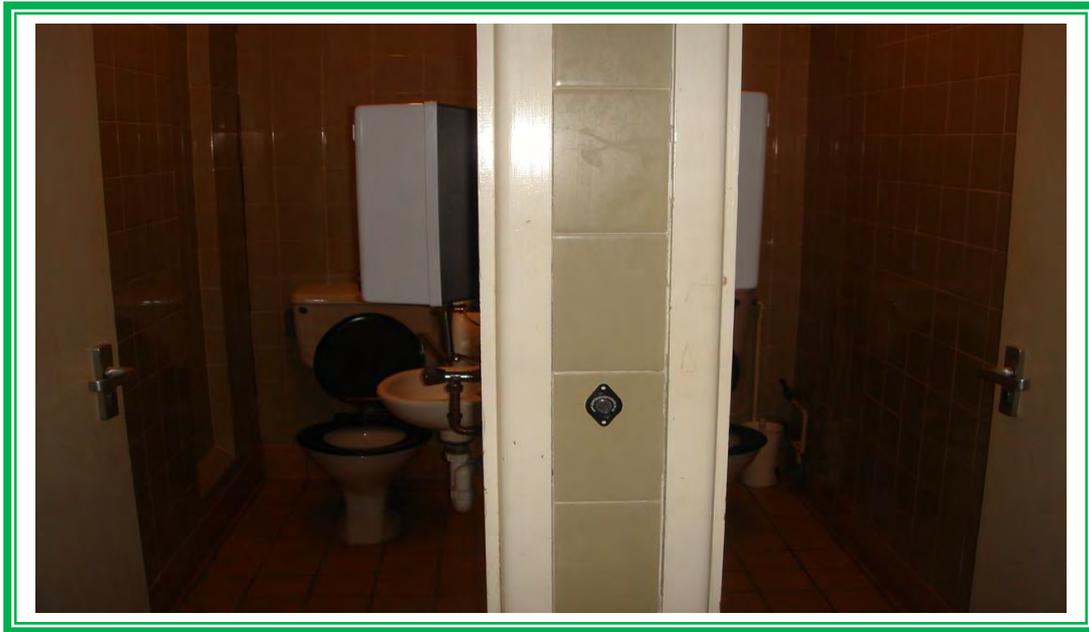
Location: 0/001 WC

Material Description:	Visual Inspection – No Suspect Materials Found	
Identification:	N/A	
Approx. quantity:	N/A	
Accessibility	N/A	Assessment Score
Product type:	N/A	N/A
Extent of Damage:	N/A	N/A
Surface Treatment:	N/A	N/A
Asbestos type:	N/A	N/A
Material Assessment Score:		N/A
Priority Assessment Score:		N/A
Action:	N/A	
Comments:	N/A

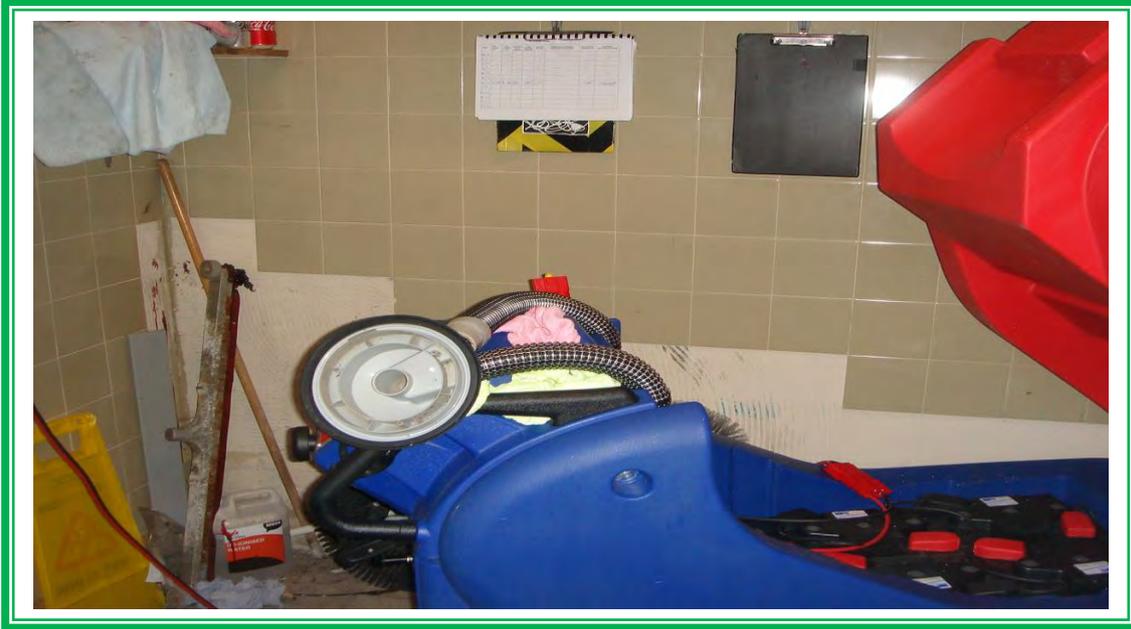
Location: 0/002 Store

Material Description:	Visual Inspection – No Suspect Materials Found	
Identification:	N/A	
Approx. quantity:	N/A	
Accessibility	N/A	Assessment Score
Product type:	N/A	N/A
Extent of Damage:	N/A	N/A
Surface Treatment:	N/A	N/A
Asbestos type:	N/A	N/A
Material Assessment Score:		N/A
Priority Assessment Score:		N/A
Action:	N/A	
Comments:	N/A

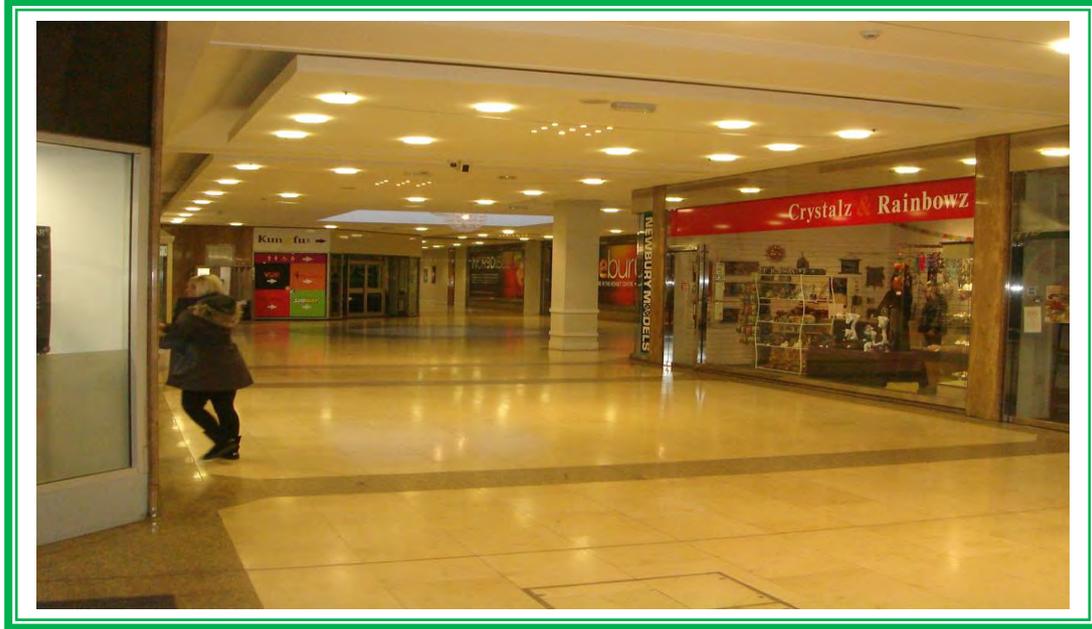
Location: 0/003 The Mall

Material Description:	Visual Inspection – No Suspect Materials Found	
Identification:	N/A	
Approx. quantity:	N/A	
Accessibility	N/A	Assessment Score
Product type:	N/A	N/A
Extent of Damage:	N/A	N/A
Surface Treatment:	N/A	N/A
Asbestos type:	N/A	N/A
Material Assessment Score:		N/A
Priority Assessment Score:		N/A
Action:	N/A	
Comments:	N/A

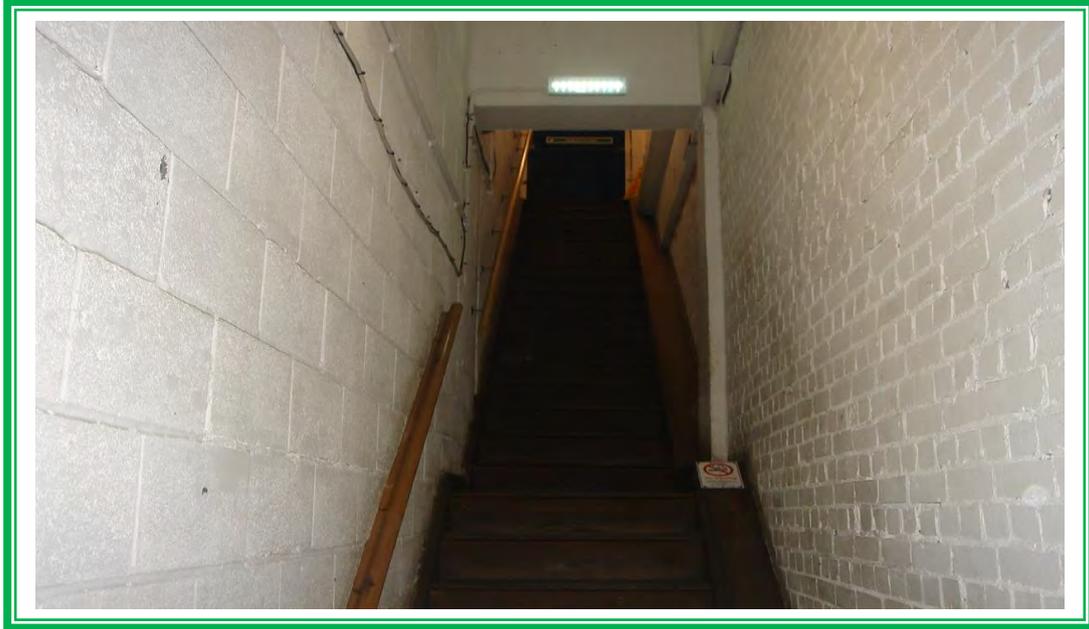
Location: 0/004 Corridor and Stairs

Material Description:	Visual Inspection – No Suspect Materials Found	
Identification:	N/A	
Approx. quantity:	N/A	
Accessibility	N/A	Assessment Score
Product type:	N/A	N/A
Extent of Damage:	N/A	N/A
Surface Treatment:	N/A	N/A
Asbestos type:	N/A	N/A
Material Assessment Score:		N/A
Priority Assessment Score:		N/A
Action:	N/A	
Comments:	N/A

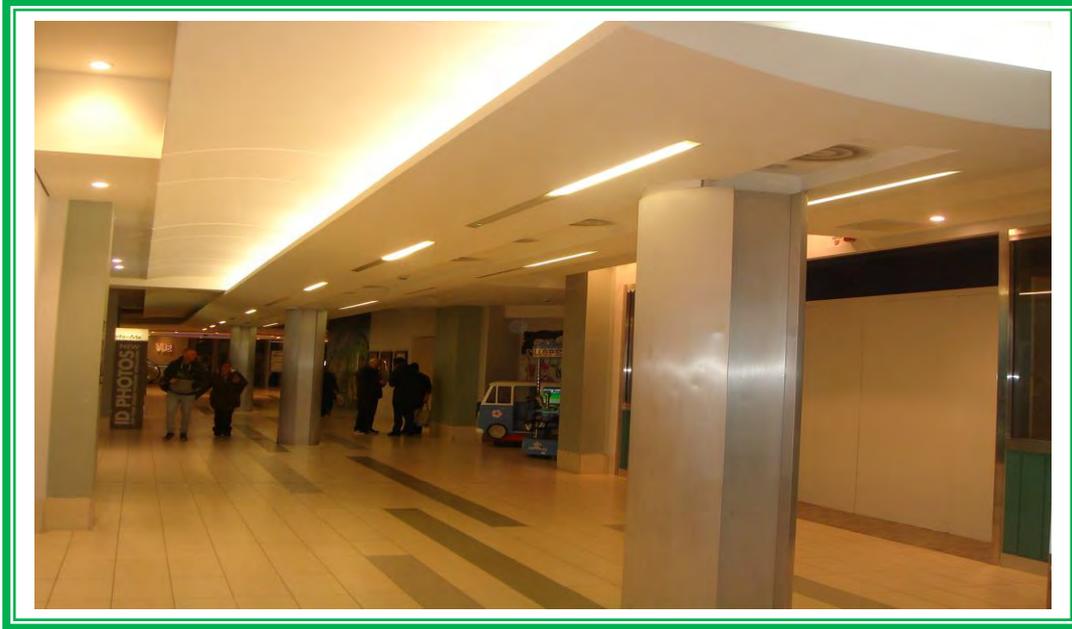
Location: Vue Cinema Area

Material Description:	Visual Inspection – No Suspect Materials Found	
Identification:	N/A	
Approx. quantity:	N/A	
Accessibility	N/A	Assessment Score
Product type:	N/A	N/A
Extent of Damage:	N/A	N/A
Surface Treatment:	N/A	N/A
Asbestos type:	N/A	N/A
Material Assessment Score:		N/A
Priority Assessment Score:		N/A
Action:	N/A	
Comments:	Built in 2009
