# EAGLE QUARTER II NEWBURY

ASBESTOS SURVEY

Management  
Asbestos Survey Report

Kennet Centre, Market Street, Newbury,  
Berkshire, RG14 5EN

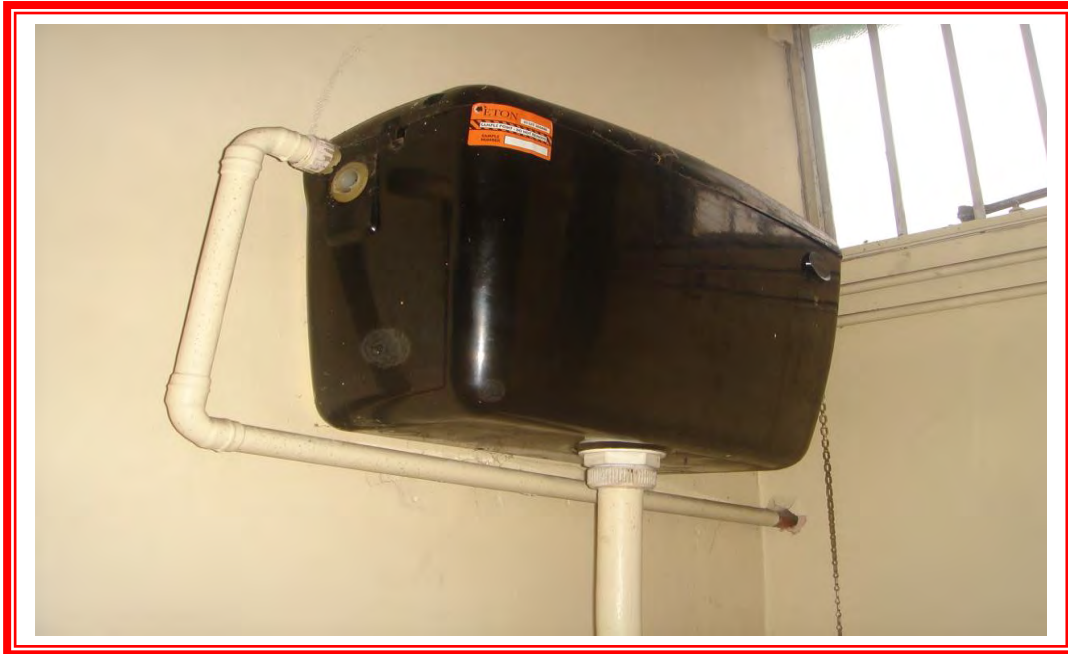
Location: 1/005 WC

Material Description:	Toilet Cistern	
Identification:	As Per Sample NE/3 - Asbestos Detected	
Approx. quantity:	1 X Item	
Accessibility	Low	Assessment Score
Product type:	Composite	1
Extent of Damage:	Good	0
Surface Treatment:	Non-Friable	0
Asbestos type:	Amosite	2
Material Assessment Score:		3
Priority Assessment Score:		Negligible
Action:	Manage	
Comments:	N/A

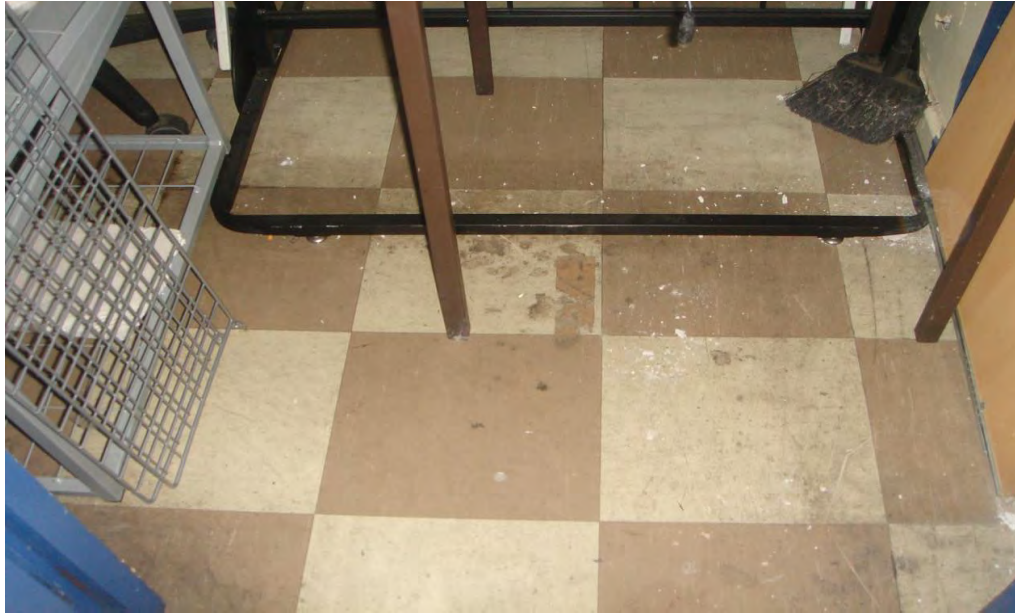
Location: 1/007

Material Description:	Vinyl Floor Tiles	
Identification:	As Per Sample NE/1 - Asbestos Detected	
Approx. quantity:	6M2	
Accessibility	Low	Assessment Score
Product type:	Vinyl	1
Extent of Damage:	Minor	1
Surface Treatment:	Non-Friable	0
Asbestos type:	Chrysotile	1
Material Assessment Score:		3
Priority Assessment Score:		Negligible
Action:	Manage	
Comments:	N/A

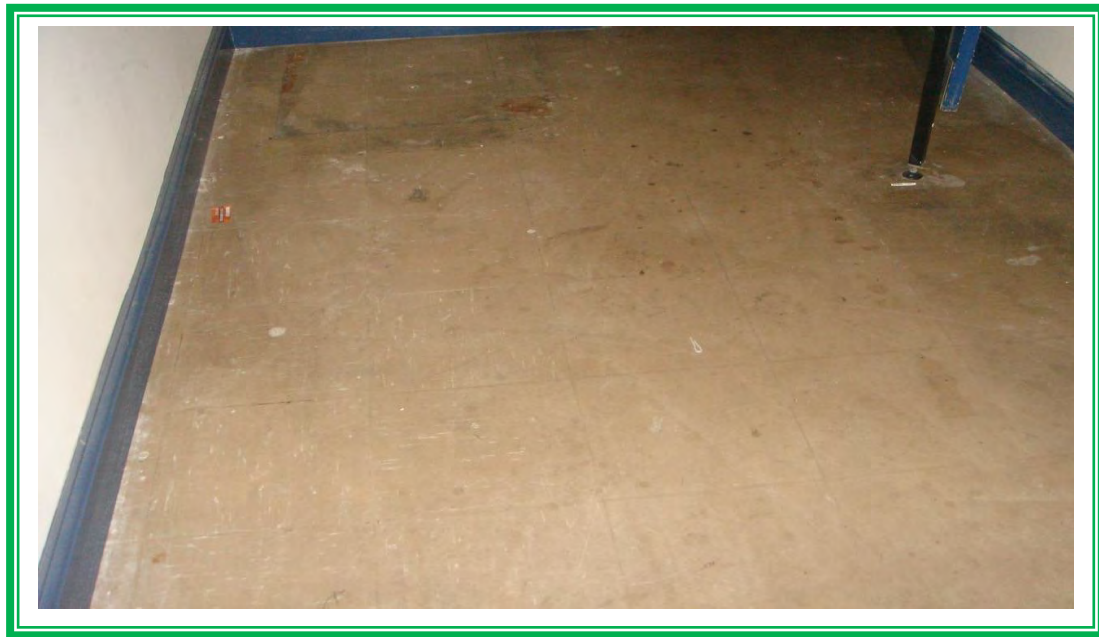
Item No: 2	Sample No: NE/2
Location: 1/002

Material Description:	Vinyl Floor Tiles	
Identification:	Sampled – No Asbestos Detected	
Approx. quantity:	4M2	
Accessibility	N/A	Assessment Score
Product type:	N/A	N/A
Extent of Damage:	N/A	N/A
Surface Treatment:	N/A	N/A
Asbestos type:	N/A	N/A
Material Assessment Score:		N/A
Priority Assessment Score:		N/A
Action:	N/A	
Comments:	N/A

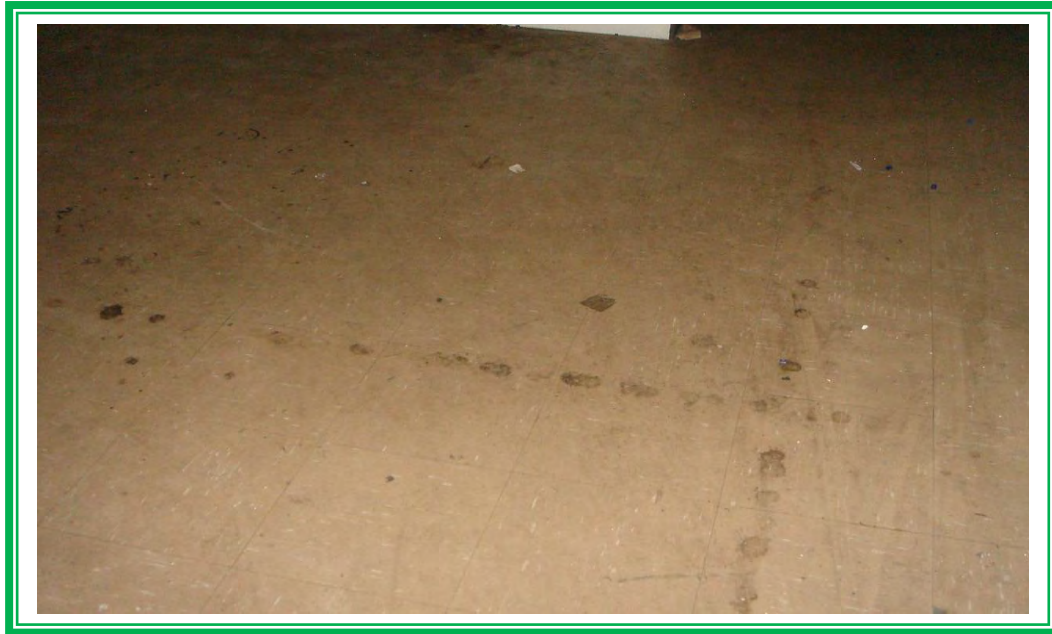
Location: 1/003 Lobby

Material Description:	Vinyl Floor Tiles	
Identification:	As Per Sample NE/2 – No Asbestos Detected	
Approx. quantity:	25M2	
Accessibility	N/A	Assessment Score
Product type:	N/A	N/A
Extent of Damage:	N/A	N/A
Surface Treatment:	N/A	N/A
Asbestos type:	N/A	N/A
Material Assessment Score:		N/A
Priority Assessment Score:		N/A
Action:	N/A	
Comments:	N/A

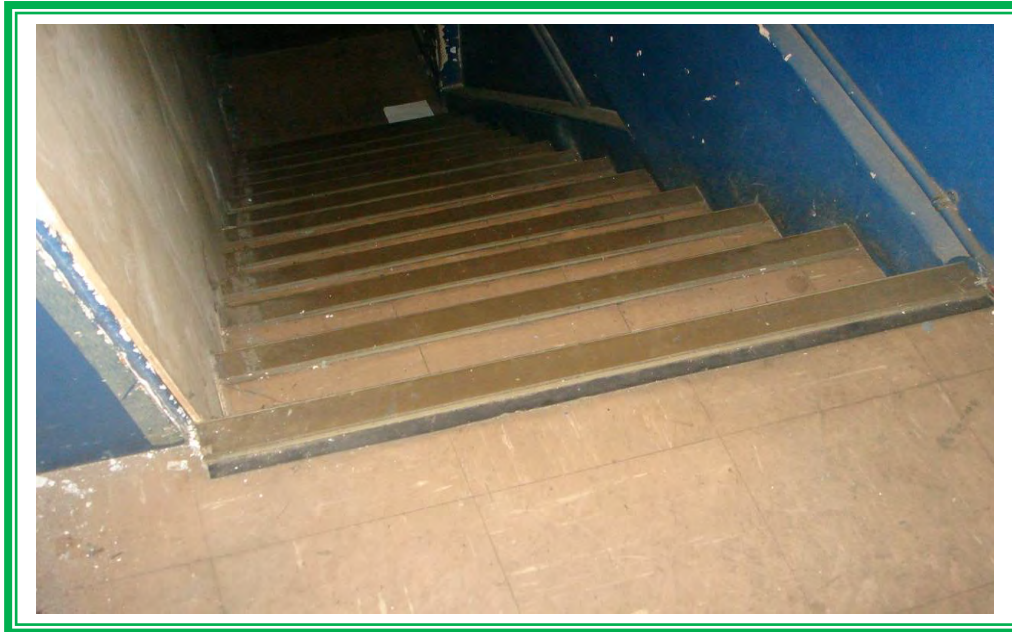
Location: 1/006 Stairs

Material Description:	Vinyl Floor Tiles	
Identification:	As Per Sample NE/2 – No Asbestos Detected	
Approx. quantity:	30M2	
Accessibility	N/A	Assessment Score
Product type:	N/A	N/A
Extent of Damage:	N/A	N/A
Surface Treatment:	N/A	N/A
Asbestos type:	N/A	N/A
Material Assessment Score:		N/A
Priority Assessment Score:		N/A
Action:	N/A	
Comments:	N/A

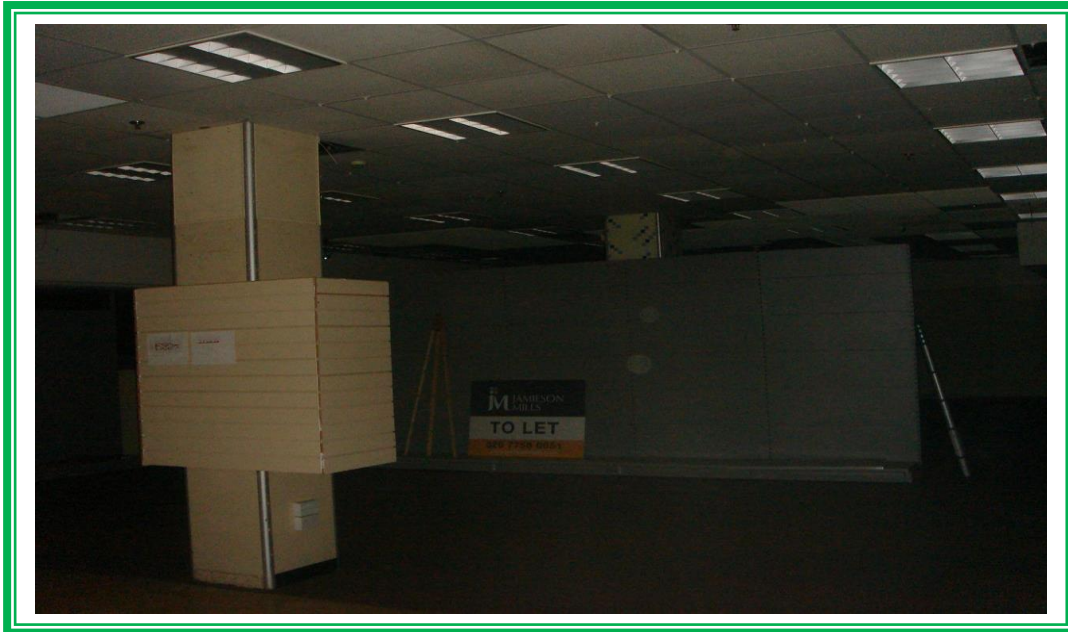
Location: 0/001 Shop Floor

Material Description:	Visual Inspection – No Suspect Materials Found	
Identification:	N/A	
Approx. quantity:	N/A	
Accessibility	N/A	Assessment Score
Product type:	N/A	N/A
Extent of Damage:	N/A	N/A
Surface Treatment:	N/A	N/A
Asbestos type:	N/A	N/A
Material Assessment Score:		N/A
Priority Assessment Score:		N/A
Action:	N/A	
Comments:	N/A

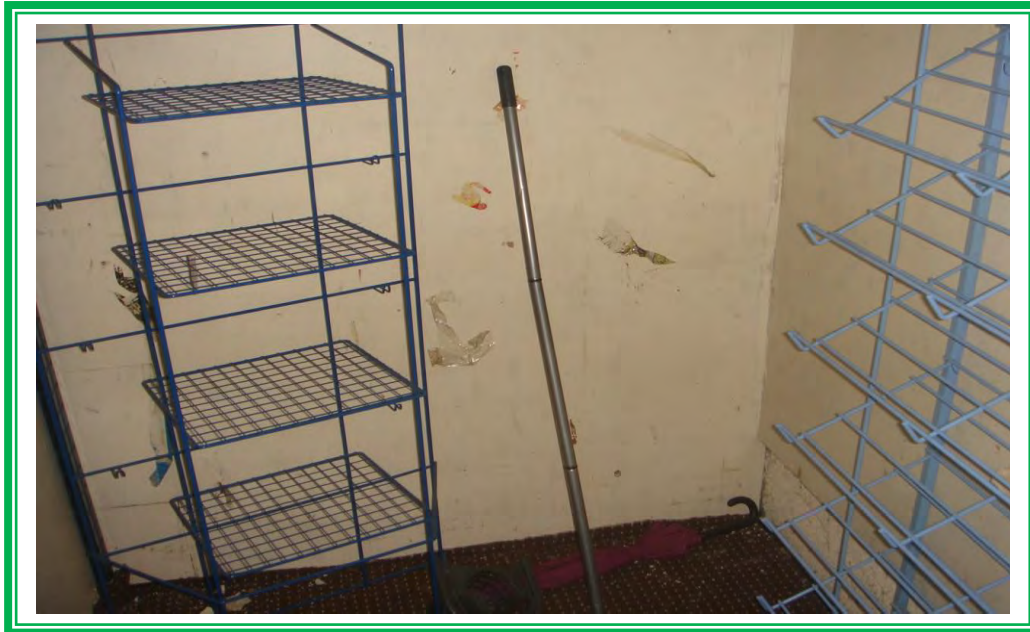
Location: 0/002 Cupboard

Material Description:	Visual Inspection – No Suspect Materials Found	
Identification:	N/A	
Approx. quantity:	N/A	
Accessibility	N/A	Assessment Score
Product type:	N/A	N/A
Extent of Damage:	N/A	N/A
Surface Treatment:	N/A	N/A
Asbestos type:	N/A	N/A
Material Assessment Score:		N/A
Priority Assessment Score:		N/A
Action:	N/A	
Comments:	N/A

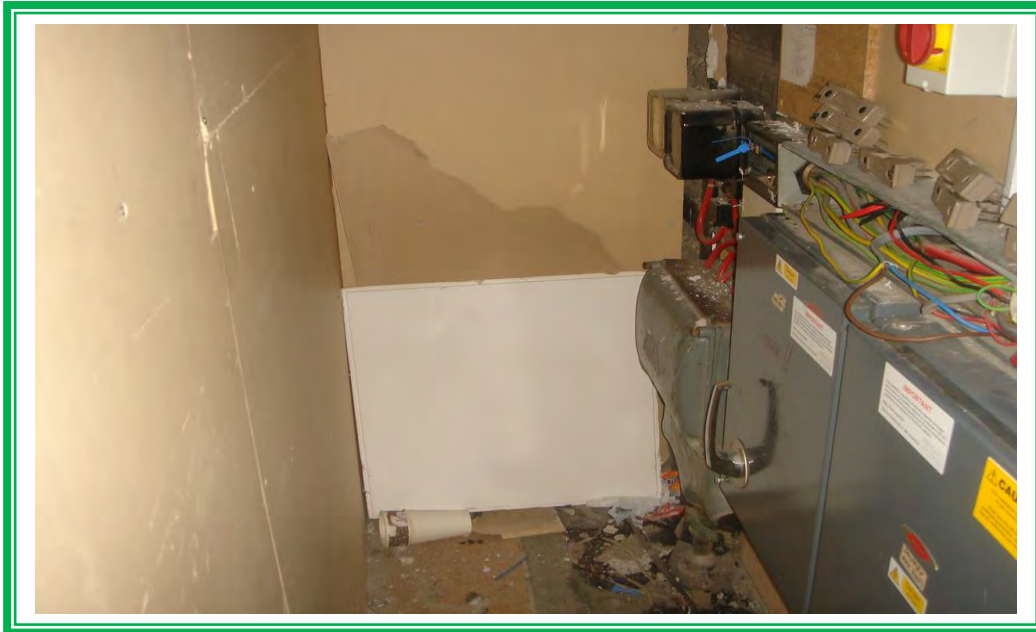
Location: 0/003 Electrics Cupboard

Material Description:	Visual Inspection – No Suspect Materials Found	
Identification:	N/A	
Approx. quantity:	N/A	
Accessibility	N/A	Assessment Score
Product type:	N/A	N/A
Extent of Damage:	N/A	N/A
Surface Treatment:	N/A	N/A
Asbestos type:	N/A	N/A
Material Assessment Score:		N/A
Priority Assessment Score:		N/A
Action:	N/A	
Comments:	N/A

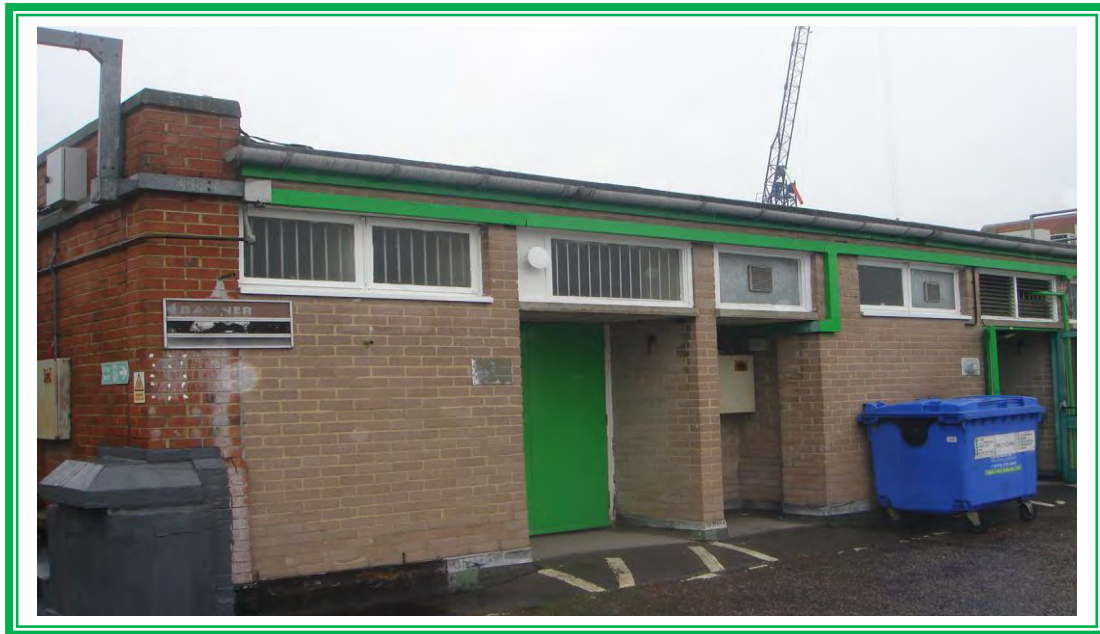
Location: 99/001 External

Material Description:	Visual Inspection – No Suspect Materials Found	
Identification:	N/A	
Approx. quantity:	N/A	
Accessibility	N/A	Assessment Score
Product type:	N/A	N/A
Extent of Damage:	N/A	N/A
Surface Treatment:	N/A	N/A
Asbestos type:	N/A	N/A
Material Assessment Score:		N/A
Priority Assessment Score:		N/A
Action:	N/A	
Comments:	N/A

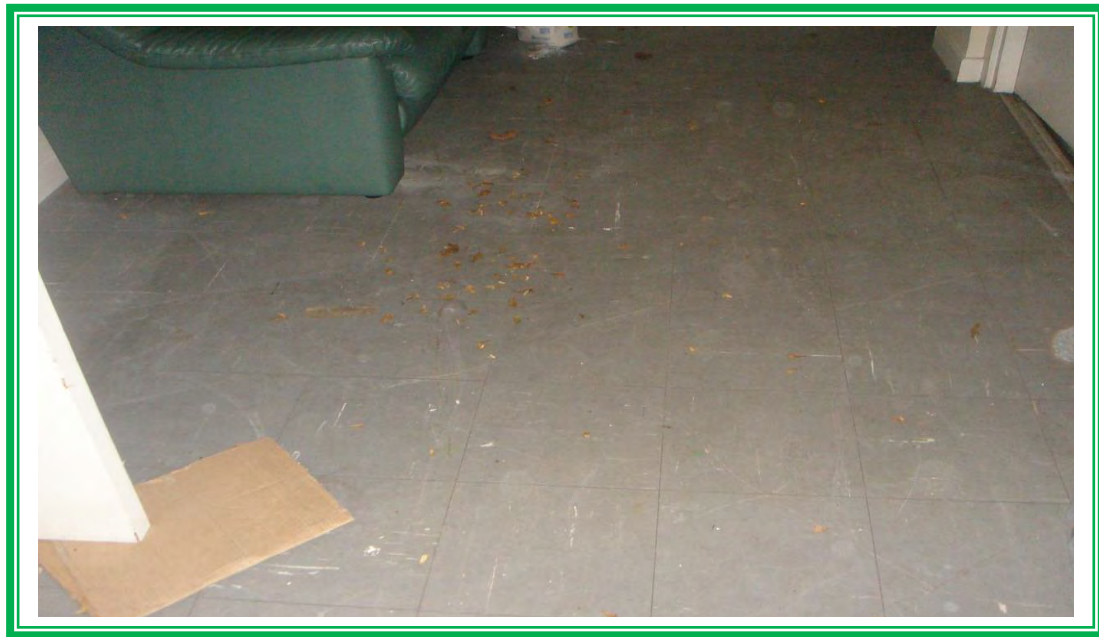
Item No: 1	Sample No: NE/1
Location: 1/001 Kitchen

Material Description:	Vinyl Floor Tiles	
Identification:	Sampled – No Asbestos Detected	
Approx. quantity:	15M2	
Accessibility	N/A	Assessment Score
Product type:	N/A	N/A
Extent of Damage:	N/A	N/A
Surface Treatment:	N/A	N/A
Asbestos type:	N/A	N/A
Material Assessment Score:		N/A
Priority Assessment Score:		N/A
Action:	N/A	
Comments:	N/A

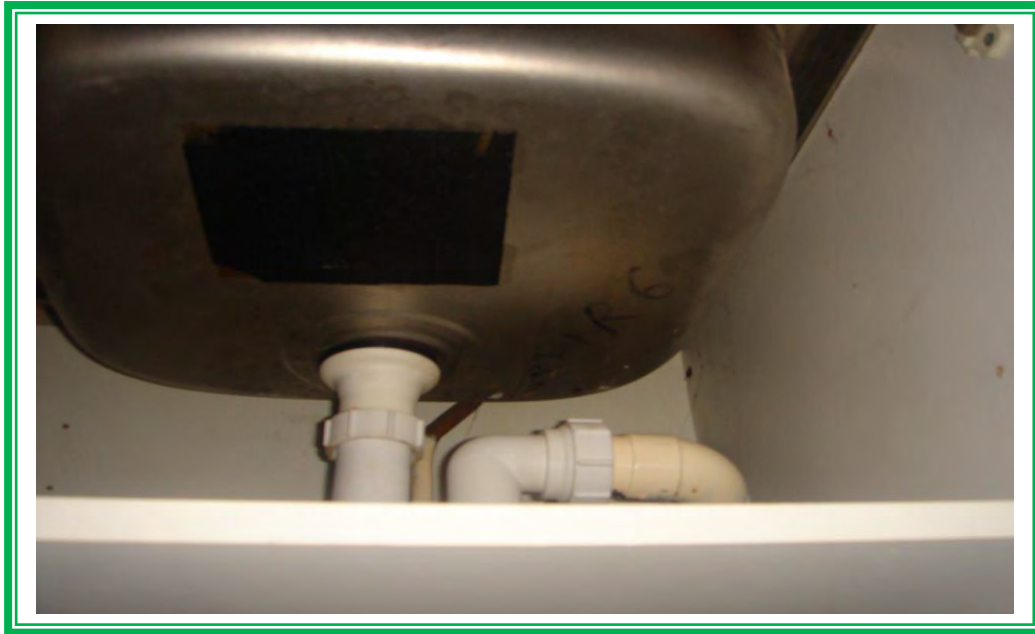
Location: 1/001 Kitchen

Material Description:	Sink Pads	
Identification:	Sampled- No Asbestos Detected	
Approx. quantity:	2 X Items	
Accessibility	N/A	Assessment Score
Product type:	N/A	N/A
Extent of Damage:	N/A	N/A
Surface Treatment:	N/A	N/A
Asbestos type:	N/A	N/A
Material Assessment Score:		N/A
Priority Assessment Score:		N/A
Action:	N/A	
Comments:	N/A

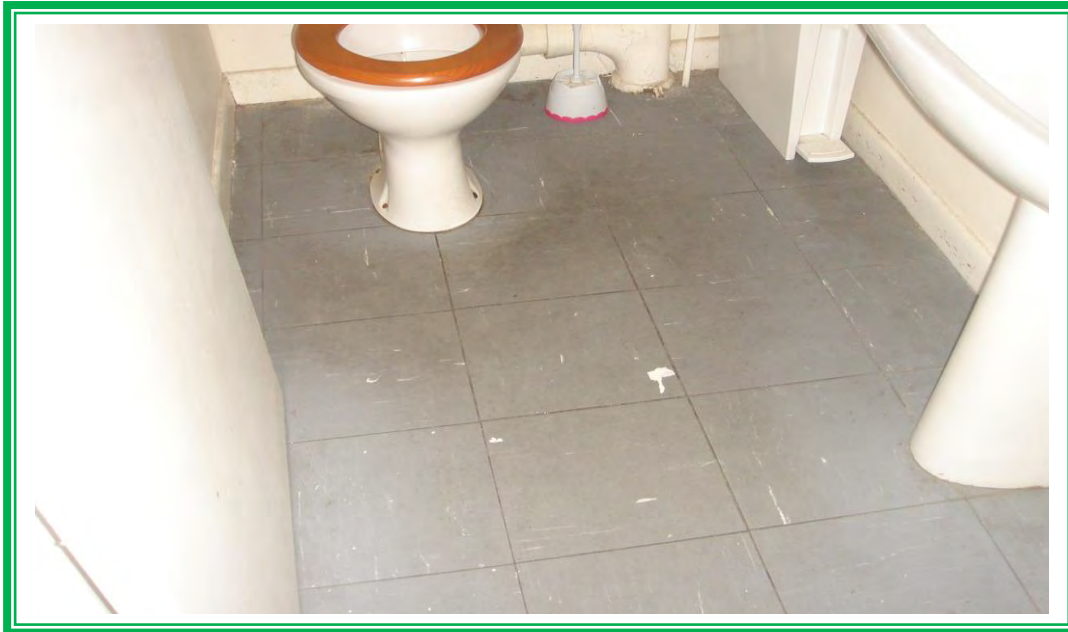
Location: 1/002 WC

Material Description:	Vinyl Floor Tiles	
Identification:	As Per Sample NE/1- No Asbestos Detected	
Approx. quantity:	4M2	
Accessibility	N/A	Assessment Score
Product type:	N/A	N/A
Extent of Damage:	N/A	N/A
Surface Treatment:	N/A	N/A
Asbestos type:	N/A	N/A
Material Assessment Score:		N/A
Priority Assessment Score:		N/A
Action:	N/A	
Comments:	N/A

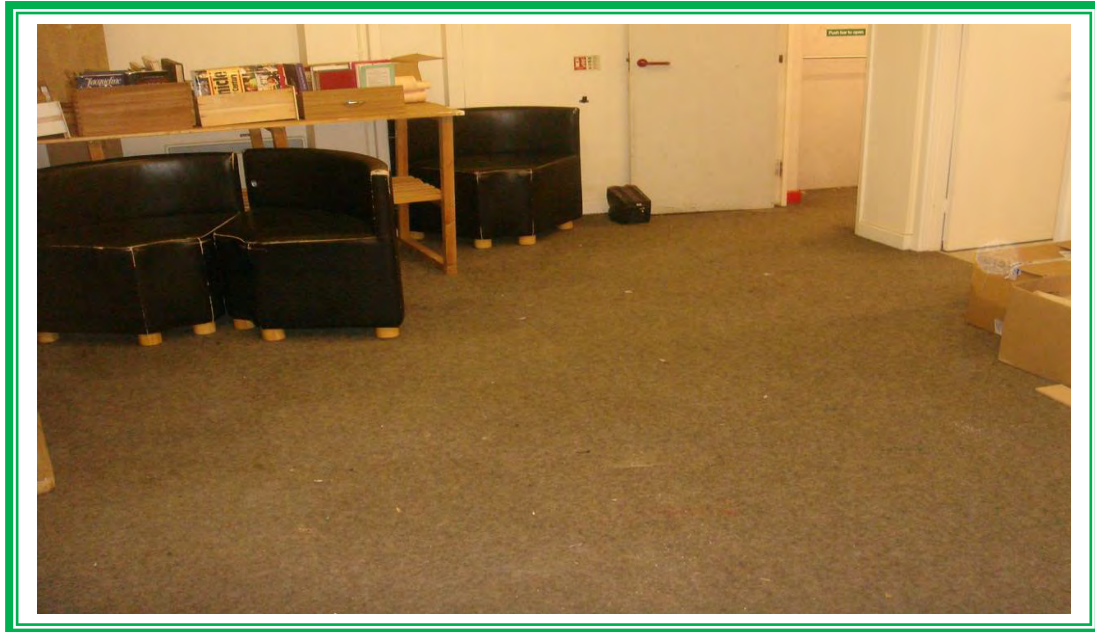
Location: 1/003 Store

Material Description:	Visual Inspection – No Suspect Materials Found	
Identification:	N/A	
Approx. quantity:	N/A	
Accessibility	N/A	Assessment Score
Product type:	N/A	N/A
Extent of Damage:	N/A	N/A
Surface Treatment:	N/A	N/A
Asbestos type:	N/A	N/A
Material Assessment Score:		N/A
Priority Assessment Score:		N/A
Action:	N/A	
Comments:	N/A

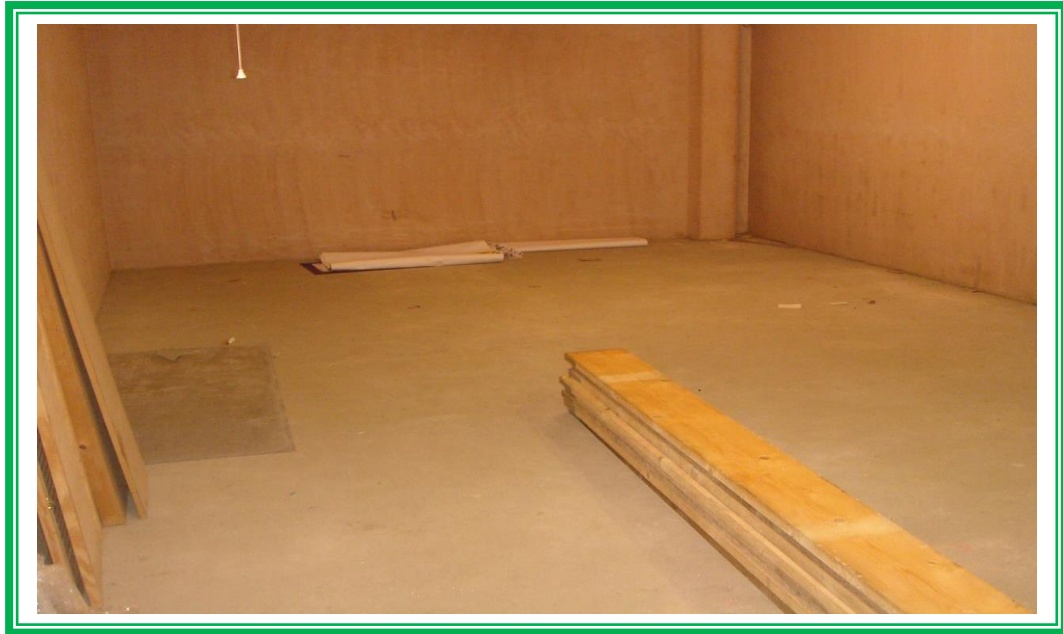
Location: 1/004 Store

Material Description:	Visual Inspection – No Suspect Materials Found	
Identification:	N/A	
Approx. quantity:	N/A	
Accessibility	N/A	Assessment Score
Product type:	N/A	N/A
Extent of Damage:	N/A	N/A
Surface Treatment:	N/A	N/A
Asbestos type:	N/A	N/A
Material Assessment Score:		N/A
Priority Assessment Score:		N/A
Action:	N/A	
Comments:	N/A

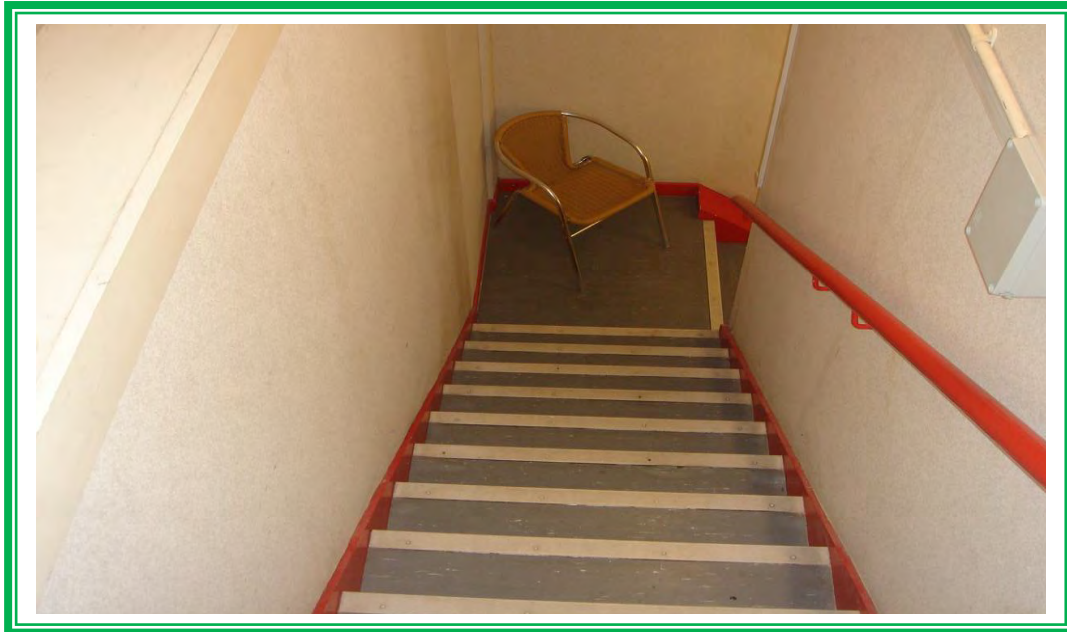
Location: 1/005 Stairs

Material Description:	Vinyl Floor Tiles	
Identification:	As Per Sample NE/1- No Asbestos Detected	
Approx. quantity:	15M2	
Accessibility	N/A	Assessment Score
Product type:	N/A	N/A
Extent of Damage:	N/A	N/A
Surface Treatment:	N/A	N/A
Asbestos type:	N/A	N/A
Material Assessment Score:		N/A
Priority Assessment Score:		N/A
Action:	N/A	
Comments:	N/A

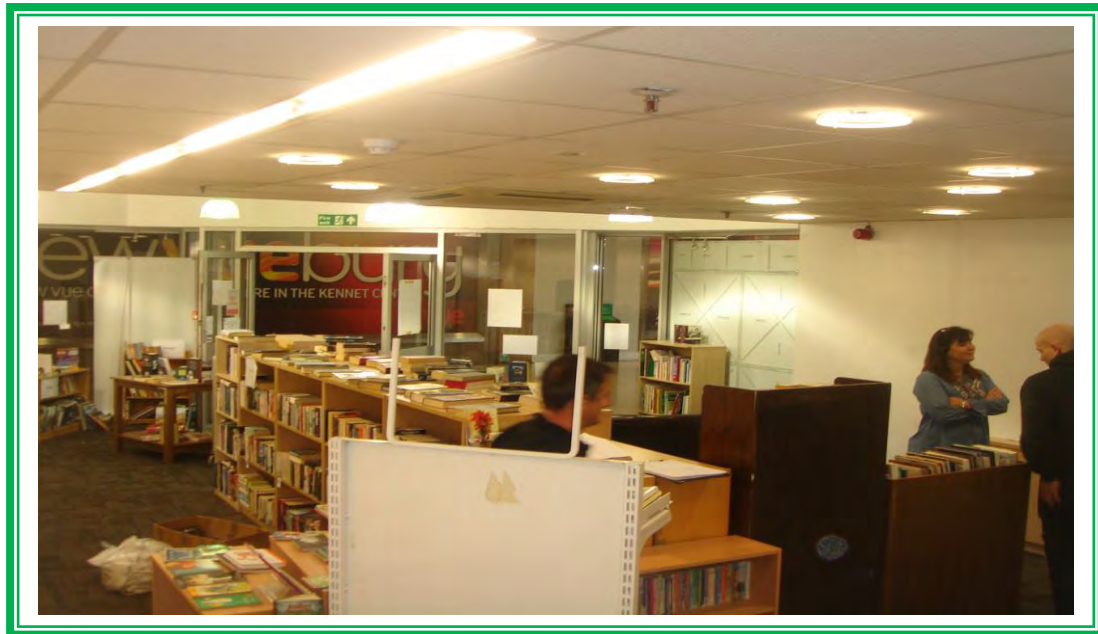
Location: 0/001 Shop Floor

Material Description:	Visual Inspection – No Suspect Materials Found	
Identification:	N/A	
Approx. quantity:	N/A	
Accessibility	N/A	Assessment Score
Product type:	N/A	N/A
Extent of Damage:	N/A	N/A
Surface Treatment:	N/A	N/A
Asbestos type:	N/A	N/A
Material Assessment Score:		N/A
Priority Assessment Score:		N/A
Action:	N/A	
Comments:	N/A

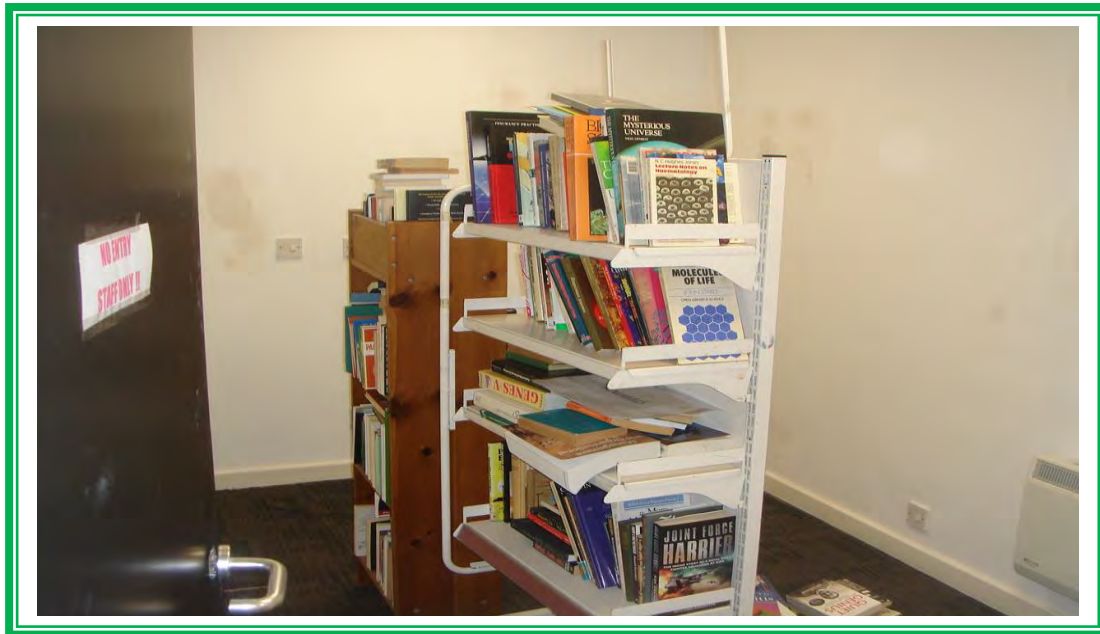
Location: 0/002 Store

Material Description:	Visual Inspection – No Suspect Materials Found	
Identification:	N/A	
Approx. quantity:	N/A	
Accessibility	N/A	Assessment Score
Product type:	N/A	N/A
Extent of Damage:	N/A	N/A
Surface Treatment:	N/A	N/A
Asbestos type:	N/A	N/A
Material Assessment Score:		N/A
Priority Assessment Score:		N/A
Action:	N/A	
Comments:	N/A

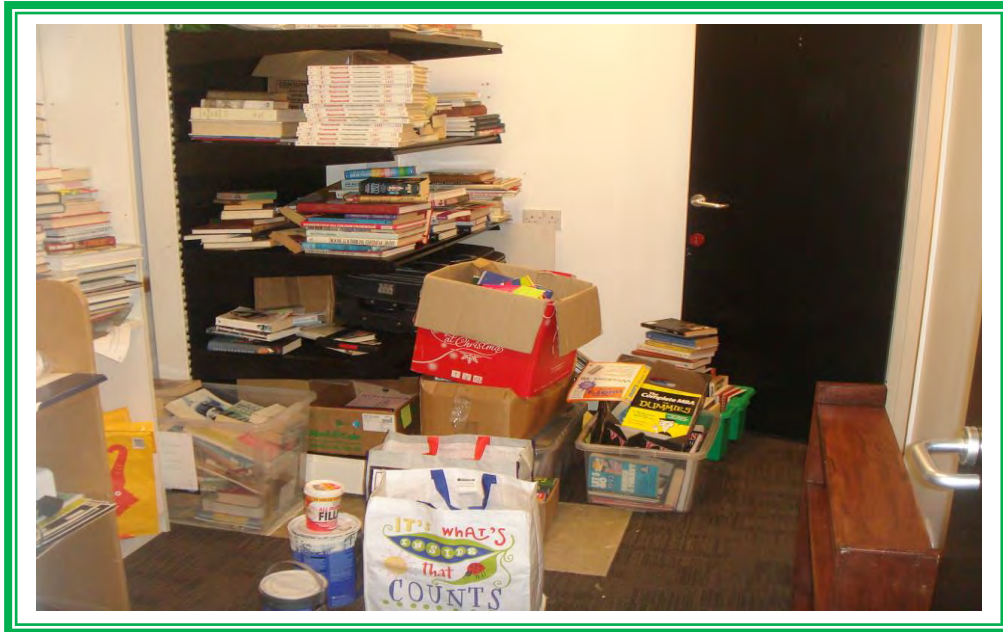
Location: 0/003 Store

Material Description:	Visual Inspection – No Suspect Materials Found	
Identification:	N/A	
Approx. quantity:	N/A	
Accessibility	N/A	Assessment Score
Product type:	N/A	N/A
Extent of Damage:	N/A	N/A
Surface Treatment:	N/A	N/A
Asbestos type:	N/A	N/A
Material Assessment Score:		N/A
Priority Assessment Score:		N/A
Action:	N/A	
Comments:	N/A

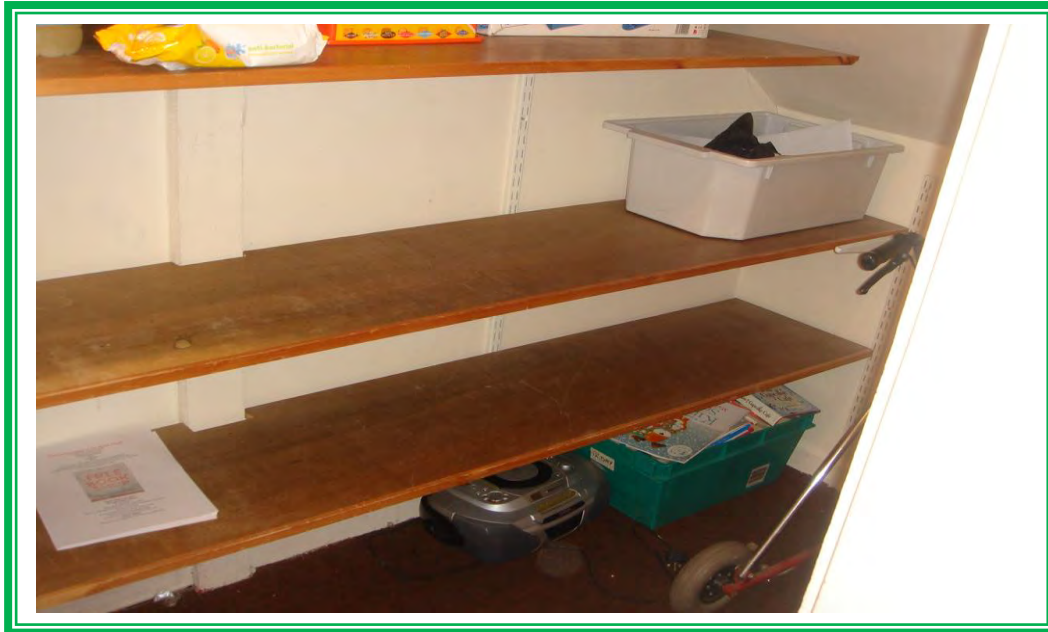
Location: 0/004

Material Description:	Visual Inspection – No Suspect Materials Found	
Identification:	N/A	
Approx. quantity:	N/A	
Accessibility	N/A	Assessment Score
Product type:	N/A	N/A
Extent of Damage:	N/A	N/A
Surface Treatment:	N/A	N/A
Asbestos type:	N/A	N/A
Material Assessment Score:		N/A
Priority Assessment Score:		N/A
Action:	N/A	
Comments:	N/A

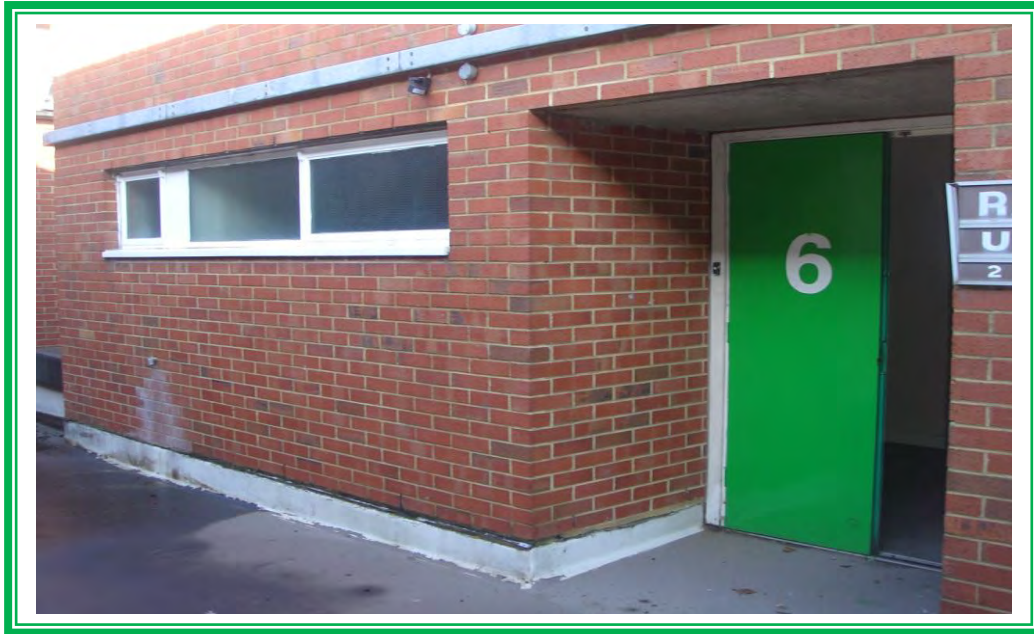
Location: 99/001 External

Material Description:	Visual Inspection – No Suspect Materials Found	
Identification:	N/A	
Approx. quantity:	N/A	
Accessibility	N/A	Assessment Score
Product type:	N/A	N/A
Extent of Damage:	N/A	N/A
Surface Treatment:	N/A	N/A
Asbestos type:	N/A	N/A
Material Assessment Score:		N/A
Priority Assessment Score:		N/A
Action:	N/A	
Comments:	N/A

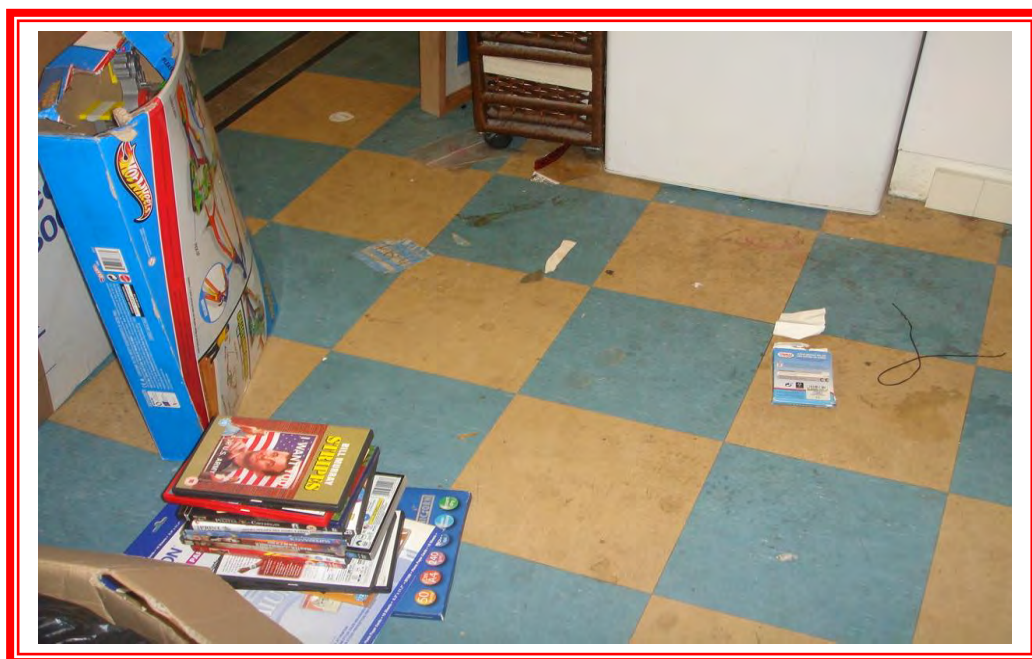
Location: 1/001 Store

Material Description:	Vinyl Floor Tiles	
Identification:	Sampled – Asbestos Detected	
Approx. quantity:	20M2	
Accessibility	Low	Assessment Score
Product type:	Vinyl	1
Extent of Damage:	Moderate	2
Surface Treatment:	Non-Friable	0
Asbestos type:	Chrysotile	1
Material Assessment Score:		4
Priority Assessment Score:		Negligible
Action:	Repair/Seal	
Comments:	N/A

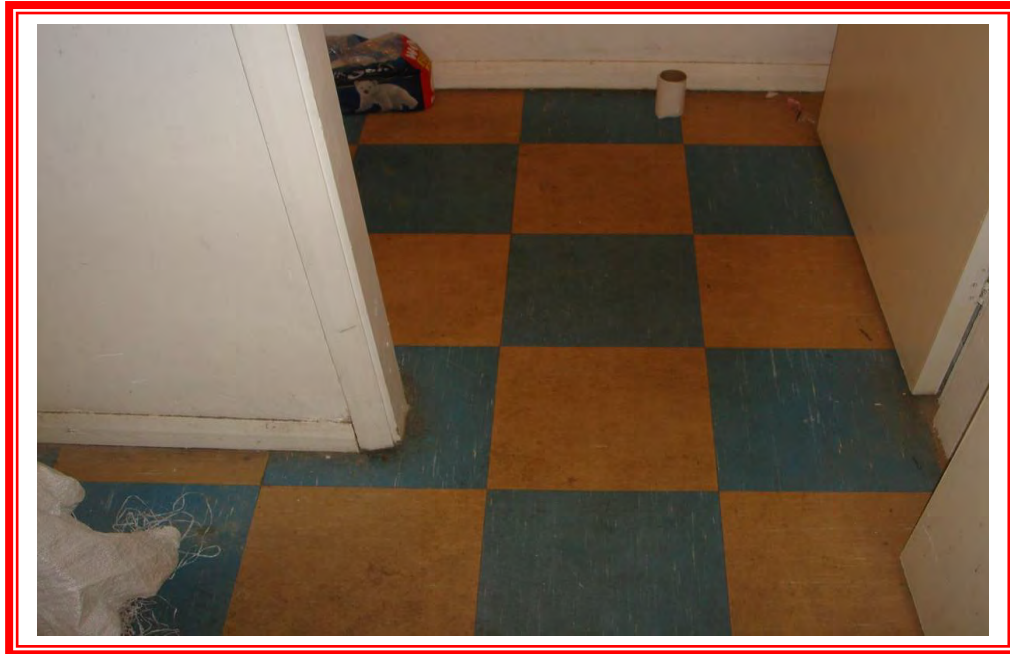
Location: 1/002 WC

Material Description:	Vinyl Floor Tiles	
Identification:	As Per Sample NE/1 – Asbestos Detected	
Approx. quantity:	4M2	
Accessibility	Low	Assessment Score
Product type:	Vinyl	1
Extent of Damage:	Minor	1
Surface Treatment:	Non-Friable	0
Asbestos type:	Chrysotile	1
Material Assessment Score:		3
Priority Assessment Score:		Negligible
Action:	Manage	
Comments:	N/A

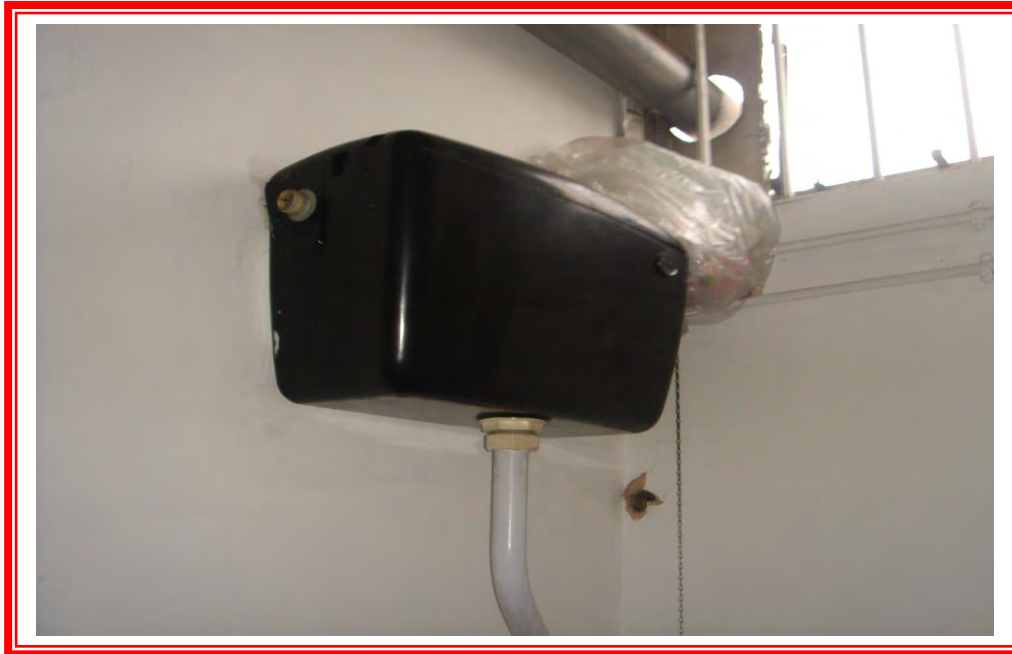
Location: 1/003 WC

Material Description:	Toilet Cistern	
Identification:	Sampled – Asbestos Detected	
Approx. quantity:	X1	
Accessibility	Low	Assessment Score
Product type:	Bakelite	1
Extent of Damage:	Good	0
Surface Treatment:	Non-Friable	0
Asbestos type:	Amosite	2
Material Assessment Score:		3
Priority Assessment Score:		Negligible
Action:	Manage	
Comments:	N/A

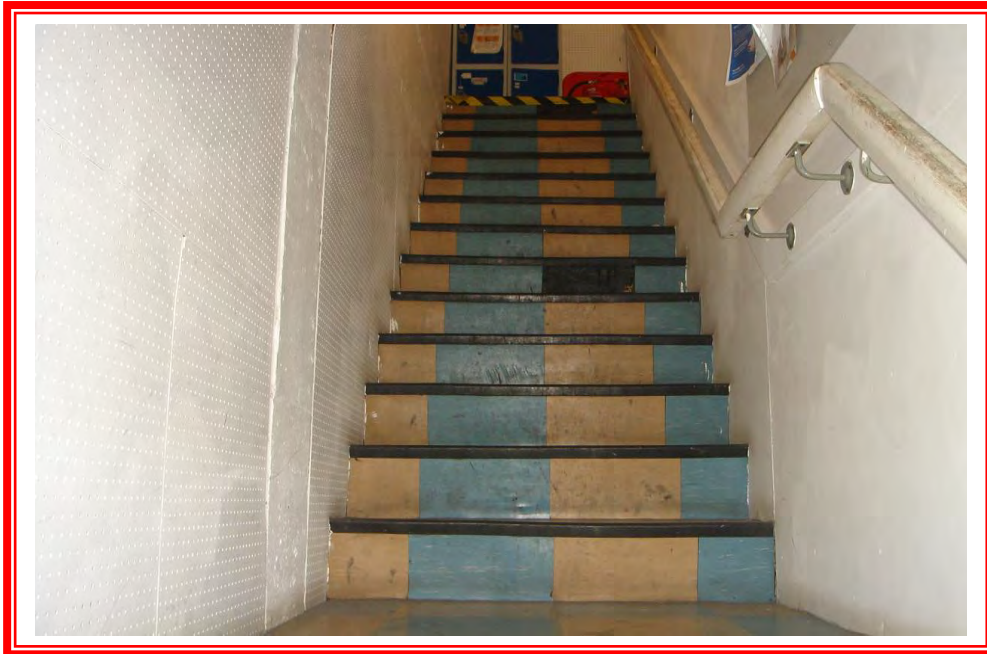
Location: 1/004 Stairs

Material Description:	Vinyl Floor Tiles	
Identification:	As Per Sample NE/1 – Asbestos Detected	
Approx. quantity:	15M2	
Accessibility	Low	Assessment Score
Product type:	Vinyl	1
Extent of Damage:	Moderate	2
Surface Treatment:	Non-Friable	0
Asbestos type:	Chrysotile	1
Material Assessment Score:		4
Priority Assessment Score:		Negligible
Action:	Manage/Repair/Seal	
Comments:	N/A

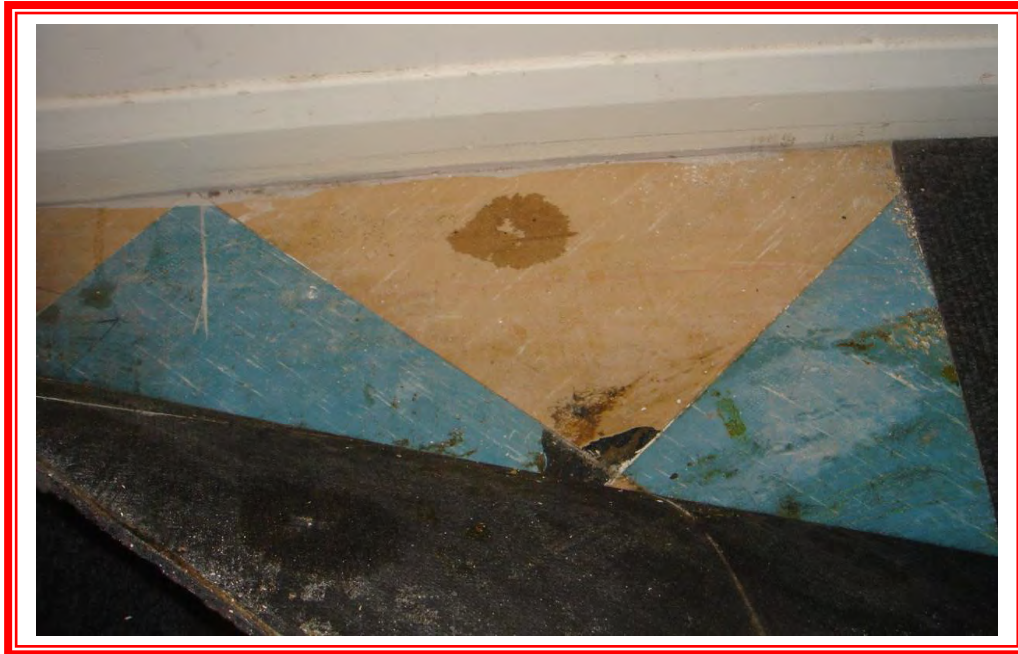
Location: 0/001 Shop Floor

Material Description:	Vinyl Floor Tiles	
Identification:	Sampled – Asbestos Detected	
Approx. quantity:	60M2	
Accessibility	Low	Assessment Score
Product type:	Vinyl	1
Extent of Damage:	Good	0
Surface Treatment:	Non-Friable	0
Asbestos type:	Chrysotile	1
Material Assessment Score:		2
Priority Assessment Score:		Negligible
Action:	Manage	
Comments:	N/A

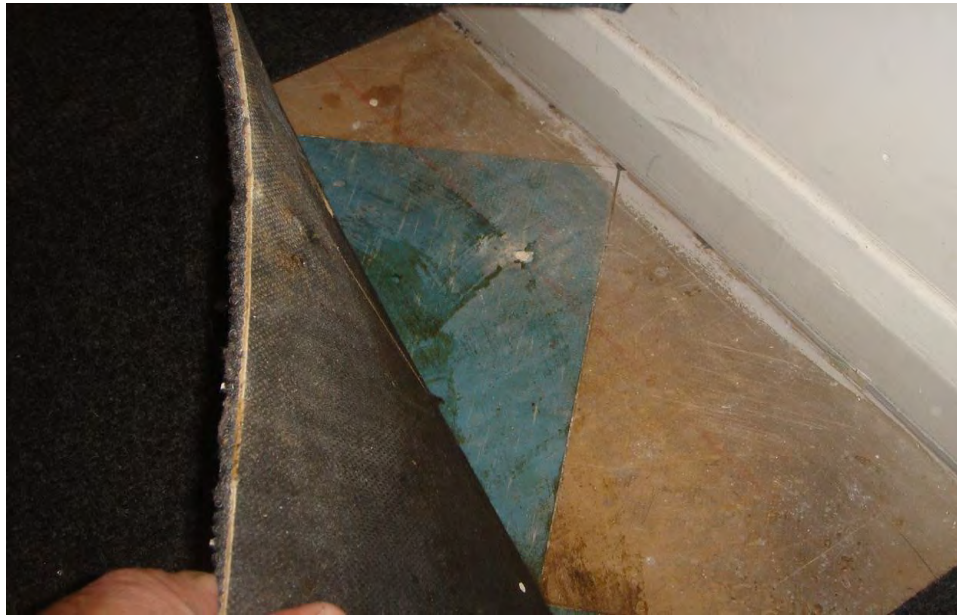
Location: 0/002 Changing Room

Material Description:	Vinyl Floor Tiles	
Identification:	As Per Sample NE/3 – Asbestos Detected	
Approx. quantity:	1M2	
Accessibility	Low	Assessment Score
Product type:	Vinyl	1
Extent of Damage:	Good	0
Surface Treatment:	Non-Friable	0
Asbestos type:	Chrysotile	1
Material Assessment Score:		2
Priority Assessment Score:		Negligible
Action:	Manage	
Comments:	N/A

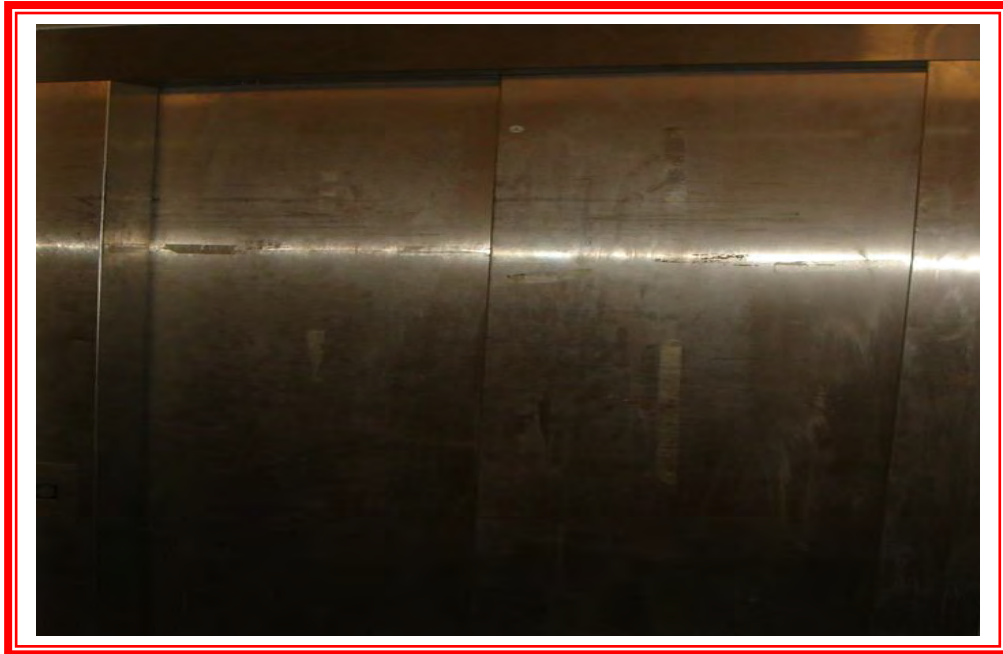
Location: Lift and Lift Shaft

Material Description:	No Access	
Identification:	Presumed to Contain Asbestos	
Approx. quantity:	Unknown	
Accessibility	Low	Assessment Score
Product type:	No Access	3
Extent of Damage:	No Access	3
Surface Treatment:	No Access	3
Asbestos type:	No Access	3
Material Assessment Score:		12
Priority Assessment Score:		High
Action:	Further Inspection Required	
Comments:	No access as no lift engineer onsite

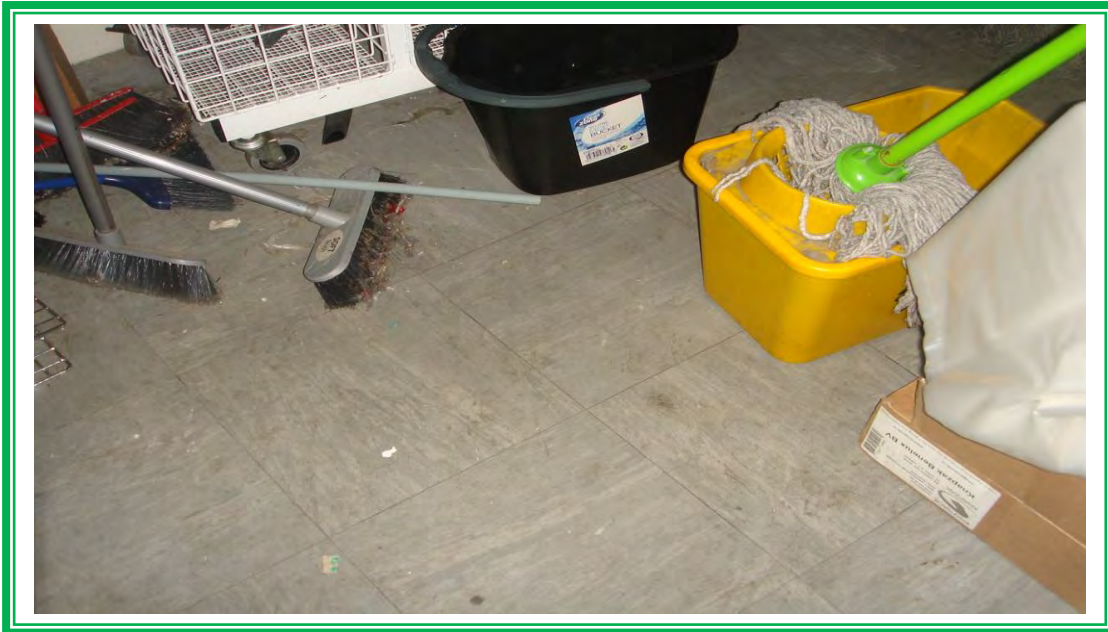
Location: 1/003 Cleaners Cupboard

Material Description:	Vinyl Floor Tiles	
Identification:	As Per Sample NE/1 – No Asbestos Detected	
Approx. quantity:	3M2	
Accessibility	N/A	Assessment Score
Product type:	N/A	N/A
Extent of Damage:	N/A	N/A
Surface Treatment:	N/A	N/A
Asbestos type:	N/A	N/A
Material Assessment Score:		N/A
Priority Assessment Score:		N/A
Action:	N/A	
Comments:	N/A

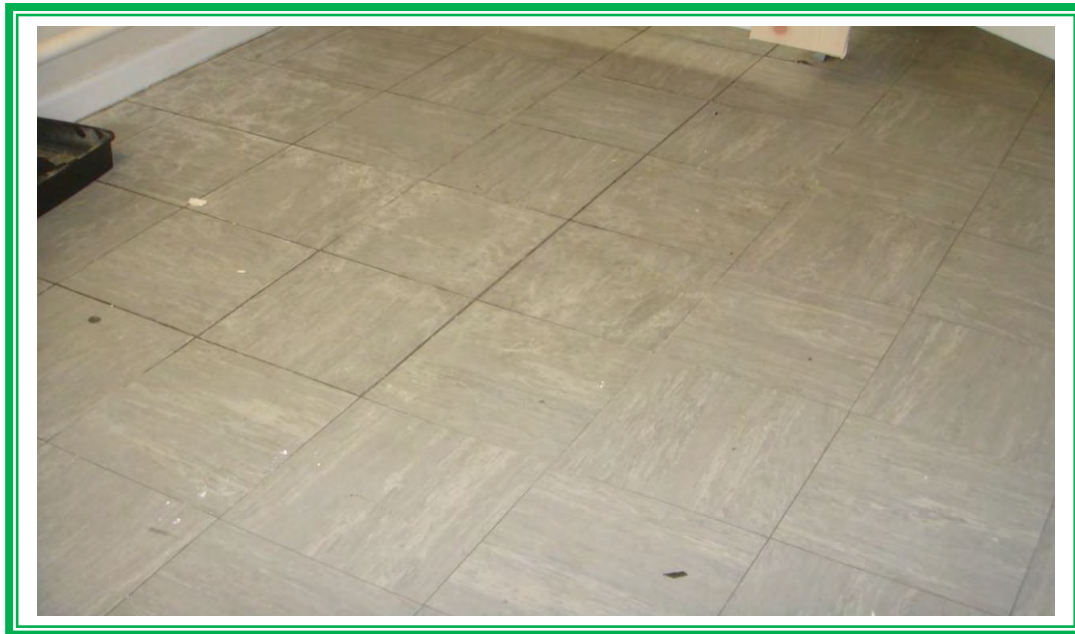
Location: 1/004 WC

Material Description:	Vinyl Floor Tiles	
Identification:	As Per Sample NE/1 – No Asbestos Detected	
Approx. quantity:	8M2	
Accessibility	N/A	Assessment Score
Product type:	N/A	N/A
Extent of Damage:	N/A	N/A
Surface Treatment:	N/A	N/A
Asbestos type:	N/A	N/A
Material Assessment Score:		N/A
Priority Assessment Score:		N/A
Action:	N/A	
Comments:	N/A
