# EAGLE QUARTER II NEWBURY

ASBESTOS SURVEY

Management  
Asbestos Survey Report

Kennet Centre, Market Street, Newbury,  
Berkshire, RG14 5EN

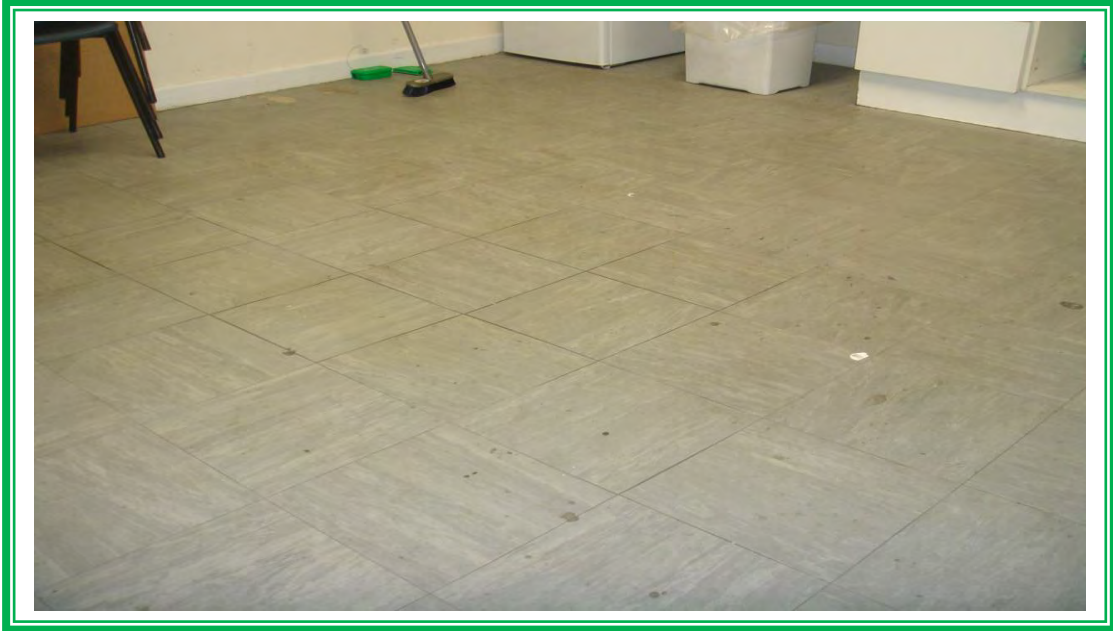
Location: 1/005 Canteen

Material Description:	Vinyl Floor Tiles	
Identification:	As Per Sample NE/1 – No Asbestos Detected	
Approx. quantity:	16M2	
Accessibility	N/A	Assessment Score
Product type:	N/A	N/A
Extent of Damage:	N/A	N/A
Surface Treatment:	N/A	N/A
Asbestos type:	N/A	N/A
Material Assessment Score:		N/A
Priority Assessment Score:		N/A
Action:	N/A	
Comments:	N/A

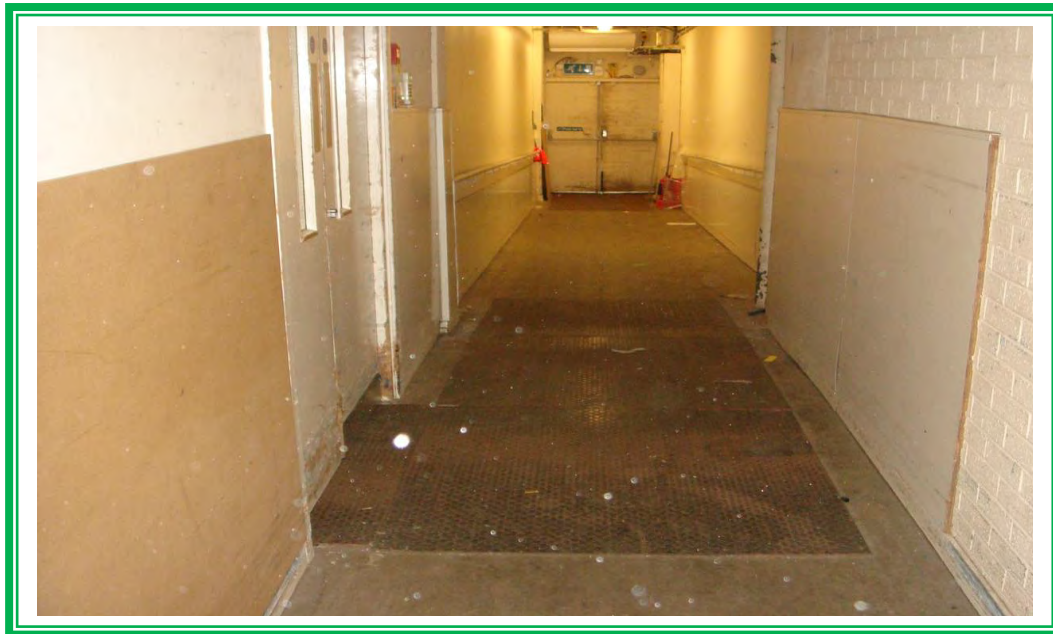
Location: 1/006 Corridor

Material Description:	Vinyl Floor Tiles	
Identification:	Sampled – No Asbestos Detected	
Approx. quantity:	16M2	
Accessibility	N/A	Assessment Score
Product type:	N/A	N/A
Extent of Damage:	N/A	N/A
Surface Treatment:	N/A	N/A
Asbestos type:	N/A	N/A
Material Assessment Score:		N/A
Priority Assessment Score:		N/A
Action:	N/A	
Comments:	N/A

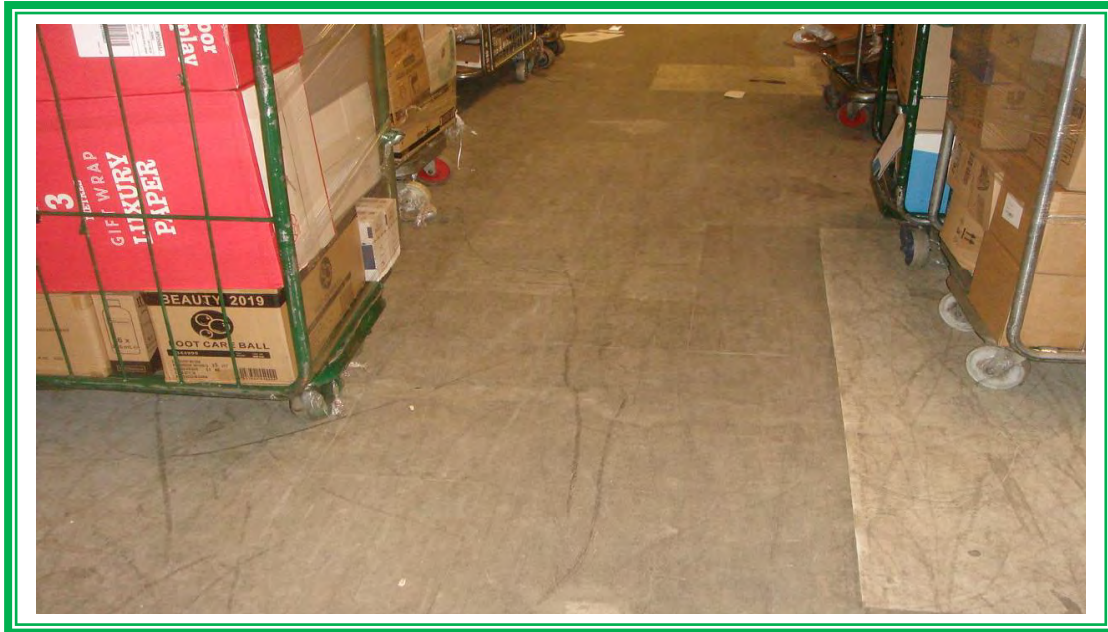
Location: 1/008 Store

Material Description:	Vinyl Floor Tiles	
Identification:	As Per Sample NE/2 – No Asbestos Detected	
Approx. quantity:	60M2	
Accessibility	N/A	Assessment Score
Product type:	N/A	N/A
Extent of Damage:	N/A	N/A
Surface Treatment:	N/A	N/A
Asbestos type:	N/A	N/A
Material Assessment Score:		N/A
Priority Assessment Score:		N/A
Action:	N/A	
Comments:	N/A

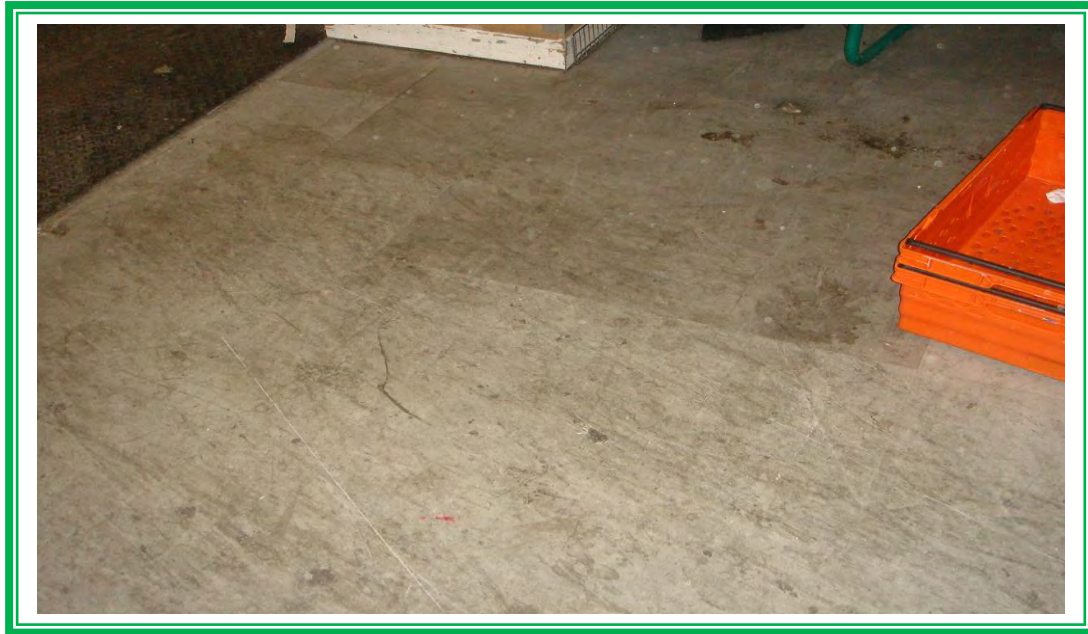
Location: 1/011 Lobby and Stairs

Material Description:	Vinyl Floor Tiles	
Identification:	As Per Sample NE/2 – No Asbestos Detected	
Approx. quantity:	30M2	
Accessibility	N/A	Assessment Score
Product type:	N/A	N/A
Extent of Damage:	N/A	N/A
Surface Treatment:	N/A	N/A
Asbestos type:	N/A	N/A
Material Assessment Score:		N/A
Priority Assessment Score:		N/A
Action:	N/A	
Comments:	N/A

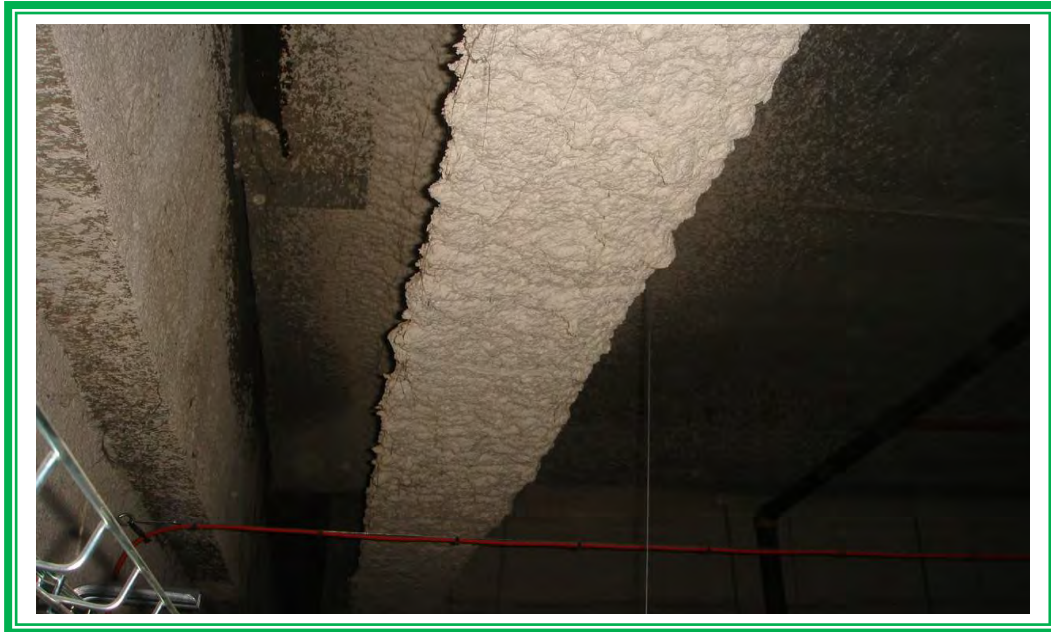
Location: 0/001 Shop Floor

Material Description:	Sprayed Coating to Beams	
Identification:	Sampled – No Asbestos Detected	
Approx. quantity:	100M	
Accessibility	N/A	Assessment Score
Product type:	N/A	N/A
Extent of Damage:	N/A	N/A
Surface Treatment:	N/A	N/A
Asbestos type:	N/A	N/A
Material Assessment Score:		N/A
Priority Assessment Score:		N/A
Action:	N/A	
Comments:	N/A

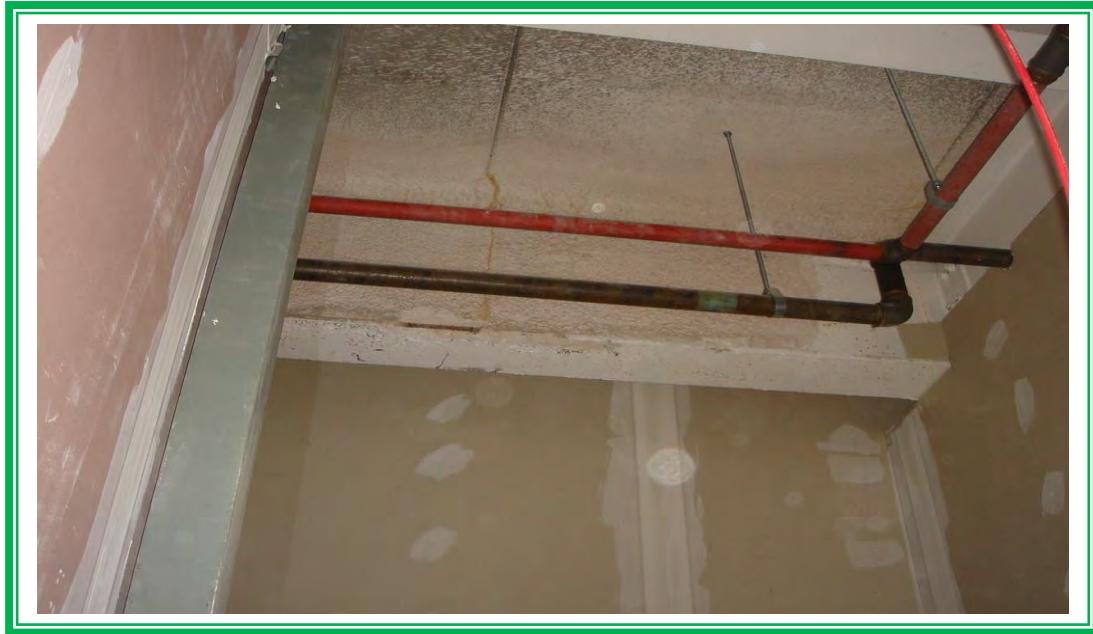
Location: 0/002 Lobby

Material Description:	Sprayed Coating to Beams	
Identification:	As Per Sample NE/3 – No Asbestos Detected	
Approx. quantity:	20M	
Accessibility	N/A	Assessment Score
Product type:	N/A	N/A
Extent of Damage:	N/A	N/A
Surface Treatment:	N/A	N/A
Asbestos type:	N/A	N/A
Material Assessment Score:		N/A
Priority Assessment Score:		N/A
Action:	N/A	
Comments:	N/A

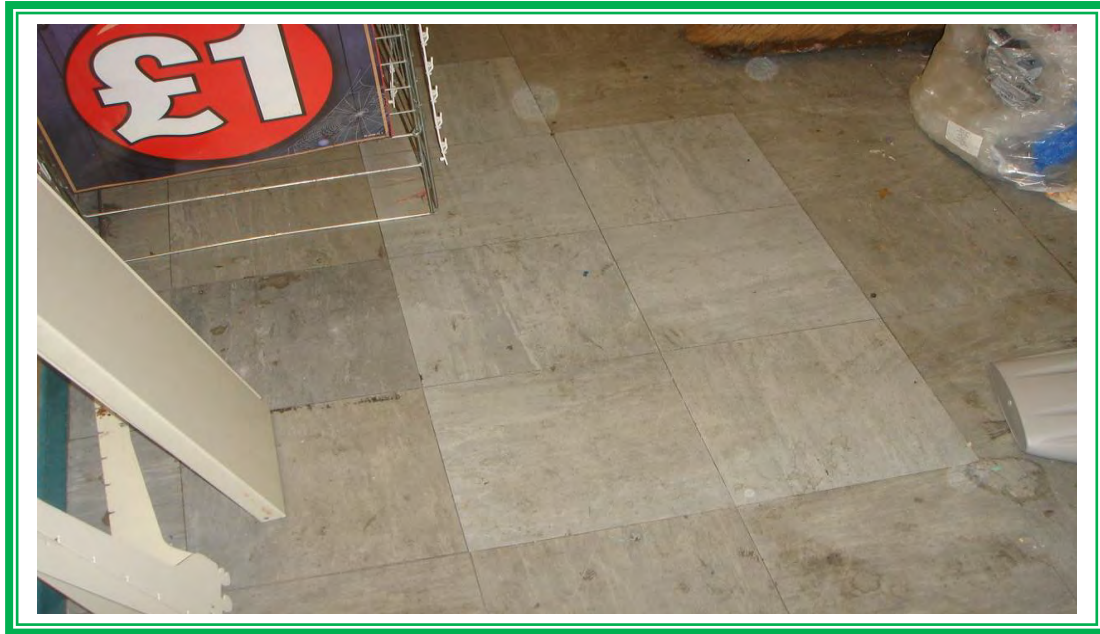
Location: 0/002 Lobby

Material Description:	Vinyl Floor Tiles	
Identification:	Sampled – No Asbestos Detected	
Approx. quantity:	16M2	
Accessibility	N/A	Assessment Score
Product type:	N/A	N/A
Extent of Damage:	N/A	N/A
Surface Treatment:	N/A	N/A
Asbestos type:	N/A	N/A
Material Assessment Score:		N/A
Priority Assessment Score:		N/A
Action:	N/A	
Comments:	N/A

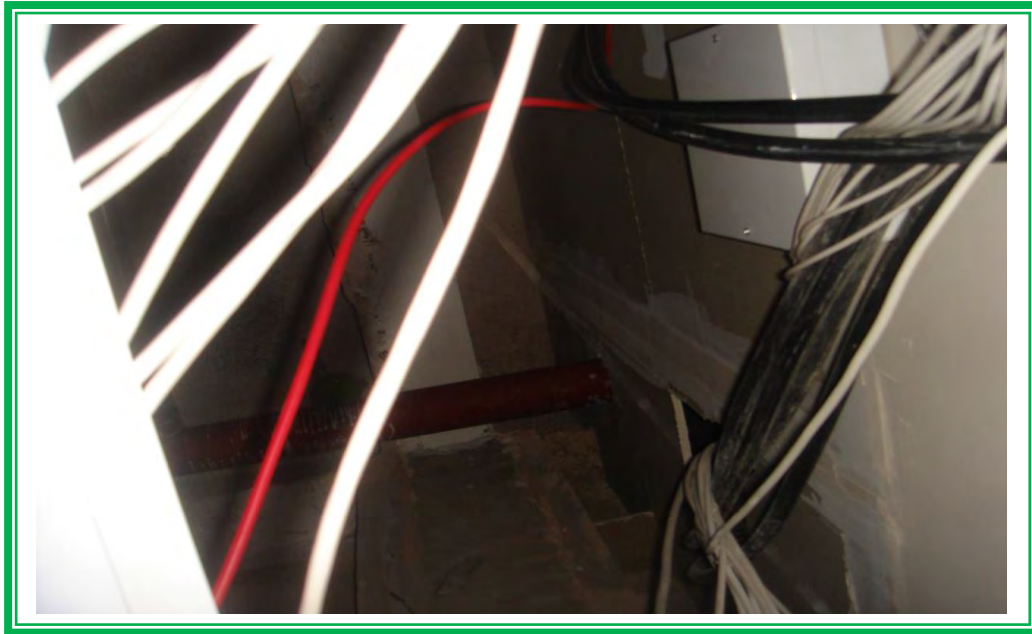
Location: 0/003 Lift Motor Room

Material Description:	Sprayed Coating to Beams	
Identification:	As Per Sample NE/3 – No Asbestos Detected	
Approx. quantity:	10M	
Accessibility	N/A	Assessment Score
Product type:	N/A	N/A
Extent of Damage:	N/A	N/A
Surface Treatment:	N/A	N/A
Asbestos type:	N/A	N/A
Material Assessment Score:		N/A
Priority Assessment Score:		N/A
Action:	N/A	
Comments:	N/A

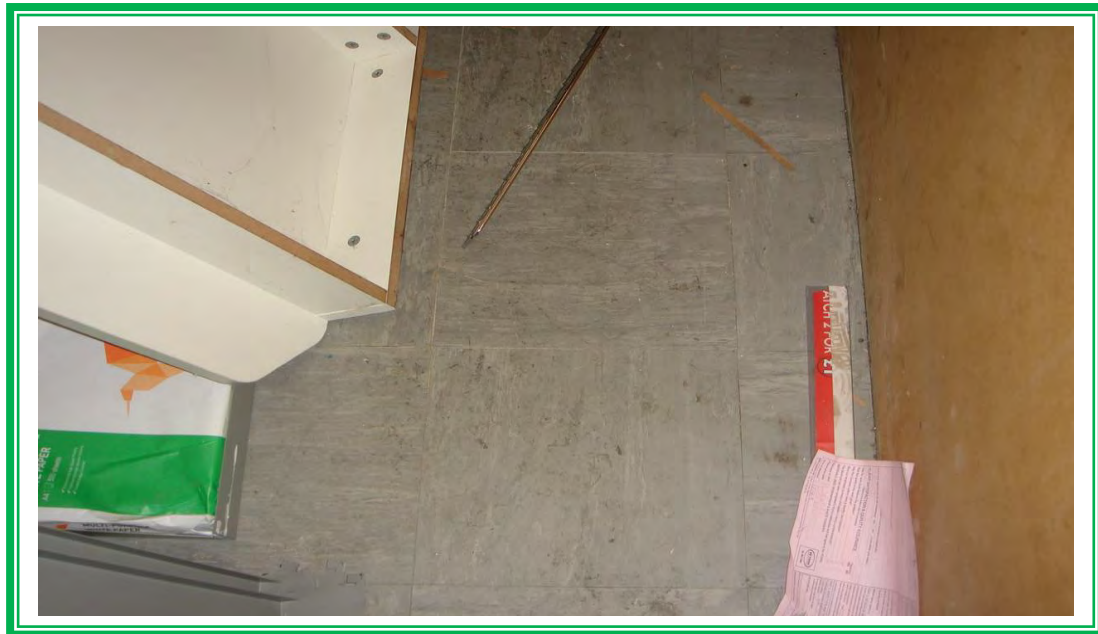
Location: 0/003 Lift Motor Room

Material Description:	Vinyl Floor Tiles	
Identification:	As Per Sample NE/4 – No Asbestos Detected	
Approx. quantity:	2M2	
Accessibility	N/A	Assessment Score
Product type:	N/A	N/A
Extent of Damage:	N/A	N/A
Surface Treatment:	N/A	N/A
Asbestos type:	N/A	N/A
Material Assessment Score:		N/A
Priority Assessment Score:		N/A
Action:	N/A	
Comments:	N/A

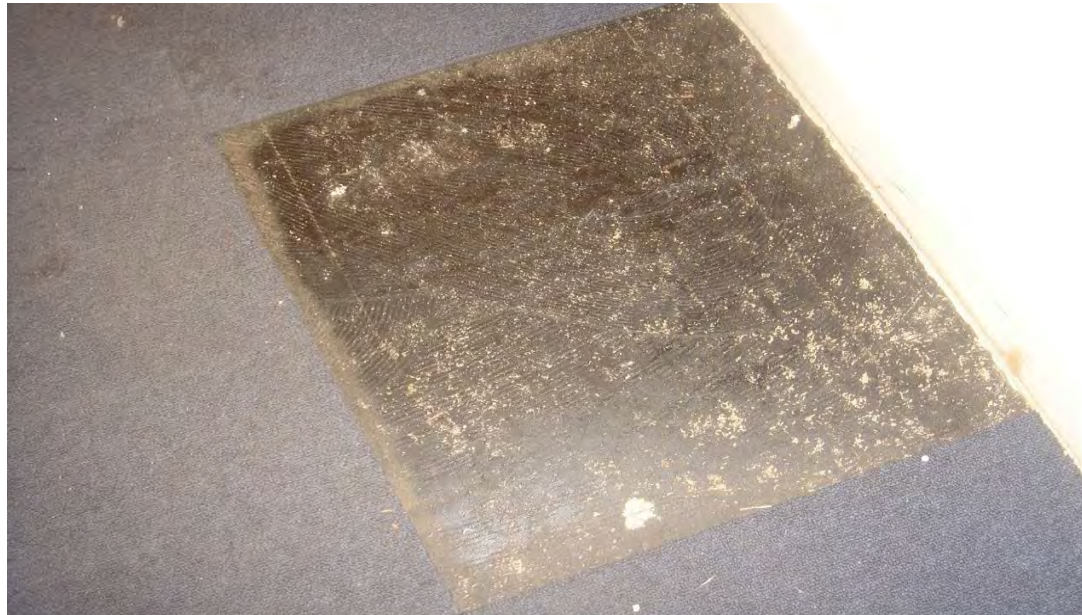
Location: 1/002 Corridor

Material Description:	Bitumen Adhesive	
Identification:	Sampled – Asbestos Detected	
Approx. quantity:	6M2	
Accessibility	Low	Assessment Score
Product type:	Bitumen	1
Extent of Damage:	Good	0
Surface Treatment:	Non-Friable	0
Asbestos type:	Chrysotile	1
Material Assessment Score:		2
Priority Assessment Score:		Negligible
Action:	Manage	
Comments:	N/A

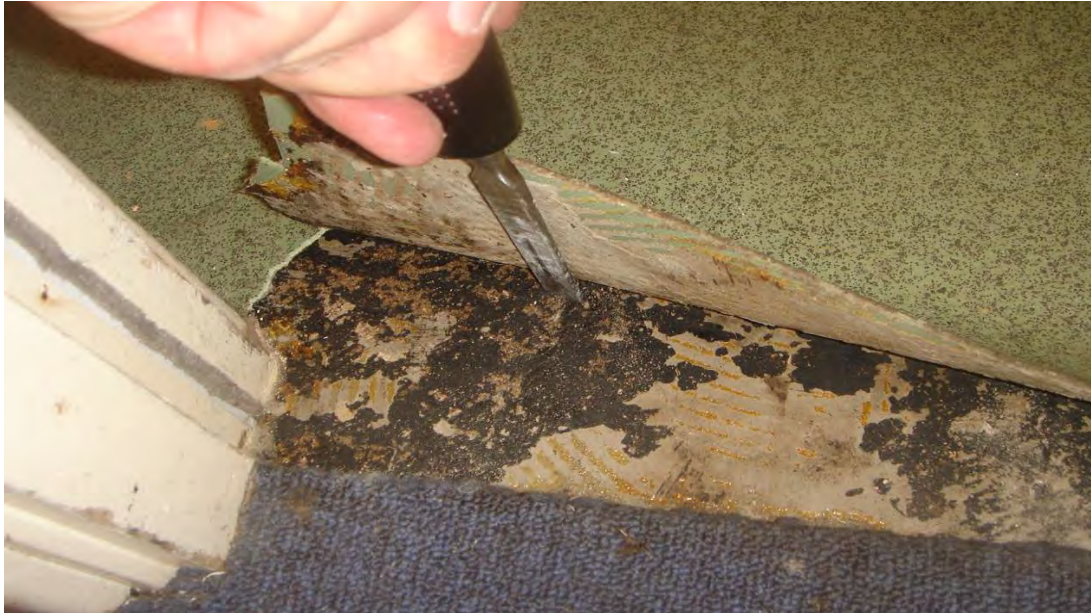
Location: 1/003 Kitchen

Material Description:	Bitumen Adhesive	
Identification:	As Per Sample NE/2 – Asbestos Detected	
Approx. quantity:	3M2	
Accessibility	Low	Assessment Score
Product type:	Bitumen	1
Extent of Damage:	Good	0
Surface Treatment:	Non-Friable	0
Asbestos type:	Chrysotile	1
Material Assessment Score:		2
Priority Assessment Score:		Negligible
Action:	Manage	
Comments:	N/A

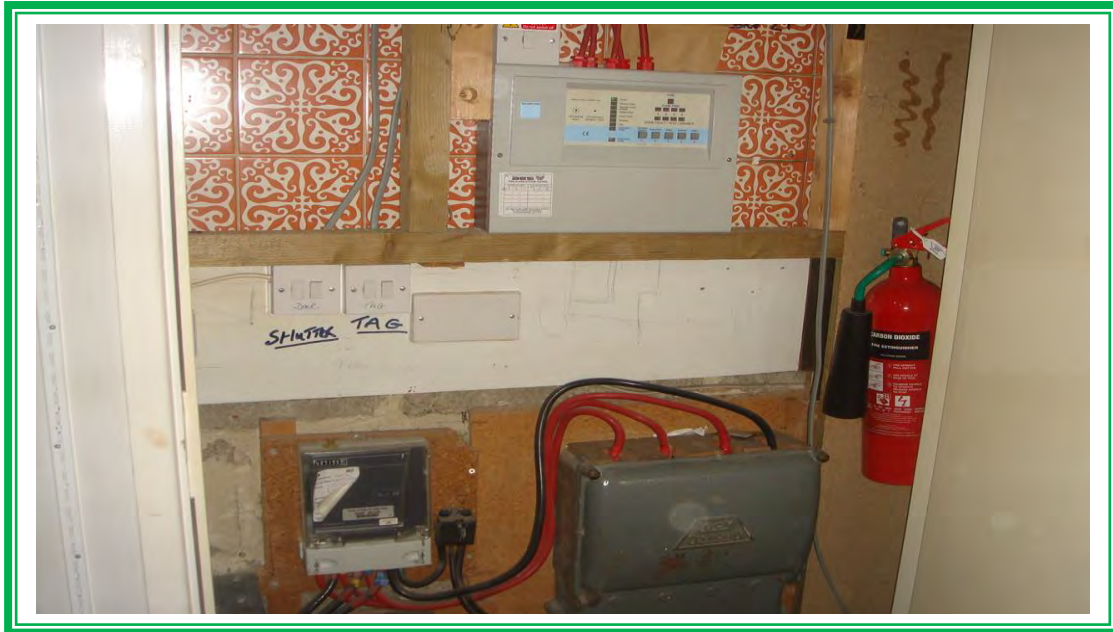
Location: 0/002 – Electric Cupboard

Material Description:	Visual Inspection – No Suspect Materials Found	
Identification:	N/A	
Approx. quantity:	N/A	
Accessibility	N/A	Assessment Score
Product type:	N/A	N/A
Extent of Damage:	N/A	N/A
Surface Treatment:	N/A	N/A
Asbestos type:	N/A	N/A
Material Assessment Score:		N/A
Priority Assessment Score:		N/A
Action:	N/A	
Comments:	N/A

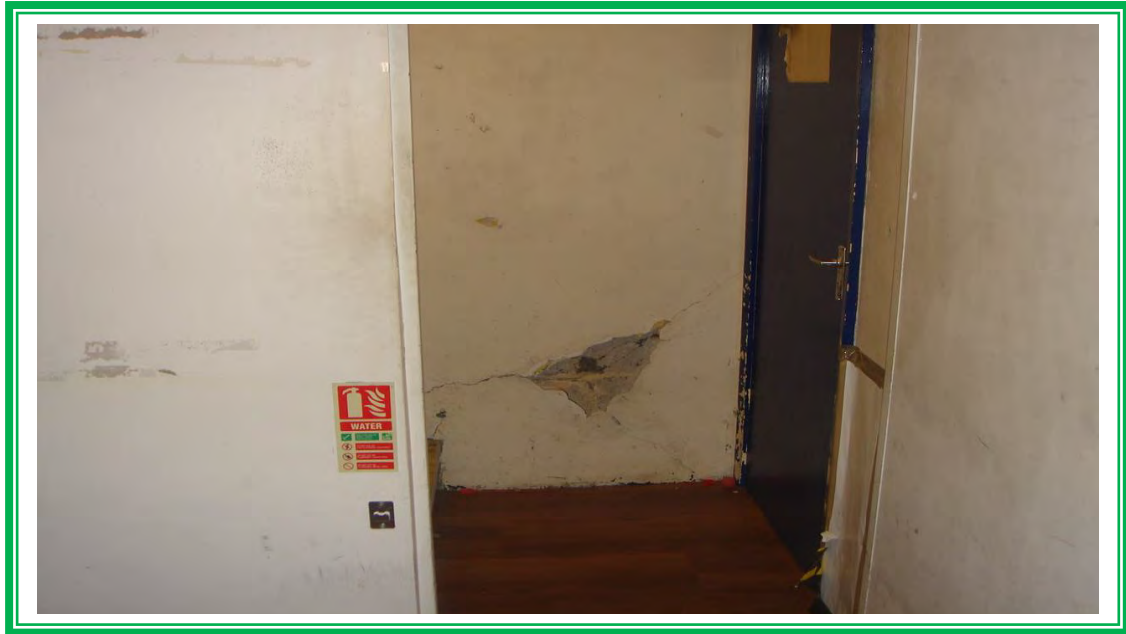
Location: 0/003 Lobby

Material Description:	Visual Inspection – No Suspect Materials Found	
Identification:	N/A	
Approx. quantity:	N/A	
Accessibility	N/A	Assessment Score
Product type:	N/A	N/A
Extent of Damage:	N/A	N/A
Surface Treatment:	N/A	N/A
Asbestos type:	N/A	N/A
Material Assessment Score:		N/A
Priority Assessment Score:		N/A
Action:	N/A	
Comments:	N/A

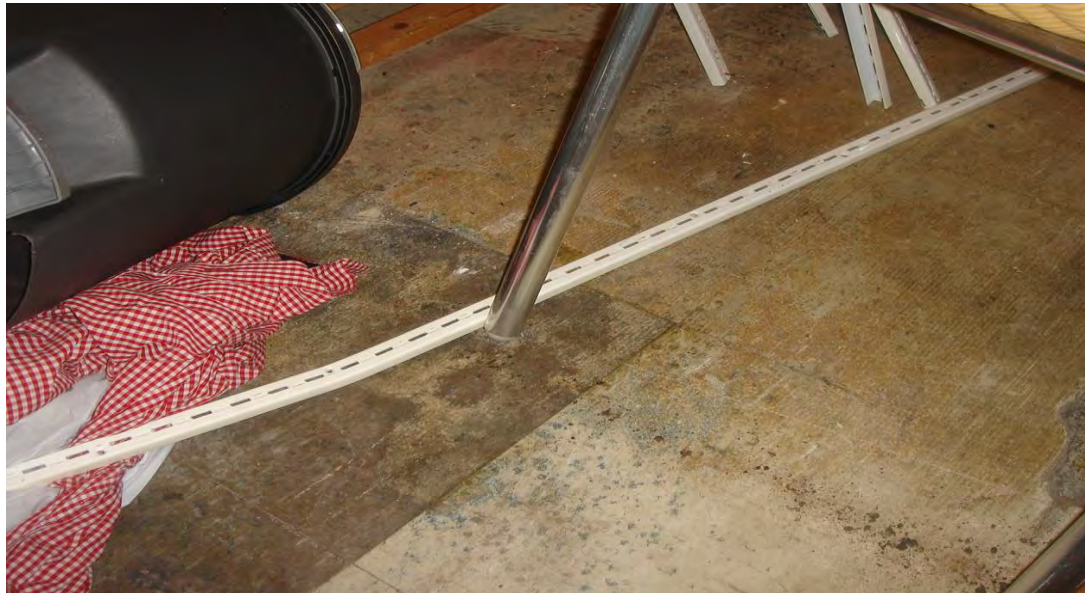
Location: 0/004

Material Description:	Vinyl Floor Tiles	
Identification:	Sampled – No Asbestos Detected	
Approx. quantity:	8M2	
Accessibility	N/A	Assessment Score
Product type:	N/A	N/A
Extent of Damage:	N/A	N/A
Surface Treatment:	N/A	N/A
Asbestos type:	N/A	N/A
Material Assessment Score:		N/A
Priority Assessment Score:		N/A
Action:	N/A	
Comments:	N/A

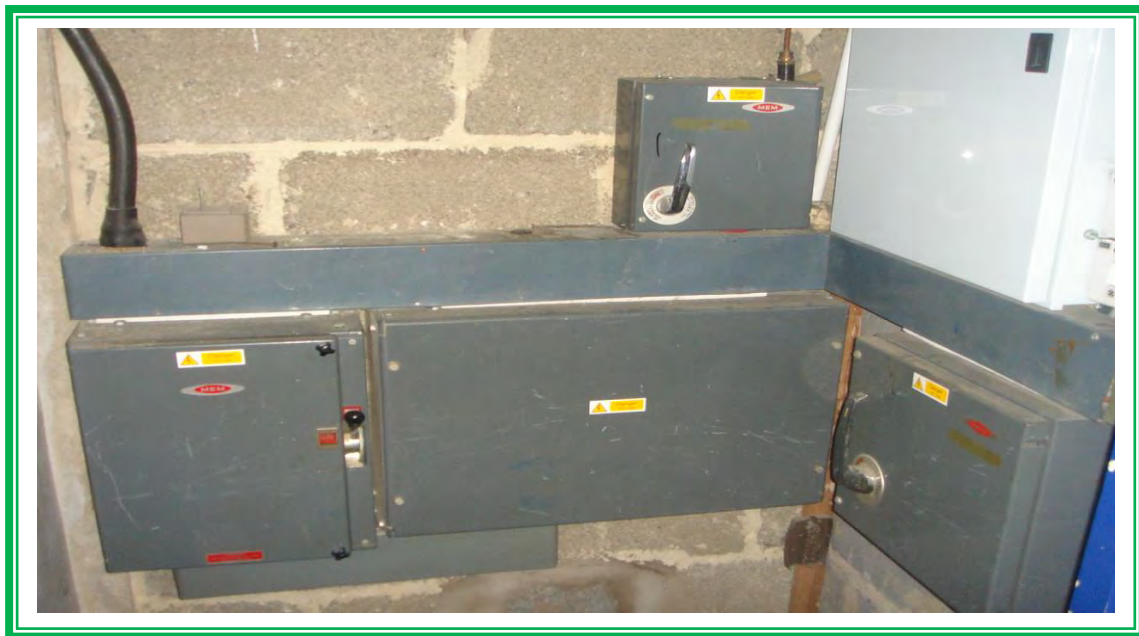
Location: 0/005 Electrics Cupboard 2

Material Description:	Visual Inspection – No Suspect Materials Found	
Identification:	N/A	
Approx. quantity:	N/A	
Accessibility	N/A	Assessment Score
Product type:	N/A	N/A
Extent of Damage:	N/A	N/A
Surface Treatment:	N/A	N/A
Asbestos type:	N/A	N/A
Material Assessment Score:		N/A
Priority Assessment Score:		N/A
Action:	N/A	
Comments:	N/A

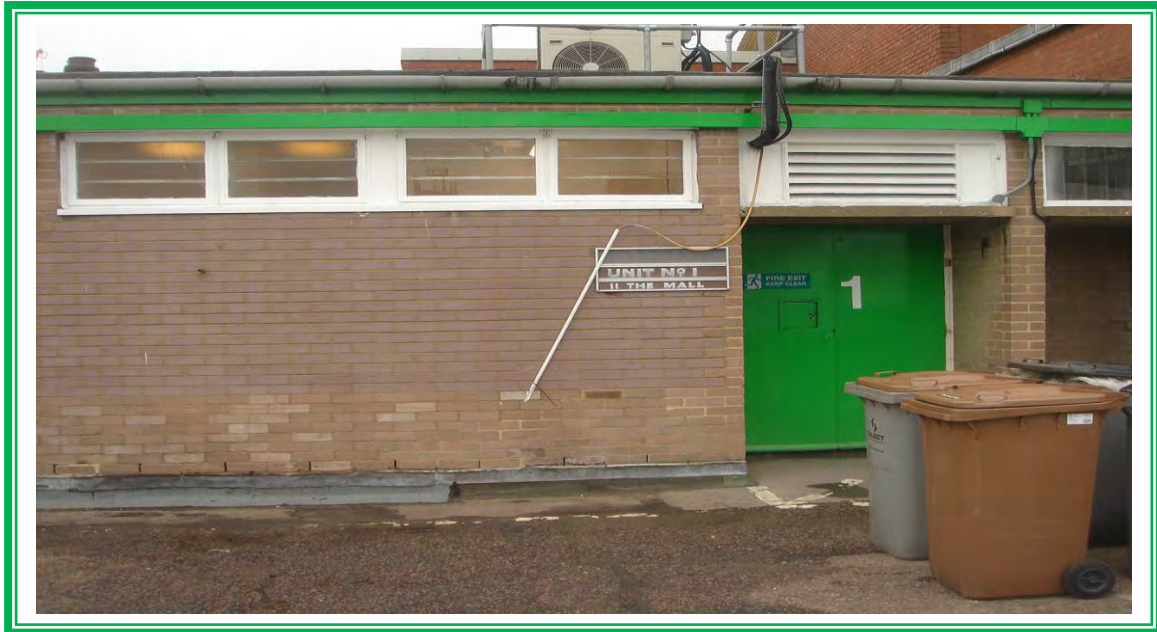
Location: 99/001 External

Material Description:	Visual Inspection – No Suspect Materials Found	
Identification:	N/A	
Approx. quantity:	N/A	
Accessibility	N/A	Assessment Score
Product type:	N/A	N/A
Extent of Damage:	N/A	N/A
Surface Treatment:	N/A	N/A
Asbestos type:	N/A	N/A
Material Assessment Score:		N/A
Priority Assessment Score:		N/A
Action:	N/A	
Comments:	N/A

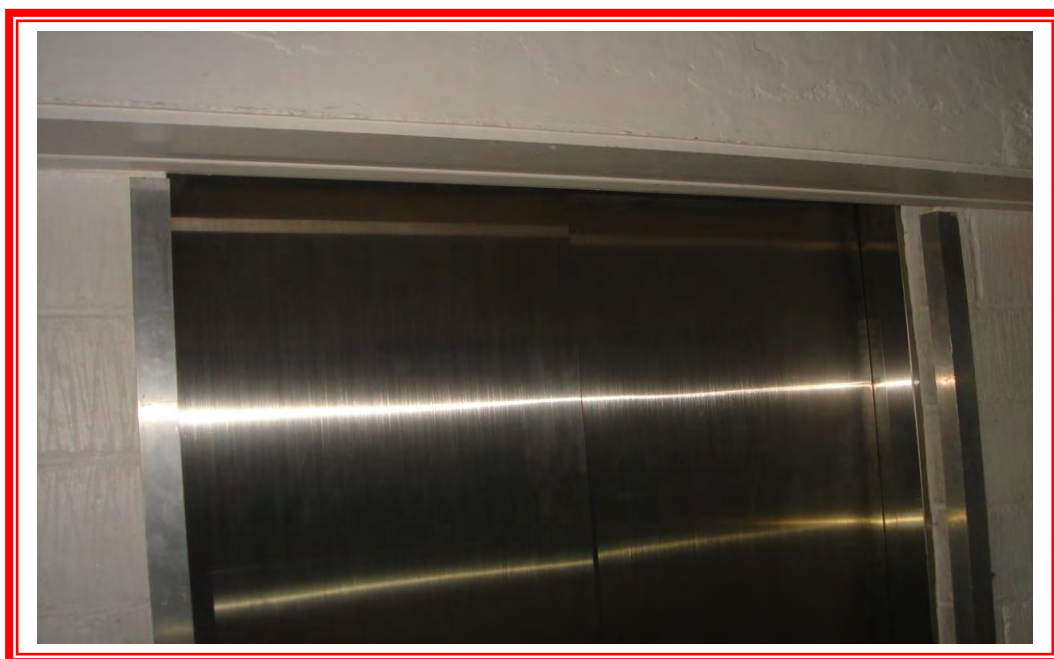
Location: Lift/Lift Shaft

Material Description:	No Access	
Identification:	Presumed to Contain Asbestos	
Approx. quantity:	Entire Lift and Lift Shaft	
Accessibility	Low	Assessment Score
Product type:	No Access	3
Extent of Damage:	No Access	3
Surface Treatment:	No Access	3
Asbestos type:	No Access	3
Material Assessment Score:		12
Priority Assessment Score:		High
Action:	Manage	
Comments:	No access as no lift engineer was onsite

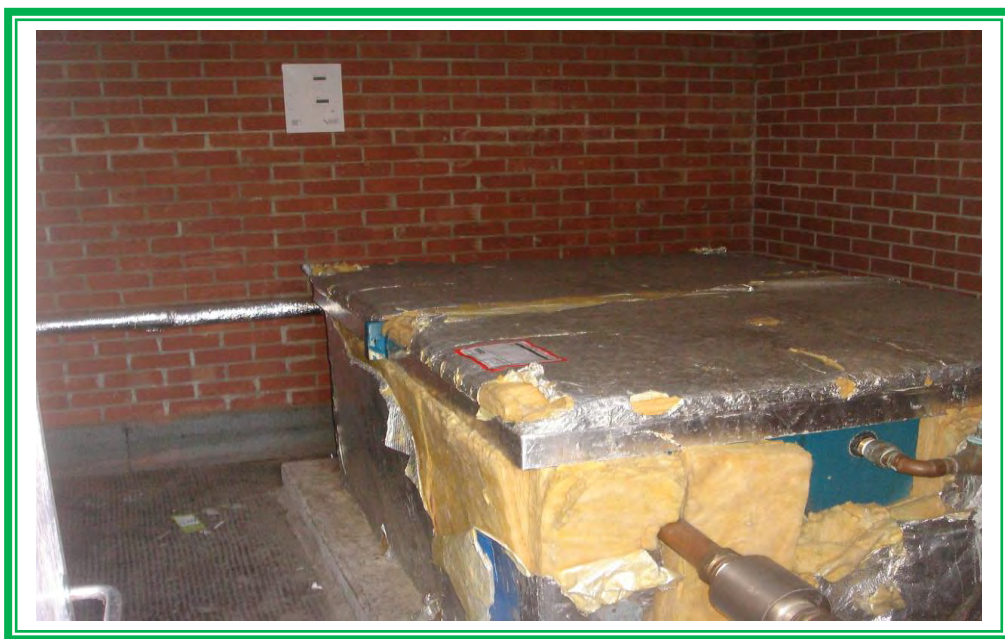
Location: 2/001 Water Tank Room

Material Description:	Visual Inspection – No Suspect Materials Found	
Identification:	N/A	
Approx. quantity:	N/A	
Accessibility	N/A	Assessment Score
Product type:	N/A	N/A
Extent of Damage:	N/A	N/A
Surface Treatment:	N/A	N/A
Asbestos type:	N/A	N/A
Material Assessment Score:		N/A
Priority Assessment Score:		N/A
Action:	N/A	
Comments:	N/A

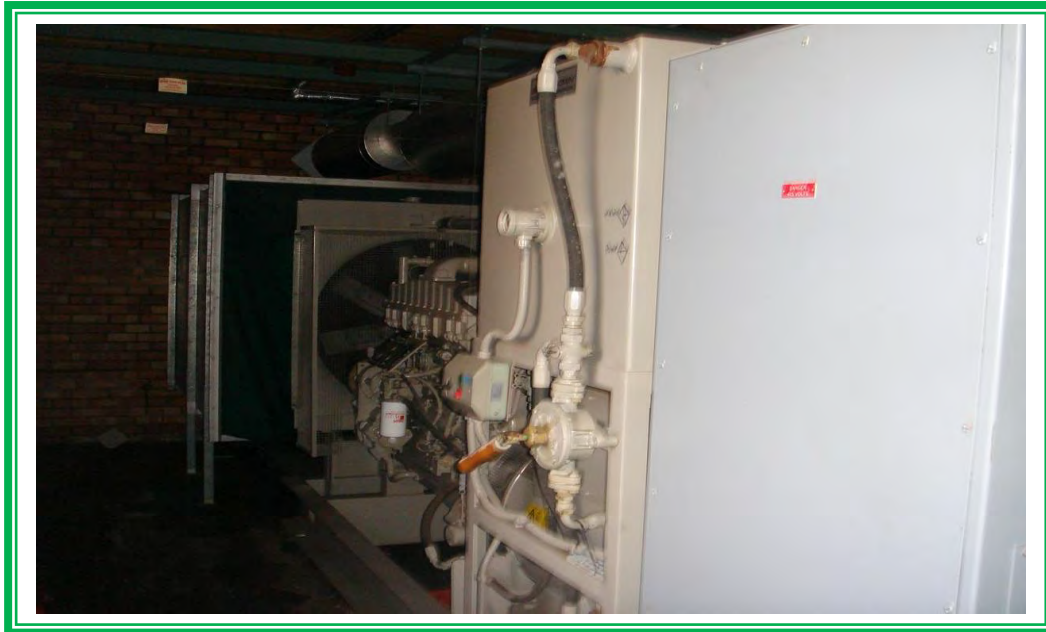
Location: 2/002 Air Con Room

Material Description:	Visual Inspection – No Suspect Materials Found	
Identification:	N/A	
Approx. quantity:	N/A	
Accessibility	N/A	Assessment Score
Product type:	N/A	N/A
Extent of Damage:	N/A	N/A
Surface Treatment:	N/A	N/A
Asbestos type:	N/A	N/A
Material Assessment Score:		N/A
Priority Assessment Score:		N/A
Action:	N/A	
Comments:	N/A

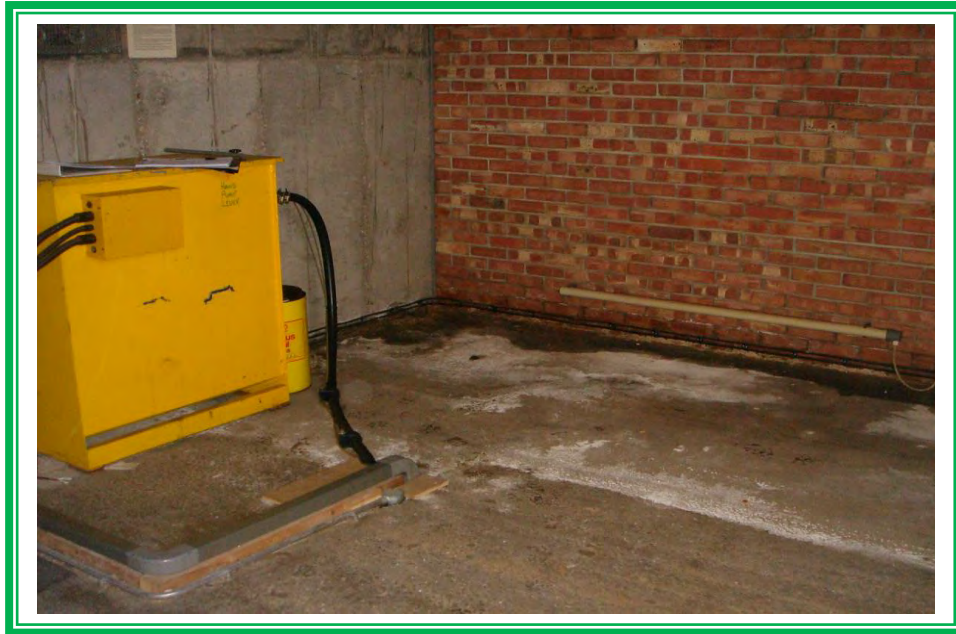
Location: 2/003 Lift Motor Room

Material Description:	Visual Inspection – No Suspect Materials Found	
Identification:	N/A	
Approx. quantity:	N/A	
Accessibility	N/A	Assessment Score
Product type:	N/A	N/A
Extent of Damage:	N/A	N/A
Surface Treatment:	N/A	N/A
Asbestos type:	N/A	N/A
Material Assessment Score:		N/A
Priority Assessment Score:		N/A
Action:	N/A	
Comments:	N/A

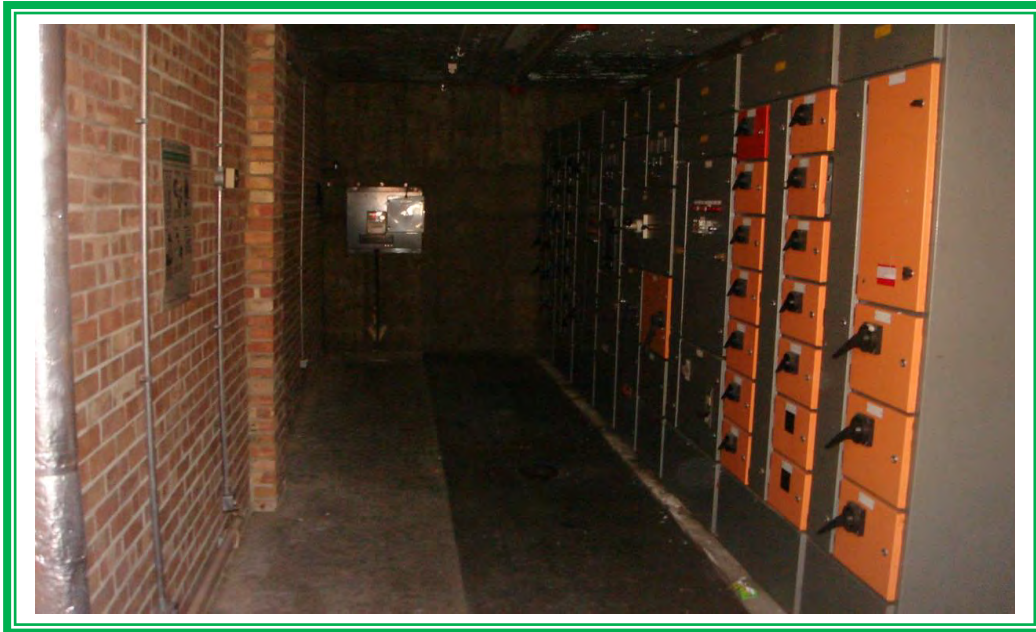
Location: 2/004 Electrics

Material Description:	Visual Inspection – No Suspect Materials Found	
Identification:	N/A	
Approx. quantity:	N/A	
Accessibility	N/A	Assessment Score
Product type:	N/A	N/A
Extent of Damage:	N/A	N/A
Surface Treatment:	N/A	N/A
Asbestos type:	N/A	N/A
Material Assessment Score:		N/A
Priority Assessment Score:		N/A
Action:	N/A	
Comments:	N/A

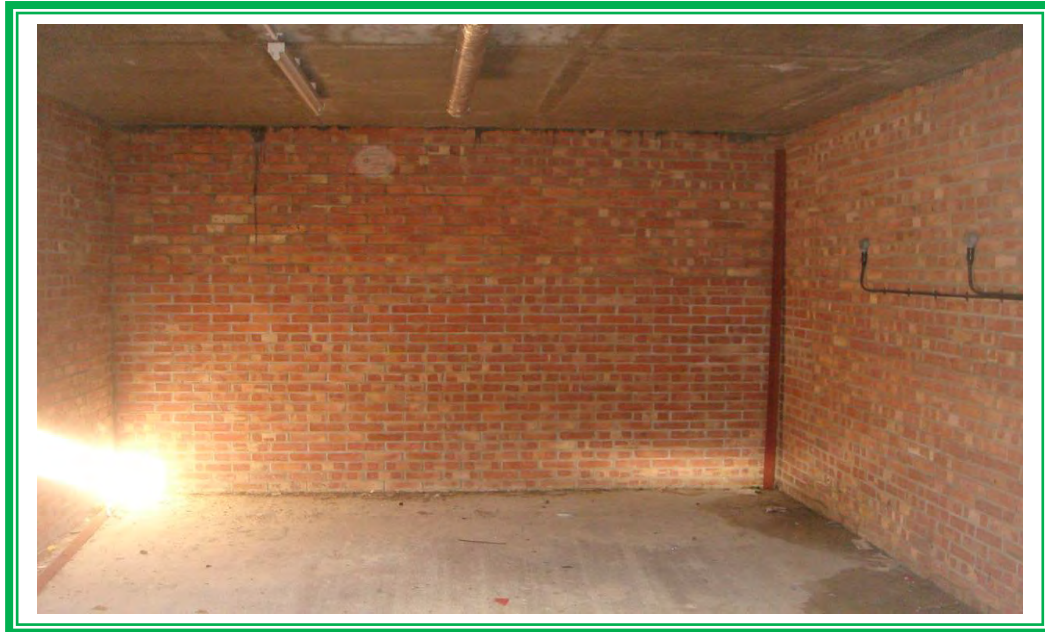
Location: 2/005

Material Description:	Visual Inspection – No Suspect Materials Found	
Identification:	N/A	
Approx. quantity:	N/A	
Accessibility	N/A	Assessment Score
Product type:	N/A	N/A
Extent of Damage:	N/A	N/A
Surface Treatment:	N/A	N/A
Asbestos type:	N/A	N/A
Material Assessment Score:		N/A
Priority Assessment Score:		N/A
Action:	N/A	
Comments:	N/A

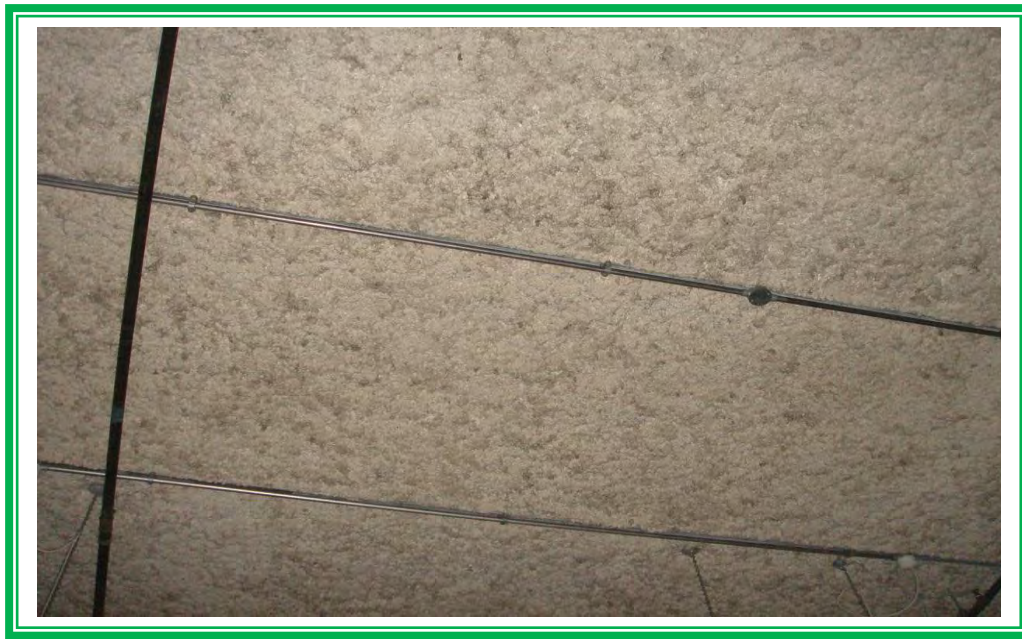
Location: 1/001, 1/002 and 1/003, Loading Bay and Stores x 2

Material Description:	Spray Coating to Ceiling/Beams	
Identification:	Sampled – No Asbestos Detected	
Approx. quantity:	Throughout Floor	
Accessibility	N/A	Assessment Score
Product type:	N/A	N/A
Extent of Damage:	N/A	N/A
Surface Treatment:	N/A	N/A
Asbestos type:	N/A	N/A
Material Assessment Score:		N/A
Priority Assessment Score:		N/A
Action:	N/A	
Comments:	N/A

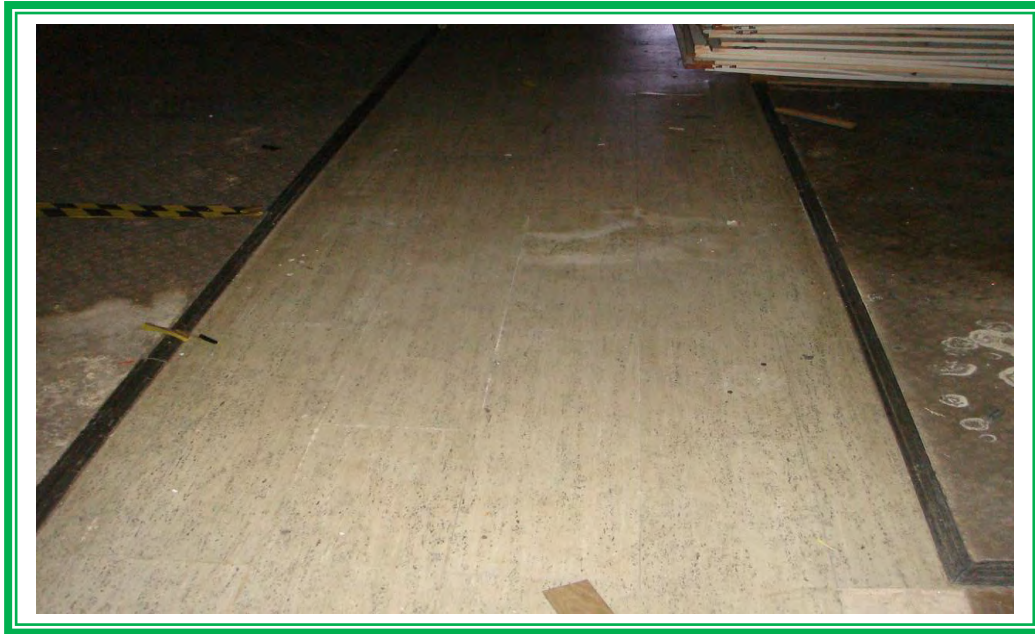
Location: 1/004 Main Shop Floor and Changing Rooms

Material Description:	Floor Tiles	
Identification:	Sampled – No Asbestos Detected	
Approx. quantity:	40M2	
Accessibility	N/A	Assessment Score
Product type:	N/A	N/A
Extent of Damage:	N/A	N/A
Surface Treatment:	N/A	N/A
Asbestos type:	N/A	N/A
Material Assessment Score:		N/A
Priority Assessment Score:		N/A
Action:	N/A	
Comments:	N/A

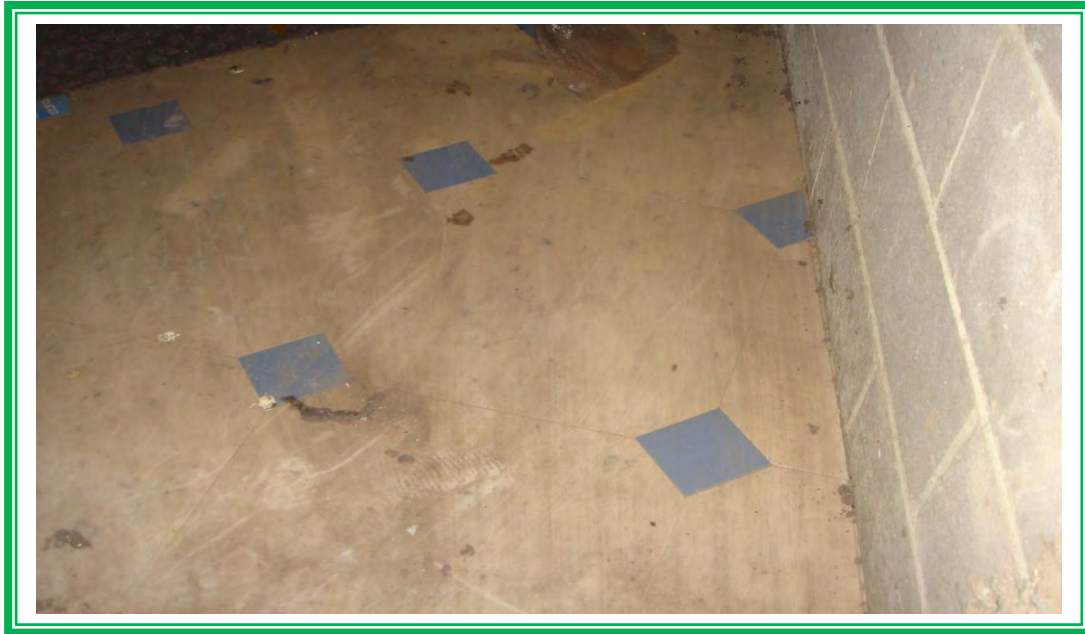
Location: 1/004 Main Shop Floor and Changing Rooms

Material Description:	Floor Tiles	
Identification:	Sampled – No Asbestos Detected	
Approx. quantity:	10M2 Visible – May be more under the carpet throughout	
Accessibility	N/A	Assessment Score
Product type:	N/A	N/A
Extent of Damage:	N/A	N/A
Surface Treatment:	N/A	N/A
Asbestos type:	N/A	N/A
Material Assessment Score:		N/A
Priority Assessment Score:		N/A
Action:	N/A	
Comments:	N/A

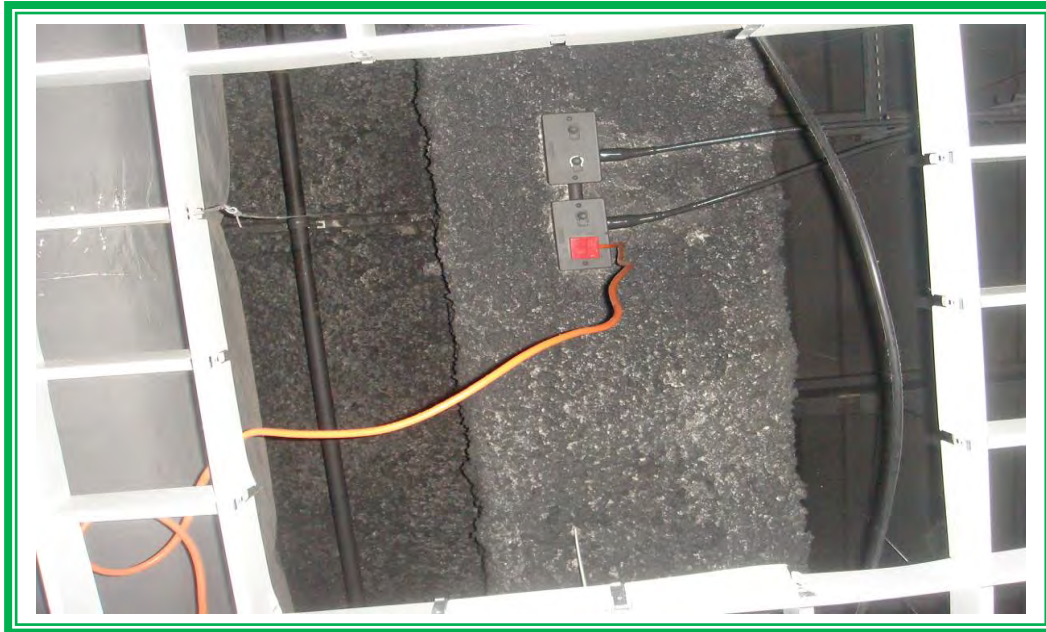
Location: 1/004 Main Shop Floor and Changing Rooms

Material Description:	Spray Coating to Ceilings/Beams	
Identification:	Sampled – No Asbestos Detected	
Approx. quantity:	Non-Quantifiable Throughout Floor	
Accessibility	N/A	Assessment Score
Product type:	N/A	N/A
Extent of Damage:	N/A	N/A
Surface Treatment:	N/A	N/A
Asbestos type:	N/A	N/A
Material Assessment Score:		N/A
Priority Assessment Score:		N/A
Action:	N/A	
Comments:	N/A

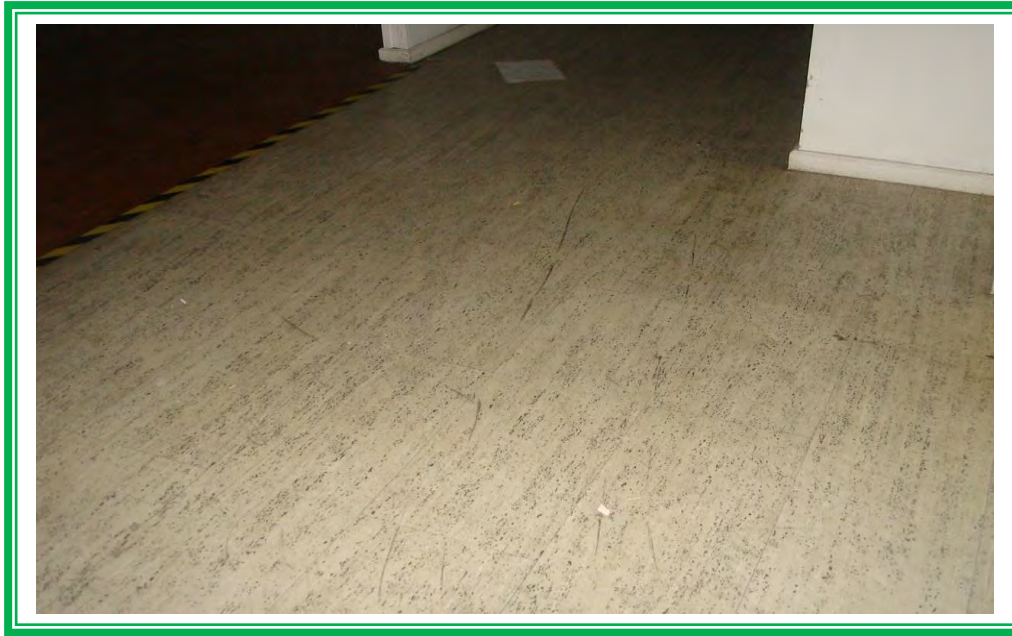
Location: 1/005 Corridor, Landing, 1006 Office and Stairwell

Material Description:	Floor Tiles	
Identification:	As Per Sample NE/2 – No Asbestos Detected	
Approx. quantity:	80M2	
Accessibility	N/A	Assessment Score
Product type:	N/A	N/A
Extent of Damage:	N/A	N/A
Surface Treatment:	N/A	N/A
Asbestos type:	N/A	N/A
Material Assessment Score:		N/A
Priority Assessment Score:		N/A
Action:	N/A	
Comments:	Non-Asbestos vermiculite panels in ceiling void

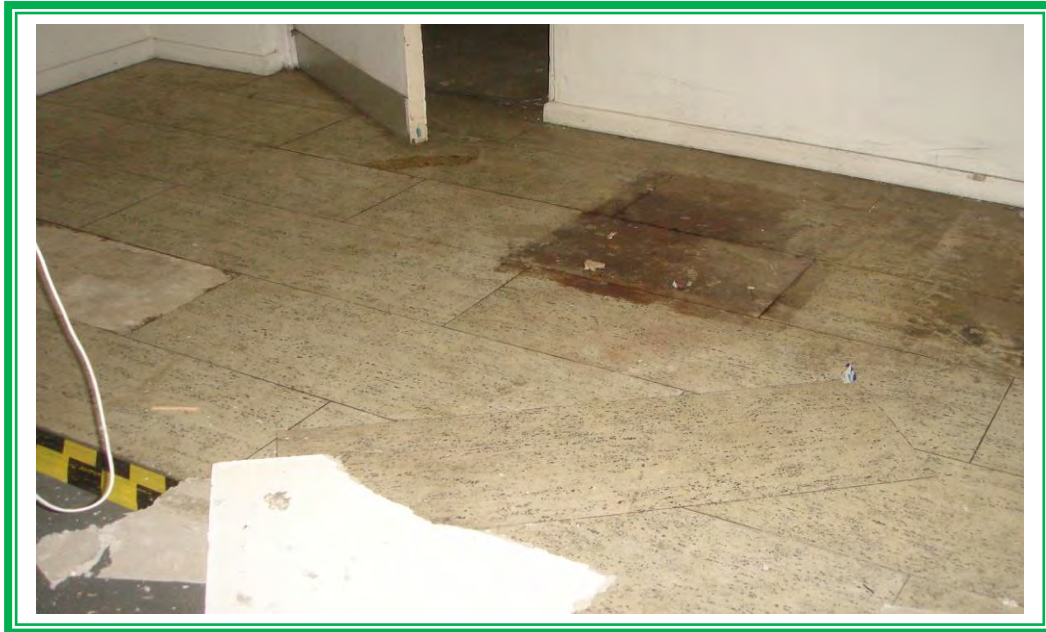
Location: 1/007 Office, 1/008 Kitchen and 1/009 Store

Material Description:	Floor Tiles	
Identification:	As Per Sample NE/2 – No Asbestos Detected	
Approx. quantity:	8M2	
Accessibility	N/A	Assessment Score
Product type:	N/A	N/A
Extent of Damage:	N/A	N/A
Surface Treatment:	N/A	N/A
Asbestos type:	N/A	N/A
Material Assessment Score:		N/A
Priority Assessment Score:		N/A
Action:	N/A	
Comments:	Modern water heater in store

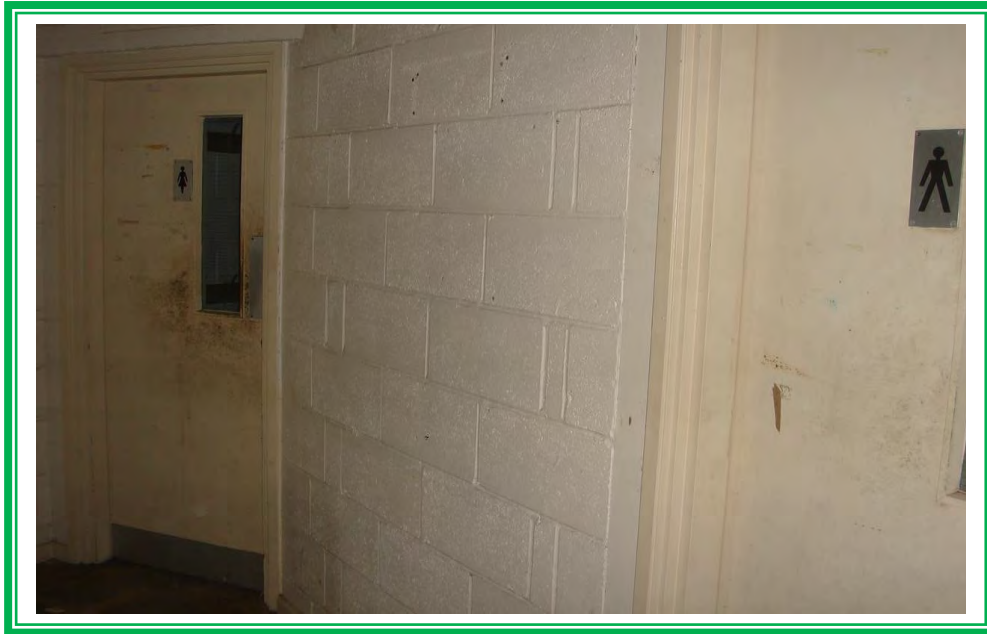
Location: 1/010 WC and 1/011 WC

Material Description:	Visual Inspection – No Suspect Materials Found	
Identification:	N/A	
Approx. quantity:	N/A	
Accessibility	N/A	Assessment Score
Product type:	N/A	N/A
Extent of Damage:	N/A	N/A
Surface Treatment:	N/A	N/A
Asbestos type:	N/A	N/A
Material Assessment Score:		N/A
Priority Assessment Score:		N/A
Action:	N/A	
Comments:	N/A
