# EAGLE QUARTER II NEWBURY

ASBESTOS SURVEY

Management  
Asbestos Survey Report

Kennet Centre, Market Street, Newbury,  
Berkshire, RG14 5EN

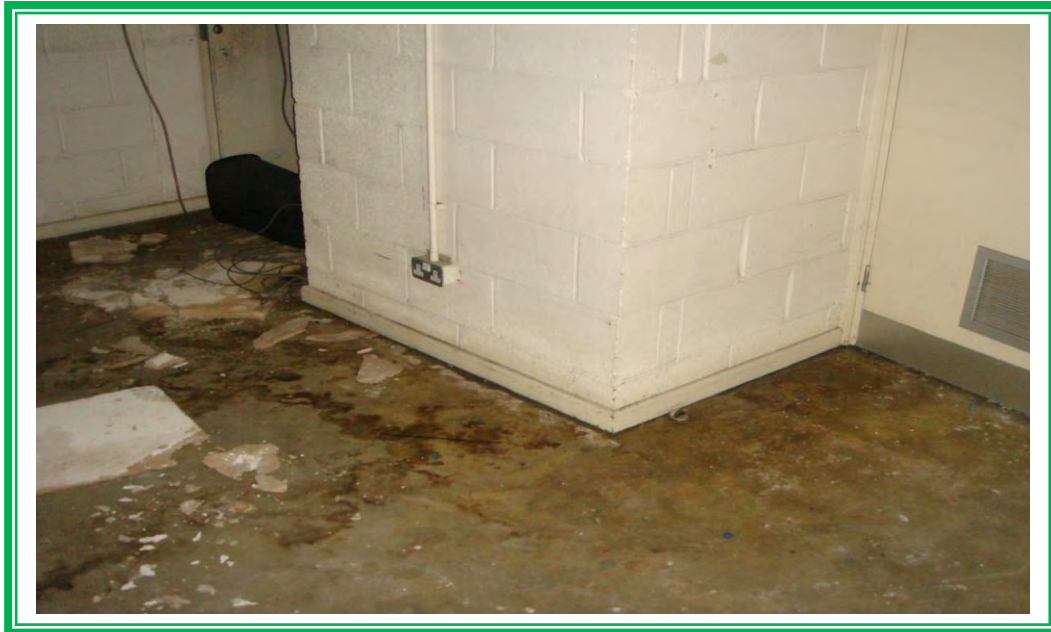
Location: 1/012 Lobby, 1/013 WC and 1/014 Office

Material Description:	Visual Inspection – No Suspect Materials Found	
Identification:	N/A	
Approx. quantity:	N/A	
Accessibility	N/A	Assessment Score
Product type:	N/A	N/A
Extent of Damage:	N/A	N/A
Surface Treatment:	N/A	N/A
Asbestos type:	N/A	N/A
Material Assessment Score:		N/A
Priority Assessment Score:		N/A
Action:	N/A	
Comments:	N/A

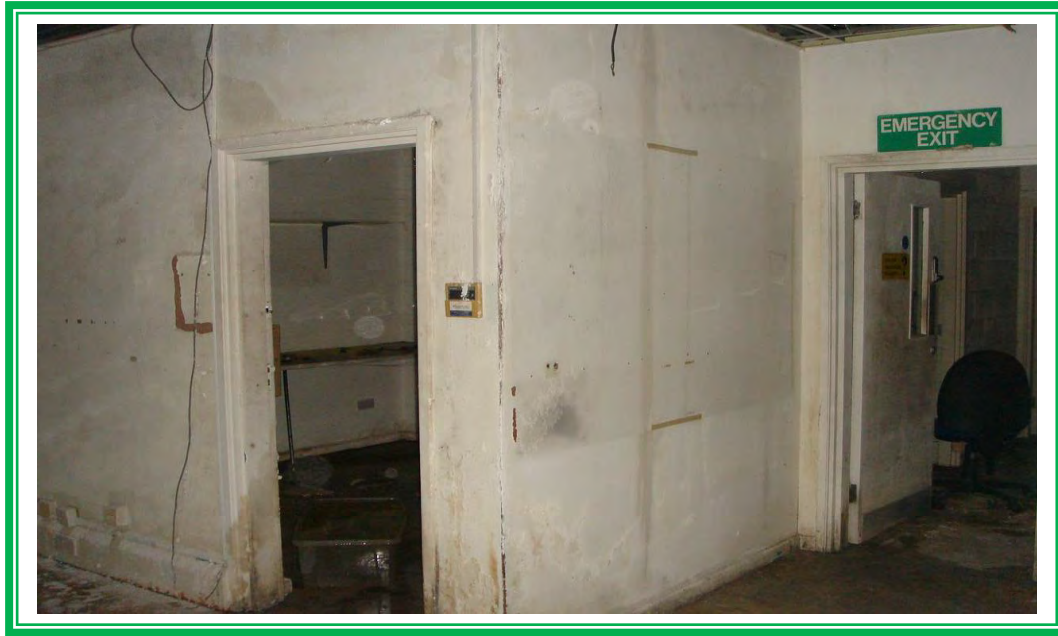
Location: 1/015 Cupboard, 1/016 Office and 1/017 Circulation

Material Description:	Visual Inspection – No Suspect Materials Found	
Identification:	N/A	
Approx. quantity:	N/A	
Accessibility	N/A	Assessment Score
Product type:	N/A	N/A
Extent of Damage:	N/A	N/A
Surface Treatment:	N/A	N/A
Asbestos type:	N/A	N/A
Material Assessment Score:		N/A
Priority Assessment Score:		N/A
Action:	N/A	
Comments:	N/A

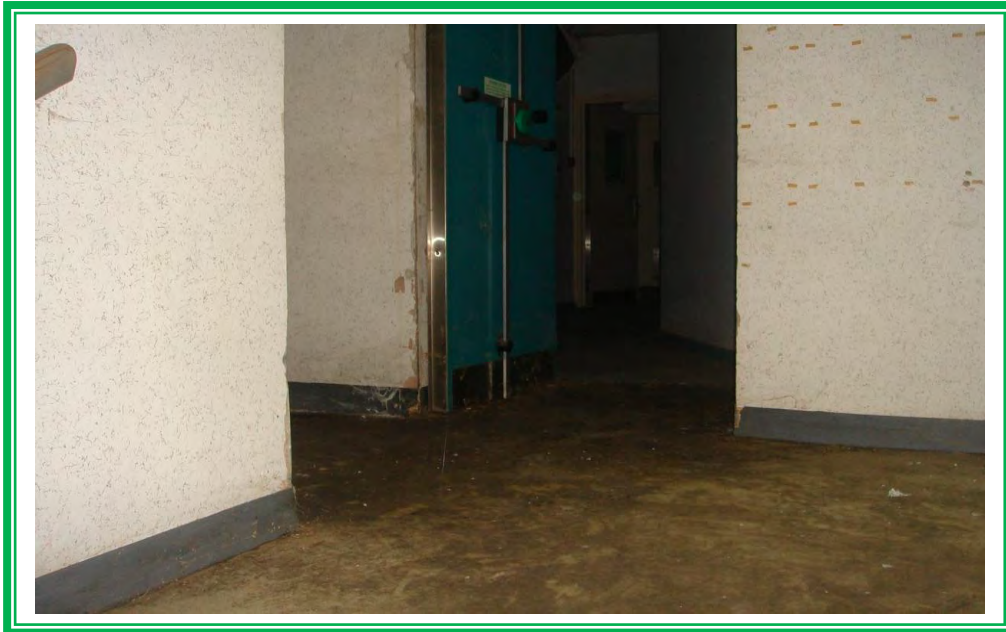
Location: 1/018 Office, 1/019 Landing and Stairwell

Material Description:	Visual Inspection – No Suspect Materials Found	
Identification:	N/A	
Approx. quantity:	N/A	
Accessibility	N/A	Assessment Score
Product type:	N/A	N/A
Extent of Damage:	N/A	N/A
Surface Treatment:	N/A	N/A
Asbestos type:	N/A	N/A
Material Assessment Score:		N/A
Priority Assessment Score:		N/A
Action:	N/A	
Comments:	Rubber Stair Nosing

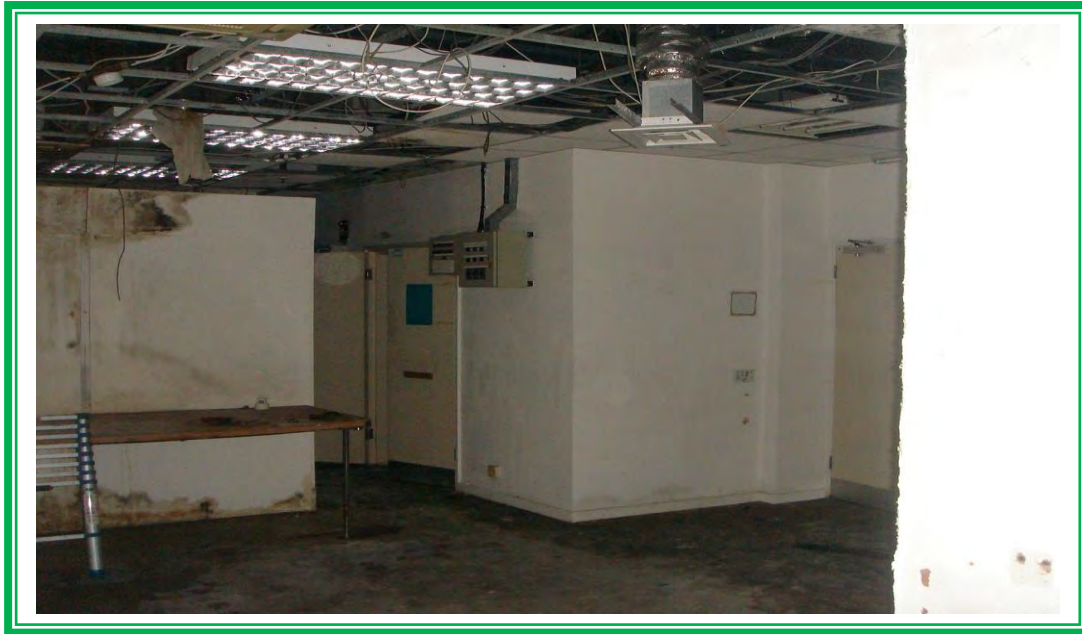
Location: 1/020 Lobby and 1/021 Office

Material Description:	Visual Inspection – No Suspect Materials Found	
Identification:	N/A	
Approx. quantity:	N/A	
Accessibility	N/A	Assessment Score
Product type:	N/A	N/A
Extent of Damage:	N/A	N/A
Surface Treatment:	N/A	N/A
Asbestos type:	N/A	N/A
Material Assessment Score:		N/A
Priority Assessment Score:		N/A
Action:	N/A	
Comments:	Non-Asbestos Electrical Panels

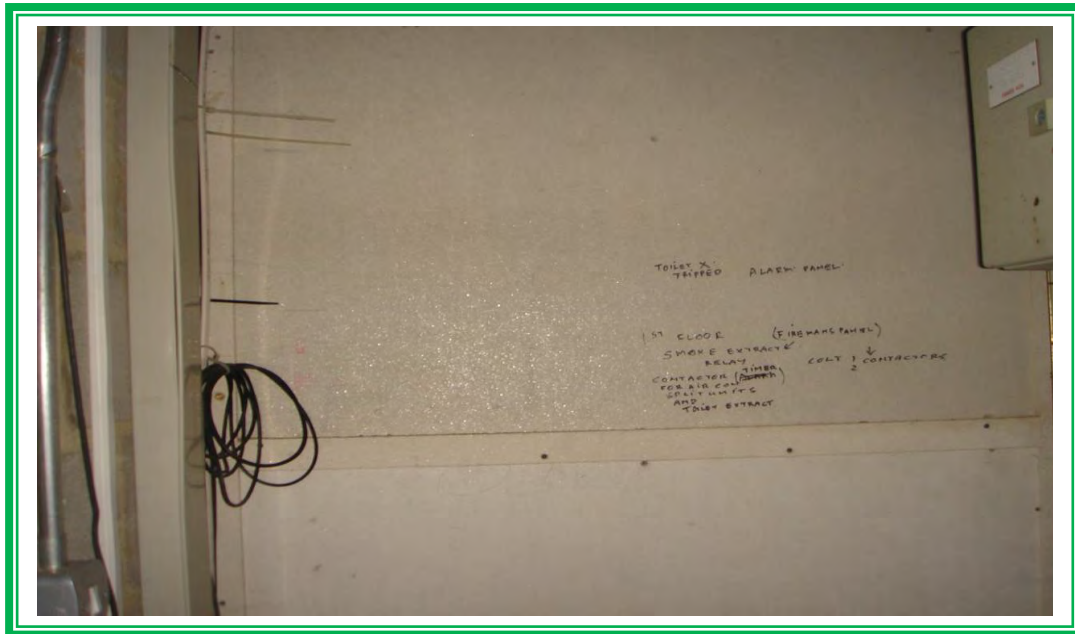
Location: 1/022 Switch Room

Material Description:	Insulation Board Wall Panels	
Identification:	Sampled – No Asbestos Detected	
Approx. quantity:	5M2	
Accessibility	N/A	Assessment Score
Product type:	N/A	N/A
Extent of Damage:	N/A	N/A
Surface Treatment:	N/A	N/A
Asbestos type:	N/A	N/A
Material Assessment Score:		N/A
Priority Assessment Score:		N/A
Action:	N/A	
Comments:	Non-Asbestos Electrics

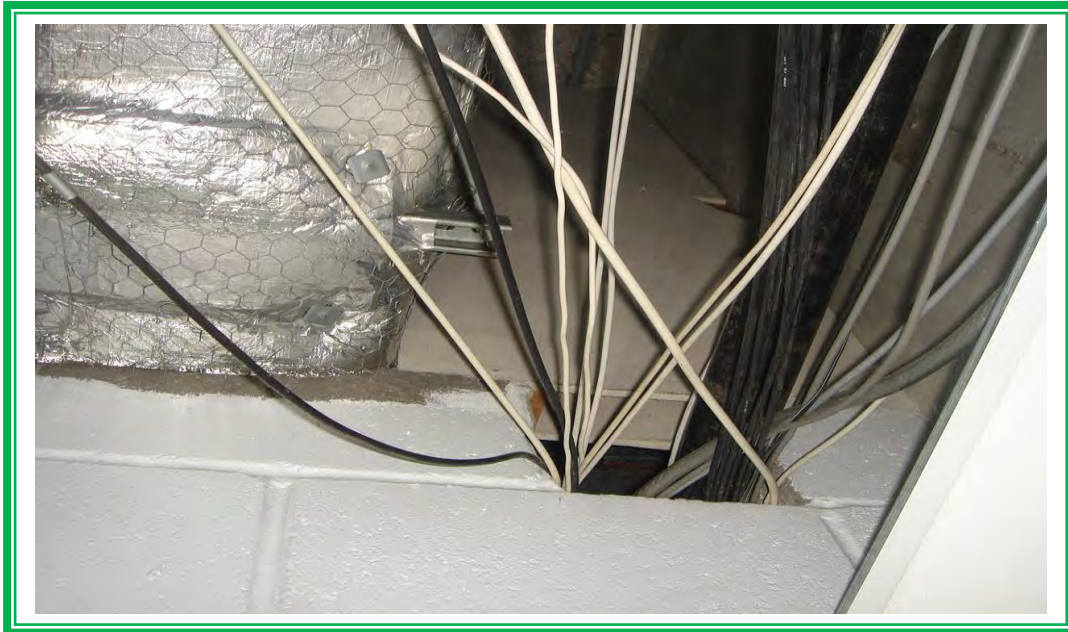
Location: 1/023 Corridor

Material Description:	Insulation Board Wall Panels	
Identification:	As Per Sample NE/5 – No Asbestos Detected	
Approx. quantity:	6M2	
Accessibility	N/A	Assessment Score
Product type:	N/A	N/A
Extent of Damage:	N/A	N/A
Surface Treatment:	N/A	N/A
Asbestos type:	N/A	N/A
Material Assessment Score:		N/A
Priority Assessment Score:		N/A
Action:	N/A	
Comments:	N/A

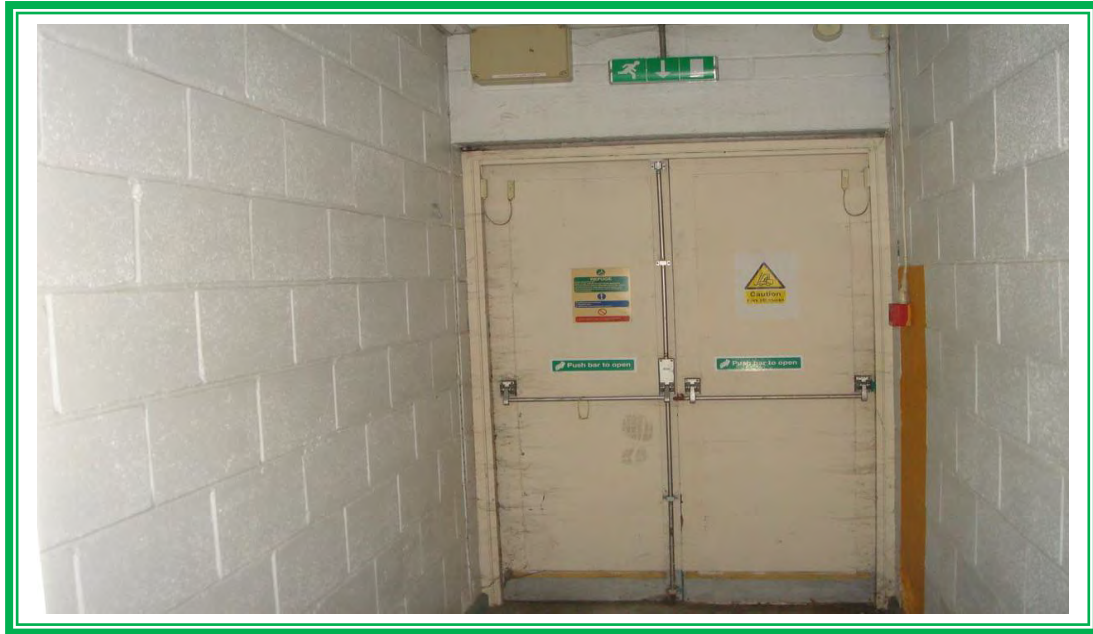
Location: 1/024 Lobby

Material Description:	Visual Inspection – No Suspect Materials Found	
Identification:	N/A	
Approx. quantity:	N/A	
Accessibility	N/A	Assessment Score
Product type:	N/A	N/A
Extent of Damage:	N/A	N/A
Surface Treatment:	N/A	N/A
Asbestos type:	N/A	N/A
Material Assessment Score:		N/A
Priority Assessment Score:		N/A
Action:	N/A	
Comments:	N/A

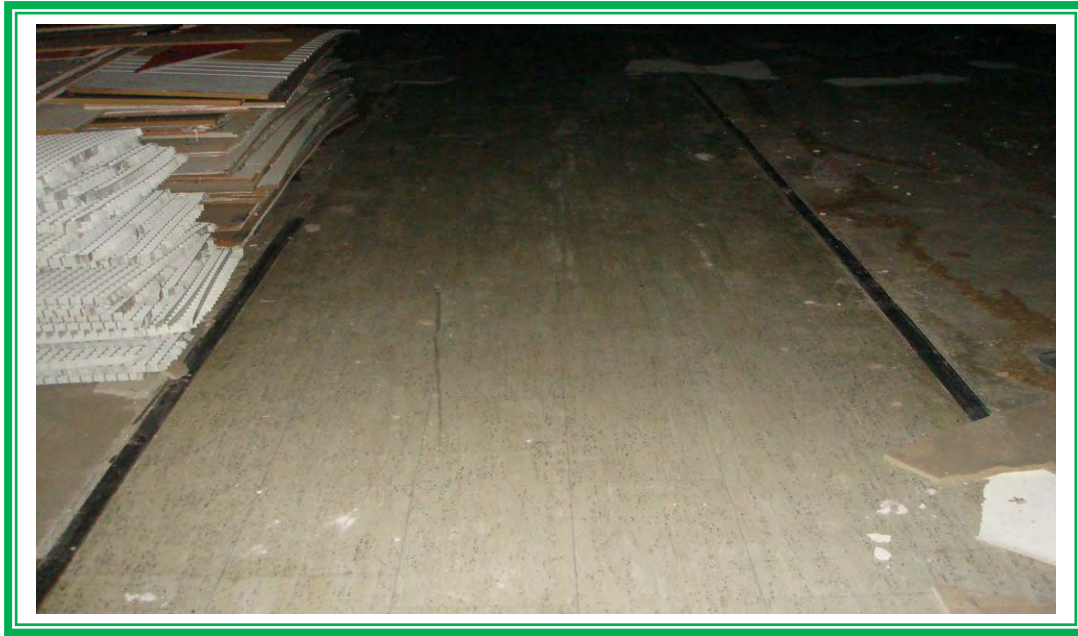
Location: 0/001 Main Shop Floor, Including stores,  
Fitting Rooms and Shop Windows

Material Description:	Floor Tiles	
Identification:	Sampled – No Asbestos Detected	
Approx. quantity:	100M2 +	
Accessibility	N/A	Assessment Score
Product type:	N/A	N/A
Extent of Damage:	N/A	N/A
Surface Treatment:	N/A	N/A
Asbestos type:	N/A	N/A
Material Assessment Score:		N/A
Priority Assessment Score:		N/A
Action:	N/A	
Comments:	N/A

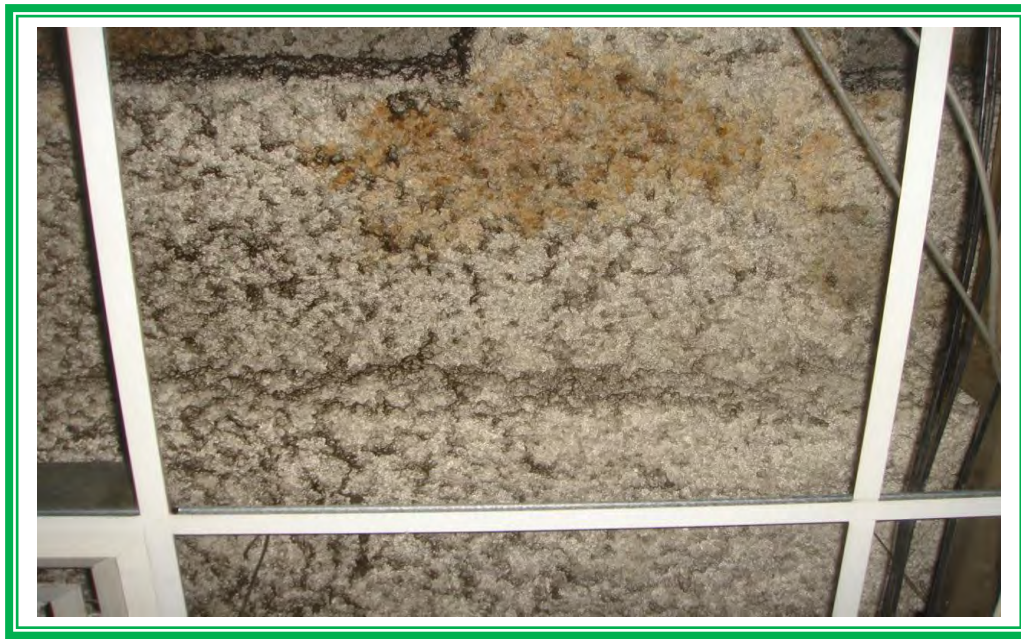
Location: 0/001 Main Shop Floor Including Stores,  
Fitting Rooms and Shop Windows

Material Description:	Spray Coating to Ceiling/Beams	
Identification:	Sampled – No Asbestos Detected	
Approx. quantity:	Non-Quantifiable Throughout Ground Floor	
Accessibility	N/A	Assessment Score
Product type:	N/A	N/A
Extent of Damage:	N/A	N/A
Surface Treatment:	N/A	N/A
Asbestos type:	N/A	N/A
Material Assessment Score:		N/A
Priority Assessment Score:		N/A
Action:	N/A	
Comments:	N/A

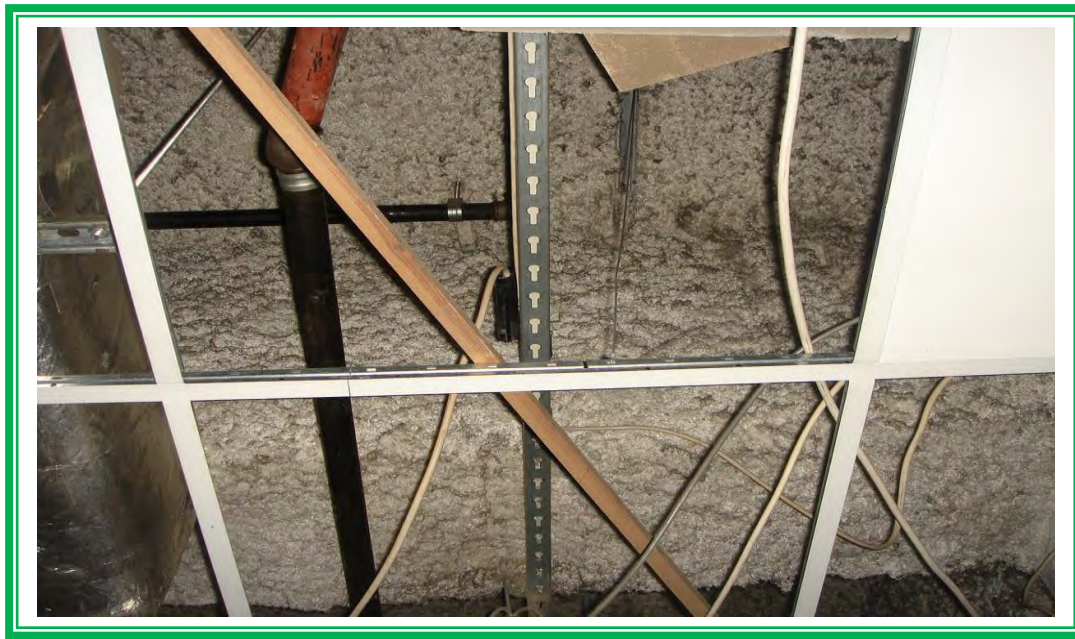
Location: 0/001 Main Shop Floor Including Stores,  
Fitting Rooms and Shop Windows

Material Description:	Spray Coating to Ceiling/Beams	
Identification:	Sampled – No Asbestos Detected	
Approx. quantity:	Non-Quantifiable Throughout Ground Floor	
Accessibility	N/A	Assessment Score
Product type:	N/A	N/A
Extent of Damage:	N/A	N/A
Surface Treatment:	N/A	N/A
Asbestos type:	N/A	N/A
Material Assessment Score:		N/A
Priority Assessment Score:		N/A
Action:	N/A	
Comments:	N/A

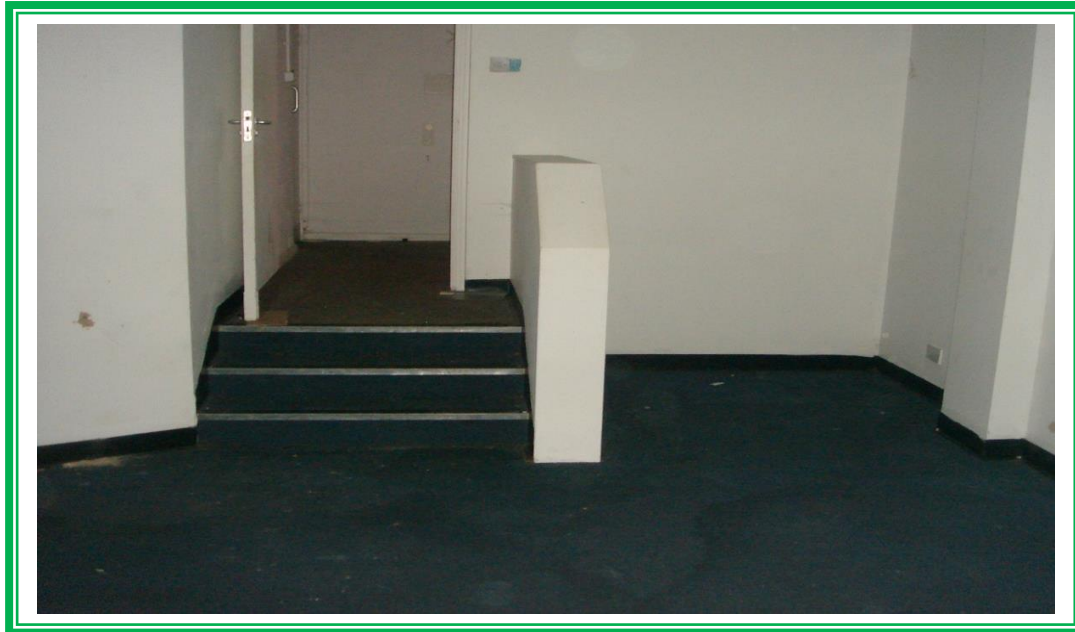
Location: 0/002 Store

Material Description:	Visual Inspection – No Suspect Materials Found	
Identification:	N/A	
Approx. quantity:	N/A	
Accessibility	N/A	Assessment Score
Product type:	N/A	N/A
Extent of Damage:	N/A	N/A
Surface Treatment:	N/A	N/A
Asbestos type:	N/A	N/A
Material Assessment Score:		N/A
Priority Assessment Score:		N/A
Action:	N/A	
Comments:	N/A

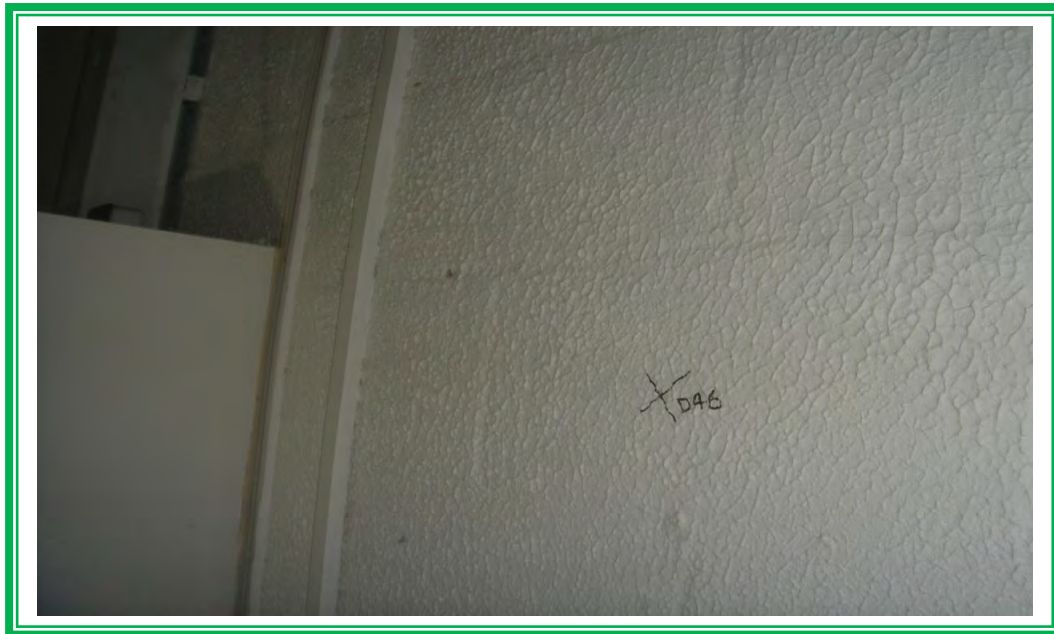
Location: 0/003 Office

Material Description:	Textured Coating to Walls	
Identification:	Sampled – No Asbestos Detected	
Approx. quantity:	22M2	
Accessibility	N/A	Assessment Score
Product type:	N/A	N/A
Extent of Damage:	N/A	N/A
Surface Treatment:	N/A	N/A
Asbestos type:	N/A	N/A
Material Assessment Score:		N/A
Priority Assessment Score:		N/A
Action:	N/A	
Comments:	Modern Electrics

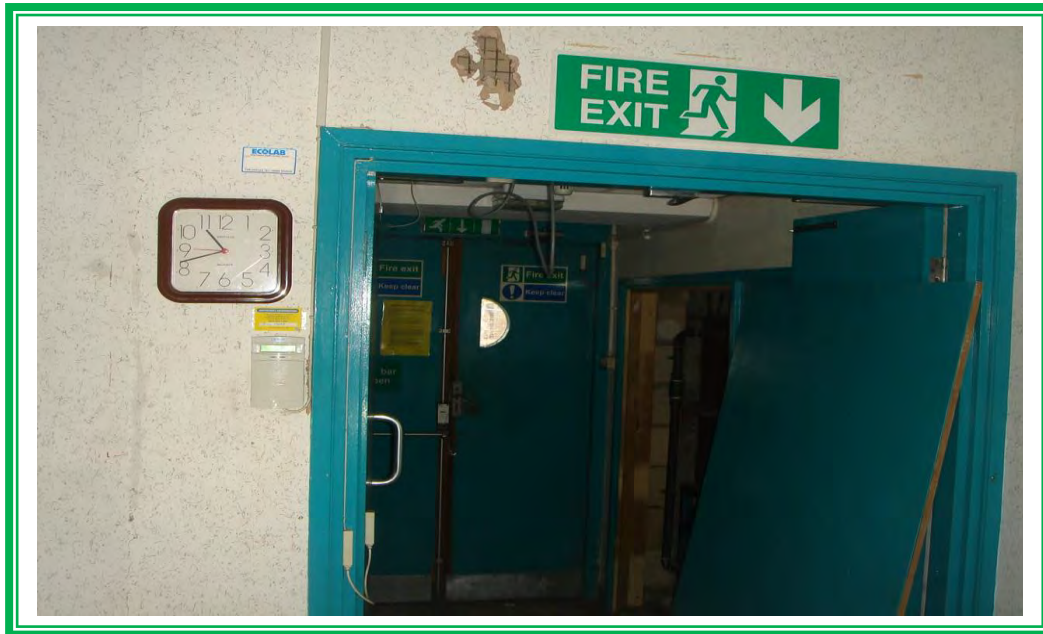
Location: 0/004 Stairwell Lobby, Lobby and Tank Room

Material Description:	Visual Inspection – No Suspect Materials Found	
Identification:	N/A	
Approx. quantity:	N/A	
Accessibility	N/A	Assessment Score
Product type:	N/A	N/A
Extent of Damage:	N/A	N/A
Surface Treatment:	N/A	N/A
Asbestos type:	N/A	N/A
Material Assessment Score:		N/A
Priority Assessment Score:		N/A
Action:	N/A	
Comments:	N/A

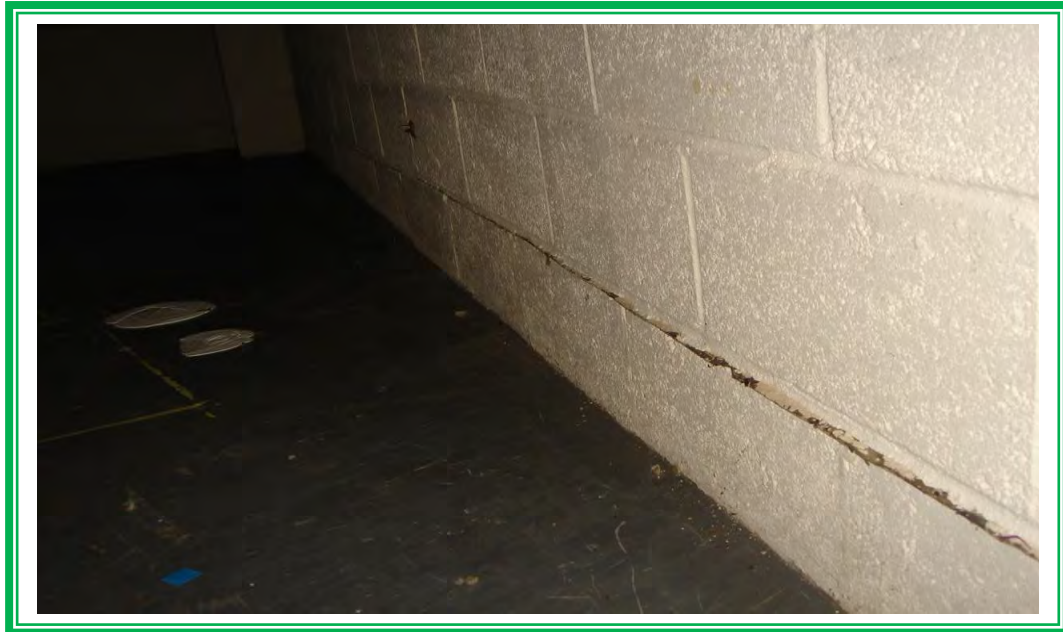
Location: 0/005 Store

Material Description:	Visual Inspection – No Suspect Materials Found	
Identification:	N/A	
Approx. quantity:	N/A	
Accessibility	N/A	Assessment Score
Product type:	N/A	N/A
Extent of Damage:	N/A	N/A
Surface Treatment:	N/A	N/A
Asbestos type:	N/A	N/A
Material Assessment Score:		N/A
Priority Assessment Score:		N/A
Action:	N/A	
Comments:	N/A

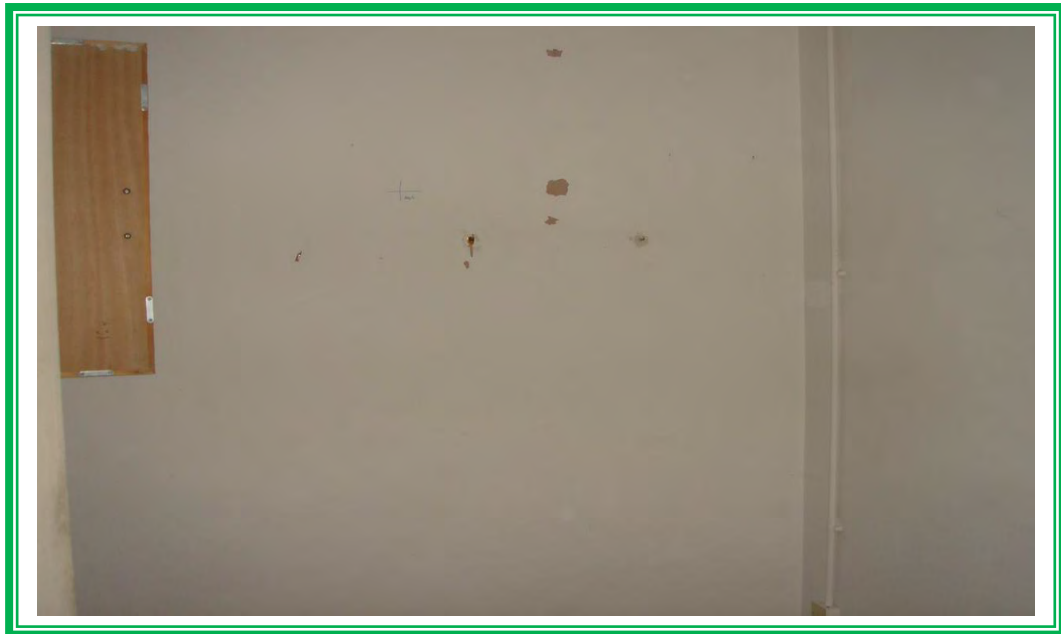
Location: 0/006 Office

Material Description:	Visual Inspection – No Suspect Materials Found	
Identification:	N/A	
Approx. quantity:	N/A	
Accessibility	N/A	Assessment Score
Product type:	N/A	N/A
Extent of Damage:	N/A	N/A
Surface Treatment:	N/A	N/A
Asbestos type:	N/A	N/A
Material Assessment Score:		N/A
Priority Assessment Score:		N/A
Action:	N/A	
Comments:	Modern Electrics

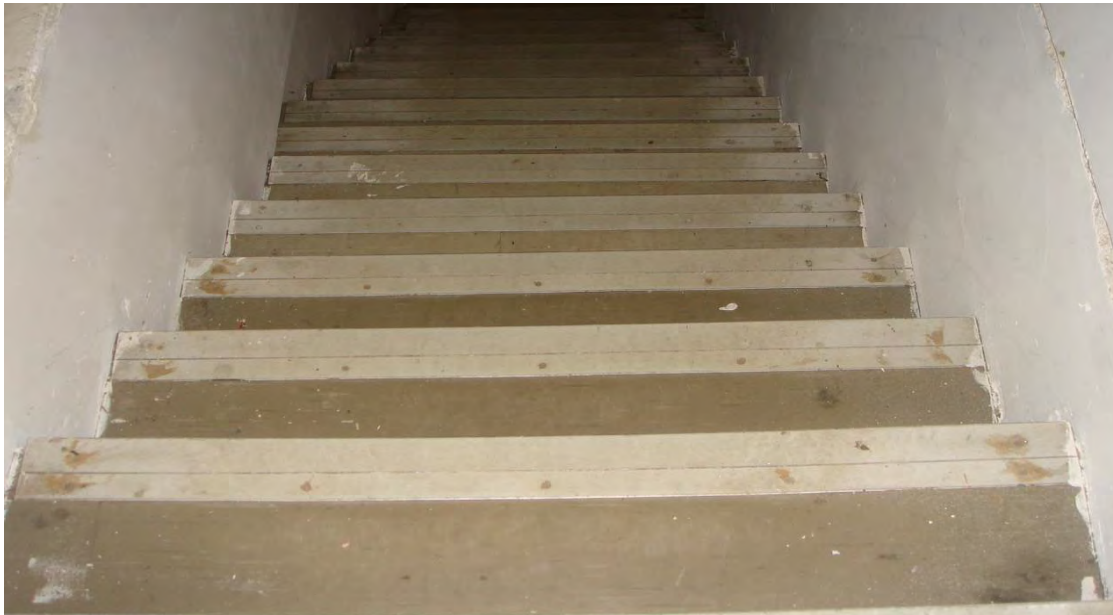
Location: 1/003 Stairs

Material Description:	Vinyl Floor Tiles	
Identification:	Sampled – Asbestos Detected	
Approx. quantity:	30M2	
Accessibility	Medium	Assessment Score
Product type:	Vinyl	1
Extent of Damage:	Minor	1
Surface Treatment:	Non-Friable	0
Asbestos type:	Chrysotile	1
Material Assessment Score:		3
Priority Assessment Score:		Negligible
Action:	Manage	
Comments:	N/A

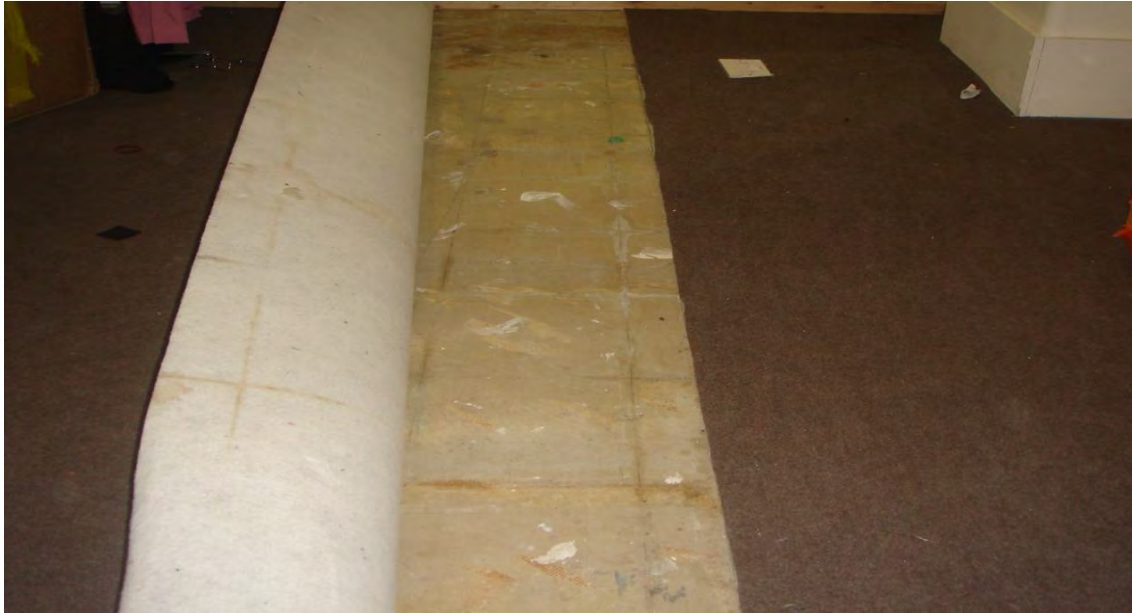
Location: 0/002 Store

Material Description:	Vinyl Floor Tiles	
Identification:	Sampled – Asbestos Detected	
Approx. quantity:	25M2	
Accessibility	Low	Assessment Score
Product type:	Vinyl	1
Extent of Damage:	Minor	1
Surface Treatment:	Non-Friable	0
Asbestos type:	Chrysotile	1
Material Assessment Score:		3
Priority Assessment Score:		Negligible
Action:	Manage	
Comments:	N/A

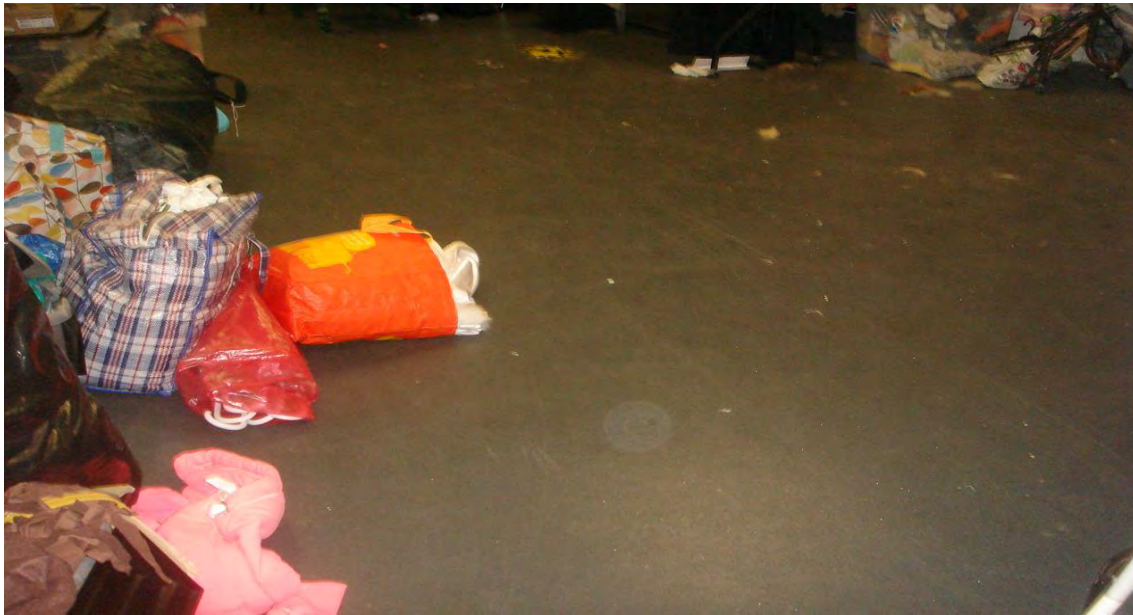
Location: 0/001

Material Description:	Vinyl Floor Tiles	
Identification:	As Per Sample NE/ - Asbestos Detected	
Approx. quantity:	75M2	
Accessibility	Low	Assessment Score
Product type:	Vinyl	1
Extent of Damage:	Minor	1
Surface Treatment:	Non-Friable	0
Asbestos type:	Chrysotile	1
Material Assessment Score:		3
Priority Assessment Score:		Negligible
Action:	Manage	
Comments:	Below Modern Vinyl

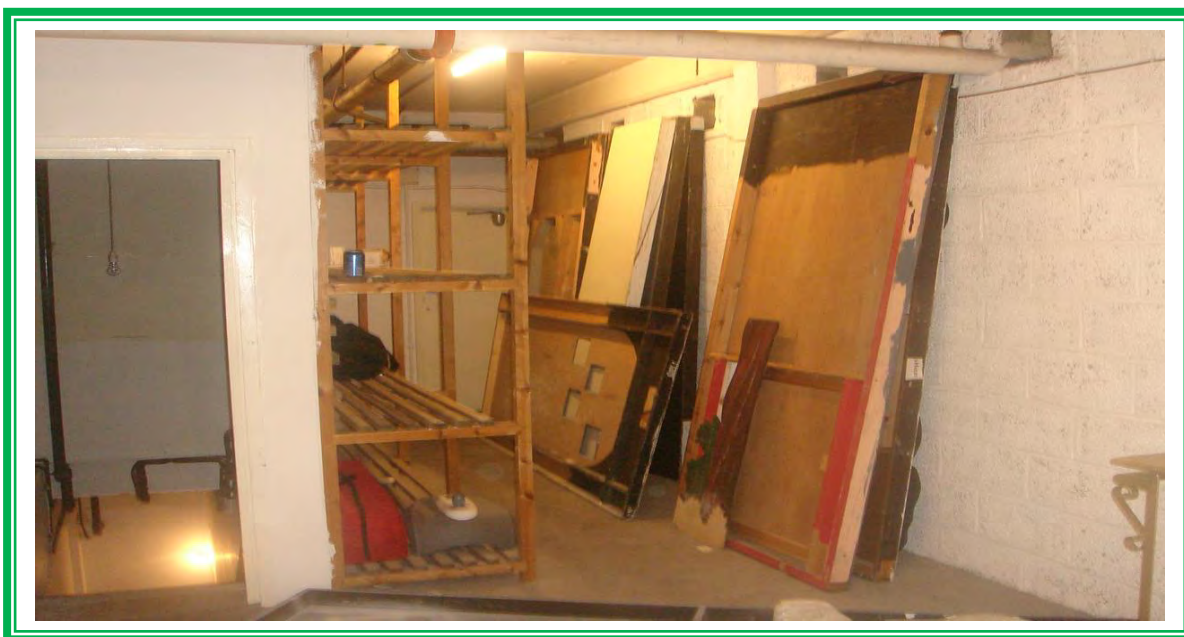
Location: 1/001 Store

Material Description:	Visual Inspection – No Suspect Materials Found	
Identification:	N/A	
Approx. quantity:	N/A	
Accessibility	N/A	Assessment Score
Product type:	N/A	N/A
Extent of Damage:	N/A	N/A
Surface Treatment:	N/A	N/A
Asbestos type:	N/A	N/A
Material Assessment Score:		N/A
Priority Assessment Score:		N/A
Action:	N/A	
Comments:	N/A

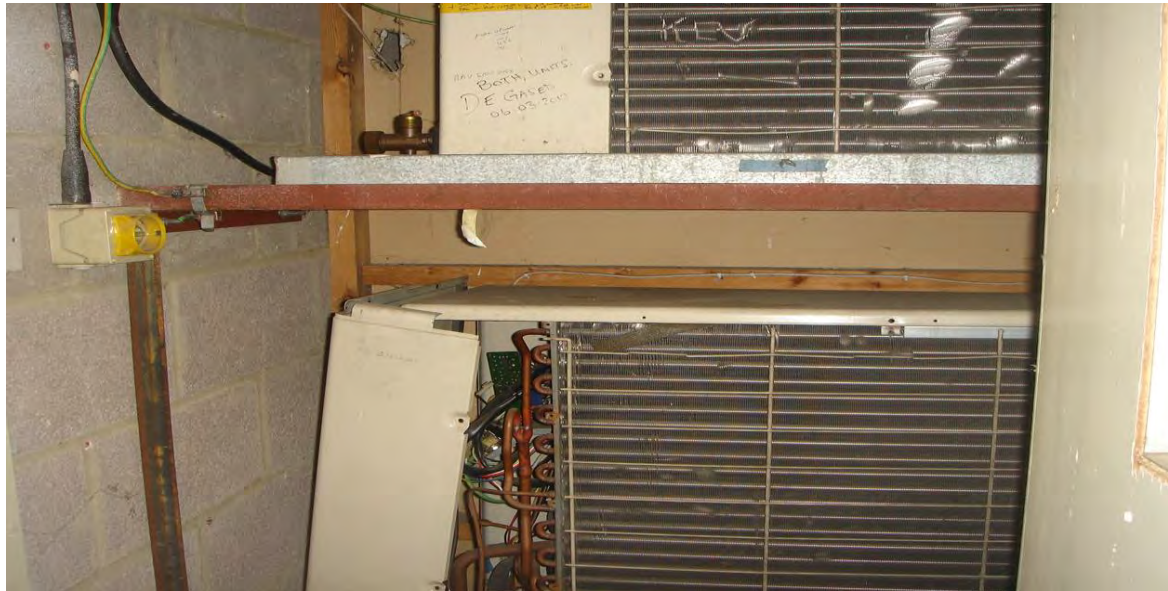
Location: 1/001A Cupboard

Material Description:	Visual Inspection – No Suspect Materials Found	
Identification:	N/A	
Approx. quantity:	N/A	
Accessibility	N/A	Assessment Score
Product type:	N/A	N/A
Extent of Damage:	N/A	N/A
Surface Treatment:	N/A	N/A
Asbestos type:	N/A	N/A
Material Assessment Score:		N/A
Priority Assessment Score:		N/A
Action:	N/A	
Comments:	N/A

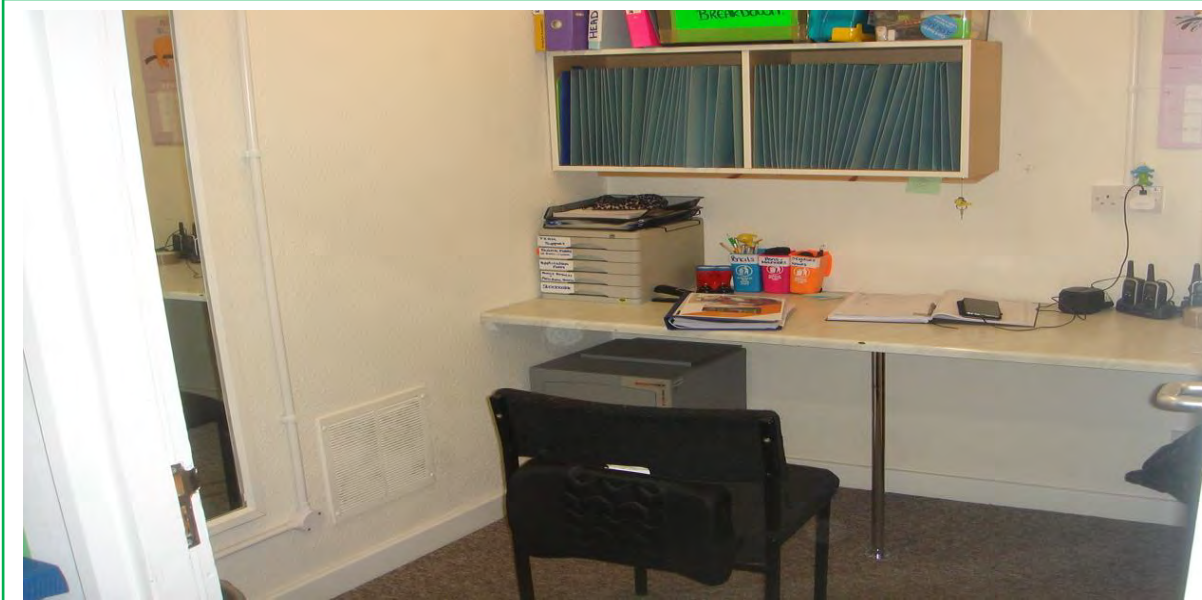
Location: 1/002 Office

Material Description:	Visual Inspection – No Suspect Materials Found	
Identification:	N/A	
Approx. quantity:	N/A	
Accessibility	N/A	Assessment Score
Product type:	N/A	N/A
Extent of Damage:	N/A	N/A
Surface Treatment:	N/A	N/A
Asbestos type:	N/A	N/A
Material Assessment Score:		N/A
Priority Assessment Score:		N/A
Action:	N/A	
Comments:	N/A

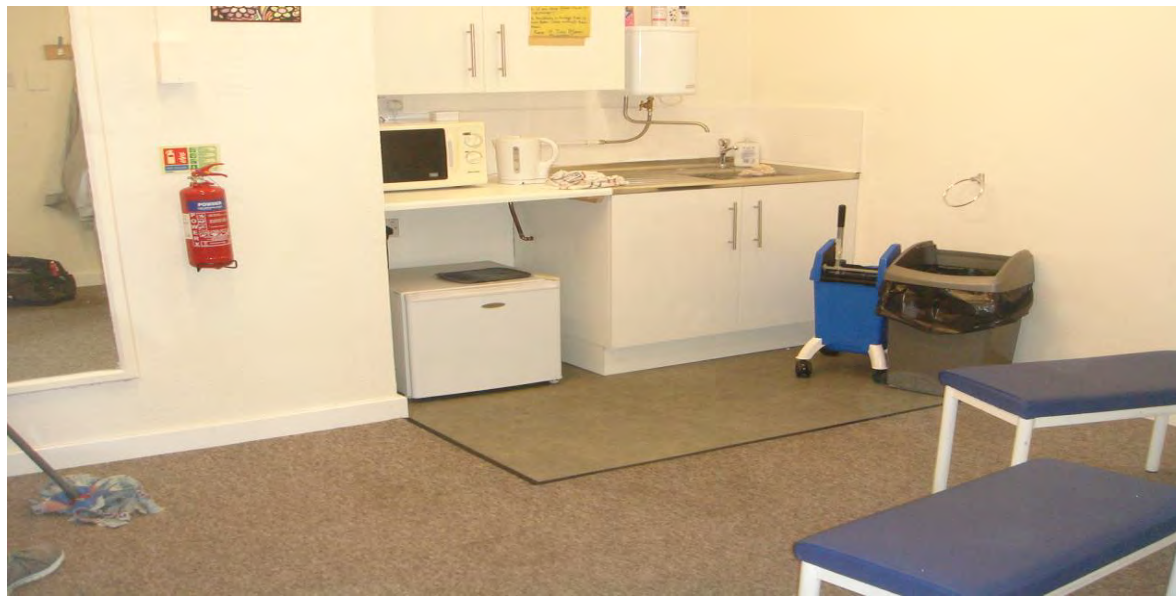
Location: 1/003 Kitchen

Material Description:	Visual Inspection – No Suspect Materials Found	
Identification:	N/A	
Approx. quantity:	N/A	
Accessibility	N/A	Assessment Score
Product type:	N/A	N/A
Extent of Damage:	N/A	N/A
Surface Treatment:	N/A	N/A
Asbestos type:	N/A	N/A
Material Assessment Score:		N/A
Priority Assessment Score:		N/A
Action:	N/A	
Comments:	N/A

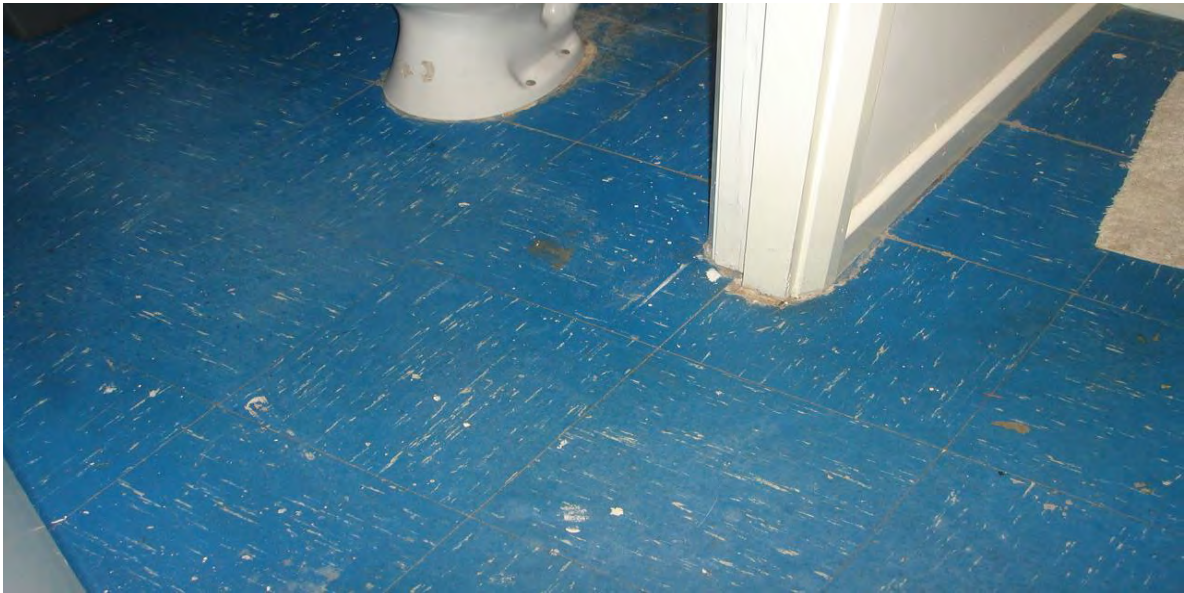
Location: 1/005 WC

Material Description:	Vinyl Floor Tiles	
Identification:	As Per Sampled NE/1 – No Asbestos Detected	
Approx. quantity:	2M2	
Accessibility	N/A	Assessment Score
Product type:	N/A	N/A
Extent of Damage:	N/A	N/A
Surface Treatment:	N/A	N/A
Asbestos type:	N/A	N/A
Material Assessment Score:		N/A
Priority Assessment Score:		N/A
Action:	N/A	
Comments:	N/A

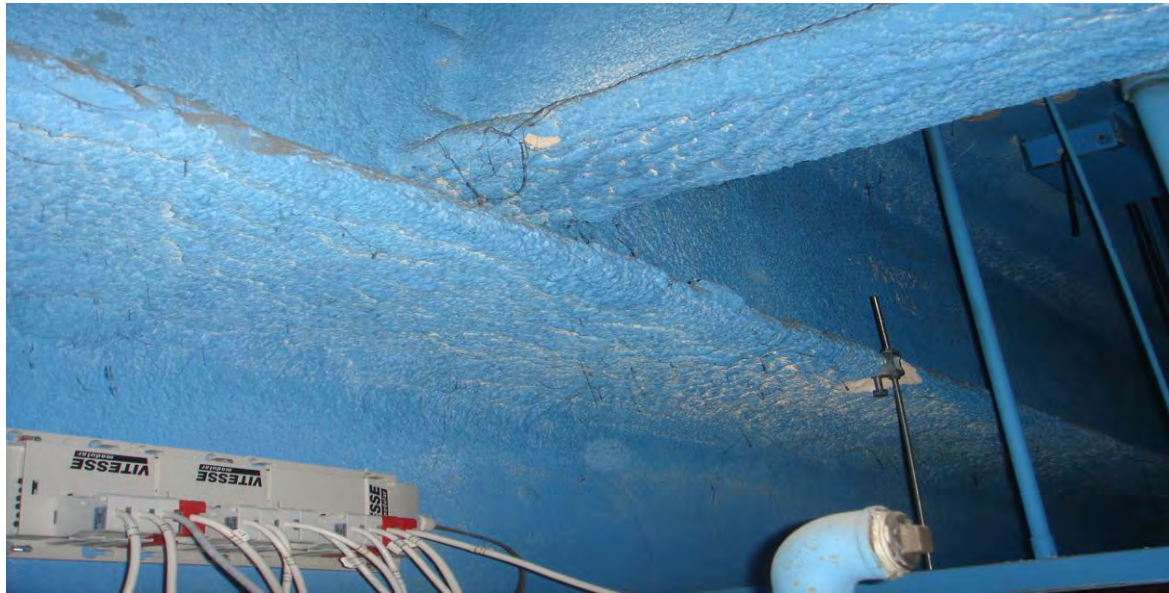
Location: 0/001 Shop Floor

Material Description:	Sprayed Coating	
Identification:	Sampled – No Asbestos Detected	
Approx. quantity:	20M2	
Accessibility	N/A	Assessment Score
Product type:	N/A	N/A
Extent of Damage:	N/A	N/A
Surface Treatment:	N/A	N/A
Asbestos type:	N/A	N/A
Material Assessment Score:		N/A
Priority Assessment Score:		N/A
Action:	N/A	
Comments:	Coating is Encapsulated

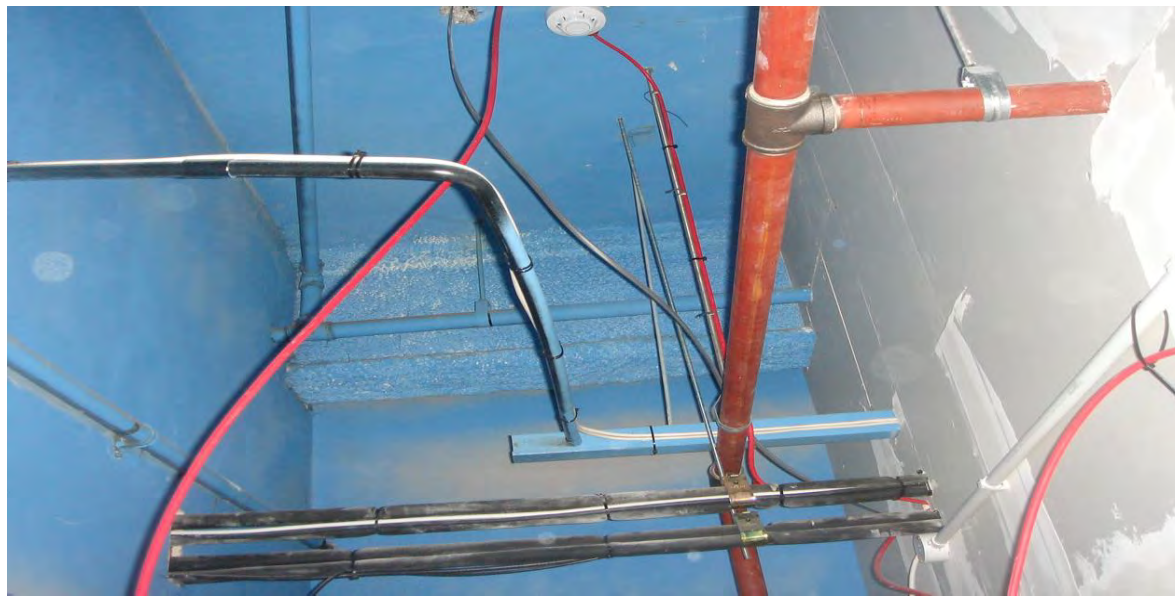
Location: 0/002 Lobby

Material Description:	Sprayed Coating to Beams	
Identification:	As Per Sample NE/2 – No Asbestos Detected	
Approx. quantity:	4M2	
Accessibility	N/A	Assessment Score
Product type:	N/A	N/A
Extent of Damage:	N/A	N/A
Surface Treatment:	N/A	N/A
Asbestos type:	N/A	N/A
Material Assessment Score:		N/A
Priority Assessment Score:		N/A
Action:	N/A	
Comments:	N/A

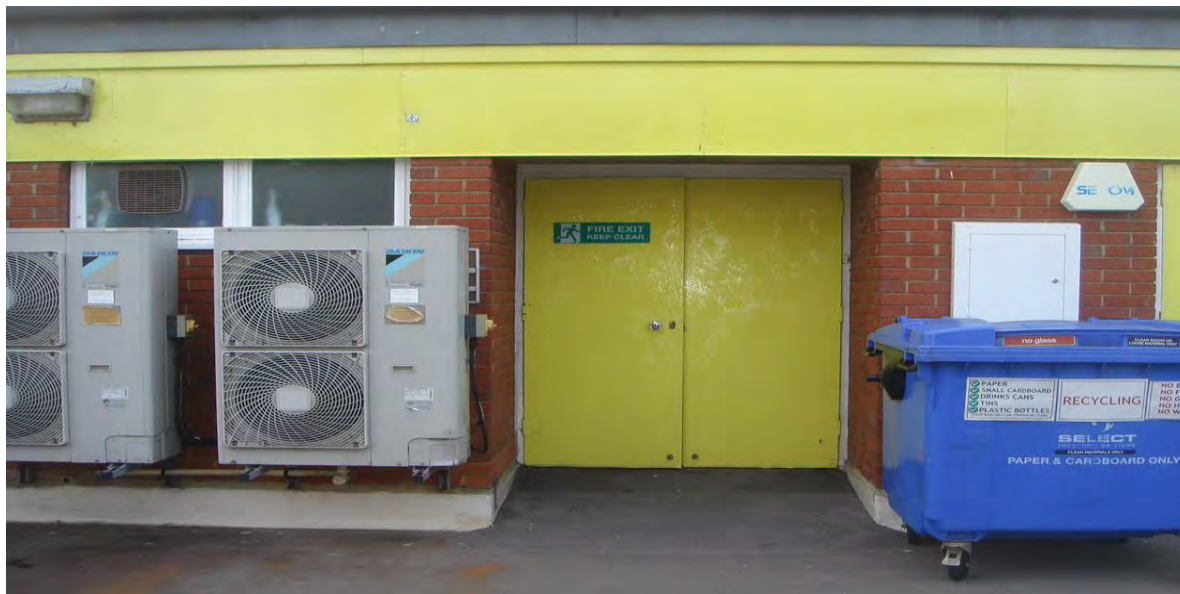
Location: 99/001

Material Description:	Visual Inspection – No Suspect Materials Found	
Identification:	N/A	
Approx. quantity:	N/A	
Accessibility	N/A	Assessment Score
Product type:	N/A	N/A
Extent of Damage:	N/A	N/A
Surface Treatment:	N/A	N/A
Asbestos type:	N/A	N/A
Material Assessment Score:		N/A
Priority Assessment Score:		N/A
Action:	N/A	
Comments:	N/A

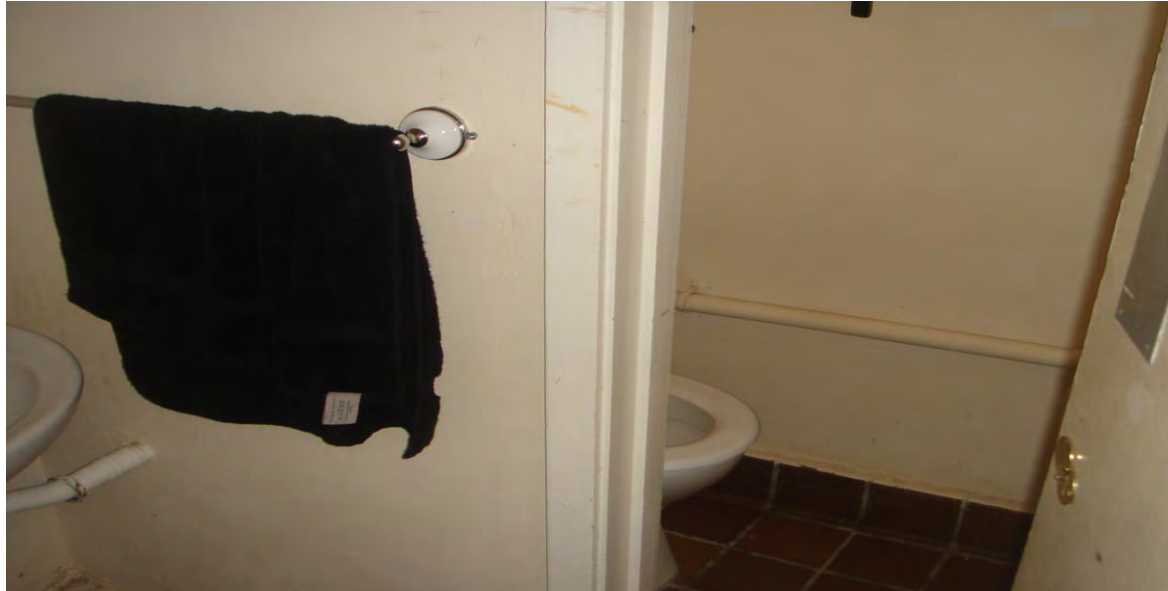
Location: 1/002 WC

Material Description:	Visual Inspection – No Suspect Materials Found	
Identification:	N/A	
Approx. quantity:	N/A	
Accessibility	N/A	Assessment Score
Product type:	N/A	N/A
Extent of Damage:	N/A	N/A
Surface Treatment:	N/A	N/A
Asbestos type:	N/A	N/A
Material Assessment Score:		N/A
Priority Assessment Score:		N/A
Action:	N/A	
Comments:	N/A

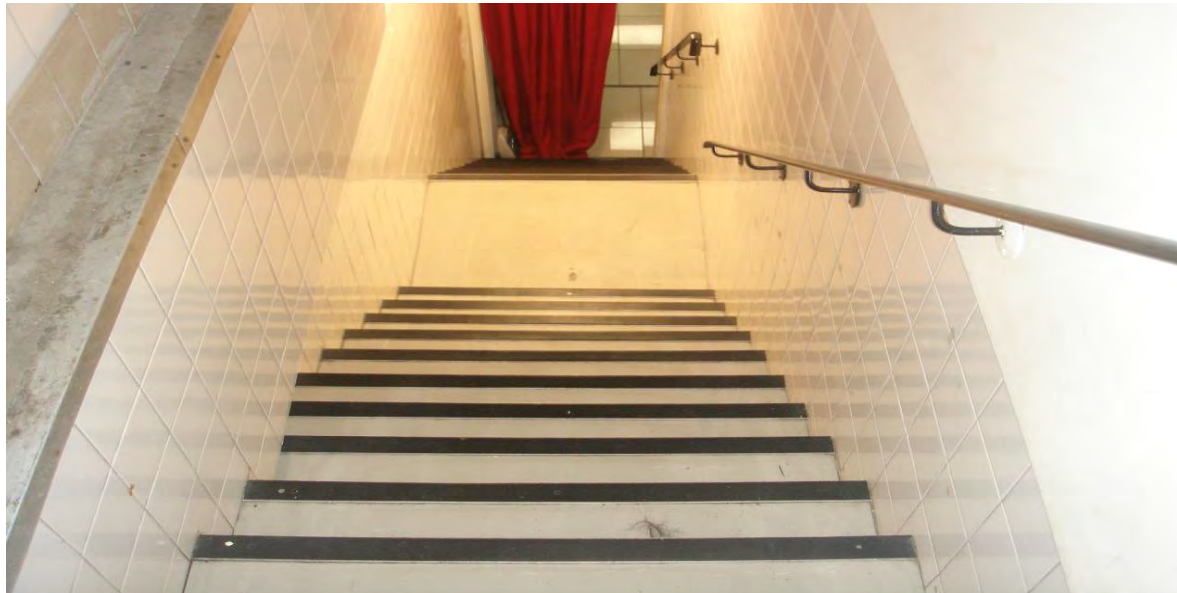
Location: 1/003 Stairs

Material Description:	Vinyl Floor Sheets	
Identification:	As Per Sample NE/1 – No Asbestos Detected	
Approx. quantity:	10M2	
Accessibility	N/A	Assessment Score
Product type:	N/A	N/A
Extent of Damage:	N/A	N/A
Surface Treatment:	N/A	N/A
Asbestos type:	N/A	N/A
Material Assessment Score:		N/A
Priority Assessment Score:		N/A
Action:	N/A	
Comments:	N/A

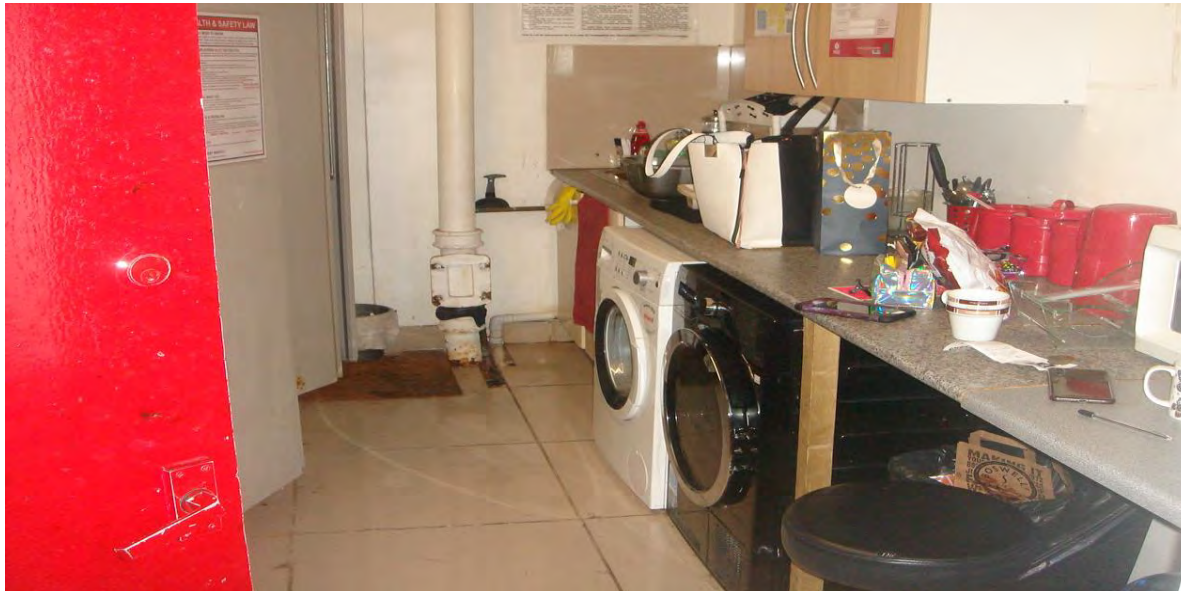
Location: 0/001 Kitchen

Material Description:	Visual Inspection – No Suspect Materials Found	
Identification:	N/A	
Approx. quantity:	N/A	
Accessibility	N/A	Assessment Score
Product type:	N/A	N/A
Extent of Damage:	N/A	N/A
Surface Treatment:	N/A	N/A
Asbestos type:	N/A	N/A
Material Assessment Score:		N/A
Priority Assessment Score:		N/A
Action:	N/A	
Comments:	N/A
