# EAGLE QUARTER II NEWBURY

ASBESTOS SURVEY

Management  
Asbestos Survey Report

Kennet Centre, Market Street, Newbury,  
Berkshire, RG14 5EN

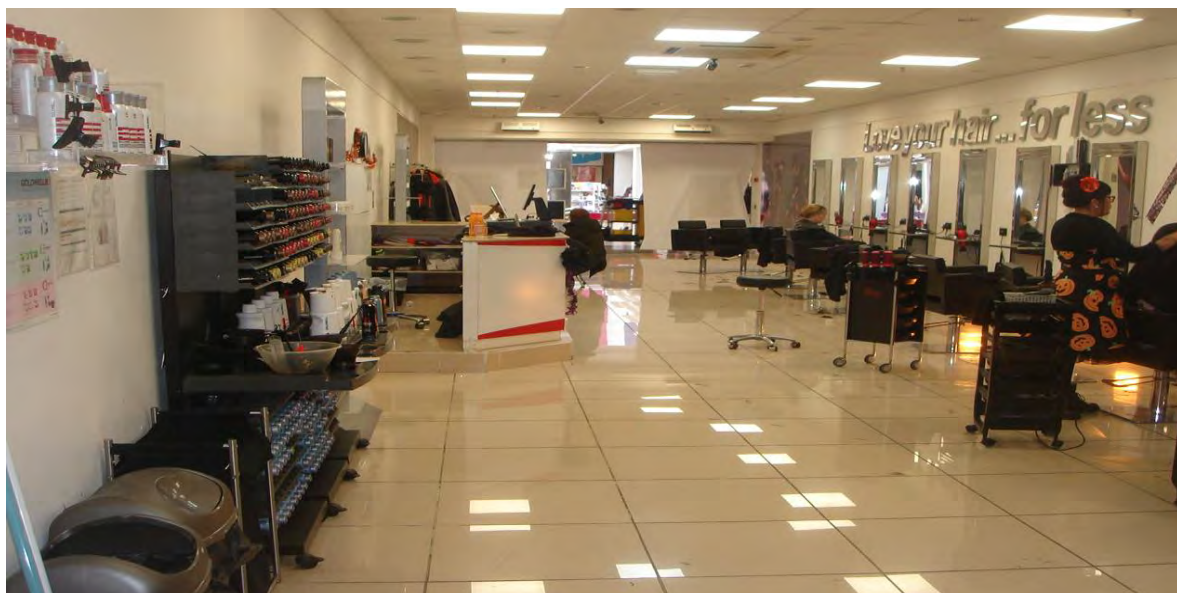
Location: 0/002 Shop Floor

Material Description:	Visual Inspection – No Suspect Materials Found	
Identification:	N/A	
Approx. quantity:	N/A	
Accessibility	N/A	Assessment Score
Product type:	N/A	N/A
Extent of Damage:	N/A	N/A
Surface Treatment:	N/A	N/A
Asbestos type:	N/A	N/A
Material Assessment Score:		N/A
Priority Assessment Score:		N/A
Action:	N/A	
Comments:	N/A

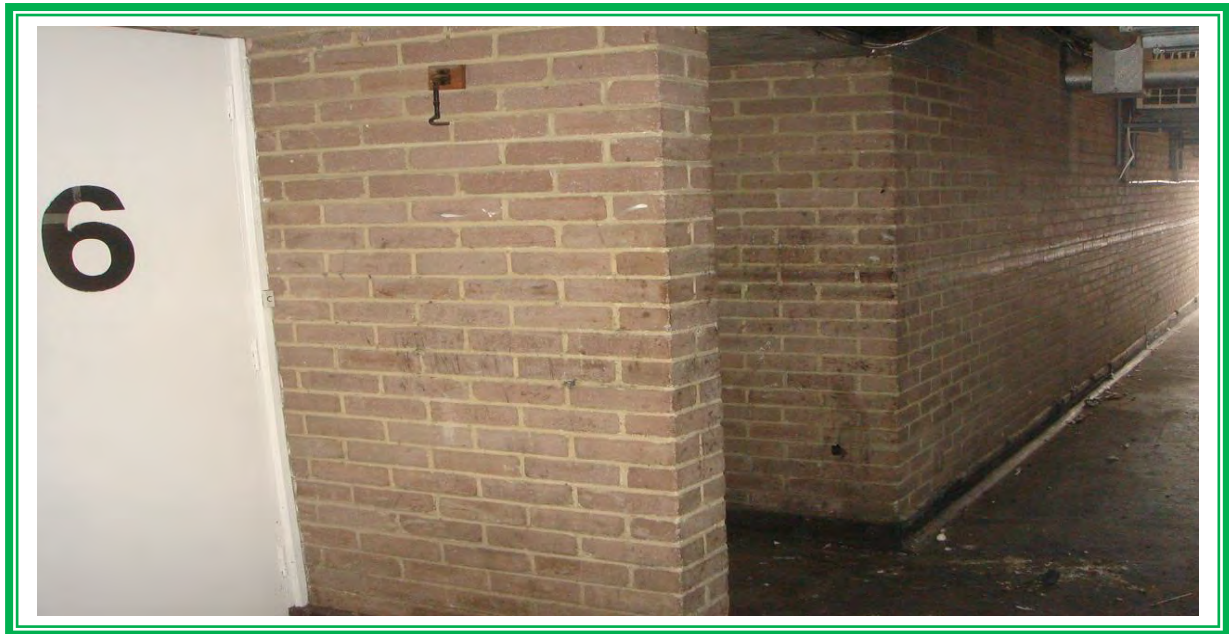
Location: 99/001

Material Description:	Visual Inspection – No Suspect Materials Found	
Identification:	N/A	
Approx. quantity:	N/A	
Accessibility	N/A	Assessment Score
Product type:	N/A	N/A
Extent of Damage:	N/A	N/A
Surface Treatment:	N/A	N/A
Asbestos type:	N/A	N/A
Material Assessment Score:		N/A
Priority Assessment Score:		N/A
Action:	N/A	
Comments:	N/A

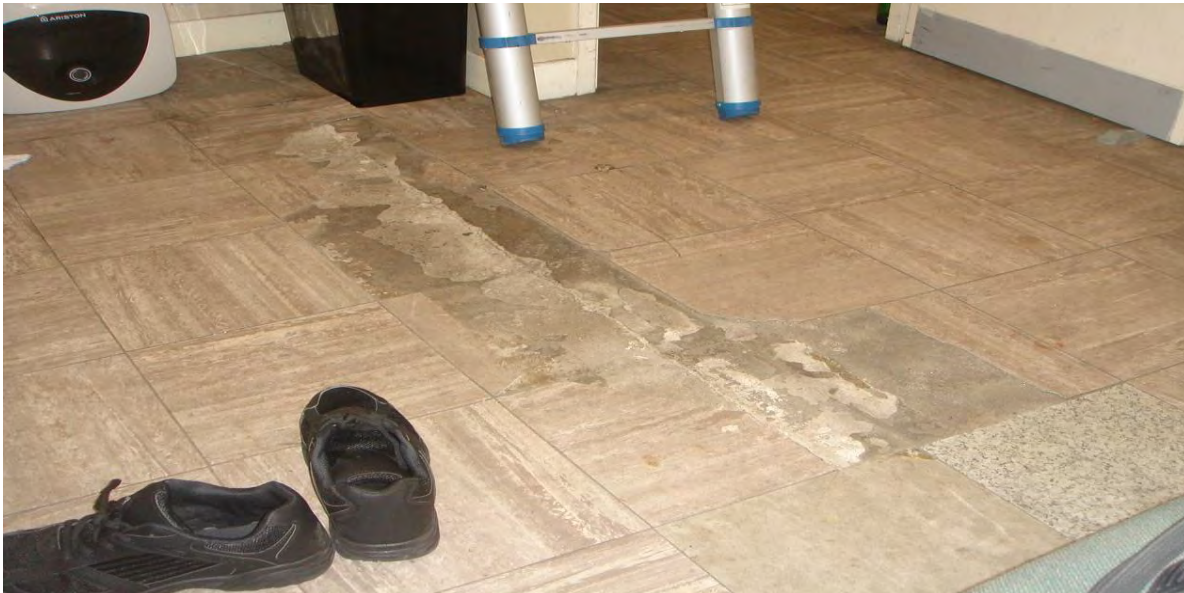
Location: 1/002 Kitchen

Material Description:	Vinyl Floor Tiles	
Identification:	As Per Sample NE/1 – No Asbestos Detected	
Approx. quantity:	9M2	
Accessibility	N/A	Assessment Score
Product type:	N/A	N/A
Extent of Damage:	N/A	N/A
Surface Treatment:	N/A	N/A
Asbestos type:	N/A	N/A
Material Assessment Score:		N/A
Priority Assessment Score:		N/A
Action:	N/A	
Comments:	N/A

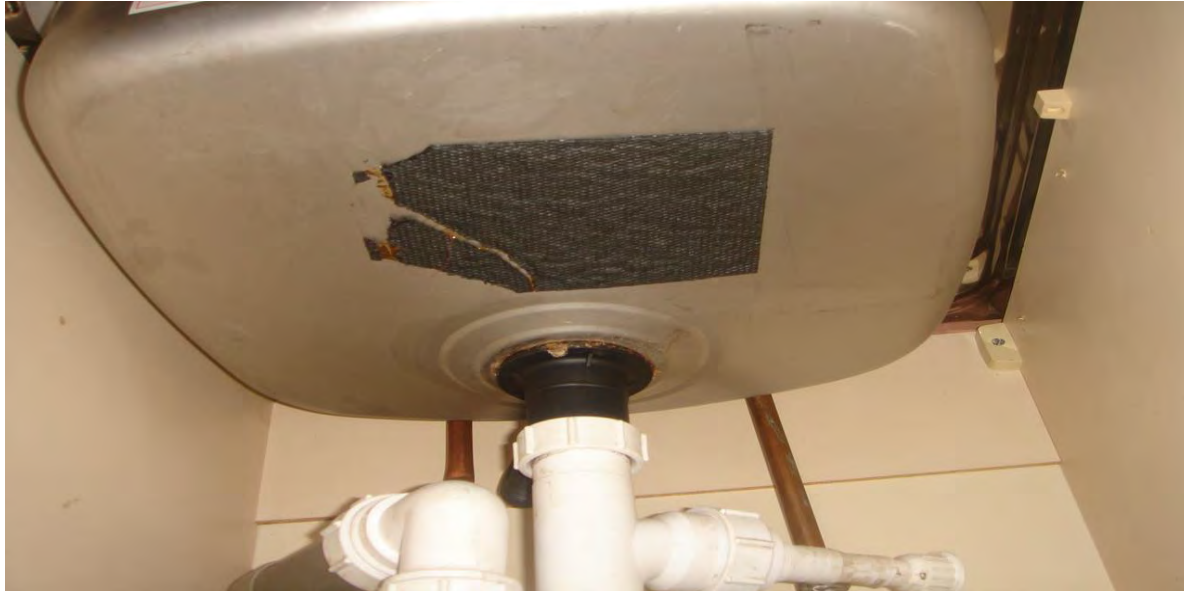
Location: 1/002 Kitchen

Material Description:	Sink Pad	
Identification:	Sampled – No Asbestos Detected	
Approx. quantity:	X 2	
Accessibility	N/A	Assessment Score
Product type:	N/A	N/A
Extent of Damage:	N/A	N/A
Surface Treatment:	N/A	N/A
Asbestos type:	N/A	N/A
Material Assessment Score:		N/A
Priority Assessment Score:		N/A
Action:	N/A	
Comments:	N/A

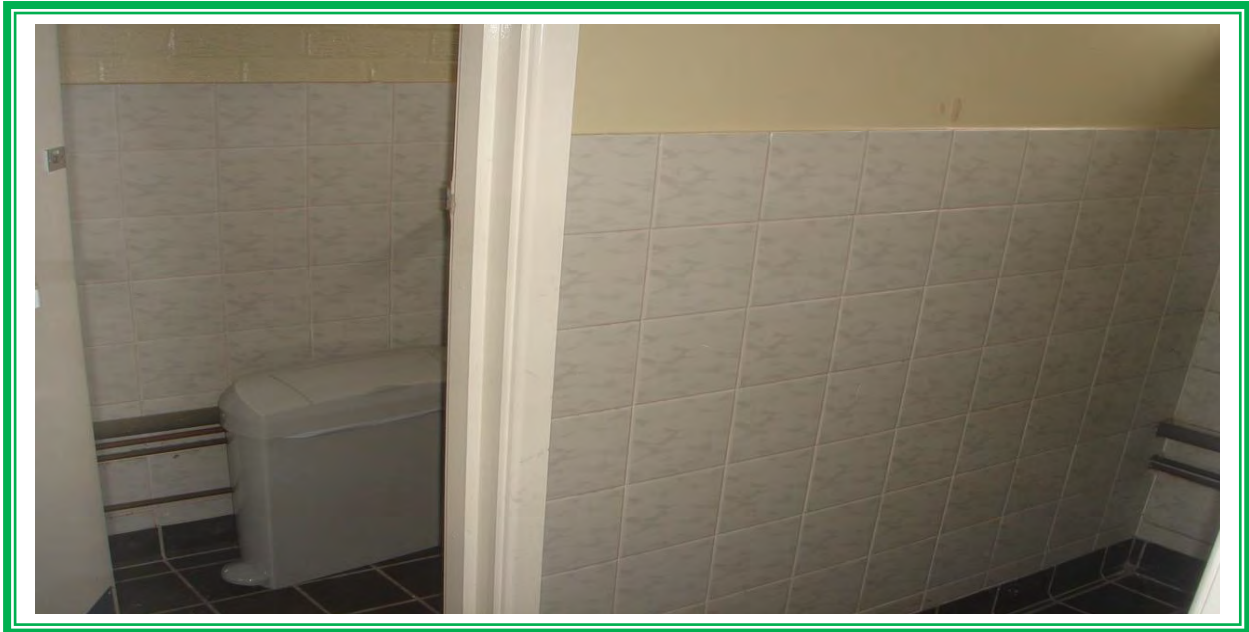
Location: 1/003 WC

Material Description:	Visual Inspection – No Suspect Materials Found	
Identification:	N/A	
Approx. quantity:	N/A	
Accessibility	N/A	Assessment Score
Product type:	N/A	N/A
Extent of Damage:	N/A	N/A
Surface Treatment:	N/A	N/A
Asbestos type:	N/A	N/A
Material Assessment Score:		N/A
Priority Assessment Score:		N/A
Action:	N/A	
Comments:	N/A

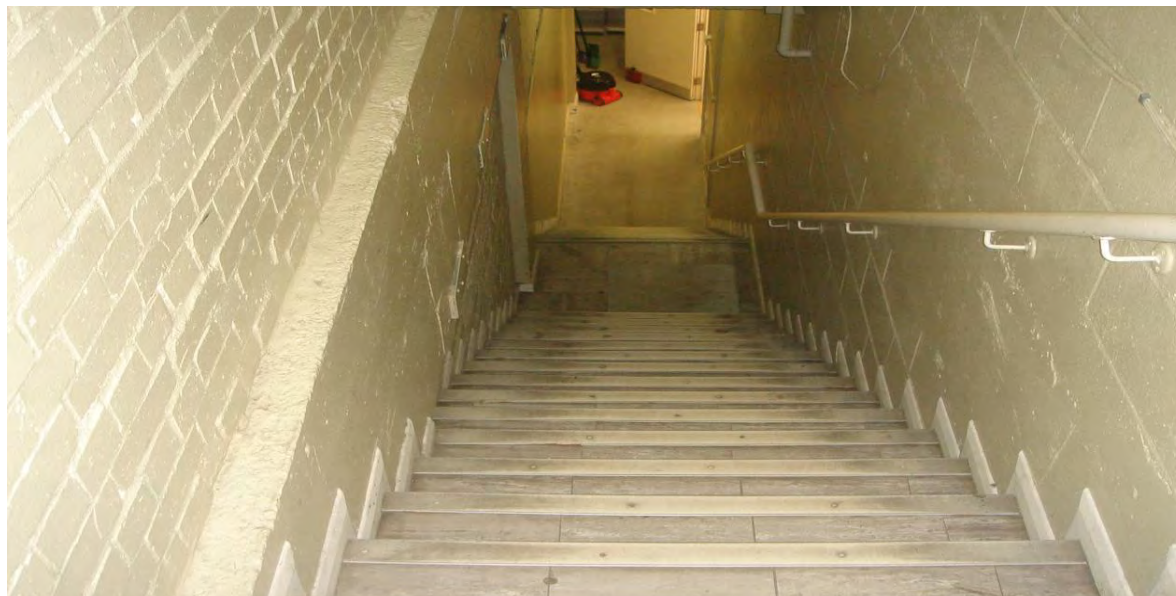
Location: 1/004 Stairs

Material Description:	Vinyl Floor Tiles	
Identification:	As Per Sample NE/1 – No Asbestos Detected	
Approx. quantity:	20M2	
Accessibility	N/A	Assessment Score
Product type:	N/A	N/A
Extent of Damage:	N/A	N/A
Surface Treatment:	N/A	N/A
Asbestos type:	N/A	N/A
Material Assessment Score:		N/A
Priority Assessment Score:		N/A
Action:	N/A	
Comments:	N/A

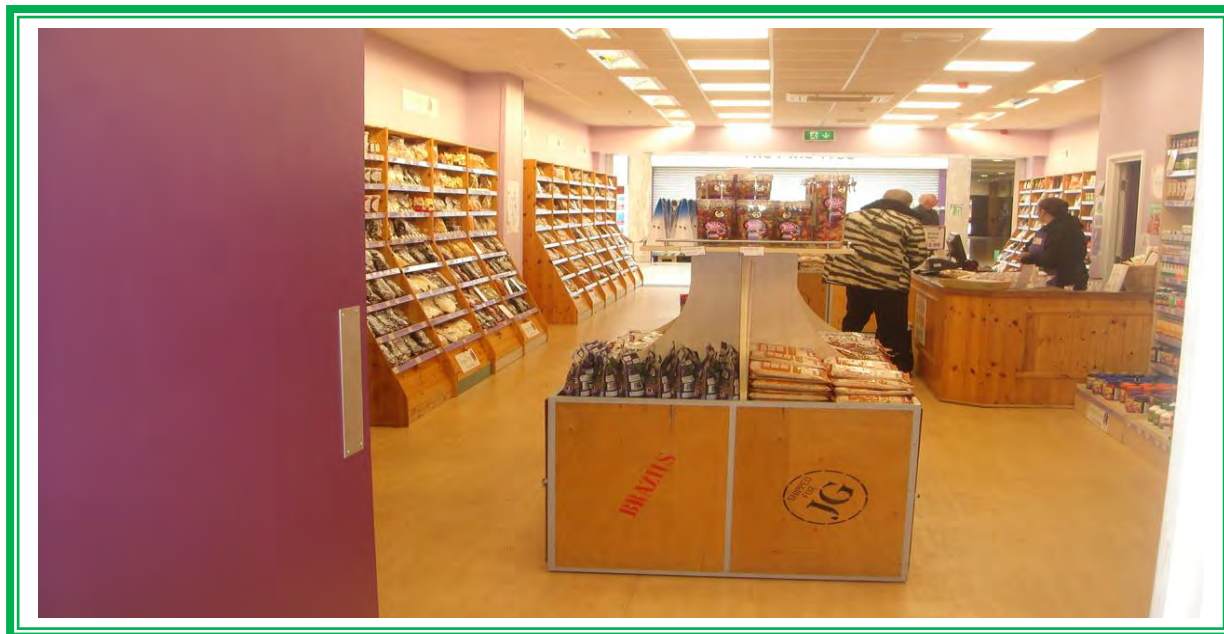
Location: 0/001 Shop Floor

Material Description:	Visual Inspection – No Suspect Materials Found	
Identification:	N/A	
Approx. quantity:	N/A	
Accessibility	N/A	Assessment Score
Product type:	N/A	N/A
Extent of Damage:	N/A	N/A
Surface Treatment:	N/A	N/A
Asbestos type:	N/A	N/A
Material Assessment Score:		N/A
Priority Assessment Score:		N/A
Action:	N/A	
Comments:	N/A

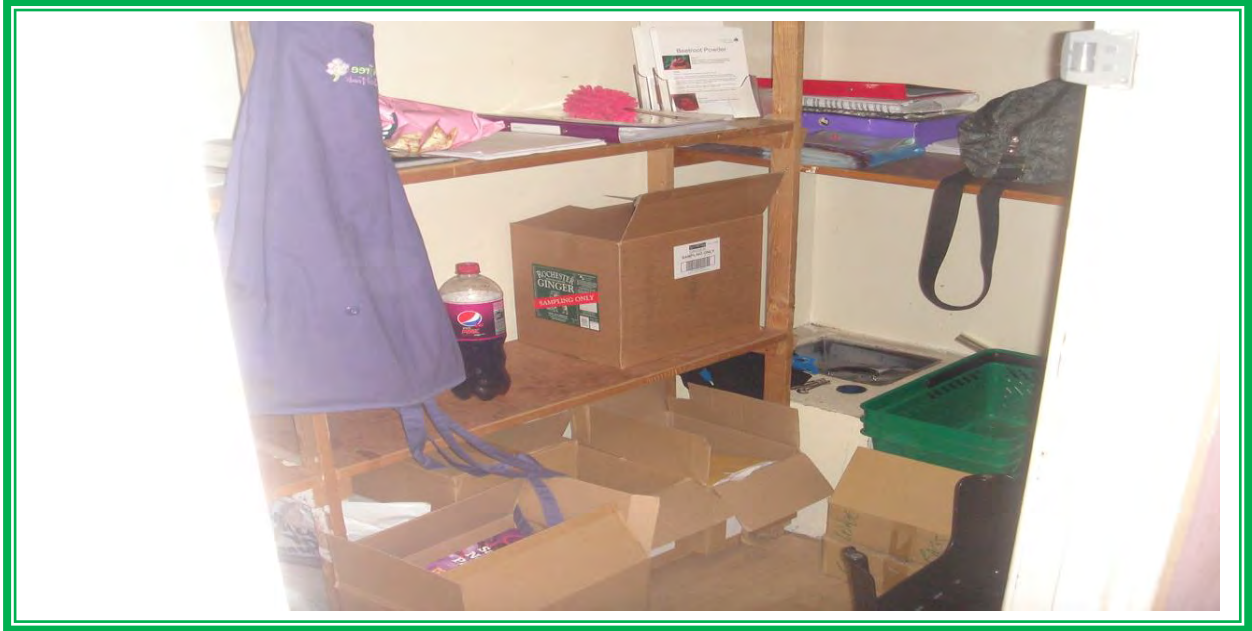
Location: 0/002 Cupboard

Material Description:	Visual Inspection – No Suspect Materials Found	
Identification:	N/A	
Approx. quantity:	N/A	
Accessibility	N/A	Assessment Score
Product type:	N/A	N/A
Extent of Damage:	N/A	N/A
Surface Treatment:	N/A	N/A
Asbestos type:	N/A	N/A
Material Assessment Score:		N/A
Priority Assessment Score:		N/A
Action:	N/A	
Comments:	N/A

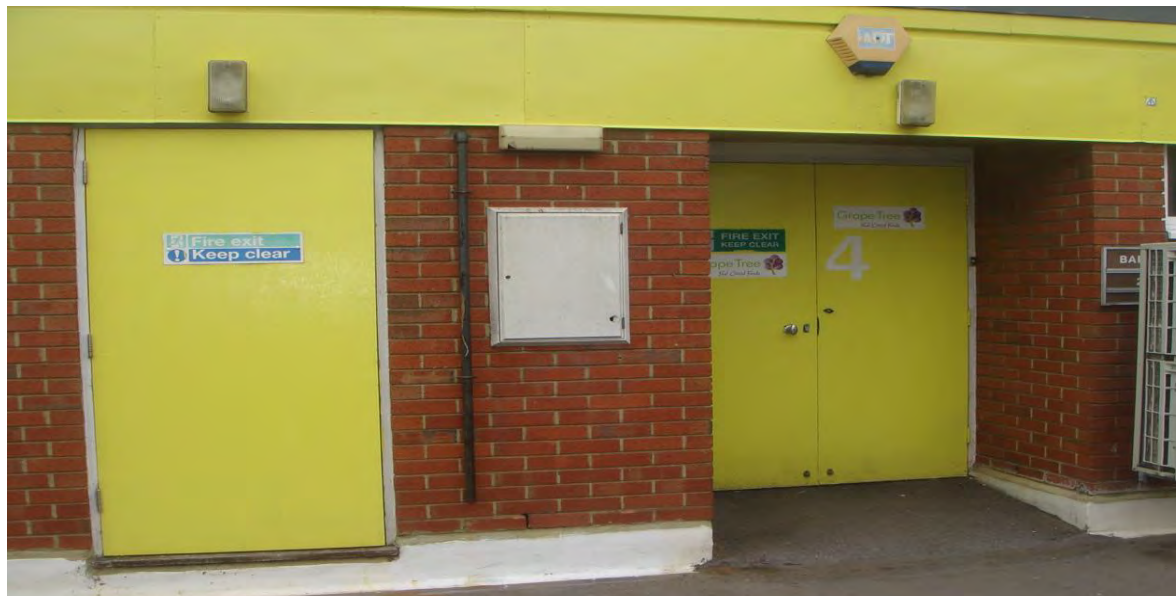
Location: 99/001

Material Description:	Visual Inspection – No Suspect Materials Found	
Identification:	N/A	
Approx. quantity:	N/A	
Accessibility	N/A	Assessment Score
Product type:	N/A	N/A
Extent of Damage:	N/A	N/A
Surface Treatment:	N/A	N/A
Asbestos type:	N/A	N/A
Material Assessment Score:		N/A
Priority Assessment Score:		N/A
Action:	N/A	
Comments:	N/A

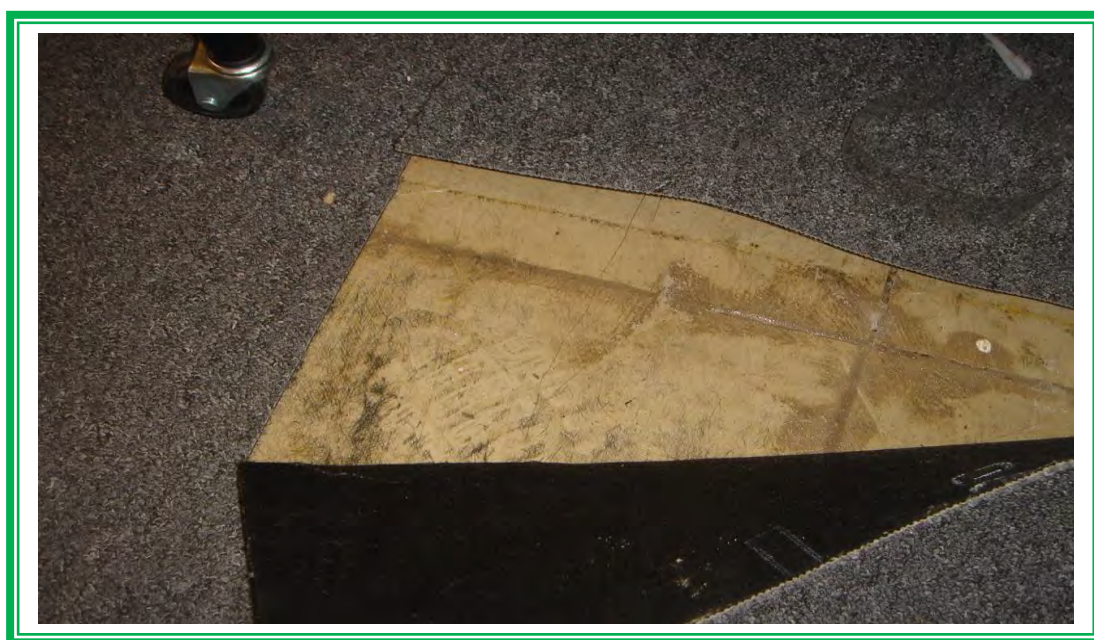
Item No: 1	Sample No: NE/1
Location: 1/001 Store

Material Description:	Vinyl Floor Tiles	
Identification:	Sampled – No Asbestos Detected	
Approx. quantity:	40M2	
Accessibility	N/A	Assessment Score
Product type:	N/A	N/A
Extent of Damage:	N/A	N/A
Surface Treatment:	N/A	N/A
Asbestos type:	N/A	N/A
Material Assessment Score:		N/A
Priority Assessment Score:		N/A
Action:	N/A	
Comments:	N/A

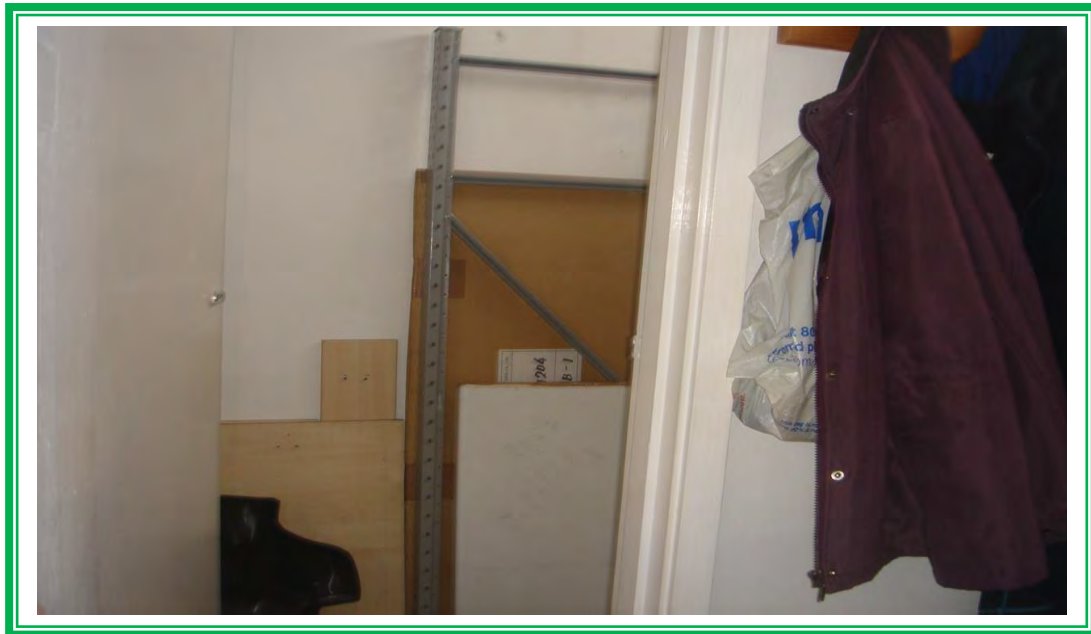
Location: 1/002 WC

Material Description:	Visual Inspection – No Suspect Materials Found	
Identification:	N/A	
Approx. quantity:	N/A	
Accessibility	N/A	Assessment Score
Product type:	N/A	N/A
Extent of Damage:	N/A	N/A
Surface Treatment:	N/A	N/A
Asbestos type:	N/A	N/A
Material Assessment Score:		N/A
Priority Assessment Score:		N/A
Action:	N/A	
Comments:	N/A

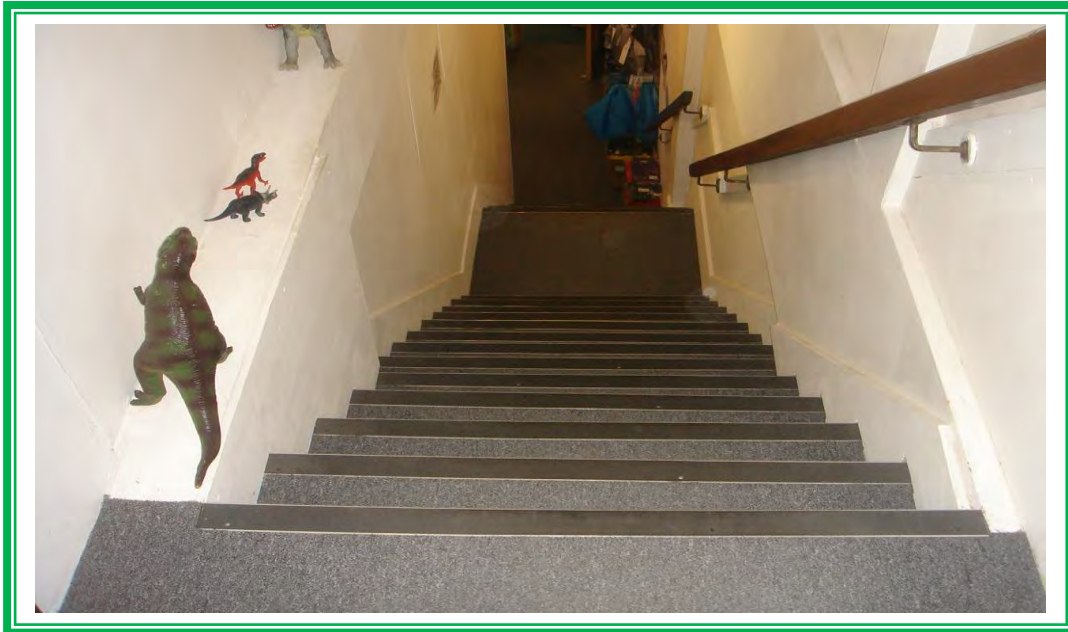
Location: 1/003 Stairs

Material Description:	Visual Inspection – No Suspect Materials Found	
Identification:	N/A	
Approx. quantity:	N/A	
Accessibility	N/A	Assessment Score
Product type:	N/A	N/A
Extent of Damage:	N/A	N/A
Surface Treatment:	N/A	N/A
Asbestos type:	N/A	N/A
Material Assessment Score:		N/A
Priority Assessment Score:		N/A
Action:	N/A	
Comments:	N/A

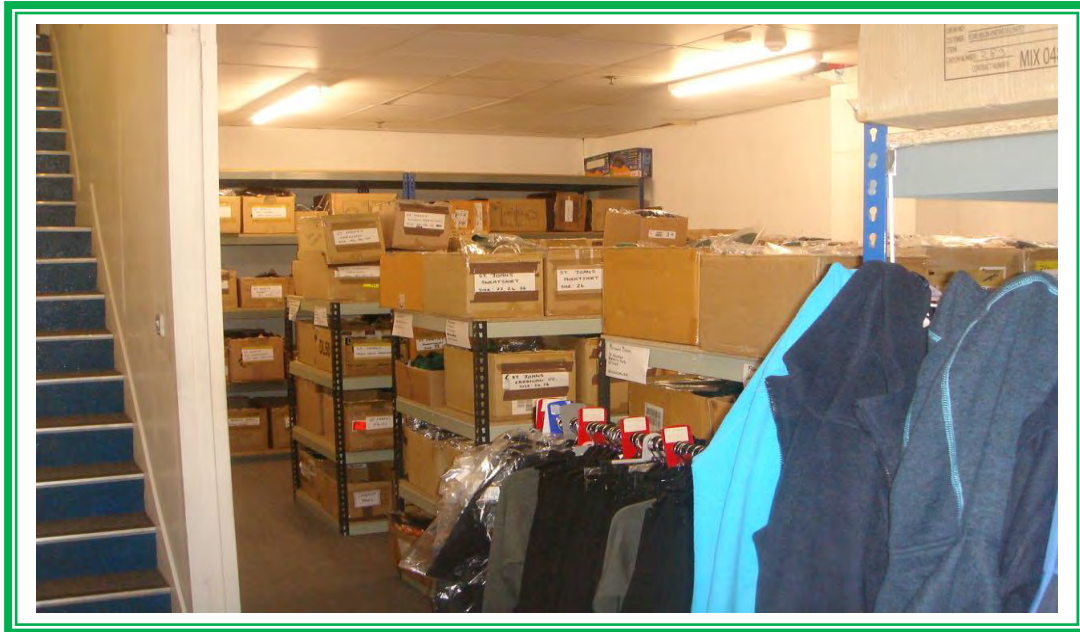
Location: 0/001 Store

Material Description:	Visual Inspection – No Suspect Materials Found	
Identification:	N/A	
Approx. quantity:	N/A	
Accessibility	N/A	Assessment Score
Product type:	N/A	N/A
Extent of Damage:	N/A	N/A
Surface Treatment:	N/A	N/A
Asbestos type:	N/A	N/A
Material Assessment Score:		N/A
Priority Assessment Score:		N/A
Action:	N/A	
Comments:	N/A

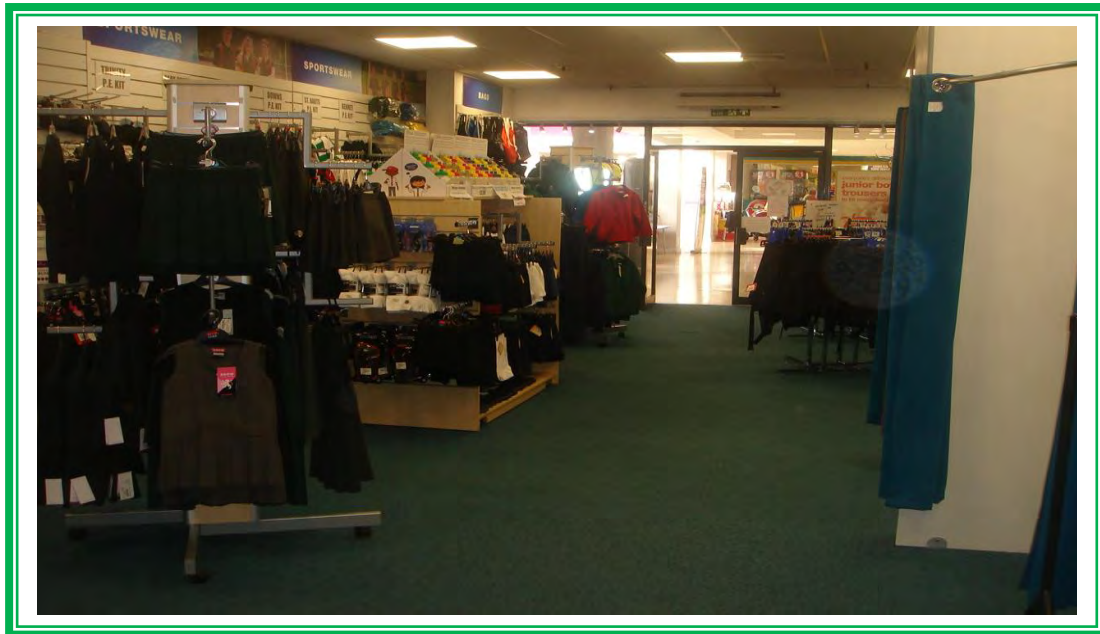
Location: 0/002 Shop Floor

Material Description:	Visual Inspection – No Suspect Materials Found	
Identification:	N/A	
Approx. quantity:	N/A	
Accessibility	N/A	Assessment Score
Product type:	N/A	N/A
Extent of Damage:	N/A	N/A
Surface Treatment:	N/A	N/A
Asbestos type:	N/A	N/A
Material Assessment Score:		N/A
Priority Assessment Score:		N/A
Action:	N/A	
Comments:	N/A

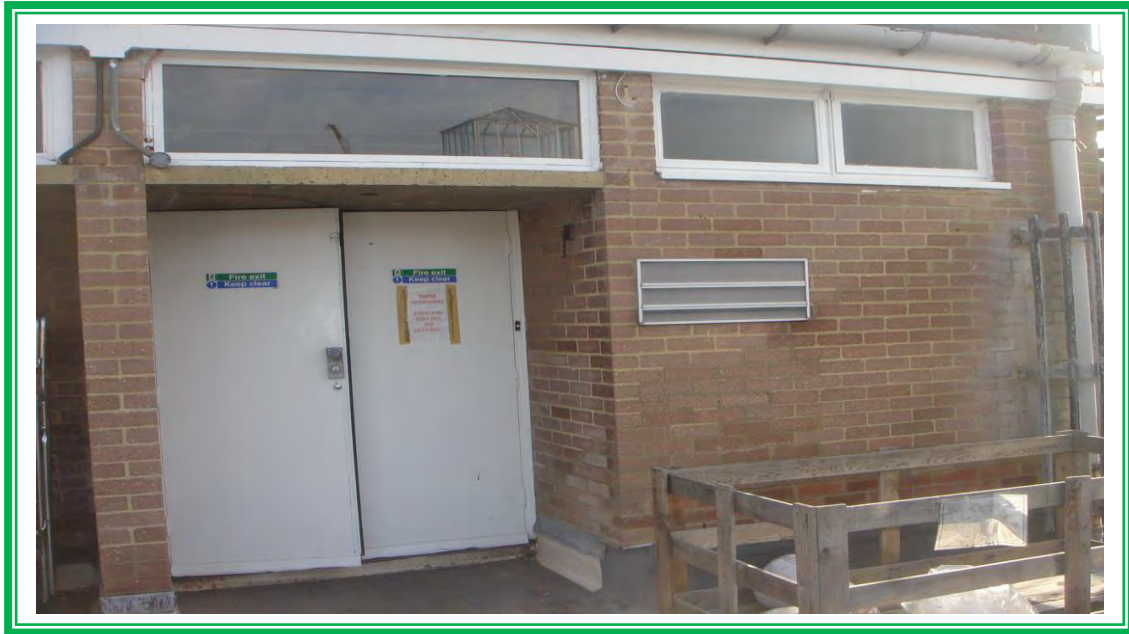
Location: 99/001 External

Material Description:	Visual Inspection – No Suspect Materials Found	
Identification:	N/A	
Approx. quantity:	N/A	
Accessibility	N/A	Assessment Score
Product type:	N/A	N/A
Extent of Damage:	N/A	N/A
Surface Treatment:	N/A	N/A
Asbestos type:	N/A	N/A
Material Assessment Score:		N/A
Priority Assessment Score:		N/A
Action:	N/A	
Comments:	N/A

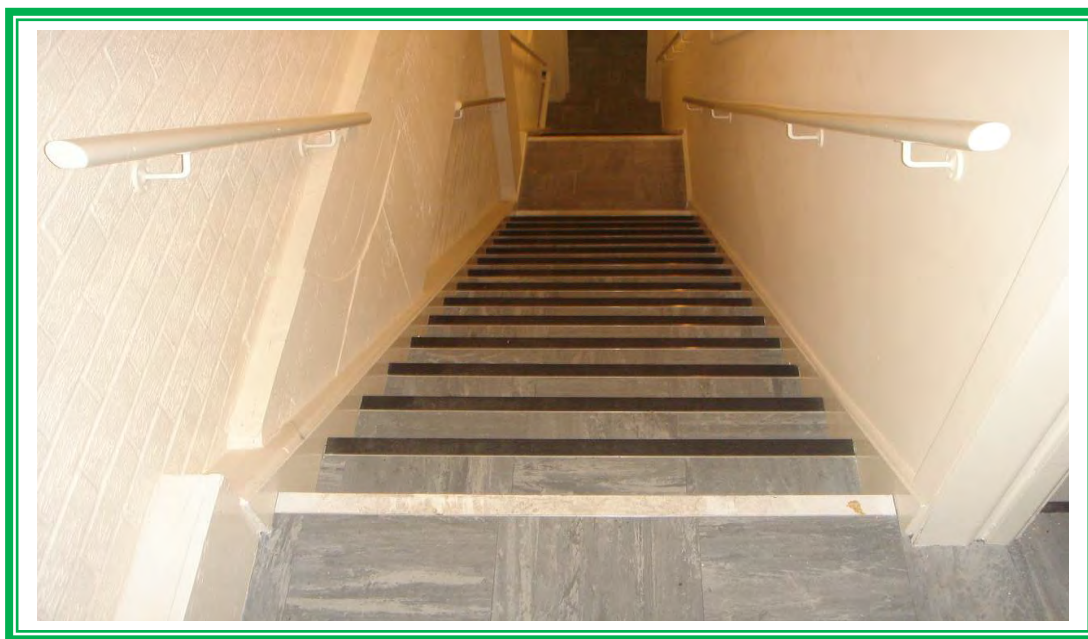
Location: 1/001 Stairs

Material Description:	Vinyl Floor Tiles	
Identification:	Sampled – No Asbestos Detected	
Approx. quantity:	15M2	
Accessibility	N/A	Assessment Score
Product type:	N/A	N/A
Extent of Damage:	N/A	N/A
Surface Treatment:	N/A	N/A
Asbestos type:	N/A	N/A
Material Assessment Score:		N/A
Priority Assessment Score:		N/A
Action:	N/A	
Comments:	N/A

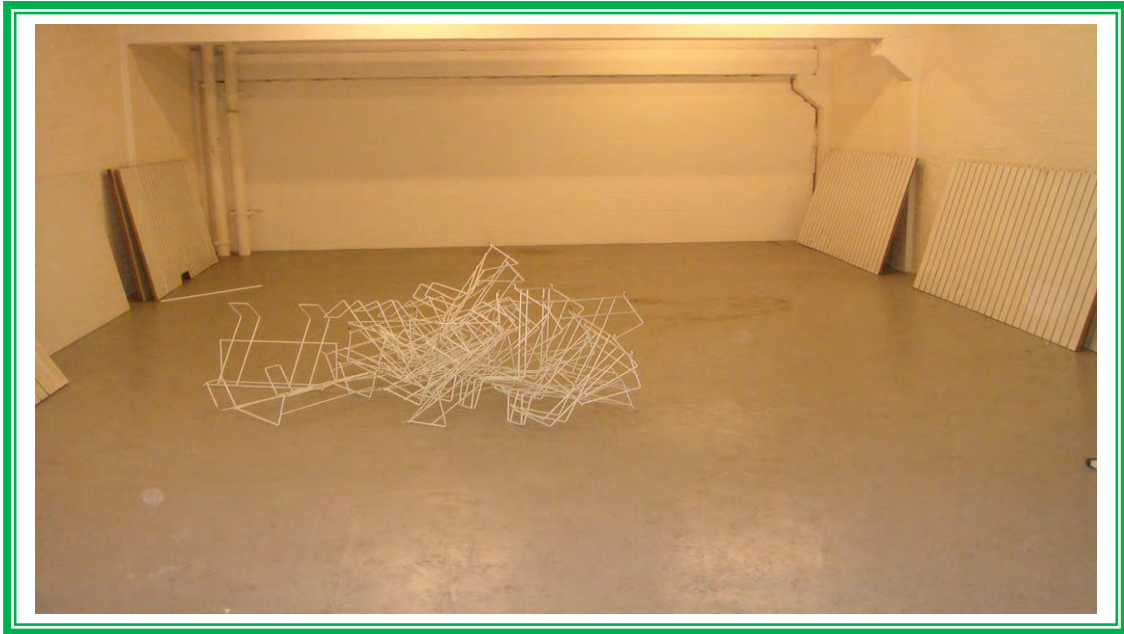
Location: 1/002 Store

Material Description:	Visual Inspection – No Suspect Materials Found	
Identification:	N/A	
Approx. quantity:	N/A	
Accessibility	N/A	Assessment Score
Product type:	N/A	N/A
Extent of Damage:	N/A	N/A
Surface Treatment:	N/A	N/A
Asbestos type:	N/A	N/A
Material Assessment Score:		N/A
Priority Assessment Score:		N/A
Action:	N/A	
Comments:	N/A

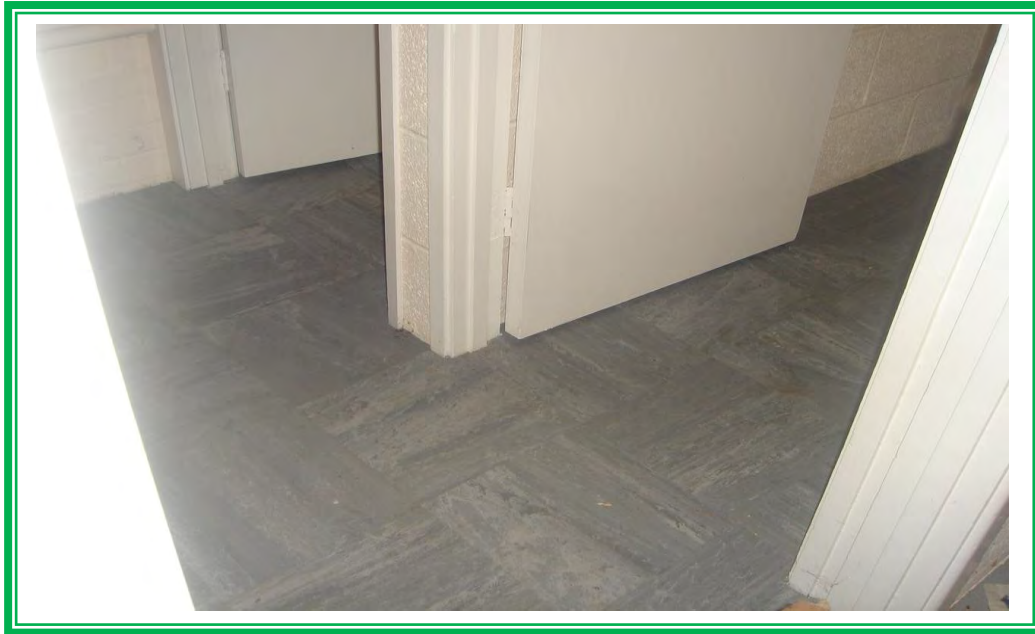
Location: 1/003 WC

Material Description:	Vinyl Floor Tiles	
Identification:	As Per Sample NE/1– No Asbestos Detected	
Approx. quantity:	6M2	
Accessibility	N/A	Assessment Score
Product type:	N/A	N/A
Extent of Damage:	N/A	N/A
Surface Treatment:	N/A	N/A
Asbestos type:	N/A	N/A
Material Assessment Score:		N/A
Priority Assessment Score:		N/A
Action:	N/A	
Comments:	N/A

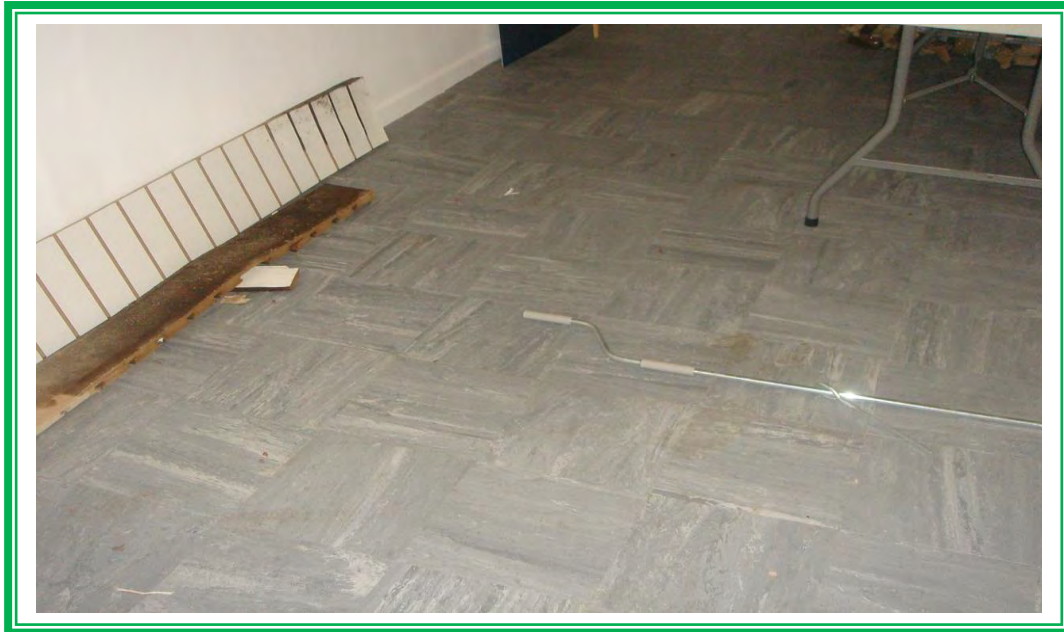
Location: 0/001 Store

Material Description:	Vinyl Floor Tiles	
Identification:	Sampled – No Asbestos Detected	
Approx. quantity:	12M2	
Accessibility	N/A	Assessment Score
Product type:	N/A	N/A
Extent of Damage:	N/A	N/A
Surface Treatment:	N/A	N/A
Asbestos type:	N/A	N/A
Material Assessment Score:		N/A
Priority Assessment Score:		N/A
Action:	N/A	
Comments:	N/A

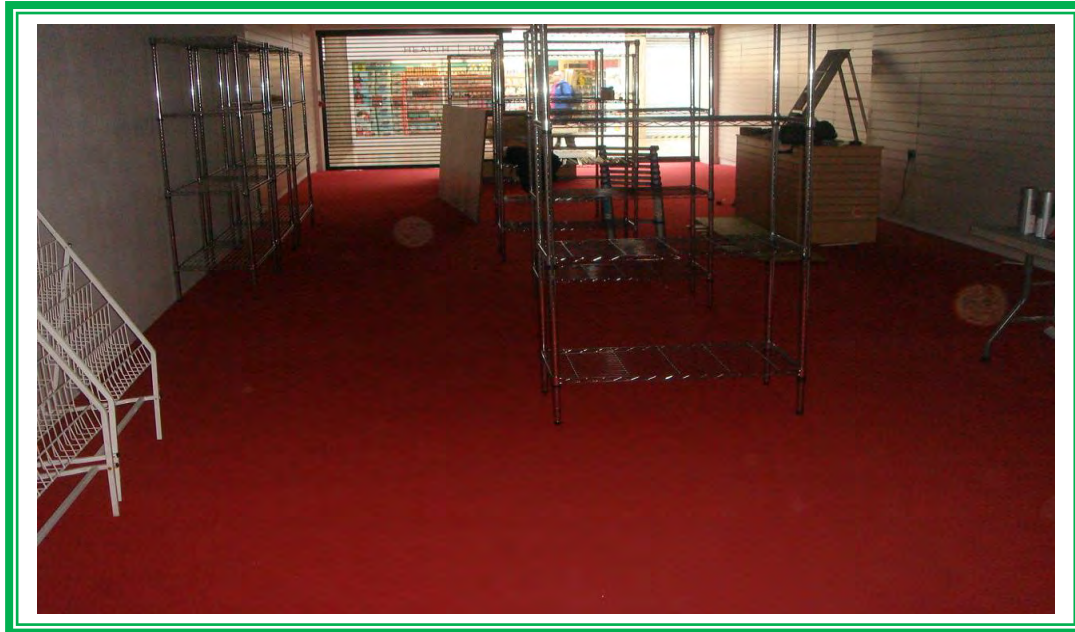
Location: 0/002 Shop Floor

Material Description:	Visual Inspection – No Suspect Materials Found	
Identification:	N/A	
Approx. quantity:	N/A	
Accessibility	N/A	Assessment Score
Product type:	N/A	N/A
Extent of Damage:	N/A	N/A
Surface Treatment:	N/A	N/A
Asbestos type:	N/A	N/A
Material Assessment Score:		N/A
Priority Assessment Score:		N/A
Action:	N/A	
Comments:	N/A

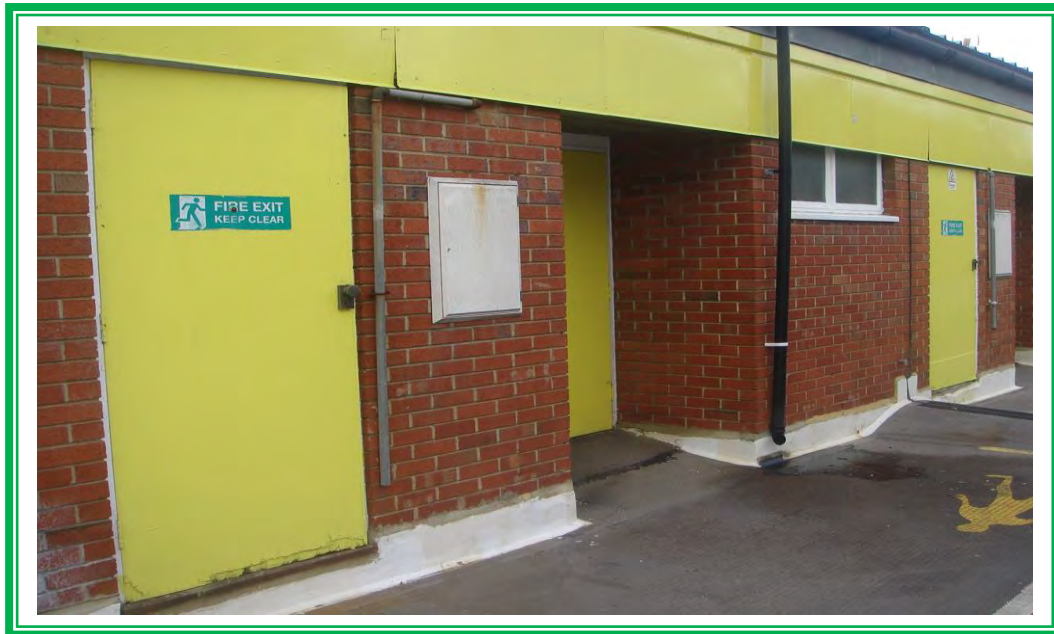
Location: 99/001 Externals

Material Description:	Visual Inspection – No Suspect Materials Found	
Identification:	N/A	
Approx. quantity:	N/A	
Accessibility	N/A	Assessment Score
Product type:	N/A	N/A
Extent of Damage:	N/A	N/A
Surface Treatment:	N/A	N/A
Asbestos type:	N/A	N/A
Material Assessment Score:		N/A
Priority Assessment Score:		N/A
Action:	N/A	
Comments:	N/A

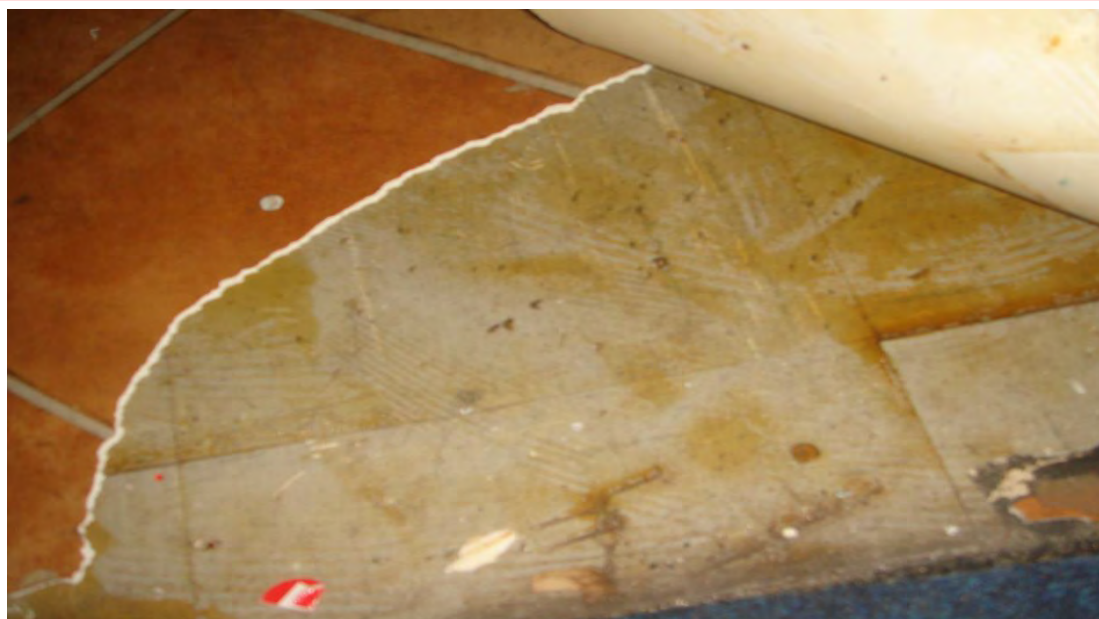
Location: 1/002 Kitchen

Material Description:	Vinyl Floor Tiles	
Identification:	Sampled – Asbestos Detected	
Approx. quantity:	10M2	
Accessibility	Low	Assessment Score
Product type:	Vinyl	1
Extent of Damage:	Minor	1
Surface Treatment:	Non-Friable	0
Asbestos type:	Chrysotile	1
Material Assessment Score:		3
Priority Assessment Score:		Negligible
Action:	Manage	
Comments:	N/A

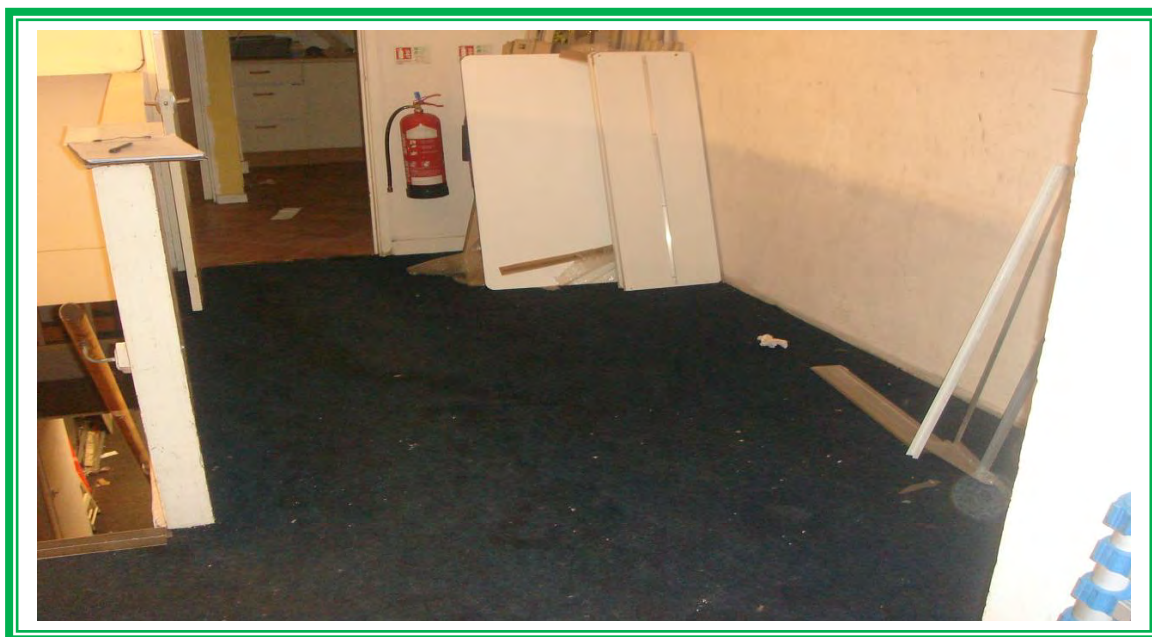
Item No: 1	Sample No: N/A
Location: 1/001 Store

Material Description:	Visual Inspection – No Suspect Materials Found	
Identification:	N/A	
Approx. quantity:	N/A	
Accessibility	N/A	Assessment Score
Product type:	N/A	N/A
Extent of Damage:	N/A	N/A
Surface Treatment:	N/A	N/A
Asbestos type:	N/A	N/A
Material Assessment Score:		N/A
Priority Assessment Score:		N/A
Action:	N/A	
Comments:	N/A

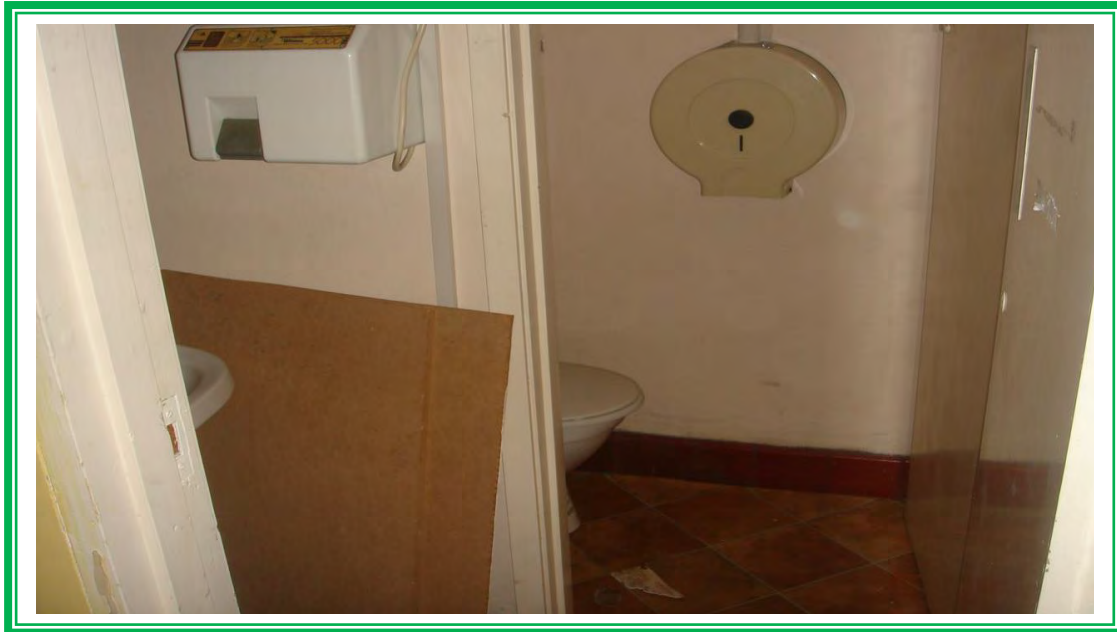
Location: 1/003 WC

Material Description:	Visual Inspection – No Suspect Materials Found	
Identification:	N/A	
Approx. quantity:	N/A	
Accessibility	N/A	Assessment Score
Product type:	N/A	N/A
Extent of Damage:	N/A	N/A
Surface Treatment:	N/A	N/A
Asbestos type:	N/A	N/A
Material Assessment Score:		N/A
Priority Assessment Score:		N/A
Action:	N/A	
Comments:	N/A

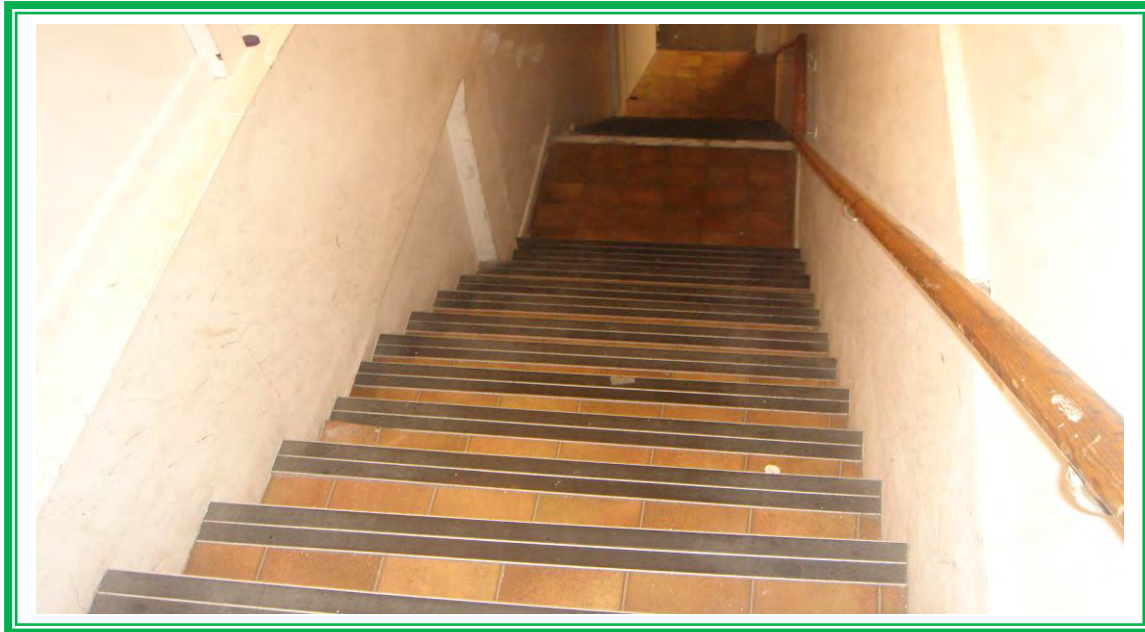
Location: 1/004 Stairs

Material Description:	Visual Inspection – No Suspect Materials Found	
Identification:	N/A	
Approx. quantity:	N/A	
Accessibility	N/A	Assessment Score
Product type:	N/A	N/A
Extent of Damage:	N/A	N/A
Surface Treatment:	N/A	N/A
Asbestos type:	N/A	N/A
Material Assessment Score:		N/A
Priority Assessment Score:		N/A
Action:	N/A	
Comments:	N/A

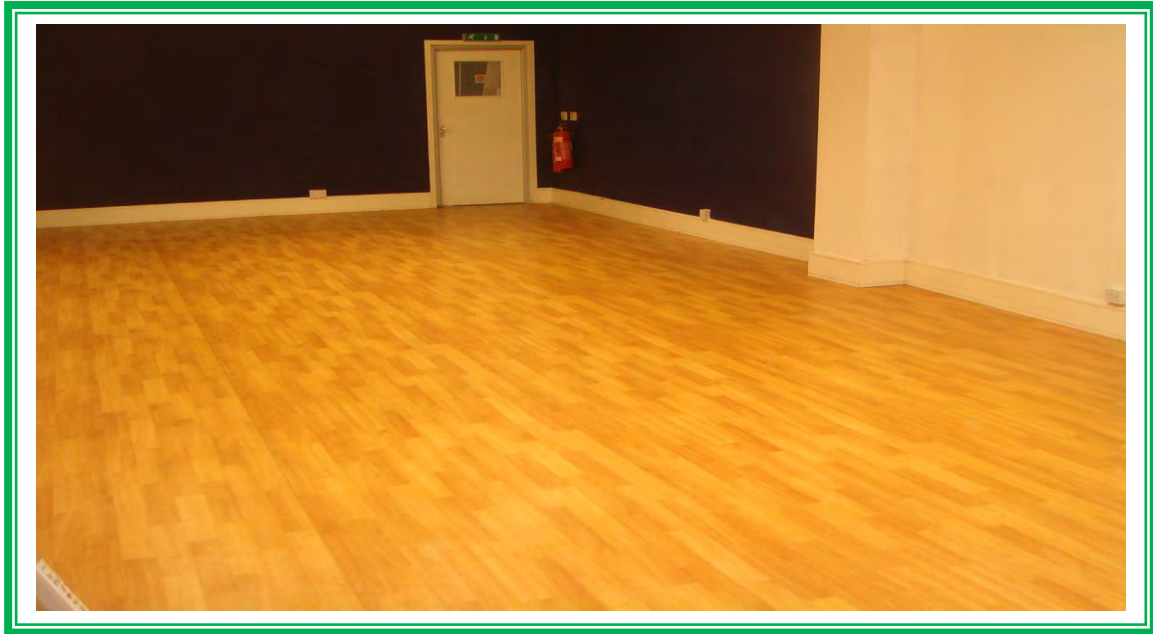
Location: 0/001 Shop Floor

Material Description:	Visual Inspection – No Suspect Materials Found	
Identification:	N/A	
Approx. quantity:	N/A	
Accessibility	N/A	Assessment Score
Product type:	N/A	N/A
Extent of Damage:	N/A	N/A
Surface Treatment:	N/A	N/A
Asbestos type:	N/A	N/A
Material Assessment Score:		N/A
Priority Assessment Score:		N/A
Action:	N/A	
Comments:	N/A

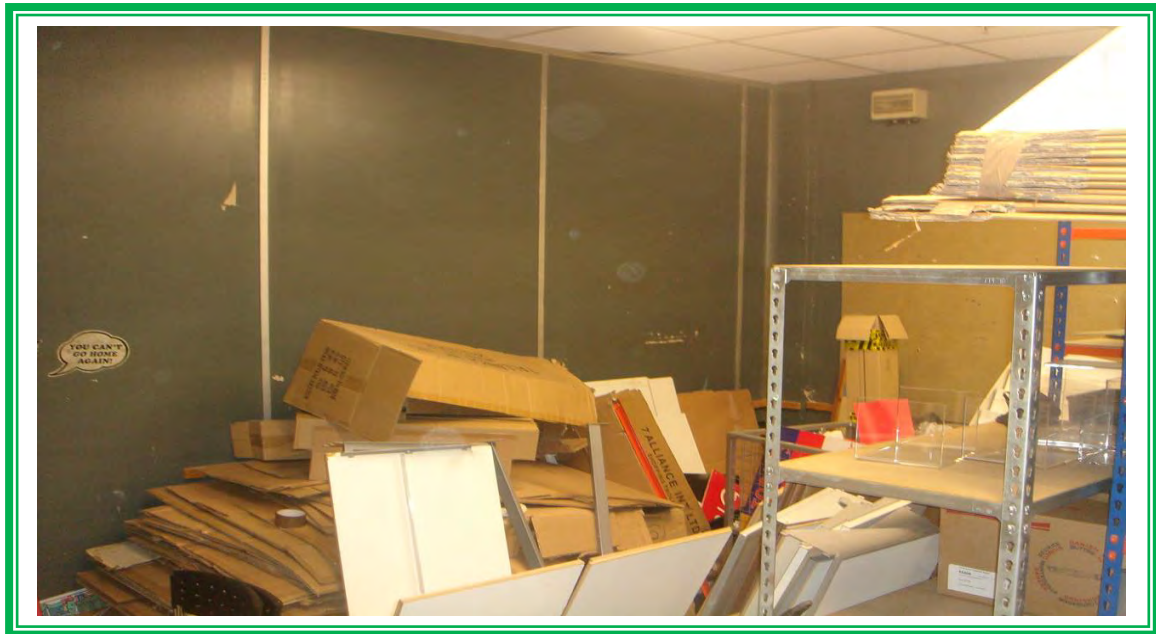
Location: 0/002 Store

Material Description:	Visual Inspection – No Suspect Materials Found	
Identification:	N/A	
Approx. quantity:	N/A	
Accessibility	N/A	Assessment Score
Product type:	N/A	N/A
Extent of Damage:	N/A	N/A
Surface Treatment:	N/A	N/A
Asbestos type:	N/A	N/A
Material Assessment Score:		N/A
Priority Assessment Score:		N/A
Action:	N/A	
Comments:	N/A

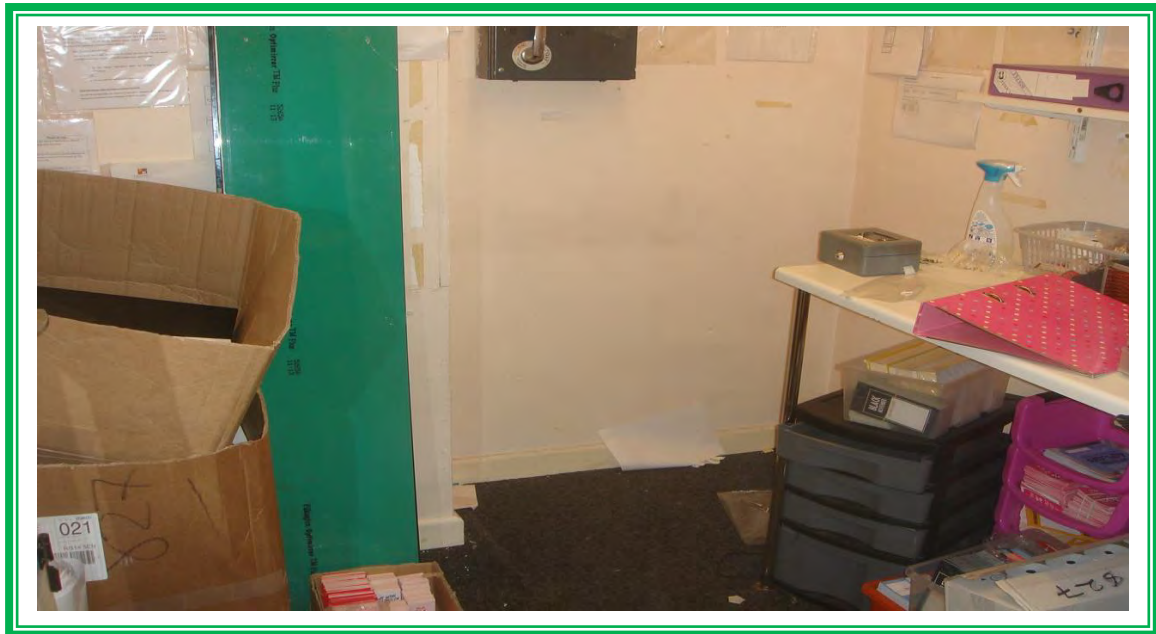
Location: 0/003 Office

Material Description:	Visual Inspection – No Suspect Materials Found	
Identification:	N/A	
Approx. quantity:	N/A	
Accessibility	N/A	Assessment Score
Product type:	N/A	N/A
Extent of Damage:	N/A	N/A
Surface Treatment:	N/A	N/A
Asbestos type:	N/A	N/A
Material Assessment Score:		N/A
Priority Assessment Score:		N/A
Action:	N/A	
Comments:	N/A
