# EAGLE QUARTER II NEWBURY

ASBESTOS SURVEY

Management  
Asbestos Survey Report

Kennet Centre, Market Street, Newbury,  
Berkshire, RG14 5EN

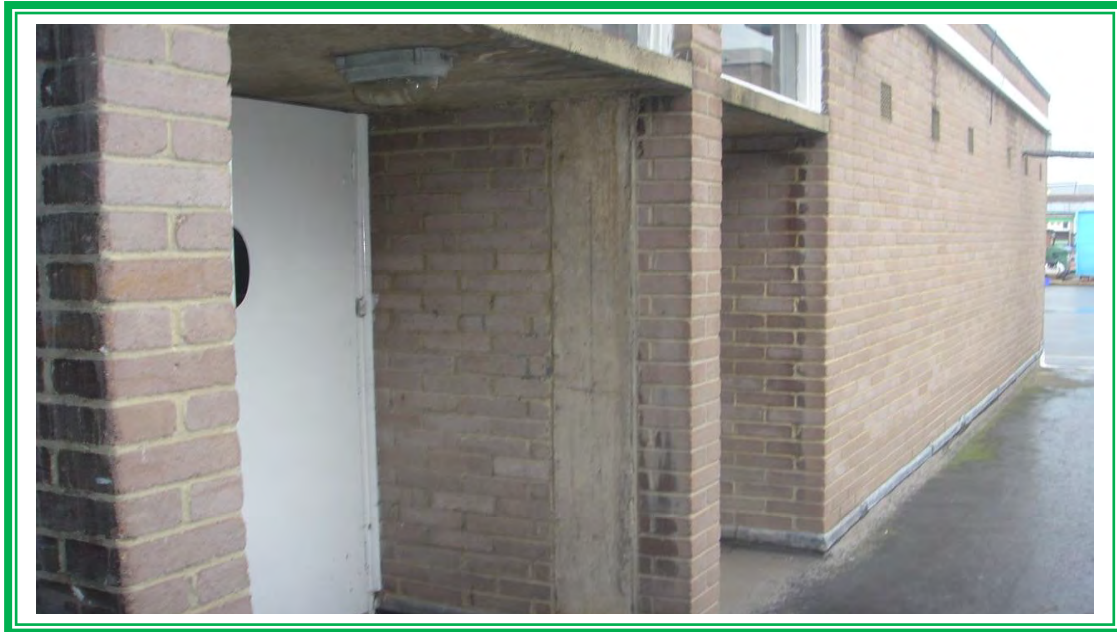
Location: 99/001 External

Material Description:	Visual Inspection – No Suspect Materials Found	
Identification:	N/A	
Approx. quantity:	N/A	
Accessibility	N/A	Assessment Score
Product type:	N/A	N/A
Extent of Damage:	N/A	N/A
Surface Treatment:	N/A	N/A
Asbestos type:	N/A	N/A
Material Assessment Score:		N/A
Priority Assessment Score:		N/A
Action:	N/A	
Comments:	N/A

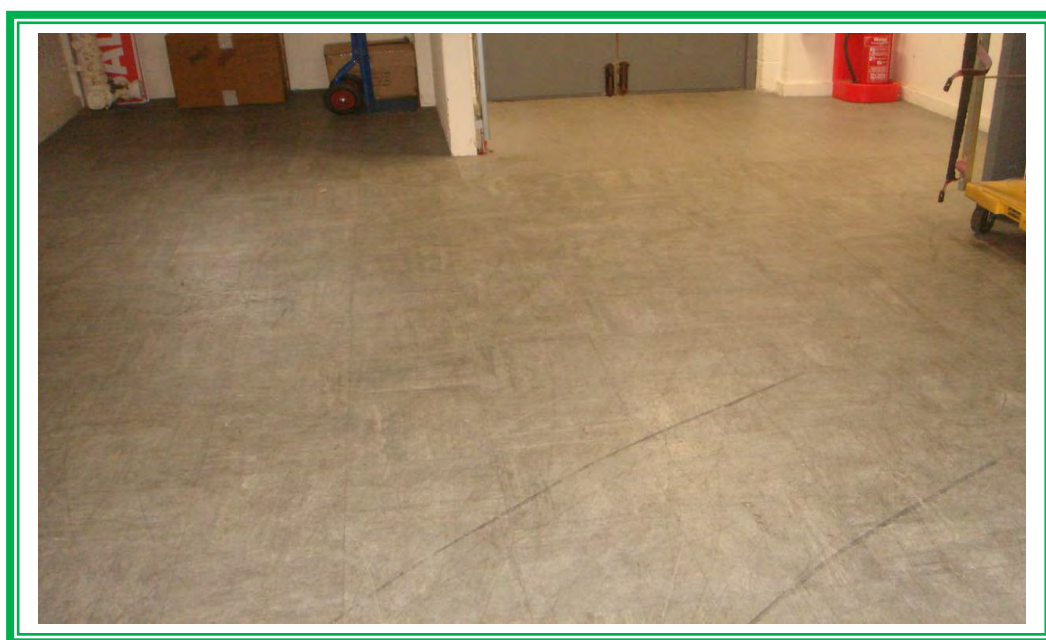
Location: 1/001 Store Area

Material Description:	Vinyl Floor Tiles	
Identification:	Sampled – No Asbestos Detected	
Approx. quantity:	50M2	
Accessibility	N/A	Assessment Score
Product type:	N/A	N/A
Extent of Damage:	N/A	N/A
Surface Treatment:	N/A	N/A
Asbestos type:	N/A	N/A
Material Assessment Score:		N/A
Priority Assessment Score:		N/A
Action:	N/A	
Comments:	N/A

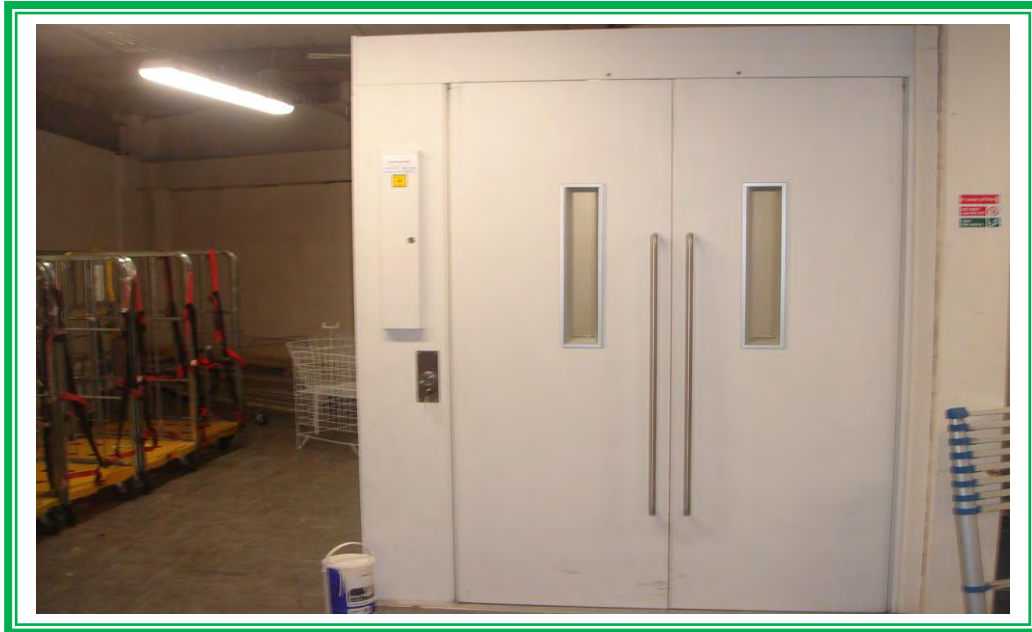
Location: 1/002 Lift and Shafts

Material Description:	Visual Inspection – No Suspect Materials Found	
Identification:	N/A	
Approx. quantity:	N/A	
Accessibility	N/A	Assessment Score
Product type:	N/A	N/A
Extent of Damage:	N/A	N/A
Surface Treatment:	N/A	N/A
Asbestos type:	N/A	N/A
Material Assessment Score:		N/A
Priority Assessment Score:		N/A
Action:	N/A	
Comments:	N/A

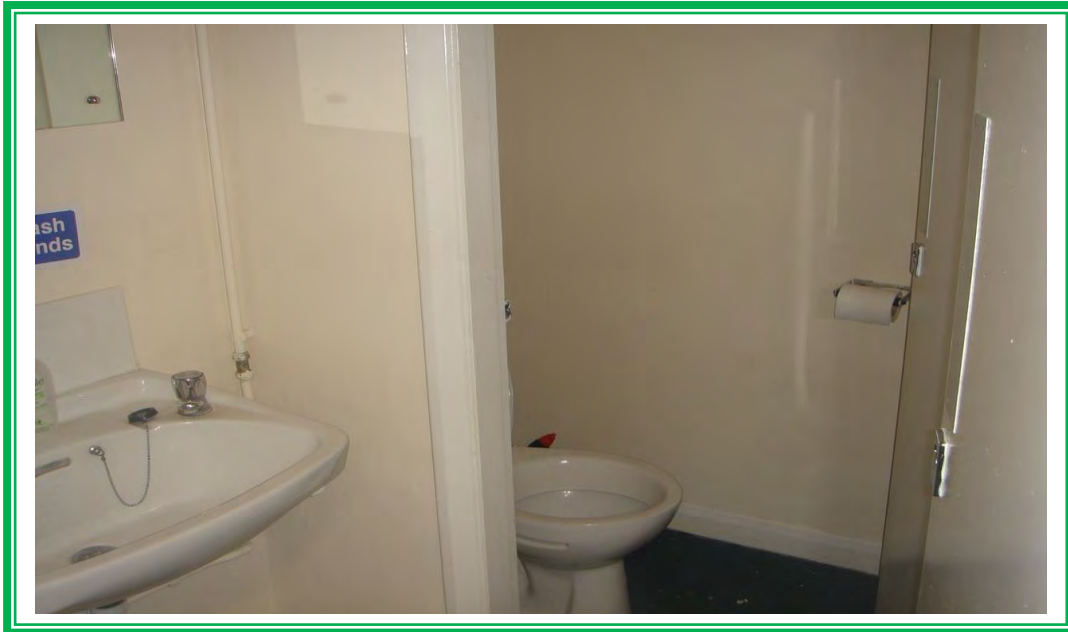
Location: 1/003 WC

Material Description:	Visual Inspection – No Suspect Materials Found	
Identification:	N/A	
Approx. quantity:	N/A	
Accessibility	N/A	Assessment Score
Product type:	N/A	N/A
Extent of Damage:	N/A	N/A
Surface Treatment:	N/A	N/A
Asbestos type:	N/A	N/A
Material Assessment Score:		N/A
Priority Assessment Score:		N/A
Action:	N/A	
Comments:	N/A

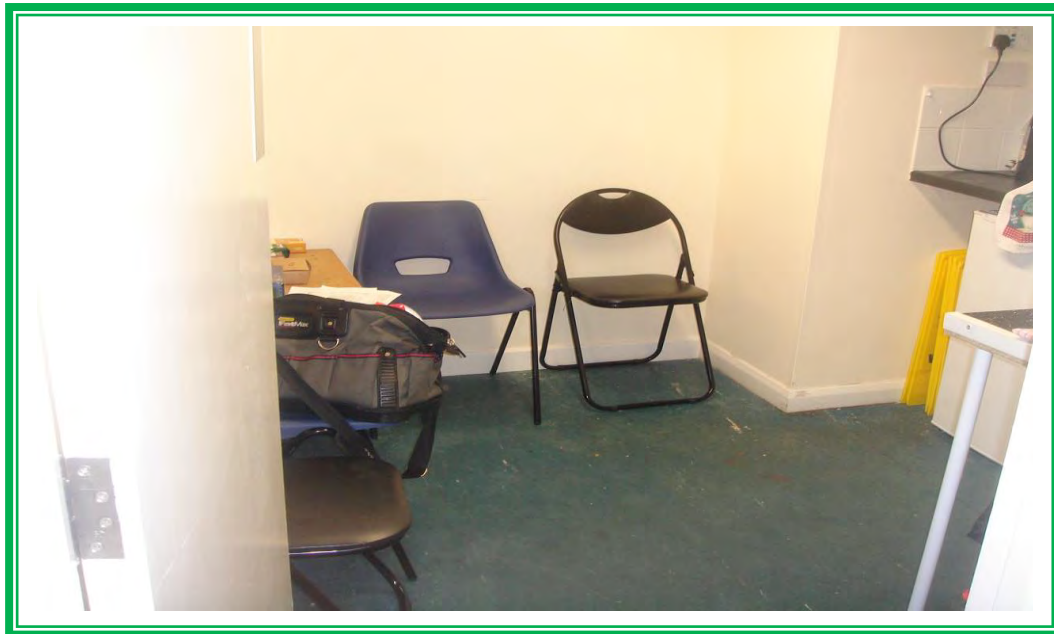
Location: 1/004 Kitchen

Material Description:	Visual Inspection – No Suspect Materials Found	
Identification:	N/A	
Approx. quantity:	N/A	
Accessibility	N/A	Assessment Score
Product type:	N/A	N/A
Extent of Damage:	N/A	N/A
Surface Treatment:	N/A	N/A
Asbestos type:	N/A	N/A
Material Assessment Score:		N/A
Priority Assessment Score:		N/A
Action:	N/A	
Comments:	N/A

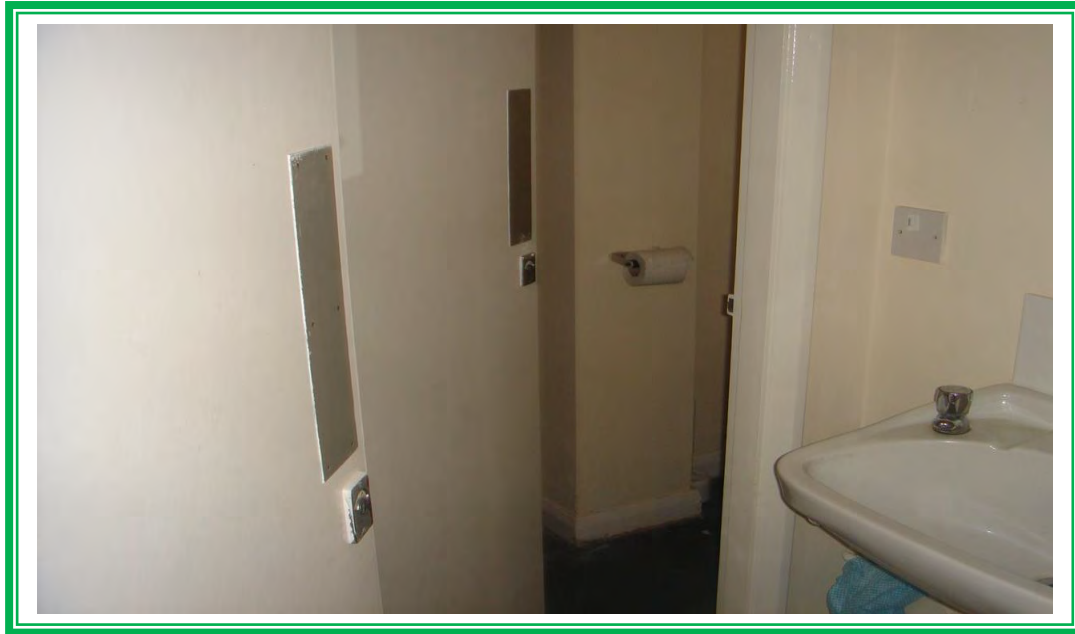
Location: 1/005 WC

Material Description:	Visual Inspection – No Suspect Materials Found	
Identification:	N/A	
Approx. quantity:	N/A	
Accessibility	N/A	Assessment Score
Product type:	N/A	N/A
Extent of Damage:	N/A	N/A
Surface Treatment:	N/A	N/A
Asbestos type:	N/A	N/A
Material Assessment Score:		N/A
Priority Assessment Score:		N/A
Action:	N/A	
Comments:	N/A

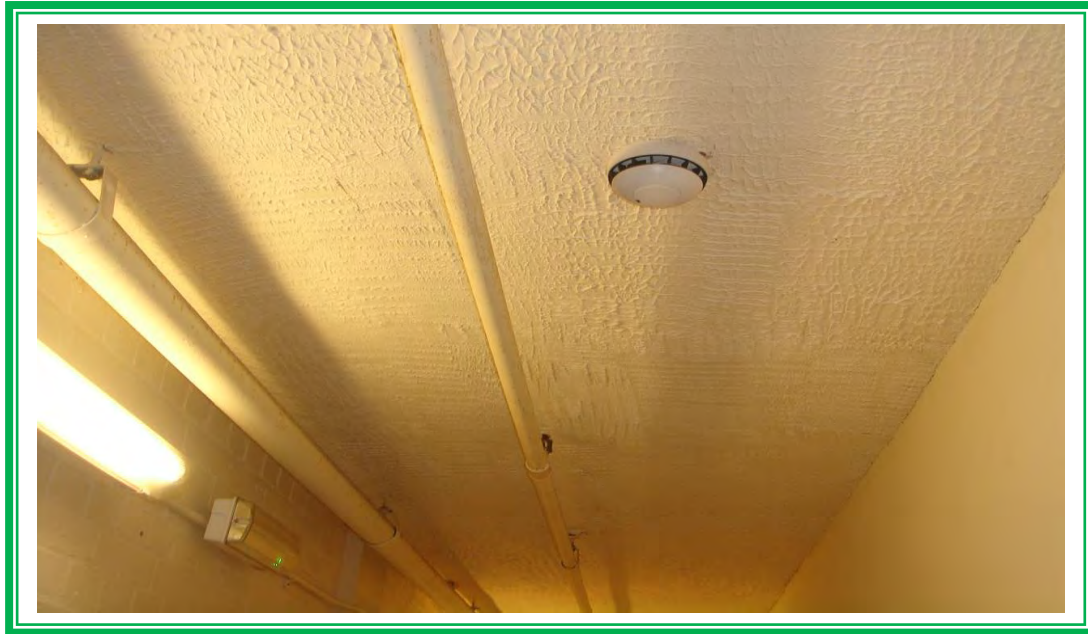
Location: 1/006 Stairs

Material Description:	Textured Coating to Ceiling	
Identification:	Sampled – No Asbestos Detected	
Approx. quantity:	15M2	
Accessibility	N/A	Assessment Score
Product type:	N/A	N/A
Extent of Damage:	N/A	N/A
Surface Treatment:	N/A	N/A
Asbestos type:	N/A	N/A
Material Assessment Score:		N/A
Priority Assessment Score:		N/A
Action:	N/A	
Comments:	N/A

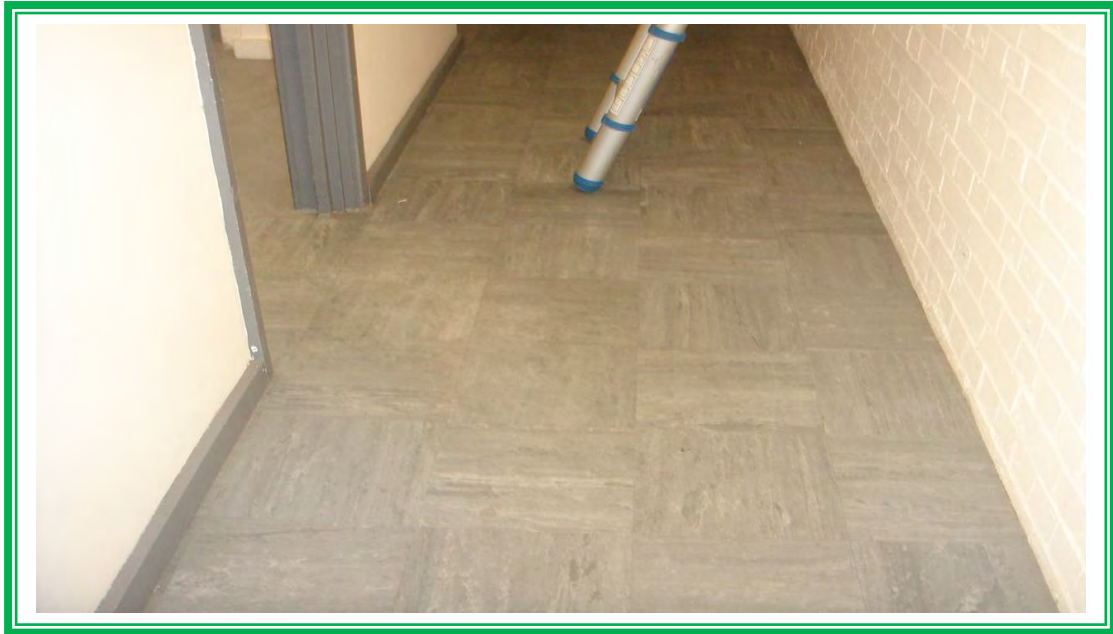
Location: 1/006 Stairs

Material Description:	Vinyl Floor Tiles	
Identification:	As Per Sample NE/1 – No Asbestos Detected	
Approx. quantity:	6M2	
Accessibility	N/A	Assessment Score
Product type:	N/A	N/A
Extent of Damage:	N/A	N/A
Surface Treatment:	N/A	N/A
Asbestos type:	N/A	N/A
Material Assessment Score:		N/A
Priority Assessment Score:		N/A
Action:	N/A	
Comments:	N/A

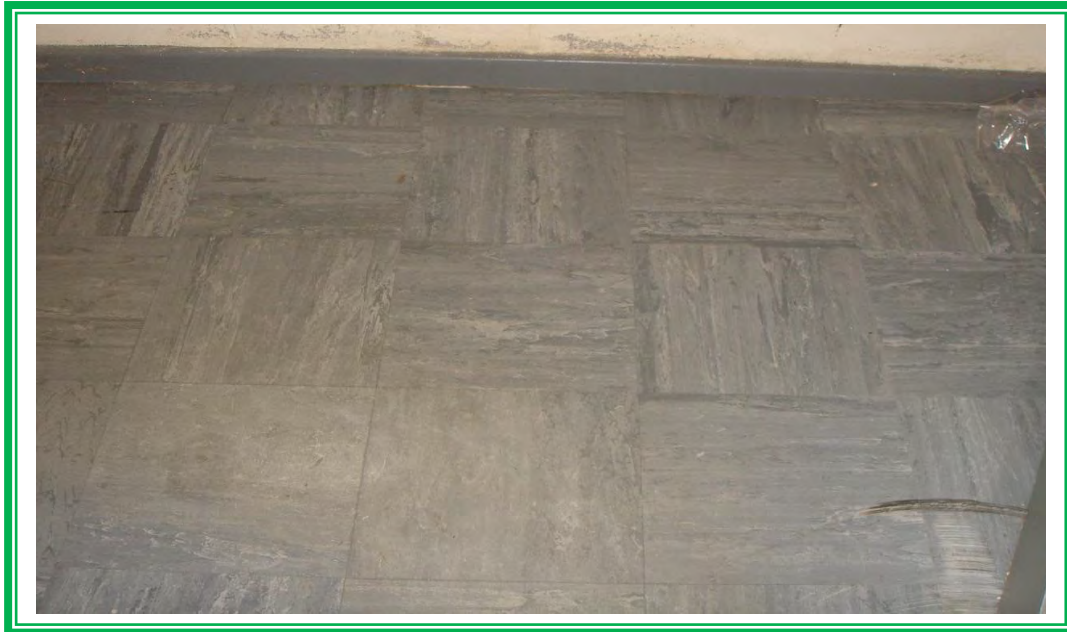
Location: 0/001 Lobby

Material Description:	Vinyl Floor Tiles	
Identification:	Sampled – No Asbestos Detected	
Approx. quantity:	4M2	
Accessibility	N/A	Assessment Score
Product type:	N/A	N/A
Extent of Damage:	N/A	N/A
Surface Treatment:	N/A	N/A
Asbestos type:	N/A	N/A
Material Assessment Score:		N/A
Priority Assessment Score:		N/A
Action:	N/A	
Comments:	N/A

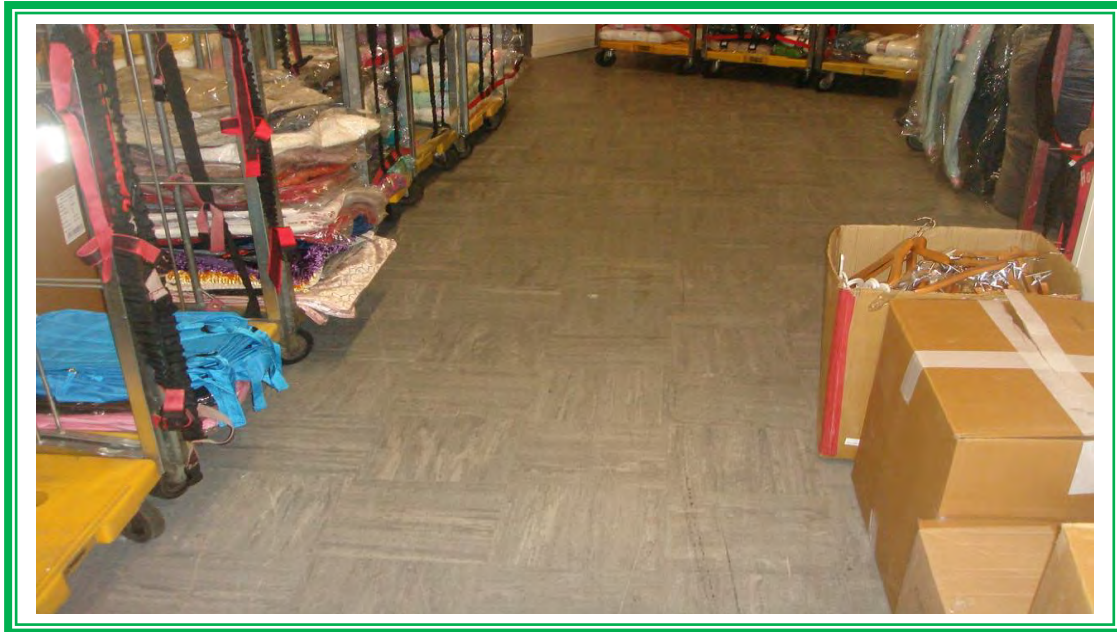
Location: 0/002 Stores

Material Description:	Vinyl Floor Tiles	
Identification:	As Per Sample NE/4 – No Asbestos Detected	
Approx. quantity:	40M2	
Accessibility	N/A	Assessment Score
Product type:	N/A	N/A
Extent of Damage:	N/A	N/A
Surface Treatment:	N/A	N/A
Asbestos type:	N/A	N/A
Material Assessment Score:		N/A
Priority Assessment Score:		N/A
Action:	N/A	
Comments:	N/A

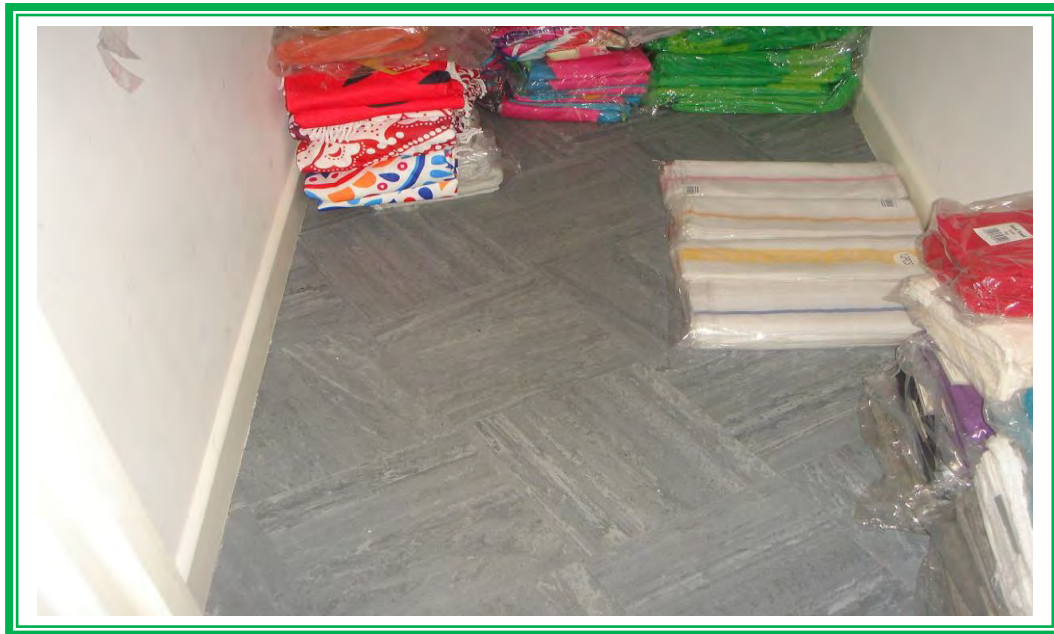
Location: 0/003A Cupboard

Material Description:	Vinyl Floor Tiles	
Identification:	As Per Sample NE/4 – No Asbestos Detected	
Approx. quantity:	2M2	
Accessibility	N/A	Assessment Score
Product type:	N/A	N/A
Extent of Damage:	N/A	N/A
Surface Treatment:	N/A	N/A
Asbestos type:	N/A	N/A
Material Assessment Score:		N/A
Priority Assessment Score:		N/A
Action:	N/A	
Comments:	N/A

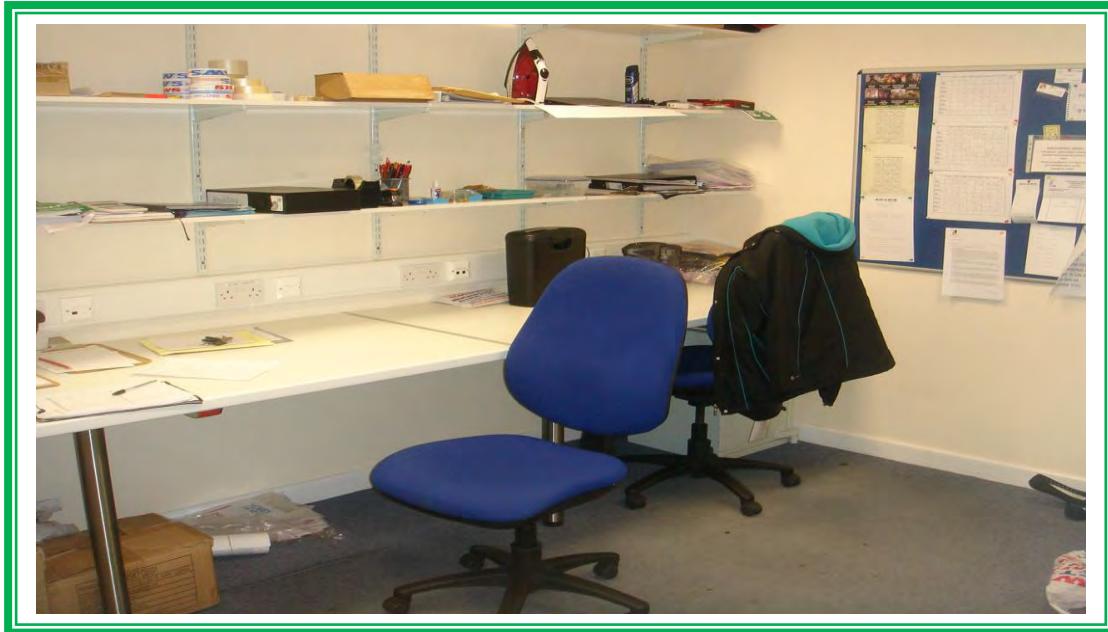
Location: 0/004 Office

Material Description:	Visual Inspection – No Suspect Materials Found	
Identification:	N/A	
Approx. quantity:	N/A	
Accessibility	N/A	Assessment Score
Product type:	N/A	N/A
Extent of Damage:	N/A	N/A
Surface Treatment:	N/A	N/A
Asbestos type:	N/A	N/A
Material Assessment Score:		N/A
Priority Assessment Score:		N/A
Action:	N/A	
Comments:	N/A

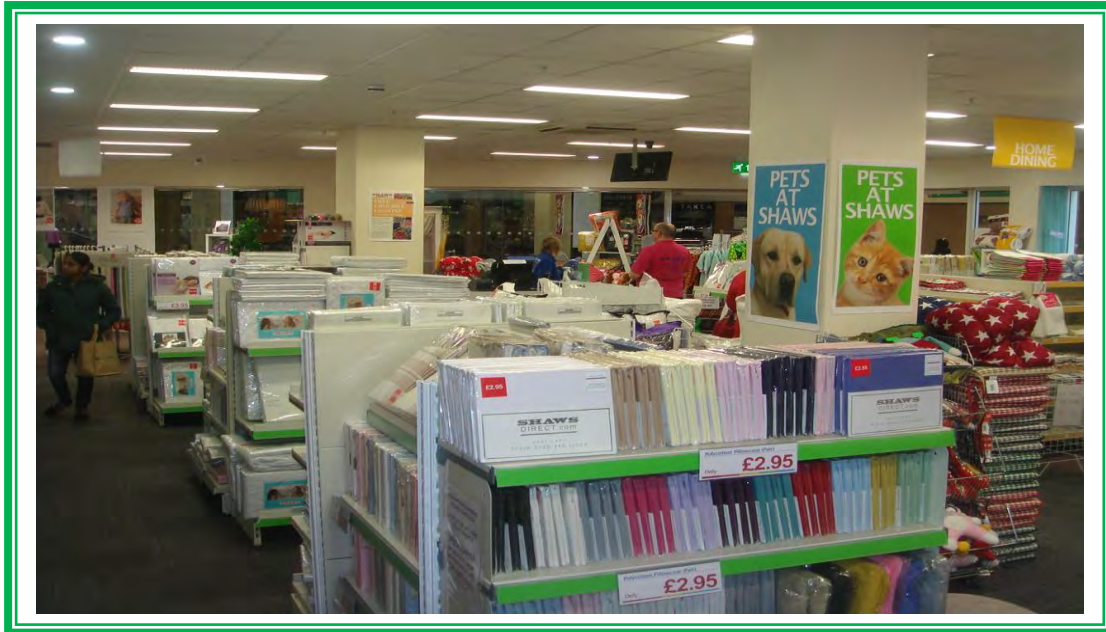
Location: 0/005 Shop Floor

Material Description:	Visual Inspection – No Suspect Materials Found	
Identification:	N/A	
Approx. quantity:	N/A	
Accessibility	N/A	Assessment Score
Product type:	N/A	N/A
Extent of Damage:	N/A	N/A
Surface Treatment:	N/A	N/A
Asbestos type:	N/A	N/A
Material Assessment Score:		N/A
Priority Assessment Score:		N/A
Action:	N/A	
Comments:	N/A

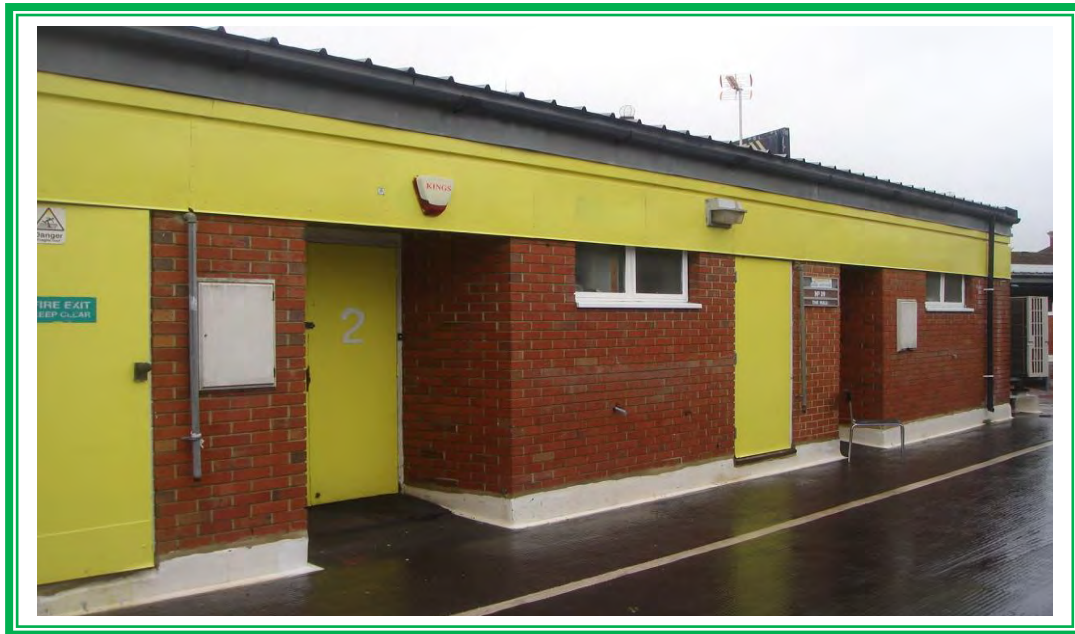
Location: 99/001 Externals

Material Description:	Visual Inspection – No Suspect Materials Found	
Identification:	N/A	
Approx. quantity:	N/A	
Accessibility	N/A	Assessment Score
Product type:	N/A	N/A
Extent of Damage:	N/A	N/A
Surface Treatment:	N/A	N/A
Asbestos type:	N/A	N/A
Material Assessment Score:		N/A
Priority Assessment Score:		N/A
Action:	N/A	
Comments:	N/A

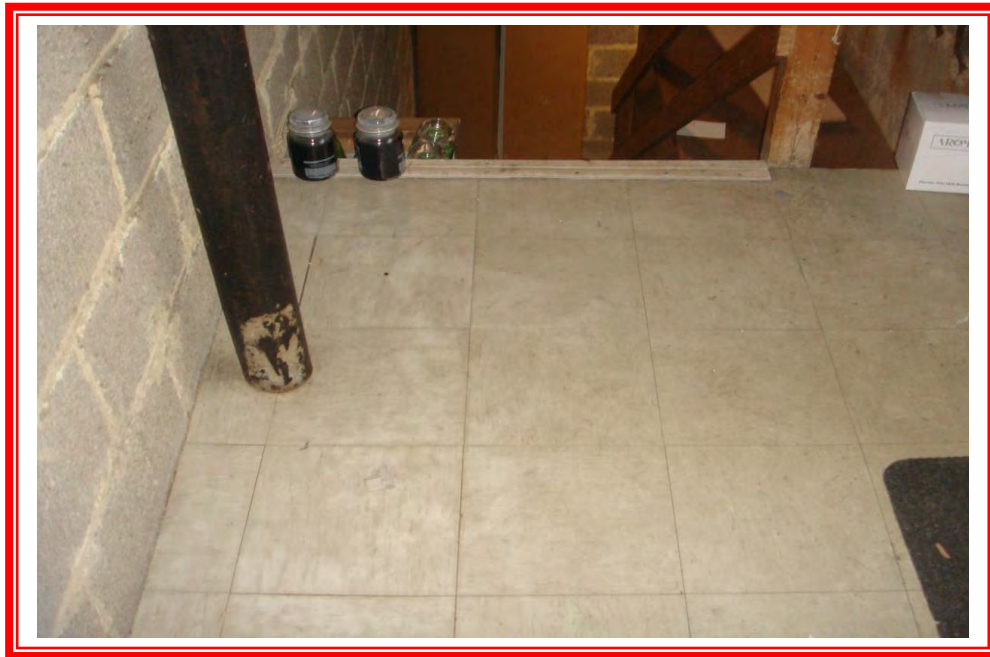
Location: 1/001 Landing and Stairs

Material Description:	Vinyl Floor Tiles	
Identification:	Sampled – Asbestos Detected	
Approx. quantity:	20M2	
Accessibility	Low	Assessment Score
Product type:	Vinyl	1
Extent of Damage:	Minor	1
Surface Treatment:	Non-Friable	0
Asbestos type:	Chrysotile	1
Material Assessment Score:		3
Priority Assessment Score:		Negligible
Action:	Manage	
Comments:	N/A

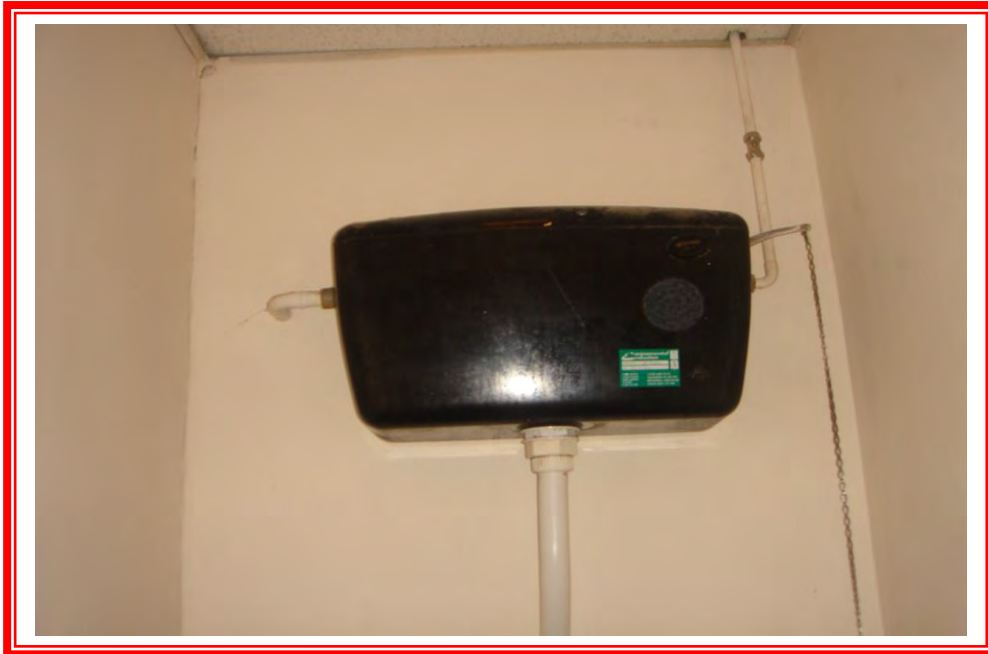
Location: 0/001 WC

Material Description:	Toilet Cistern	
Identification:	Sampled – Asbestos Detected	
Approx. quantity:	X 1	
Accessibility	Low	Assessment Score
Product type:	Bakelite	1
Extent of Damage:	Good	0
Surface Treatment:	Non-Friable	0
Asbestos type:	Amosite	2
Material Assessment Score:		3
Priority Assessment Score:		Negligible
Action:	Manage	
Comments:	N/A

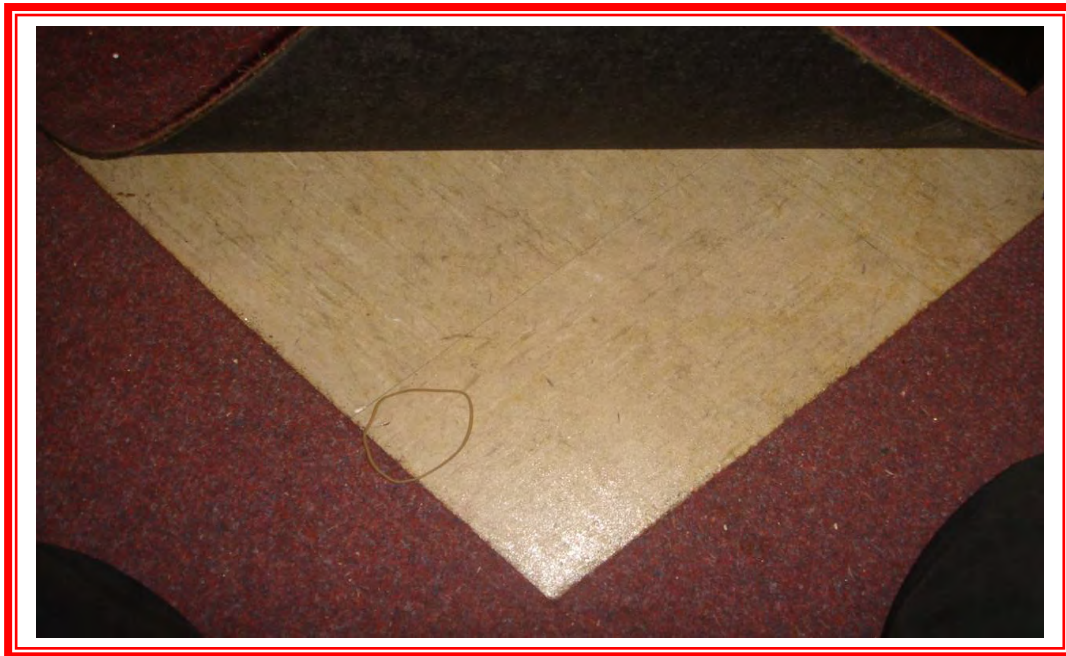
Location: 0/002 Office

Material Description:	Vinyl Floor Tiles	
Identification:	Sampled – Asbestos Detected	
Approx. quantity:	2M2	
Accessibility	Low	Assessment Score
Product type:	Vinyl	1
Extent of Damage:	Good	0
Surface Treatment:	Non-Friable	0
Asbestos type:	Chrysotile	1
Material Assessment Score:		2
Priority Assessment Score:		Negligible
Action:	Manage	
Comments:	N/A

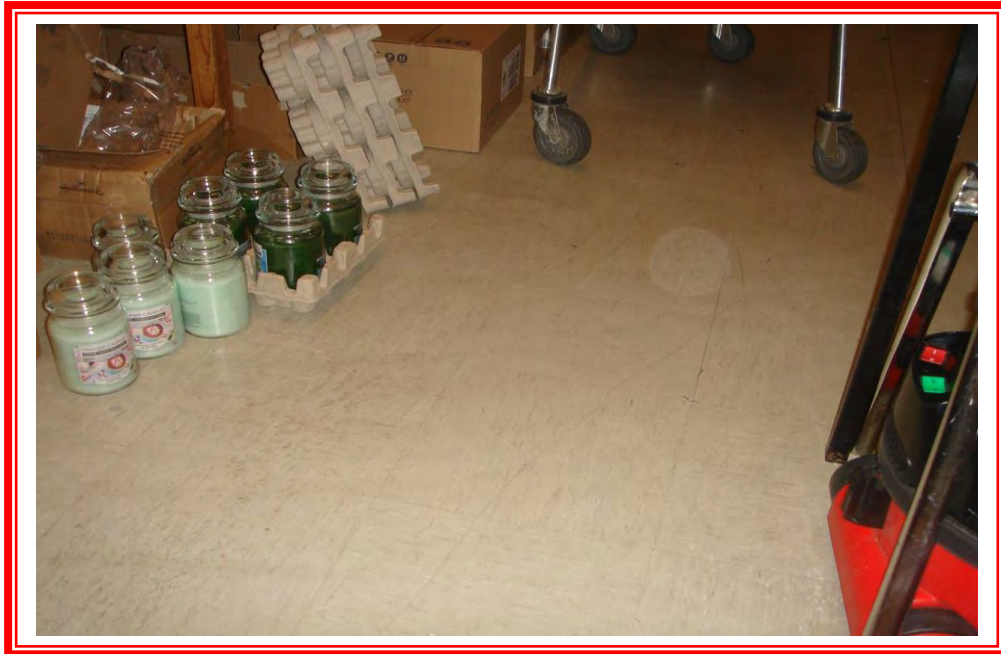
Location: 0/003 Store/Kitchen

Material Description:	Vinyl Floor Tiles	
Identification:	As Per Sample NE/3- Asbestos Detected	
Approx. quantity:	15M2	
Accessibility	Low	Assessment Score
Product type:	Vinyl	1
Extent of Damage:	Minor	1
Surface Treatment:	Non-Friable	0
Asbestos type:	Chrysotile	1
Material Assessment Score:		3
Priority Assessment Score:		Negligible
Action:	Manage	
Comments:	N/A

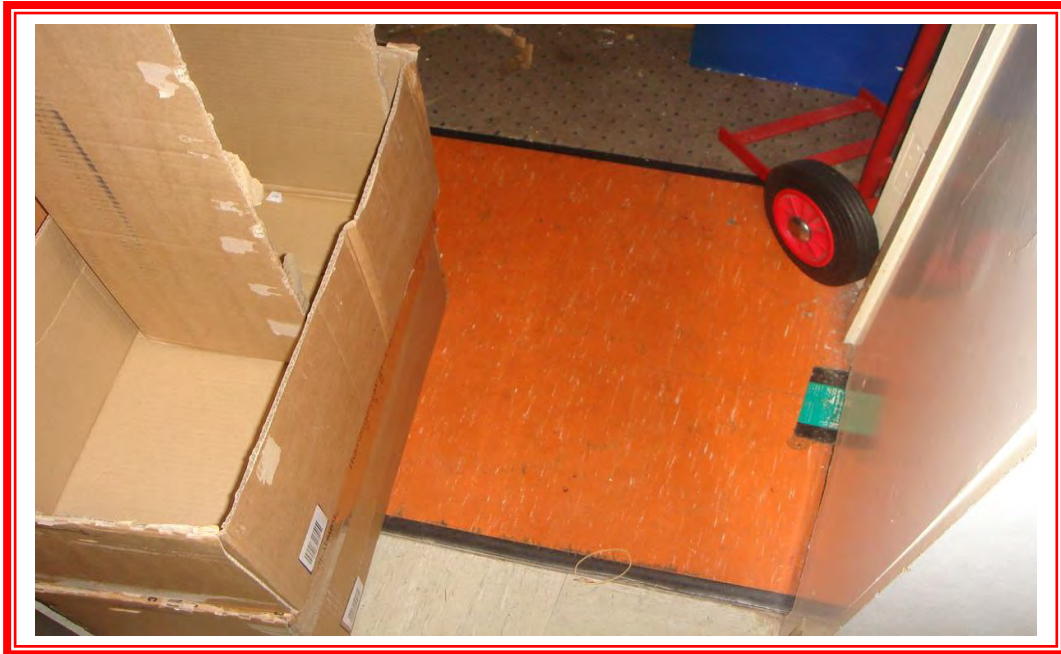
Sample No: NE/4

Location: 0/003 Store/Kitchen

Material Description:	Vinyl Floor Tiles (Orange)	
Identification:	Sampled – Asbestos Detected	
Approx. quantity:	1M2	
Accessibility	Low	Assessment Score
Product type:	Vinyl	1
Extent of Damage:	Minor	1
Surface Treatment:	Non-Friable	0
Asbestos type:	Chrysotile	1
Material Assessment Score:		3
Priority Assessment Score:		Negligible
Action:	Manage	
Comments:	N/A

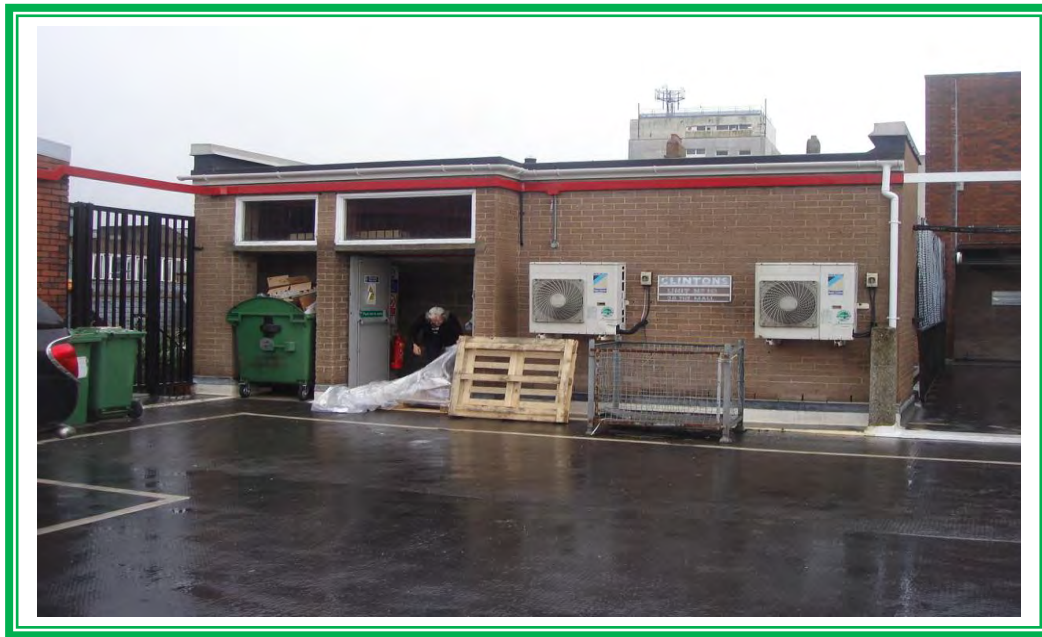
Location: 99/001 External

Material Description:	Visual Inspection – No Suspect Materials Found	
Identification:	N/A	
Approx. quantity:	N/A	
Accessibility	N/A	Assessment Score
Product type:	N/A	N/A
Extent of Damage:	N/A	N/A
Surface Treatment:	N/A	N/A
Asbestos type:	N/A	N/A
Material Assessment Score:		N/A
Priority Assessment Score:		N/A
Action:	N/A	
Comments:	N/A

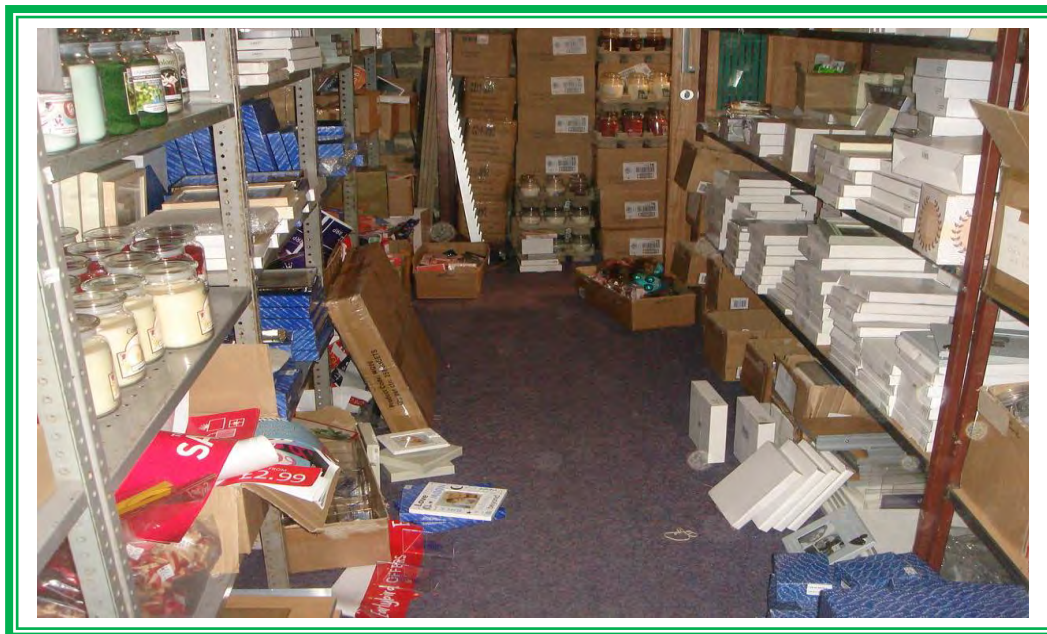
Location: 0/004 Store

Material Description:	Visual Inspection – No Suspect Materials Found	
Identification:	N/A	
Approx. quantity:	N/A	
Accessibility	N/A	Assessment Score
Product type:	N/A	N/A
Extent of Damage:	N/A	N/A
Surface Treatment:	N/A	N/A
Asbestos type:	N/A	N/A
Material Assessment Score:		N/A
Priority Assessment Score:		N/A
Action:	N/A	
Comments:	N/A

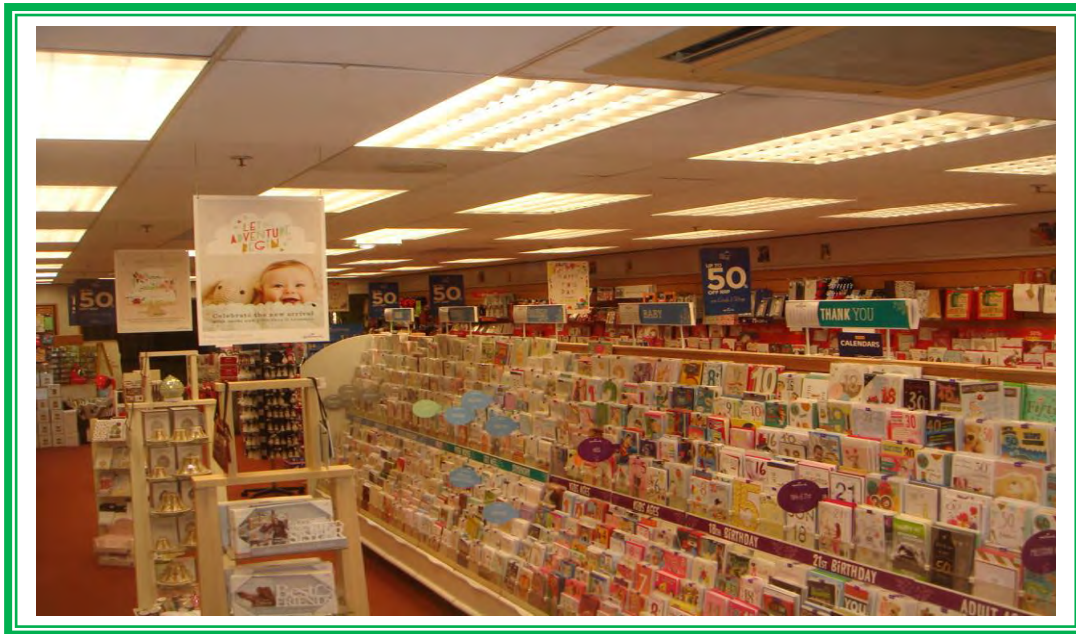
Location: 0/005 Shop Floor

Material Description:	Visual Inspection – No Suspect Materials Found	
Identification:	N/A	
Approx. quantity:	N/A	
Accessibility	N/A	Assessment Score
Product type:	N/A	N/A
Extent of Damage:	N/A	N/A
Surface Treatment:	N/A	N/A
Asbestos type:	N/A	N/A
Material Assessment Score:		N/A
Priority Assessment Score:		N/A
Action:	N/A	
Comments:	N/A

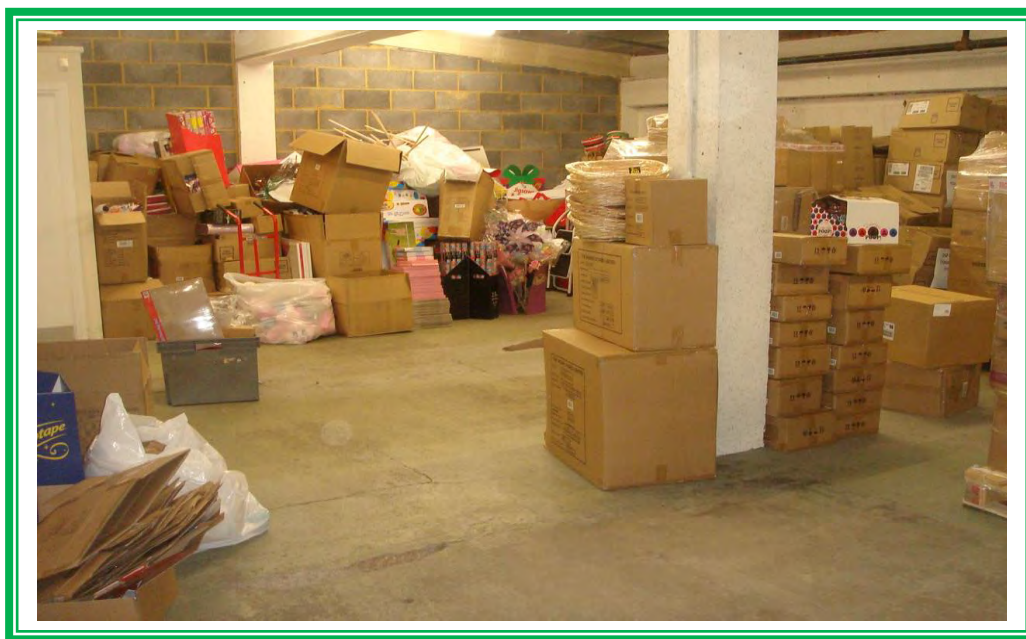
Location: 1/001 Store

Material Description:	Visual Inspection – No Suspect Materials Found	
Identification:	N/A	
Approx. quantity:	N/A	
Accessibility	N/A	Assessment Score
Product type:	N/A	N/A
Extent of Damage:	N/A	N/A
Surface Treatment:	N/A	N/A
Asbestos type:	N/A	N/A
Material Assessment Score:		N/A
Priority Assessment Score:		N/A
Action:	N/A	
Comments:	N/A

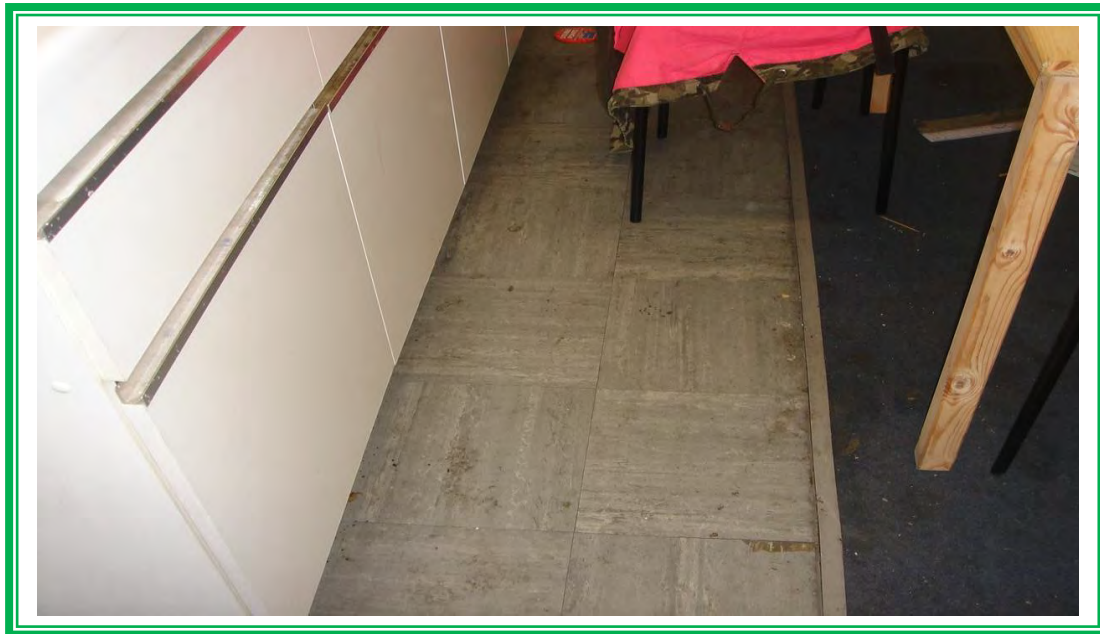
Sample No: NE/1

Location: 1/002 Kitchen

Material Description:	Vinyl Floor Tiles	
Identification:	Sampled – No Asbestos Detected	
Approx. quantity:	1M2	
Accessibility	N/A	Assessment Score
Product type:	N/A	N/A
Extent of Damage:	N/A	N/A
Surface Treatment:	N/A	N/A
Asbestos type:	N/A	N/A
Material Assessment Score:		N/A
Priority Assessment Score:		N/A
Action:	N/A	
Comments:	N/A

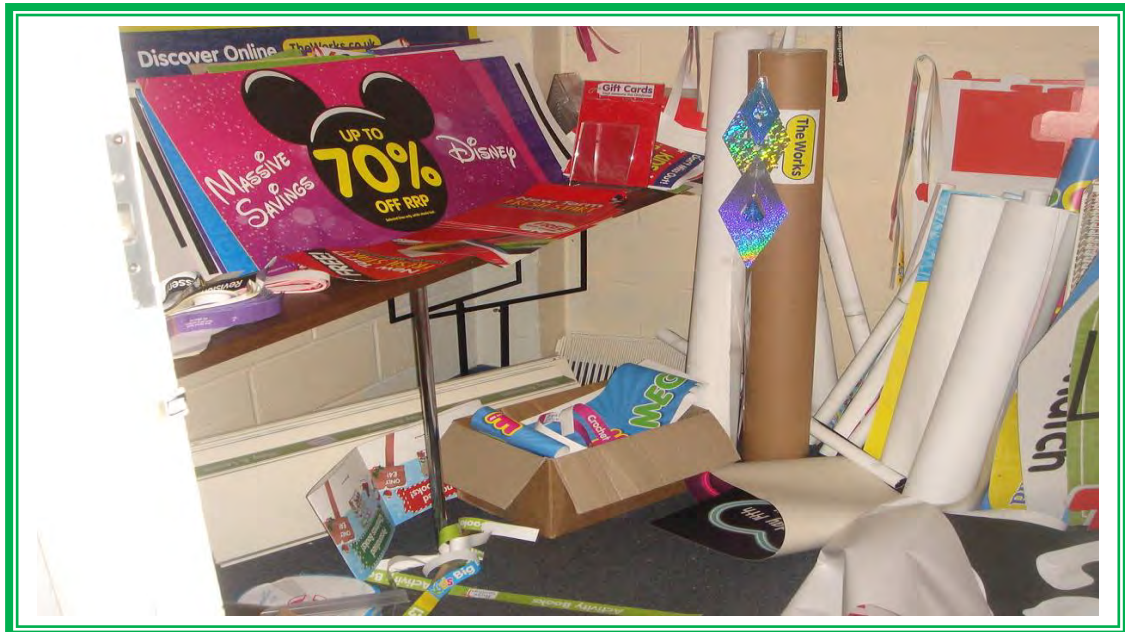
Location: 1/003 Store

Material Description:	Visual Inspection – No Suspect Materials Found	
Identification:	N/A	
Approx. quantity:	N/A	
Accessibility	N/A	Assessment Score
Product type:	N/A	N/A
Extent of Damage:	N/A	N/A
Surface Treatment:	N/A	N/A
Asbestos type:	N/A	N/A
Material Assessment Score:		N/A
Priority Assessment Score:		N/A
Action:	N/A	
Comments:	N/A

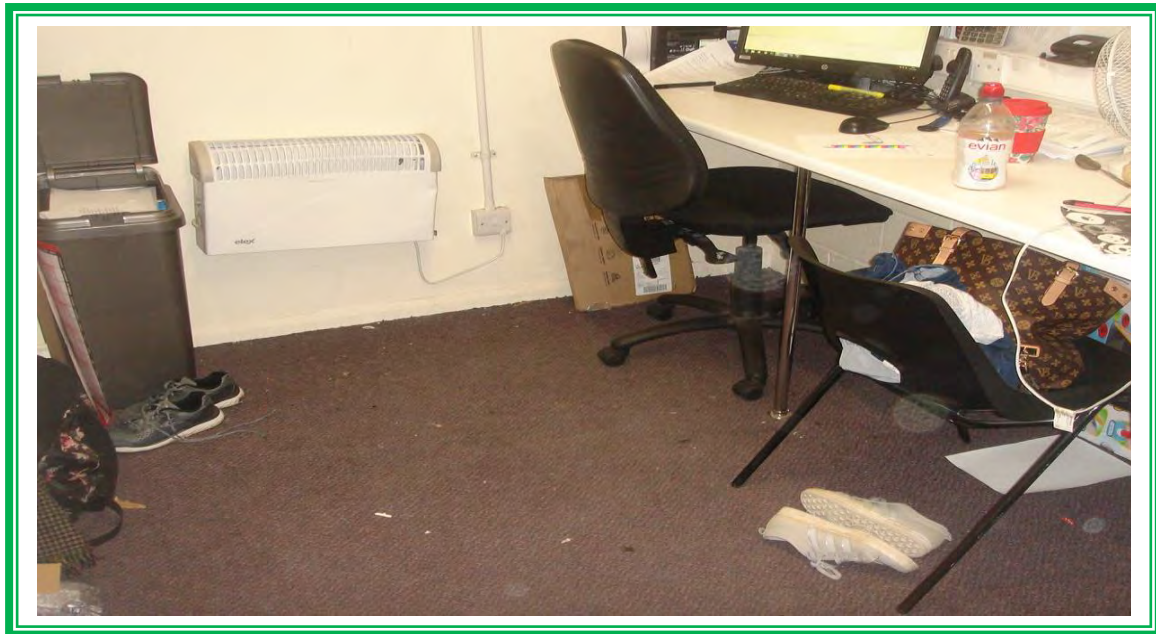
Location: 1/004 Office

Material Description:	Visual Inspection – No Suspect Materials Found	
Identification:	N/A	
Approx. quantity:	N/A	
Accessibility	N/A	Assessment Score
Product type:	N/A	N/A
Extent of Damage:	N/A	N/A
Surface Treatment:	N/A	N/A
Asbestos type:	N/A	N/A
Material Assessment Score:		N/A
Priority Assessment Score:		N/A
Action:	N/A	
Comments:	N/A

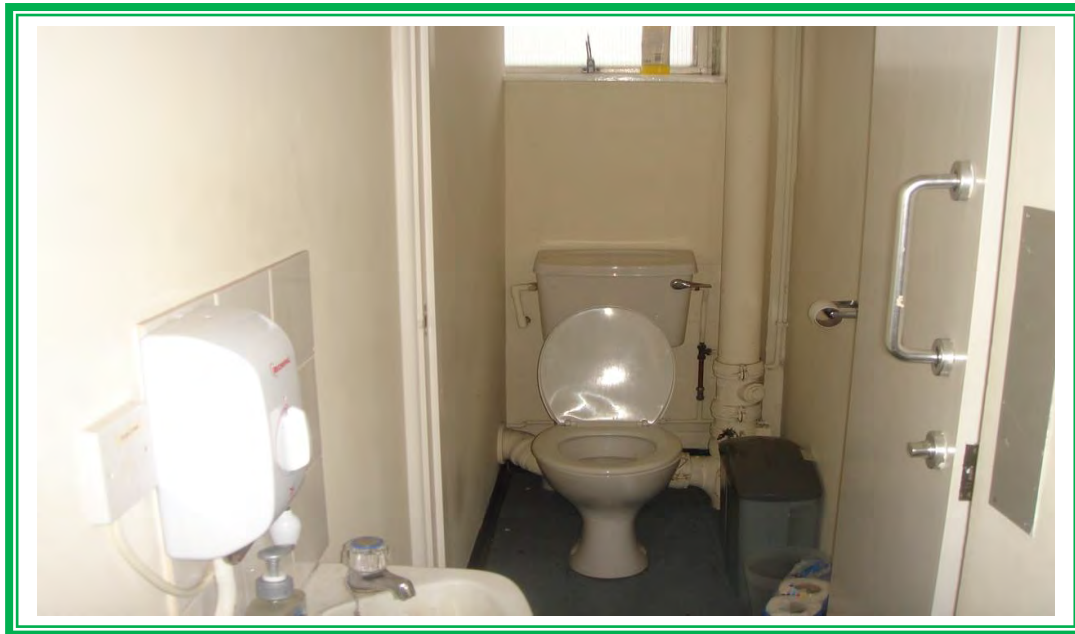
Location: 1/005 WC

Material Description:	Visual Inspection – No Suspect Materials Found	
Identification:	N/A	
Approx. quantity:	N/A	
Accessibility	N/A	Assessment Score
Product type:	N/A	N/A
Extent of Damage:	N/A	N/A
Surface Treatment:	N/A	N/A
Asbestos type:	N/A	N/A
Material Assessment Score:		N/A
Priority Assessment Score:		N/A
Action:	N/A	
Comments:	N/A

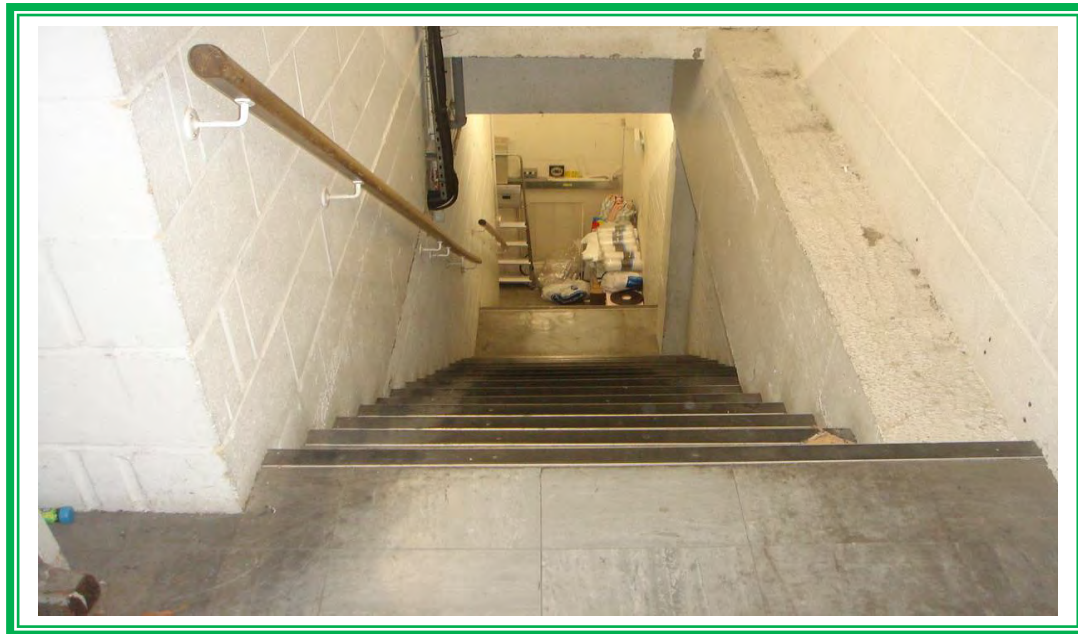
Location: 1/006 Stairwell

Material Description:	Vinyl Floor Tiles	
Identification:	As Per Sample NE/1 – No Asbestos Detected	
Approx. quantity:	20M2	
Accessibility	N/A	Assessment Score
Product type:	N/A	N/A
Extent of Damage:	N/A	N/A
Surface Treatment:	N/A	N/A
Asbestos type:	N/A	N/A
Material Assessment Score:		N/A
Priority Assessment Score:		N/A
Action:	N/A	
Comments:	N/A

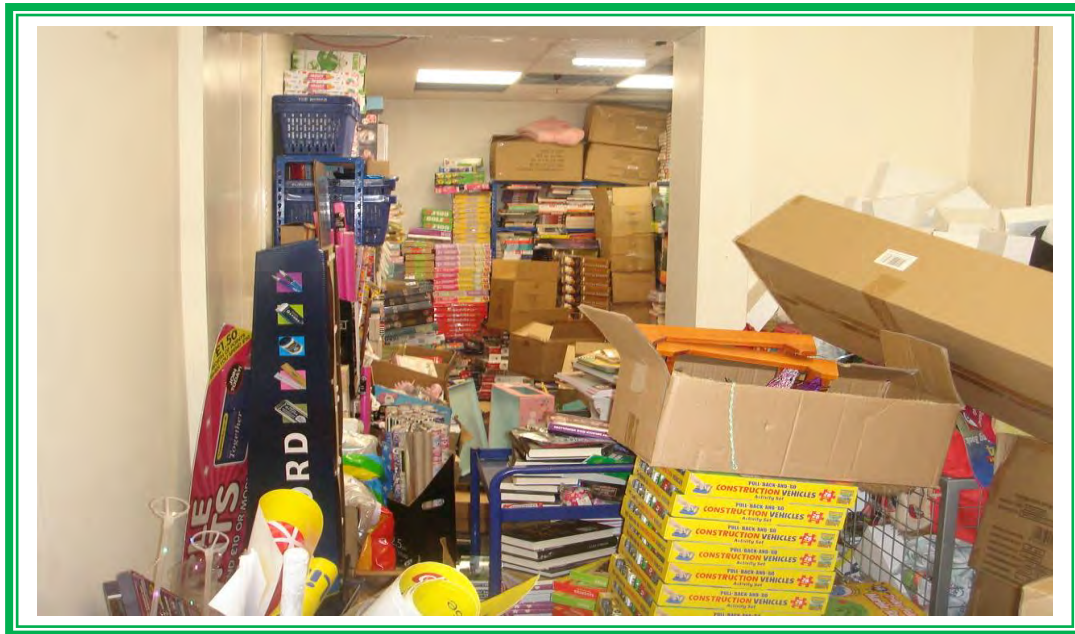
Location: 0/001 Store

Material Description:	Visual Inspection – No Suspect Materials Found	
Identification:	N/A	
Approx. quantity:	N/A	
Accessibility	N/A	Assessment Score
Product type:	N/A	N/A
Extent of Damage:	N/A	N/A
Surface Treatment:	N/A	N/A
Asbestos type:	N/A	N/A
Material Assessment Score:		N/A
Priority Assessment Score:		N/A
Action:	N/A	
Comments:	N/A
