# EAGLE QUARTER II NEWBURY

ASBESTOS SURVEY

Management  
Asbestos Survey Report

Kennet Centre, Market Street, Newbury,  
Berkshire, RG14 5EN

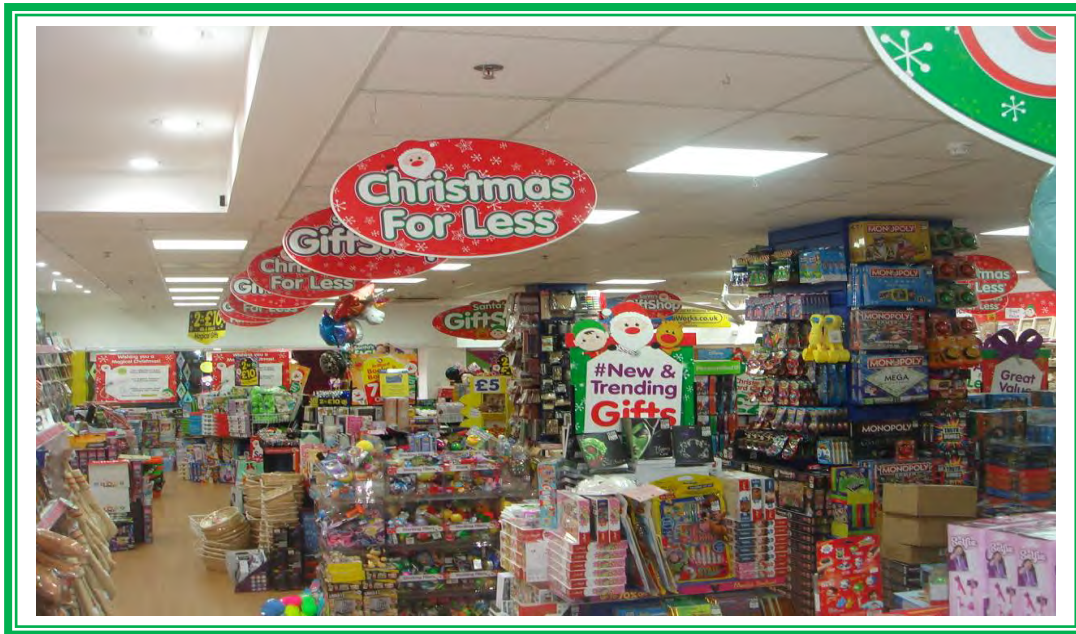
Location: 0/002 Shop Floor

Material Description:	Visual Inspection – No Suspect Materials Found	
Identification:	N/A	
Approx. quantity:	N/A	
Accessibility	N/A	Assessment Score
Product type:	N/A	N/A
Extent of Damage:	N/A	N/A
Surface Treatment:	N/A	N/A
Asbestos type:	N/A	N/A
Material Assessment Score:		N/A
Priority Assessment Score:		N/A
Action:	N/A	
Comments:	N/A

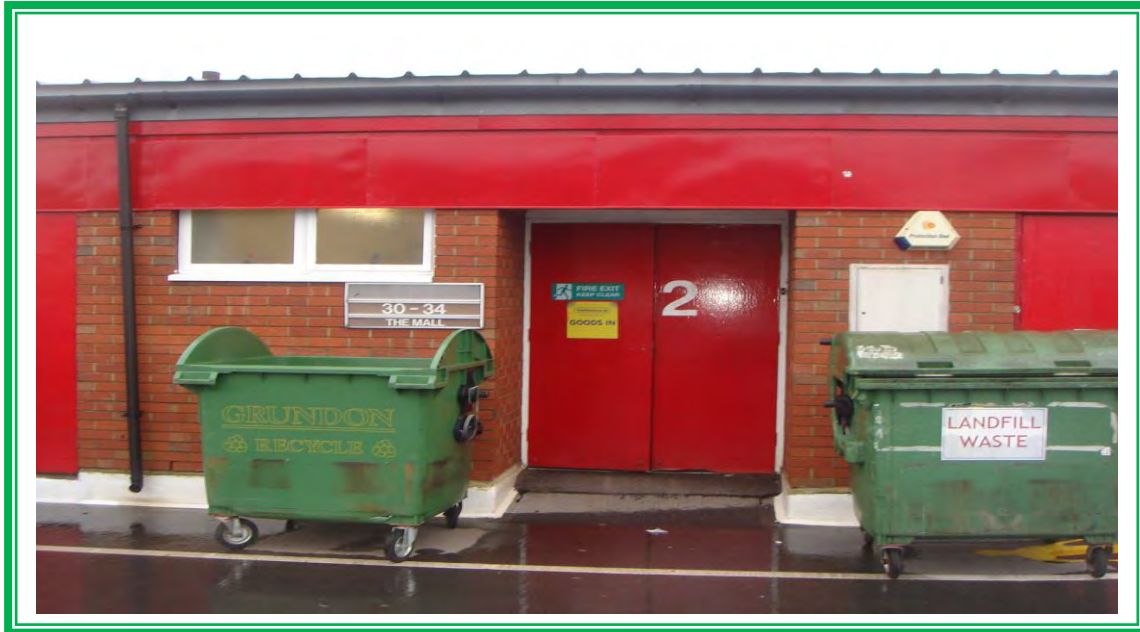
Location: 99/001 External

Material Description:	Visual Inspection – No Suspect Materials Found	
Identification:	N/A	
Approx. quantity:	N/A	
Accessibility	N/A	Assessment Score
Product type:	N/A	N/A
Extent of Damage:	N/A	N/A
Surface Treatment:	N/A	N/A
Asbestos type:	N/A	N/A
Material Assessment Score:		N/A
Priority Assessment Score:		N/A
Action:	N/A	
Comments:	N/A

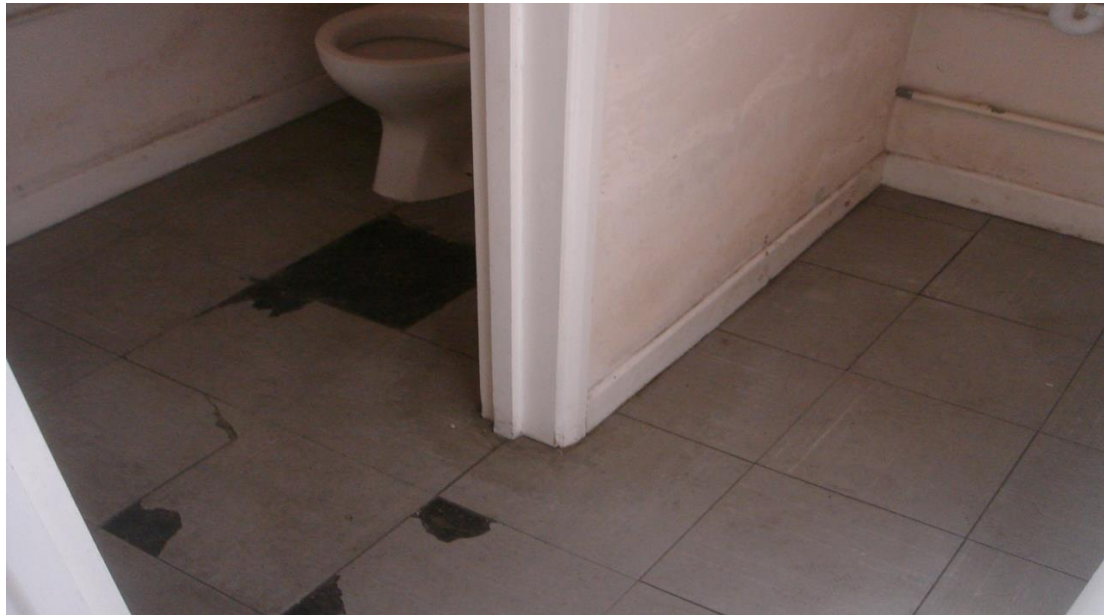
Location: 1/002 WC

Material Description:	Vinyl Floor Tiles	
Identification:	As Per Sample NE/1 – Asbestos Detected	
Approx. quantity:	2M2	
Accessibility	Low	Assessment Score
Product type:	Vinyl	1
Extent of Damage:	Low	1
Surface Treatment:	Non-Friable	0
Asbestos type:	Chrysotile	1
Material Assessment Score:		3
Priority Assessment Score:		Negligible
Action:	Manage	
Comments:	N/A

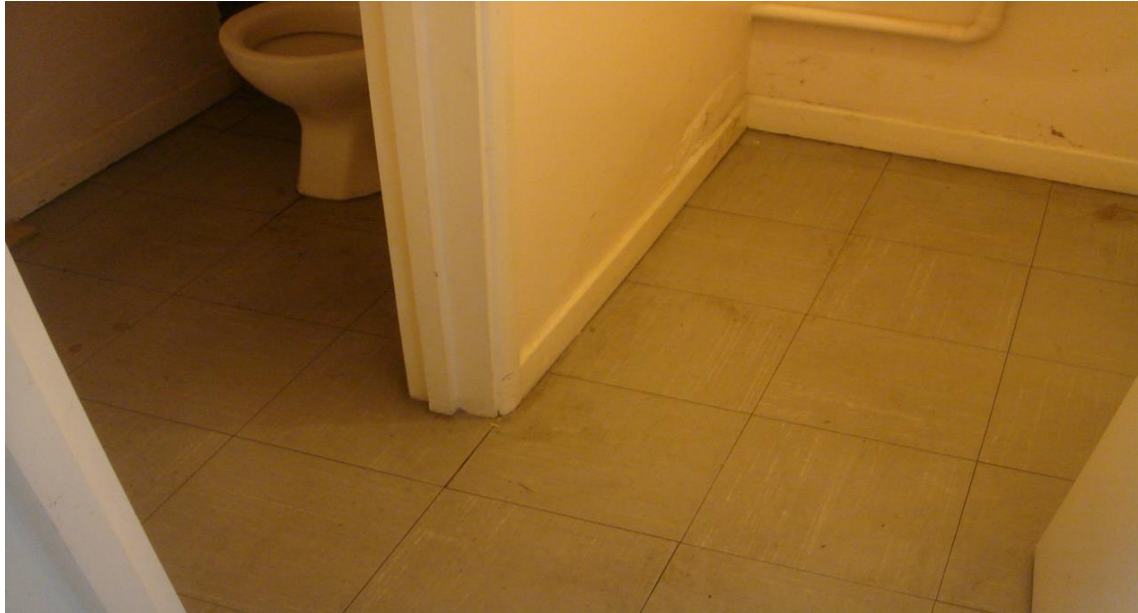
Location: 1/003

Material Description:	Vinyl floor Tiles	
Identification:	As Per Sample NE/1 - Asbestos Detected	
Approx. quantity:	2M2	
Accessibility	Low	Assessment Score
Product type:	Vinyl	1
Extent of Damage:	Low	1
Surface Treatment:	Non-Friable	0
Asbestos type:	Chrysotile	1
Material Assessment Score:		3
Priority Assessment Score:		Negligible
Action:	Manage	
Comments:	N/A

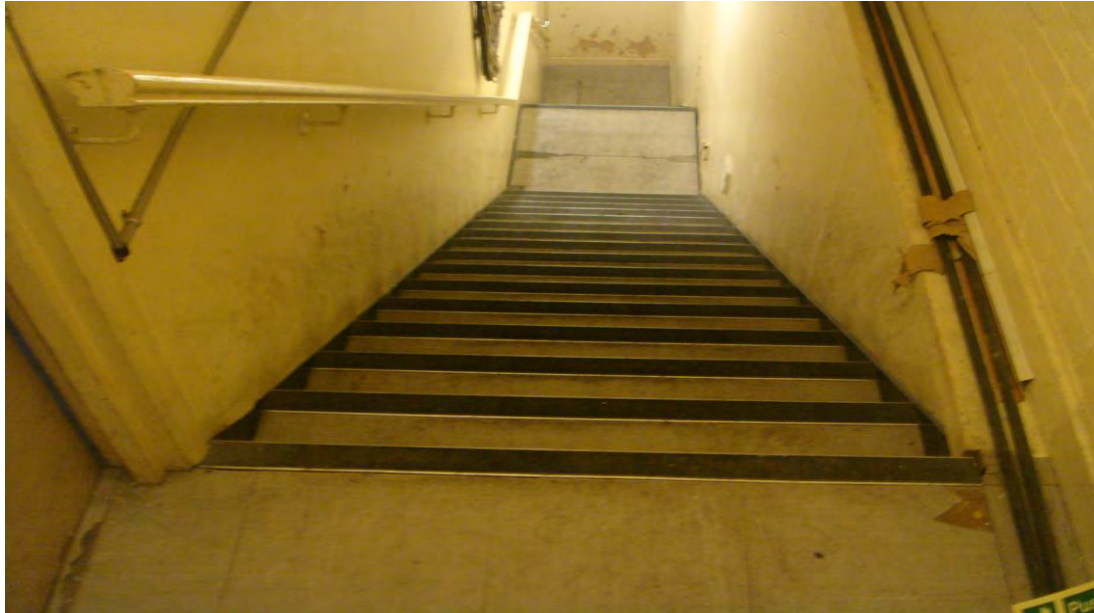
Location: 1/004 Stairs

Material Description:	Vinyl Floor Tiles	
Identification:	As per Sample NE/1 – Asbestos Detected	
Approx. quantity:	20M2	
Accessibility	Low	Assessment Score
Product type:	Vinyl	1
Extent of Damage:	Low	1
Surface Treatment:	Non-Friable	0
Asbestos type:	Chrysotile	1
Material Assessment Score:		3
Priority Assessment Score:		Negligible
Action:	Manage	
Comments:	N/A

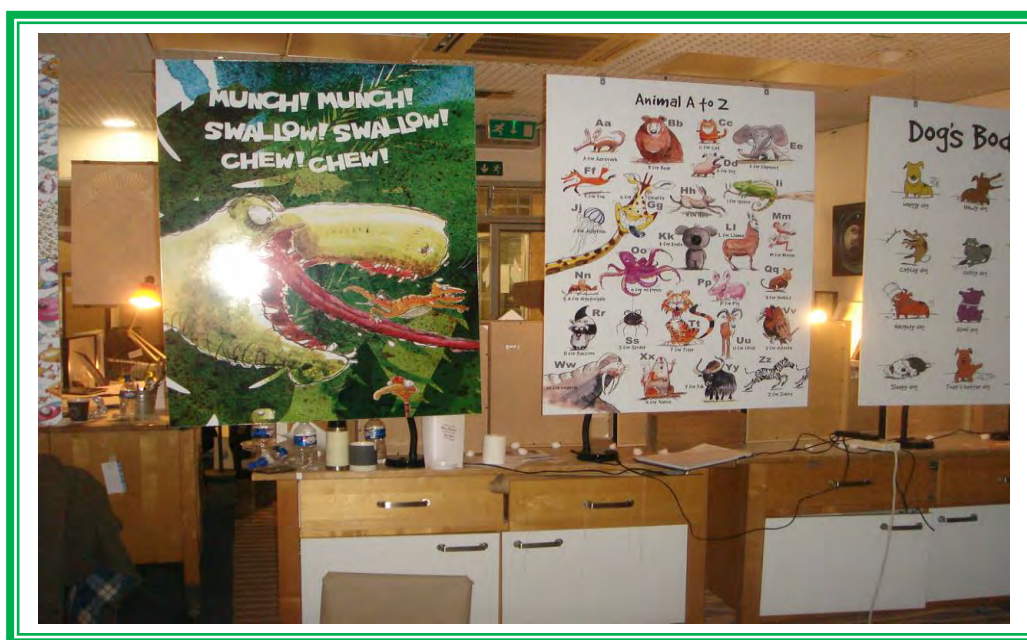
Location: 0/001 Shop Floor

Material Description:	Visual Inspection – No Suspect Materials Found	
Identification:	N/A	
Approx. quantity:	N/A	
Accessibility	N/A	Assessment Score
Product type:	N/A	N/A
Extent of Damage:	N/A	N/A
Surface Treatment:	N/A	N/A
Asbestos type:	N/A	N/A
Material Assessment Score:		N/A
Priority Assessment Score:		N/A
Action:	N/A	
Comments:	N/A

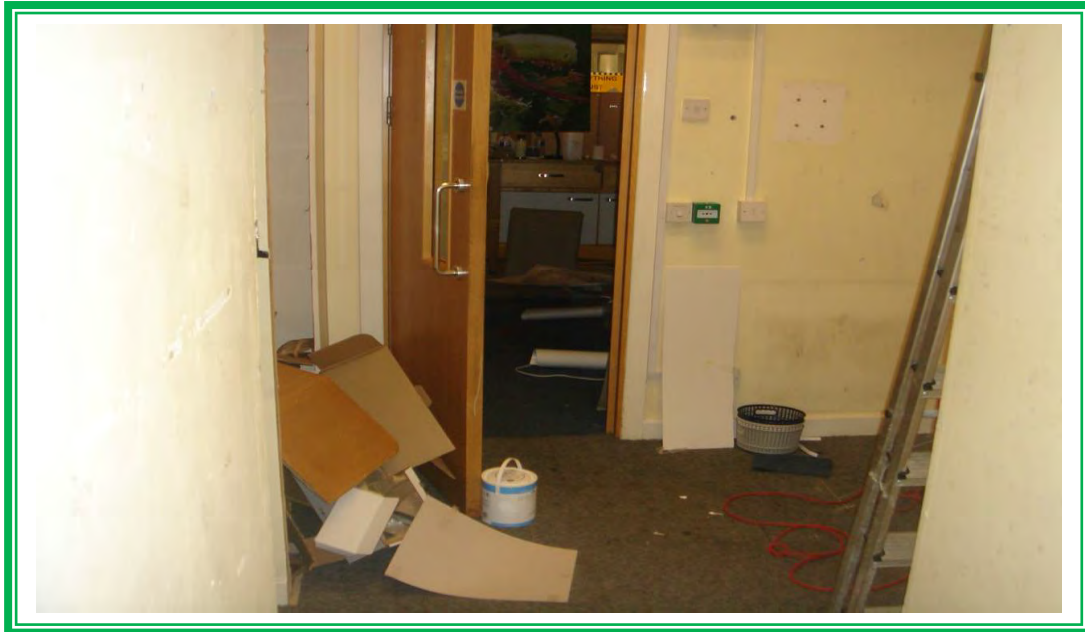
Location: 0/02 Stores

Material Description:	Visual Inspection – No Suspect Materials Found	
Identification:	N/A	
Approx. quantity:	N/A	
Accessibility	N/A	Assessment Score
Product type:	N/A	N/A
Extent of Damage:	N/A	N/A
Surface Treatment:	N/A	N/A
Asbestos type:	N/A	N/A
Material Assessment Score:		N/A
Priority Assessment Score:		N/A
Action:	N/A	
Comments:	N/A

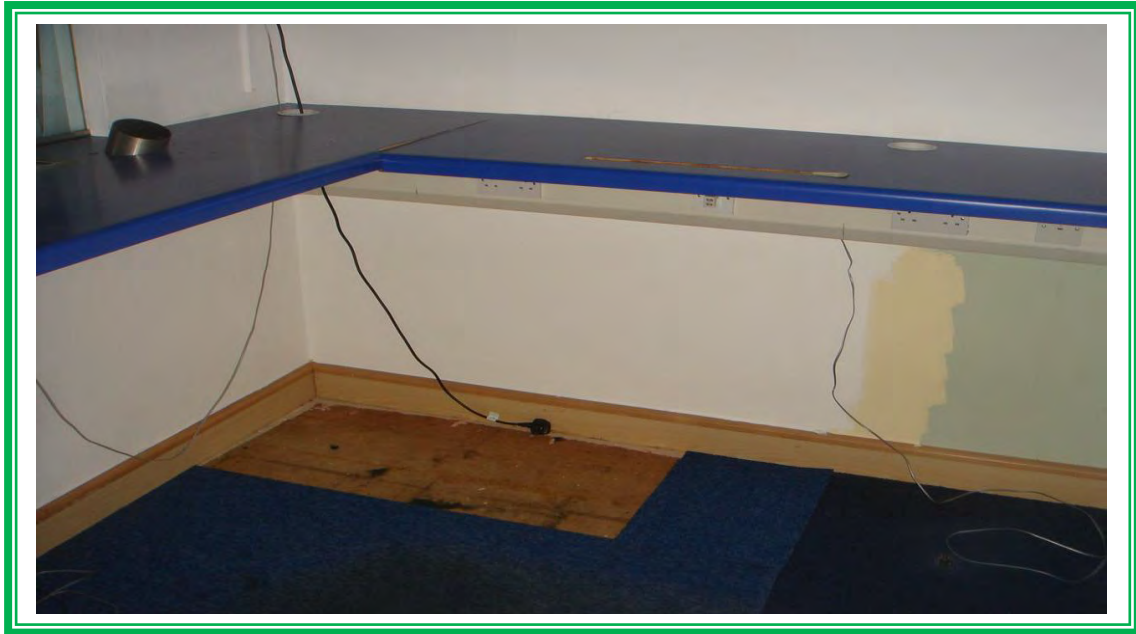
Location: 0/003 Office

Material Description:	Visual Inspection – No Suspect Materials Found	
Identification:	N/A	
Approx. quantity:	N/A	
Accessibility	N/A	Assessment Score
Product type:	N/A	N/A
Extent of Damage:	N/A	N/A
Surface Treatment:	N/A	N/A
Asbestos type:	N/A	N/A
Material Assessment Score:		N/A
Priority Assessment Score:		N/A
Action:	N/A	
Comments:	N/A

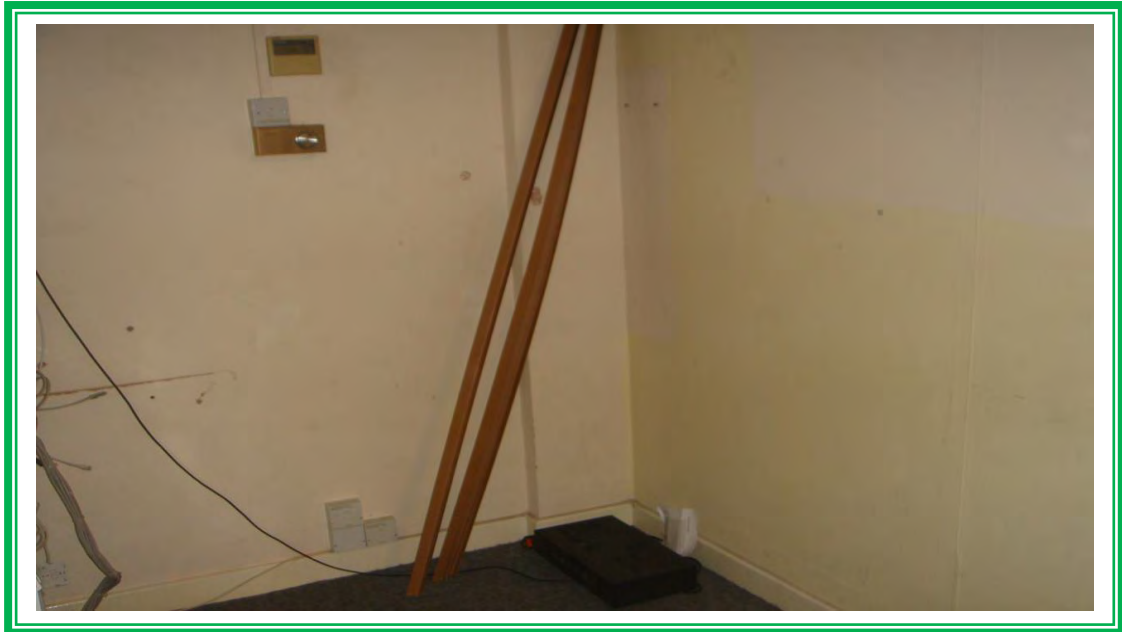
Location: 0/004 Office

Material Description:	Visual Inspection – No Suspect Materials Found	
Identification:	N/A	
Approx. quantity:	N/A	
Accessibility	N/A	Assessment Score
Product type:	N/A	N/A
Extent of Damage:	N/A	N/A
Surface Treatment:	N/A	N/A
Asbestos type:	N/A	N/A
Material Assessment Score:		N/A
Priority Assessment Score:		N/A
Action:	N/A	
Comments:	N/A

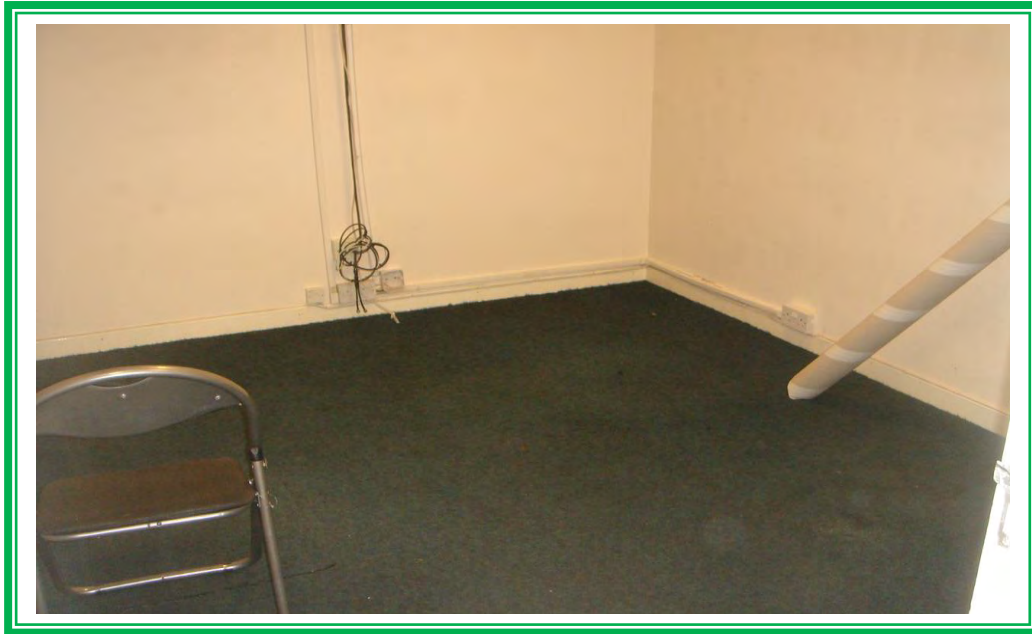
Location: 0/005 Office

Material Description:	Visual Inspection – No Suspect Materials Found	
Identification:	N/A	
Approx. quantity:	N/A	
Accessibility	N/A	Assessment Score
Product type:	N/A	N/A
Extent of Damage:	N/A	N/A
Surface Treatment:	N/A	N/A
Asbestos type:	N/A	N/A
Material Assessment Score:		N/A
Priority Assessment Score:		N/A
Action:	N/A	
Comments:	N/A

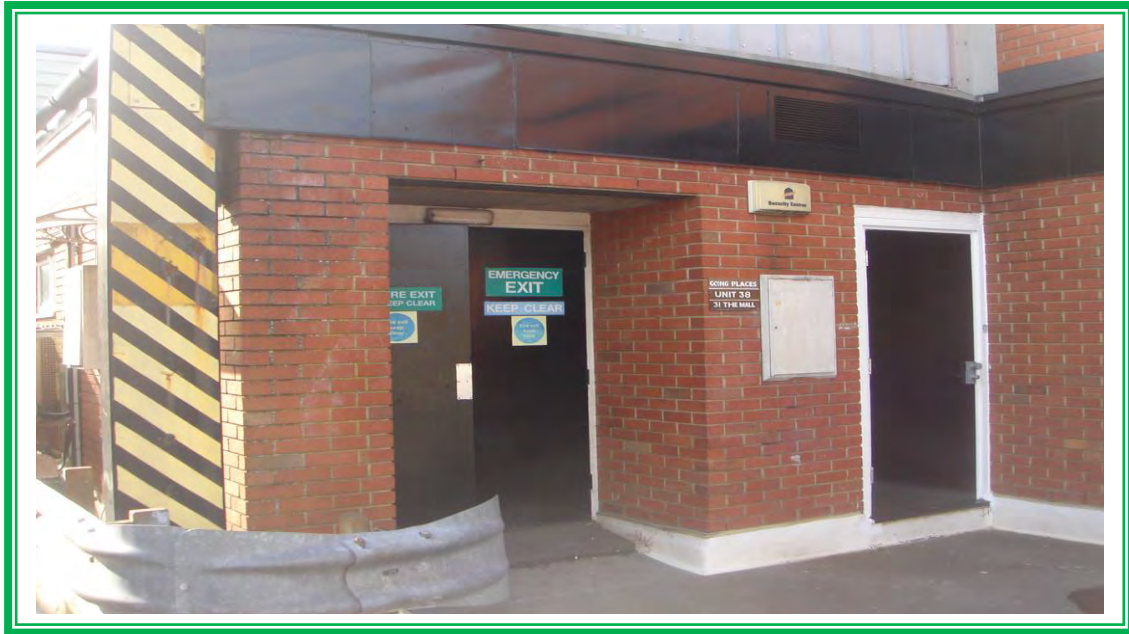
Location: 99/001 External

Material Description:	Visual Inspection – No Suspect Materials Found	
Identification:	N/A	
Approx. quantity:	N/A	
Accessibility	N/A	Assessment Score
Product type:	N/A	N/A
Extent of Damage:	N/A	N/A
Surface Treatment:	N/A	N/A
Asbestos type:	N/A	N/A
Material Assessment Score:		N/A
Priority Assessment Score:		N/A
Action:	N/A	
Comments:	N/A

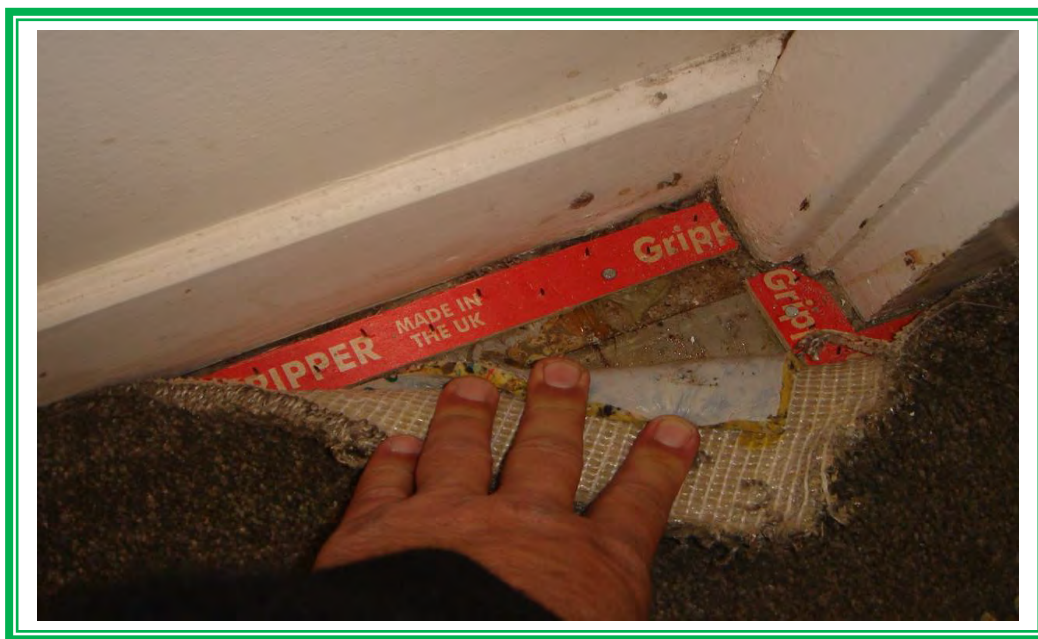
Sample No: NE/1

Location: 1/001 Lobby

Material Description:	Vinyl Floor Tiles	
Identification:	Sampled – No Asbestos Detected	
Approx. quantity:	2M2	
Accessibility	N/A	Assessment Score
Product type:	N/A	N/A
Extent of Damage:	N/A	N/A
Surface Treatment:	N/A	N/A
Asbestos type:	N/A	N/A
Material Assessment Score:		N/A
Priority Assessment Score:		N/A
Action:	N/A	
Comments:	N/A

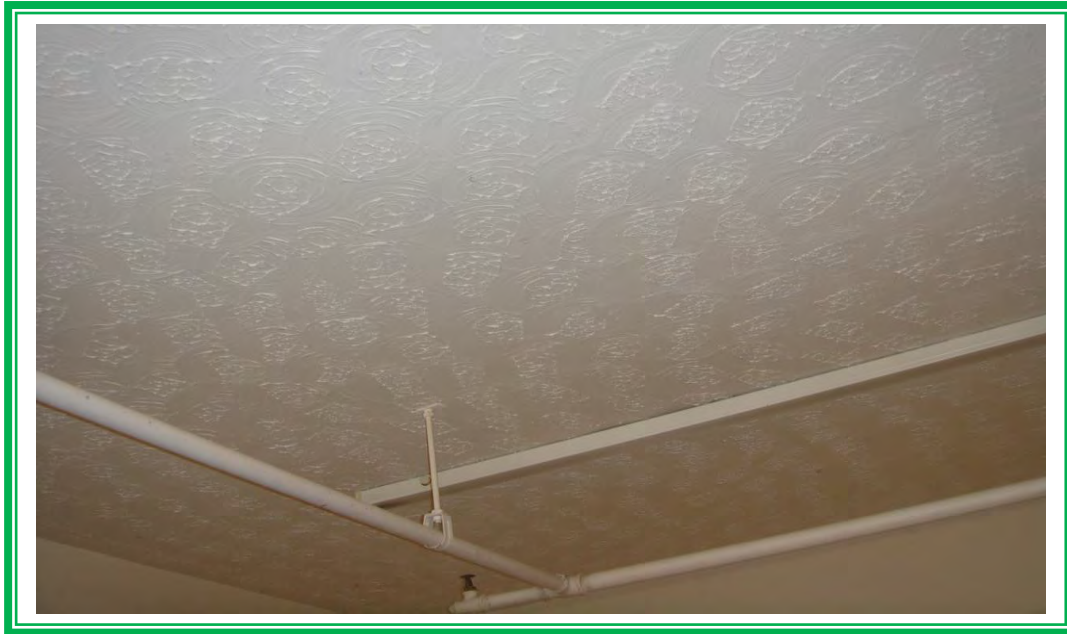
Location: 1/003 Kitchen

Material Description:	Textured Coating	
Identification:	As Per Sample NE/2- No Asbestos Detected	
Approx. quantity:	12M2	
Accessibility	N/A	Assessment Score
Product type:	N/A	N/A
Extent of Damage:	N/A	N/A
Surface Treatment:	N/A	N/A
Asbestos type:	N/A	N/A
Material Assessment Score:		N/A
Priority Assessment Score:		N/A
Action:	N/A	
Comments:	N/A

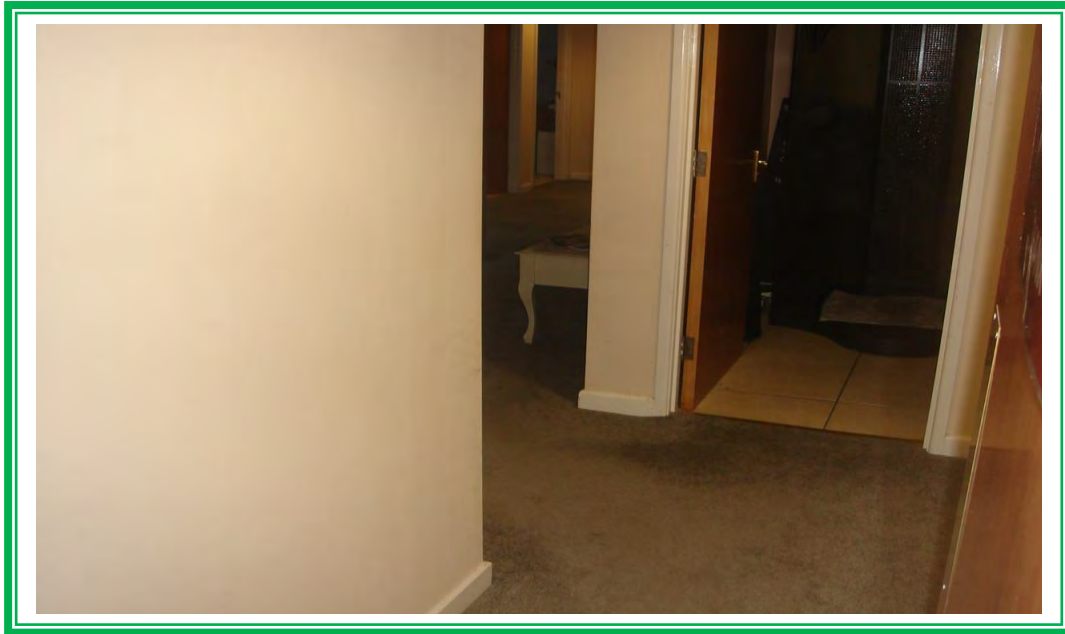
Location: 1/004 Corridor

Material Description:	Visual Inspection – No Suspect Materials Found	
Identification:	N/A	
Approx. quantity:	N/A	
Accessibility	N/A	Assessment Score
Product type:	N/A	N/A
Extent of Damage:	N/A	N/A
Surface Treatment:	N/A	N/A
Asbestos type:	N/A	N/A
Material Assessment Score:		N/A
Priority Assessment Score:		N/A
Action:	N/A	
Comments:	N/A

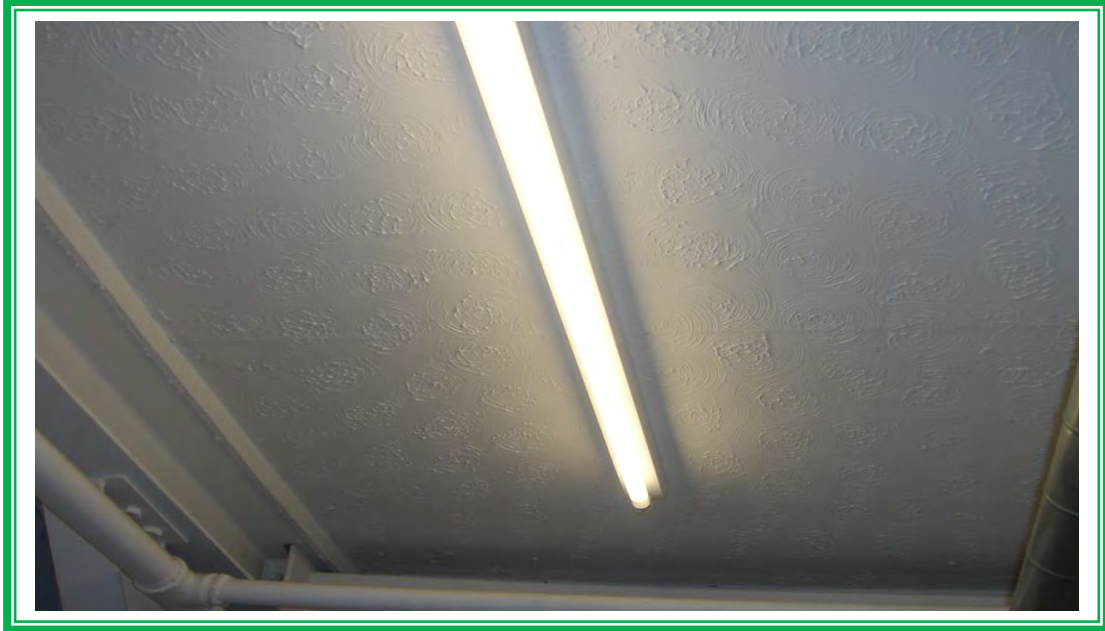
Location: 1/005 Store

Material Description:	Textured Coating	
Identification:	As Per Sample NE/2 – No Asbestos Detected	
Approx. quantity:	2M2	
Accessibility	N/A	Assessment Score
Product type:	N/A	N/A
Extent of Damage:	N/A	N/A
Surface Treatment:	N/A	N/A
Asbestos type:	N/A	N/A
Material Assessment Score:		N/A
Priority Assessment Score:		N/A
Action:	N/A	
Comments:	N/A

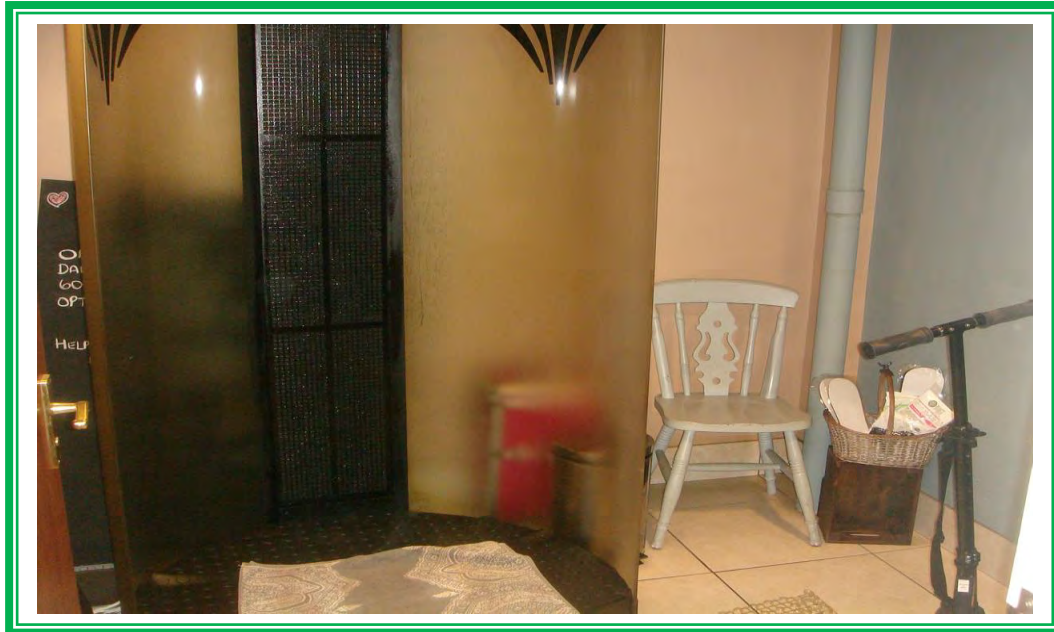
Location: 1/006 Tan Room

Material Description:	Visual Inspection – No Suspect Materials Found	
Identification:	N/A	
Approx. quantity:	N/A	
Accessibility	N/A	Assessment Score
Product type:	N/A	N/A
Extent of Damage:	N/A	N/A
Surface Treatment:	N/A	N/A
Asbestos type:	N/A	N/A
Material Assessment Score:		N/A
Priority Assessment Score:		N/A
Action:	N/A	
Comments:	N/A

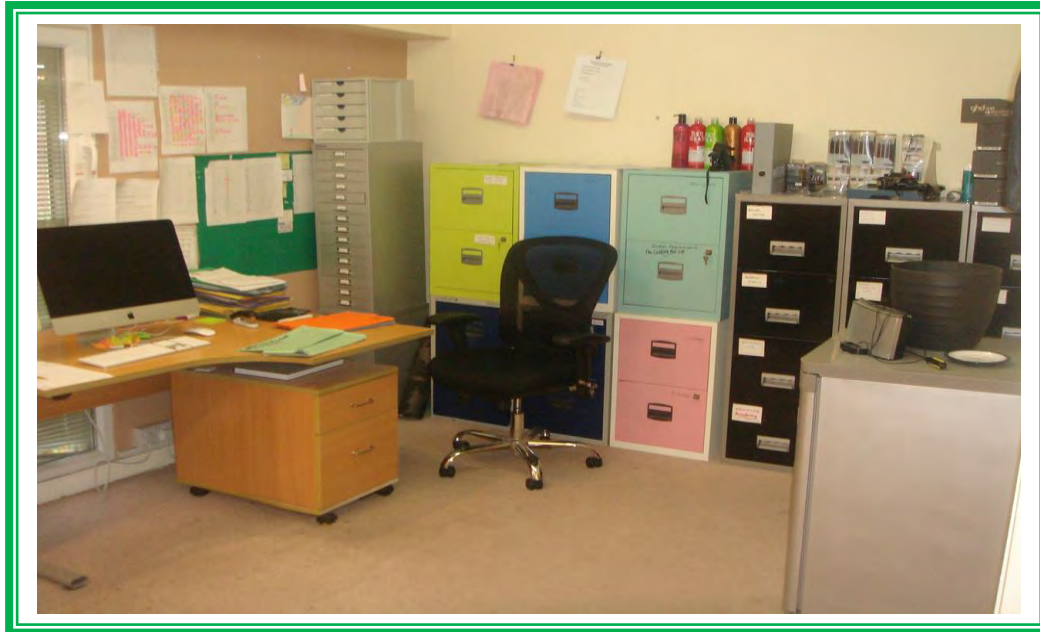
Location: 1/007 Office

Material Description:	Visual Inspection – No Suspect Materials Found	
Identification:	N/A	
Approx. quantity:	N/A	
Accessibility	N/A	Assessment Score
Product type:	N/A	N/A
Extent of Damage:	N/A	N/A
Surface Treatment:	N/A	N/A
Asbestos type:	N/A	N/A
Material Assessment Score:		N/A
Priority Assessment Score:		N/A
Action:	N/A	
Comments:	N/A

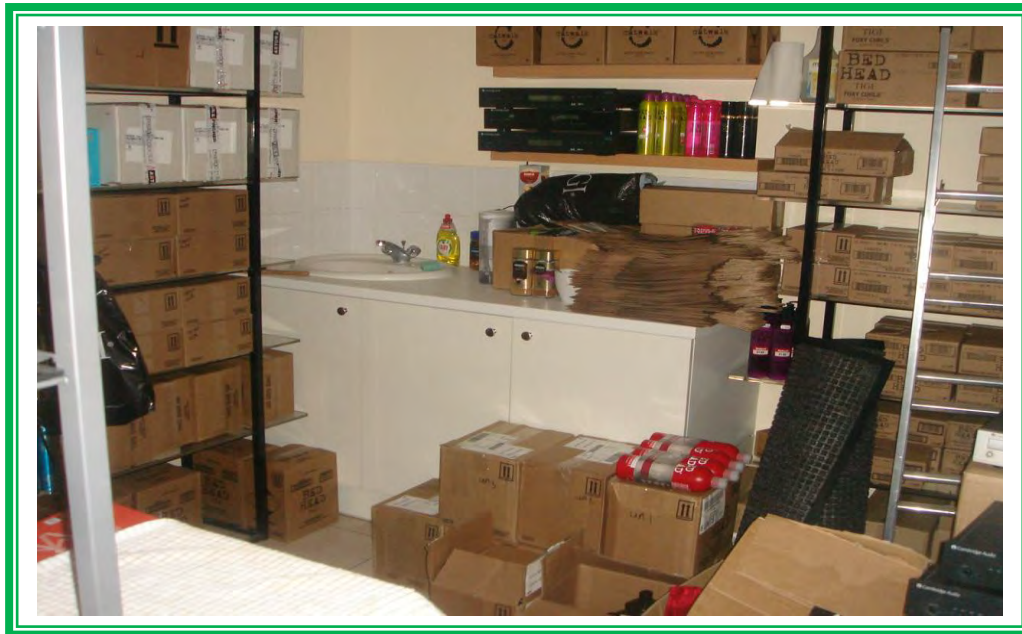
Location: 1/008 Store

Material Description:	Visual Inspection – No Suspect Materials Found	
Identification:	N/A	
Approx. quantity:	N/A	
Accessibility	N/A	Assessment Score
Product type:	N/A	N/A
Extent of Damage:	N/A	N/A
Surface Treatment:	N/A	N/A
Asbestos type:	N/A	N/A
Material Assessment Score:		N/A
Priority Assessment Score:		N/A
Action:	N/A	
Comments:	N/A

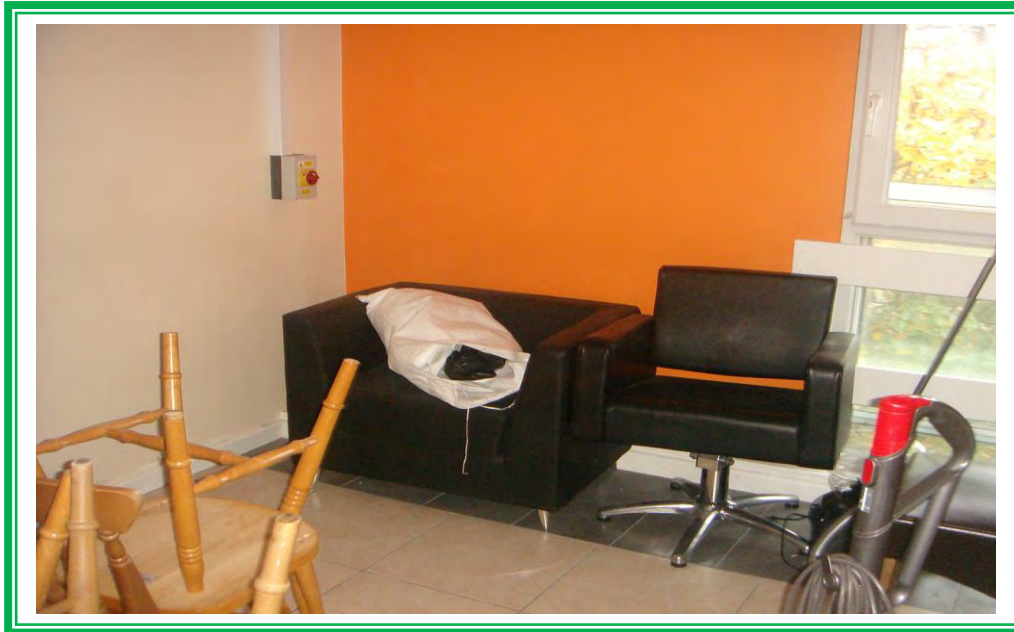
Location: 1/009 Treatment Room

Material Description:	Visual Inspection – No Suspect Materials Found	
Identification:	N/A	
Approx. quantity:	N/A	
Accessibility	N/A	Assessment Score
Product type:	N/A	N/A
Extent of Damage:	N/A	N/A
Surface Treatment:	N/A	N/A
Asbestos type:	N/A	N/A
Material Assessment Score:		N/A
Priority Assessment Score:		N/A
Action:	N/A	
Comments:	N/A

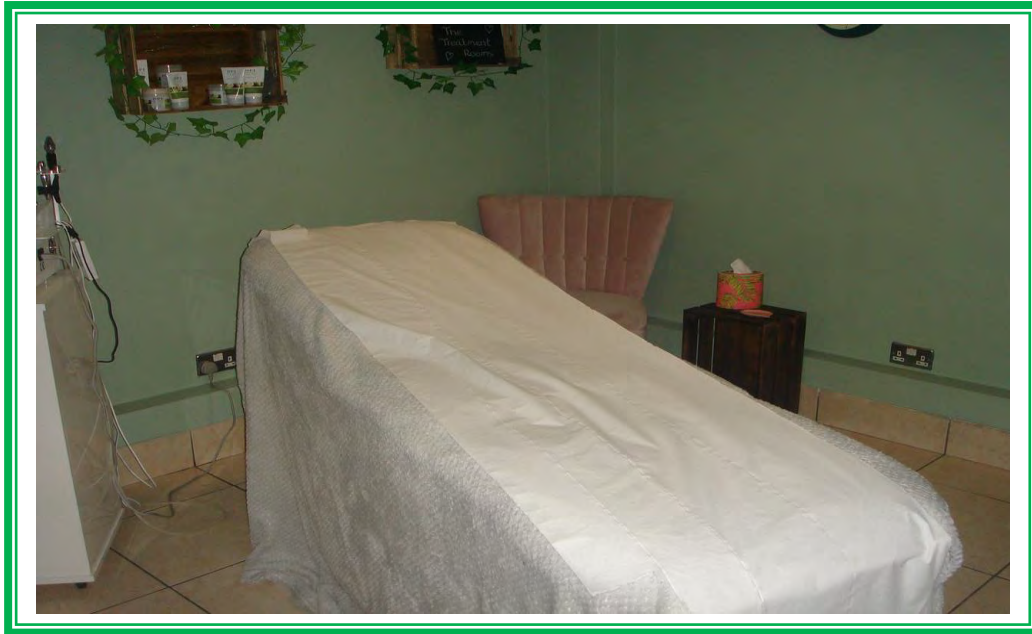
Location: 1/010 Treatment Room

Material Description:	Visual Inspection – No Suspect Materials Found	
Identification:	N/A	
Approx. quantity:	N/A	
Accessibility	N/A	Assessment Score
Product type:	N/A	N/A
Extent of Damage:	N/A	N/A
Surface Treatment:	N/A	N/A
Asbestos type:	N/A	N/A
Material Assessment Score:		N/A
Priority Assessment Score:		N/A
Action:	N/A	
Comments:	N/A

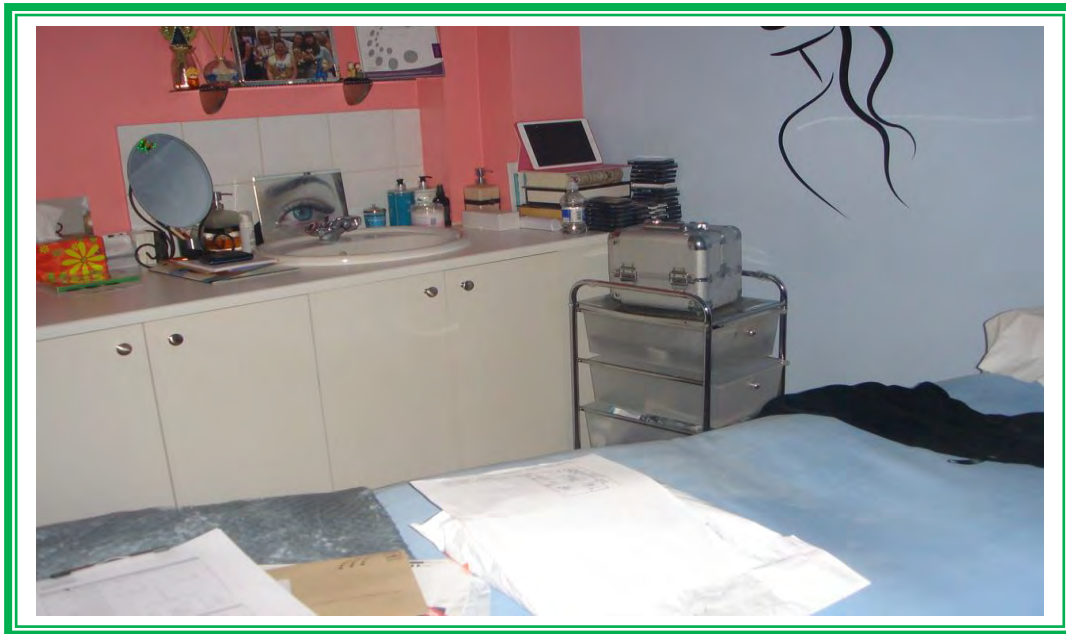
Location: 1/011 Treatment Room

Material Description:	Visual Inspection – No Suspect Materials Found	
Identification:	N/A	
Approx. quantity:	N/A	
Accessibility	N/A	Assessment Score
Product type:	N/A	N/A
Extent of Damage:	N/A	N/A
Surface Treatment:	N/A	N/A
Asbestos type:	N/A	N/A
Material Assessment Score:		N/A
Priority Assessment Score:		N/A
Action:	N/A	
Comments:	N/A

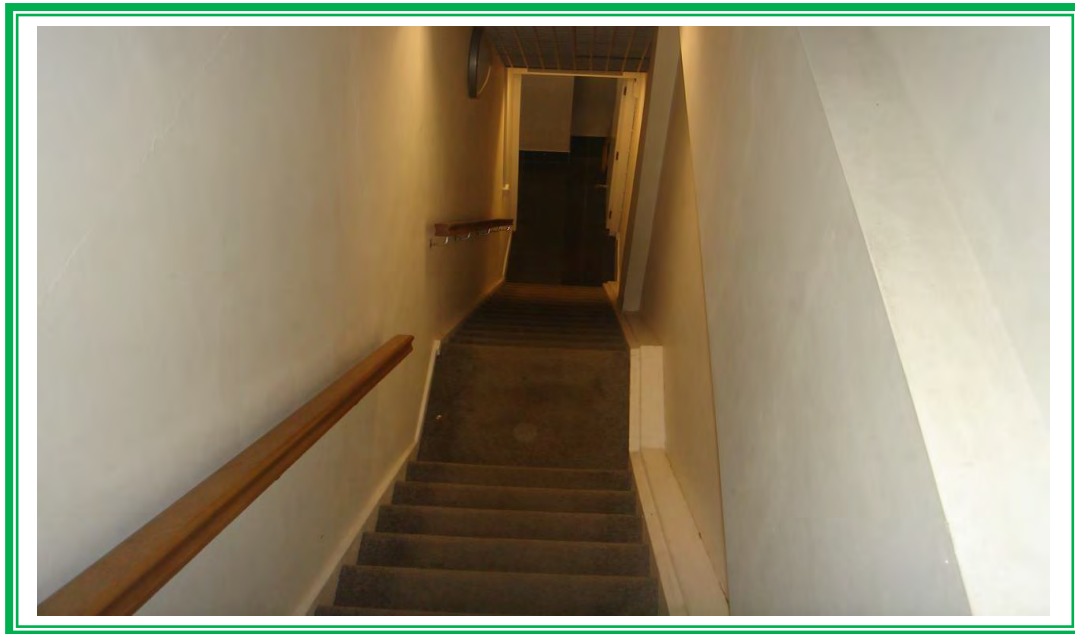
Location: 1/012 Stairs

Material Description:	Visual Inspection – No Suspect Materials Found	
Identification:	N/A	
Approx. quantity:	N/A	
Accessibility	N/A	Assessment Score
Product type:	N/A	N/A
Extent of Damage:	N/A	N/A
Surface Treatment:	N/A	N/A
Asbestos type:	N/A	N/A
Material Assessment Score:		N/A
Priority Assessment Score:		N/A
Action:	N/A	
Comments:	N/A

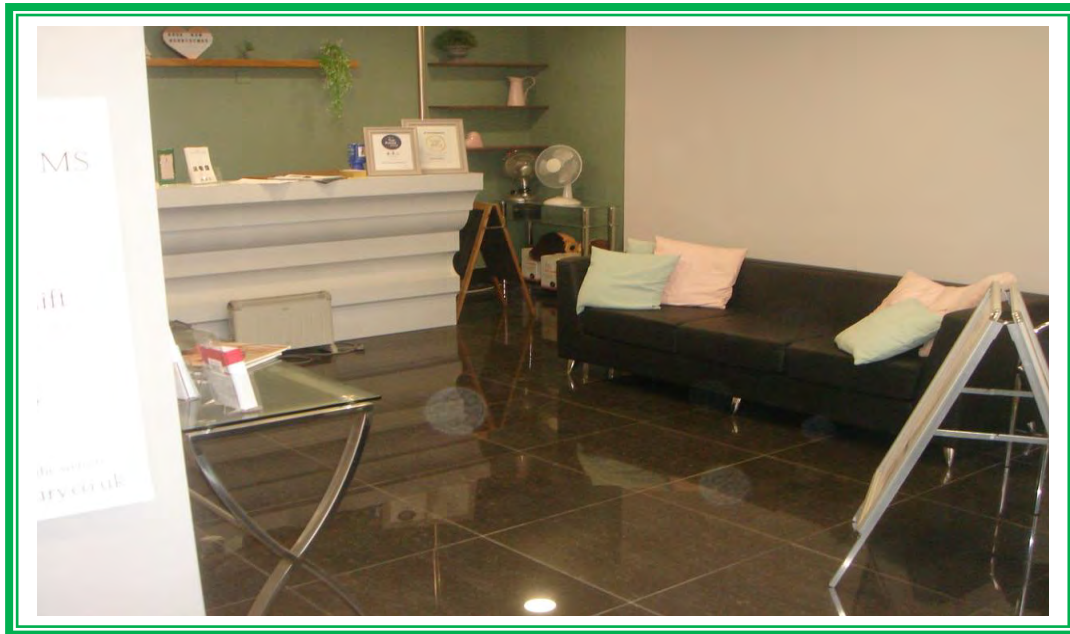
Location: 0/001 Reception

Material Description:	Visual Inspection – No Suspect Materials Found	
Identification:	N/A	
Approx. quantity:	N/A	
Accessibility	N/A	Assessment Score
Product type:	N/A	N/A
Extent of Damage:	N/A	N/A
Surface Treatment:	N/A	N/A
Asbestos type:	N/A	N/A
Material Assessment Score:		N/A
Priority Assessment Score:		N/A
Action:	N/A	
Comments:	N/A

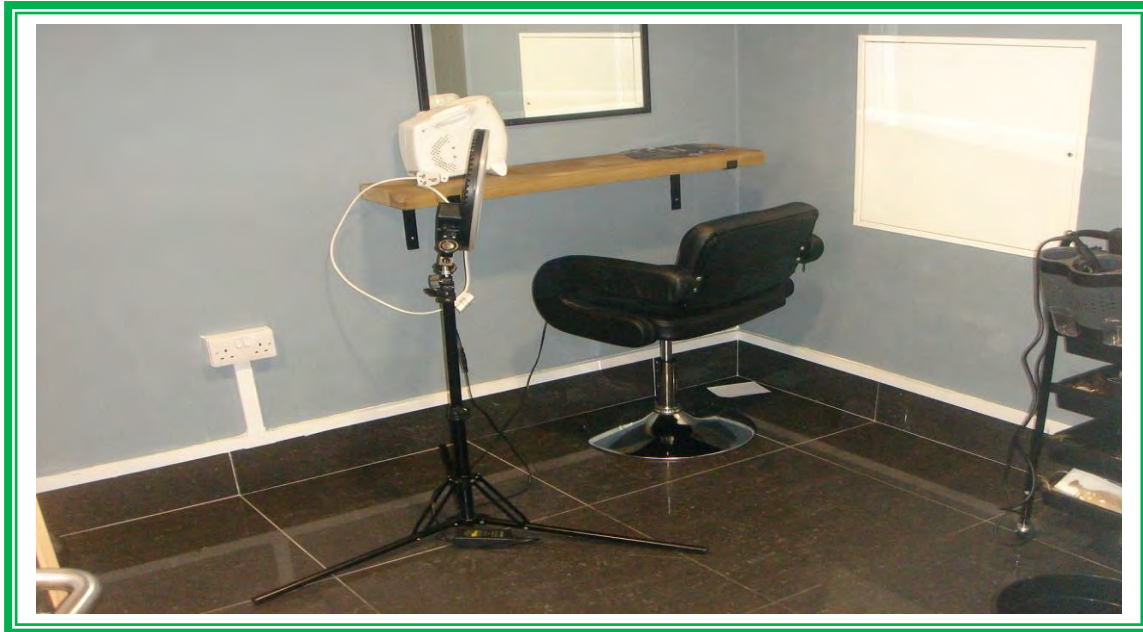
Location: 0/002 Treatment Room

Material Description:	Visual Inspection – No Suspect Materials Found	
Identification:	N/A	
Approx. quantity:	N/A	
Accessibility	N/A	Assessment Score
Product type:	N/A	N/A
Extent of Damage:	N/A	N/A
Surface Treatment:	N/A	N/A
Asbestos type:	N/A	N/A
Material Assessment Score:		N/A
Priority Assessment Score:		N/A
Action:	N/A	
Comments:	N/A

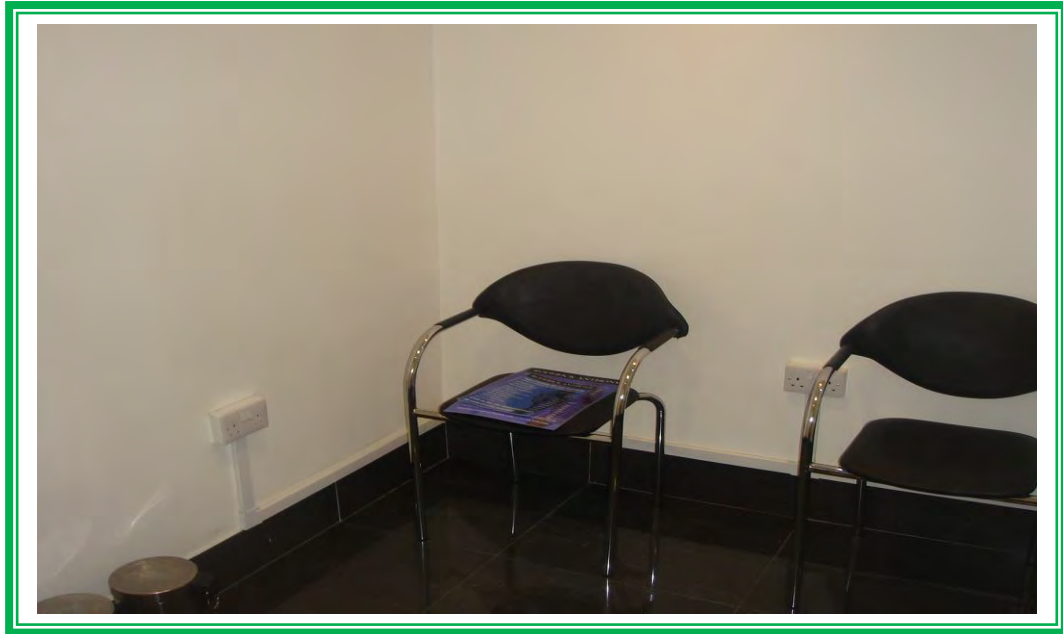
Location: 0/003 Treatment Room

Material Description:	Visual Inspection – No Suspect Materials Found	
Identification:	N/A	
Approx. quantity:	N/A	
Accessibility	N/A	Assessment Score
Product type:	N/A	N/A
Extent of Damage:	N/A	N/A
Surface Treatment:	N/A	N/A
Asbestos type:	N/A	N/A
Material Assessment Score:		N/A
Priority Assessment Score:		N/A
Action:	N/A	
Comments:	N/A

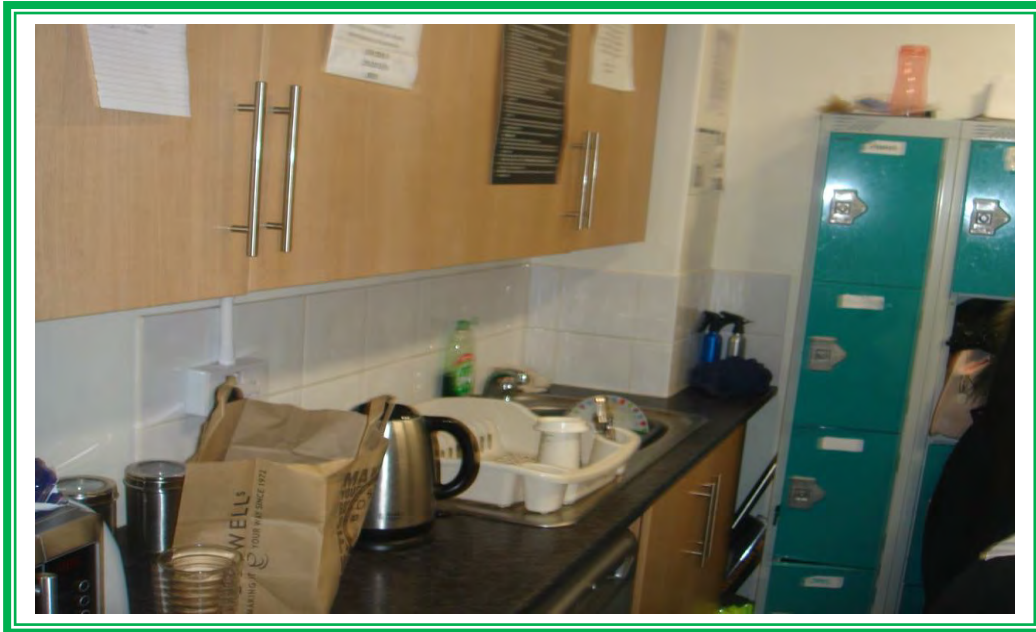
Location: 0/004 Kitchen

Material Description:	Visual Inspection – No Suspect Materials Found	
Identification:	N/A	
Approx. quantity:	N/A	
Accessibility	N/A	Assessment Score
Product type:	N/A	N/A
Extent of Damage:	N/A	N/A
Surface Treatment:	N/A	N/A
Asbestos type:	N/A	N/A
Material Assessment Score:		N/A
Priority Assessment Score:		N/A
Action:	N/A	
Comments:	N/A

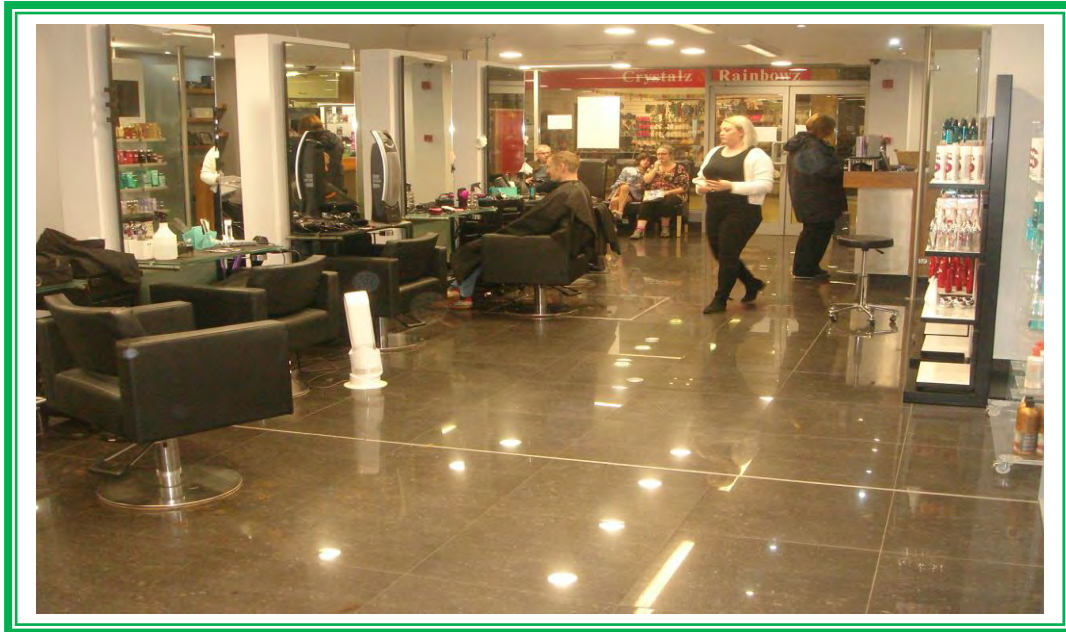
Location: 0/005 Shop Floor

Material Description:	Visual Inspection – No Suspect Materials Found	
Identification:	N/A	
Approx. quantity:	N/A	
Accessibility	N/A	Assessment Score
Product type:	N/A	N/A
Extent of Damage:	N/A	N/A
Surface Treatment:	N/A	N/A
Asbestos type:	N/A	N/A
Material Assessment Score:		N/A
Priority Assessment Score:		N/A
Action:	N/A	
Comments:	N/A

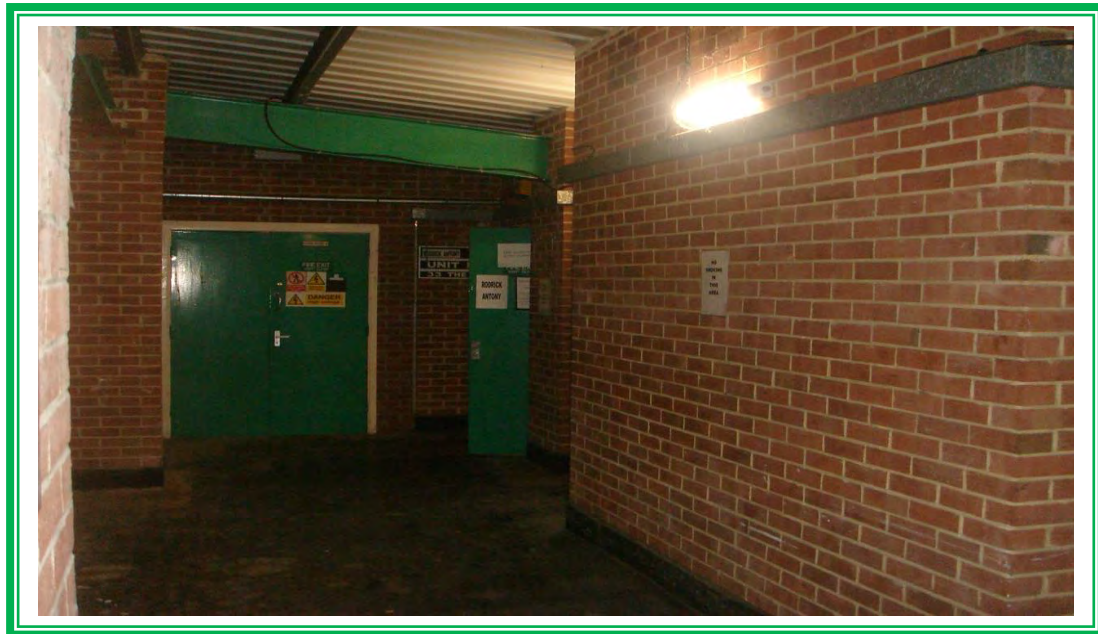
Location: 99/001

Material Description:	Visual Inspection – No Suspect Materials Found	
Identification:	N/A	
Approx. quantity:	N/A	
Accessibility	N/A	Assessment Score
Product type:	N/A	N/A
Extent of Damage:	N/A	N/A
Surface Treatment:	N/A	N/A
Asbestos type:	N/A	N/A
Material Assessment Score:		N/A
Priority Assessment Score:		N/A
Action:	N/A	
Comments:	N/A

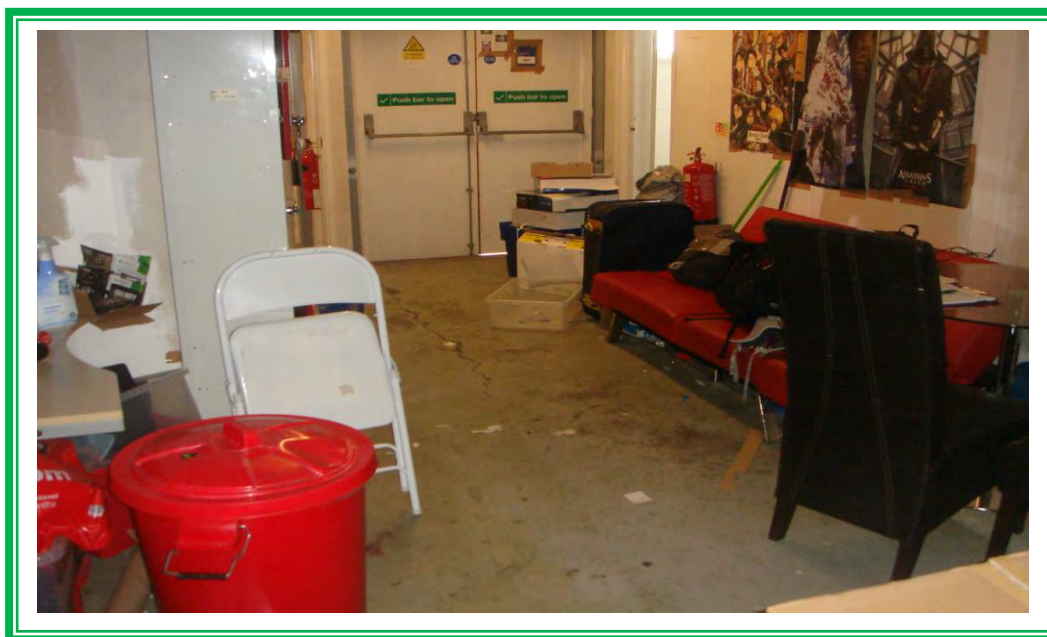
Location: 1/001 Store

Material Description:	Visual Inspection – No Suspect Materials Found	
Identification:	N/A	
Approx. quantity:	N/A	
Accessibility	N/A	Assessment Score
Product type:	N/A	N/A
Extent of Damage:	N/A	N/A
Surface Treatment:	N/A	N/A
Asbestos type:	N/A	N/A
Material Assessment Score:		N/A
Priority Assessment Score:		N/A
Action:	N/A	
Comments:	N/A
