# EAGLE QUARTER II NEWBURY

ASBESTOS SURVEY

Management  
Asbestos Survey Report

Kennet Centre, Market Street, Newbury,  
Berkshire, RG14 5EN

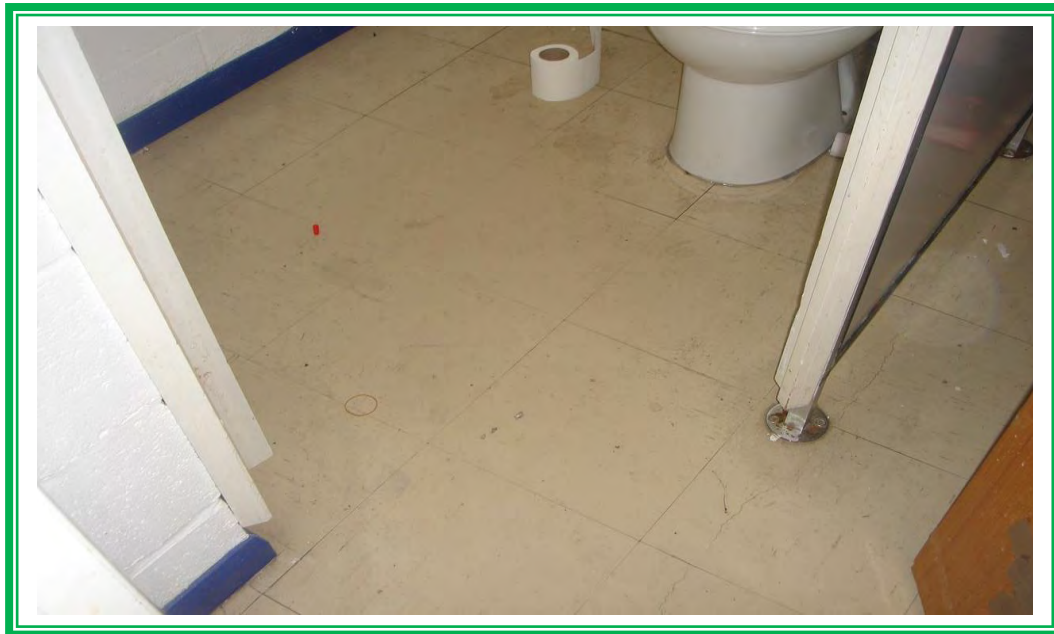
Location: 1/002 WC

Material Description:	Vinyl Floor Tiles	
Identification:	Sampled – No Asbestos Detected	
Approx. quantity:	6M2	
Accessibility	N/A	Assessment Score
Product type:	N/A	N/A
Extent of Damage:	N/A	N/A
Surface Treatment:	N/A	N/A
Asbestos type:	N/A	N/A
Material Assessment Score:		N/A
Priority Assessment Score:		N/A
Action:	N/A	
Comments:	N/A

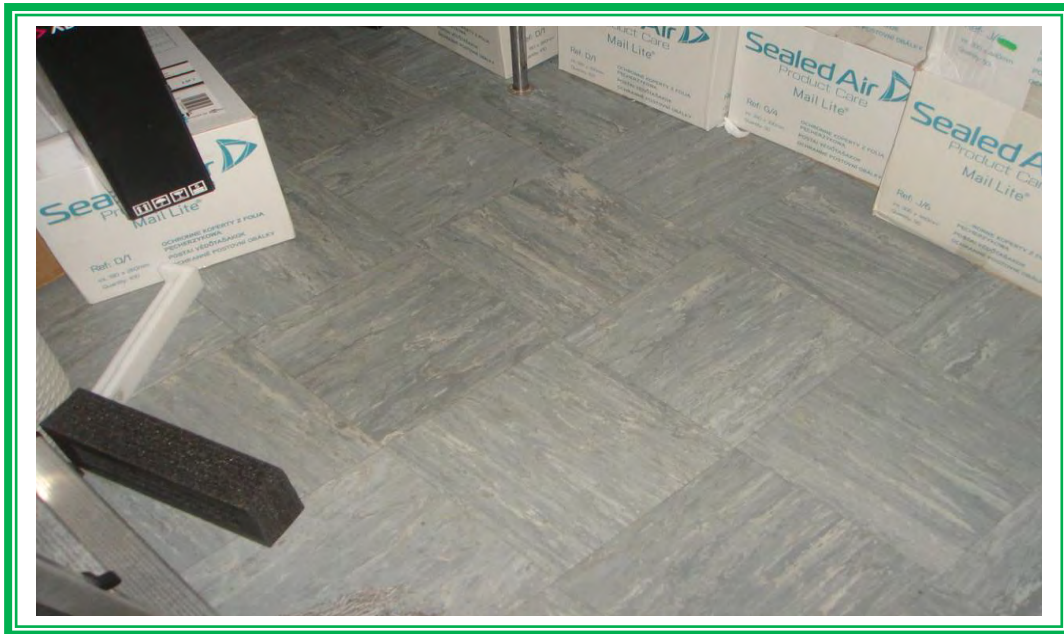
Location: 1/003 Kitchen

Material Description:	Vinyl Floor Tiles	
Identification:	Sampled – No Asbestos Detected	
Approx. quantity:	8M2	
Accessibility	N/A	Assessment Score
Product type:	N/A	N/A
Extent of Damage:	N/A	N/A
Surface Treatment:	N/A	N/A
Asbestos type:	N/A	N/A
Material Assessment Score:		N/A
Priority Assessment Score:		N/A
Action:	N/A	
Comments:	N/A

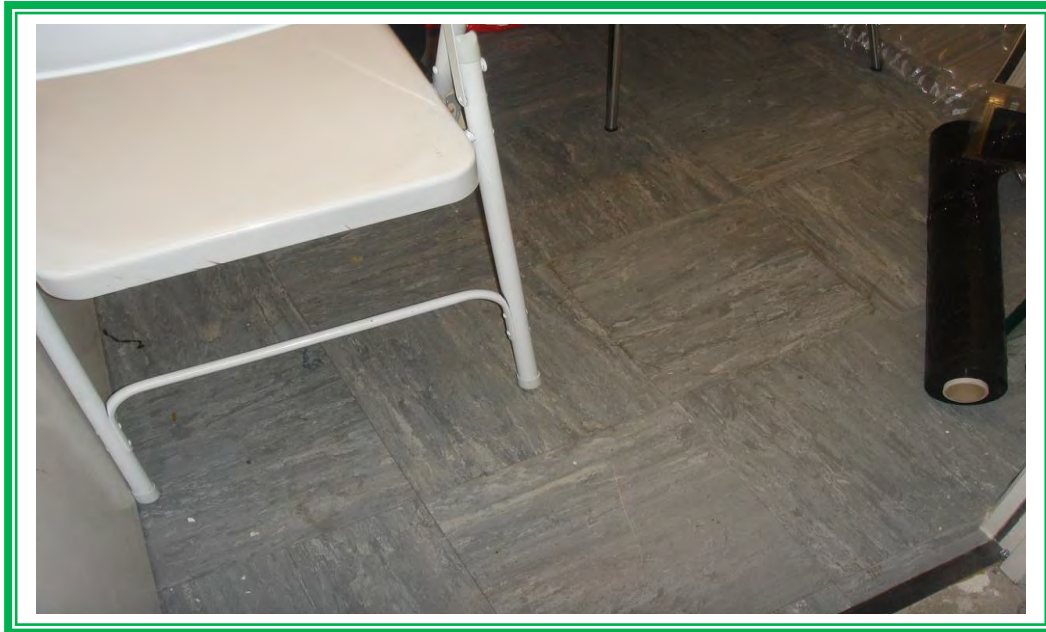
Location: 1/004 Office

Material Description:	Vinyl Floor Tiles	
Identification:	As Per Sample NE/2 – No Asbestos Detected	
Approx. quantity:	2M2	
Accessibility	N/A	Assessment Score
Product type:	N/A	N/A
Extent of Damage:	N/A	N/A
Surface Treatment:	N/A	N/A
Asbestos type:	N/A	N/A
Material Assessment Score:		N/A
Priority Assessment Score:		N/A
Action:	N/A	
Comments:	N/A

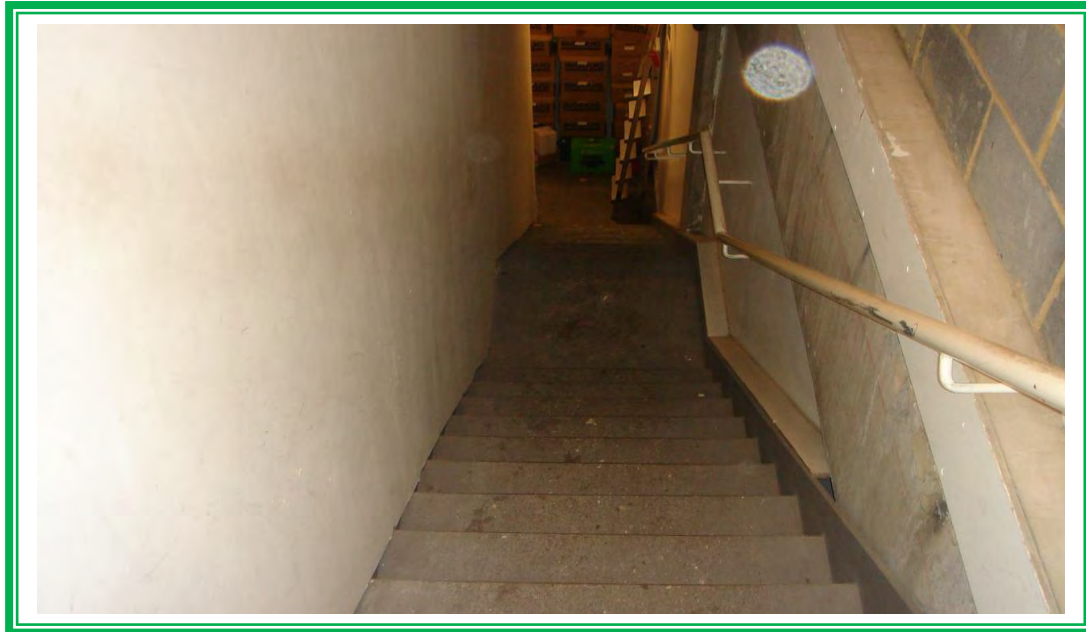
Location: 1/005 Stairs

Material Description:	Visual Inspection – No Suspect Materials Found	
Identification:	N/A	
Approx. quantity:	N/A	
Accessibility	N/A	Assessment Score
Product type:	N/A	N/A
Extent of Damage:	N/A	N/A
Surface Treatment:	N/A	N/A
Asbestos type:	N/A	N/A
Material Assessment Score:		N/A
Priority Assessment Score:		N/A
Action:	N/A	
Comments:	N/A

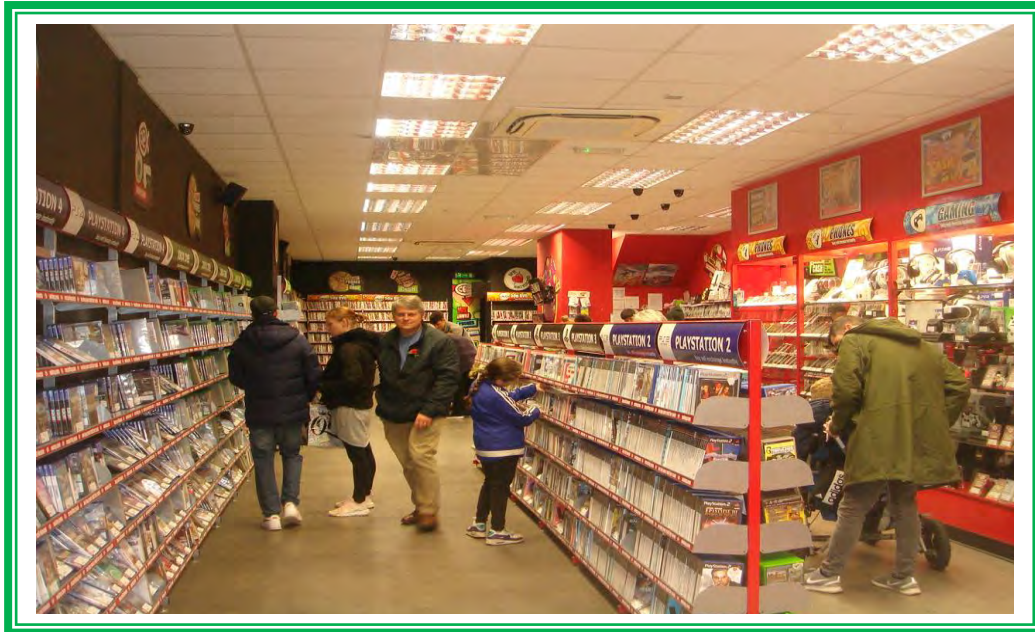
Location: 0/001 Shop Floor

Material Description:	Visual Inspection – No Suspect Materials Found	
Identification:	N/A	
Approx. quantity:	N/A	
Accessibility	N/A	Assessment Score
Product type:	N/A	N/A
Extent of Damage:	N/A	N/A
Surface Treatment:	N/A	N/A
Asbestos type:	N/A	N/A
Material Assessment Score:		N/A
Priority Assessment Score:		N/A
Action:	N/A	
Comments:	N/A

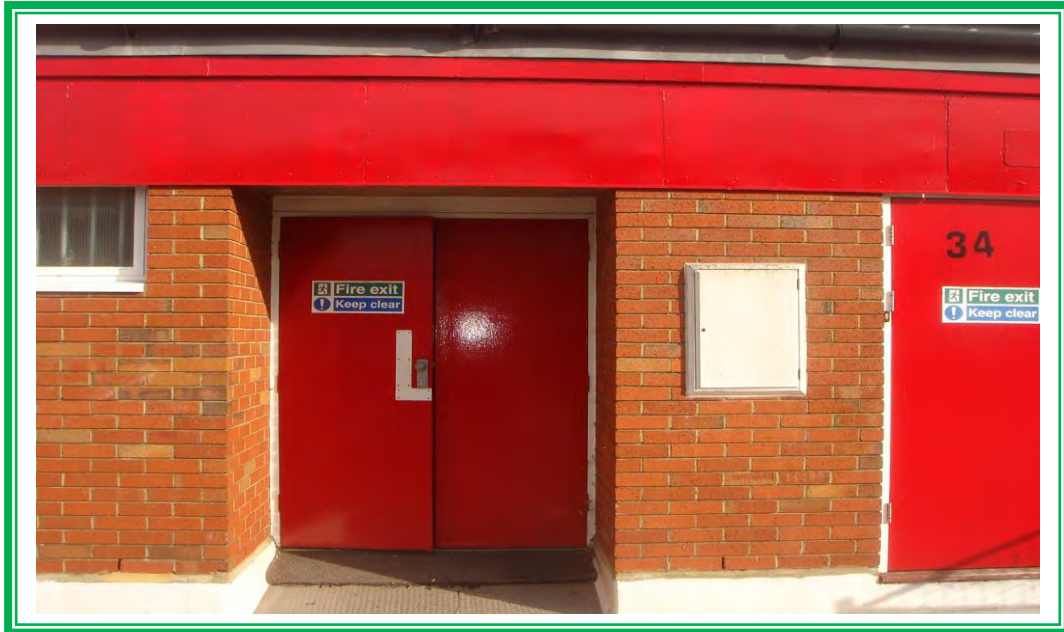
Location: 99/001

Material Description:	Visual Inspection – No Suspect Materials Found	
Identification:	N/A	
Approx. quantity:	N/A	
Accessibility	N/A	Assessment Score
Product type:	N/A	N/A
Extent of Damage:	N/A	N/A
Surface Treatment:	N/A	N/A
Asbestos type:	N/A	N/A
Material Assessment Score:		N/A
Priority Assessment Score:		N/A
Action:	N/A	
Comments:	N/A

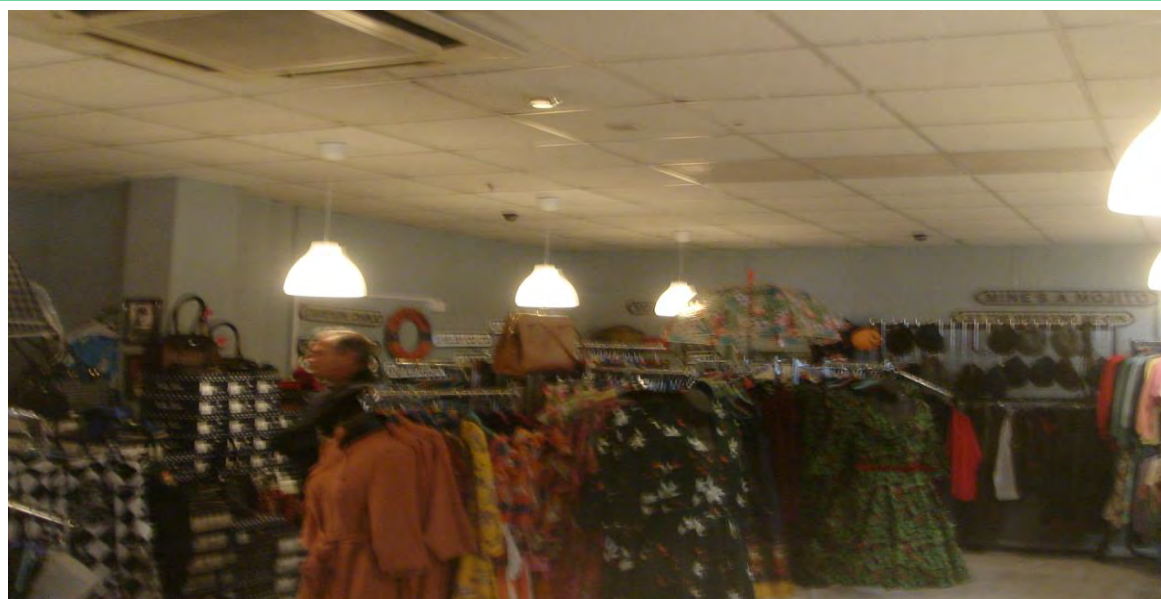
Location: 0/001 Shop Floor

Material Description:	Visual Inspection – No Suspect Materials Found	
Identification:	N/A	
Approx. quantity:	N/A	
Accessibility	N/A	Assessment Score
Product type:	N/A	N/A
Extent of Damage:	N/A	N/A
Surface Treatment:	N/A	N/A
Asbestos type:	N/A	N/A
Material Assessment Score:		N/A
Priority Assessment Score:		N/A
Action:	N/A	
Comments:	N/A

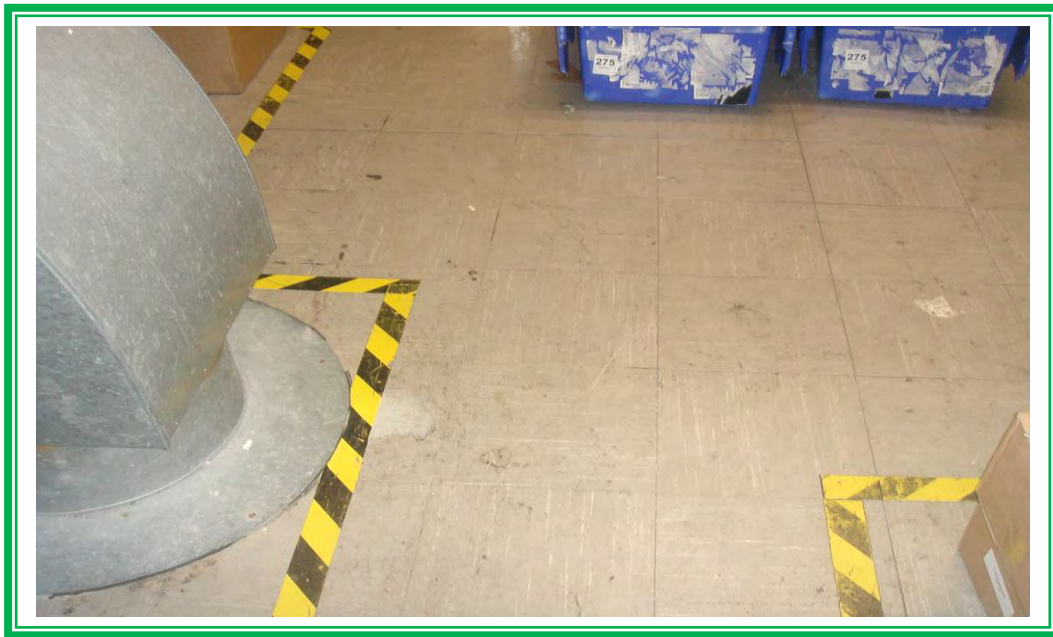
Item No: 1	Sample No: NE/1
Location: 1/001 Store

Material Description:	Vinyl Floor Tiles	
Identification:	Sampled – No Asbestos Detected	
Approx. quantity:	30M2	
Accessibility	N/A	Assessment Score
Product type:	N/A	N/A
Extent of Damage:	N/A	N/A
Surface Treatment:	N/A	N/A
Asbestos type:	N/A	N/A
Material Assessment Score:		N/A
Priority Assessment Score:		N/A
Action:	N/A	
Comments:	N/A

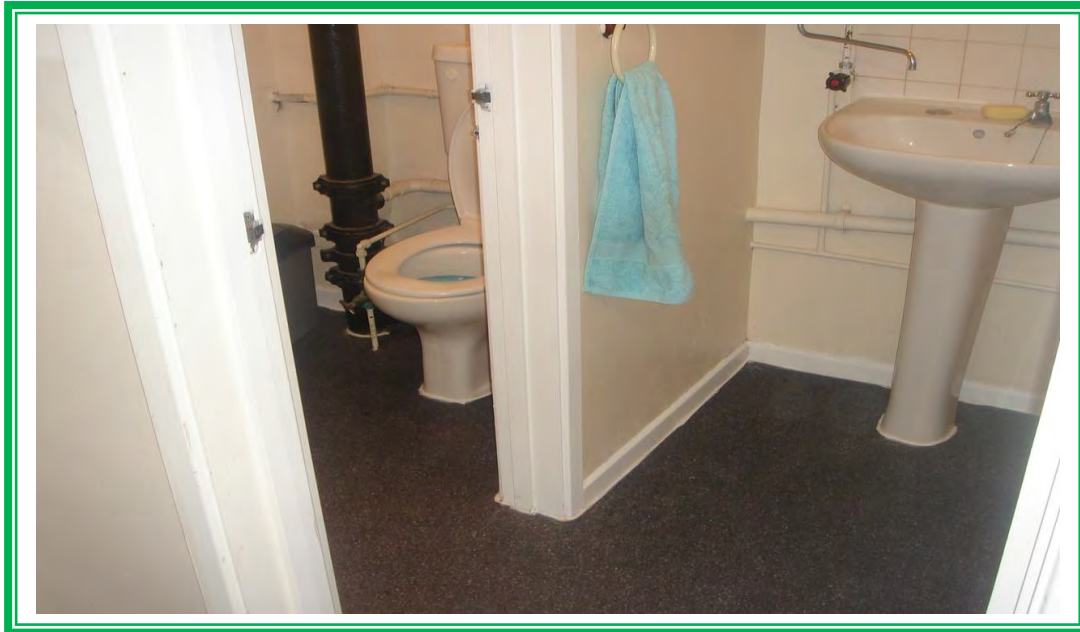
Location: 1/003 WC

Material Description:	Visual Inspection – No Suspect Materials Found	
Identification:	N/A	
Approx. quantity:	N/A	
Accessibility	N/A	Assessment Score
Product type:	N/A	N/A
Extent of Damage:	N/A	N/A
Surface Treatment:	N/A	N/A
Asbestos type:	N/A	N/A
Material Assessment Score:		N/A
Priority Assessment Score:		N/A
Action:	N/A	
Comments:	N/A

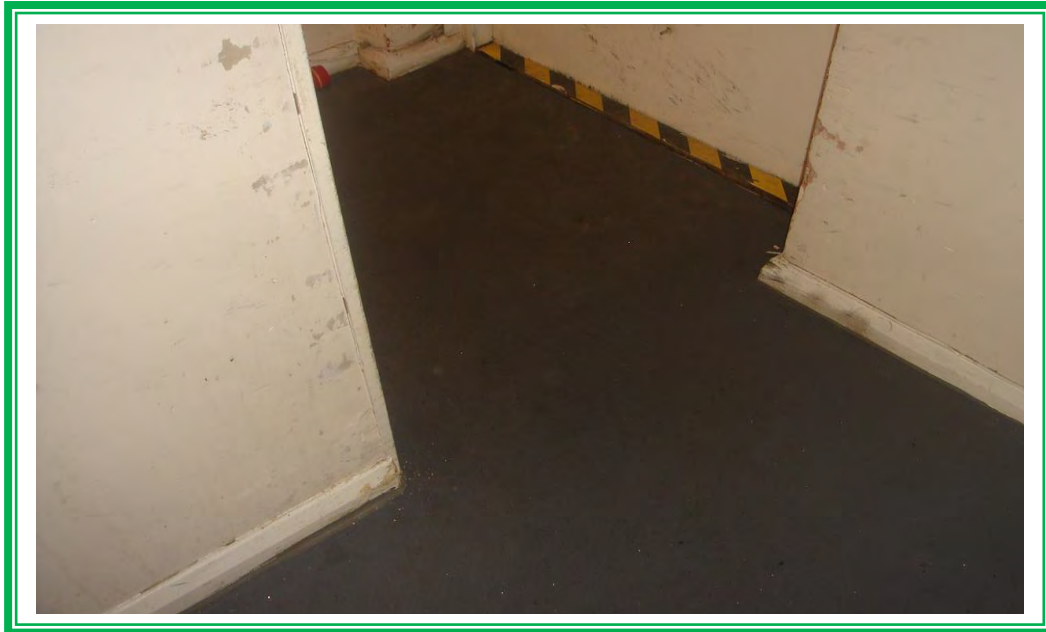
Location: 1/004 Stairs

Material Description:	Vinyl Floor Tiles	
Identification:	As Per Sample NE/2 – No Asbestos Detected	
Approx. quantity:	4M2	
Accessibility	N/A	Assessment Score
Product type:	N/A	N/A
Extent of Damage:	N/A	N/A
Surface Treatment:	N/A	N/A
Asbestos type:	N/A	N/A
Material Assessment Score:		N/A
Priority Assessment Score:		N/A
Action:	N/A	
Comments:	N/A

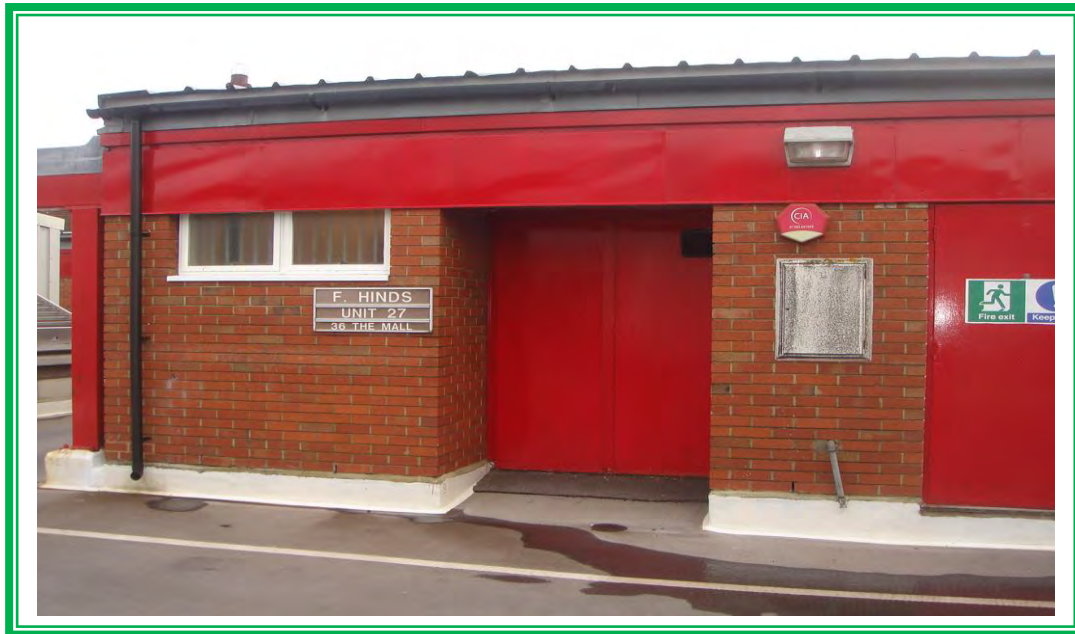
Location: 99/001 External

Material Description:	Visual Inspection – No Suspect Materials Found	
Identification:	N/A	
Approx. quantity:	N/A	
Accessibility	N/A	Assessment Score
Product type:	N/A	N/A
Extent of Damage:	N/A	N/A
Surface Treatment:	N/A	N/A
Asbestos type:	N/A	N/A
Material Assessment Score:		N/A
Priority Assessment Score:		N/A
Action:	N/A	
Comments:	N/A

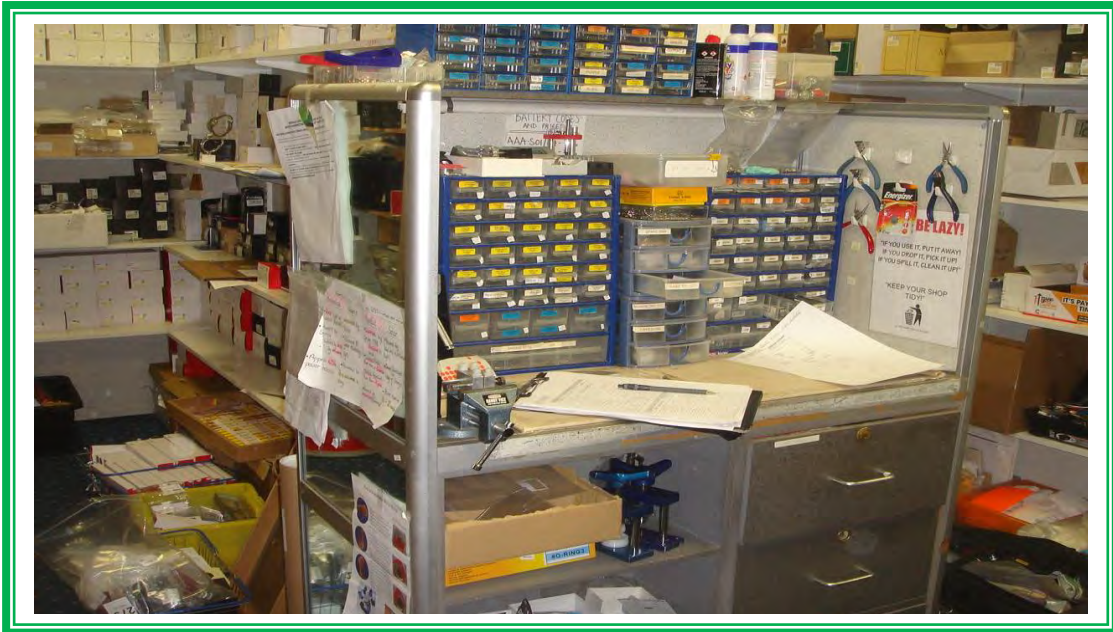
Location: 0/001 Office/Store

Material Description:	Visual Inspection – No Suspect Materials Found	
Identification:	N/A	
Approx. quantity:	N/A	
Accessibility	N/A	Assessment Score
Product type:	N/A	N/A
Extent of Damage:	N/A	N/A
Surface Treatment:	N/A	N/A
Asbestos type:	N/A	N/A
Material Assessment Score:		N/A
Priority Assessment Score:		N/A
Action:	N/A	
Comments:	N/A

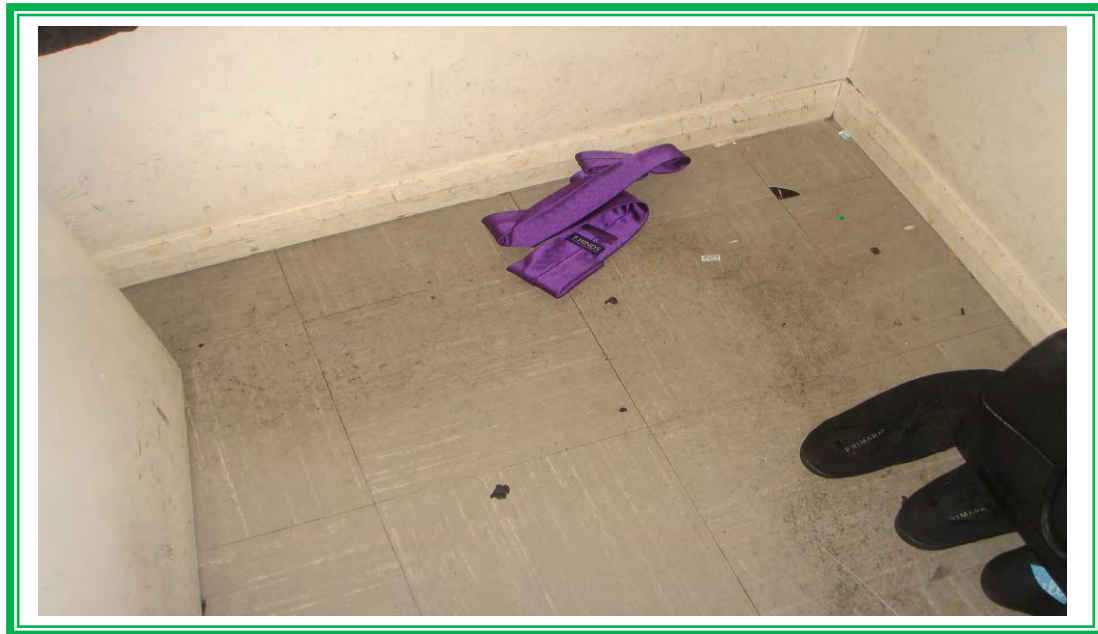
Location: 0/002 Cupboard

Material Description:	Vinyl Floor Tiles	
Identification:	Sampled – No Asbestos Detected	
Approx. quantity:	2M2	
Accessibility	N/A	Assessment Score
Product type:	N/A	N/A
Extent of Damage:	N/A	N/A
Surface Treatment:	N/A	N/A
Asbestos type:	N/A	N/A
Material Assessment Score:		N/A
Priority Assessment Score:		N/A
Action:	N/A	
Comments:	N/A

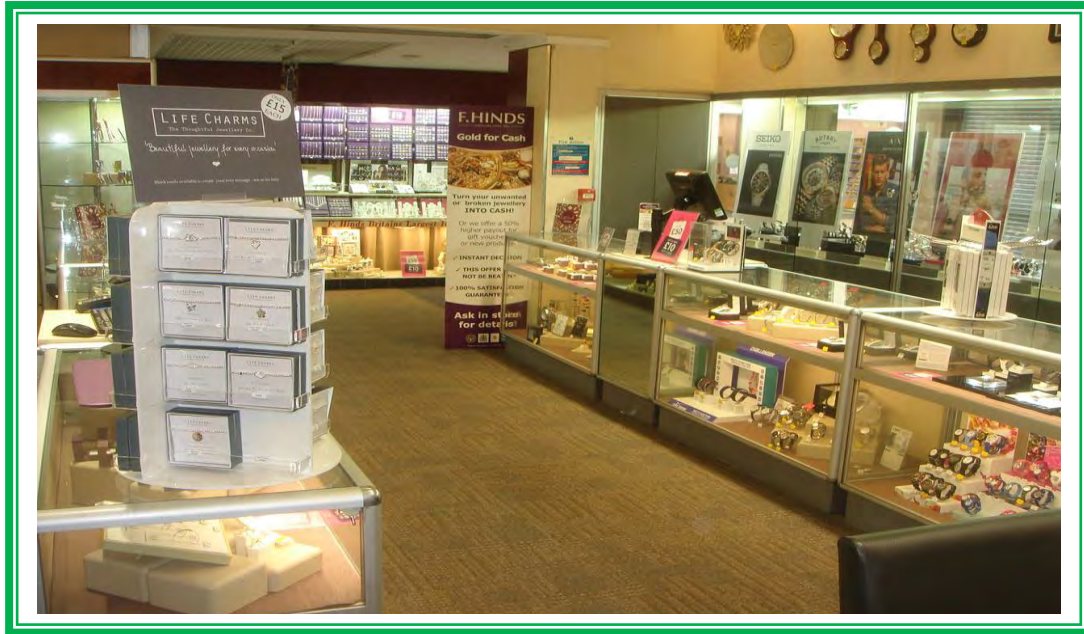
Location: 0/003 Shop Floor

Material Description:	Visual Inspection – No Suspect Materials Found	
Identification:	N/A	
Approx. quantity:	N/A	
Accessibility	N/A	Assessment Score
Product type:	N/A	N/A
Extent of Damage:	N/A	N/A
Surface Treatment:	N/A	N/A
Asbestos type:	N/A	N/A
Material Assessment Score:		N/A
Priority Assessment Score:		N/A
Action:	N/A	
Comments:	N/A

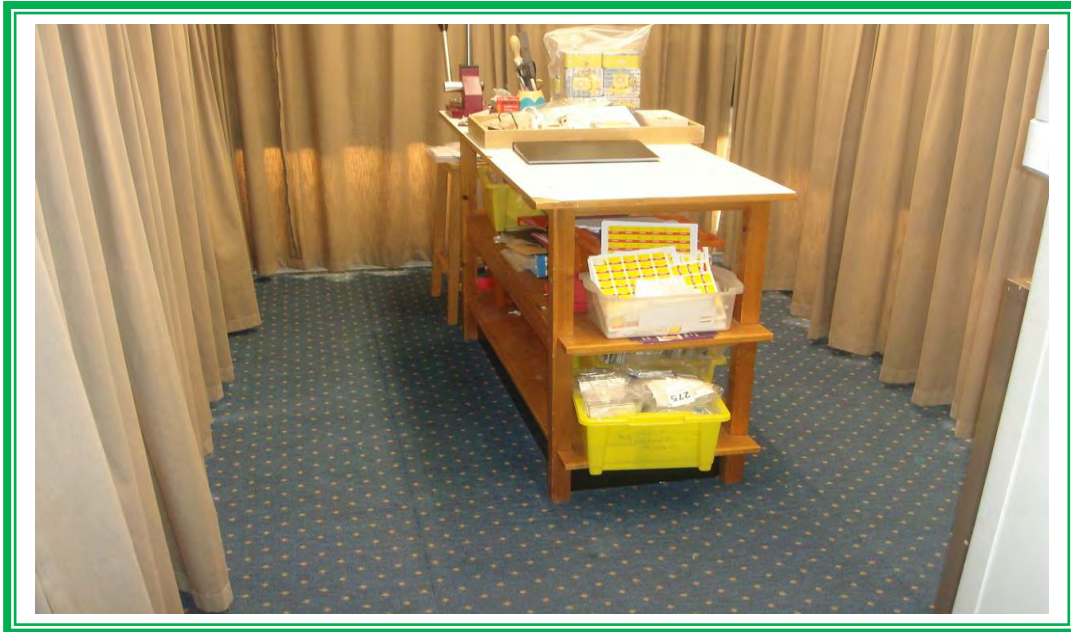
Location: 0/004 Gold Room

Material Description:	Visual Inspection – No Suspect Materials Found	
Identification:	N/A	
Approx. quantity:	N/A	
Accessibility	N/A	Assessment Score
Product type:	N/A	N/A
Extent of Damage:	N/A	N/A
Surface Treatment:	N/A	N/A
Asbestos type:	N/A	N/A
Material Assessment Score:		N/A
Priority Assessment Score:		N/A
Action:	N/A	
Comments:	N/A

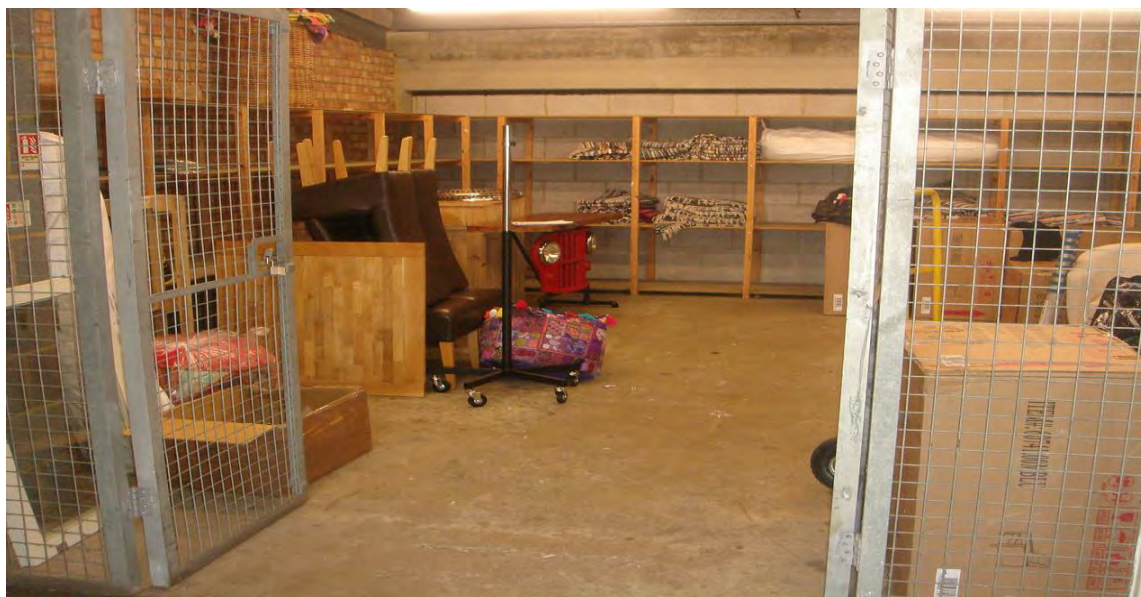
Location: 1/001 Store

Material Description:	Visual Inspection – No Suspect Materials Found	
Identification:	N/A	
Approx. quantity:	N/A	
Accessibility	N/A	Assessment Score
Product type:	N/A	N/A
Extent of Damage:	N/A	N/A
Surface Treatment:	N/A	N/A
Asbestos type:	N/A	N/A
Material Assessment Score:		N/A
Priority Assessment Score:		N/A
Action:	N/A	
Comments:	N/A

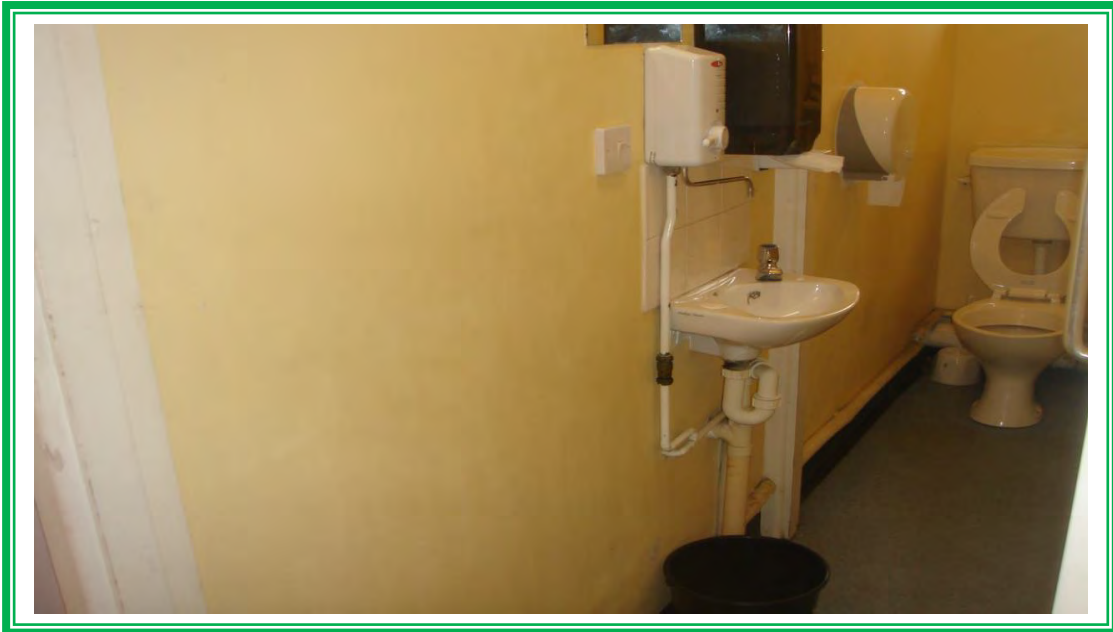
Location: 1/002 WC

Material Description:	Visual Inspection – No Suspect Materials Found	
Identification:	N/A	
Approx. quantity:	N/A	
Accessibility	N/A	Assessment Score
Product type:	N/A	N/A
Extent of Damage:	N/A	N/A
Surface Treatment:	N/A	N/A
Asbestos type:	N/A	N/A
Material Assessment Score:		N/A
Priority Assessment Score:		N/A
Action:	N/A	
Comments:	N/A

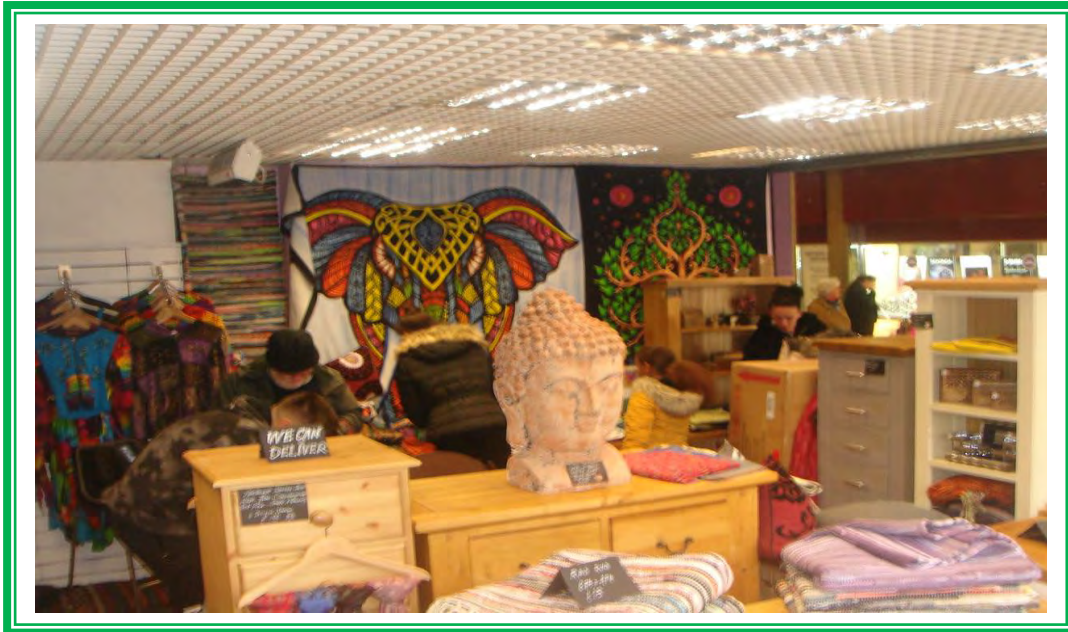
Location: 0/001 Shop Floor

Material Description:	Visual Inspection – No Suspect Materials Found	
Identification:	N/A	
Approx. quantity:	N/A	
Accessibility	N/A	Assessment Score
Product type:	N/A	N/A
Extent of Damage:	N/A	N/A
Surface Treatment:	N/A	N/A
Asbestos type:	N/A	N/A
Material Assessment Score:		N/A
Priority Assessment Score:		N/A
Action:	N/A	
Comments:	N/A

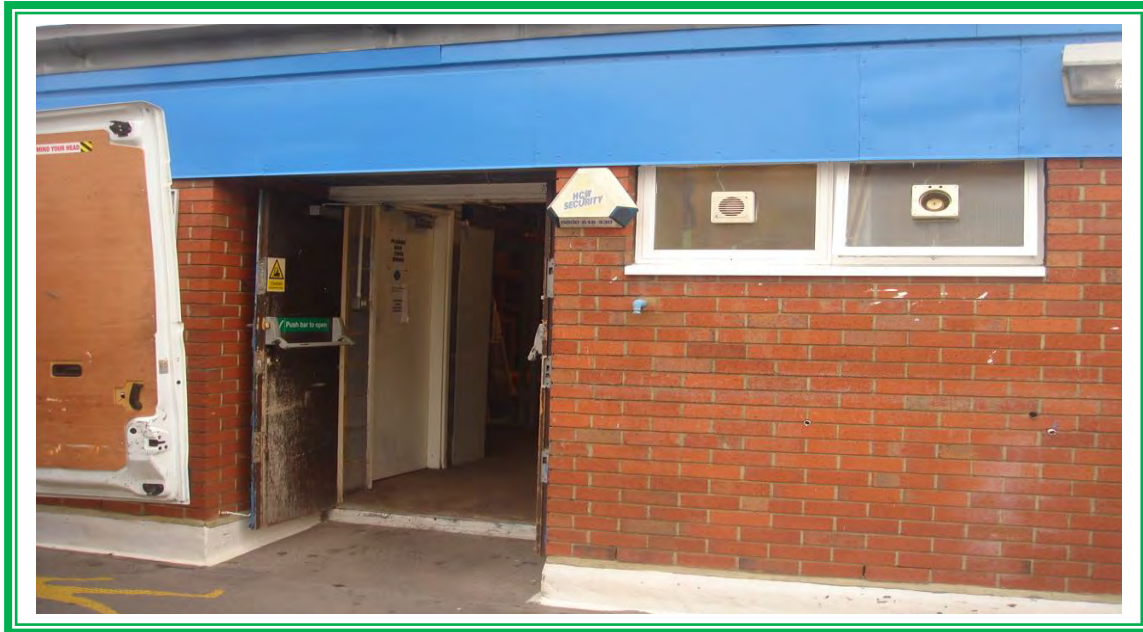
Location: 99/001 External

Material Description:	Visual Inspection – No Suspect Materials Found	
Identification:	N/A	
Approx. quantity:	N/A	
Accessibility	N/A	Assessment Score
Product type:	N/A	N/A
Extent of Damage:	N/A	N/A
Surface Treatment:	N/A	N/A
Asbestos type:	N/A	N/A
Material Assessment Score:		N/A
Priority Assessment Score:		N/A
Action:	N/A	
Comments:	N/A

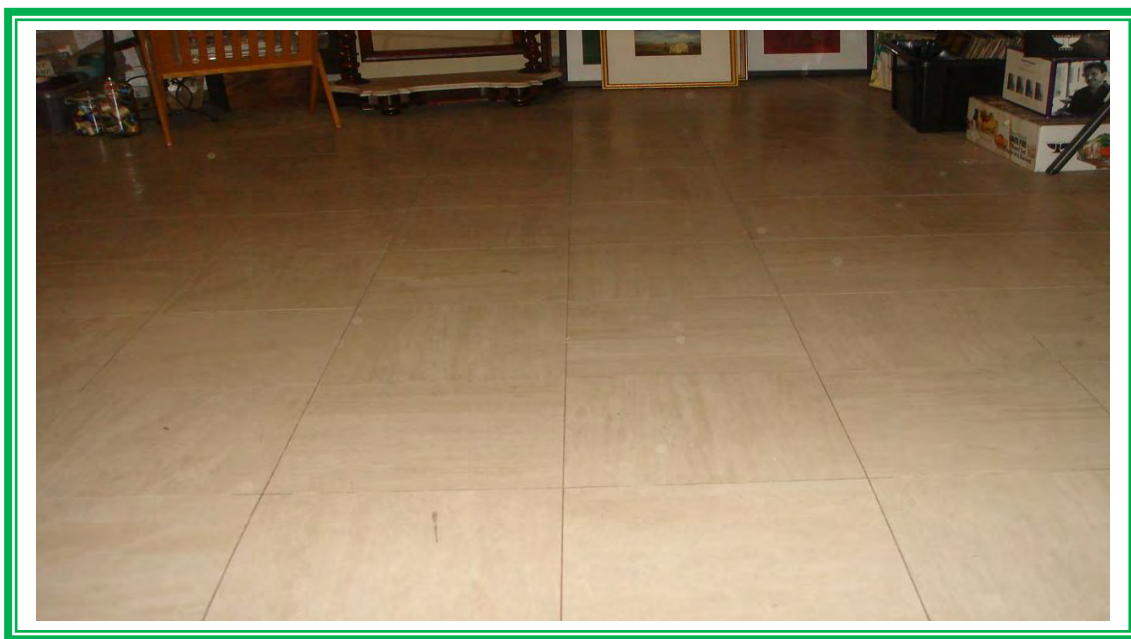
Location: 0/001 Shop Floor

Material Description:	Vinyl Floor Tiles	
Identification:	Sampled – No Asbestos Detected	
Approx. quantity:	40M2	
Accessibility	N/A	Assessment Score
Product type:	N/A	N/A
Extent of Damage:	N/A	N/A
Surface Treatment:	N/A	N/A
Asbestos type:	N/A	N/A
Material Assessment Score:		N/A
Priority Assessment Score:		N/A
Action:	N/A	
Comments:	N/A

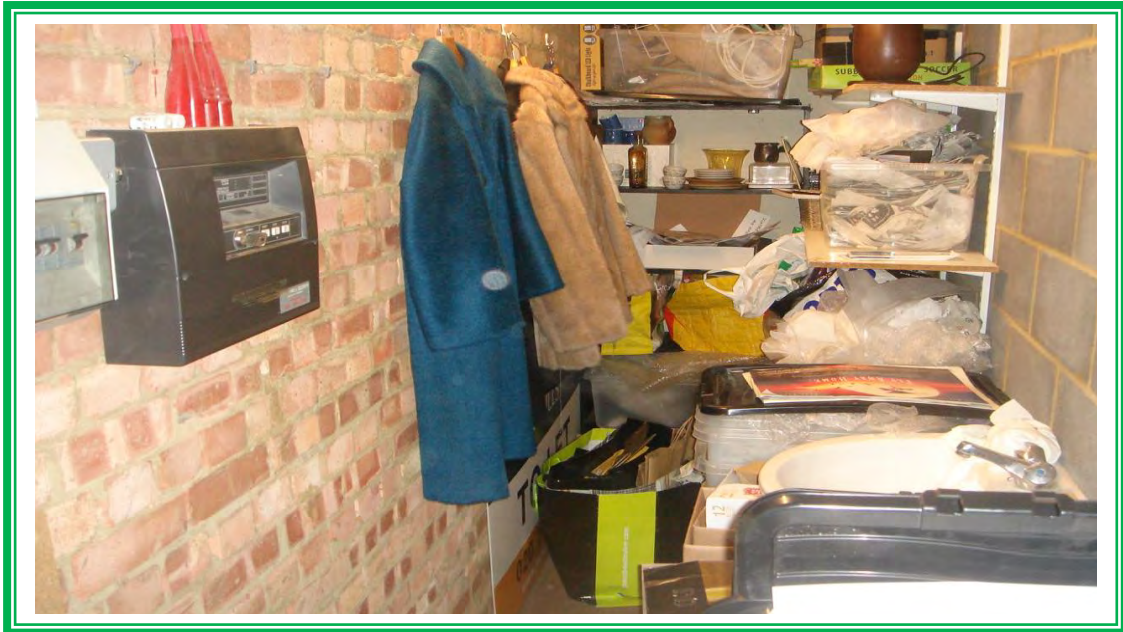
Location: 0/002 Store Cupboard

Material Description:	Visual Inspection – No Suspect Materials Found	
Identification:	N/A	
Approx. quantity:	N/A	
Accessibility	N/A	Assessment Score
Product type:	N/A	N/A
Extent of Damage:	N/A	N/A
Surface Treatment:	N/A	N/A
Asbestos type:	N/A	N/A
Material Assessment Score:		N/A
Priority Assessment Score:		N/A
Action:	N/A	
Comments:	N/A

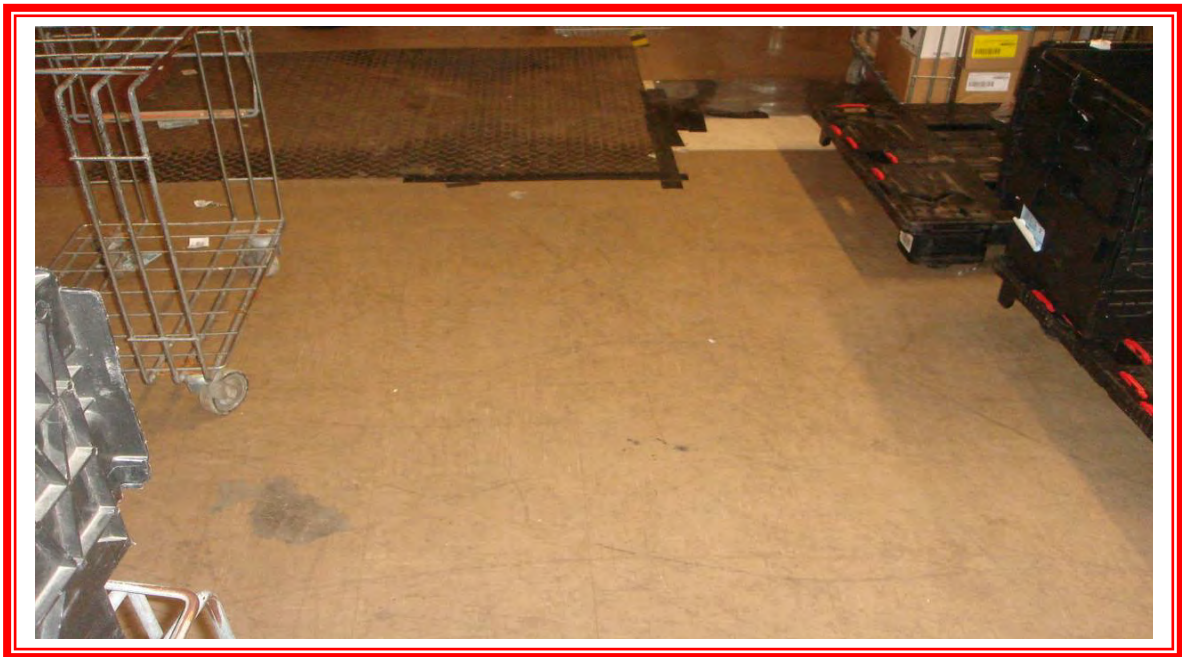
Item No: 1	Sample No: NE/1
Location: 1/001 Store

Material Description:	Vinyl Floor Tiles	
Identification:	Sampled – Asbestos Detected	
Approx. quantity:	50M2	
Accessibility	Low	Assessment Score
Product type:	Vinyl	1
Extent of Damage:	Low	1
Surface Treatment:	Non-Friable	0
Asbestos type:	Chrysotile	1
Material Assessment Score:		3
Priority Assessment Score:		Negligible
Action:	Manage	
Comments:	N/A

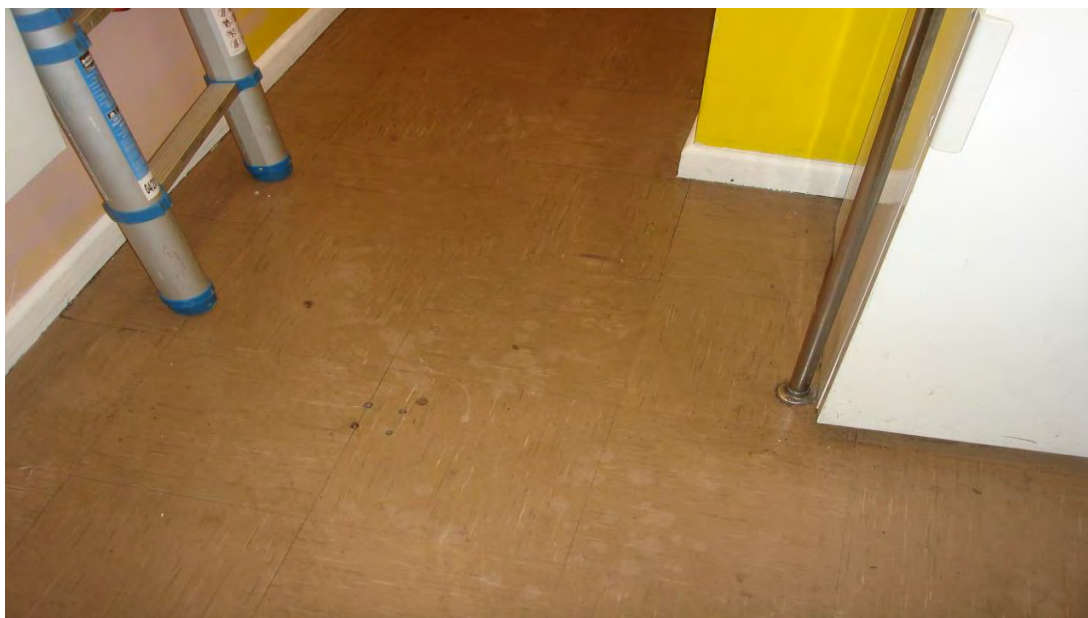
Location: 1/002 Kitchen

Material Description:	Vinyl Floor Tiles	
Identification:	As Per Sample NE/1 – Asbestos Detected	
Approx. quantity:	10M2	
Accessibility	Low	Assessment Score
Product type:	Vinyl	1
Extent of Damage:	Low	1
Surface Treatment:	Non-Friable	0
Asbestos type:	Chrysotile	1
Material Assessment Score:		3
Priority Assessment Score:		Negligible
Action:	Manage	
Comments:	N/A

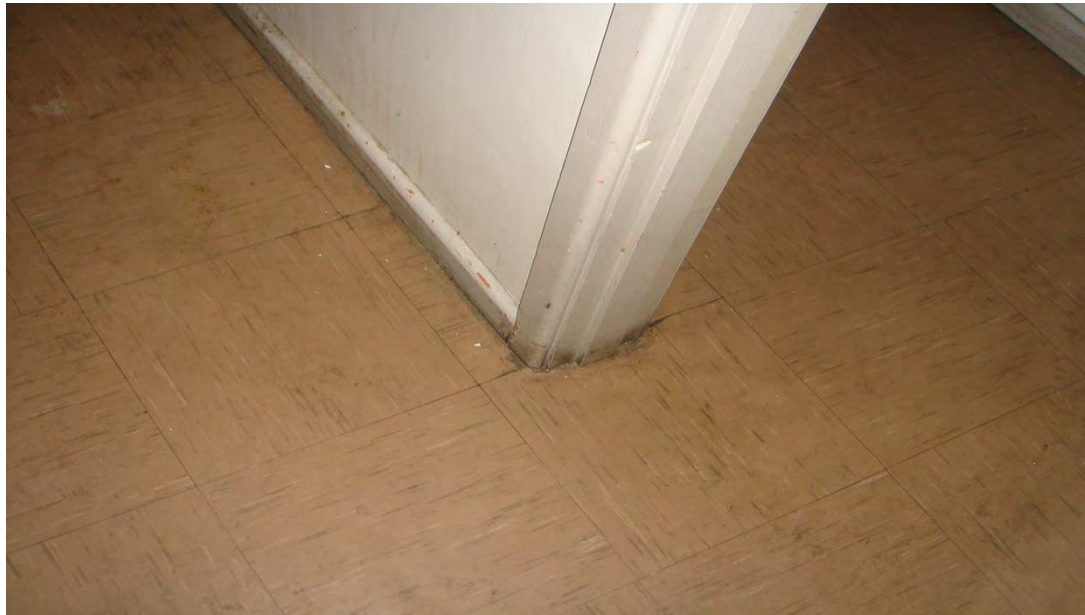
Location: 1/003 WC

Material Description:	Vinyl Floor Tiles	
Identification:	As Per Sample NE/1 – Asbestos Detected	
Approx. quantity:	2M2	
Accessibility	Low	Assessment Score
Product type:	Vinyl	1
Extent of Damage:	Low	1
Surface Treatment:	Non-Friable	0
Asbestos type:	Chrysotile	1
Material Assessment Score:		3
Priority Assessment Score:		Negligible
Action:	Manage	
Comments:	N/A

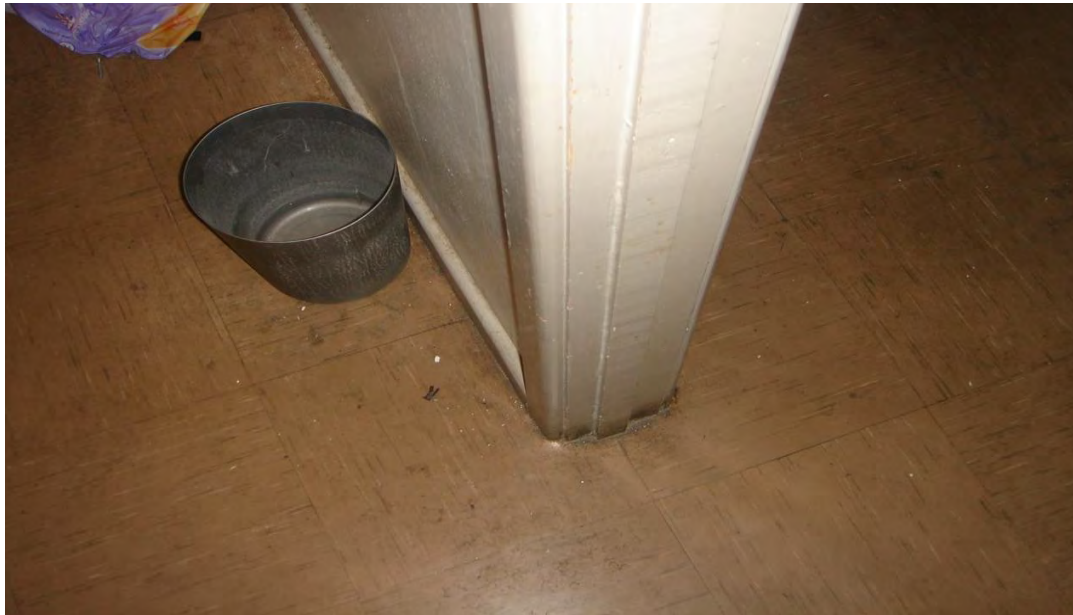
Location: 1/004 WC

Material Description:	Vinyl Floor Tiles	
Identification:	As Per Sample NE/1 – Asbestos Detected	
Approx. quantity:	2M2	
Accessibility	Low	Assessment Score
Product type:	Vinyl	1
Extent of Damage:	Low	1
Surface Treatment:	Non-Friable	0
Asbestos type:	Chrysotile	1
Material Assessment Score:		3
Priority Assessment Score:		Negligible
Action:	Manage	
Comments:	N/A

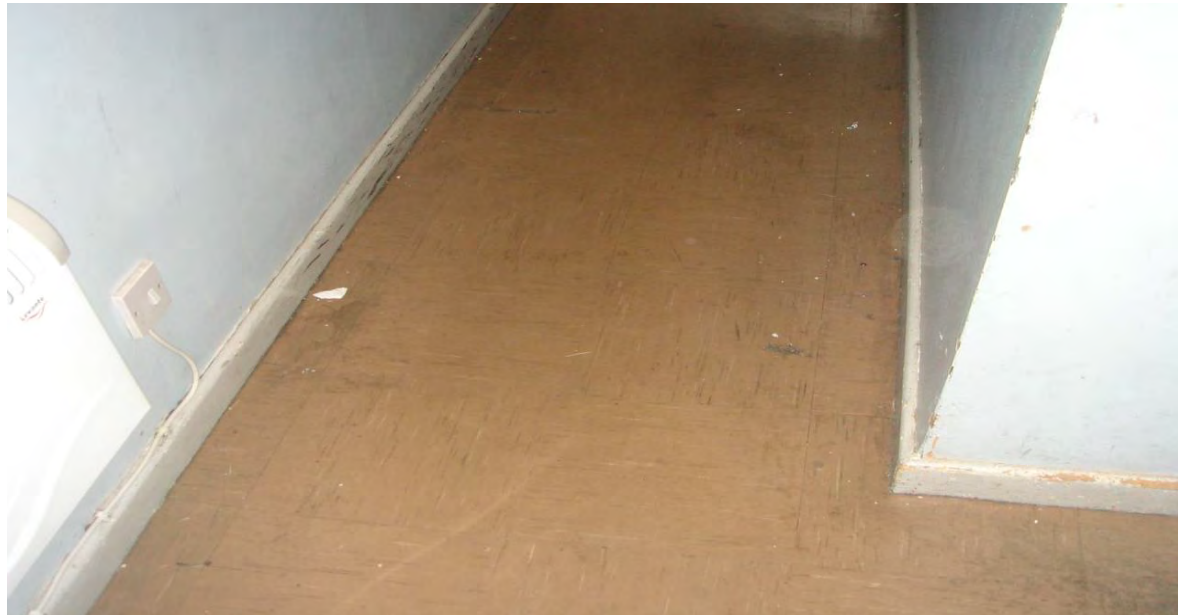
Location: 1/005 Office

Material Description:	Vinyl Floor Tiles	
Identification:	Sampled – Asbestos Detected	
Approx. quantity:	6M2	
Accessibility	Low	Assessment Score
Product type:	Vinyl	1
Extent of Damage:	Low	1
Surface Treatment:	Non-Friable	0
Asbestos type:	Chrysotile	1
Material Assessment Score:		3
Priority Assessment Score:		Negligible
Action:	Manage	
Comments:	N/A

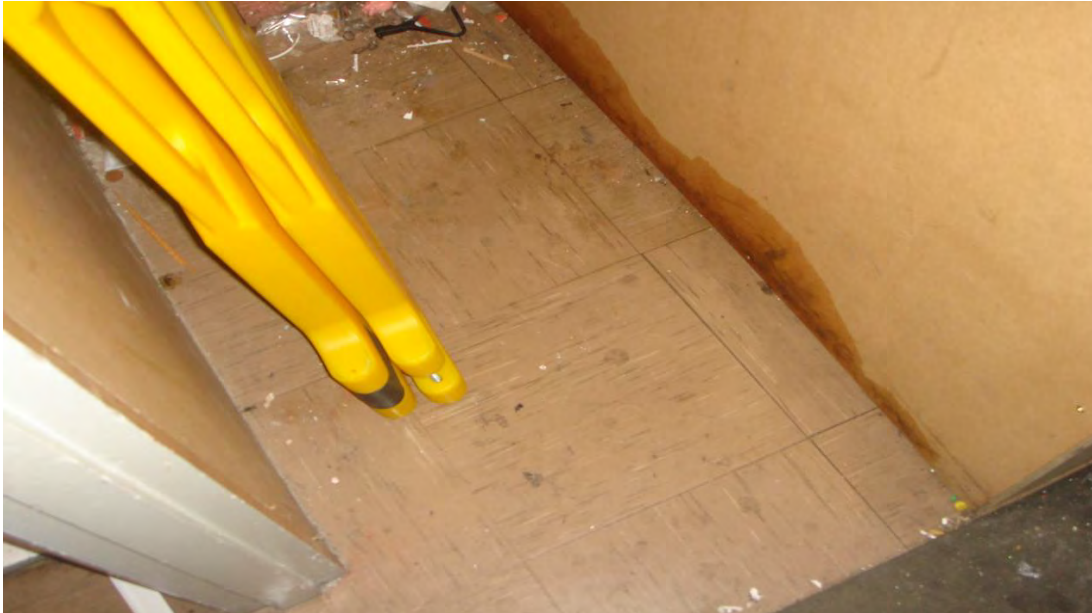
Location: 1/006 Store

Material Description:	Vinyl Floor Tiles	
Identification:	As Per Sample NE/2 – Asbestos Detected	
Approx. quantity:	1M2	
Accessibility	Low	Assessment Score
Product type:	Vinyl	1
Extent of Damage:	Low	1
Surface Treatment:	Non-Friable	0
Asbestos type:	Chrysotile	1
Material Assessment Score:		3
Priority Assessment Score:		Negligible
Action:	Manage	
Comments:	N/A

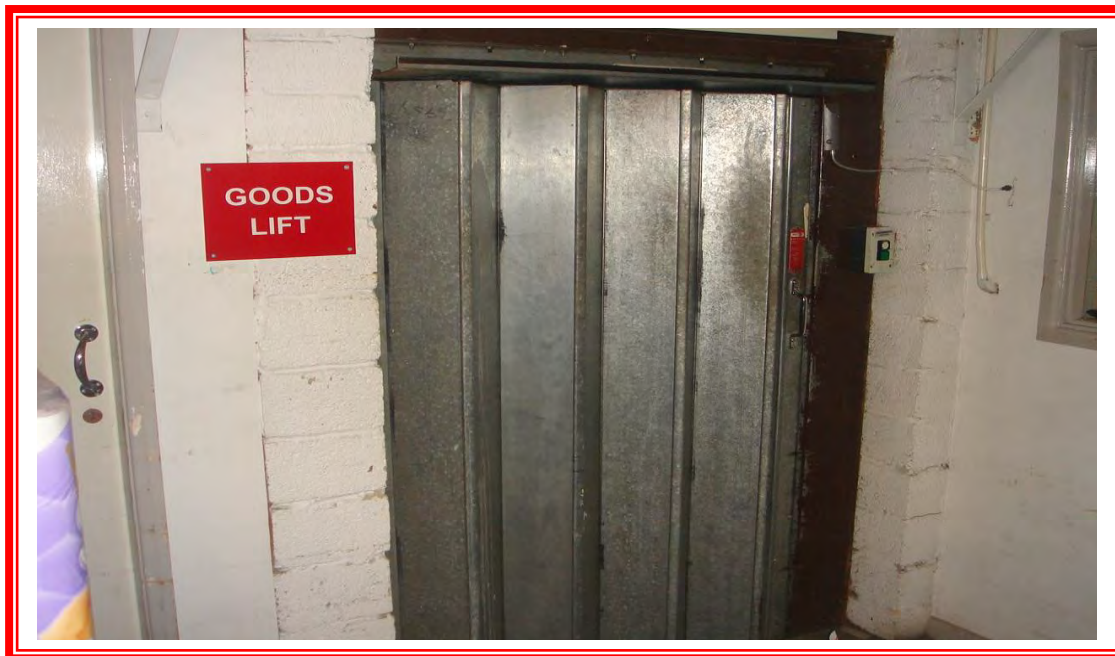
Location: 1/007 Lift and Shaft

Material Description:	No Access	
Identification:	Presumed to Contain Asbestos	
Approx. quantity:	Unknown	
Accessibility	Low	Assessment Score
Product type:	No Access	3
Extent of Damage:	No Access	3
Surface Treatment:	No Access	3
Asbestos type:	No Access	3
Material Assessment Score:		12
Priority Assessment Score:		High
Action:	Further Investigation Required	
Comments:	No access as no lift engineer was onsite

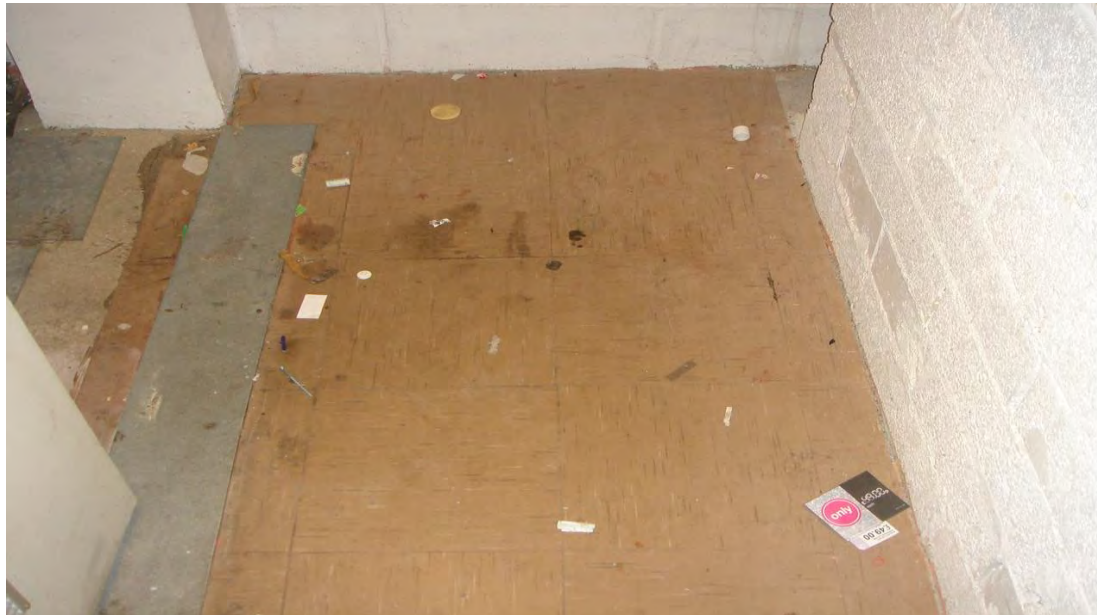
Location: 1/008 Store

Material Description:	Vinyl Floor Tiles	
Identification:	As Per Sample NE/2 – Asbestos Detected	
Approx. quantity:	2M2	
Accessibility	Low	Assessment Score
Product type:	Vinyl	1
Extent of Damage:	Low	1
Surface Treatment:	Non-Friable	0
Asbestos type:	Chrysotile	1
Material Assessment Score:		3
Priority Assessment Score:		Negligible
Action:	Manage	
Comments:	N/A
