# EAGLE QUARTER II NEWBURY

ASBESTOS SURVEY

Management  
Asbestos Survey Report

Kennet Centre, Market Street, Newbury,  
Berkshire, RG14 5EN

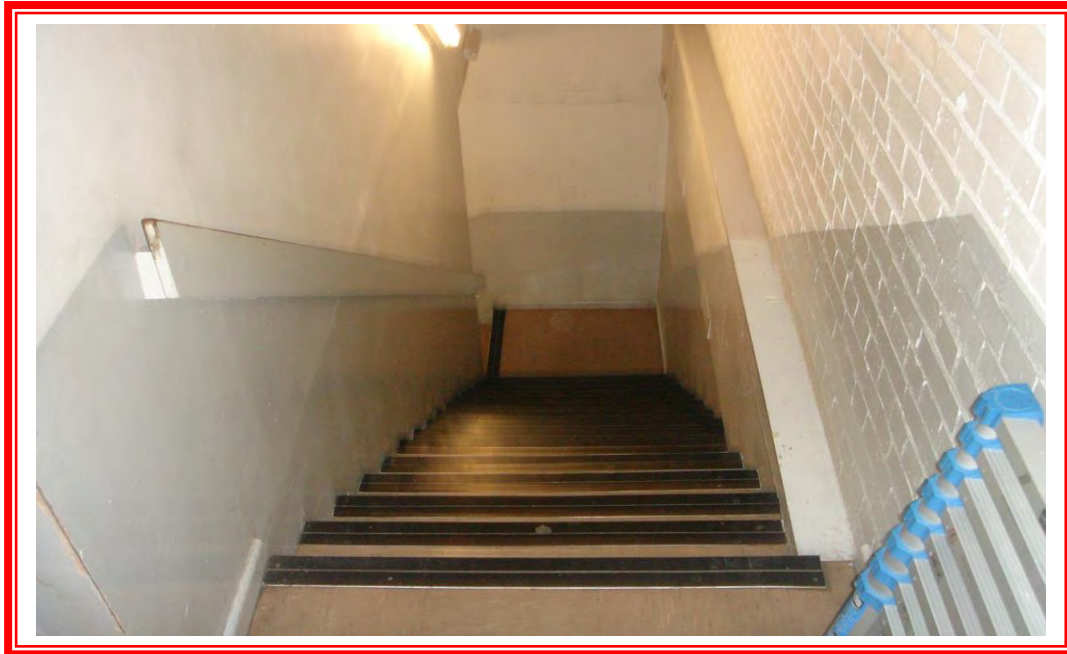
Location: 1/009 Stairs

Material Description:	Vinyl Floor Tiles	
Identification:	As Per Sample NE/2 – Asbestos Detected	
Approx. quantity:	30M2	
Accessibility	Low	Assessment Score
Product type:	Vinyl	1
Extent of Damage:	Low	1
Surface Treatment:	Non-Friable	0
Asbestos type:	Chrysotile	1
Material Assessment Score:		3
Priority Assessment Score:		Negligible
Action:	Manage	
Comments:	N/A

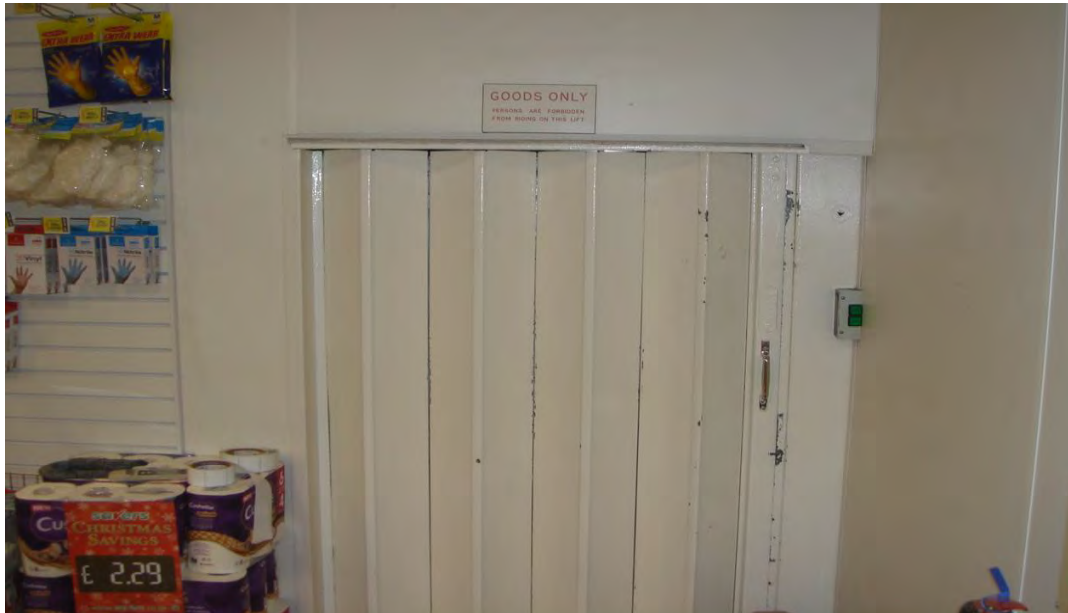
Location: 0/002 Lift and Shaft

Material Description:	No Access	
Identification:	Presumed to Contain Asbestos	
Approx. quantity:	Unknown	
Accessibility	Low	Assessment Score
Product type:	No Access	3
Extent of Damage:	No Access	3
Surface Treatment:	No Access	3
Asbestos type:	No Access	3
Material Assessment Score:		12
Priority Assessment Score:		High
Action:	Further Investigation Required	
Comments:	No access as no lift engineer was onsite

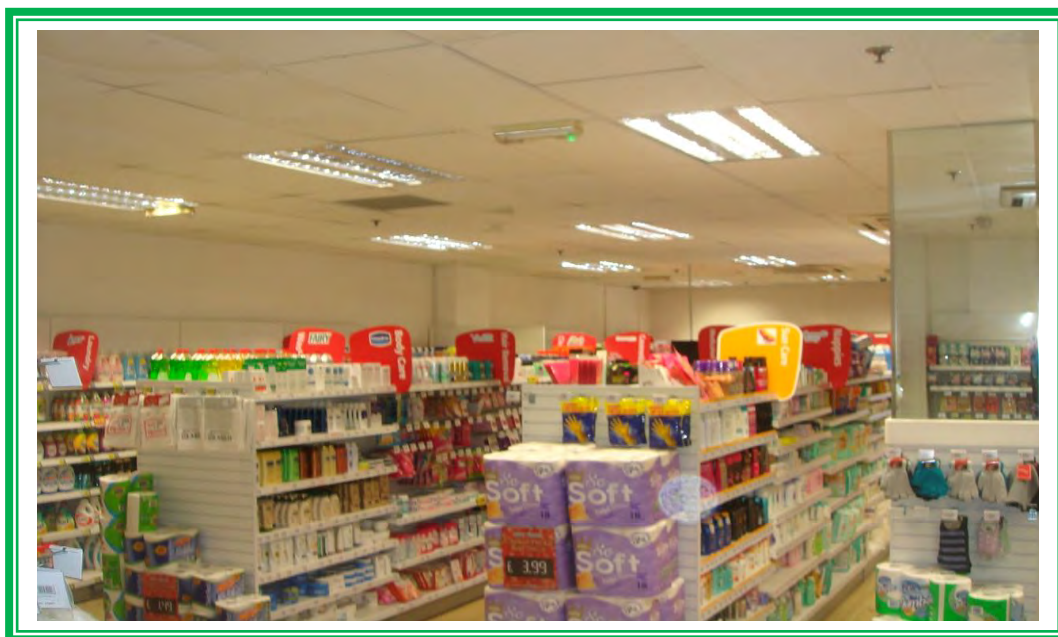
Location: 0/001 Shop Floor

Material Description:	Visual Inspection – No Suspect Materials Found	
Identification:	N/A	
Approx. quantity:	N/A	
Accessibility	N/A	Assessment Score
Product type:	N/A	N/A
Extent of Damage:	N/A	N/A
Surface Treatment:	N/A	N/A
Asbestos type:	N/A	N/A
Material Assessment Score:		N/A
Priority Assessment Score:		N/A
Action:	N/A	
Comments:	N/A

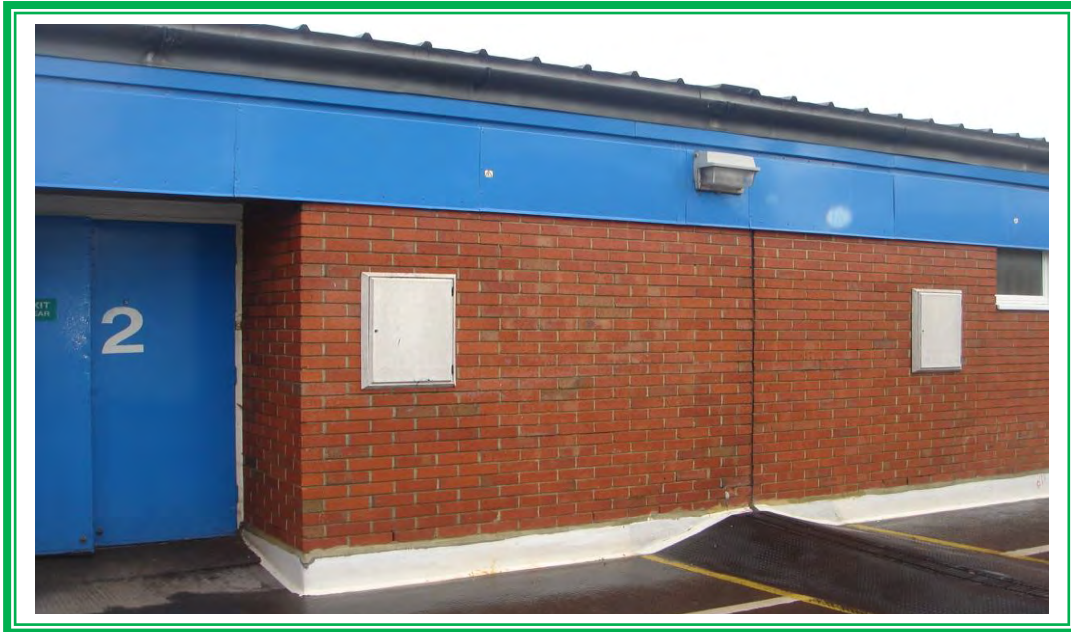
Location: 99/001

Material Description:	Visual Inspection – No Suspect Materials Found	
Identification:	N/A	
Approx. quantity:	N/A	
Accessibility	N/A	Assessment Score
Product type:	N/A	N/A
Extent of Damage:	N/A	N/A
Surface Treatment:	N/A	N/A
Asbestos type:	N/A	N/A
Material Assessment Score:		N/A
Priority Assessment Score:		N/A
Action:	N/A	
Comments:	N/A

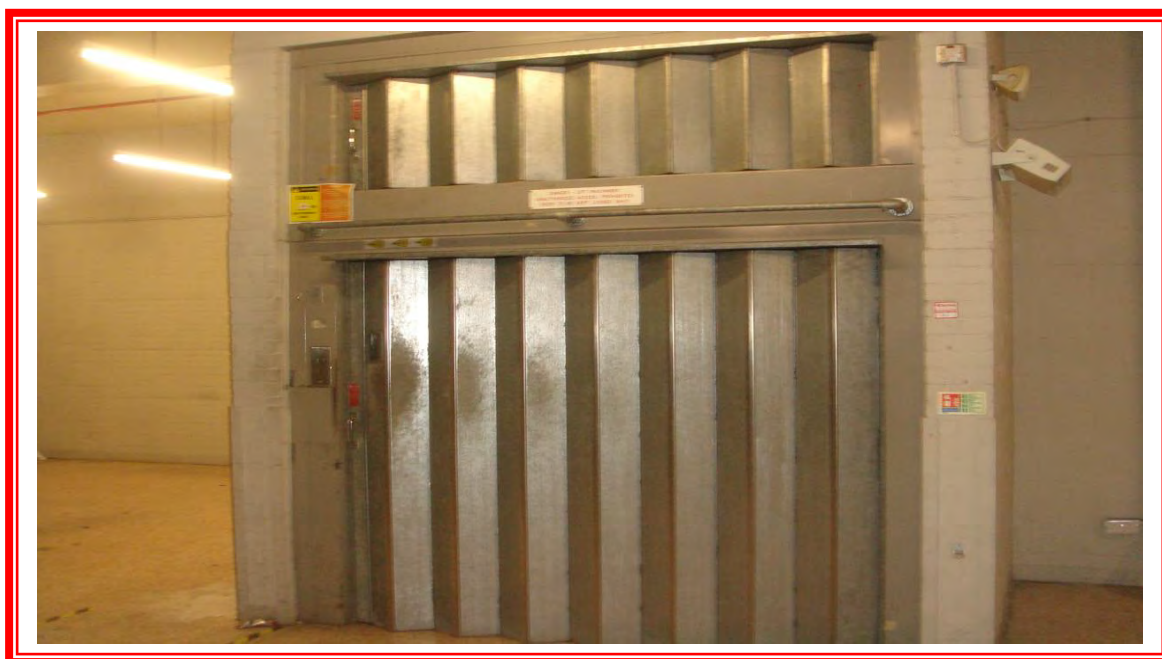
Item No: 2	Sample No: N/A
Location: 1/002 Lift

Material Description:	No Access	
Identification:	Presumed to Contain Asbestos	
Approx. quantity:	Unknown	
Accessibility	Low	Assessment Score
Product type:	No Access	3
Extent of Damage:	No Access	3
Surface Treatment:	No Access	3
Asbestos type:	No Access	3
Material Assessment Score:		12
Priority Assessment Score:		High
Action:	Further Investigation Required	
Comments:	No Access to inspect as there was no lift engineer onsite

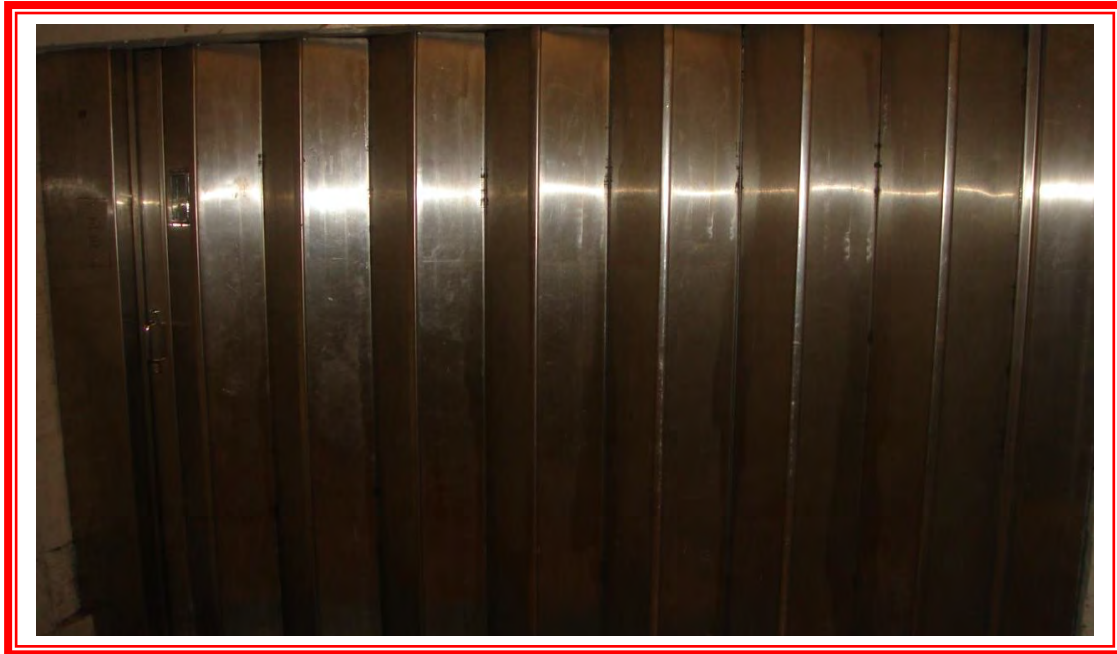
Location: 0/003 Lift

Material Description:	No Access to Lift or Shaft	
Identification:	Presumed to Contain Asbestos	
Approx. quantity:	Unknown	
Accessibility	Low	Assessment Score
Product type:	No Access	3
Extent of Damage:	No Access	3
Surface Treatment:	No Access	3
Asbestos type:	No Access	3
Material Assessment Score:		12
Priority Assessment Score:		High
Action:	Further Investigation Required	
Comments:	No Access to inspect as there was no lift engineer onsite

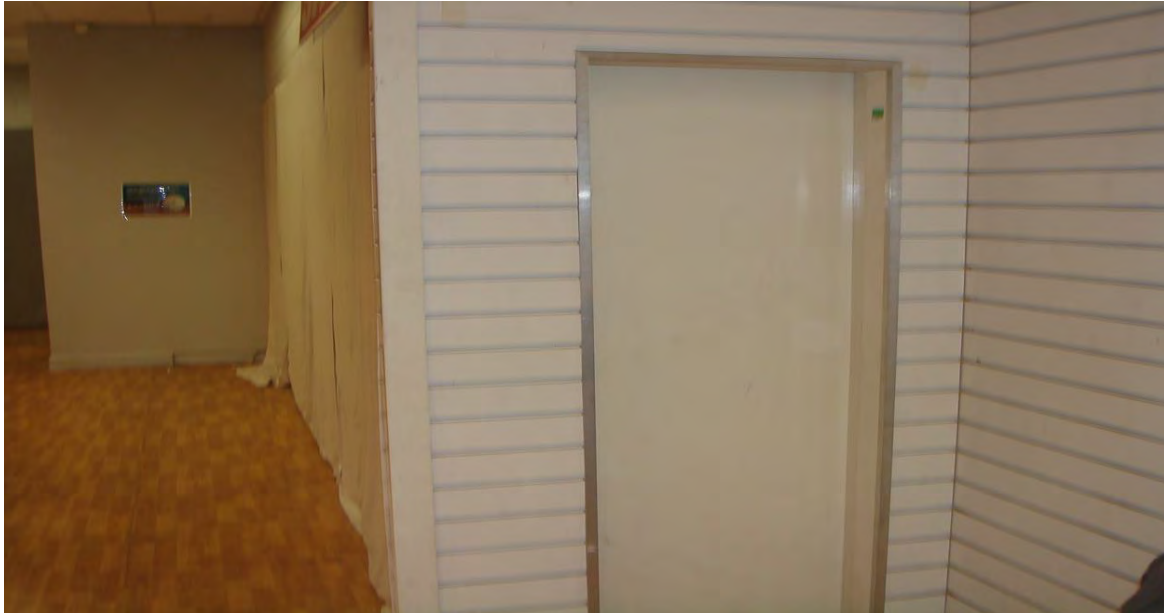
Location: 0/004 Cupboard

Material Description:	No Access	
Identification:	Presumed to Contain Asbestos	
Approx. quantity:	Unknown	
Accessibility	Low	Assessment Score
Product type:	No Access	3
Extent of Damage:	No Access	3
Surface Treatment:	No Access	3
Asbestos type:	No Access	3
Material Assessment Score:		12
Priority Assessment Score:		High
Action:	Further Investigation Required	
Comments:	No Access, no Keys at Time of Survey

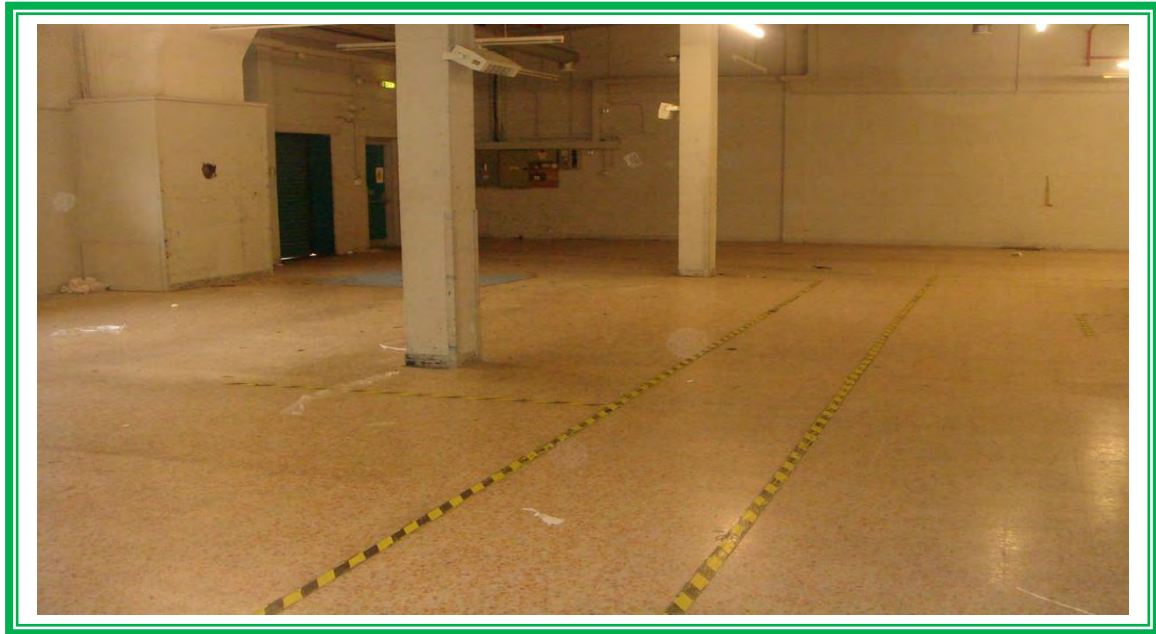
Item No: 1	Sample No: N/A
Location: 1/001

Material Description:	Visual Inspection – No Suspect Materials Found	
Identification:	N/A	
Approx. quantity:	N/A	
Accessibility	N/A	Assessment Score
Product type:	N/A	N/A
Extent of Damage:	N/A	N/A
Surface Treatment:	N/A	N/A
Asbestos type:	N/A	N/A
Material Assessment Score:		N/A
Priority Assessment Score:		N/A
Action:	N/A	
Comments:	N/A

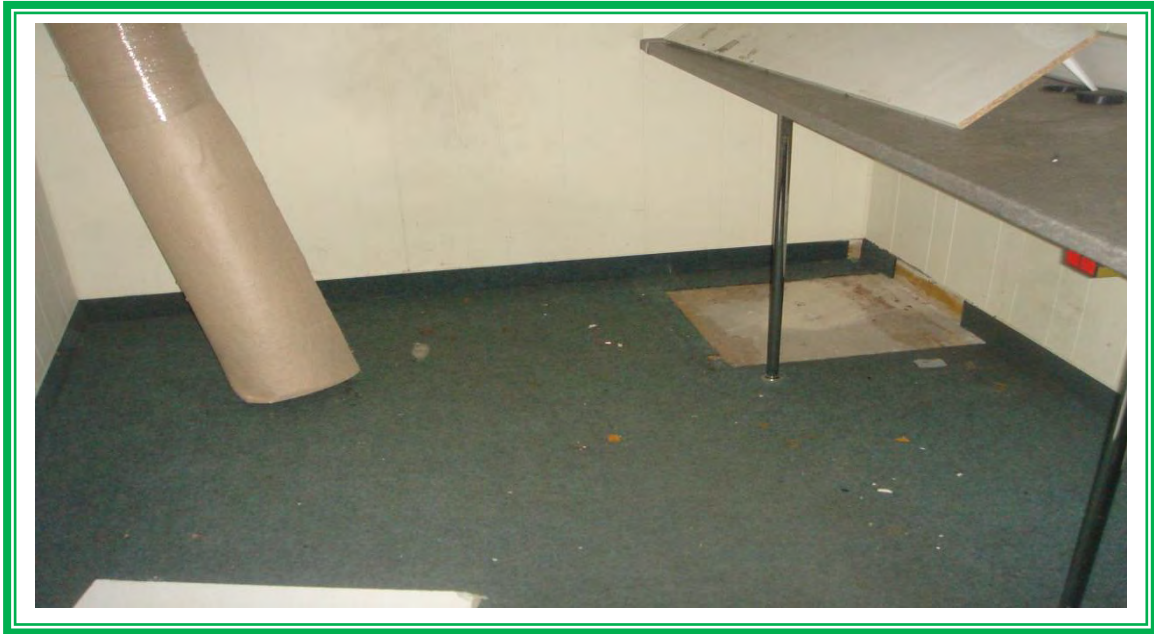
Location: 1/003 Office

Material Description:	Visual Inspection – No Suspect Materials Found	
Identification:	N/A	
Approx. quantity:	N/A	
Accessibility	N/A	Assessment Score
Product type:	N/A	N/A
Extent of Damage:	N/A	N/A
Surface Treatment:	N/A	N/A
Asbestos type:	N/A	N/A
Material Assessment Score:		N/A
Priority Assessment Score:		N/A
Action:	N/A	
Comments:	N/A

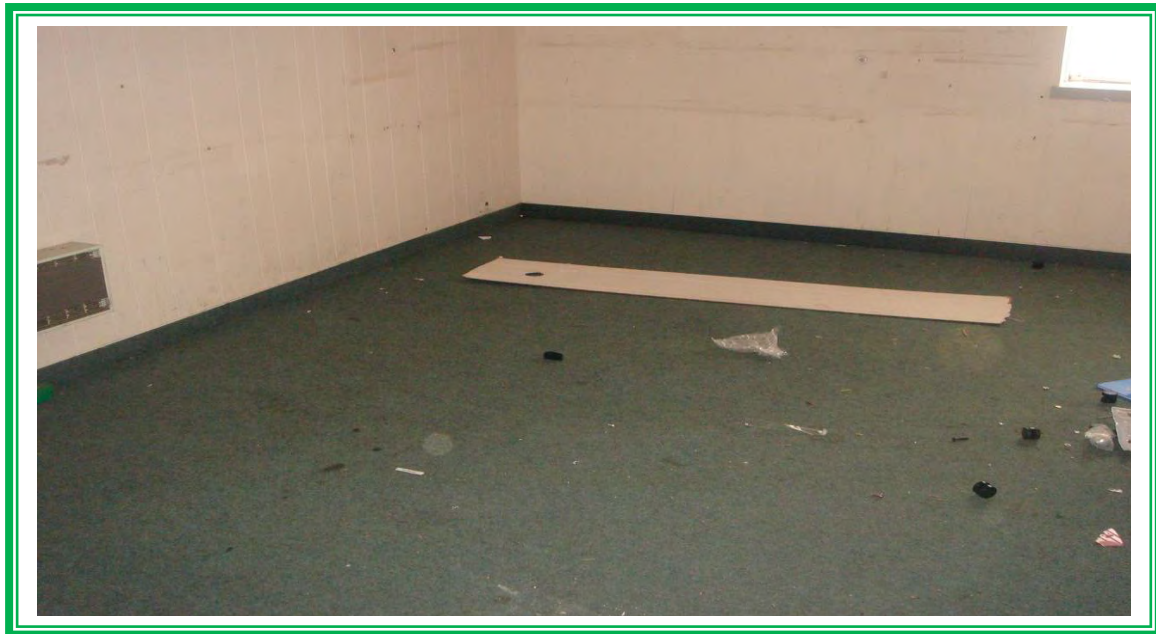
Location: 1/004 Mess Room

Material Description:	Visual Inspection – No Suspect Materials Found	
Identification:	N/A	
Approx. quantity:	N/A	
Accessibility	N/A	Assessment Score
Product type:	N/A	N/A
Extent of Damage:	N/A	N/A
Surface Treatment:	N/A	N/A
Asbestos type:	N/A	N/A
Material Assessment Score:		N/A
Priority Assessment Score:		N/A
Action:	N/A	
Comments:	N/A

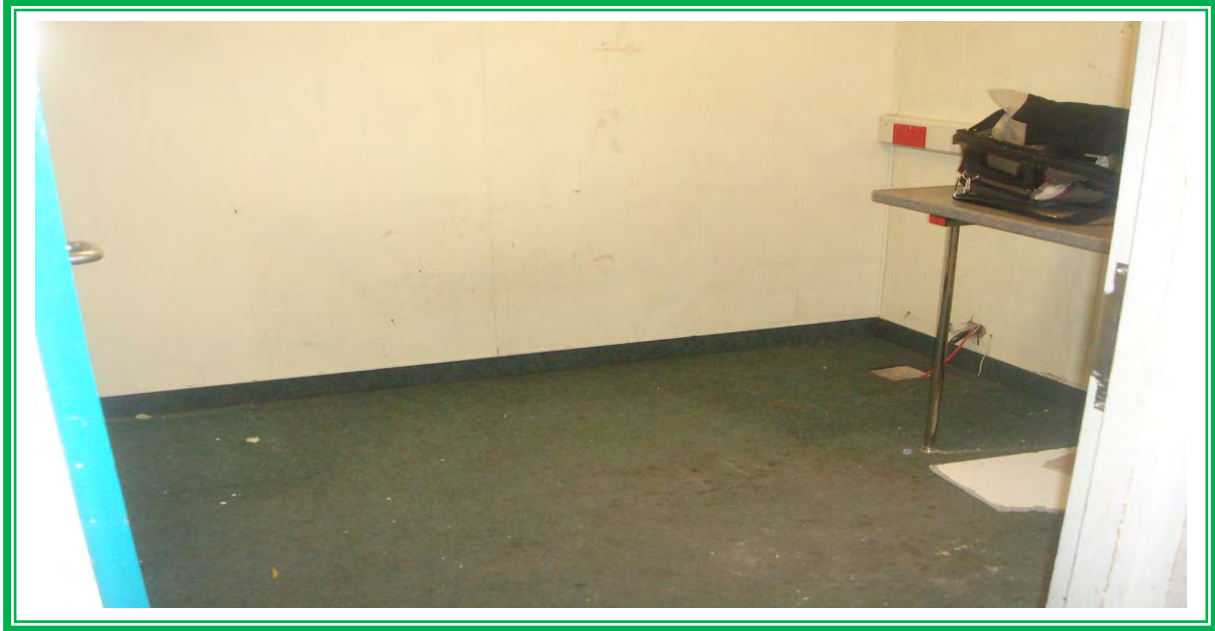
Location: 1/005 Office

Material Description:	Visual Inspection – No Suspect Materials Found	
Identification:	N/A	
Approx. quantity:	N/A	
Accessibility	N/A	Assessment Score
Product type:	N/A	N/A
Extent of Damage:	N/A	N/A
Surface Treatment:	N/A	N/A
Asbestos type:	N/A	N/A
Material Assessment Score:		N/A
Priority Assessment Score:		N/A
Action:	N/A	
Comments:	N/A

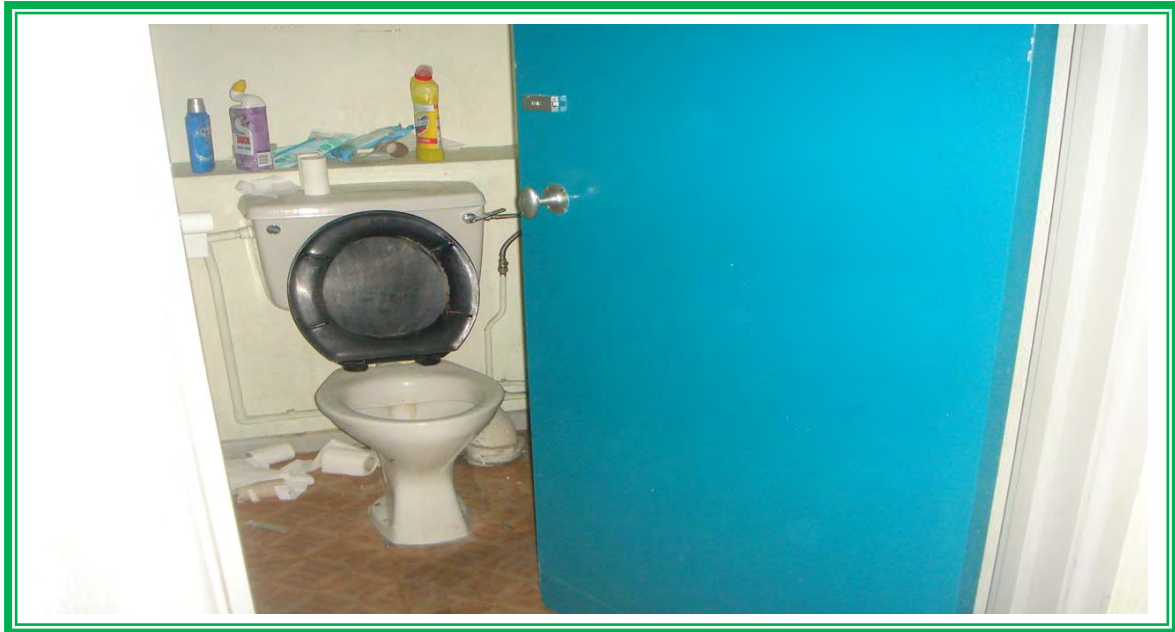
Location: 1/006 WC

Material Description:	Visual Inspection – No Suspect Materials Found	
Identification:	N/A	
Approx. quantity:	N/A	
Accessibility	N/A	Assessment Score
Product type:	N/A	N/A
Extent of Damage:	N/A	N/A
Surface Treatment:	N/A	N/A
Asbestos type:	N/A	N/A
Material Assessment Score:		N/A
Priority Assessment Score:		N/A
Action:	N/A	
Comments:	N/A

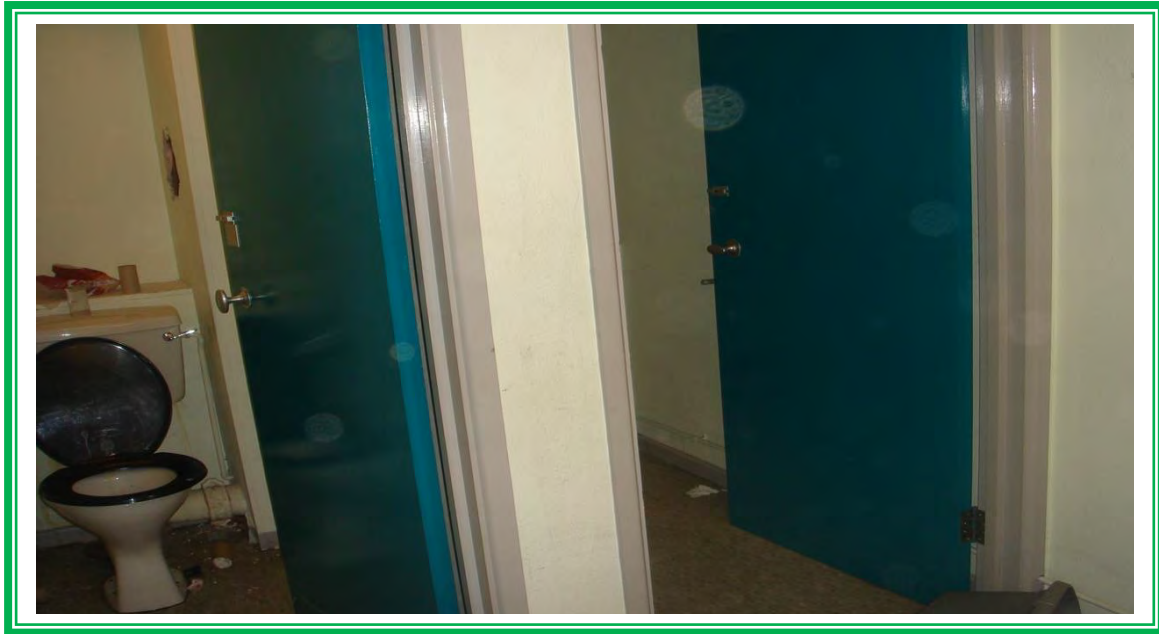
Location: 1/007 WC

Material Description:	Visual Inspection – No Suspect Materials Found	
Identification:	N/A	
Approx. quantity:	N/A	
Accessibility	N/A	Assessment Score
Product type:	N/A	N/A
Extent of Damage:	N/A	N/A
Surface Treatment:	N/A	N/A
Asbestos type:	N/A	N/A
Material Assessment Score:		N/A
Priority Assessment Score:		N/A
Action:	N/A	
Comments:	N/A

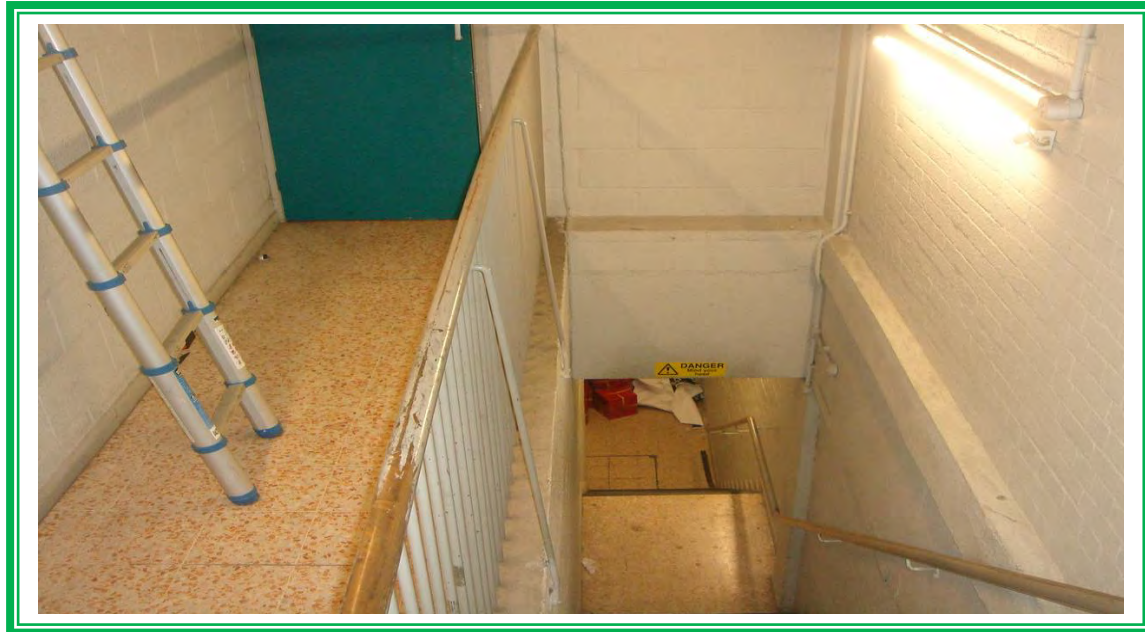
Location: 1/008 Stairs

Material Description:	Visual Inspection – No Suspect Materials Found	
Identification:	N/A	
Approx. quantity:	N/A	
Accessibility	N/A	Assessment Score
Product type:	N/A	N/A
Extent of Damage:	N/A	N/A
Surface Treatment:	N/A	N/A
Asbestos type:	N/A	N/A
Material Assessment Score:		N/A
Priority Assessment Score:		N/A
Action:	N/A	
Comments:	N/A

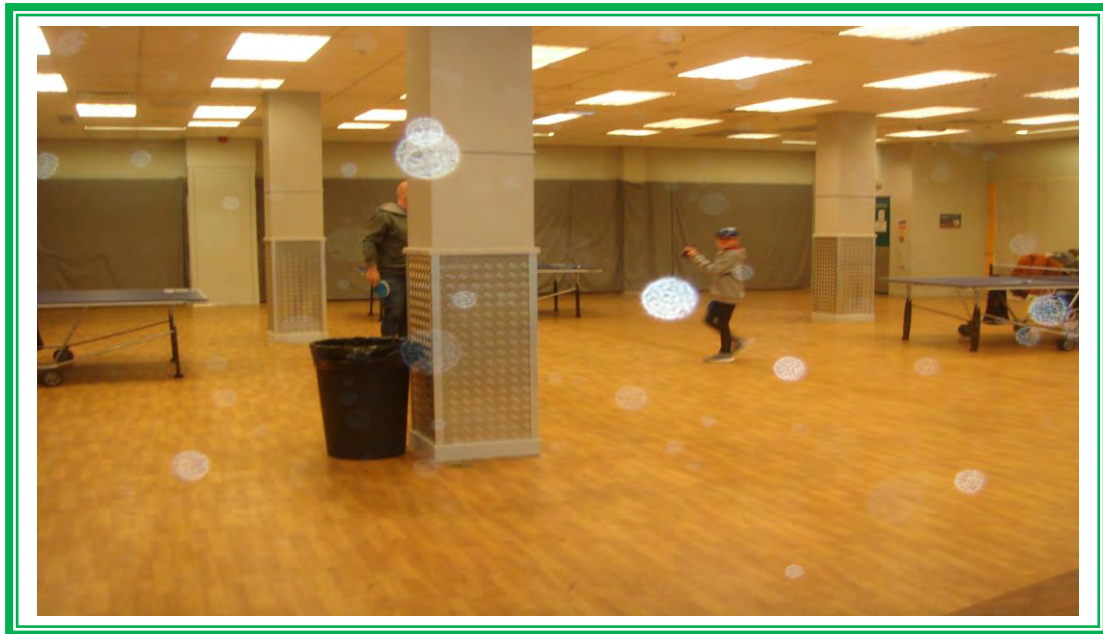
Location: 0/001 Shop Floor

Material Description:	Visual Inspection – No Suspect Materials Found	
Identification:	N/A	
Approx. quantity:	N/A	
Accessibility	N/A	Assessment Score
Product type:	N/A	N/A
Extent of Damage:	N/A	N/A
Surface Treatment:	N/A	N/A
Asbestos type:	N/A	N/A
Material Assessment Score:		N/A
Priority Assessment Score:		N/A
Action:	N/A	
Comments:	N/A

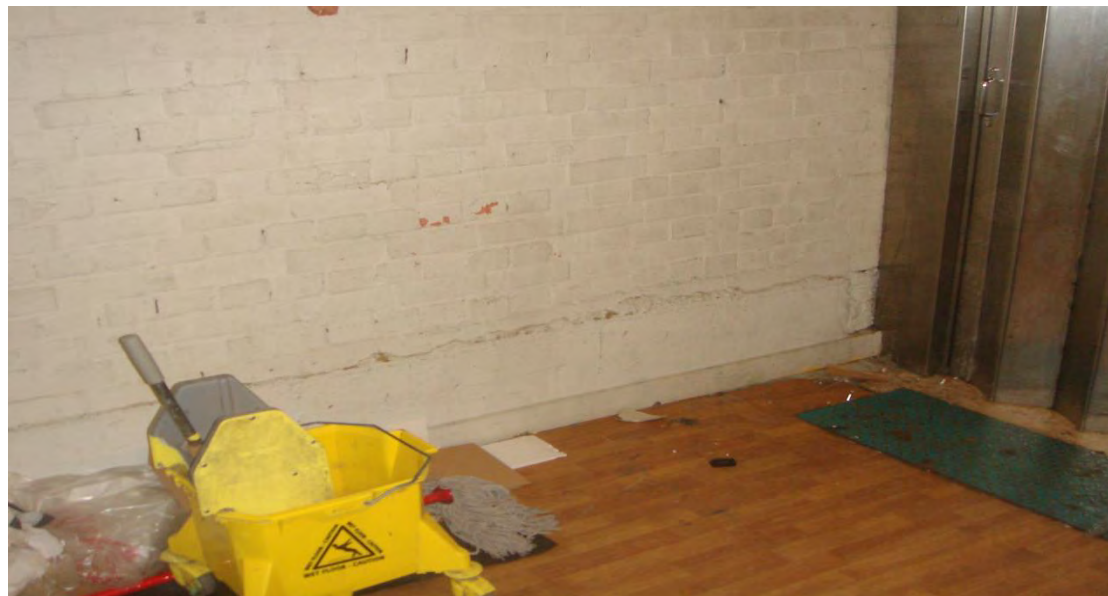
Location: 0/002 Lift Lobby

Material Description:	Visual Inspection – No Suspect Materials Found	
Identification:	N/A	
Approx. quantity:	N/A	
Accessibility	N/A	Assessment Score
Product type:	N/A	N/A
Extent of Damage:	N/A	N/A
Surface Treatment:	N/A	N/A
Asbestos type:	N/A	N/A
Material Assessment Score:		N/A
Priority Assessment Score:		N/A
Action:	N/A	
Comments:	N/A

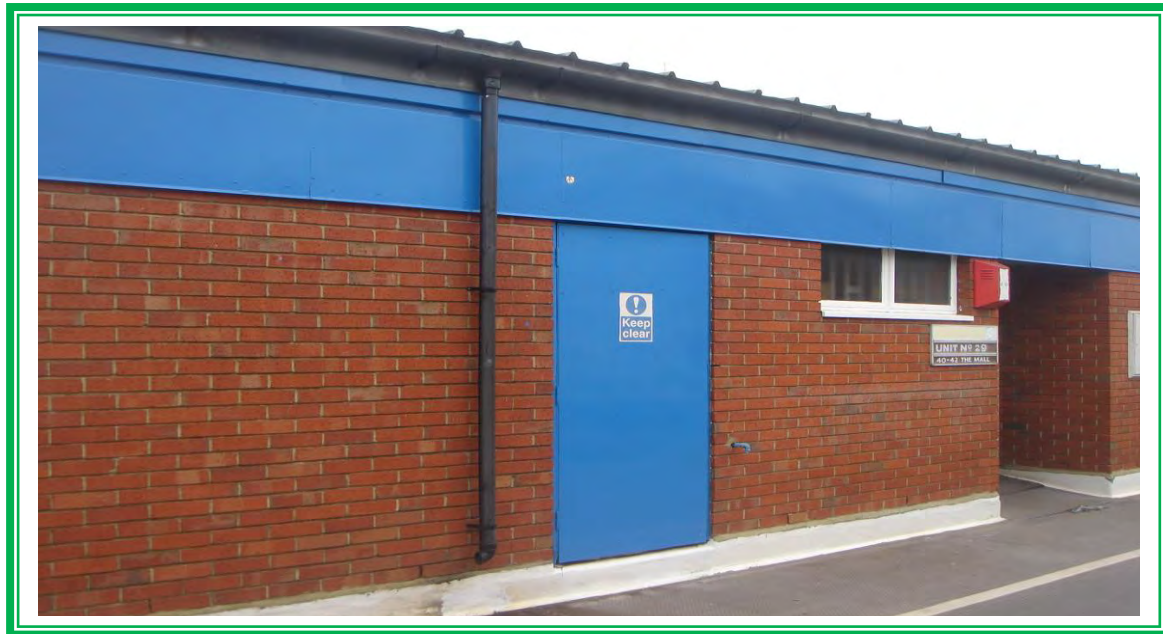
Location: 99/001

Material Description:	Visual Inspection – No Suspect Materials Found	
Identification:	N/A	
Approx. quantity:	N/A	
Accessibility	N/A	Assessment Score
Product type:	N/A	N/A
Extent of Damage:	N/A	N/A
Surface Treatment:	N/A	N/A
Asbestos type:	N/A	N/A
Material Assessment Score:		N/A
Priority Assessment Score:		N/A
Action:	N/A	
Comments:	N/A

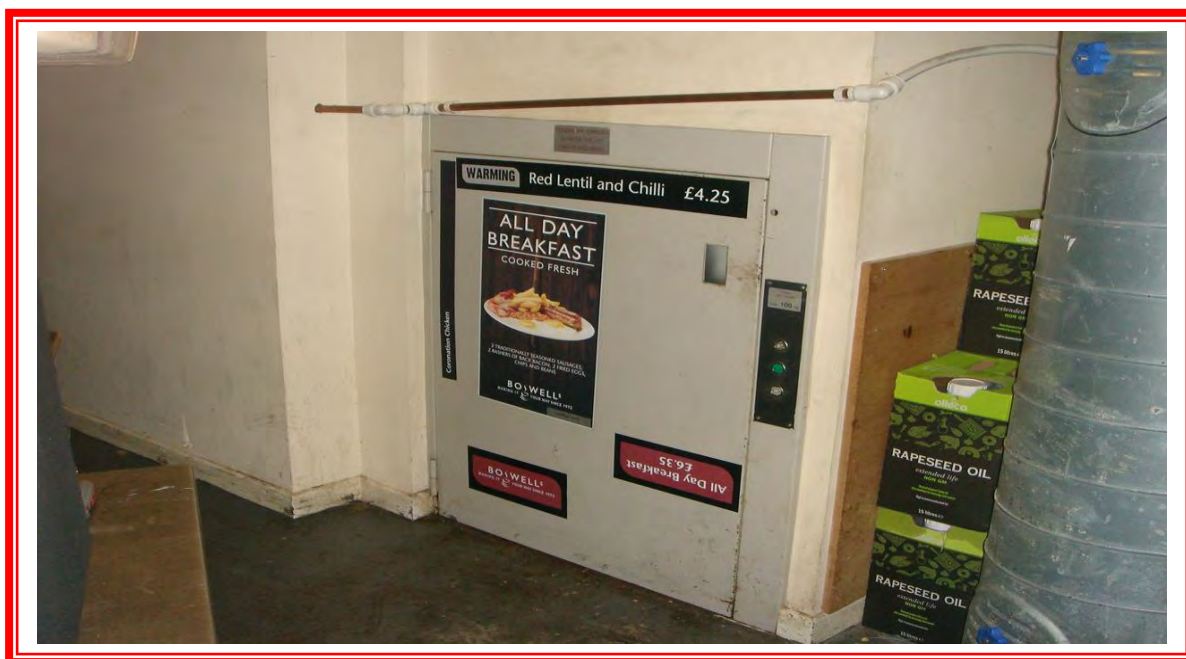
Location: 1/004 Lift and Shafts

Material Description:	No Access	
Identification:	Presumed to Contain Asbestos	
Approx. quantity:	Lift and Lift Shaft	
Accessibility	Low	Assessment Score
Product type:	No Access	3
Extent of Damage:	No Access	3
Surface Treatment:	No Access	3
Asbestos type:	No Access	3
Material Assessment Score:		12
Priority Assessment Score:		High
Action:	Further Inspection Required	
Comments:	Unable to gain access as no lift engineer was onsite

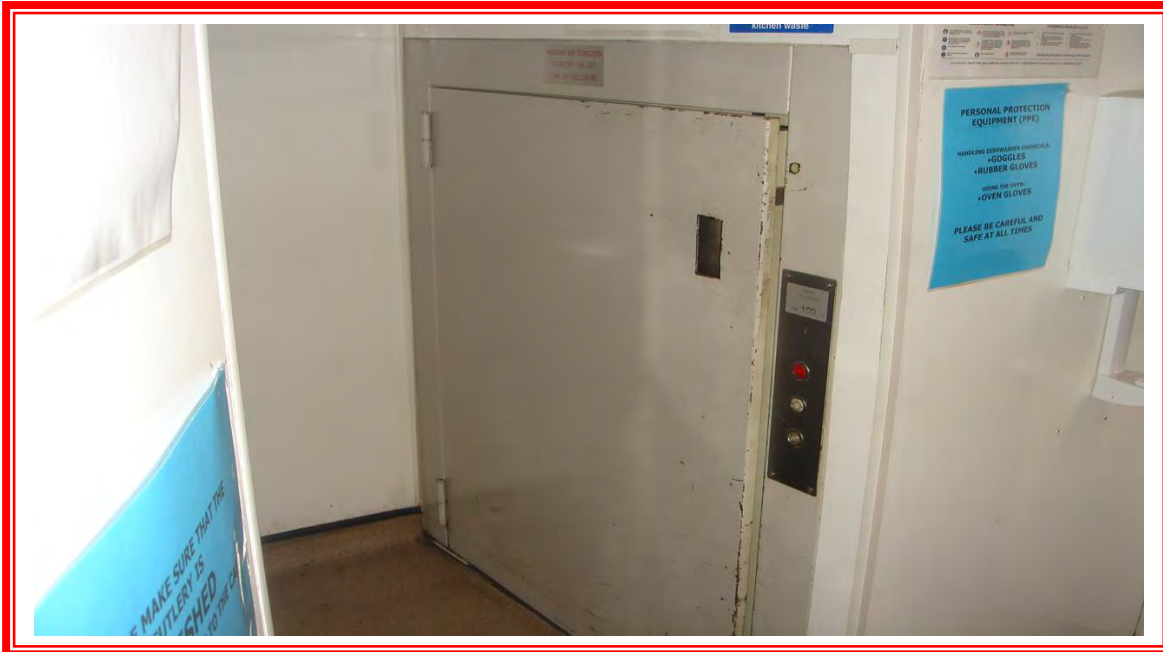
Location: 0/005 Lift and Shaft

Material Description:	No Access	
Identification:	Presumed to Contain Asbestos	
Approx. quantity:	Lift and Lift Shaft	
Accessibility	Low	Assessment Score
Product type:	No Access	3
Extent of Damage:	No Access	3
Surface Treatment:	No Access	3
Asbestos type:	No Access	3
Material Assessment Score:		12
Priority Assessment Score:		High
Action:	Further Inspection Required	
Comments:	Unable to gain access as no lift engineer was onsite

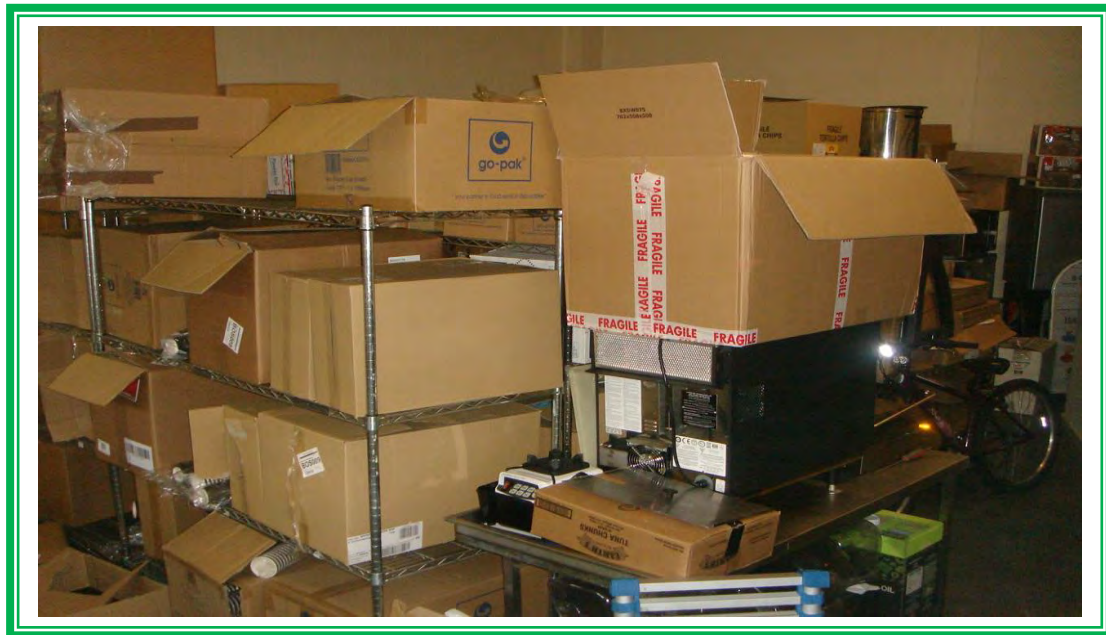
Location: 1/001 Store

Material Description:	Visual Inspection – No Suspect Materials Found	
Identification:	N/A	
Approx. quantity:	N/A	
Accessibility	N/A	Assessment Score
Product type:	N/A	N/A
Extent of Damage:	N/A	N/A
Surface Treatment:	N/A	N/A
Asbestos type:	N/A	N/A
Material Assessment Score:		N/A
Priority Assessment Score:		N/A
Action:	N/A	
Comments:	N/A

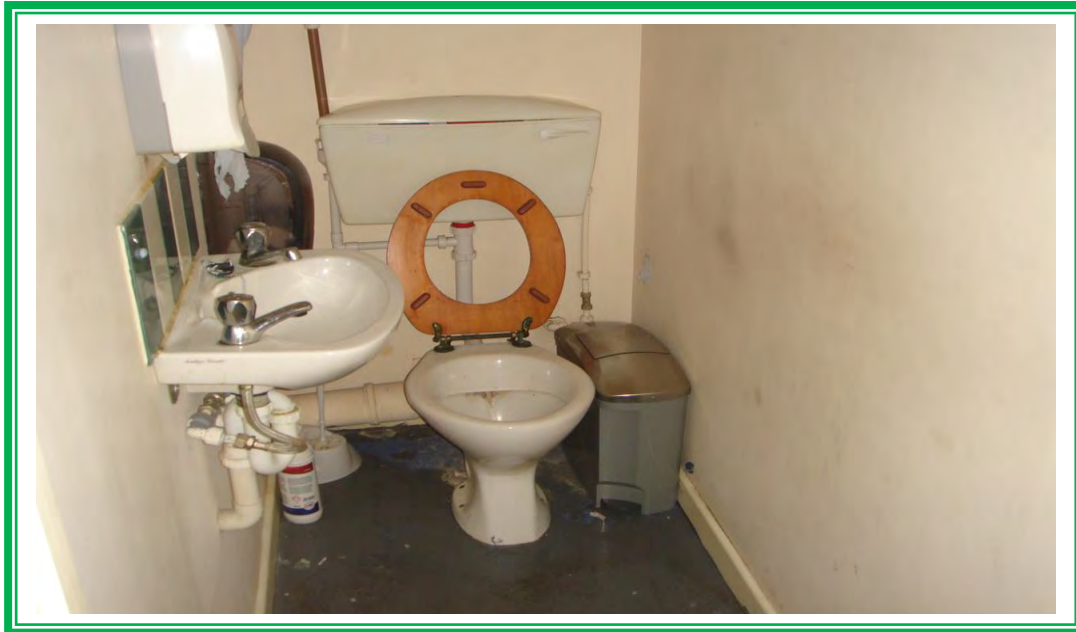
Location: 1/002 WC

Material Description:	Visual Inspection – No Suspect Materials Found	
Identification:	N/A	
Approx. quantity:	N/A	
Accessibility	N/A	Assessment Score
Product type:	N/A	N/A
Extent of Damage:	N/A	N/A
Surface Treatment:	N/A	N/A
Asbestos type:	N/A	N/A
Material Assessment Score:		N/A
Priority Assessment Score:		N/A
Action:	N/A	
Comments:	N/A

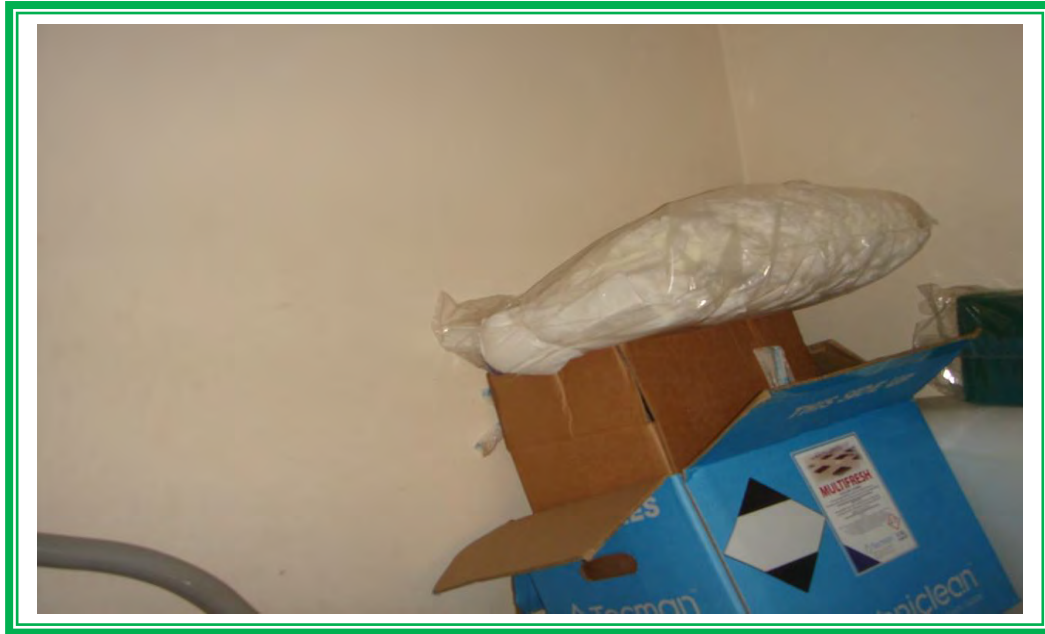
Location: 1/003

Material Description:	Visual Inspection – No Suspect Materials Found	
Identification:	N/A	
Approx. quantity:	N/A	
Accessibility	N/A	Assessment Score
Product type:	N/A	N/A
Extent of Damage:	N/A	N/A
Surface Treatment:	N/A	N/A
Asbestos type:	N/A	N/A
Material Assessment Score:		N/A
Priority Assessment Score:		N/A
Action:	N/A	
Comments:	N/A

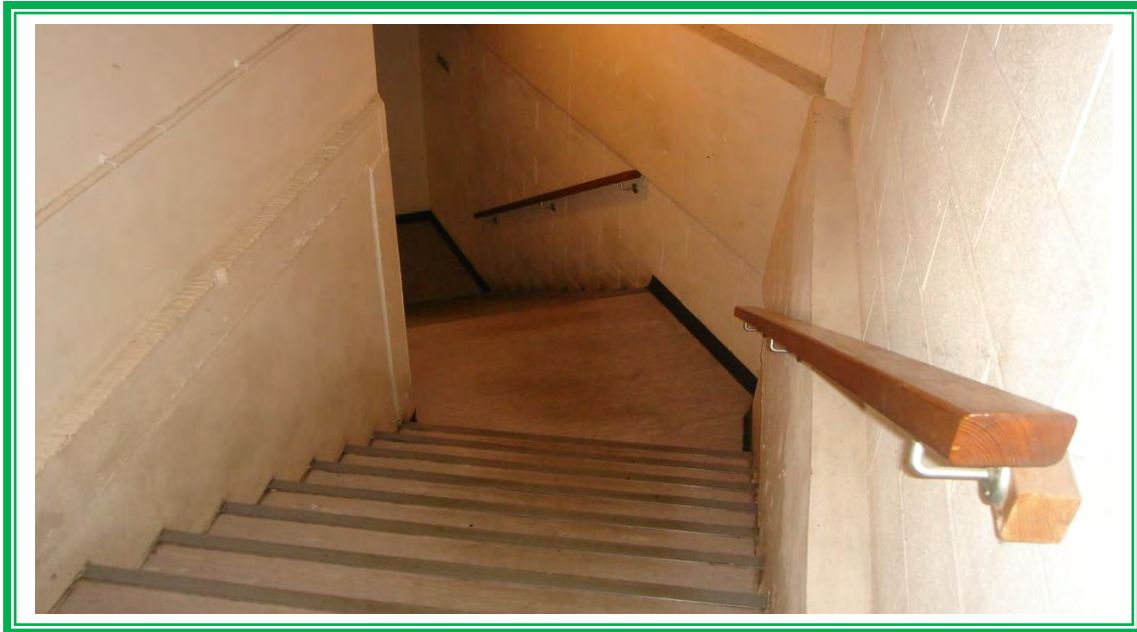
Location: 1/005 Stairs

Material Description:	Visual Inspection – No Suspect Materials Found	
Identification:	N/A	
Approx. quantity:	N/A	
Accessibility	N/A	Assessment Score
Product type:	N/A	N/A
Extent of Damage:	N/A	N/A
Surface Treatment:	N/A	N/A
Asbestos type:	N/A	N/A
Material Assessment Score:		N/A
Priority Assessment Score:		N/A
Action:	N/A	
Comments:	N/A

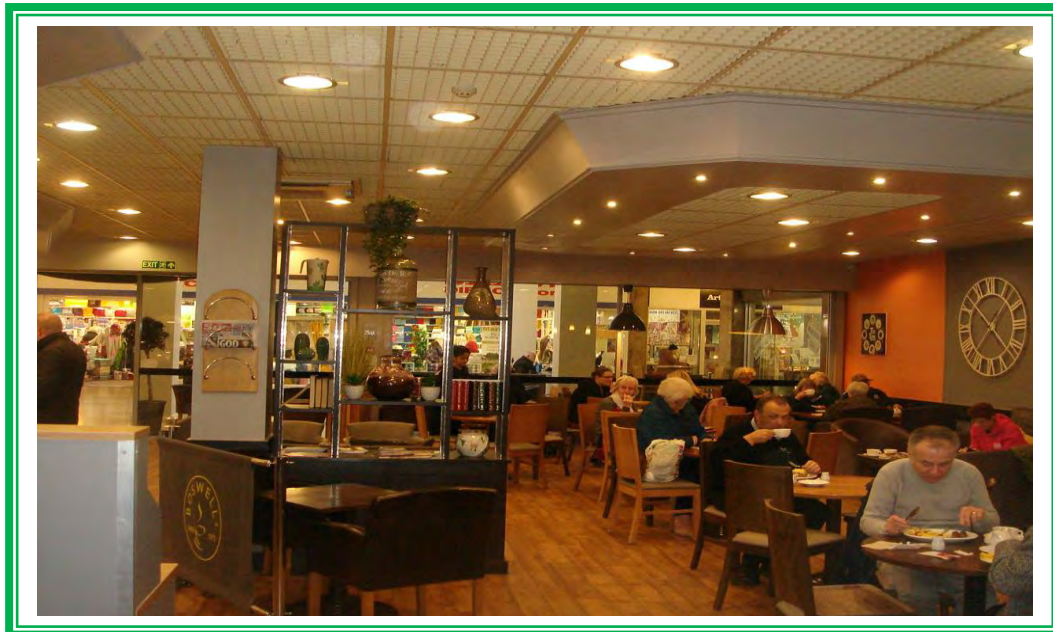
Location: 0/001 Café and Servery

Material Description:	Visual Inspection – No Suspect Materials Found	
Identification:	N/A	
Approx. quantity:	N/A	
Accessibility	N/A	Assessment Score
Product type:	N/A	N/A
Extent of Damage:	N/A	N/A
Surface Treatment:	N/A	N/A
Asbestos type:	N/A	N/A
Material Assessment Score:		N/A
Priority Assessment Score:		N/A
Action:	N/A	
Comments:	N/A

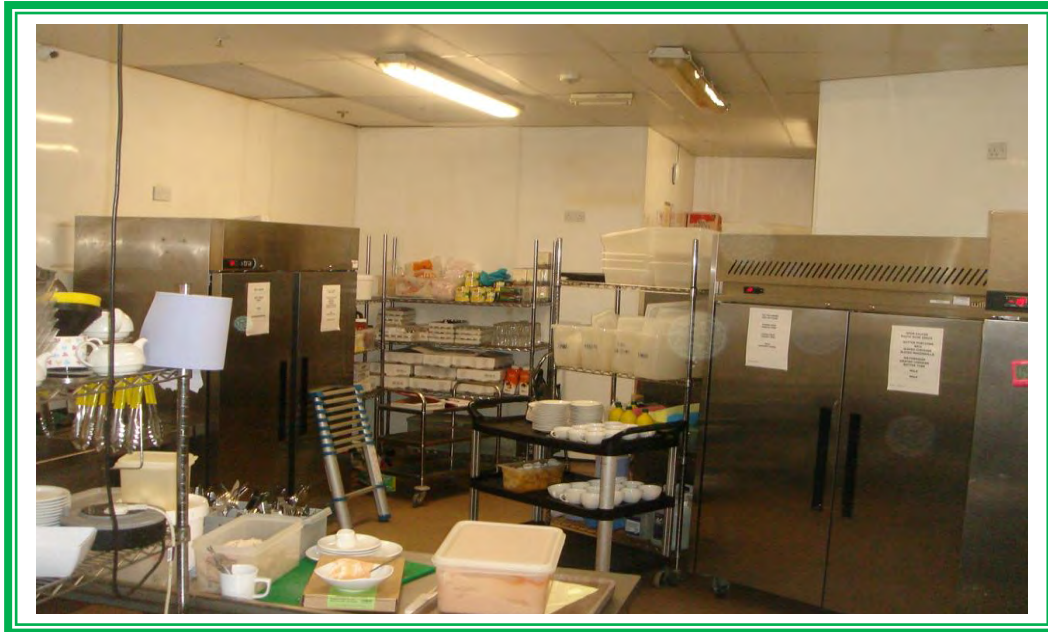
Location: 0/002 Kitchen

Material Description:	Visual Inspection – No Suspect Materials Found	
Identification:	N/A	
Approx. quantity:	N/A	
Accessibility	N/A	Assessment Score
Product type:	N/A	N/A
Extent of Damage:	N/A	N/A
Surface Treatment:	N/A	N/A
Asbestos type:	N/A	N/A
Material Assessment Score:		N/A
Priority Assessment Score:		N/A
Action:	N/A	
Comments:	N/A

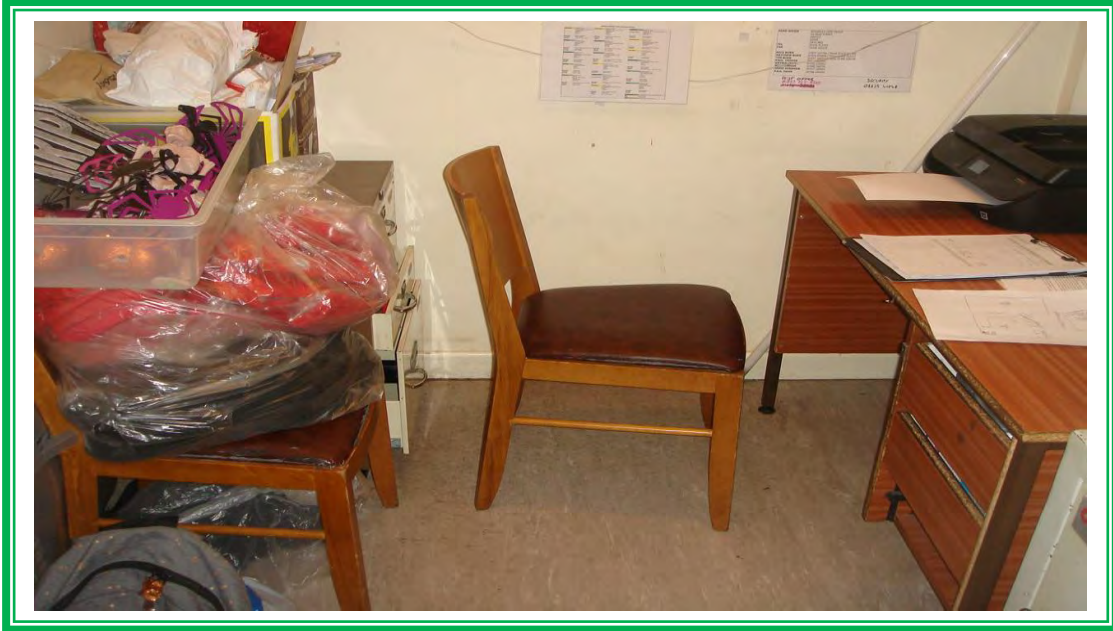
Location: 0/003 Office

Material Description:	Visual Inspection – No Suspect Materials Found	
Identification:	N/A	
Approx. quantity:	N/A	
Accessibility	N/A	Assessment Score
Product type:	N/A	N/A
Extent of Damage:	N/A	N/A
Surface Treatment:	N/A	N/A
Asbestos type:	N/A	N/A
Material Assessment Score:		N/A
Priority Assessment Score:		N/A
Action:	N/A	
Comments:	N/A

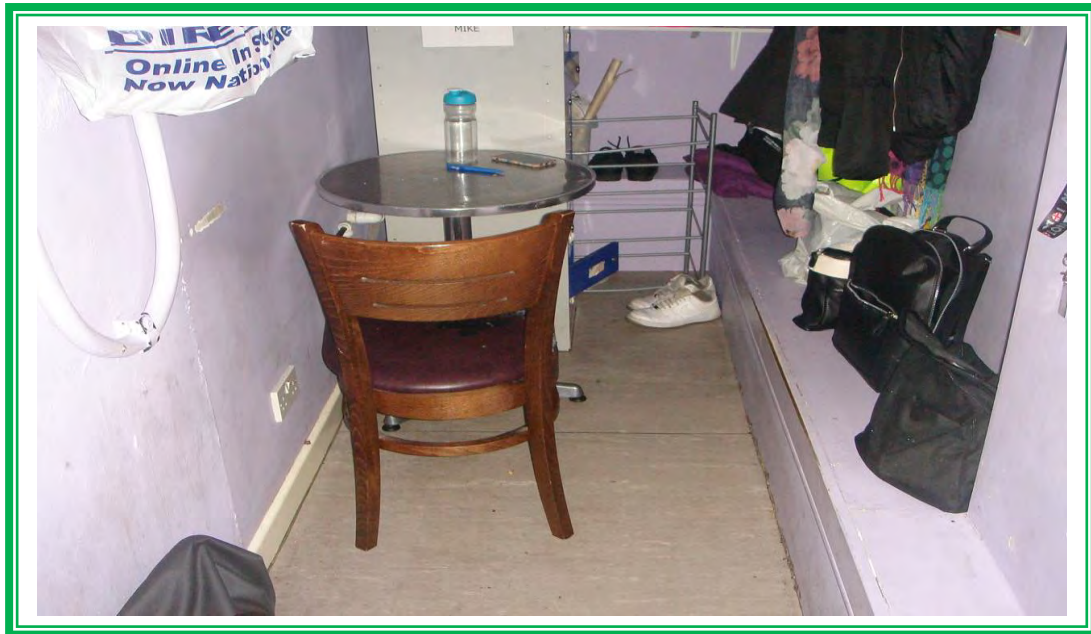
Location: 0/004 Cupboard

Material Description:	Visual Inspection – No Suspect Materials Found	
Identification:	N/A	
Approx. quantity:	N/A	
Accessibility	N/A	Assessment Score
Product type:	N/A	N/A
Extent of Damage:	N/A	N/A
Surface Treatment:	N/A	N/A
Asbestos type:	N/A	N/A
Material Assessment Score:		N/A
Priority Assessment Score:		N/A
Action:	N/A	
Comments:	N/A

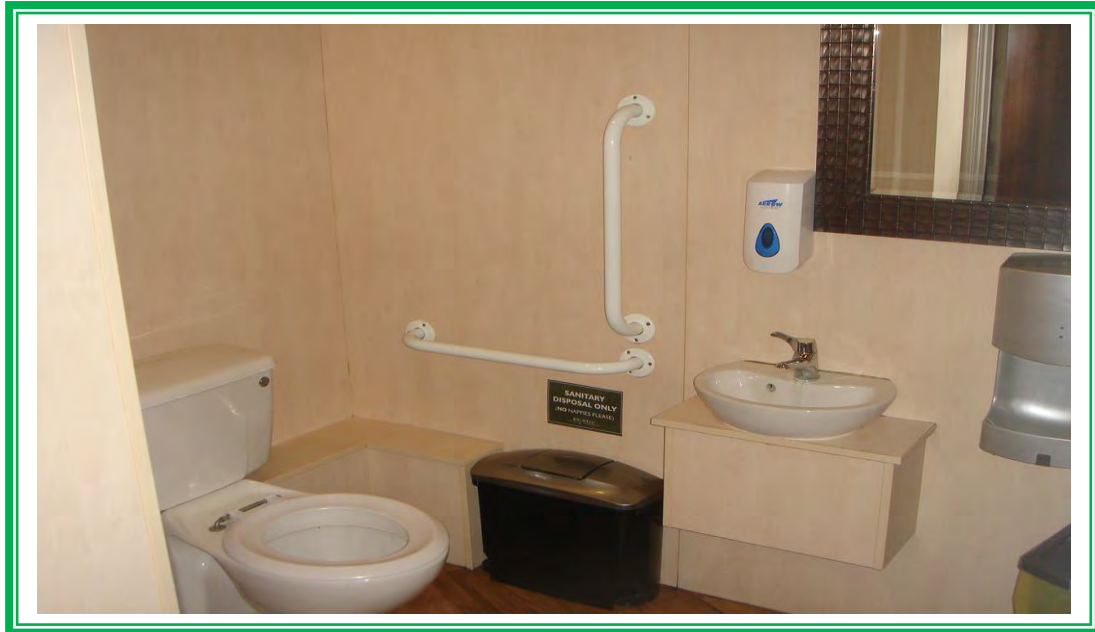
Location: 0/006 WC

Material Description:	Visual Inspection – No Suspect Materials Found	
Identification:	N/A	
Approx. quantity:	N/A	
Accessibility	N/A	Assessment Score
Product type:	N/A	N/A
Extent of Damage:	N/A	N/A
Surface Treatment:	N/A	N/A
Asbestos type:	N/A	N/A
Material Assessment Score:		N/A
Priority Assessment Score:		N/A
Action:	N/A	
Comments:	N/A
