# EAGLE QUARTER II NEWBURY

ASBESTOS SURVEY

Management  
Asbestos Survey Report

Kennet Centre, Market Street, Newbury,  
Berkshire, RG14 5EN

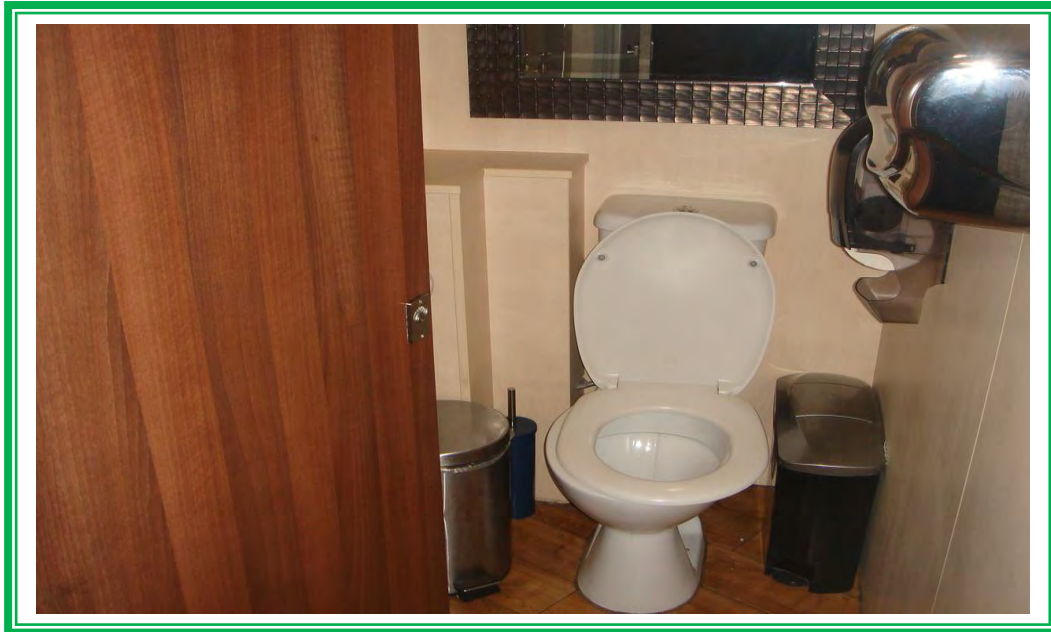
Location: 0/007 WC

Material Description:	Visual Inspection – No Suspect Materials Found	
Identification:	N/A	
Approx. quantity:	N/A	
Accessibility	N/A	Assessment Score
Product type:	N/A	N/A
Extent of Damage:	N/A	N/A
Surface Treatment:	N/A	N/A
Asbestos type:	N/A	N/A
Material Assessment Score:		N/A
Priority Assessment Score:		N/A
Action:	N/A	
Comments:	N/A

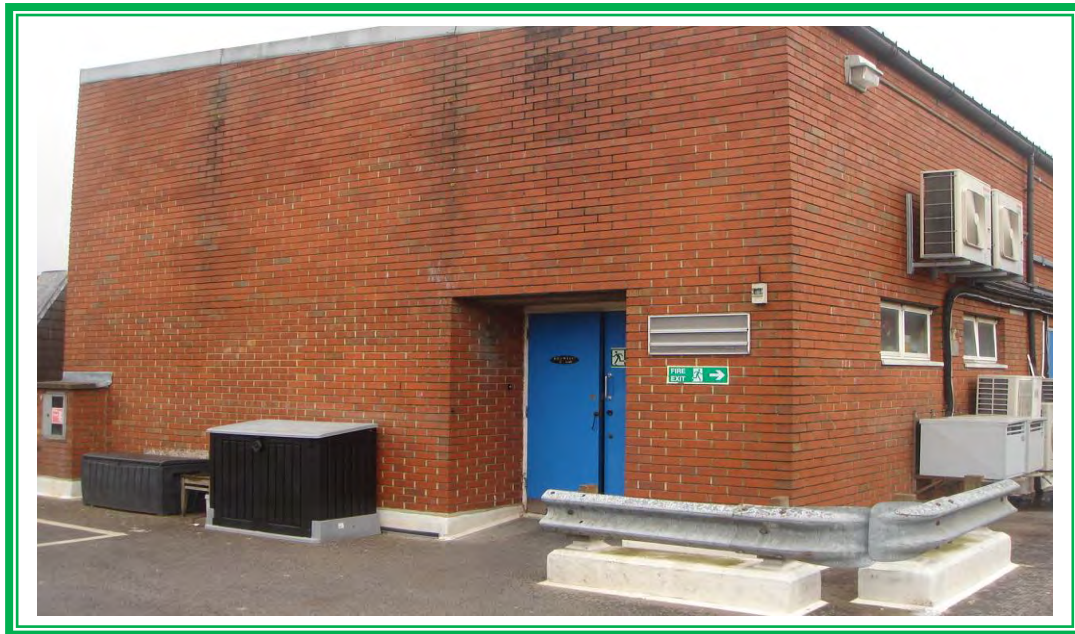
Location: 99/001 External

Material Description:	Visual Inspection – No Suspect Materials Found	
Identification:	N/A	
Approx. quantity:	N/A	
Accessibility	N/A	Assessment Score
Product type:	N/A	N/A
Extent of Damage:	N/A	N/A
Surface Treatment:	N/A	N/A
Asbestos type:	N/A	N/A
Material Assessment Score:		N/A
Priority Assessment Score:		N/A
Action:	N/A	
Comments:	N/A

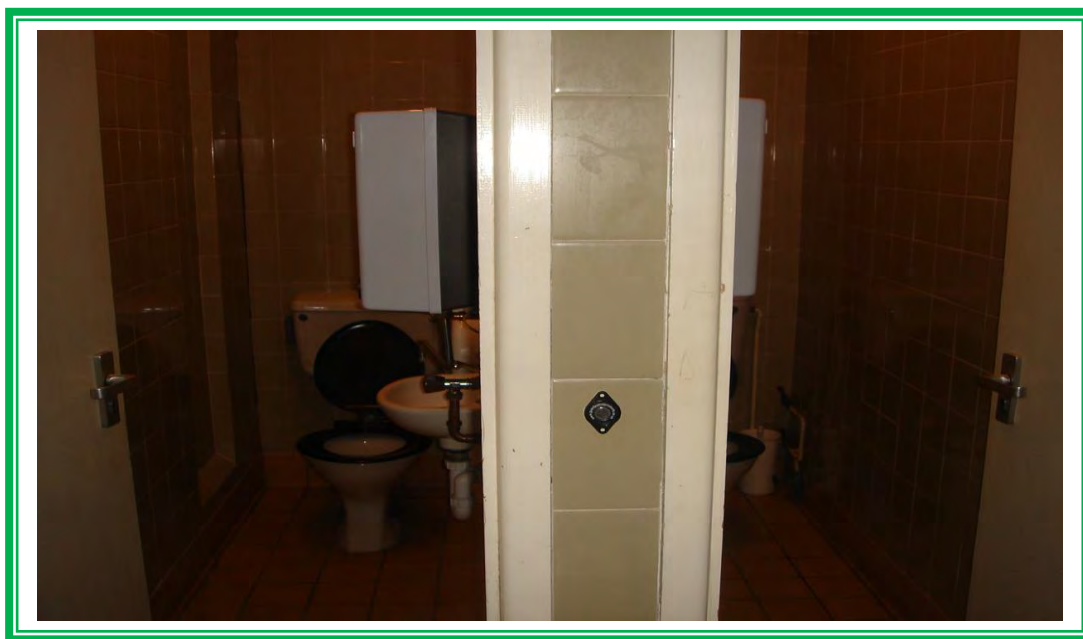
Location: 0/001 WC

Material Description:	Visual Inspection – No Suspect Materials Found	
Identification:	N/A	
Approx. quantity:	N/A	
Accessibility	N/A	Assessment Score
Product type:	N/A	N/A
Extent of Damage:	N/A	N/A
Surface Treatment:	N/A	N/A
Asbestos type:	N/A	N/A
Material Assessment Score:		N/A
Priority Assessment Score:		N/A
Action:	N/A	
Comments:	N/A

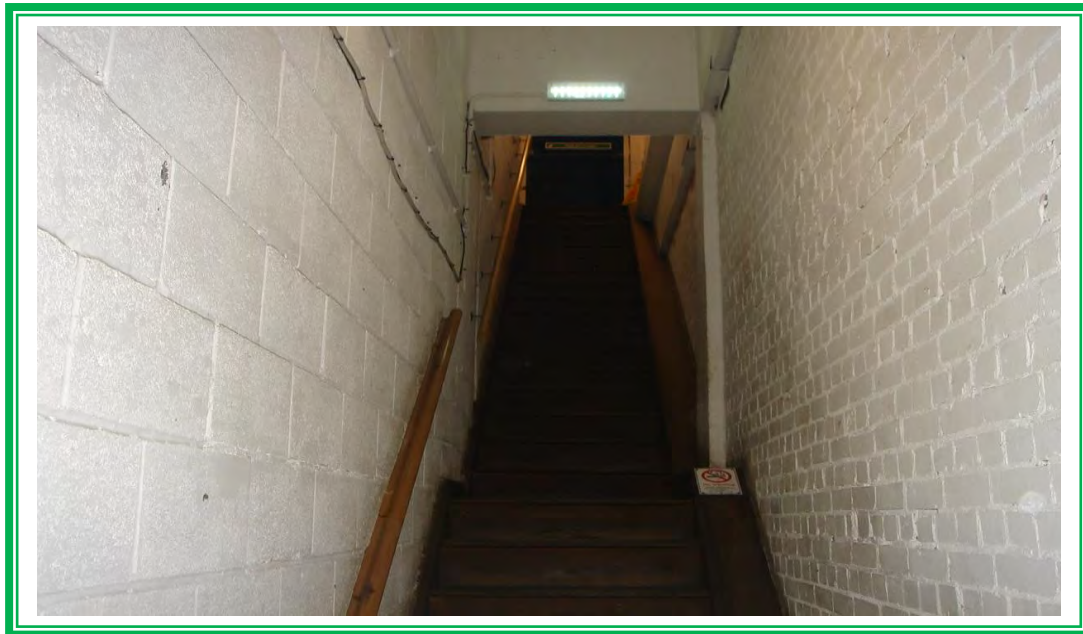
Location: 0/004 Corridor and Stairs

Material Description:	Visual Inspection – No Suspect Materials Found	
Identification:	N/A	
Approx. quantity:	N/A	
Accessibility	N/A	Assessment Score
Product type:	N/A	N/A
Extent of Damage:	N/A	N/A
Surface Treatment:	N/A	N/A
Asbestos type:	N/A	N/A
Material Assessment Score:		N/A
Priority Assessment Score:		N/A
Action:	N/A	
Comments:	N/A
