Project Number 3113

Management
Asbestos Survey Report

Kennet Centre, Market Street, Newbury,
Berkshire, RG14 5EN

1-3 The Mall

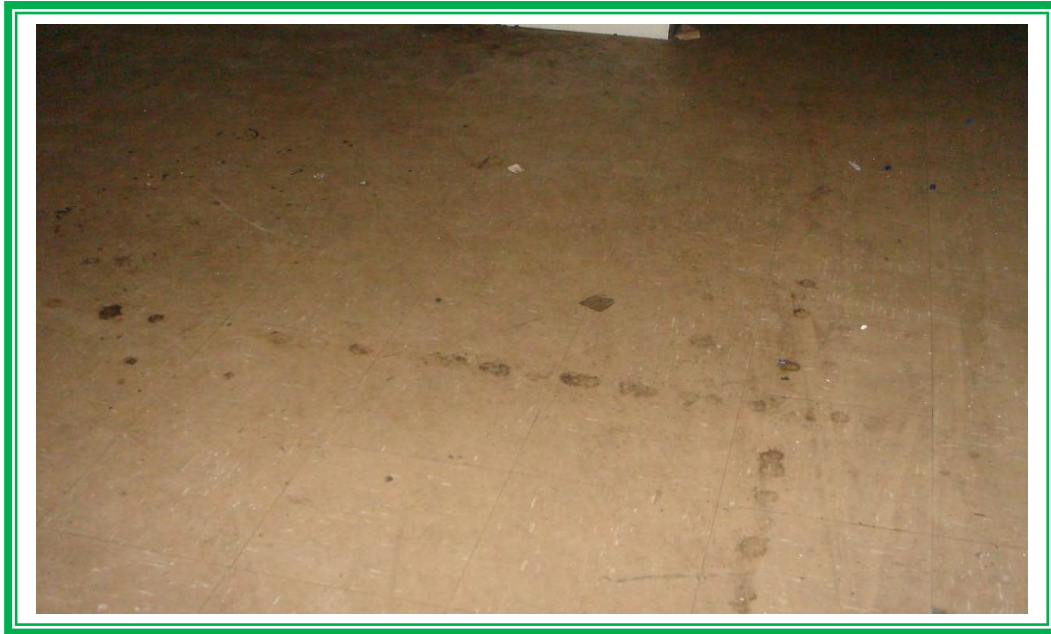
Location: 1/003 Lobby

Material Description:	Vinyl Floor Tiles	
Identification:	As Per Sample NE/2 – No Asbestos Detected	
Approx. quantity:	25M2	
Accessibility	N/A	Assessment Score
Product type:	N/A	N/A
Extent of Damage:	N/A	N/A
Surface Treatment:	N/A	N/A
Asbestos type:	N/A	N/A
Material Assessment Score:		N/A
Priority Assessment Score:		N/A
Action:	N/A	
Comments:	N/A

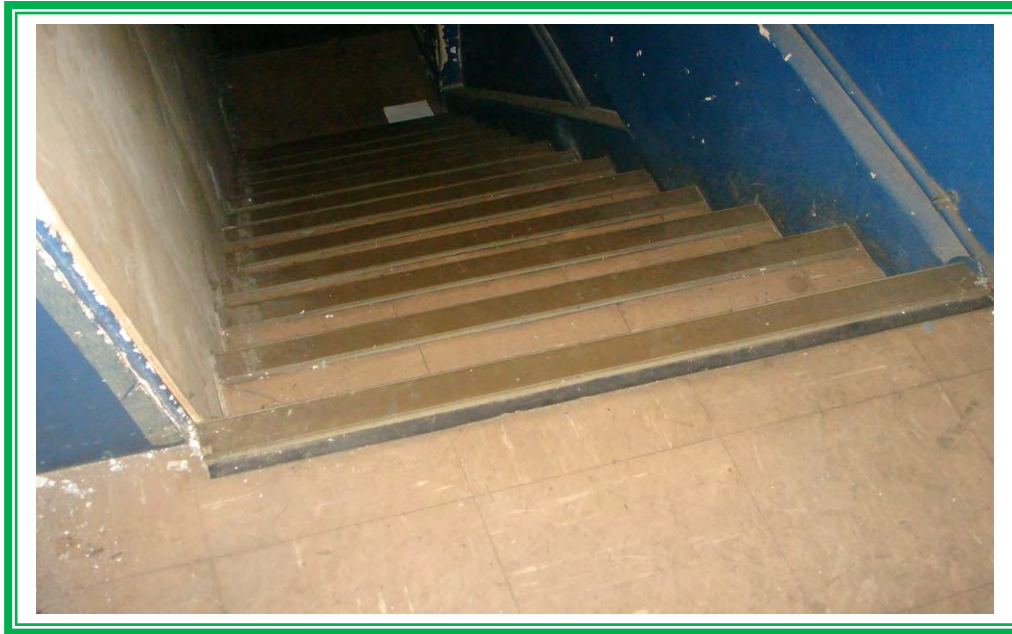
Location: 1/006 Stairs

Material Description:	Vinyl Floor Tiles	
Identification:	As Per Sample NE/2 – No Asbestos Detected	
Approx. quantity:	30M2	
Accessibility	N/A	Assessment Score
Product type:	N/A	N/A
Extent of Damage:	N/A	N/A
Surface Treatment:	N/A	N/A
Asbestos type:	N/A	N/A
Material Assessment Score:		N/A
Priority Assessment Score:		N/A
Action:	N/A	
Comments:	N/A

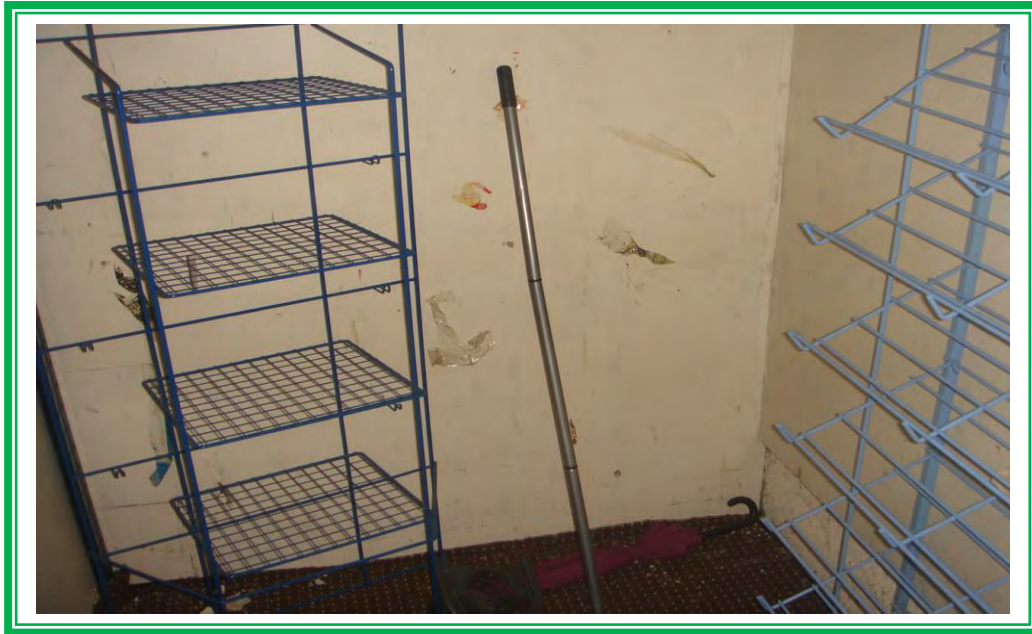
Location: 0/002 Cupboard

Material Description:	Visual Inspection – No Suspect Materials Found	
Identification:	N/A	
Approx. quantity:	N/A	
Accessibility	N/A	Assessment Score
Product type:	N/A	N/A
Extent of Damage:	N/A	N/A
Surface Treatment:	N/A	N/A
Asbestos type:	N/A	N/A
Material Assessment Score:		N/A
Priority Assessment Score:		N/A
Action:	N/A	
Comments:	N/A

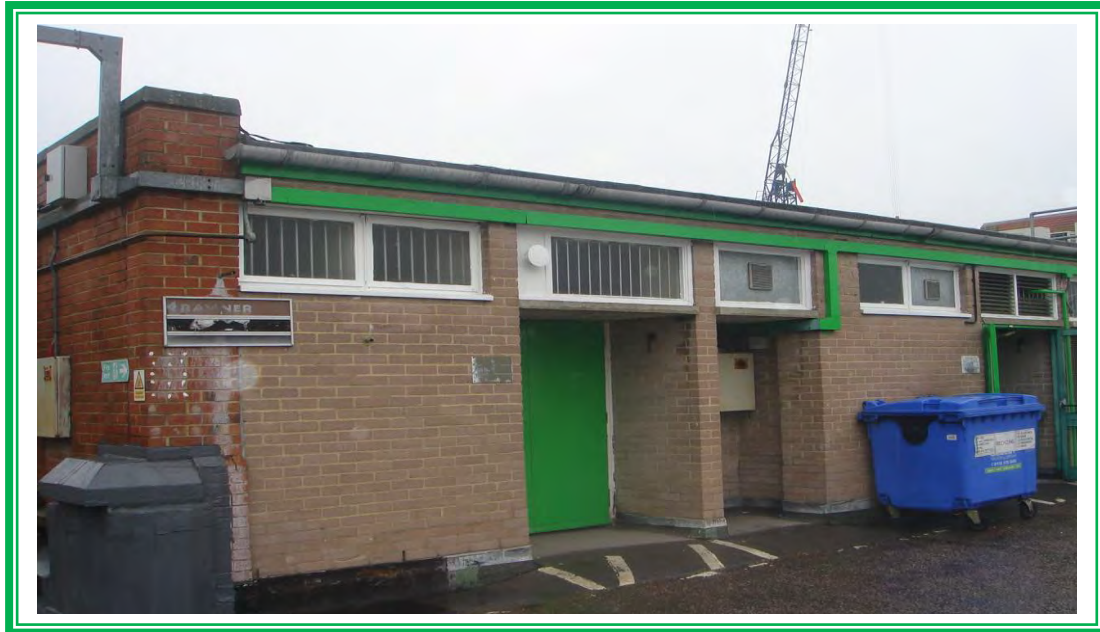
Location: 99/001 External

Material Description:	Visual Inspection – No Suspect Materials Found	
Identification:	N/A	
Approx. quantity:	N/A	
Accessibility	N/A	Assessment Score
Product type:	N/A	N/A
Extent of Damage:	N/A	N/A
Surface Treatment:	N/A	N/A
Asbestos type:	N/A	N/A
Material Assessment Score:		N/A
Priority Assessment Score:		N/A
Action:	N/A	
Comments:	N/A

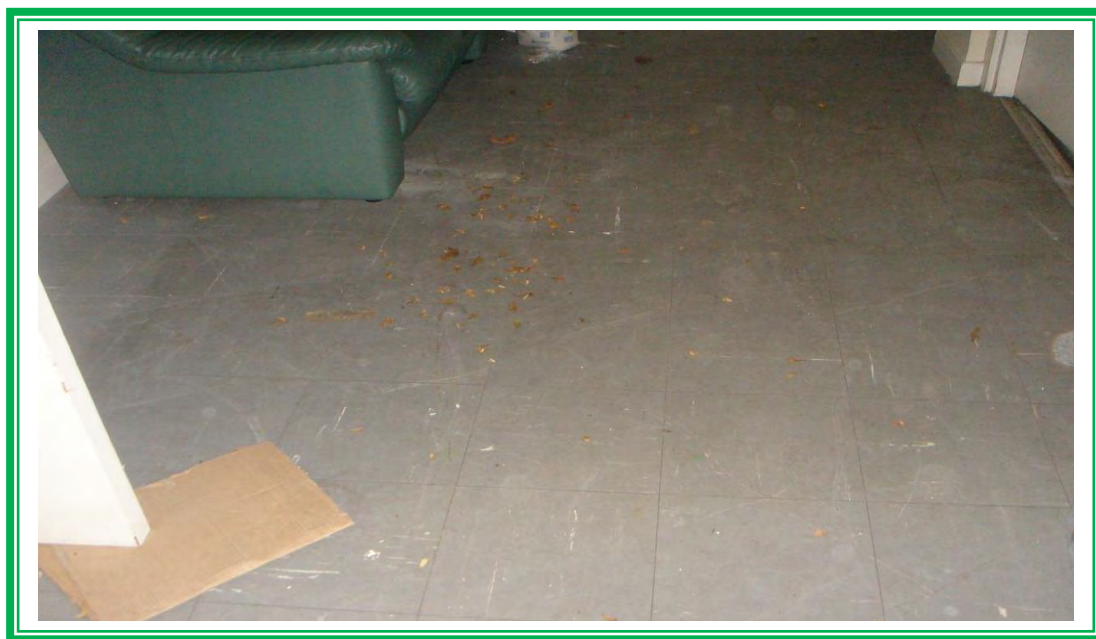
Location: 1/001 Kitchen

Material Description:	Vinyl Floor Tiles	
Identification:	Sampled – No Asbestos Detected	
Approx. quantity:	15M2	
Accessibility	N/A	Assessment Score
Product type:	N/A	N/A
Extent of Damage:	N/A	N/A
Surface Treatment:	N/A	N/A
Asbestos type:	N/A	N/A
Material Assessment Score:		N/A
Priority Assessment Score:		N/A
Action:	N/A	
Comments:	N/A

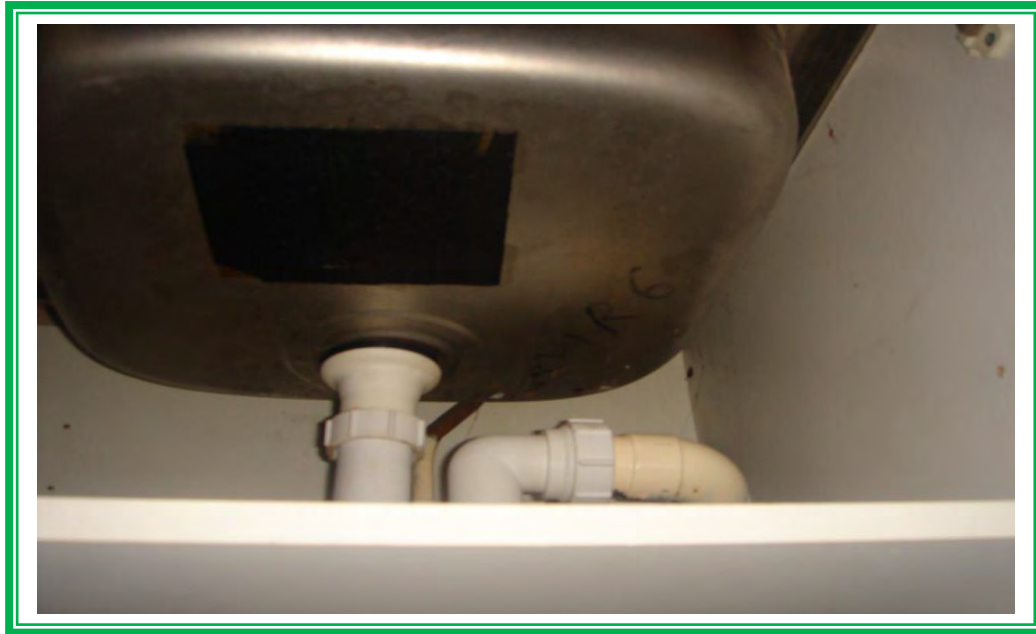
Location: 1/001 Kitchen

Material Description:	Sink Pads	
Identification:	Sampled- No Asbestos Detected	
Approx. quantity:	2 X Items	
Accessibility	N/A	Assessment Score
Product type:	N/A	N/A
Extent of Damage:	N/A	N/A
Surface Treatment:	N/A	N/A
Asbestos type:	N/A	N/A
Material Assessment Score:		N/A
Priority Assessment Score:		N/A
Action:	N/A	
Comments:	N/A

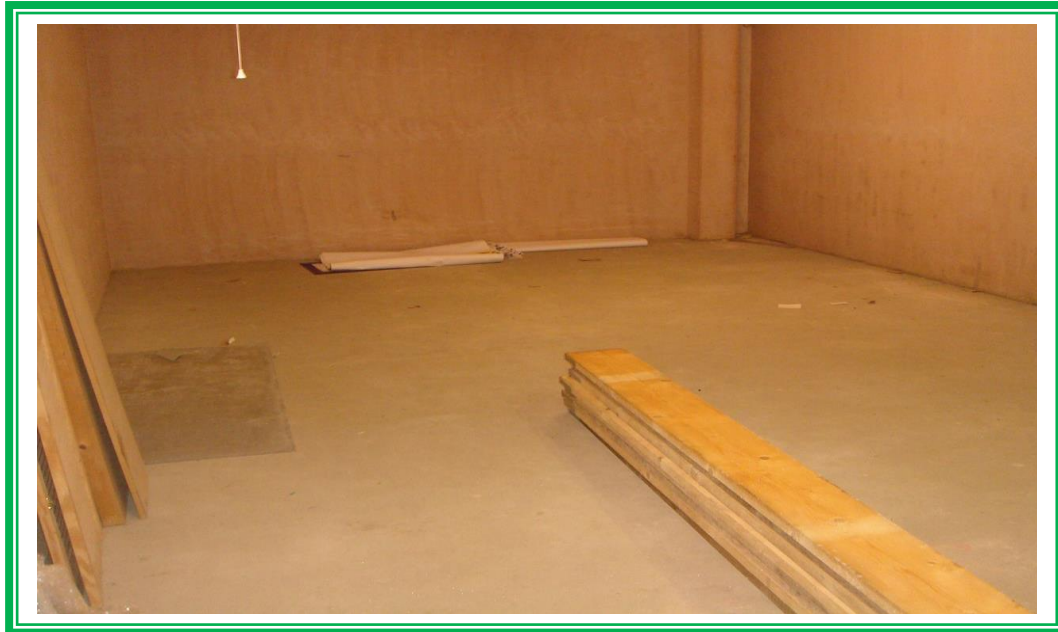
Location: 1/004 Store

Material Description:	Visual Inspection – No Suspect Materials Found	
Identification:	N/A	
Approx. quantity:	N/A	
Accessibility	N/A	Assessment Score
Product type:	N/A	N/A
Extent of Damage:	N/A	N/A
Surface Treatment:	N/A	N/A
Asbestos type:	N/A	N/A
Material Assessment Score:		N/A
Priority Assessment Score:		N/A
Action:	N/A	
Comments:	N/A

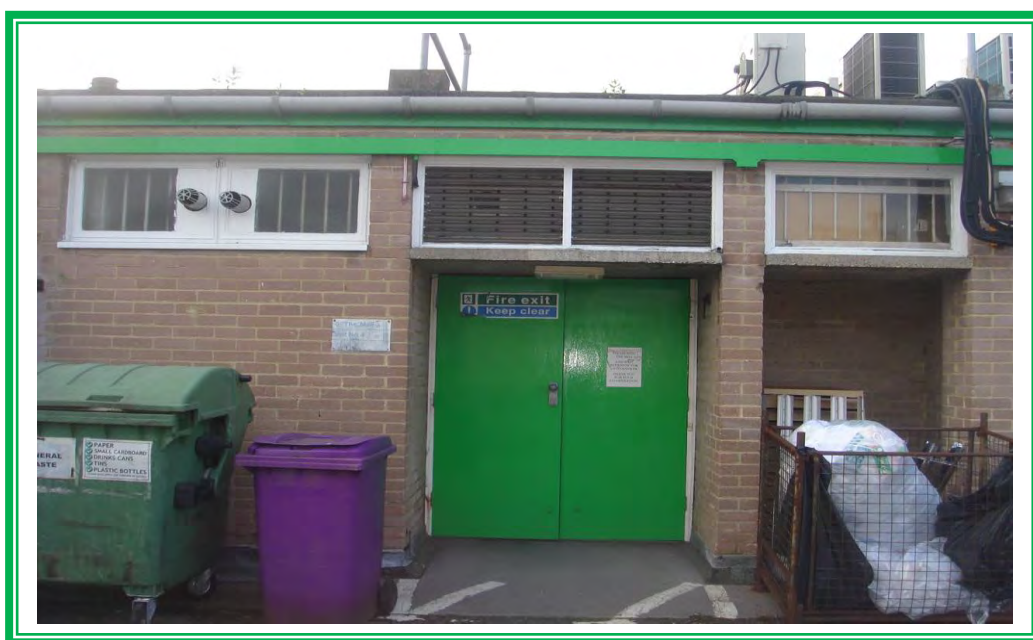
Location: 99/001 External

Material Description:	Visual Inspection – No Suspect Materials Found	
Identification:	N/A	
Approx. quantity:	N/A	
Accessibility	N/A	Assessment Score
Product type:	N/A	N/A
Extent of Damage:	N/A	N/A
Surface Treatment:	N/A	N/A
Asbestos type:	N/A	N/A
Material Assessment Score:		N/A
Priority Assessment Score:		N/A
Action:	N/A	
Comments:	N/A

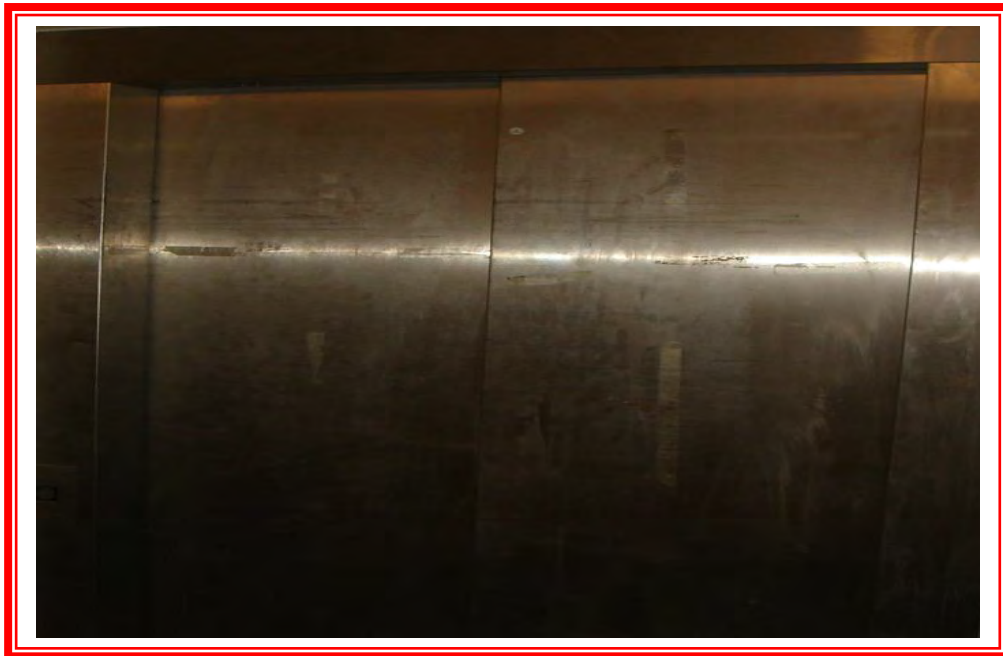
Location: Lift and Lift Shaft

Material Description:	No Access	
Identification:	Presumed to Contain Asbestos	
Approx. quantity:	Unknown	
Accessibility	Low	Assessment Score
Product type:	No Access	3
Extent of Damage:	No Access	3
Surface Treatment:	No Access	3
Asbestos type:	No Access	3
Material Assessment Score:		12
Priority Assessment Score:		High
Action:	Further Inspection Required	
Comments:	No access as no lift engineer onsite

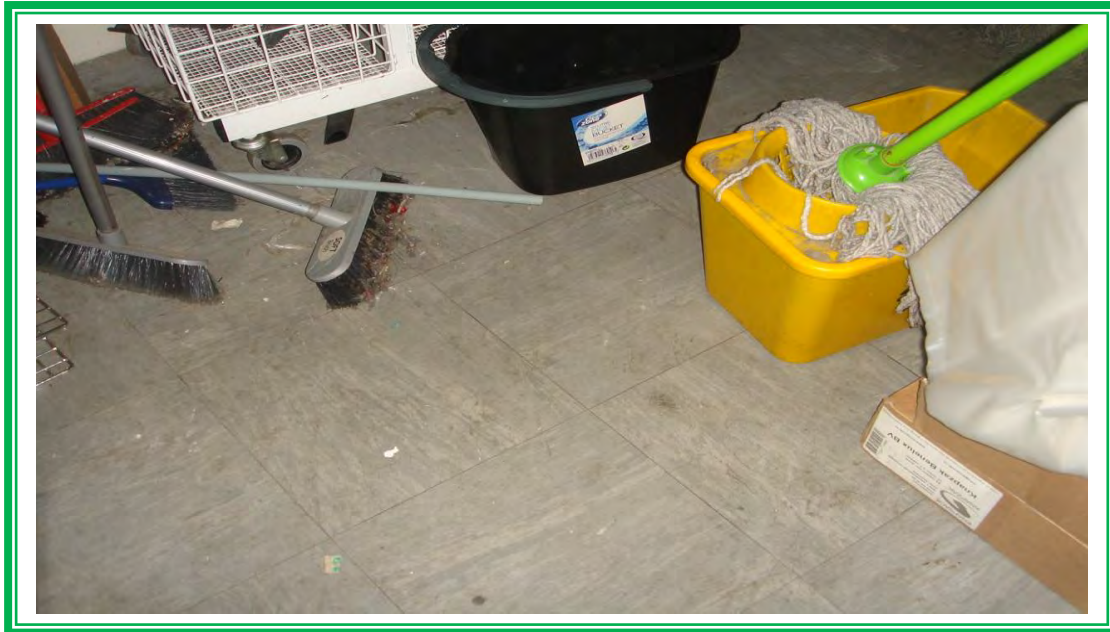
Location: 1/003 Cleaners Cupboard

Material Description:	Vinyl Floor Tiles	
Identification:	As Per Sample NE/1 – No Asbestos Detected	
Approx. quantity:	3M2	
Accessibility	N/A	Assessment Score
Product type:	N/A	N/A
Extent of Damage:	N/A	N/A
Surface Treatment:	N/A	N/A
Asbestos type:	N/A	N/A
Material Assessment Score:		N/A
Priority Assessment Score:		N/A
Action:	N/A	
Comments:	N/A

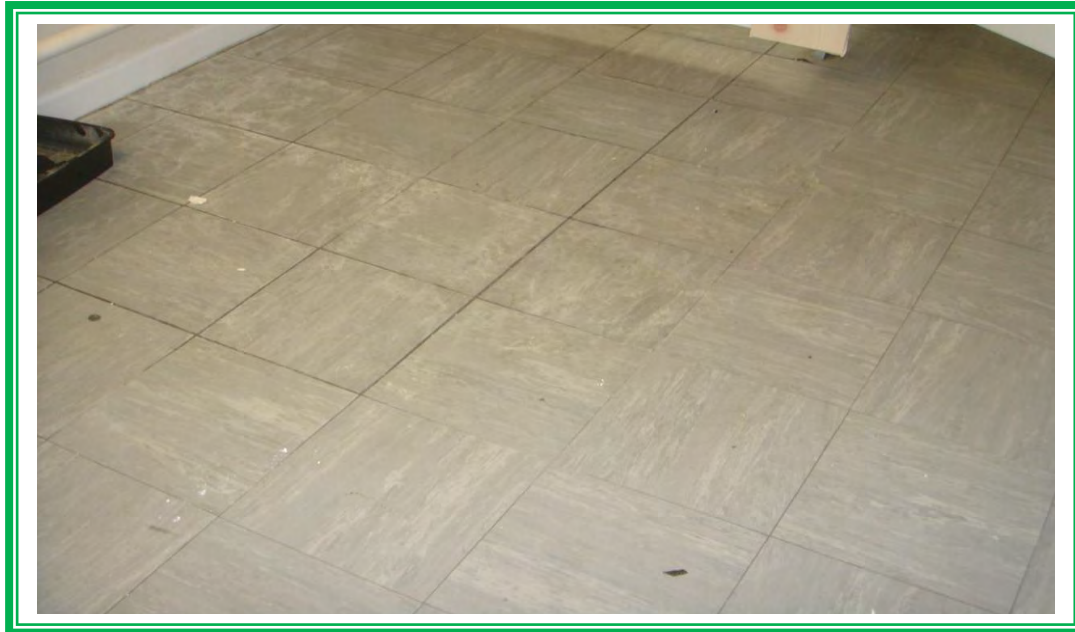
Location: 1/004 WC

Material Description:	Vinyl Floor Tiles	
Identification:	As Per Sample NE/1 – No Asbestos Detected	
Approx. quantity:	8M2	
Accessibility	N/A	Assessment Score
Product type:	N/A	N/A
Extent of Damage:	N/A	N/A
Surface Treatment:	N/A	N/A
Asbestos type:	N/A	N/A
Material Assessment Score:		N/A
Priority Assessment Score:		N/A
Action:	N/A	
Comments:	N/A

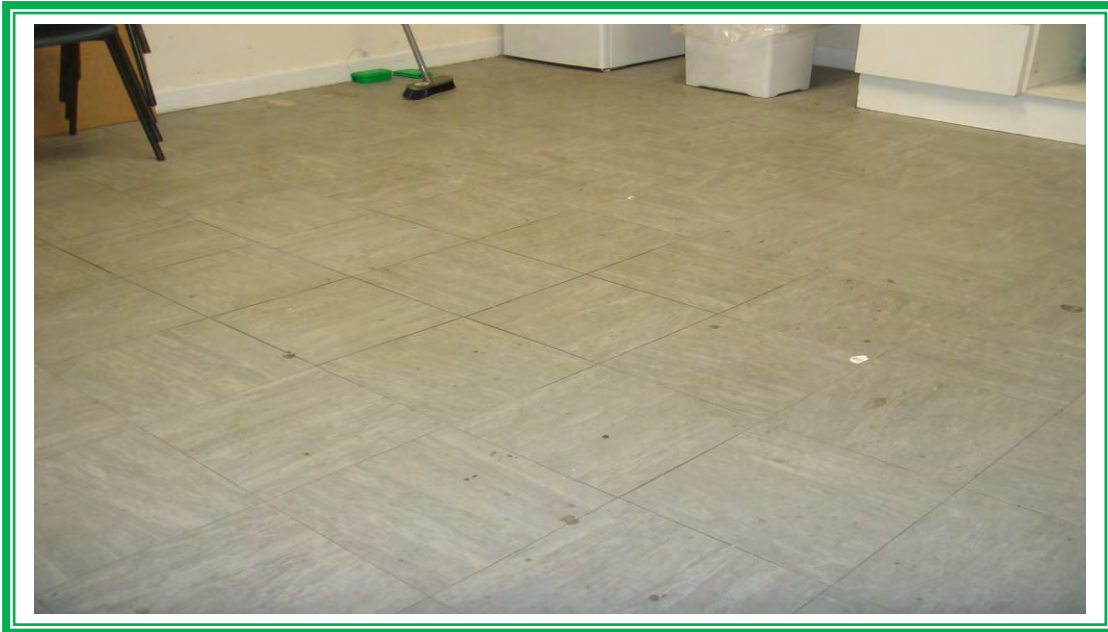
Location: 1/005 Canteen

Material Description:	Vinyl Floor Tiles	
Identification:	As Per Sample NE/1 – No Asbestos Detected	
Approx. quantity:	16M2	
Accessibility	N/A	Assessment Score
Product type:	N/A	N/A
Extent of Damage:	N/A	N/A
Surface Treatment:	N/A	N/A
Asbestos type:	N/A	N/A
Material Assessment Score:		N/A
Priority Assessment Score:		N/A
Action:	N/A	
Comments:	N/A

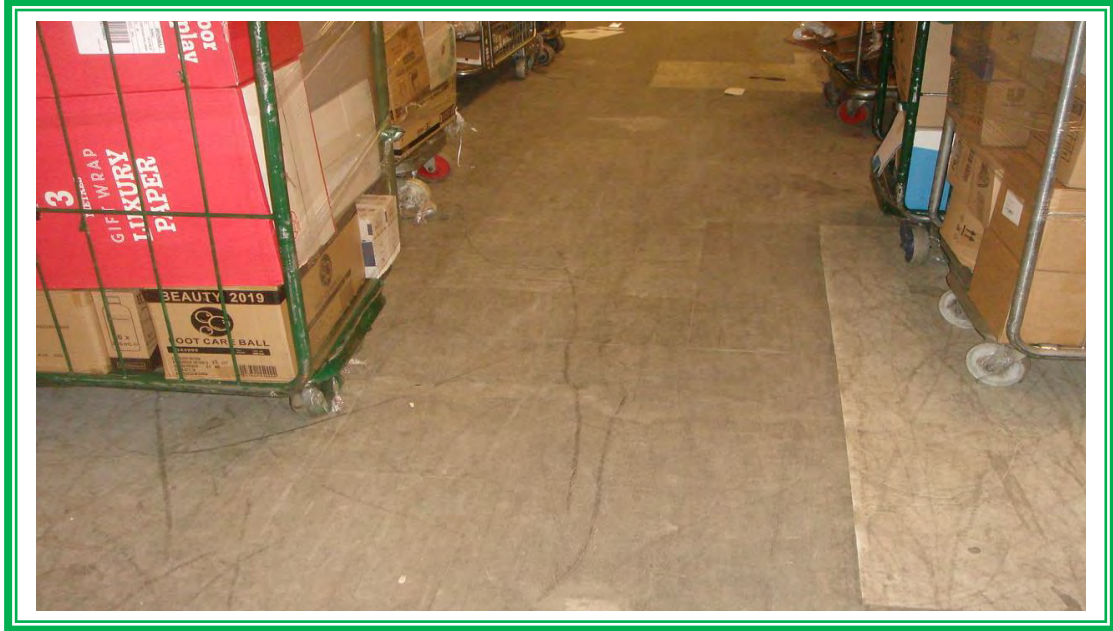
Location: 1/008 Store

Material Description:	Vinyl Floor Tiles	
Identification:	As Per Sample NE/2 – No Asbestos Detected	
Approx. quantity:	60M2	
Accessibility	N/A	Assessment Score
Product type:	N/A	N/A
Extent of Damage:	N/A	N/A
Surface Treatment:	N/A	N/A
Asbestos type:	N/A	N/A
Material Assessment Score:		N/A
Priority Assessment Score:		N/A
Action:	N/A	
Comments:	N/A

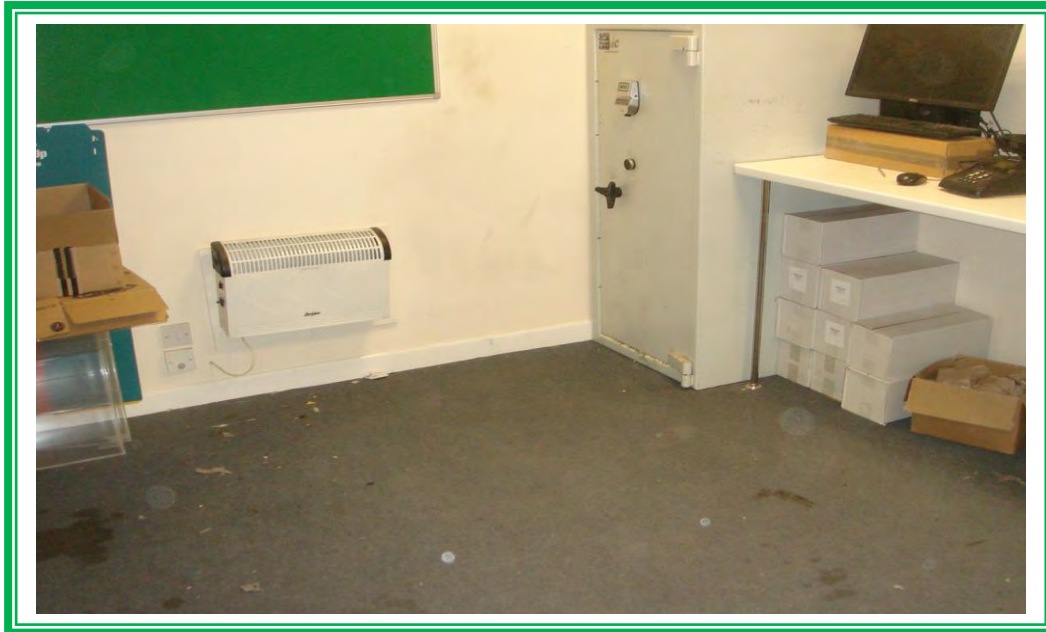
Location: 1/009 Cash Office

Material Description:	Visual Inspection – No Suspect Materials Found	
Identification:	N/A	
Approx. quantity:	N/A	
Accessibility	N/A	Assessment Score
Product type:	N/A	N/A
Extent of Damage:	N/A	N/A
Surface Treatment:	N/A	N/A
Asbestos type:	N/A	N/A
Material Assessment Score:		N/A
Priority Assessment Score:		N/A
Action:	N/A	
Comments:	N/A

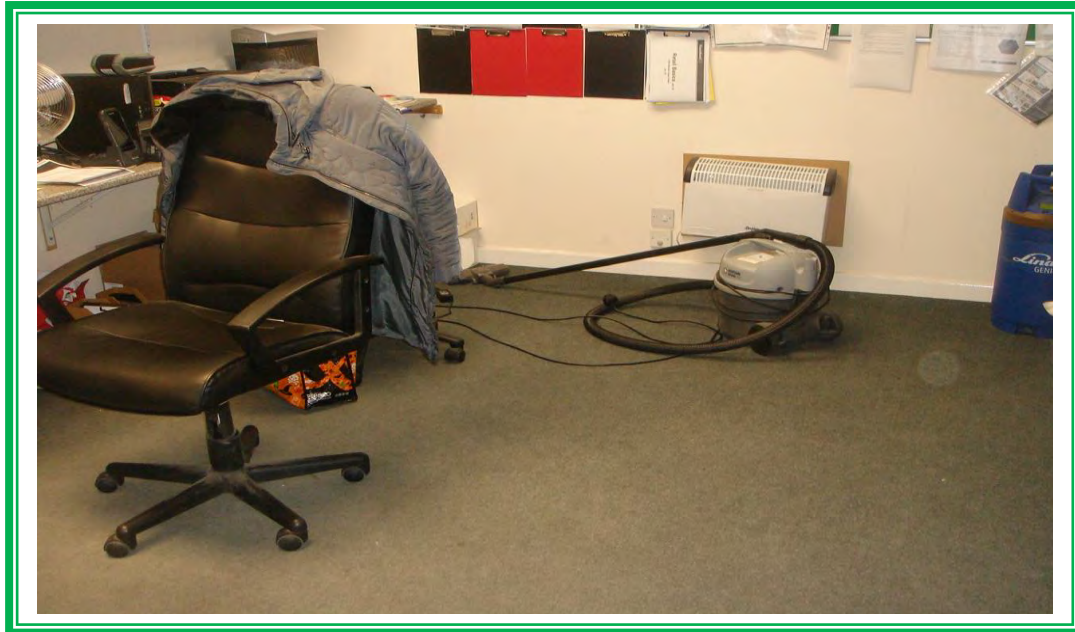
Location: 1/010 Office

Material Description:	Visual Inspection – No Suspect Materials Found	
Identification:	N/A	
Approx. quantity:	N/A	
Accessibility	N/A	Assessment Score
Product type:	N/A	N/A
Extent of Damage:	N/A	N/A
Surface Treatment:	N/A	N/A
Asbestos type:	N/A	N/A
Material Assessment Score:		N/A
Priority Assessment Score:		N/A
Action:	N/A	
Comments:	N/A

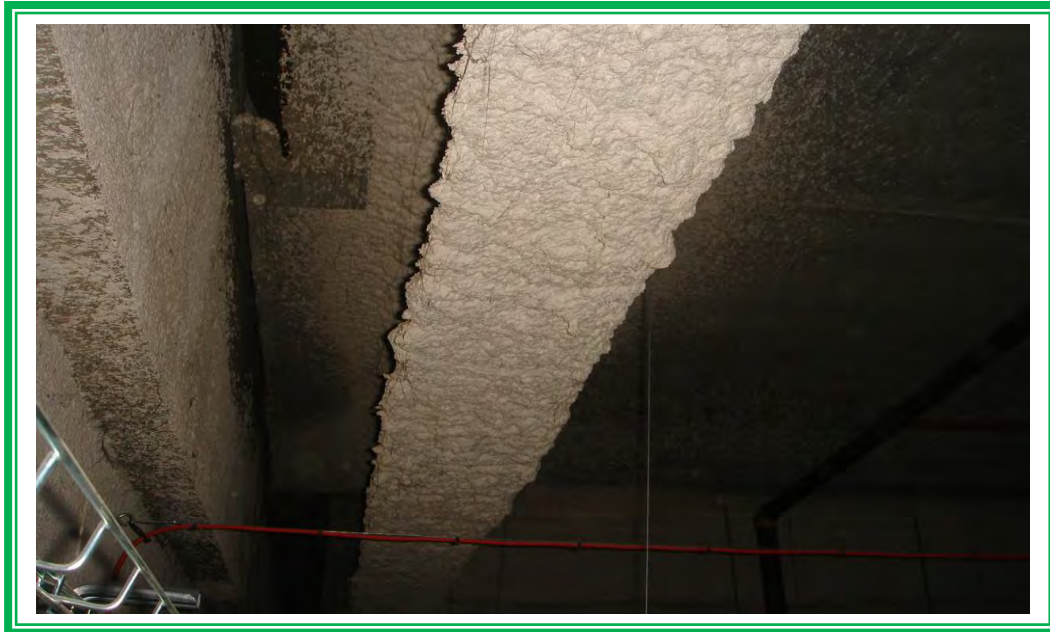
Location: 0/001 Shop Floor

Material Description:	Sprayed Coating to Beams	
Identification:	Sampled – No Asbestos Detected	
Approx. quantity:	100M	
Accessibility	N/A	Assessment Score
Product type:	N/A	N/A
Extent of Damage:	N/A	N/A
Surface Treatment:	N/A	N/A
Asbestos type:	N/A	N/A
Material Assessment Score:		N/A
Priority Assessment Score:		N/A
Action:	N/A	
Comments:	N/A

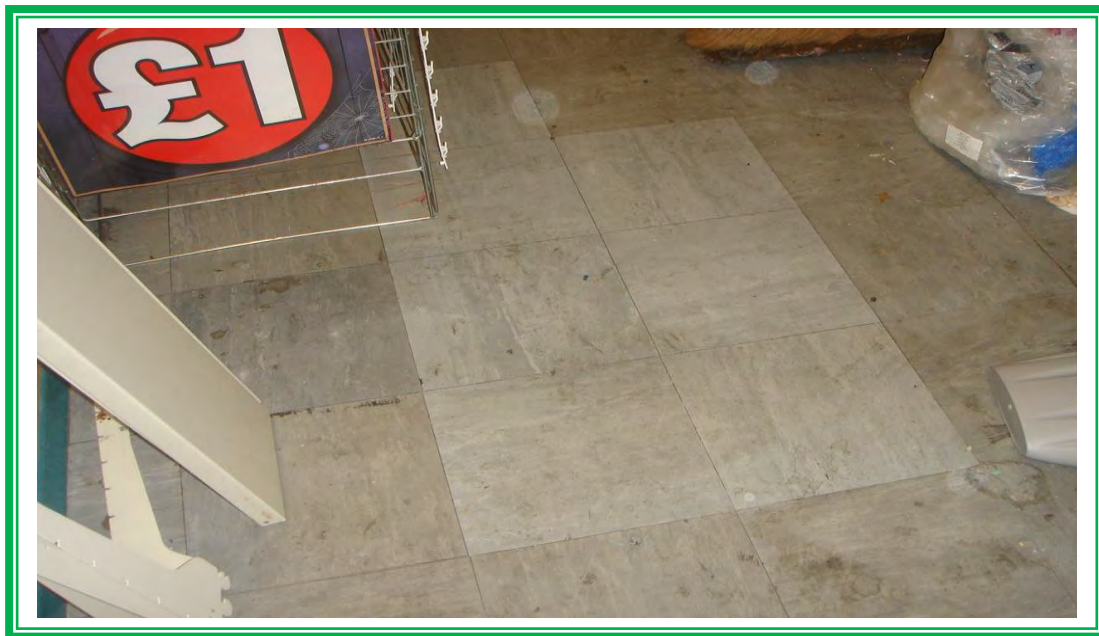
Location: 0/002 Lobby

Material Description:	Vinyl Floor Tiles	
Identification:	Sampled – No Asbestos Detected	
Approx. quantity:	16M2	
Accessibility	N/A	Assessment Score
Product type:	N/A	N/A
Extent of Damage:	N/A	N/A
Surface Treatment:	N/A	N/A
Asbestos type:	N/A	N/A
Material Assessment Score:		N/A
Priority Assessment Score:		N/A
Action:	N/A	
Comments:	N/A

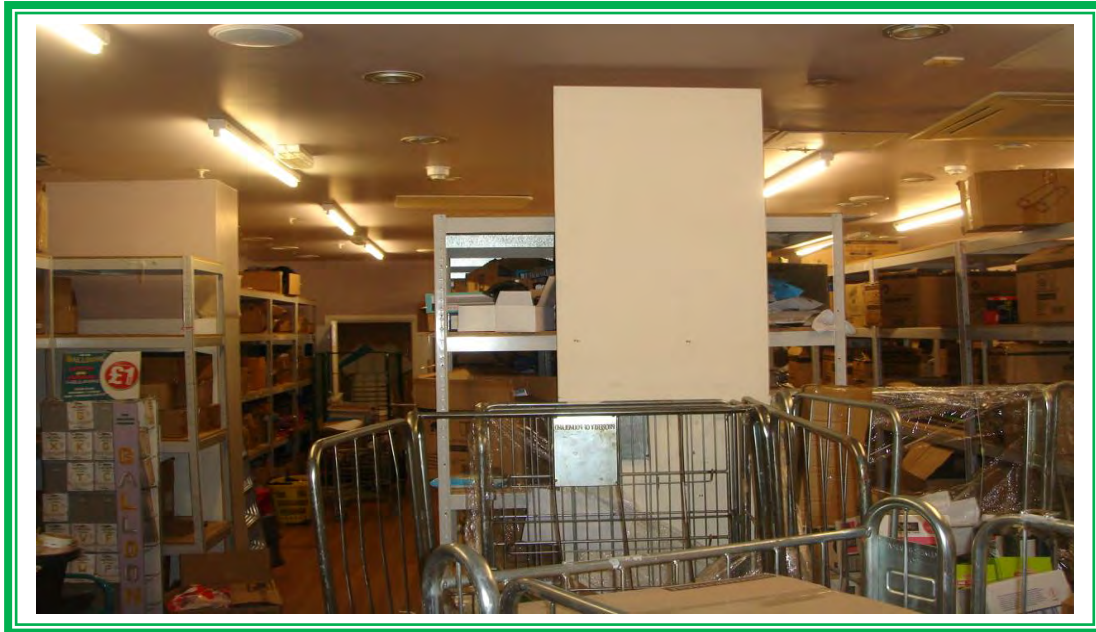
Location: 0/004 Store

Material Description:	Visual Inspection – No Suspect Materials Found	
Identification:	N/A	
Approx. quantity:	N/A	
Accessibility	N/A	Assessment Score
Product type:	N/A	N/A
Extent of Damage:	N/A	N/A
Surface Treatment:	N/A	N/A
Asbestos type:	N/A	N/A
Material Assessment Score:		N/A
Priority Assessment Score:		N/A
Action:	N/A	
Comments:	N/A

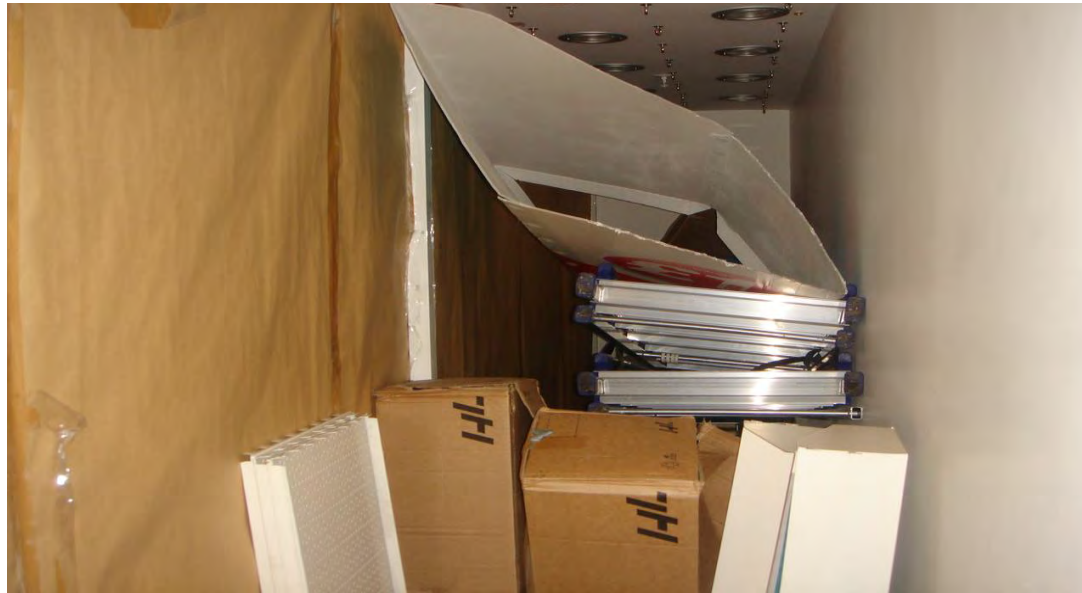
Location: 0/005 Display/Store

Material Description:	Visual Inspection – No Suspect Materials Found	
Identification:	N/A	
Approx. quantity:	N/A	
Accessibility	N/A	Assessment Score
Product type:	N/A	N/A
Extent of Damage:	N/A	N/A
Surface Treatment:	N/A	N/A
Asbestos type:	N/A	N/A
Material Assessment Score:		N/A
Priority Assessment Score:		N/A
Action:	N/A	
Comments:	N/A

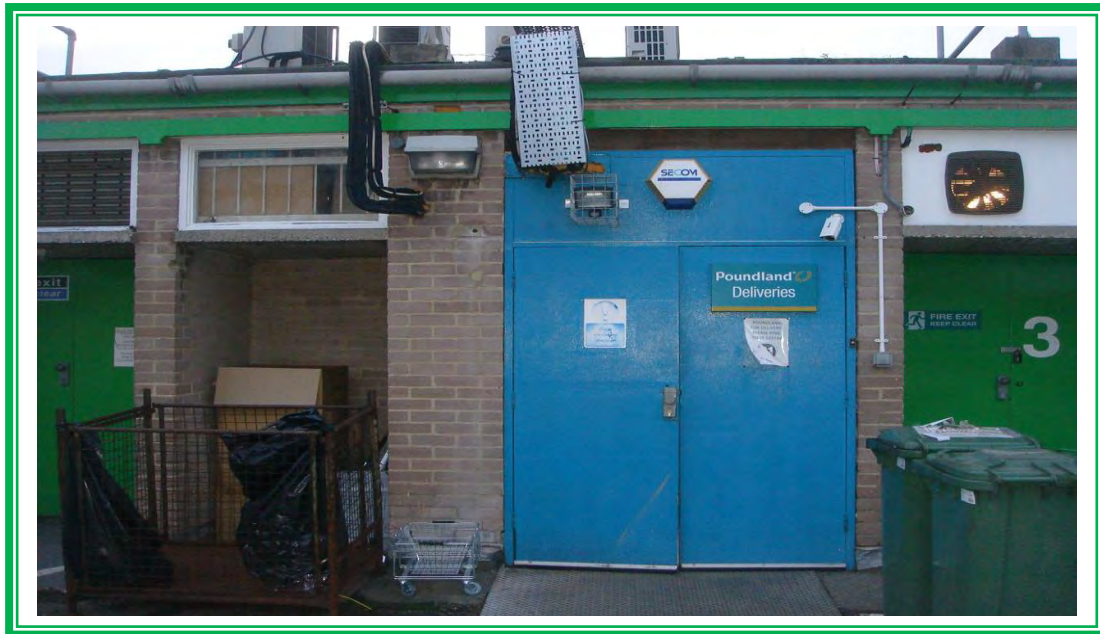
Location: 99/001 External

Material Description:	Visual Inspection – No Suspect Materials Found	
Identification:	N/A	
Approx. quantity:	N/A	
Accessibility	N/A	Assessment Score
Product type:	N/A	N/A
Extent of Damage:	N/A	N/A
Surface Treatment:	N/A	N/A
Asbestos type:	N/A	N/A
Material Assessment Score:		N/A
Priority Assessment Score:		N/A
Action:	N/A	
Comments:	N/A

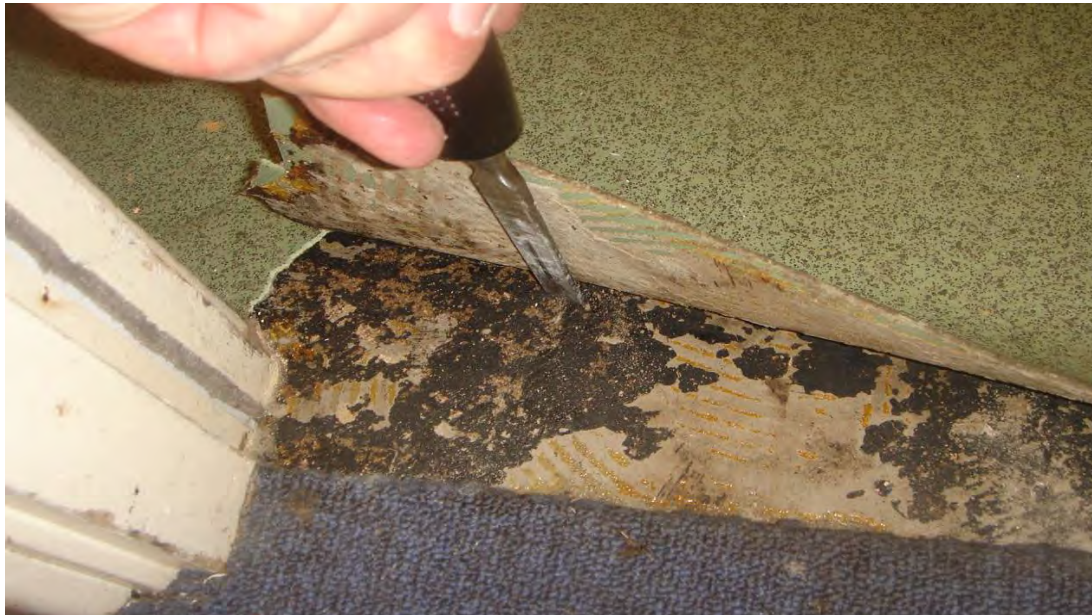
Location: 1/003 Kitchen

Material Description:	Bitumen Adhesive	
Identification:	As Per Sample NE/2 – Asbestos Detected	
Approx. quantity:	3M2	
Accessibility	Low	Assessment Score
Product type:	Bitumen	1
Extent of Damage:	Good	0
Surface Treatment:	Non-Friable	0
Asbestos type:	Chrysotile	1
Material Assessment Score:		2
Priority Assessment Score:		Negligible
Action:	Manage	
Comments:	N/A

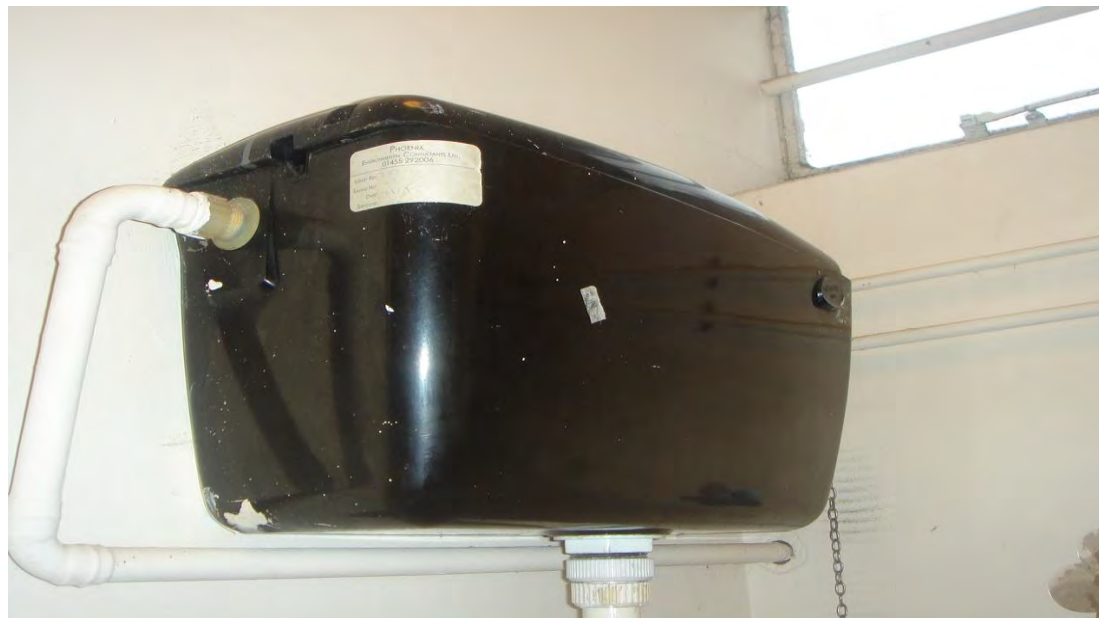
Location: 1/004 WC

Material Description:	Toilet Cistern	
Identification:	Sampled – Asbestos Detected	
Approx. quantity:	1 X Cistern	
Accessibility	Low	Assessment Score
Product type:	Bakelite	1
Extent of Damage:	Good	0
Surface Treatment:	Non-Friable	0
Asbestos type:	Amosite	2
Material Assessment Score:		3
Priority Assessment Score:		Negligible
Action:	Manage	
Comments:	N/A

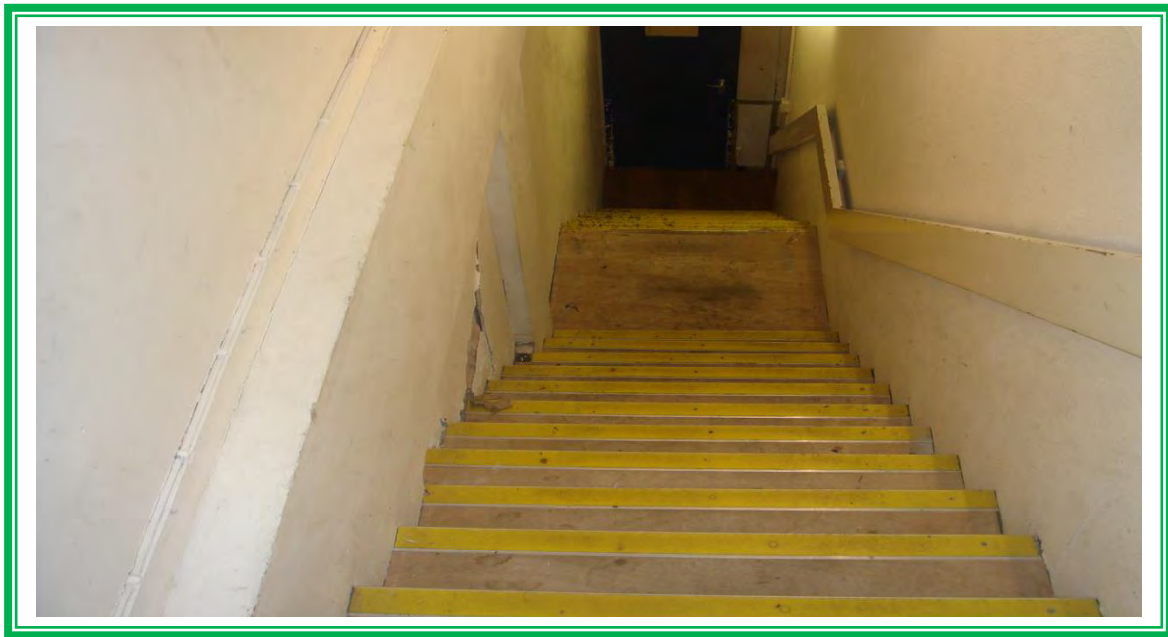
Item No: 5	Sample No: N/A
Location: 1/005

Material Description:	Visual Inspection – No Suspect Materials Found	
Identification:	N/A	
Approx. quantity:	N/A	
Accessibility	N/A	Assessment Score
Product type:	N/A	N/A
Extent of Damage:	N/A	N/A
Surface Treatment:	N/A	N/A
Asbestos type:	N/A	N/A
Material Assessment Score:		N/A
Priority Assessment Score:		N/A
Action:	N/A	
Comments:	N/A

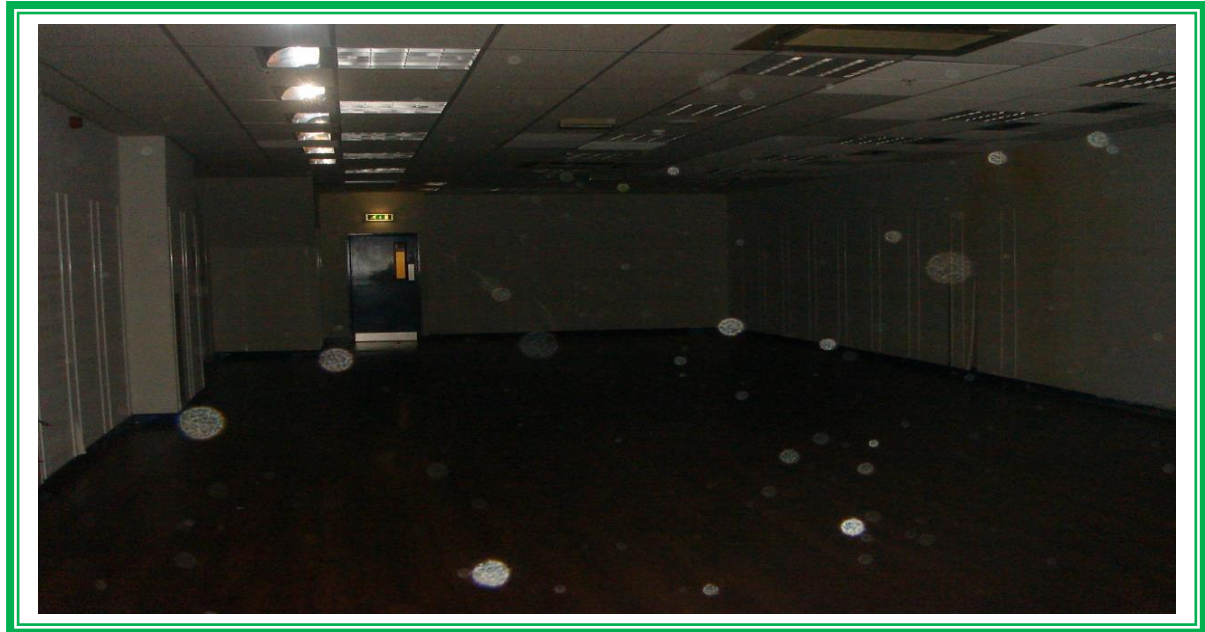
Location: 0/001 Shop Floor

Material Description:	Visual Inspection – No Suspect Materials Found	
Identification:	N/A	
Approx. quantity:	N/A	
Accessibility	N/A	Assessment Score
Product type:	N/A	N/A
Extent of Damage:	N/A	N/A
Surface Treatment:	N/A	N/A
Asbestos type:	N/A	N/A
Material Assessment Score:		N/A
Priority Assessment Score:		N/A
Action:	N/A	
Comments:	N/A

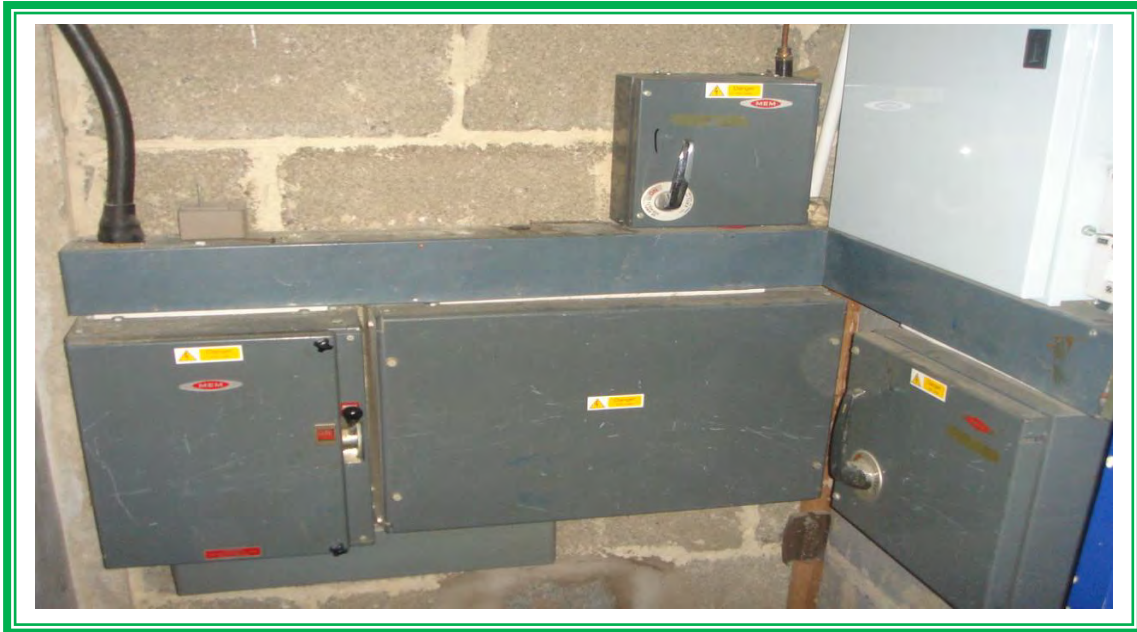
Location: 0/005 Electrics Cupboard 2

Material Description:	Visual Inspection – No Suspect Materials Found	
Identification:	N/A	
Approx. quantity:	N/A	
Accessibility	N/A	Assessment Score
Product type:	N/A	N/A
Extent of Damage:	N/A	N/A
Surface Treatment:	N/A	N/A
Asbestos type:	N/A	N/A
Material Assessment Score:		N/A
Priority Assessment Score:		N/A
Action:	N/A	
Comments:	N/A

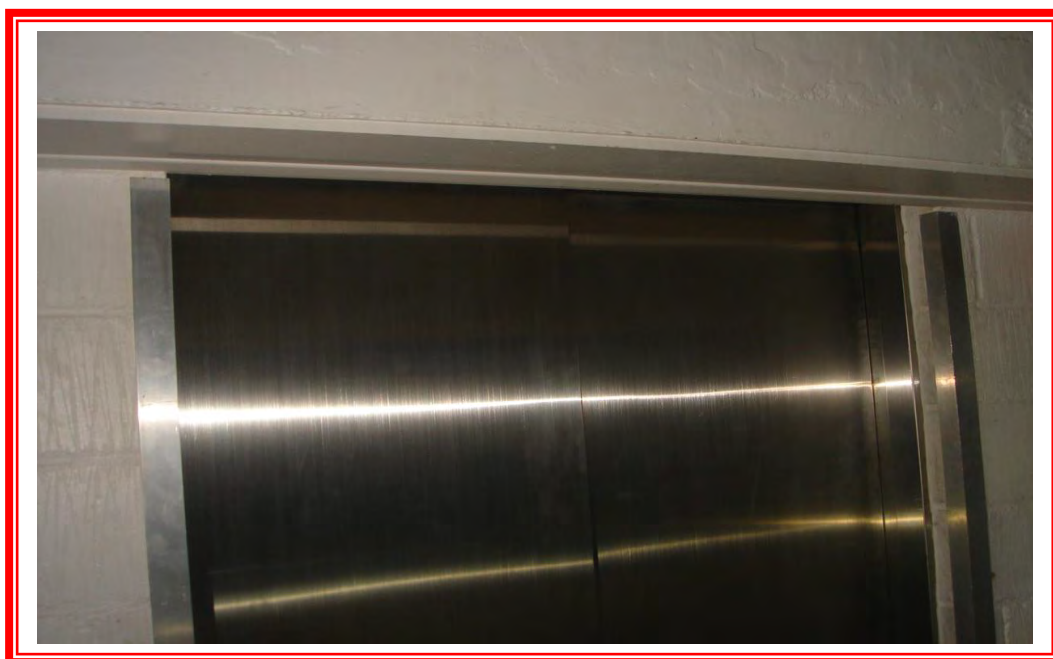
Location: Lift/Lift Shaft

Material Description:	No Access	
Identification:	Presumed to Contain Asbestos	
Approx. quantity:	Entire Lift and Lift Shaft	
Accessibility	Low	Assessment Score
Product type:	No Access	3
Extent of Damage:	No Access	3
Surface Treatment:	No Access	3
Asbestos type:	No Access	3
Material Assessment Score:		12
Priority Assessment Score:		High
Action:	Manage	
Comments:	No access as no lift engineer was onsite

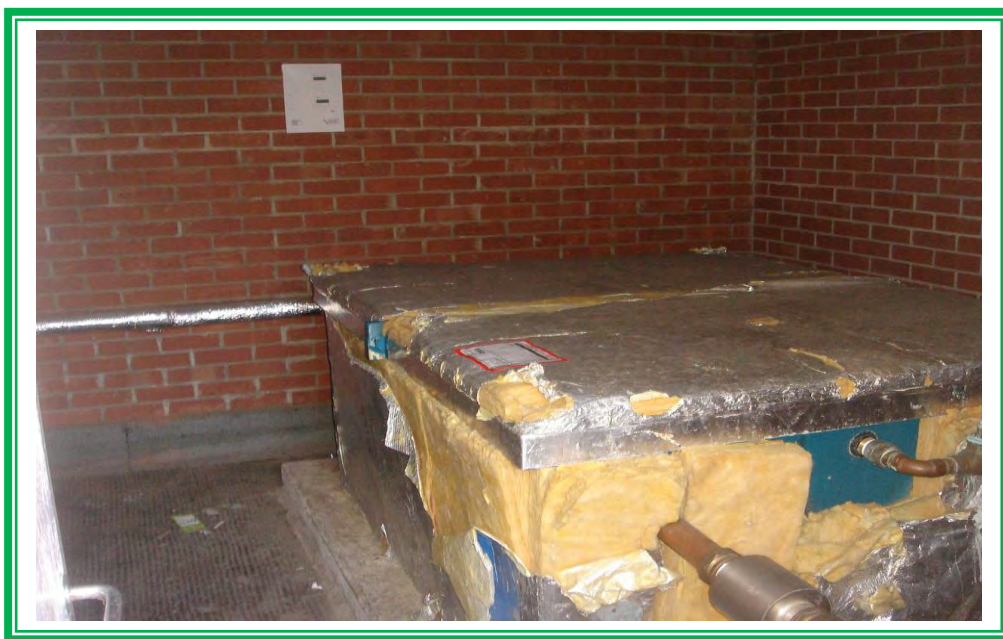
Location: 2/001 Water Tank Room

Material Description:	Visual Inspection – No Suspect Materials Found	
Identification:	N/A	
Approx. quantity:	N/A	
Accessibility	N/A	Assessment Score
Product type:	N/A	N/A
Extent of Damage:	N/A	N/A
Surface Treatment:	N/A	N/A
Asbestos type:	N/A	N/A
Material Assessment Score:		N/A
Priority Assessment Score:		N/A
Action:	N/A	
Comments:	N/A

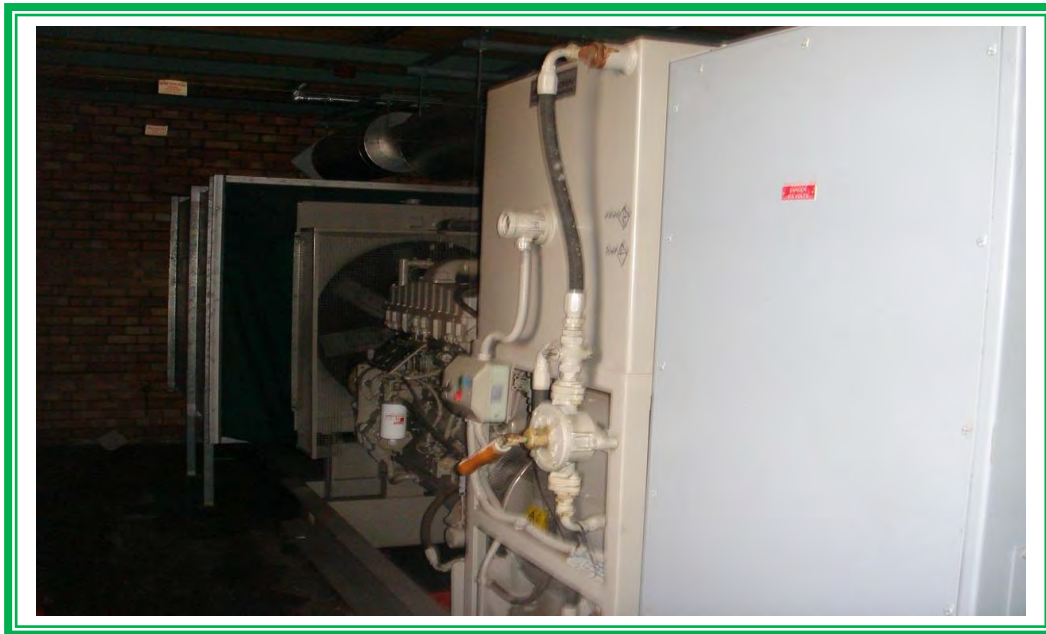
Location: 2/002 Air Con Room

Material Description:	Visual Inspection – No Suspect Materials Found	
Identification:	N/A	
Approx. quantity:	N/A	
Accessibility	N/A	Assessment Score
Product type:	N/A	N/A
Extent of Damage:	N/A	N/A
Surface Treatment:	N/A	N/A
Asbestos type:	N/A	N/A
Material Assessment Score:		N/A
Priority Assessment Score:		N/A
Action:	N/A	
Comments:	N/A

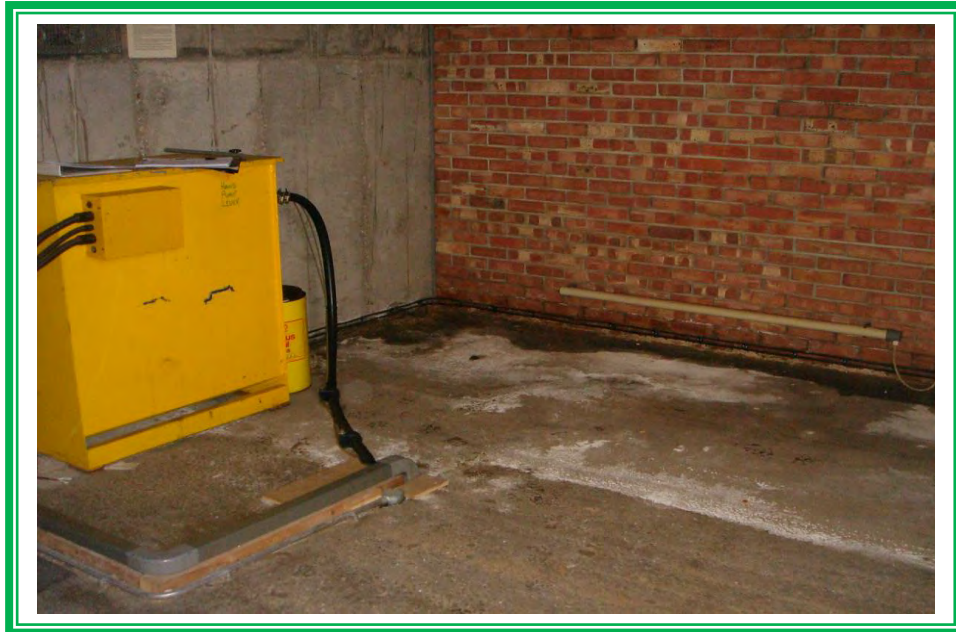
Location: 2/003 Lift Motor Room

Material Description:	Visual Inspection – No Suspect Materials Found	
Identification:	N/A	
Approx. quantity:	N/A	
Accessibility	N/A	Assessment Score
Product type:	N/A	N/A
Extent of Damage:	N/A	N/A
Surface Treatment:	N/A	N/A
Asbestos type:	N/A	N/A
Material Assessment Score:		N/A
Priority Assessment Score:		N/A
Action:	N/A	
Comments:	N/A
