Project Number 3113

Management
Asbestos Survey Report

Kennet Centre, Market Street, Newbury,
Berkshire, RG14 5EN

1-3 The Mall

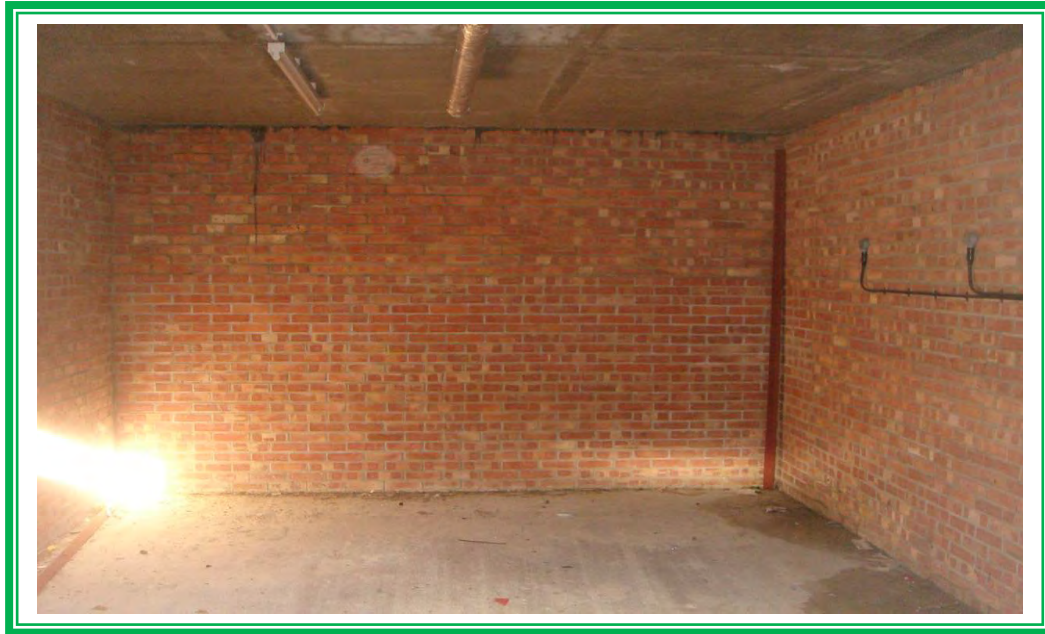
Location: 2/005

Material Description:	Visual Inspection – No Suspect Materials Found	
Identification:	N/A	
Approx. quantity:	N/A	
Accessibility	N/A	Assessment Score
Product type:	N/A	N/A
Extent of Damage:	N/A	N/A
Surface Treatment:	N/A	N/A
Asbestos type:	N/A	N/A
Material Assessment Score:		N/A
Priority Assessment Score:		N/A
Action:	N/A	
Comments:	N/A

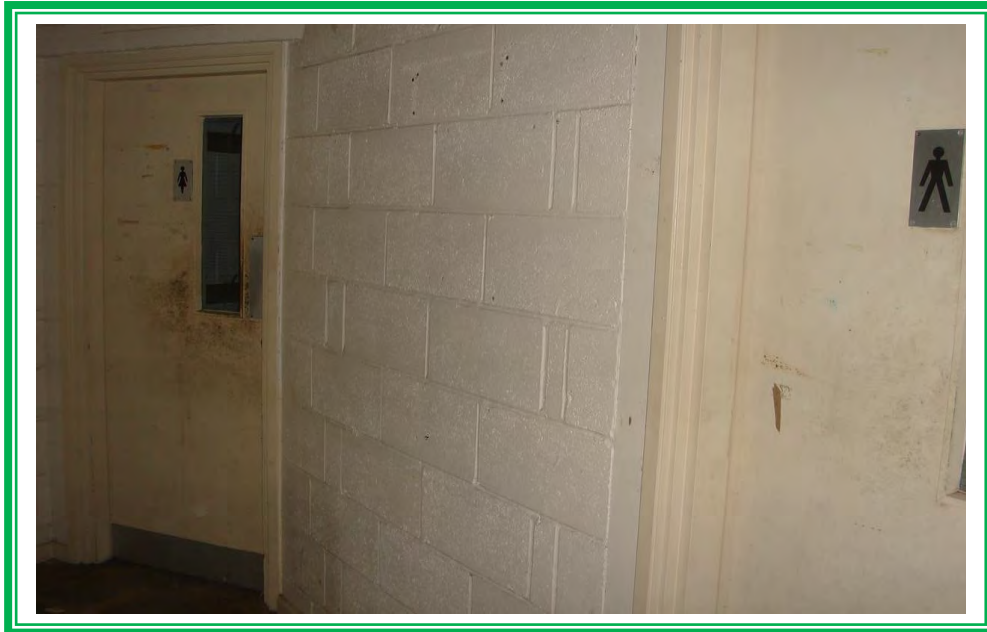
Location: 1/010 WC and 1/011 WC

Material Description:	Visual Inspection – No Suspect Materials Found	
Identification:	N/A	
Approx. quantity:	N/A	
Accessibility	N/A	Assessment Score
Product type:	N/A	N/A
Extent of Damage:	N/A	N/A
Surface Treatment:	N/A	N/A
Asbestos type:	N/A	N/A
Material Assessment Score:		N/A
Priority Assessment Score:		N/A
Action:	N/A	
Comments:	N/A

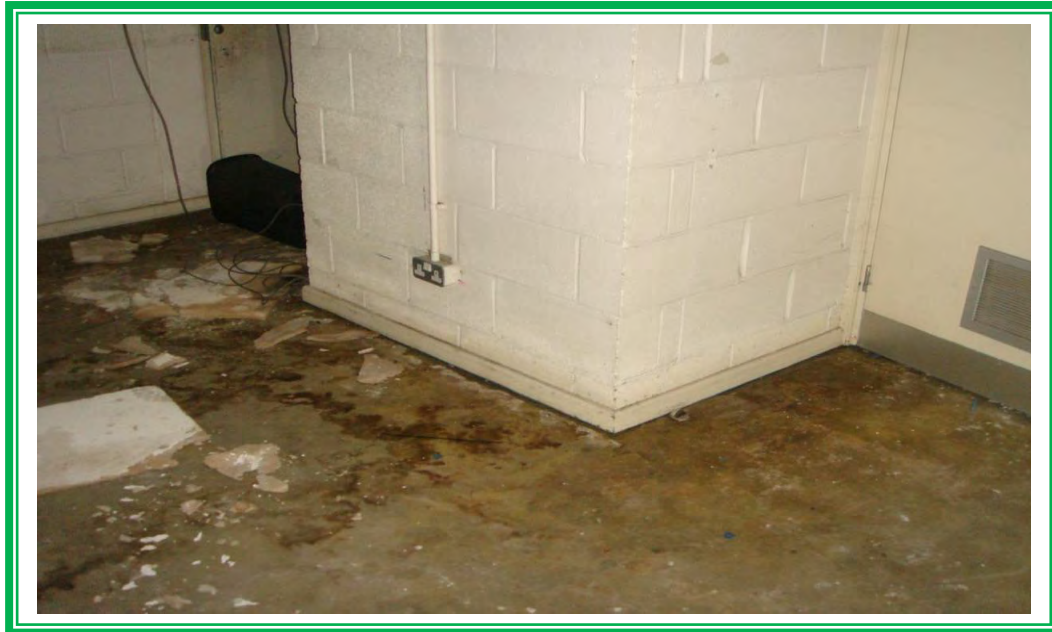
Location: 1/012 Lobby, 1/013 WC and 1/014 Office

Material Description:	Visual Inspection – No Suspect Materials Found	
Identification:	N/A	
Approx. quantity:	N/A	
Accessibility	N/A	Assessment Score
Product type:	N/A	N/A
Extent of Damage:	N/A	N/A
Surface Treatment:	N/A	N/A
Asbestos type:	N/A	N/A
Material Assessment Score:		N/A
Priority Assessment Score:		N/A
Action:	N/A	
Comments:	N/A

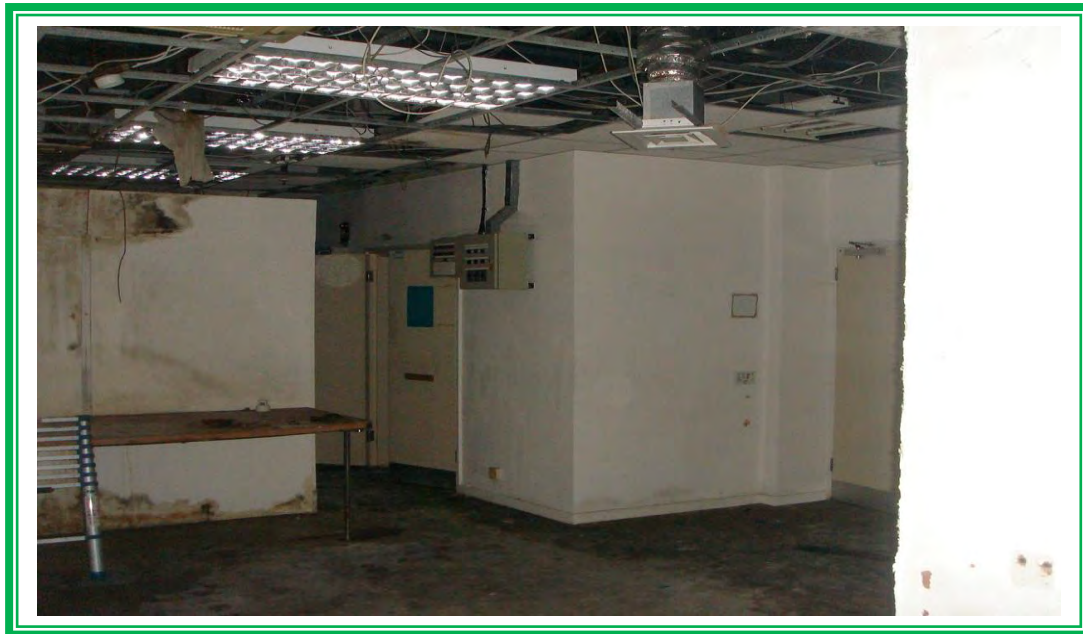
Location: 1/020 Lobby and 1/021 Office

Material Description:	Visual Inspection – No Suspect Materials Found	
Identification:	N/A	
Approx. quantity:	N/A	
Accessibility	N/A	Assessment Score
Product type:	N/A	N/A
Extent of Damage:	N/A	N/A
Surface Treatment:	N/A	N/A
Asbestos type:	N/A	N/A
Material Assessment Score:		N/A
Priority Assessment Score:		N/A
Action:	N/A	
Comments:	Non-Asbestos Electrical Panels

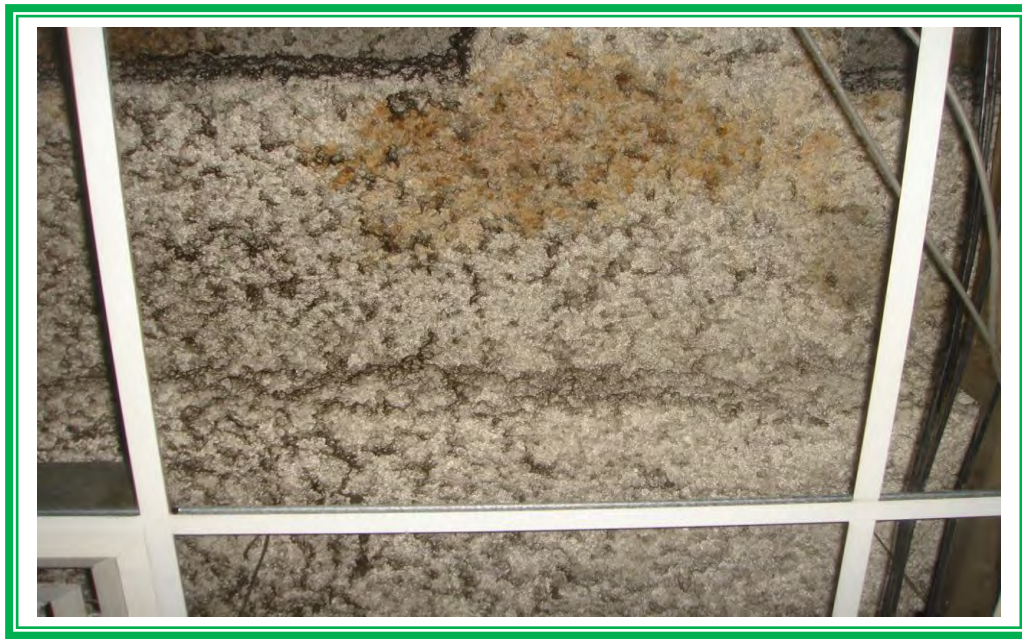
Location: 0/001 Main Shop Floor Including Stores,
Fitting Rooms and Shop Windows

Material Description:	Spray Coating to Ceiling/Beams	
Identification:	Sampled – No Asbestos Detected	
Approx. quantity:	Non-Quantifiable Throughout Ground Floor	
Accessibility	N/A	Assessment Score
Product type:	N/A	N/A
Extent of Damage:	N/A	N/A
Surface Treatment:	N/A	N/A
Asbestos type:	N/A	N/A
Material Assessment Score:		N/A
Priority Assessment Score:		N/A
Action:	N/A	
Comments:	N/A

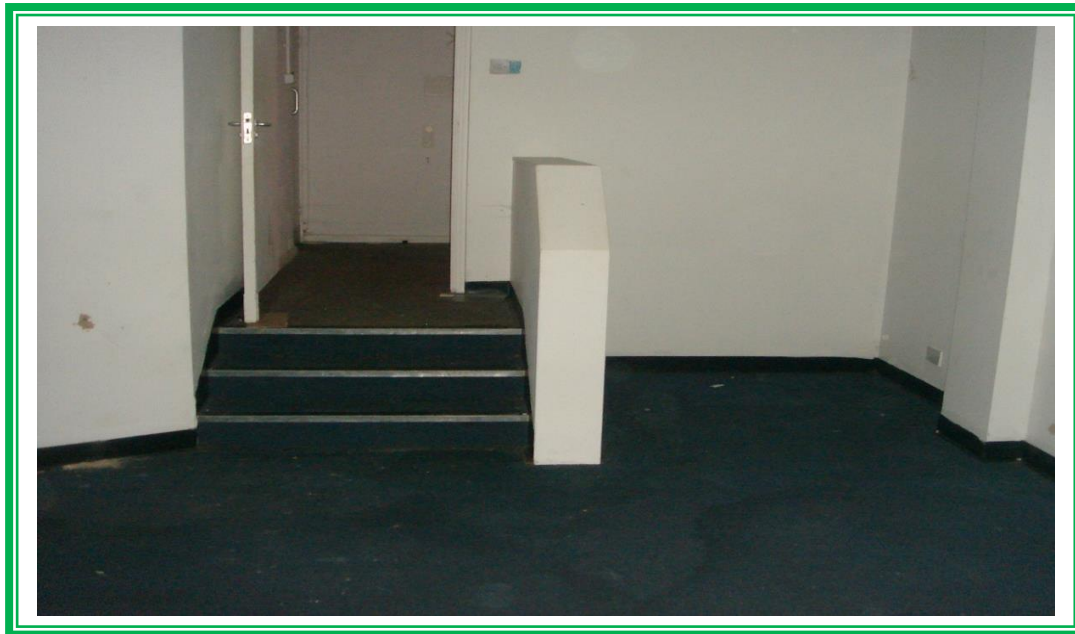
Location: 0/002 Store

Material Description:	Visual Inspection – No Suspect Materials Found	
Identification:	N/A	
Approx. quantity:	N/A	
Accessibility	N/A	Assessment Score
Product type:	N/A	N/A
Extent of Damage:	N/A	N/A
Surface Treatment:	N/A	N/A
Asbestos type:	N/A	N/A
Material Assessment Score:		N/A
Priority Assessment Score:		N/A
Action:	N/A	
Comments:	N/A

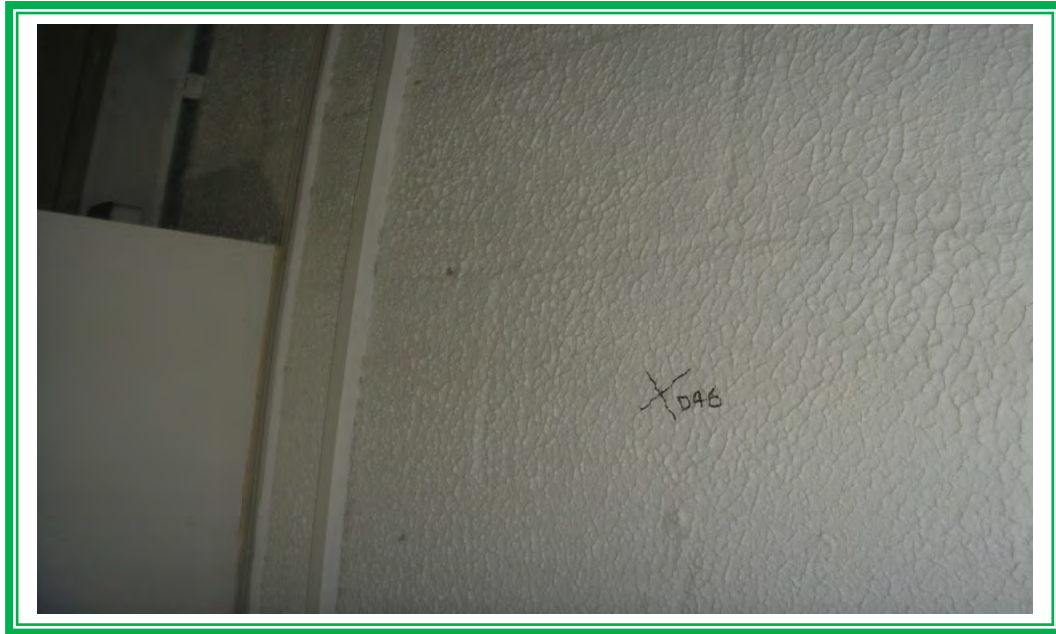
Location: 0/003 Office

Material Description:	Textured Coating to Walls	
Identification:	Sampled – No Asbestos Detected	
Approx. quantity:	22M2	
Accessibility	N/A	Assessment Score
Product type:	N/A	N/A
Extent of Damage:	N/A	N/A
Surface Treatment:	N/A	N/A
Asbestos type:	N/A	N/A
Material Assessment Score:		N/A
Priority Assessment Score:		N/A
Action:	N/A	
Comments:	Modern Electrics

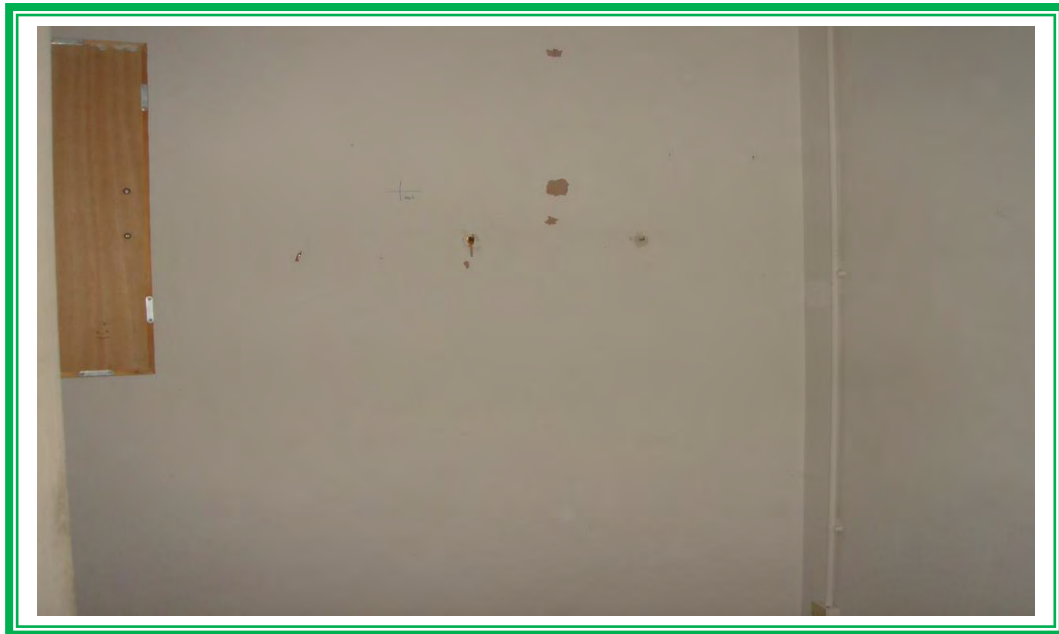
Location: 0/006 Office

Material Description:	Visual Inspection – No Suspect Materials Found	
Identification:	N/A	
Approx. quantity:	N/A	
Accessibility	N/A	Assessment Score
Product type:	N/A	N/A
Extent of Damage:	N/A	N/A
Surface Treatment:	N/A	N/A
Asbestos type:	N/A	N/A
Material Assessment Score:		N/A
Priority Assessment Score:		N/A
Action:	N/A	
Comments:	Modern Electrics

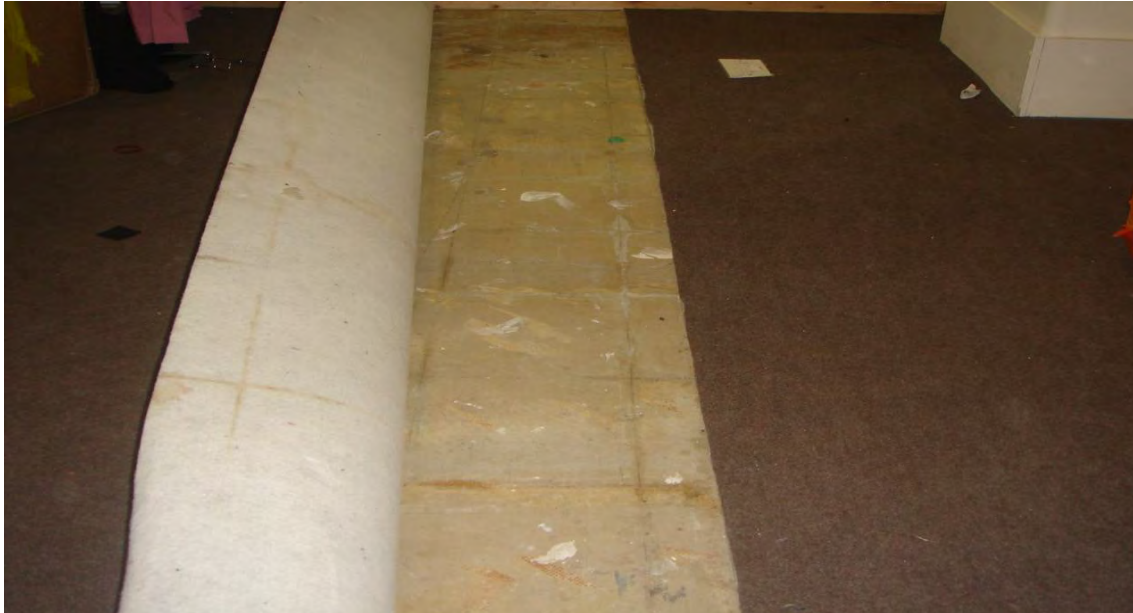
Location: 0/002 Store

Material Description:	Vinyl Floor Tiles	
Identification:	Sampled – Asbestos Detected	
Approx. quantity:	25M2	
Accessibility	Low	Assessment Score
Product type:	Vinyl	1
Extent of Damage:	Minor	1
Surface Treatment:	Non-Friable	0
Asbestos type:	Chrysotile	1
Material Assessment Score:		3
Priority Assessment Score:		Negligible
Action:	Manage	
Comments:	N/A

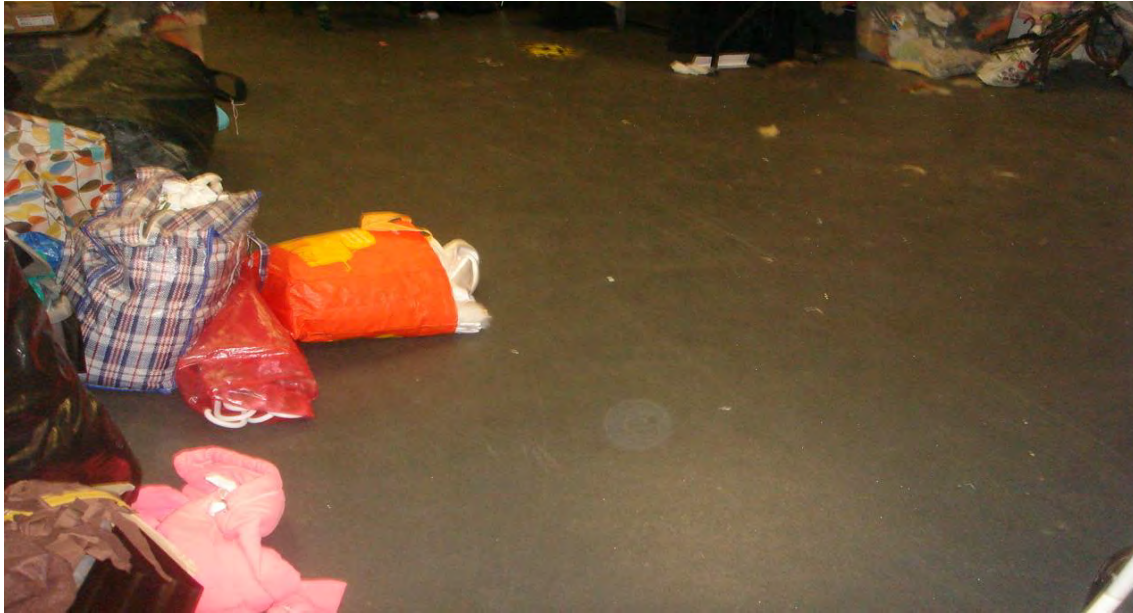
Location: 0/001

Material Description:	Vinyl Floor Tiles	
Identification:	As Per Sample NE/ - Asbestos Detected	
Approx. quantity:	75M2	
Accessibility	Low	Assessment Score
Product type:	Vinyl	1
Extent of Damage:	Minor	1
Surface Treatment:	Non-Friable	0
Asbestos type:	Chrysotile	1
Material Assessment Score:		3
Priority Assessment Score:		Negligible
Action:	Manage	
Comments:	Below Modern Vinyl

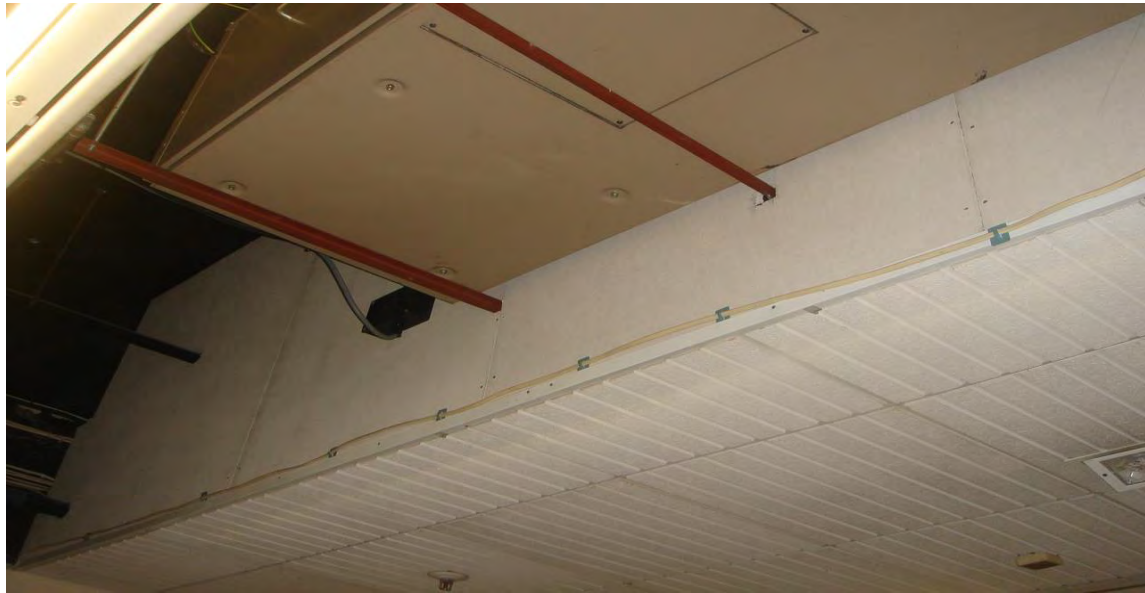
Location: 0/002 Store

Material Description:	Insulating Board – High Level to Air Con Unit	
Identification:	As Per Sampled NE/3 – No Asbestos Detected	
Approx. quantity:	10M2	
Accessibility	N/A	Assessment Score
Product type:	N/A	N/A
Extent of Damage:	N/A	N/A
Surface Treatment:	N/A	N/A
Asbestos type:	N/A	N/A
Material Assessment Score:		N/A
Priority Assessment Score:		N/A
Action:	N/A	
Comments:	N/A

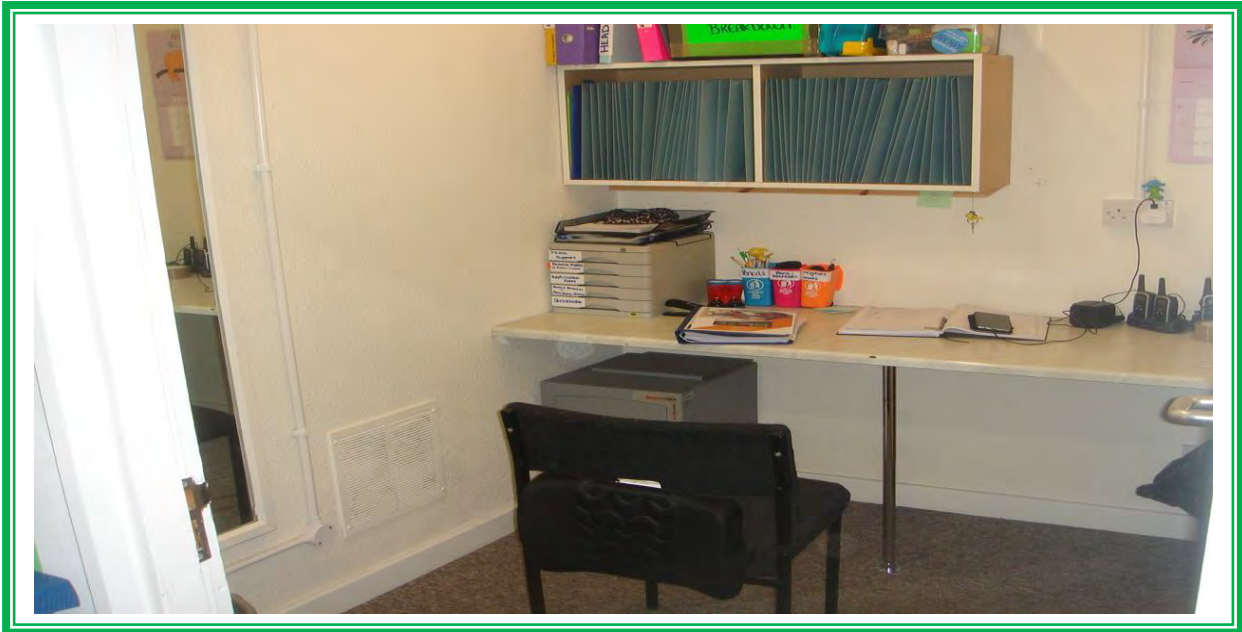
Location: 1/002 Office

Material Description:	Visual Inspection – No Suspect Materials Found	
Identification:	N/A	
Approx. quantity:	N/A	
Accessibility	N/A	Assessment Score
Product type:	N/A	N/A
Extent of Damage:	N/A	N/A
Surface Treatment:	N/A	N/A
Asbestos type:	N/A	N/A
Material Assessment Score:		N/A
Priority Assessment Score:		N/A
Action:	N/A	
Comments:	N/A

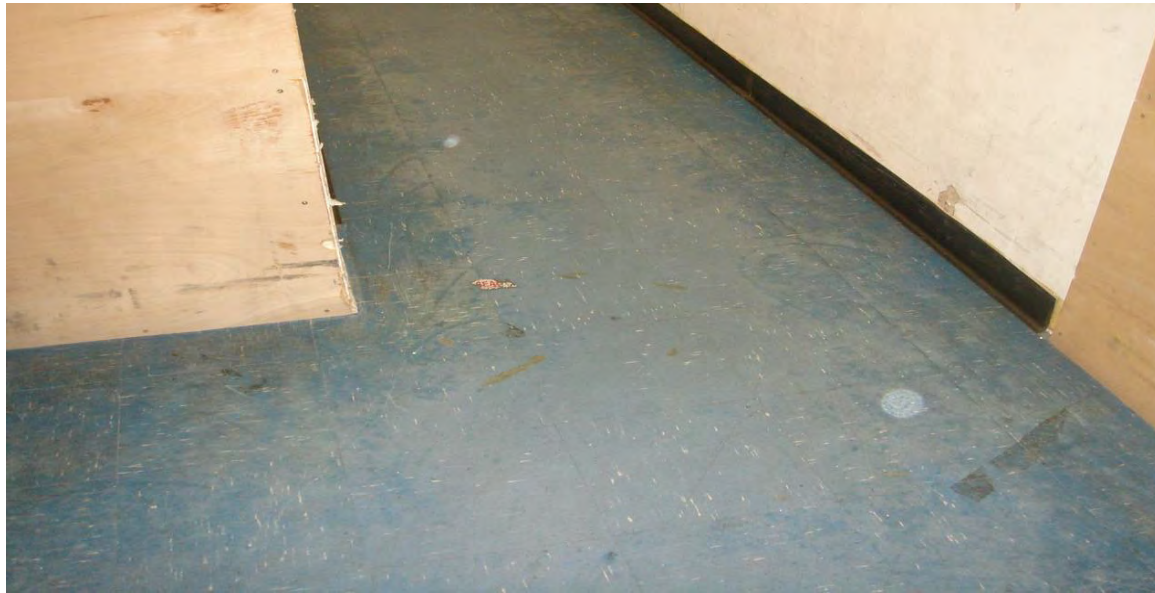
Location: 1/004 Lobby

Material Description:	Vinyl Floor Tiles	
Identification:	As Per Sample NE/1 – No Asbestos Detected	
Approx. quantity:	10M2	
Accessibility	N/A	Assessment Score
Product type:	N/A	N/A
Extent of Damage:	N/A	N/A
Surface Treatment:	N/A	N/A
Asbestos type:	N/A	N/A
Material Assessment Score:		N/A
Priority Assessment Score:		N/A
Action:	N/A	
Comments:	N/A

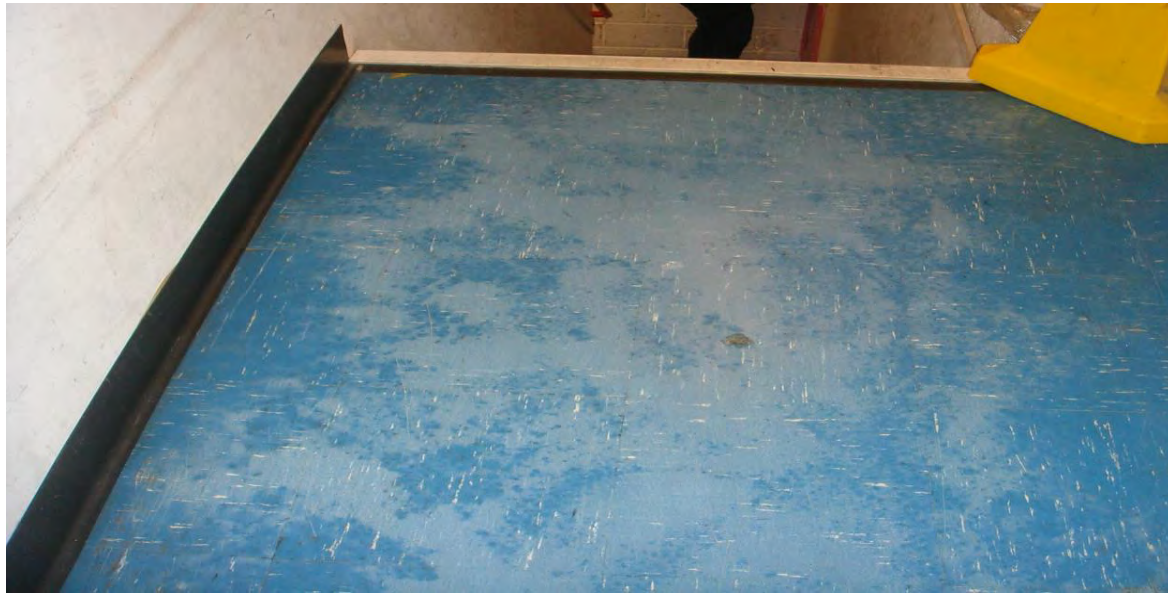
Location: 1/006 Stairs and Fire Exit

Material Description:	Vinyl Floor Tiles	
Identification:	As Per Sample NE/1 – No Asbestos Detected	
Approx. quantity:	26M2	
Accessibility	N/A	Assessment Score
Product type:	N/A	N/A
Extent of Damage:	N/A	N/A
Surface Treatment:	N/A	N/A
Asbestos type:	N/A	N/A
Material Assessment Score:		N/A
Priority Assessment Score:		N/A
Action:	N/A	
Comments:	N/A

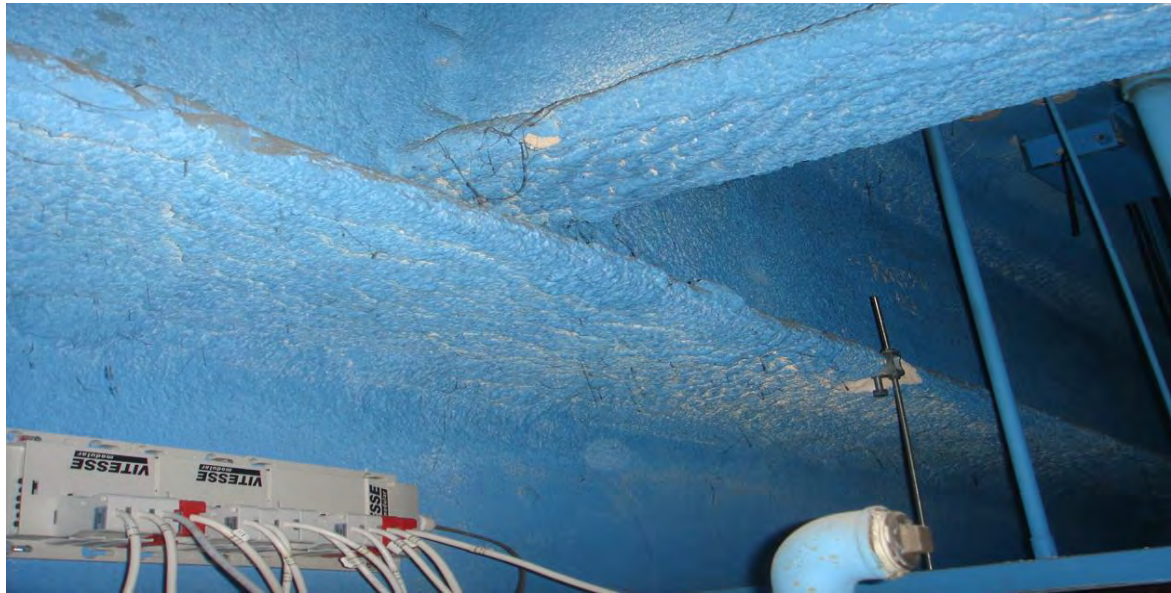
Location: 0/001 Shop Floor

Material Description:	Sprayed Coating	
Identification:	Sampled – No Asbestos Detected	
Approx. quantity:	20M2	
Accessibility	N/A	Assessment Score
Product type:	N/A	N/A
Extent of Damage:	N/A	N/A
Surface Treatment:	N/A	N/A
Asbestos type:	N/A	N/A
Material Assessment Score:		N/A
Priority Assessment Score:		N/A
Action:	N/A	
Comments:	Coating is Encapsulated

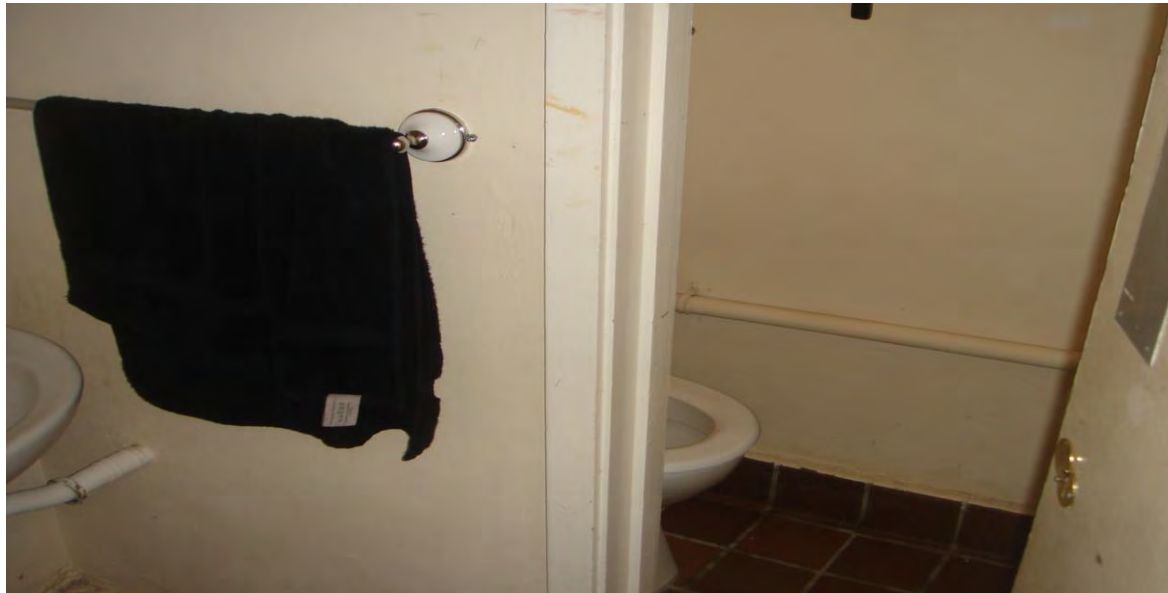
Location: 1/002 WC

Material Description:	Visual Inspection – No Suspect Materials Found	
Identification:	N/A	
Approx. quantity:	N/A	
Accessibility	N/A	Assessment Score
Product type:	N/A	N/A
Extent of Damage:	N/A	N/A
Surface Treatment:	N/A	N/A
Asbestos type:	N/A	N/A
Material Assessment Score:		N/A
Priority Assessment Score:		N/A
Action:	N/A	
Comments:	N/A

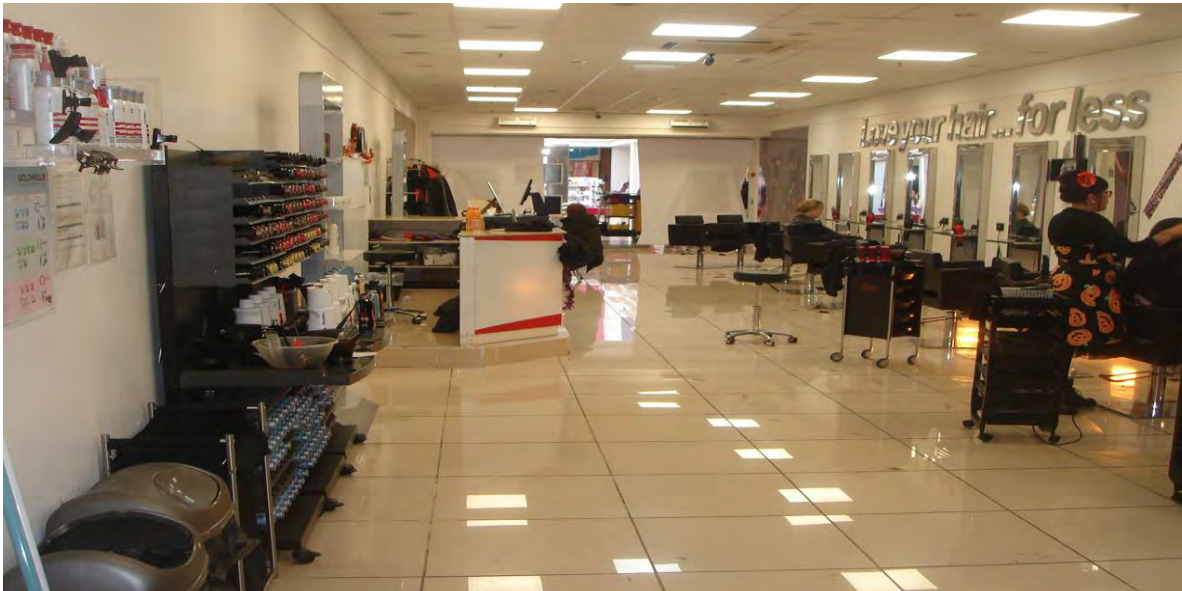
Location: 0/002 Shop Floor

Material Description:	Visual Inspection – No Suspect Materials Found	
Identification:	N/A	
Approx. quantity:	N/A	
Accessibility	N/A	Assessment Score
Product type:	N/A	N/A
Extent of Damage:	N/A	N/A
Surface Treatment:	N/A	N/A
Asbestos type:	N/A	N/A
Material Assessment Score:		N/A
Priority Assessment Score:		N/A
Action:	N/A	
Comments:	N/A

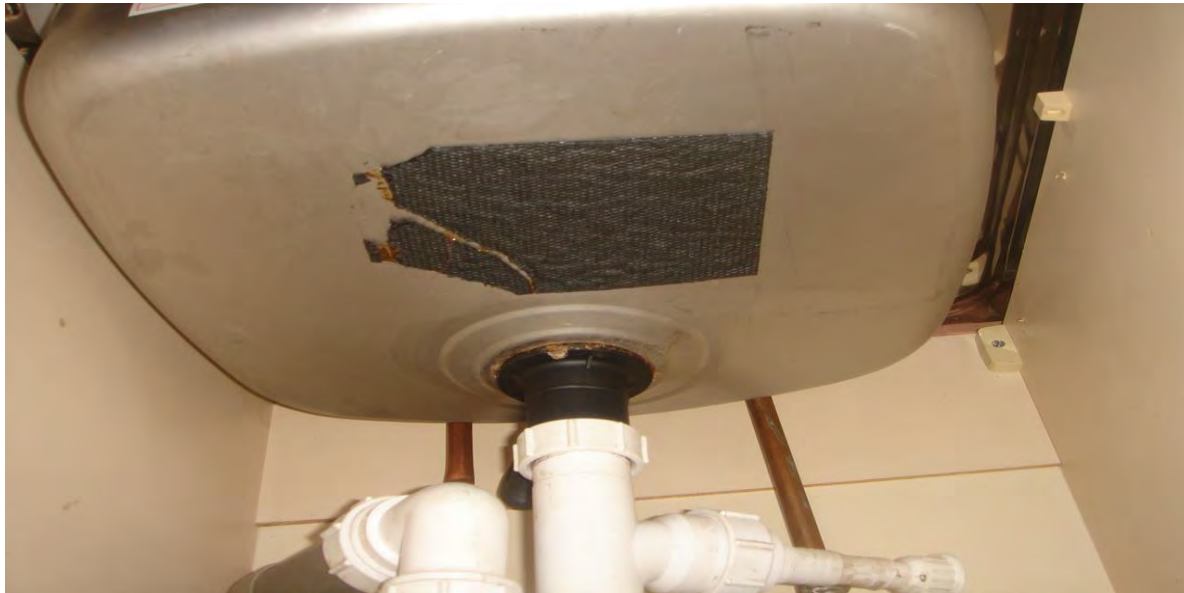
Location: 1/002 Kitchen

Material Description:	Sink Pad	
Identification:	Sampled – No Asbestos Detected	
Approx. quantity:	X 2	
Accessibility	N/A	Assessment Score
Product type:	N/A	N/A
Extent of Damage:	N/A	N/A
Surface Treatment:	N/A	N/A
Asbestos type:	N/A	N/A
Material Assessment Score:		N/A
Priority Assessment Score:		N/A
Action:	N/A	
Comments:	N/A

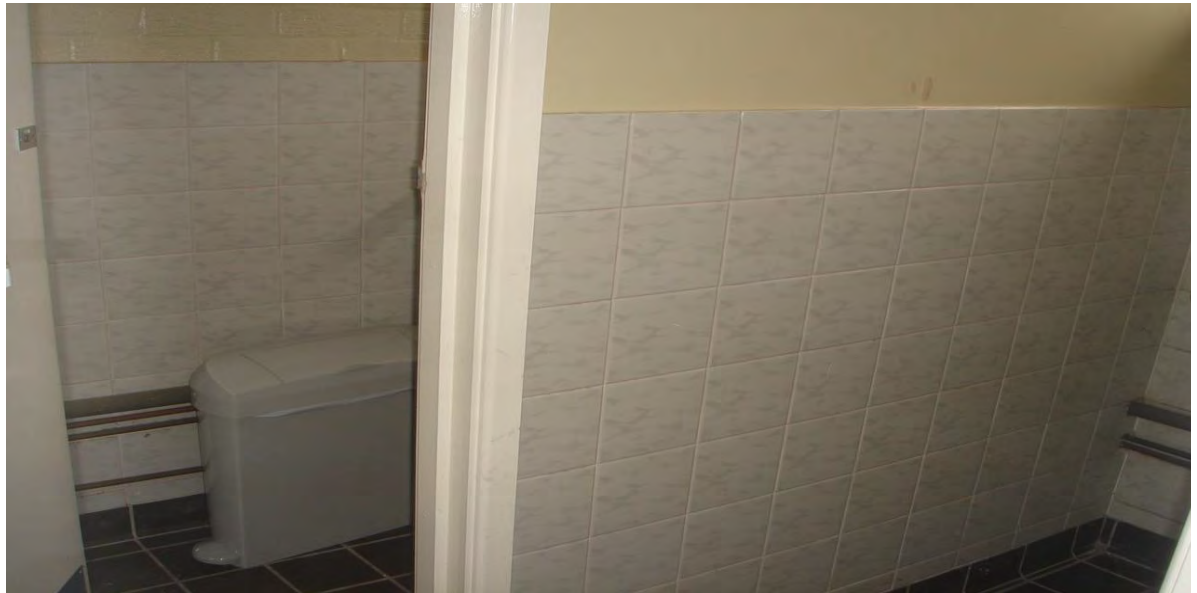
Location: 1/003 WC

Material Description:	Visual Inspection – No Suspect Materials Found	
Identification:	N/A	
Approx. quantity:	N/A	
Accessibility	N/A	Assessment Score
Product type:	N/A	N/A
Extent of Damage:	N/A	N/A
Surface Treatment:	N/A	N/A
Asbestos type:	N/A	N/A
Material Assessment Score:		N/A
Priority Assessment Score:		N/A
Action:	N/A	
Comments:	N/A

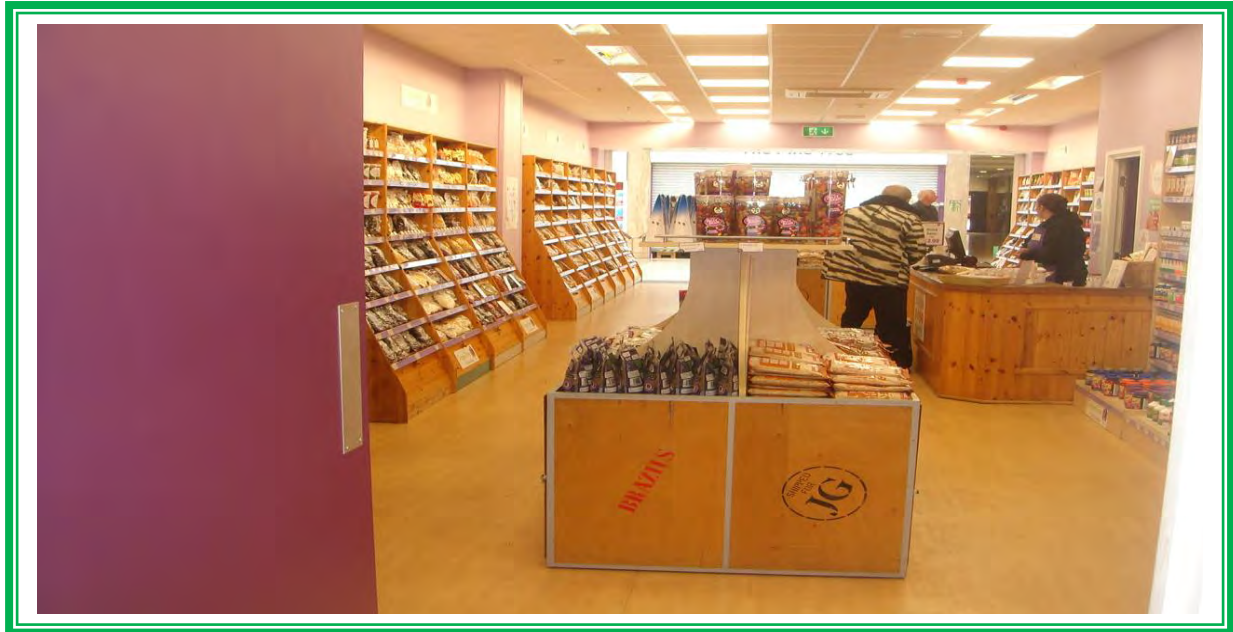
Location: 0/001 Shop Floor

Material Description:	Visual Inspection – No Suspect Materials Found	
Identification:	N/A	
Approx. quantity:	N/A	
Accessibility	N/A	Assessment Score
Product type:	N/A	N/A
Extent of Damage:	N/A	N/A
Surface Treatment:	N/A	N/A
Asbestos type:	N/A	N/A
Material Assessment Score:		N/A
Priority Assessment Score:		N/A
Action:	N/A	
Comments:	N/A

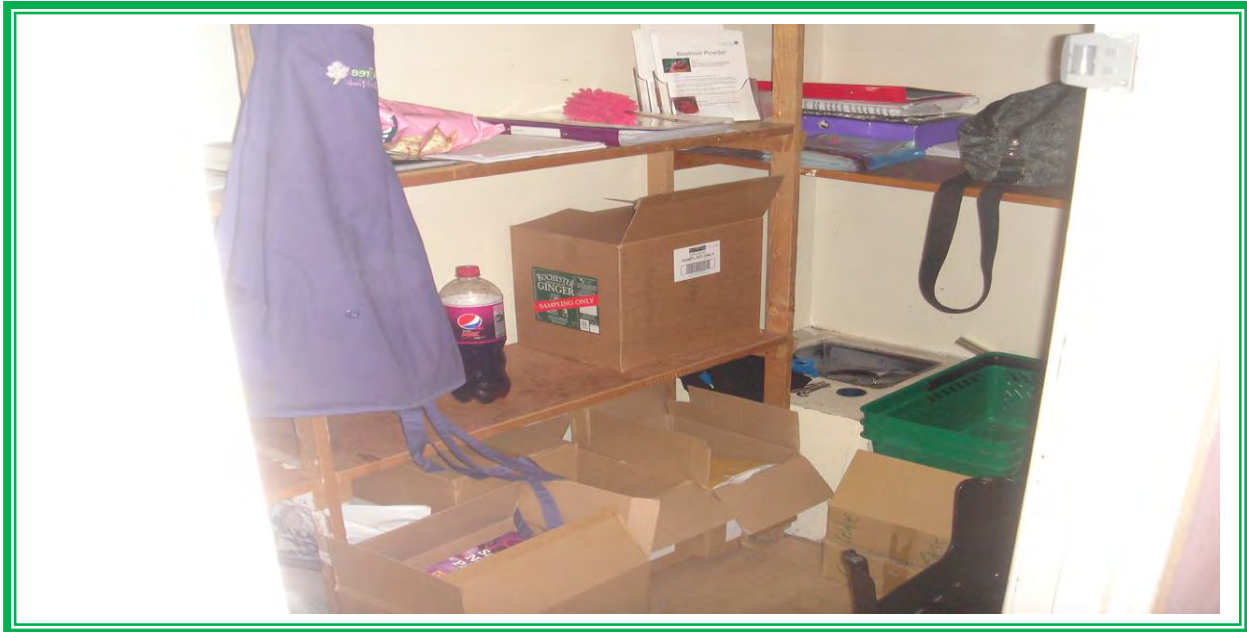
Location: 0/002 Cupboard

Material Description:	Visual Inspection – No Suspect Materials Found	
Identification:	N/A	
Approx. quantity:	N/A	
Accessibility	N/A	Assessment Score
Product type:	N/A	N/A
Extent of Damage:	N/A	N/A
Surface Treatment:	N/A	N/A
Asbestos type:	N/A	N/A
Material Assessment Score:		N/A
Priority Assessment Score:		N/A
Action:	N/A	
Comments:	N/A

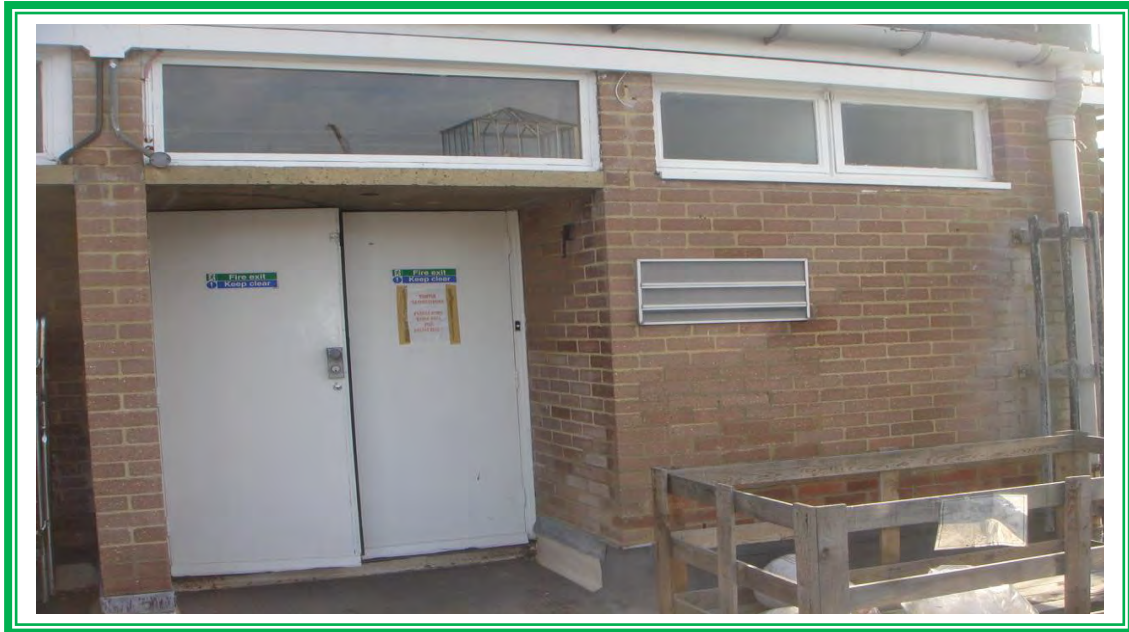
Location: 99/001 External

Material Description:	Visual Inspection – No Suspect Materials Found	
Identification:	N/A	
Approx. quantity:	N/A	
Accessibility	N/A	Assessment Score
Product type:	N/A	N/A
Extent of Damage:	N/A	N/A
Surface Treatment:	N/A	N/A
Asbestos type:	N/A	N/A
Material Assessment Score:		N/A
Priority Assessment Score:		N/A
Action:	N/A	
Comments:	N/A

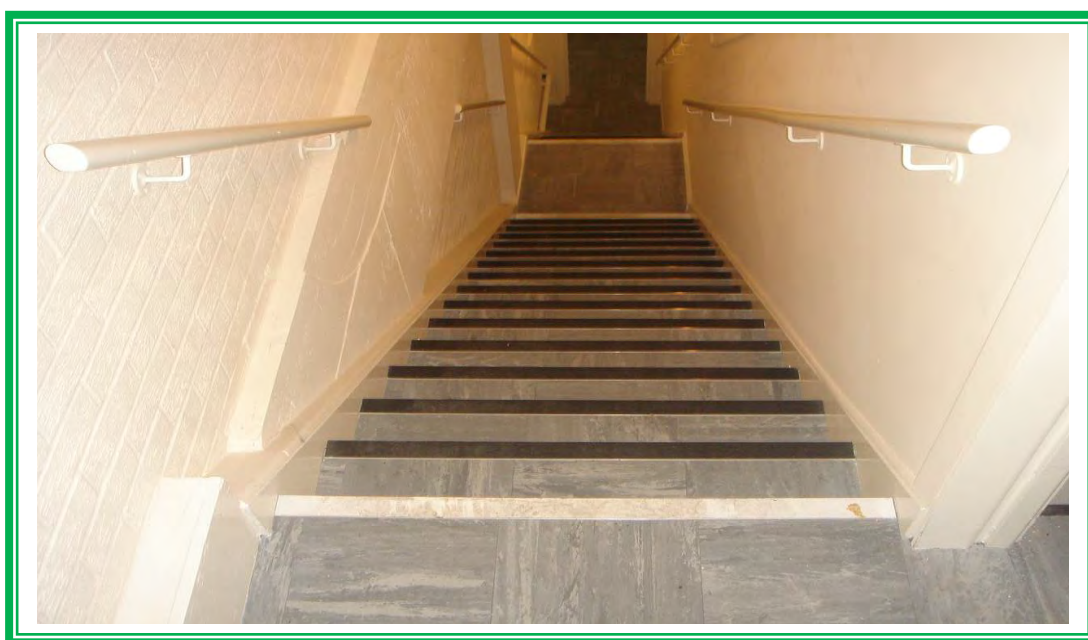
Location: 1/001 Stairs

Material Description:	Vinyl Floor Tiles	
Identification:	Sampled – No Asbestos Detected	
Approx. quantity:	15M2	
Accessibility	N/A	Assessment Score
Product type:	N/A	N/A
Extent of Damage:	N/A	N/A
Surface Treatment:	N/A	N/A
Asbestos type:	N/A	N/A
Material Assessment Score:		N/A
Priority Assessment Score:		N/A
Action:	N/A	
Comments:	N/A

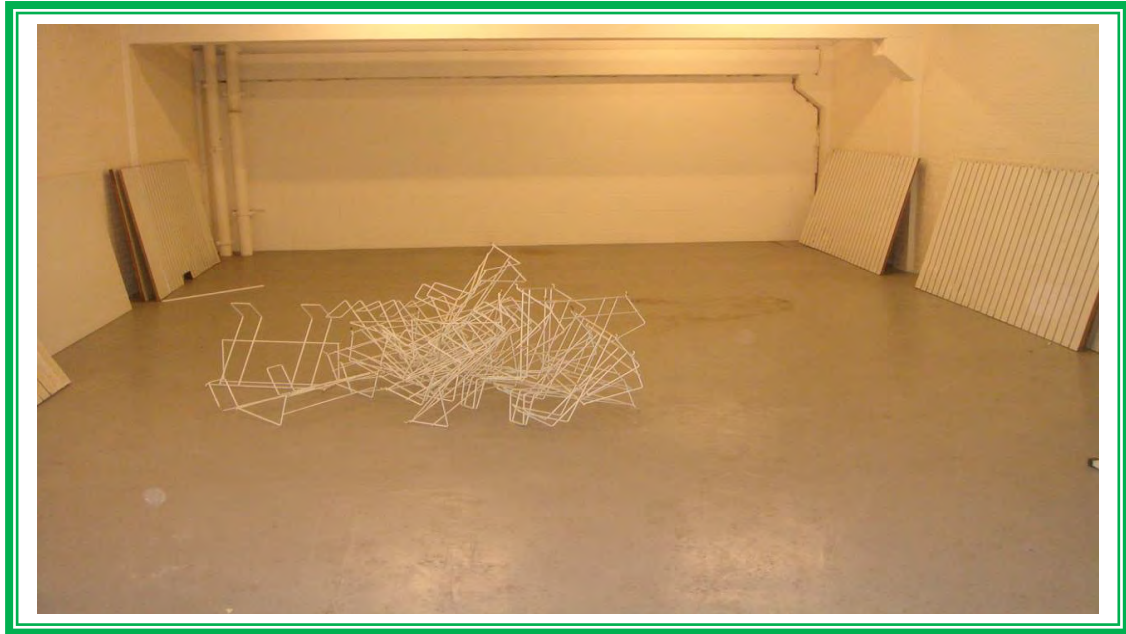
Location: 1/002 Store

Material Description:	Visual Inspection – No Suspect Materials Found	
Identification:	N/A	
Approx. quantity:	N/A	
Accessibility	N/A	Assessment Score
Product type:	N/A	N/A
Extent of Damage:	N/A	N/A
Surface Treatment:	N/A	N/A
Asbestos type:	N/A	N/A
Material Assessment Score:		N/A
Priority Assessment Score:		N/A
Action:	N/A	
Comments:	N/A

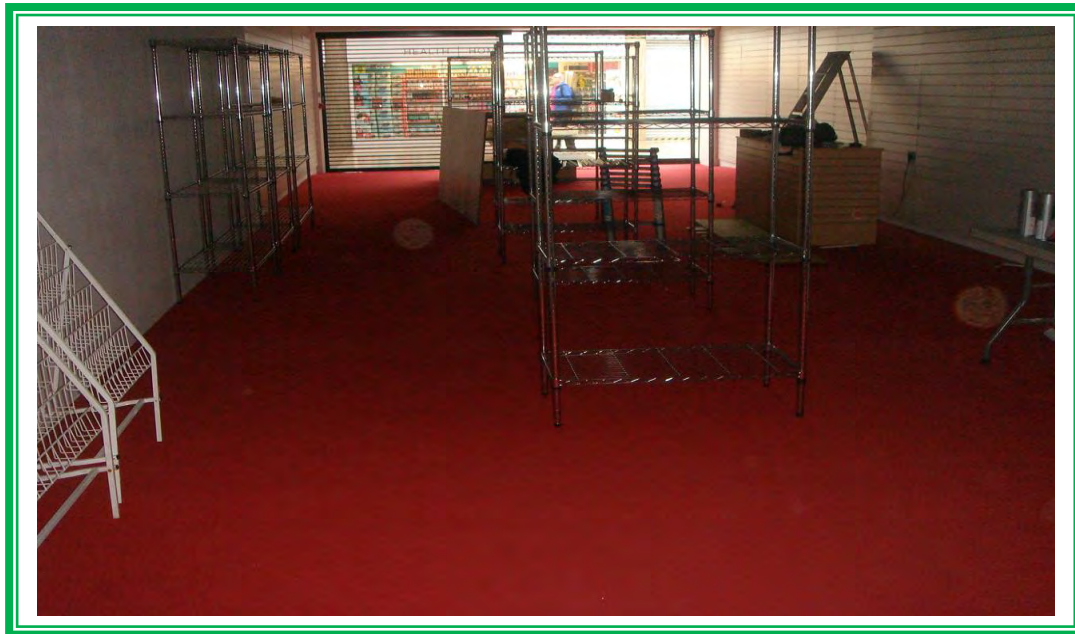
Location: 0/002 Shop Floor

Material Description:	Visual Inspection – No Suspect Materials Found	
Identification:	N/A	
Approx. quantity:	N/A	
Accessibility	N/A	Assessment Score
Product type:	N/A	N/A
Extent of Damage:	N/A	N/A
Surface Treatment:	N/A	N/A
Asbestos type:	N/A	N/A
Material Assessment Score:		N/A
Priority Assessment Score:		N/A
Action:	N/A	
Comments:	N/A

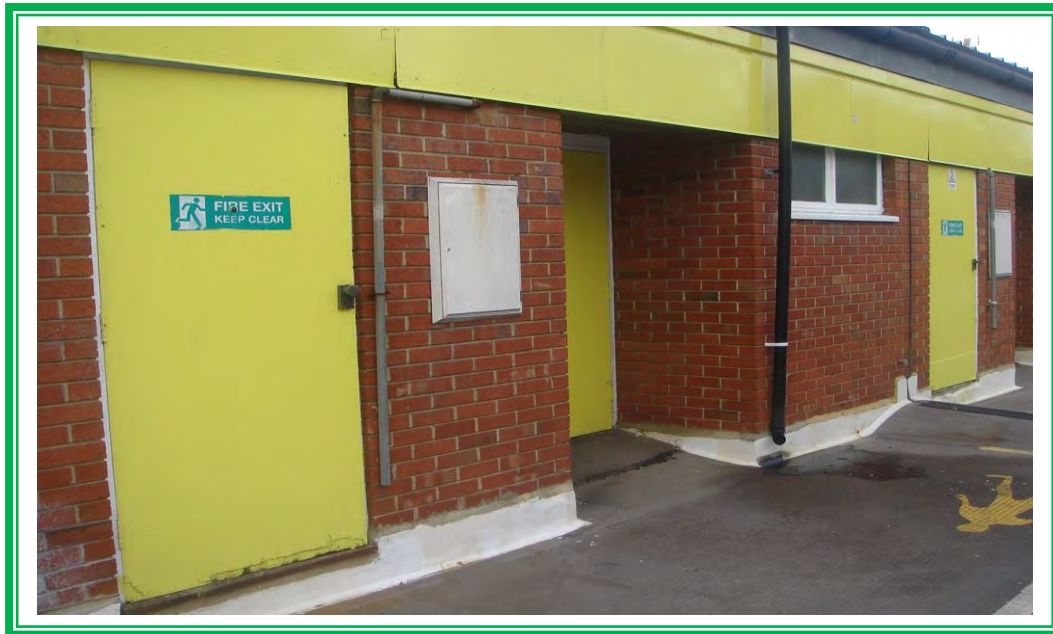
Location: 99/001 Externals

Material Description:	Visual Inspection – No Suspect Materials Found	
Identification:	N/A	
Approx. quantity:	N/A	
Accessibility	N/A	Assessment Score
Product type:	N/A	N/A
Extent of Damage:	N/A	N/A
Surface Treatment:	N/A	N/A
Asbestos type:	N/A	N/A
Material Assessment Score:		N/A
Priority Assessment Score:		N/A
Action:	N/A	
Comments:	N/A

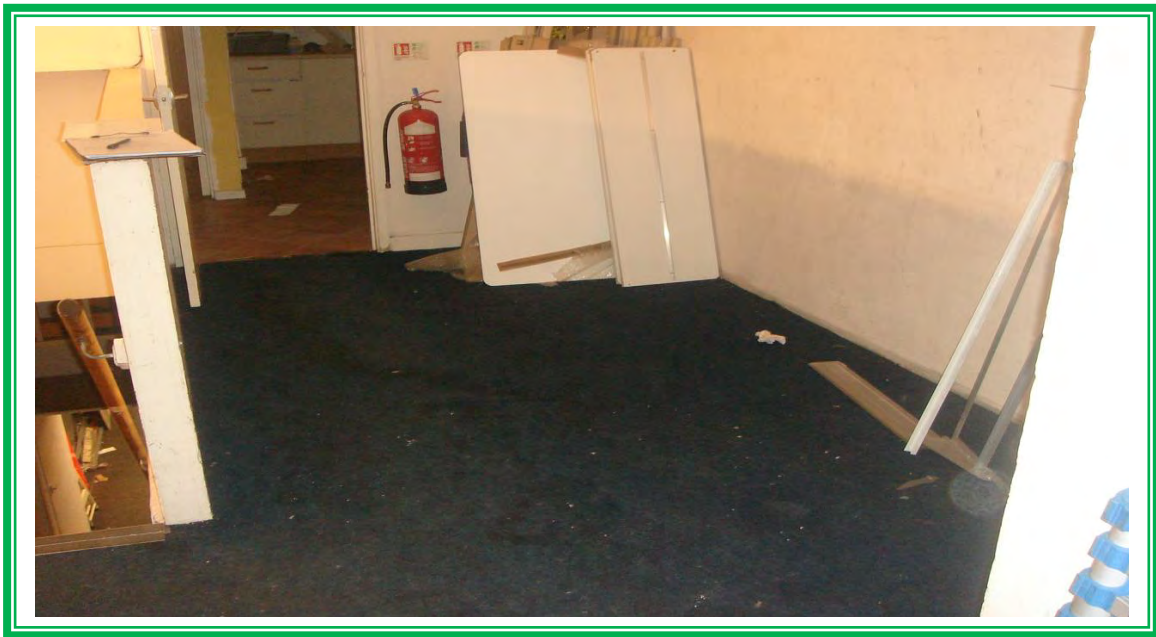
Item No: 1	Sample No: N/A
Location: 1/001 Store

Material Description:	Visual Inspection – No Suspect Materials Found	
Identification:	N/A	
Approx. quantity:	N/A	
Accessibility	N/A	Assessment Score
Product type:	N/A	N/A
Extent of Damage:	N/A	N/A
Surface Treatment:	N/A	N/A
Asbestos type:	N/A	N/A
Material Assessment Score:		N/A
Priority Assessment Score:		N/A
Action:	N/A	
Comments:	N/A

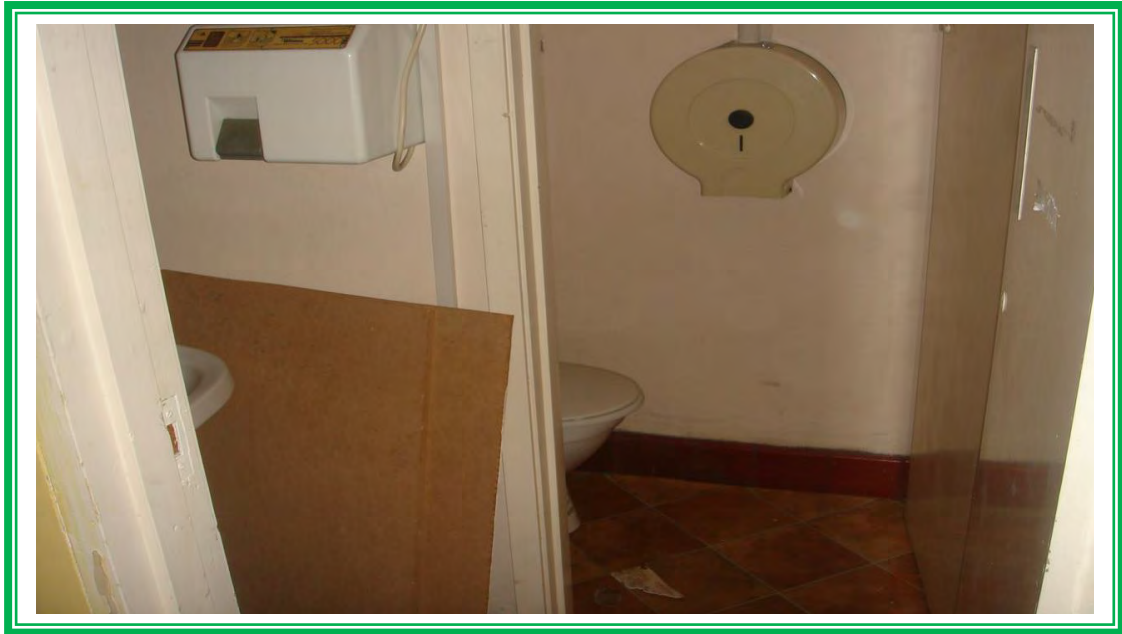
Location: 1/003 WC

Material Description:	Visual Inspection – No Suspect Materials Found	
Identification:	N/A	
Approx. quantity:	N/A	
Accessibility	N/A	Assessment Score
Product type:	N/A	N/A
Extent of Damage:	N/A	N/A
Surface Treatment:	N/A	N/A
Asbestos type:	N/A	N/A
Material Assessment Score:		N/A
Priority Assessment Score:		N/A
Action:	N/A	
Comments:	N/A
