Project Number 3113

Management
Asbestos Survey Report

Kennet Centre, Market Street, Newbury,
Berkshire, RG14 5EN

1-3 The Mall

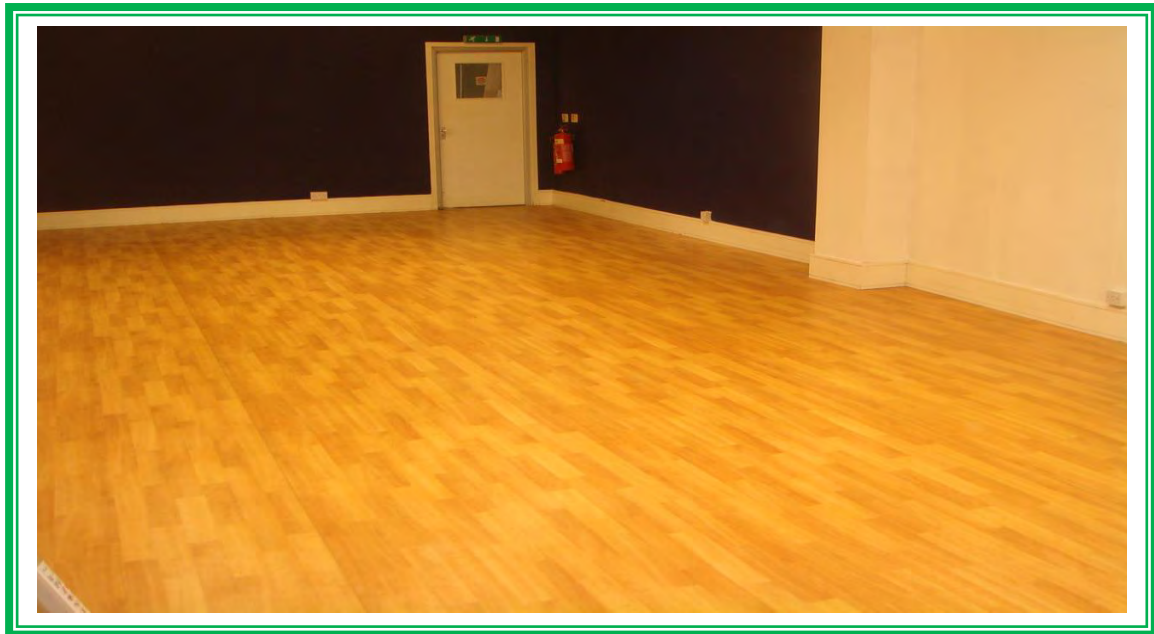
Location: 0/001 Shop Floor

Material Description:	Visual Inspection – No Suspect Materials Found	
Identification:	N/A	
Approx. quantity:	N/A	
Accessibility	N/A	Assessment Score
Product type:	N/A	N/A
Extent of Damage:	N/A	N/A
Surface Treatment:	N/A	N/A
Asbestos type:	N/A	N/A
Material Assessment Score:		N/A
Priority Assessment Score:		N/A
Action:	N/A	
Comments:	N/A

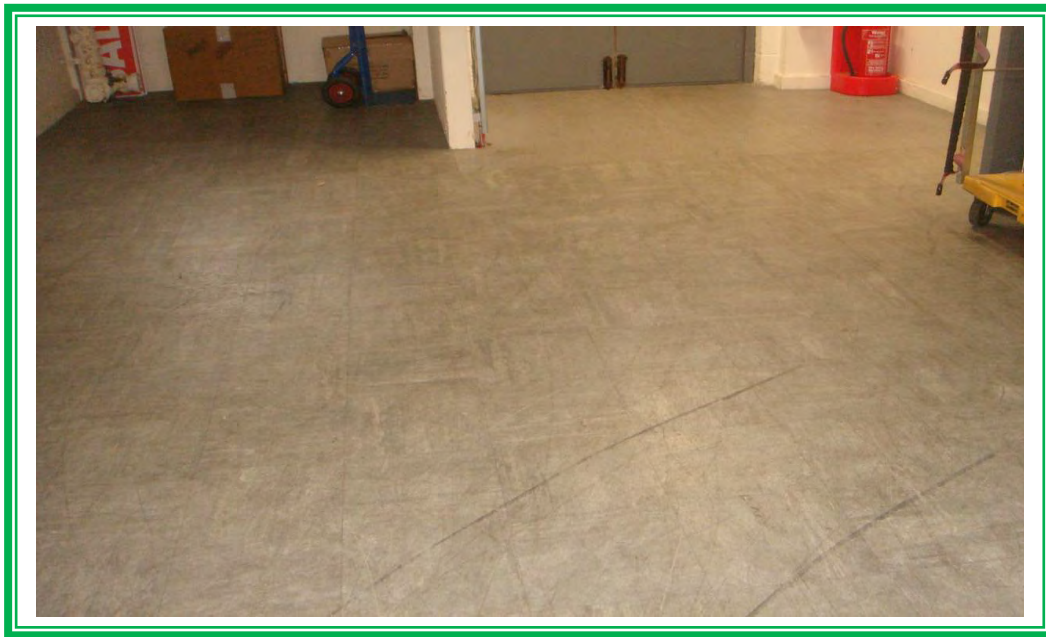
Location: 1/001 Store Area

Material Description:	Vinyl Floor Tiles	
Identification:	Sampled – No Asbestos Detected	
Approx. quantity:	50M2	
Accessibility	N/A	Assessment Score
Product type:	N/A	N/A
Extent of Damage:	N/A	N/A
Surface Treatment:	N/A	N/A
Asbestos type:	N/A	N/A
Material Assessment Score:		N/A
Priority Assessment Score:		N/A
Action:	N/A	
Comments:	N/A

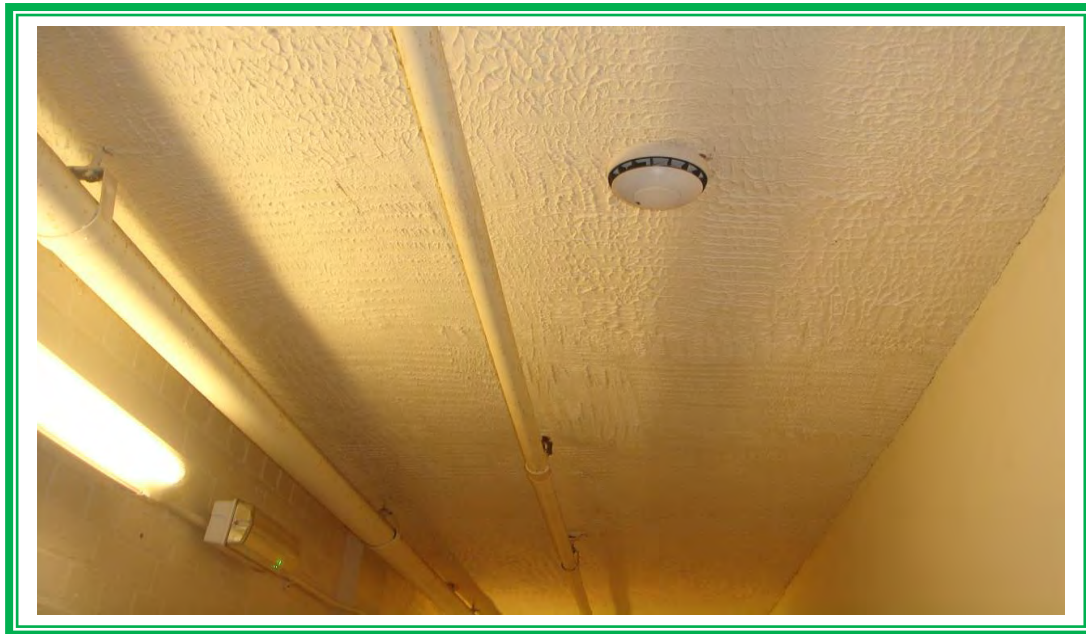
Location: 1/006 Stairs

Material Description:	Textured Coating to Ceiling	
Identification:	Sampled – No Asbestos Detected	
Approx. quantity:	15M2	
Accessibility	N/A	Assessment Score
Product type:	N/A	N/A
Extent of Damage:	N/A	N/A
Surface Treatment:	N/A	N/A
Asbestos type:	N/A	N/A
Material Assessment Score:		N/A
Priority Assessment Score:		N/A
Action:	N/A	
Comments:	N/A

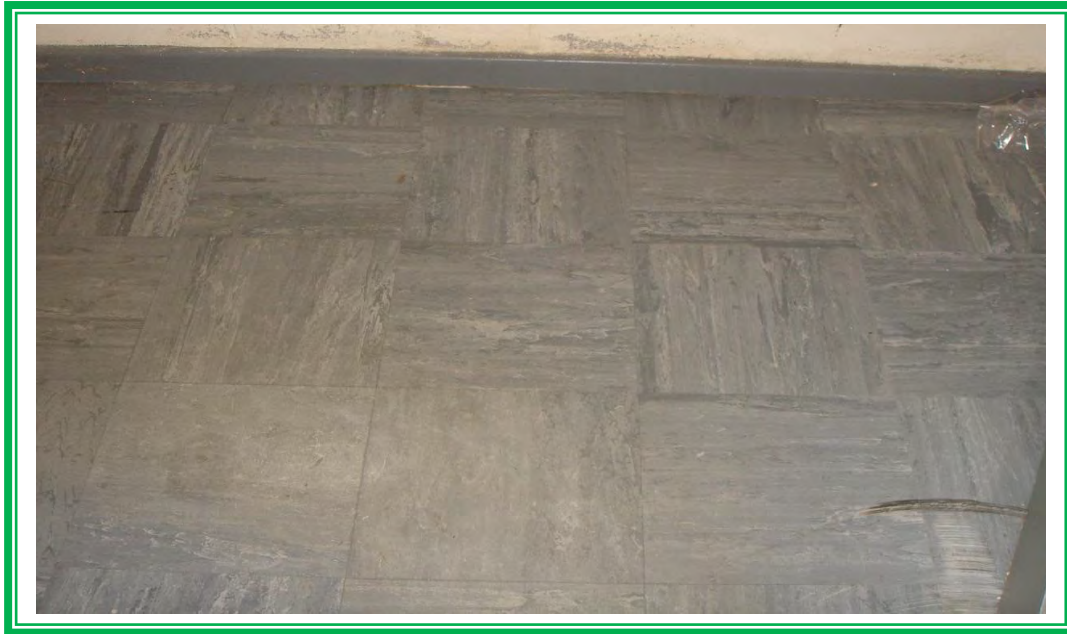
Location: 0/001 Lobby

Material Description:	Vinyl Floor Tiles	
Identification:	Sampled – No Asbestos Detected	
Approx. quantity:	4M2	
Accessibility	N/A	Assessment Score
Product type:	N/A	N/A
Extent of Damage:	N/A	N/A
Surface Treatment:	N/A	N/A
Asbestos type:	N/A	N/A
Material Assessment Score:		N/A
Priority Assessment Score:		N/A
Action:	N/A	
Comments:	N/A

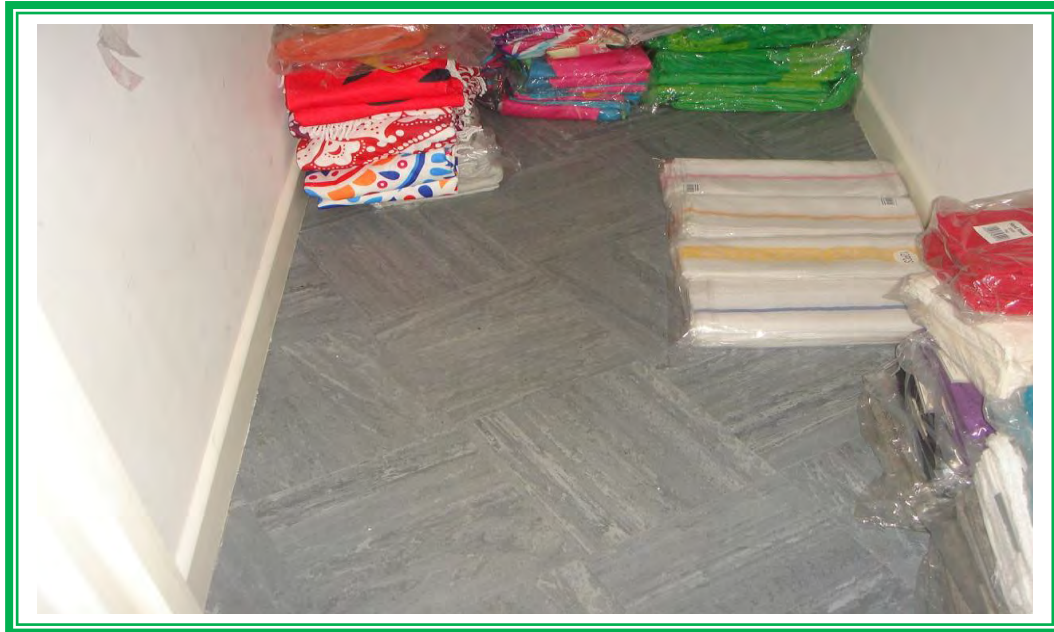
Location: 0/003A Cupboard

Material Description:	Vinyl Floor Tiles	
Identification:	As Per Sample NE/4 – No Asbestos Detected	
Approx. quantity:	2M2	
Accessibility	N/A	Assessment Score
Product type:	N/A	N/A
Extent of Damage:	N/A	N/A
Surface Treatment:	N/A	N/A
Asbestos type:	N/A	N/A
Material Assessment Score:		N/A
Priority Assessment Score:		N/A
Action:	N/A	
Comments:	N/A

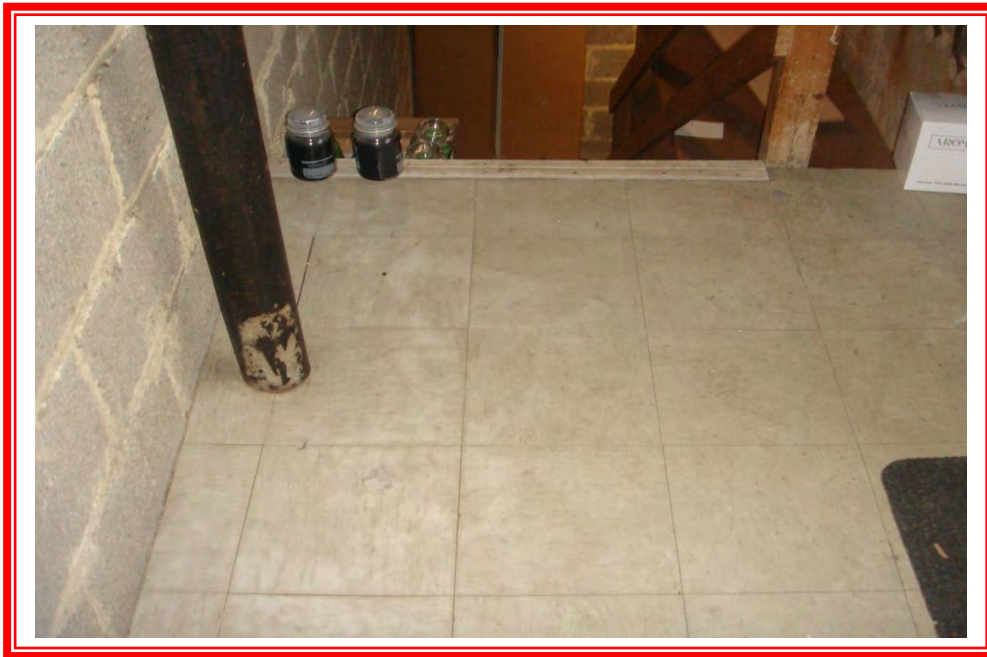
Location: 1/001 Landing and Stairs

Material Description:	Vinyl Floor Tiles	
Identification:	Sampled – Asbestos Detected	
Approx. quantity:	20M2	
Accessibility	Low	Assessment Score
Product type:	Vinyl	1
Extent of Damage:	Minor	1
Surface Treatment:	Non-Friable	0
Asbestos type:	Chrysotile	1
Material Assessment Score:		3
Priority Assessment Score:		Negligible
Action:	Manage	
Comments:	N/A

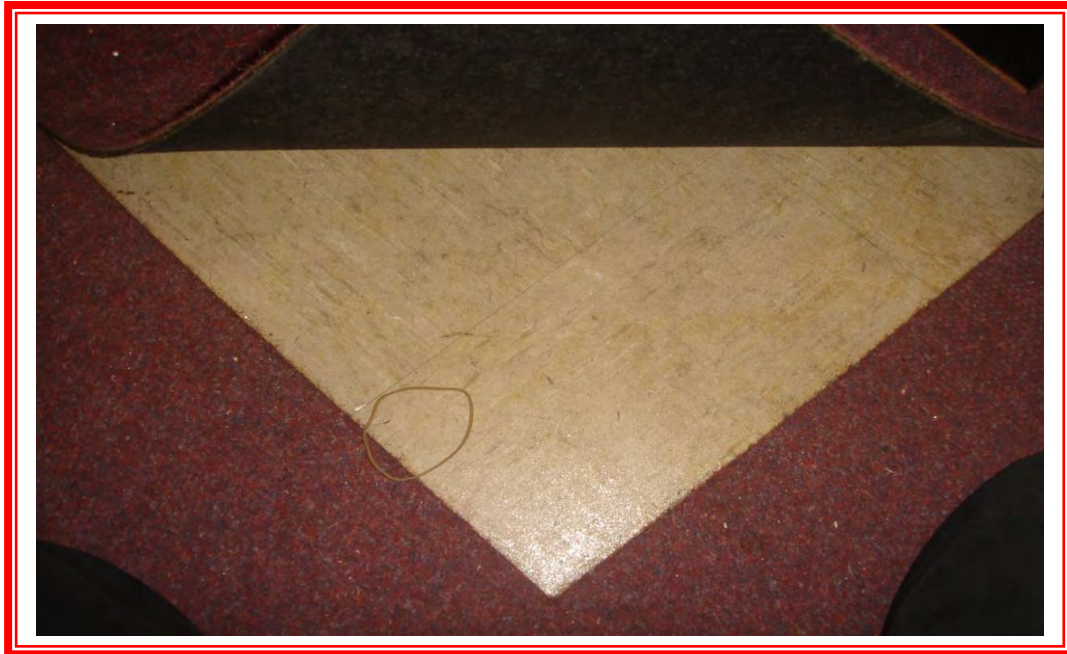
Location: 0/002 Office

Material Description:	Vinyl Floor Tiles	
Identification:	Sampled – Asbestos Detected	
Approx. quantity:	2M2	
Accessibility	Low	Assessment Score
Product type:	Vinyl	1
Extent of Damage:	Good	0
Surface Treatment:	Non-Friable	0
Asbestos type:	Chrysotile	1
Material Assessment Score:		2
Priority Assessment Score:		Negligible
Action:	Manage	
Comments:	N/A

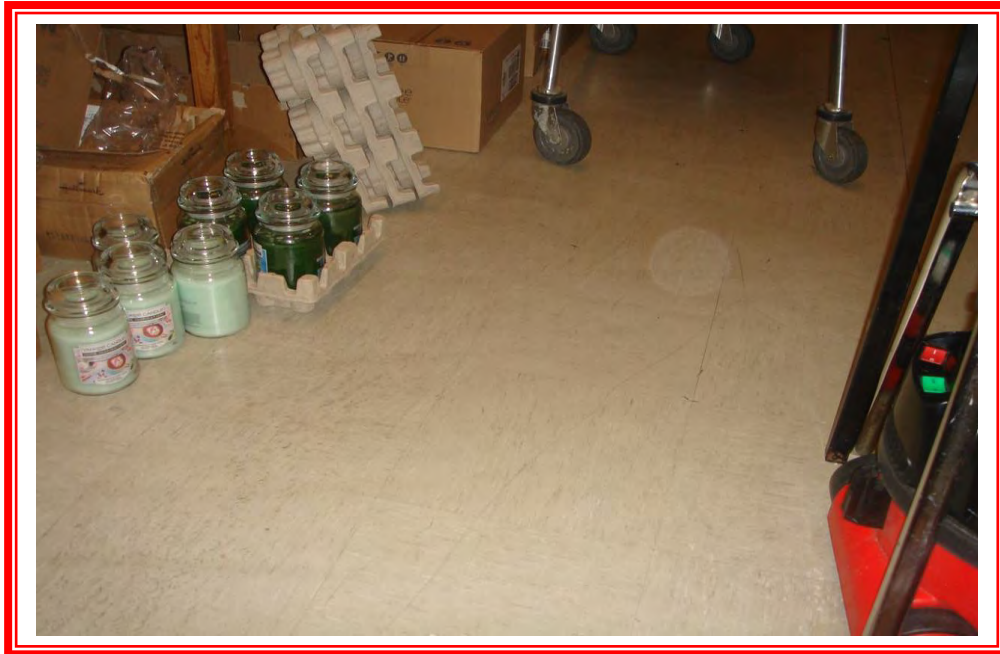
Location: 0/003 Store/Kitchen

Material Description:	Vinyl Floor Tiles	
Identification:	As Per Sample NE/3- Asbestos Detected	
Approx. quantity:	15M2	
Accessibility	Low	Assessment Score
Product type:	Vinyl	1
Extent of Damage:	Minor	1
Surface Treatment:	Non-Friable	0
Asbestos type:	Chrysotile	1
Material Assessment Score:		3
Priority Assessment Score:		Negligible
Action:	Manage	
Comments:	N/A

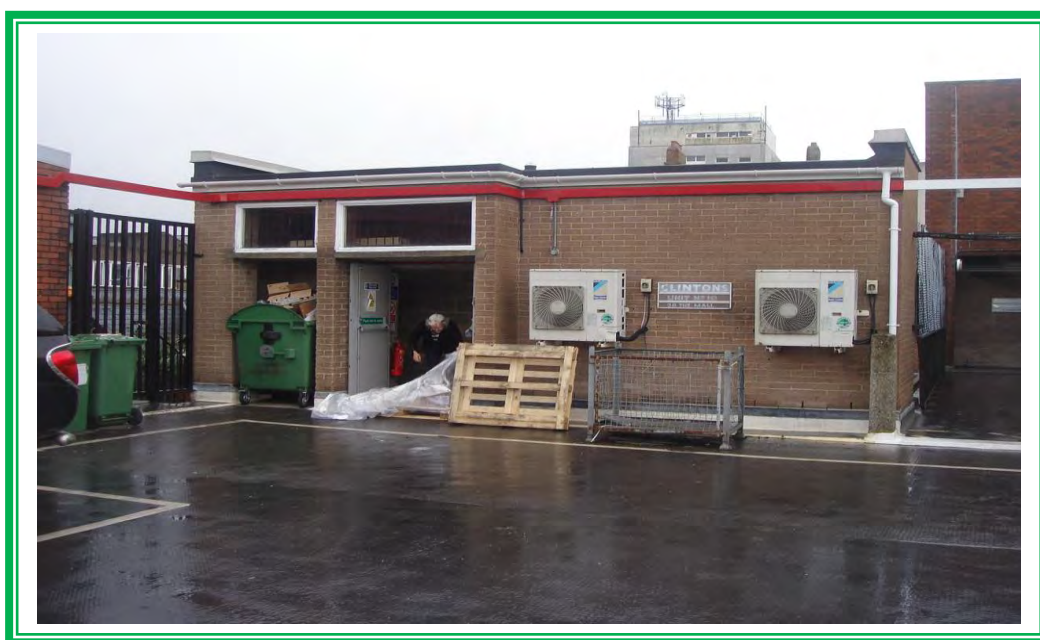
Location: 99/001 External

Material Description:	Visual Inspection – No Suspect Materials Found	
Identification:	N/A	
Approx. quantity:	N/A	
Accessibility	N/A	Assessment Score
Product type:	N/A	N/A
Extent of Damage:	N/A	N/A
Surface Treatment:	N/A	N/A
Asbestos type:	N/A	N/A
Material Assessment Score:		N/A
Priority Assessment Score:		N/A
Action:	N/A	
Comments:	N/A

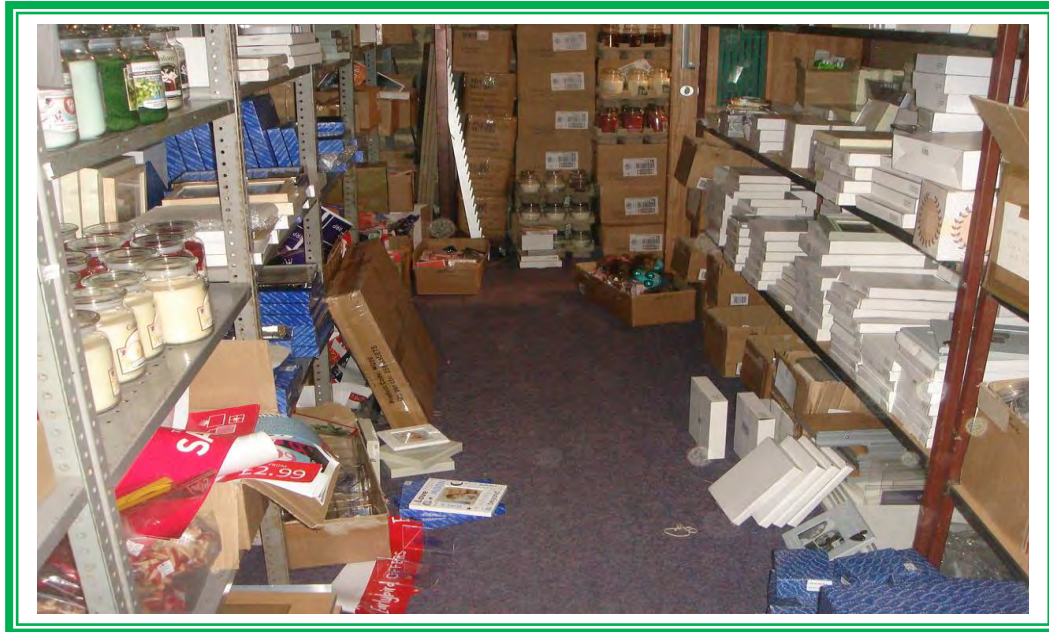
Location: 0/004 Store

Material Description:	Visual Inspection – No Suspect Materials Found	
Identification:	N/A	
Approx. quantity:	N/A	
Accessibility	N/A	Assessment Score
Product type:	N/A	N/A
Extent of Damage:	N/A	N/A
Surface Treatment:	N/A	N/A
Asbestos type:	N/A	N/A
Material Assessment Score:		N/A
Priority Assessment Score:		N/A
Action:	N/A	
Comments:	N/A

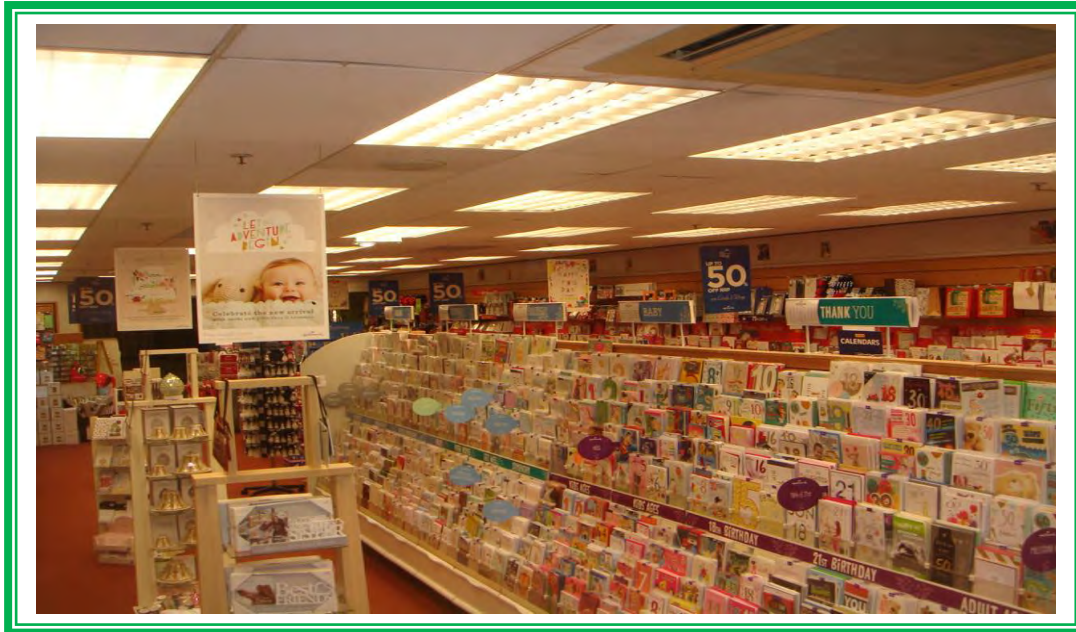
Location: 0/005 Shop Floor

Material Description:	Visual Inspection – No Suspect Materials Found	
Identification:	N/A	
Approx. quantity:	N/A	
Accessibility	N/A	Assessment Score
Product type:	N/A	N/A
Extent of Damage:	N/A	N/A
Surface Treatment:	N/A	N/A
Asbestos type:	N/A	N/A
Material Assessment Score:		N/A
Priority Assessment Score:		N/A
Action:	N/A	
Comments:	N/A

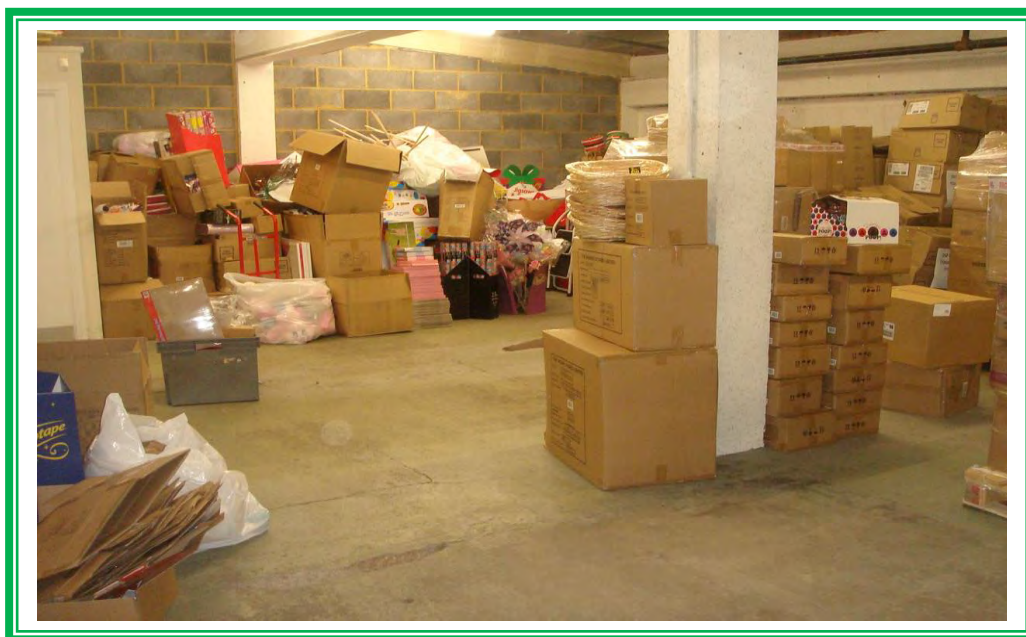
Location: 1/001 Store

Material Description:	Visual Inspection – No Suspect Materials Found	
Identification:	N/A	
Approx. quantity:	N/A	
Accessibility	N/A	Assessment Score
Product type:	N/A	N/A
Extent of Damage:	N/A	N/A
Surface Treatment:	N/A	N/A
Asbestos type:	N/A	N/A
Material Assessment Score:		N/A
Priority Assessment Score:		N/A
Action:	N/A	
Comments:	N/A

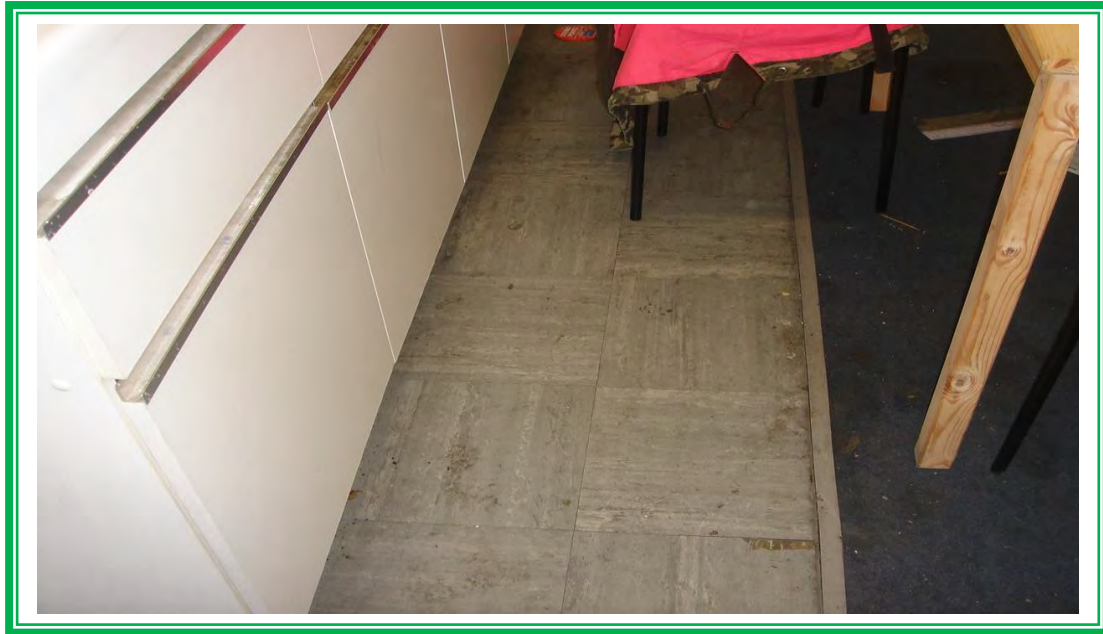
Location: 1/002 Kitchen

Material Description:	Vinyl Floor Tiles	
Identification:	Sampled – No Asbestos Detected	
Approx. quantity:	1M2	
Accessibility	N/A	Assessment Score
Product type:	N/A	N/A
Extent of Damage:	N/A	N/A
Surface Treatment:	N/A	N/A
Asbestos type:	N/A	N/A
Material Assessment Score:		N/A
Priority Assessment Score:		N/A
Action:	N/A	
Comments:	N/A

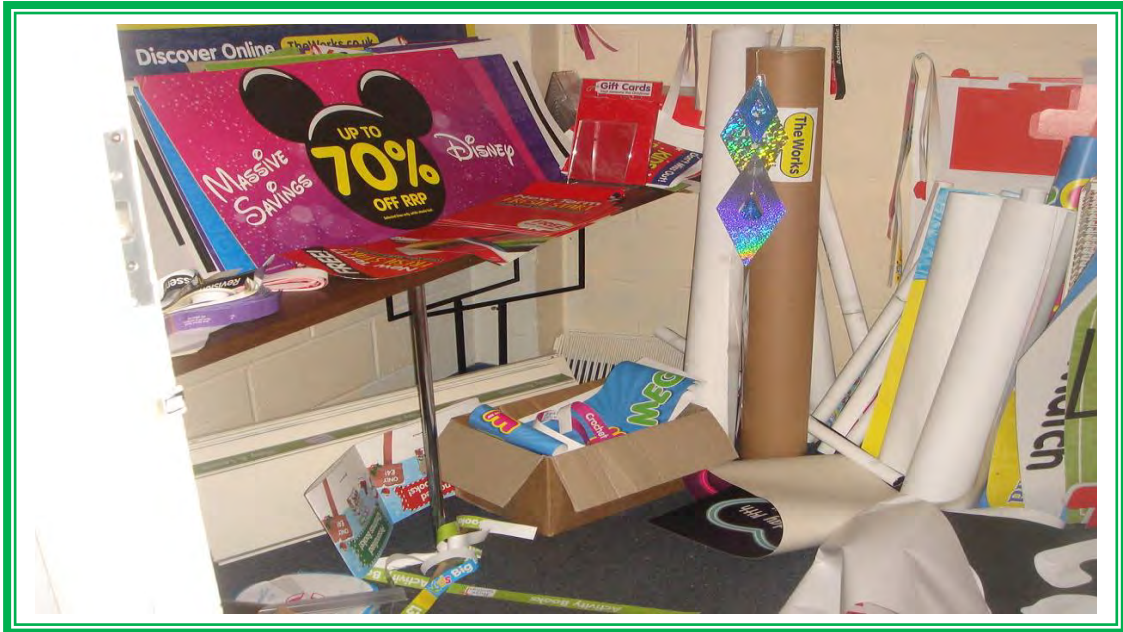
Location: 1/003 Store

Material Description:	Visual Inspection – No Suspect Materials Found	
Identification:	N/A	
Approx. quantity:	N/A	
Accessibility	N/A	Assessment Score
Product type:	N/A	N/A
Extent of Damage:	N/A	N/A
Surface Treatment:	N/A	N/A
Asbestos type:	N/A	N/A
Material Assessment Score:		N/A
Priority Assessment Score:		N/A
Action:	N/A	
Comments:	N/A

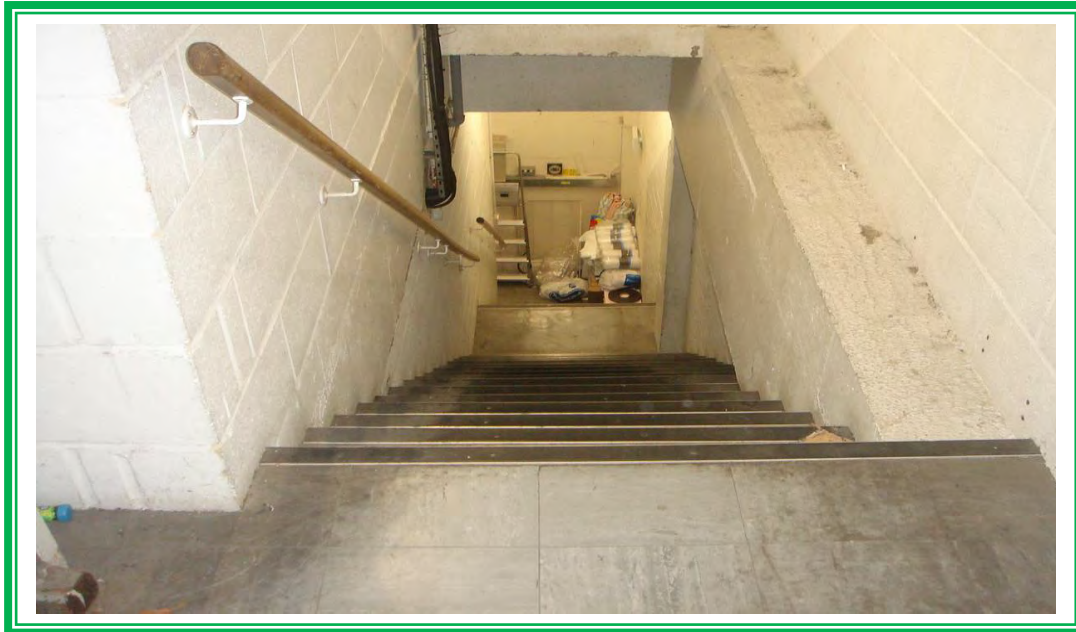
Location: 1/006 Stairwell

Material Description:	Vinyl Floor Tiles	
Identification:	As Per Sample NE/1 – No Asbestos Detected	
Approx. quantity:	20M2	
Accessibility	N/A	Assessment Score
Product type:	N/A	N/A
Extent of Damage:	N/A	N/A
Surface Treatment:	N/A	N/A
Asbestos type:	N/A	N/A
Material Assessment Score:		N/A
Priority Assessment Score:		N/A
Action:	N/A	
Comments:	N/A

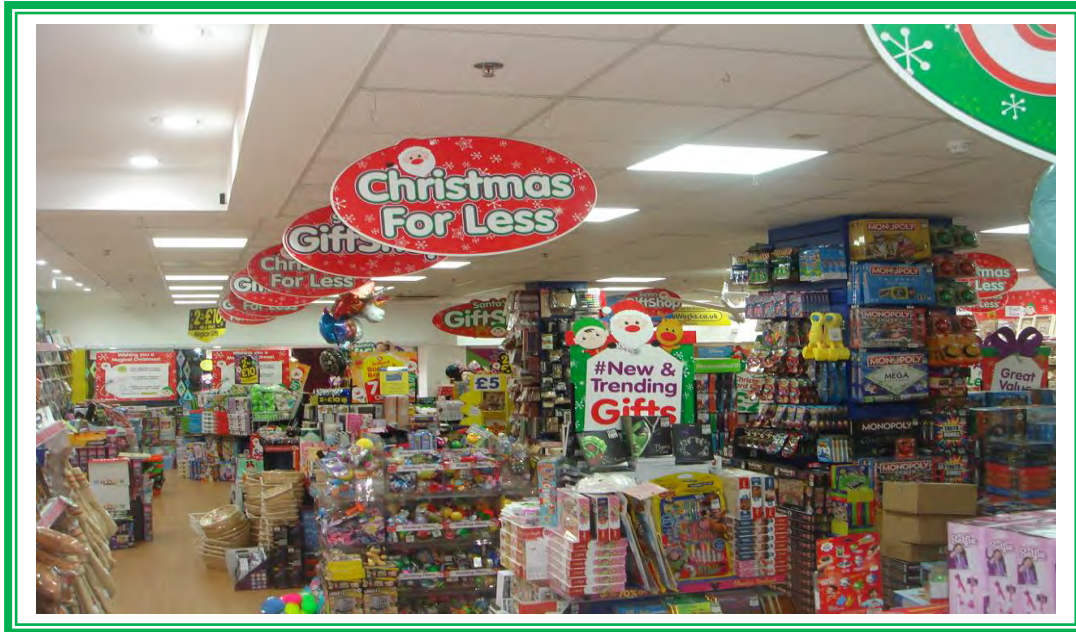
Location: 0/002 Shop Floor

Material Description:	Visual Inspection – No Suspect Materials Found	
Identification:	N/A	
Approx. quantity:	N/A	
Accessibility	N/A	Assessment Score
Product type:	N/A	N/A
Extent of Damage:	N/A	N/A
Surface Treatment:	N/A	N/A
Asbestos type:	N/A	N/A
Material Assessment Score:		N/A
Priority Assessment Score:		N/A
Action:	N/A	
Comments:	N/A

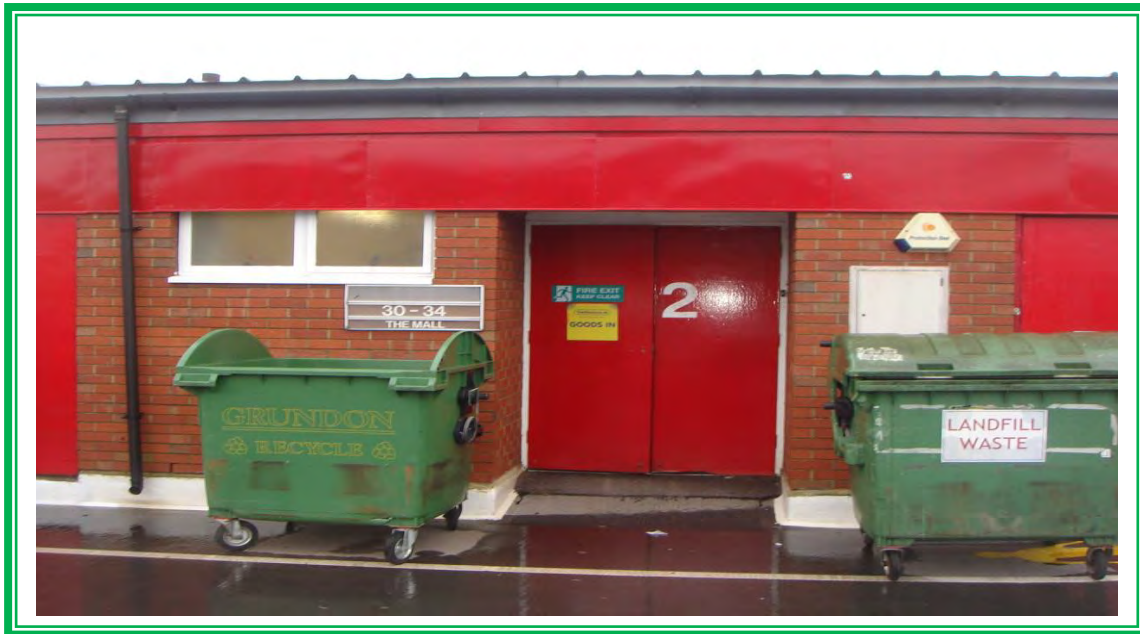
Location: 99/001 External

Material Description:	Visual Inspection – No Suspect Materials Found	
Identification:	N/A	
Approx. quantity:	N/A	
Accessibility	N/A	Assessment Score
Product type:	N/A	N/A
Extent of Damage:	N/A	N/A
Surface Treatment:	N/A	N/A
Asbestos type:	N/A	N/A
Material Assessment Score:		N/A
Priority Assessment Score:		N/A
Action:	N/A	
Comments:	N/A

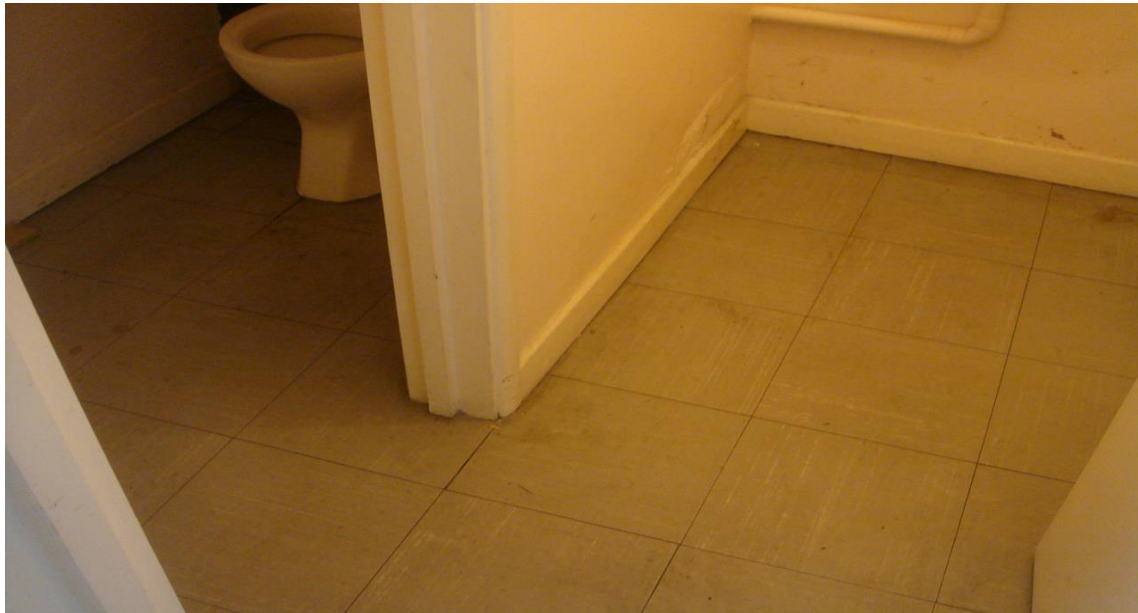
Location: 1/003

Material Description:	Vinyl floor Tiles	
Identification:	As Per Sample NE/1 - Asbestos Detected	
Approx. quantity:	2M2	
Accessibility	Low	Assessment Score
Product type:	Vinyl	1
Extent of Damage:	Low	1
Surface Treatment:	Non-Friable	0
Asbestos type:	Chrysotile	1
Material Assessment Score:		3
Priority Assessment Score:		Negligible
Action:	Manage	
Comments:	N/A

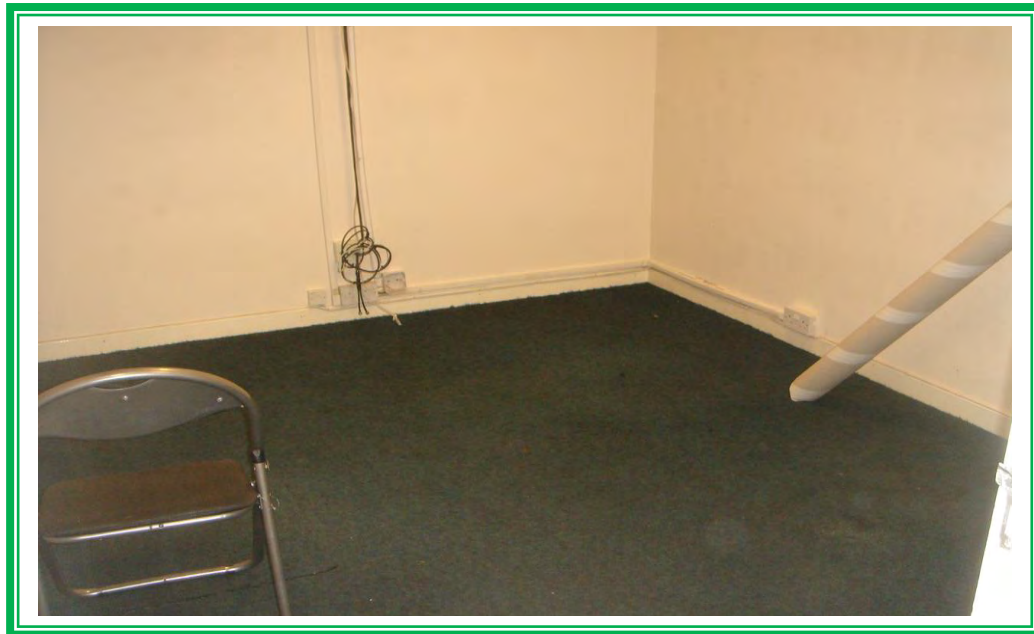
Location: 0/005 Office

Material Description:	Visual Inspection – No Suspect Materials Found	
Identification:	N/A	
Approx. quantity:	N/A	
Accessibility	N/A	Assessment Score
Product type:	N/A	N/A
Extent of Damage:	N/A	N/A
Surface Treatment:	N/A	N/A
Asbestos type:	N/A	N/A
Material Assessment Score:		N/A
Priority Assessment Score:		N/A
Action:	N/A	
Comments:	N/A

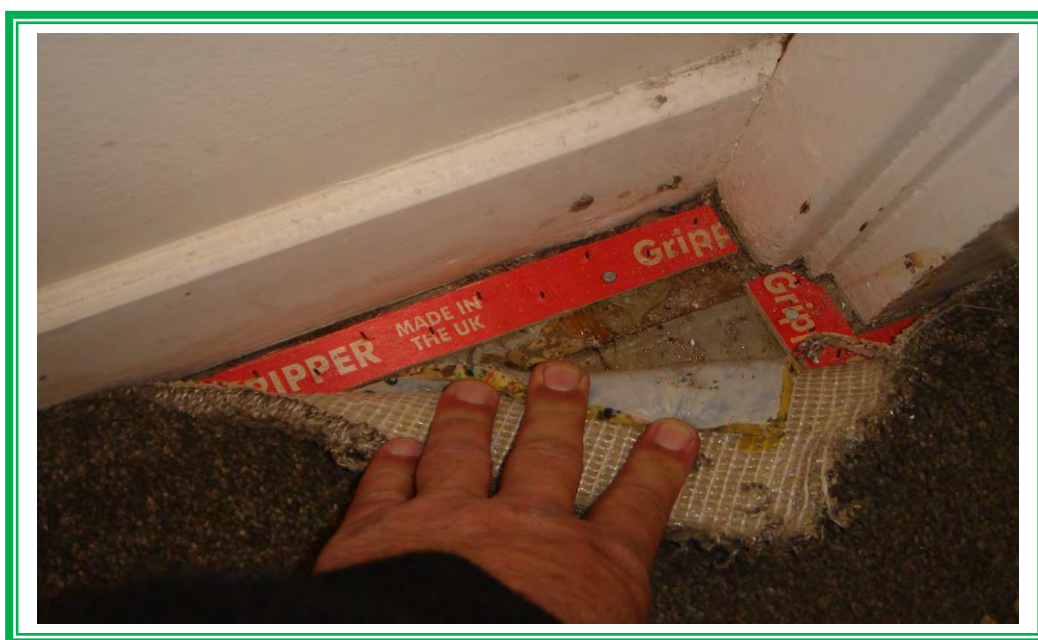
Location: 1/001 Lobby

Material Description:	Vinyl Floor Tiles	
Identification:	Sampled – No Asbestos Detected	
Approx. quantity:	2M2	
Accessibility	N/A	Assessment Score
Product type:	N/A	N/A
Extent of Damage:	N/A	N/A
Surface Treatment:	N/A	N/A
Asbestos type:	N/A	N/A
Material Assessment Score:		N/A
Priority Assessment Score:		N/A
Action:	N/A	
Comments:	N/A

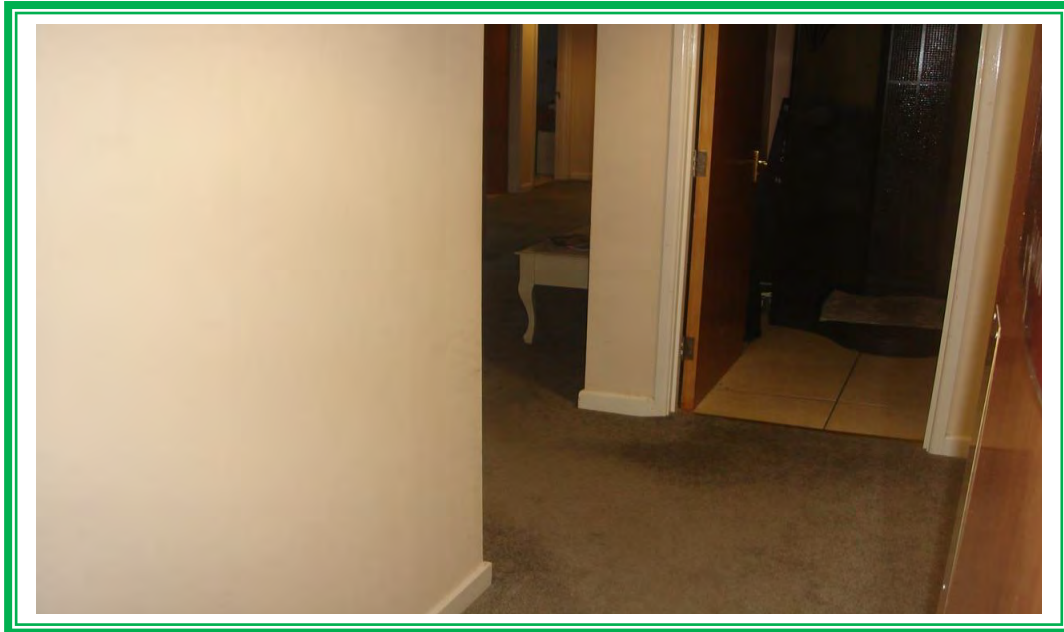
Location: 1/004 Corridor

Material Description:	Visual Inspection – No Suspect Materials Found	
Identification:	N/A	
Approx. quantity:	N/A	
Accessibility	N/A	Assessment Score
Product type:	N/A	N/A
Extent of Damage:	N/A	N/A
Surface Treatment:	N/A	N/A
Asbestos type:	N/A	N/A
Material Assessment Score:		N/A
Priority Assessment Score:		N/A
Action:	N/A	
Comments:	N/A

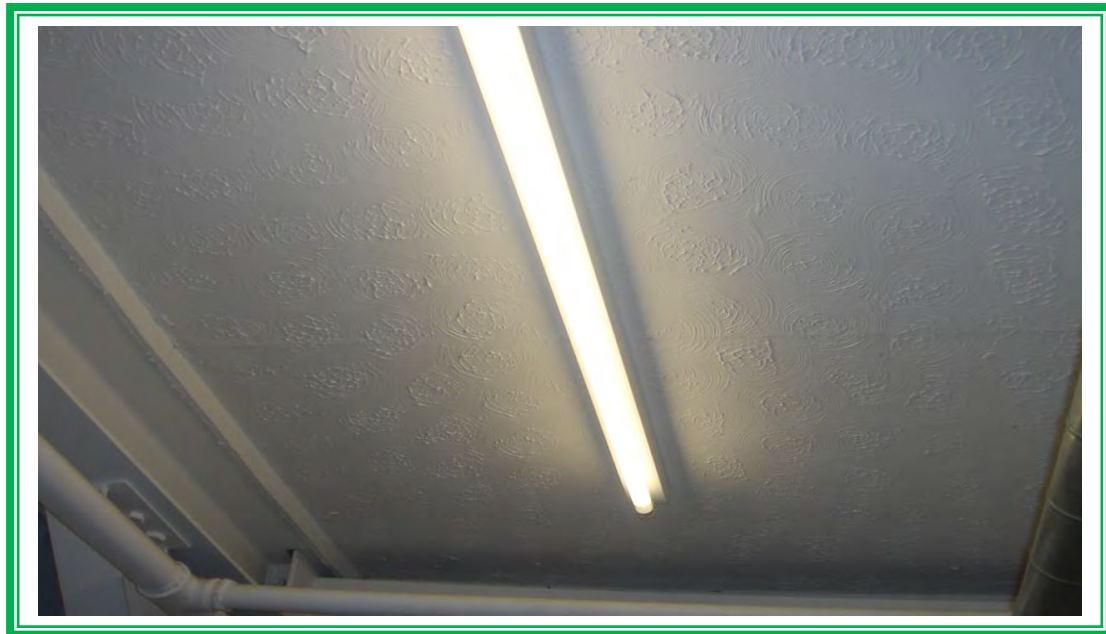
Location: 1/005 Store

Material Description:	Textured Coating	
Identification:	As Per Sample NE/2 – No Asbestos Detected	
Approx. quantity:	2M2	
Accessibility	N/A	Assessment Score
Product type:	N/A	N/A
Extent of Damage:	N/A	N/A
Surface Treatment:	N/A	N/A
Asbestos type:	N/A	N/A
Material Assessment Score:		N/A
Priority Assessment Score:		N/A
Action:	N/A	
Comments:	N/A

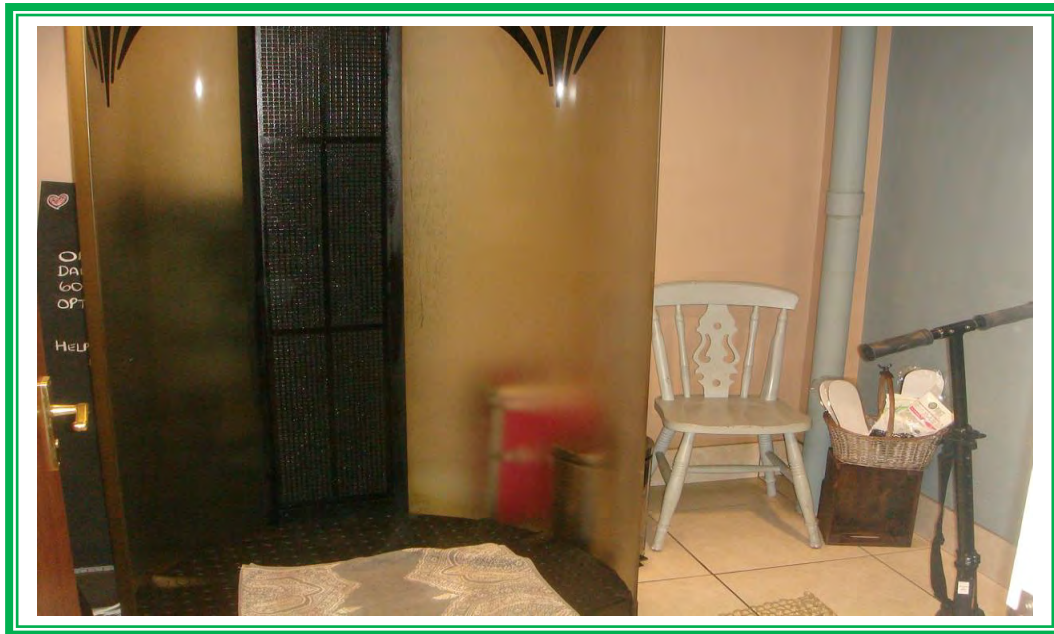
Location: 1/006 Tan Room

Material Description:	Visual Inspection – No Suspect Materials Found	
Identification:	N/A	
Approx. quantity:	N/A	
Accessibility	N/A	Assessment Score
Product type:	N/A	N/A
Extent of Damage:	N/A	N/A
Surface Treatment:	N/A	N/A
Asbestos type:	N/A	N/A
Material Assessment Score:		N/A
Priority Assessment Score:		N/A
Action:	N/A	
Comments:	N/A

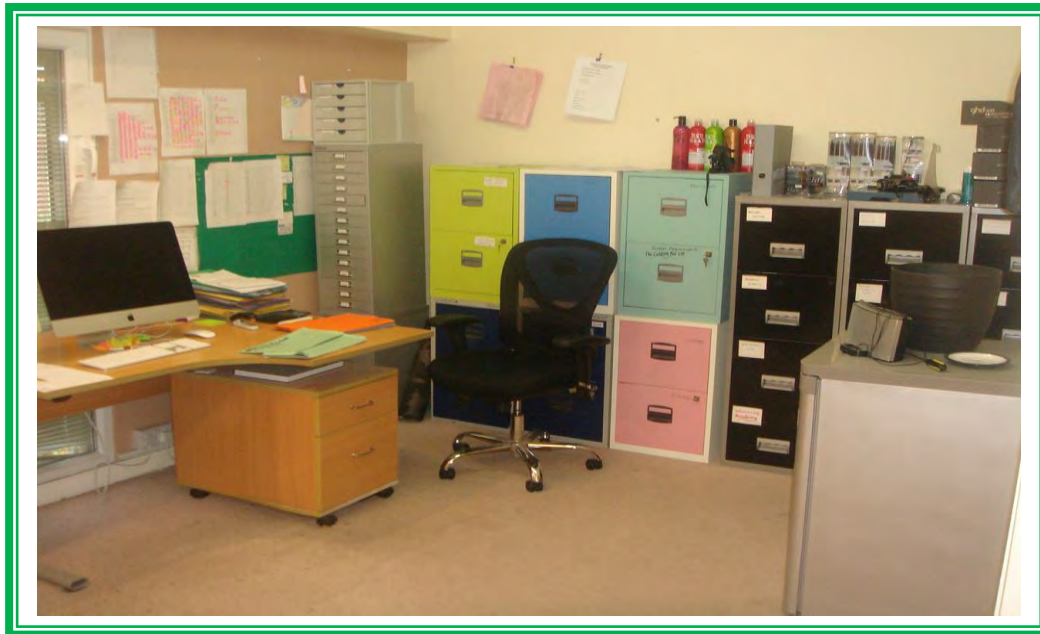
Location: 1/007 Office

Material Description:	Visual Inspection – No Suspect Materials Found	
Identification:	N/A	
Approx. quantity:	N/A	
Accessibility	N/A	Assessment Score
Product type:	N/A	N/A
Extent of Damage:	N/A	N/A
Surface Treatment:	N/A	N/A
Asbestos type:	N/A	N/A
Material Assessment Score:		N/A
Priority Assessment Score:		N/A
Action:	N/A	
Comments:	N/A

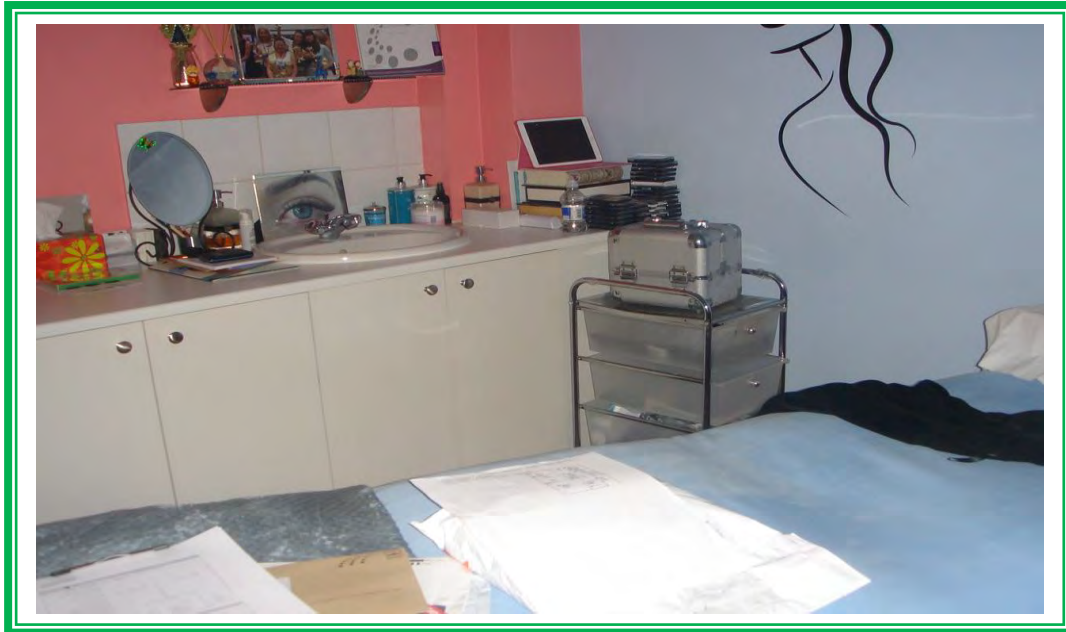
Location: 1/011 Treatment Room

Material Description:	Visual Inspection – No Suspect Materials Found	
Identification:	N/A	
Approx. quantity:	N/A	
Accessibility	N/A	Assessment Score
Product type:	N/A	N/A
Extent of Damage:	N/A	N/A
Surface Treatment:	N/A	N/A
Asbestos type:	N/A	N/A
Material Assessment Score:		N/A
Priority Assessment Score:		N/A
Action:	N/A	
Comments:	N/A

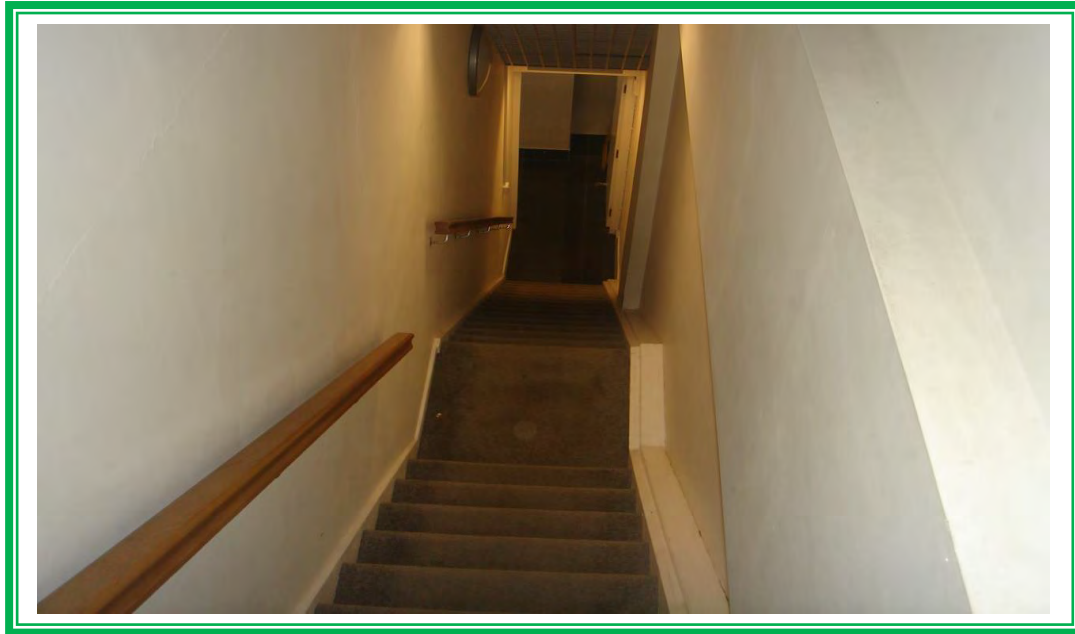
Location: 1/012 Stairs

Material Description:	Visual Inspection – No Suspect Materials Found	
Identification:	N/A	
Approx. quantity:	N/A	
Accessibility	N/A	Assessment Score
Product type:	N/A	N/A
Extent of Damage:	N/A	N/A
Surface Treatment:	N/A	N/A
Asbestos type:	N/A	N/A
Material Assessment Score:		N/A
Priority Assessment Score:		N/A
Action:	N/A	
Comments:	N/A

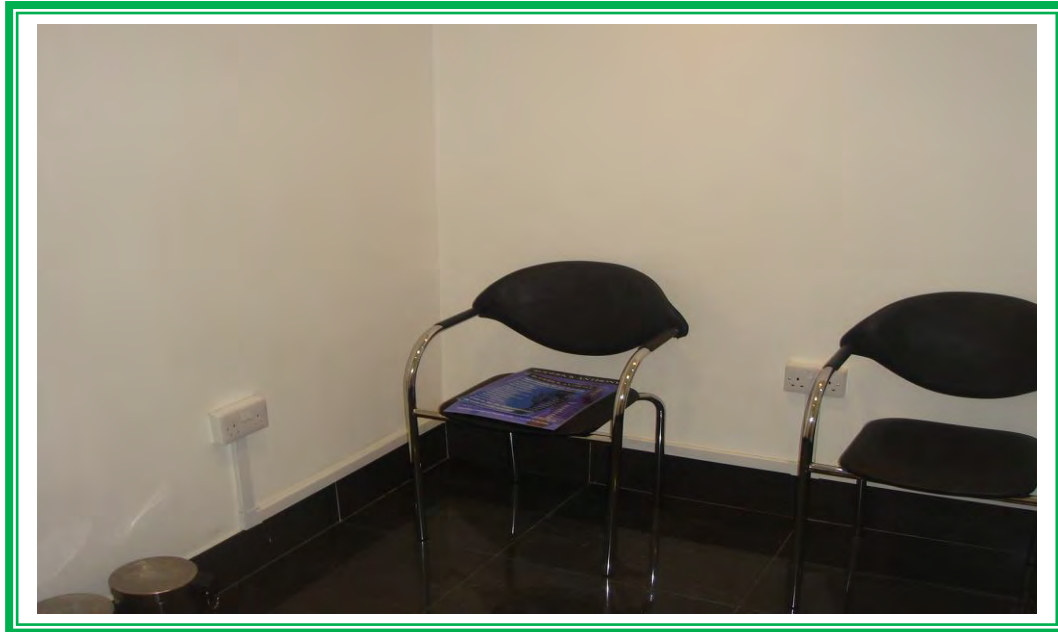
Location: 0/003 Treatment Room

Material Description:	Visual Inspection – No Suspect Materials Found	
Identification:	N/A	
Approx. quantity:	N/A	
Accessibility	N/A	Assessment Score
Product type:	N/A	N/A
Extent of Damage:	N/A	N/A
Surface Treatment:	N/A	N/A
Asbestos type:	N/A	N/A
Material Assessment Score:		N/A
Priority Assessment Score:		N/A
Action:	N/A	
Comments:	N/A

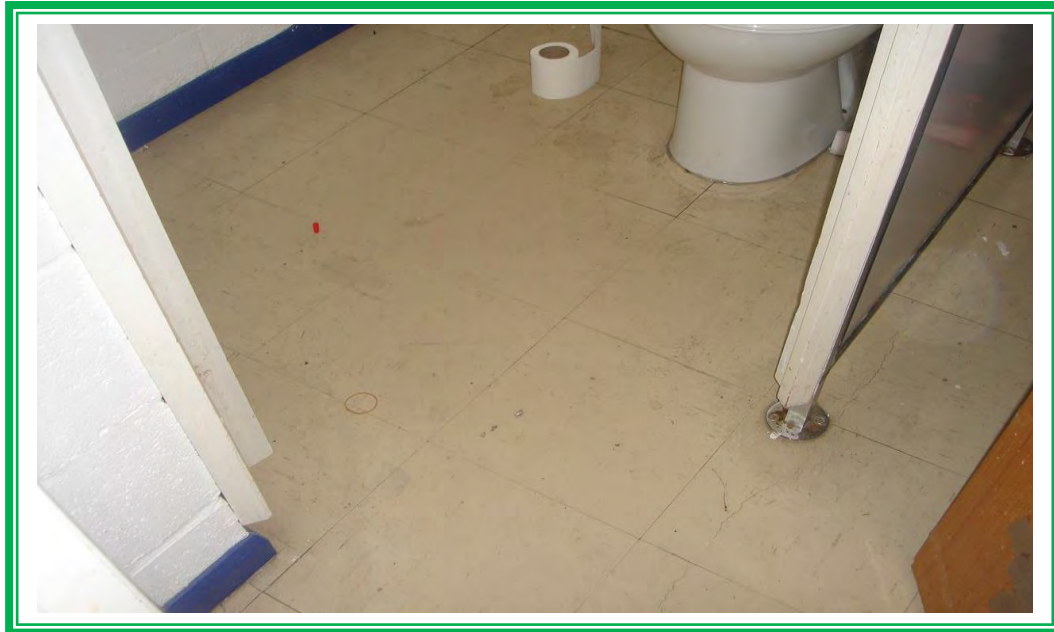
Location: 1/002 WC

Material Description:	Vinyl Floor Tiles	
Identification:	Sampled – No Asbestos Detected	
Approx. quantity:	6M2	
Accessibility	N/A	Assessment Score
Product type:	N/A	N/A
Extent of Damage:	N/A	N/A
Surface Treatment:	N/A	N/A
Asbestos type:	N/A	N/A
Material Assessment Score:		N/A
Priority Assessment Score:		N/A
Action:	N/A	
Comments:	N/A

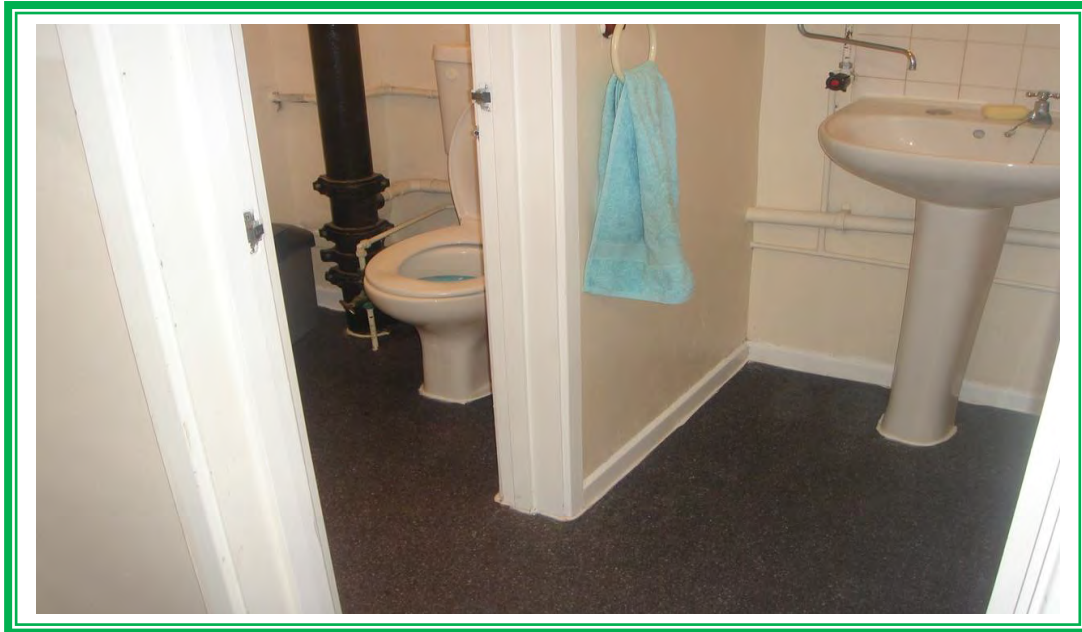
Location: 1/003 WC

Material Description:	Visual Inspection – No Suspect Materials Found	
Identification:	N/A	
Approx. quantity:	N/A	
Accessibility	N/A	Assessment Score
Product type:	N/A	N/A
Extent of Damage:	N/A	N/A
Surface Treatment:	N/A	N/A
Asbestos type:	N/A	N/A
Material Assessment Score:		N/A
Priority Assessment Score:		N/A
Action:	N/A	
Comments:	N/A
