Project Number 3113

Management
Asbestos Survey Report

Kennet Centre, Market Street, Newbury,
Berkshire, RG14 5EN

1-3 The Mall

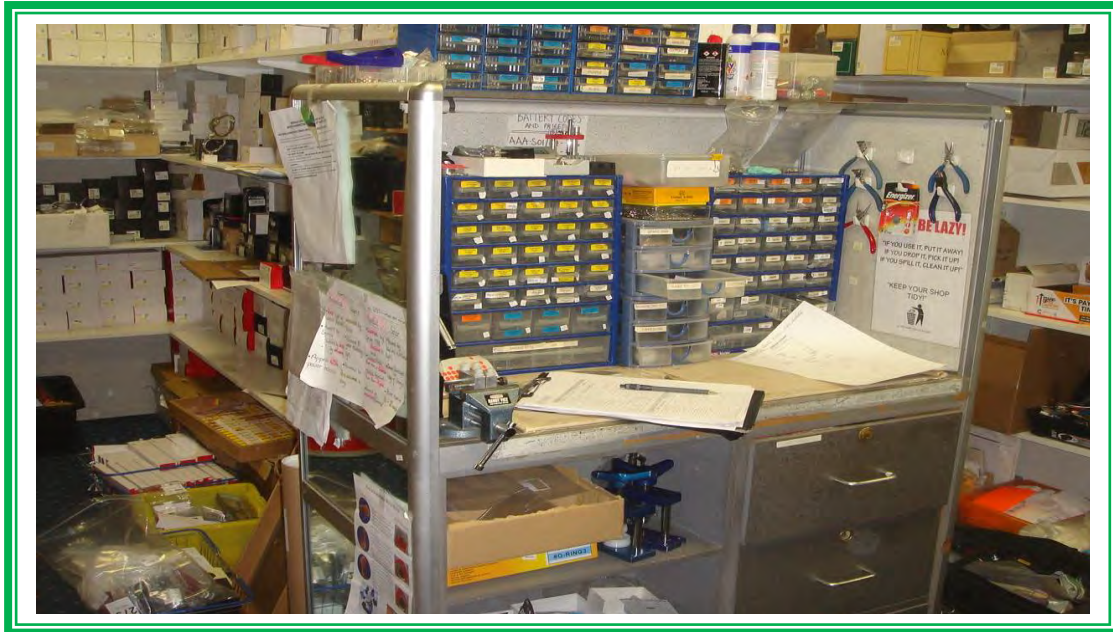
Location: 0/001 Office/Store

Material Description:	Visual Inspection – No Suspect Materials Found	
Identification:	N/A	
Approx. quantity:	N/A	
Accessibility	N/A	Assessment Score
Product type:	N/A	N/A
Extent of Damage:	N/A	N/A
Surface Treatment:	N/A	N/A
Asbestos type:	N/A	N/A
Material Assessment Score:		N/A
Priority Assessment Score:		N/A
Action:	N/A	
Comments:	N/A

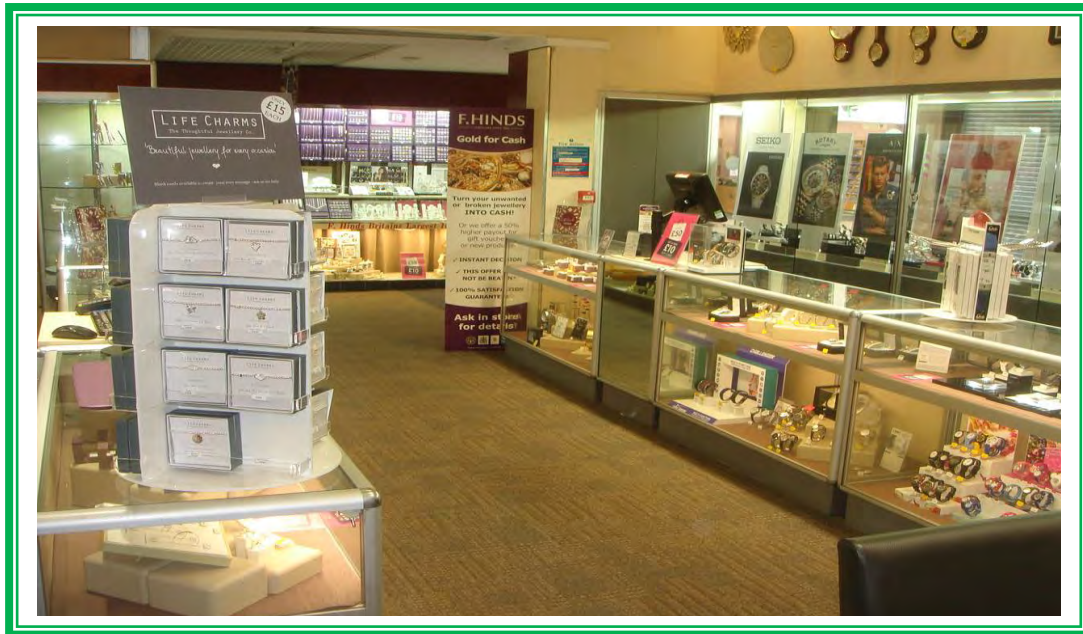
Location: 0/003 Shop Floor

Material Description:	Visual Inspection – No Suspect Materials Found	
Identification:	N/A	
Approx. quantity:	N/A	
Accessibility	N/A	Assessment Score
Product type:	N/A	N/A
Extent of Damage:	N/A	N/A
Surface Treatment:	N/A	N/A
Asbestos type:	N/A	N/A
Material Assessment Score:		N/A
Priority Assessment Score:		N/A
Action:	N/A	
Comments:	N/A

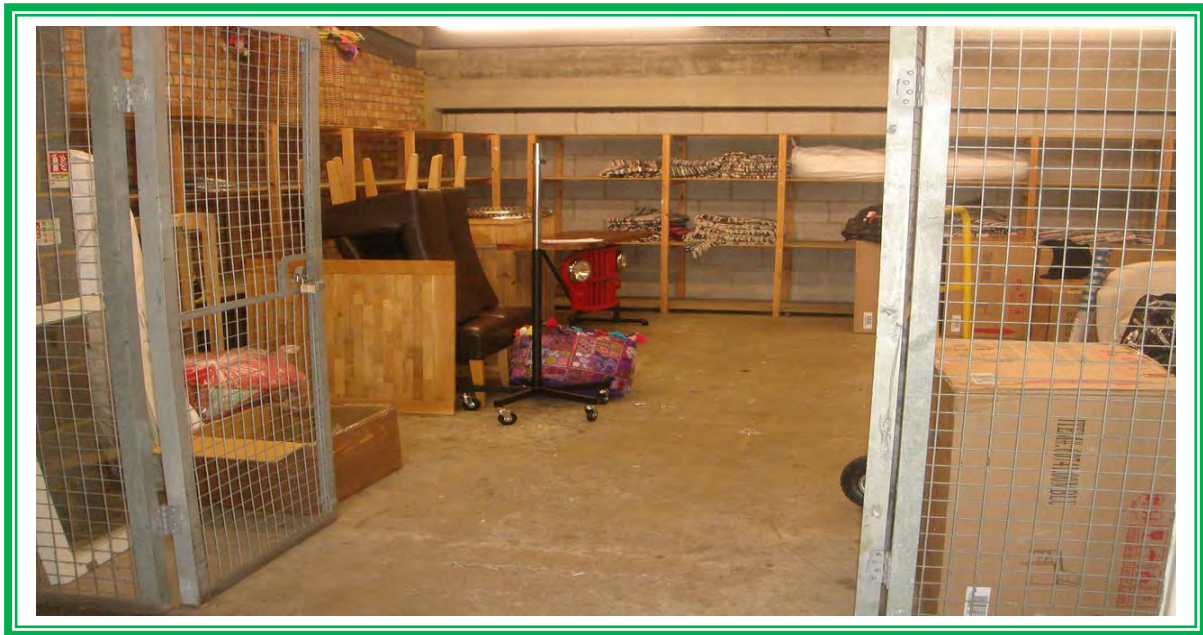
Item No: 1	Sample No: N/A
Location: 1/001 Store

Material Description:	Visual Inspection – No Suspect Materials Found	
Identification:	N/A	
Approx. quantity:	N/A	
Accessibility	N/A	Assessment Score
Product type:	N/A	N/A
Extent of Damage:	N/A	N/A
Surface Treatment:	N/A	N/A
Asbestos type:	N/A	N/A
Material Assessment Score:		N/A
Priority Assessment Score:		N/A
Action:	N/A	
Comments:	N/A

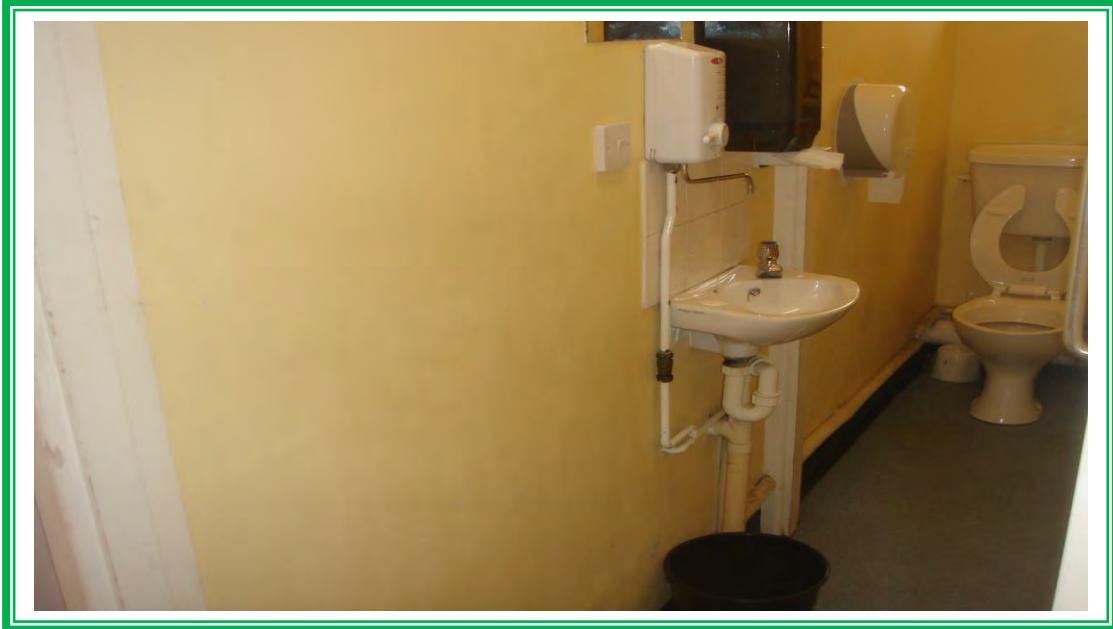
Location: 1/002 WC

Material Description:	Visual Inspection – No Suspect Materials Found	
Identification:	N/A	
Approx. quantity:	N/A	
Accessibility	N/A	Assessment Score
Product type:	N/A	N/A
Extent of Damage:	N/A	N/A
Surface Treatment:	N/A	N/A
Asbestos type:	N/A	N/A
Material Assessment Score:		N/A
Priority Assessment Score:		N/A
Action:	N/A	
Comments:	N/A

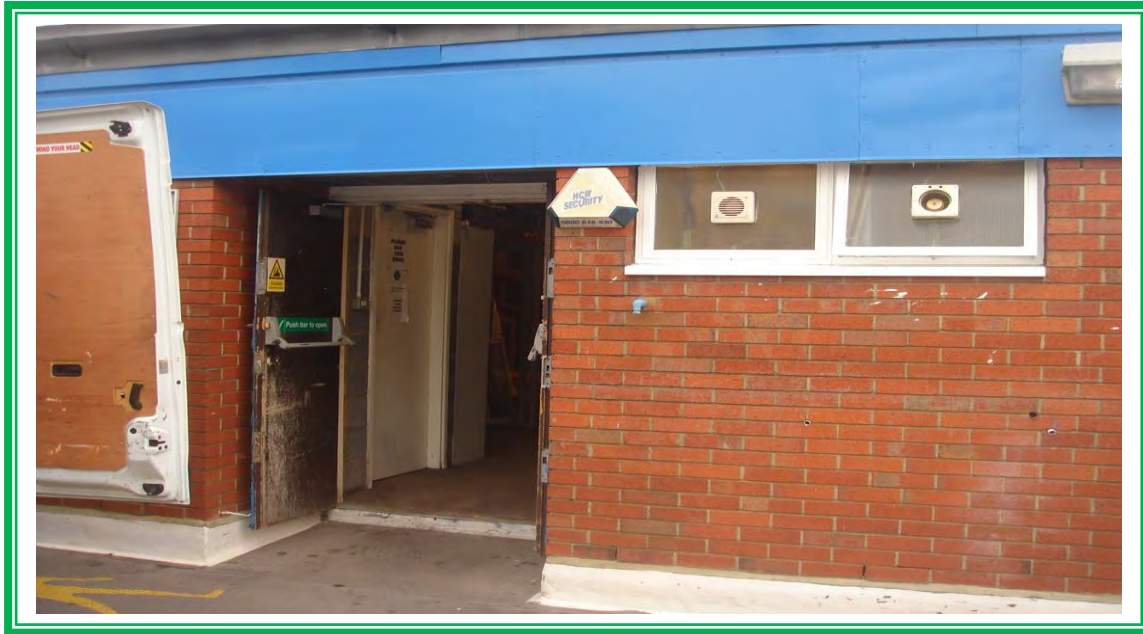
Location: 99/001 External

Material Description:	Visual Inspection – No Suspect Materials Found	
Identification:	N/A	
Approx. quantity:	N/A	
Accessibility	N/A	Assessment Score
Product type:	N/A	N/A
Extent of Damage:	N/A	N/A
Surface Treatment:	N/A	N/A
Asbestos type:	N/A	N/A
Material Assessment Score:		N/A
Priority Assessment Score:		N/A
Action:	N/A	
Comments:	N/A

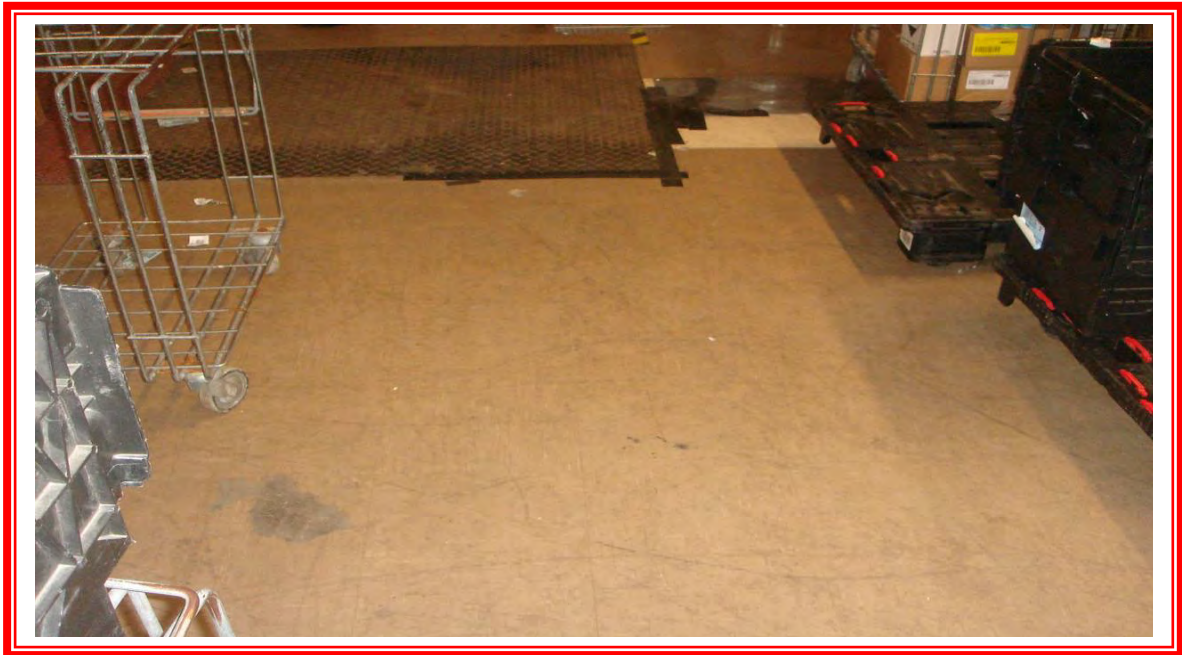
Item No: 1	Sample No: NE/1
Location: 1/001 Store

Material Description:	Vinyl Floor Tiles	
Identification:	Sampled – Asbestos Detected	
Approx. quantity:	50M2	
Accessibility	Low	Assessment Score
Product type:	Vinyl	1
Extent of Damage:	Low	1
Surface Treatment:	Non-Friable	0
Asbestos type:	Chrysotile	1
Material Assessment Score:		3
Priority Assessment Score:		Negligible
Action:	Manage	
Comments:	N/A

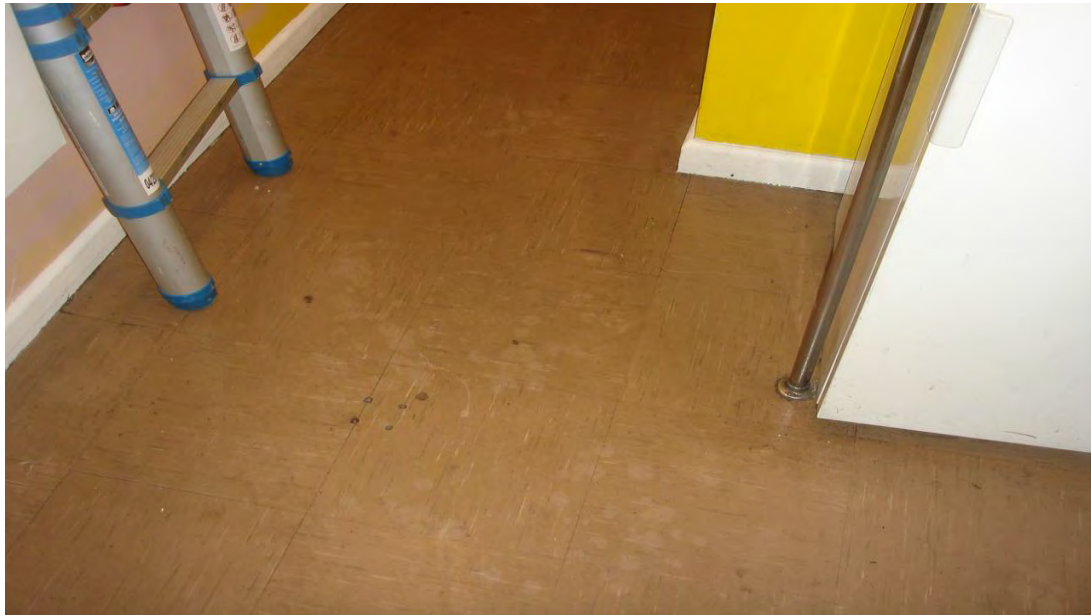
Location: 1/002 Kitchen

Material Description:	Vinyl Floor Tiles	
Identification:	As Per Sample NE/1 – Asbestos Detected	
Approx. quantity:	10M2	
Accessibility	Low	Assessment Score
Product type:	Vinyl	1
Extent of Damage:	Low	1
Surface Treatment:	Non-Friable	0
Asbestos type:	Chrysotile	1
Material Assessment Score:		3
Priority Assessment Score:		Negligible
Action:	Manage	
Comments:	N/A

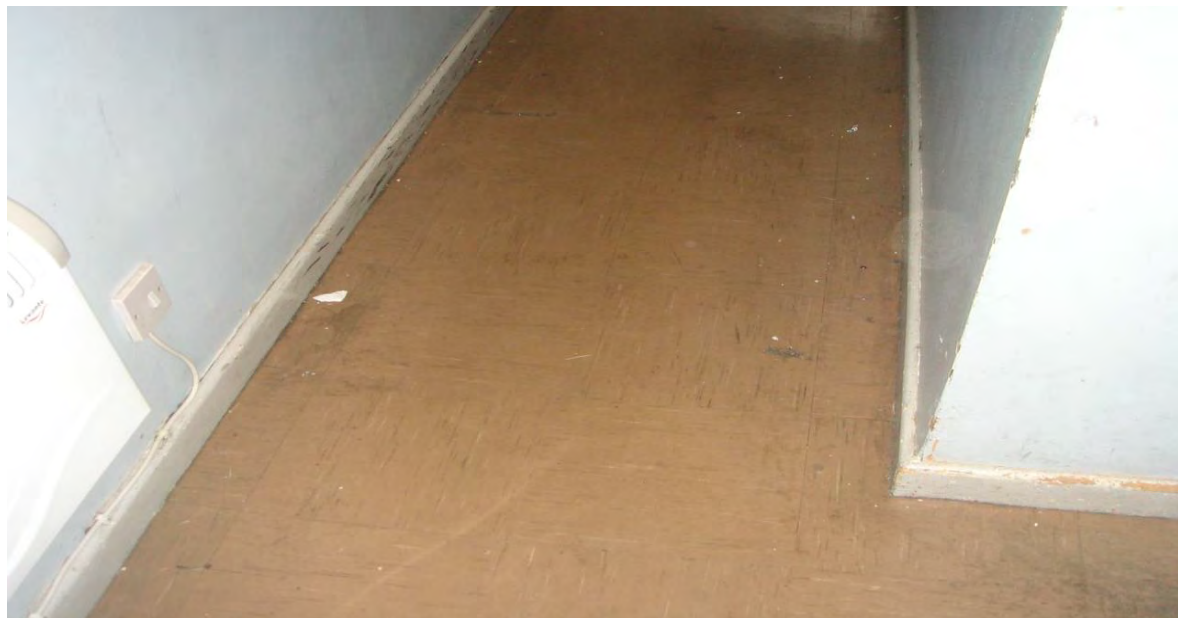
Location: 1/005 Office

Material Description:	Vinyl Floor Tiles	
Identification:	Sampled – Asbestos Detected	
Approx. quantity:	6M2	
Accessibility	Low	Assessment Score
Product type:	Vinyl	1
Extent of Damage:	Low	1
Surface Treatment:	Non-Friable	0
Asbestos type:	Chrysotile	1
Material Assessment Score:		3
Priority Assessment Score:		Negligible
Action:	Manage	
Comments:	N/A

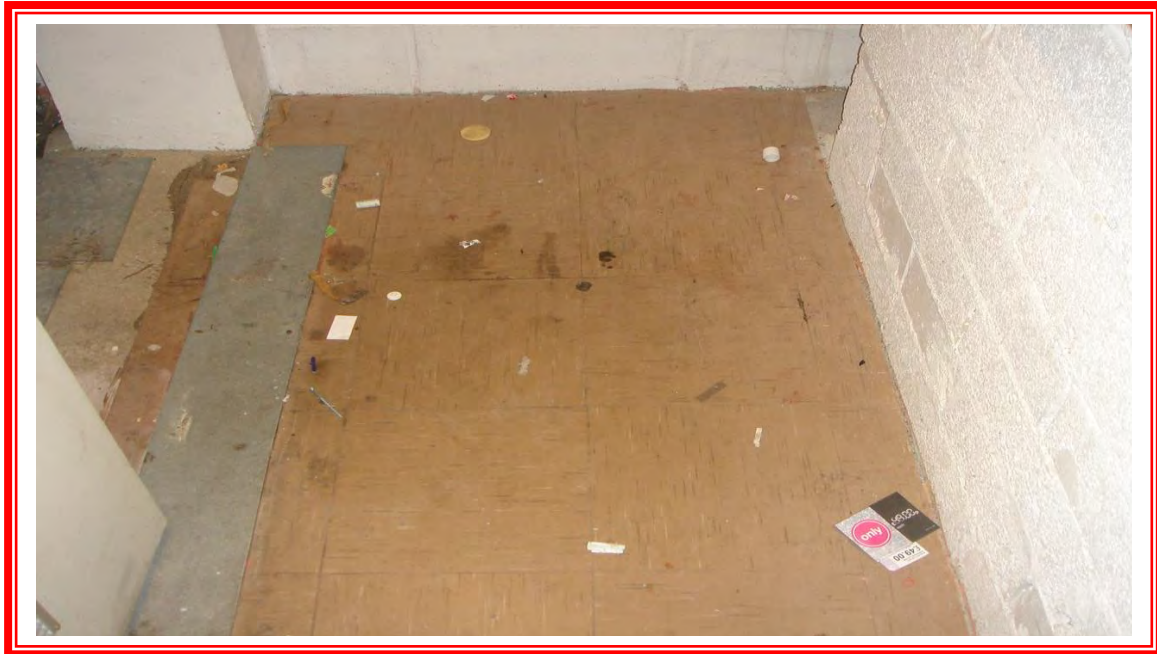
Location: 1/008 Store

Material Description:	Vinyl Floor Tiles	
Identification:	As Per Sample NE/2 – Asbestos Detected	
Approx. quantity:	2M2	
Accessibility	Low	Assessment Score
Product type:	Vinyl	1
Extent of Damage:	Low	1
Surface Treatment:	Non-Friable	0
Asbestos type:	Chrysotile	1
Material Assessment Score:		3
Priority Assessment Score:		Negligible
Action:	Manage	
Comments:	N/A

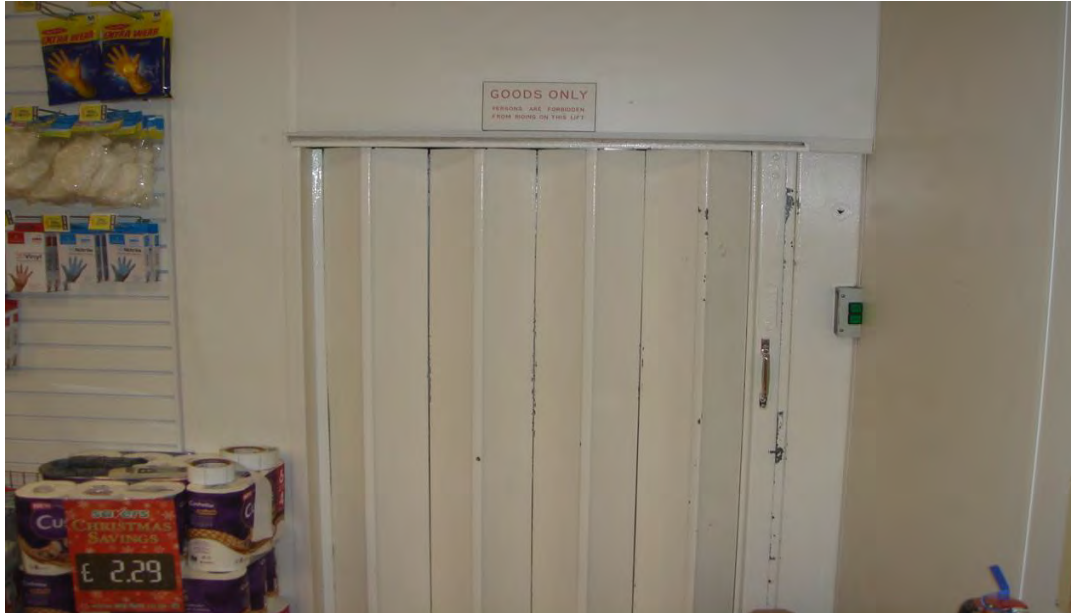
Location: 0/002 Lift and Shaft

Material Description:	No Access	
Identification:	Presumed to Contain Asbestos	
Approx. quantity:	Unknown	
Accessibility	Low	Assessment Score
Product type:	No Access	3
Extent of Damage:	No Access	3
Surface Treatment:	No Access	3
Asbestos type:	No Access	3
Material Assessment Score:		12
Priority Assessment Score:		High
Action:	Further Investigation Required	
Comments:	No access as no lift engineer was onsite

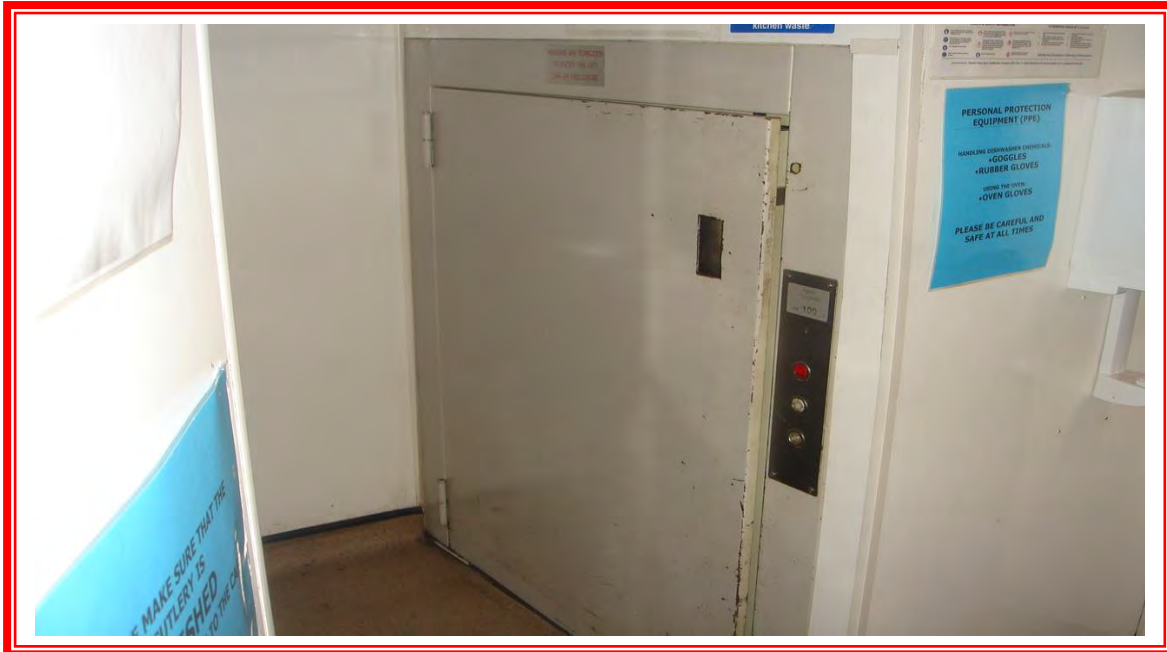
Location: 0/005 Lift and Shaft

Material Description:	No Access	
Identification:	Presumed to Contain Asbestos	
Approx. quantity:	Lift and Lift Shaft	
Accessibility	Low	Assessment Score
Product type:	No Access	3
Extent of Damage:	No Access	3
Surface Treatment:	No Access	3
Asbestos type:	No Access	3
Material Assessment Score:		12
Priority Assessment Score:		High
Action:	Further Inspection Required	
Comments:	Unable to gain access as no lift engineer was onsite

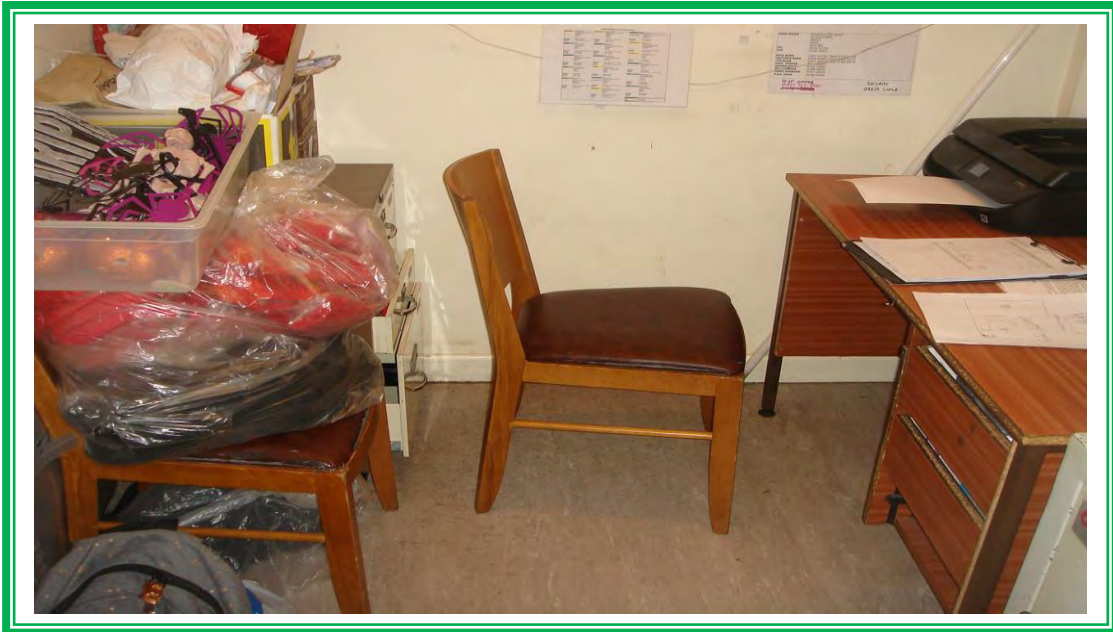
Location: 0/003 Office

Material Description:	Visual Inspection – No Suspect Materials Found	
Identification:	N/A	
Approx. quantity:	N/A	
Accessibility	N/A	Assessment Score
Product type:	N/A	N/A
Extent of Damage:	N/A	N/A
Surface Treatment:	N/A	N/A
Asbestos type:	N/A	N/A
Material Assessment Score:		N/A
Priority Assessment Score:		N/A
Action:	N/A	
Comments:	N/A

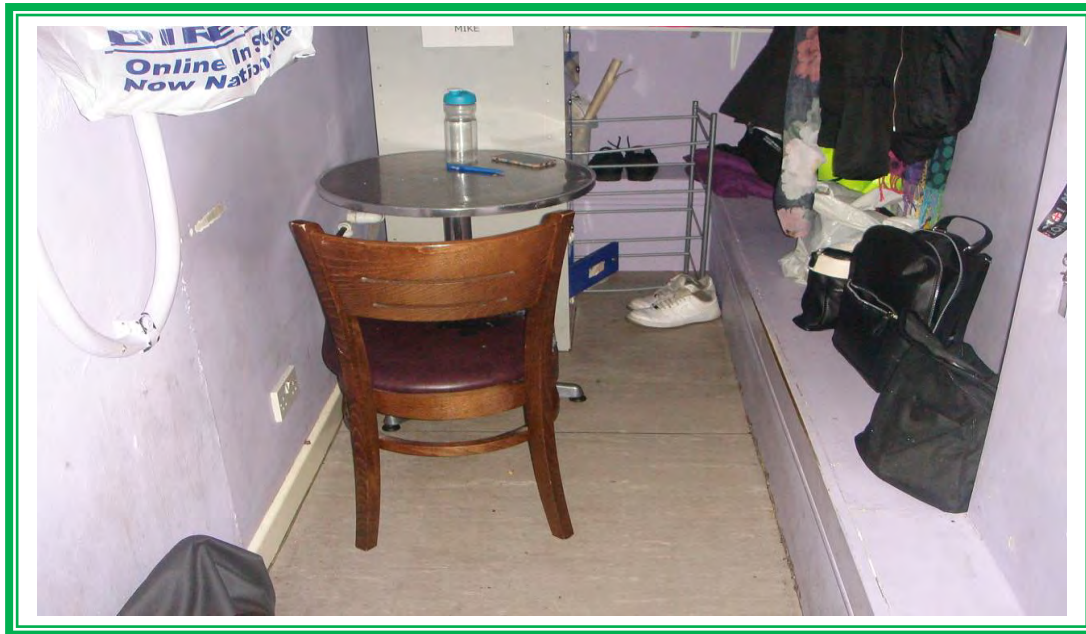
Location: 0/004 Cupboard

Material Description:	Visual Inspection – No Suspect Materials Found	
Identification:	N/A	
Approx. quantity:	N/A	
Accessibility	N/A	Assessment Score
Product type:	N/A	N/A
Extent of Damage:	N/A	N/A
Surface Treatment:	N/A	N/A
Asbestos type:	N/A	N/A
Material Assessment Score:		N/A
Priority Assessment Score:		N/A
Action:	N/A	
Comments:	N/A

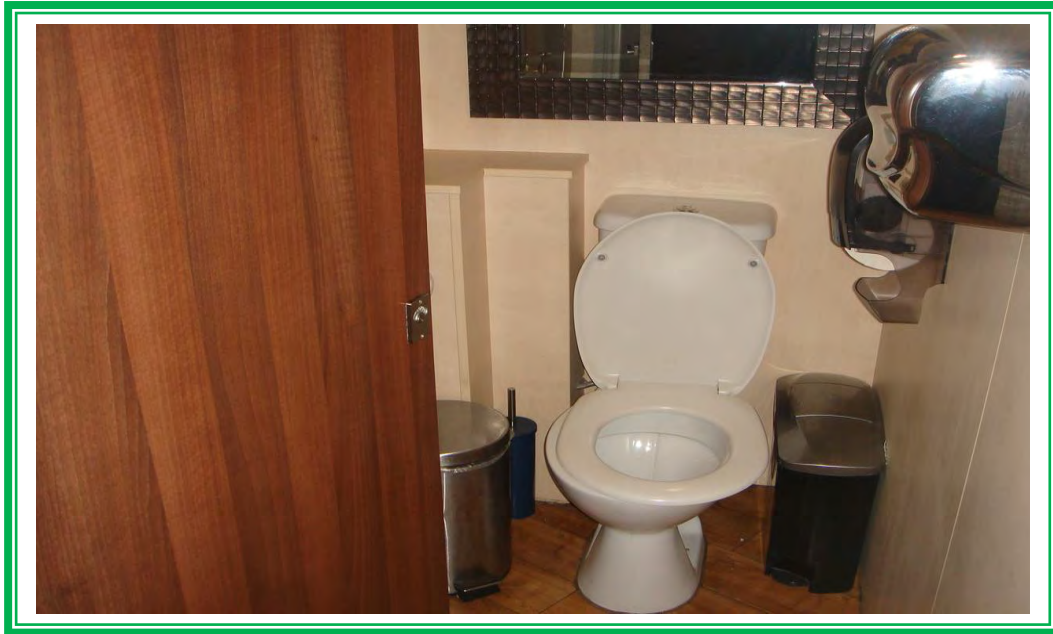
Location: 0/007 WC

Material Description:	Visual Inspection – No Suspect Materials Found	
Identification:	N/A	
Approx. quantity:	N/A	
Accessibility	N/A	Assessment Score
Product type:	N/A	N/A
Extent of Damage:	N/A	N/A
Surface Treatment:	N/A	N/A
Asbestos type:	N/A	N/A
Material Assessment Score:		N/A
Priority Assessment Score:		N/A
Action:	N/A	
Comments:	N/A

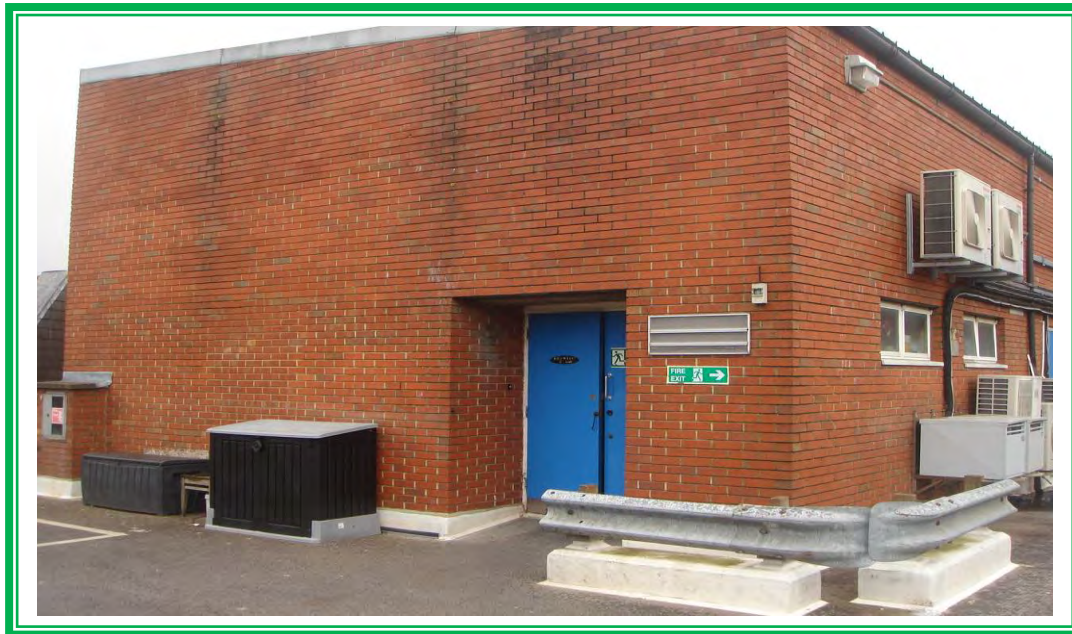
Location: 99/001 External

Material Description:	Visual Inspection – No Suspect Materials Found	
Identification:	N/A	
Approx. quantity:	N/A	
Accessibility	N/A	Assessment Score
Product type:	N/A	N/A
Extent of Damage:	N/A	N/A
Surface Treatment:	N/A	N/A
Asbestos type:	N/A	N/A
Material Assessment Score:		N/A
Priority Assessment Score:		N/A
Action:	N/A	
Comments:	N/A

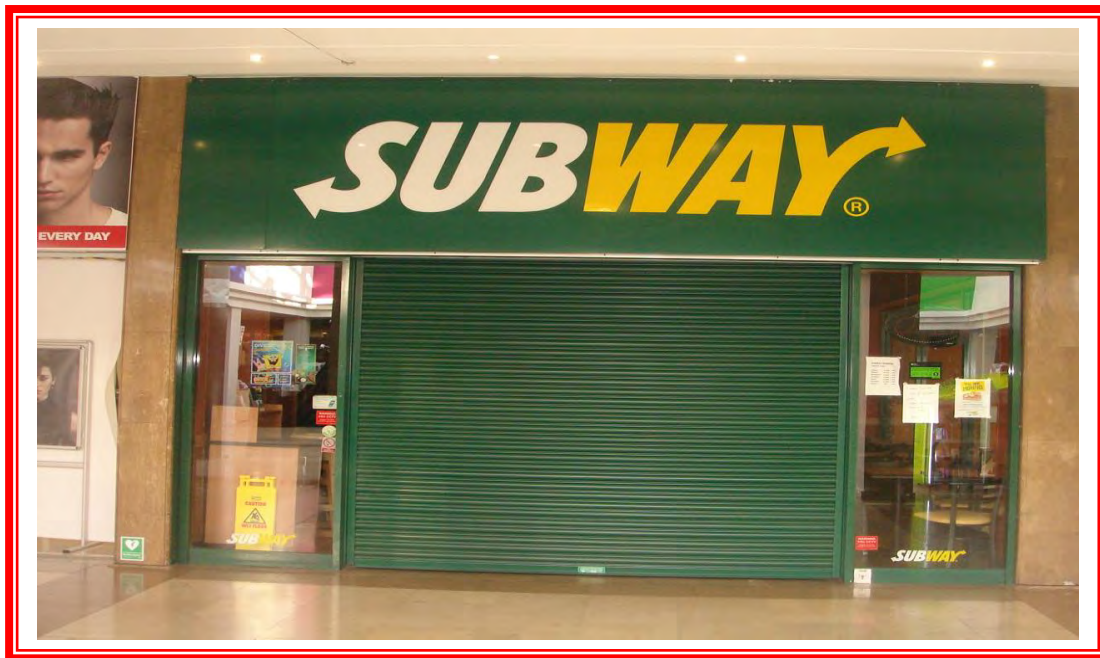
Location: 20 The Mall

Material Description:	No Access	
Identification:	Presumed to Contain Asbestos	
Approx. quantity:	Unknown	
Accessibility	Low	Assessment Score
Product type:	No Access	3
Extent of Damage:	No Access	3
Surface Treatment:	No Access	3
Asbestos type:	No Access	3
Material Assessment Score:		12
Priority Assessment Score:		High
Action:	Further Inspection Required	
Comments:	No Access as still in lease but vacant – No Keys (The Vacant Nightclub)

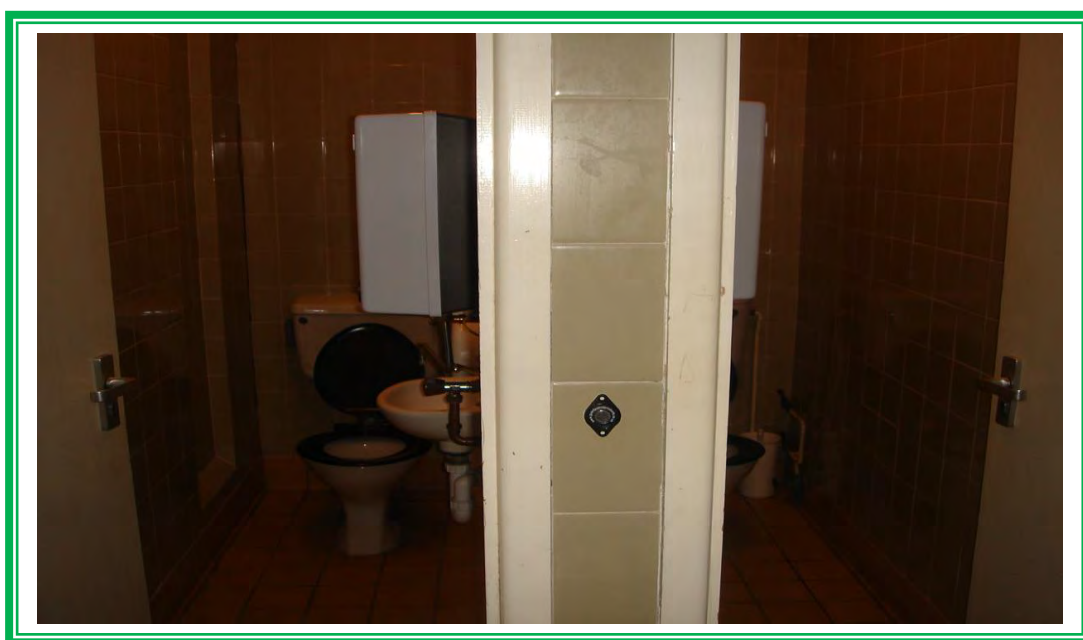
Item No: 1	Sample No: N/A
Location: 0/001 WC

Material Description:	Visual Inspection – No Suspect Materials Found	
Identification:	N/A	
Approx. quantity:	N/A	
Accessibility	N/A	Assessment Score
Product type:	N/A	N/A
Extent of Damage:	N/A	N/A
Surface Treatment:	N/A	N/A
Asbestos type:	N/A	N/A
Material Assessment Score:		N/A
Priority Assessment Score:		N/A
Action:	N/A	
Comments:	N/A
